Geotechnical Completion Report

HITCHEN BLOCK STAGES 6E AND 10A TO 10D

DFH JOINT VENTURE LIMITED

16 December 2020

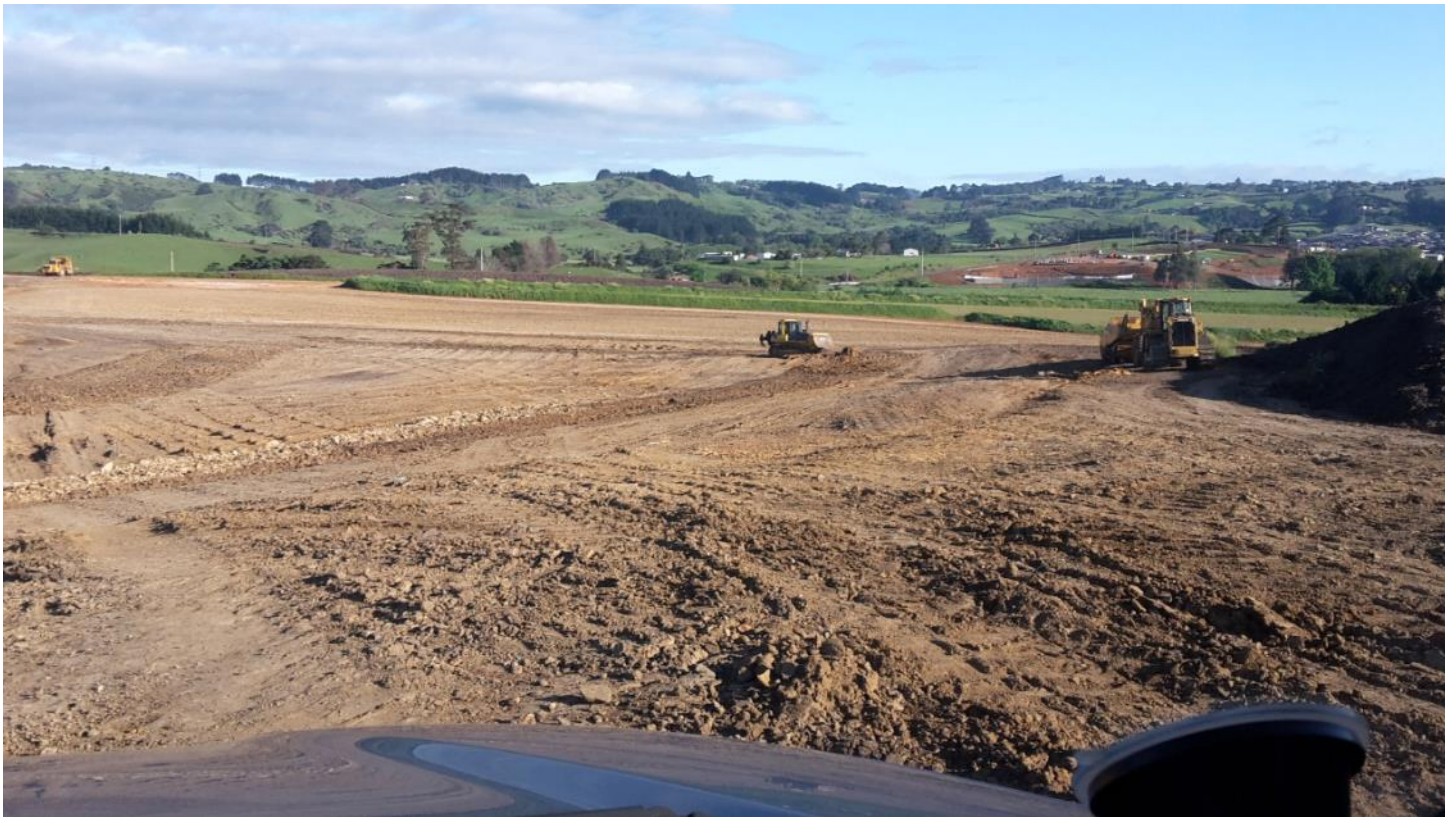
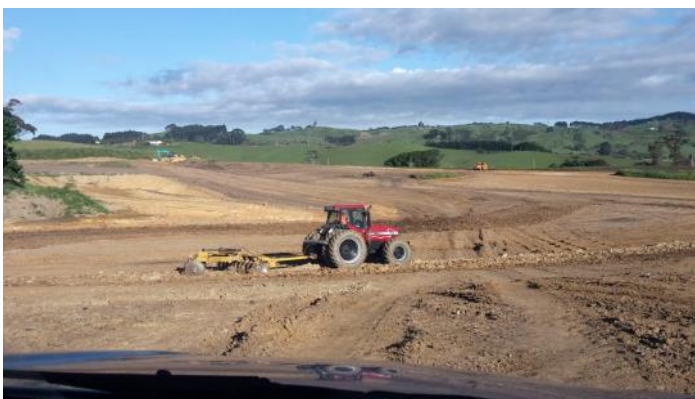
Courtesy visit of site. Observed that topsoil is being stripped from proposed fill areas for this season and fill materials are being conditioned in the centre of the site to dry them out. Bulk works will be starting this week and Mike is to go out to observe topsoil stripping from first areas tomorrow morning.

Conditioning materials

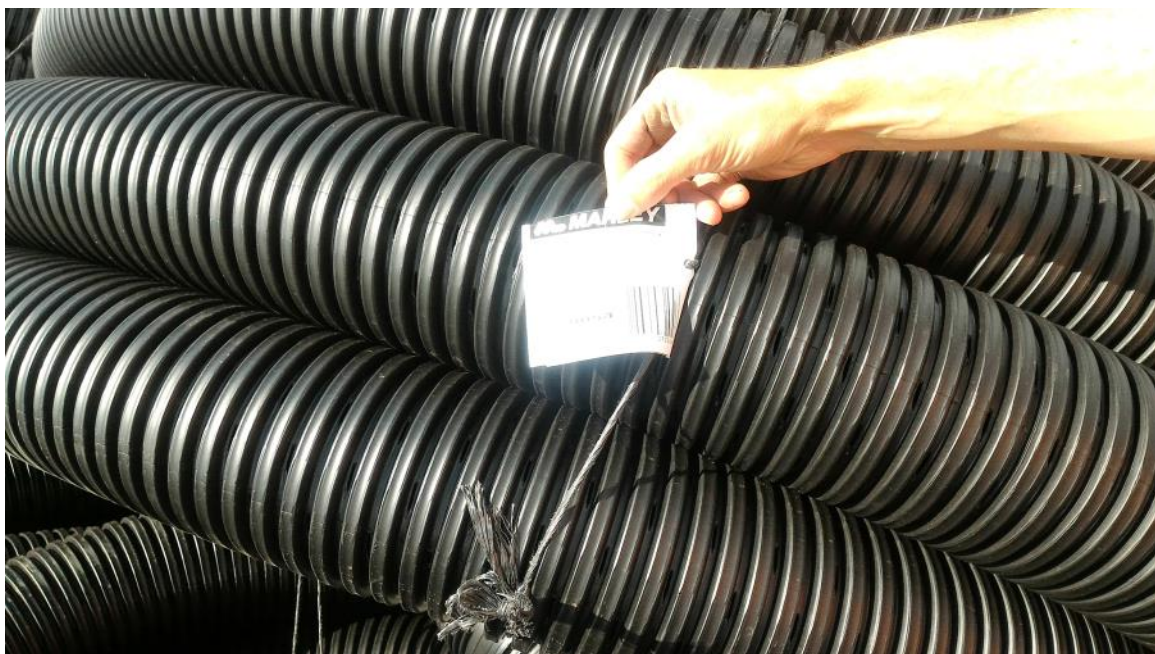
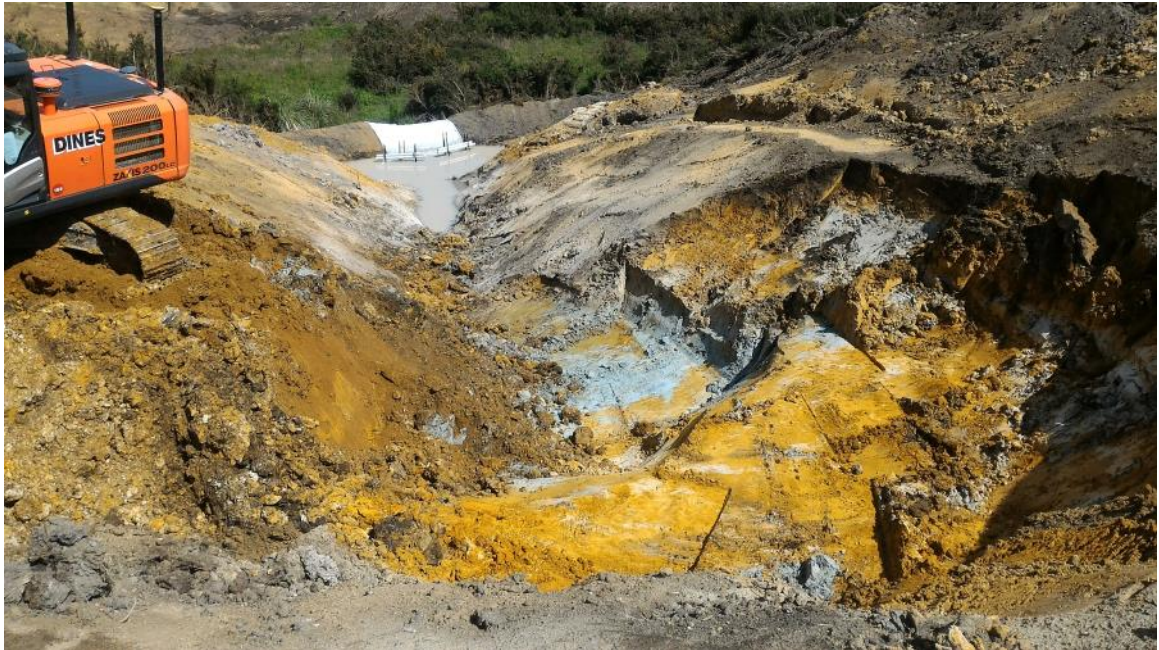
Fill O Gully

Fill F Gully has been mucked out and shear strengths in the base were all over 80kPa, we are satisfied this is undercut down to competent ground. Discussed underfills in the main gully of fill F. Several springs will need to be tapped with novaflos in trenches and run down the invert of the gullies.

Gullies at Fill O and Fill N were being mucked out and looked to be into inorganic materials, however the rain over the last couple of days has caused minor slips. Will test these gullies on Friday.

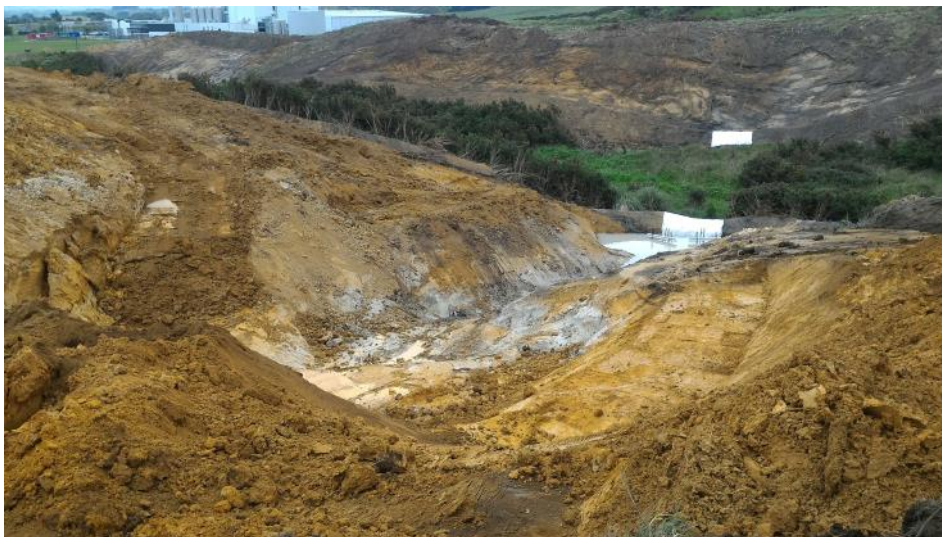
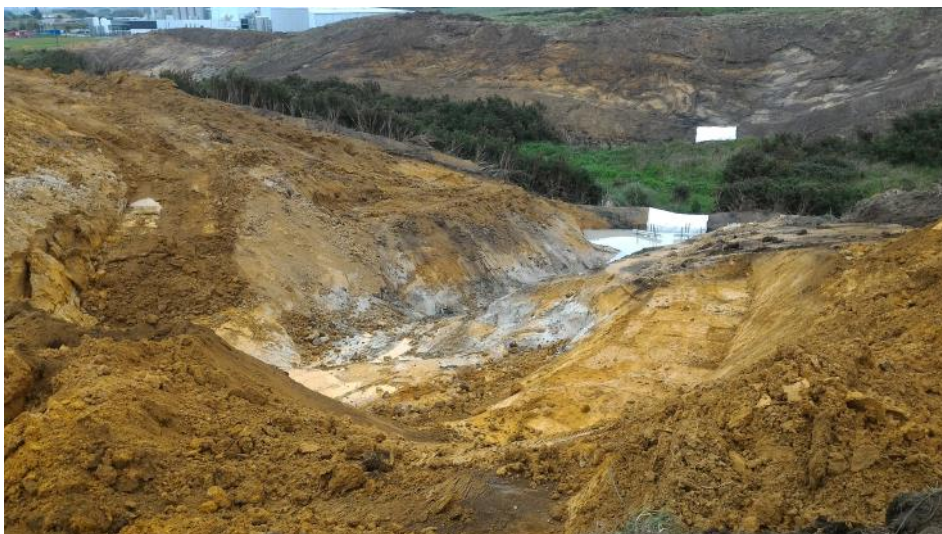
Underfills were installed as per our recommendations. However, in Fill R, they could not continue as the waterlevel in the invert of the gully was too high to place the gravel. In Fill F, the contaminated area had not been backfilled with hardfill yet so they couldn't extend the drain coil across the pit.

Fill O gully had been mucked out again and had been benched on the western side, however they are yet to bench it on the eastern side.

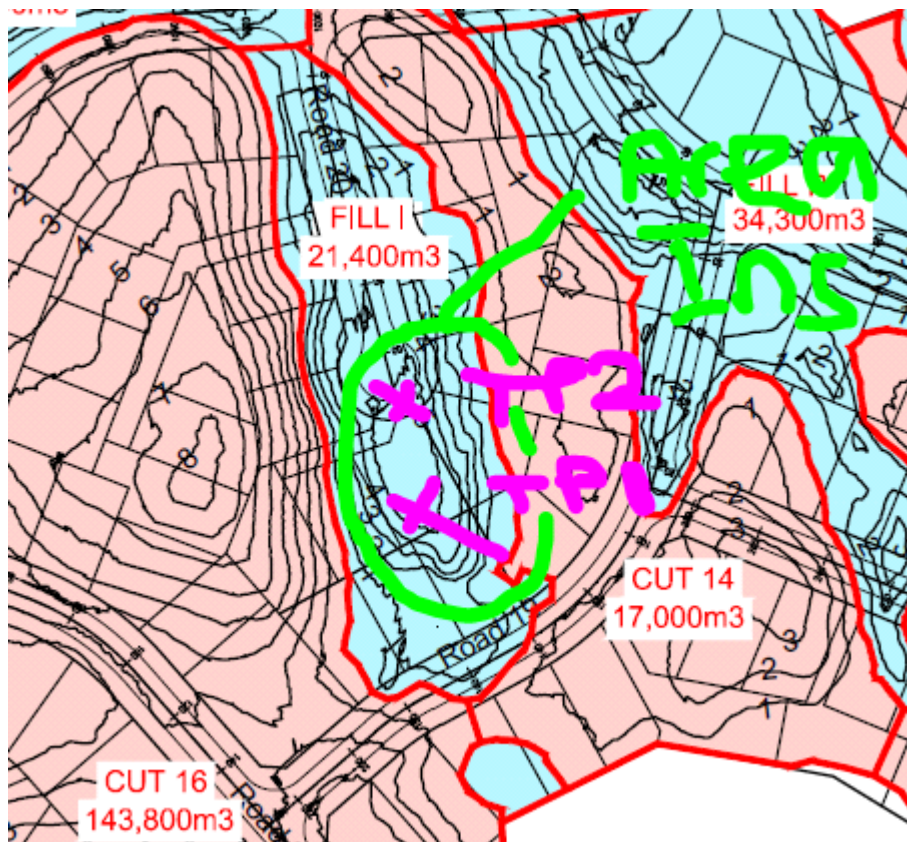
Noted that the upper portion of fill I gully contains an approx. 25m wide by 100m long area of very soft material (ie. very hard to walk on).

Dug two trial pits through the material, which confirmed that it comprised of saturated pumiceous clayey silt with shears around 10kPa to 15kPa. The depth of the material is unknown as could only dig to between 2 and 2.8m due to pit cave in. Appears that this material will need to be undercut, but will check with Shane to check if any other options (ie. settlement monitoring before instructing Dines. Fill over this area is around 3 to 5m.

TP 1 - shit stuff to at least 2m

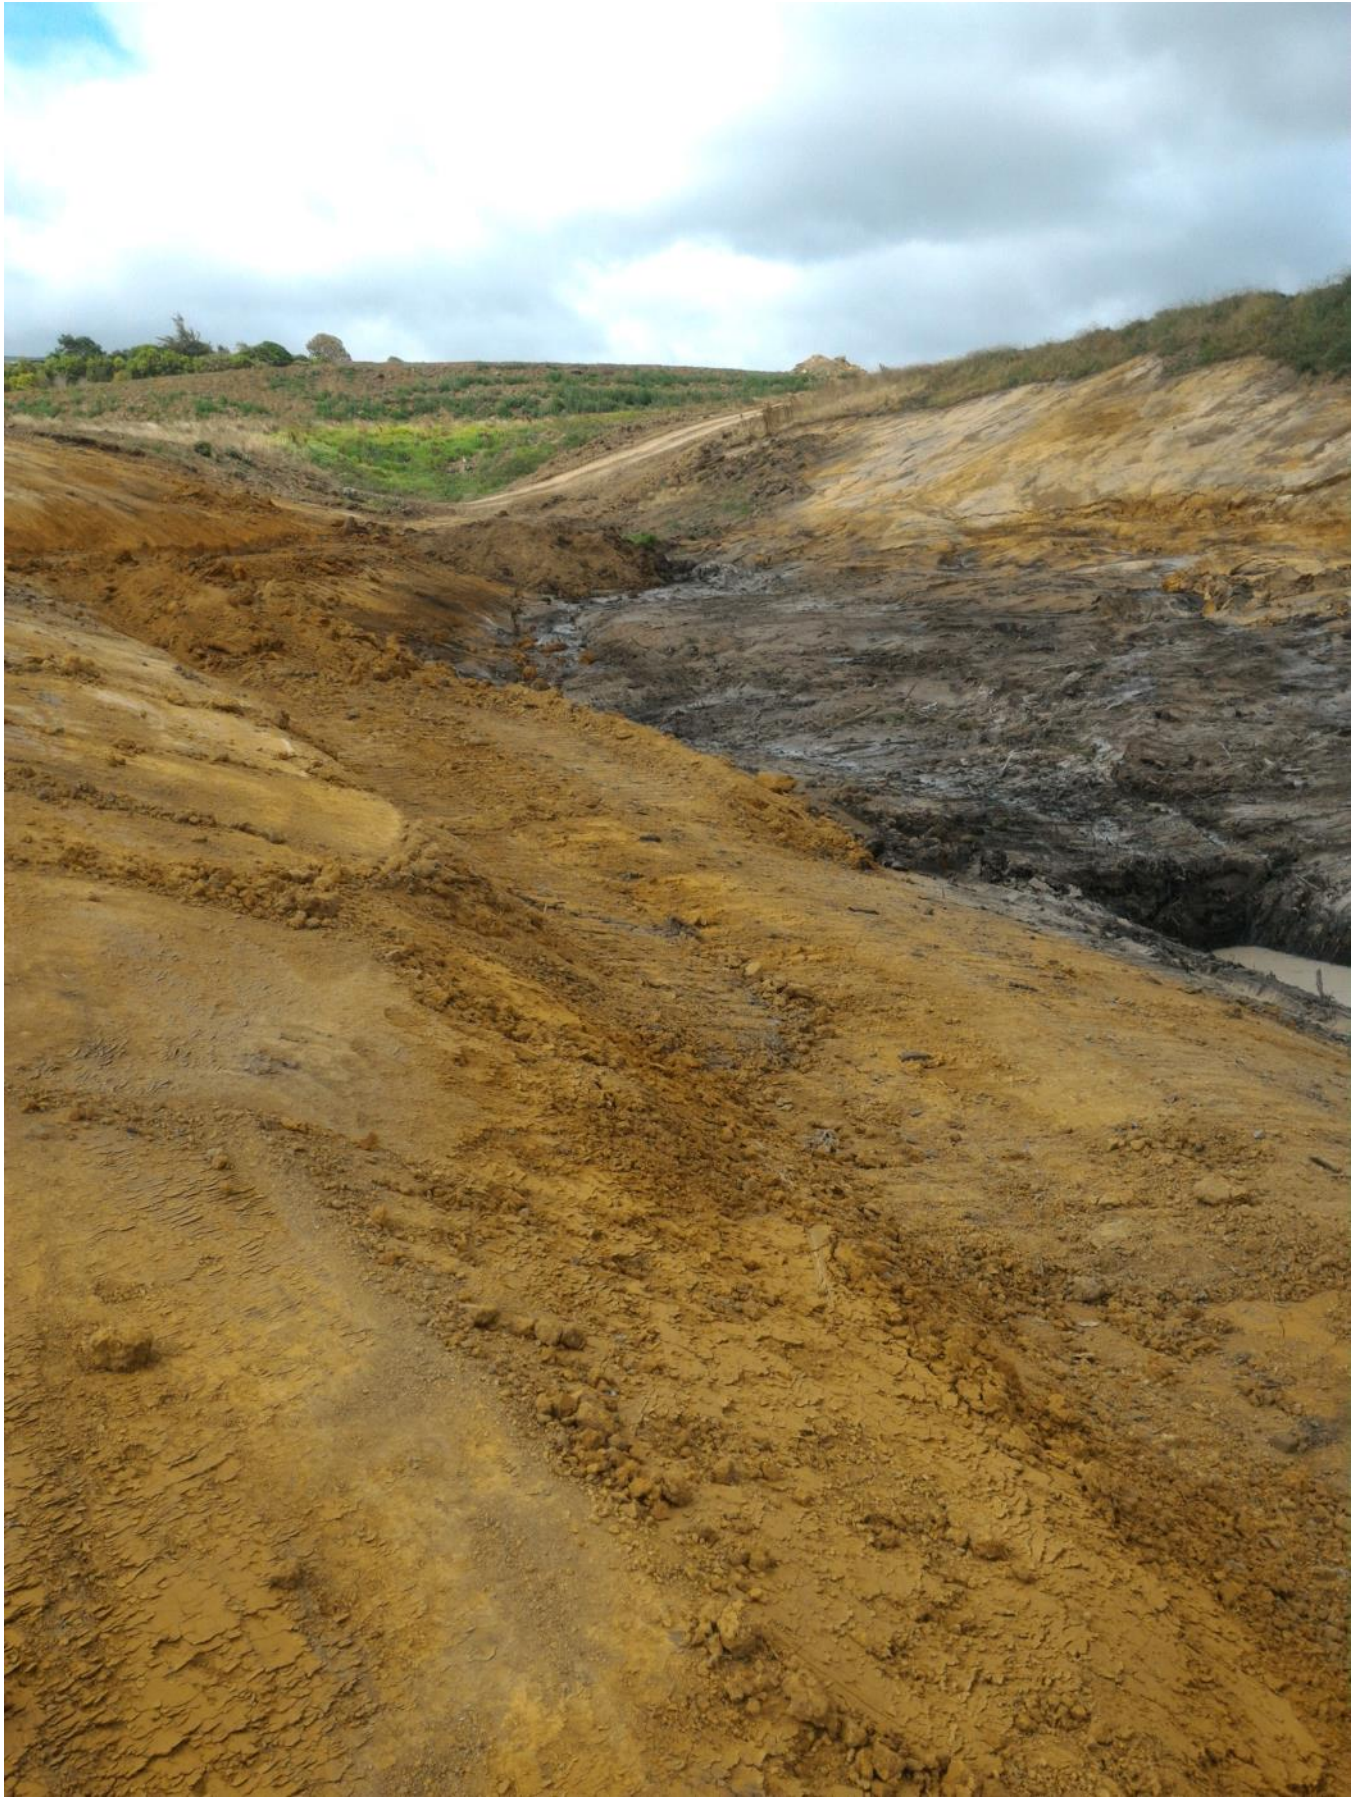
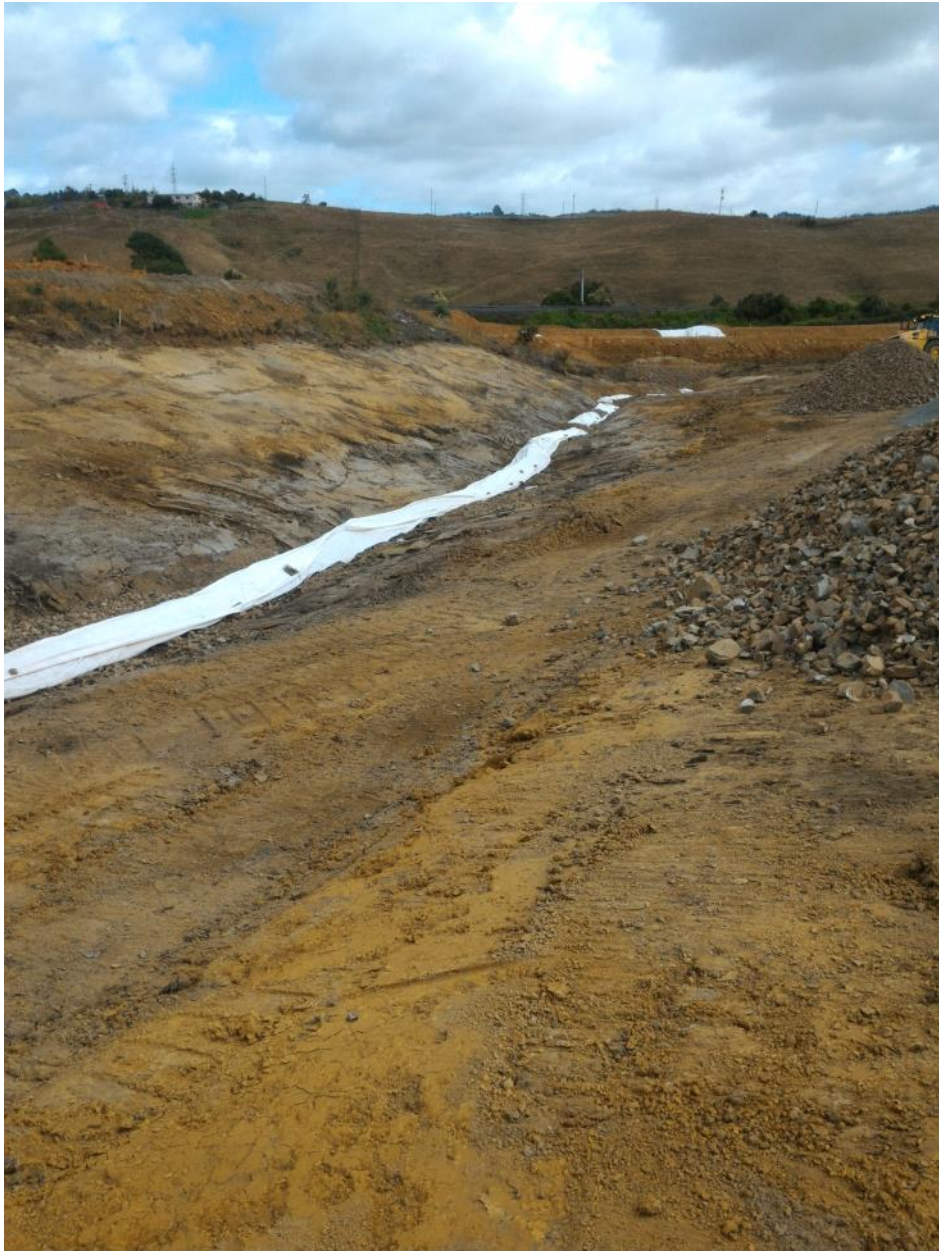
Visited site at request of Trevor Moir to observe underfill drainage placement in Gully I and P. Gully P

Underfills have been installed as per our recommendations, up to the soft spot in Gully P.

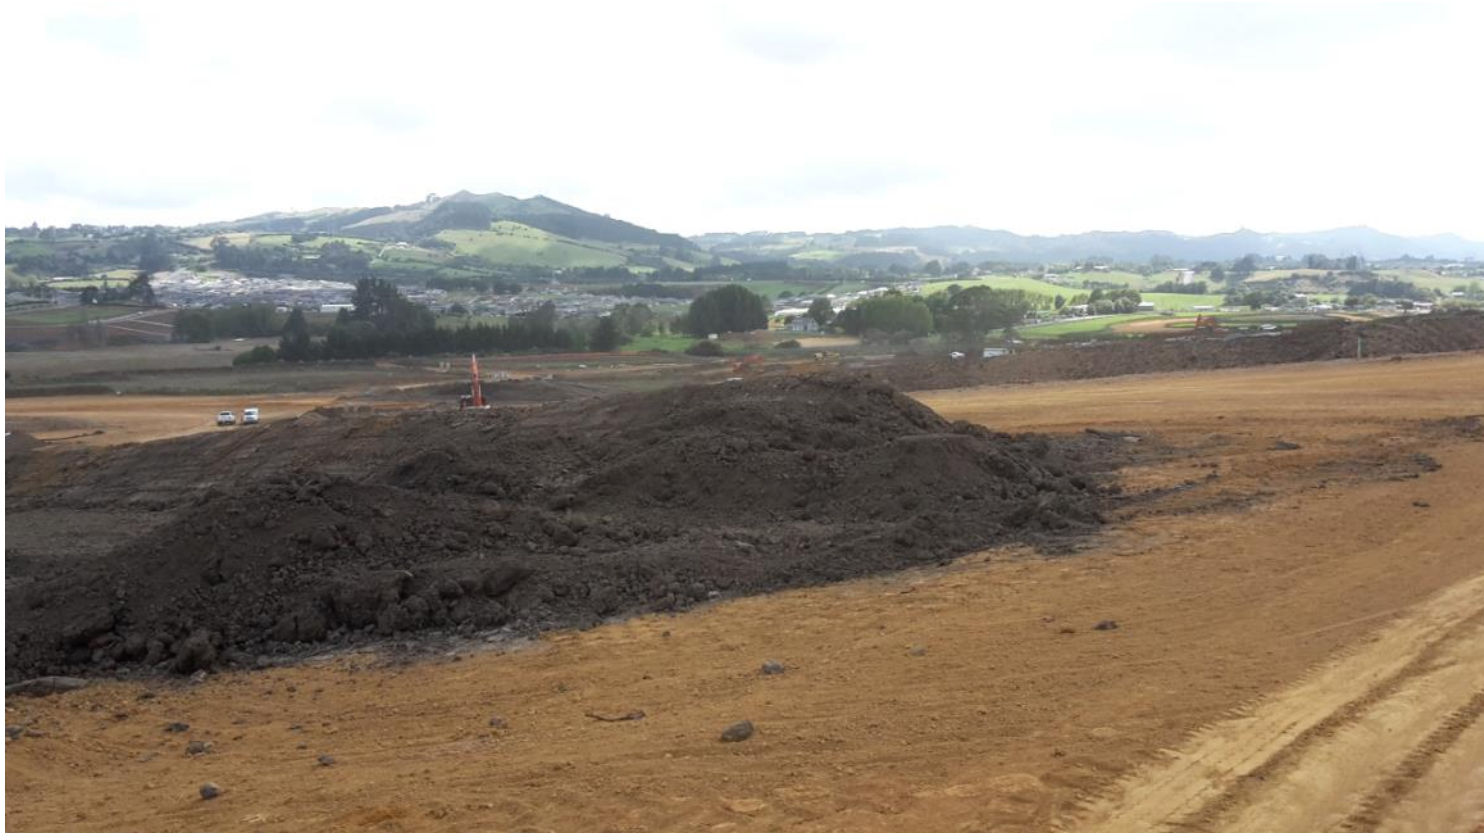
The clay fill appears to be going down well across the lower reaches of these gullies, with shear strengths all over 140kPa.

An area on the ridgeline is pumping (likely due to groundwater pressures) and a trial pit investigation is planned for next Monday. Possible that this area should be undercut and tapped with a drain coil and wrapped drainage media, running into the underfill in Fill I, then backfilled with compacted clay.

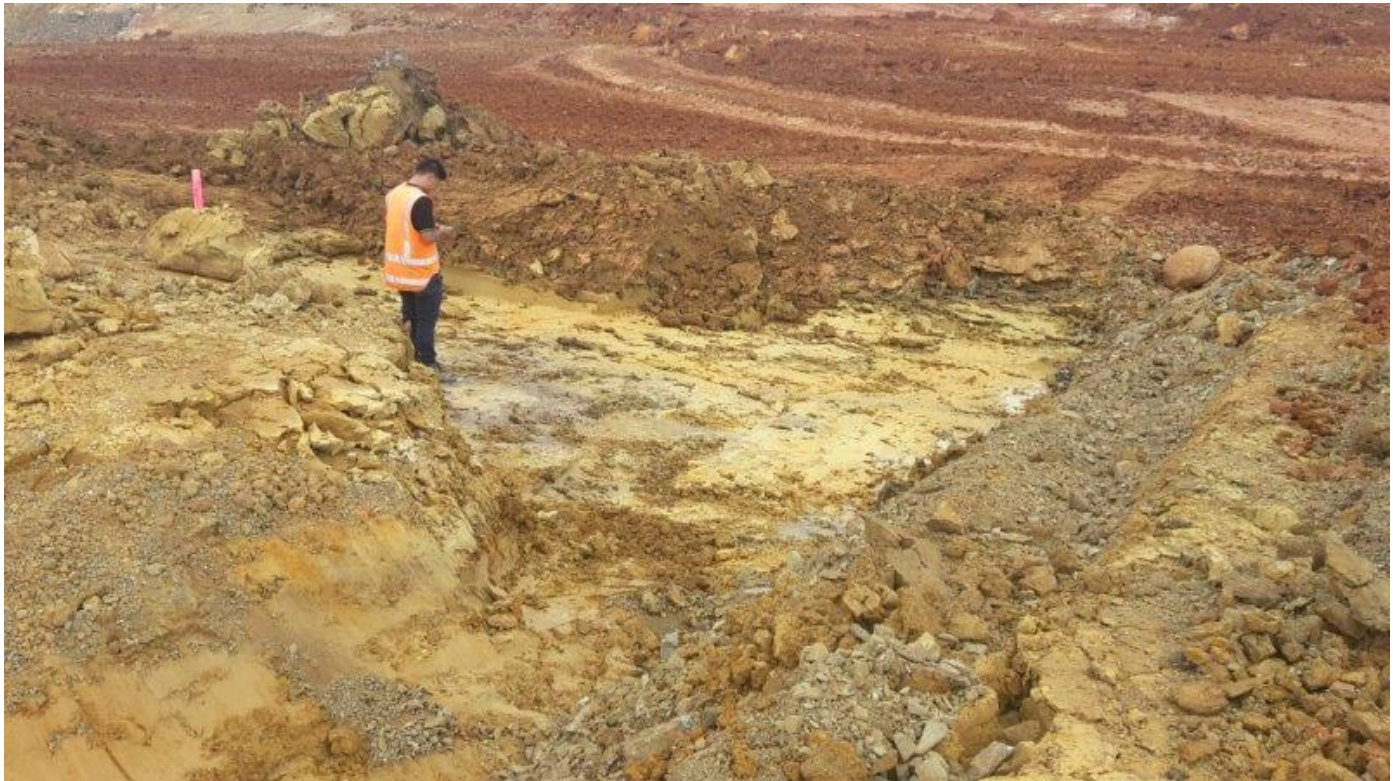
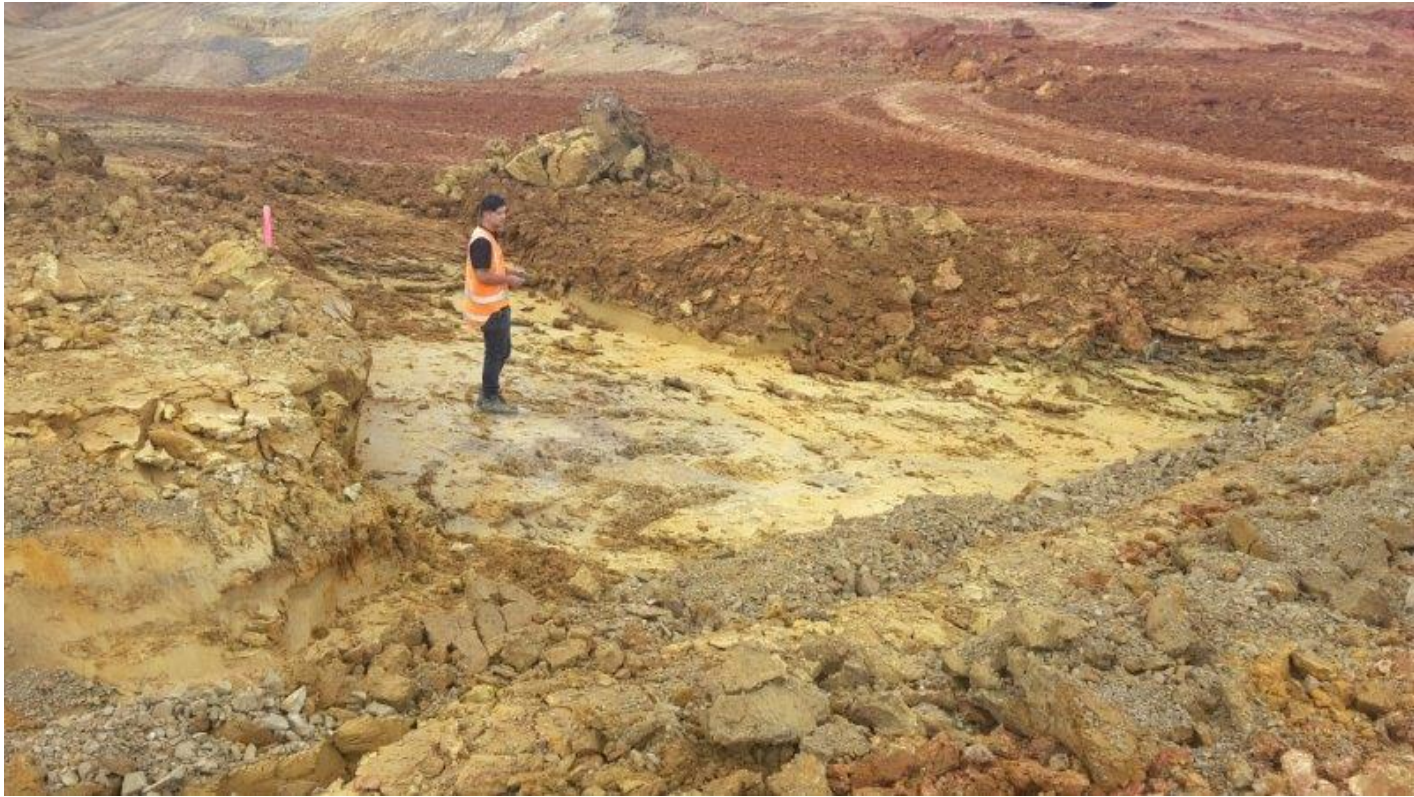
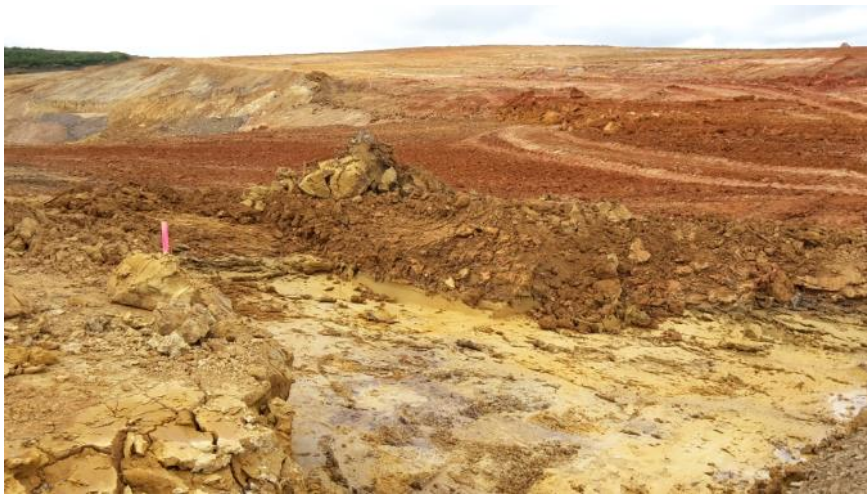
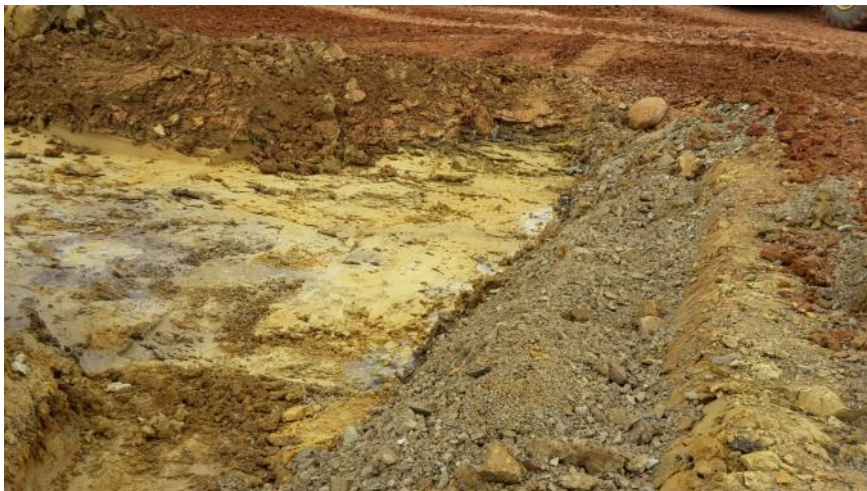
Observed there is a spring still coming through the area at the base of gully to the side of the metal placed yesterday. Spring will need to be tapped with novacoil and run to underfill drain before filling over area with clay.

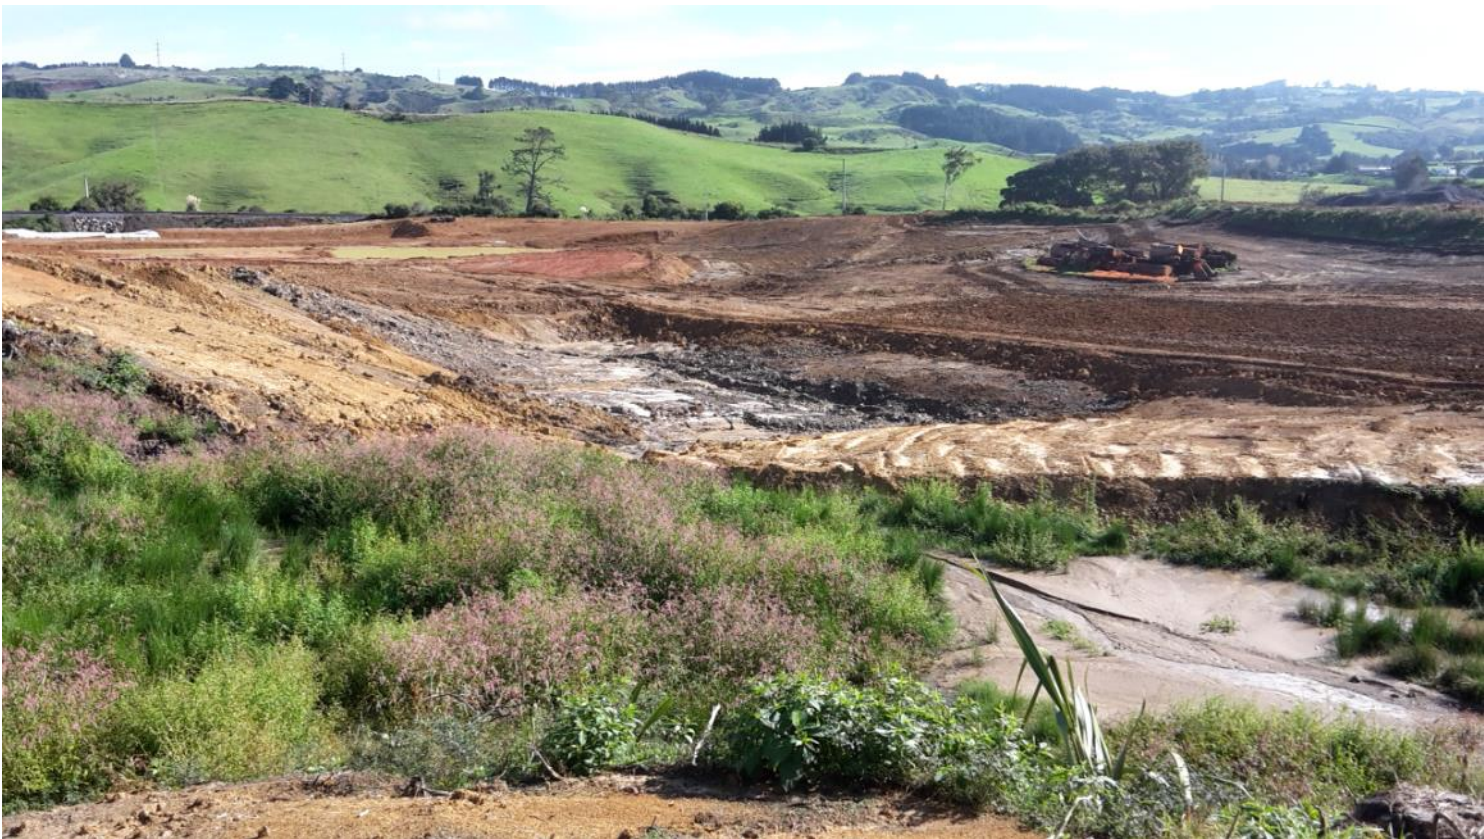
Looked at middle tributary gully strip (middle gully) of Fill P. This strip has begun at the elevated portions and has not yet connected to the gully junction. Drain coil, cloth and rock all look good and to normal standards.

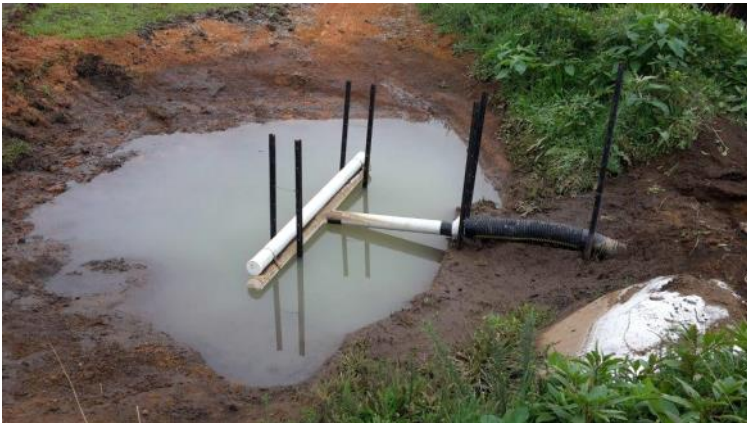
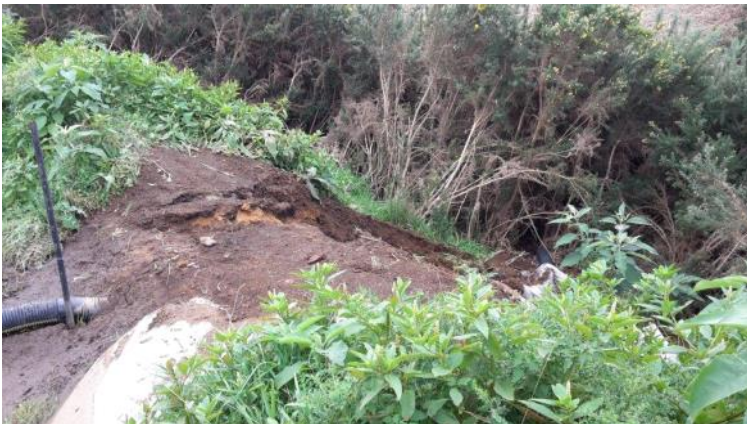
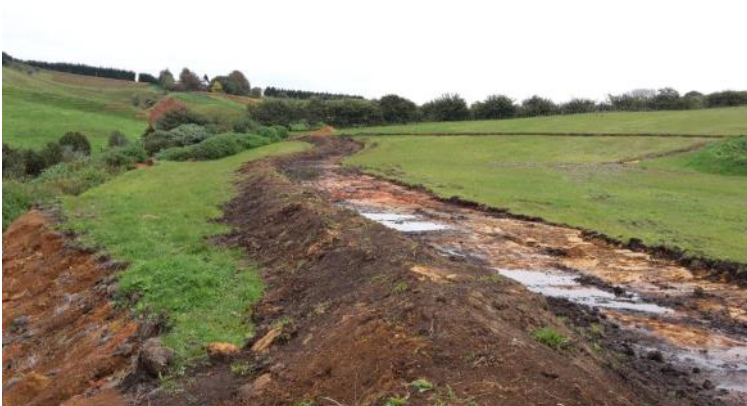
Inspected the Slip that has formed near Fill O. Looks like has formed due to overland flow. Shane is going to meet with Russell tomorrow to discuss options. Will get repaired as part of works next season.

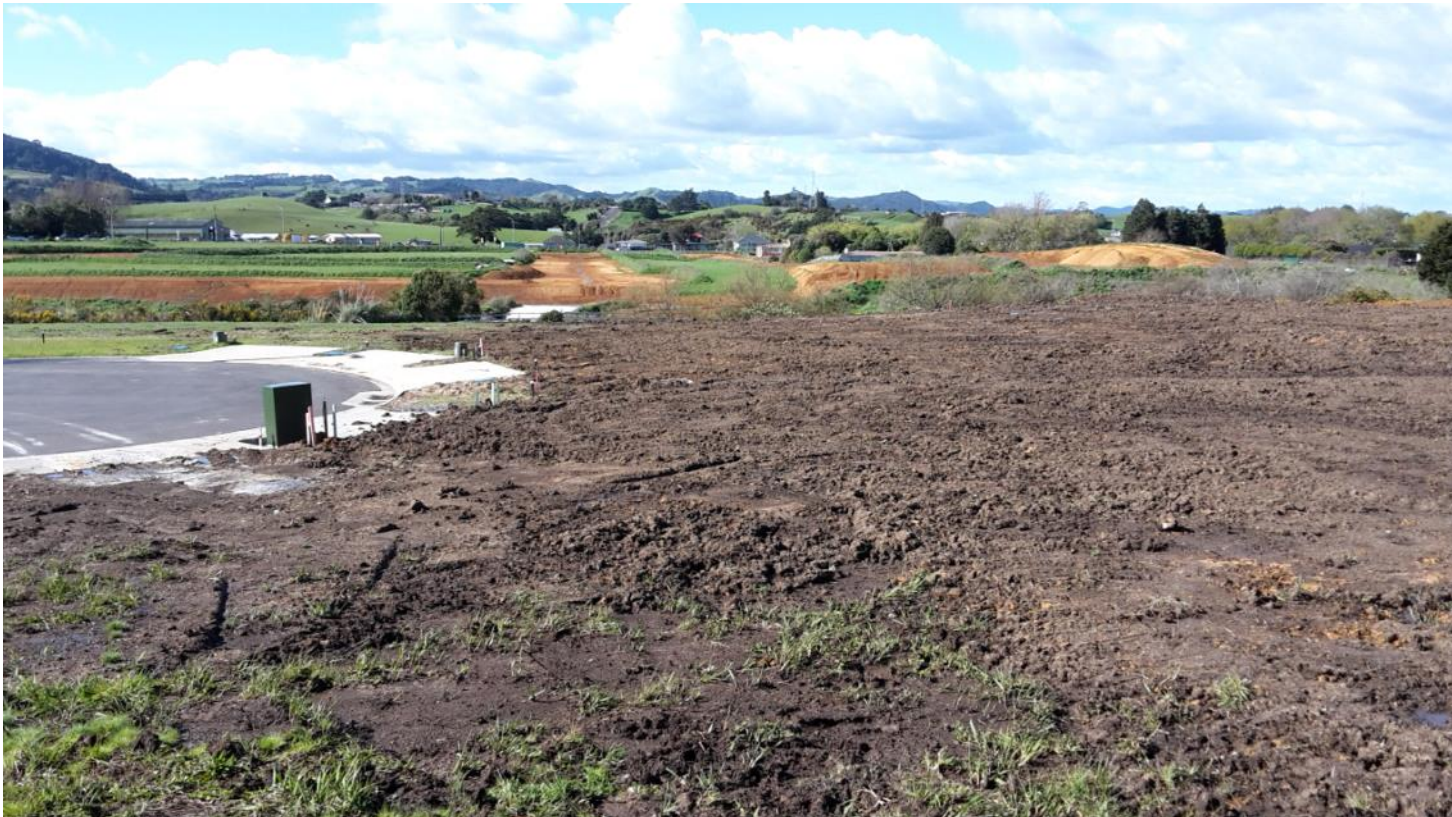
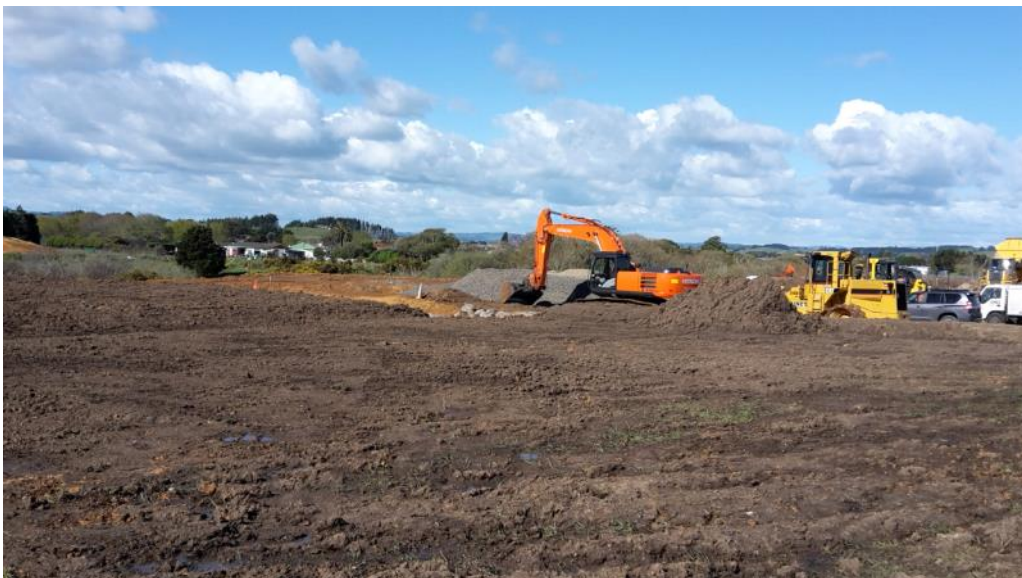
Visited site to inspect fill placement over lots 60-61 where minor cut to fill had occurred late last week.

The lots had already been topsoiled. Drilled 5 boreholes into the topsoil to expose the fill and vane shear strengths were all off the dial (140+) or UTP. Soil appeared well compacted and moist.

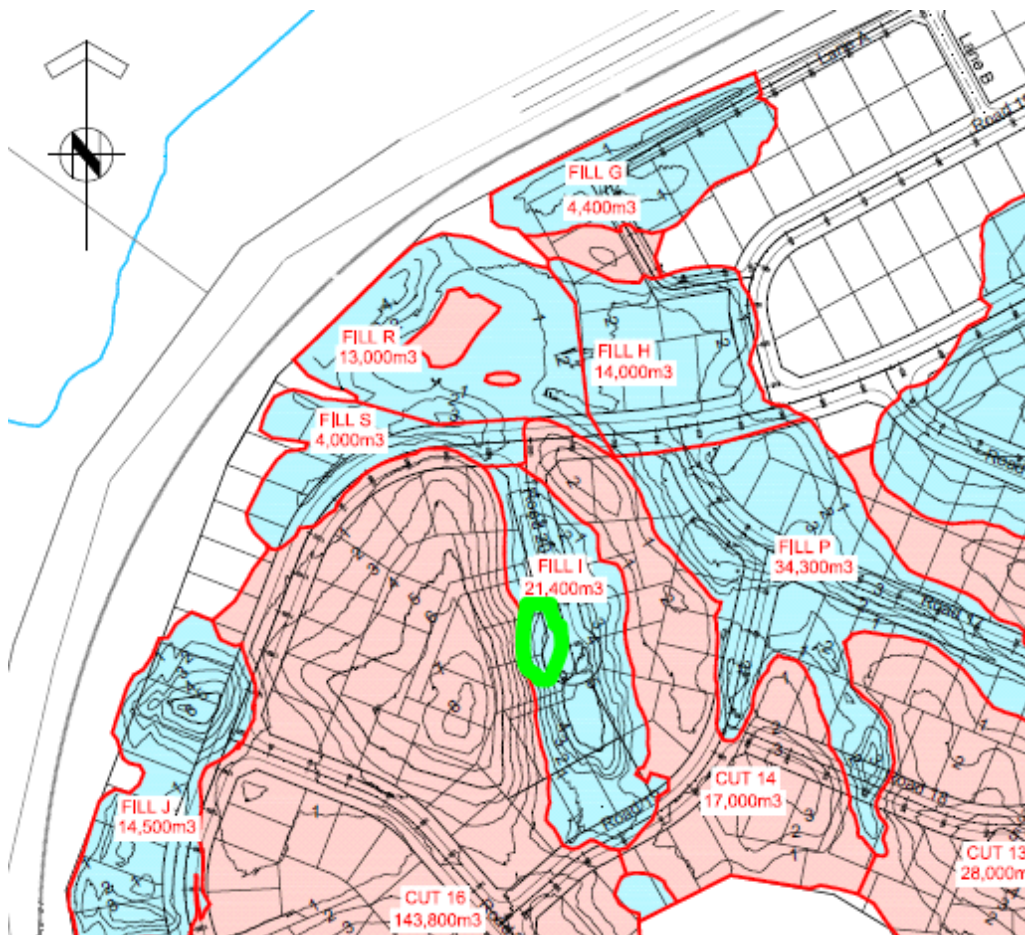
- Observed digout of new section of fill I. Observed they had excavated all mullock and were onto a loose sand. They are going to backfill over this with 1m of SPR100 prior to filling with clay. Fill over this area is 3m to 4m deep.

Area mucked out circled green.

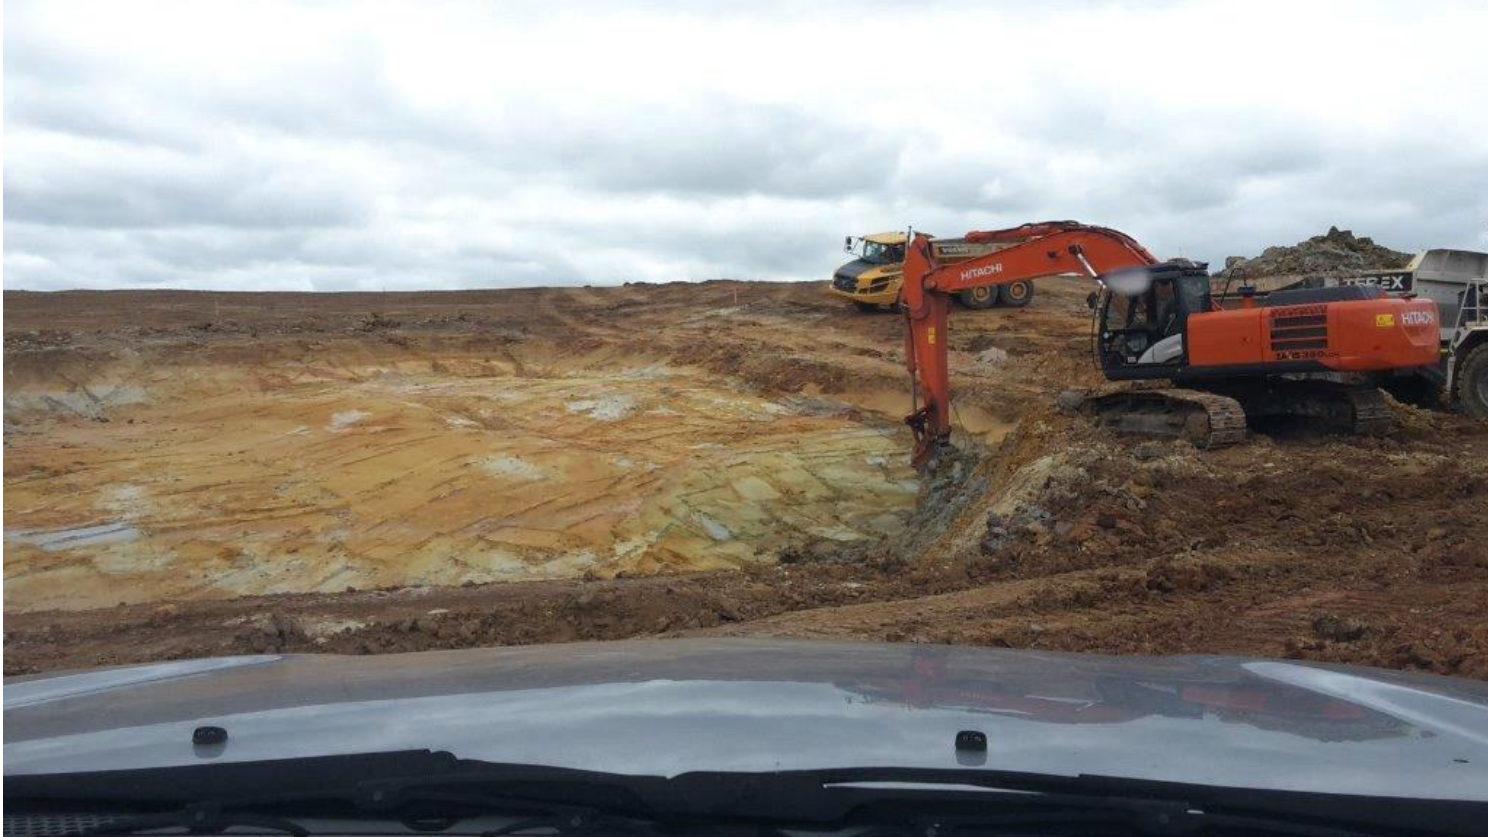
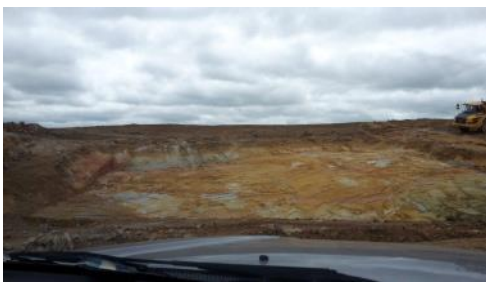
Observed the progress of the digout of the soft area as circled below. They have chased 70% of area, and will have it completed for inspection early next week.

A layer of SPR will be placed in the base of the area in the deepest portion, however there is nowhere to outlet a drain (it is lower than everywhere else) so a drain won't be installed. Did not note any groundwater seepages.

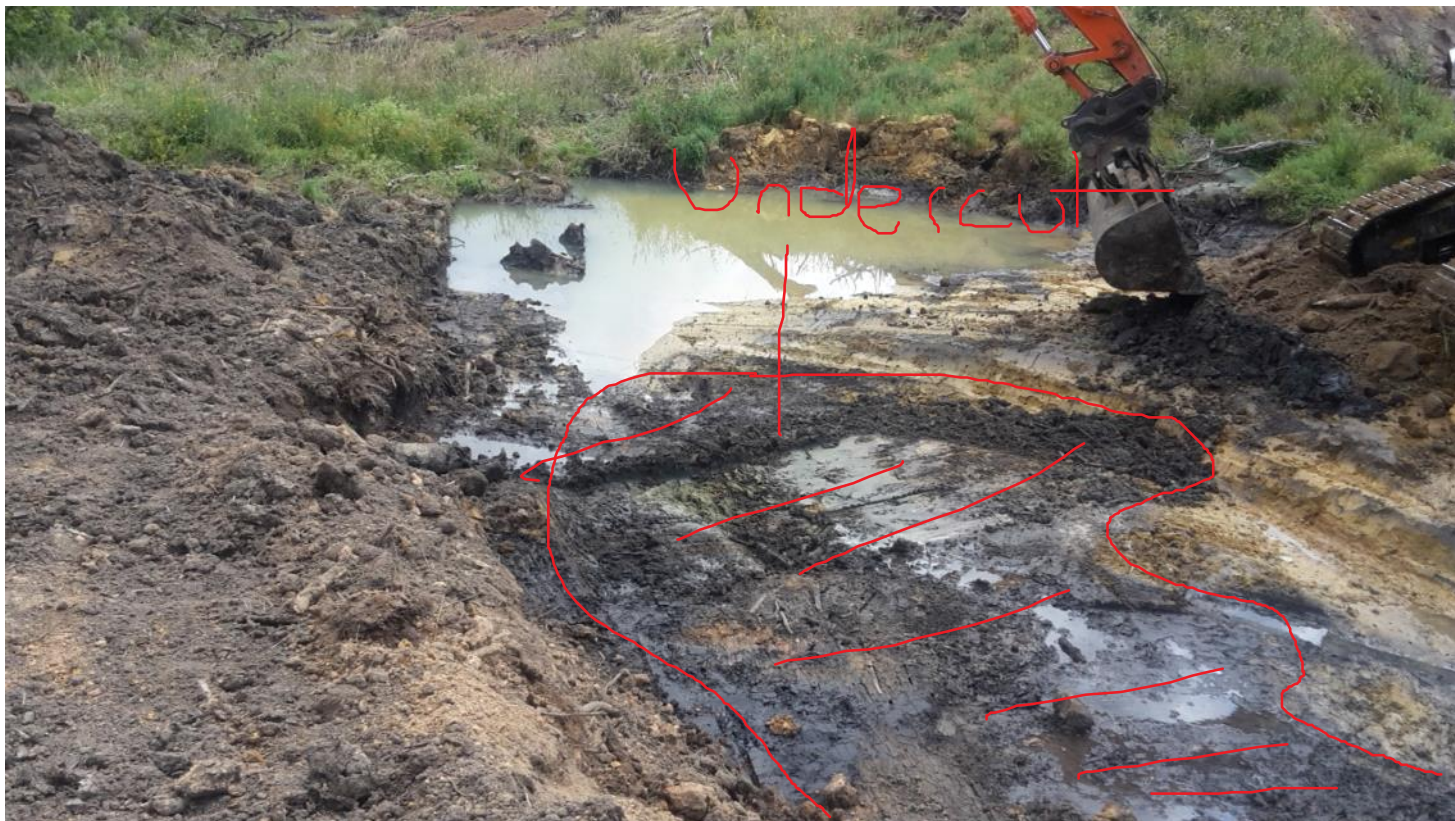
Visited site at request of trevor to inspect the muckout operations of the southernmost gully in Fill K. In most places, they had stripped down to something firm to place their SPR mattress upon, however, some organic material was still present and this was advised to be undercut (only by 500mm to something decent).

Advised trevor to use the same methodology on the easternmost gully.

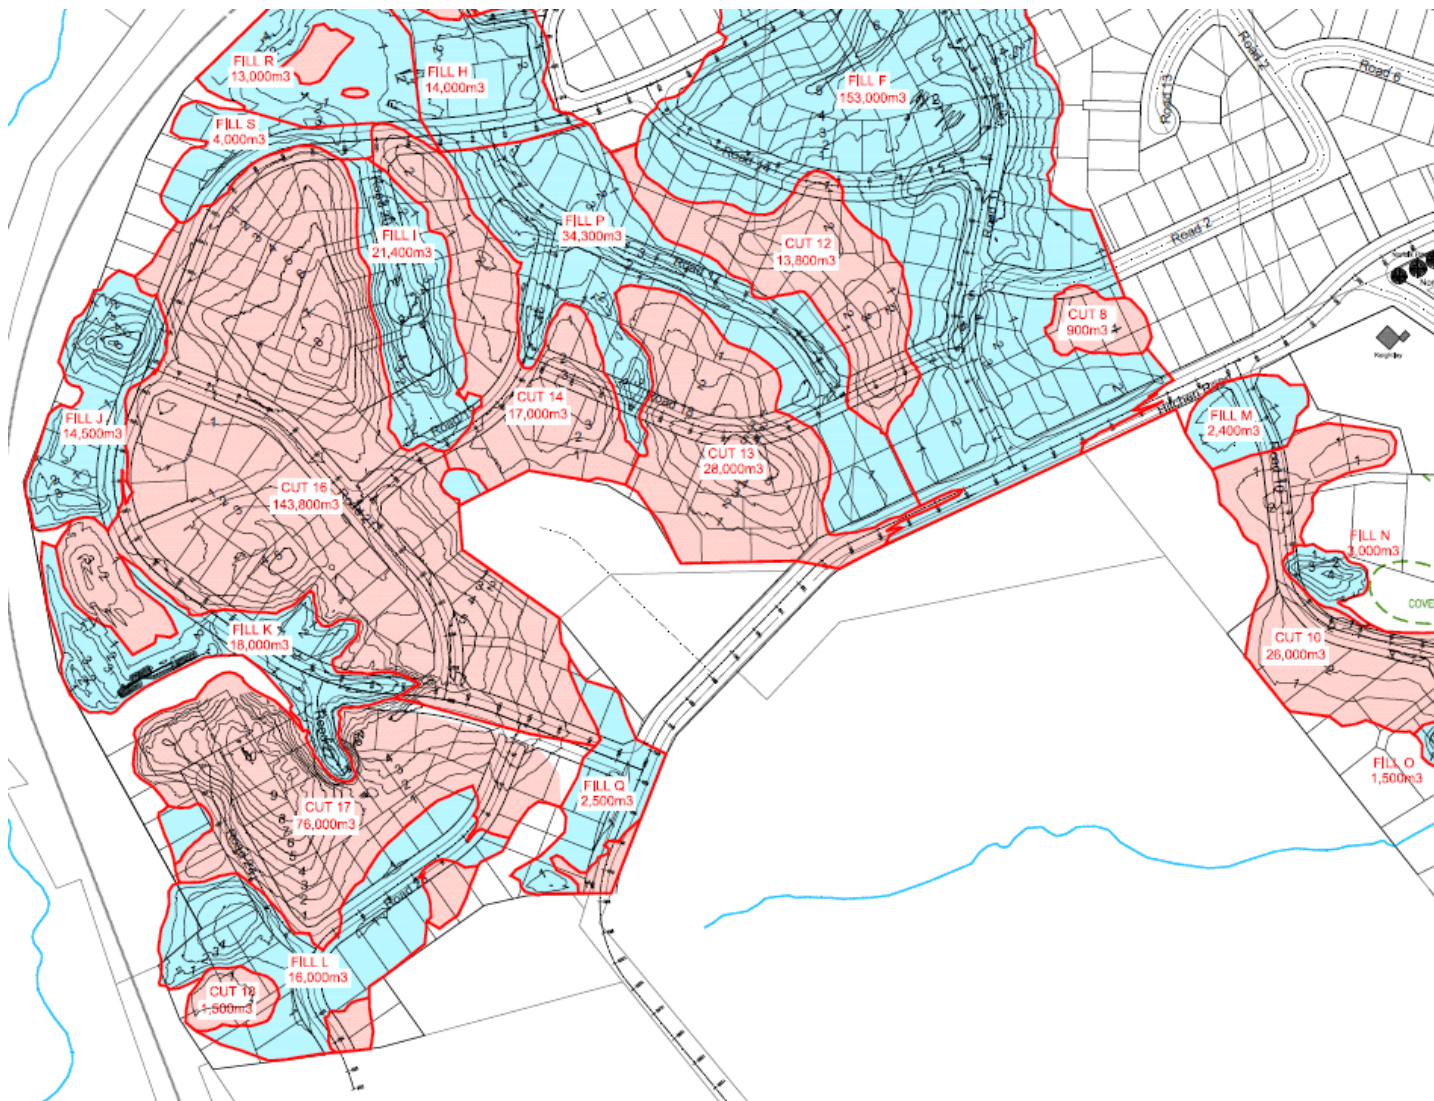
There is a lot of gully mullock material from the Fill K pond muckout. This material will be dried out, root raked and then mixed with clean clay and placed in the deeper fills.
