Geotechnical Completion Report

HITCHEN BLOCK STAGES 6E AND 10A TO 10D

DFH JOINT VENTURE LIMITED

16 December 2020

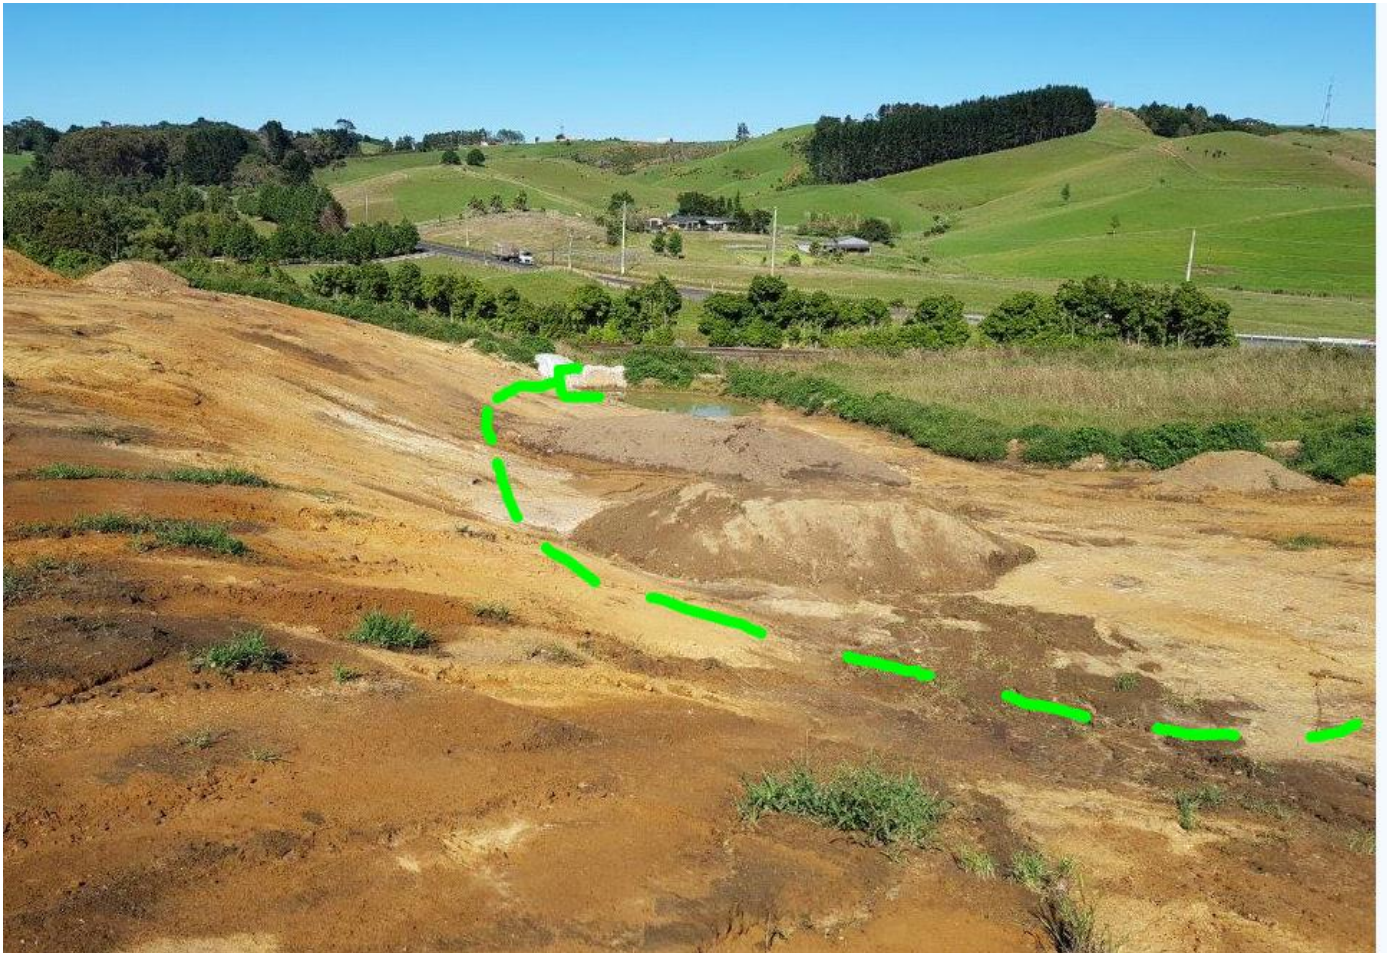
Noted that the topsoil had been stripped adequately to expose stiff natural ground. Requested that an underfill drain is installed as per the picture below, the slope still needs to be benched.

Requested underfill drain in green.

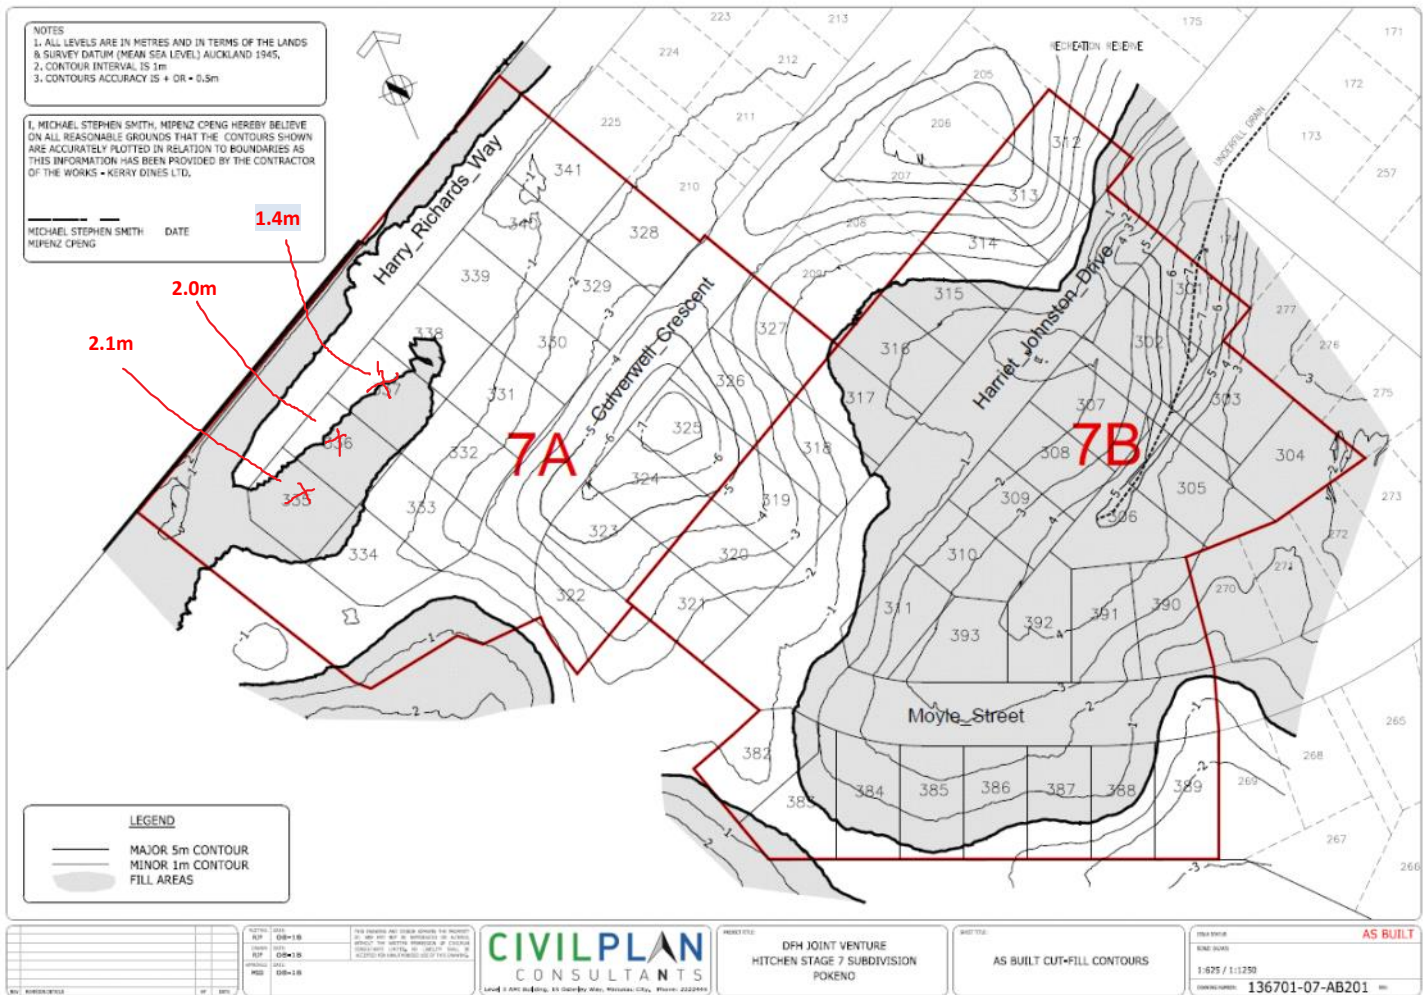
Natural ground was consistently yellow/brown silt that was impenetrable with shear vane tests.

Advised contractor to remove fill down to natural ground in lots 337 and 336 and get in touch with us to inspect. Difficult to determine whether all the fill needs to be removed in lot 335 as only the top 0.5m was below 140kPa (non-engineered). Will be subject to inspections once undercutting commences.

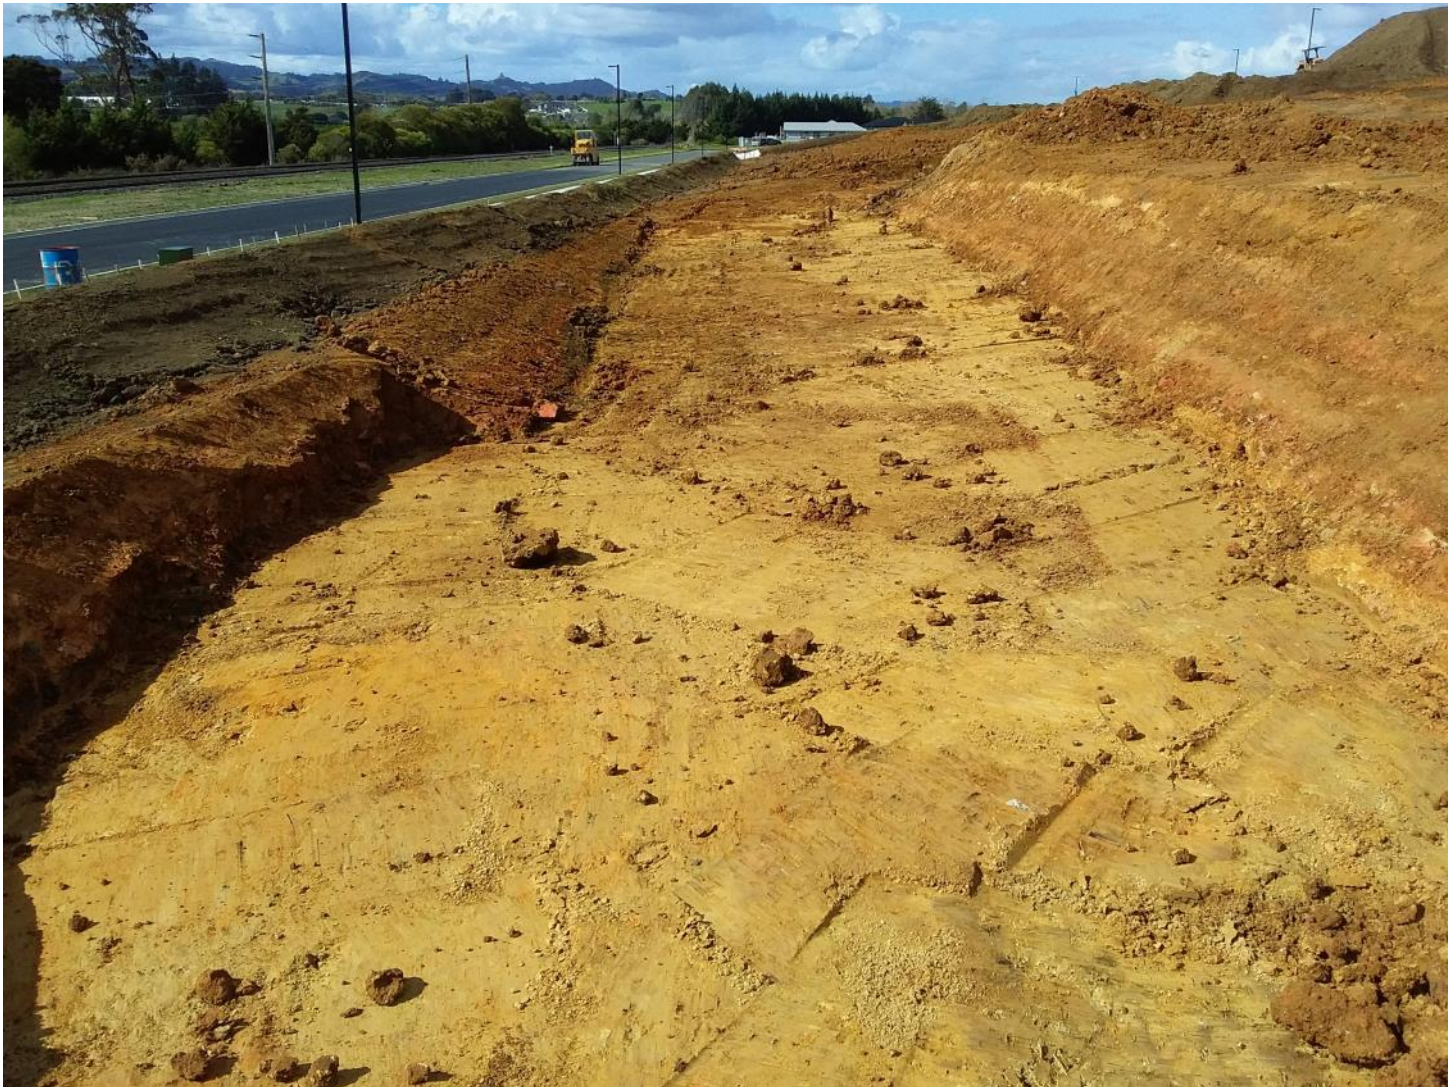
Lot 335 had not been undercut yet. Advised Trevor to undercut towards the trial pit in Lot 335. Only the top 0.5m required undercutting apparent from the trial pit, and the contractor was also advised to chase the seam of wet fill til it runs out. Trevor will take photographs and Lander to confirm the undercut is to its satisfaction.
