DFH Joint Venture Limited

GEOTECHNICAL COMPLETION REPORT

Hitchen Block Stage 18, Pokeno

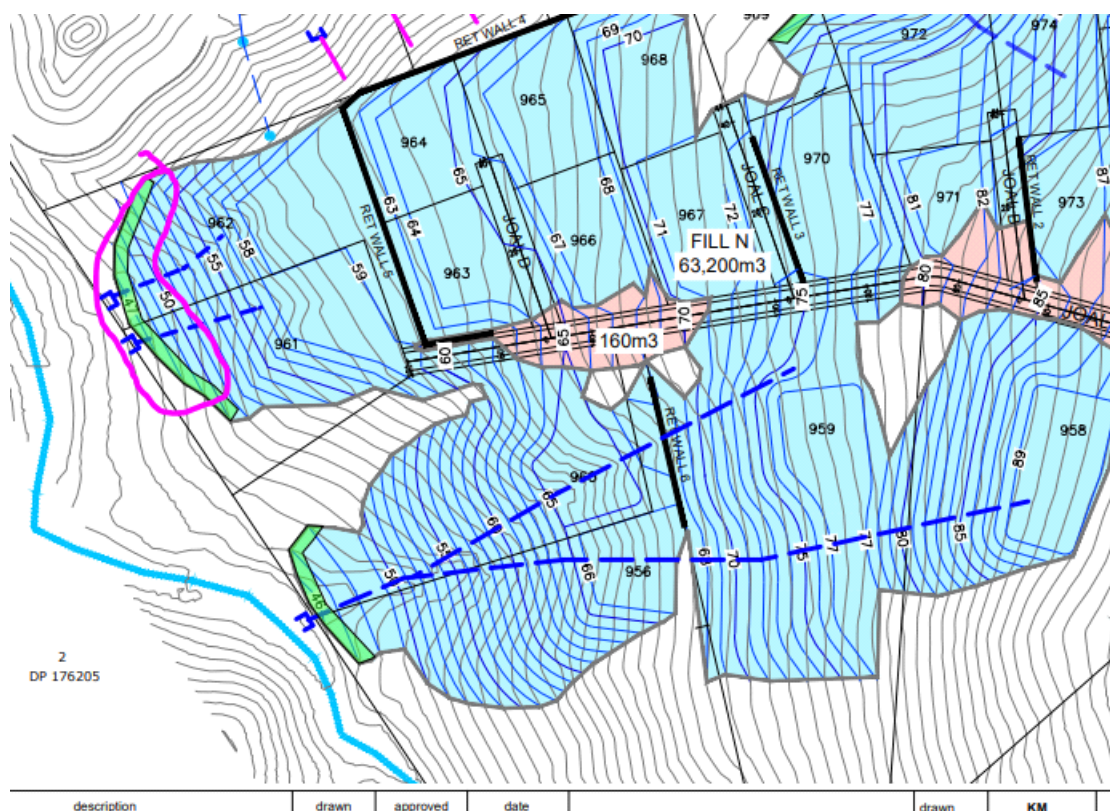
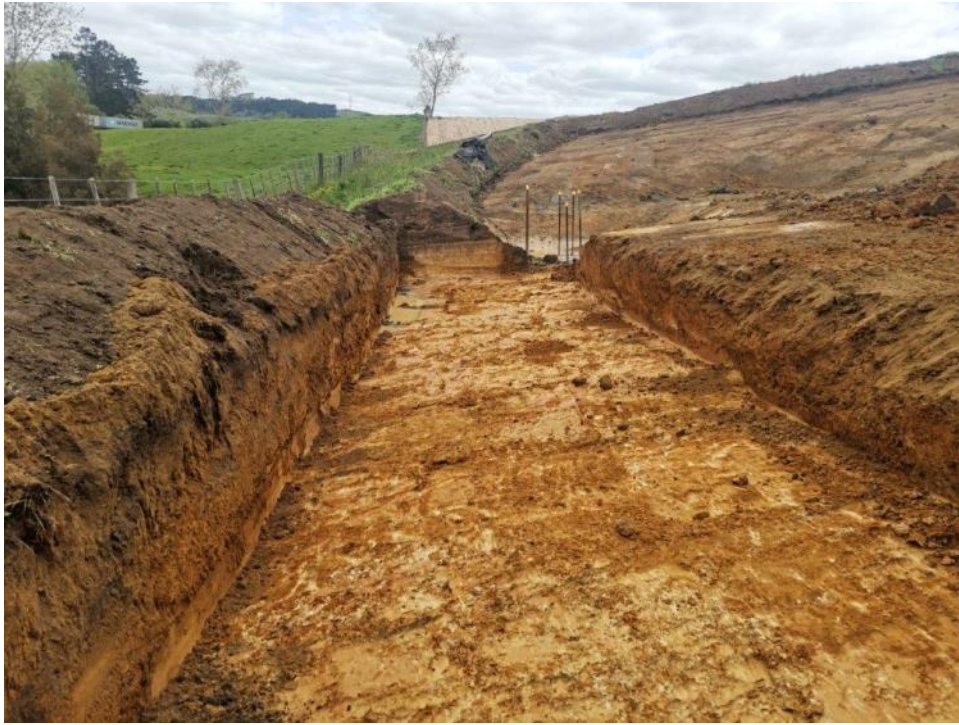
Observed excavation of toe key at least 1m below original ground level as per purple outline on the annotated plan below. Advised contractor to bench the sides and then fill compaction with clay can commence. Also advised that the underfill drains be installed as per our detail and should not extend beyond the lower retaining wall.

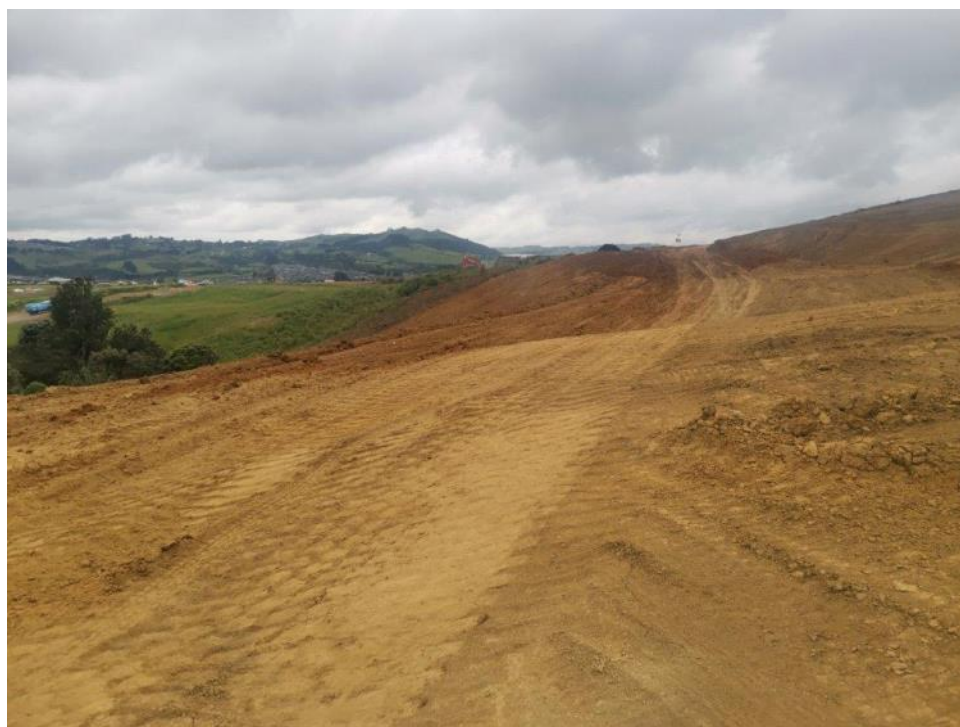
Counterfort drains in are mostly complete, the final drain is still being constructed - loose materials have been undercut, benched out and clay fill placed. Drain depth to digger reach.

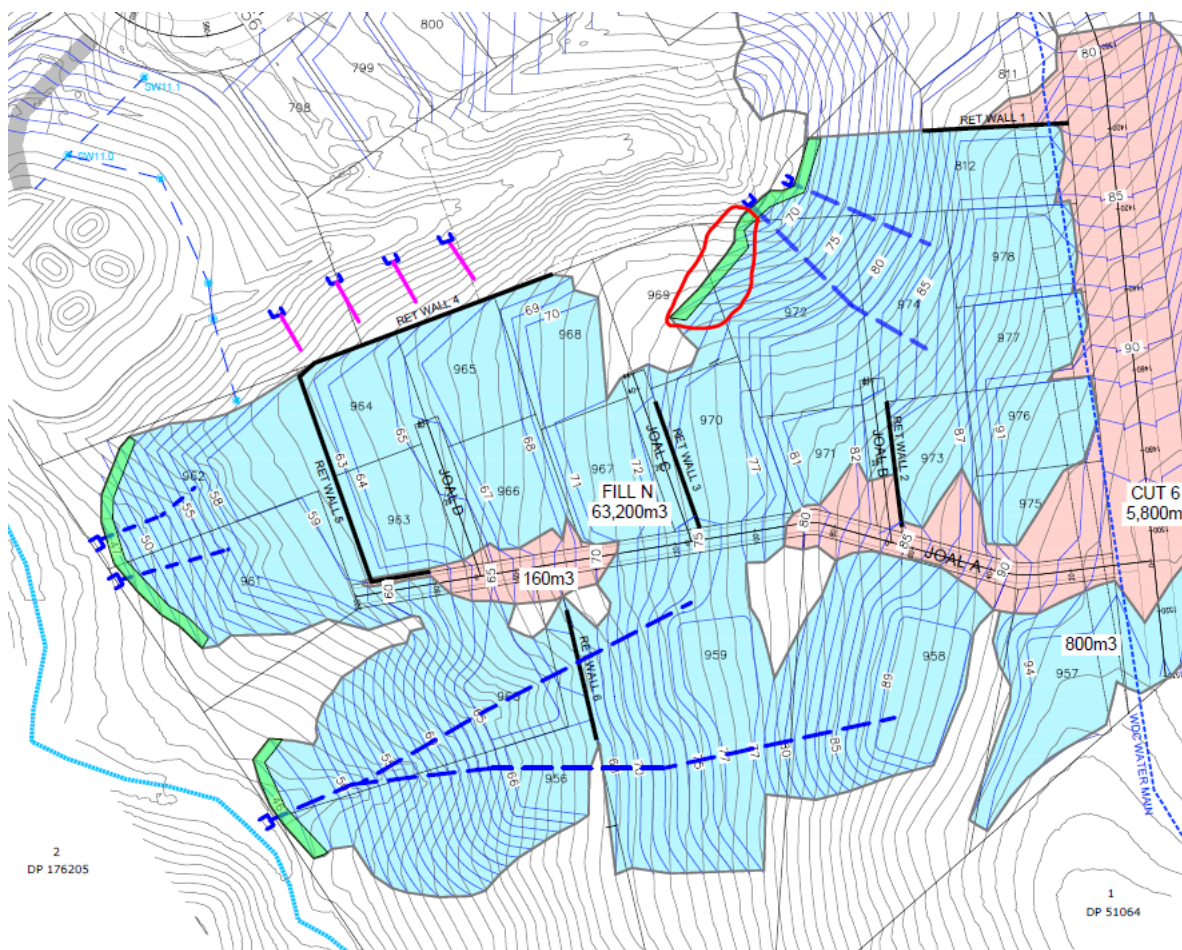
Observed excavation of toe key at least 1m below original ground level as per purple outline on the annotated plan below.

- Base of the toes key returned shear vanes of greater than 217kPa, with the vane blade unable to penetrate the soil in some instances.
- Discussed with contractor that they would bench the sides and then fill compaction with clay can commence.

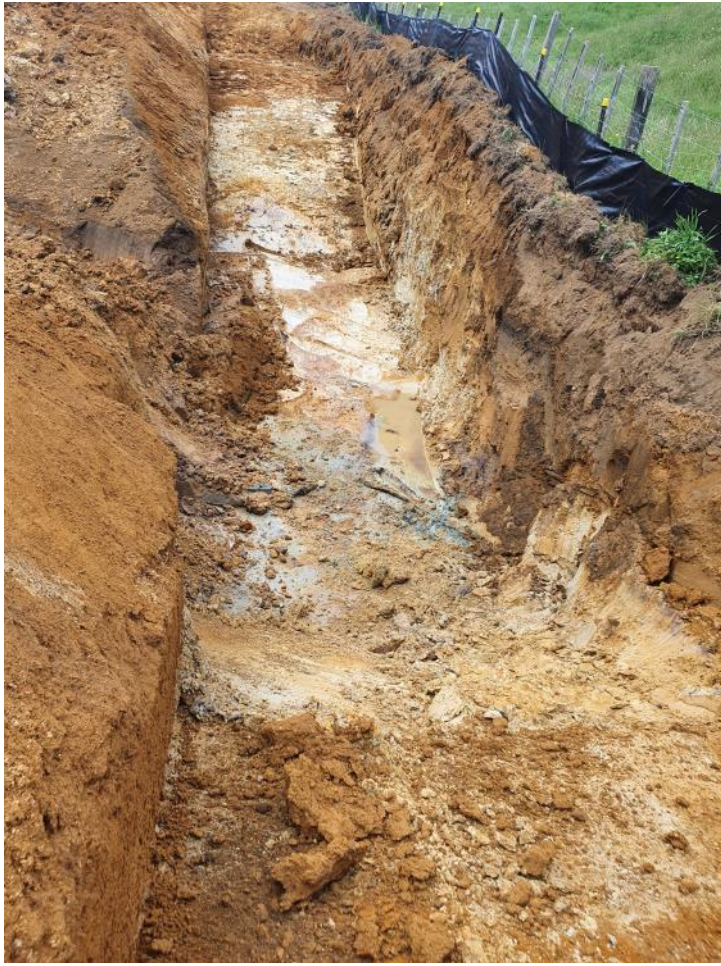
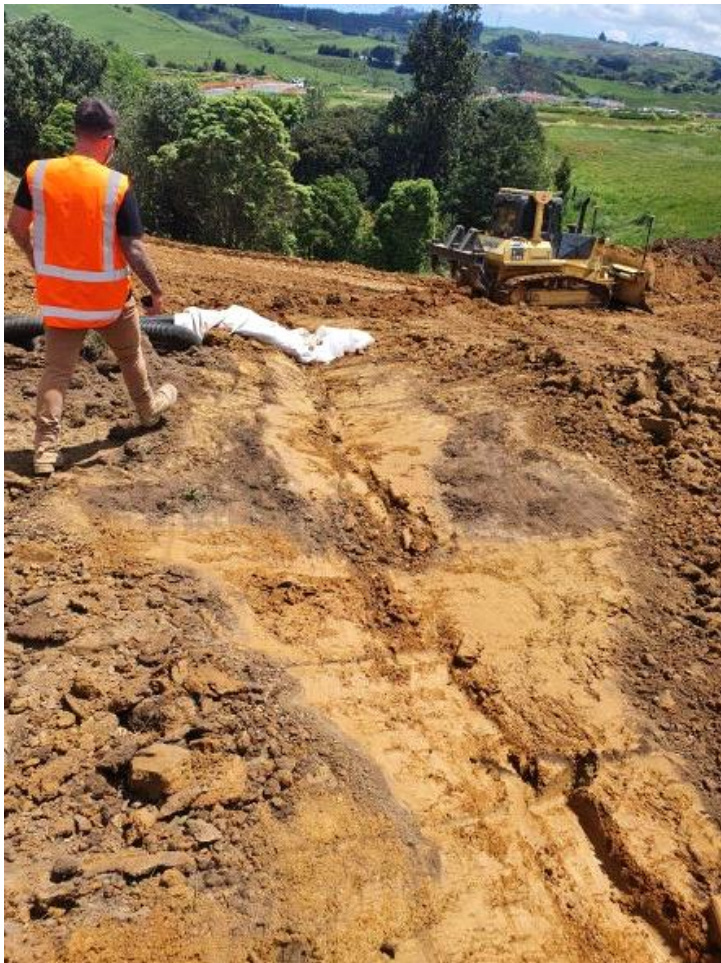
- Also observed the underfill drains circled in black below:

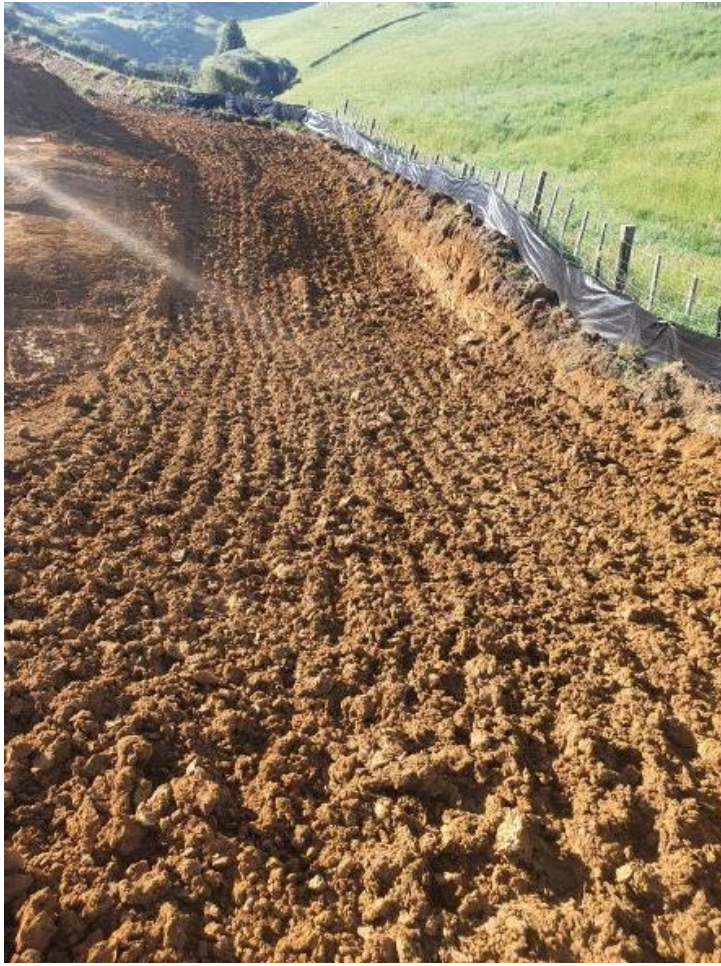
- Fill consisted of hard, highly plastic clays.
- A 1m deep hand auger was drilled and found no wet or saturated soils. Satisfactory to continue placing fills.

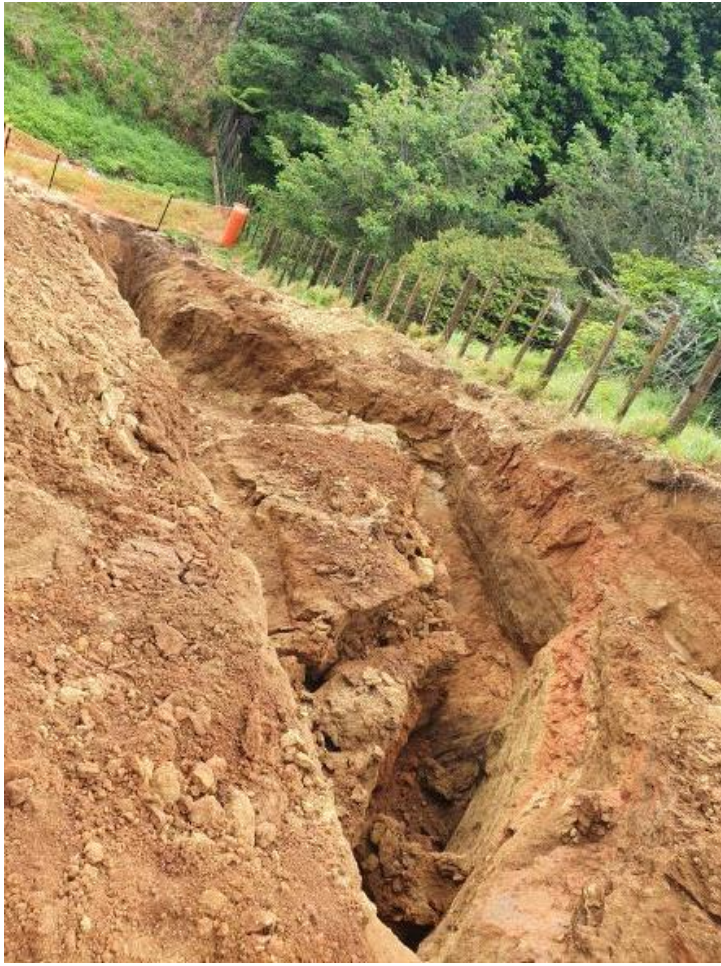
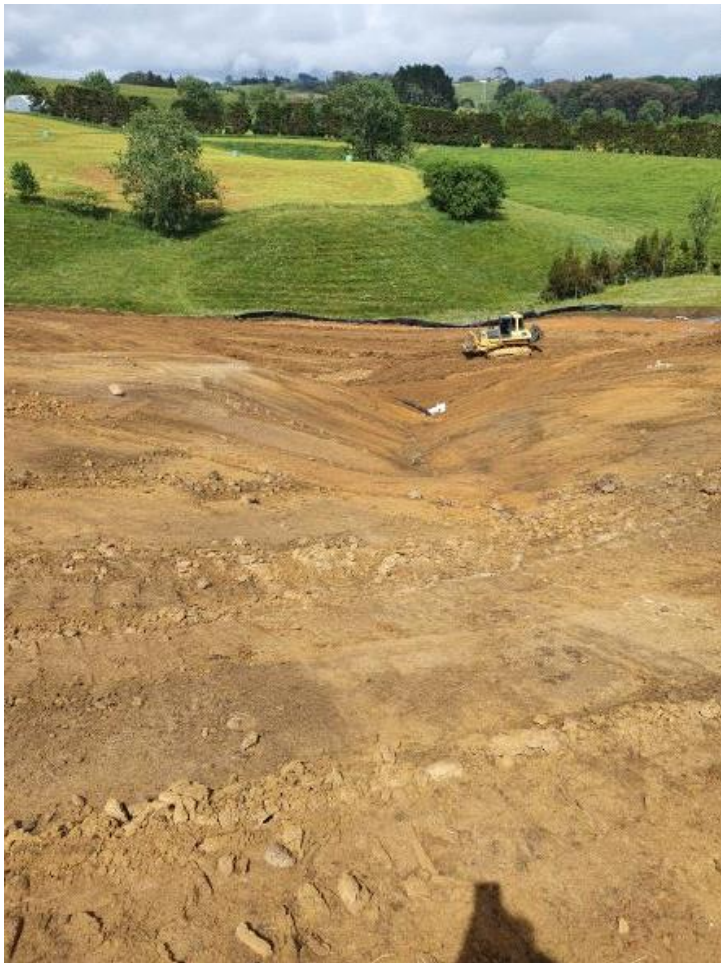
Also observed construction of underfill drains and discussed with contractor where the drains are to extend up to (approx. pink pegs in final image below).

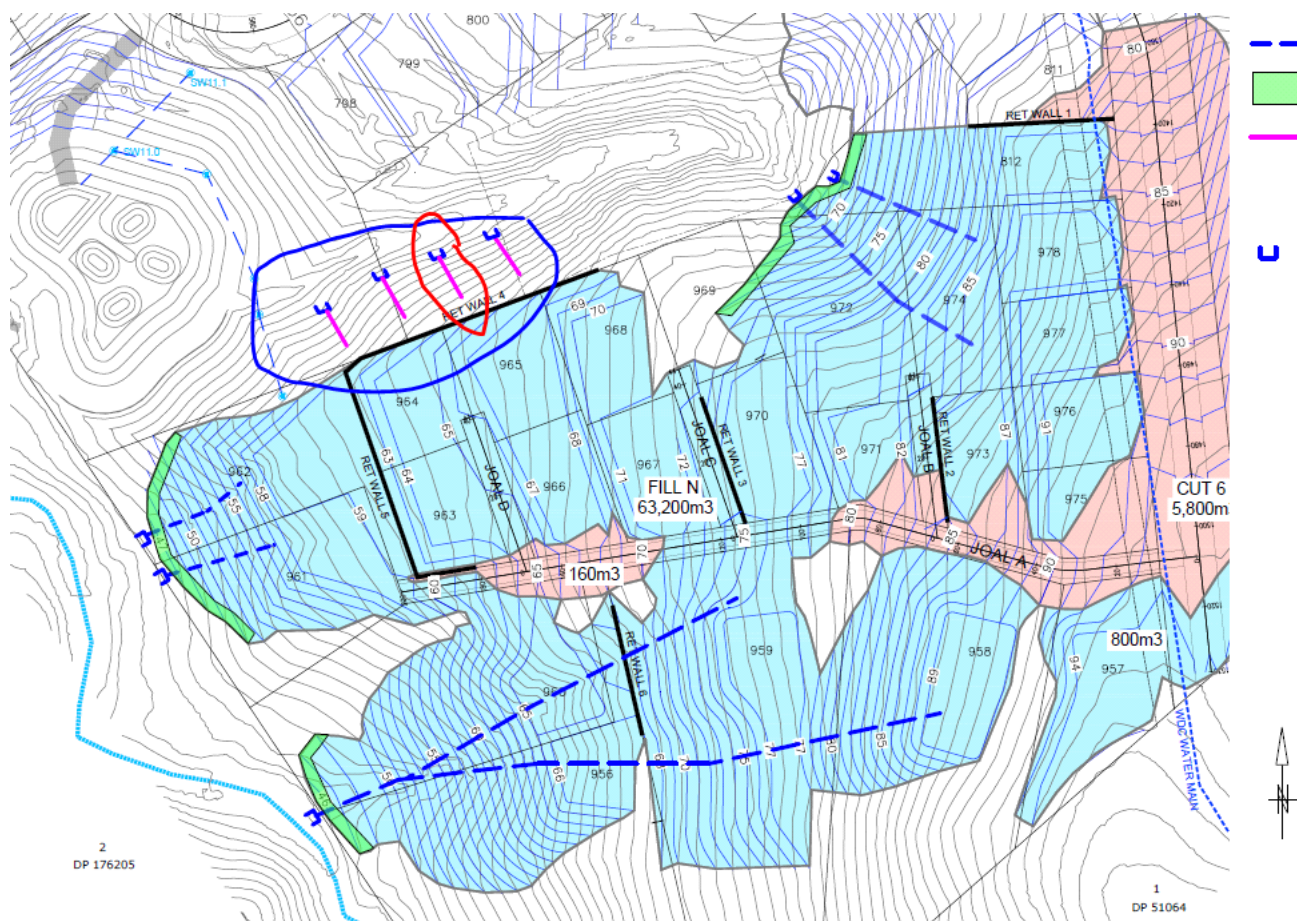
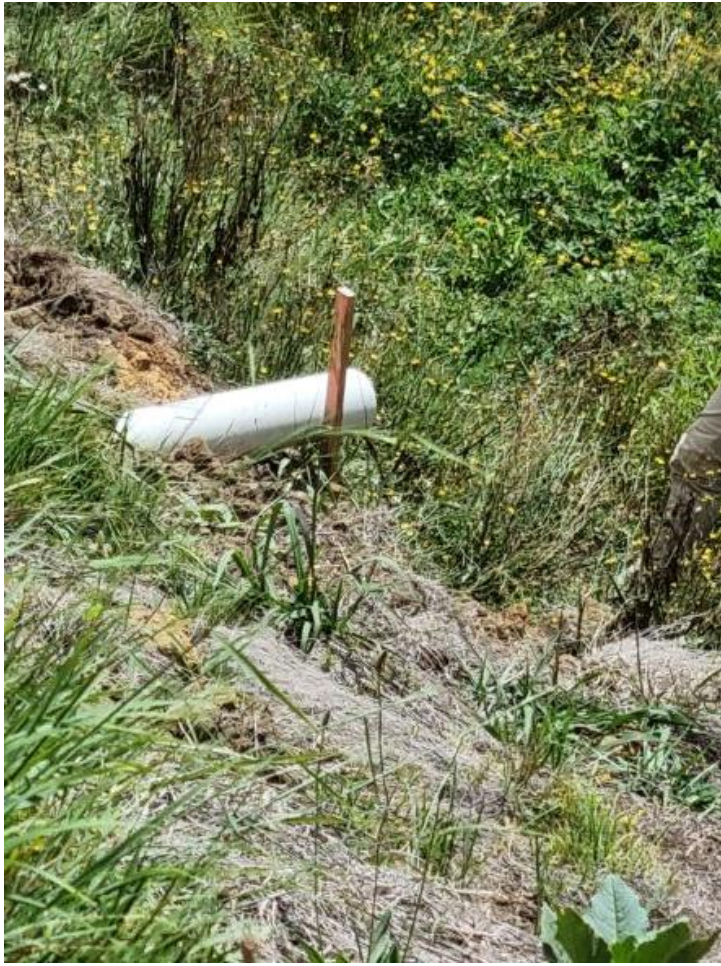
Observed flushing of 1 x drain (circled red below) - remaining drains to be flushed tomorrow following pre-soaking.

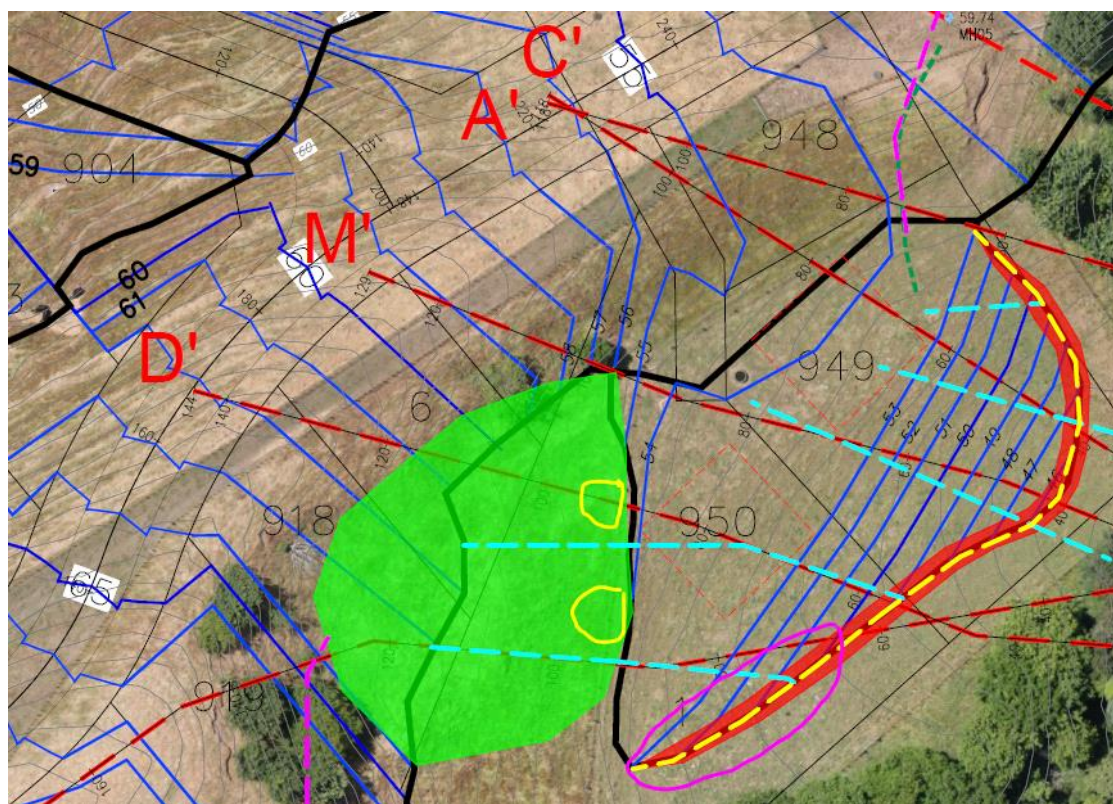
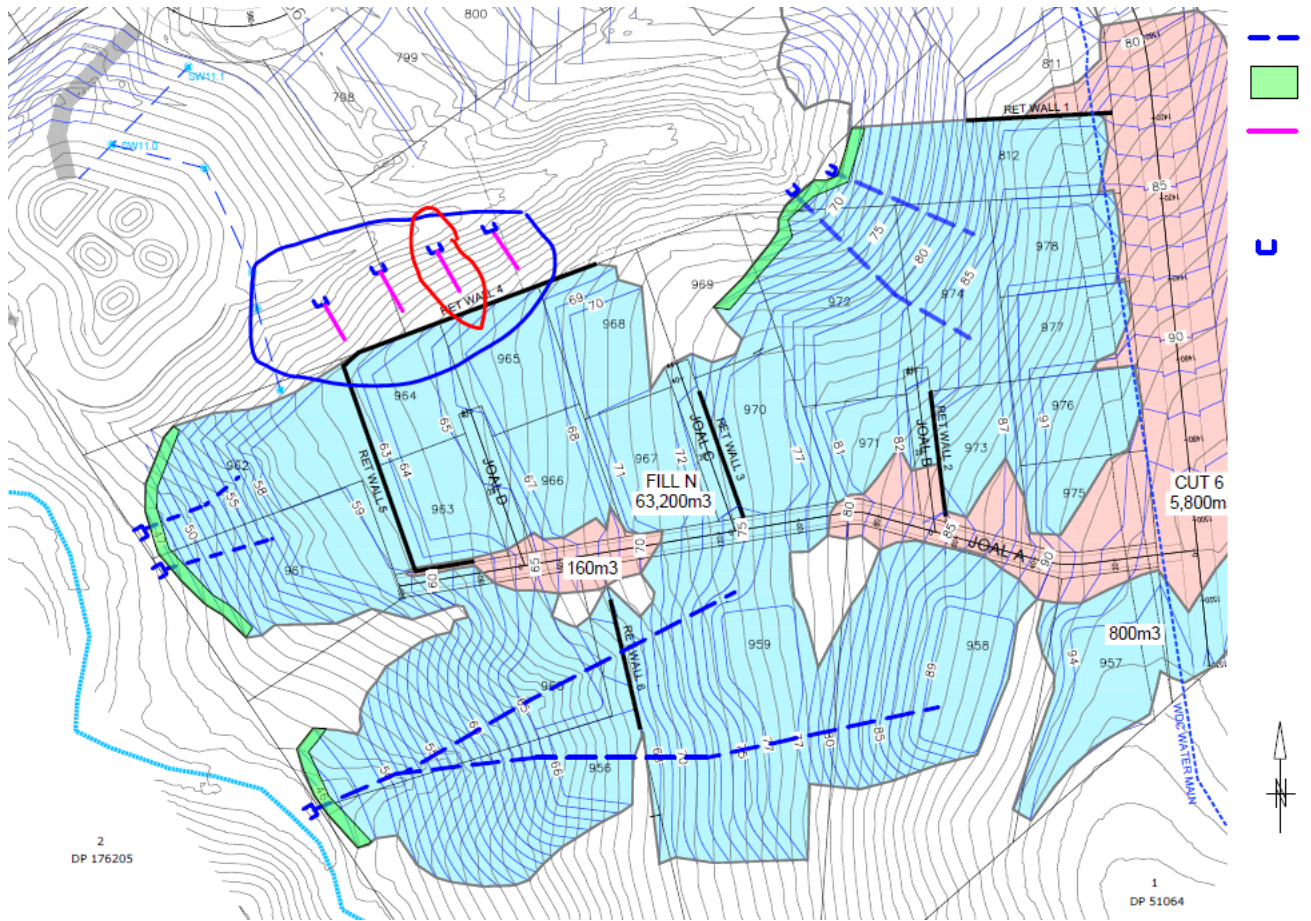
Walked over the counterfort drain alignments. All drains were spaced at approximately 15m spacings.

Stage 6 counterforts all flushed, with clear water observed coming out of the outlet.

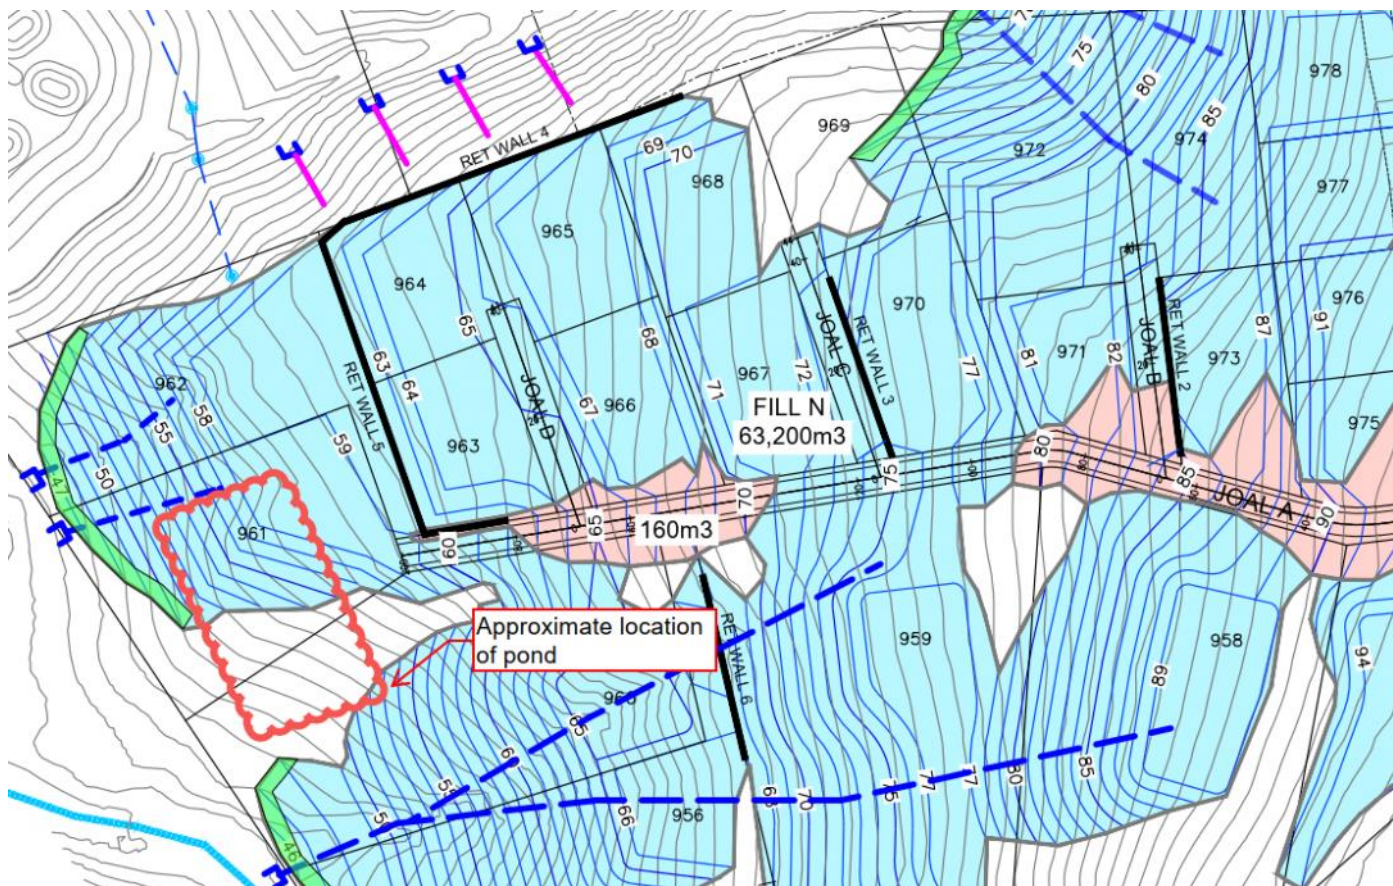
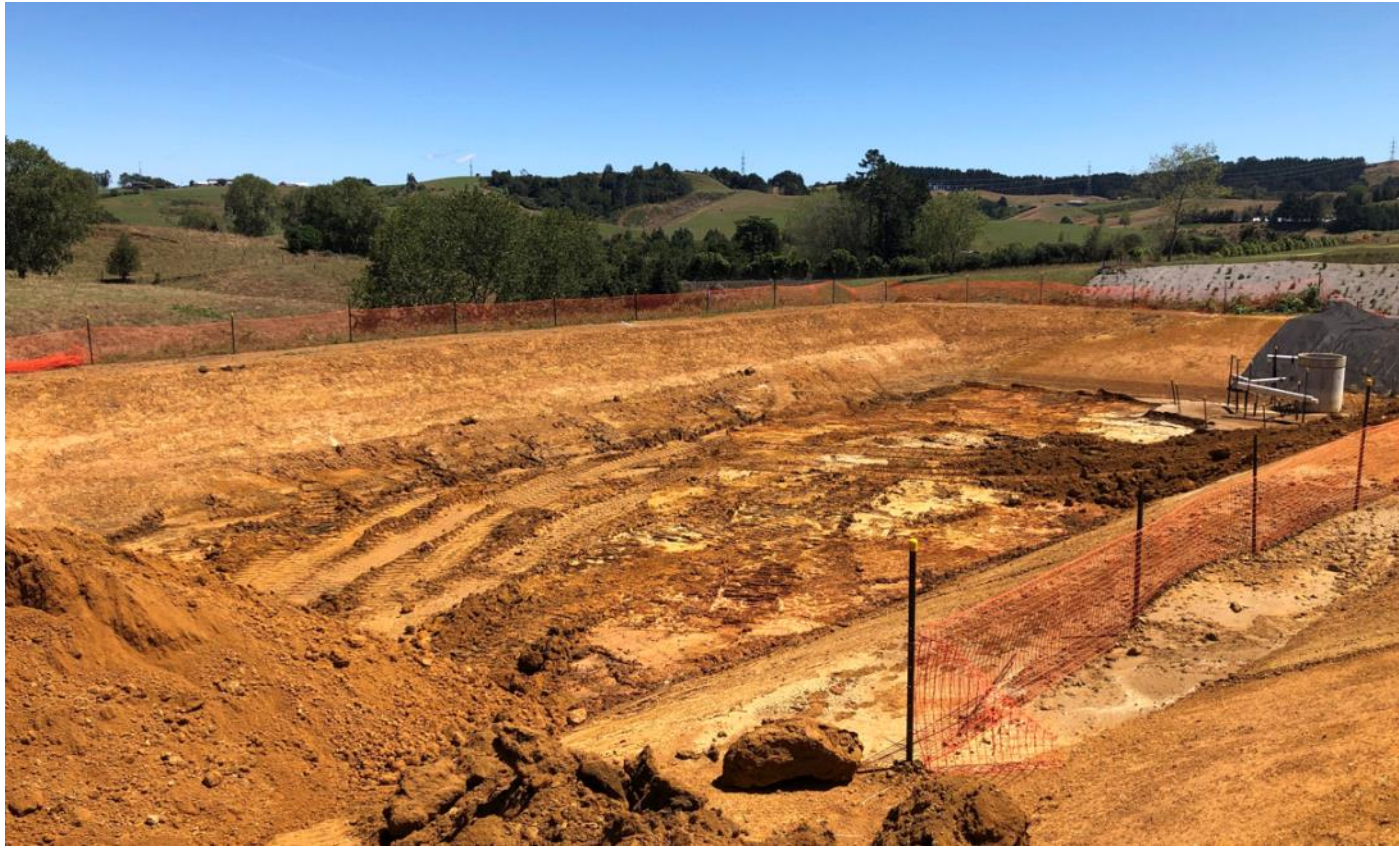
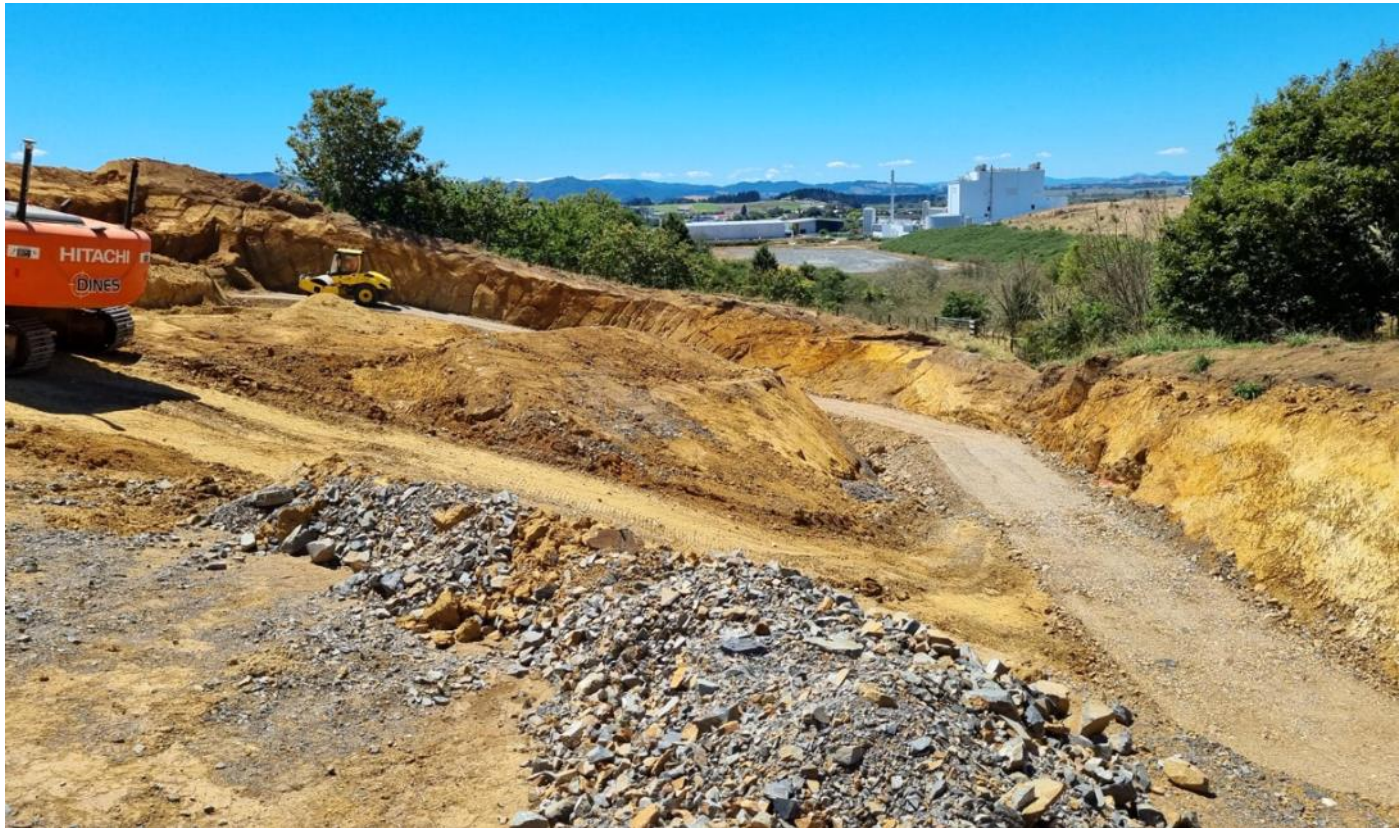
- Base of pond consisted of natural, inorganic material.
- Shear strengths greater than 100 kPa
- Satisfactory to place fill
- Minor vegetation was noted on pond batters. Recommended to remove prior to fill.

Visual Inspection of meadows shear key construction. Hardfill at final height (observed being rolled).
Drainage to be placed tomorrow.

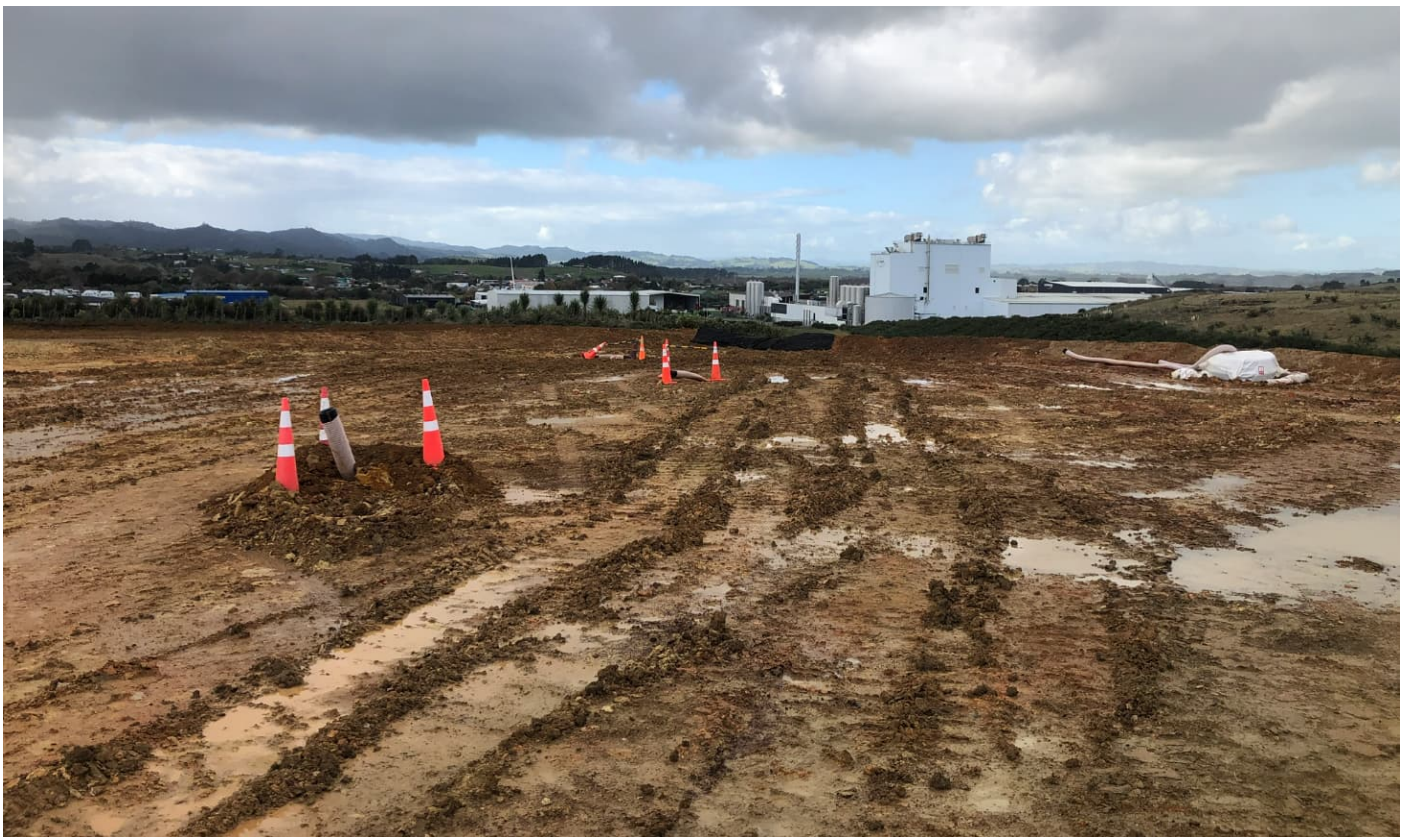
- Counterfort Drains 2-5 completed, counterfort drain 1 yet to be fully excavated.
- Observed topsoil spread over meadows area.

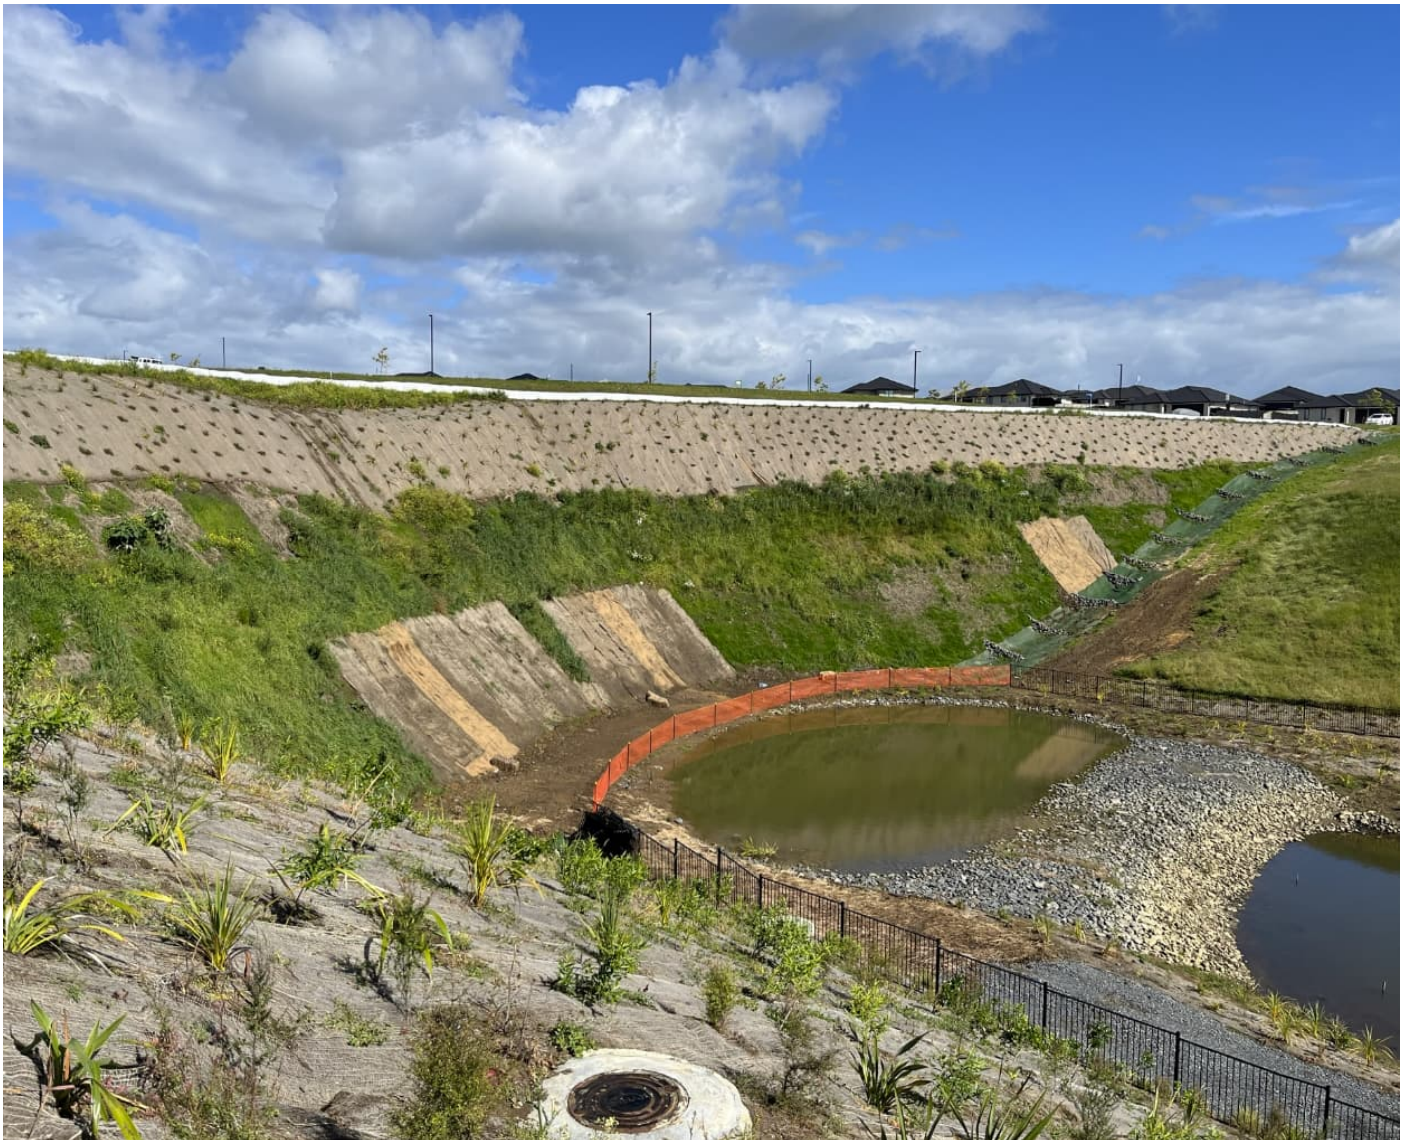
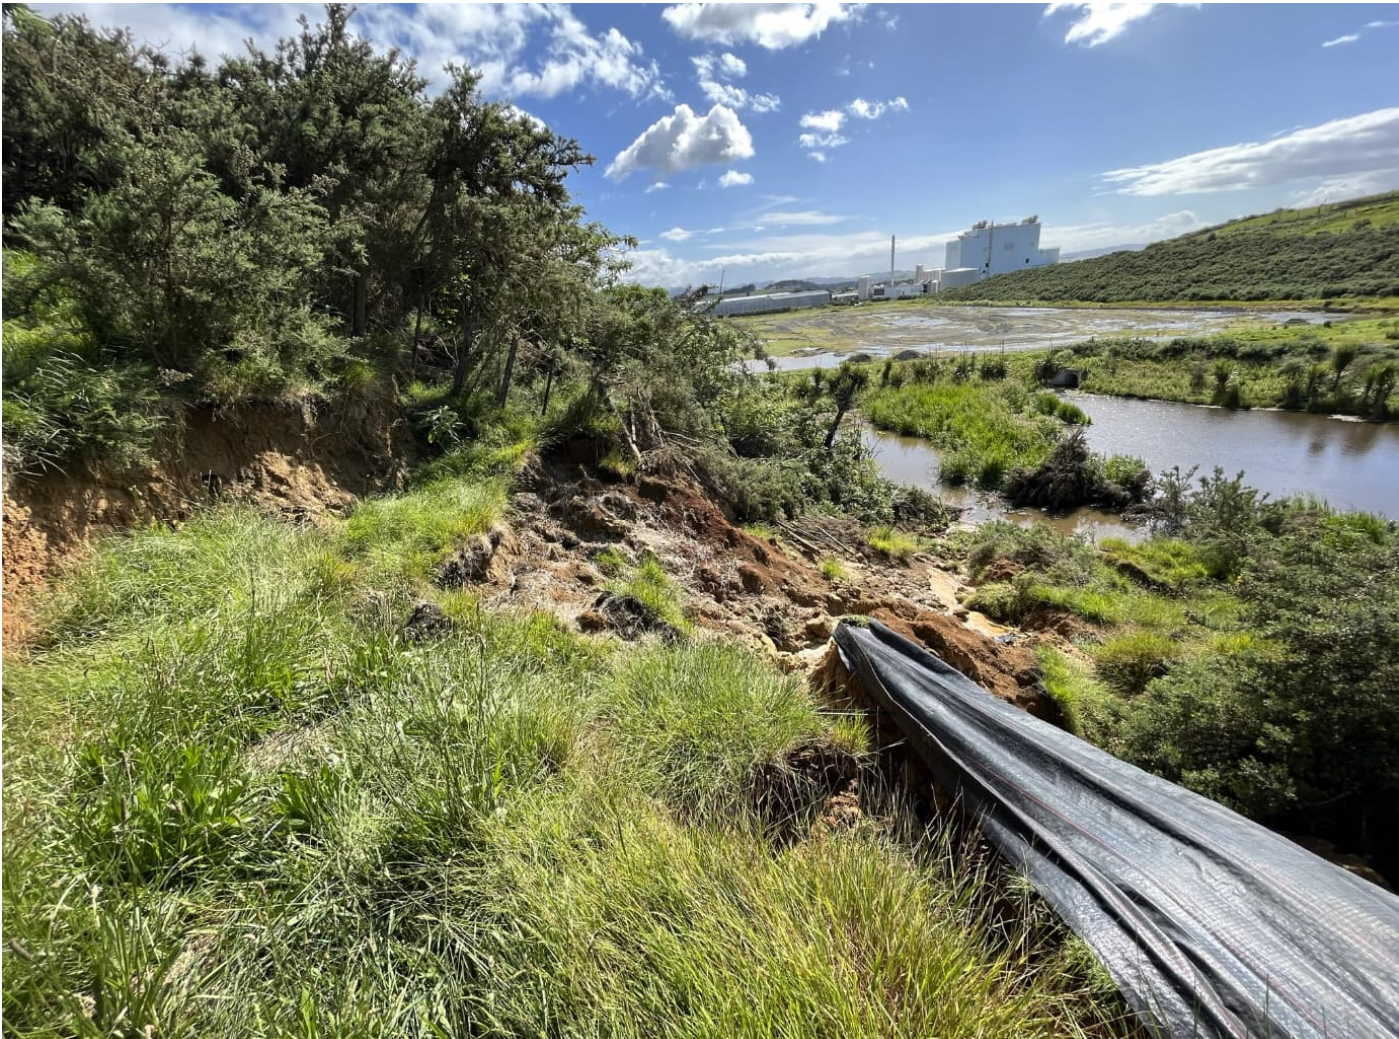
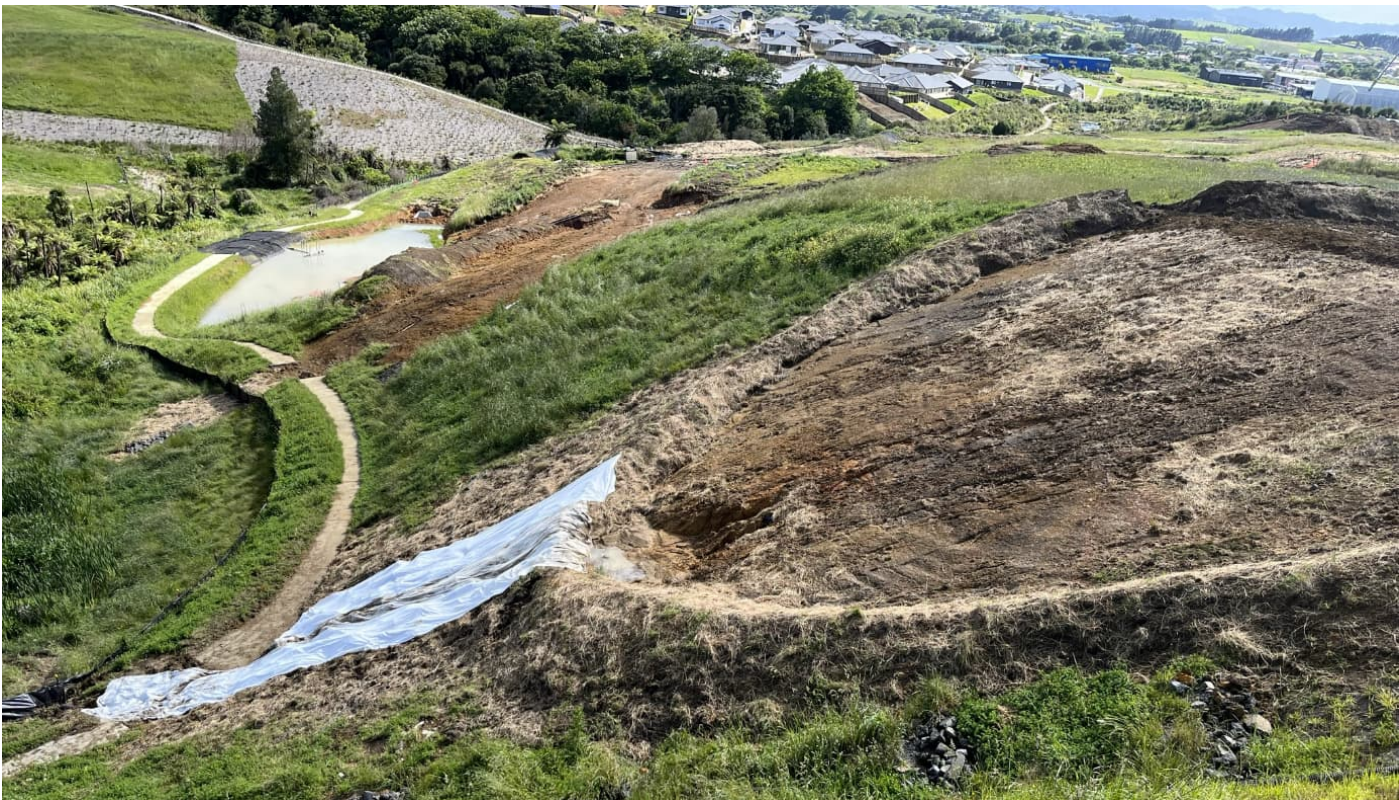
- REB 1 appears to have new vegetation growth within the face of the slope. Contractor advised that the face will be hydroseeded during the next fine weather window. They are aiming for today or tomorrow.
- Inspected the existing slip behind Lot 945. No additional movement appears to have happened since this was originally observed and assessed in September 2022. Groundwater was noted to be seeping from several points within the exposed transition materials.
- Contractor awaiting fine weather window to continue work on cutting the building platform within Lot 951.
- Inspected backfill along WWN1, which returned shear vanes in excess of 150kPa.
- Observed set out of 3x counterfort drains below Lot 925 with set out in accordance with our recommendations. Contractor advised a maximum distance between these drains of 7.5m applies at the upslope extent of the drains.

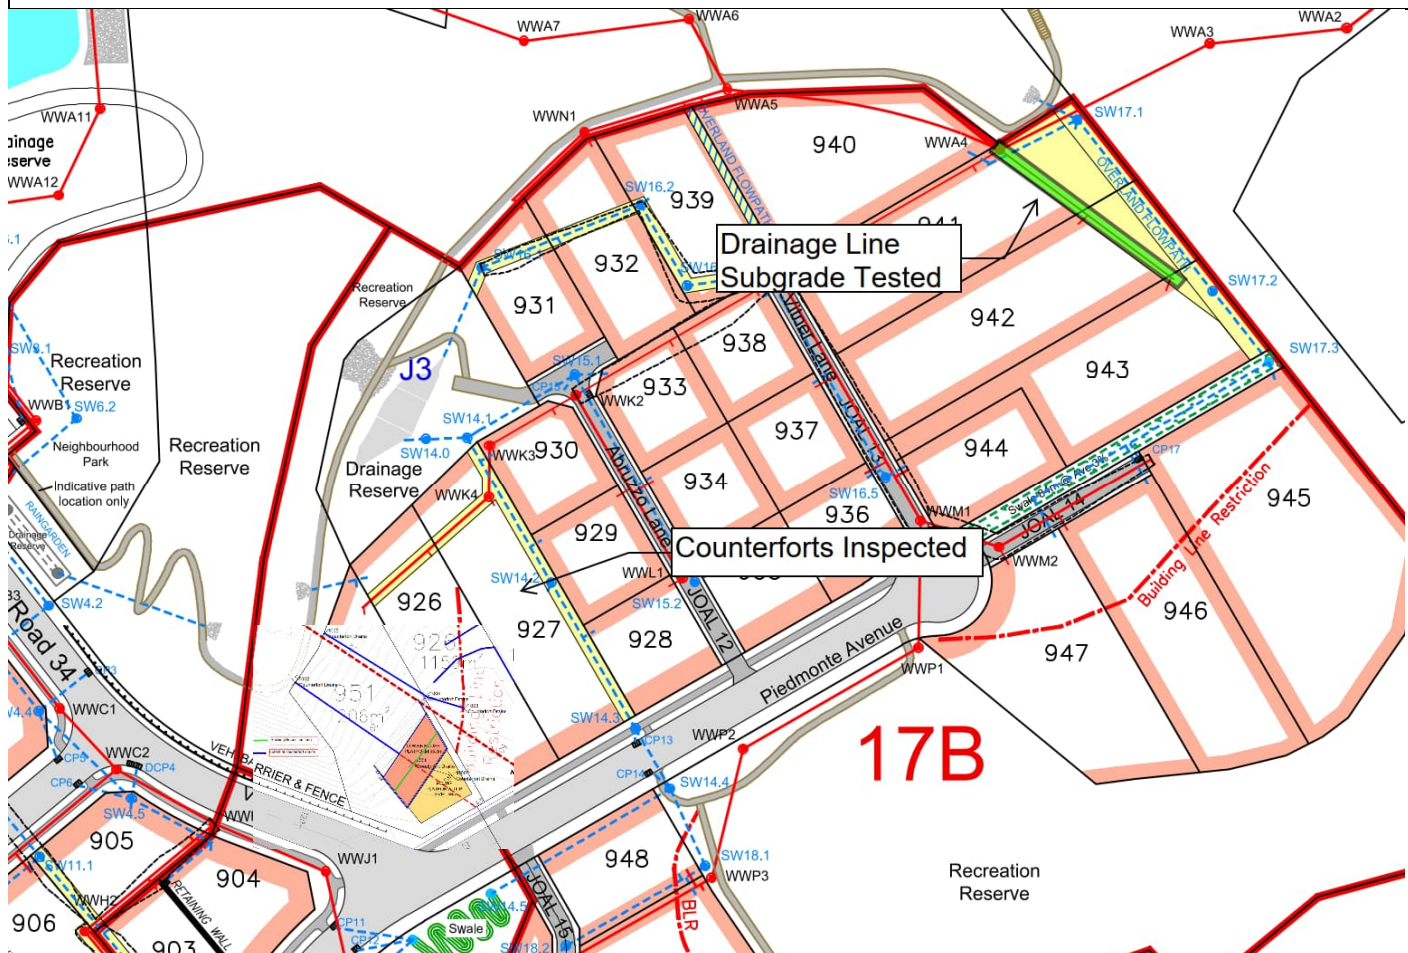
Counterfort construction in accordance with our design. Drainage line subgrade suitable for pipe placement.
