DFH Joint Venture Limited

GEOTECHNICAL COMPLETION REPORT

Hitchen Block Stage 18, Pokeno

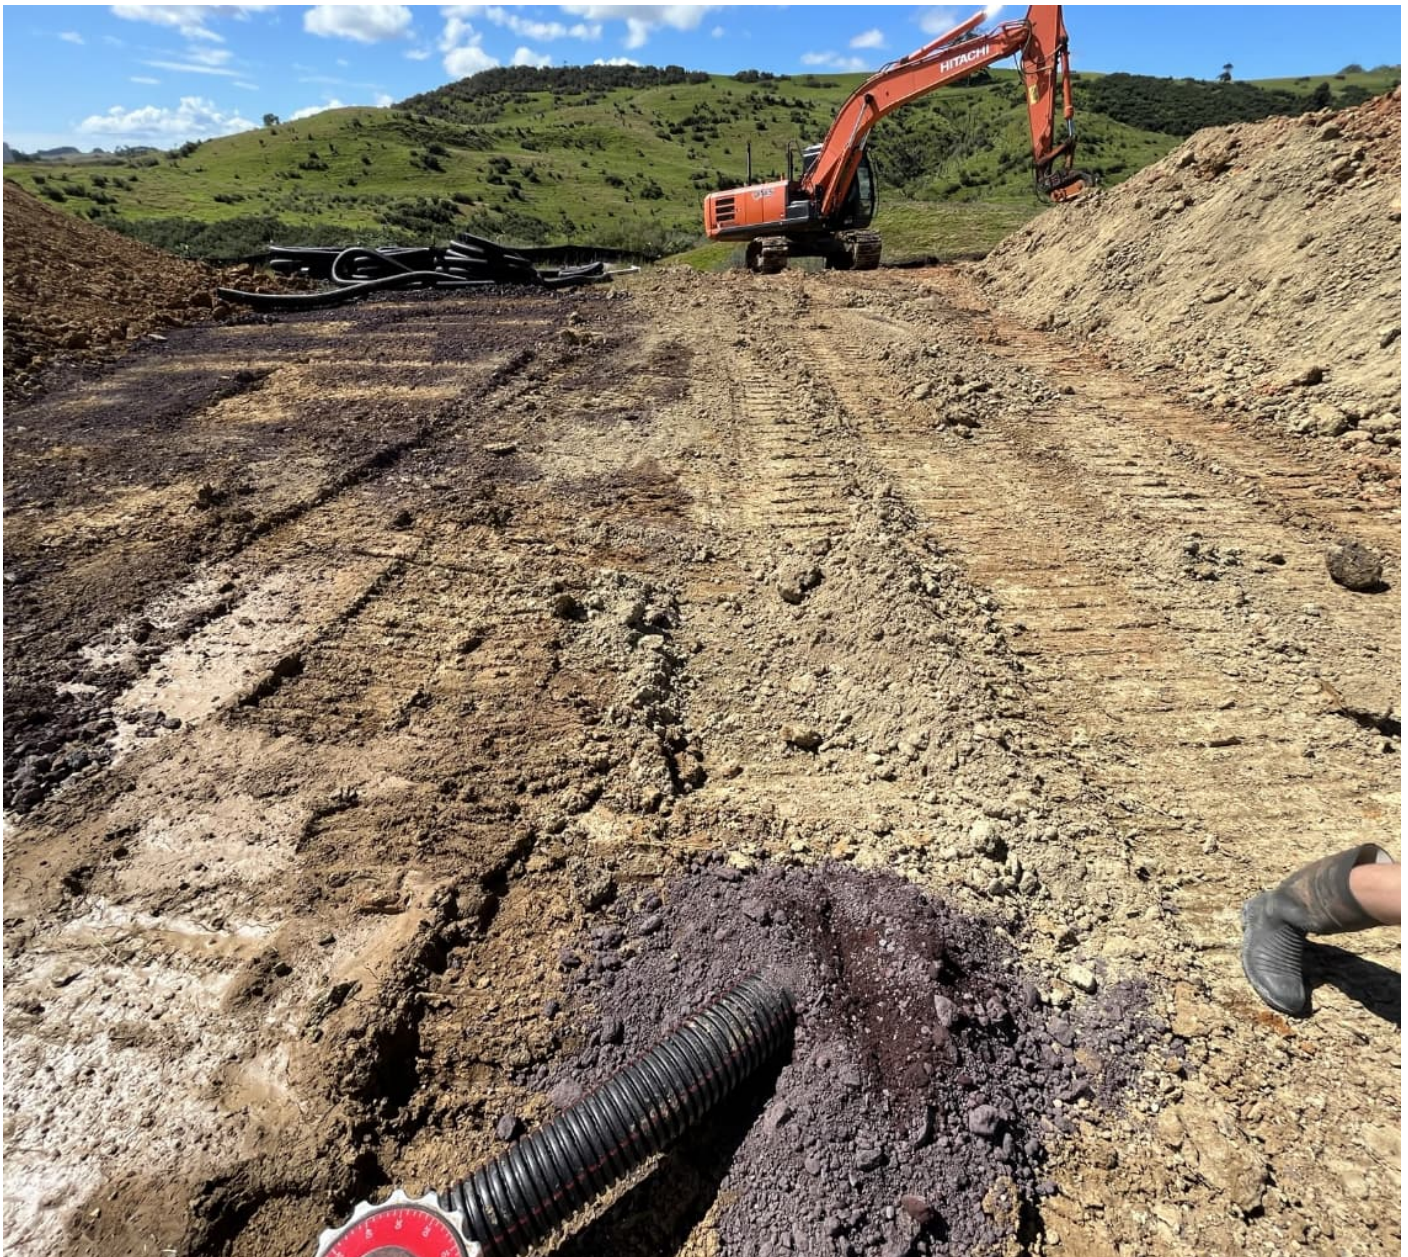
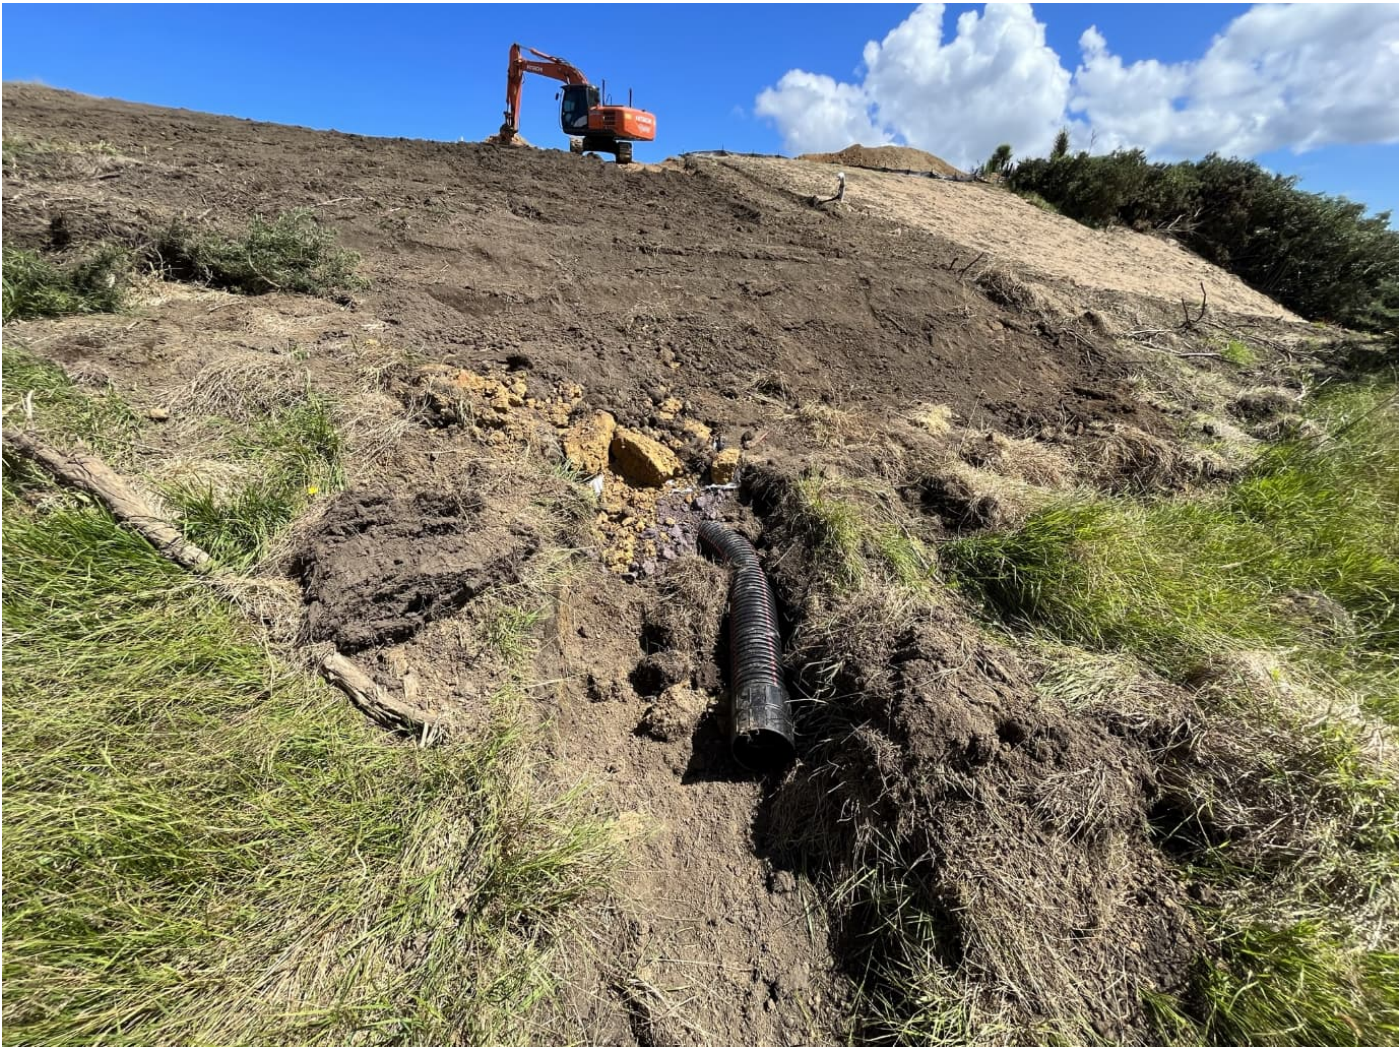
- Observed that contractor has completed Counterfort Drain 8. Contractor to provide photos for us to review.
- Observed that permanent outlets have not yet been formed for the counterfort drains, not solid pipes installed at the outlet position. Contractor advised these will be completed nearer to completion of the stage.

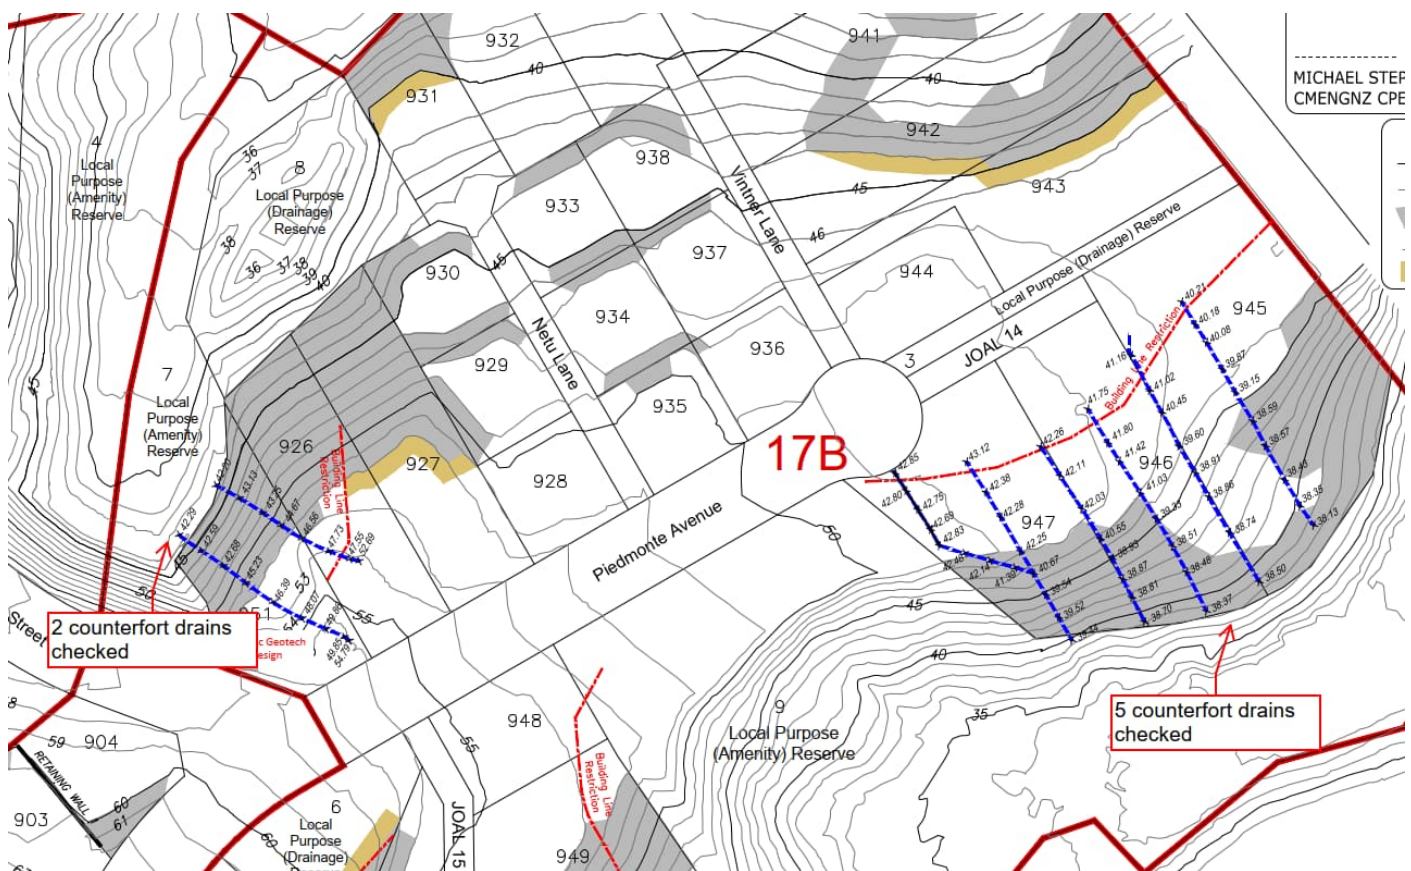
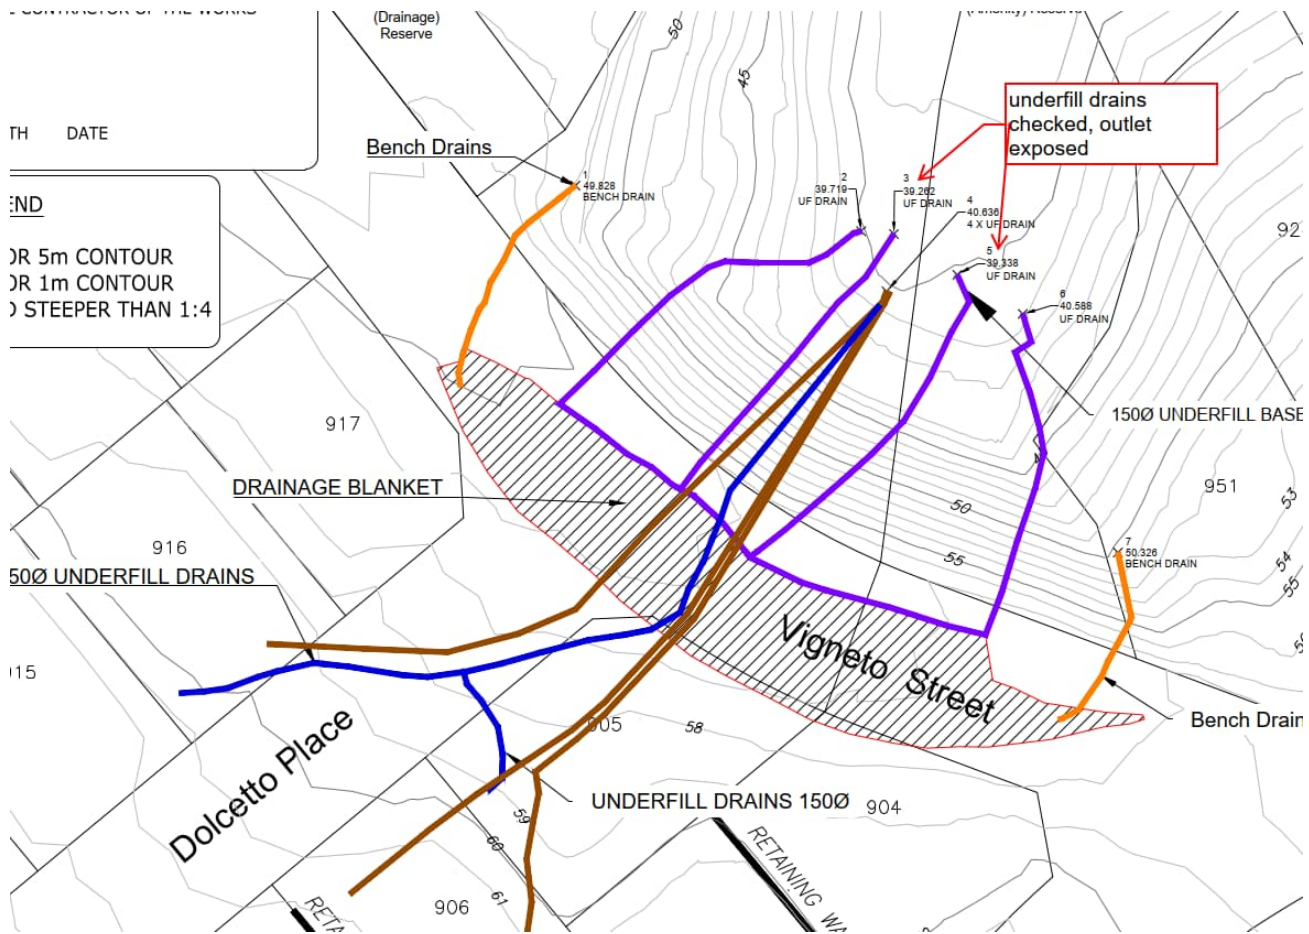
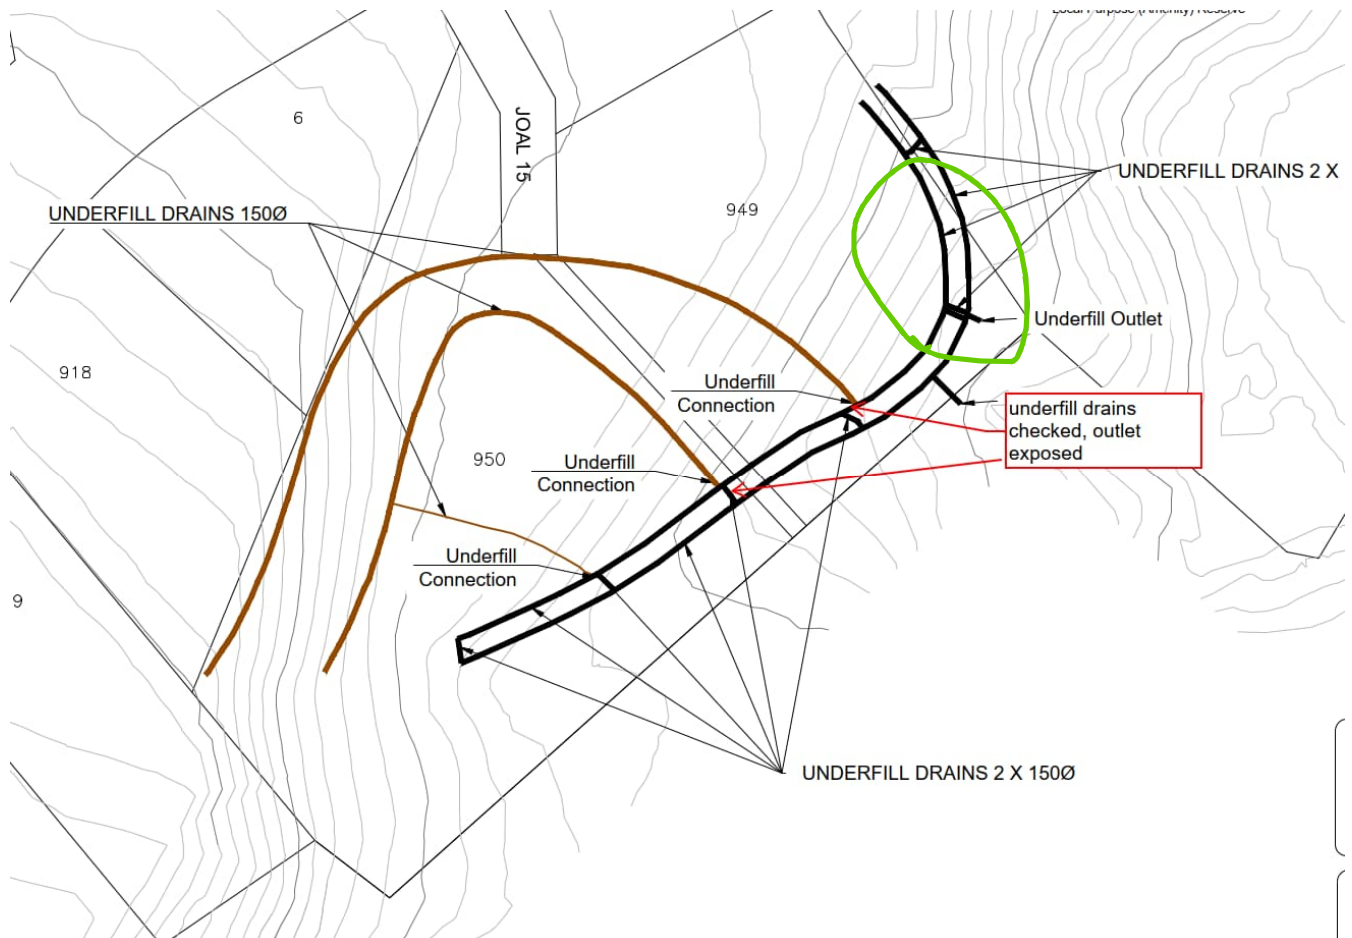
Inspected 7 counterfort drains flushing at above site (refer to plan below).

- All counterfort drains function properly as per design. Water outlet observed at the end of the drains.
- Checked underfill drain at the toe of REB1, contractor exposed the outlets and cleared debris
- Checked underfill drain in lots 949 and 950, contractor exposed the outlets and placed boulders at the outlet.

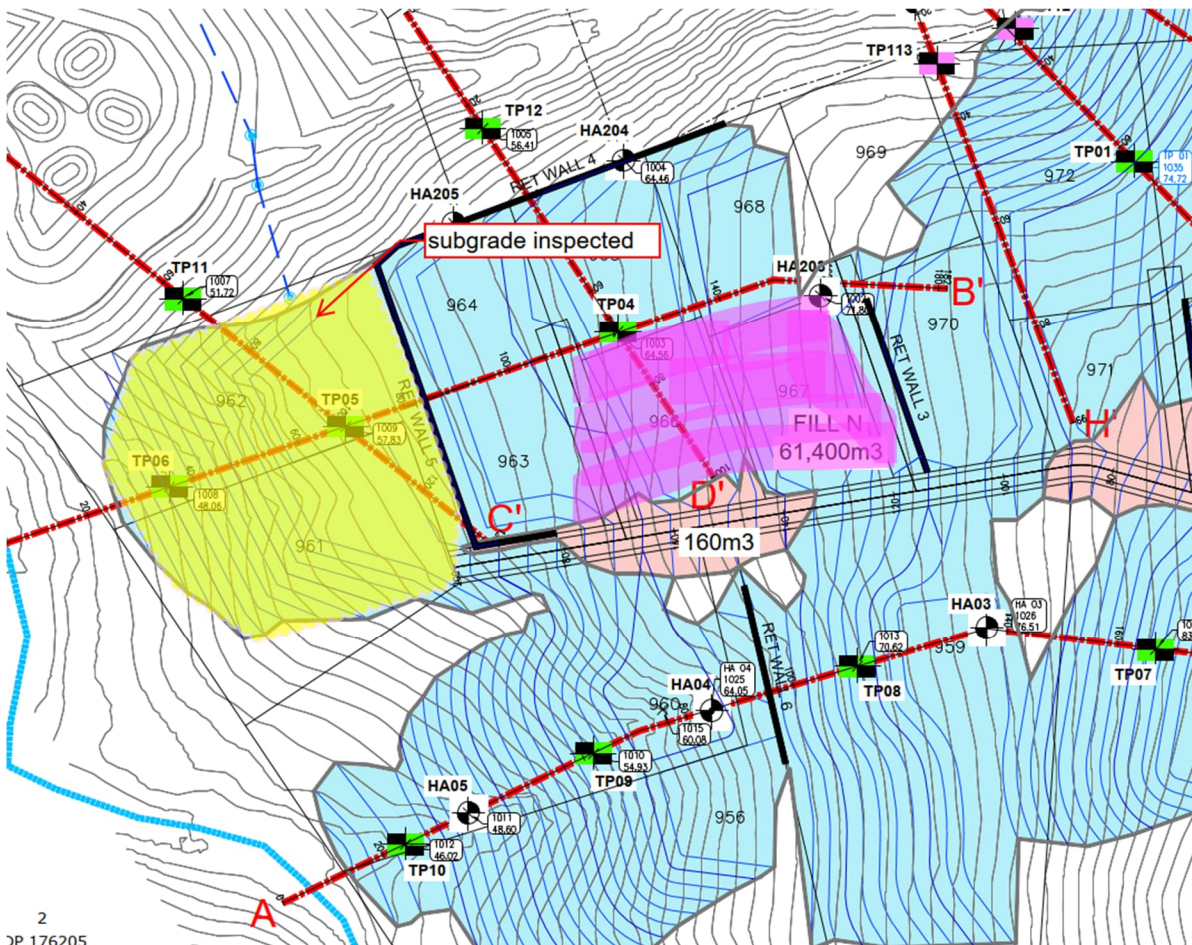
- Area highlighted in pink:
 - Ground revealed engineered fill. Contractor noted this area is near finished level and will be ready for topsoil placement once the minor trimming is completed. We consider the ground conditions are suitable for topsoil placement.
- Area highlighted in yellow:
 - Contractor has placed clay fill prior to our stripped subgrade inspection.
 - Several shallow hand augers were conducted, the ground revealed 400-500mm of clay fill and competent natural ground is found below.
 - Shear vane readings within the natural ground were in excess of 100kPa.
 - We consider the clay fill is suitable to remain. Recommended the contractor to contact us prior to bulk filling.

Subgrade near finished level

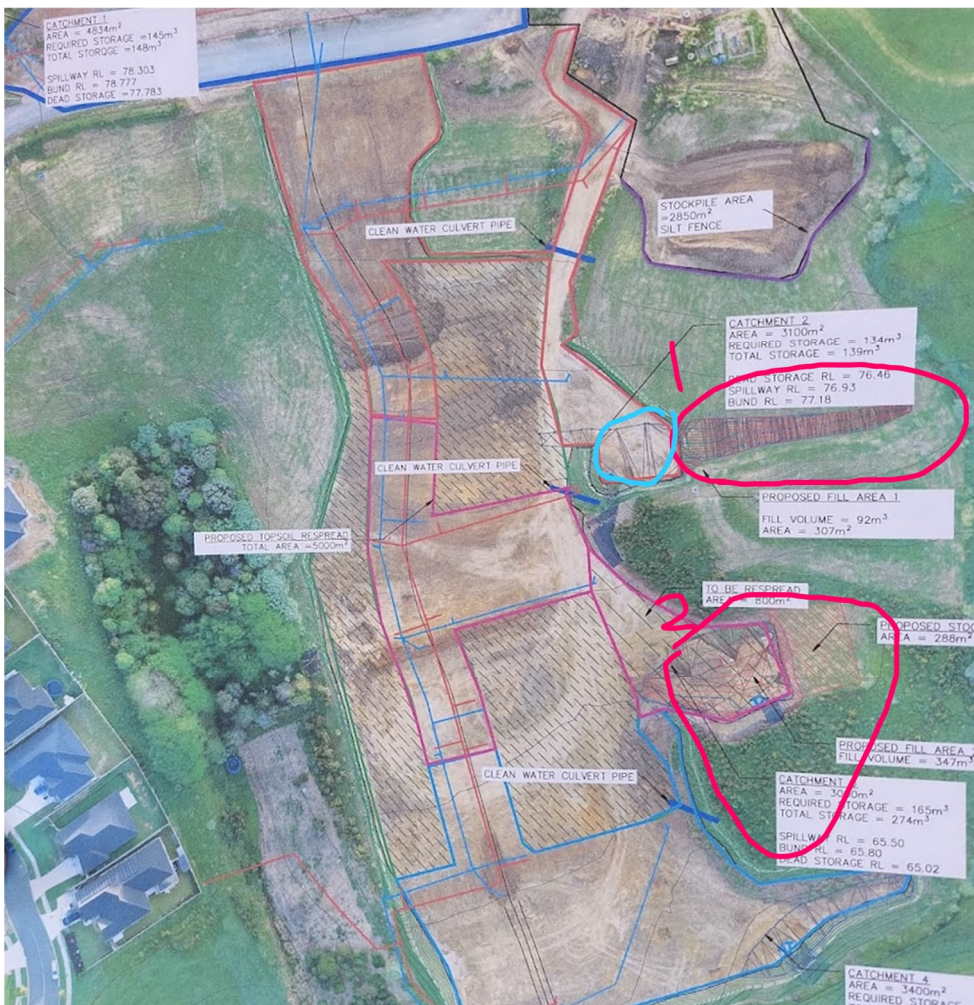
- Proposed earthwork areas (circled in red on below plan)
 - Contractor noted they have excess fill and propose to lose the fill in these areas.
 - The site profile is steep (greater than 1v in 4h), we requested the contractor to provide the proposed long section of the area for our stability check.

- Update 8 Nov 24: Contractor noted they do not plan to open up the area at this stage. The only filling involved will be within the area circled in blue. This is to make the ground level with the adjacent area. The fill depth is no more than 300mm. We consider this area is appropriate to place fill upon.

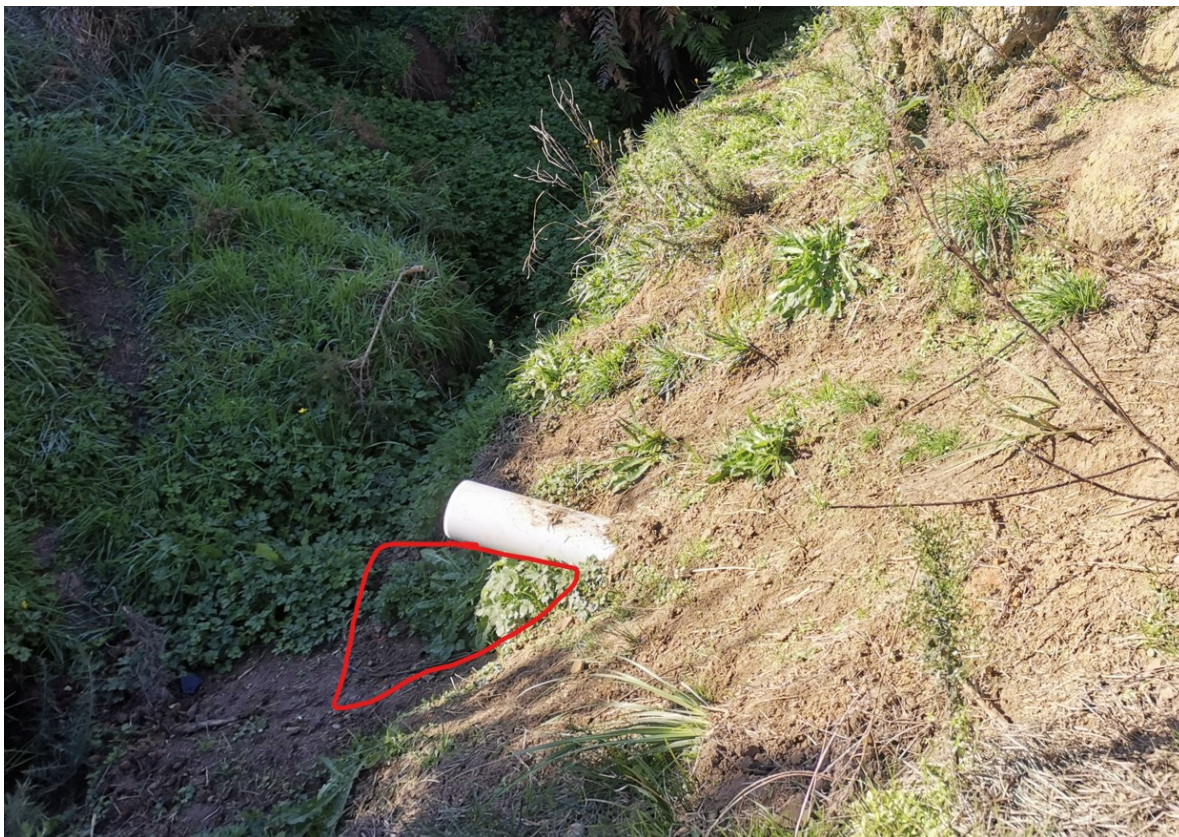
Below the topsoil bund in Stage 18 there is a vertical face of soil that looks to be held up with a silt fence currently (just below the red line shown below, near the farm fence). This should be trimmed back to the design gradient if possible to avoid long-term failure?

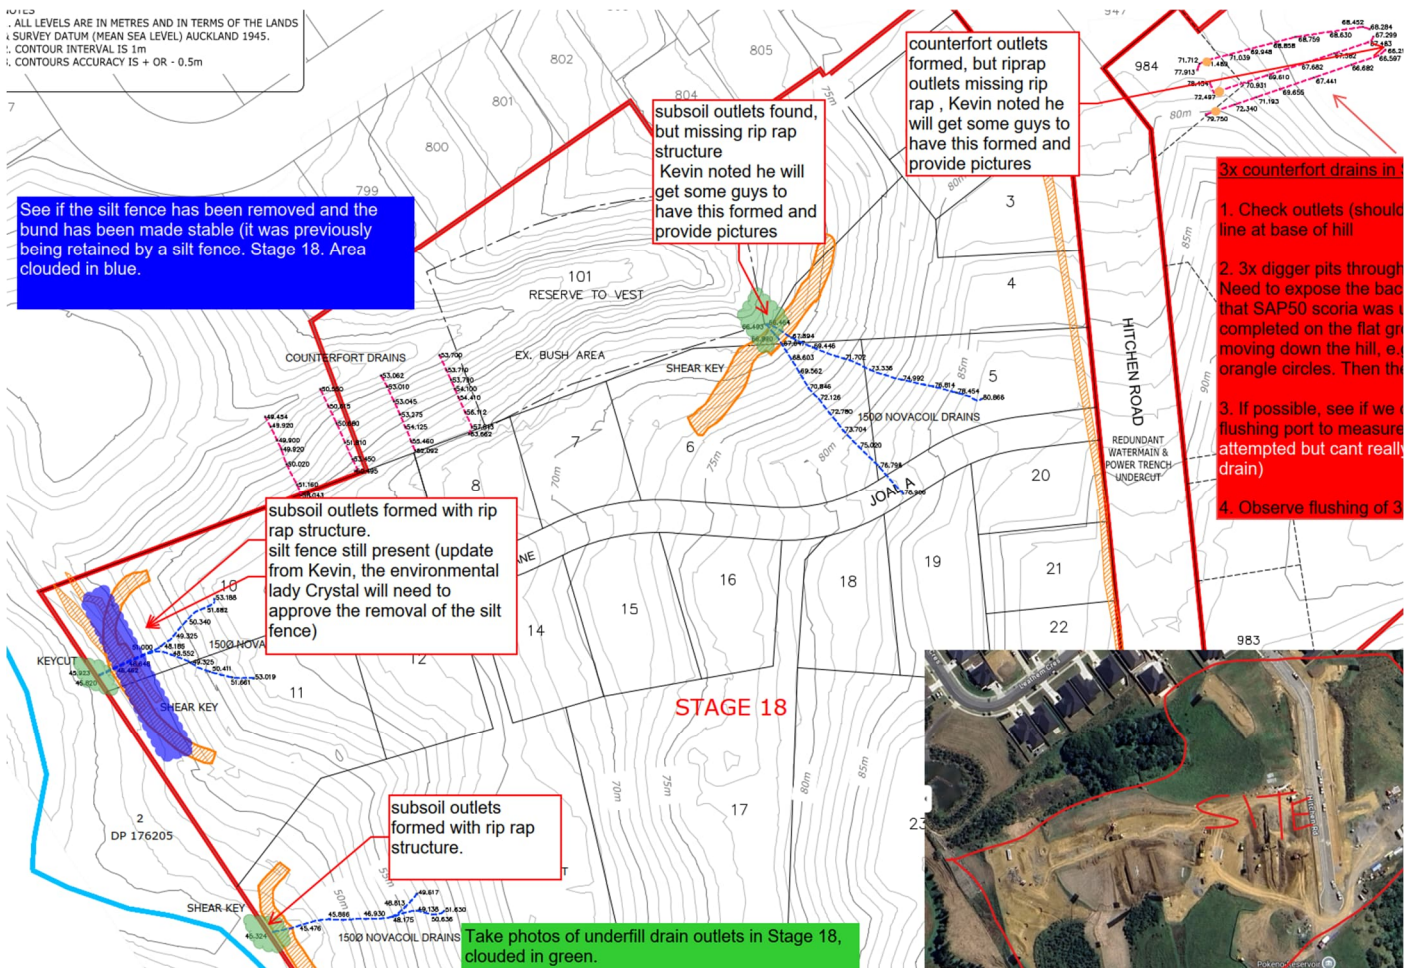
Visited site with Kevin to inspect the counterfort flushing and identifying the subsoil drain outlets. Refer to below site plan annotation.

- Three pits were conducted to expose the caps. Scoria was present below the cloth.
- All three counterforts flushed.
- Riprap structures are required at the outlets for all counterfort drains and the subsoil within lot 4.
- Contractor advised the silt fence installed will require environmental engineer approval prior to removal.

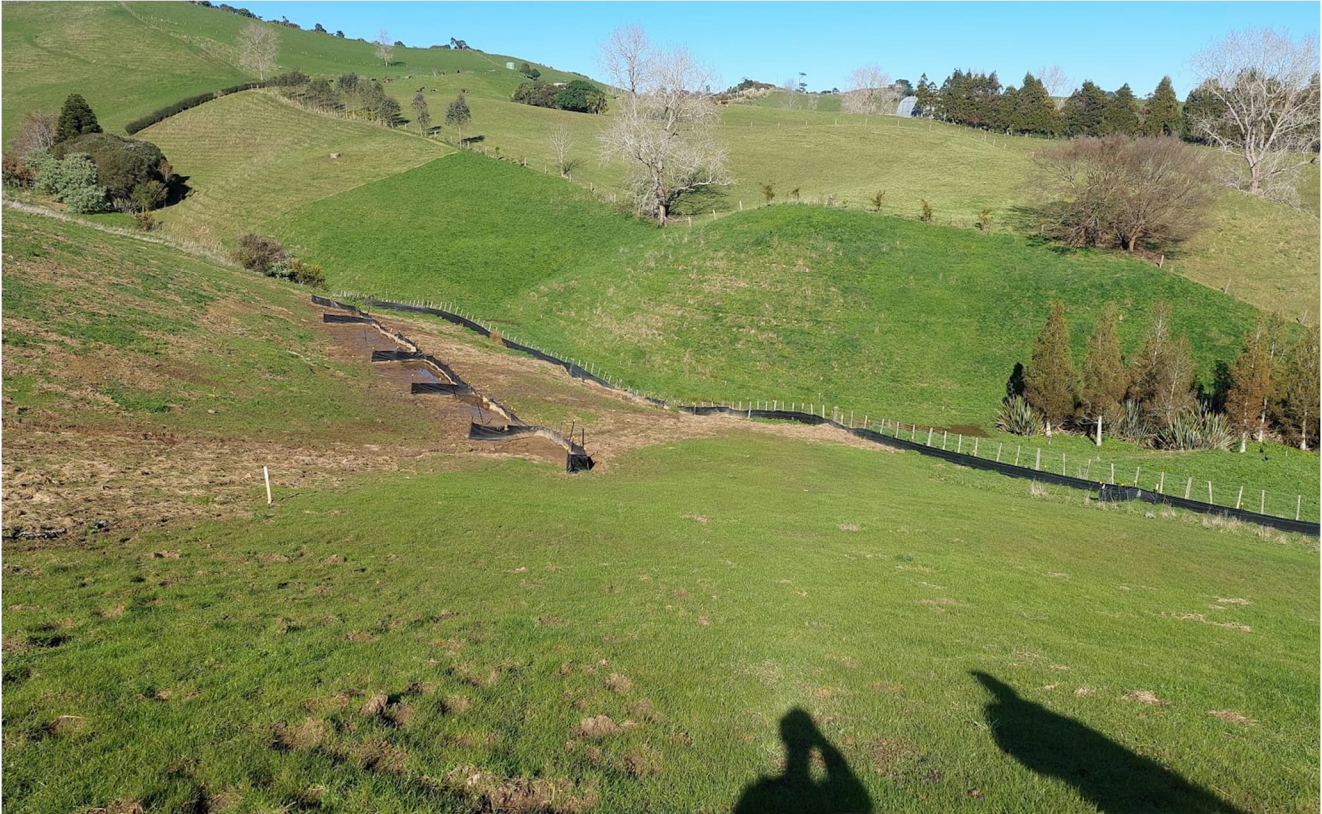
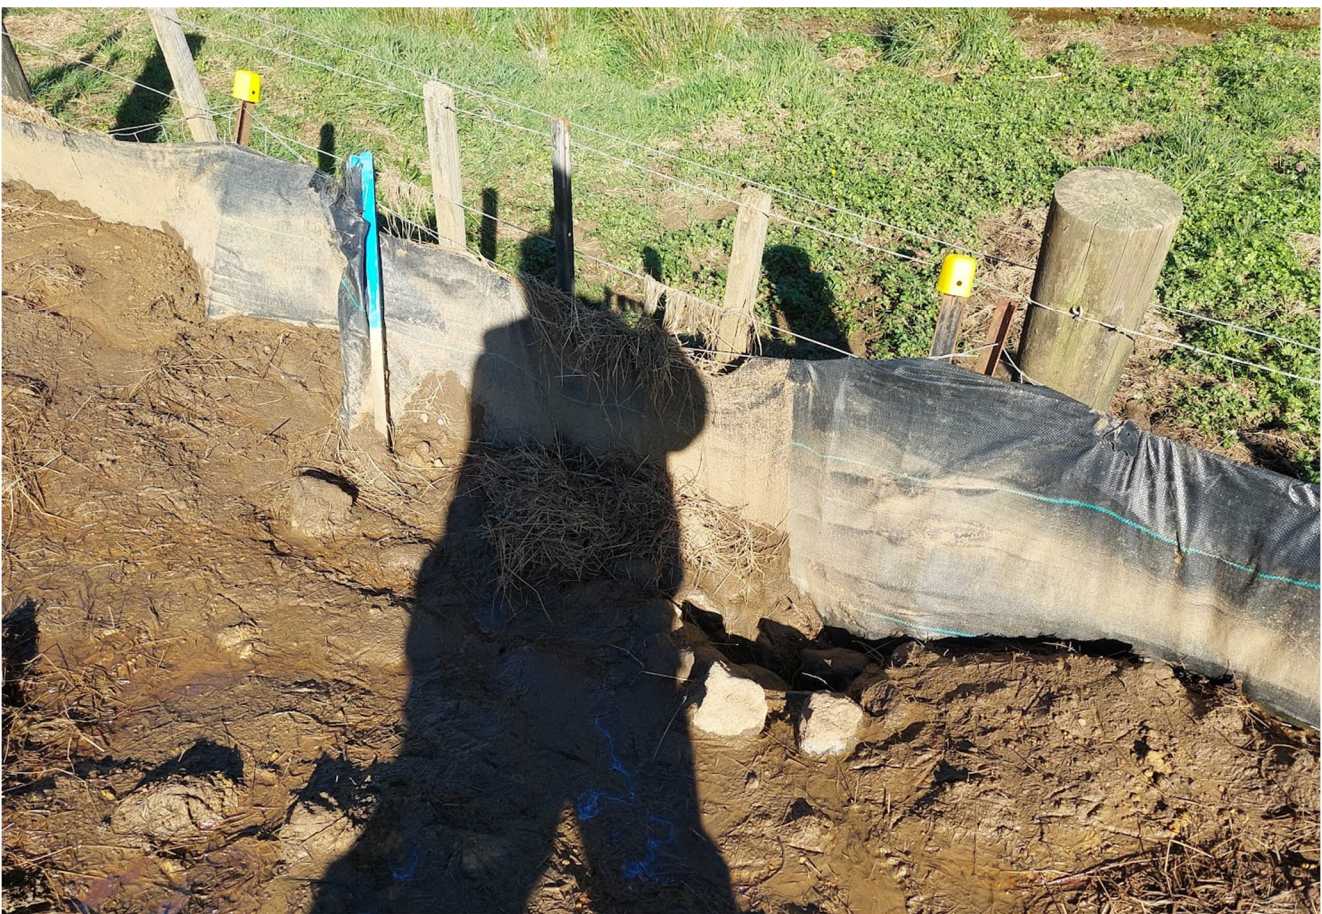
Most southern subsoil outlet (lot 13 subsoil outlet): located behind the silt fence with riprap formed. The outlet is currently sitting behind the silt fence. Kevin noted the outlet may need to be reformed once the silt fence is removed.
