DFH Joint Venture Limited

GEOTECHNICAL COMPLETION REPORT

Hitchen Block Stage 19, Pokeno

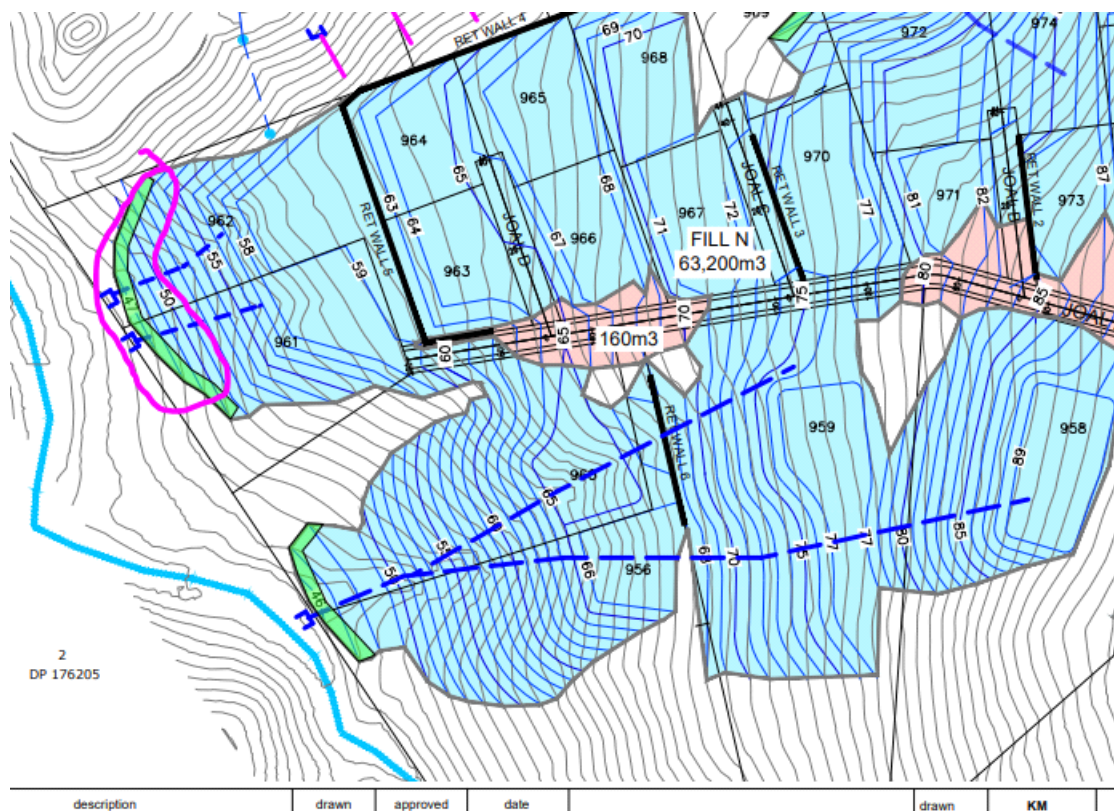
Observed excavation of toe key at least 1m below original ground level as per purple outline on the annotated plan below. Advised contractor to bench the sides and then fill compaction with clay can commence. Also advised that the underfill drains be installed as per our detail and should not extend beyond the lower retaining wall.

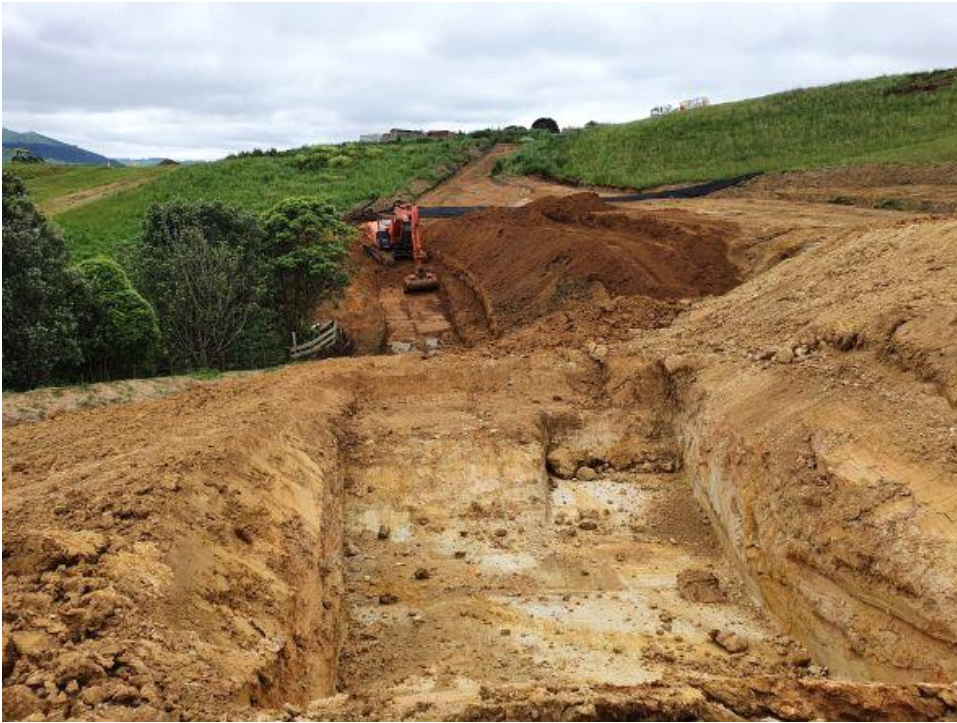
Observed excavation of toe key at least 1m below original ground level as per red and blue outline on the annotated plan below.

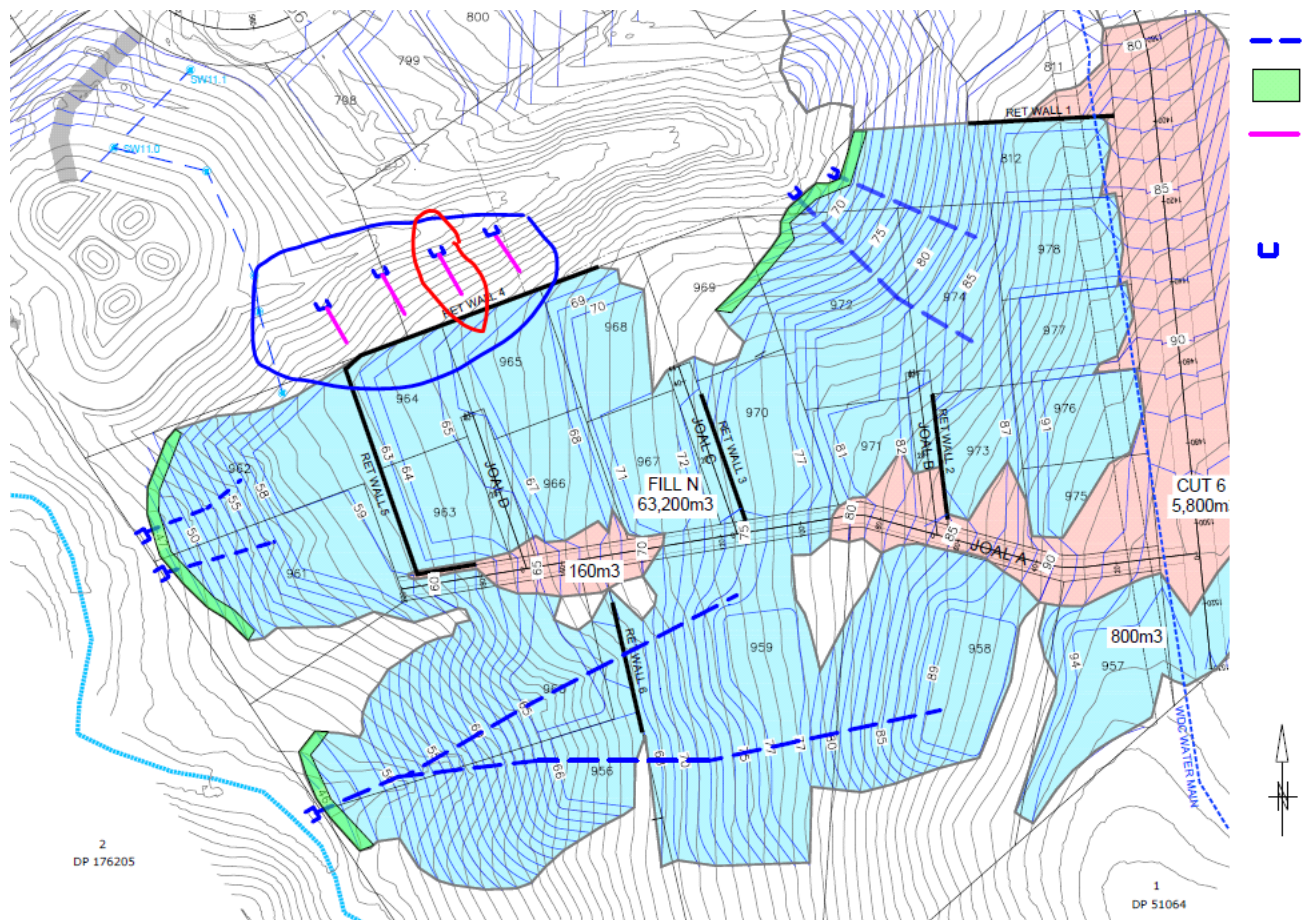
Observed flushing of 1 x drain (circled red below) - remaining drains to be flushed tomorrow following pre-soaking.

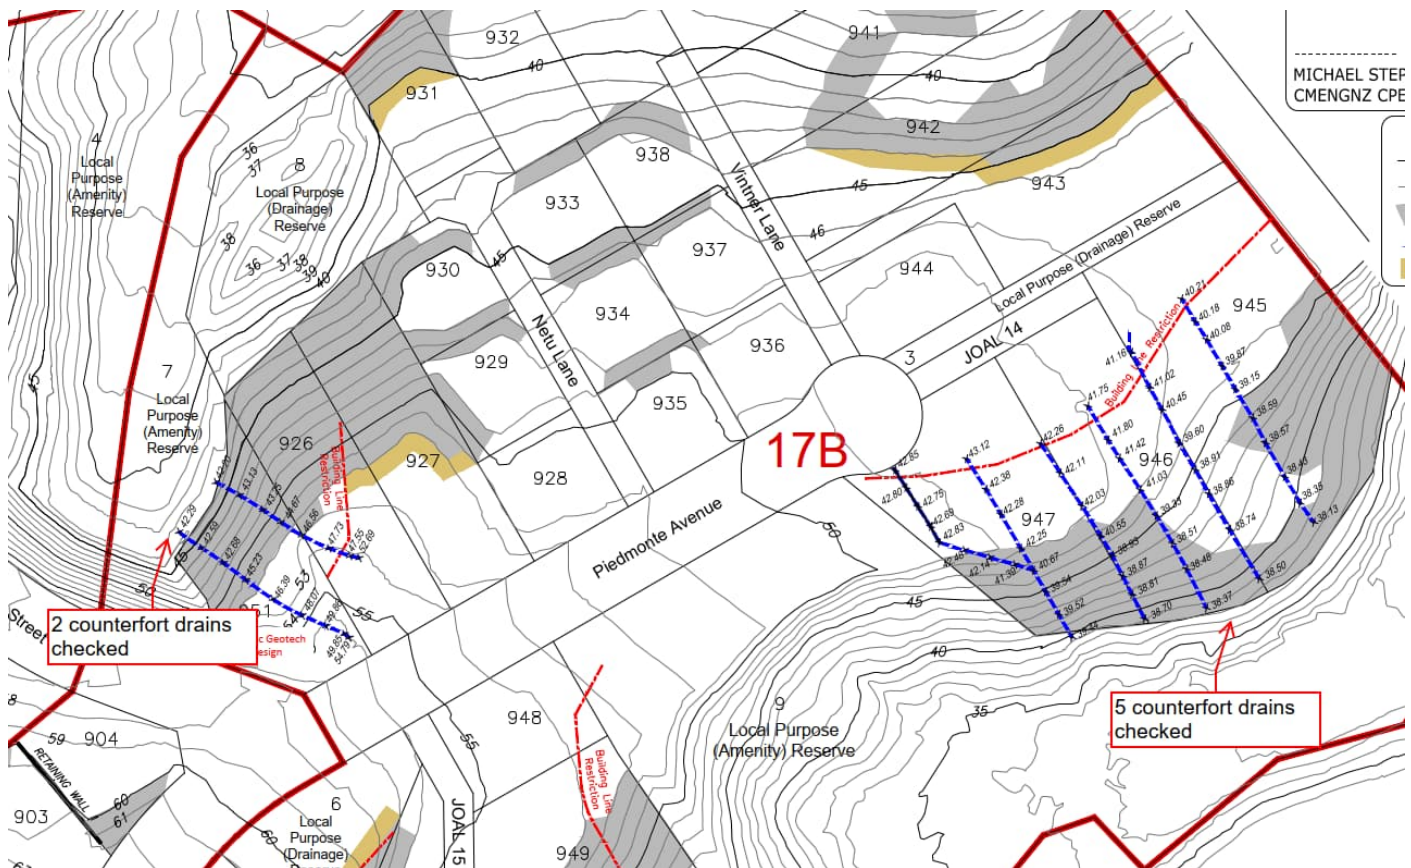
Inspected 7 counterfort drains flushing at above site (refer to plan below).

- All counterfort drains function properly as per design. Water outlet observed at the end of the drains.
- Checked underfill drain at the toe of REB1, contractor exposed the outlets and cleared debris
- Checked underfill drain in lots 949 and 950, contractor exposed the outlets and placed boulders at the outlet.

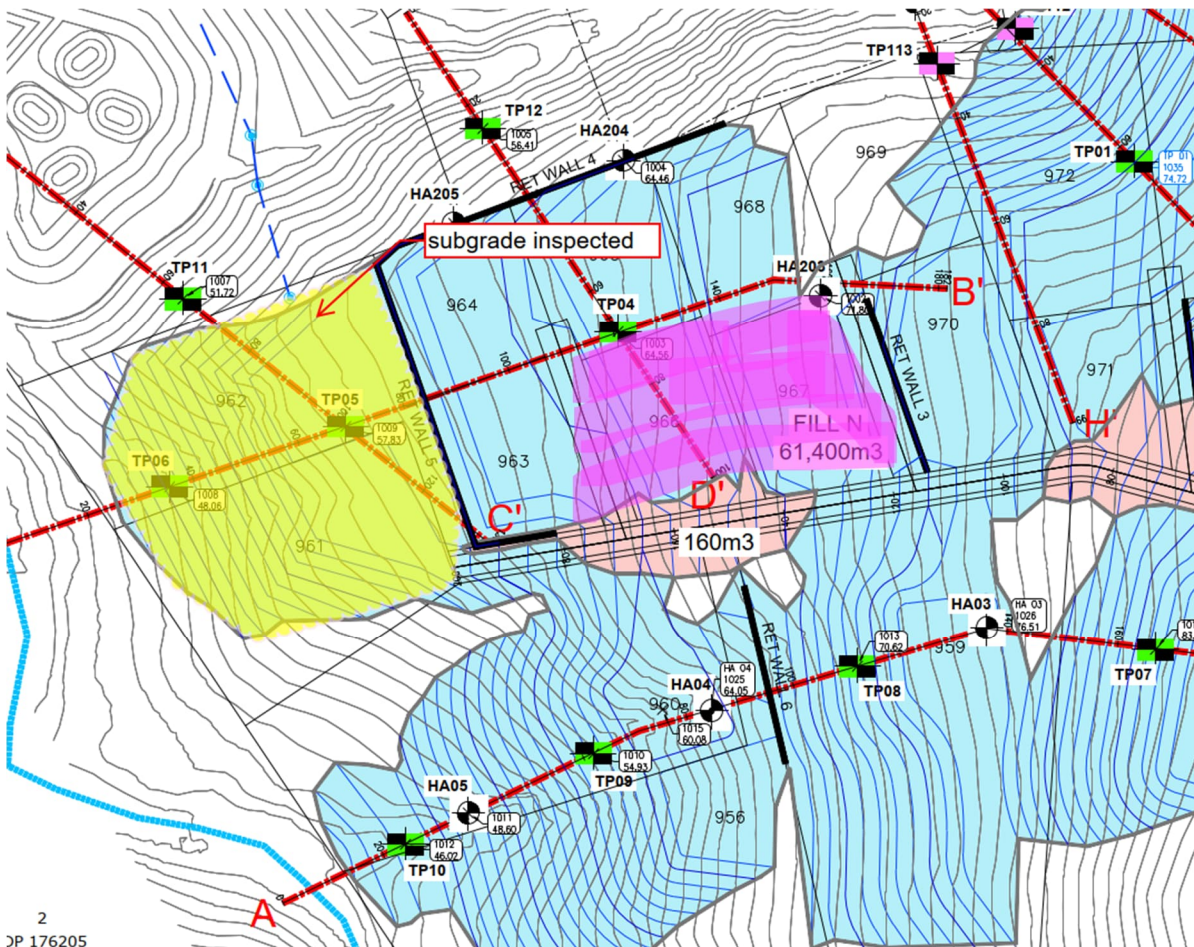
- Area highlighted in pink:
 - Ground revealed engineered fill. Contractor noted this area is near finished level and will be ready for topsoil placement once the minor trimming is completed. We consider the ground conditions are suitable for topsoil placement.
- Area highlighted in yellow:
 - Contractor has placed clay fill prior to our stripped subgrade inspection.
 - Several shallow hand augers were conducted, the ground revealed 400-500mm of clay fill and competent natural ground is found below.
 - Shear vane readings within the natural ground were in excess of 100kPa.
 - We consider the clay fill is suitable to remain. Recommended the contractor to contact us prior to bulk filling.

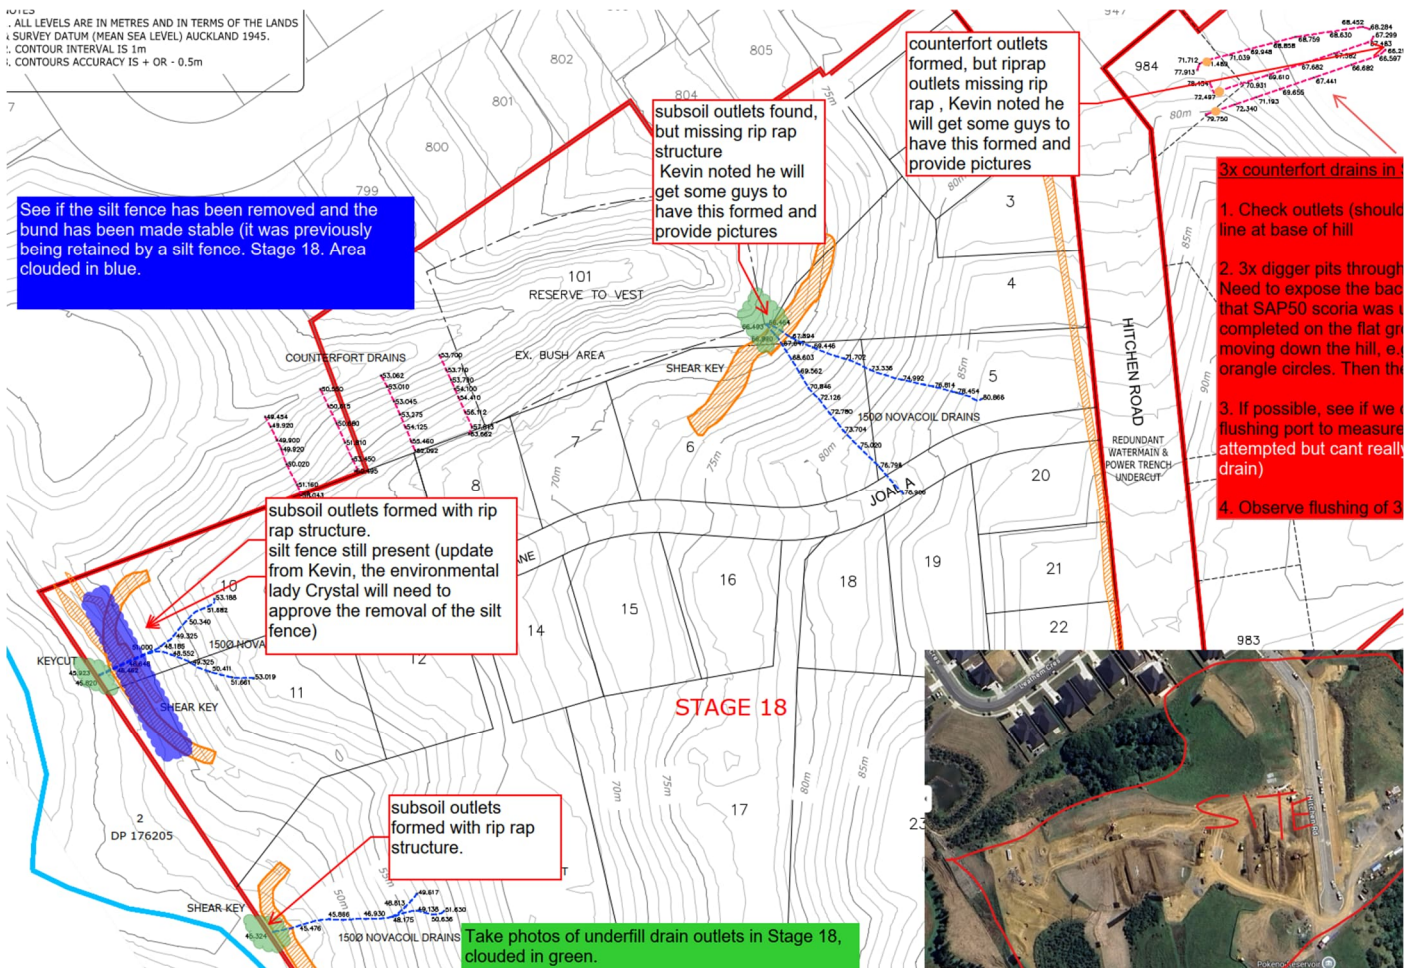
Visited site with Kevin to inspect the counterfort flushing and identifying the subsoil drain outlets. Refer to below site plan annotation.

- Three pits were conducted to expose the caps. Scoria was present below the cloth.
- All three counterforts flushed.
- Riprap structures are required at the outlets for all counterfort drains and the subsoil within lot 4.
- Contractor advised the silt fence installed will require environmental engineer approval prior to removal.

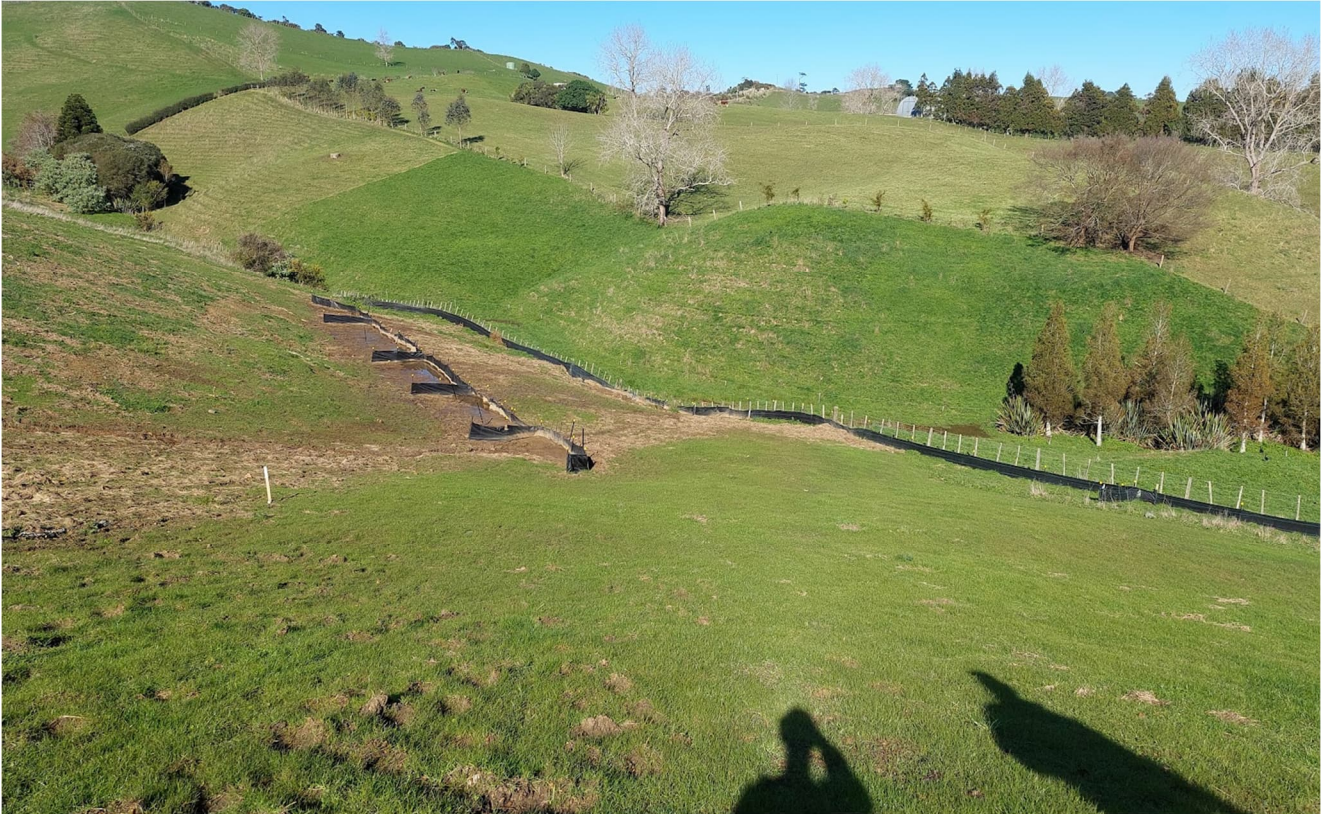
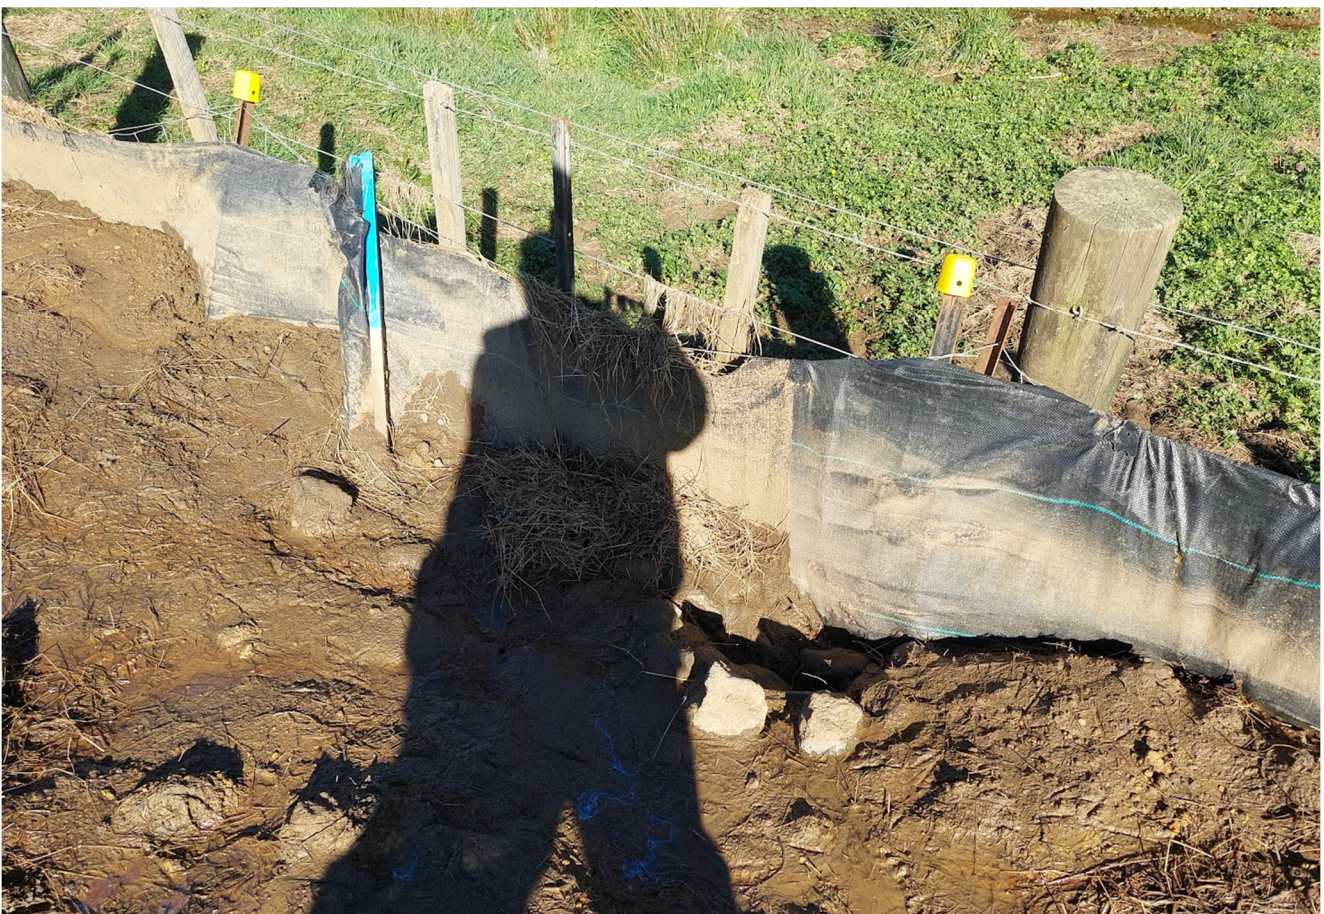
Most southern subsoil outlet (lot 13 subsoil outlet): located behind the silt fence with riprap formed. The outlet is currently sitting behind the silt fence. Kevin noted the outlet may need to be reformed once the silt fence is removed.
