Geotechnical Completion Report

HITCHEN BLOCK STAGE 13B

17 January 2022

Ref No: J00113

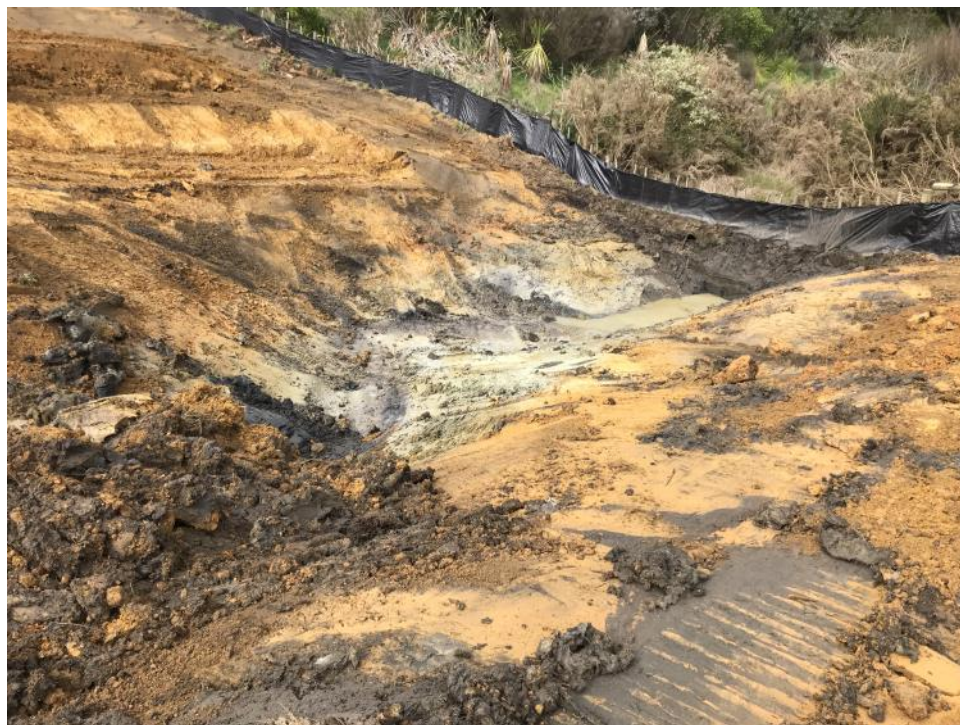
Small area of organics observed and contractor will chase this out.

Contractor also to install nominal toe key. Discussed with Trevor that this should be a buckets width wide at base and should extend across the face of the gully. Trevor to send photos once this is complete.

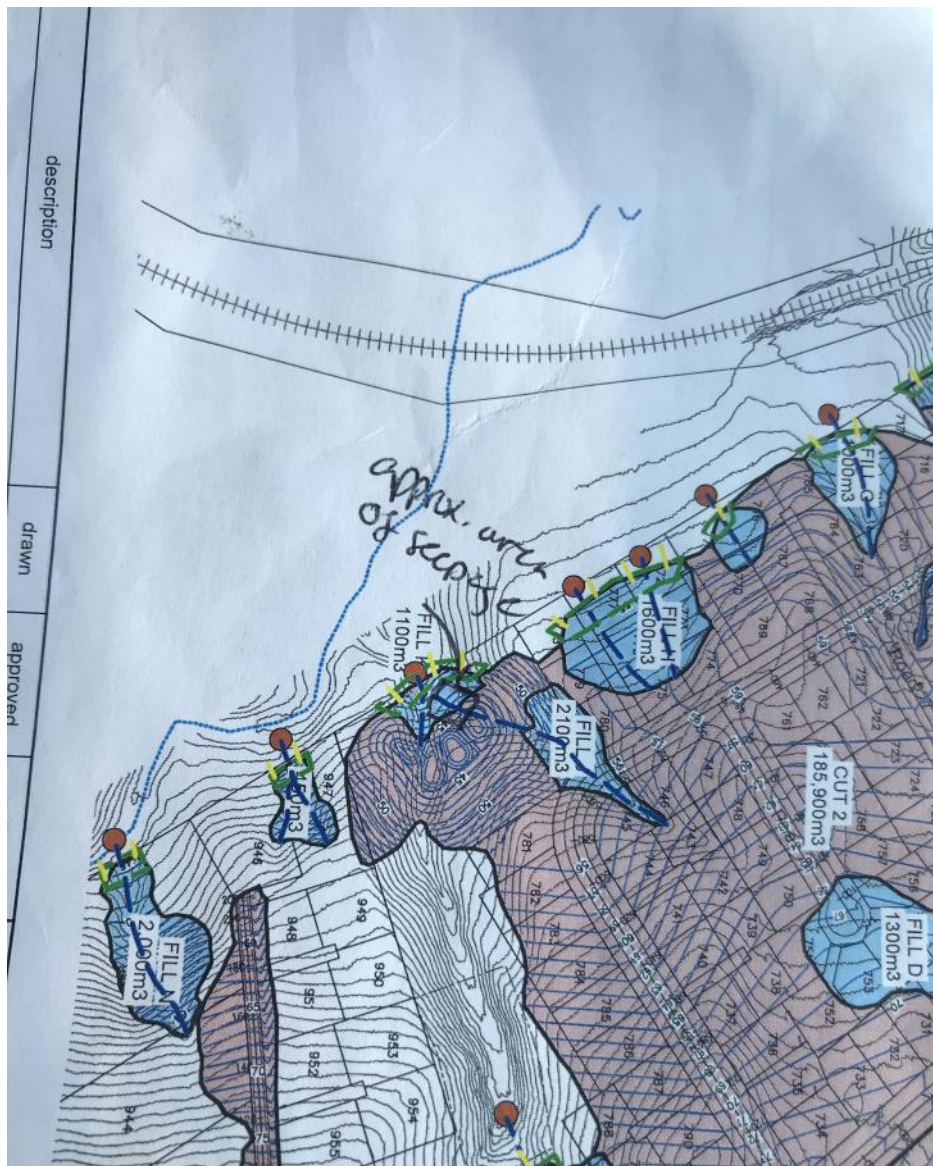
Visited site to observe gully muckout and drain installation. Muckout was deeper than our previous recommendation due to a 1m clay cap needed below the pond.

There is a small area of seepage near the base of the gully muckout which showed some seepage. We recommended that an extra drain is installed here to connect into the main underfill, ensure a 1m clay cap beyond the pond is satisfied. We will prepare a CAN detailing this.

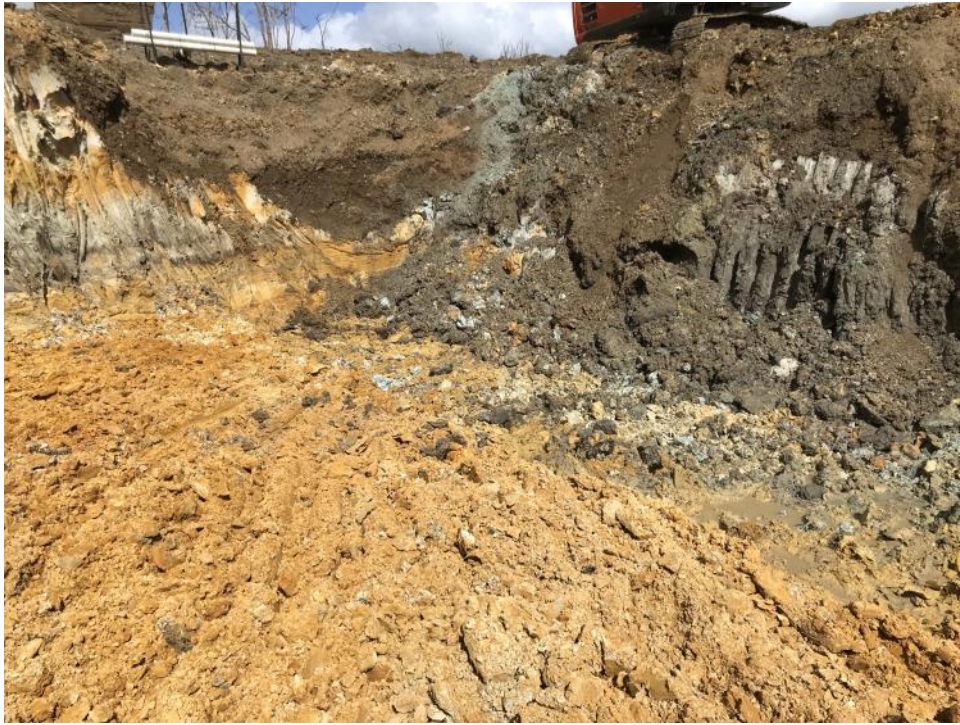
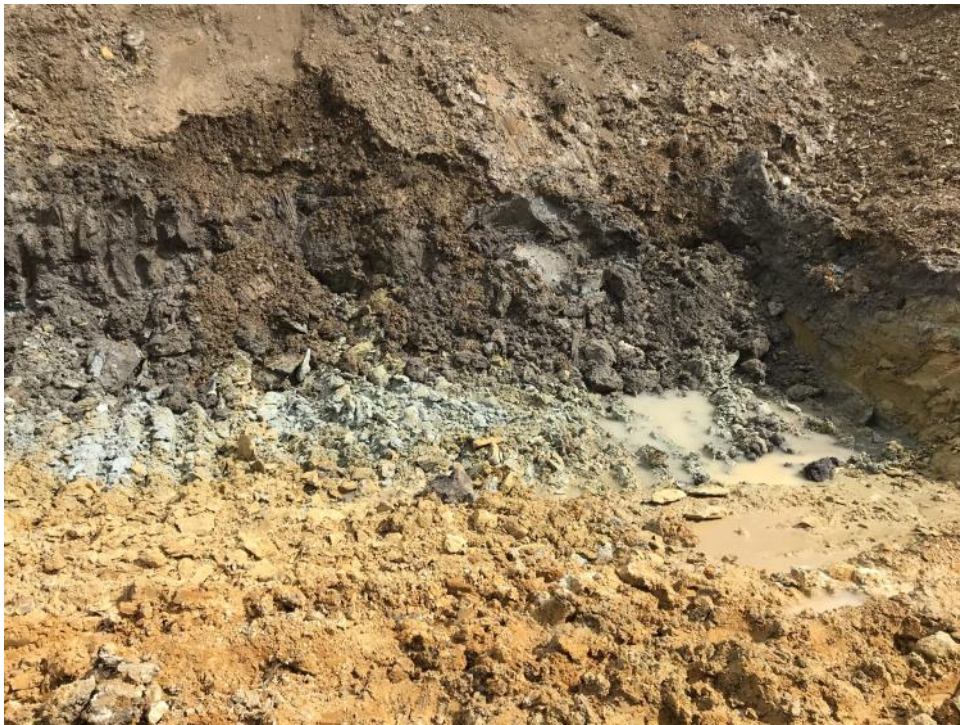
Sides of batter are also sub-vertical. Recommended these be battered to a safe angle to provide a safe working area below.

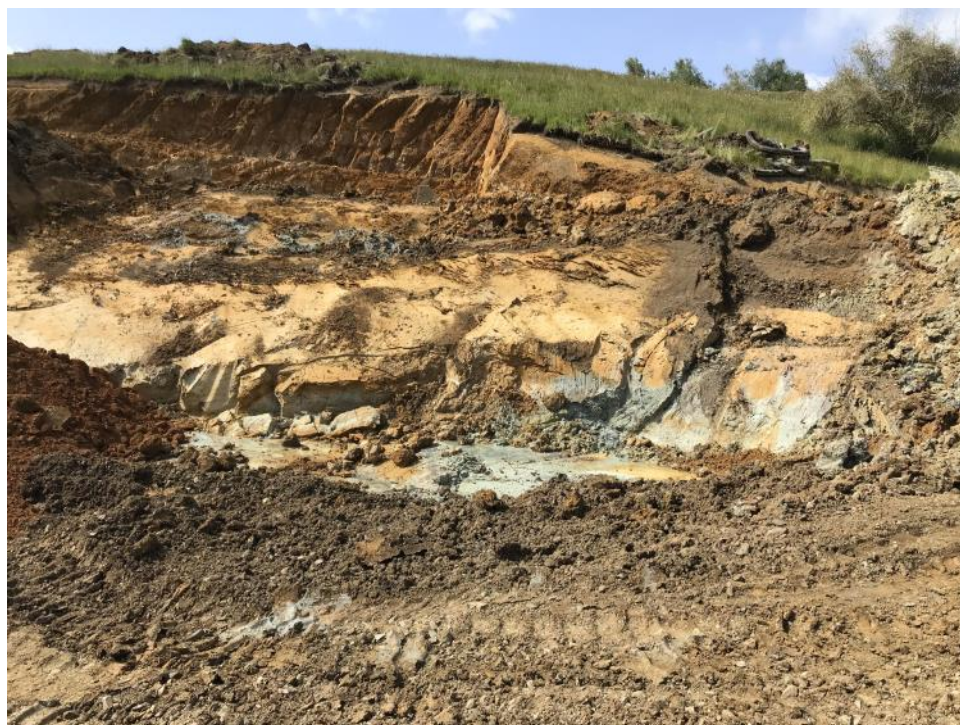
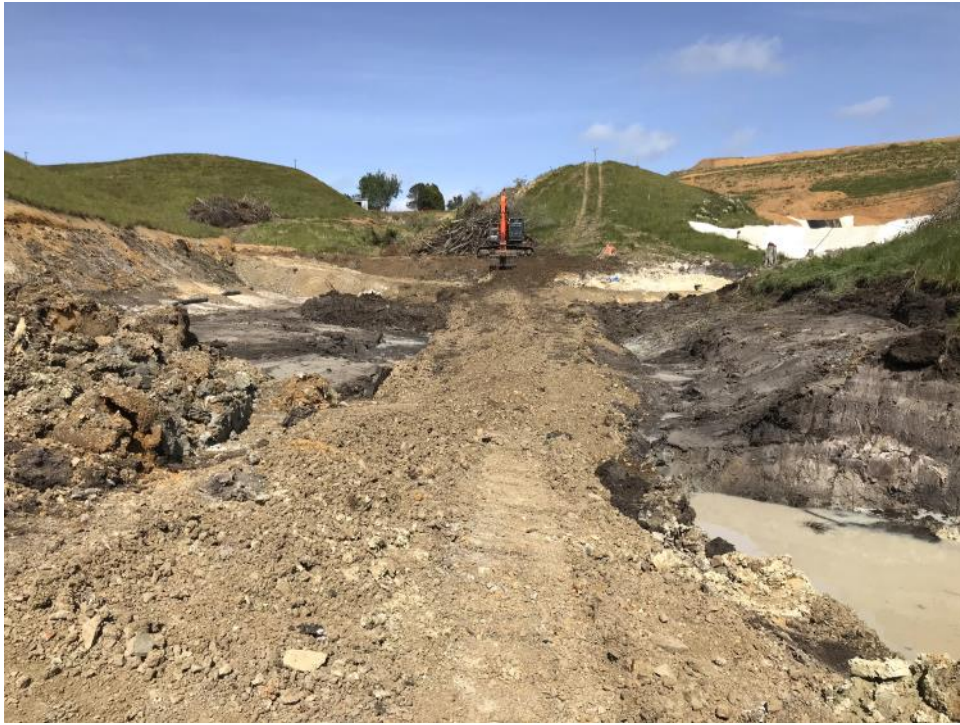
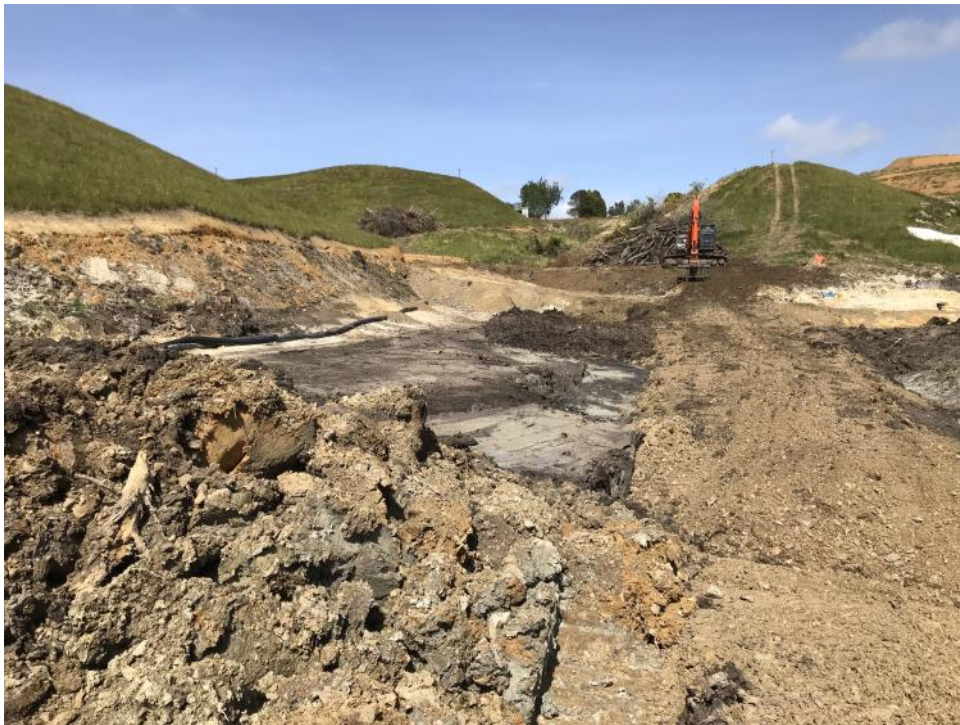
Ground had softened at the base of the pond due to water seepages. Recommended that a nominal undercut of say 0.2m to 0.5m be carried out (based on shallow hand augers drilled), ensuring the area remains drained (i.e. leave the pumps on while filling) to ensure the subgrade stays dry. We will need to inspect the final subgrade and so recommended this should be carried out in small stages with filling operations commencing immediately after we have seen the subgrade.

Also brought up the idea of laying some trenches to catch water seepages. I will discuss this with Chris later and prepare a CAN outlining our recommendations.

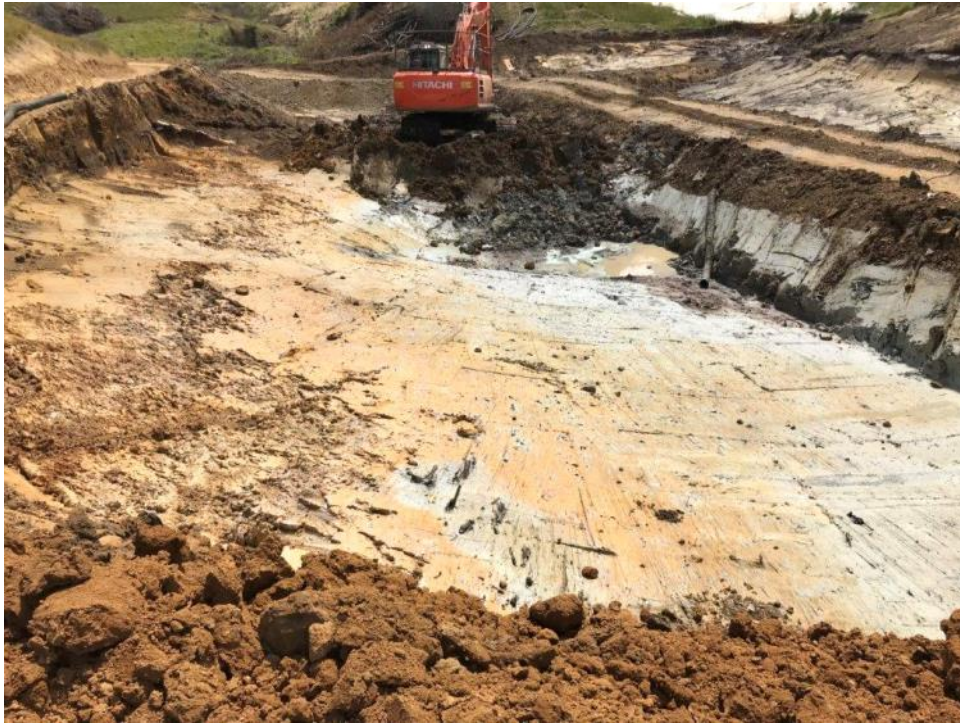
Visited site to inspect first area of pond undercut (cut 4) as shown in blue on the plan below. Stiff natural ground in excess of 60kPa throughout. There is a small area of water ponding in the area of deepest cut and we recommended that that be pumped out / dug out prior to placing fill.

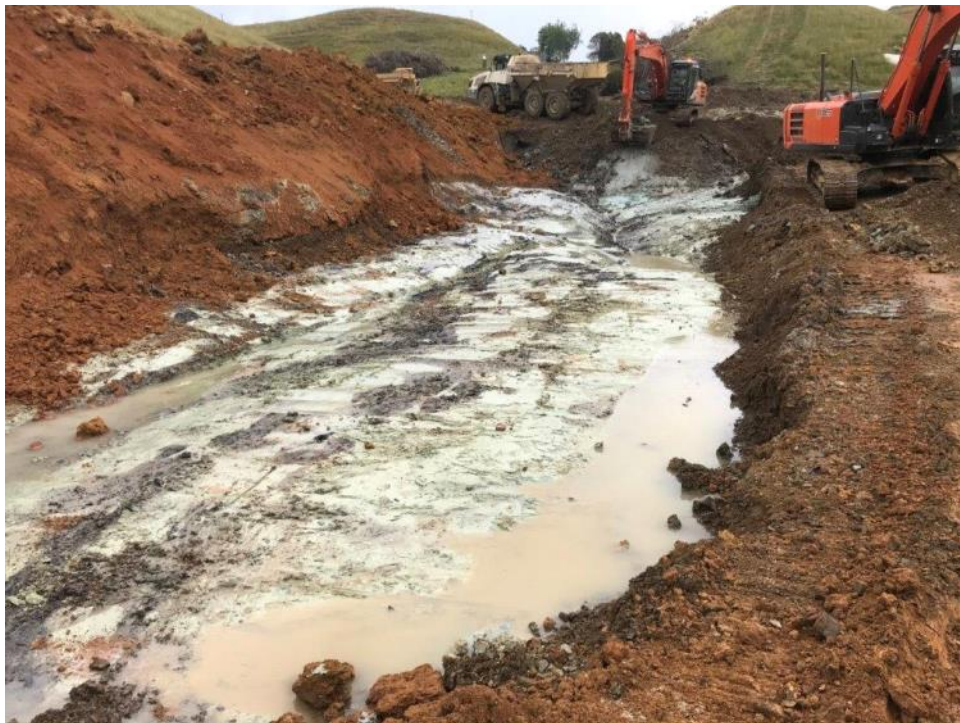
Visited site at request of Dylan to inspect next section of pond base fill subgrade. Very stiff ground throughout. Some areas had softened where water is ponding and we recommended that these areas be undercut to remove the softer soils. We have now seen almost all of the pond base. There is only a small area and Dylan will send photos once this is down to subgrade level.

Pond wall has been filled to near final level.

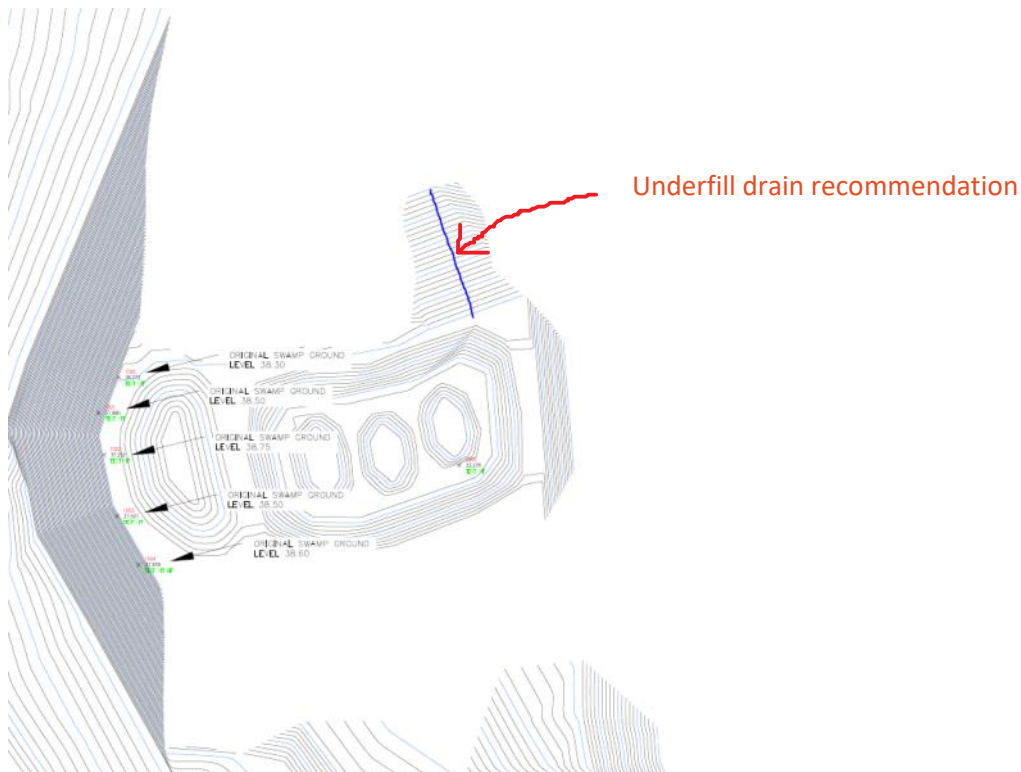
Observed Cut 4 pond. This area has been filled with clear and is now near pond base invert level. While down here discussed a proposed fill batter which we recommended has an underfill drain installed to tap any groundwater pressures (area shown on the plan below).

Contractors also removing fill from an old rubbish pit found on site at the start of the season.

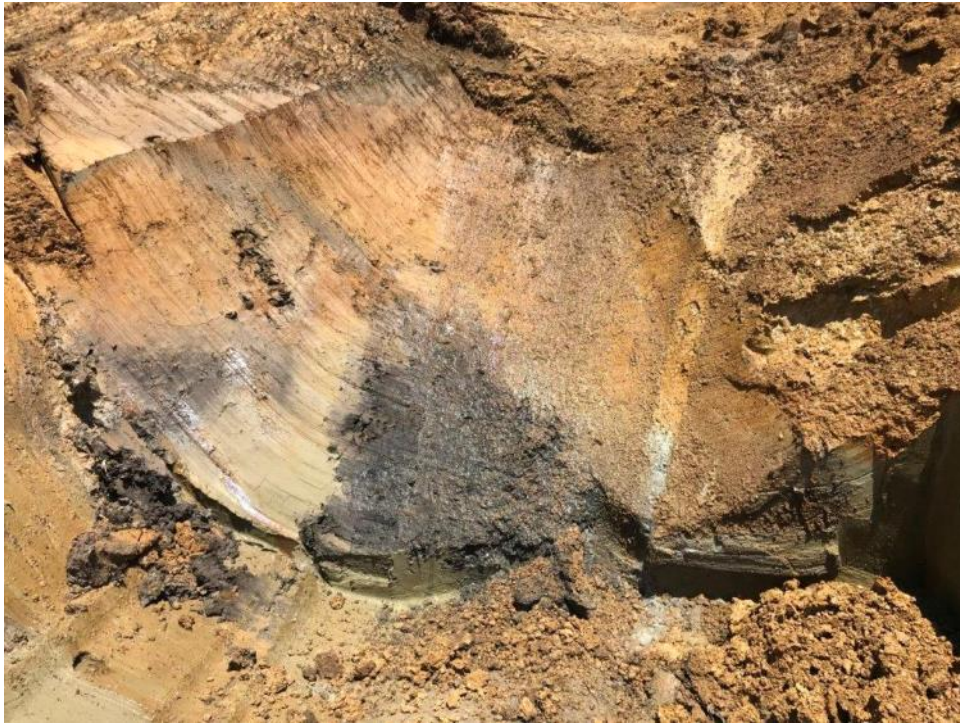
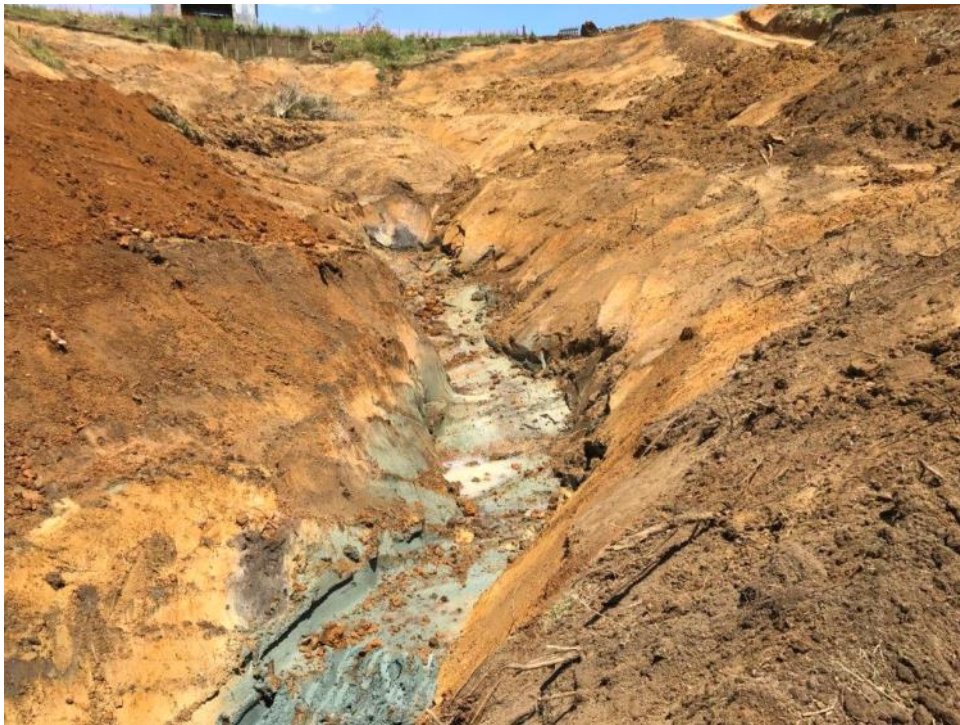
Visited site at the request of Dylan to inspect muckout of lower portion of gully as per yesterdays recommendation. Generally stiff soils exposed at the base of the gully.

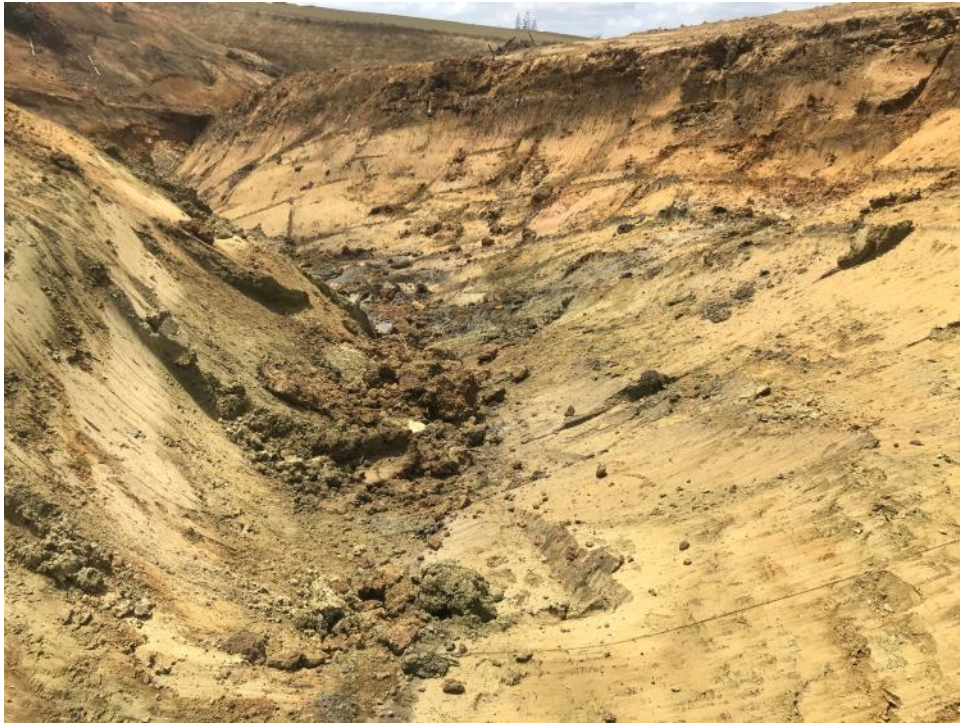
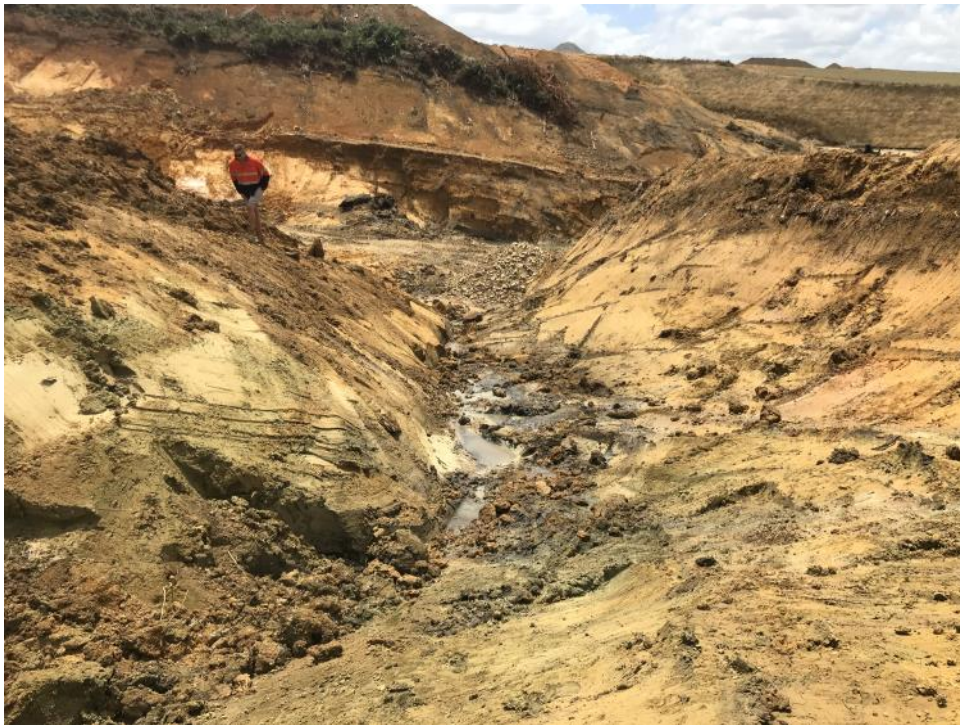
Visited site at the request of Dylan to inspect gully muckout in Fill A. Stiff to hard natural ground observed throughout.

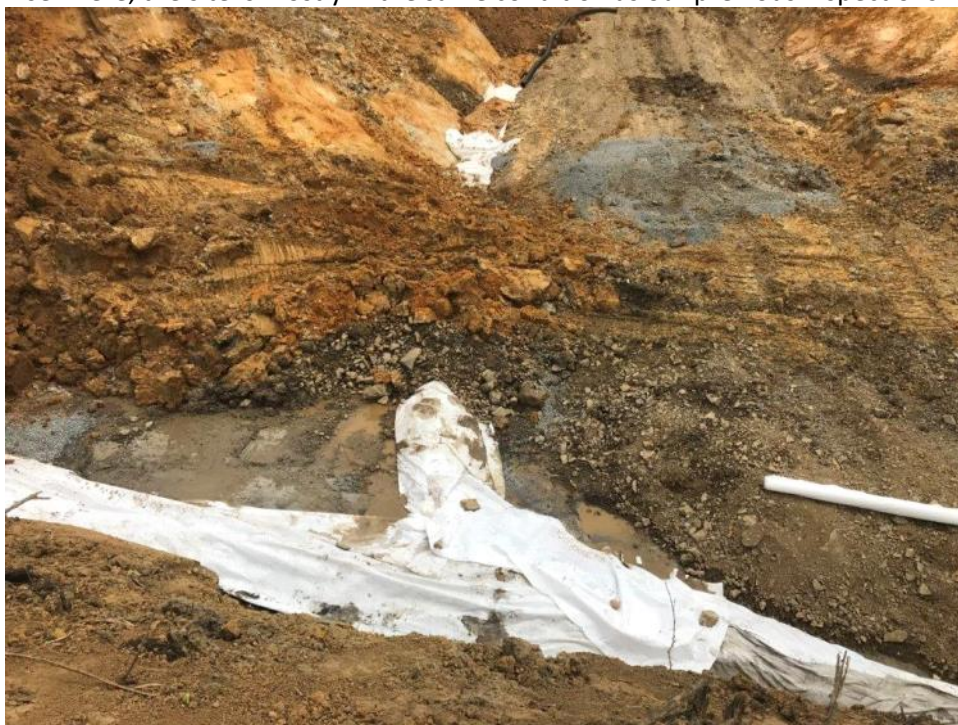
Underfill drain has been placed within Fill A gully observed during previous inspection.

Elsewhere, the site is mostly in the same condition as our previous inspections.

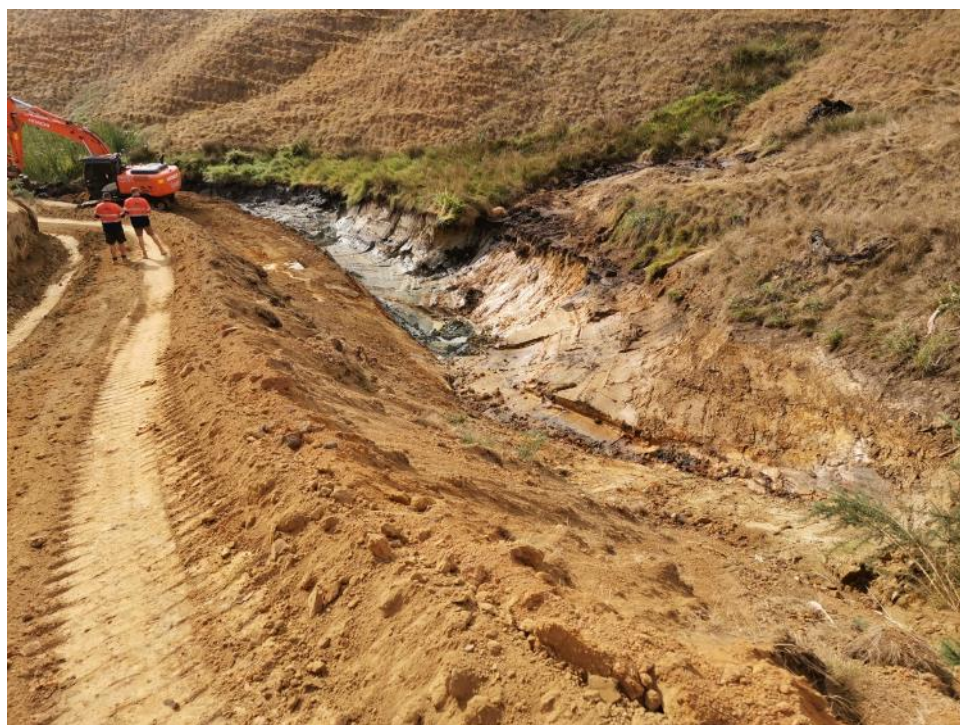
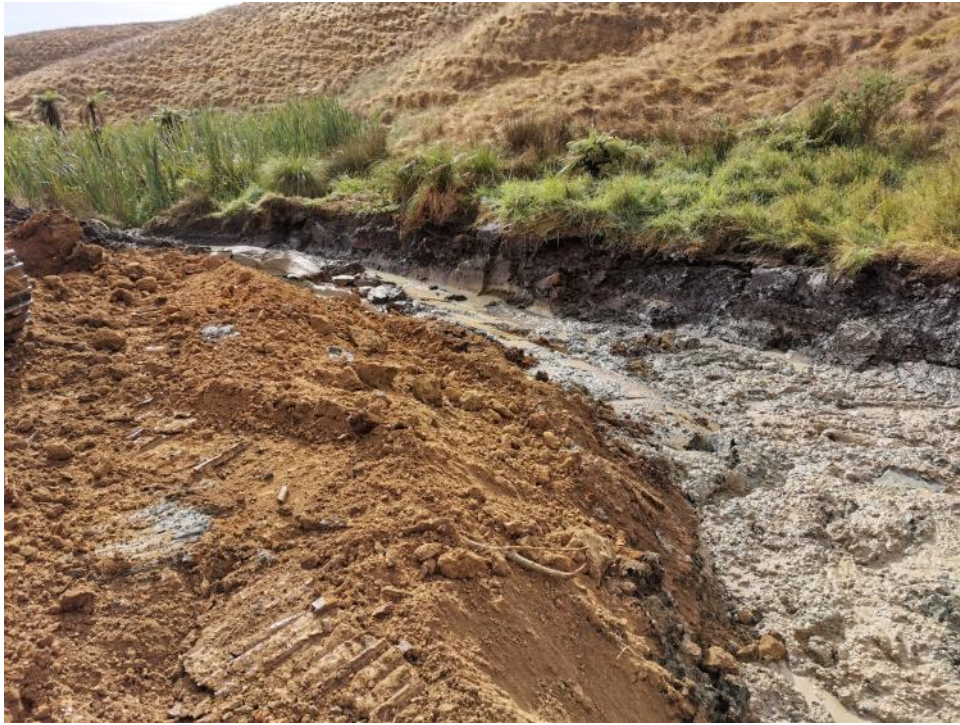
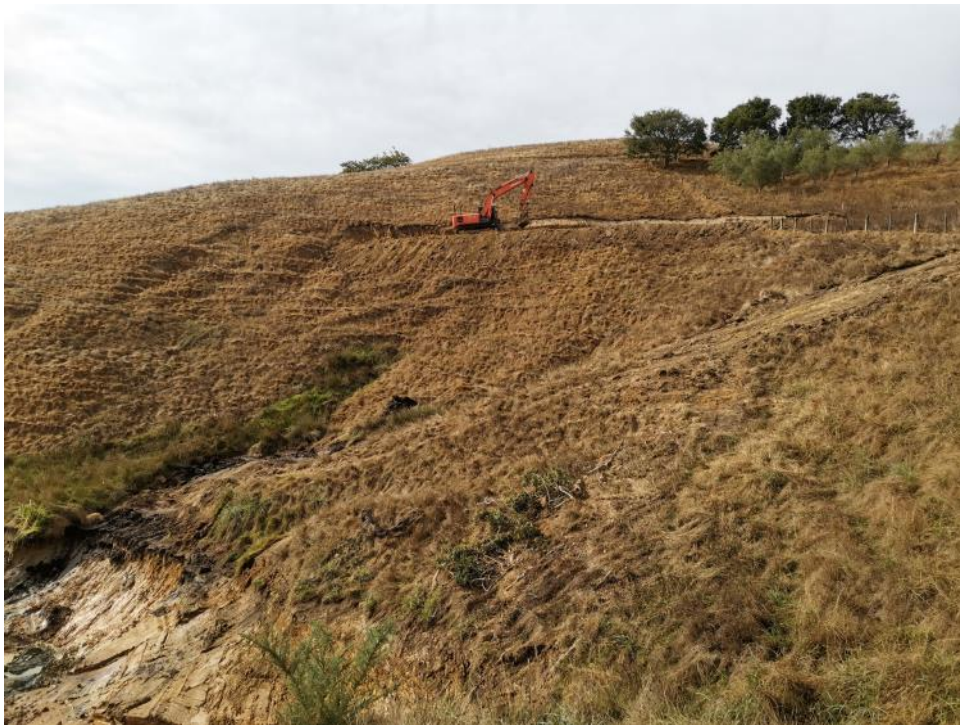
Visited site at the request of Dylan to inspect first gully muckout for Fill B. Generally stiff ground is exposed at the base of the gully. The contractor was advised to strip wet/softer ground where encountered.

Also discussed installing another underfill drain up the gully branches as there has been some groundwater seepage / slippage observed which the contractor has cleared out prior to our visit. Advised we can look at this which stripping operations commence in this area.

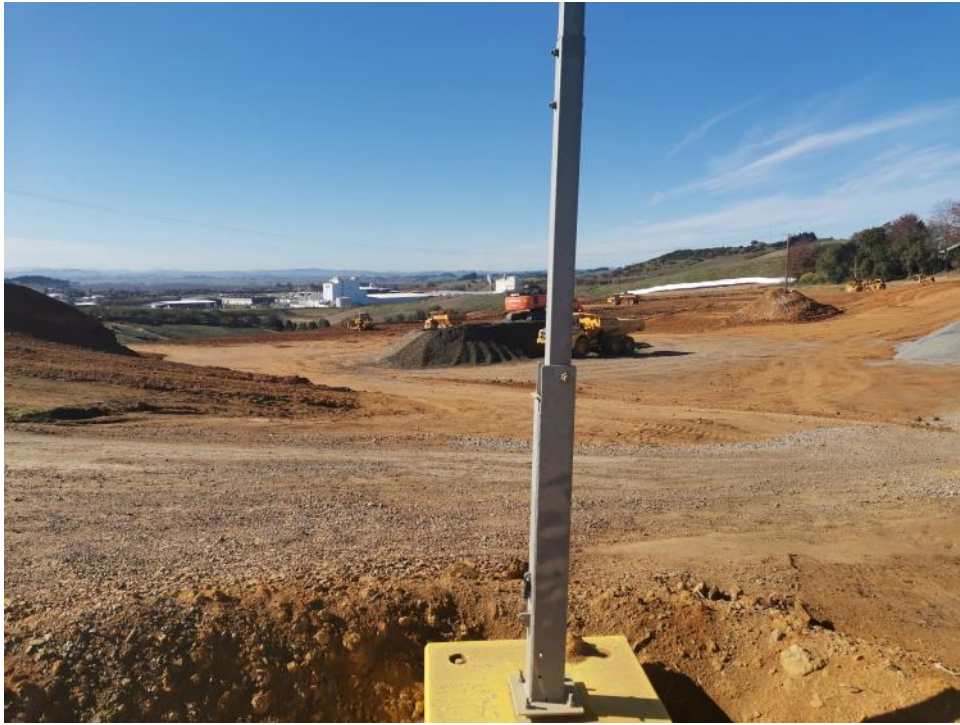
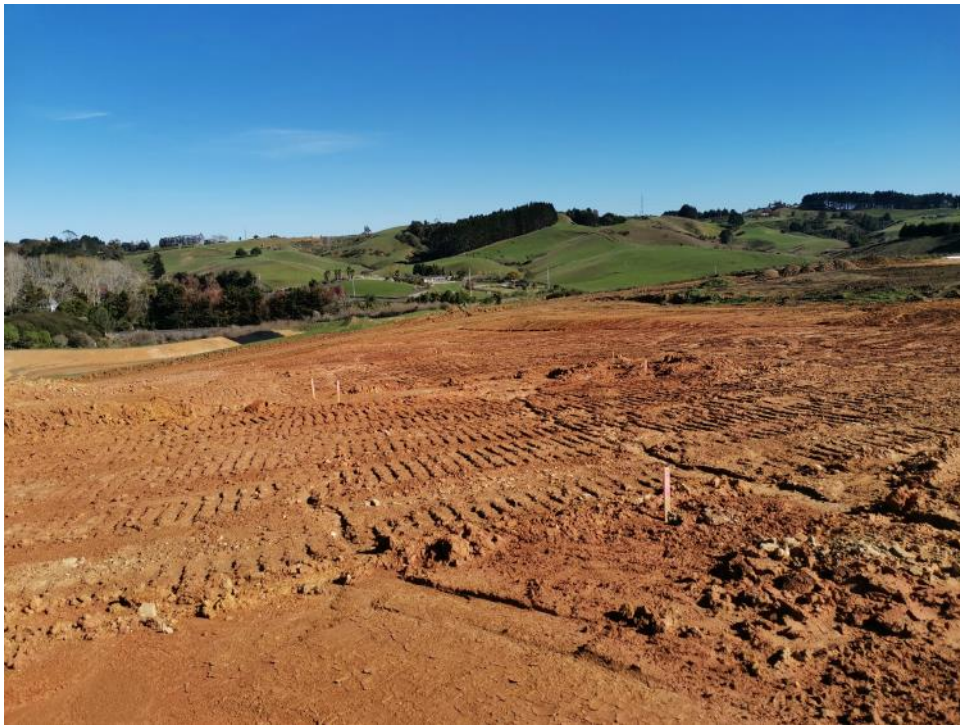
- Visited site at the request of Dylan to inspect subgrade level in cut lots. The lots are being formed to their final levels within cut ground. Very soft AS's exposed at the stripped surface.
- There is some scarring / water damage over the area. The contractors plan to tidy this up and then topsoil the lots.
- In REBZ, GAD6R filling operations are continuing. Discussed that GE would come out to site on Wednesday to discuss geogrid placement and the rear drainage blanket.

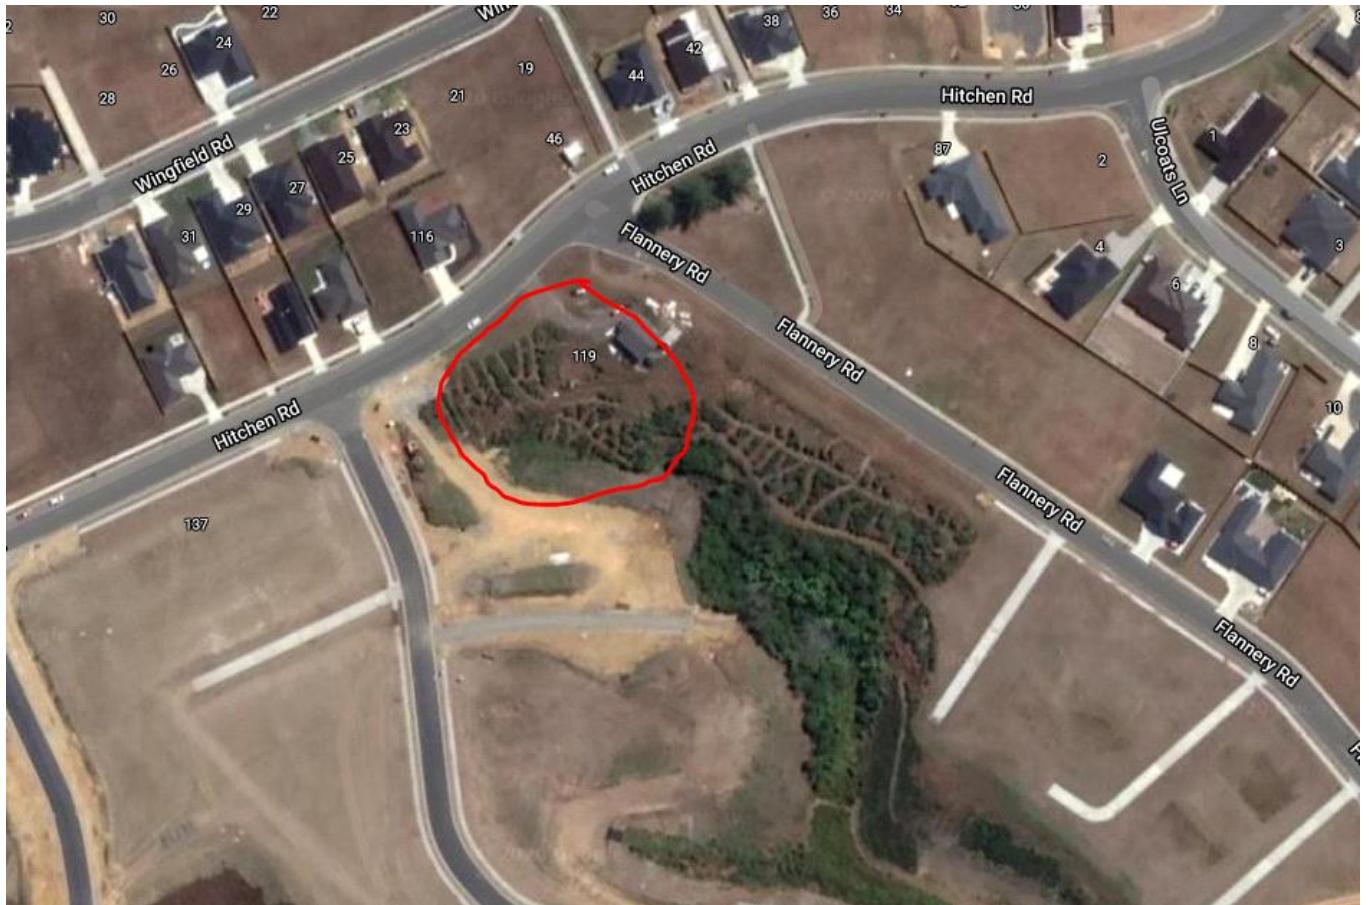
Observed muck out of portion of gully circled below. Decant to be formed here to allow further earthworks up slope within gully. Muck out looked suitable with benches to be formed 2 compactors width in flanks to lock this fill batter in. Batter only temporary until next season when earthworks occur downslope. Underfill drain to be placed through this area (discussed specs which are consistent with other drains across site) that will lead into the earthworks upslope and eventually downslope as well. Fill materials to cut from cut area above which looked fine to use. Testing to take place every 1m lift. Contractor to get in touch when gully upslope is being stripped.

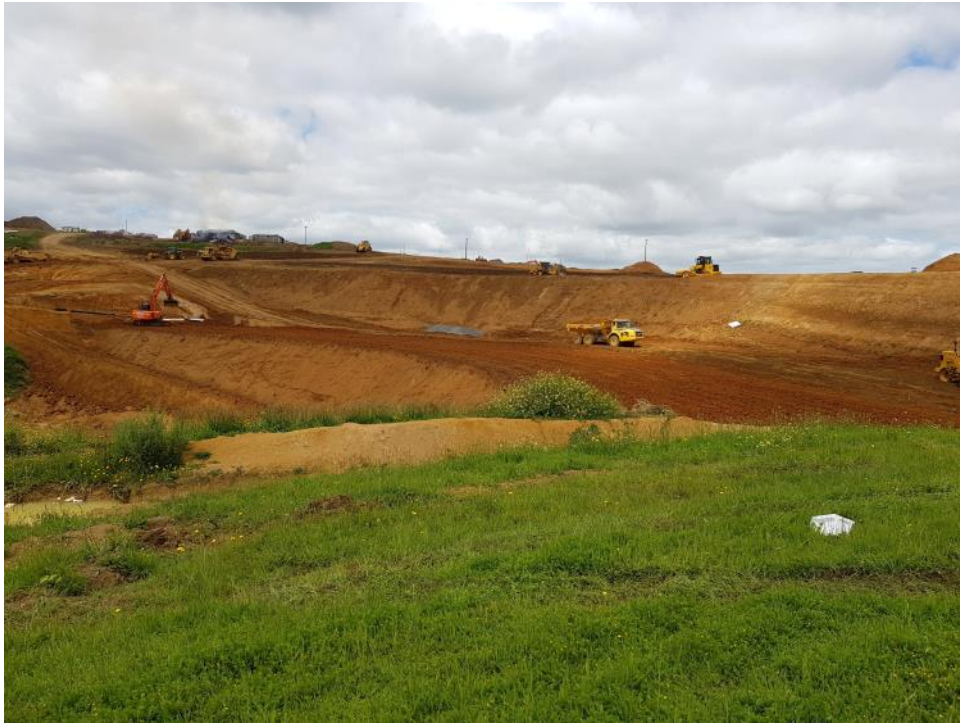
Works have re-started on REB1 after the wet weather. Contractor was about to commence placement of another grid layer. Clay material still being dried out/ conditioned.

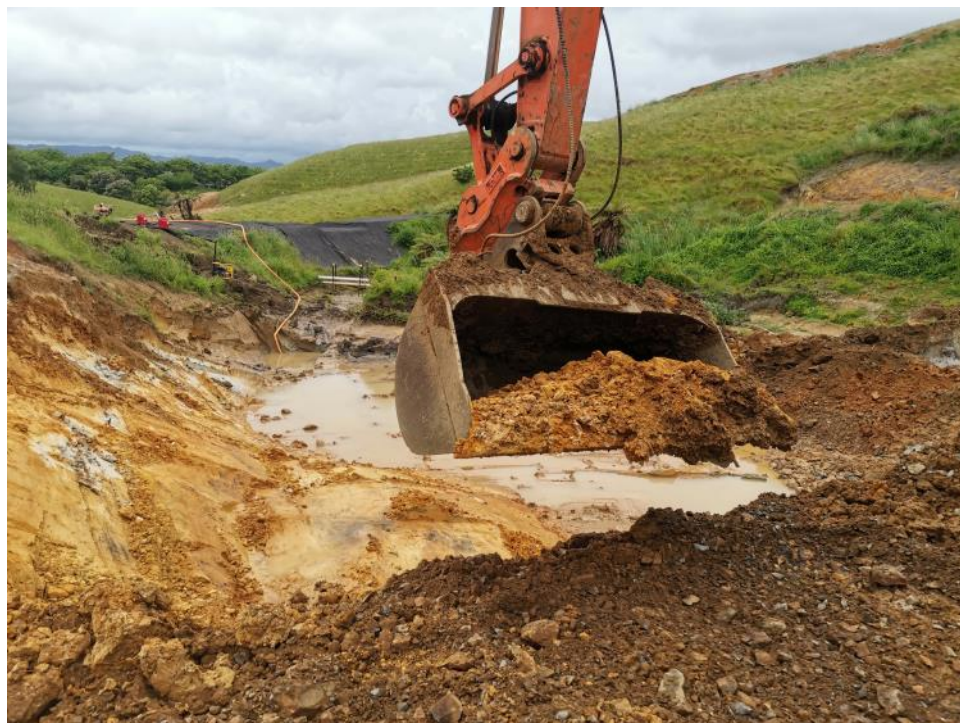
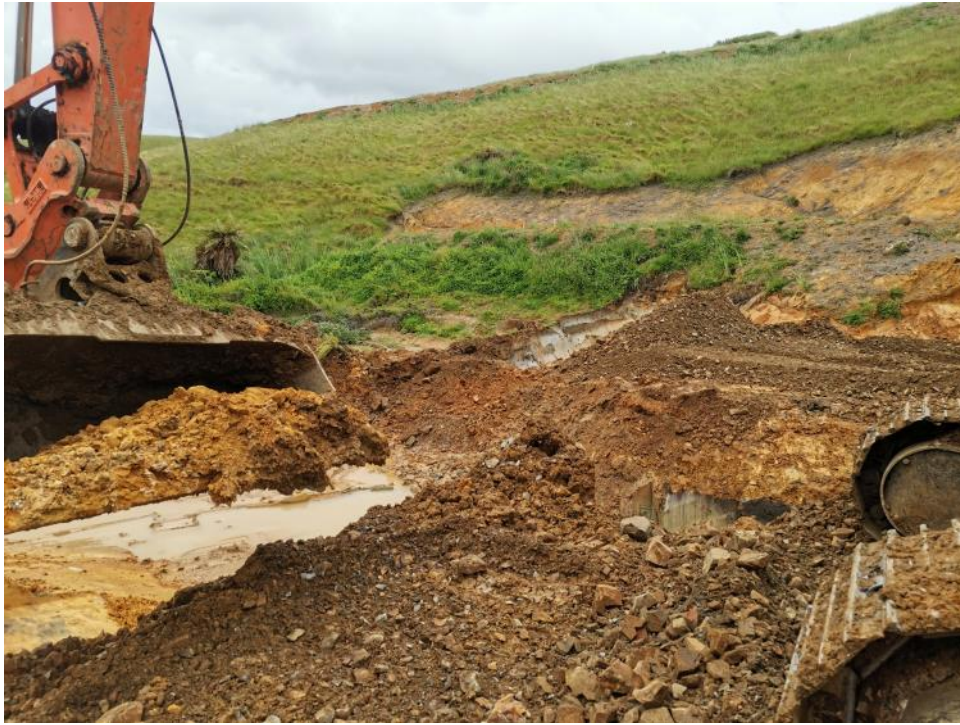
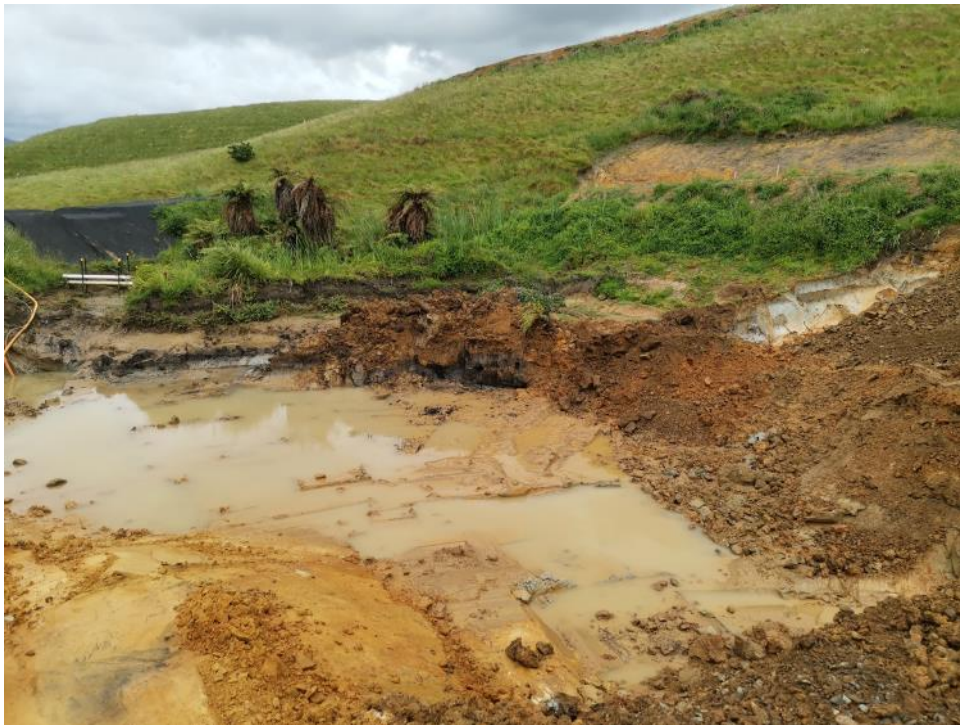
Visited site at the request of Dylan to inspect the undercut for the shear key in REB2. The contractors had cut down approx 4m from original ground level and had excavated down to hard orange silts.

Checked these works against our model which confirmed that the approximate depths and materials were consistent with our model. Informed Dylan that shear key operations could continue as planned, but 2 or 3 trial pits will be required in the base of the shear key once it has been opened up to further validate the ground conditions beneath the base of the shear key.

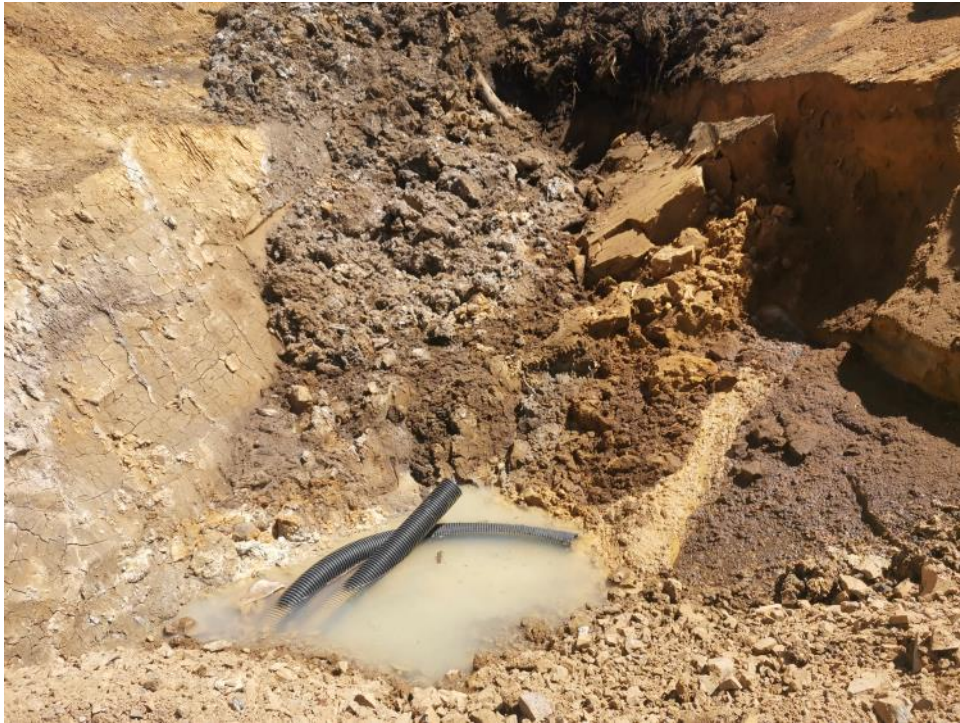
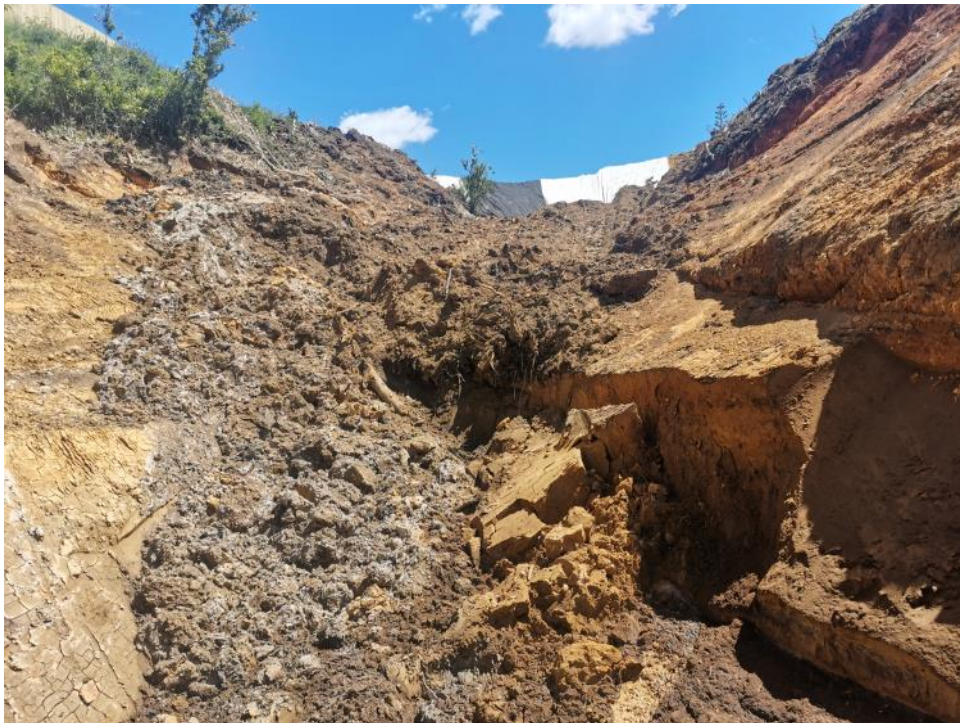
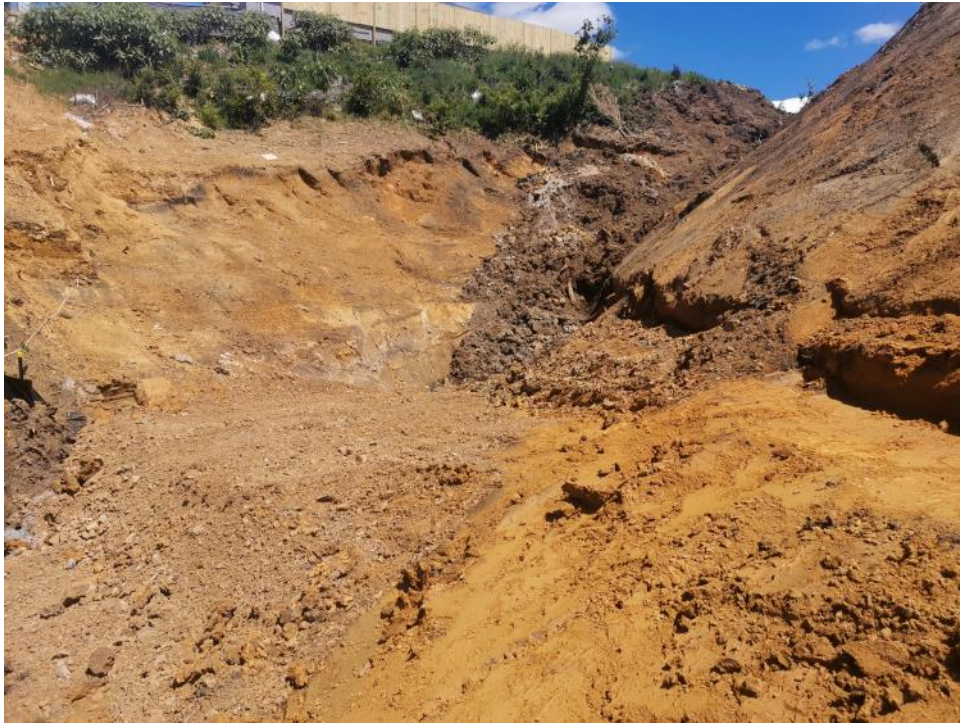
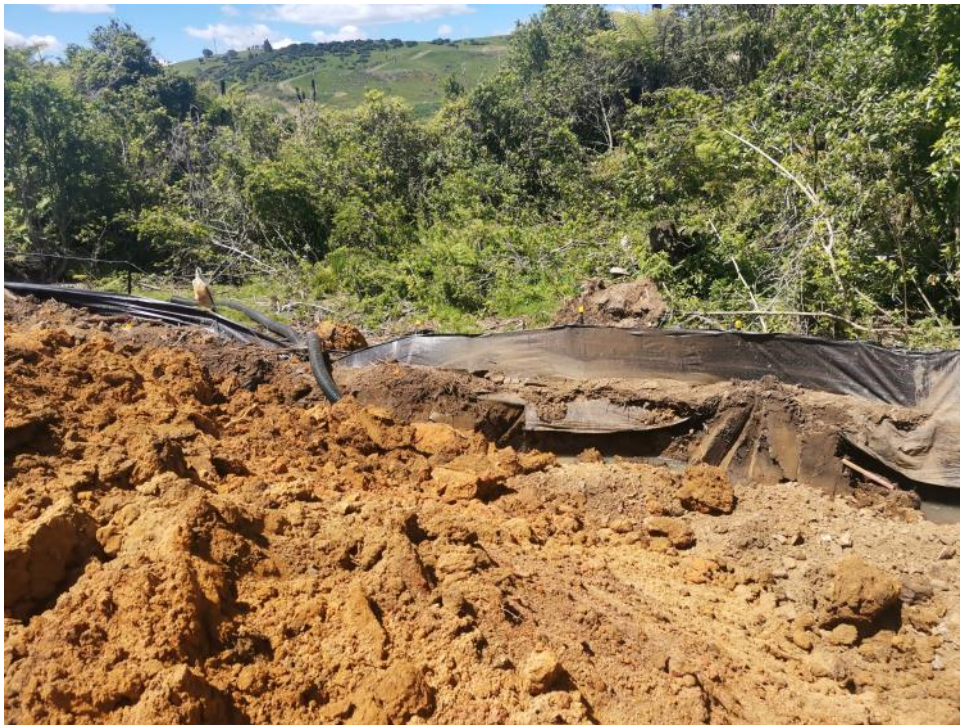
Stage 12D:

Not much progress has been made since our last inspection in this area. The SPR in the base of the gully is still loose and requires compaction. The contractor is planning to bring a pad-foot roller down to this area to start backfilling the gully.
