Geotechnical Completion Report

HITCHEN BLOCK STAGE 13B

17 January 2022

Ref No: J00113

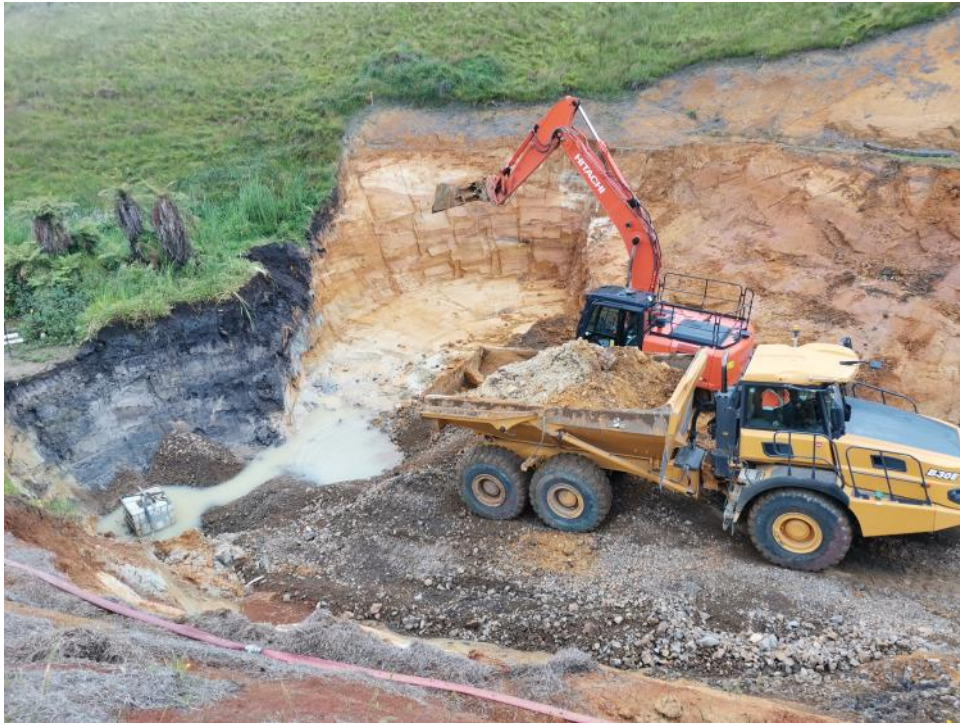
Damaged underfill drain in REB2:

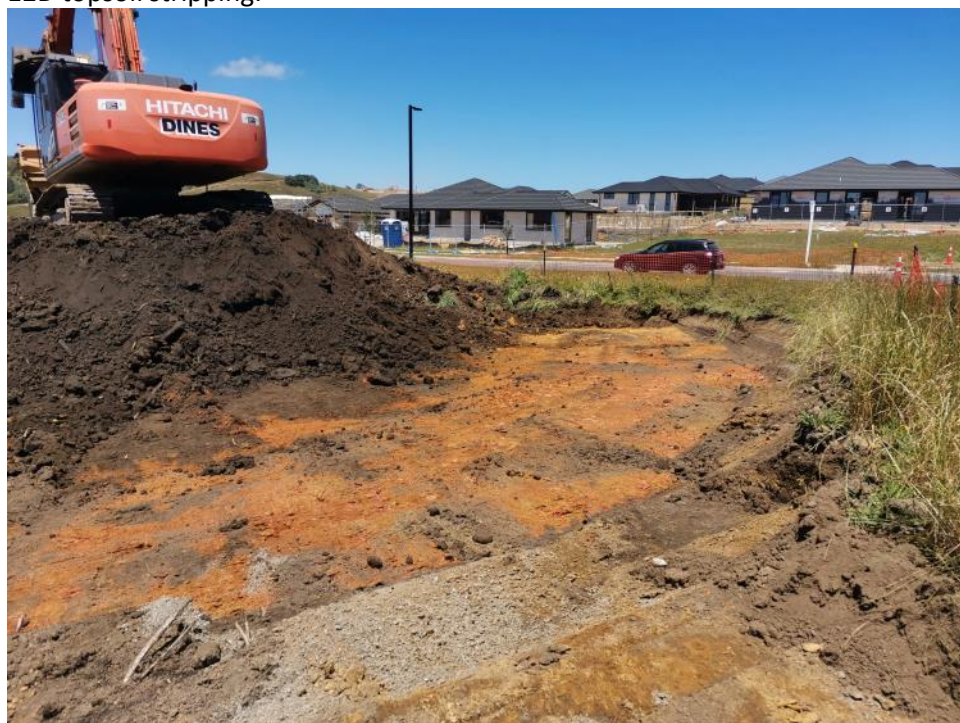
12D topsoil stripping:

Also, inspected stripping over Lots 612 & 612. Generally very stiff natural ash soils were exposed, however, some topsoil/rubbish was observed which we recommended be undercut to natural ground. Will look at this again tomorrow afternoon with Chris.

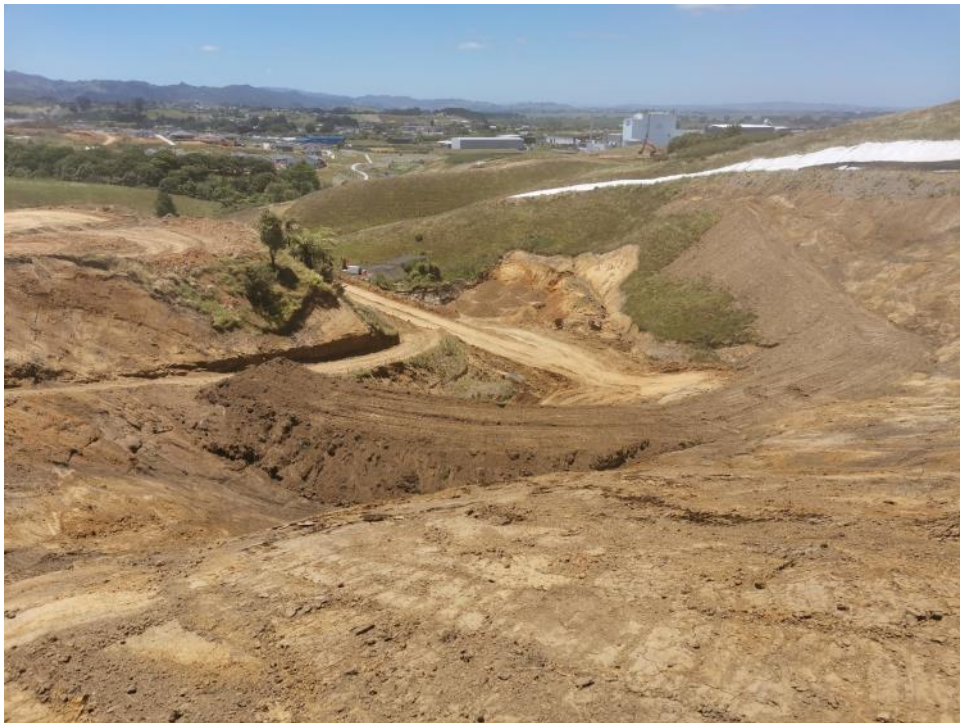
- Also observed the stripping area in lots 611 and 612. Rubbish/pre-existing fills are still present. Reiterated that these materials be fully undercut. Will return to site tomorrow to observe general earthworks operations.

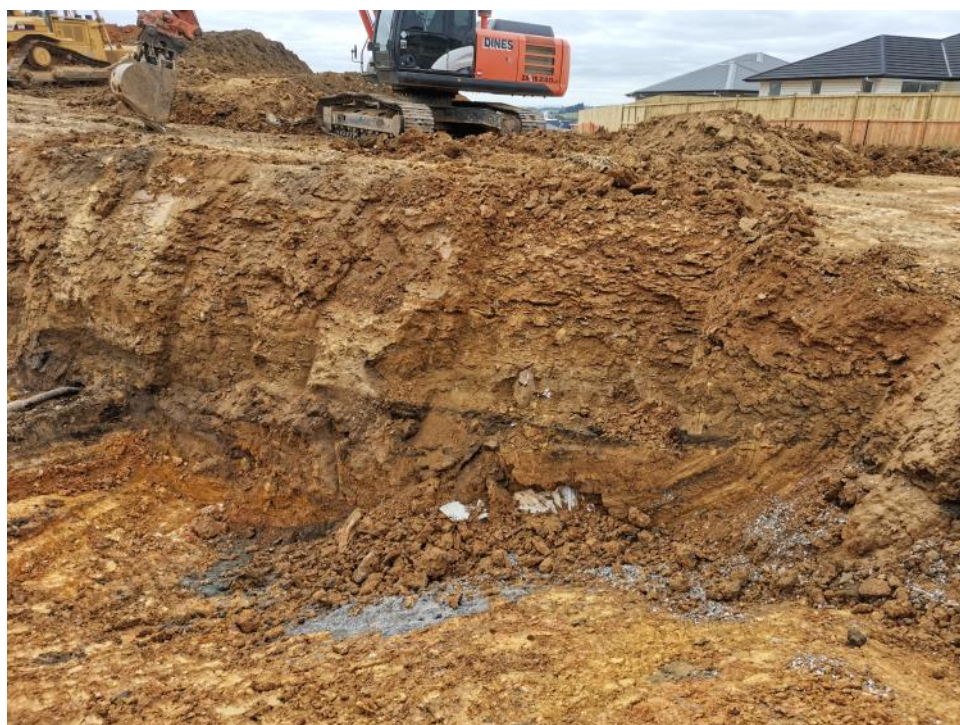
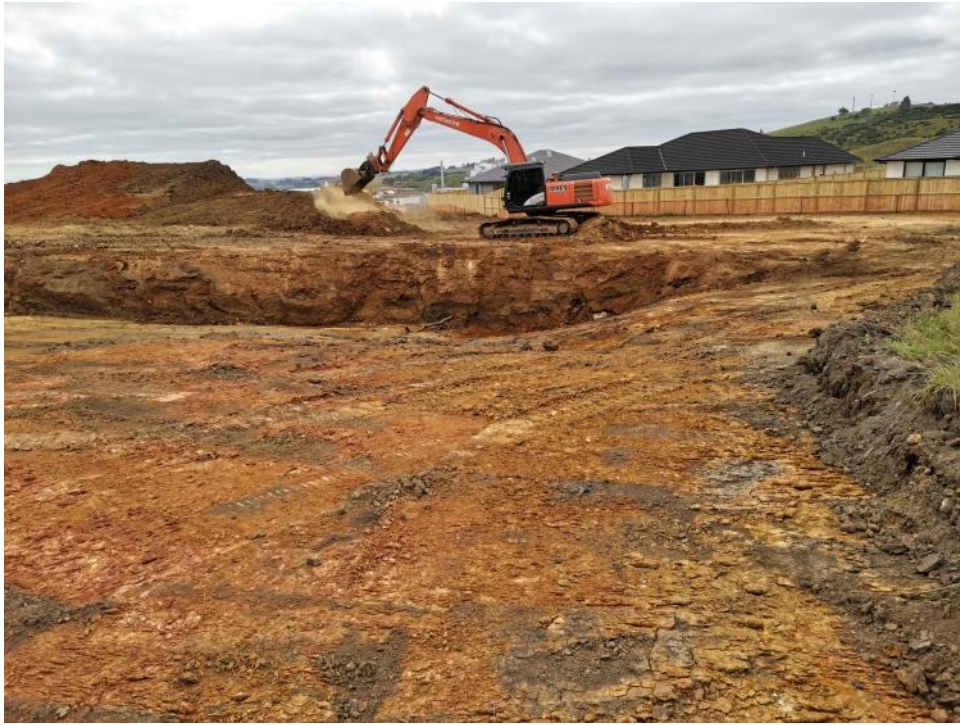
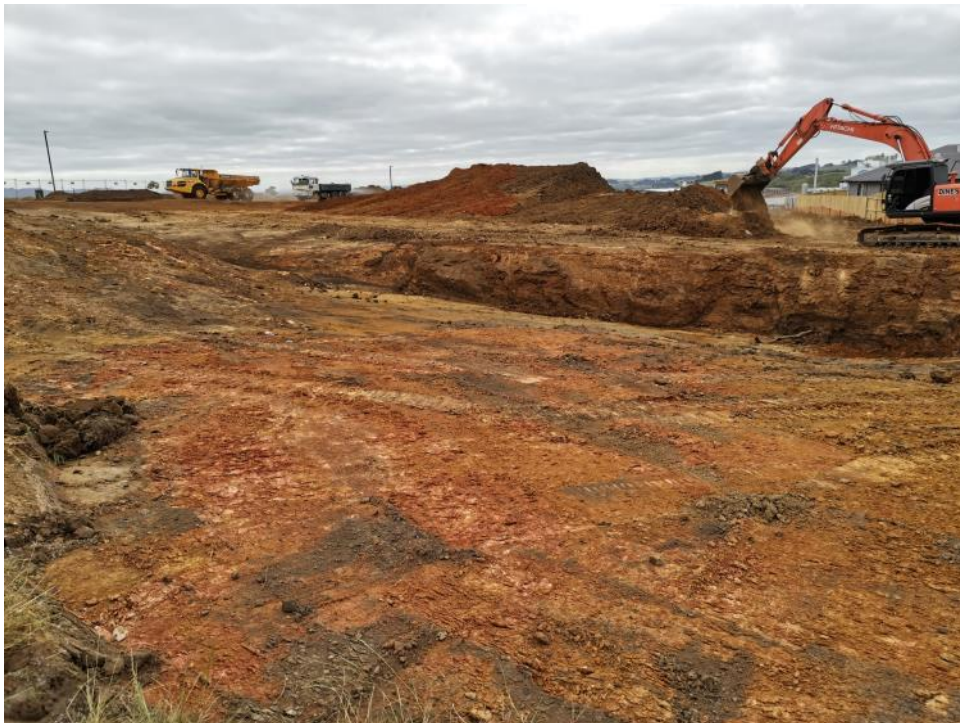
Inspected backfill in 12D toe key. Compaction appears to be going well with no obvious deflections noted under a 12T smooth drum roller. The latest fill test passed on both clegg hammer and backscatter testing.

Also observed undercutting of topsoil/pre-existing fill in the top section of Stage 12D. The base of the undercut is generally down to natural ground, although there is some minor topsoil mottling to chase out. The existing fill cut shows a layer of topsoil within the fill placed by Dines which is within 2m of surface level. Advised that this should be undercut and removed from the fill. Will return to site again tomorrow morning to inspect.

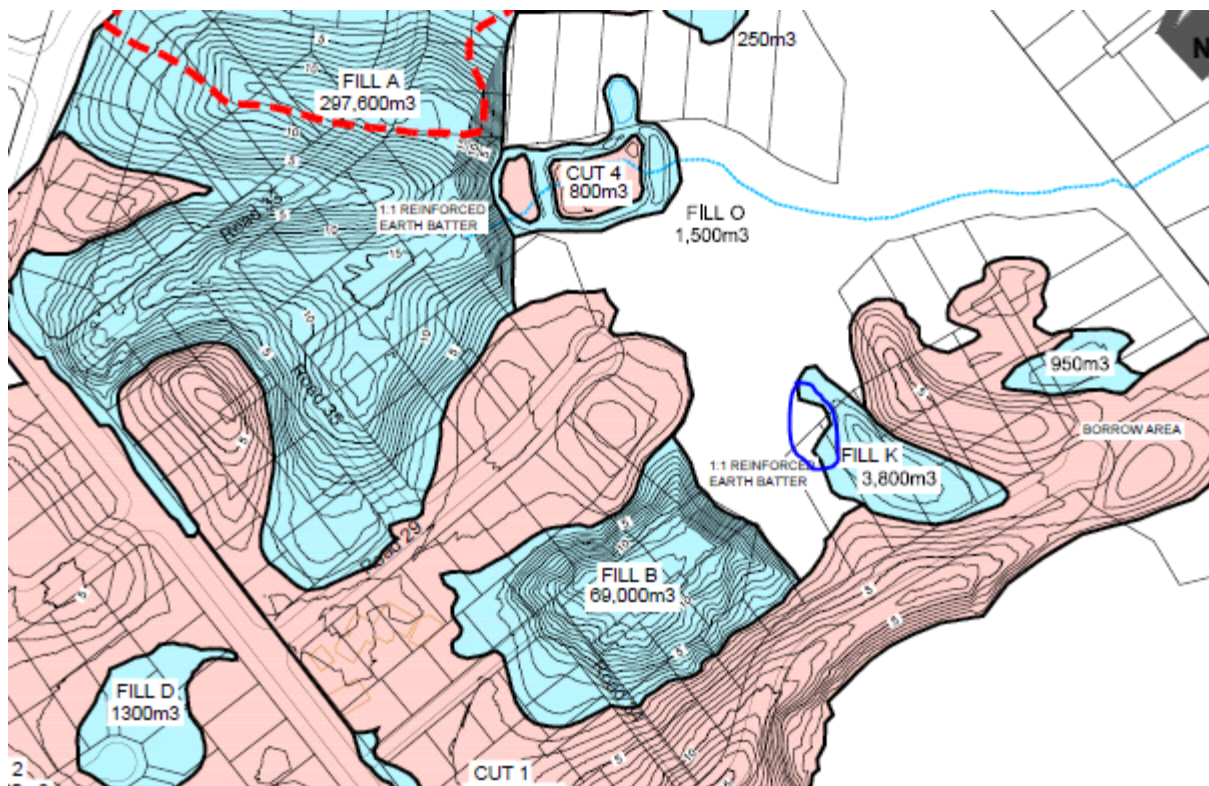
- Extent of works adjacent to Fill K: Approximate area shown in blue on the annotated drawing below. Trevor discussed that the area is to be extended down to the main gully now. Advised that any stripping needs to be down to the stiff natural ground and any mullock or colluvium removed. Further advice to be given once the area is opened up and we can observe ground conditions. Trevor will send some plans through to us for our initial thoughts on what engineering solution may be required.

- Welded tuff area: The contractors have about 1m of further cut required to achieve design subgrade level. Trevor advised that they will survey the welded tuff once they reach this depth so we can advise Dines.

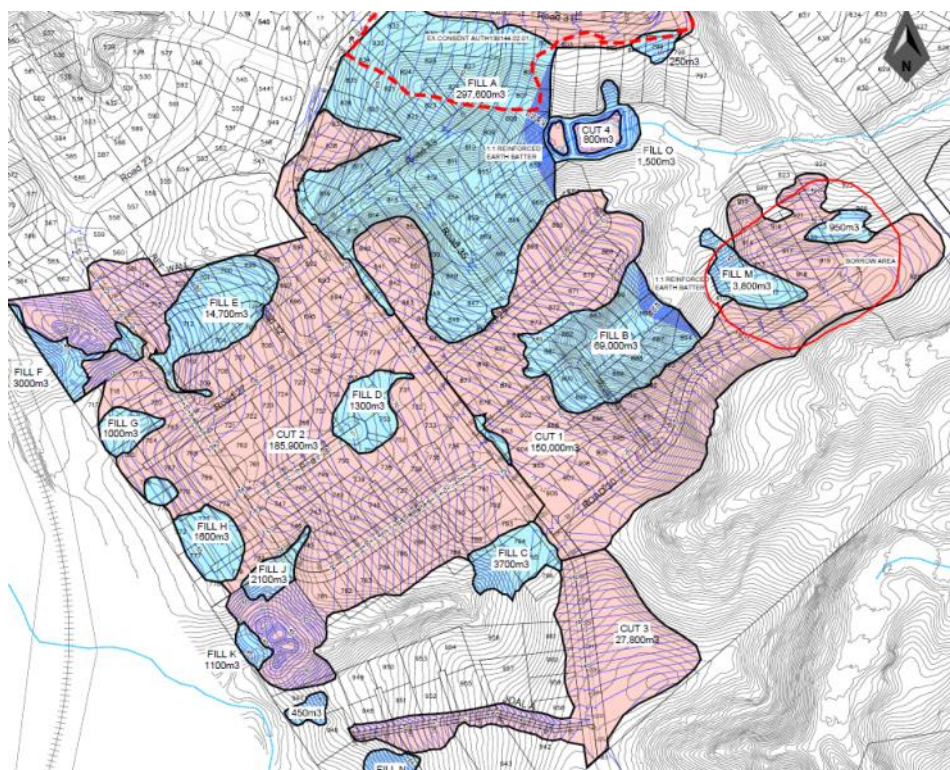
Visited site at the request of Dylan to inspect stripping for cut 1 in the approximate area outlined in red on the image below. Cut exposed very stiff natural ground. No seepages or soft ground observed though this area. Minor fills to be placed in this area next.

Also inspected REB 2 shear key progress. Backfill of the shear key in progress. Fill testing was being carried out at the time of our inspection of the area beyond the key where the groundwater was being pumped from.

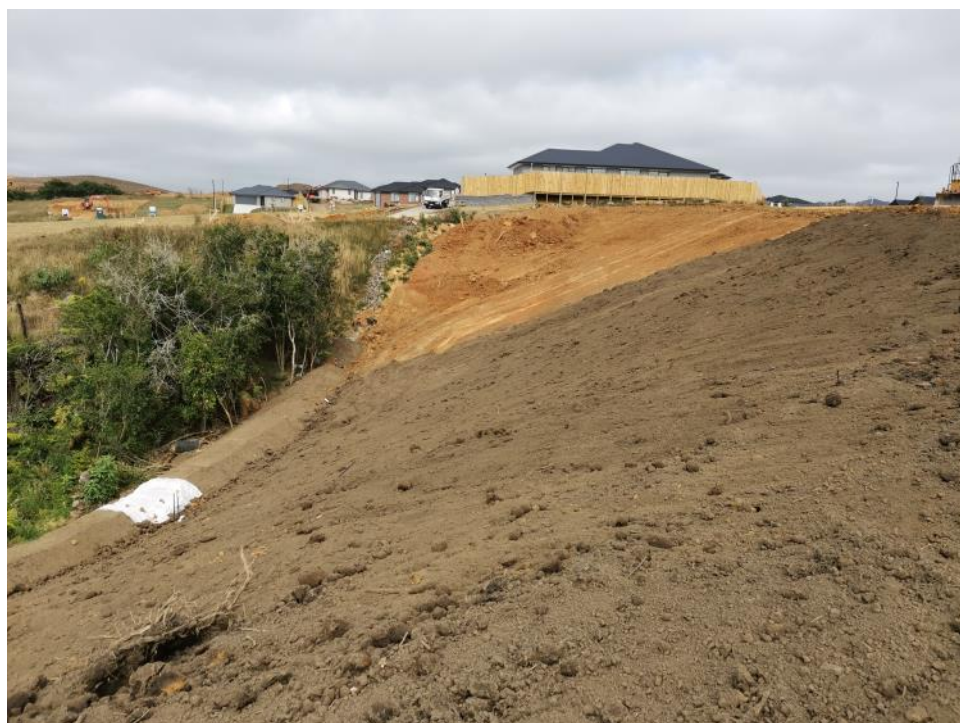
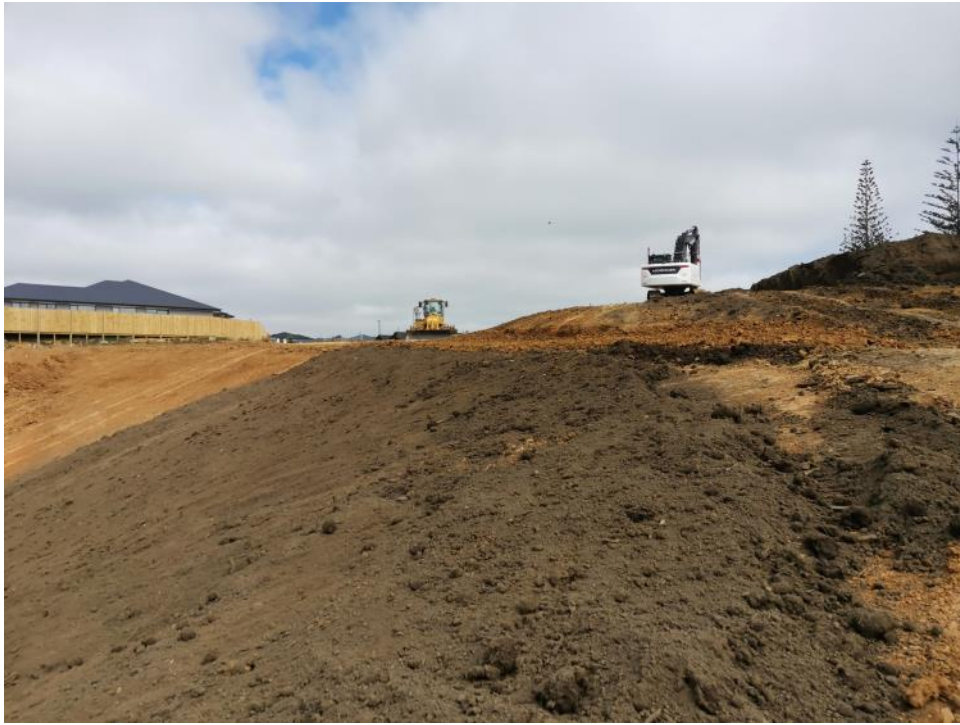
- Within Stage 12D the 1(v) in 3(h) batter has been formed to final height and has been trimmed and topsoiled.
- Stripping has commenced up the flanks of the gully in REB2 for preparation of the fill batter placement. Recommended the installation of 3 additional underfill drains in areas of seepage, two up the eastern flank and one up the southern (rear) which will connect into the existing underfill drain.
- Discussed that benching into the flanks will require an average bench depth of 2m which Dines have already programmed up.
- Will meet on Friday with Cirtex and Chris to discuss topsoiling the face of REB1 as the contractors are having difficulty getting the topsoil to stay in place.

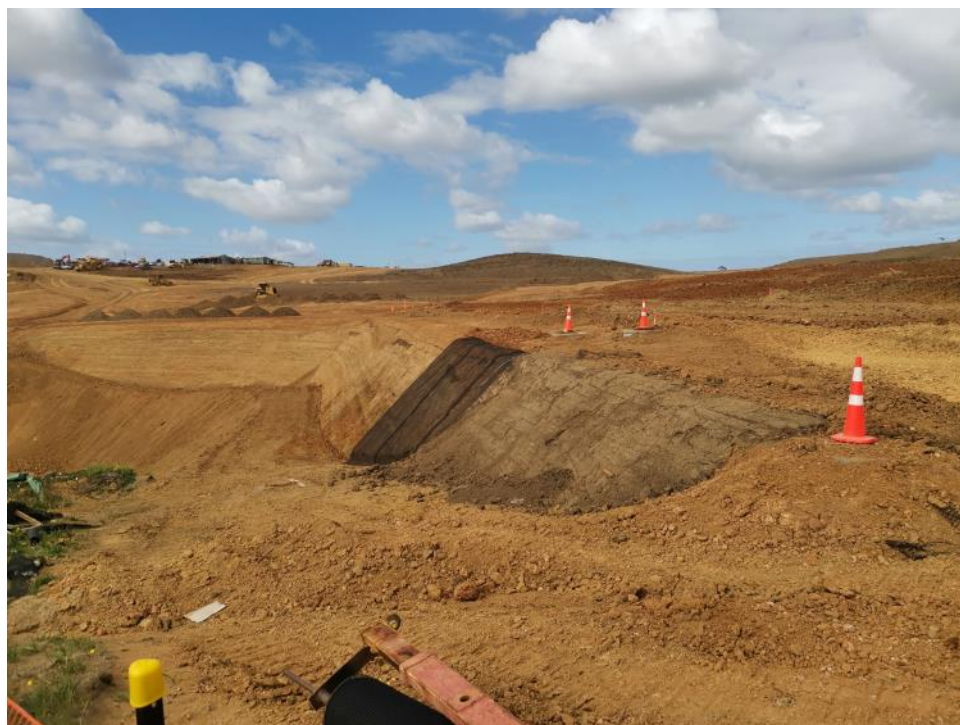
At REB 2, construction of the shear key is almost complete and several underfill drains have been installed as per our recommendations.

Also inspected final works for lots 611 and 612, adjacent to stage 12D. Both lots have been topsoiled, with 100mm of topsoil measured in both lots.

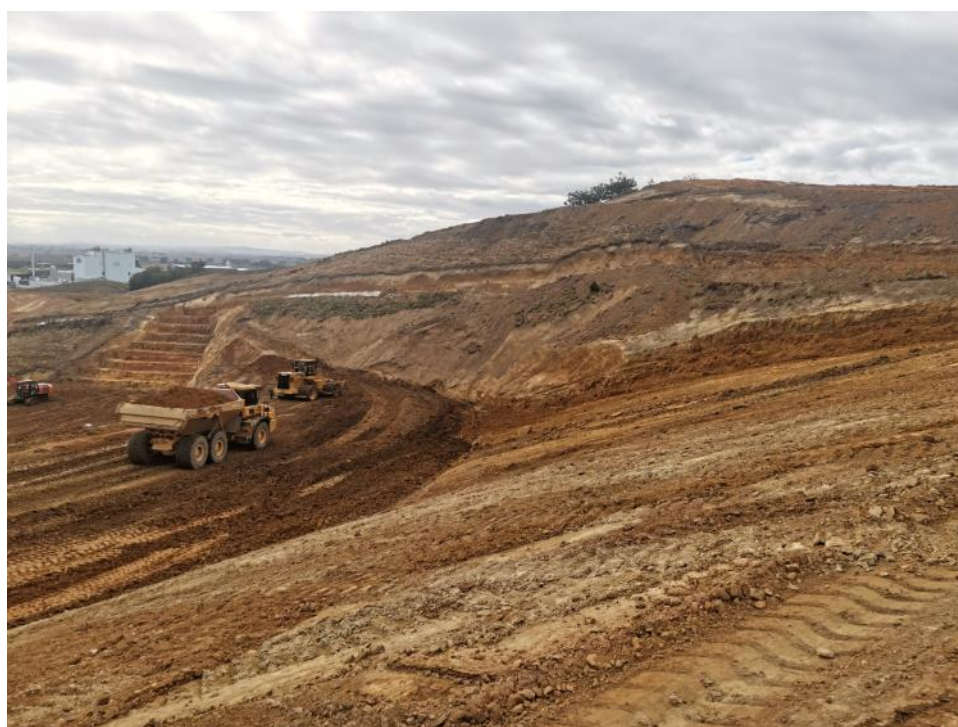
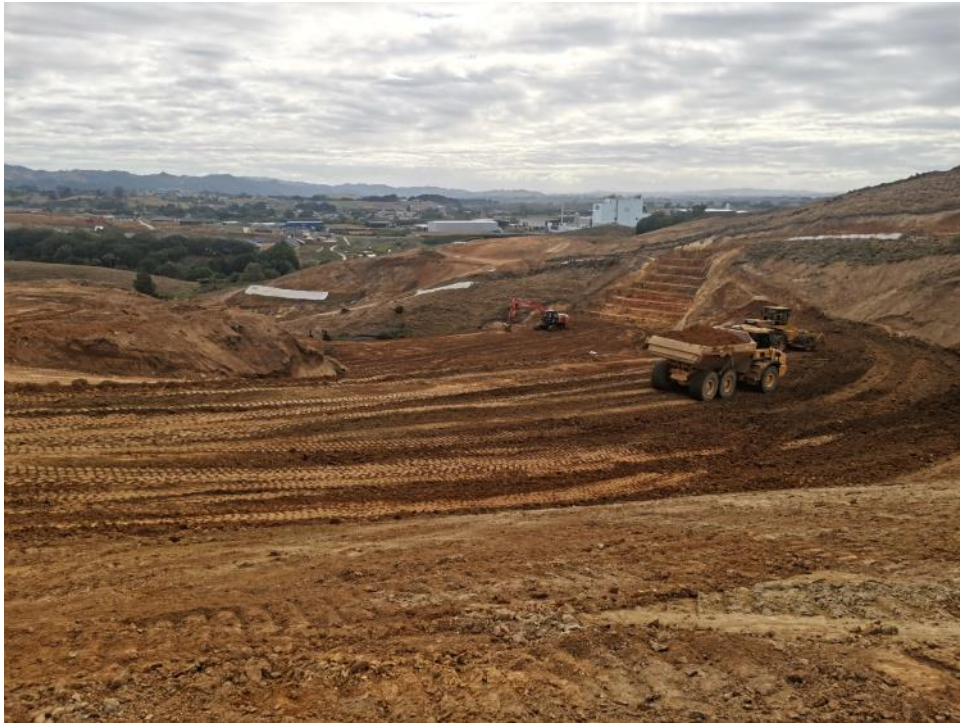
- Fills are progressing in REB2. All 4x underfill drains can still be observed at the toe of the batter.
- Slip remediation works progressing below DEB10 (adjacent to REB1 silt pond). Underfill drain observed below current fill batter as per our recommendations.

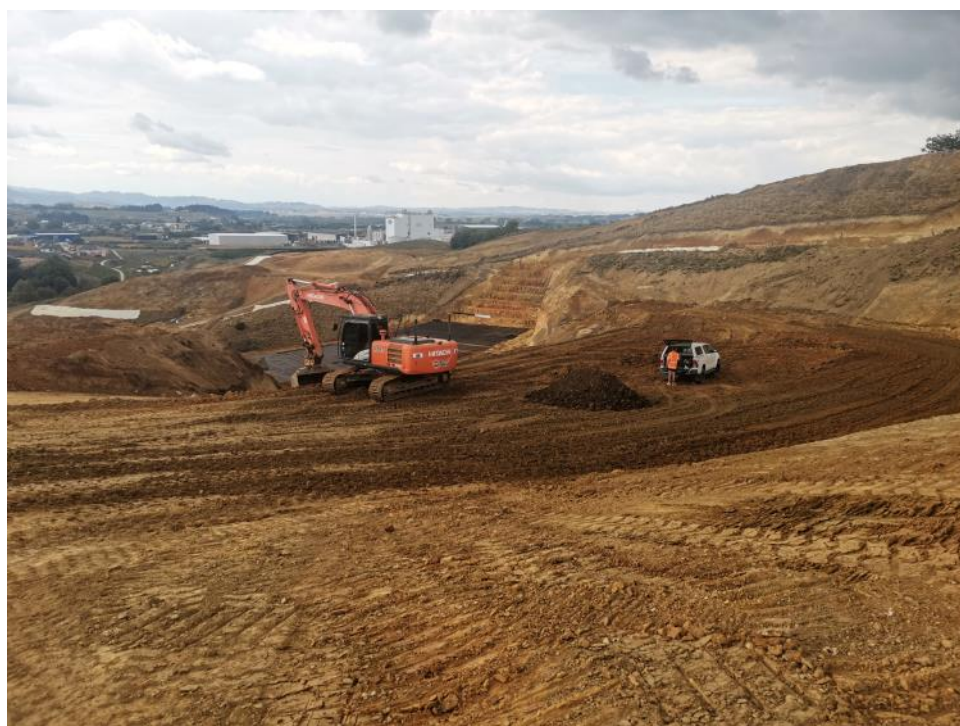
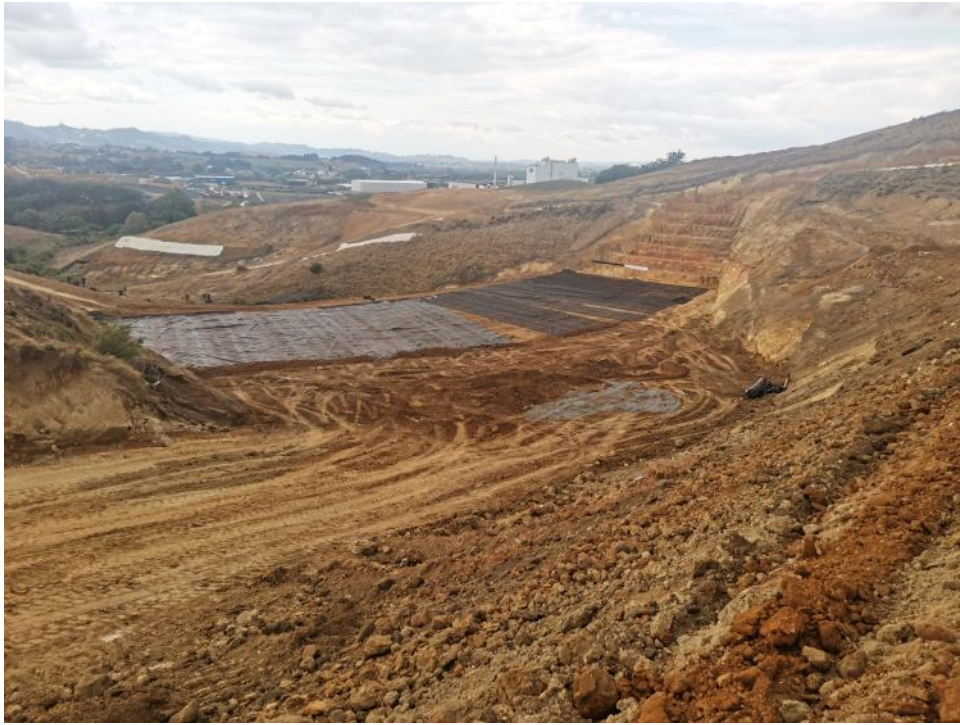
- Observed progress of REB2 batter fill operations.
- Geogrid laid out to approx. 19m length as per our design. A gap remains in the centre section which is to be picked up and covered at the next primary grid lift.
- Fill compaction results have generally been passing, after a series of failed fill tests a few weeks ago (failed on air voids).
- Adequate benching exposed along the gully flanks.

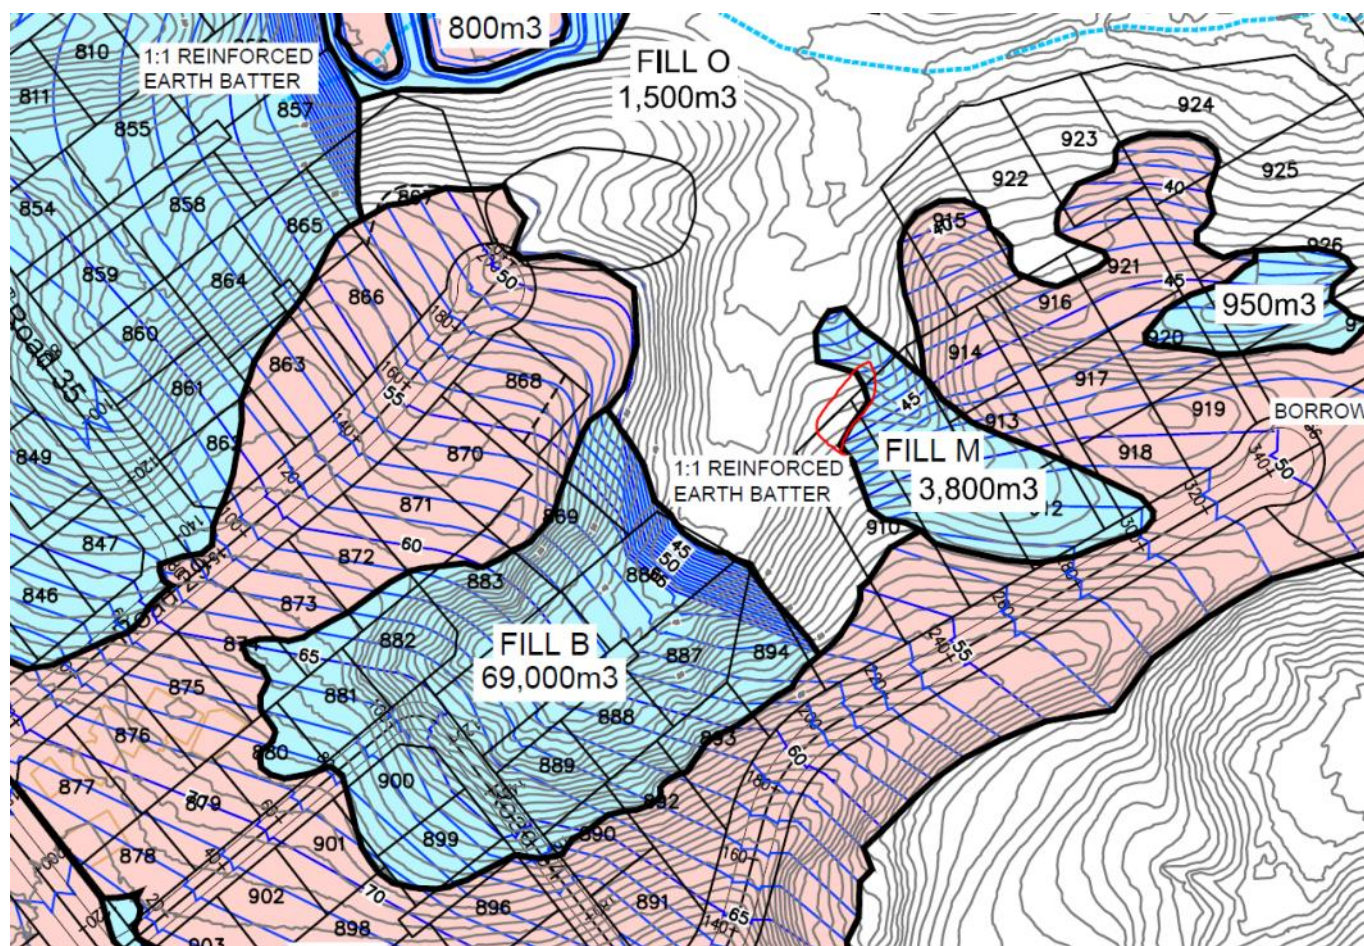
- Inspected topsoil stripping in Fill O. Approximate location shown by black annotation. Very stiff ash soils exposed throughout. Recommended that an underfill drain to be placed along the existing overland flowpath here.
- Observed progress of REB 2 fill works. Approx. 3.5m of fill left to place before trimming of the 1(v) in 1(h) batter begins. Rear face drain is now complete, with the final section of this drain being installed today.
- Observed permanent stormwater pond below Fill M, approximate position shown in red below. Contractors had mucked out the pond and backfilled without notifying us. Several trial pits dug in this area which identified SPR to beyond 3m and at least 1.5-2m below the adjacent fully invert.
