Geotechnical Completion Report

HITCHEN BLOCK STAGES 10E AND 10F

DFH JOINT VENTURE LIMITED

11 March 2021

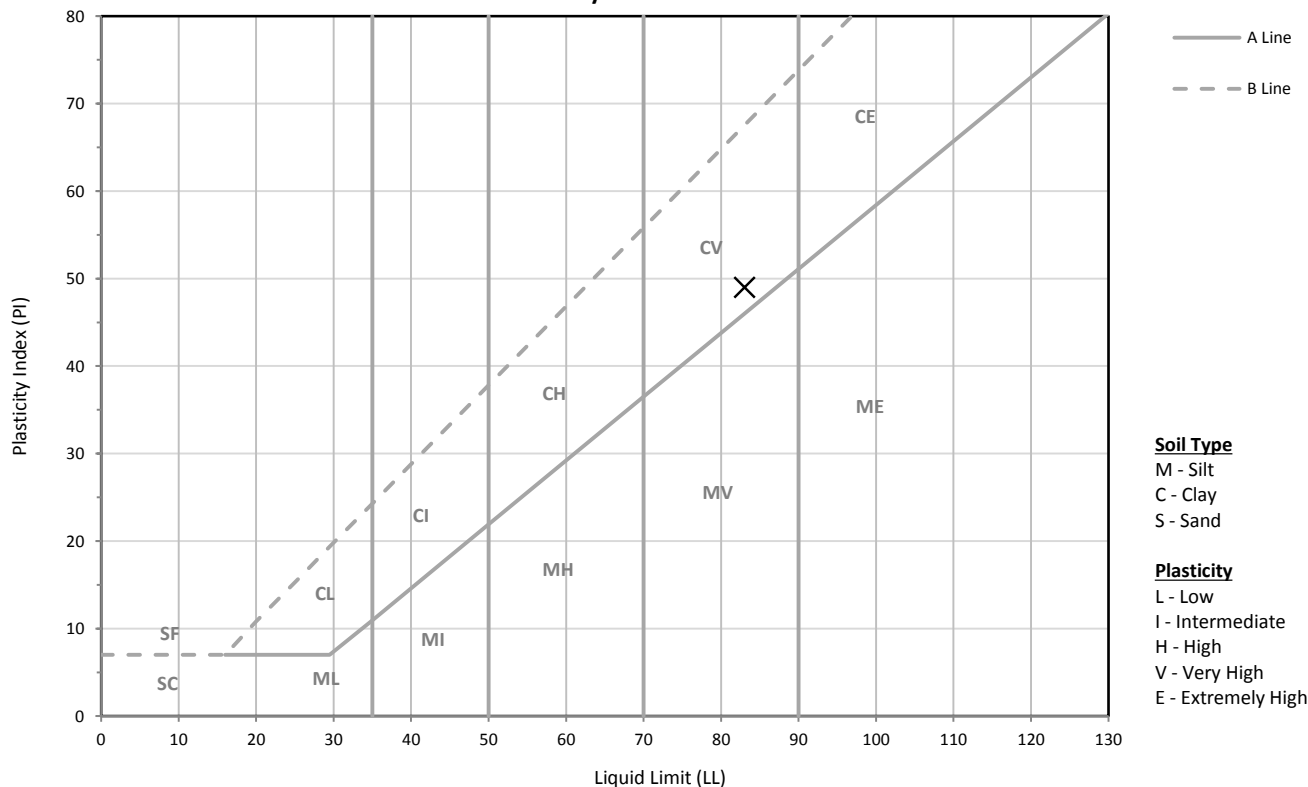
Plasticity Chart - BS 5930:1999

| | Description | silty CLAY with trace rootlets; brown. moist to dry, very high plasticity. | | |

Liquid Limit **83**
Plastic Limit **34**
Plasticity Index **49**

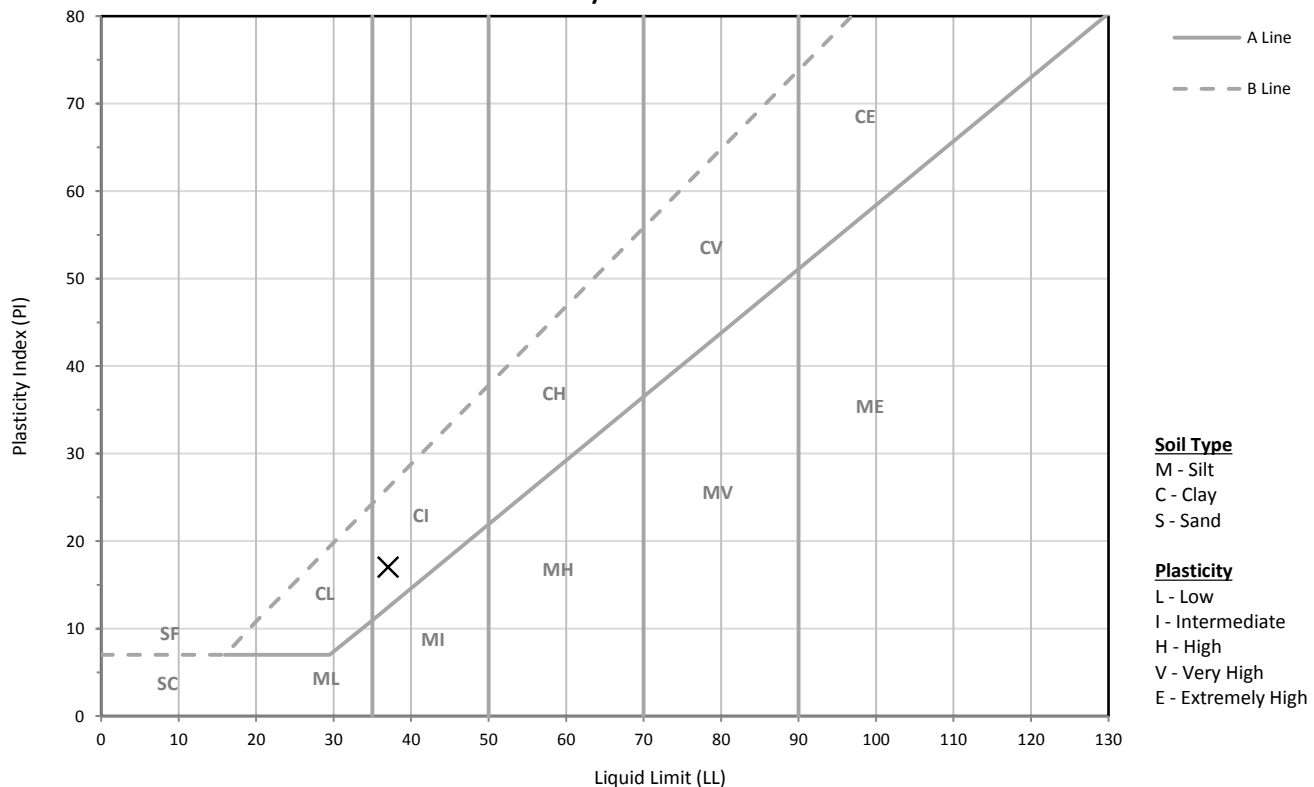
Plasticity Chart - BS 5930:1999

Liquid Limit 37
Plastic Limit 20
Plasticity Index 17

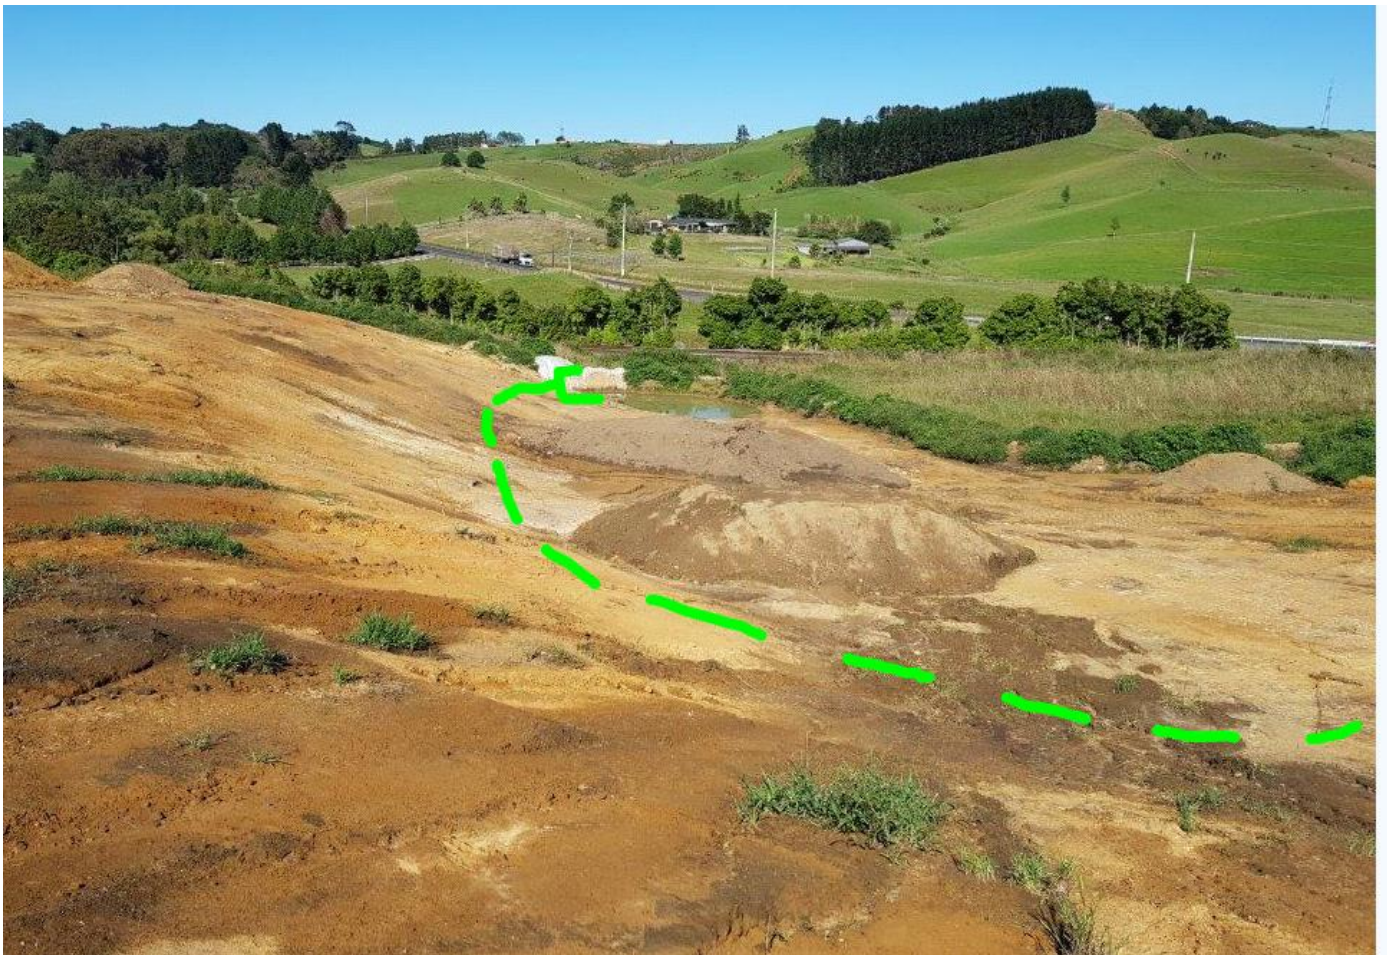
Noted that the topsoil had been stripped adequately to expose stiff natural ground. Requested that an underfill drain is installed as per the picture below, the slope still needs to be benched.

Requested underfill drain in green.

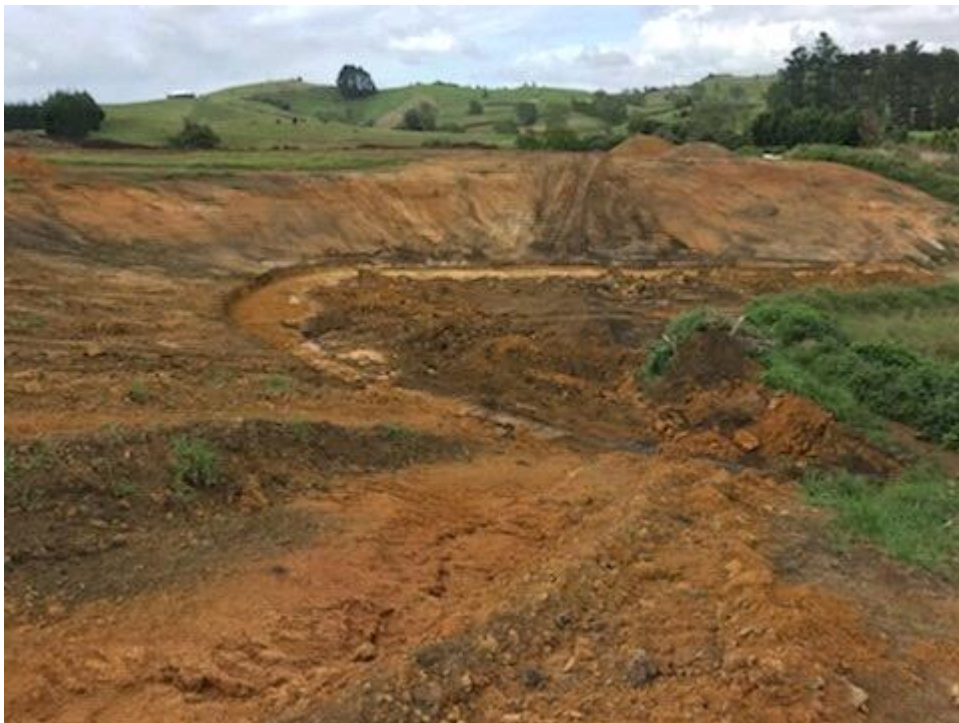
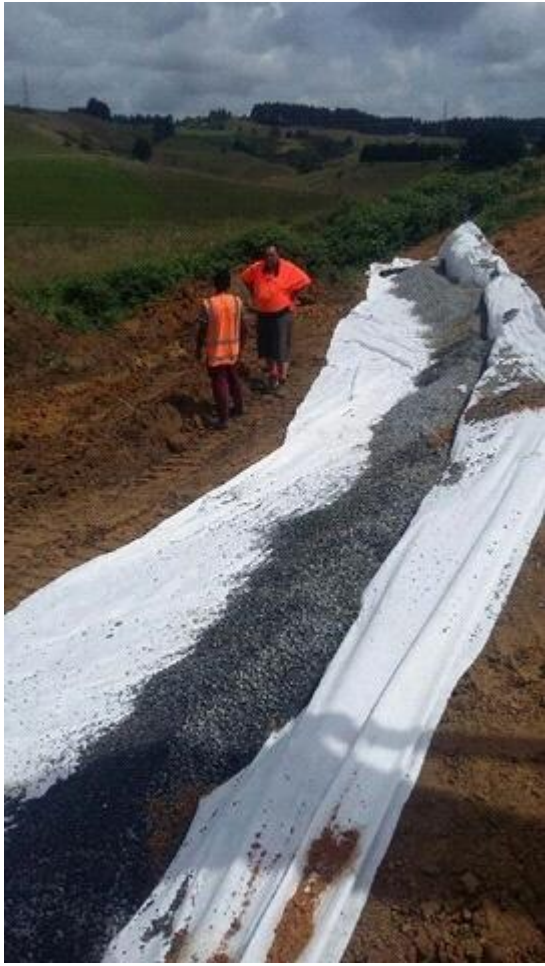
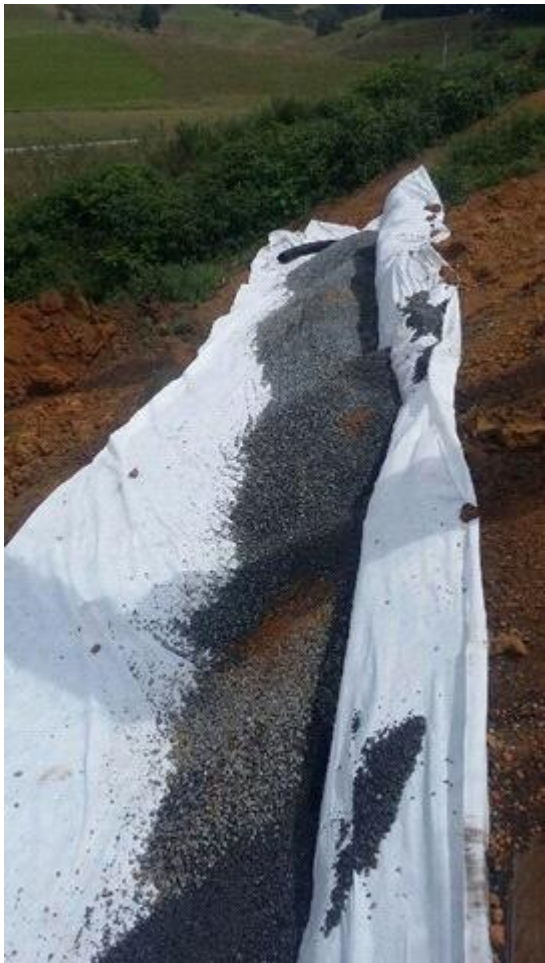
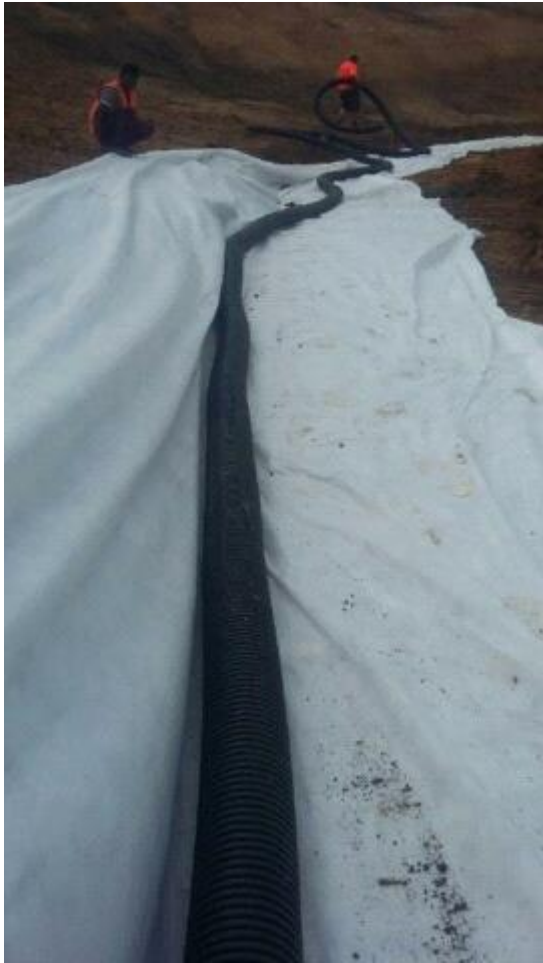
Photos from Trevor of Fill L drainage installation. Installation appears to have occurred as per CAN that we issued on the matter.

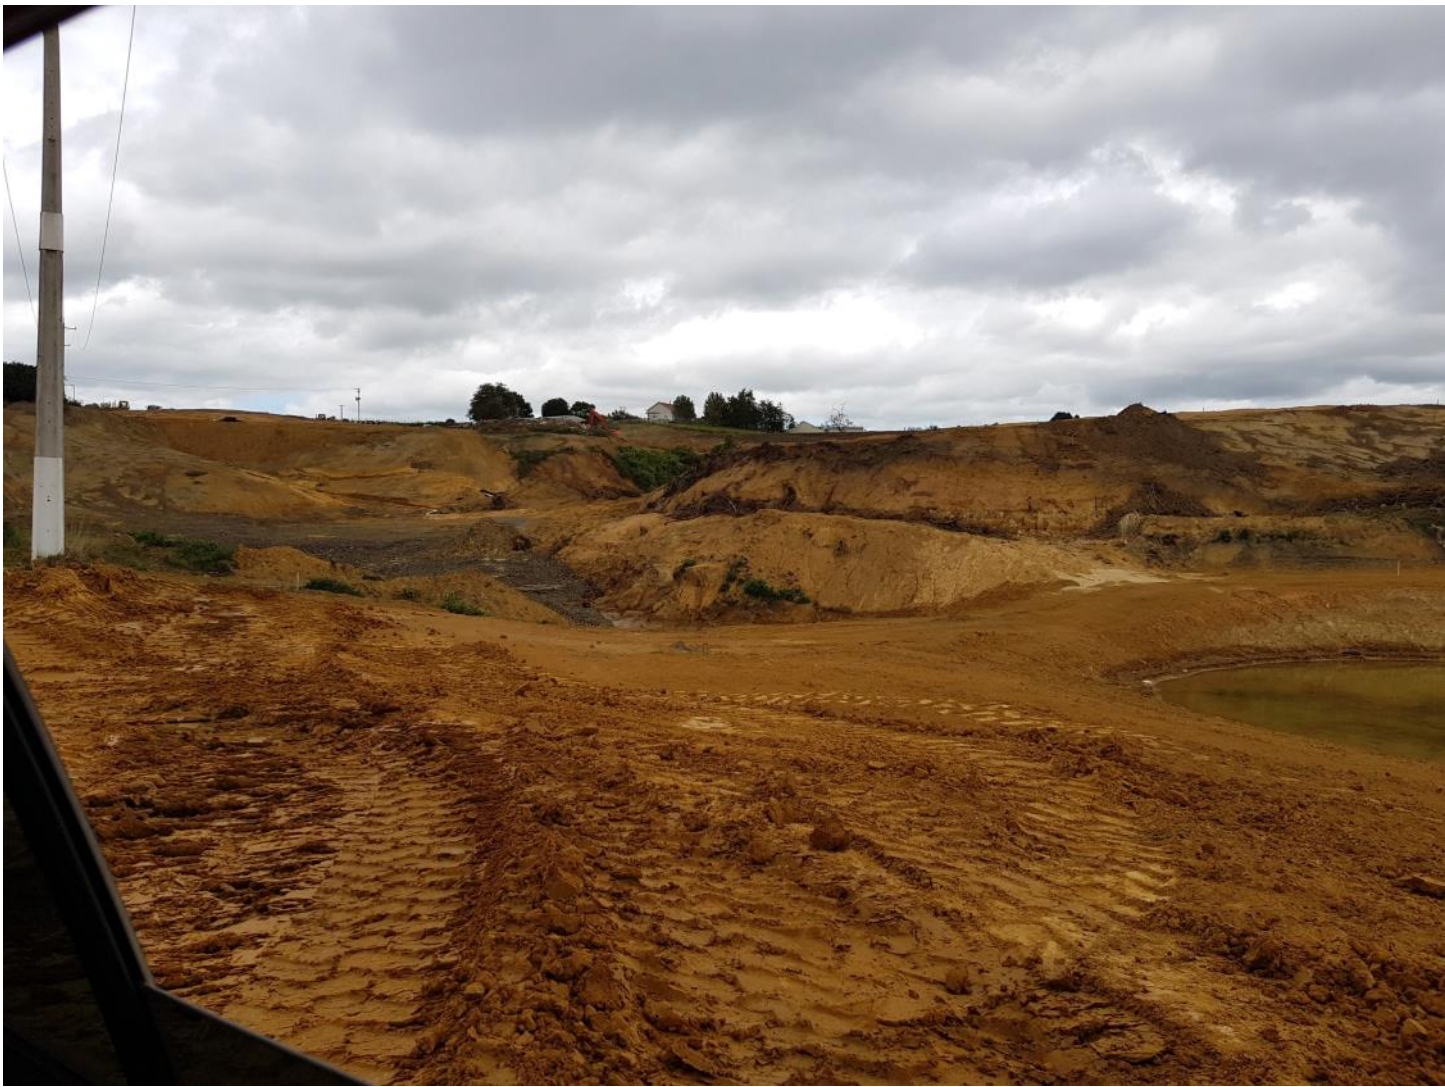
Observation of progress of works on site. They have only 2 scrapers and 1 compactor working (as rest of plant is on the Bridge and Hynds).

Cut to fill around the pond area in the western part of stage 3 is the focus currently. Have asked Mike to get in contact with Trevor to ensure the appropriate level of fill testing is taking place.
