Geotechnical Completion Report

HITCHEN BLOCK STAGE 12D

Ref No: J00113

RE: Geotechnical Completion Report for Hitchen Block Stage 12D, Pokeno

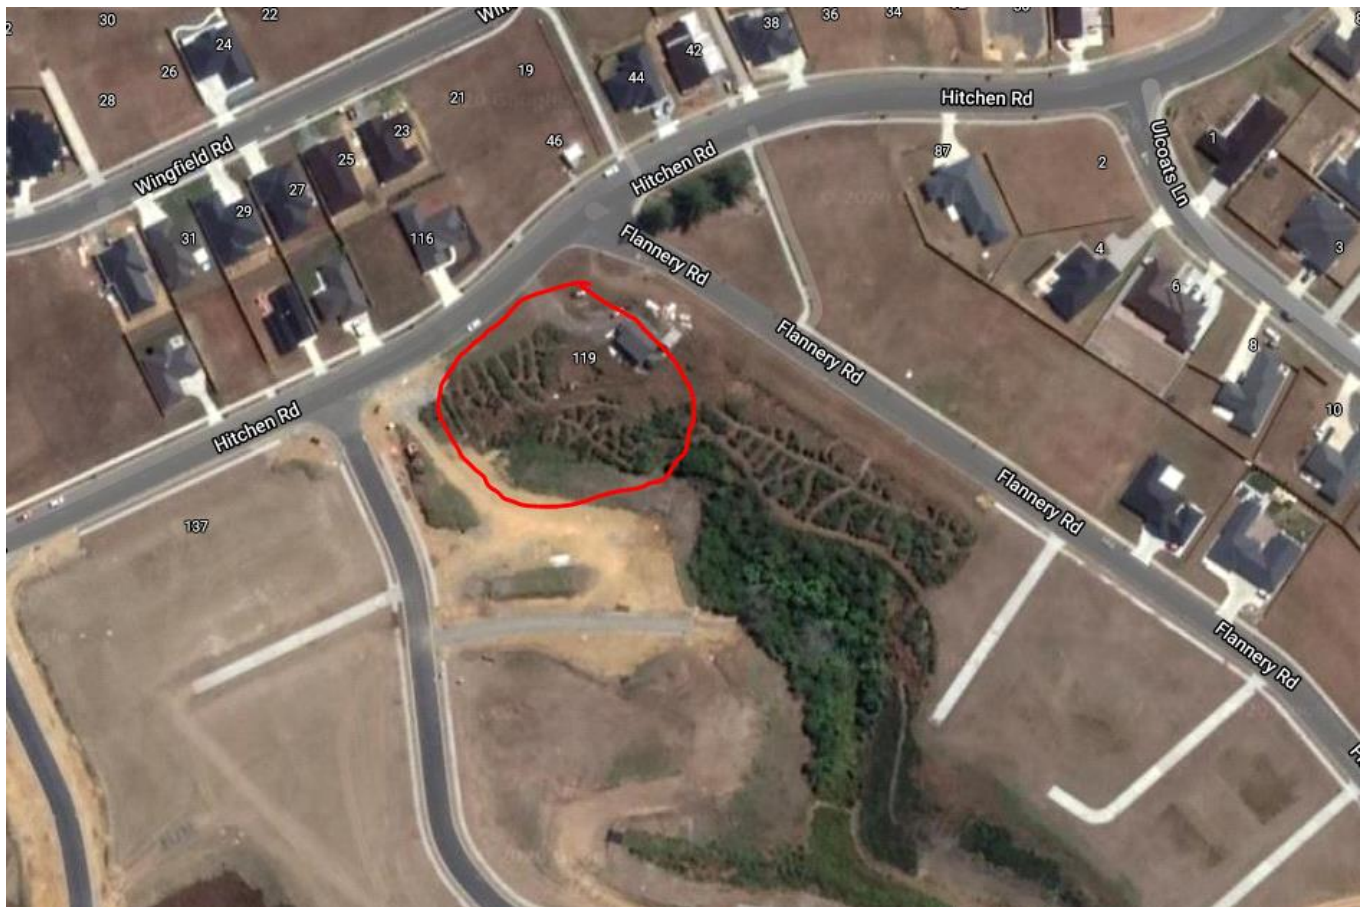
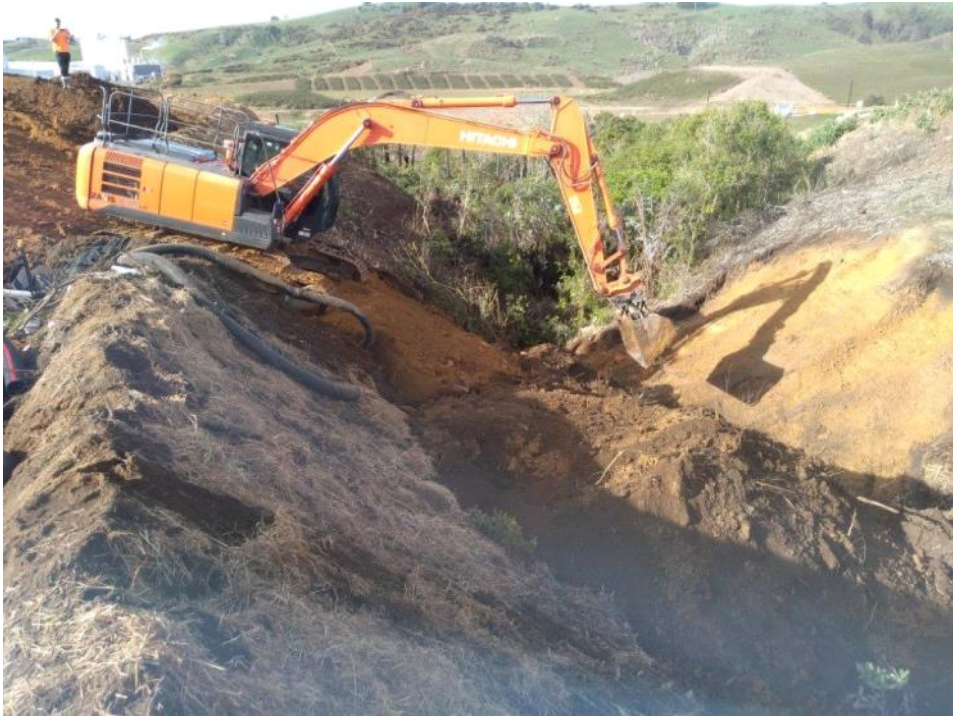
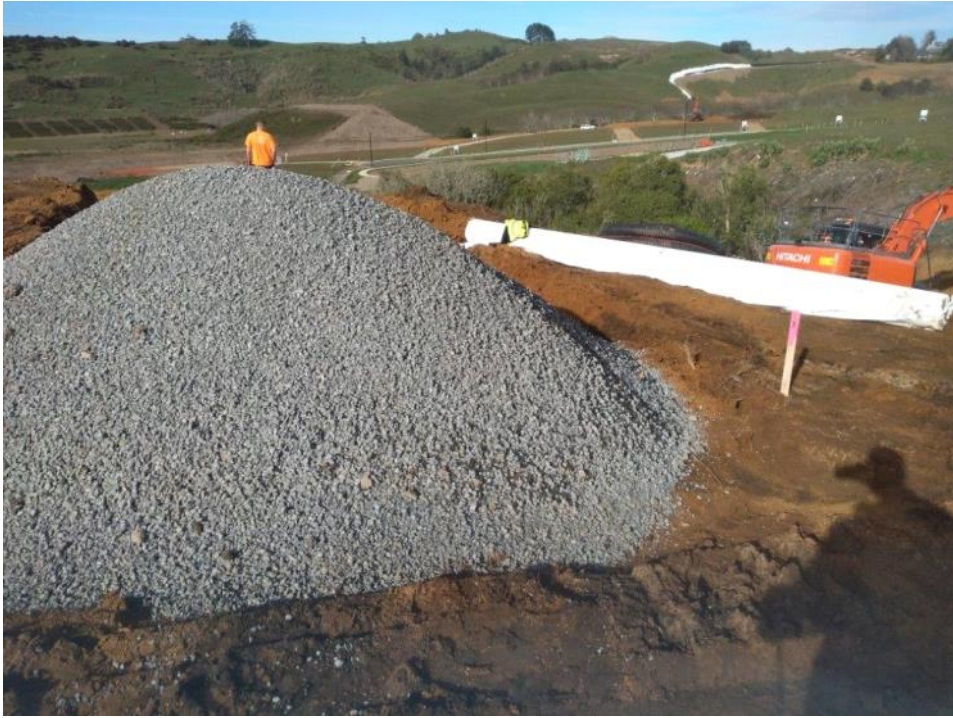
Observed muck out of portion of gully circled below. Decant to be formed here to allow further earthworks up slope within gully. Muck out looked suitable with benches to be formed 2 compactors width in flanks to lock this fill batter in. Batter only temporary until next season when earthworks occur downslope. Underfill drain to be placed through this area (discussed specs which are consistent with other drains across site) that will lead into the earthworks upslope and eventually downslope as well. Fill materials to cut from cut area above which looked fine to use. Testing to take place every 1m lift. Contractor to get in touch when gully upslope is being stripped.

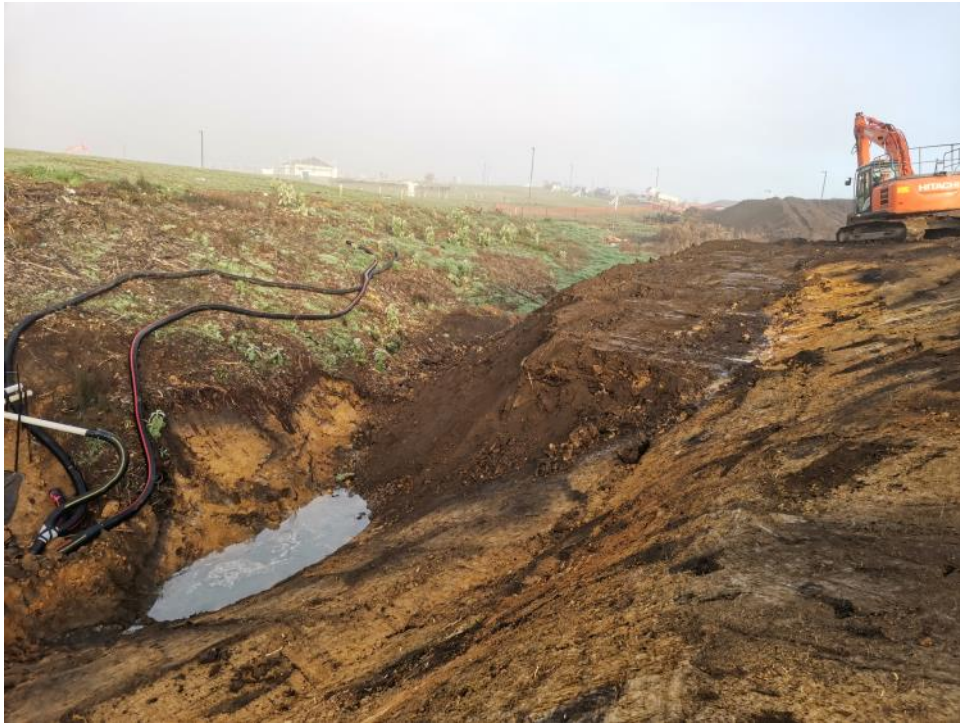
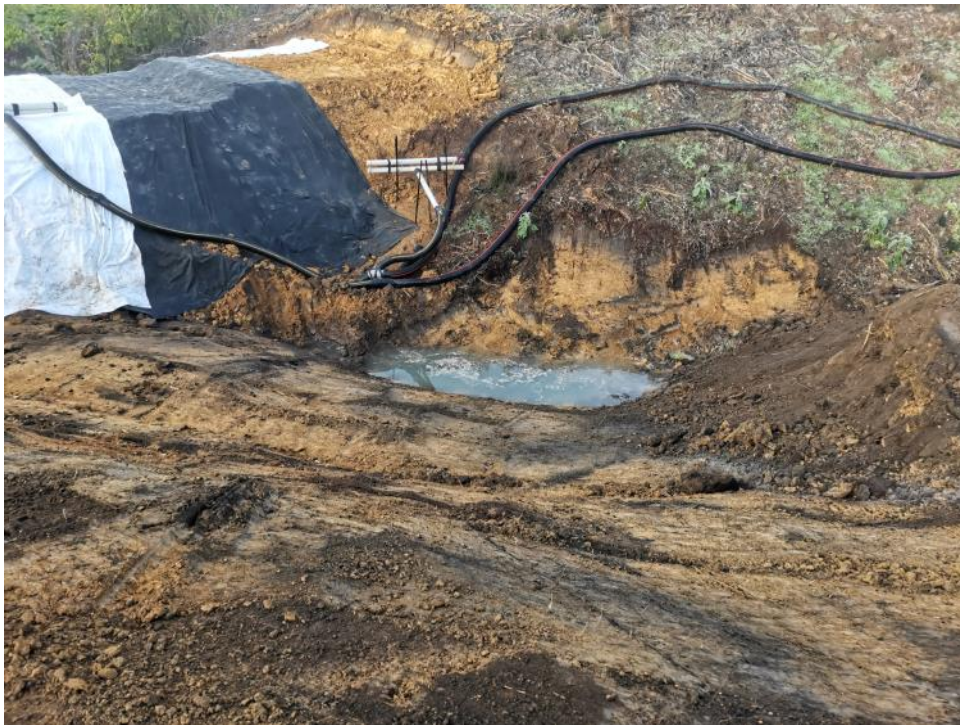
Project no. and name: J00113 - Hitchen Block	Date & Time: 4.08.20
Client/contractors present:	Lander staff: KM SV no:
Plant operating: 1 excavator, 1 mixer	
Inspection for (tick all that apply): Shallow Foundations <input type="checkbox"/> Pile Foundations <input type="checkbox"/> Site Meeting <input type="checkbox"/> Subgrade <input checked="" type="checkbox"/> Retaining Wall <input type="checkbox"/> Other <input type="checkbox"/>	
Observations/Discussions: <p>Fenner's Rd</p> <p>Hitchen Rd</p> <p>x = stripped to natural, inorganic very ripe ash soils</p> <p>area of sully skip exposed very ripe ash soils</p> <p>/// = sully chipping still in progress</p>	
Inspection Result:	Pass <input checked="" type="checkbox"/> Fail <input type="checkbox"/>

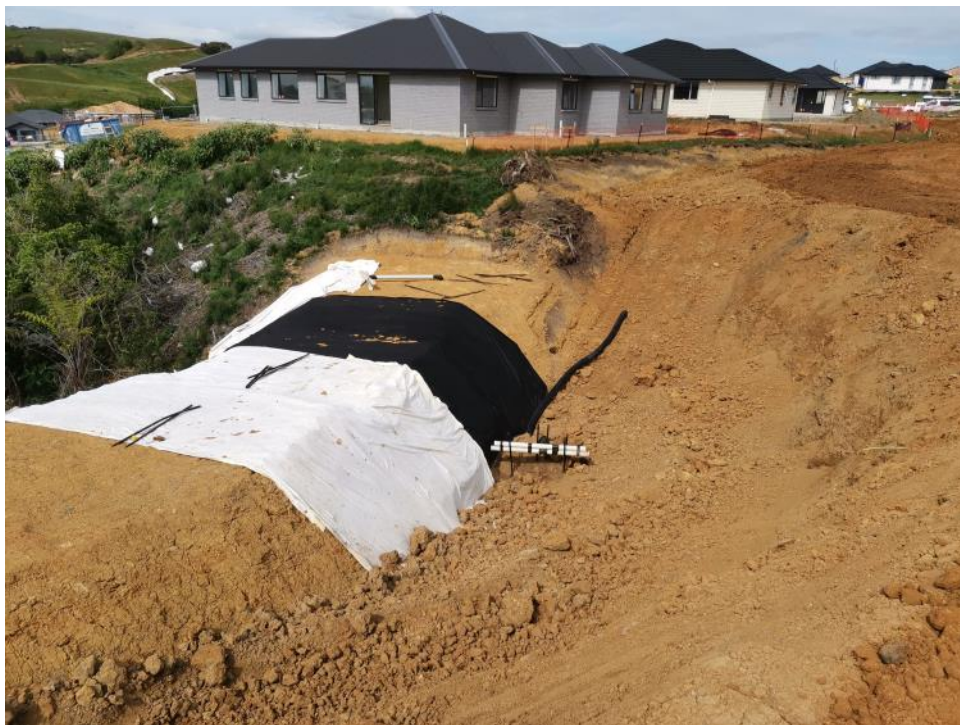
Earthworks are also commencing in the large slip area at the far end of the site. Silt controls are currently being formed for these works prior to stripping operations commencing.

In Stage 12D, earthworks filling operations are progressing, and the underfill drain is likely to be extended in the next week or two.

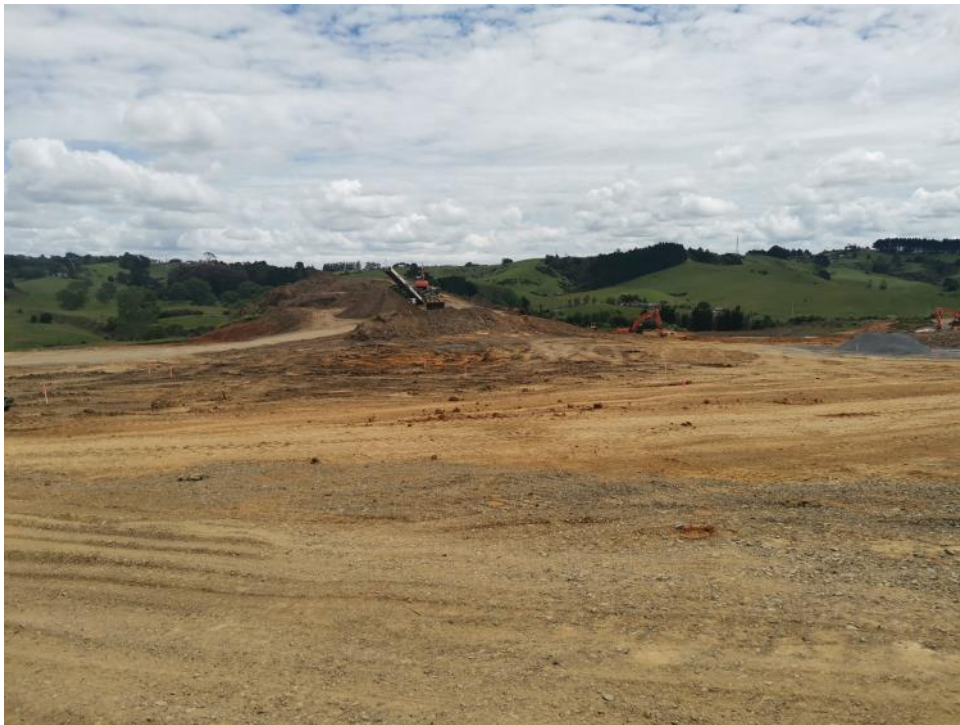
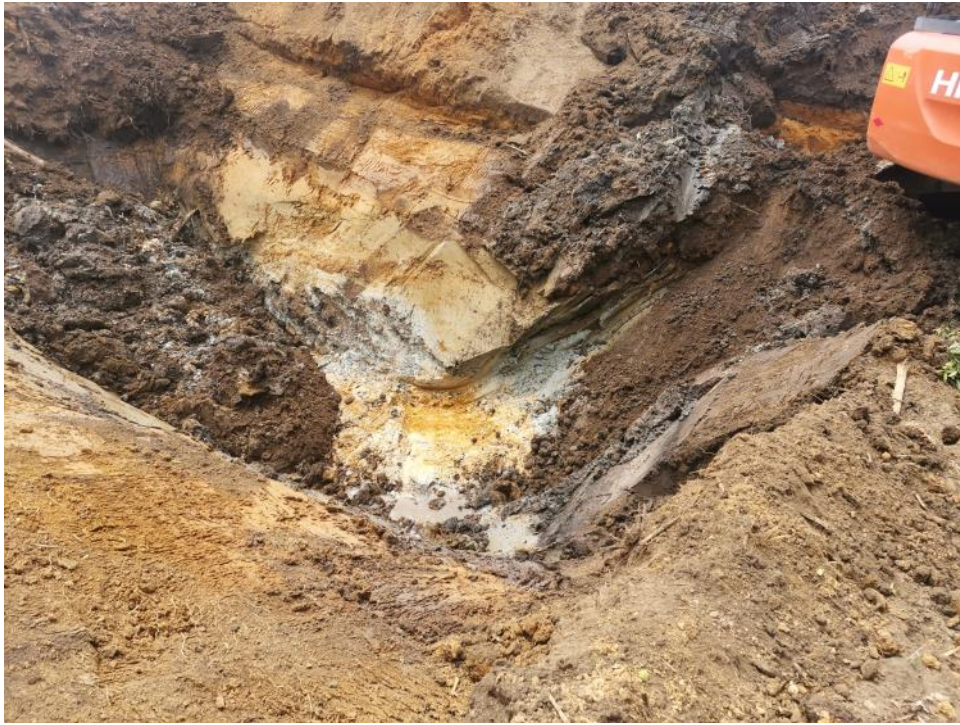
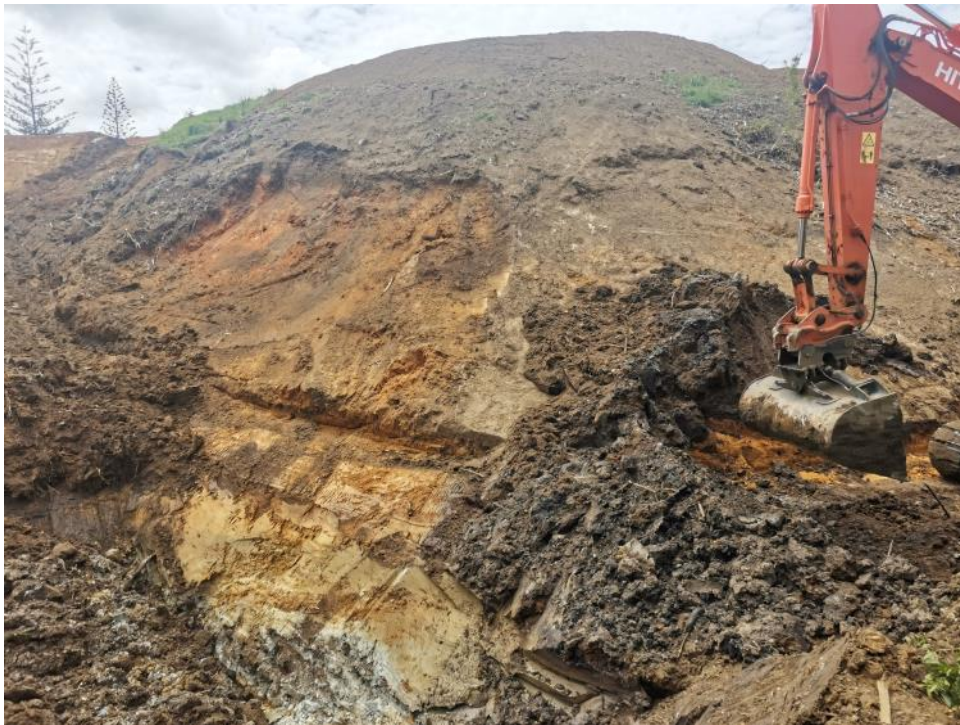
16/11/20 - PM - Stage 12D

Also inspected the removal the stockpile materials within Fill D. Very stiff, orange/brown ash soils were exposed consistent with the stripped soils previously sighted within the adjacent cut areas.

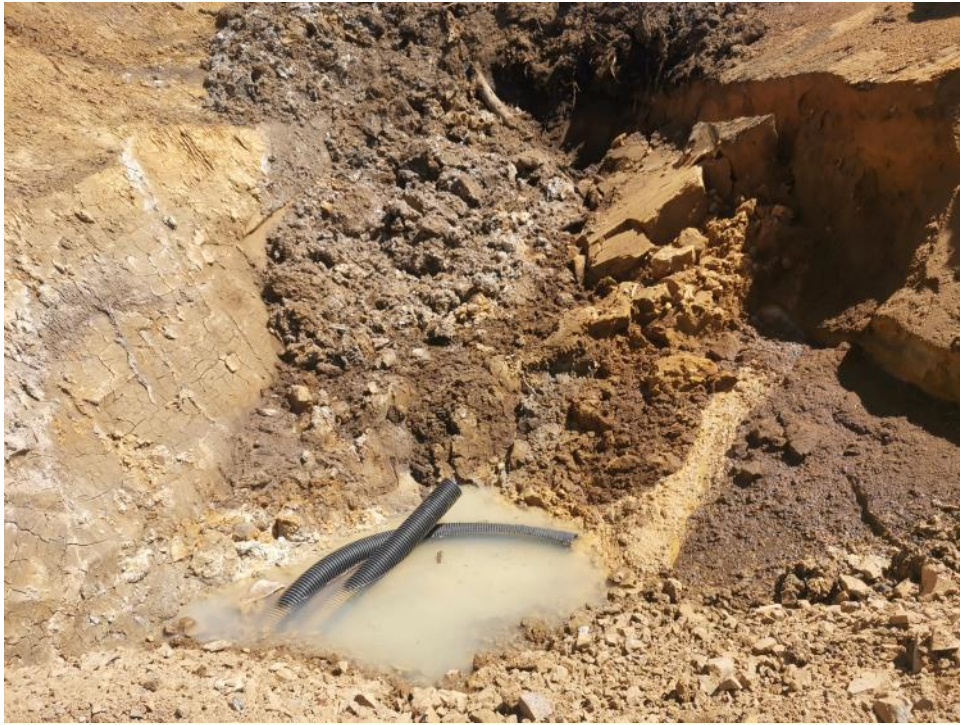
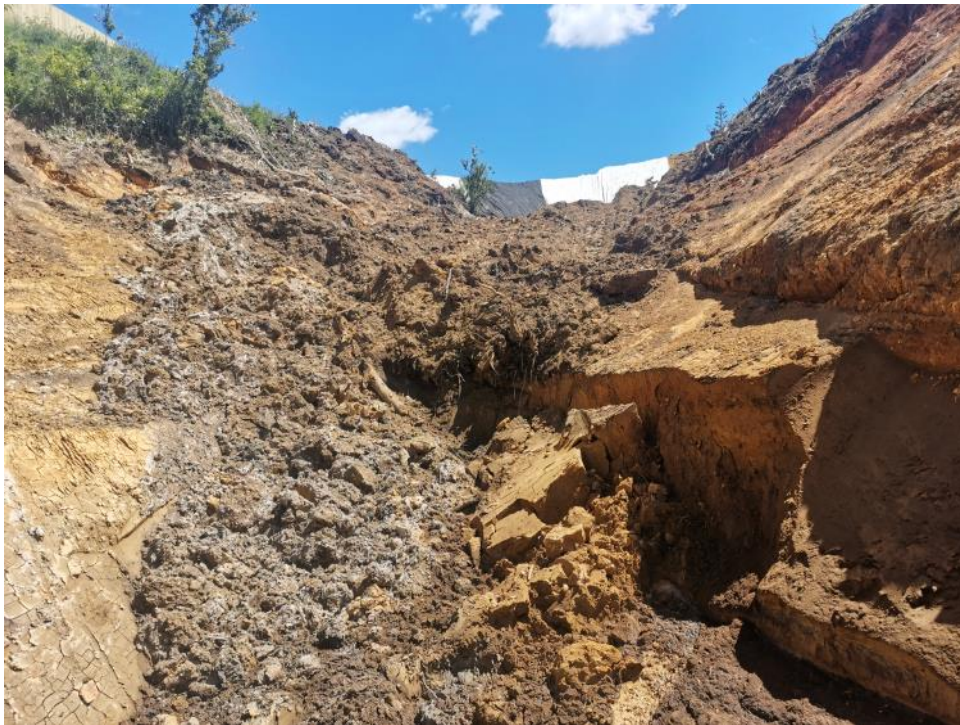
Not much progress has been made since our last inspection in this area. The SPR in the base of the gully is still loose and requires compaction. The contractor is planning to bring a pad-foot roller down to this area to start backfilling the gully.

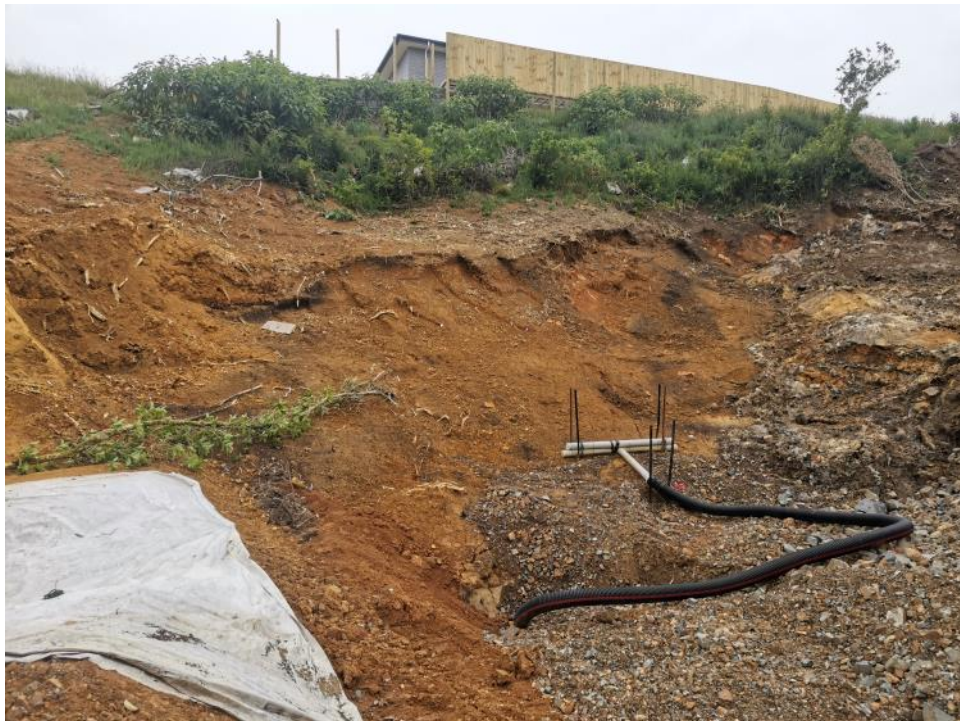
30/11/20 - Stage 12D

Not much progress has been made since our previous inspection and there is spoil along the gully which is still to be cleared. Also discussed that a toe key is required at the base of the proposed fill batter, which the contractors are proposing to install prior to building the fill batter.

Also discussed the stripping in Lots 611 and 612 which Russell emailed about last week. This area is still covered by a topsoil stockpile. Advised the operator to get Dylan to get us in for an inspection prior to placing fill in this area.

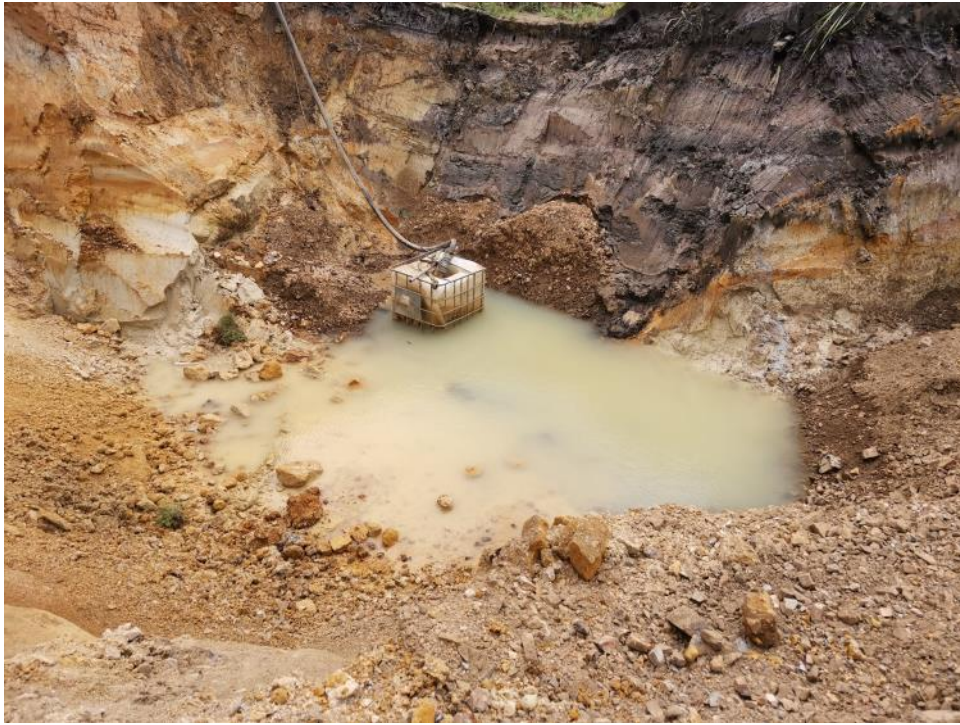
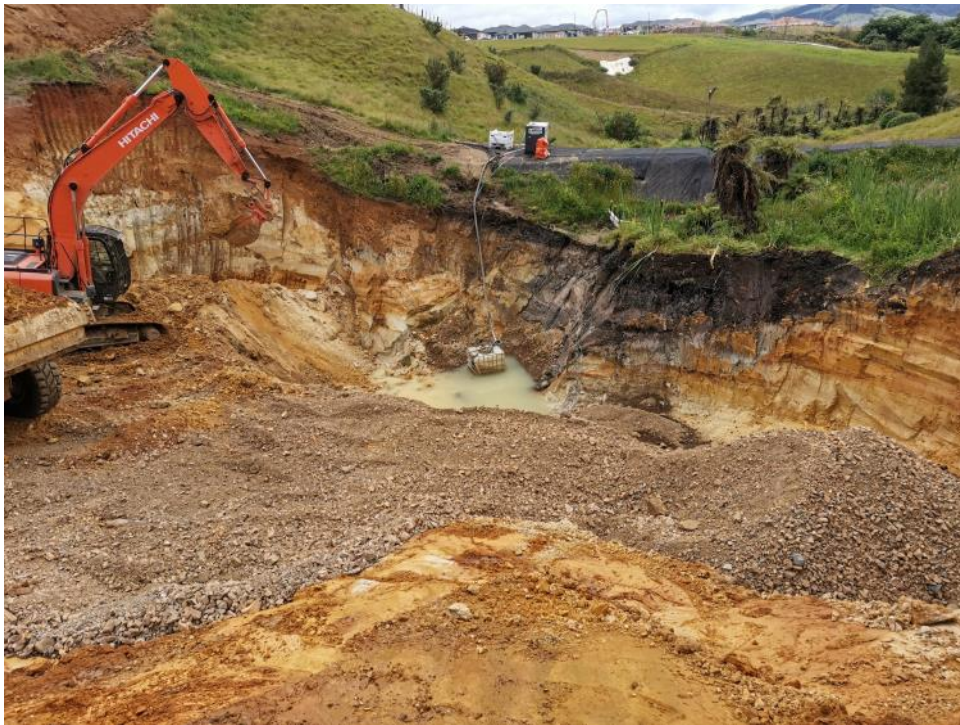
REB 2 shear key:

- Inspected toe key in Stage 12D. Contractors have excavated to approx. 4m with no improvement in ground conditions. Advised that they could place a 500mm raft of compacted SPR to allow them to start backfilling.
- Inspected shear key excavations in REB2. Hard ground exposed throughout along the base of the key which had been further excavated since yesterday. Advised that backfilling can commence with SPR100 once they have pumped the water out of the excavation. Plateau test from REB1 will still remain relevant.

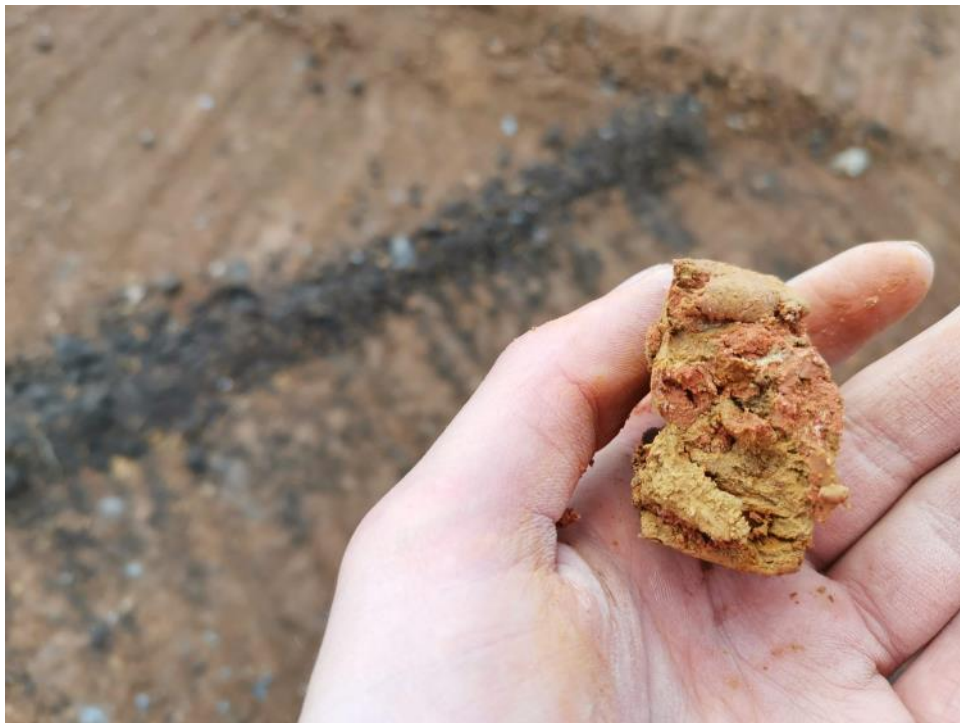
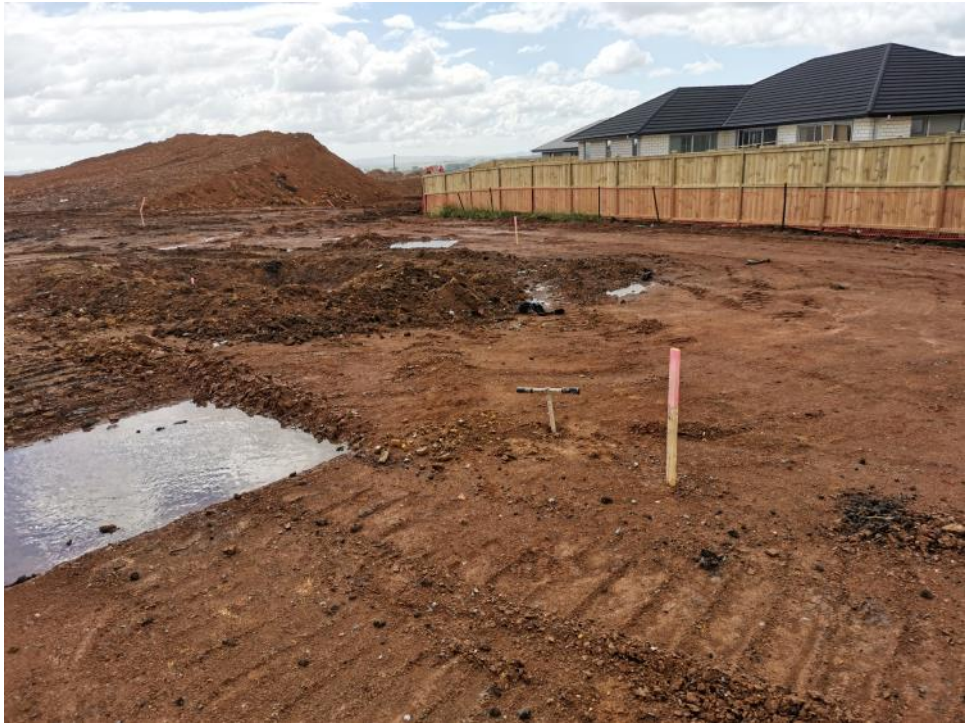
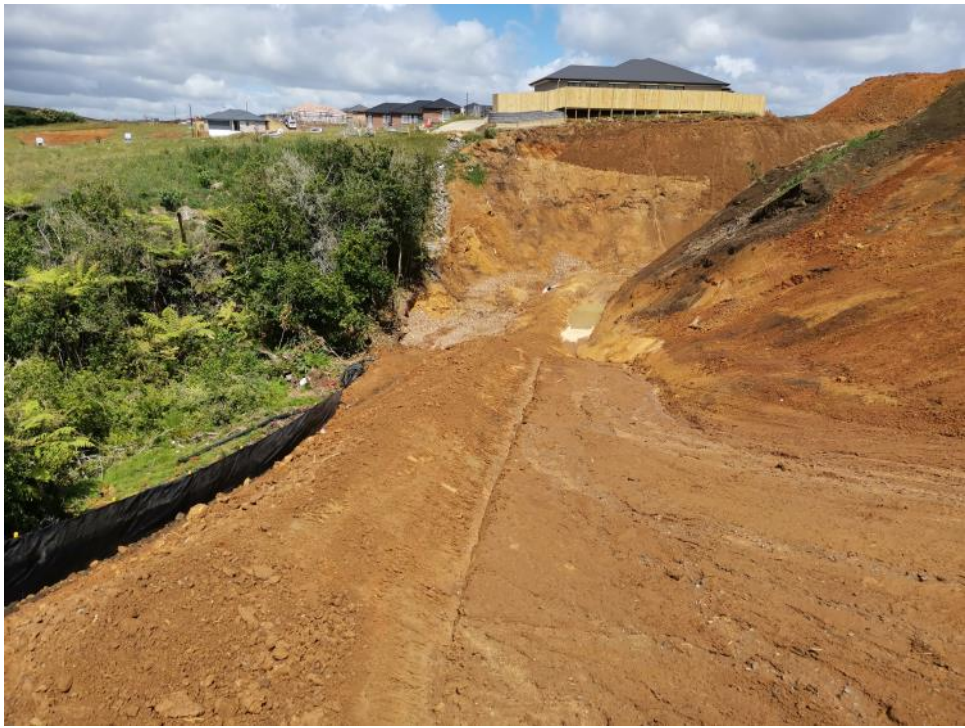
Visited site to check on toe key works in Stage 12D. The first section of the toe key has been backfilled with hardfill.

Also, drilled at hand auger in Lot 612. Encountered approx. 0.6m of fill overlying very stiff, natural ash soils.

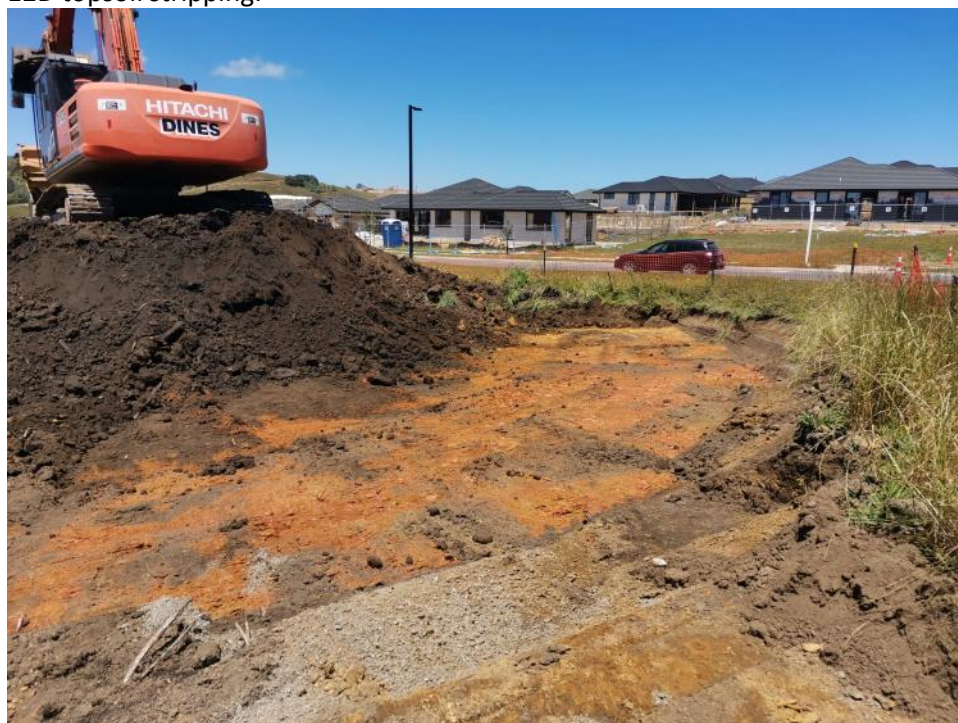
12D topsoil stripping:

Also, inspected stripping over Lots 612 & 612. Generally very stiff natural ash soils were exposed, however, some topsoil/rubbish was observed which we recommended be undercut to natural ground. Will look at this again tomorrow afternoon with Chris.

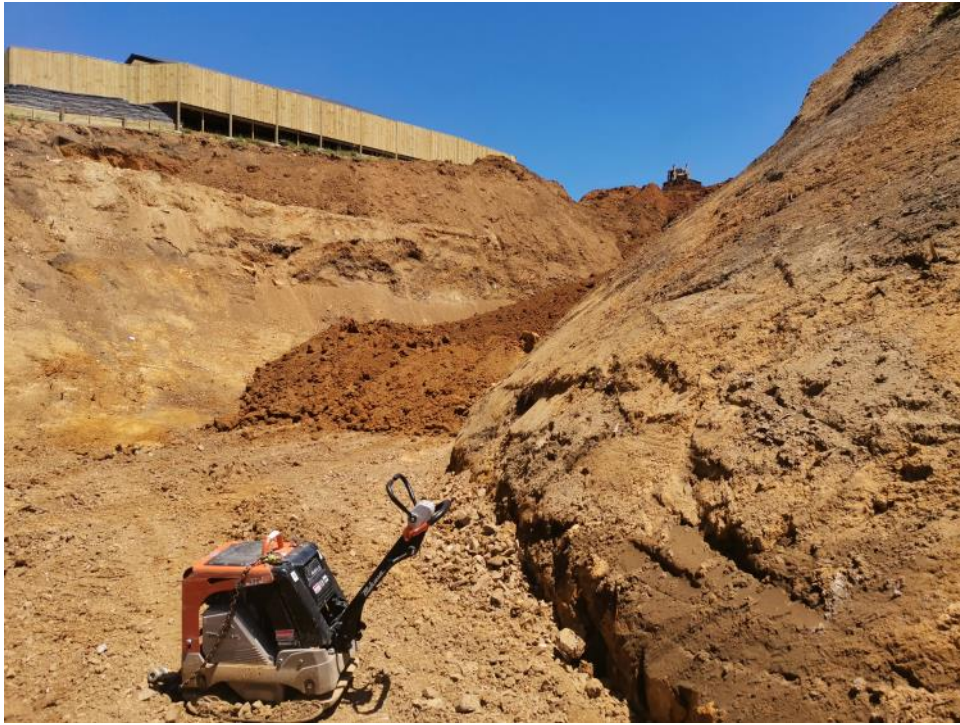
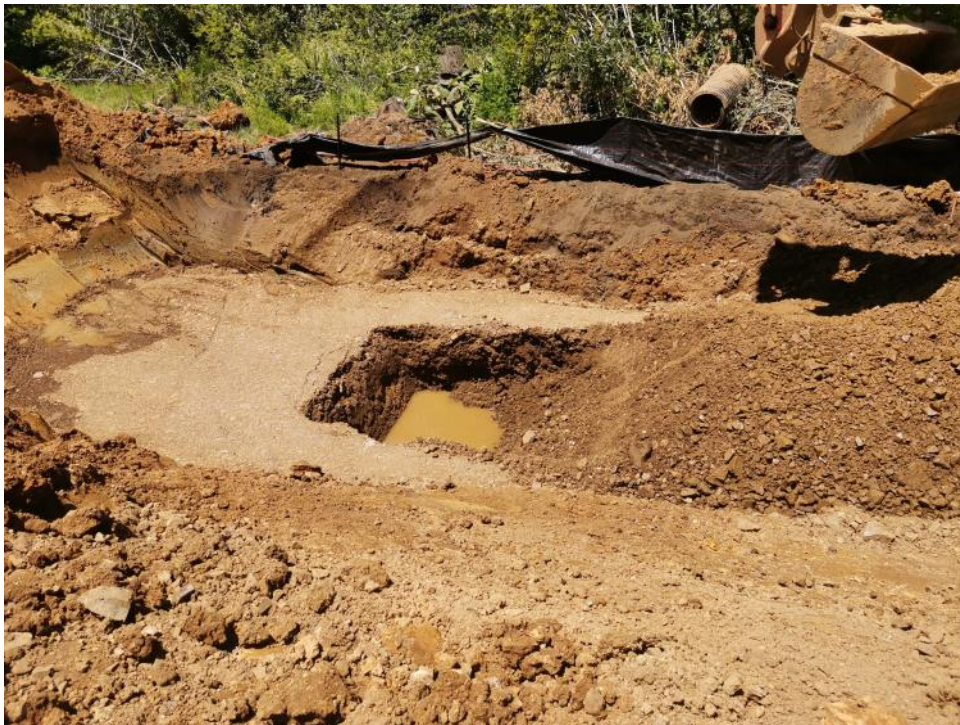
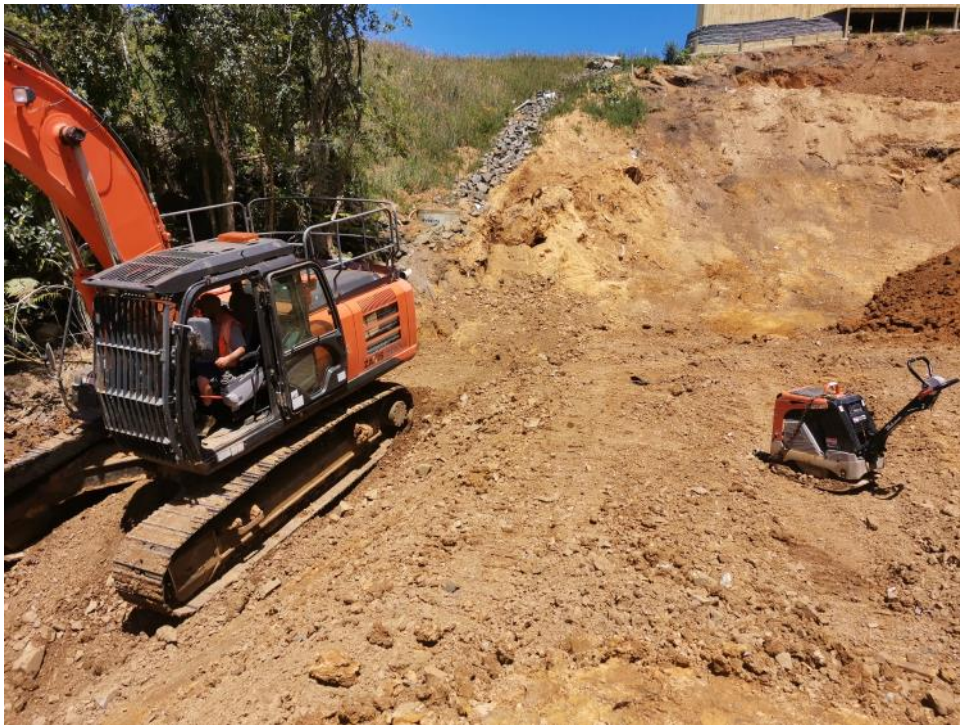
12D fill/toe key area:

Visited site to inspect 12D toe key. Contractor had already filled with SPR to 1.5m without getting us to inspect or getting fill testing so asked them to dig back to subgrade in the centre. Firm soils exposed at the base, however, the toe key will be about 2-3m thick so no undercut was recommended. Contractors said they needed to backfill the area immediately. We advised that they need to give adequate notice for geotech and fill test inspection in this case.

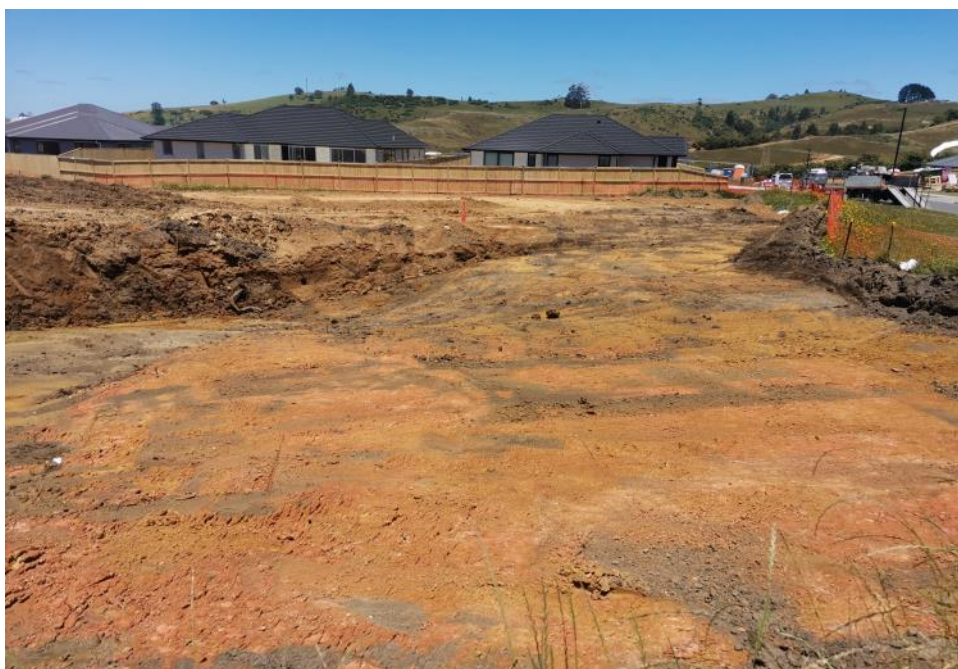
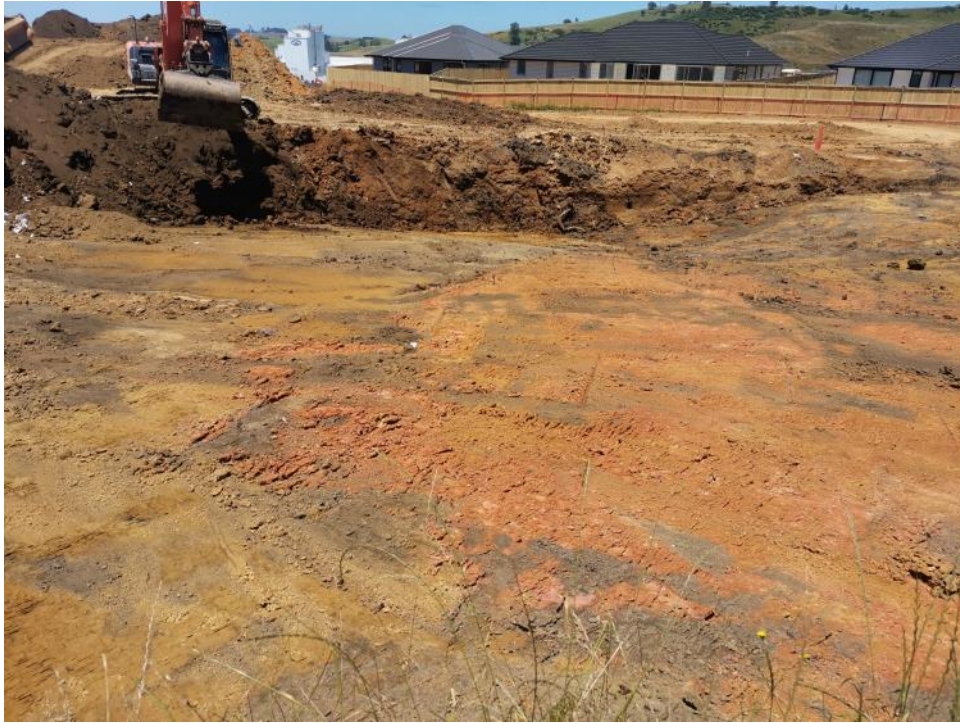
- Stage 12D toe key. The contractors failed their previous test here, achieved CIV readings of around 10. They removed the material, discarded the wetter SPR and refilled with a heavier roller. Josh to retest. The model also needs to be rechecked to confirm minimum toe key requirements are adequate.

- Also observed the stripping area in lots 611 and 612. Rubbish/pre-existing fills are still present. Reiterated that these materials be fully undercut. Will return to site tomorrow to observe general earthworks operations.

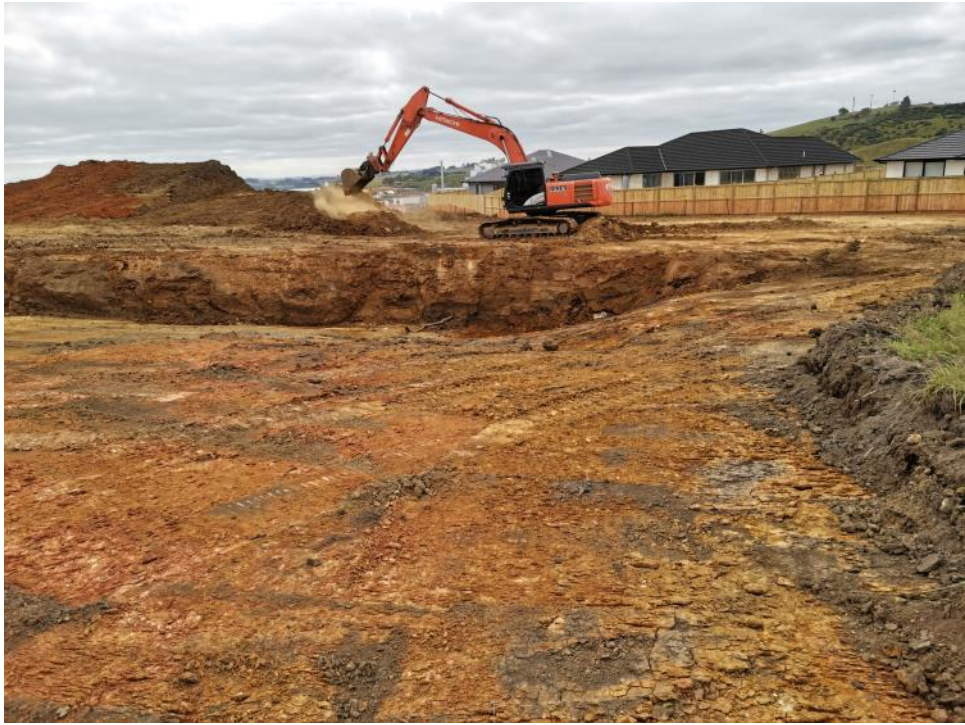
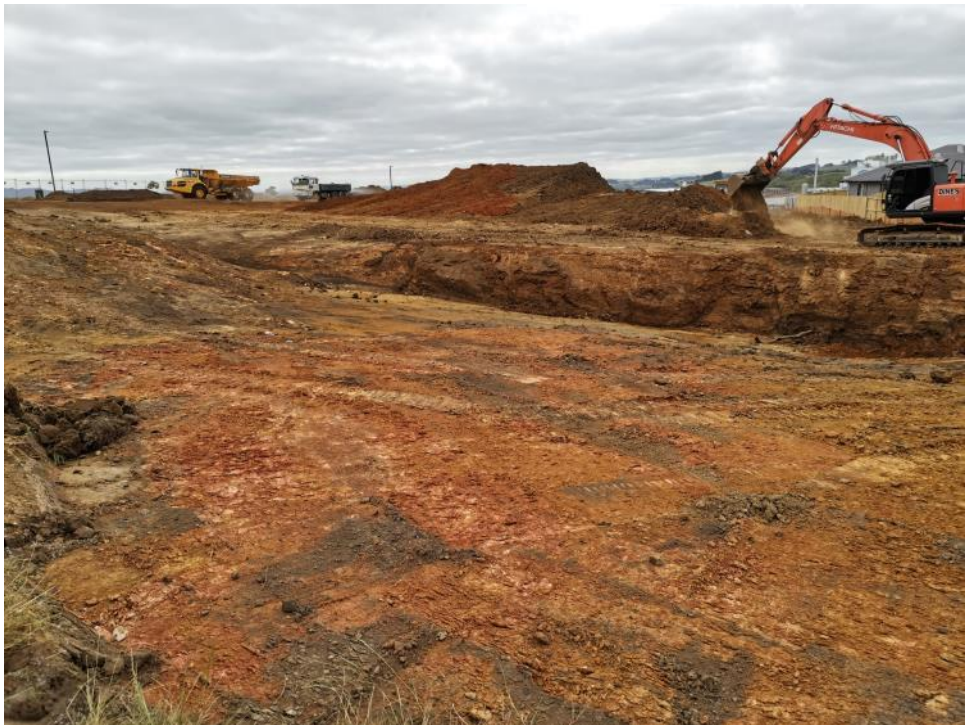
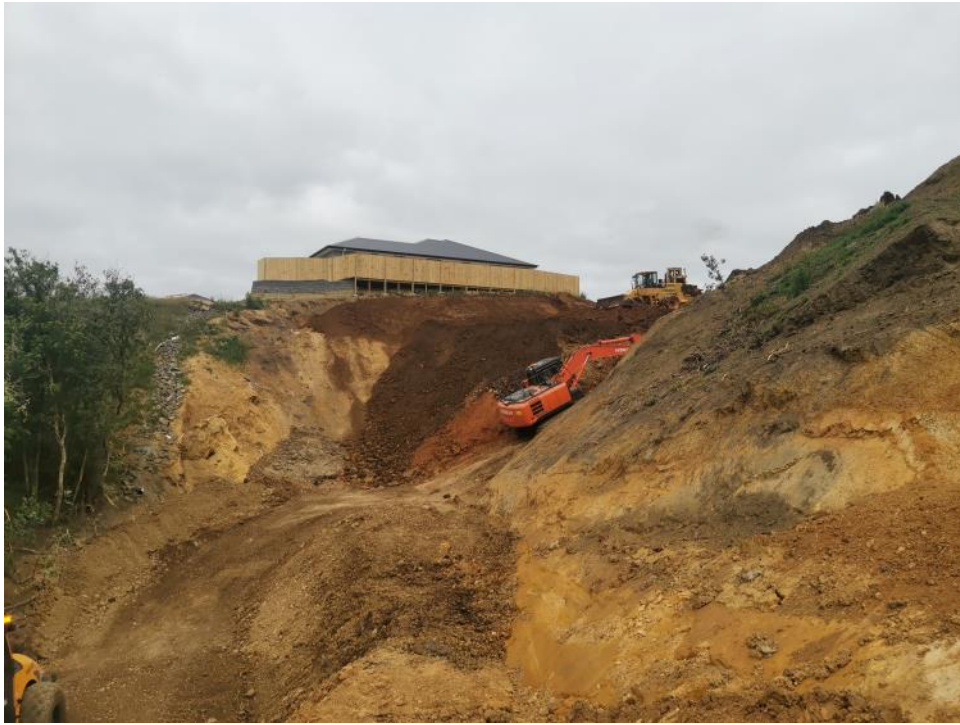
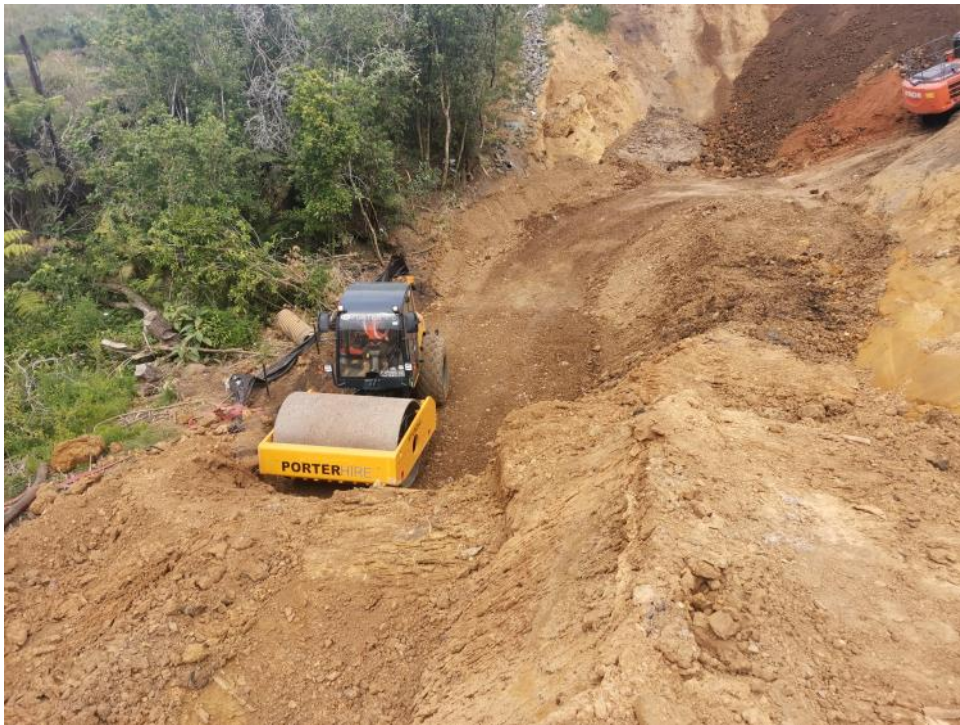
Inspected backfill in 12D toe key. Compaction appears to be going well with no obvious deflections noted under a 12T smooth drum roller. The latest fill test passed on both clegg hammer and backscatter testing.

Also observed undercutting of topsoil/pre-existing fill in the top section of Stage 12D. The base of the undercut is generally down to natural ground, although there is some minor topsoil mottling to chase out. The existing fill cut shows a layer of topsoil within the fill placed by Dines which is within 2m of surface level. Advised that this should be undercut and removed from the fill. Will return to site again tomorrow morning to inspect.

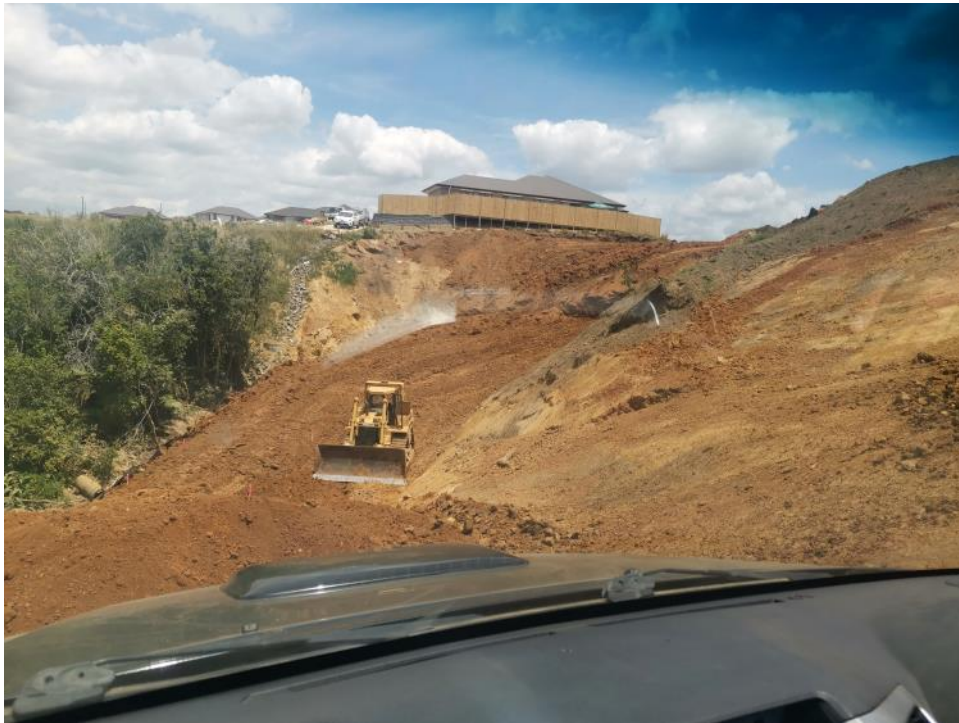
21/12/20 - Stage 12D

Visited site at request of Dylan to observe site works prior to the Christmas break. Not much has progressed since our previous visit. Toe key has been completed and clay fill for the 1(v) in 3(h) batter is now commencing.

Also requested that some more fill be placed to buttress the site cut at the top of the gully flank to ensure stability is maintained to the house.
