Geotechnical Completion Report

HITCHEN BLOCK STAGE 12D

Ref No: J00113

RE: Geotechnical Completion Report for Hitchen Block Stage 12D, Pokeno

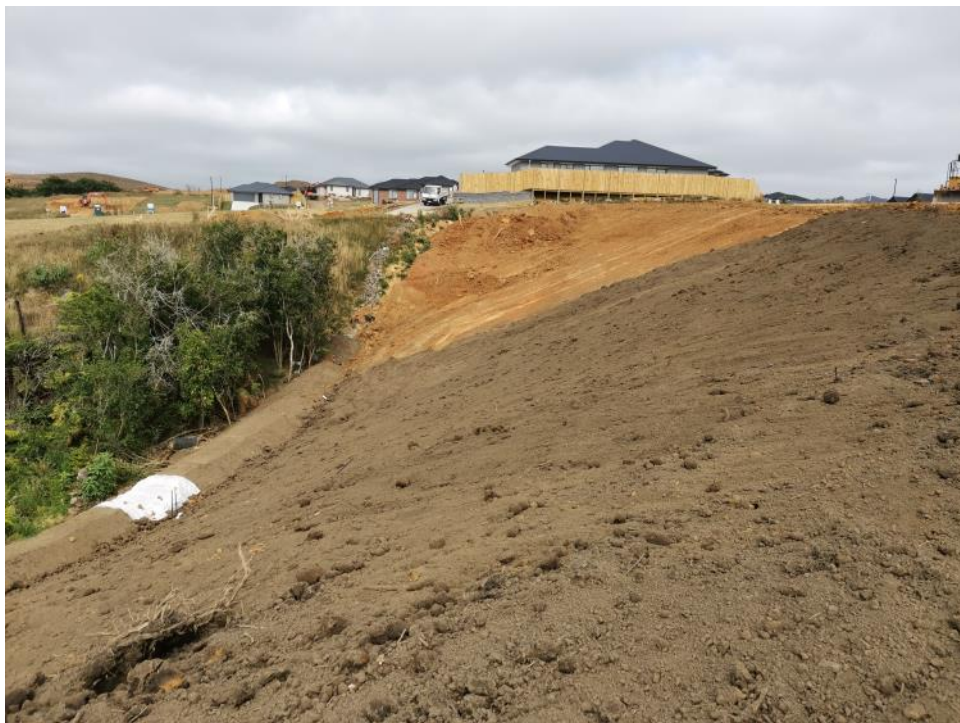
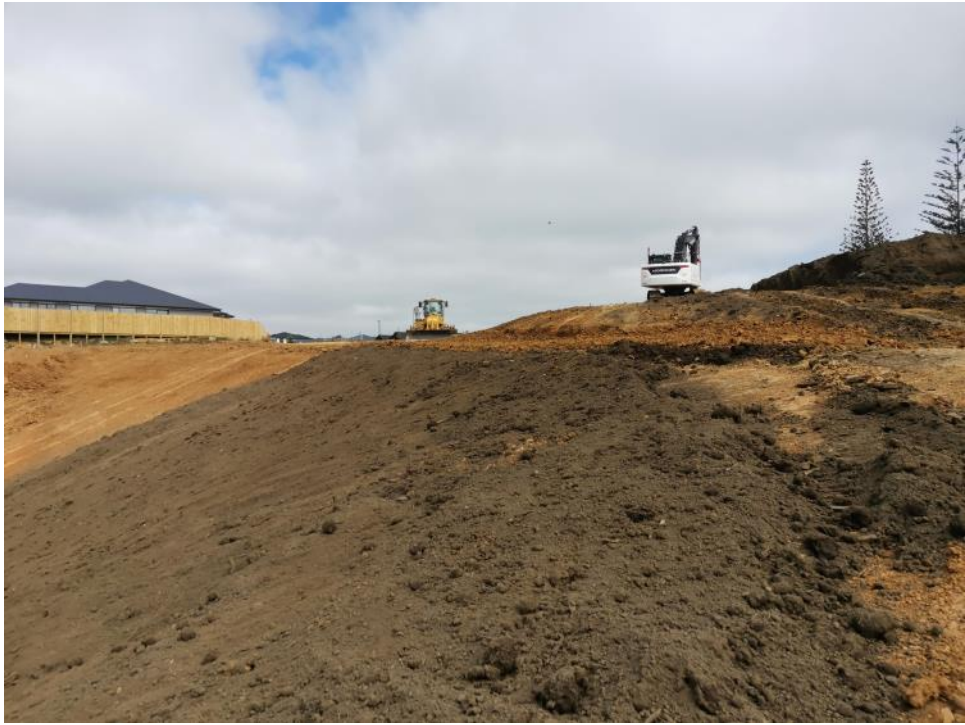
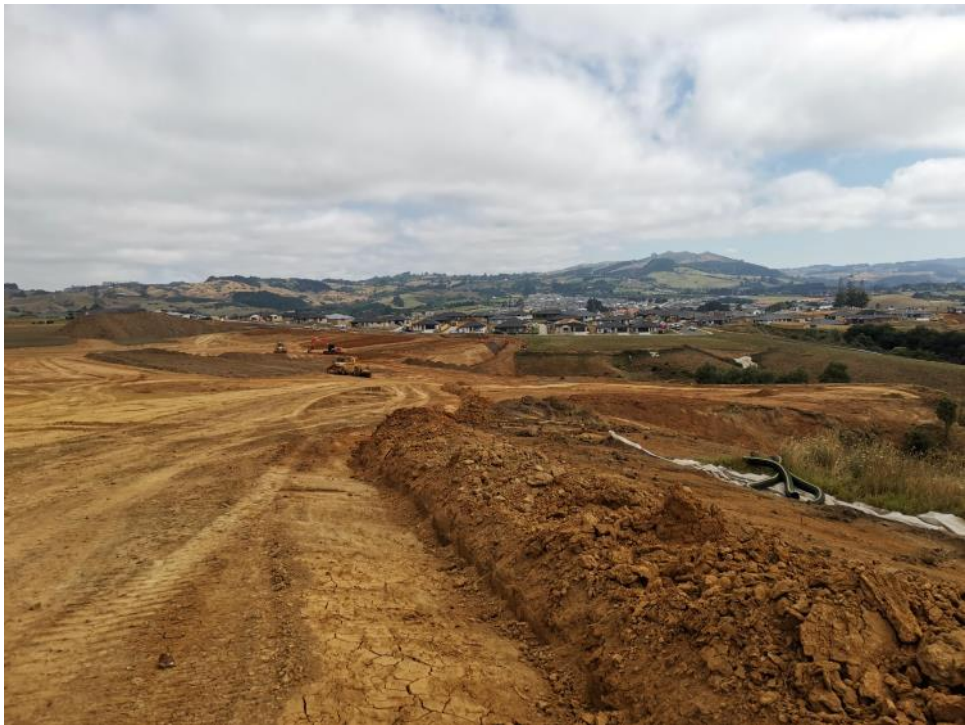
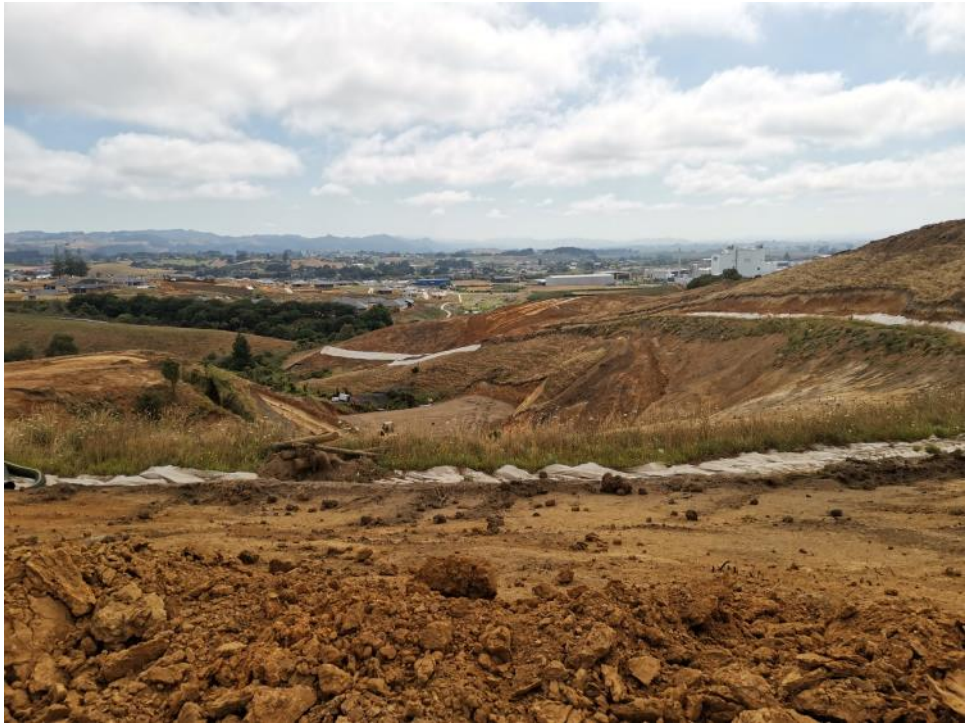
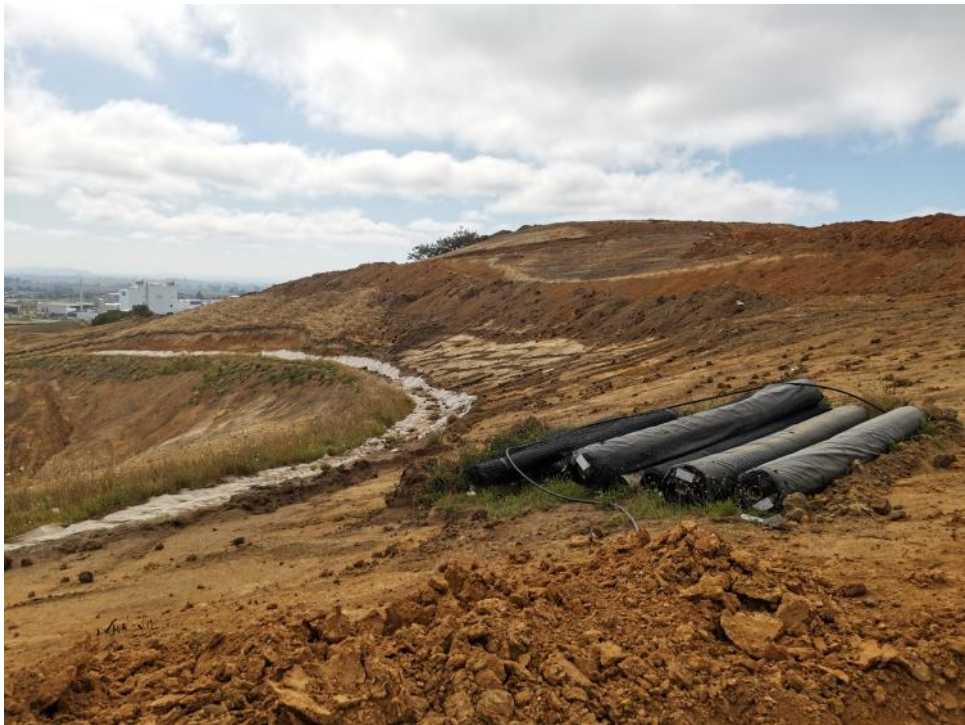
- Within Stage 12D the 1(v) in 3(h) batter has been formed to final height and has been trimmed and topsoiled.
- Stripping has commenced up the flanks of the gully in REB2 for preparation of the fill batter placement. Recommended the installation of 3 additional underfill drains in areas of seepage, two up the eastern flank and one up the southern (rear) which will connect into the existing underfill drain.
- Discussed that benching into the flanks will require an average bench depth of 2m which Dines have already programmed up.
- Will meet on Friday with Cirtex and Chris to discuss topsoiling the face of REB1 as the contractors are having difficulty getting the topsoil to stay in place.
