Geotechnical Completion Report

HITCHEN BLOCK STAGES 6E AND 10A TO 10D

DFH JOINT VENTURE LIMITED

16 December 2020

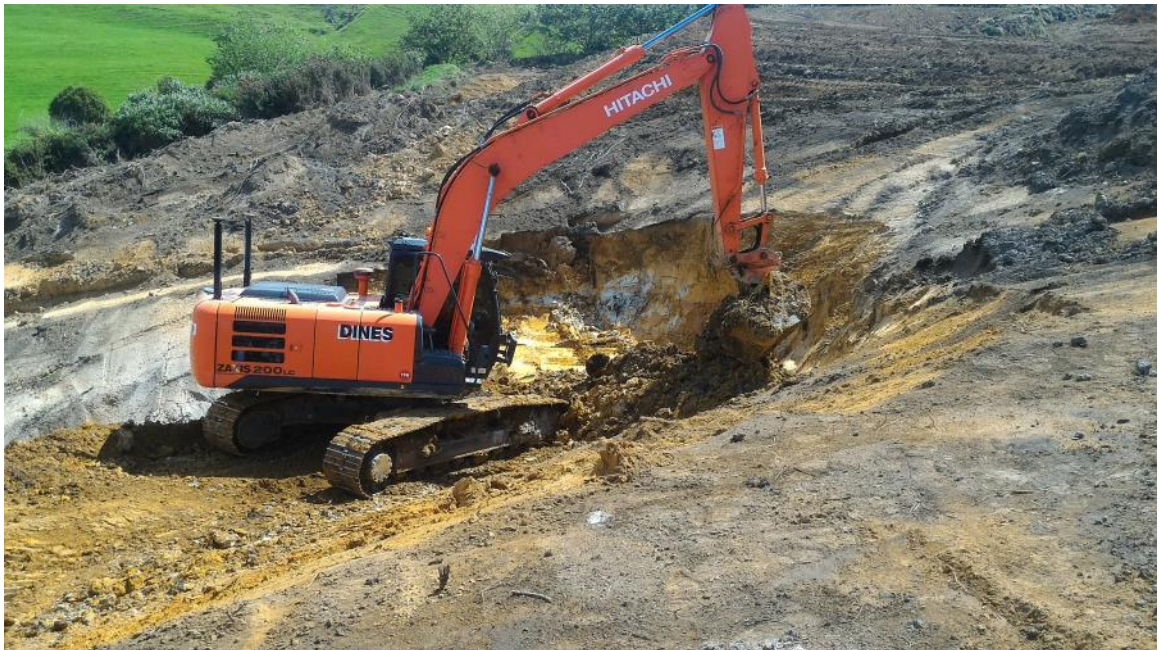
Fill O Gully

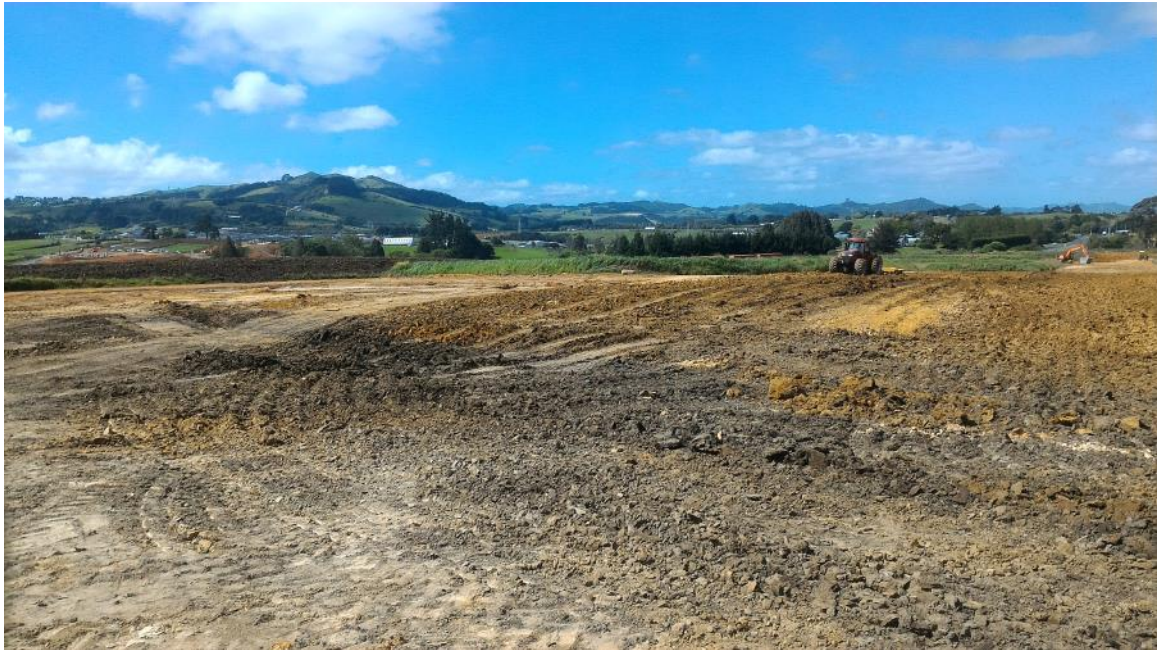
Fill O Gully

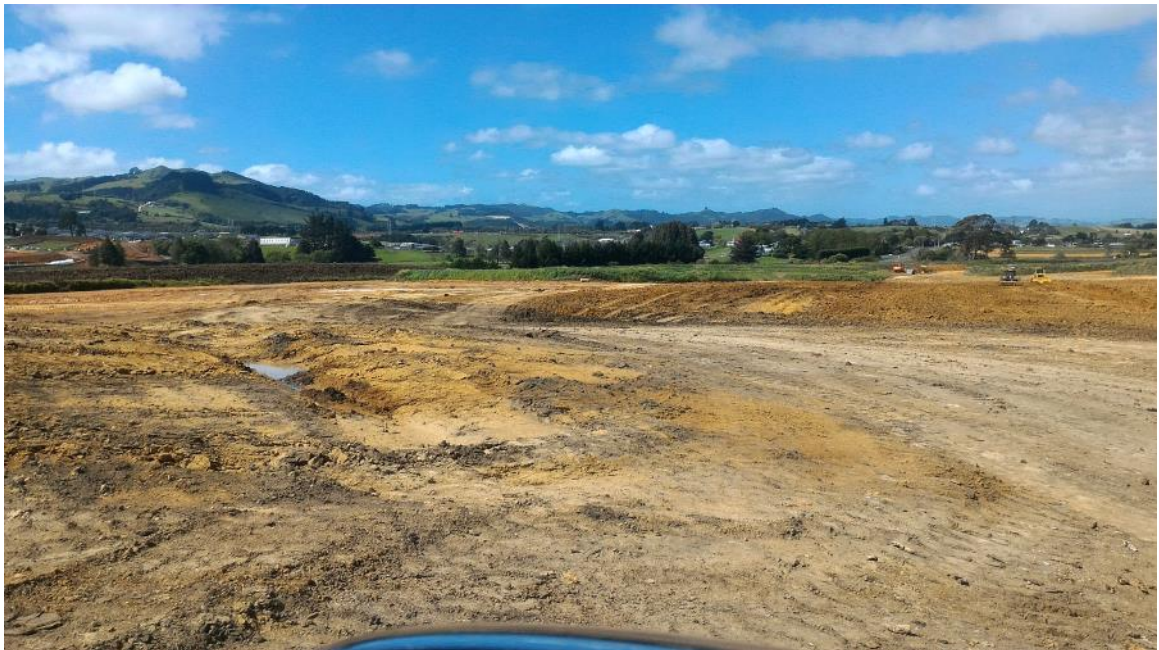
Dark patch of Fill F

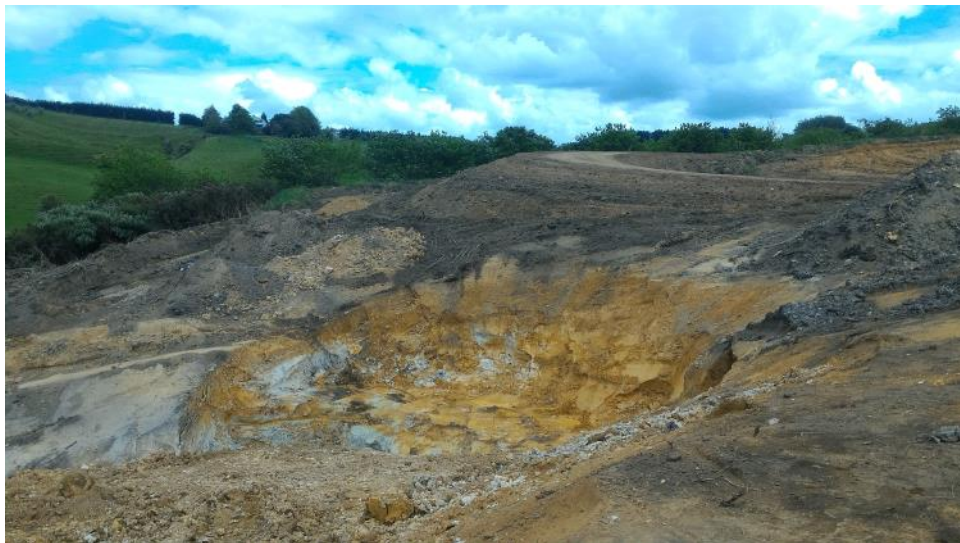
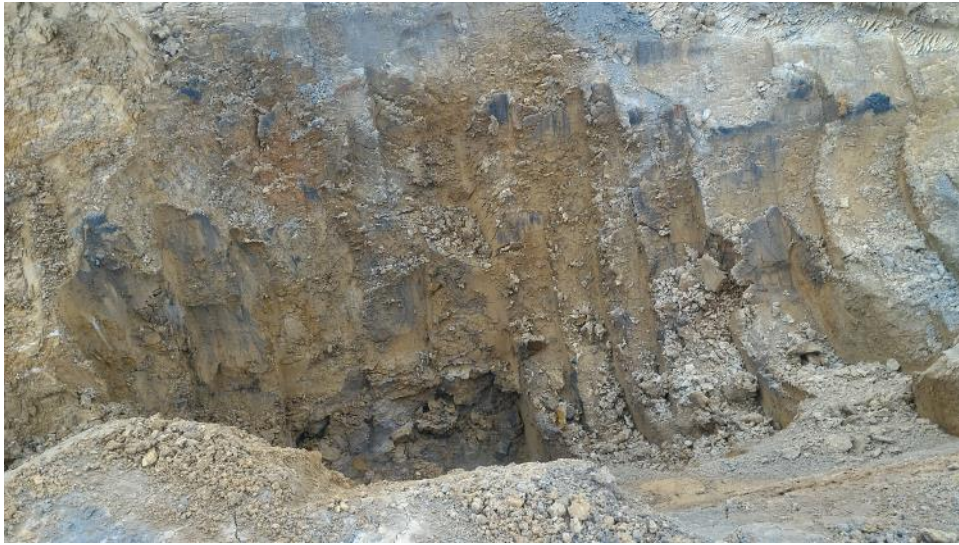
The contaminated area undercut was mostly above 80kPa with occasional soft soft spots where some slurry was but over 4m of proposed fill will overly this. Advised Brett to lay fully wrapped underfills in this area too, hardfill i.e. gap65 will need to be used below this in the bottom of the pit to allow the water table to rise up to the underfill to alleviate groundwater pressures.

4m deep pit at contaminated area undercut

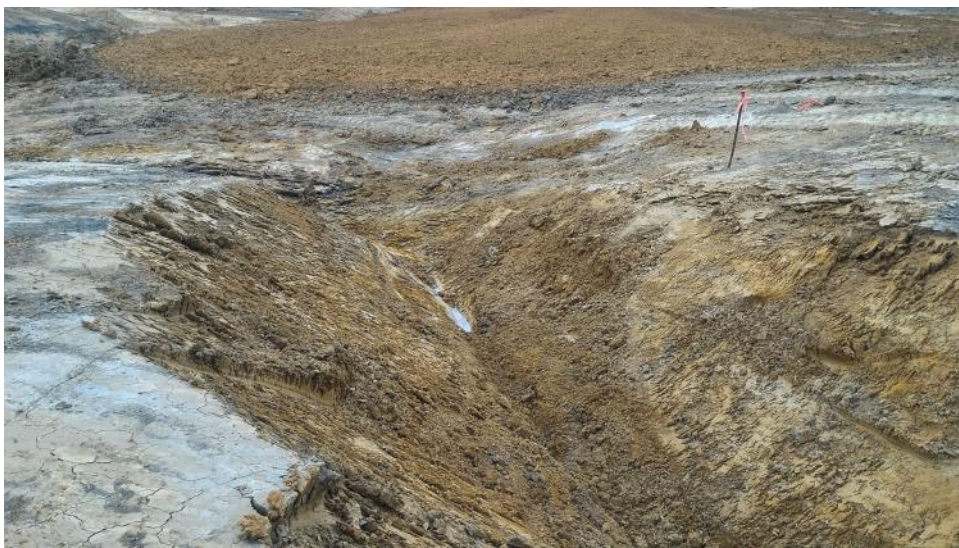
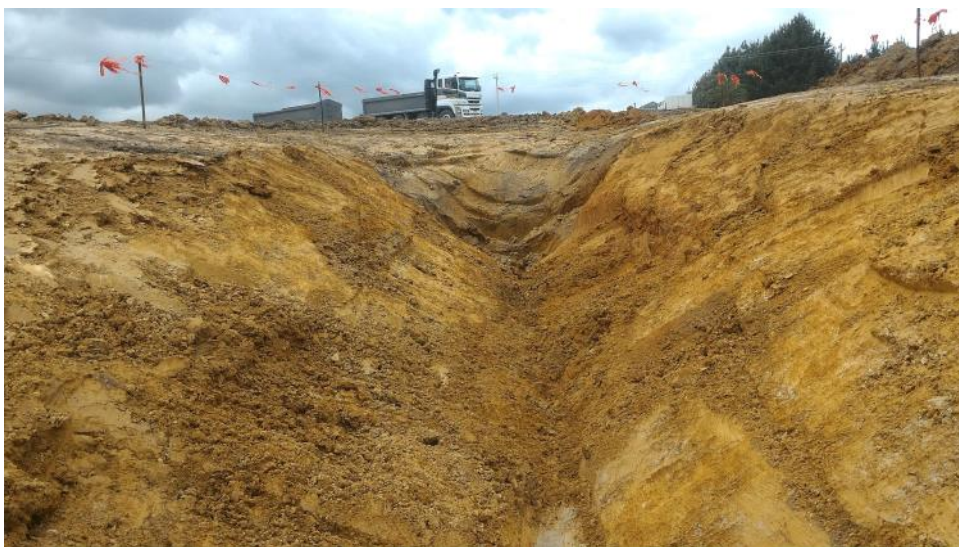
Looking up contaminated area undercut

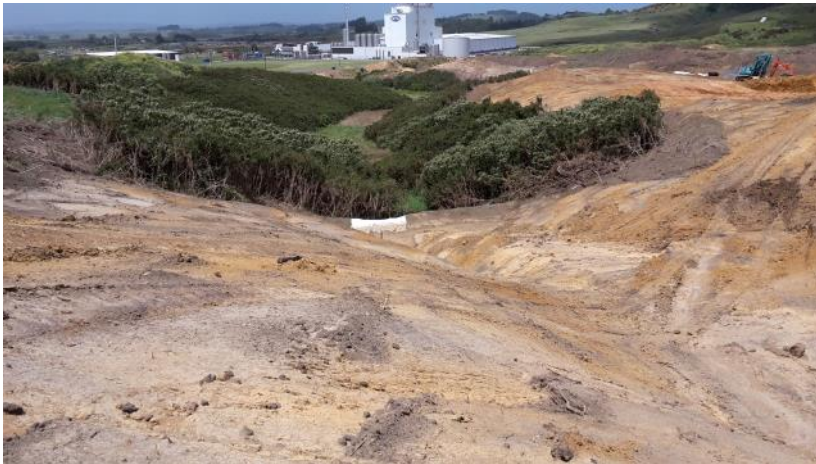
Fill N gully mucked out

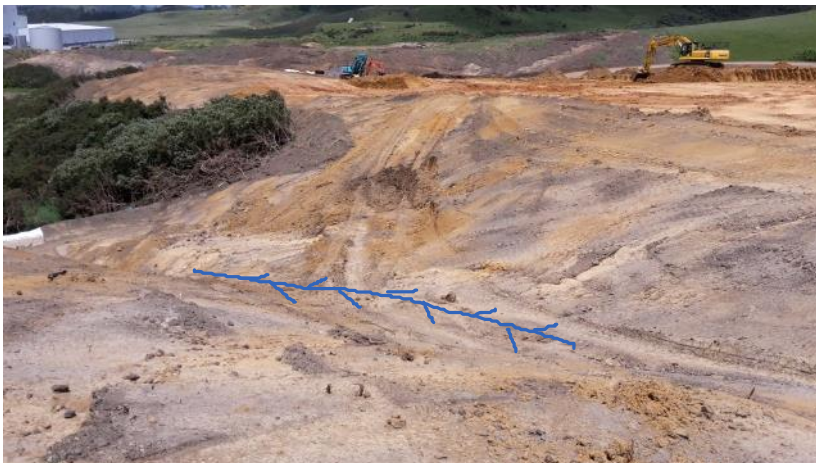
Fill N - Proposed Underfill

Satisfied with fill N, all shear strengths were above 90kPA. Recommended that an underfill drain coil is run up the invert fully wrapped in drainage and SPR is placed for a flat base to compact on.

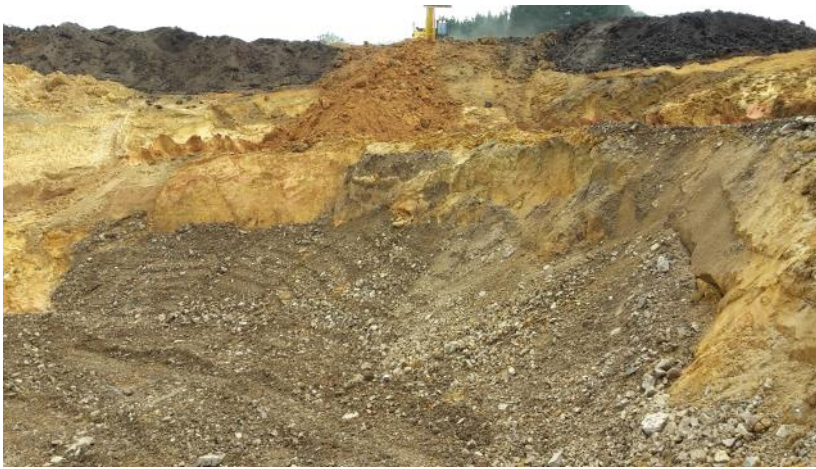
!
Fill O SPR down

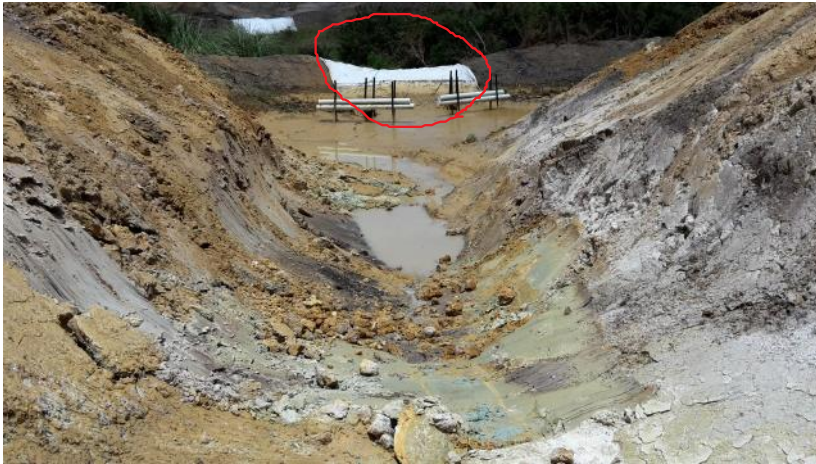
TheThe
Fill O organic area

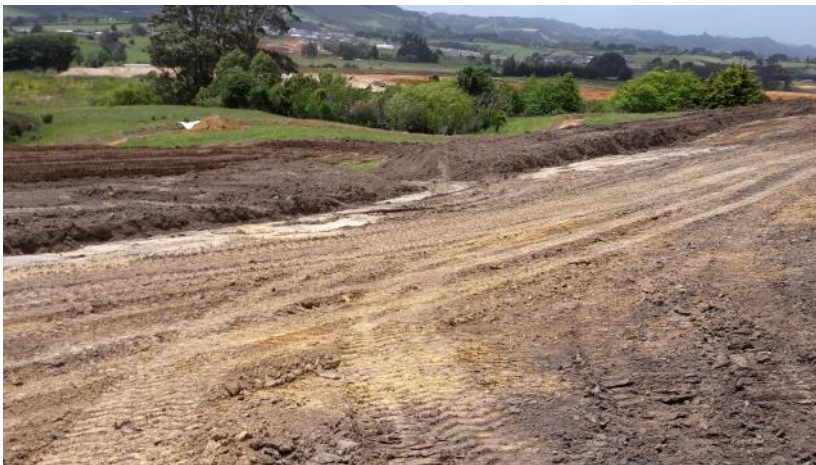
Haul road stripped

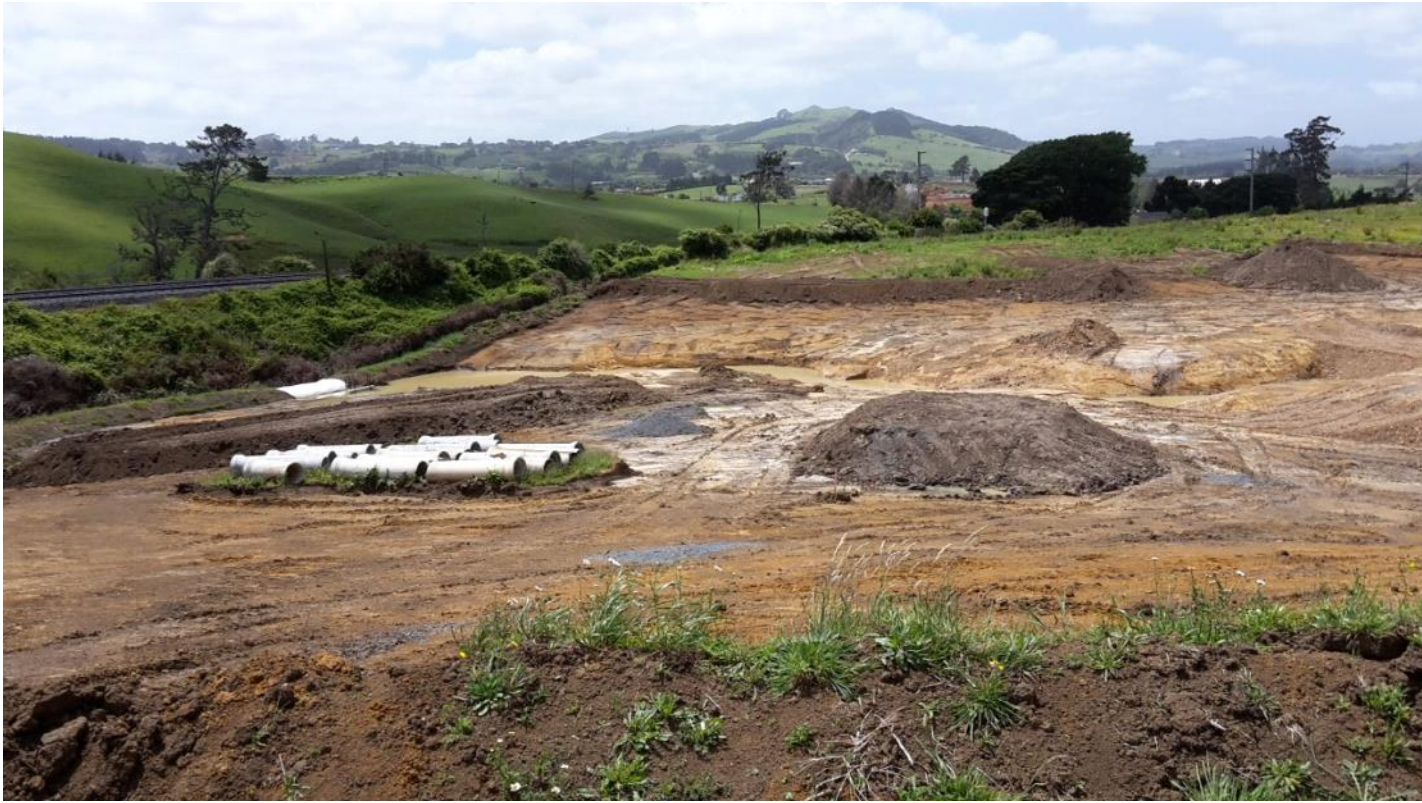
Satisfied with topsoil strip at pond 8. Although still need to see under topsoil stockpiles.

Pond 8 stripped with topsoil needing removal

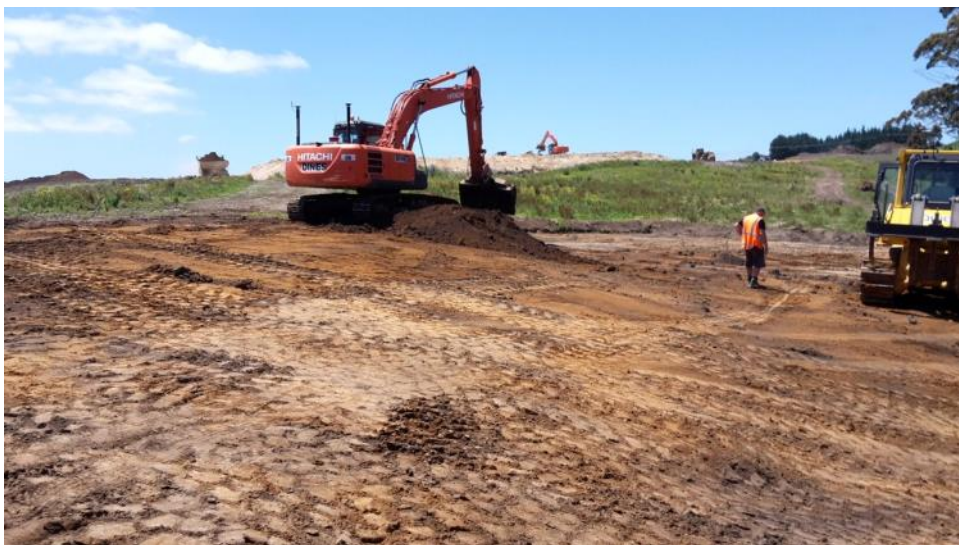
Pond 8 topsoil stockpile being moved

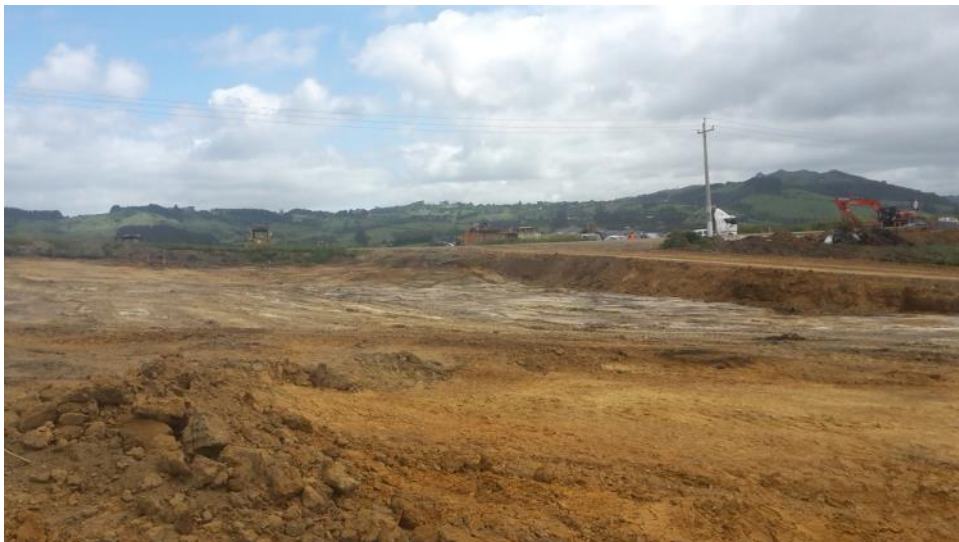
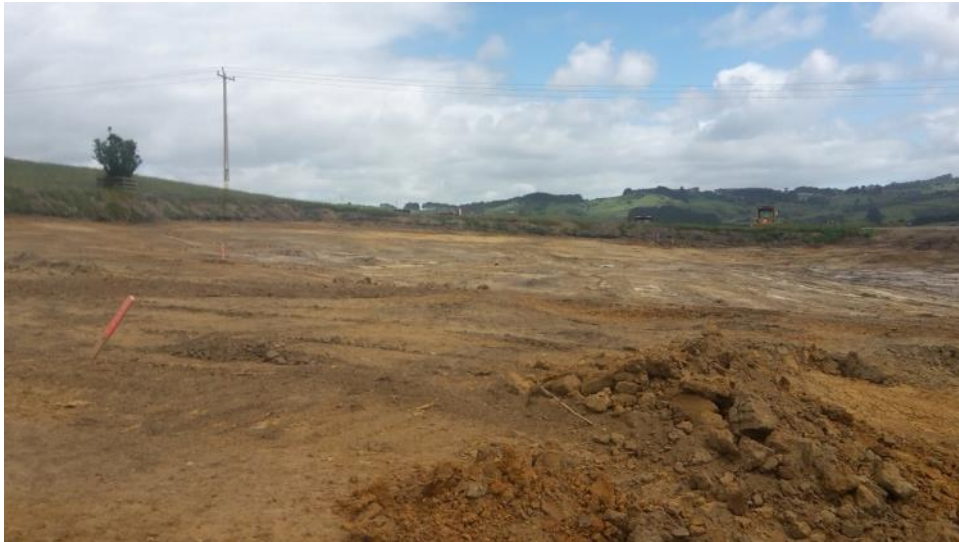
Fill M topsoil strip

Action: Discuss with chris of where to position an underfill at fill M for any winter seepage.

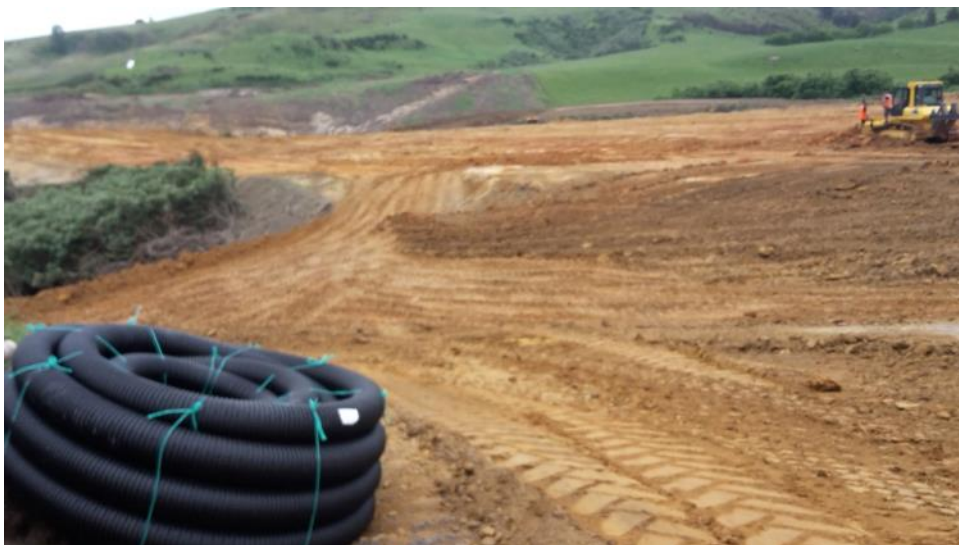
Fill N gully being filled

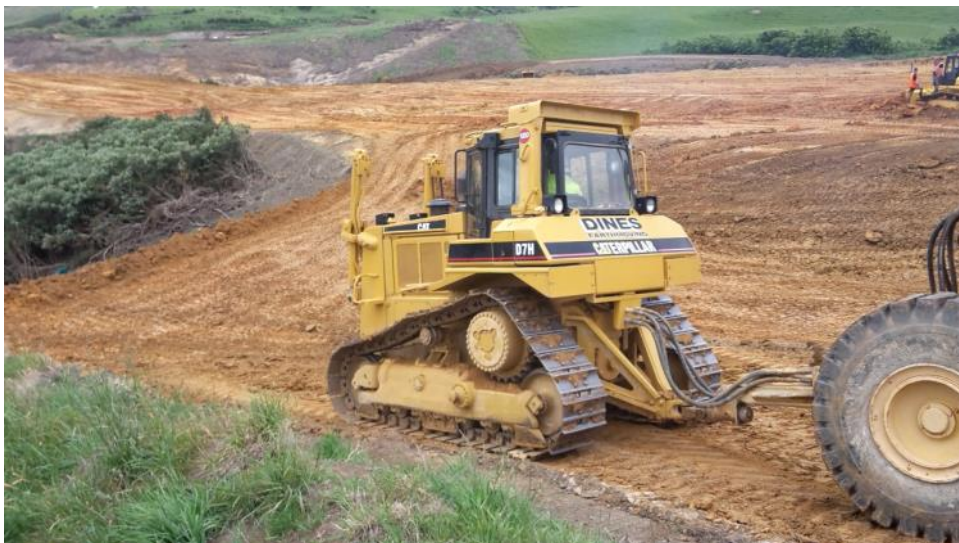
Fill N materials being dropped

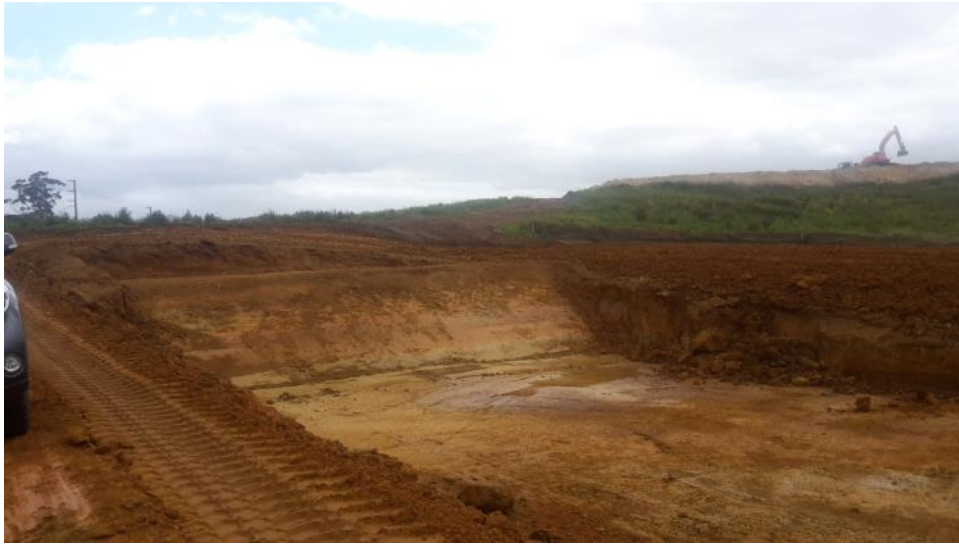
Silt pond 8 preparation

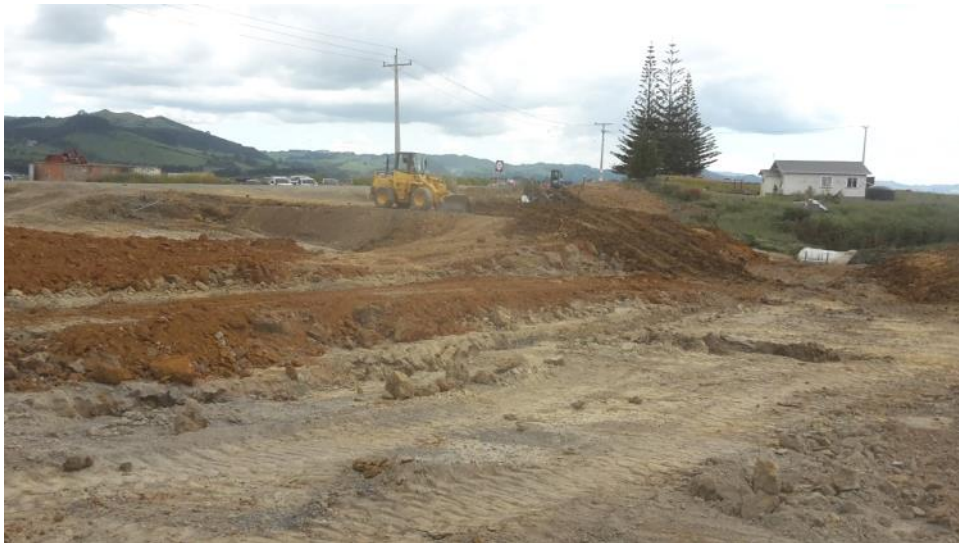
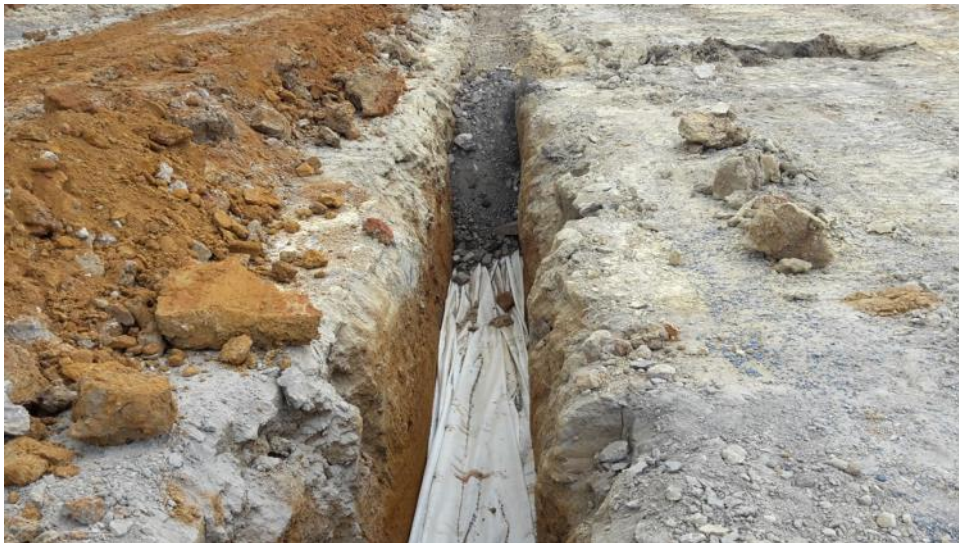
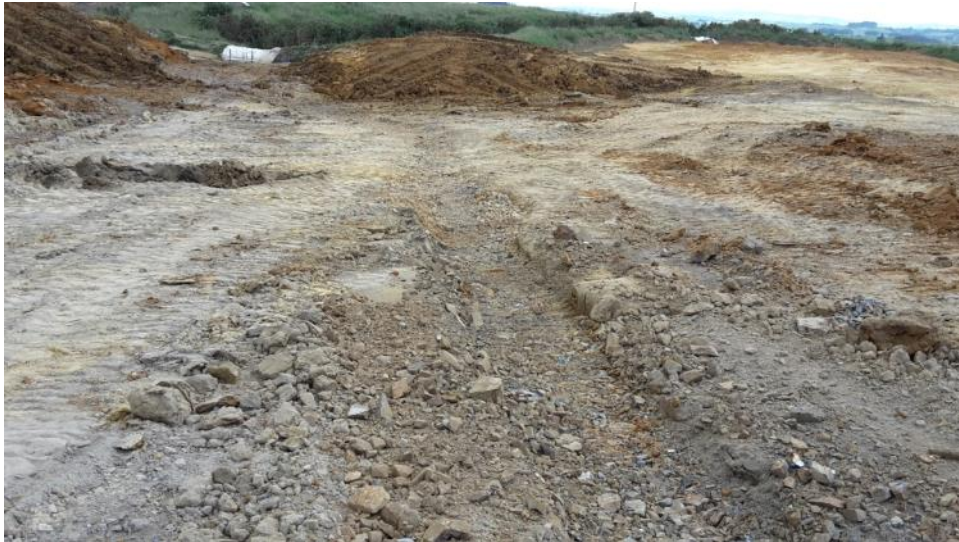
Fill M subsoils

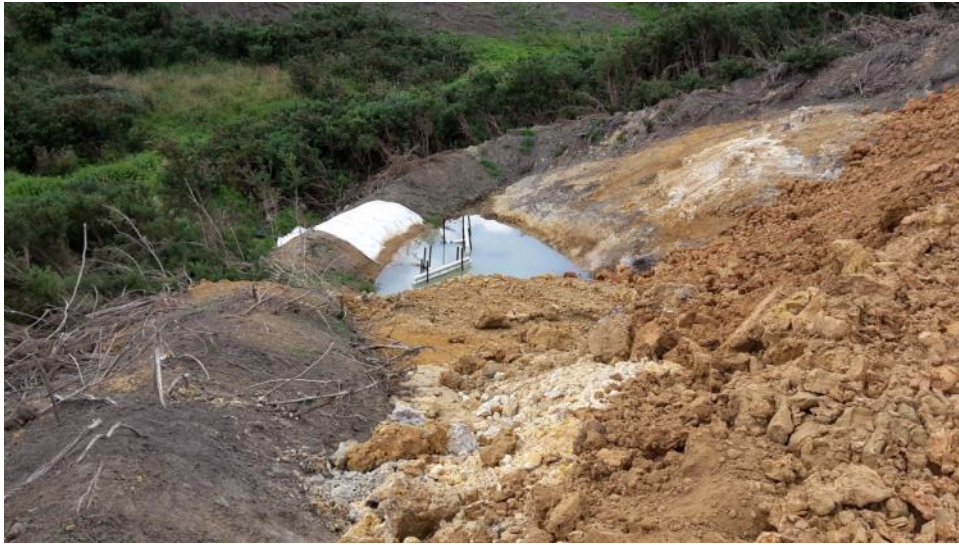
Fill O steep batter

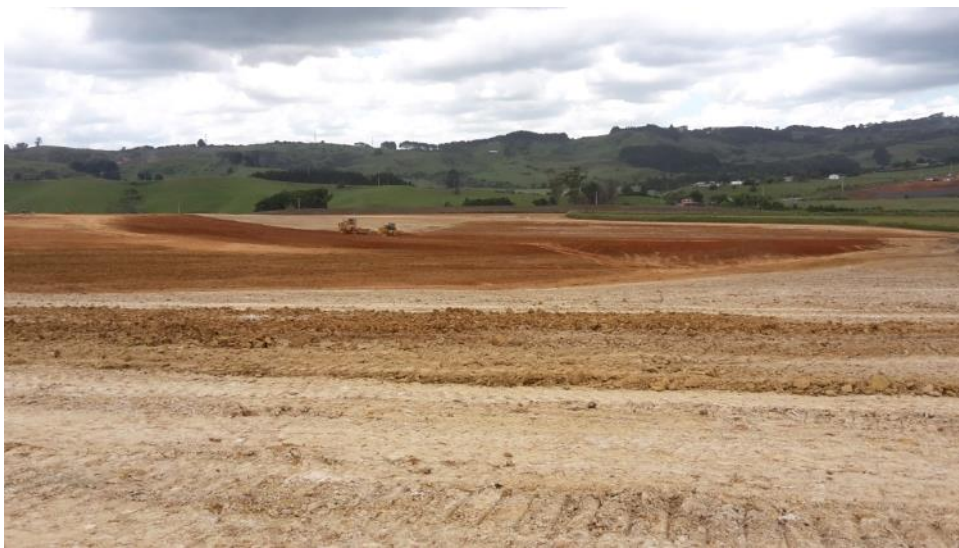
Fill F gullies filled over

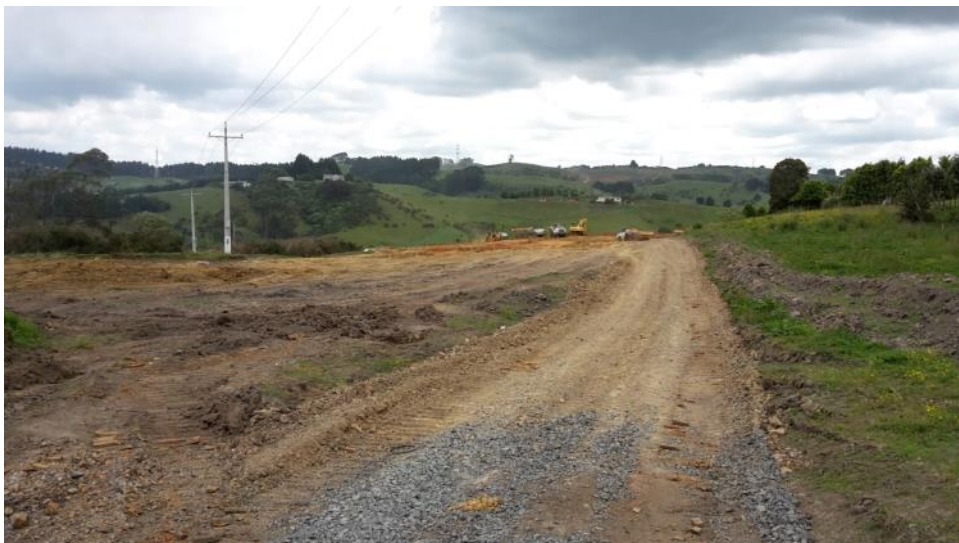
Cut 16 full bore

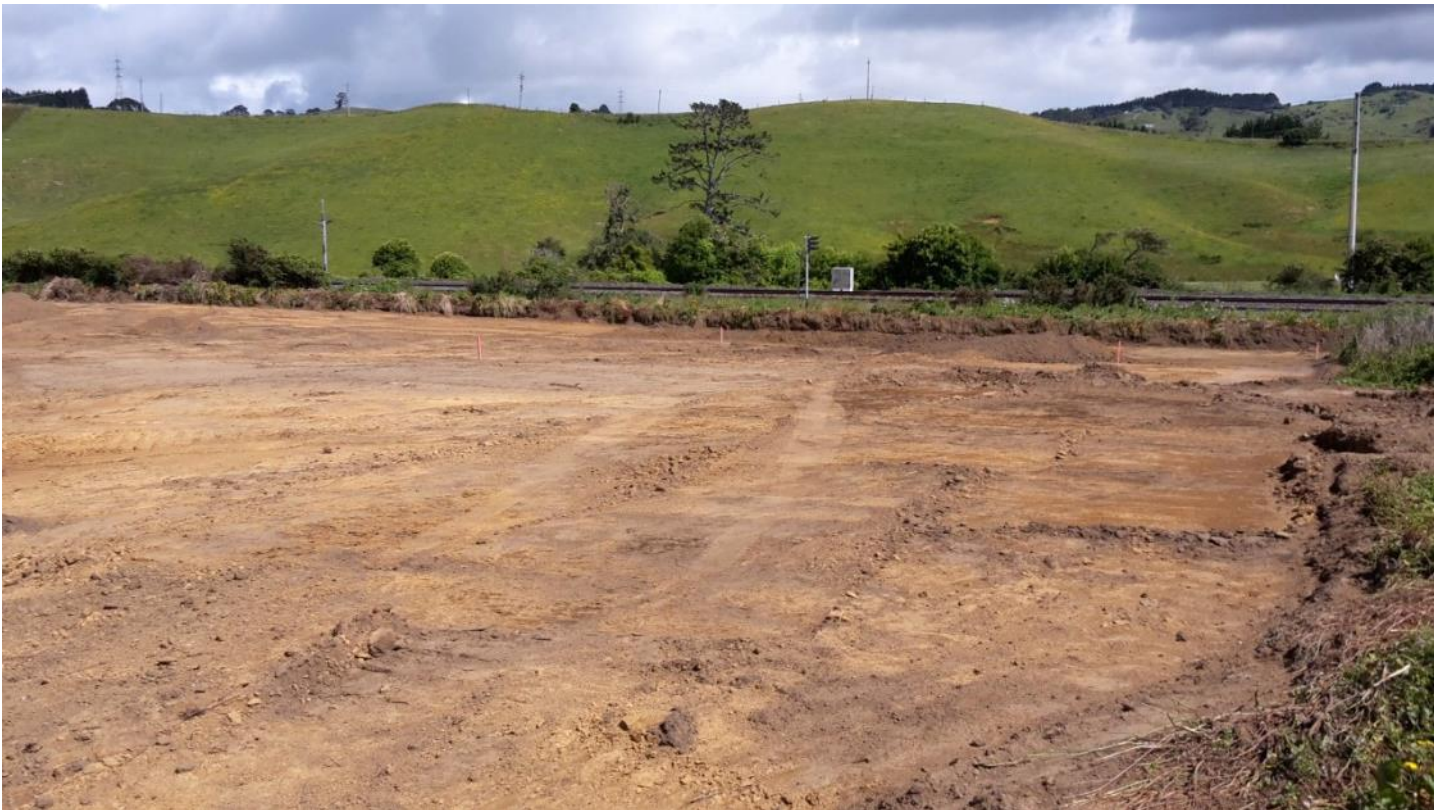
Fill G and H needs minor tidy up

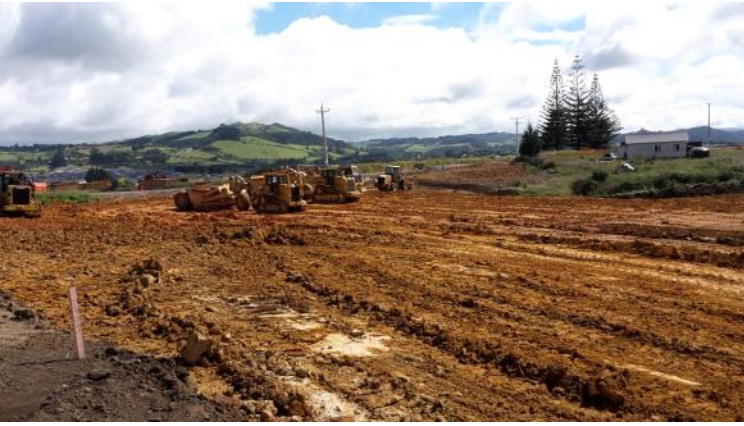
Also observed fill placement across Fill M. Fill materials were mostly red and orange inorganic silty clays. Shear strengths were UTP in most places.

Fill M looking to road

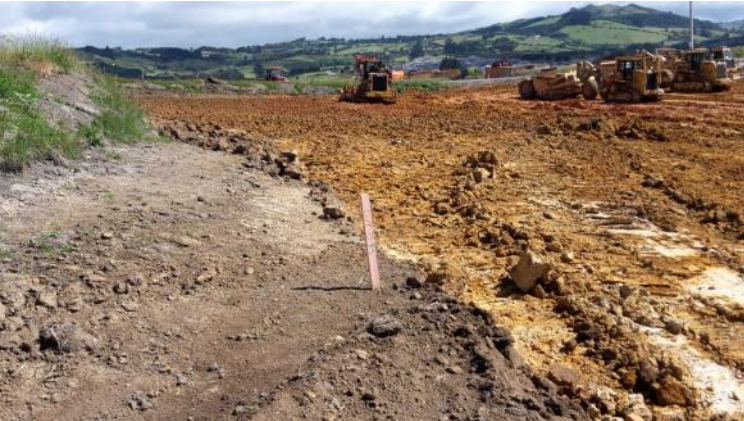
Cut 0.85m

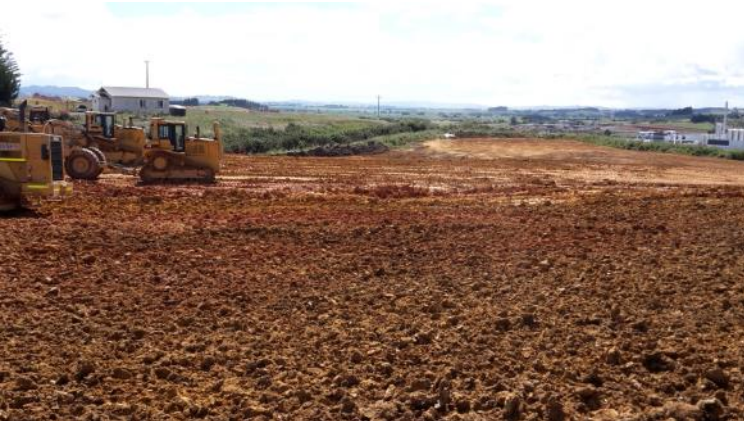
Fill M looking east downslope to gully

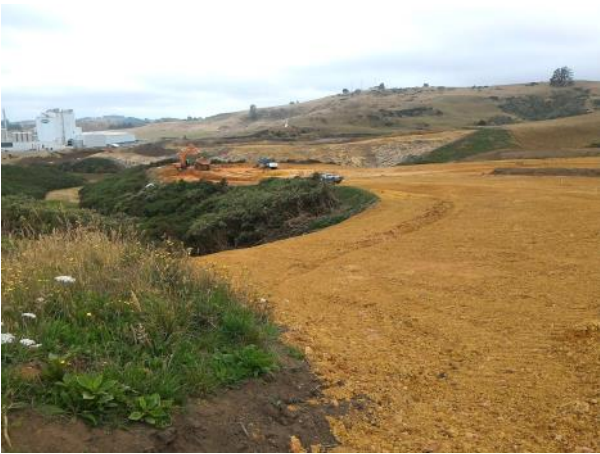
Toploading at cut 10, almost completed

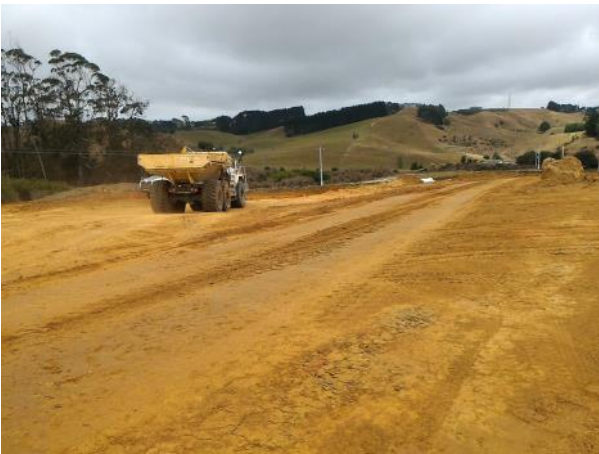
Cut 16 being top loaded

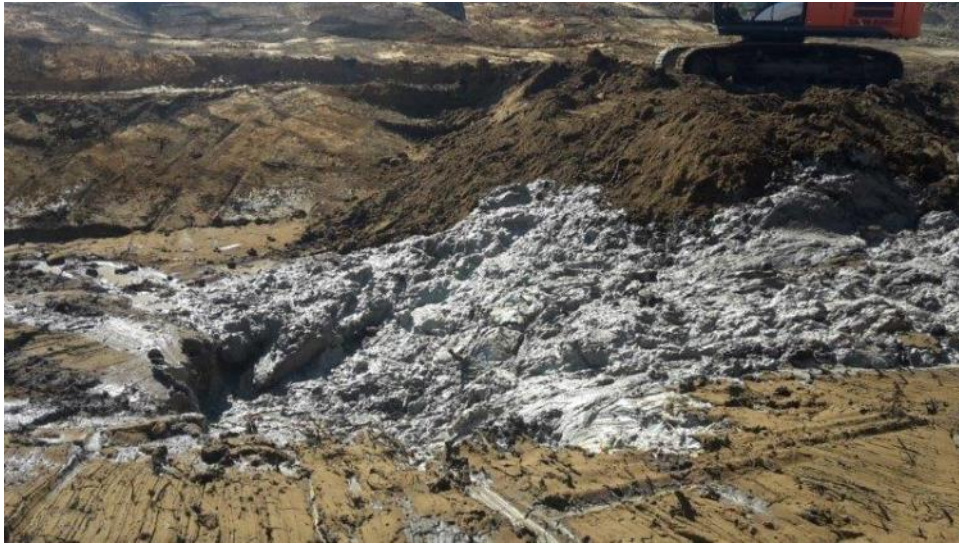
Dug two trial pits through the material, which confirmed that it comprised of saturated pumiceous clayey silt with shears around 10kPa to 15kPa. The depth of the material is unknown as could only dig to between 2 and 2.8m due to pit cave in. Appears that this material will need to be undercut, but will check with Shane to check if any other options (ie. settlement monitoring before instructing Dines. Fill over this area is around 3 to 5m.

TP 1 - shit stuff to at least 2m

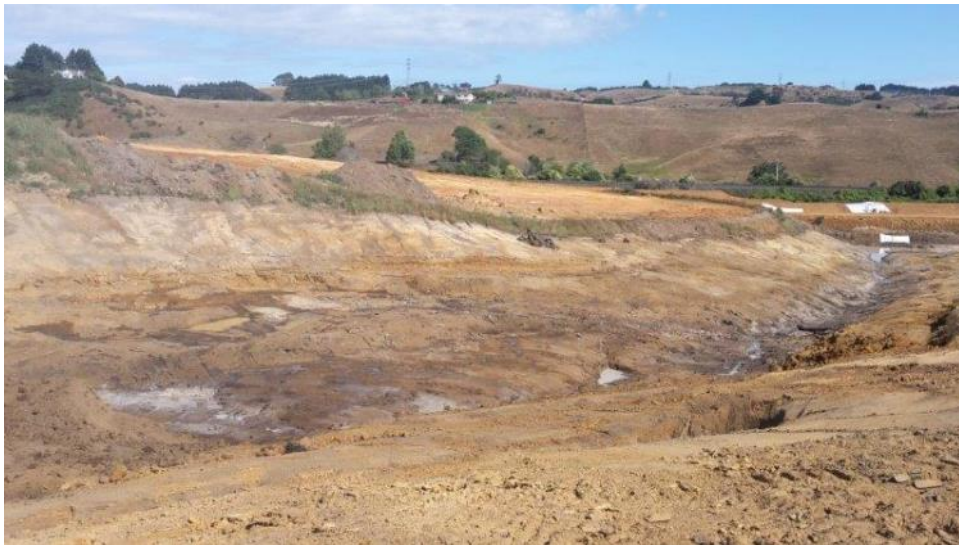
Noted that the upper portion of fill I gully contains an approx. 25m wide by 100m long area of very soft material (ie. very hard to walk on).

Gully inspected

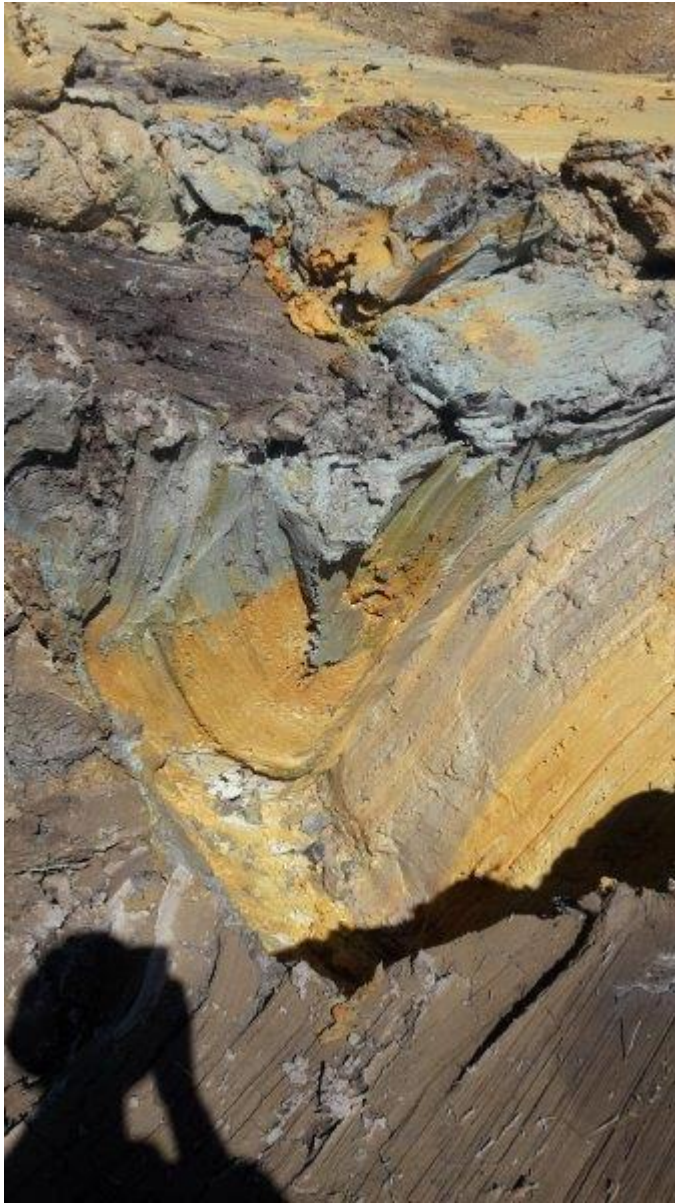
TP2 - shit stuff to at least 2 to 3m

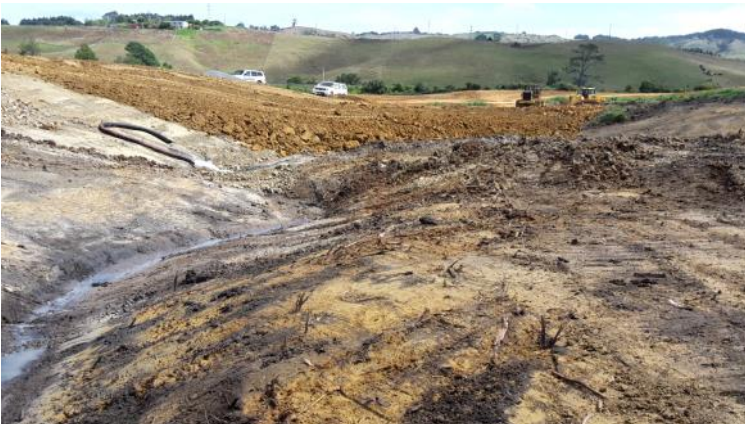
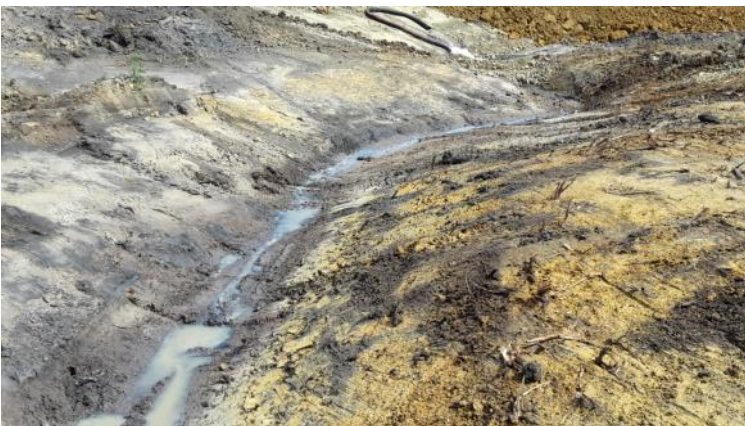
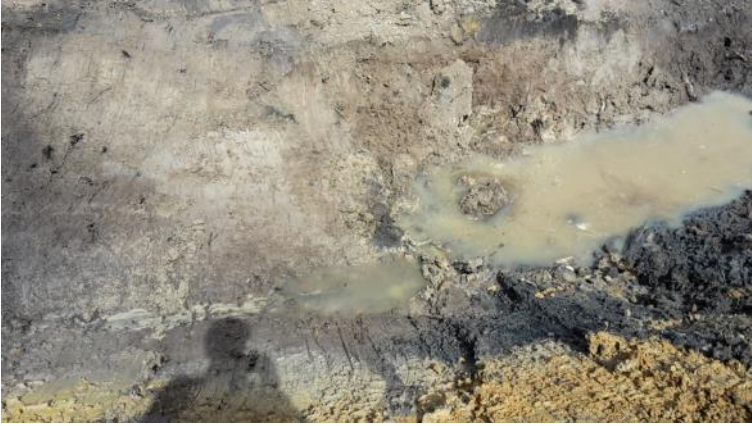
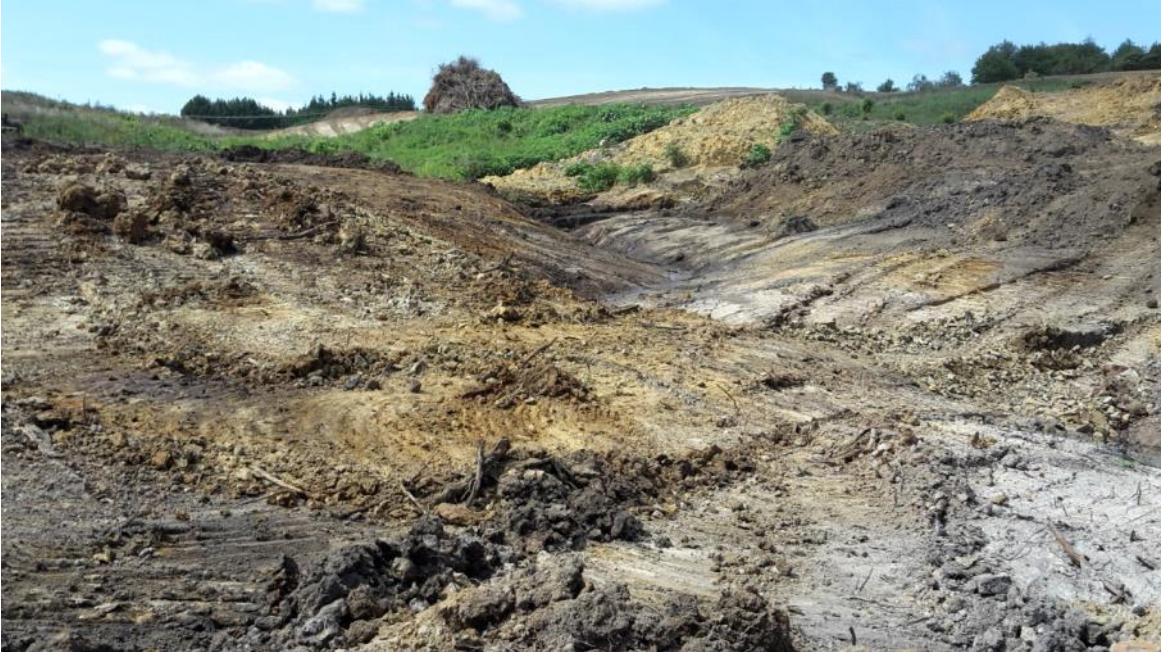
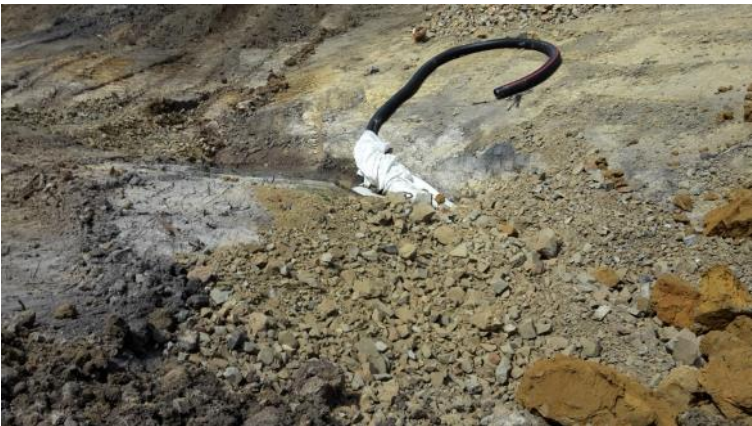
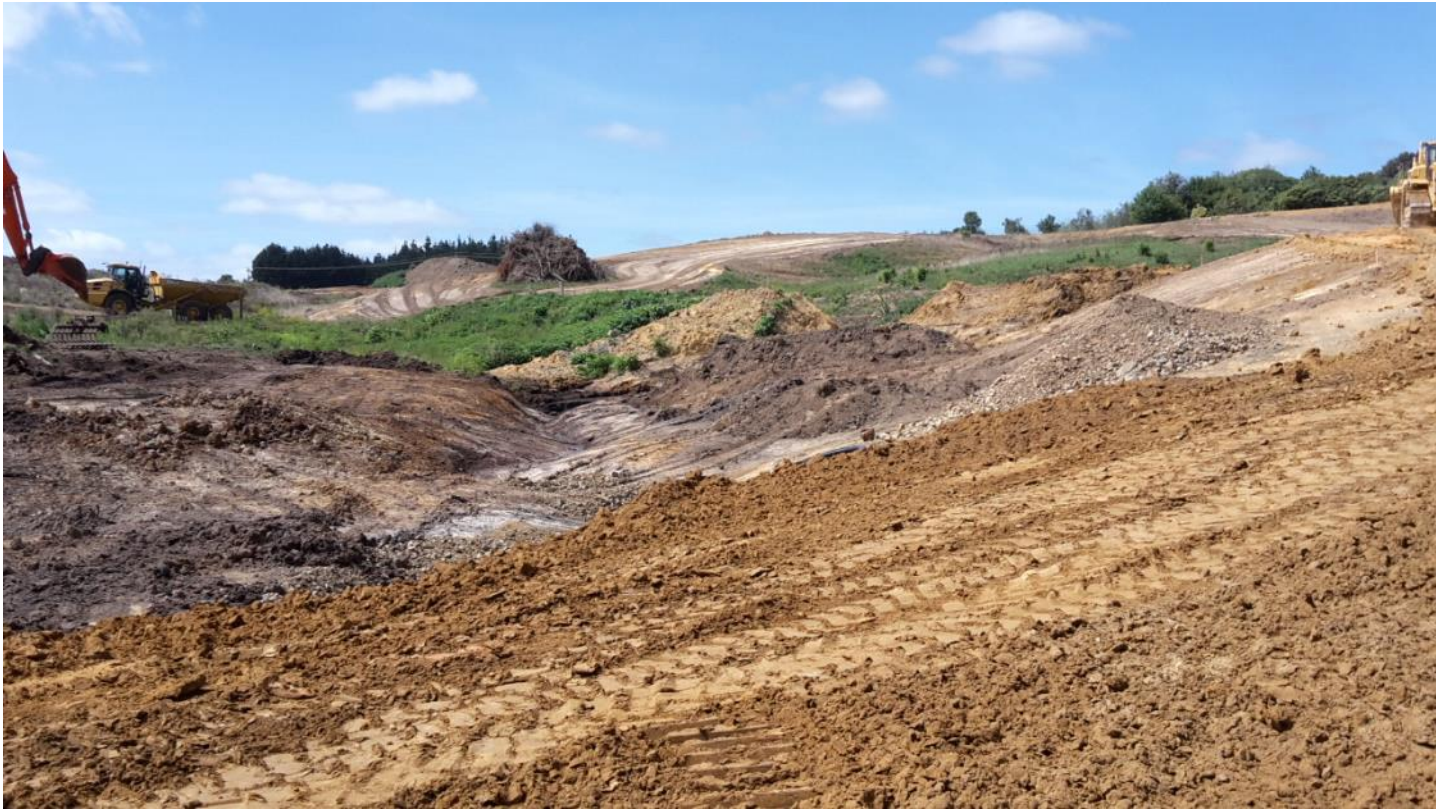
06/03/17

Gully P had been stripped another 30-40m upslope. Strip had gotten rid of most unsuitables. Told operator to continue this through and continue placing at least half a meter of rotten rock in the invert of the gully where it is wet to elevate clay from wetting.

Since the subgrade has been sheared, undercutting will be necessary in this area sometime later in the week or next week (weather dependent) and advise when it is exposed so a method of drainage can be confirmed.

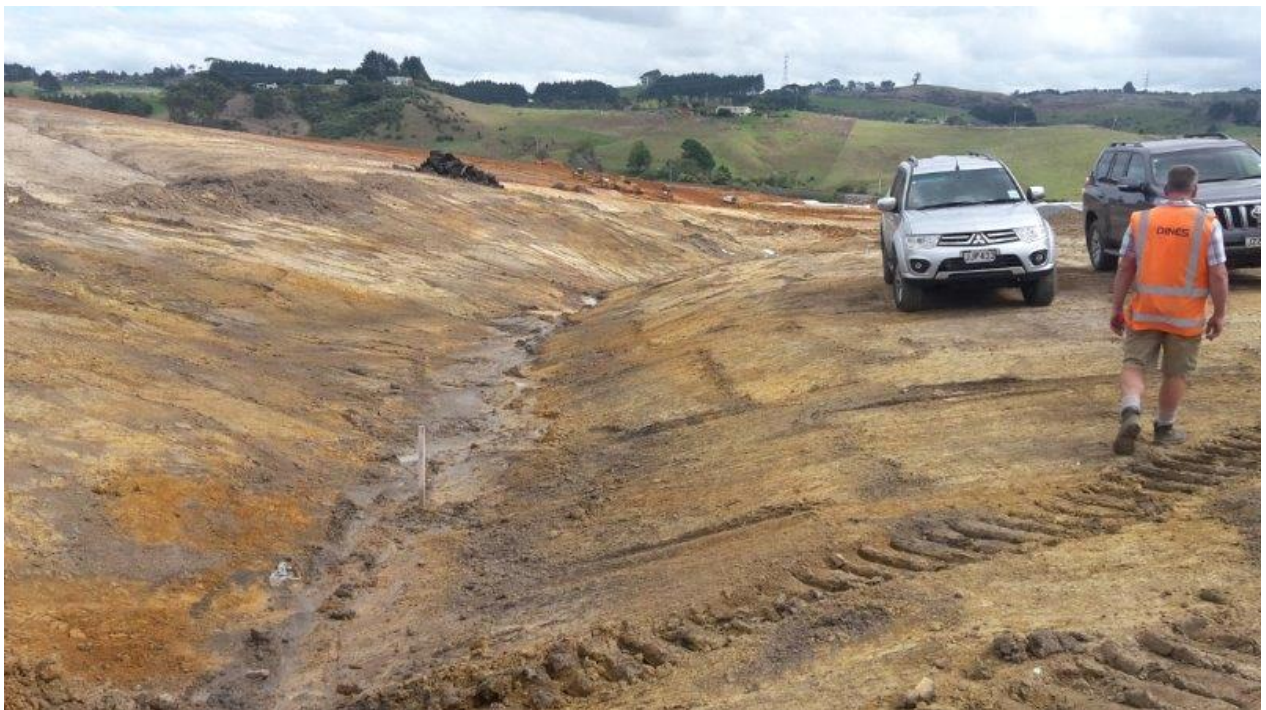
Top of gully - needs drain run up as chimney drain once fill cover less than 2m to tap spring and ensure adequate coverage over drain is maintained
