Geotechnical Completion Report

HITCHEN BLOCK STAGES 6E AND 10A TO 10D

DFH JOINT VENTURE LIMITED

16 December 2020

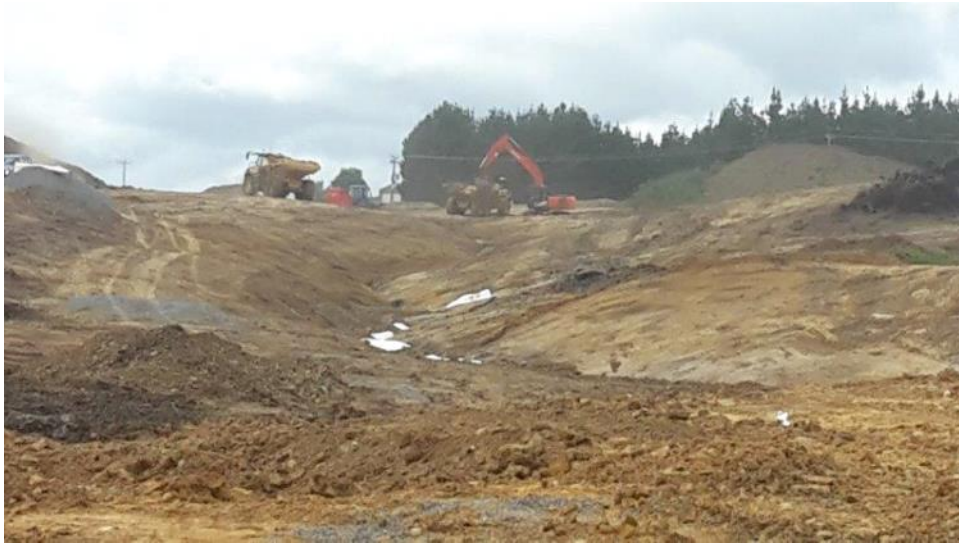
Underfill drain being installed

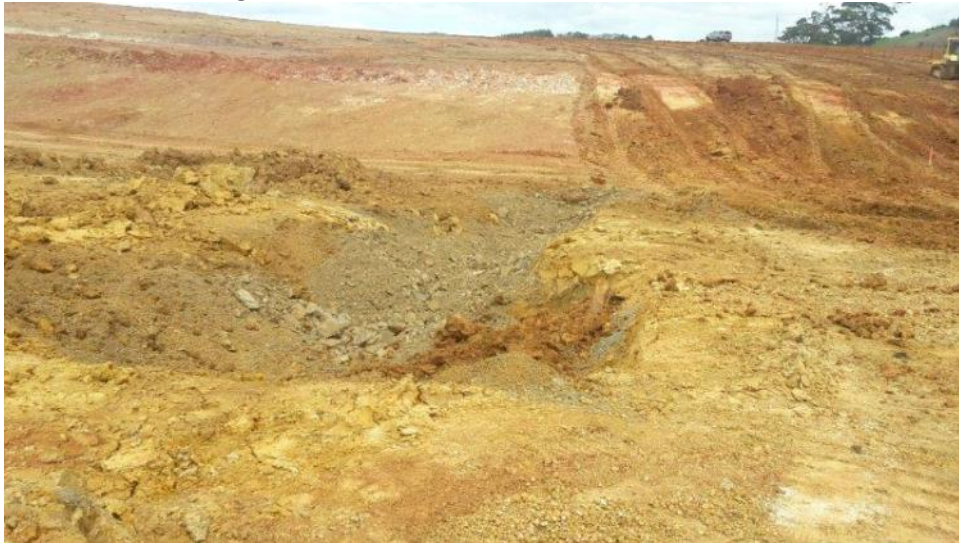
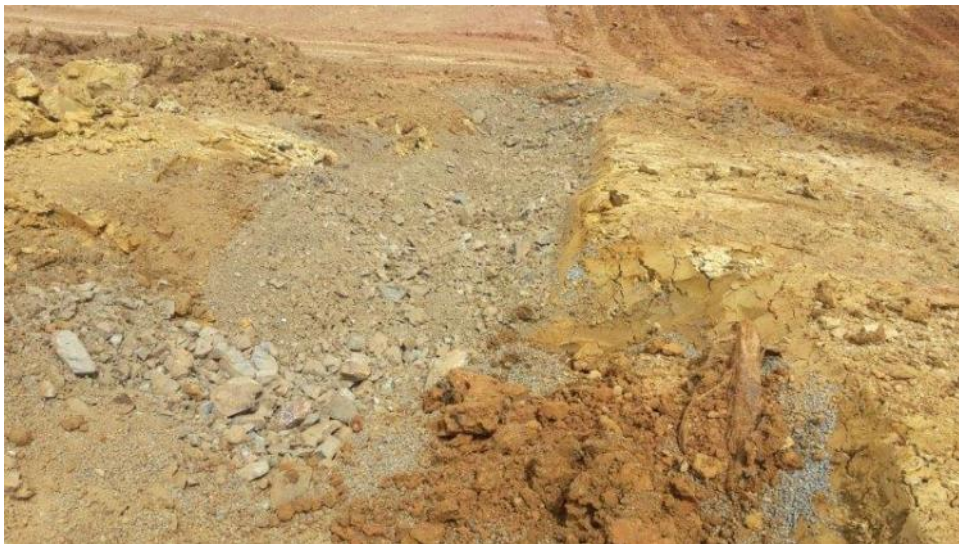
Spring area at base of gully (near subgrade level). This area is under road and just needs to be treated as necessary to build road.

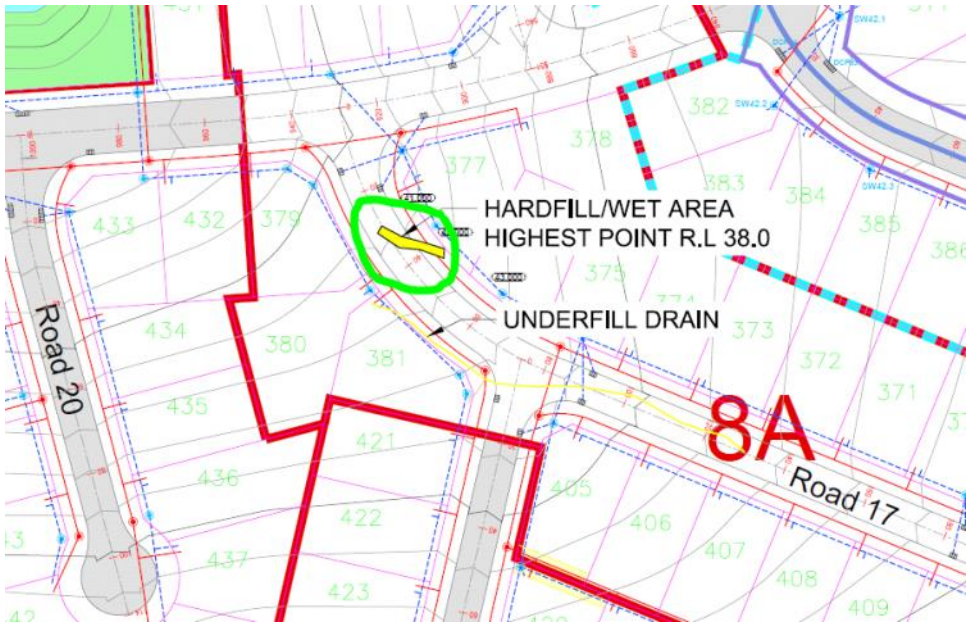
Area of spring (base of gully) circled with green pen.

Observed there is a spring still coming through the area at the base of gully to the side of the metal placed yesterday. Spring will need to be tapped with novacoil and run to underfill drain before filling over area with clay.

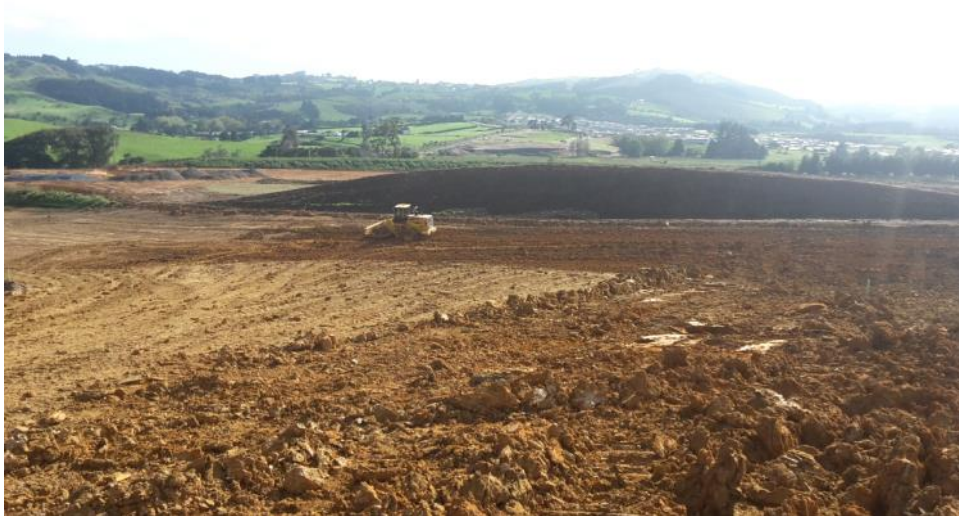
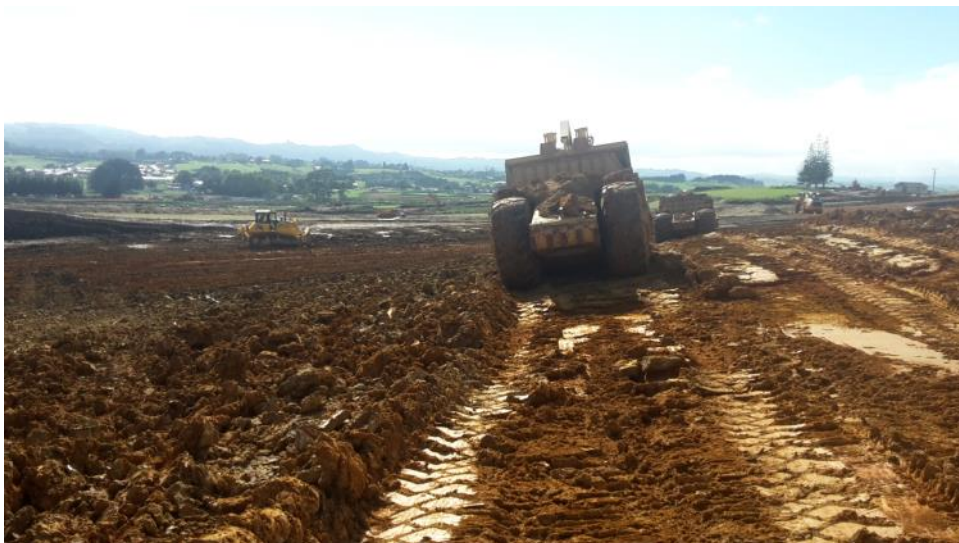
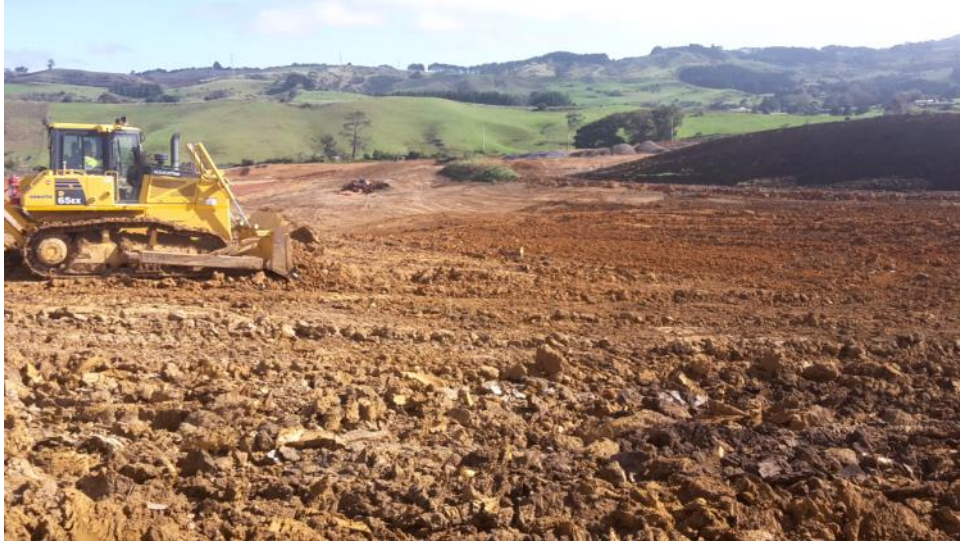
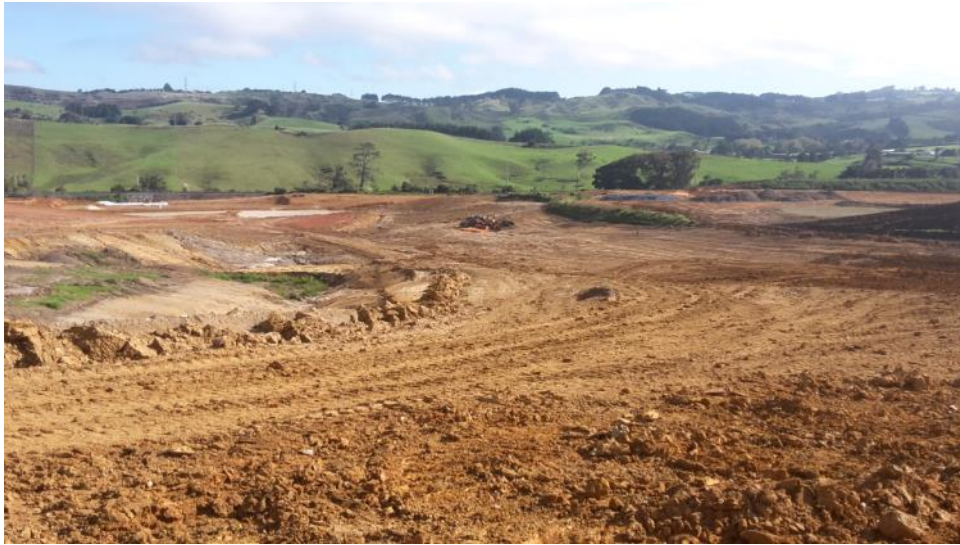
10/04/17

Visit to observe progress on site. Noted that it looks like contractors have started earthmoving again following bad weather last week. Works focusing on fill near top of slope by site offices. Lower portions of site still too wet.

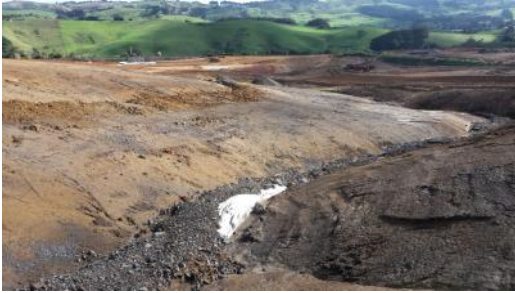
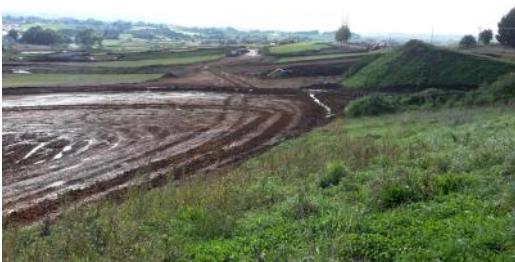
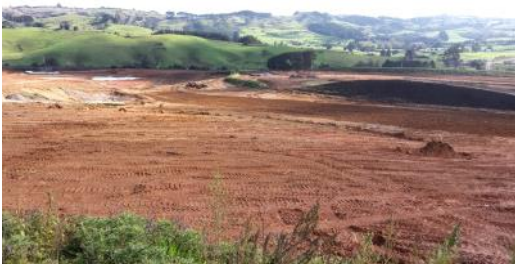
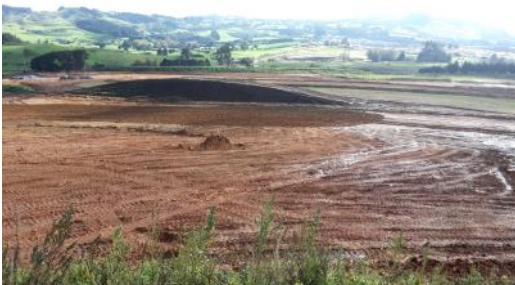
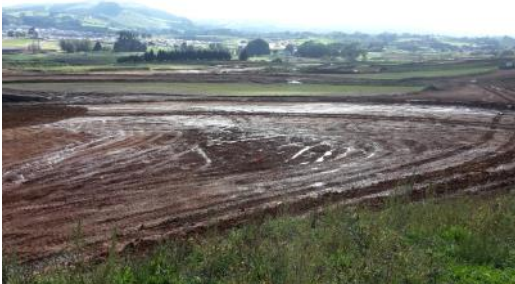
18/04/17

Visited site at request of Trevor. Looked at seepages coming from south-eastern corner of Cut 13. Looks to still be seeping on the surface. Discussed drainage. Will get Trevor to send through a surveyed plan of areas affected by the seepage.

Looked at middle tributary gully strip (middle gully) of Fill P. This strip has begun at the elevated portions and has not yet connected to the gully junction. Drain coil, cloth and rock all look good and to normal standards.

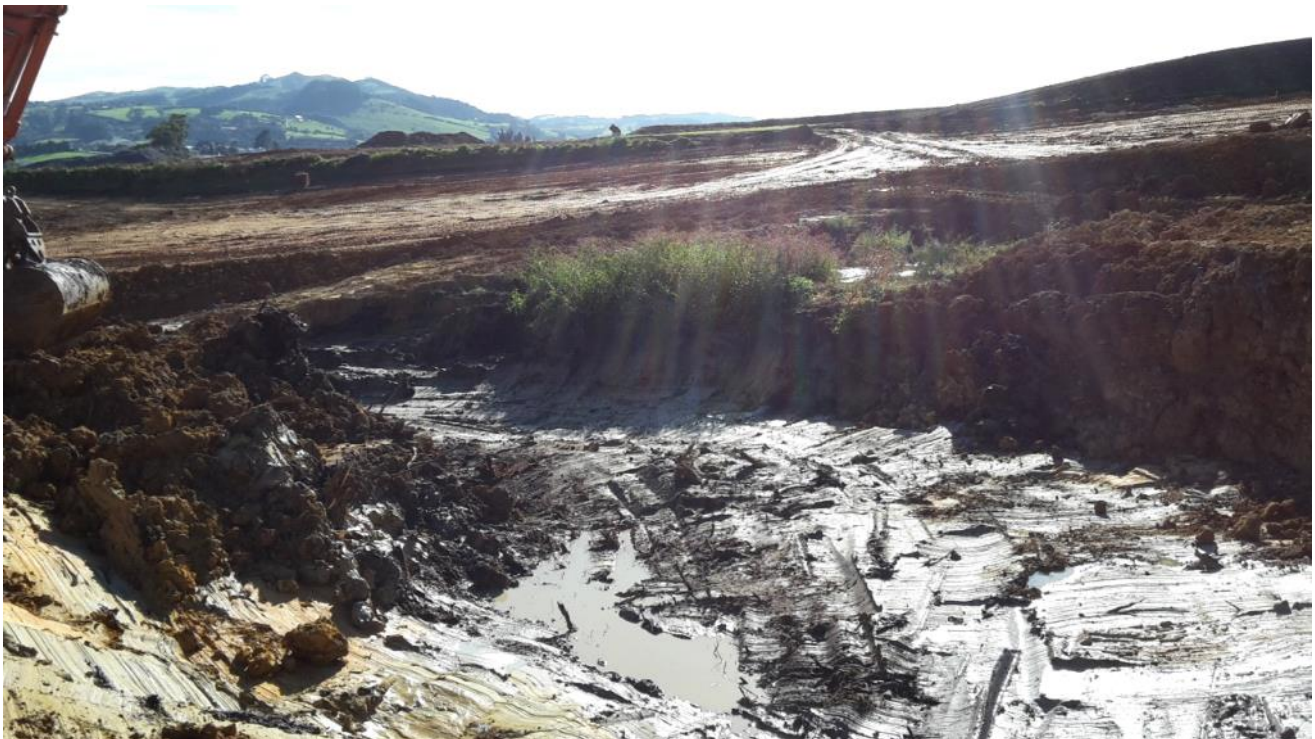
Visited site at request of Trevor Moir to check westernmost tributary gully within Fill P. Drain coil extending to the head of the gully with approx. 400mm drainage metal, fully wrapped, and 0.5m SPR blanket should be required up to the head of this gully. More mucking out is required.

Trevor thinks that the seepage at the Cut 13 southern portions is due to perched GW table above a hard pan of silts/clays.

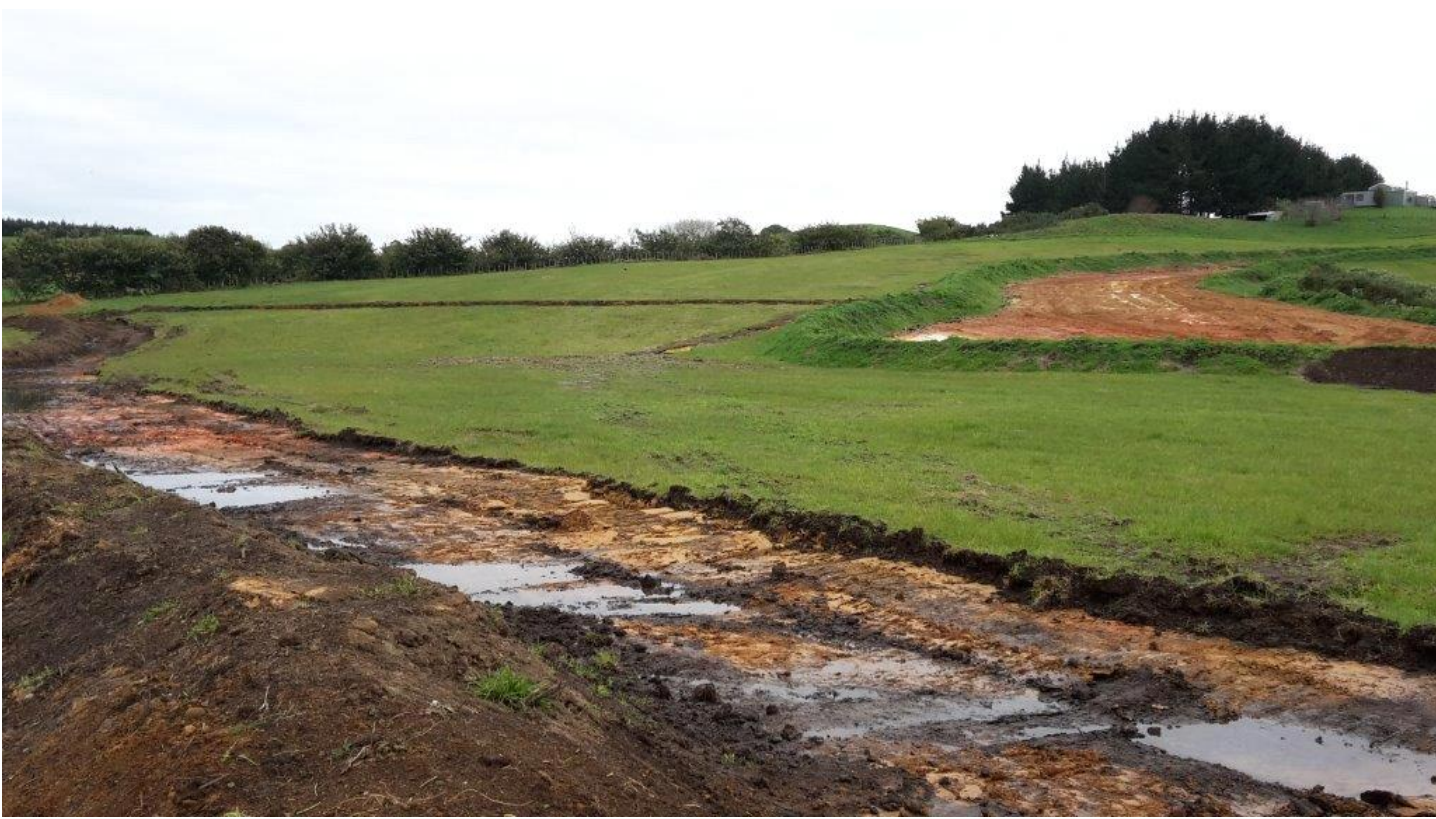
Inspected the Slip that has formed near Fill O. Looks like has formed due to overland flow. Shane is going to meet with Russell tomorrow to discuss options. Will get repaired as part of works next season.

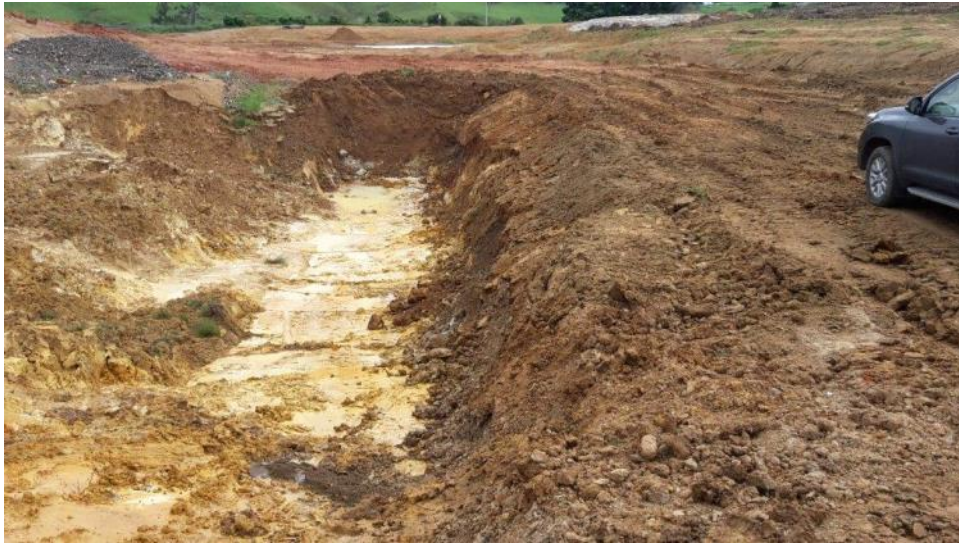
- Observed digout of new section of fill I. Observed they had excavated all mullock and were onto a loose sand. They are going to backfill over this with 1m of SPR100 prior to filling with clay. Fill over this area is 3m to 4m deep.

Muckout picture

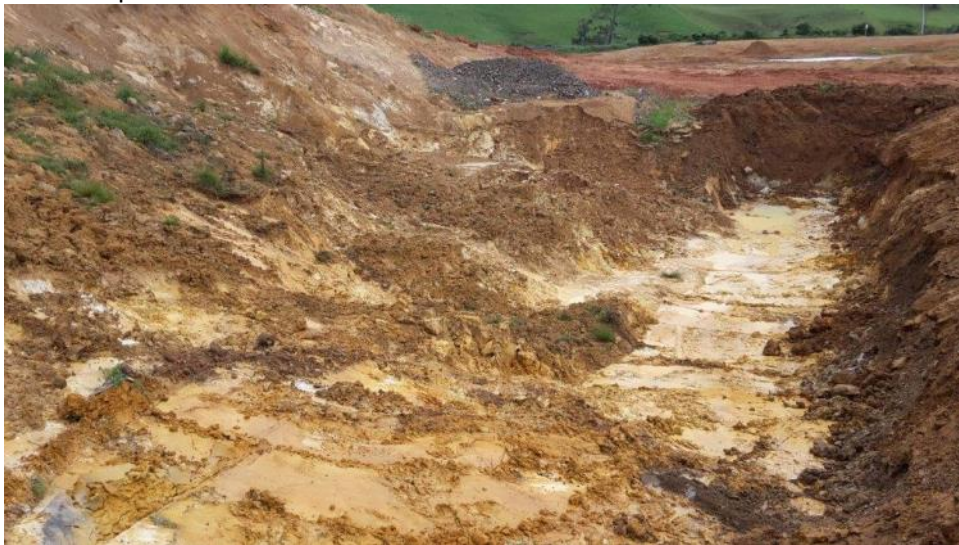
Muckout picture

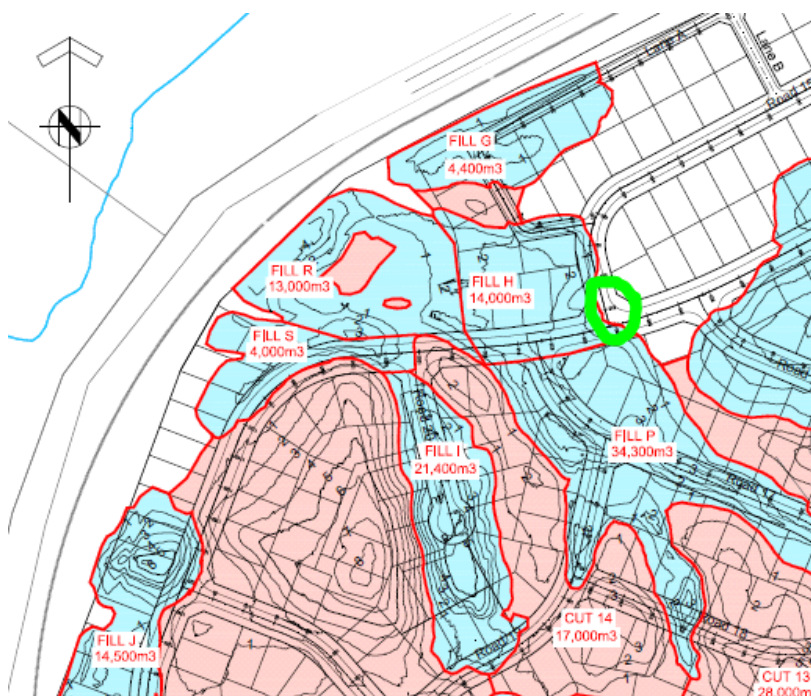
- Also investigated a soft spot on the edge of Fill H. The soft ground is about 1.5m to 1m deep (shearing 20 on the dial), below the soft ground is stiff clayey silt (shearing above 70 to 100 on the dial). Advised trevor that we will need to chase out this soft area, will send through CAN for this.

Soft area approx. circled TP1 through the soft ground

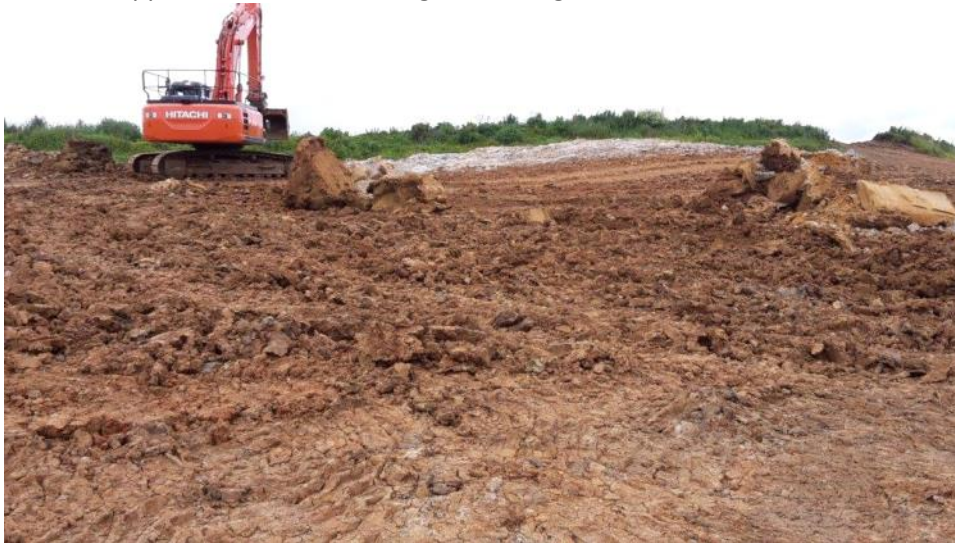
Area of soft ground

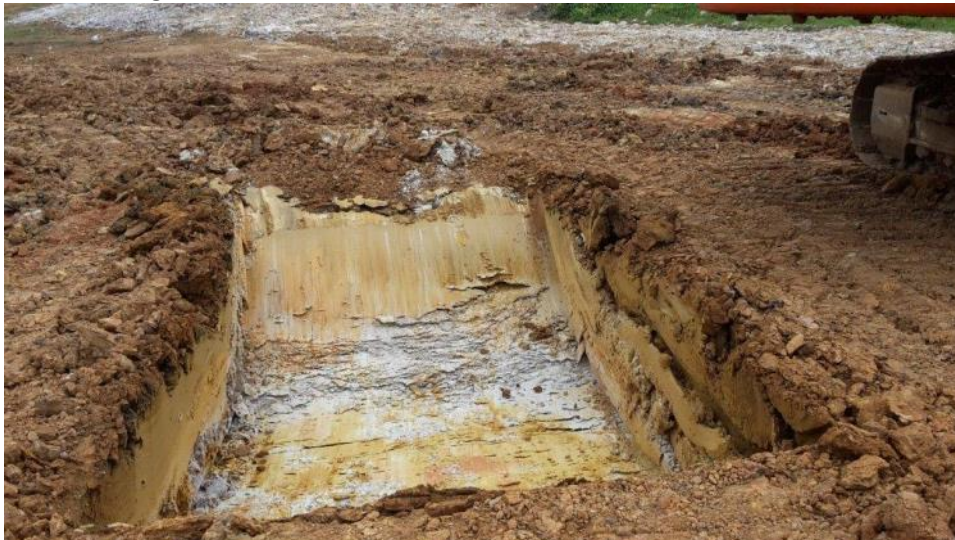
TP2 through the soft ground

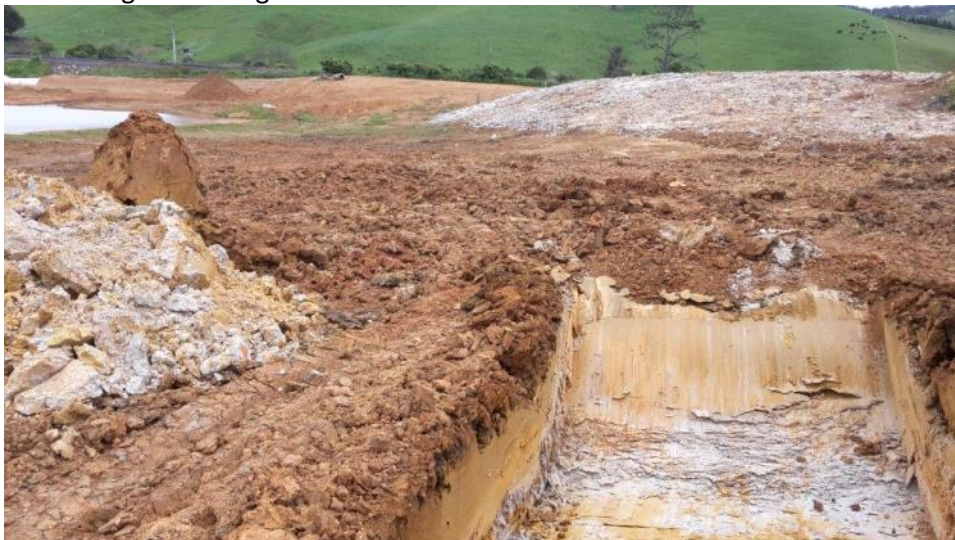
TP2 through the soft ground

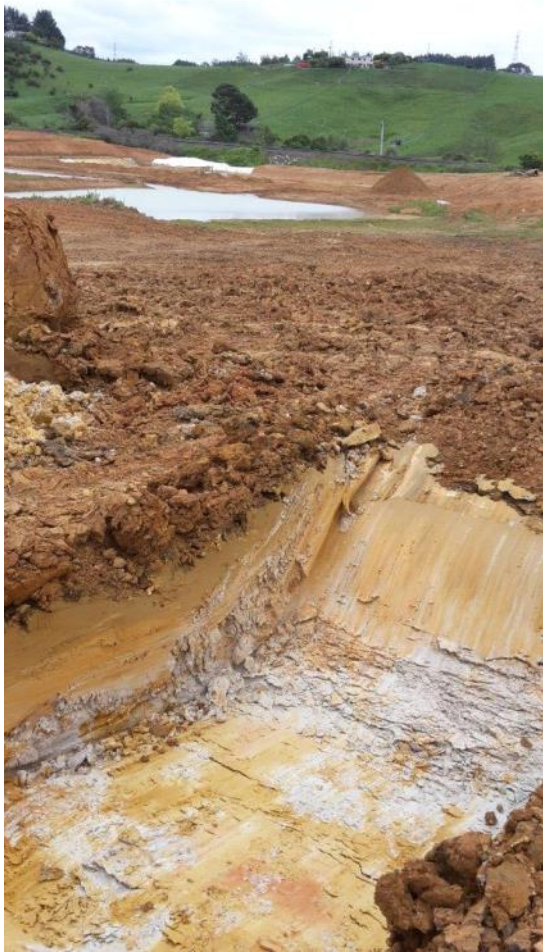
TP1 through the soft ground

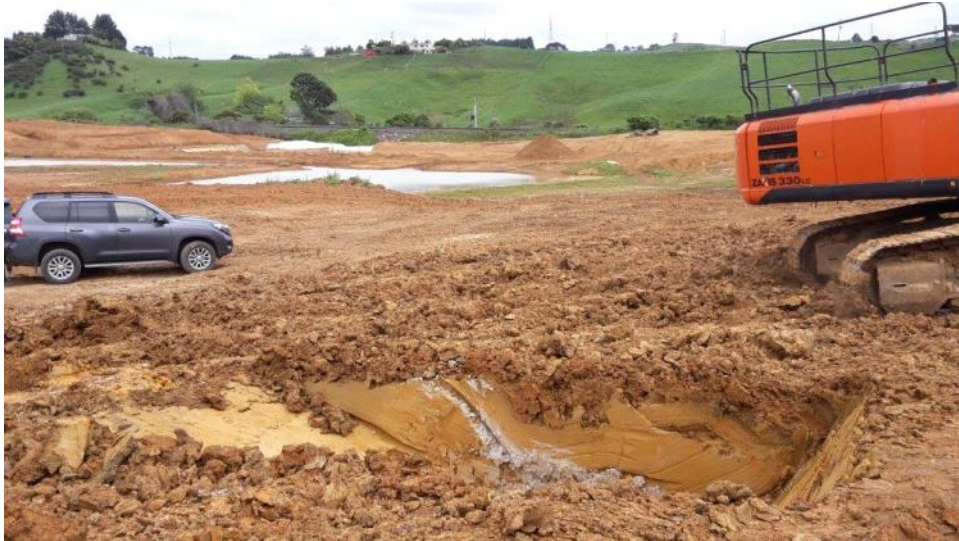
TP1 through the soft ground

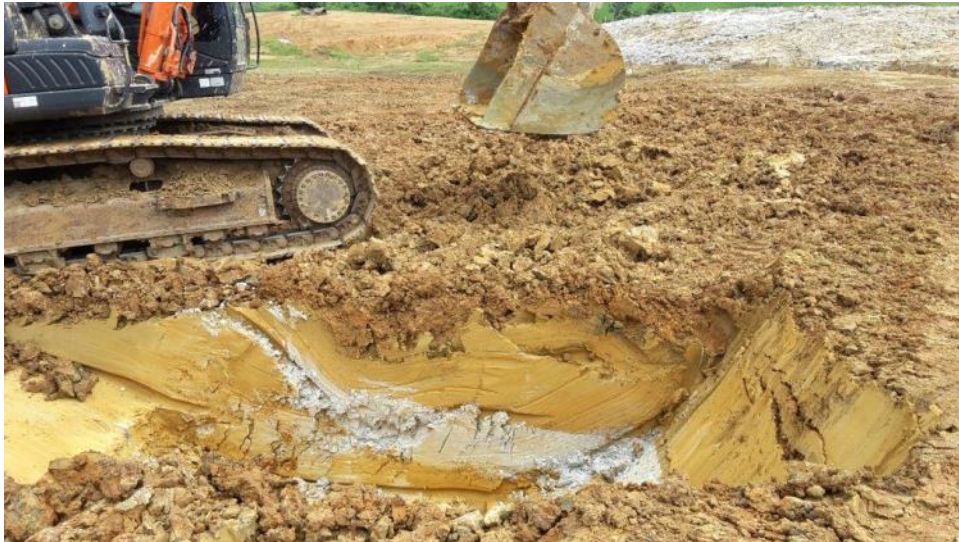
TP1 through the soft ground

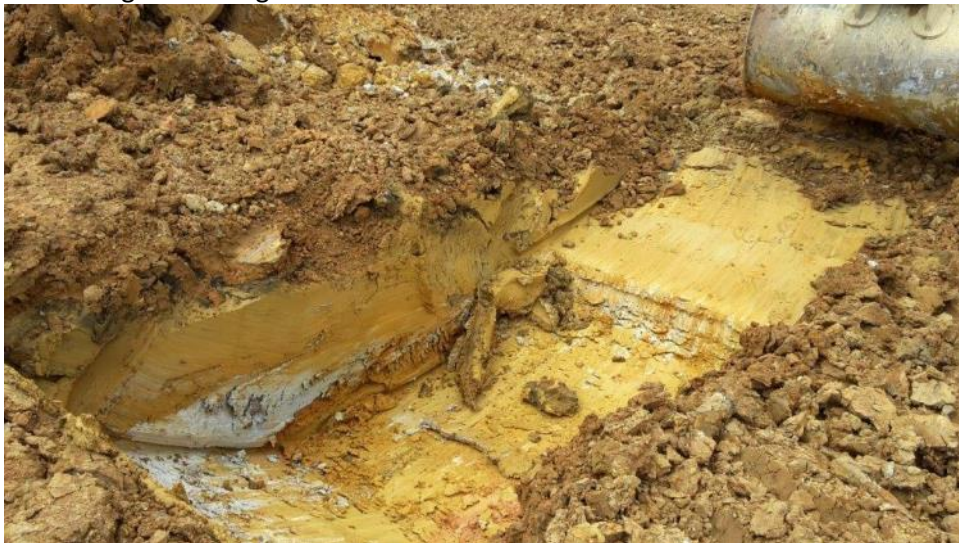
TP1 through the soft ground

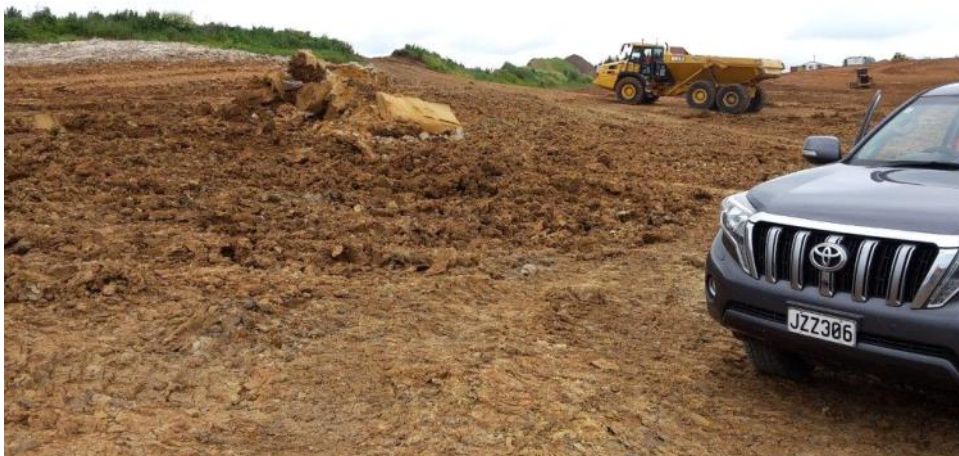
Area of soft ground

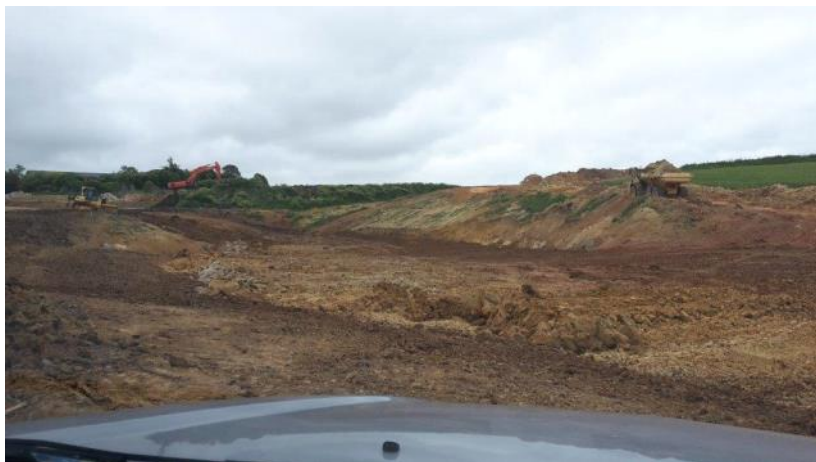
Fill 1 - there is an area of seeping groundwater on the right face of the gully- Trevor is going to extend the SPR blanket up this face and tap into the underfill drain in the area.

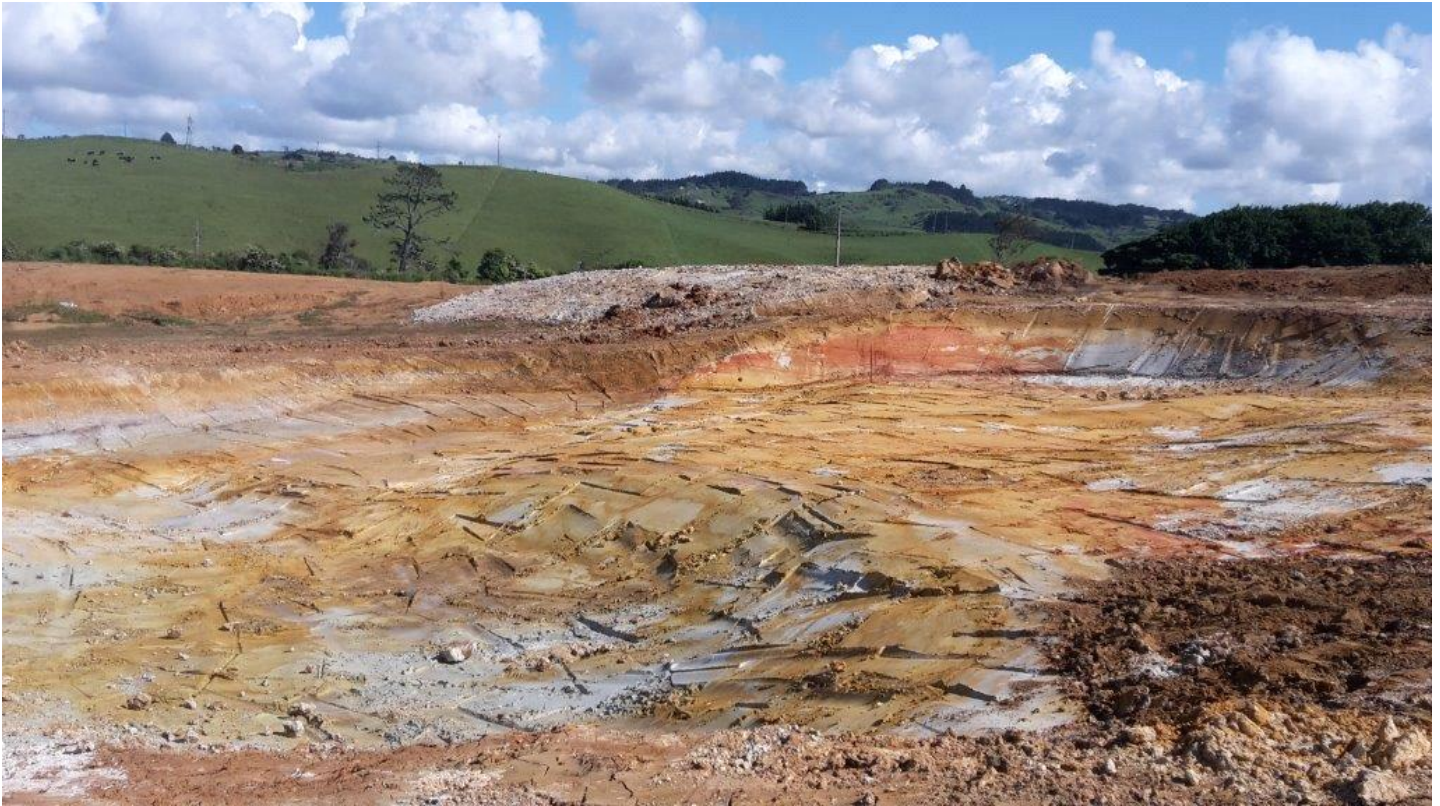
Undercut area

Observed the completion of the undercut. They have cut down to firm ground and the extents of the undercut either have a 2m to 2.5m capping over the softer material or extends under the road. Advised Trevor that we are happy to backfill area, however a base of SPR should be placed to deal with areas of seeping water.

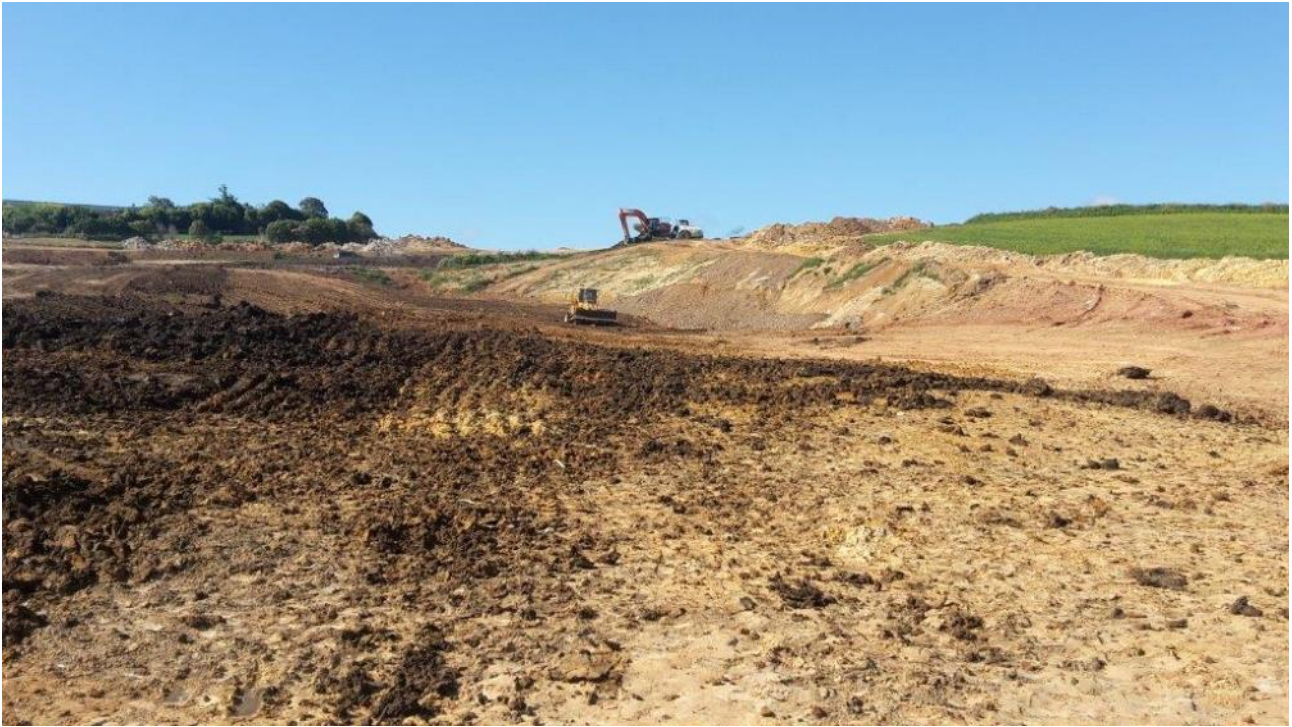
They have also installed the SPR rock blanket in Fill I where some water seepage was noted in gully face.

Fill 1 - SPR blanket located near where compactor is.

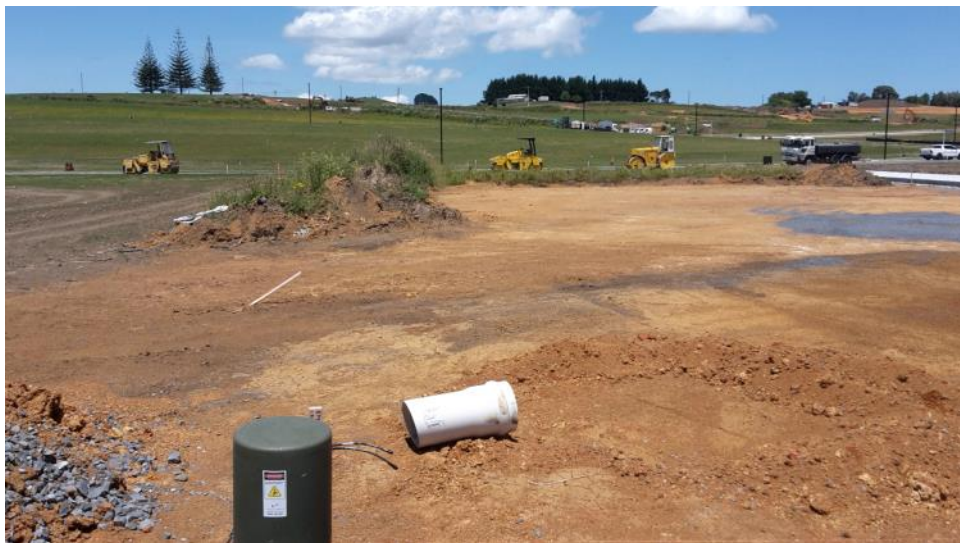
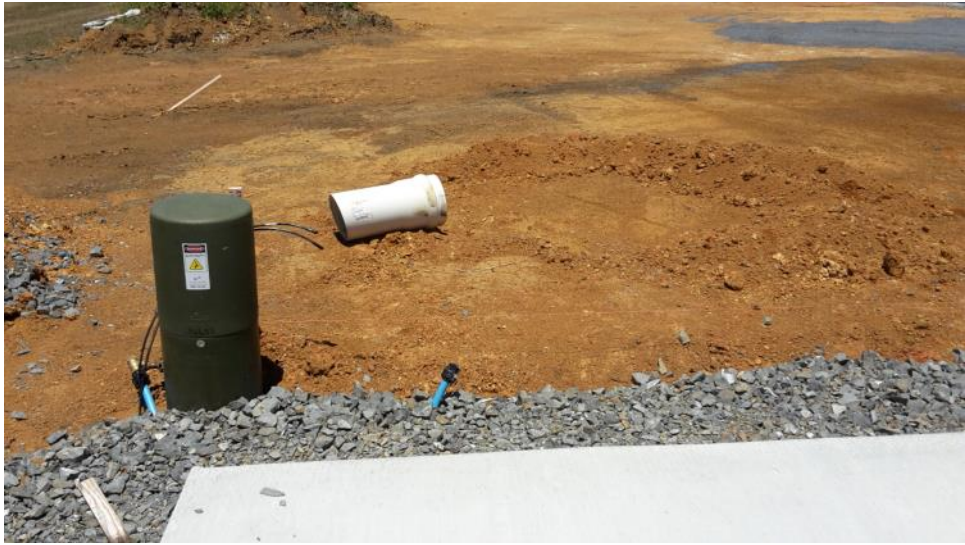
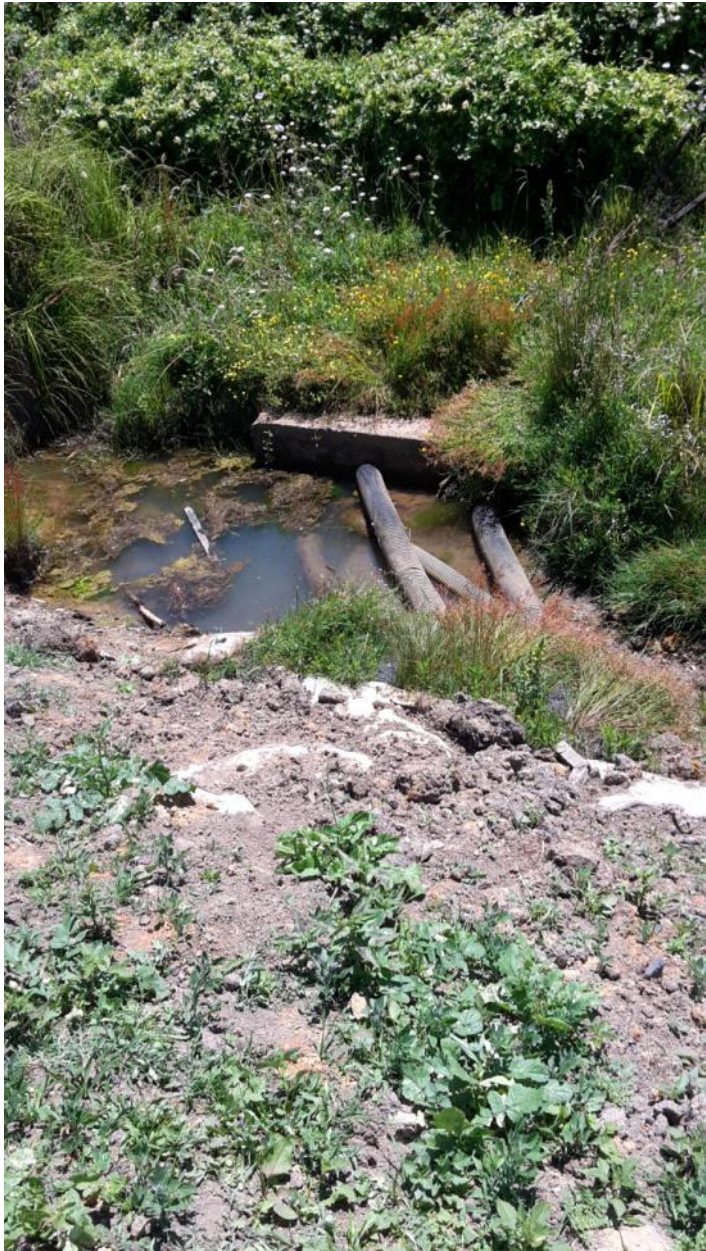
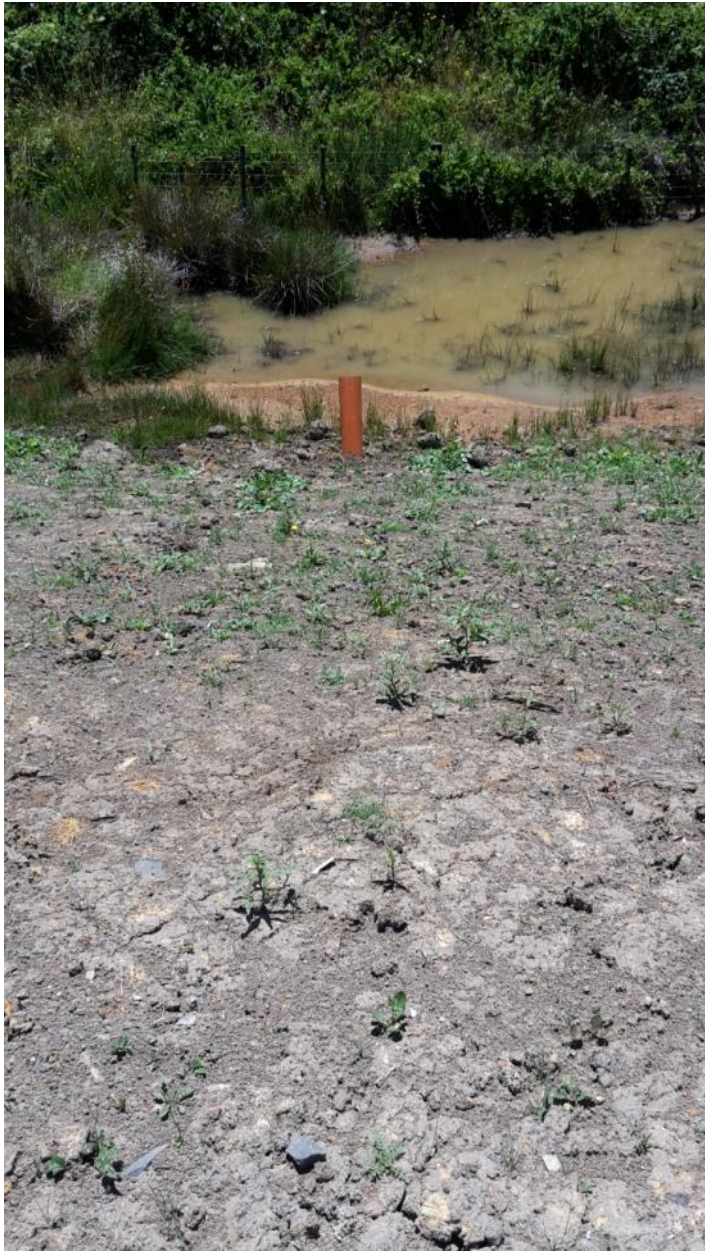
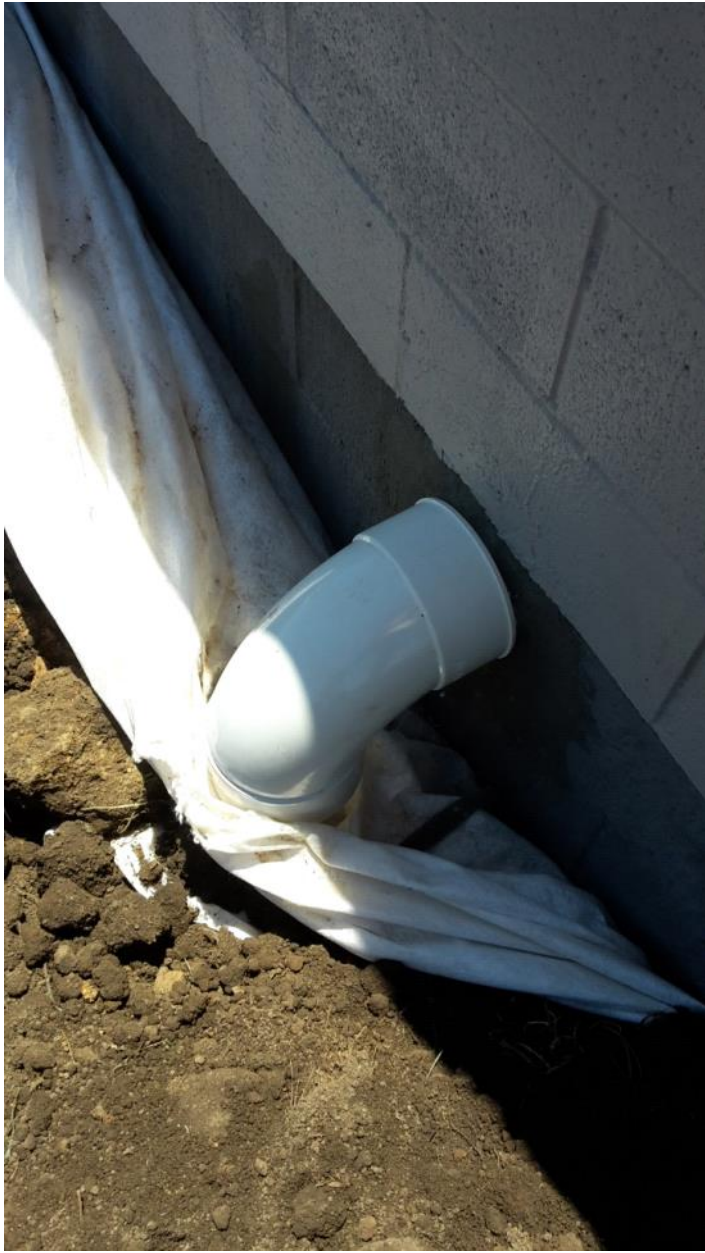
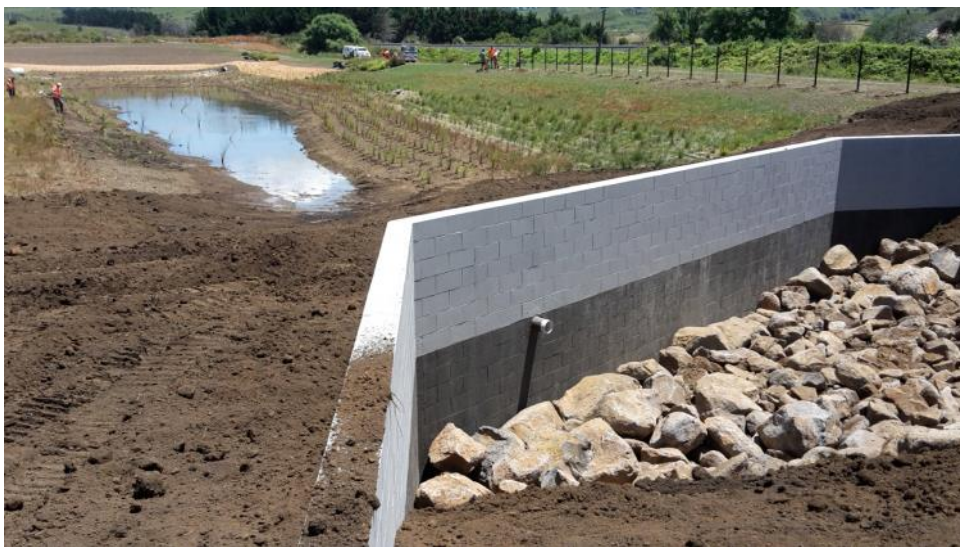
Also inspected fill J gullies. Topsoil was stripped adequately where it had been stripped. Southern one was completely stripped but northern one was half stripped. Advised Trevor we would send a can through to put underfill drains in these areas, although they were dry, it is likely that springing will occur during winter months.
