Geotechnical Completion Report

HITCHEN BLOCK STAGES 6E AND 10A TO 10D

DFH JOINT VENTURE LIMITED

16 December 2020

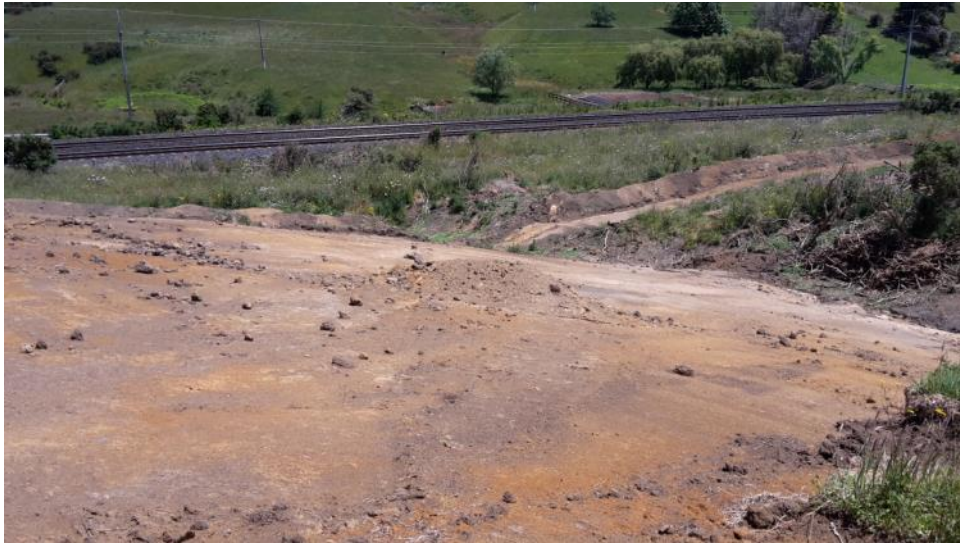
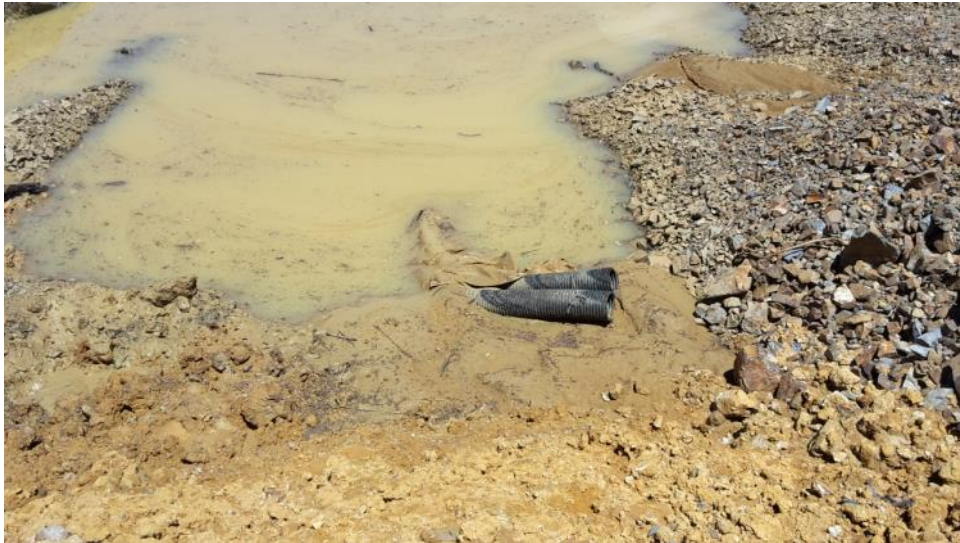
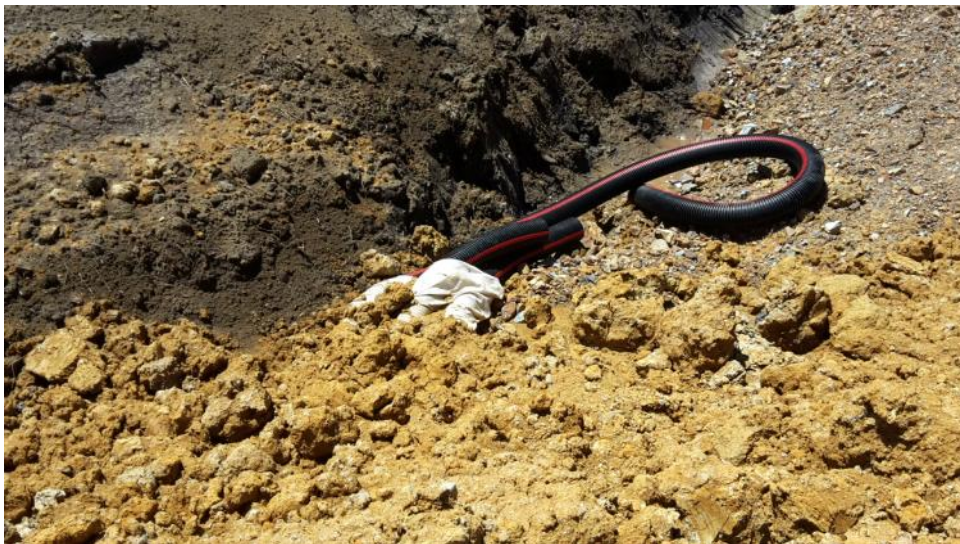
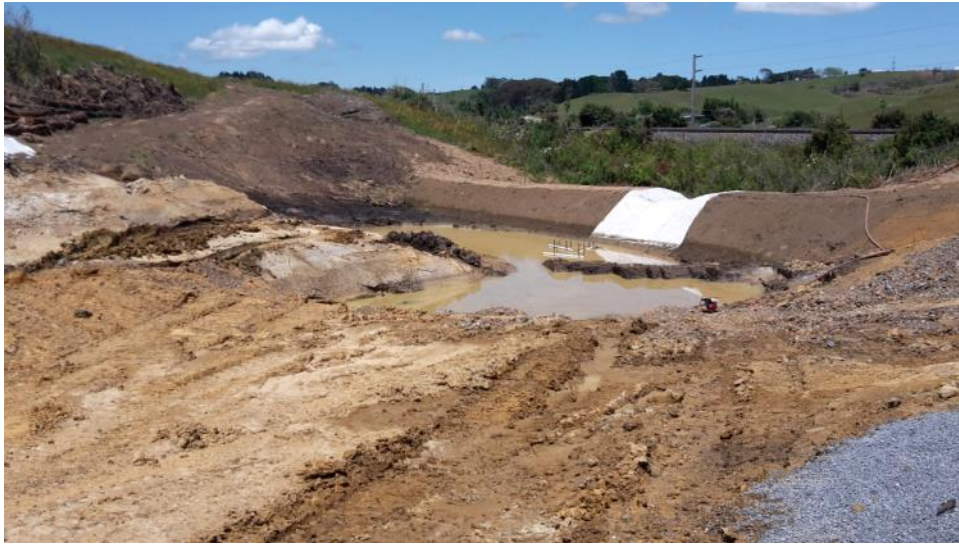
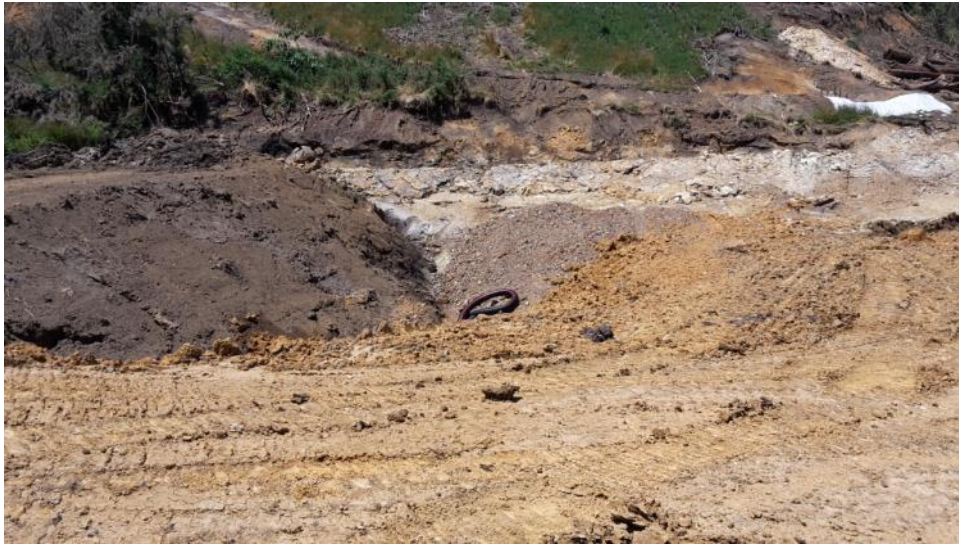
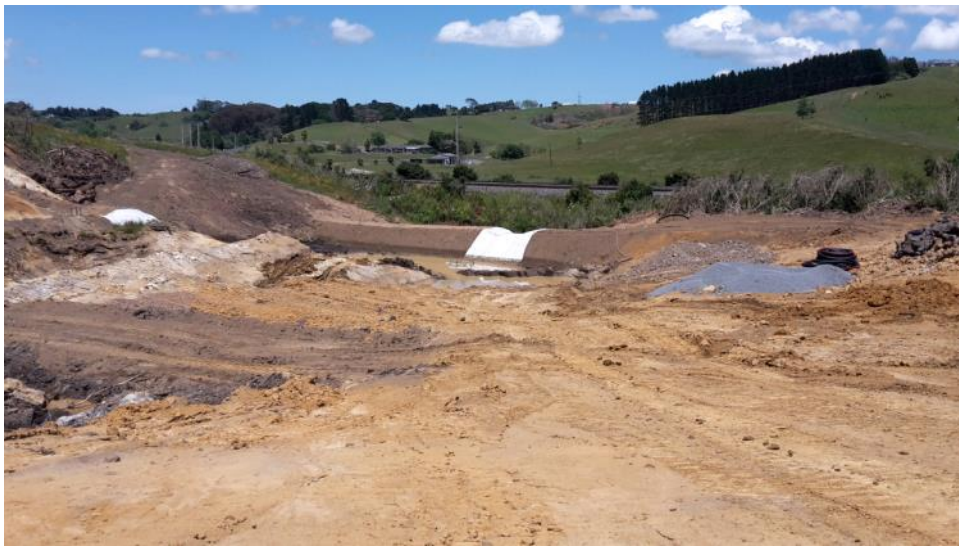
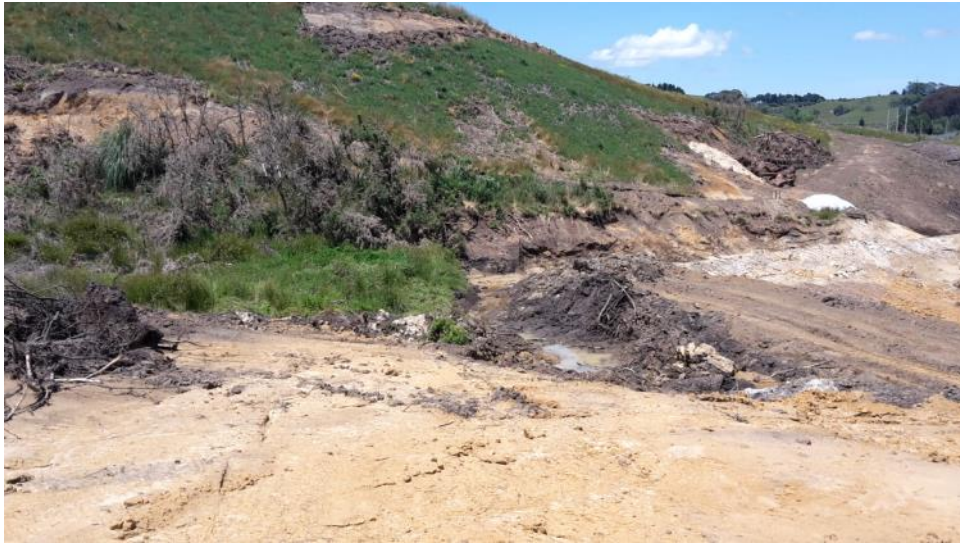
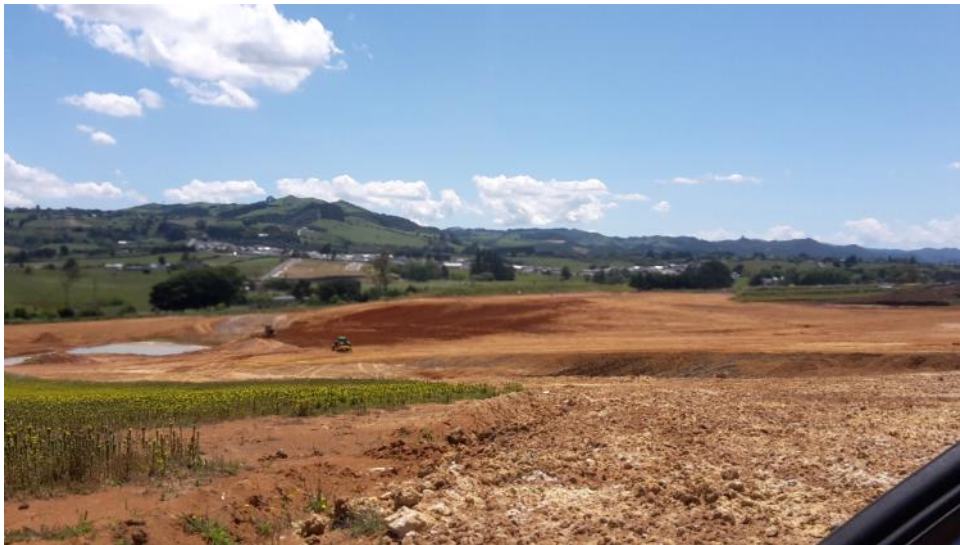
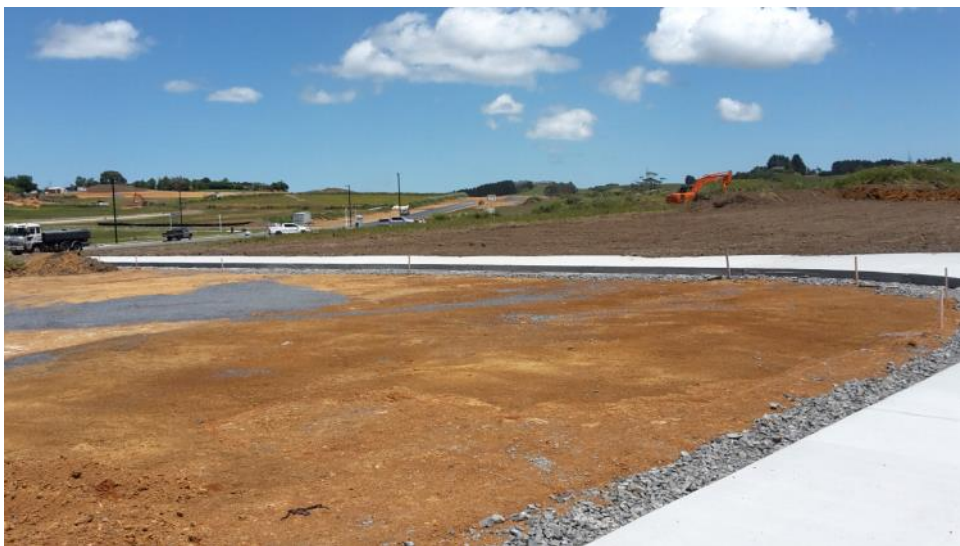
Visited site at request of trevor to inspect the muckout operations of the southernmost gully in Fill K. In most places, they had stripped down to something firm to place their SPR mattress upon, however, some organic material was still present and this was advised to be undercut (only by 500mm to something decent).

Advised trevor to use the same methodology on the easternmost gully.

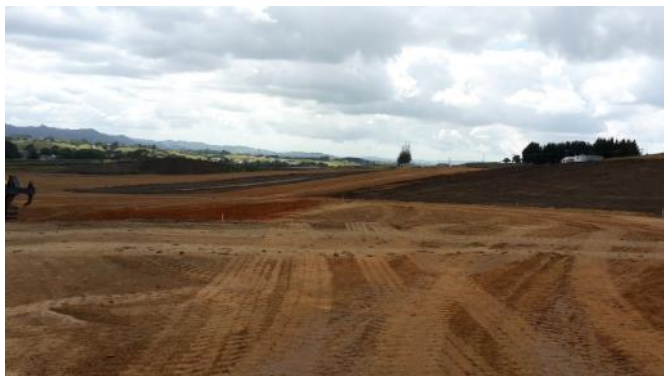
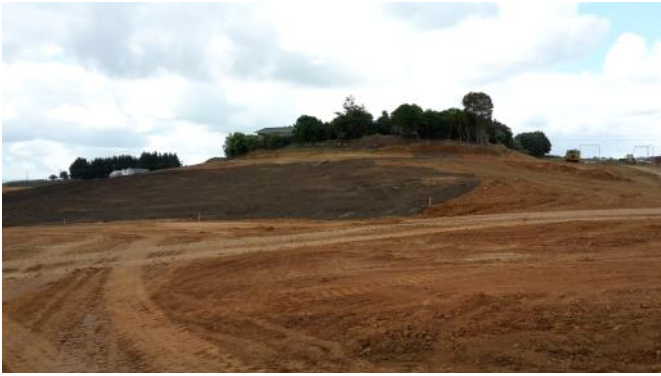
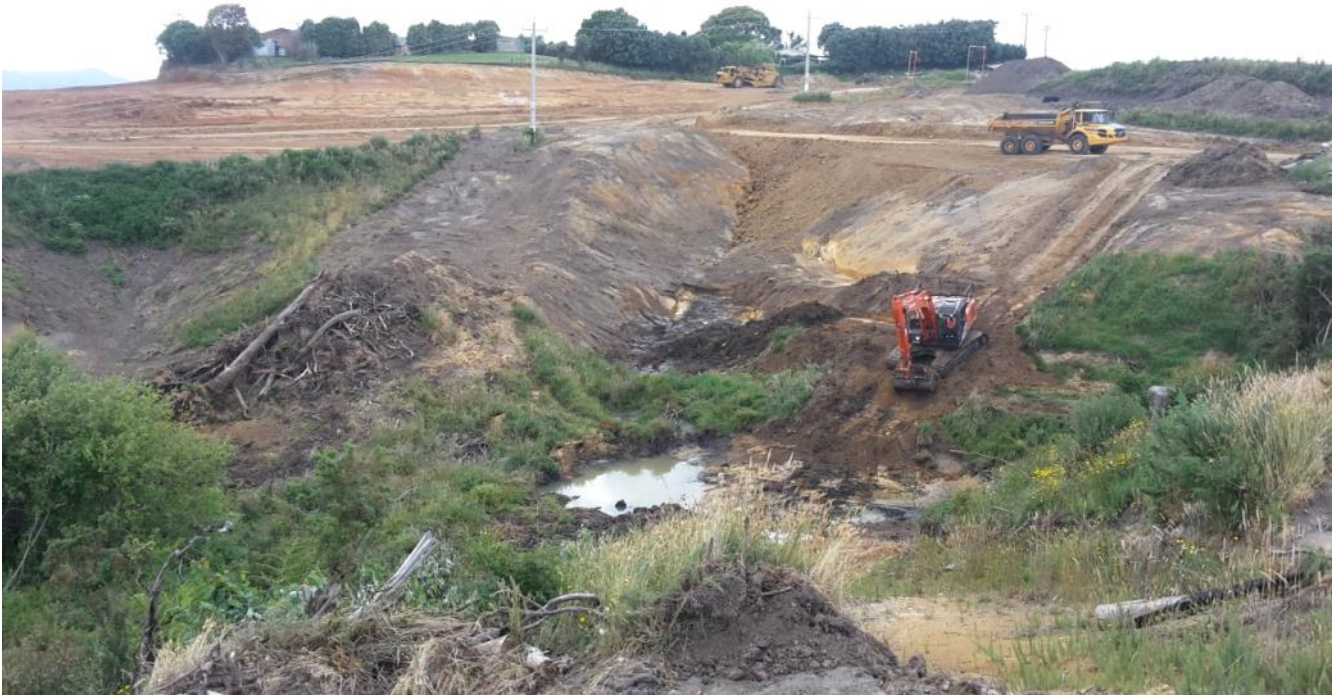
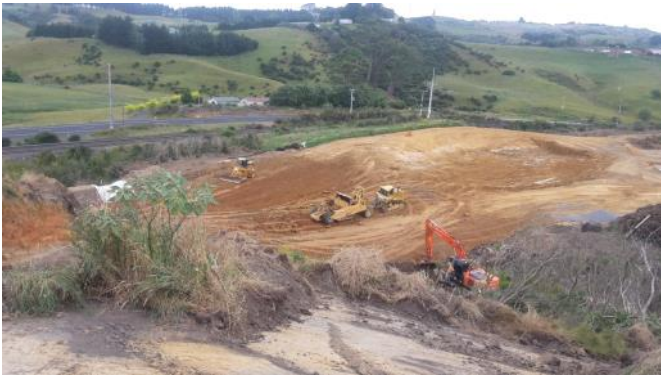
Inspected Fill K gully muckout just upslope of proposed pond. Trevor was considering leaving some of the organic materials in, provided we have enough cover of good materials above. It appears to be 2.5m from the top of the mucked out organics to the finished level of the road*. Chris will send a CAN.

*Some of the muckout will be within a lot.

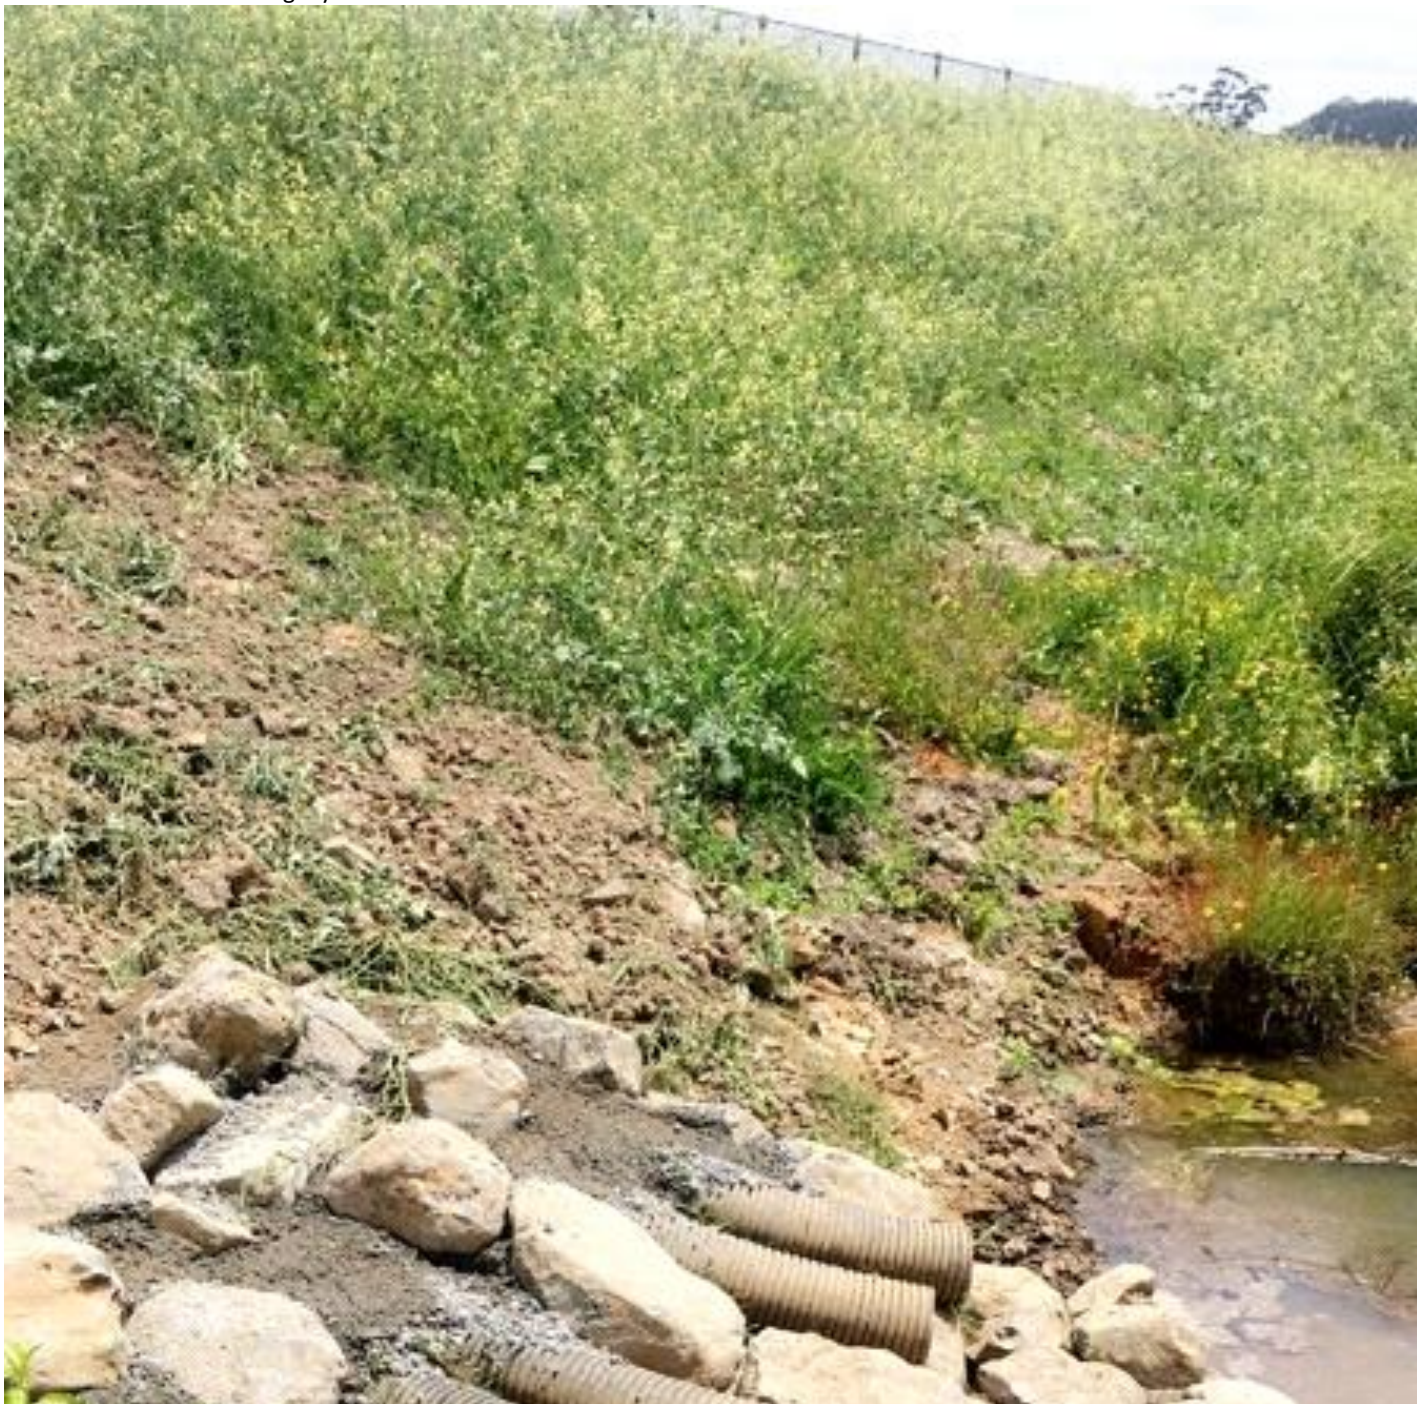
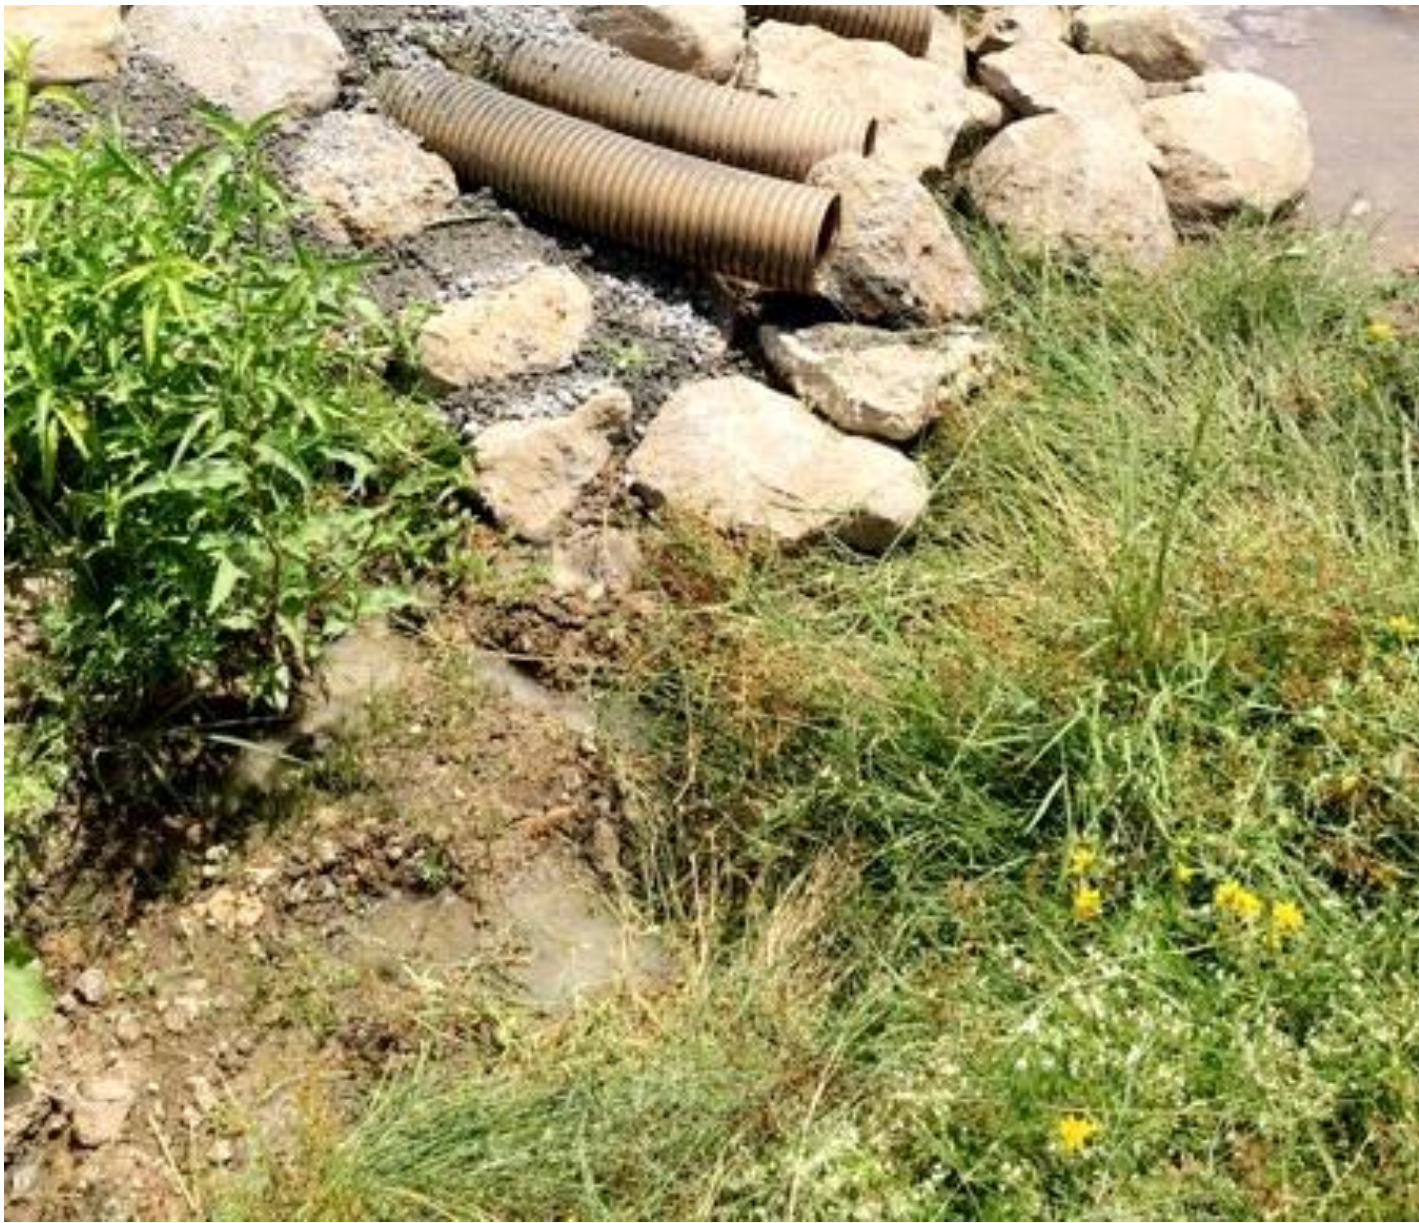
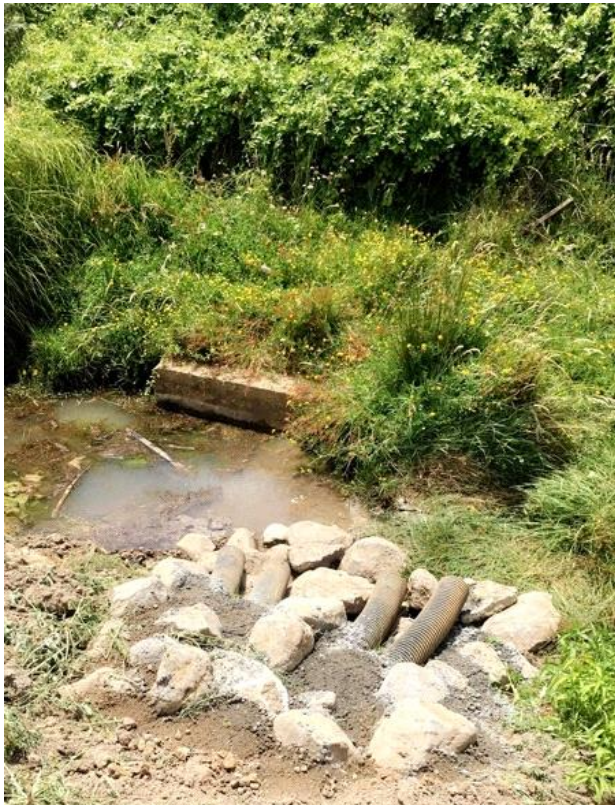
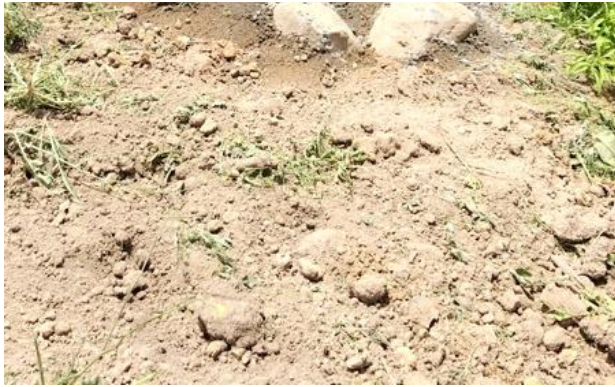
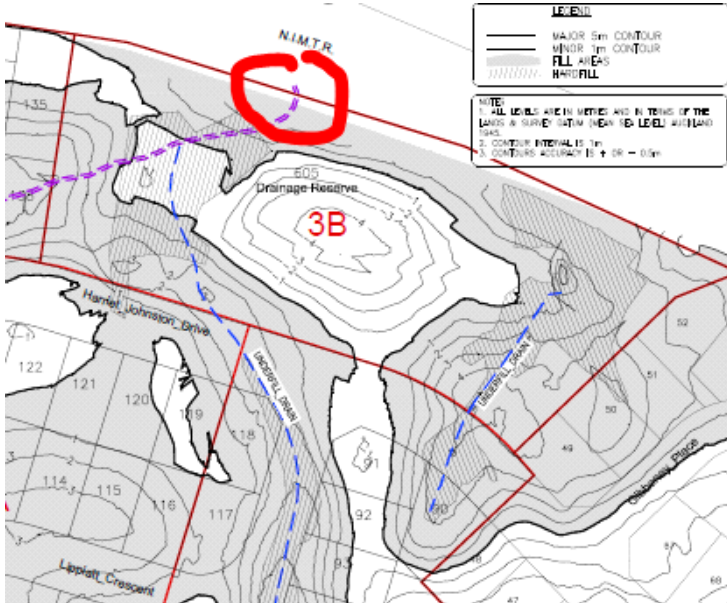
Outlet for the main 4x coil gully

Russell sent through the underfill drain outlets pictures for the Stage 3B pond as per below.

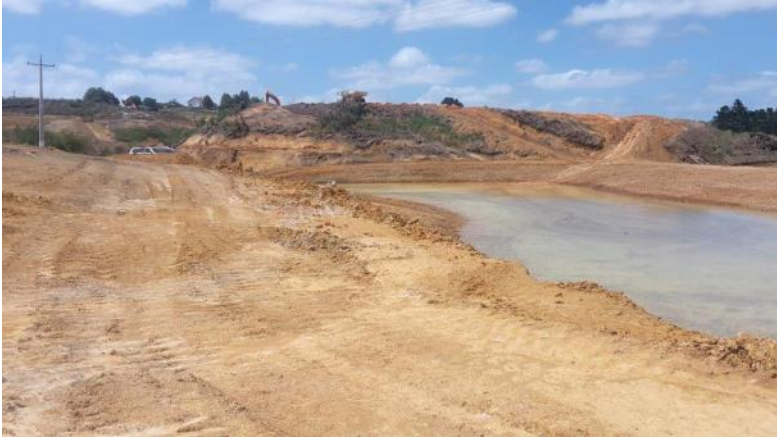
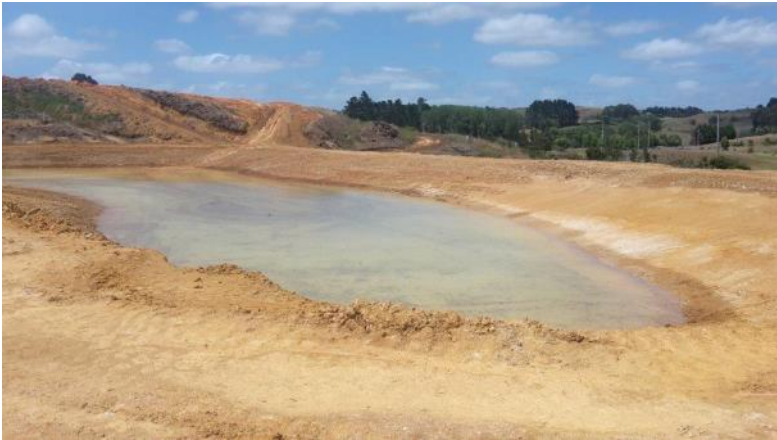
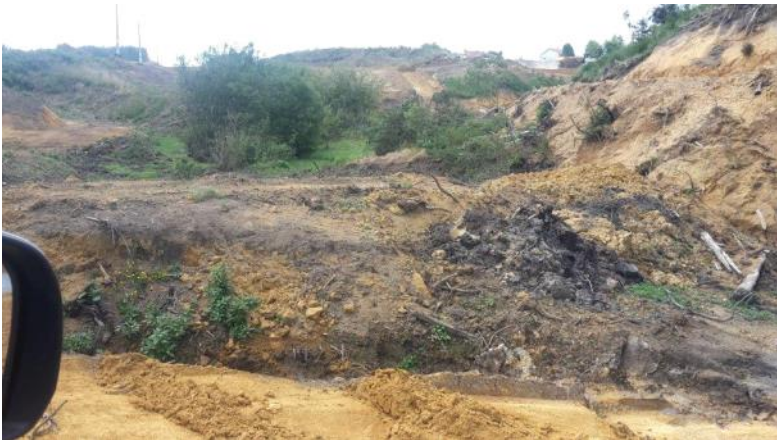
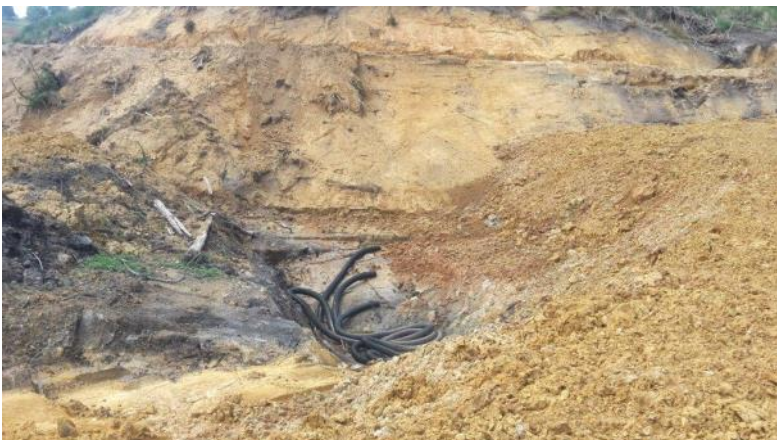
There is a lot of gully mullock material from the Fill K pond muckout. This material will be dried out, root raked and then mixed with clean clay and placed in the deeper fills.

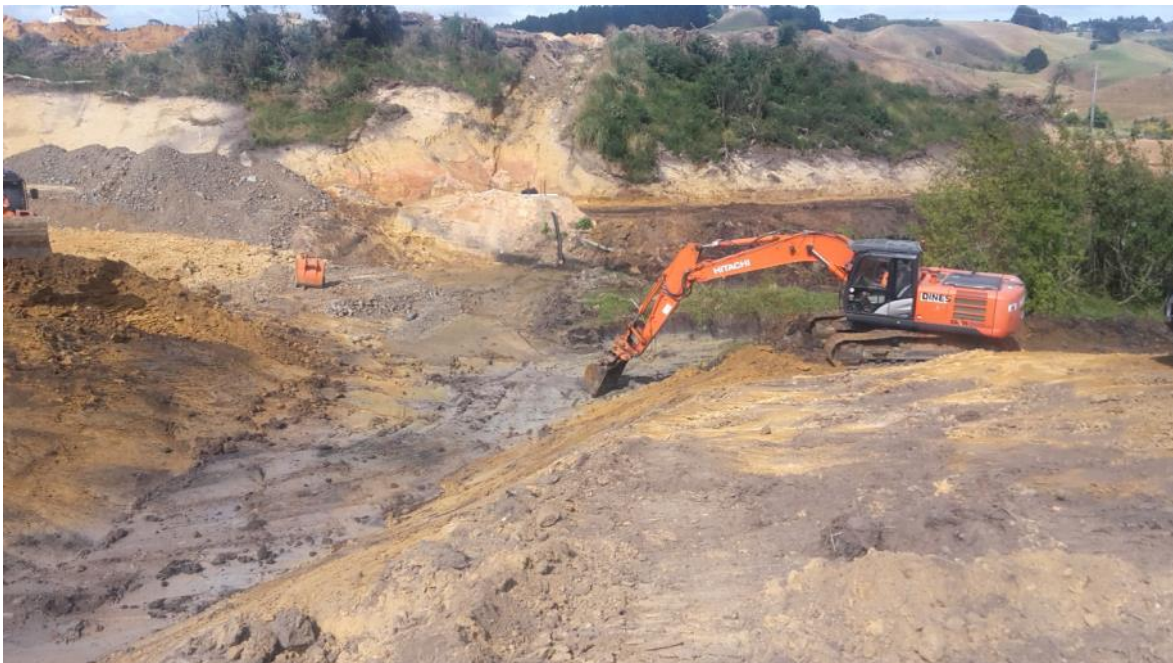
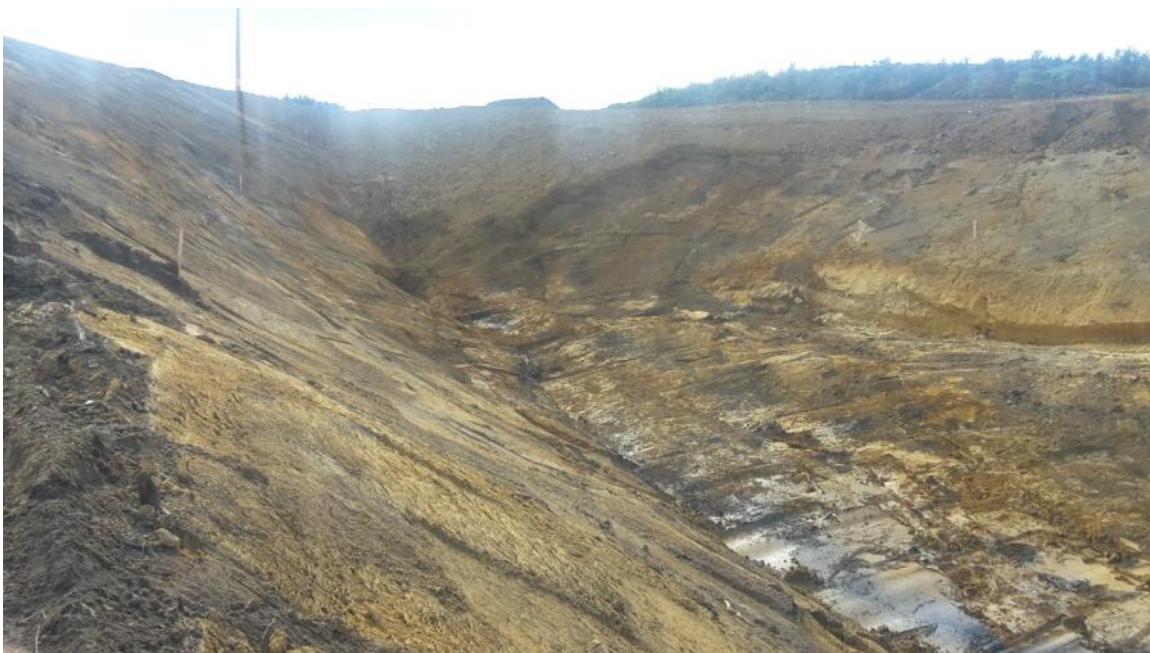
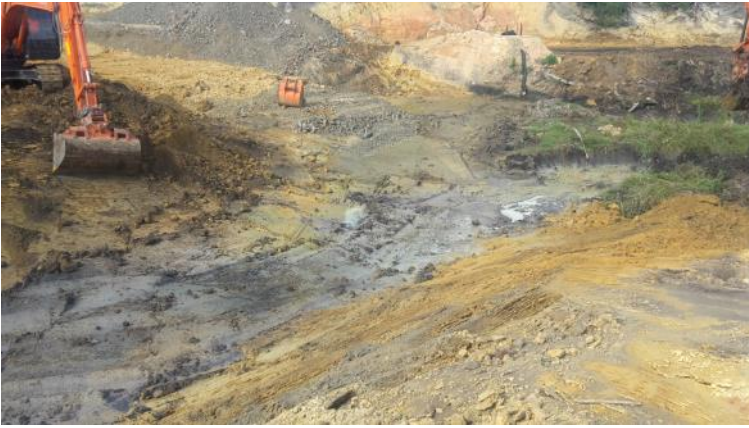
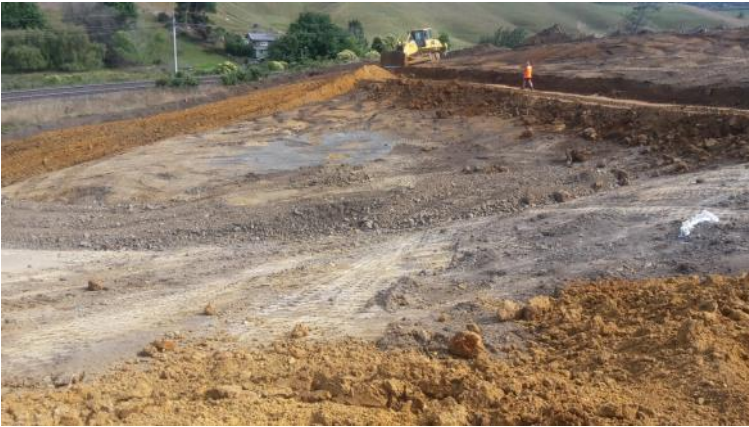
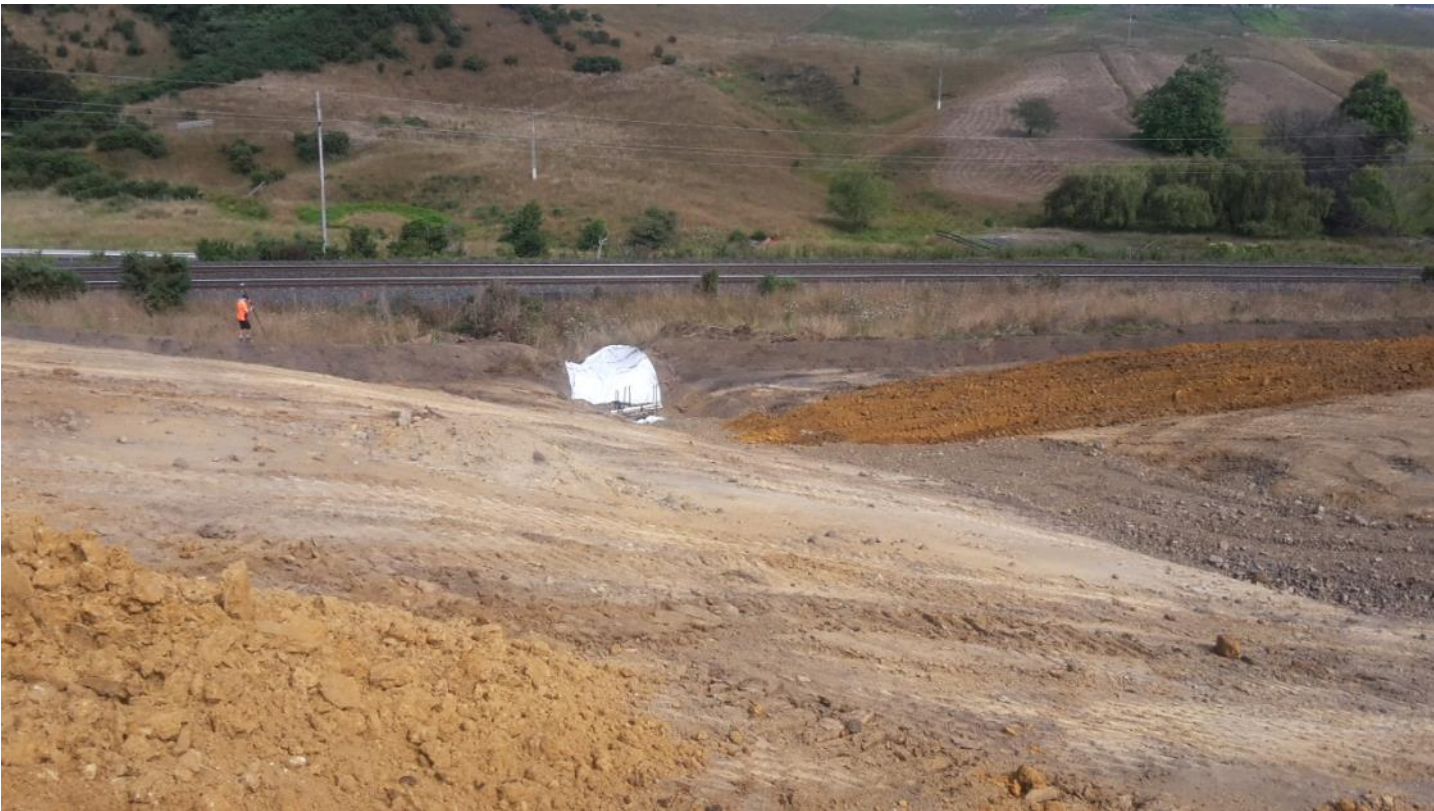
Visited site at request of Trevor to catch up following christmas/new year break. Underfills and SPR have been placed in Fill J, pond has been completed to grade, and the easternmost gully in fill K has been mucked out. Northernmost Tributary gullies still to be mucked out.

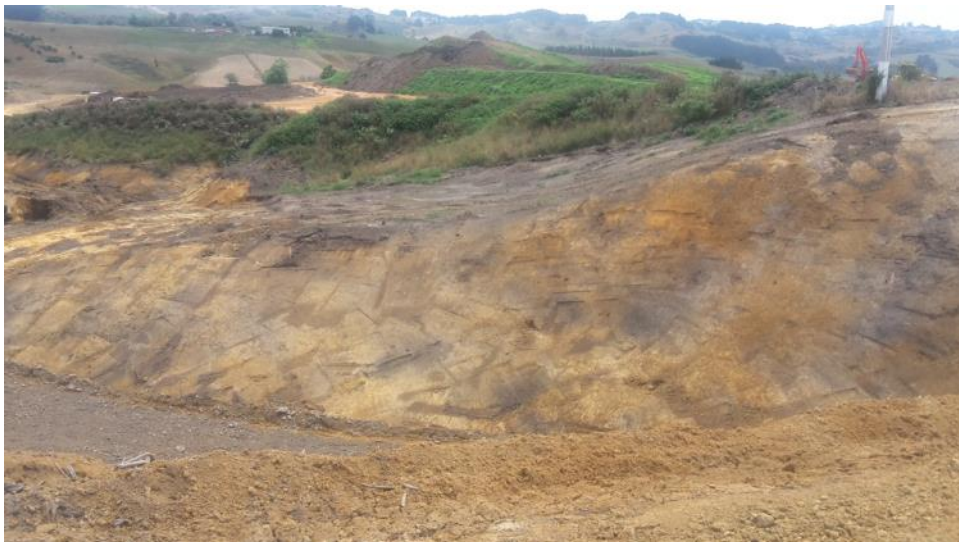
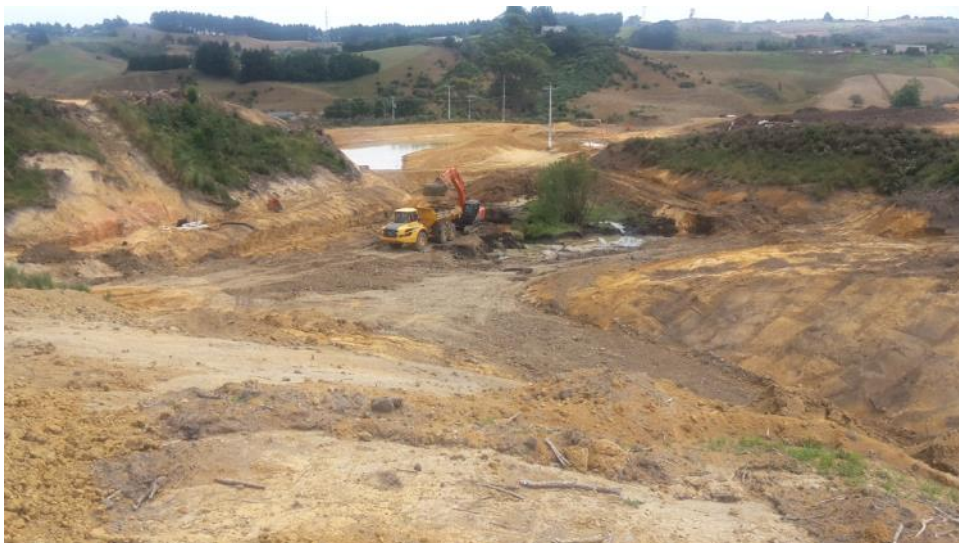
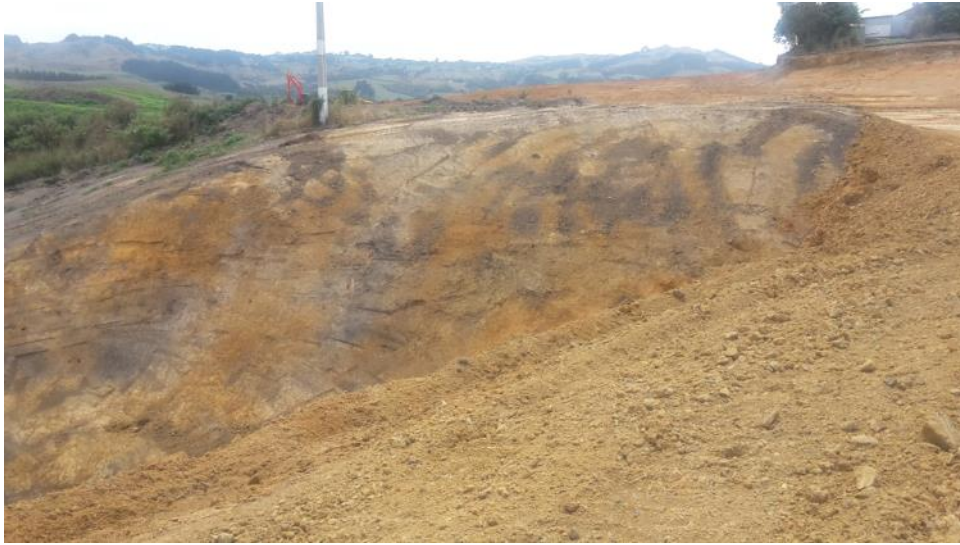
Visited site at request of Trevor to observe gully muckout procedures. He has sent photos through and they are consistently undercutting down to the green/grey silts before placing SPR.

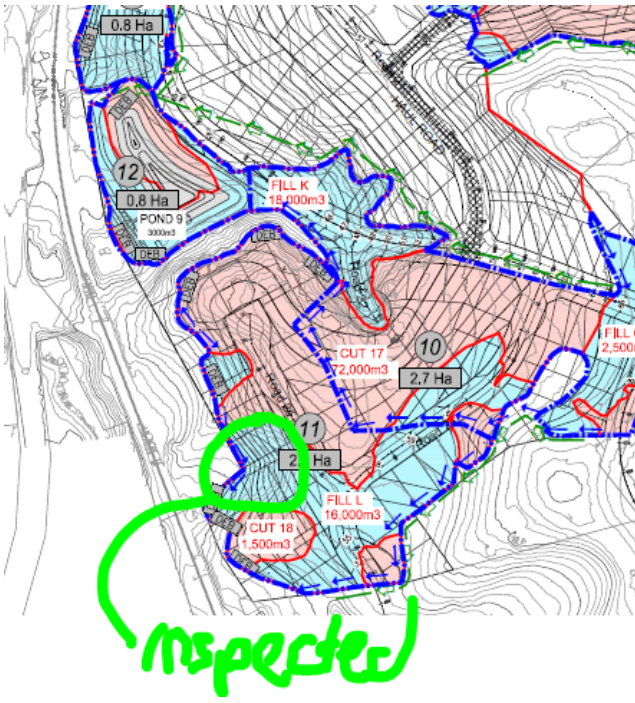
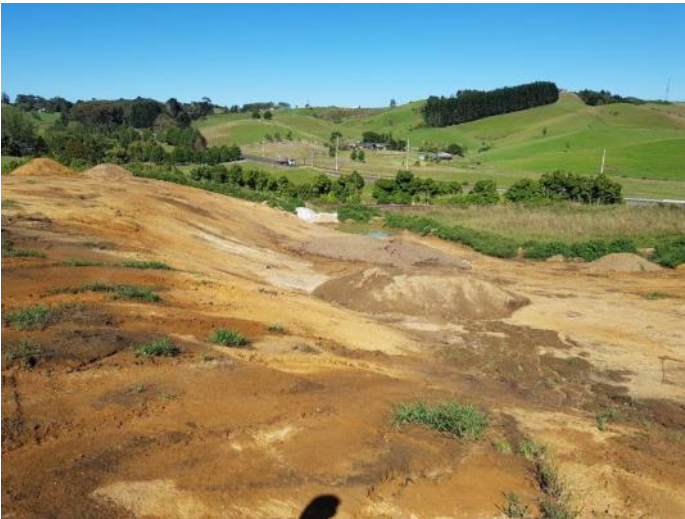
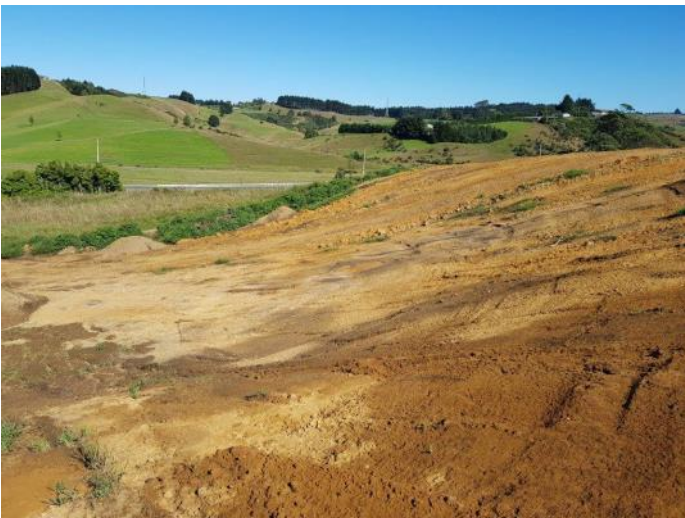
Noted that the topsoil had been stripped adequately to expose stiff natural ground. Requested that an underfill drain is installed as per the picture below, the slope still needs to be benched.

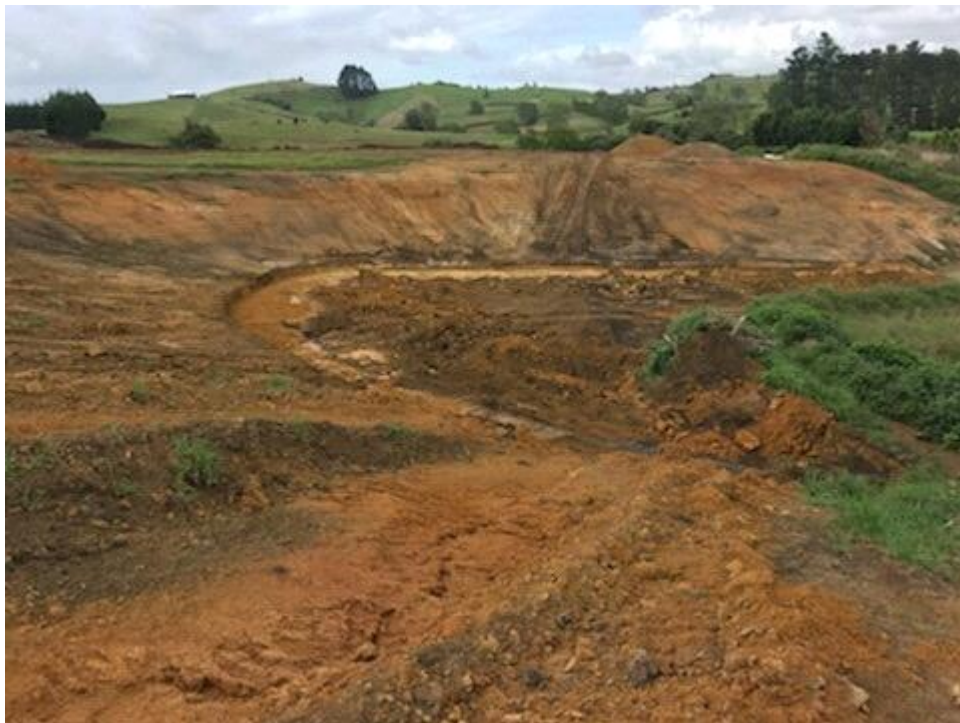
Photos from Trevor of Fill L drainage installation. Installation appears to have occurred as per CAN that we issued on the matter.
