Geotechnical Completion Report

HITCHEN BLOCK STAGES 6E AND 10A TO 10D

DFH JOINT VENTURE LIMITED

16 December 2020

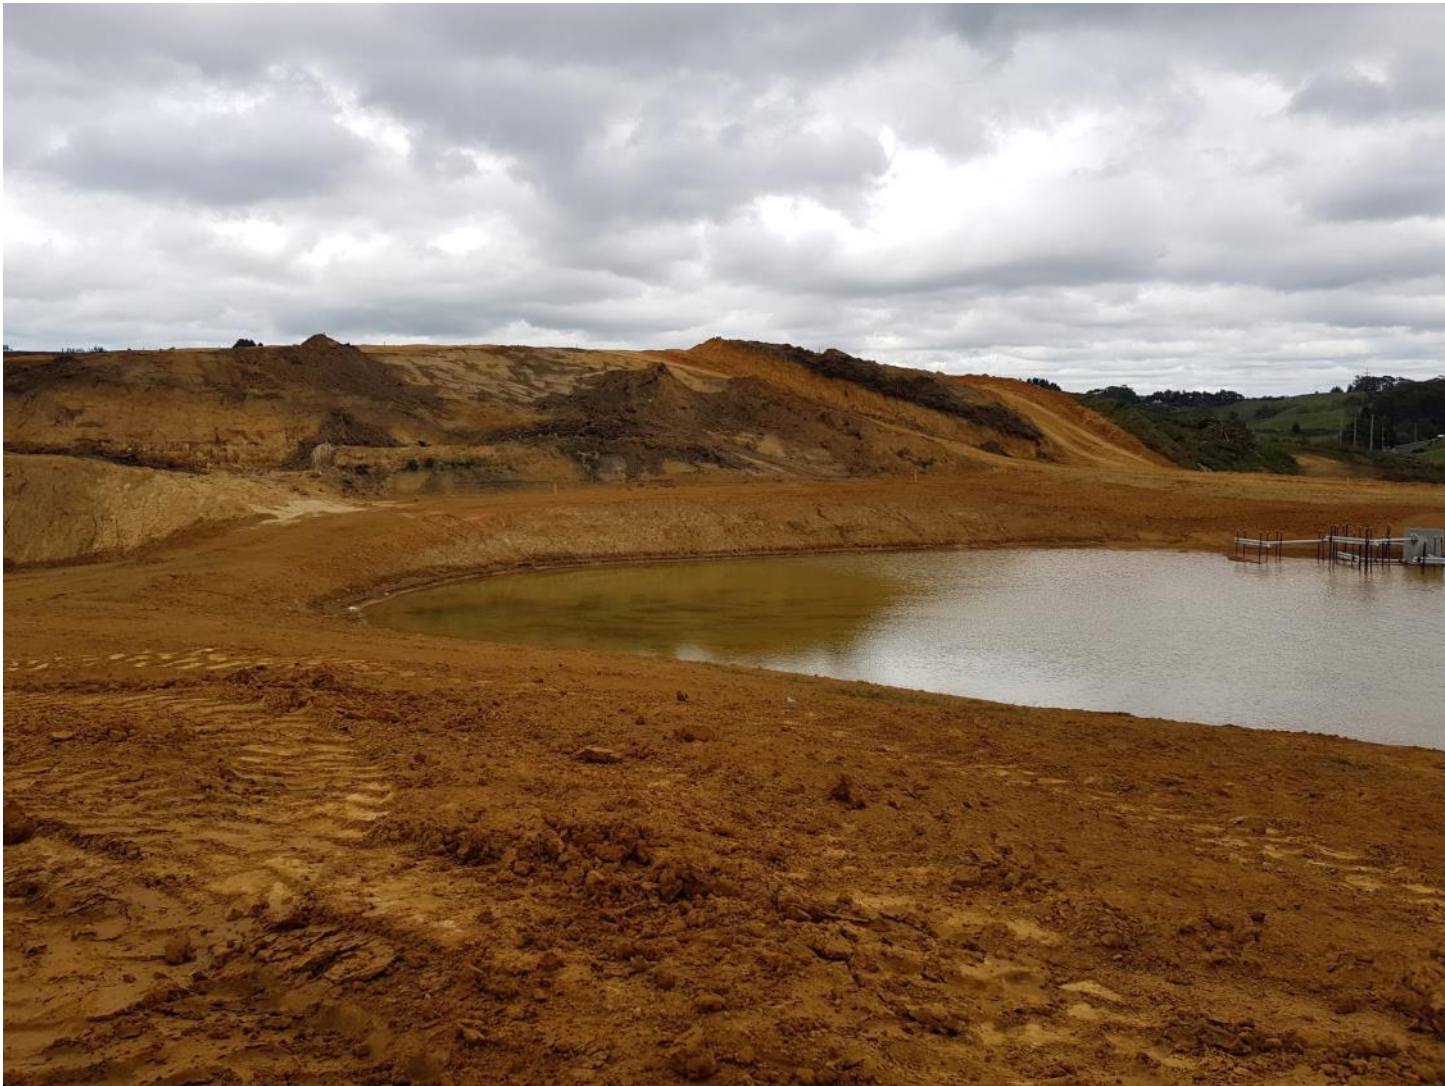
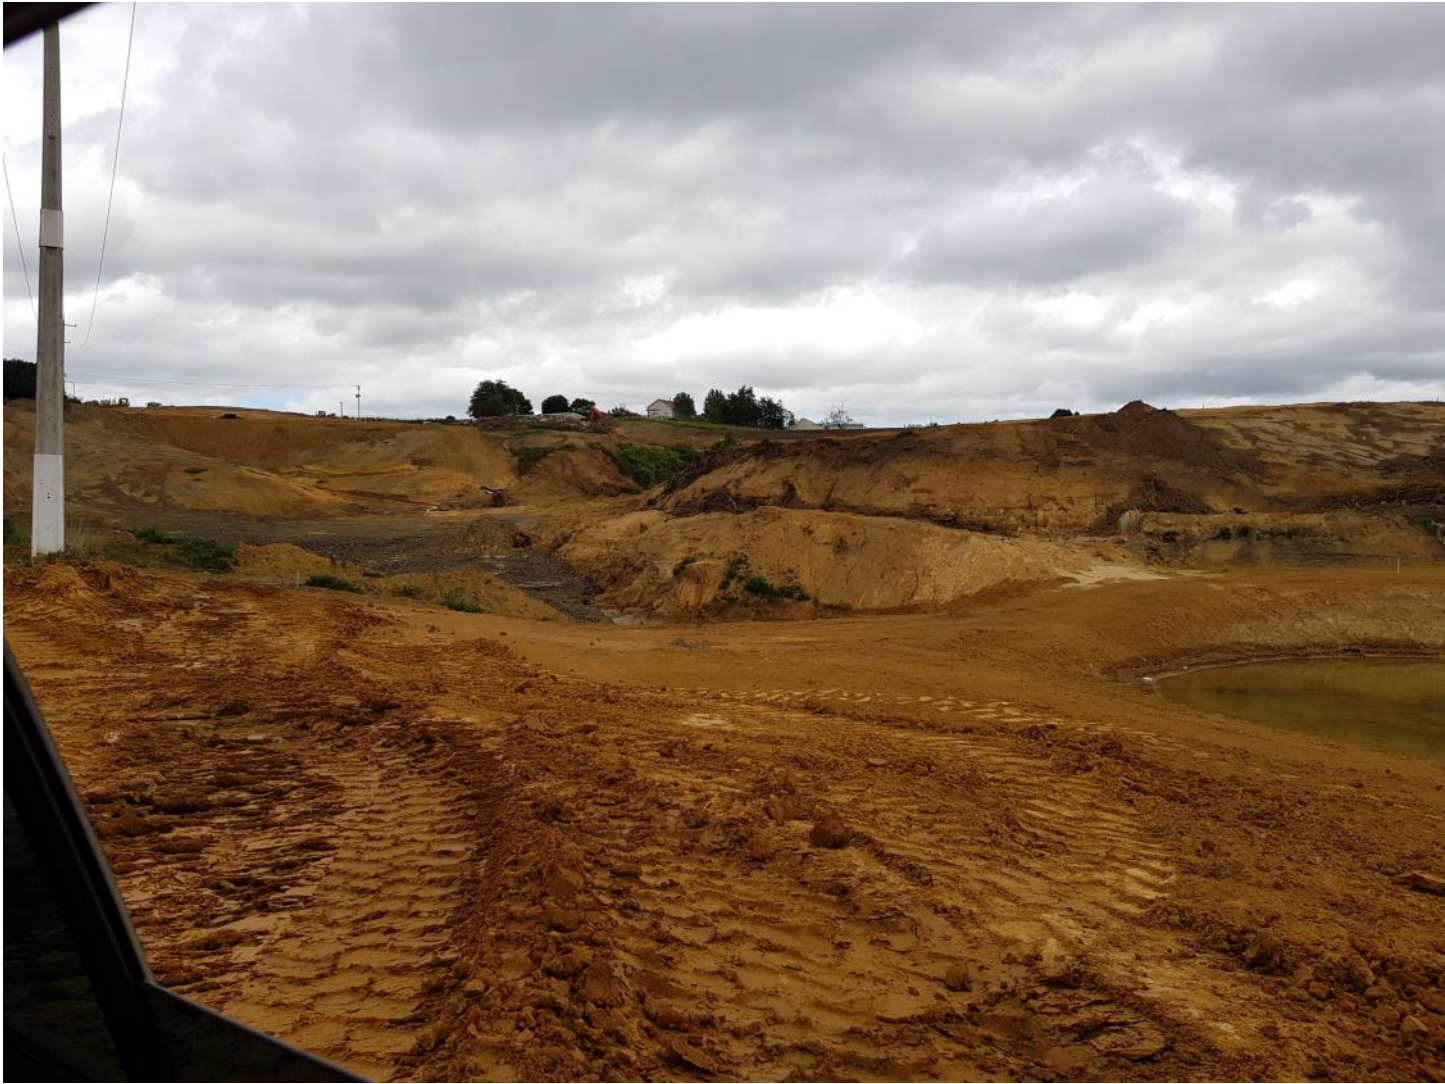
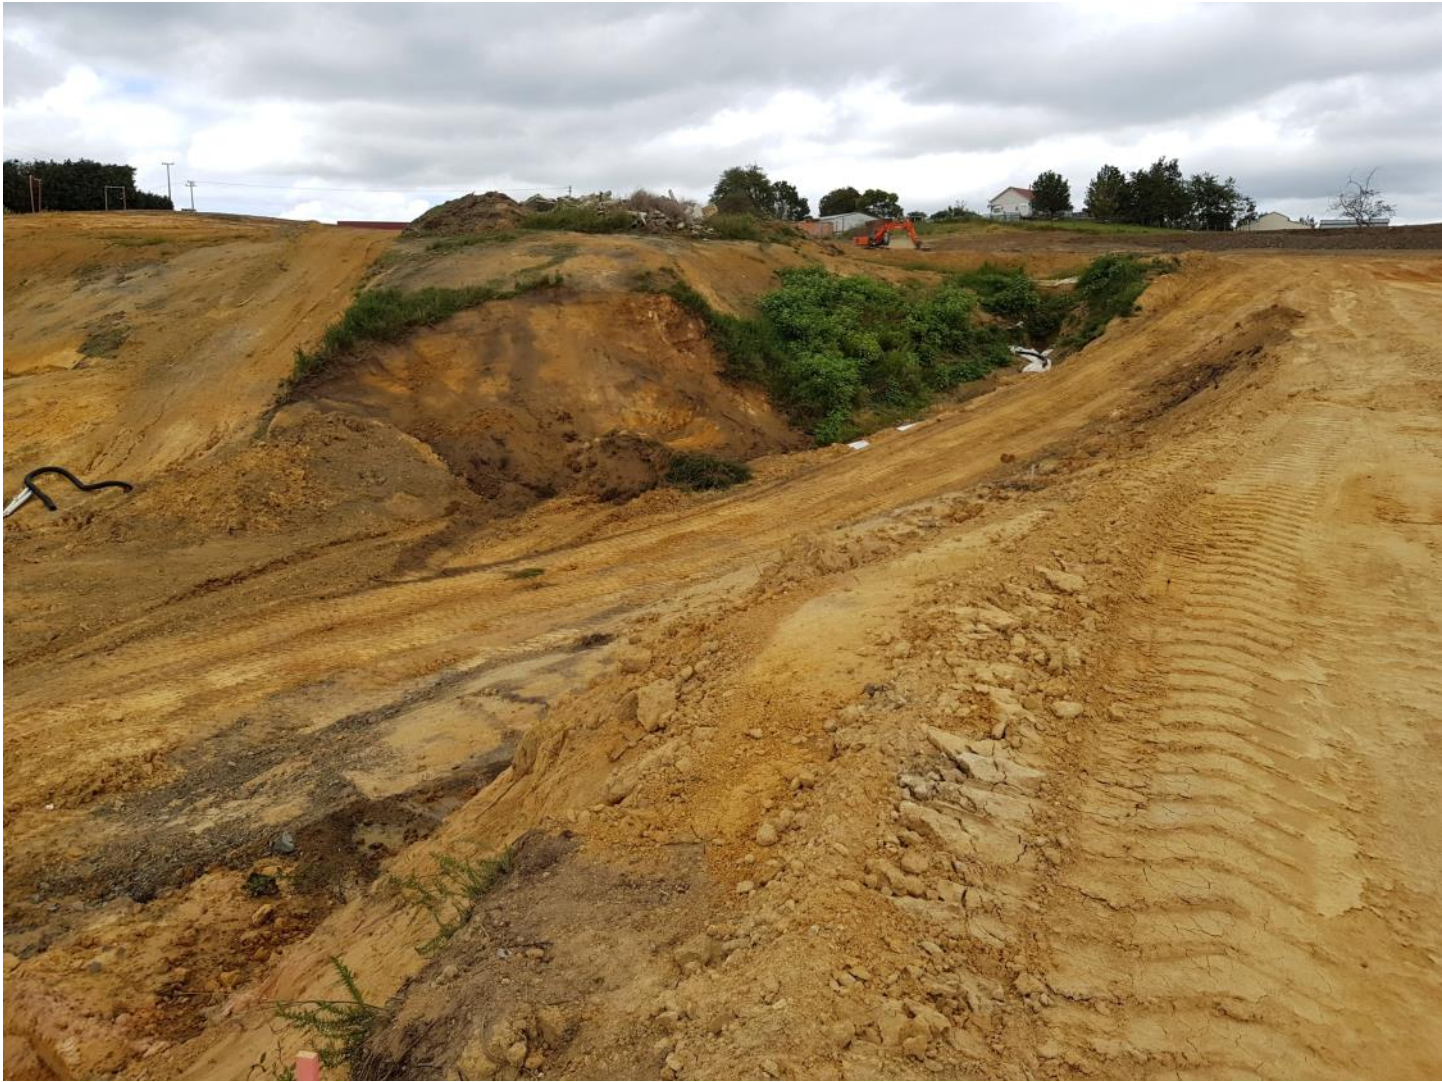
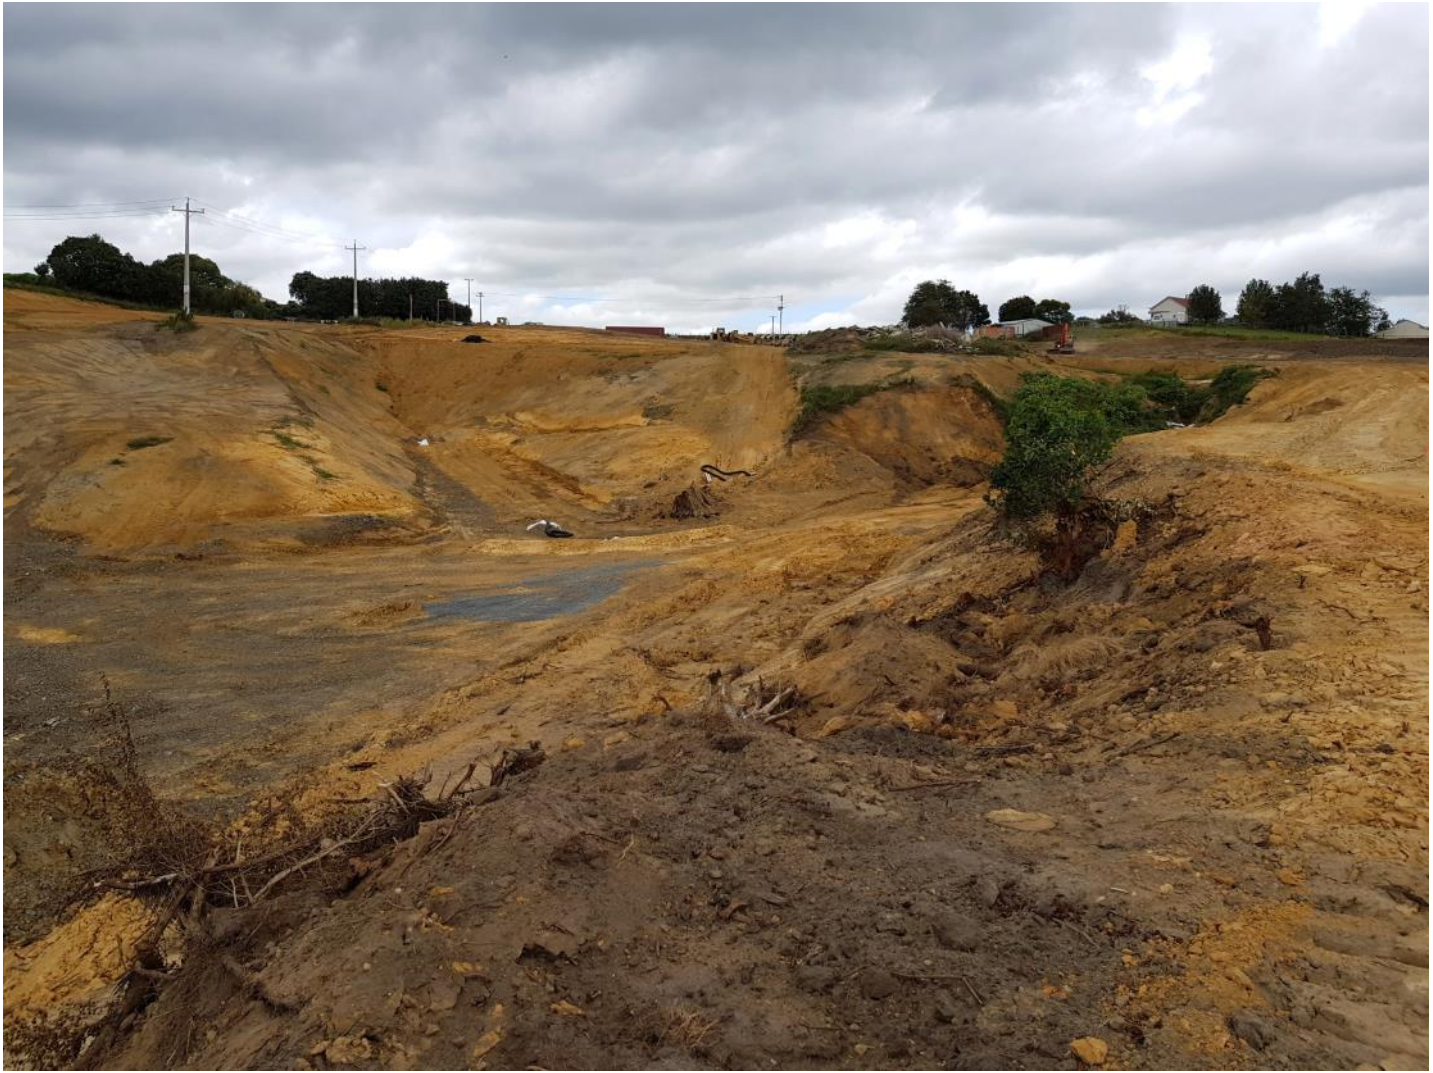
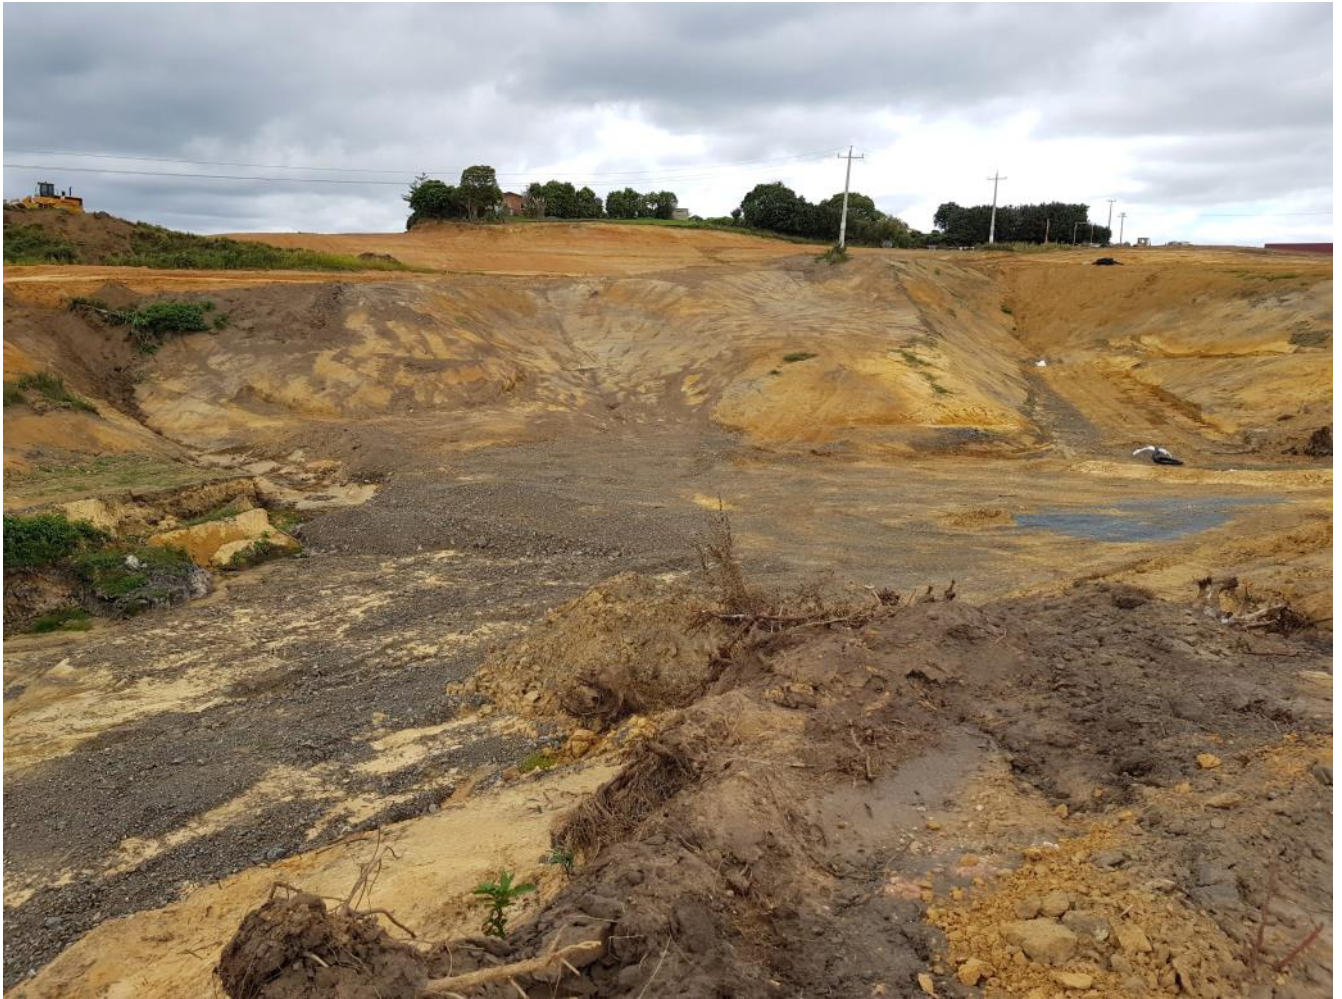
Observation of progress of works on site. They have only 2 scrapers and 1 compactor working (as rest of plant is on the Bridge and Hynds).

Cut to fill around the pond area in the western part of stage 3 is the focus currently. Have asked Mike to get in contact with Trevor to ensure the appropriate level of fill testing is taking place.

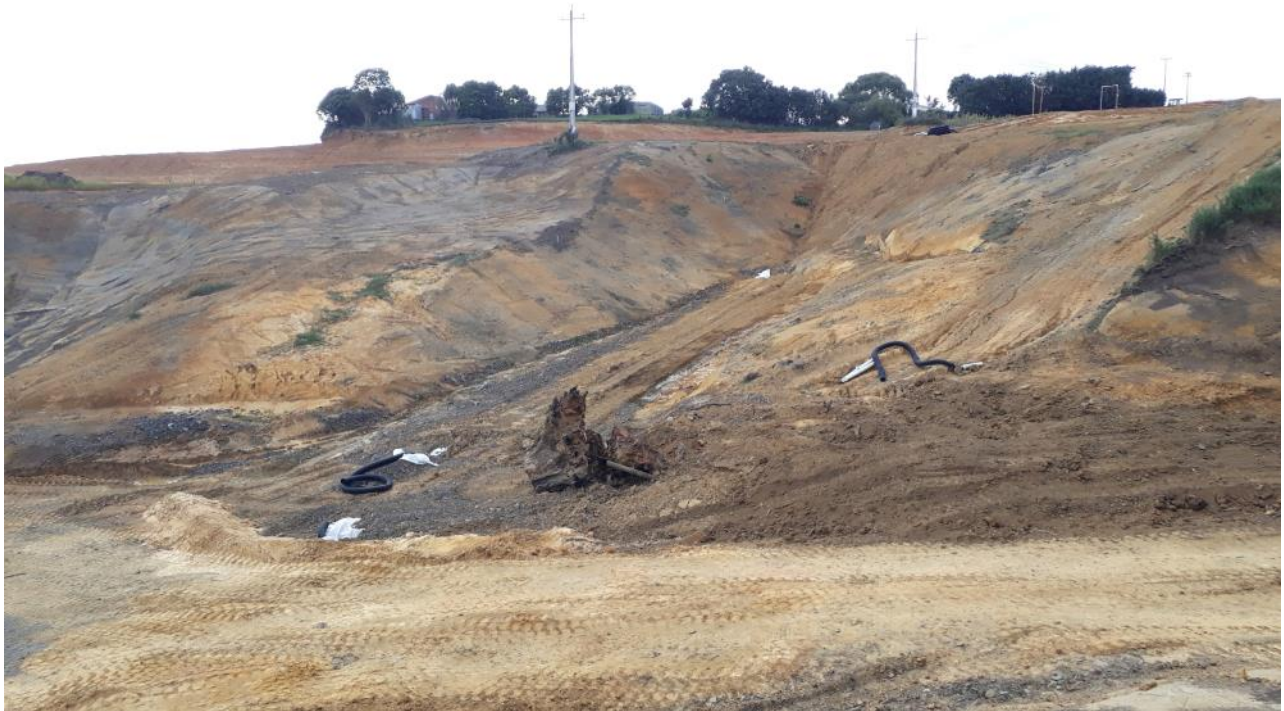
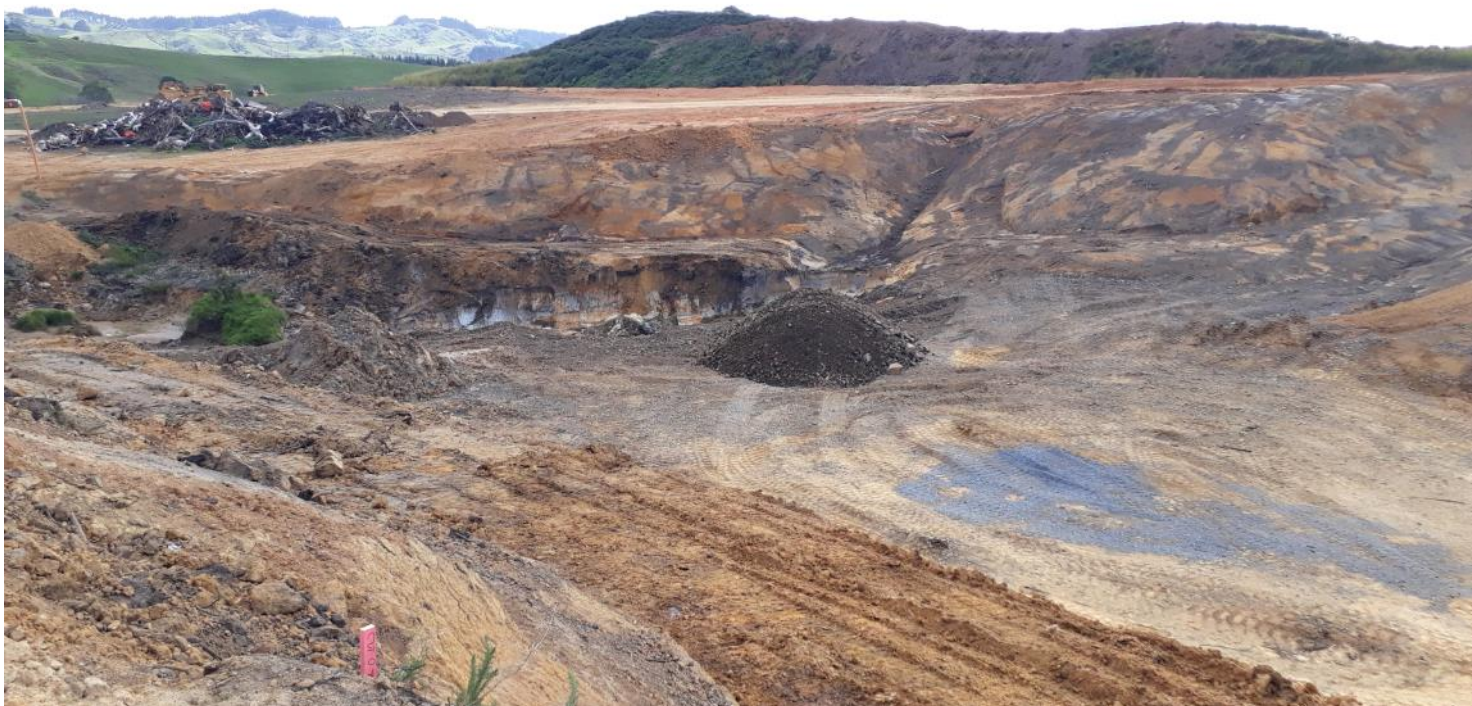
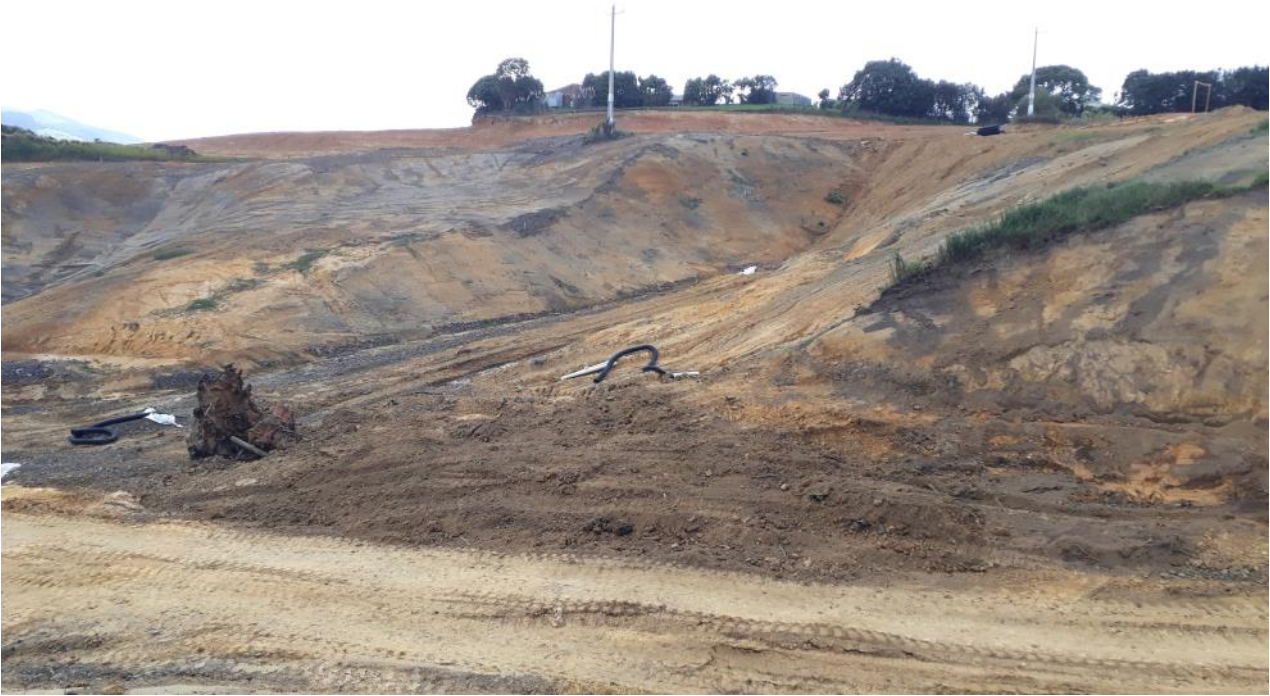
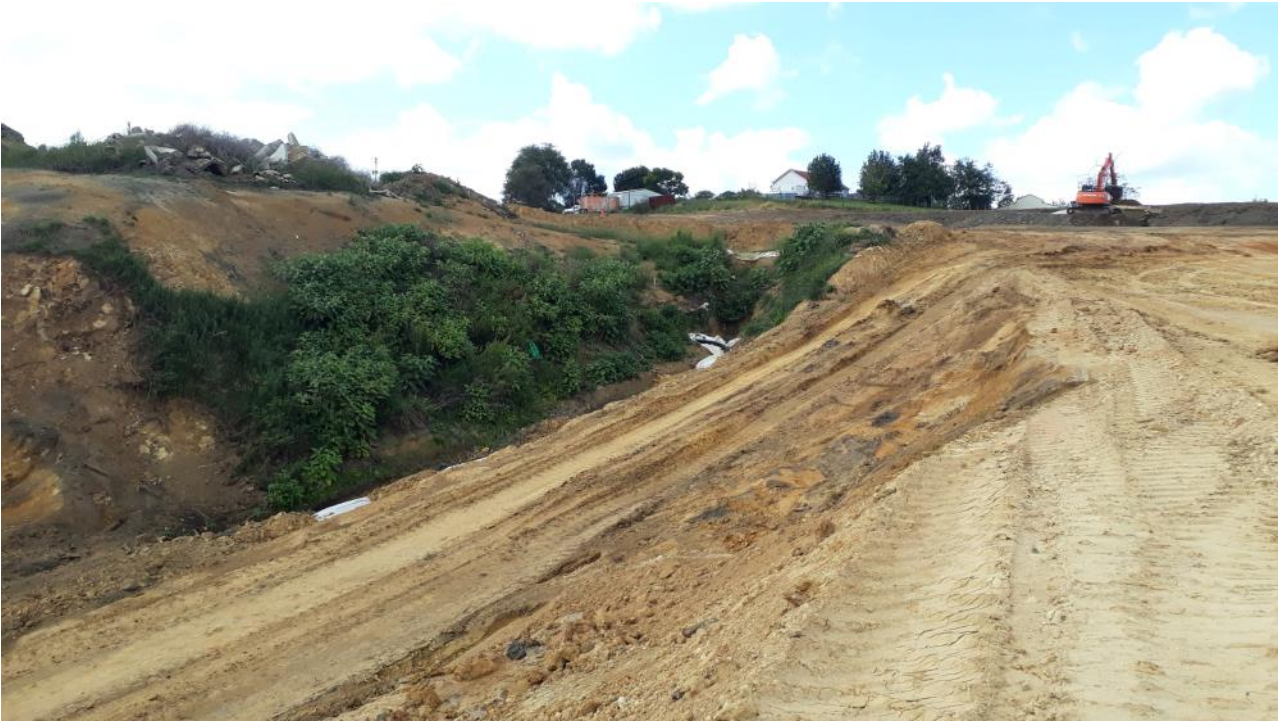
Visited site at request of Trevor to inspect gully muckout above permanent pond. Looks to be going well. Still some material to come out on the north-eastern branch of the gully before putting their drain coil through.

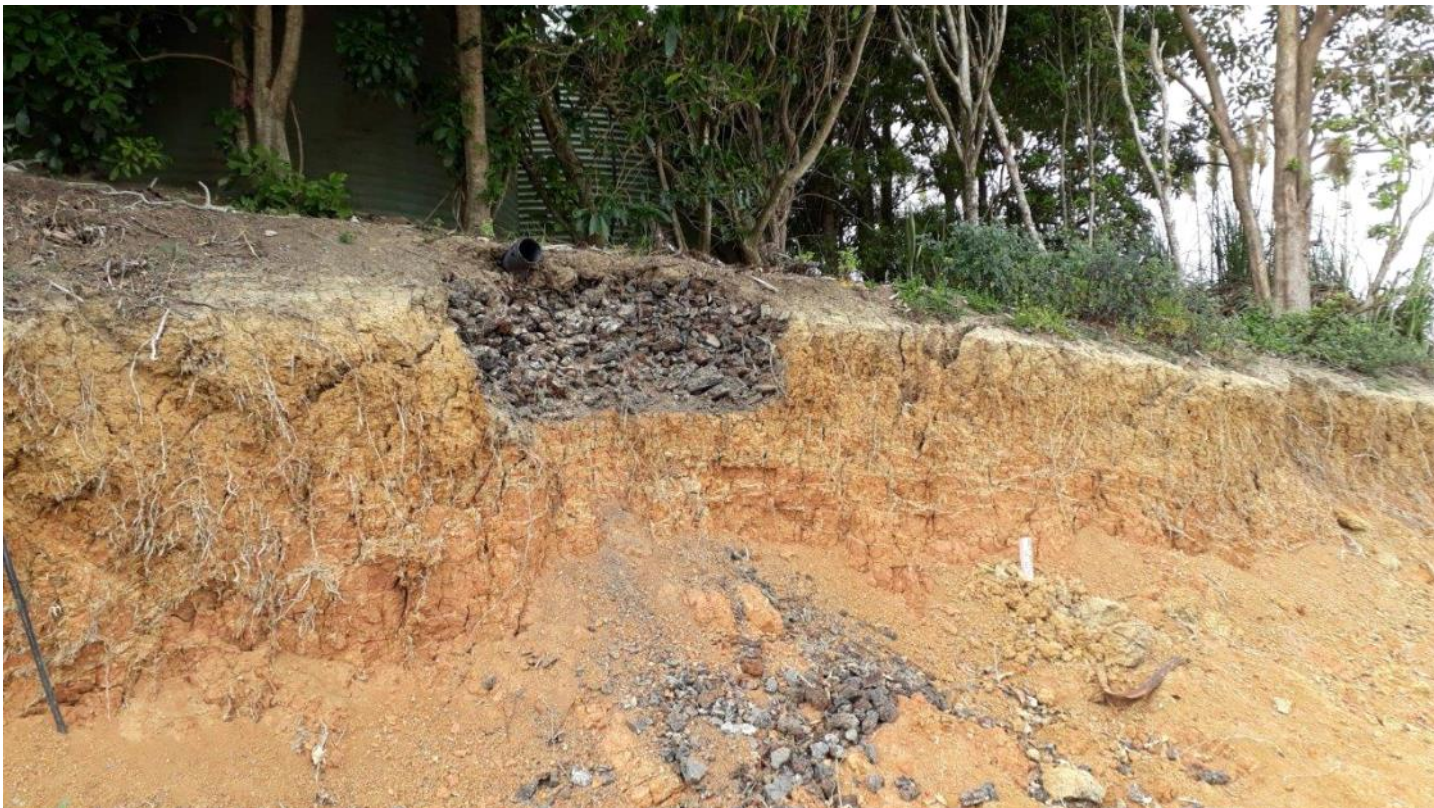
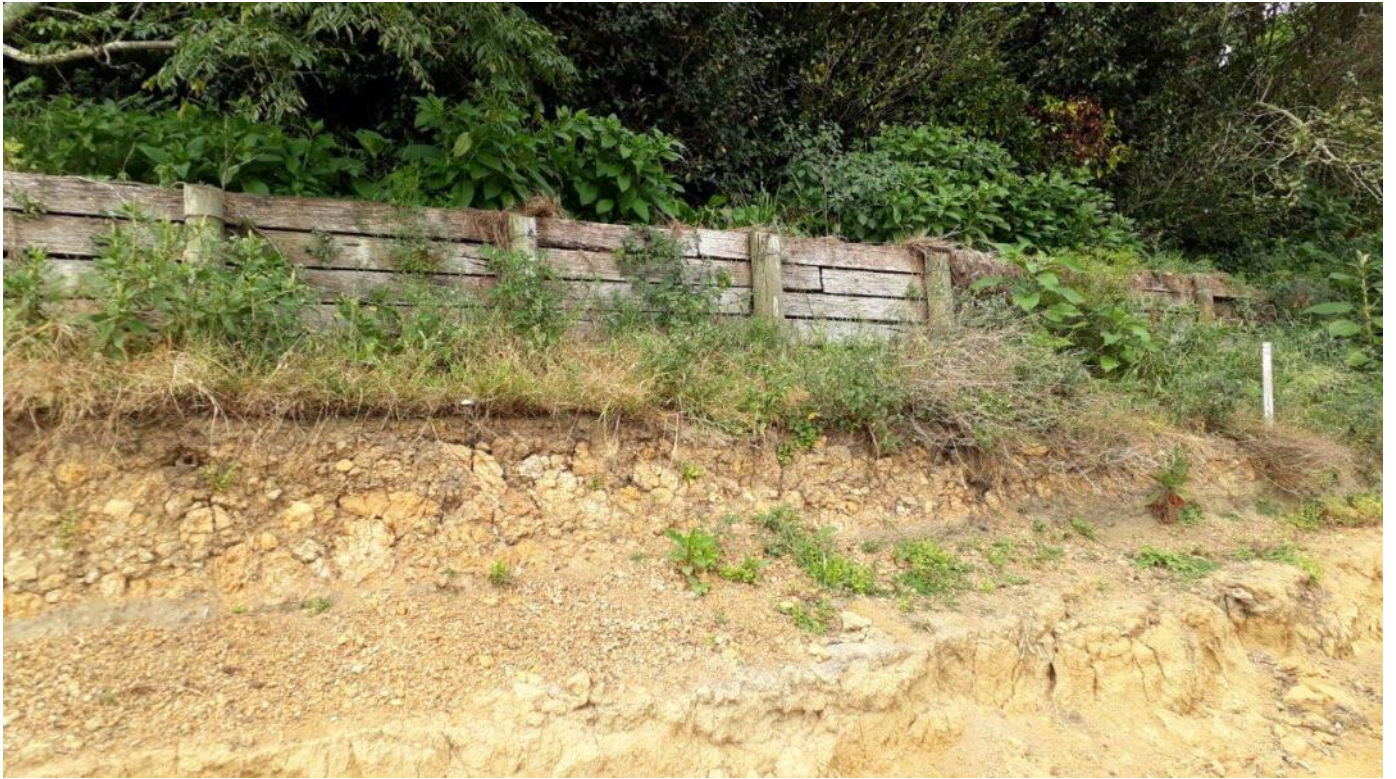
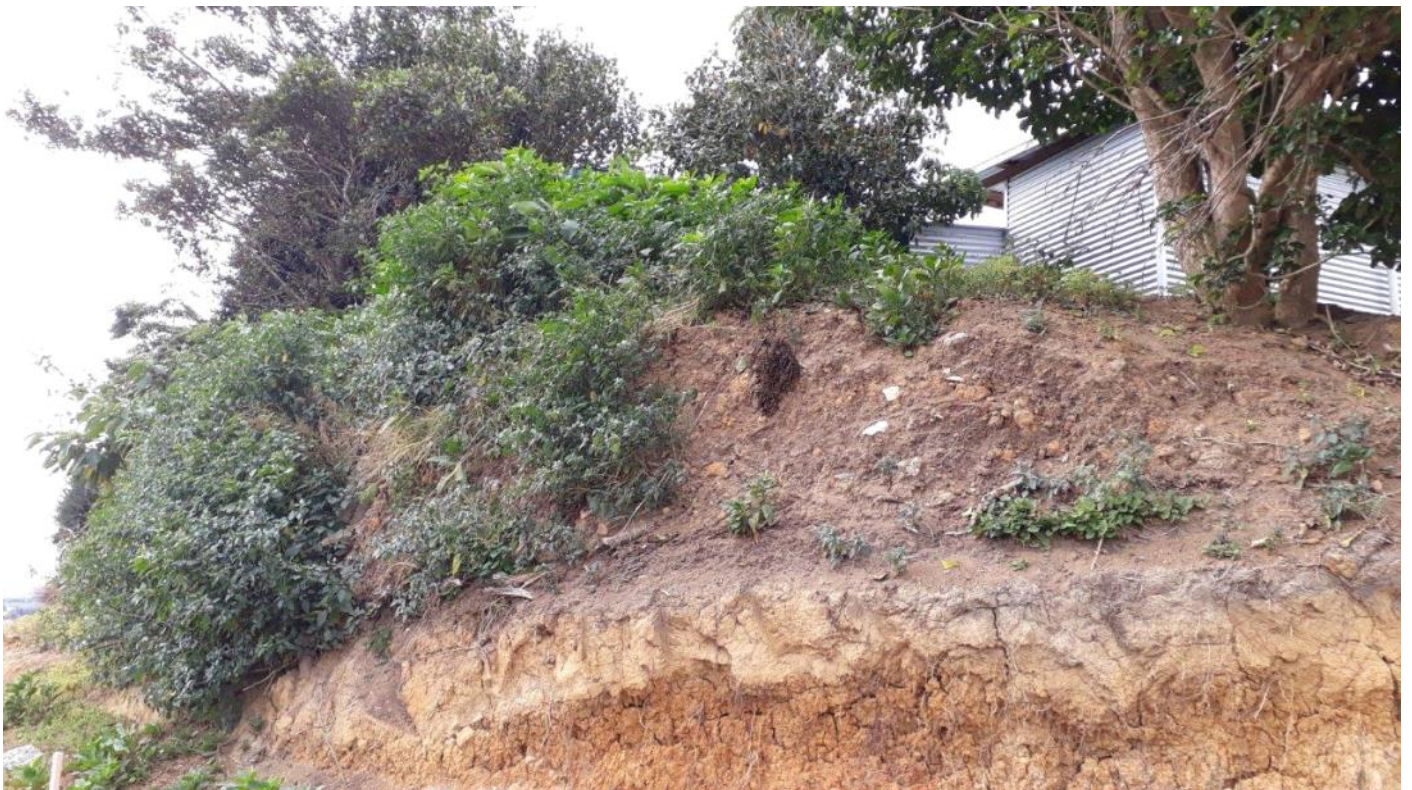
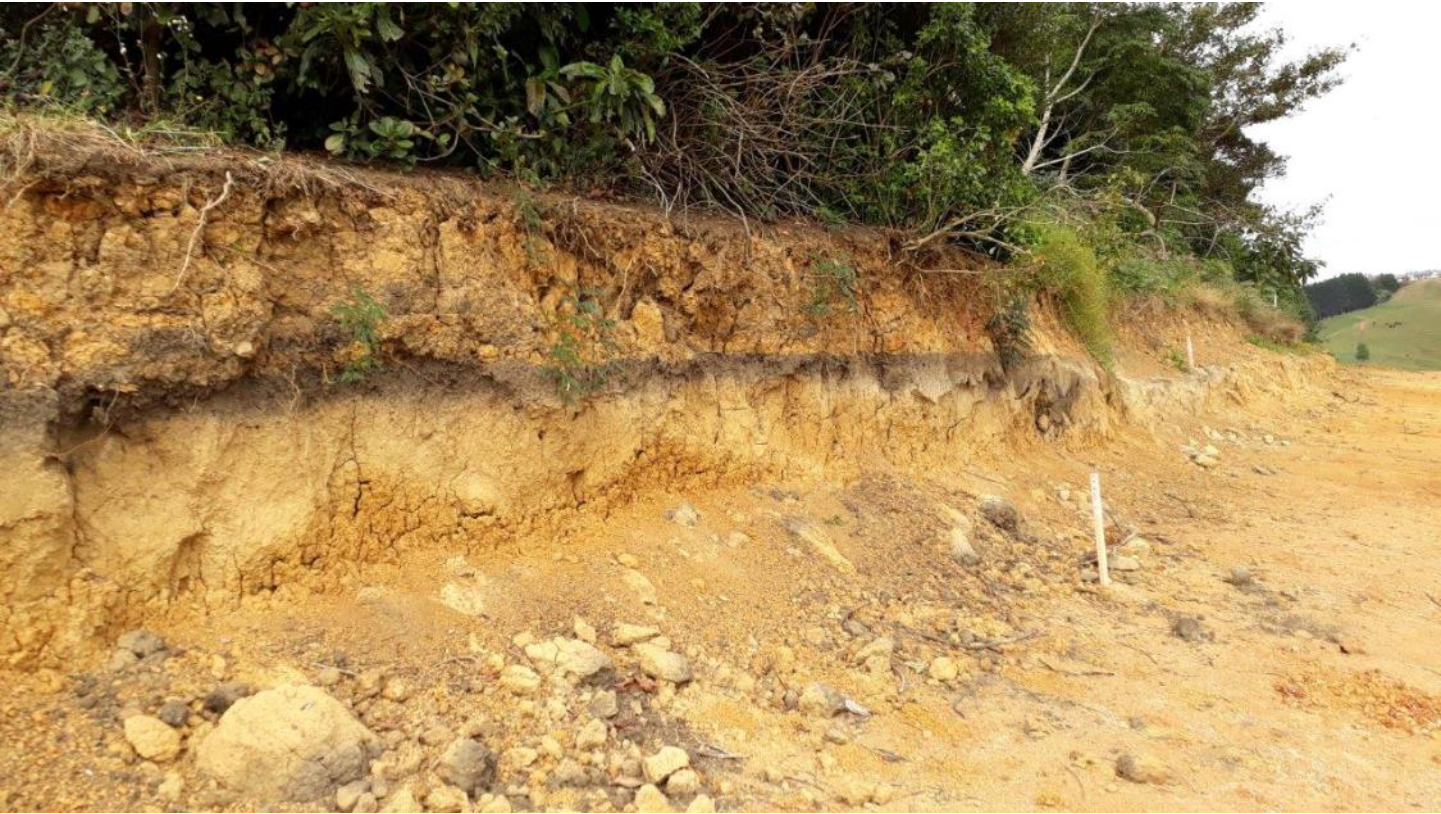
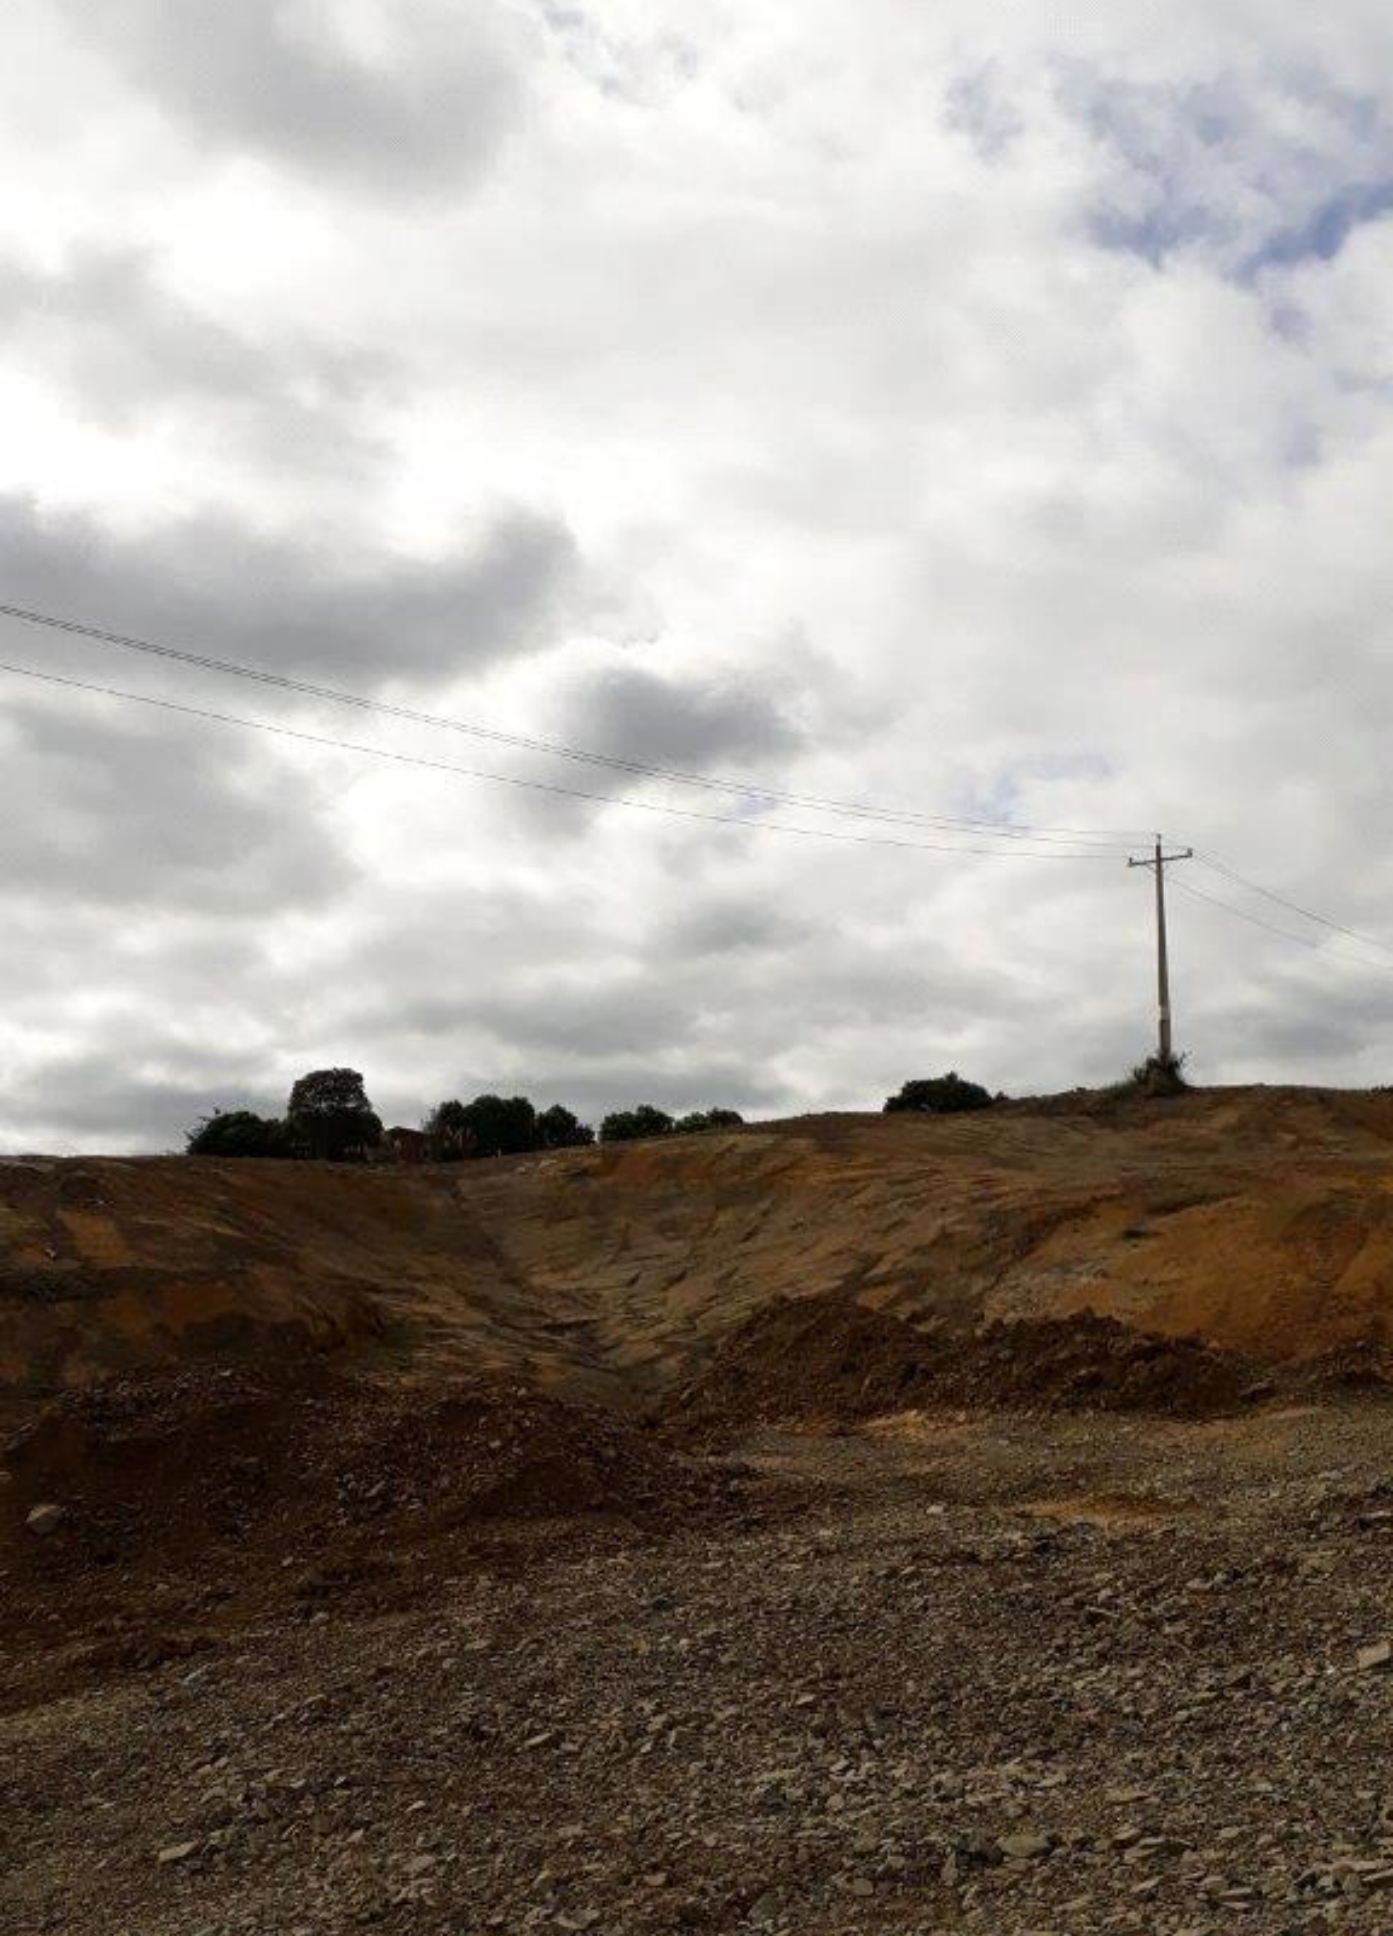
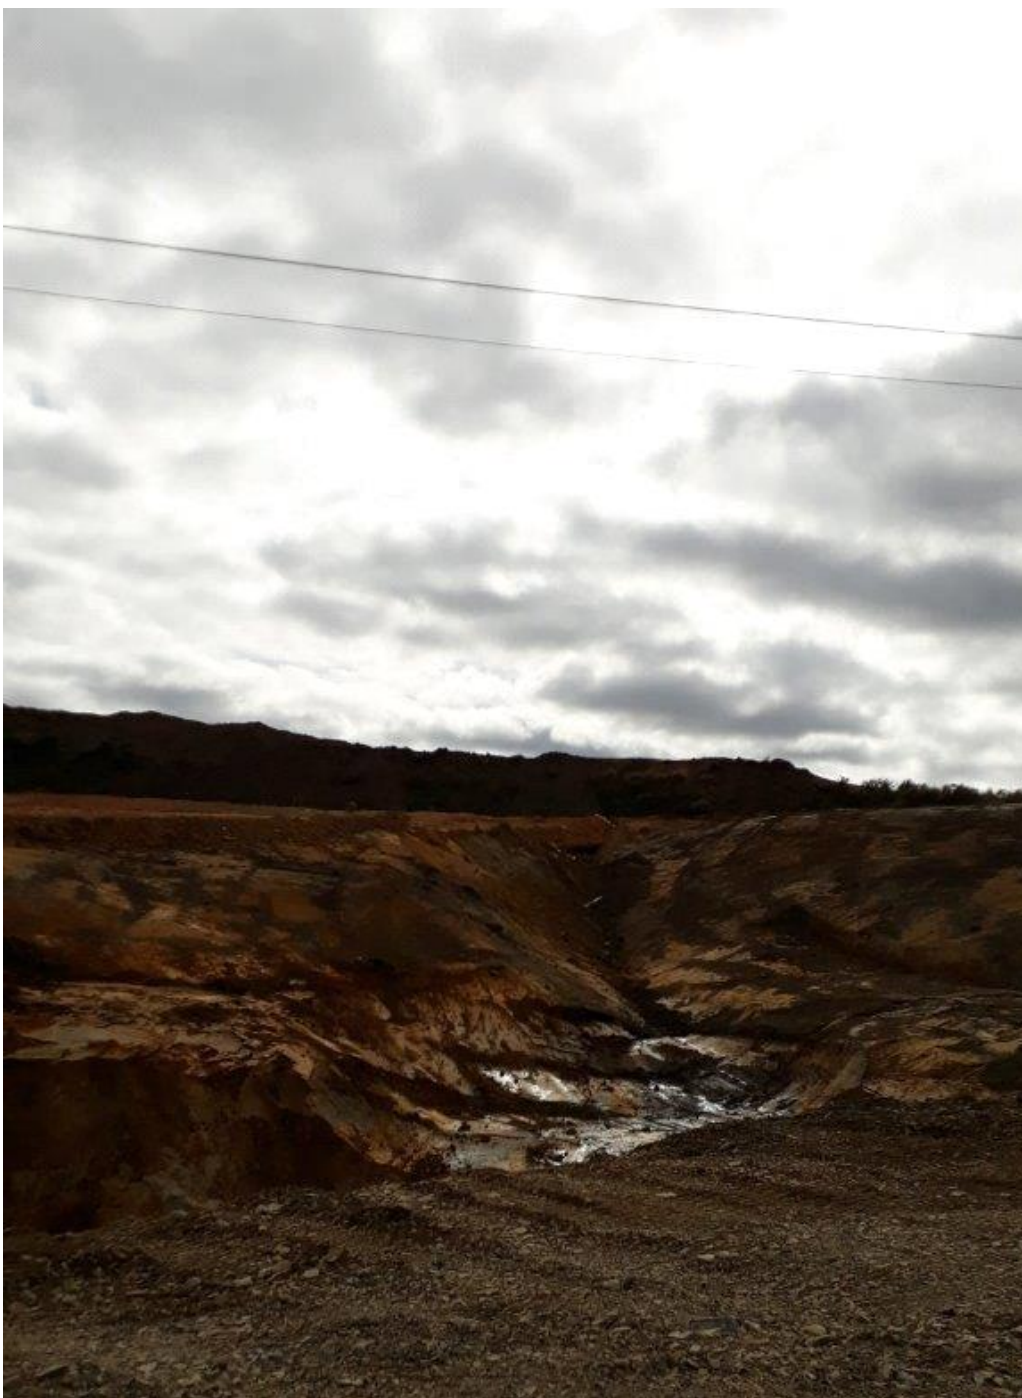
At CH58, there is an underfill drain trench outletting at the proposed wall cut face.

Elsewhere, they have two gully underfills to place upslope of the permanent pond in the northern portions of Stage 3

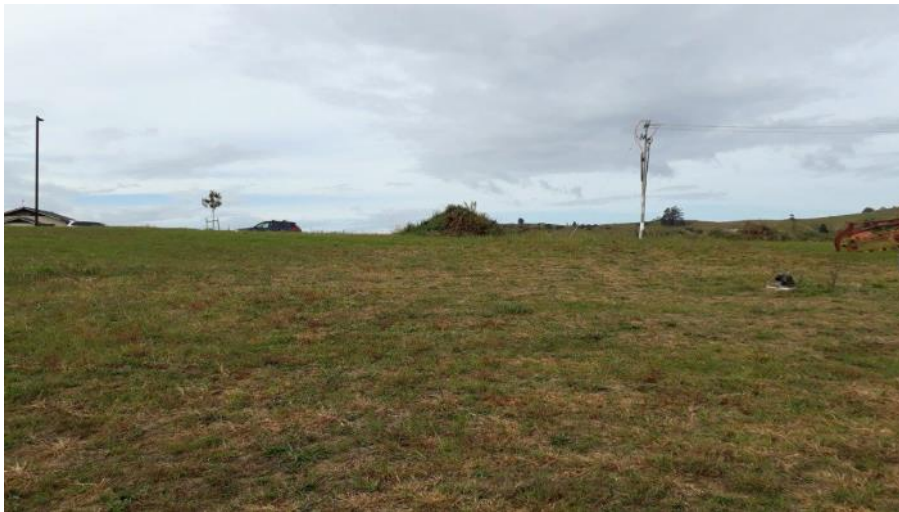
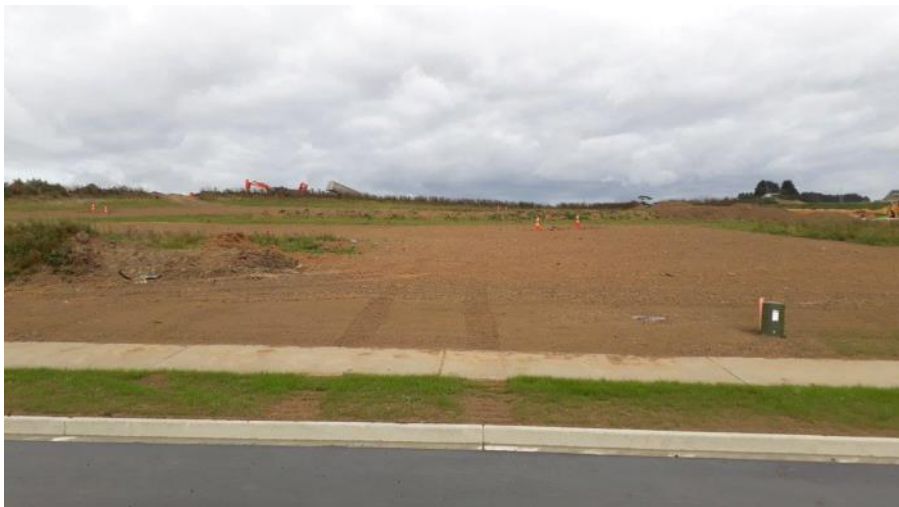
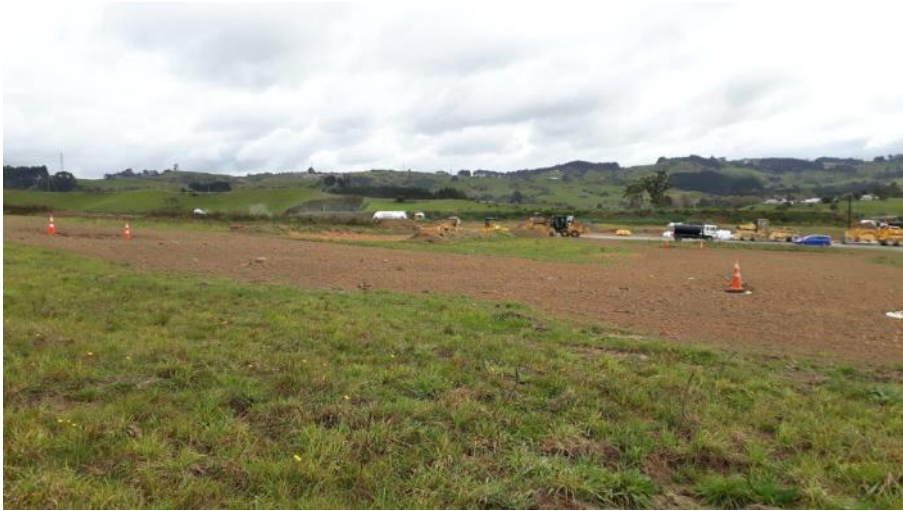
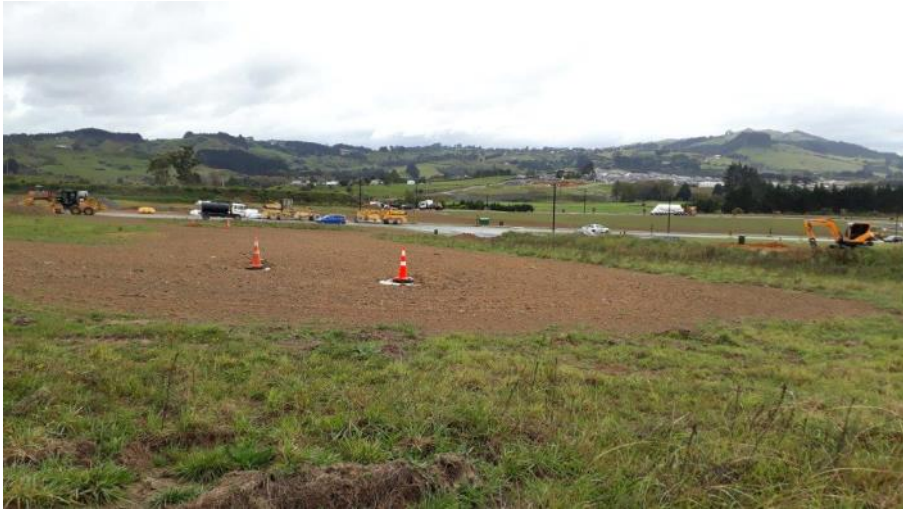
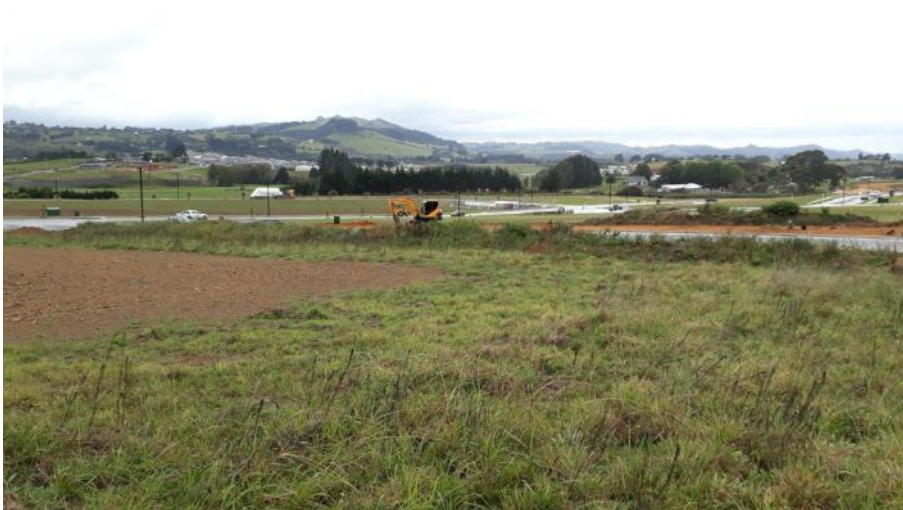
Lots 277 had 250mm of topsoil following re-spread.

Lots 296 and 297 were still bare of topsoil.

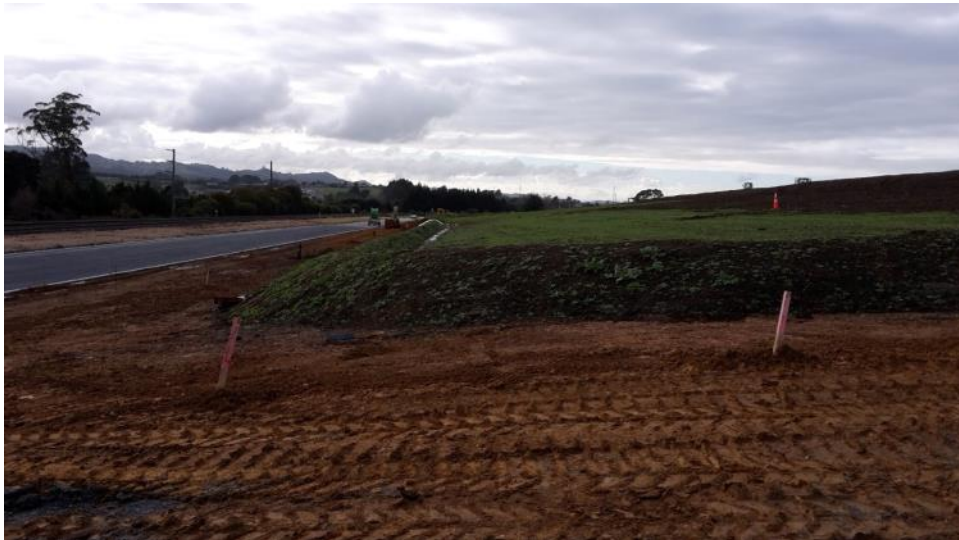
18/09/18

Visited site at request of Trevor to inspect a groundwater spring at the cut/fill line between Fill K and Cut 17, to the west of Road 22 cul-de-sac. Groundwater effects appeared to be localised to the area and no surface weaving was observed that could indicate excess porewater pressures beneath the fill here.

See CAN09 recommendations for this groundwater spring.
