Geotechnical Completion Report

HITCHEN BLOCK STAGES 6E AND 10A TO 10D

DFH JOINT VENTURE LIMITED

16 December 2020

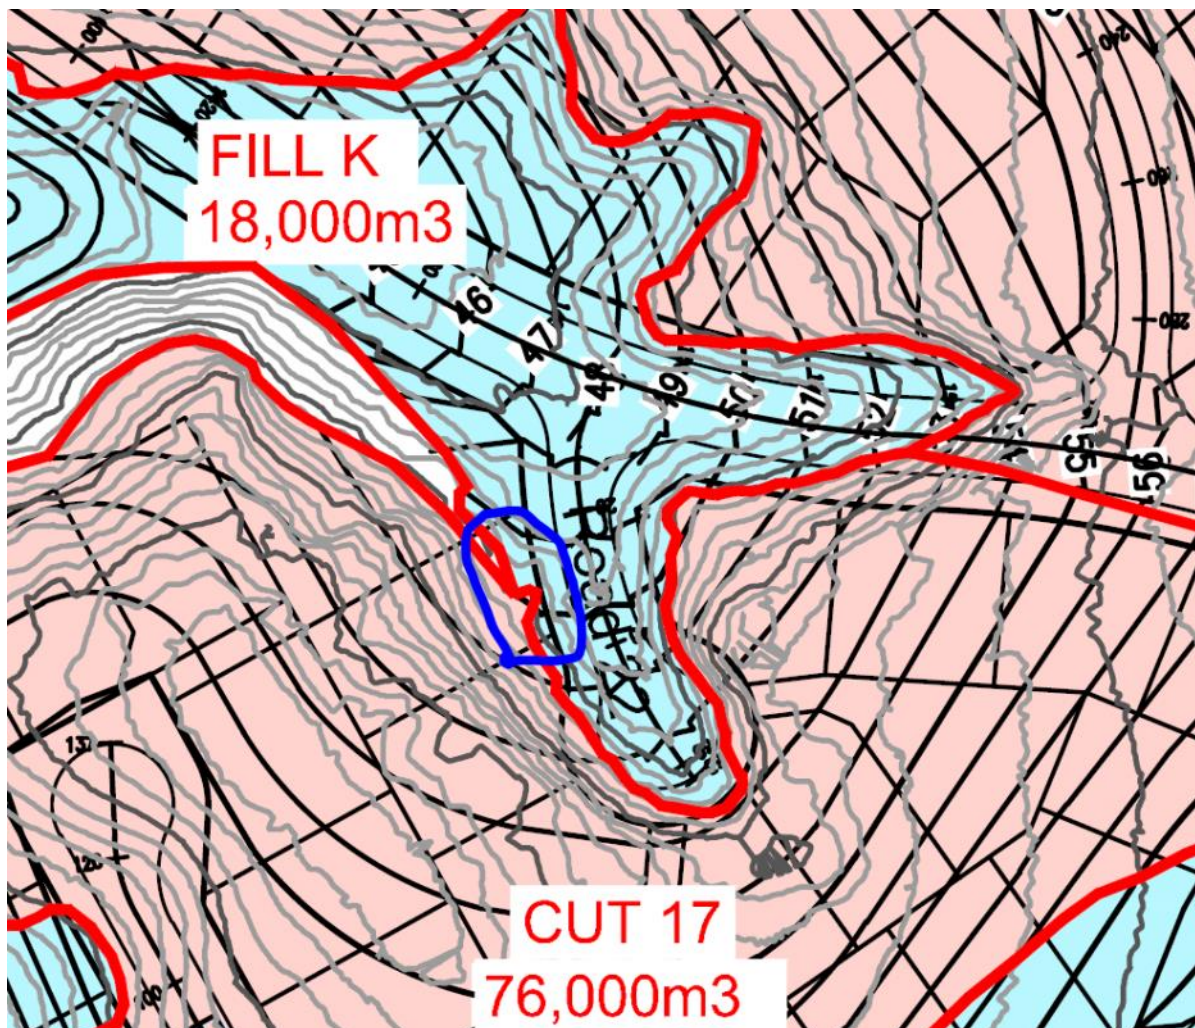
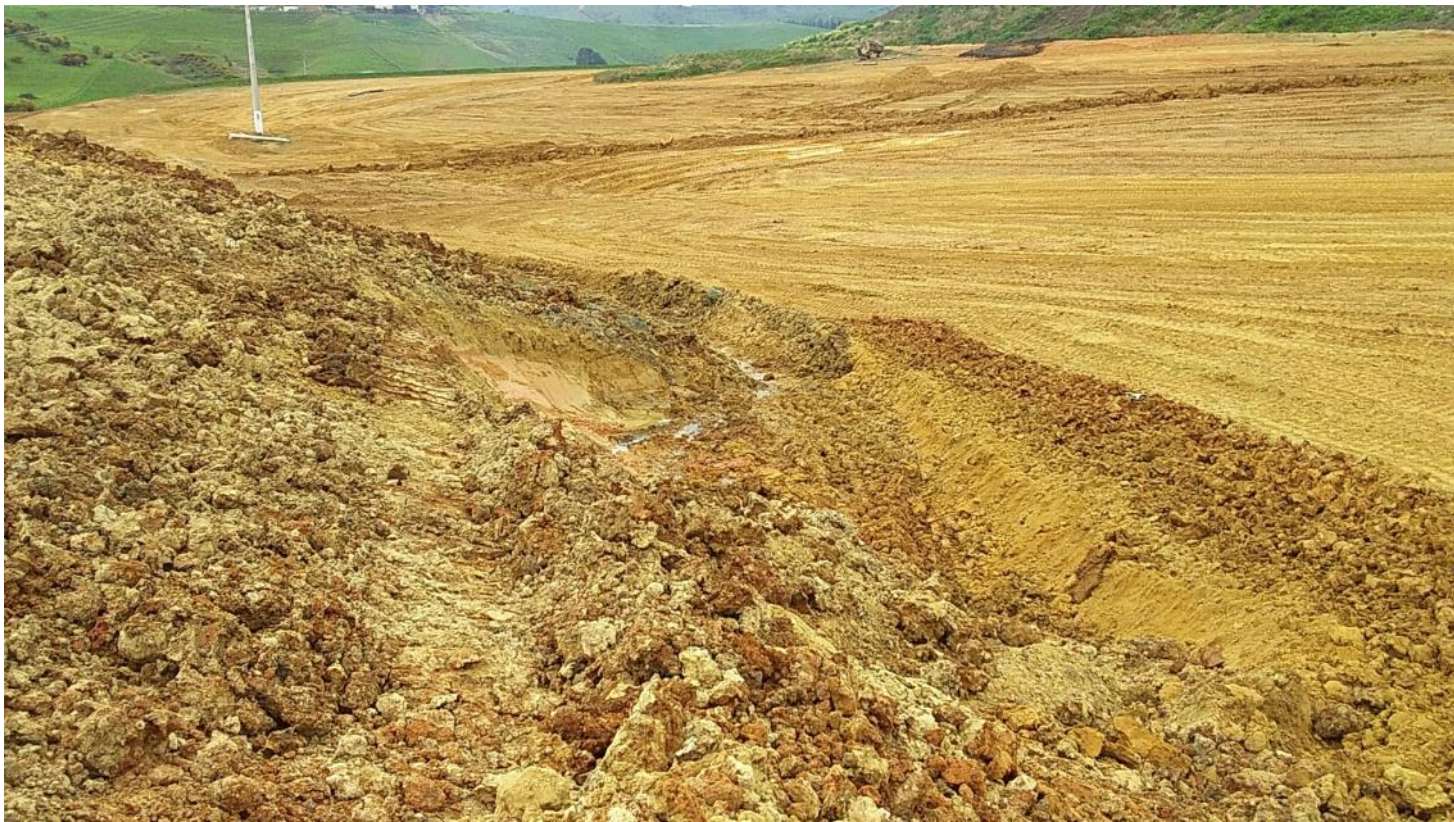
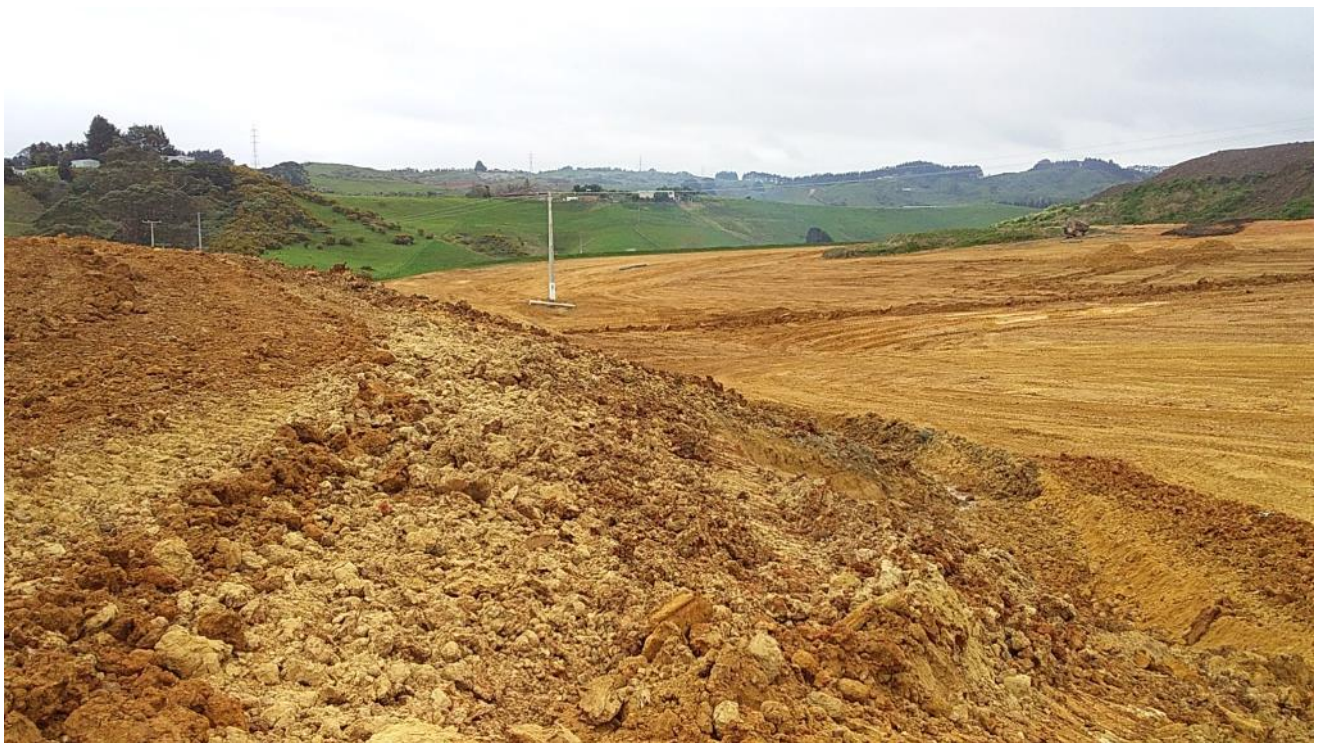
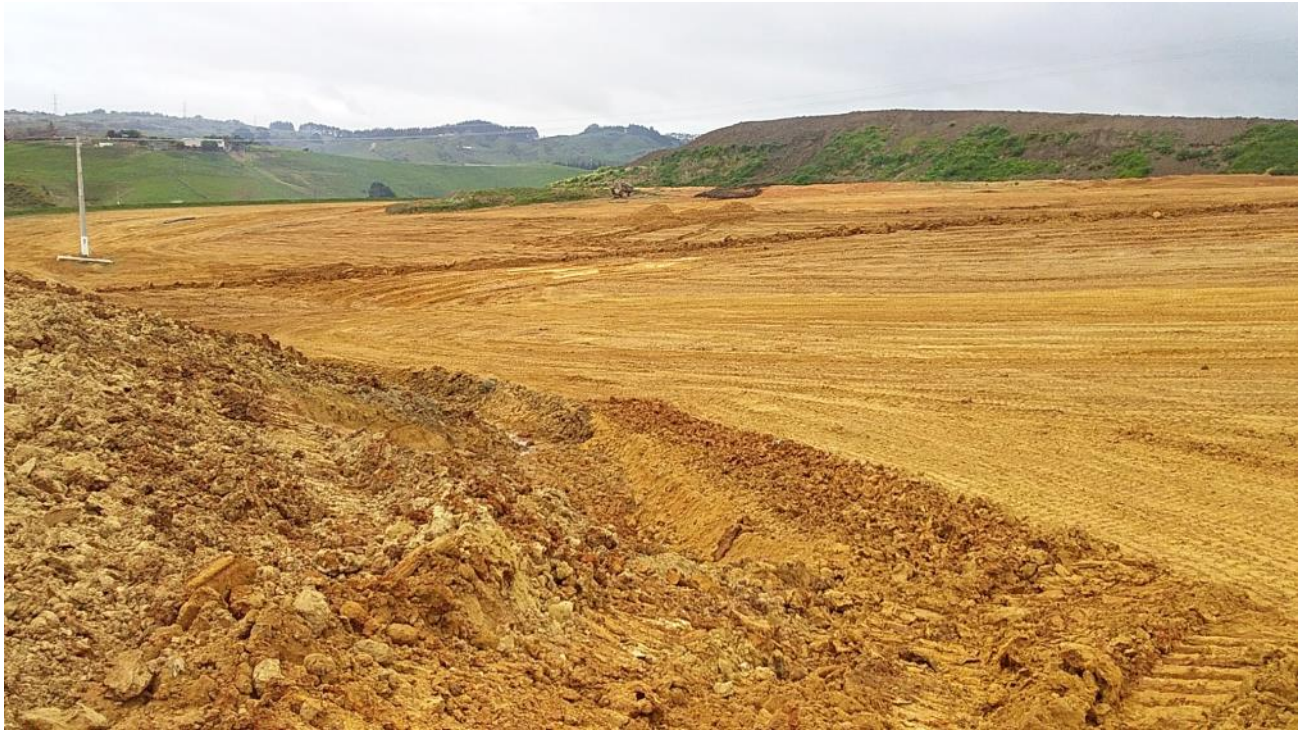
Site Inspection Record

Visited site to carry out trial pits with Trevor over lots 335-337 where the GCR borehole for lot 336 found firm and wet clay fill at depths of up to 1.8m.

Lot 337 found natural ground at 1.4m. Groundwater was seeping out at 1m depth, less than 140kPa shear strengths around that depth. Likely due to the upper layer of fill being placed while wet. Fill underneath was hard.

Lot 336 found natural ground at 2.0m. Groundwater seepages were noted between the fill and natural interface, less than 140kPa shear strengths from approx. 1.5 - 2.0m depth bgl.

Lot 335 found natural ground at 2.1m. Top half metre of fill appeared wet of optimum and was failing in shear strength. Fill beneath this up to 2.1m appeared very stiff to hard.

Natural ground was consistently yellow/brown silt that was impenetrable with shear vane tests.

Advised contractor to remove fill down to natural ground in lots 337 and 336 and get in touch with us to inspect. Difficult to determine whether all the fill needs to be removed in lot 335 as only the top 0.5m was below 140kPa (non-engineered). Will be subject to inspections once undercutting commences.

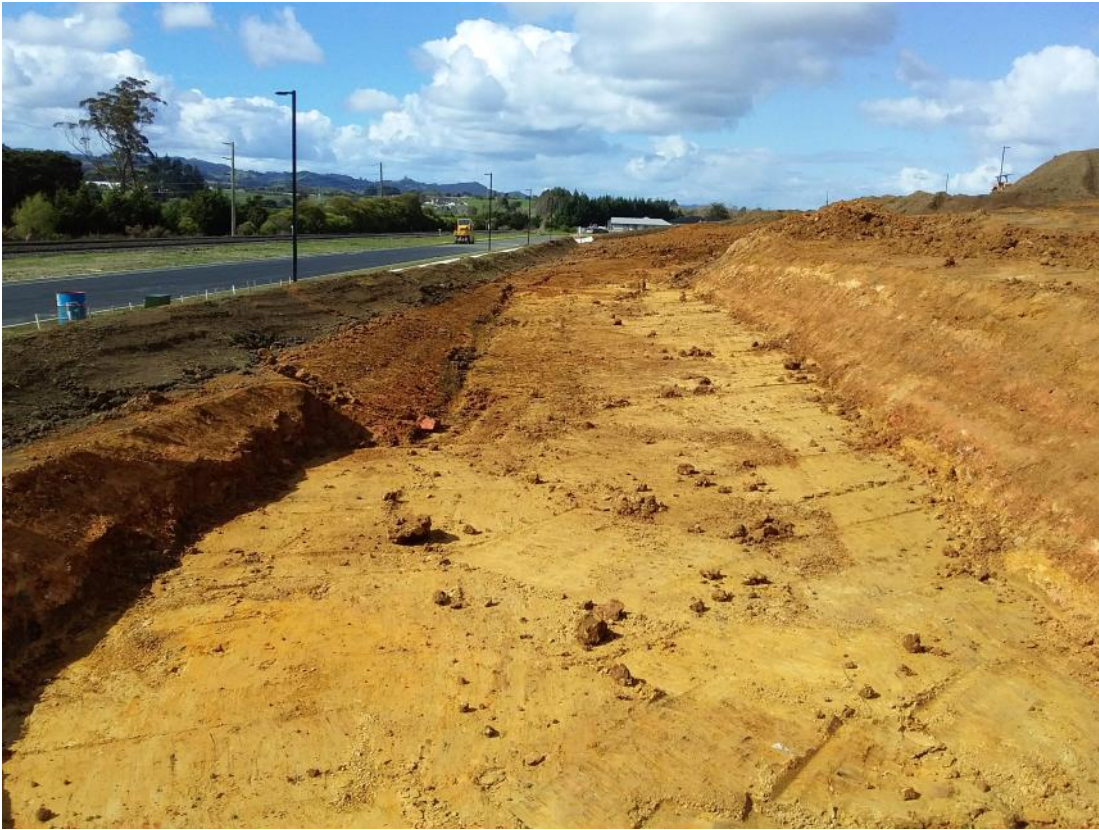
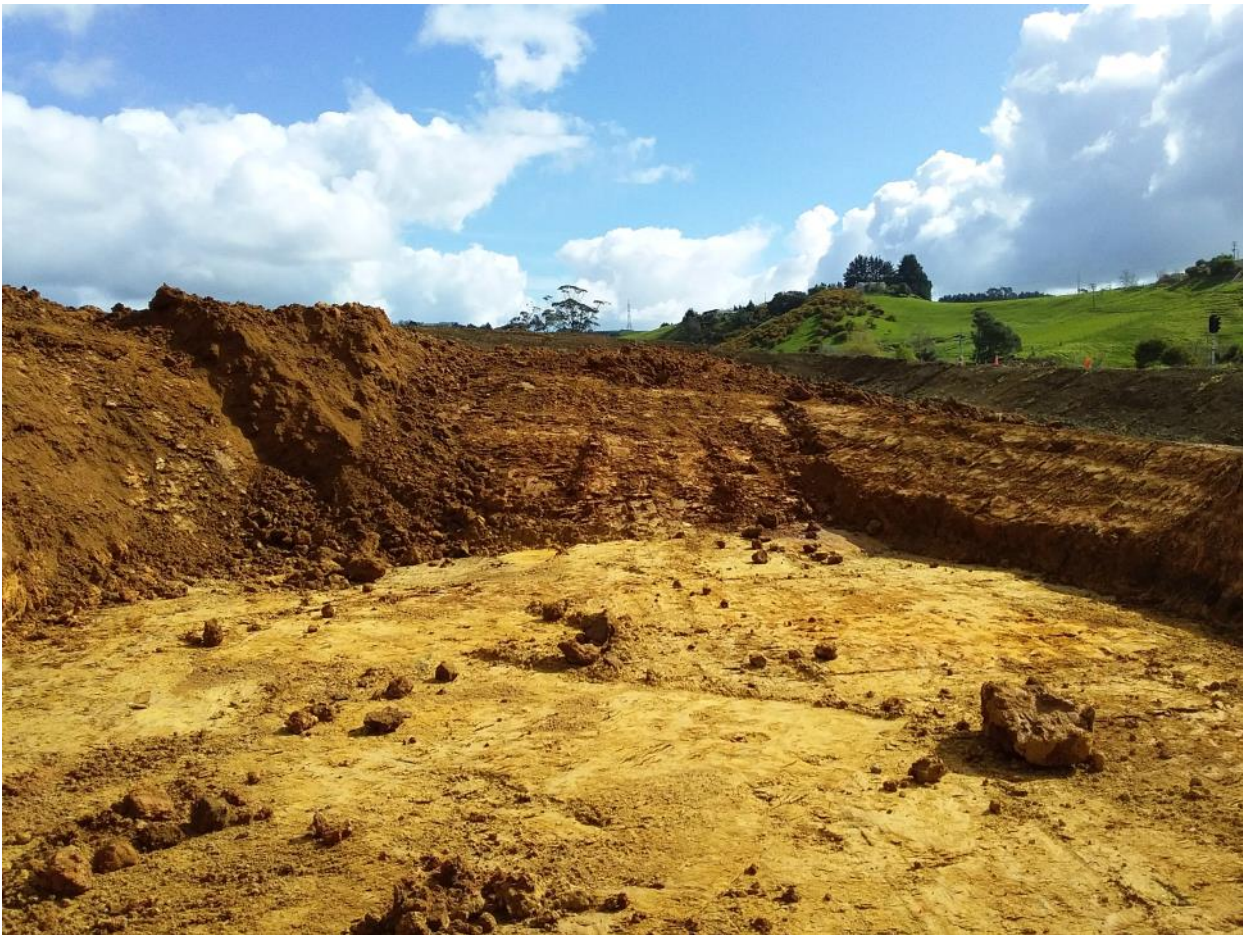
27/09/18

Lot 335 had not been undercut yet. Advised Trevor to undercut towards the trial pit in Lot 335. Only the top 0.5m required undercutting apparent from the trial pit, and the contractor was also advised to chase the seam of wet fill til it runs out. Trevor will take photographs and Lander to confirm the undercut is to its satisfaction.
