DFH Joint Venture Limited

GEOTECHNICAL COMPLETION REPORT

Hitchen Block Stage 18, Pokeno

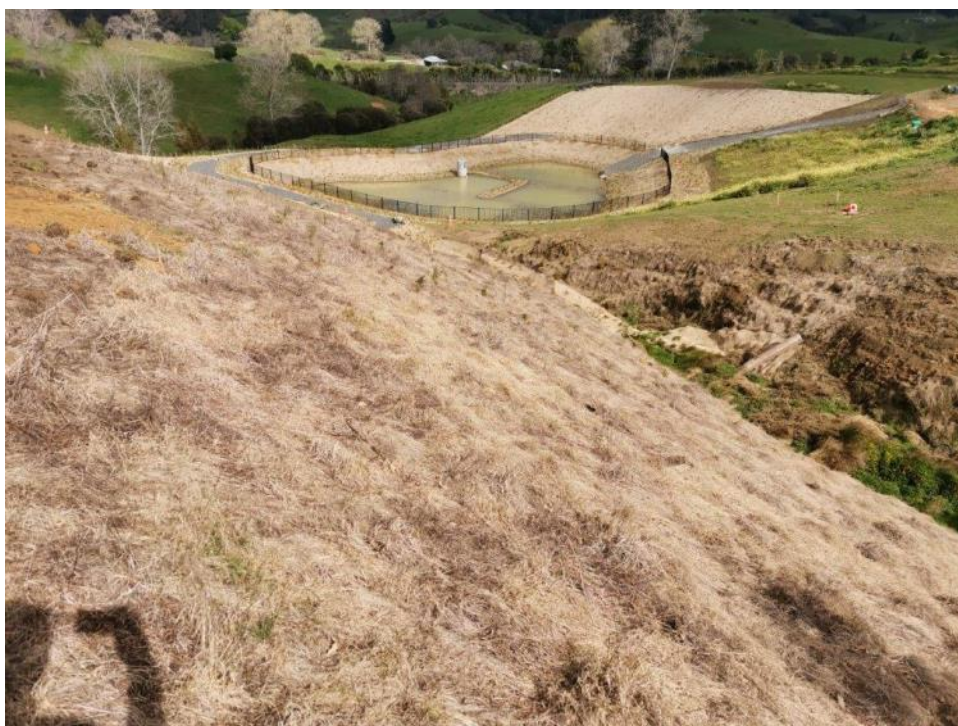
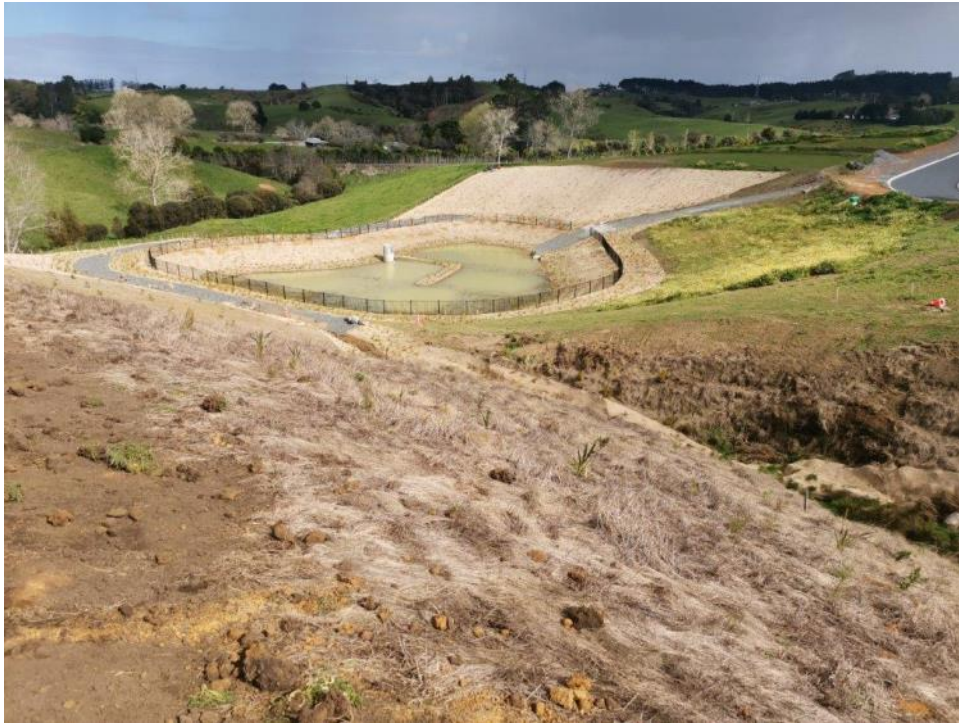
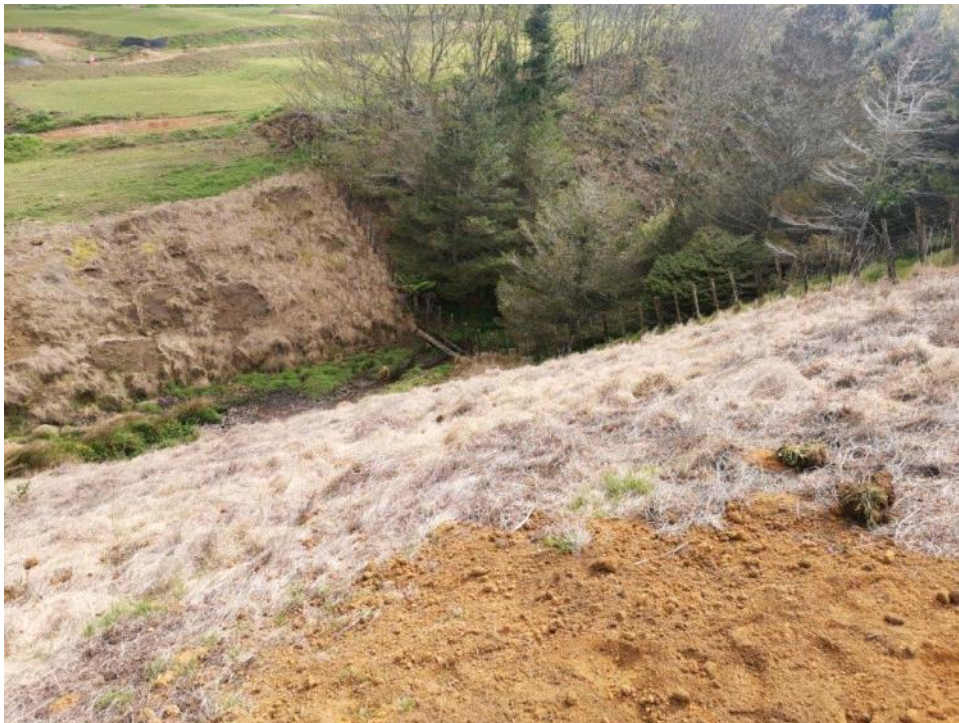
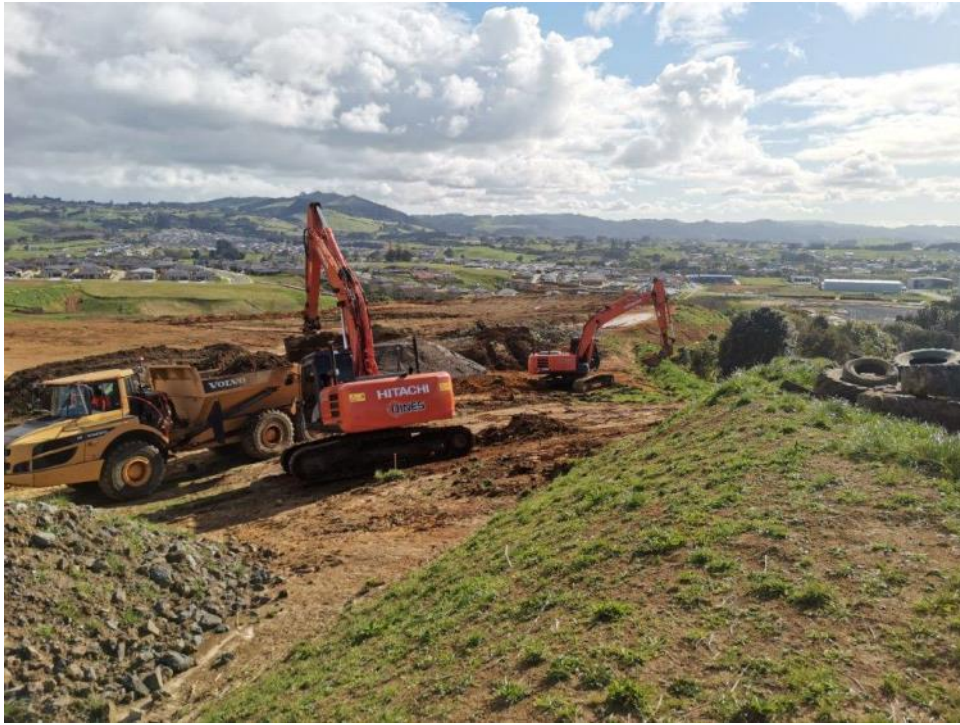
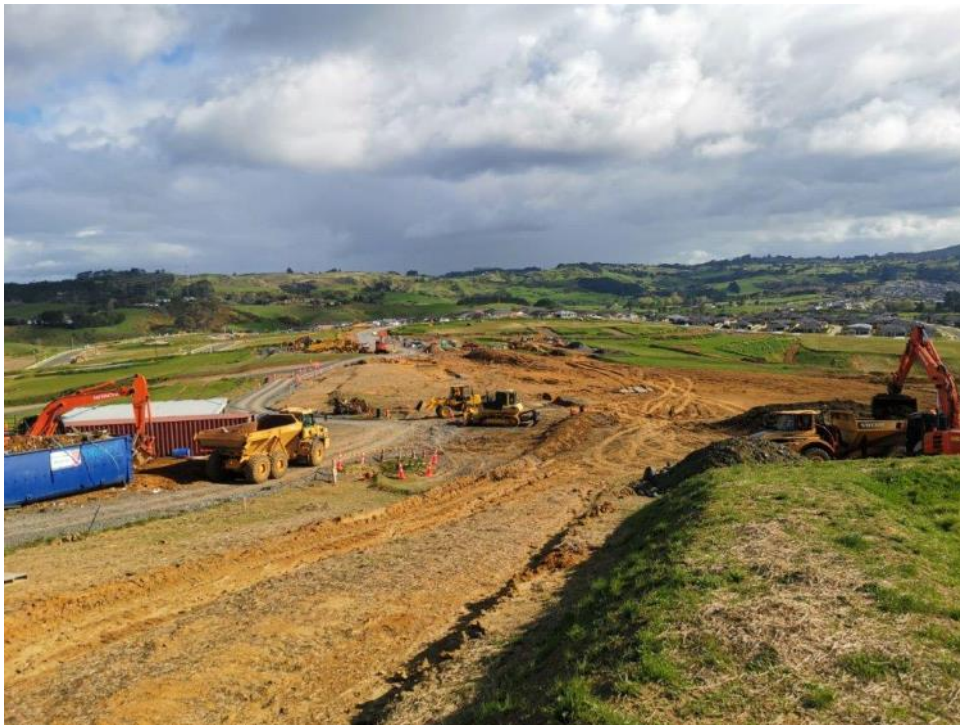
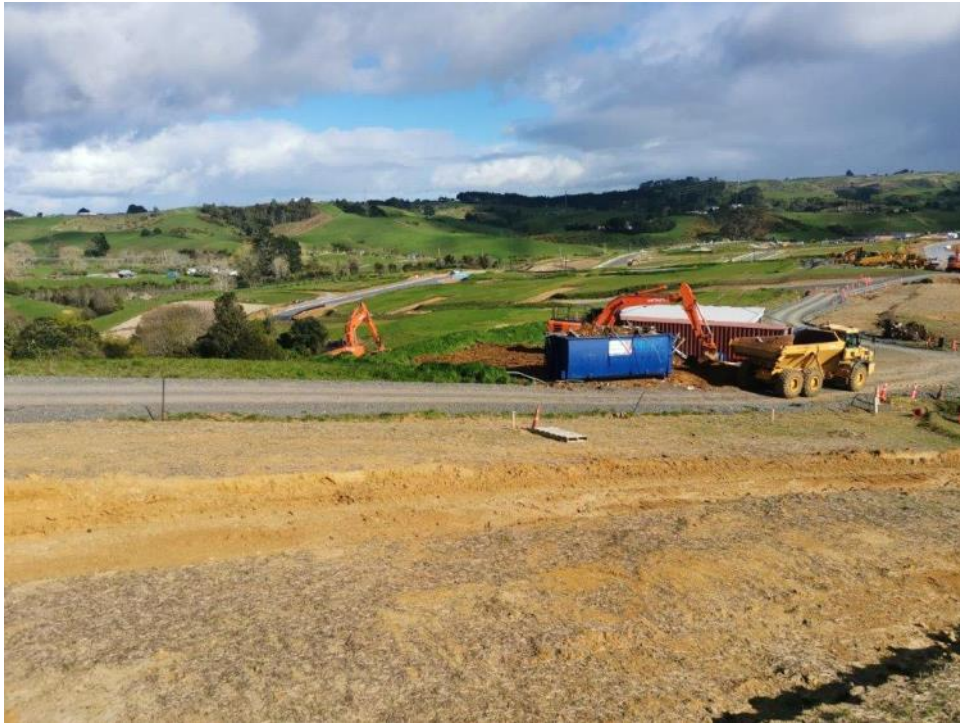
- Visited site to discuss Stage 6 earthworks with Trevor and Simon (new foreman for Dines). Items discussed were:
 - o Nominal toe keys required at toe of proposed fills. 1m depth minimum into very stiff soils.
 - o Nominal underfill drains will be required, must keep 2m of fill cover wherever possible. Some drains will likely need to be trenched in 0.5m. Drains will outlet over the top of the toe keys into the gullies.
 - o Counterfort drains: 4x required below proposed retaining wall. Will discuss flush point with Chris. Dines may have to bench the slope to get the drains in as the slopes are very steep.
 - o Retaining walls will be constructed by Dines as part of the civil works. Drain outlets will be directed to the public reticulation network.

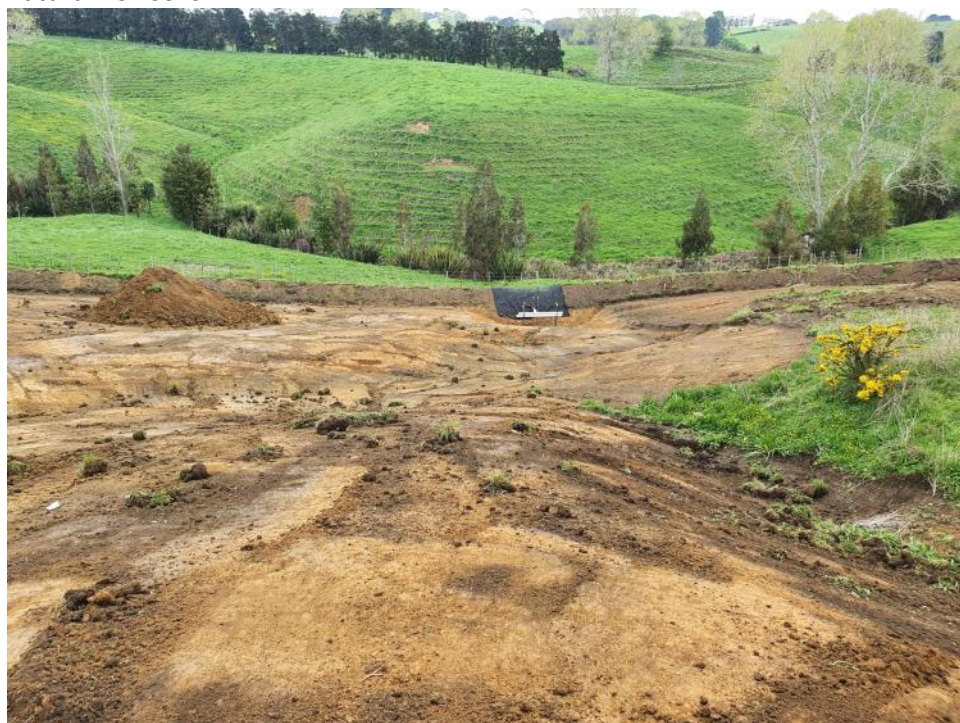
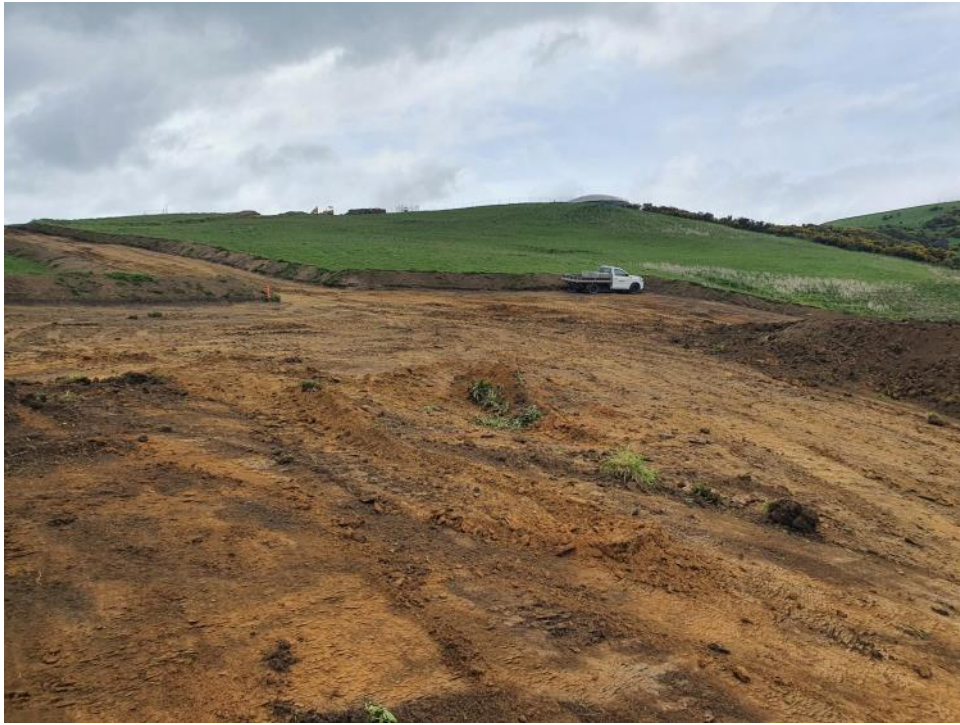
06/10/21 - Site Walkover

Attended site for a site walkover/ handover from KM to RG. Observed the beginning of works (forming of drainage) within Stage 6. The beginning site strip was occurring within stiff to very stiff natural Ash soils.

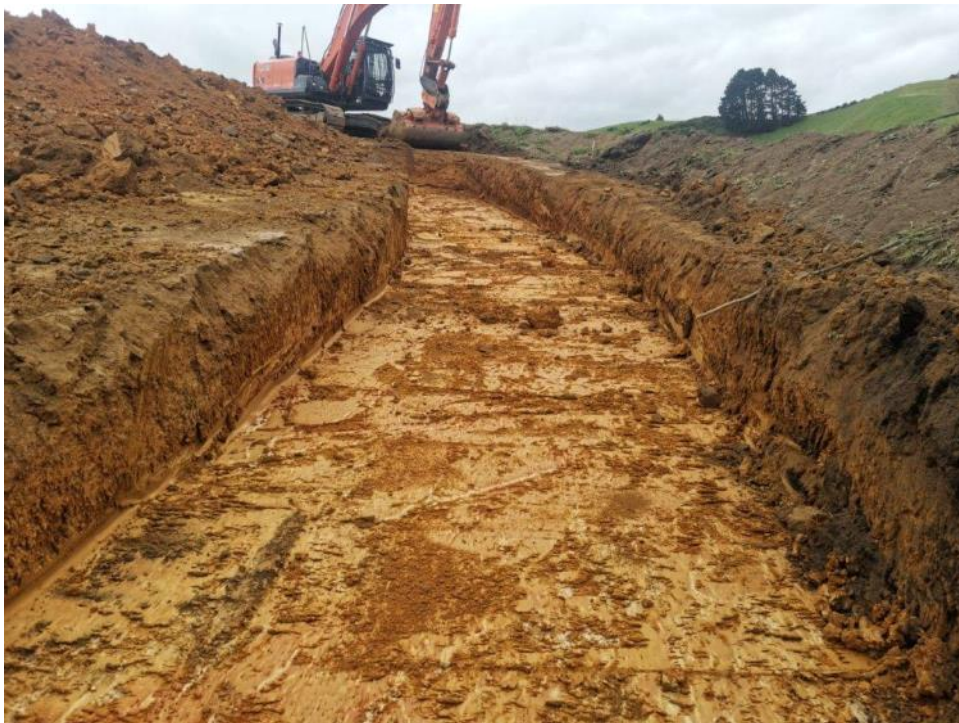
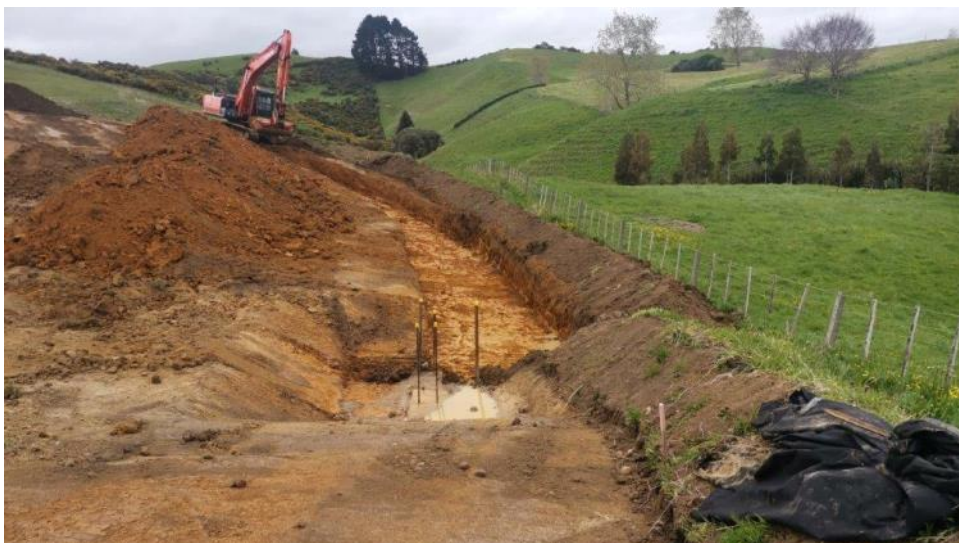
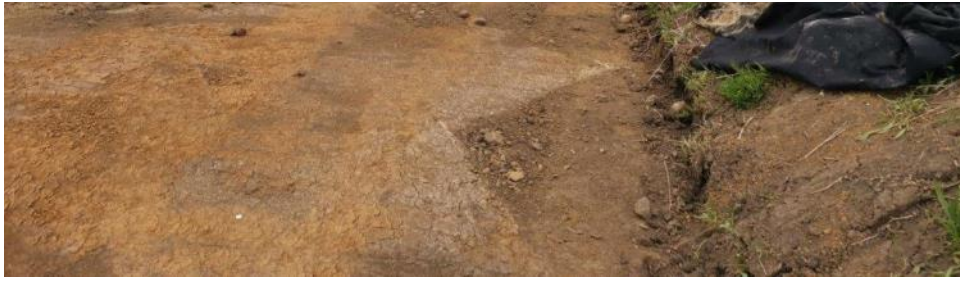
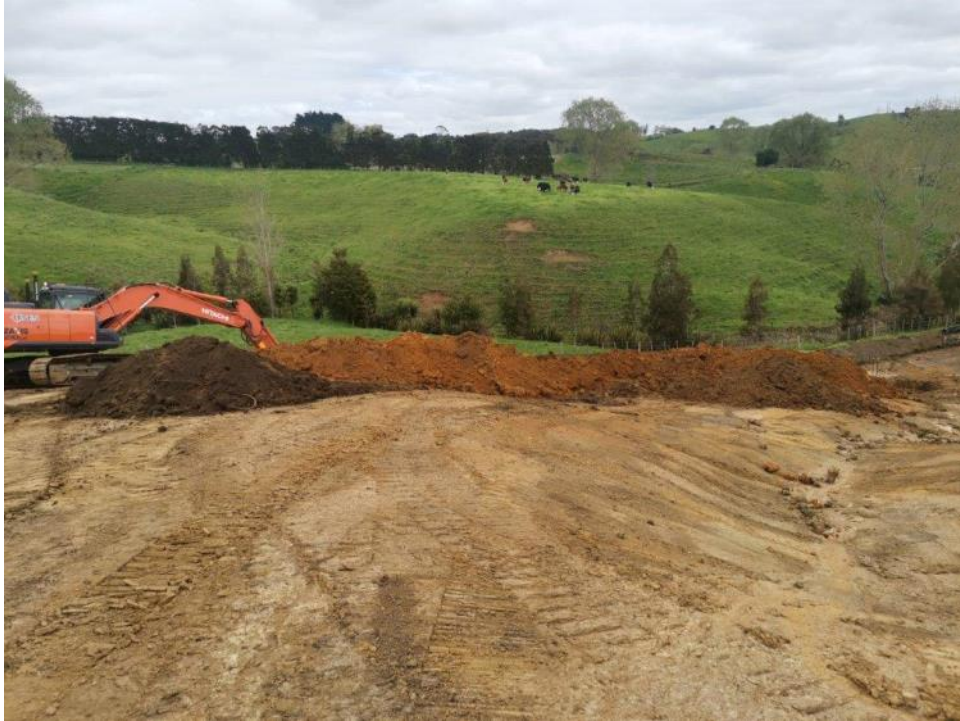
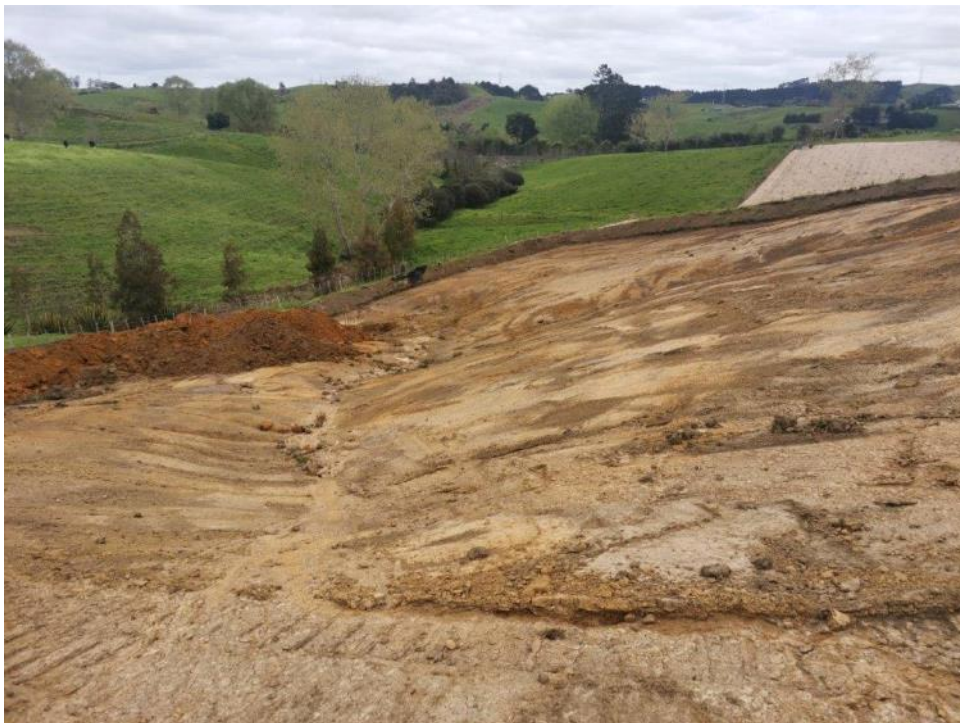
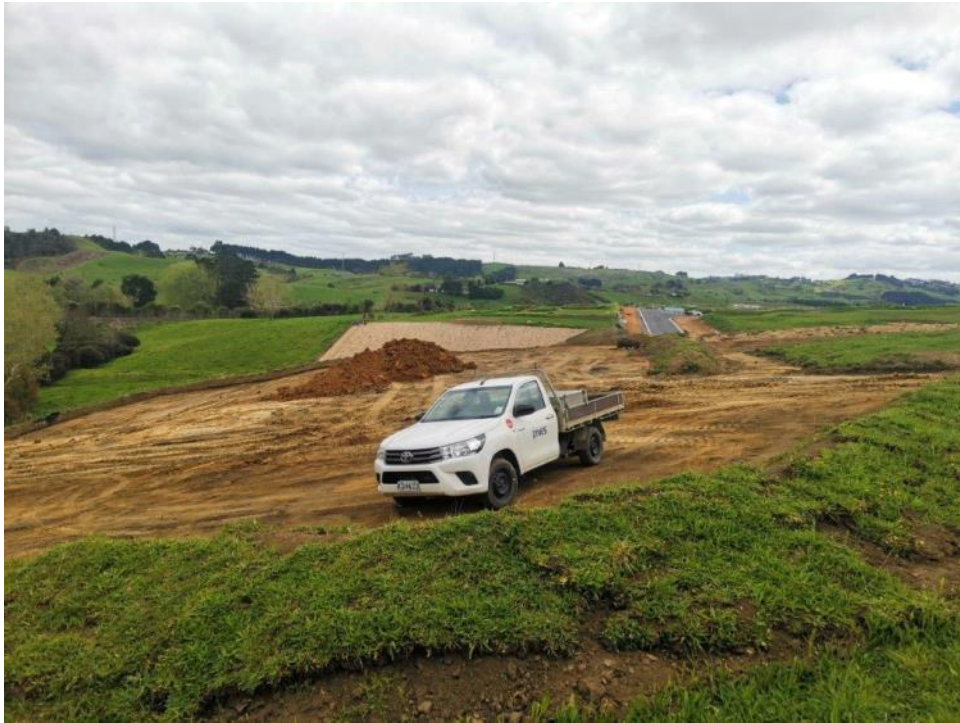
11/10/21

Observed excavation of toe key at least 1m below original ground level as per purple outline on the annotated plan below. Advised contractor to bench the sides and then fill compaction with clay can commence. Also advised that the underfill drains be installed as per our detail and should not extend beyond the lower retaining wall.

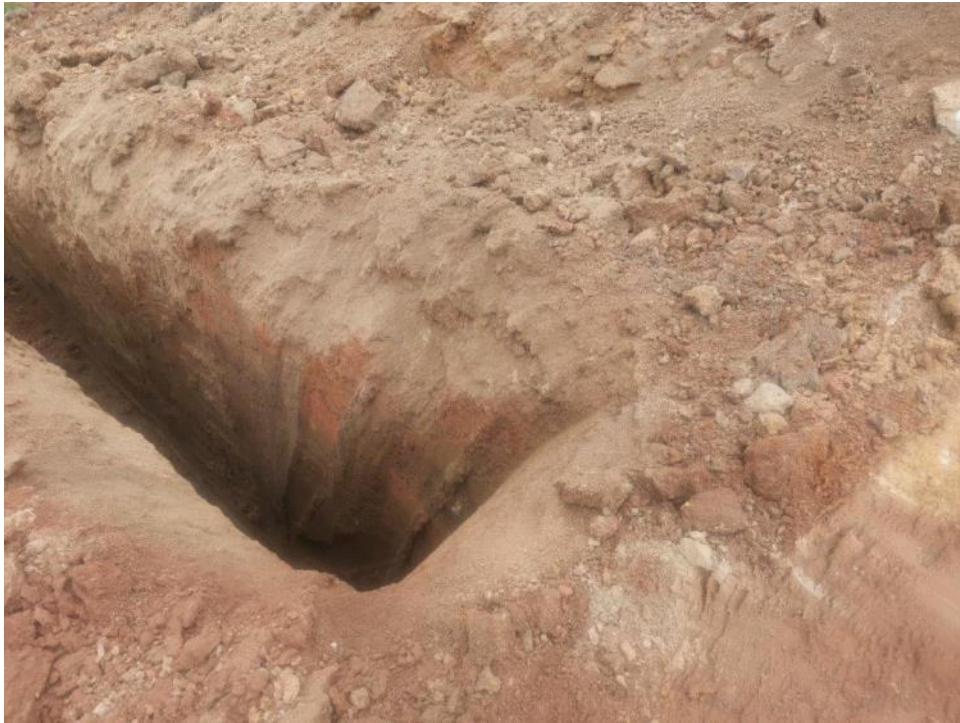
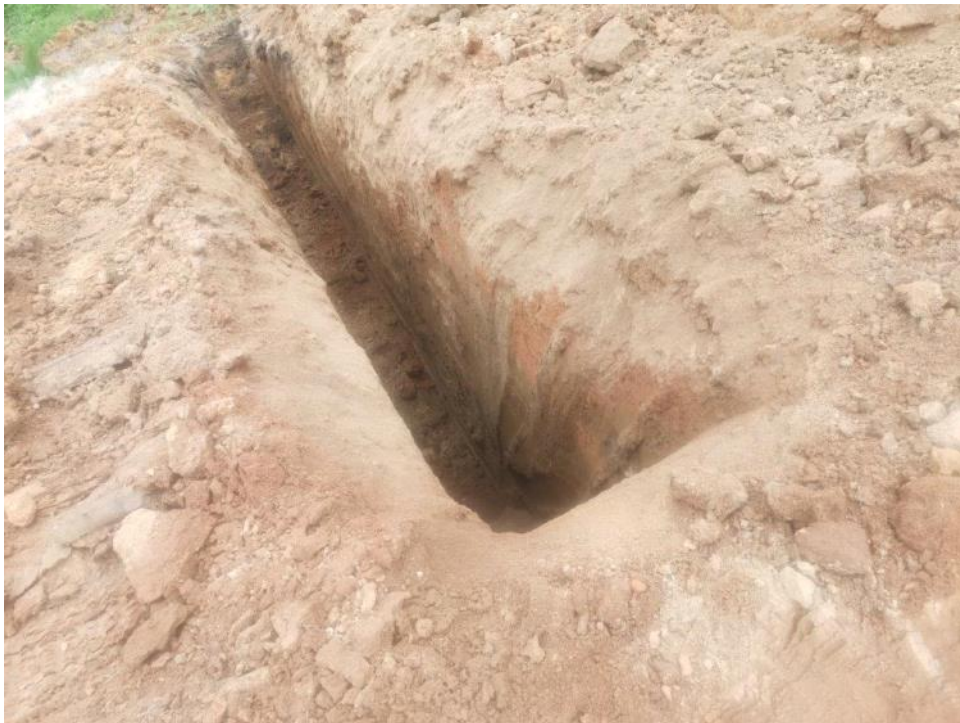
30/11/21

Counterfort drains in are mostly complete, the final drain is still being constructed - loose materials have been undercut, benched out and clay fill placed. Drain depth to digger reach.

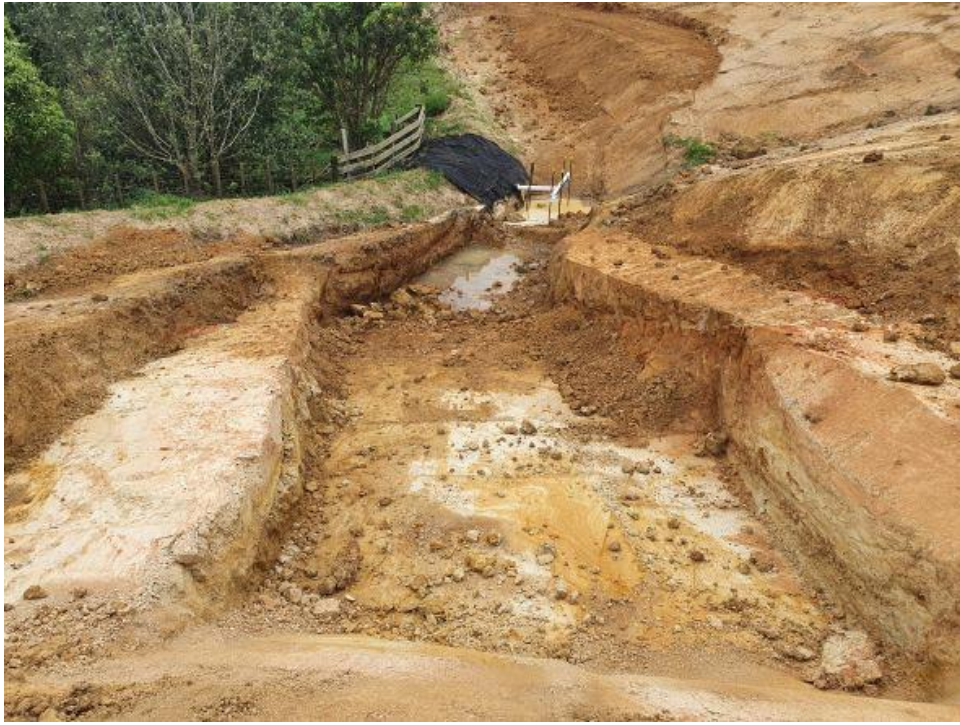
05/11/21

Observed excavation of toe key at least 1m below original ground level as per purple outline on the annotated plan below.

- Base of the toes key returned shear vanes of greater than 217kPa, with the vane blade unable to penetrate the soil in some instances.
- Discussed with contractor that they would bench the sides and then fill compaction with clay can commence.

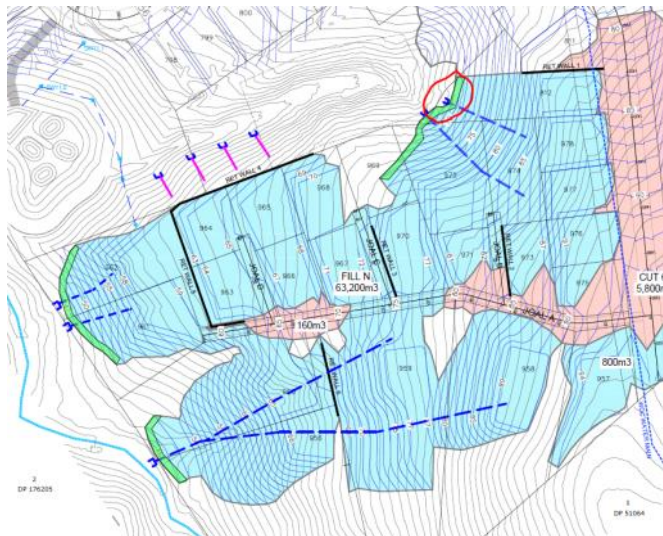
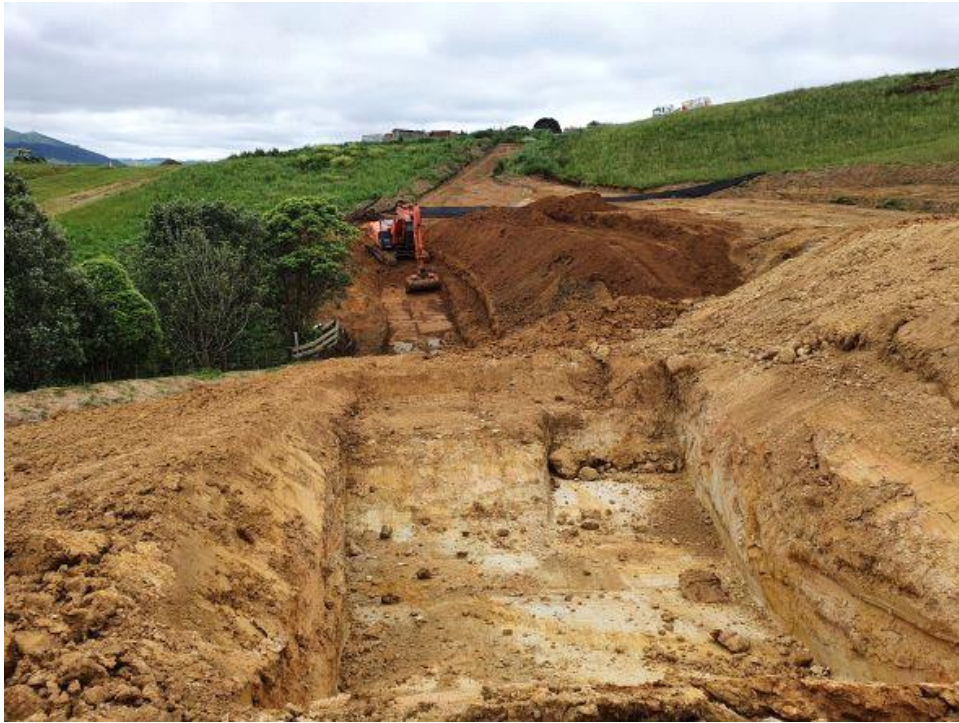
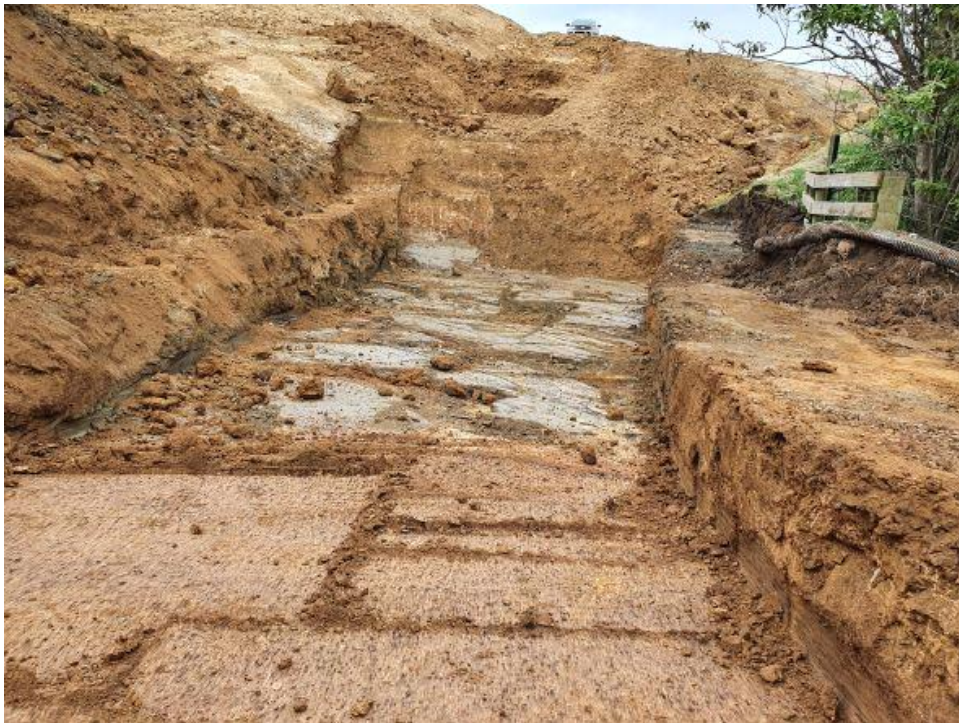
08/11/21

Observed excavation of toe key at least 1m below original ground level as per red and blue outline on the annotated plan below.

- Base of the red circled toe key returned shear vanes of greater than 217kPa, with the vane blade unable to penetrate the soil in several instances.
- Base of the blue circled toe key was into tuff and the shear vane blade was unable to penetrate.
- Discussed with contractor that they would bench the sides and then fill compaction with clay can commence. Drain outlet to be placed once filling completed.

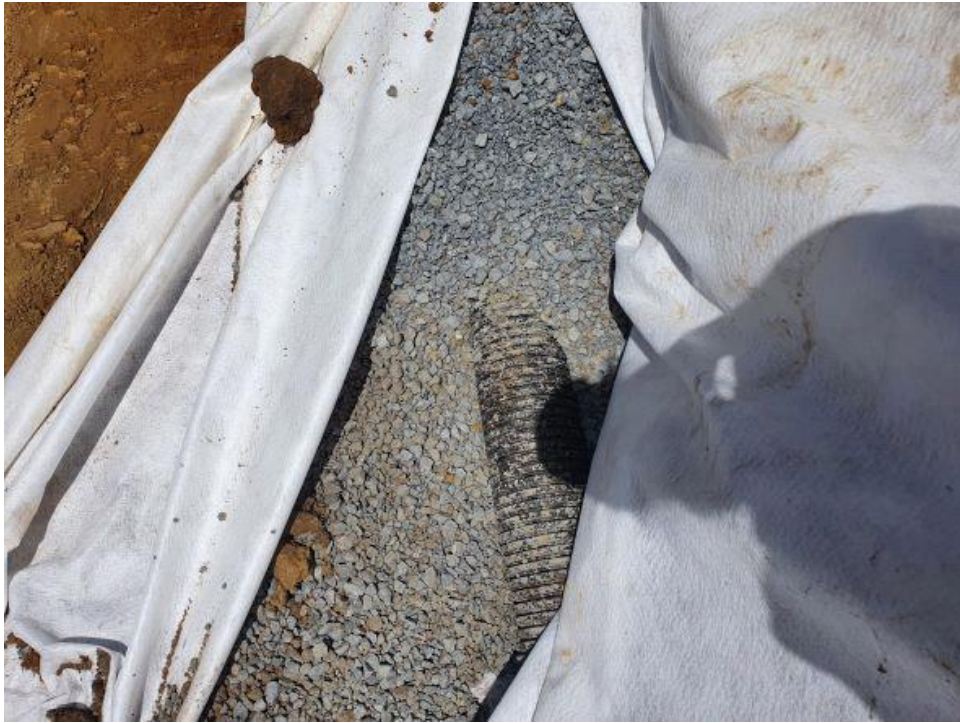
Observed toe key circled in red on the below site plan:

- Also observed the underfill drains circled in black below:

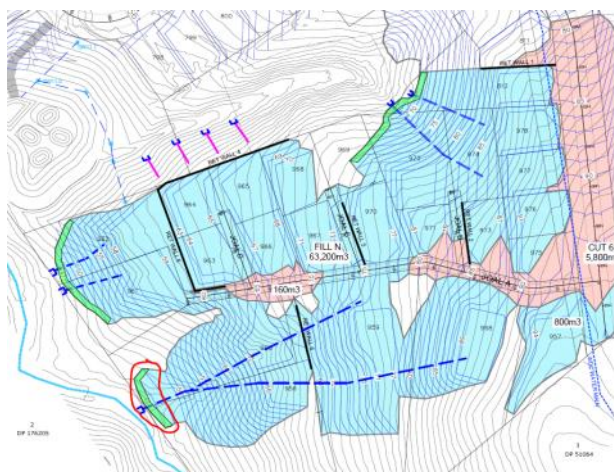
10/11/21

Attended site to observe the first lift of fill placed within the toe key circled red on the below site plan.

- Fill consisted of hard, highly plastic clays.
- A 1m deep hand auger was drilled and found no wet or saturated soils. Satisfactory to continue placing fills.

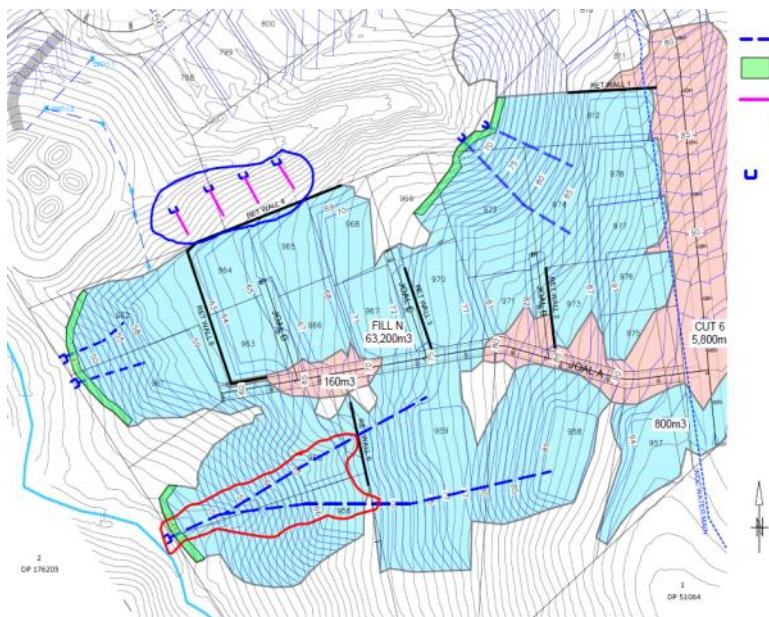
11/11/21

Attended site to observe to underfill drains (circled red) and counterfort drain locations (circled blue).

- Underfill drains were located within the low points of the slope and consisted of 160mm heavy duty novocoil, covered with 20/7 fill and wrapped with bidim cloth.
- The drains will be continued further up the slope once filling near the toe of the slope has been completed.
- The location of the counterfort drains had been pegged out. The counterfort on the west end is to be moved around 1m to the east to be located within a natural low point in the slope.
- From the top of the slope, these were set around 1.5m away from the approximate retaining wall location.
- Each counterfort was spaced by 15m.
- Contractor bringin in scoria backfill today, drain construction to start next week.

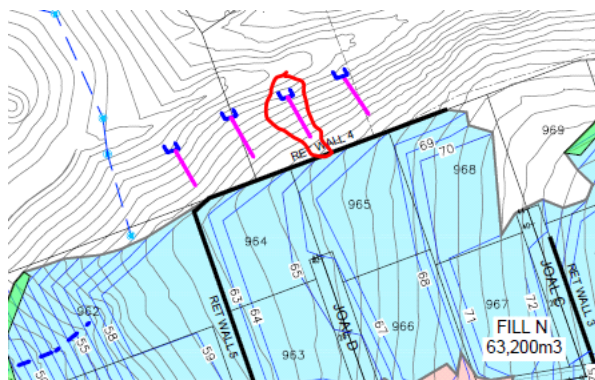
19/11/21 - AM

Attended site with KM to observe the construction of the first counterfort drain, circled red below.

- A 160mm heavy duty novocoil drain had been placed at the base of the trench and backfilled already with scoria.
- Contractor advised that trench was 6m deep and the base of the trench has been as-built.
- Construction of the eastern most drain to begin today, will return later to observe.

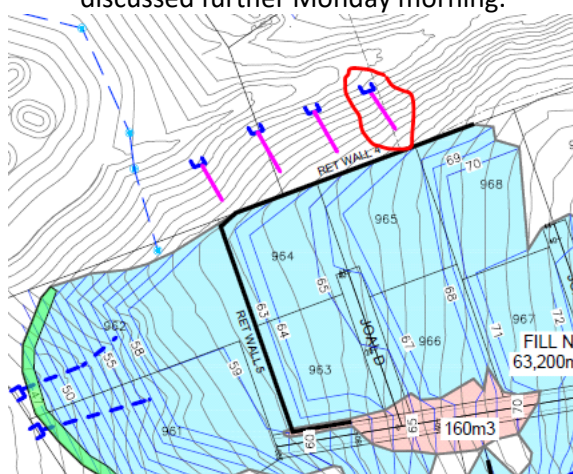
19/11/21 - PM

Attended site to observe construction of counterfort drain circled red below.

- Drain was constructed to approximately halfway up the slope and was 6m deep, in accordance with our design.
- Contacted by contractor around 1.5 hrs later to say the drain had collapsed. This is to be discussed further Monday morning.

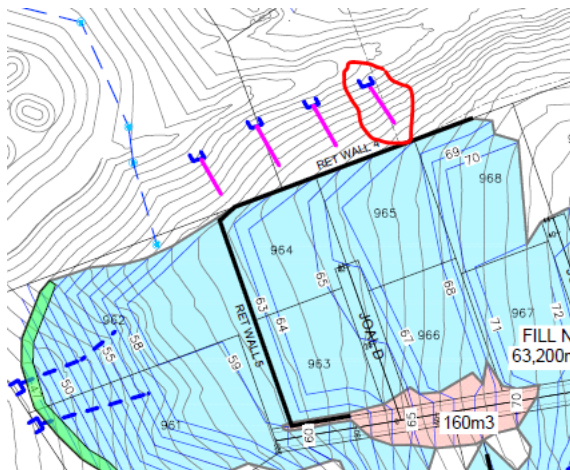
22/11/21

A block of material has failed along a plane on the eastern wall of the excavations. Decided that:

Also observed construction of underfill drains and discussed with contractor where the drains are to extend up to (approx. pink pegs in final image below).

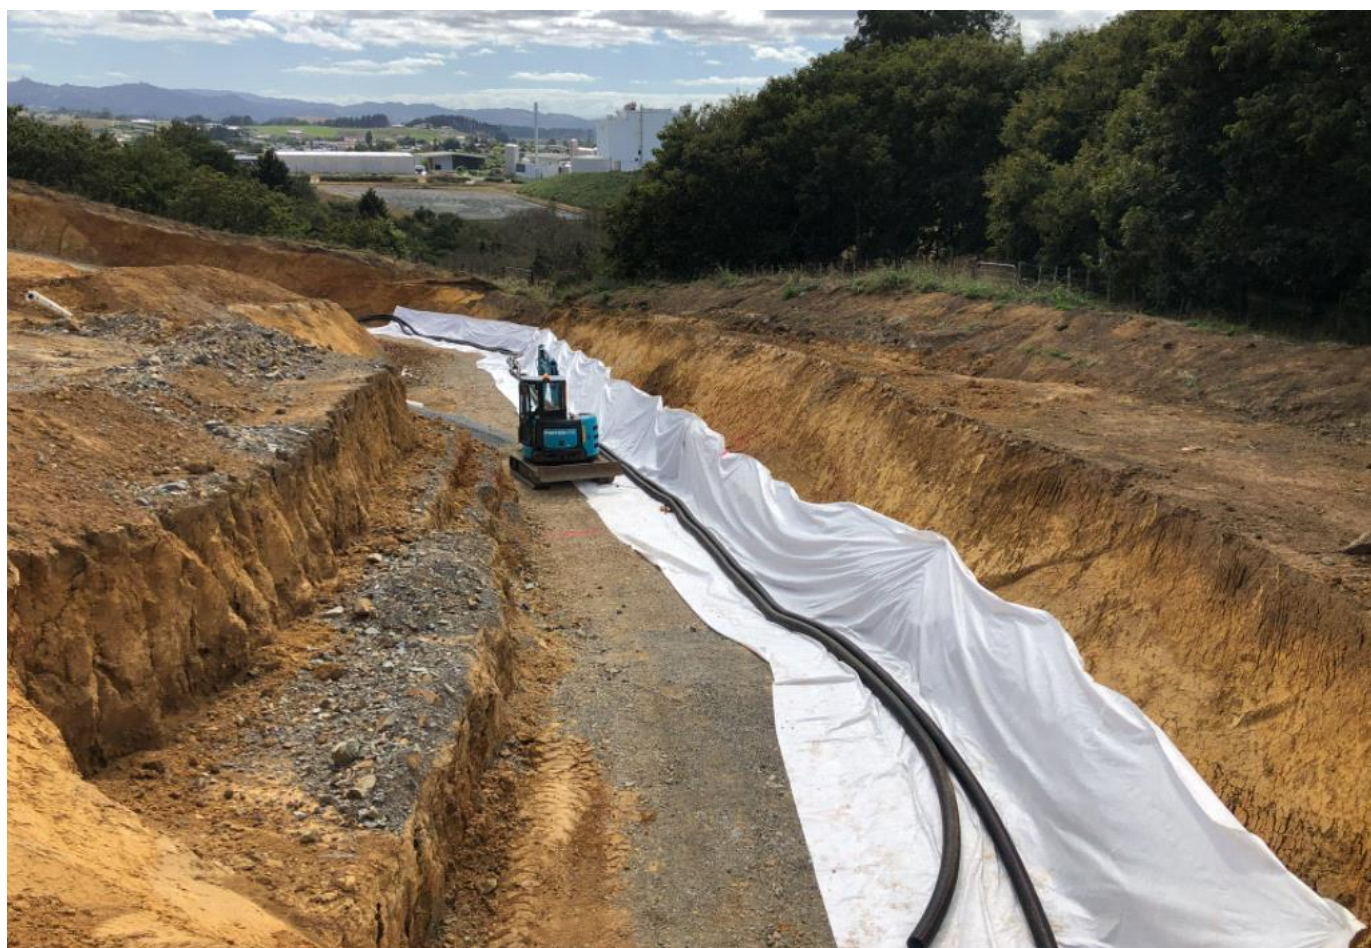
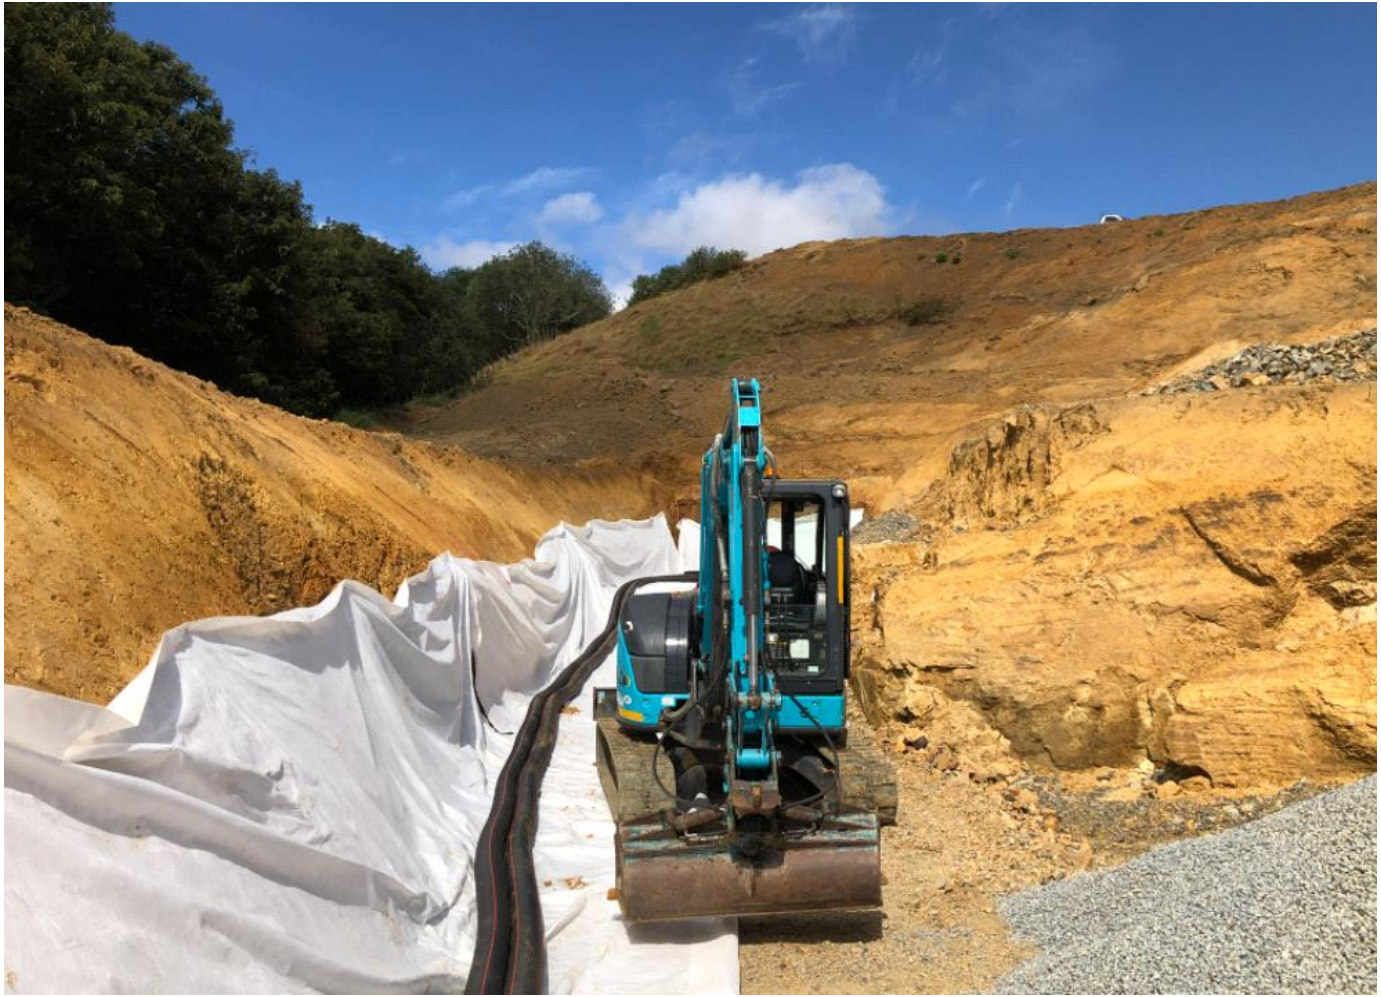
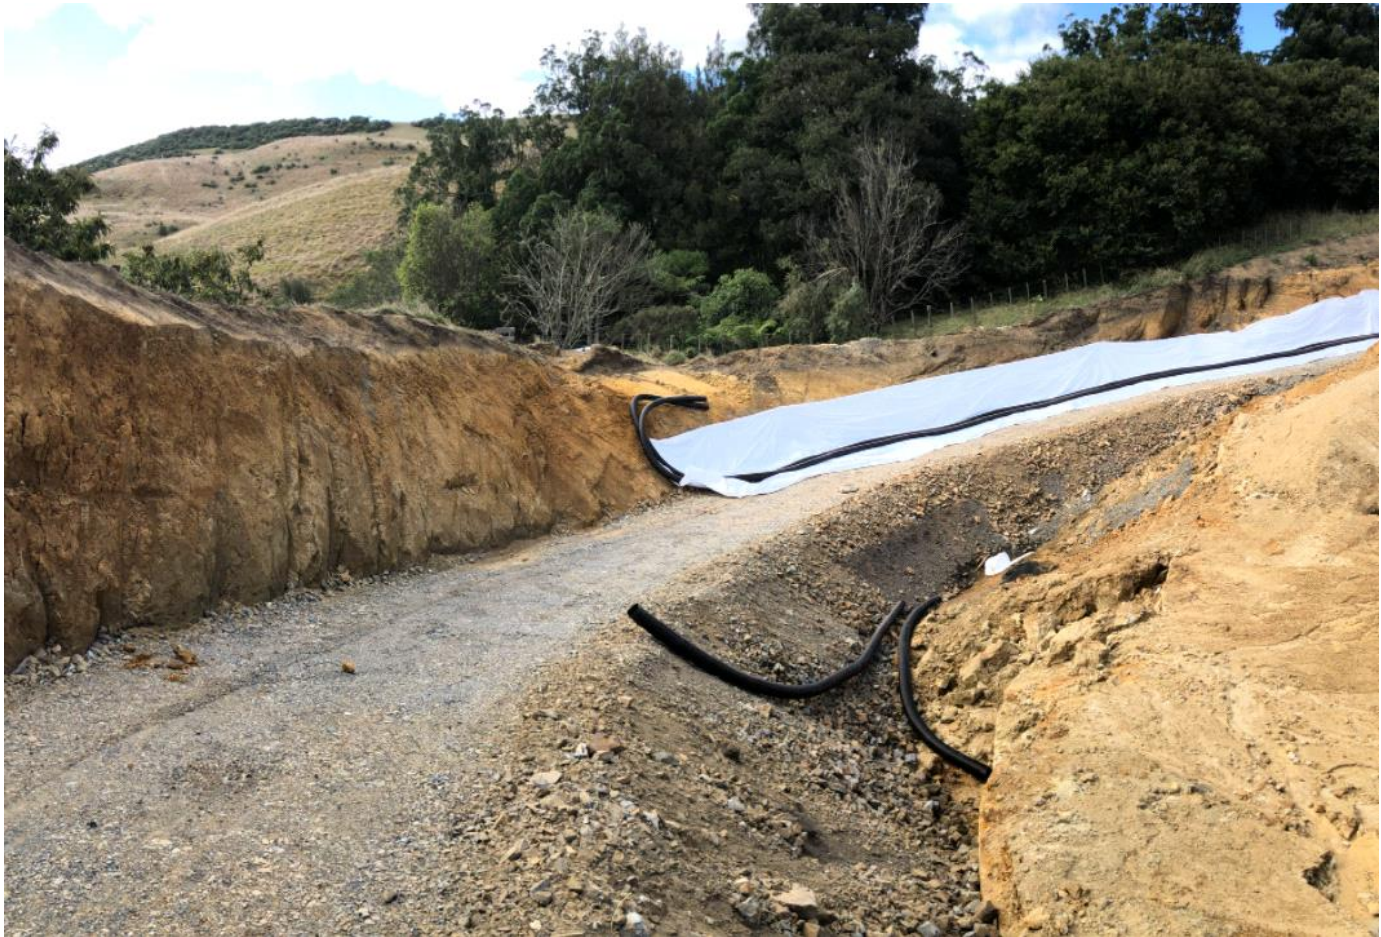
Inspected shear key collector drain (shown in images below). Drain is compliant with drainage detail. Spoke to contractor about achieving full coverage of drains by either overlaying an additional lift of aggregate or trenching into the existing level.
