DFH Joint Venture Limited

GEOTECHNICAL COMPLETION REPORT

Hitchen Block Stage 18, Pokeno

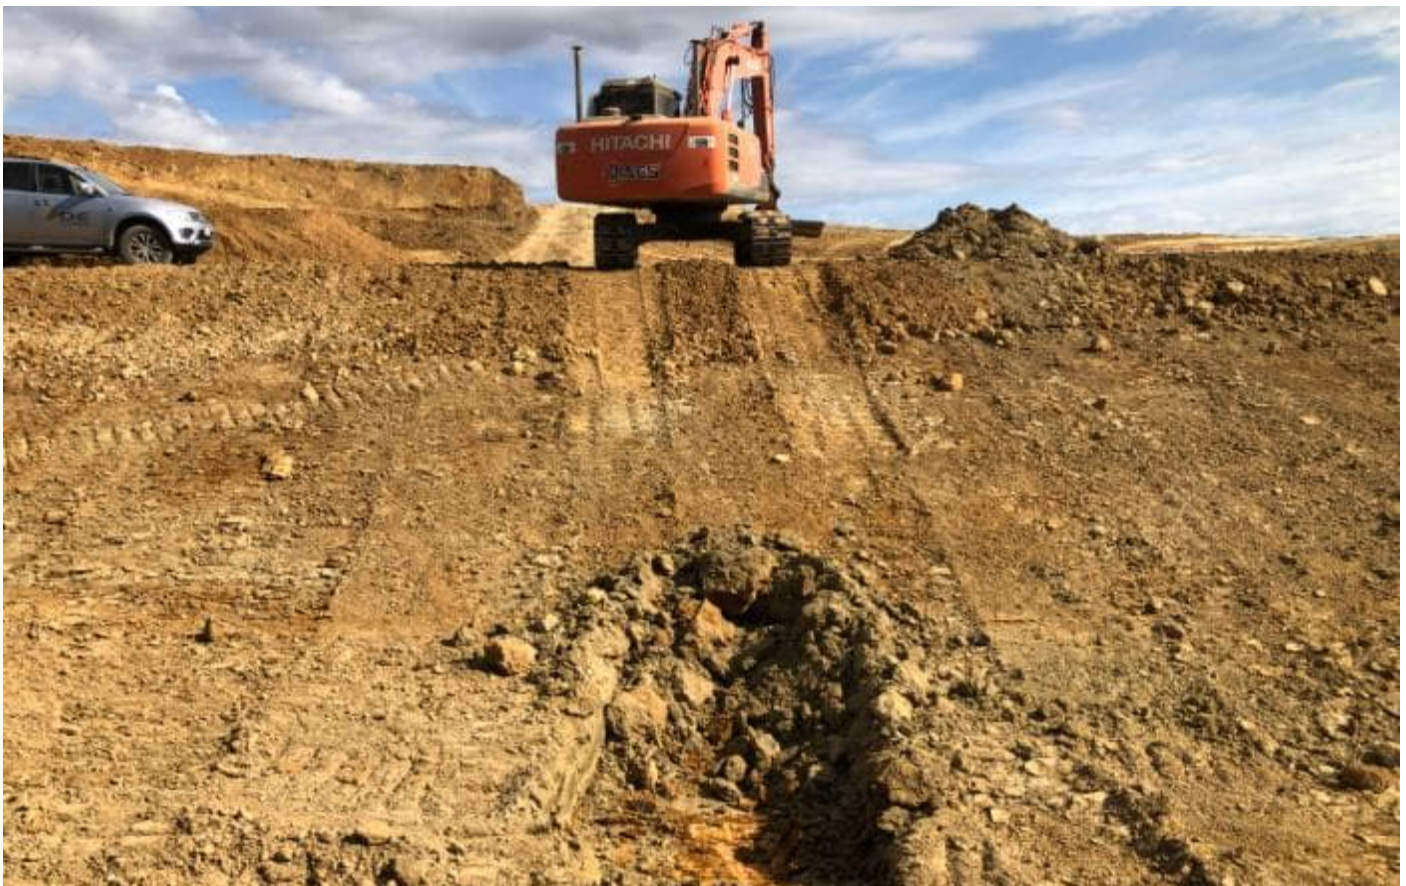
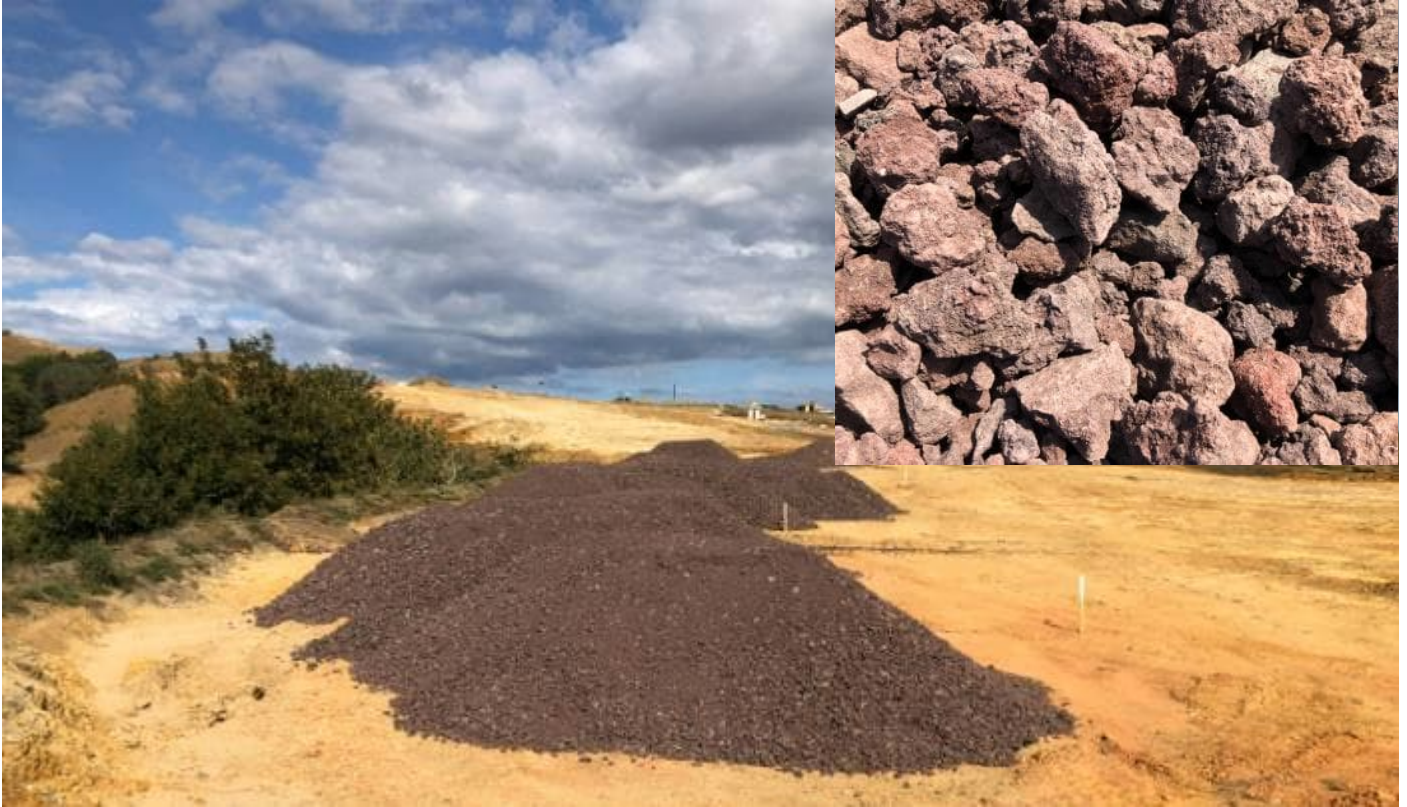
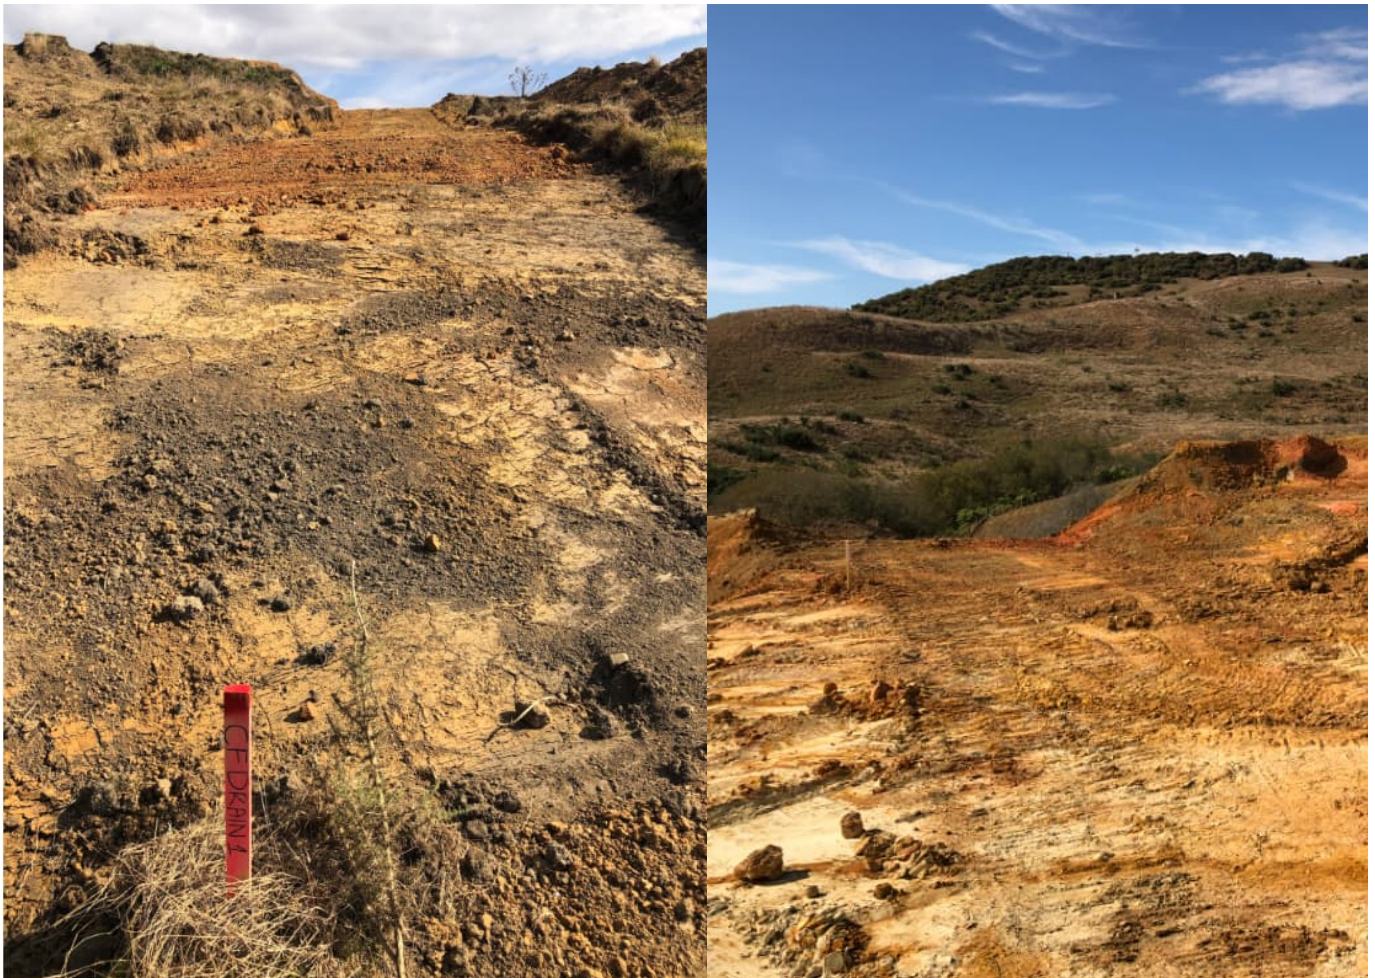
Attended site to observe beginning of meadows shear key underfill drain trenching. Observed stripping of topsoil for Counterfort Drain 01. Drainage aggregate stockpiled near Counterfort Drains is SAP50.

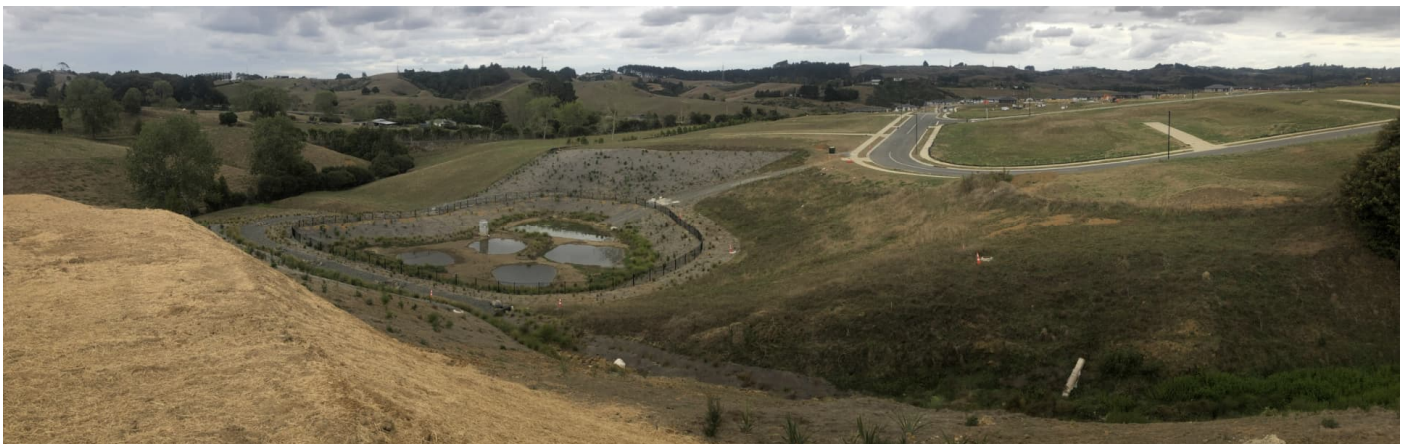
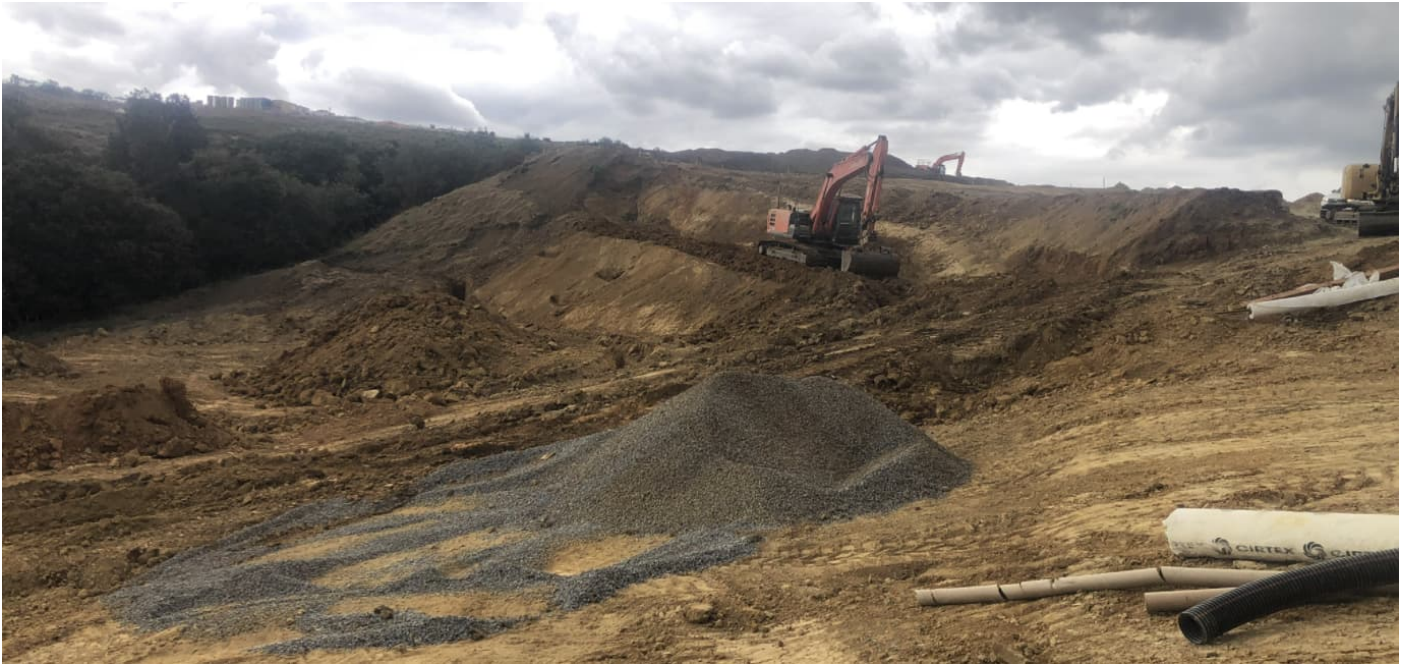
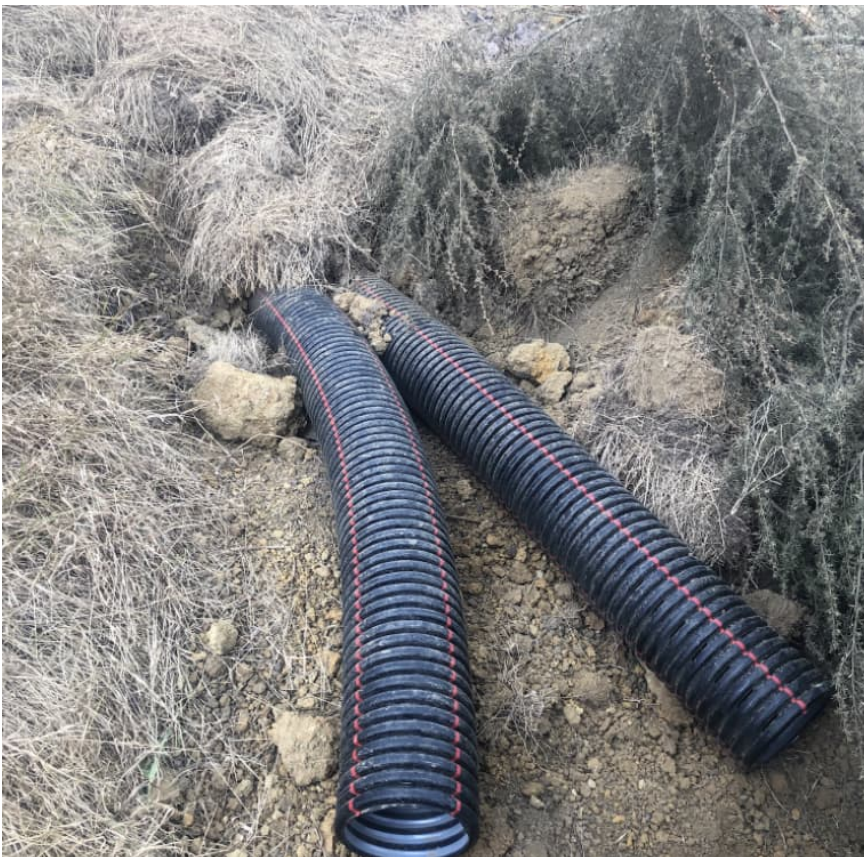
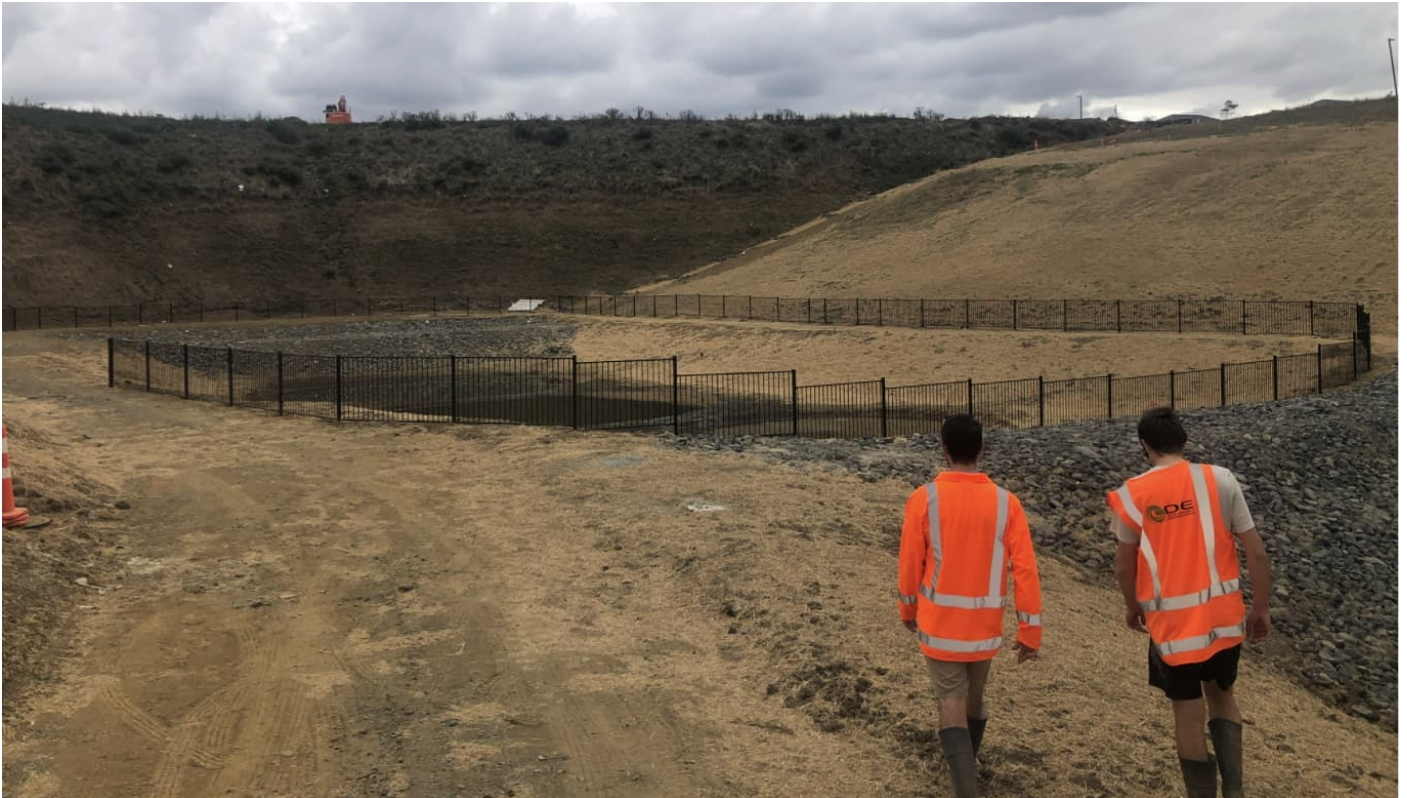
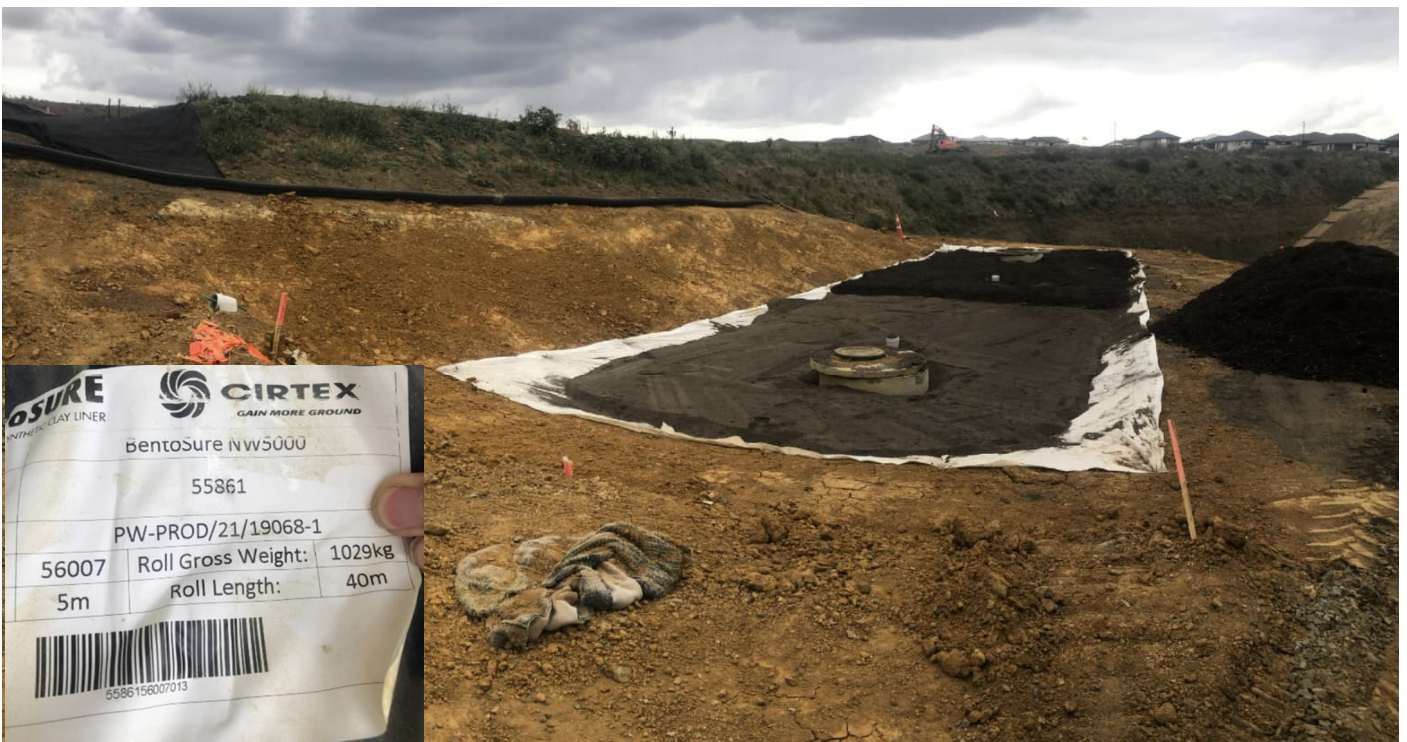
- Observed construction of underfill drainage installation in stage 17 meadows.
- Observed collector drain outlet point from stage 17.
- Observed outlet drains on REB walls.
- Observed rain garden geotextile materials.

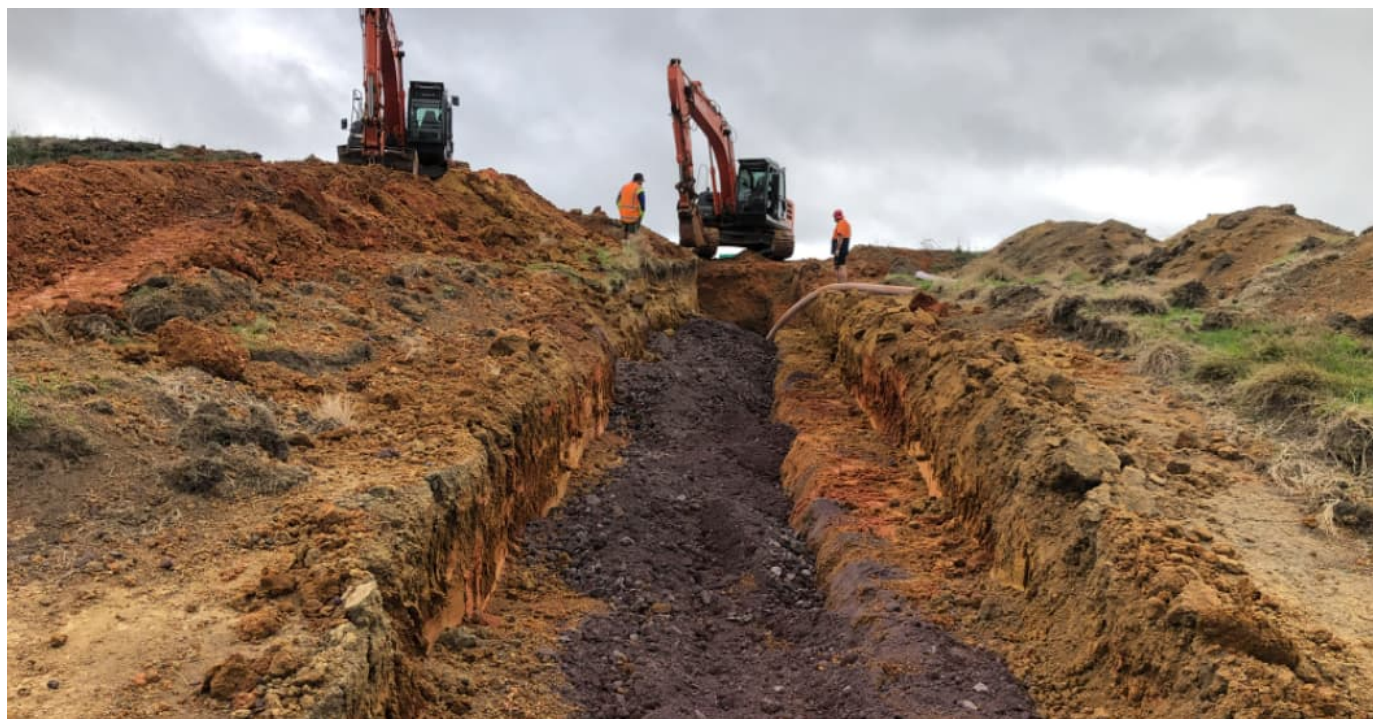
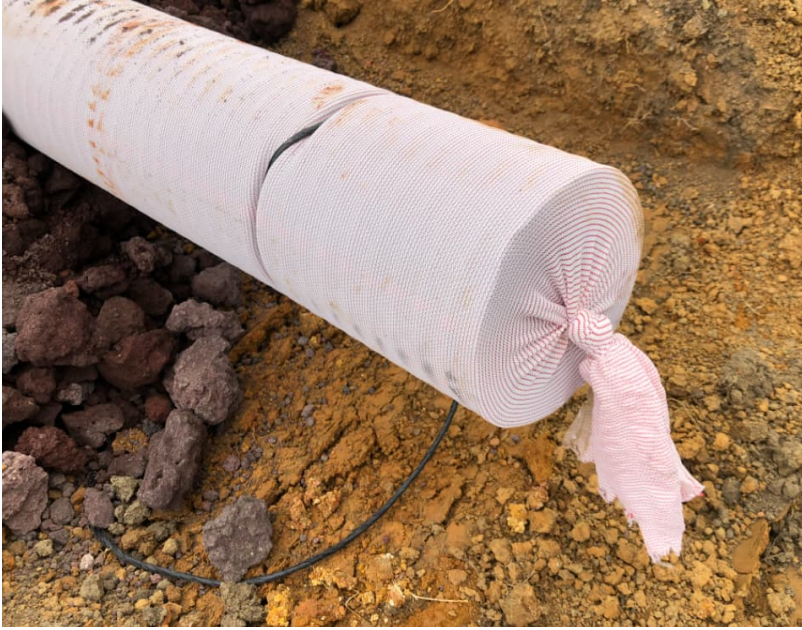
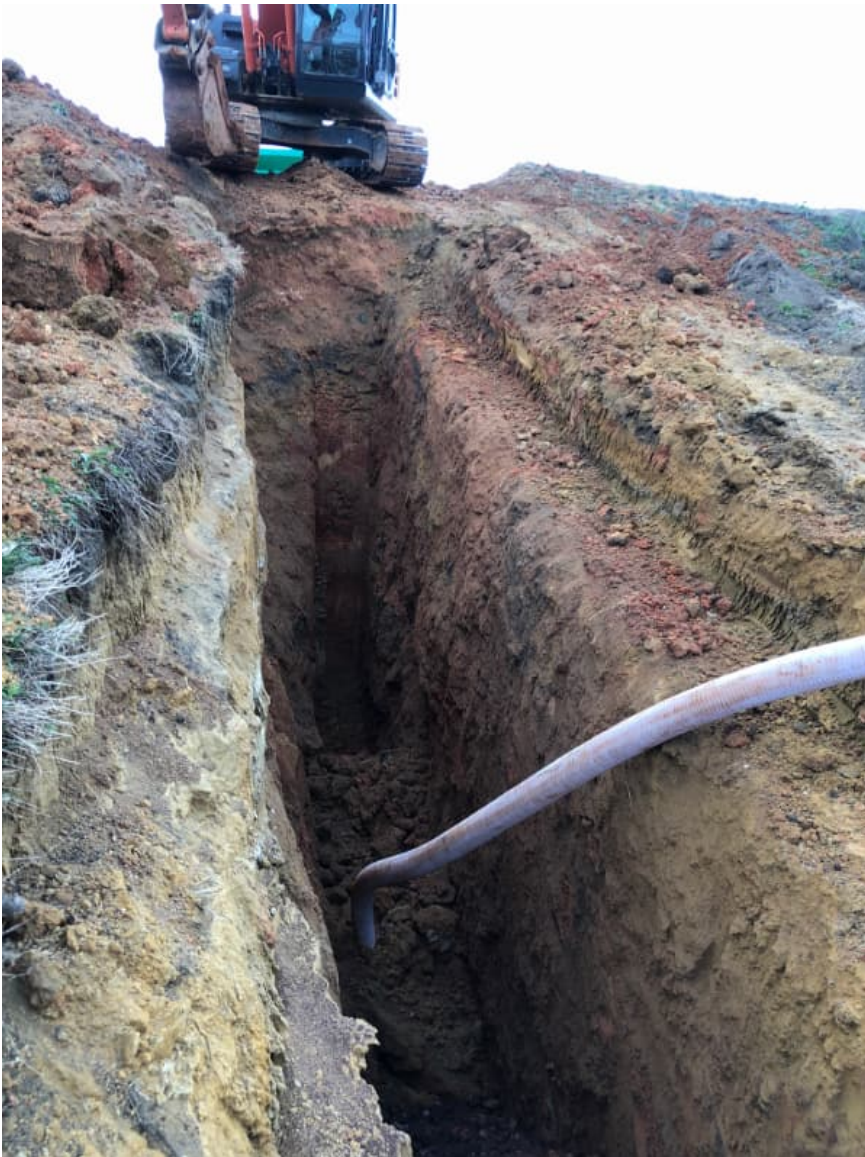
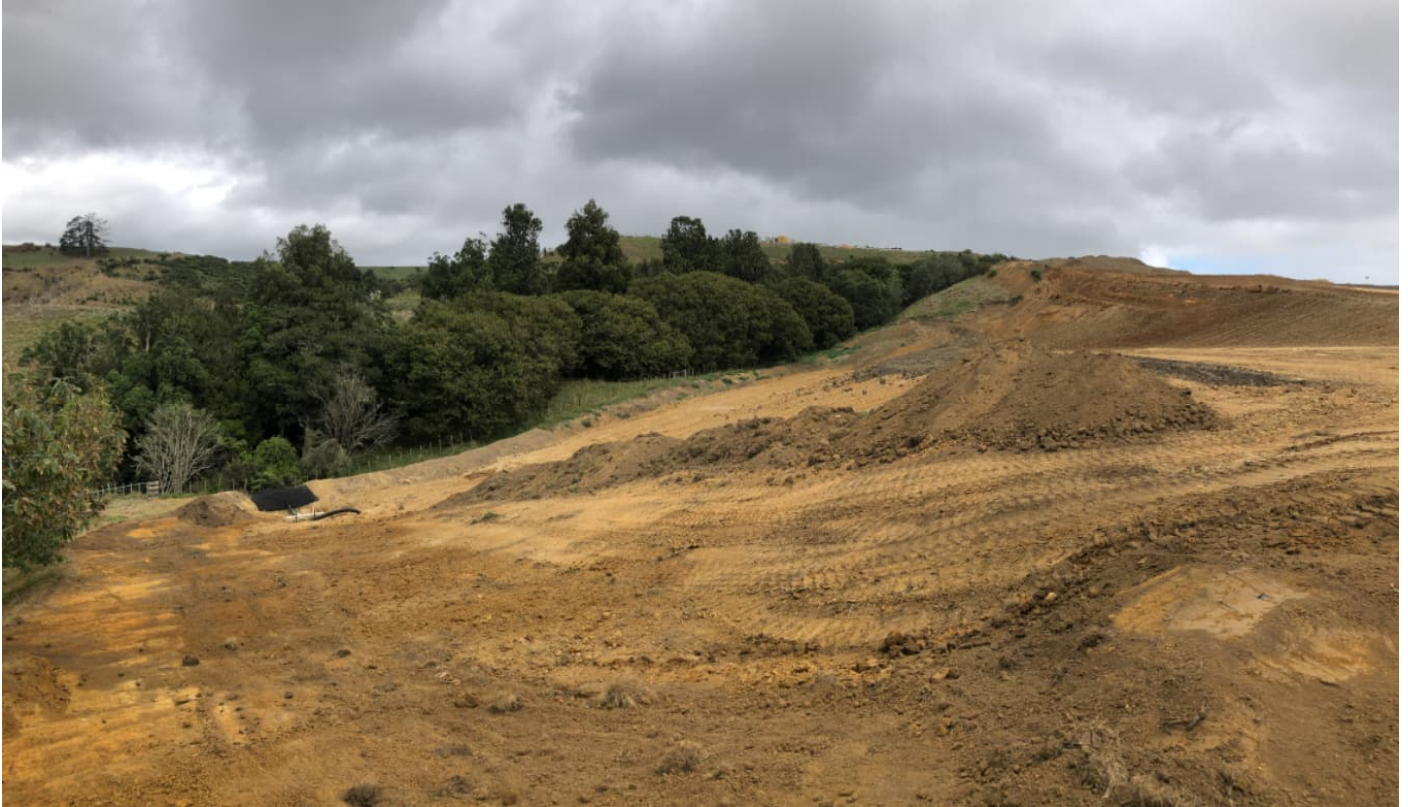
- Contractor advised that trench collapse was occurring once the trench reached 6 metres below existing ground level.
- Single 160mm nova coil placed in base of trench, backfilled with SAP50, compliant with design.
- Observed Stage 17 Meadows shear key completion. Underfill drainage has been backfilled and connected into collector drains.

Counterfort trench progress to be inspected frequently. Contractor advised that alternate excavation methodology (ie benching) may be required to address trench collapse issues.

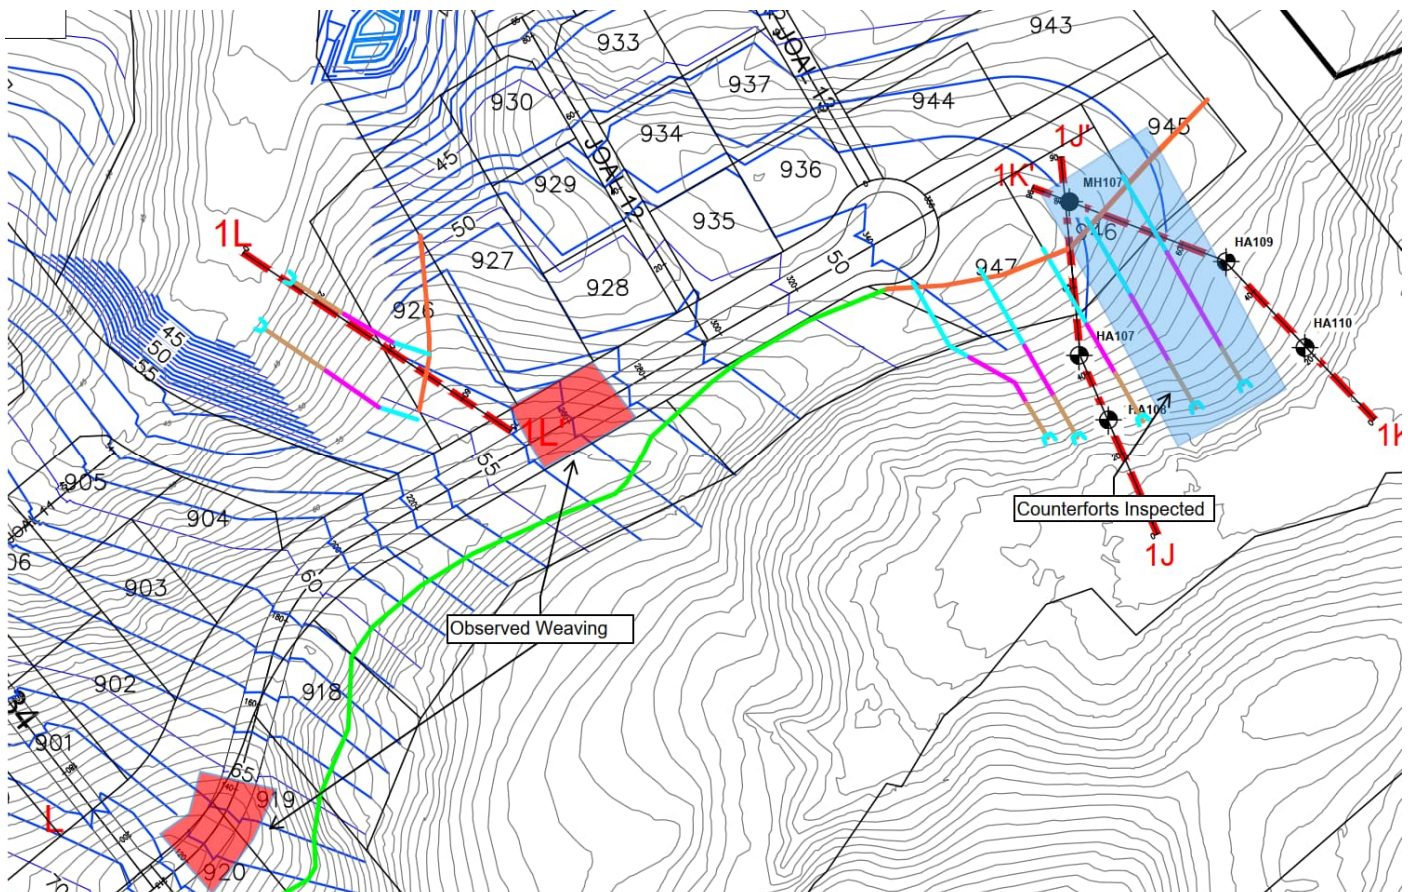
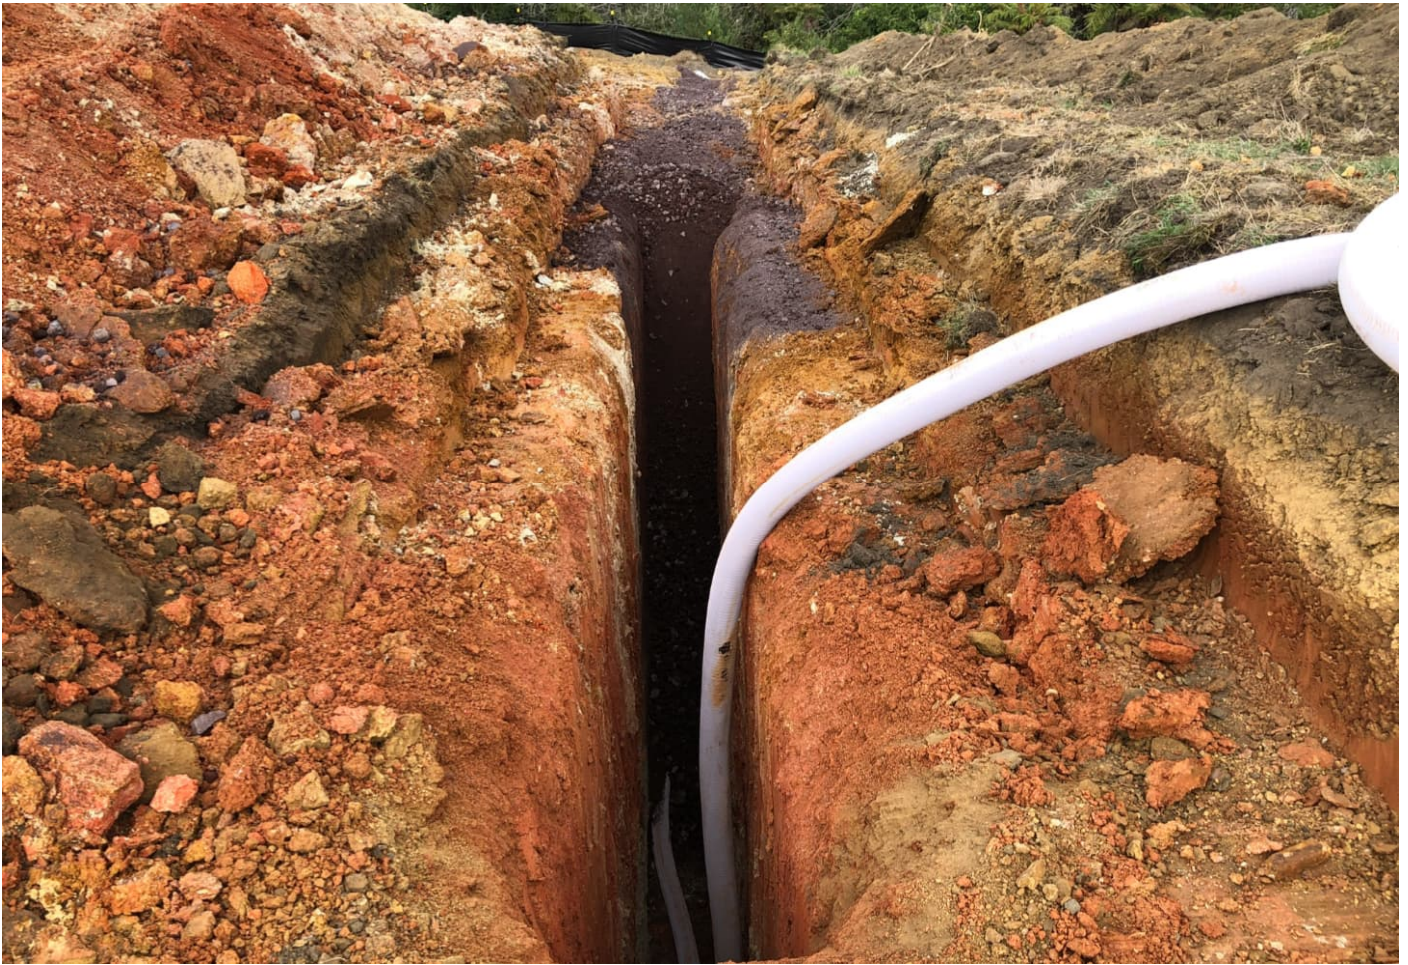
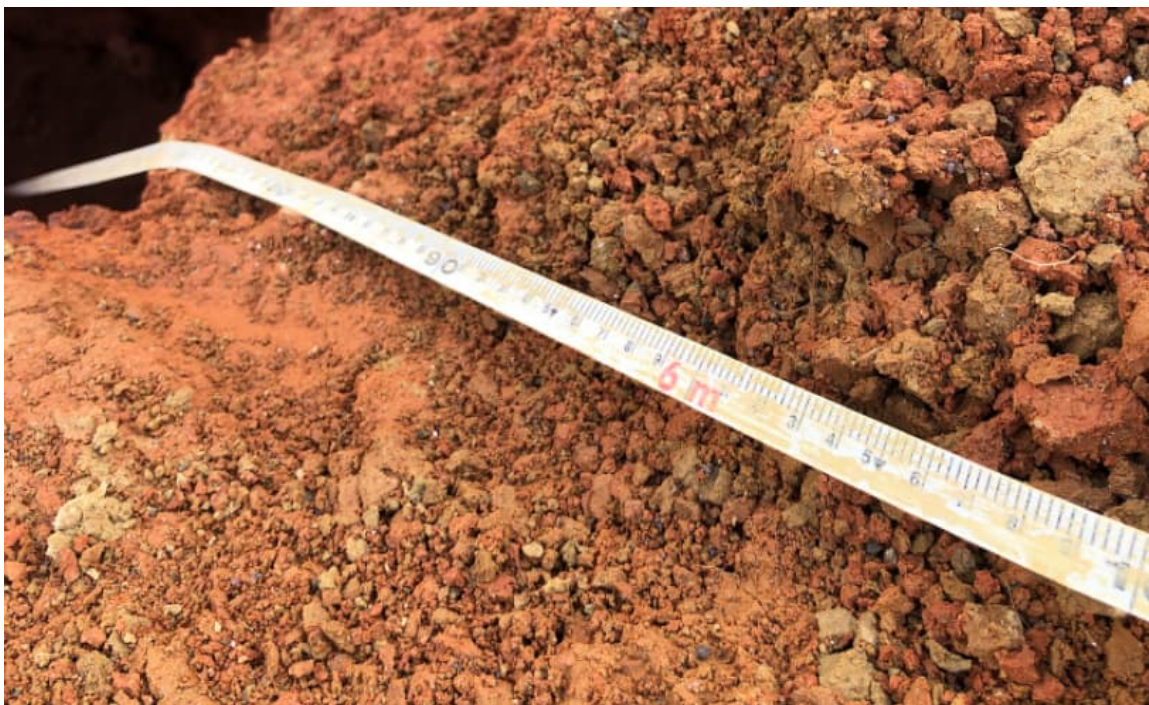
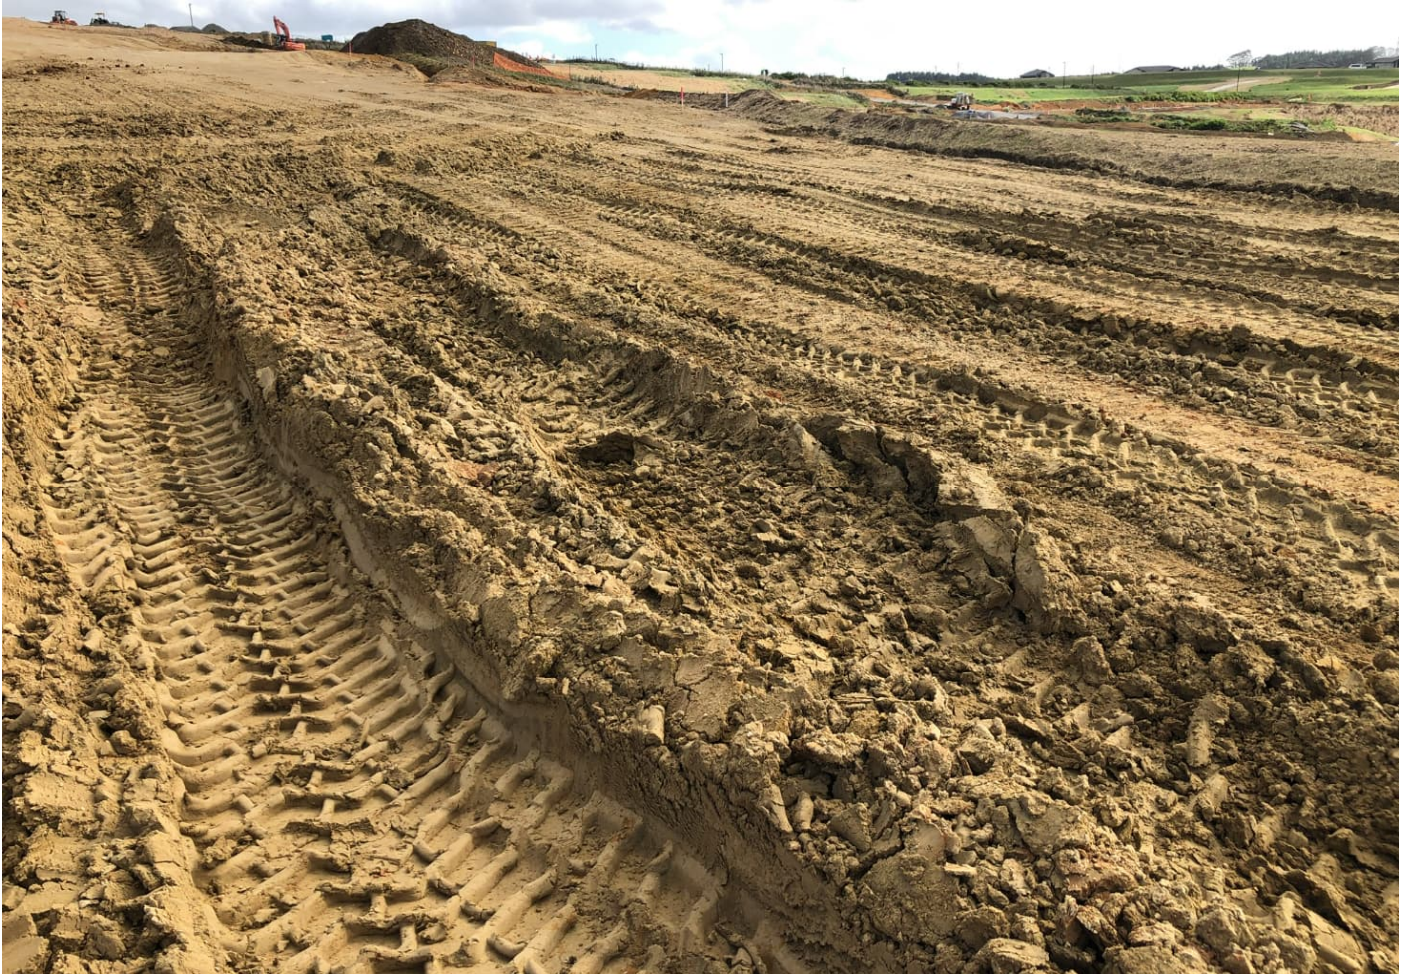
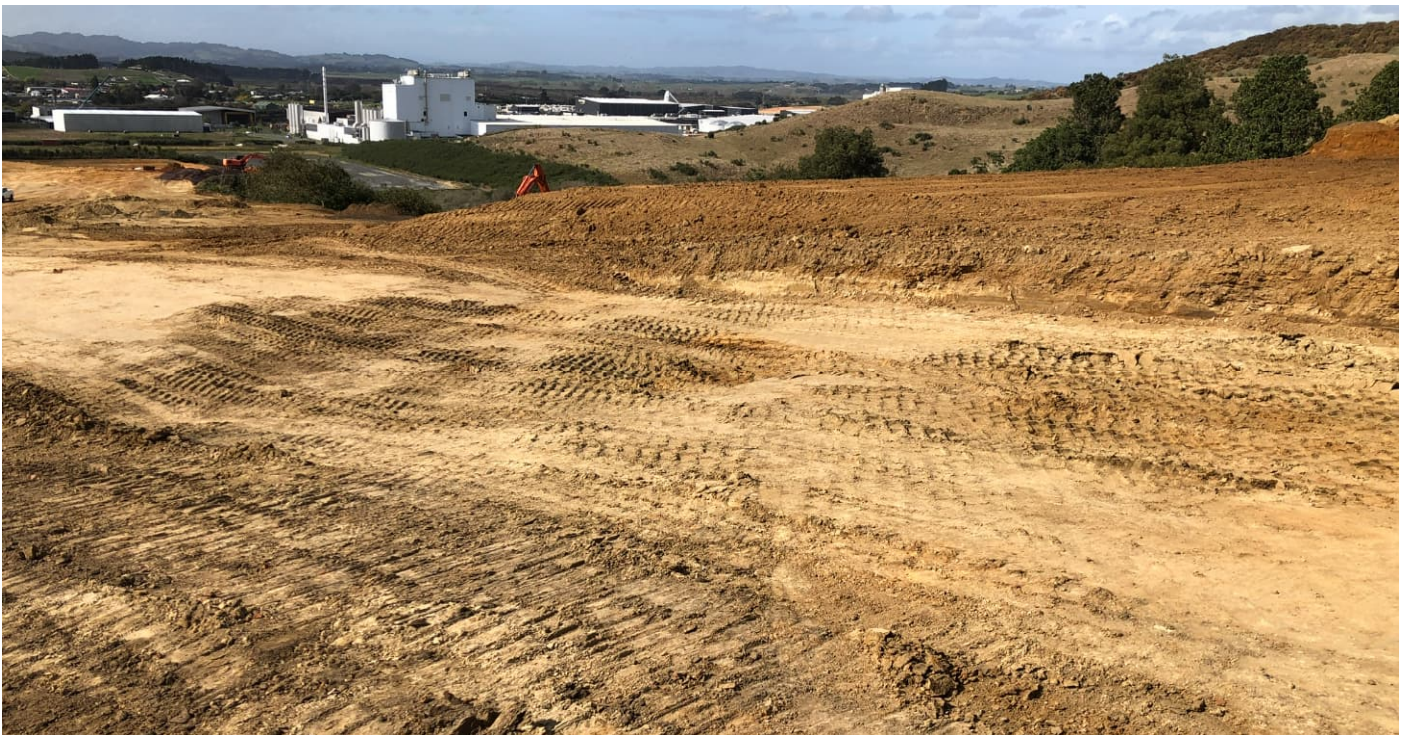
Attended site to observe construction of counterfort drains highlighted in plan below. Additionally observed two areas of weaving along Road 30 with Ali (Dines).

- Counterfort drains appear compliant with design.
- Two areas of weaving/soft material were observed between chainage 120-140, and 250-270. Test pits revealed very stiff, natural material at a depth of approximately 0.3m below current ground level. CAN to follow regarding remediation recommendations.

Counterforts to be inspected regularly until completed. CAN to follow regarding road subgrade.

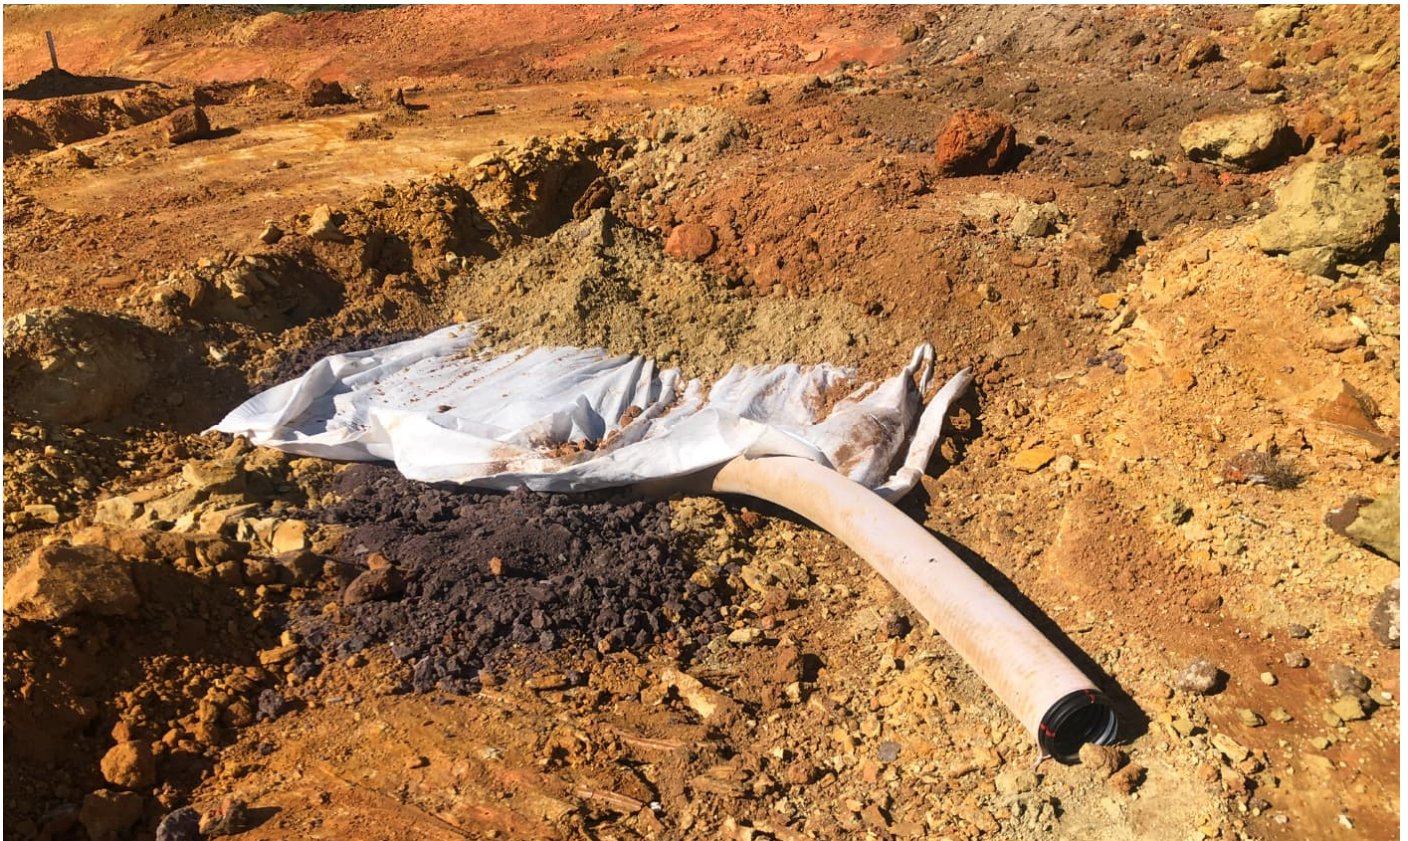
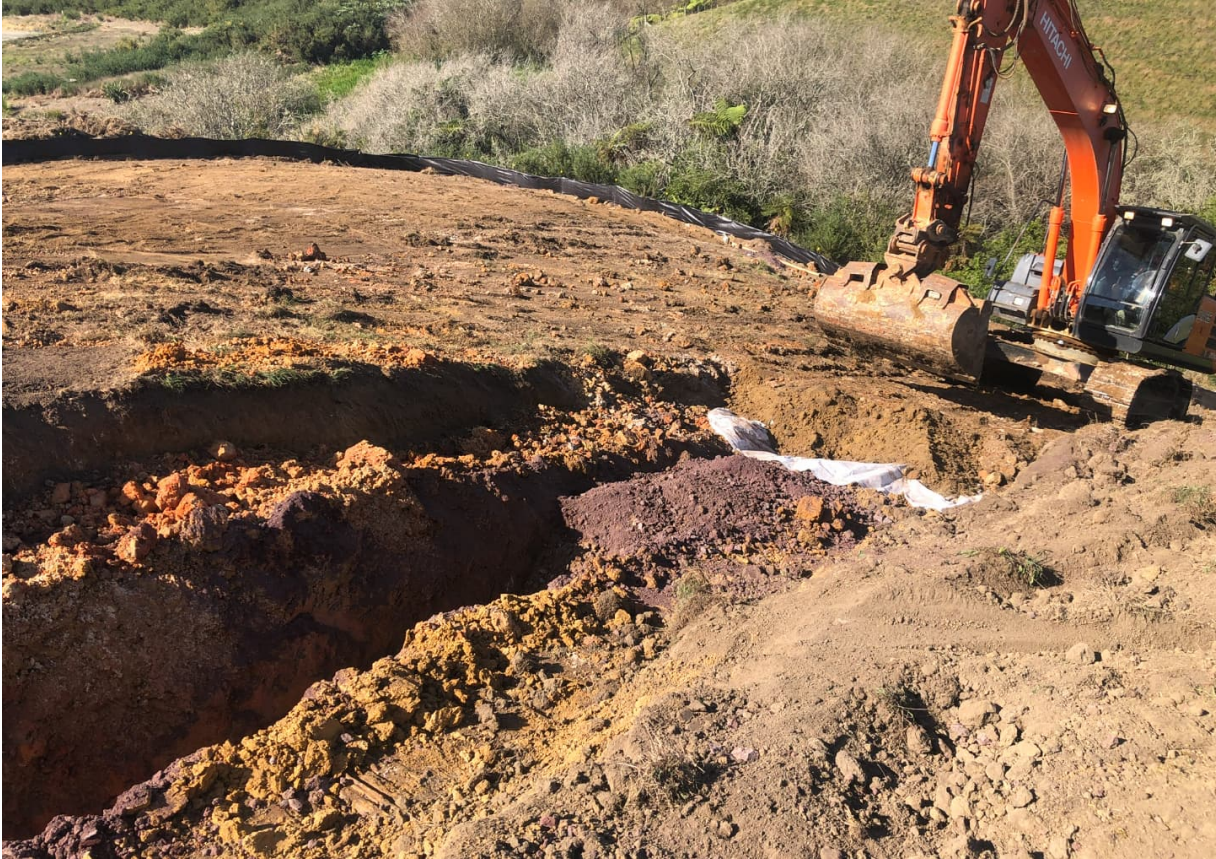
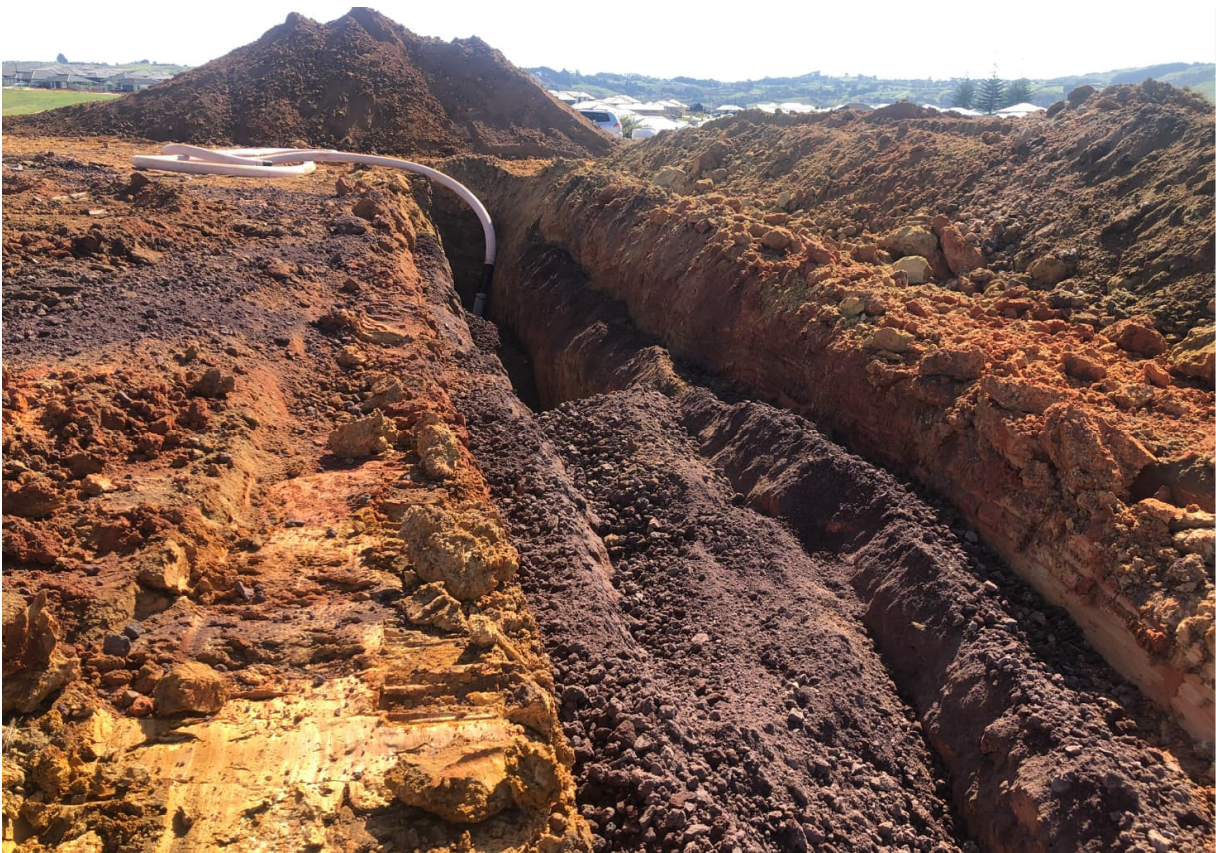
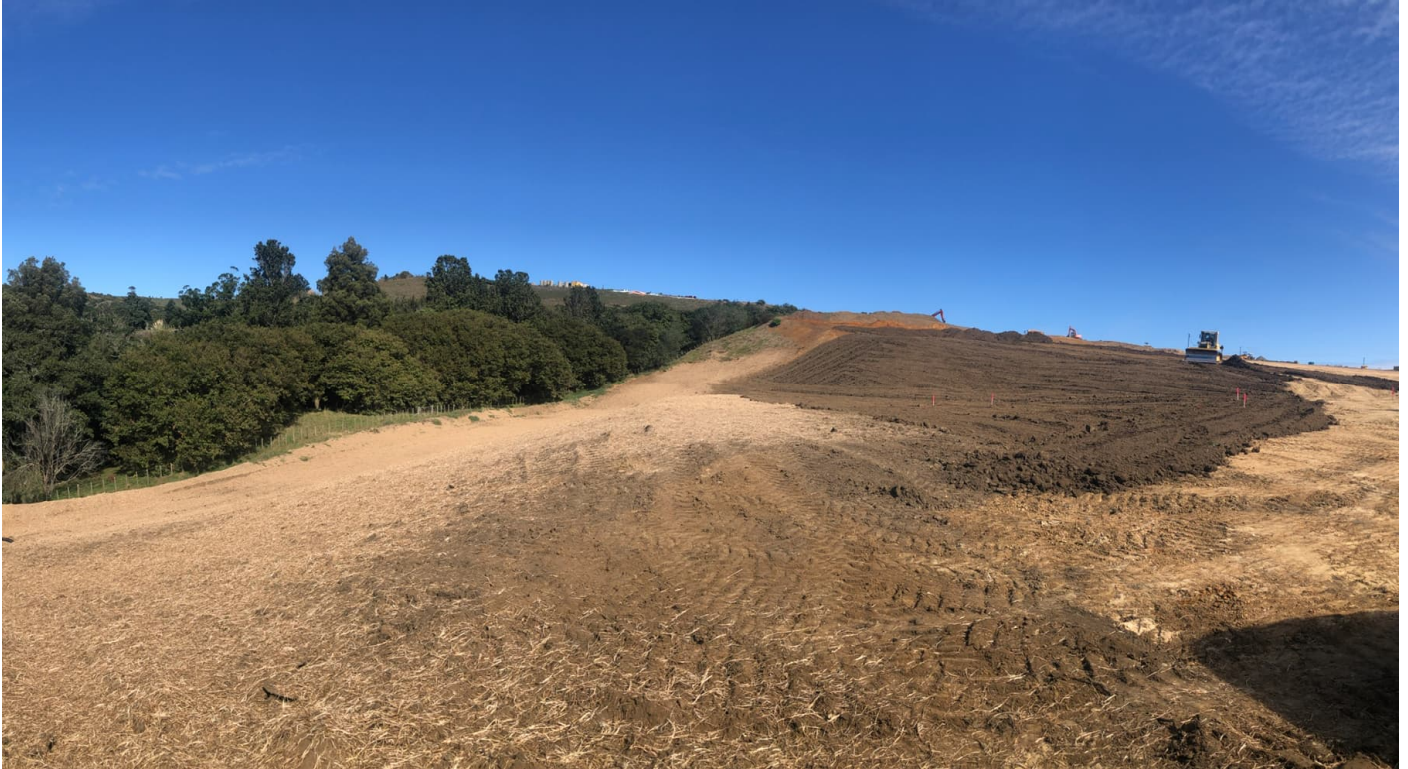
- Contractor advised that excavations were going well with no trench stability issues on the current trench.
- Contractor advised that additional scoria required for backfill is expected to be delivered to site in 5-7 days time.
- Observed topsoil being spread across stage 17 meadows.

N/A. Counterforts to be inspected once additional scoria is delivered.
