DFH Joint Venture Limited

GEOTECHNICAL COMPLETION REPORT

Hitchen Block Stage 18, Pokeno

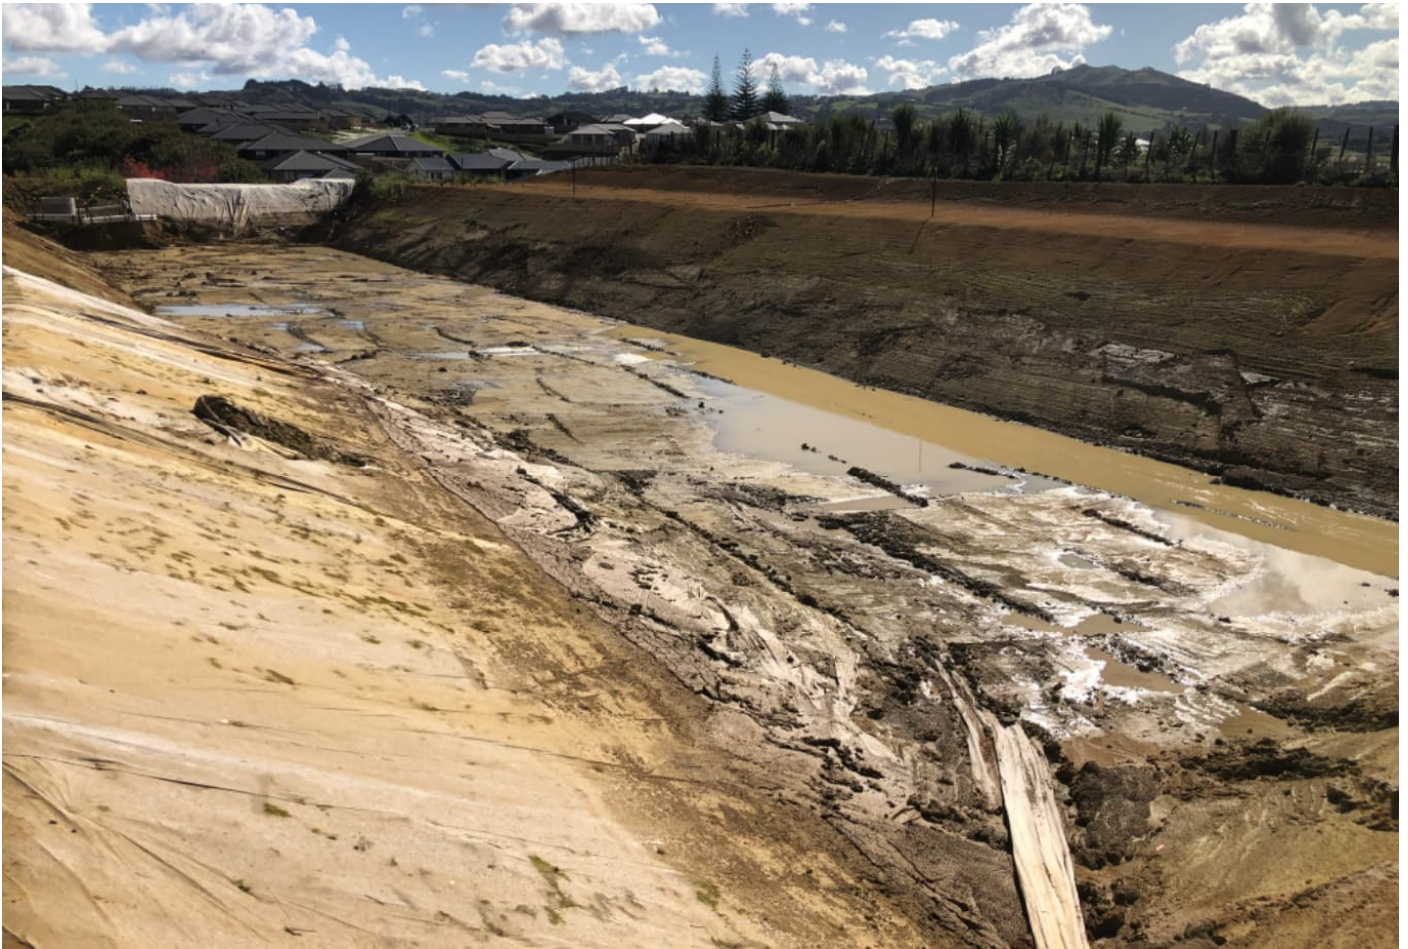
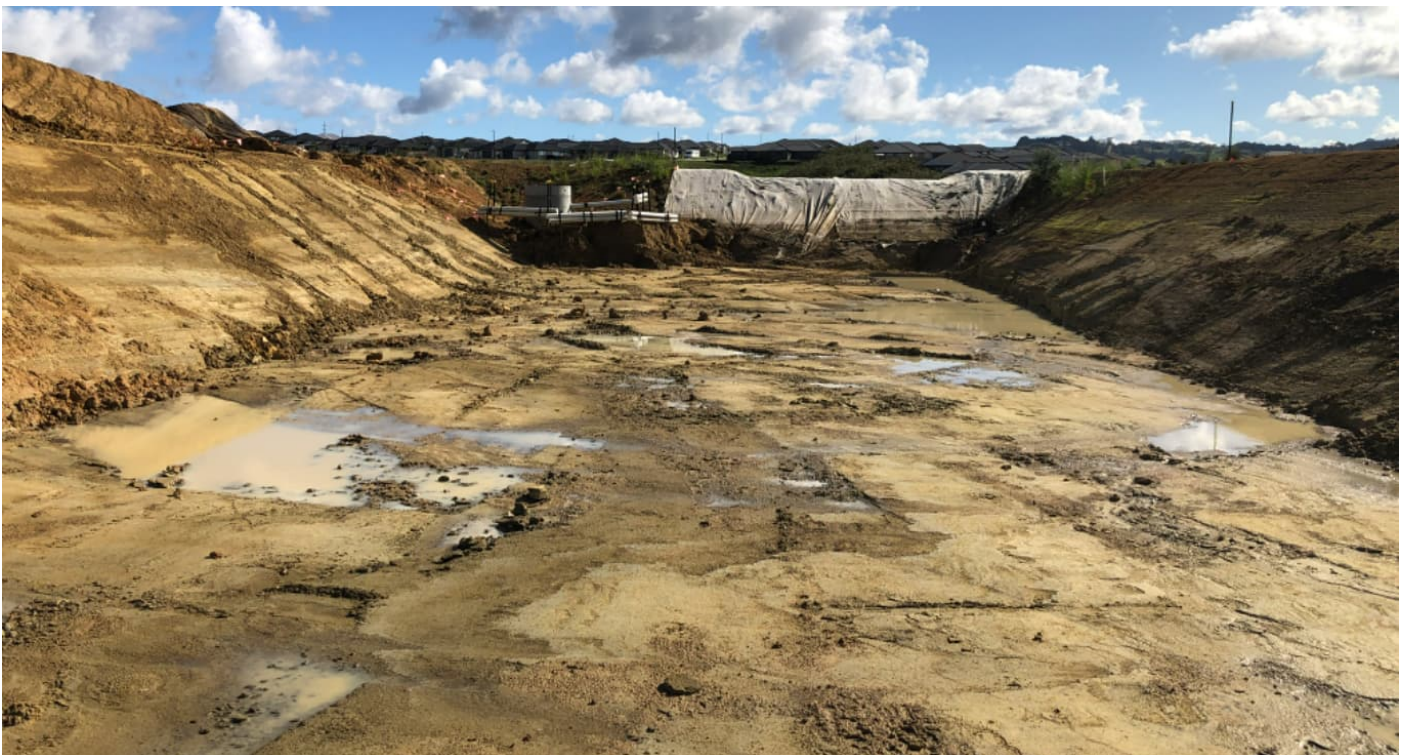
- Pond base comprised very stiff, inorganic, natural material, with the shear vane unable to penetrate across the base.
- Minor vegetation was observed on north-western batter.
- Counterforts 4 & 5 Intersection point observed.

Recommended to Contractor (Ali) to trim off vegetation on north-western batter. Otherwise, pond satisfactory for backfill.

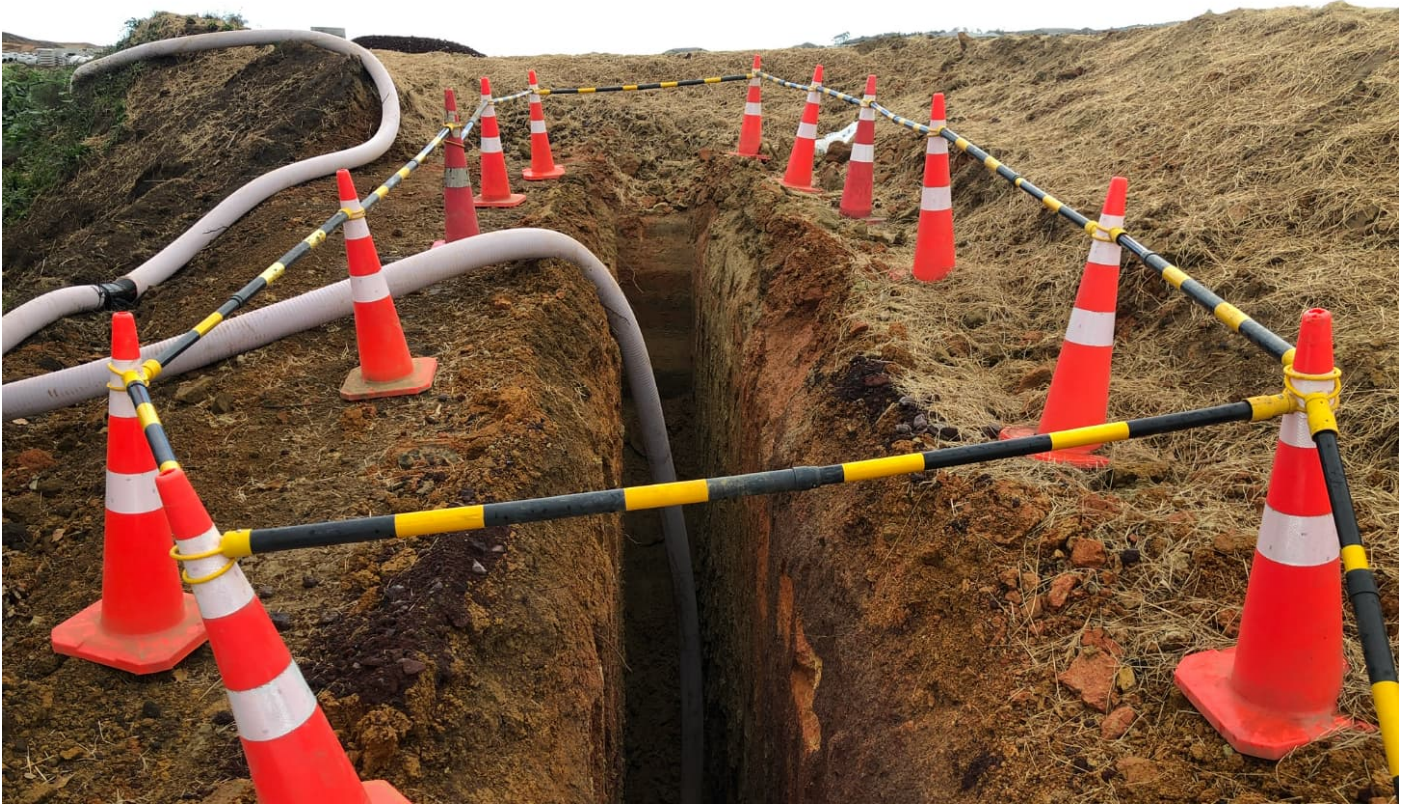
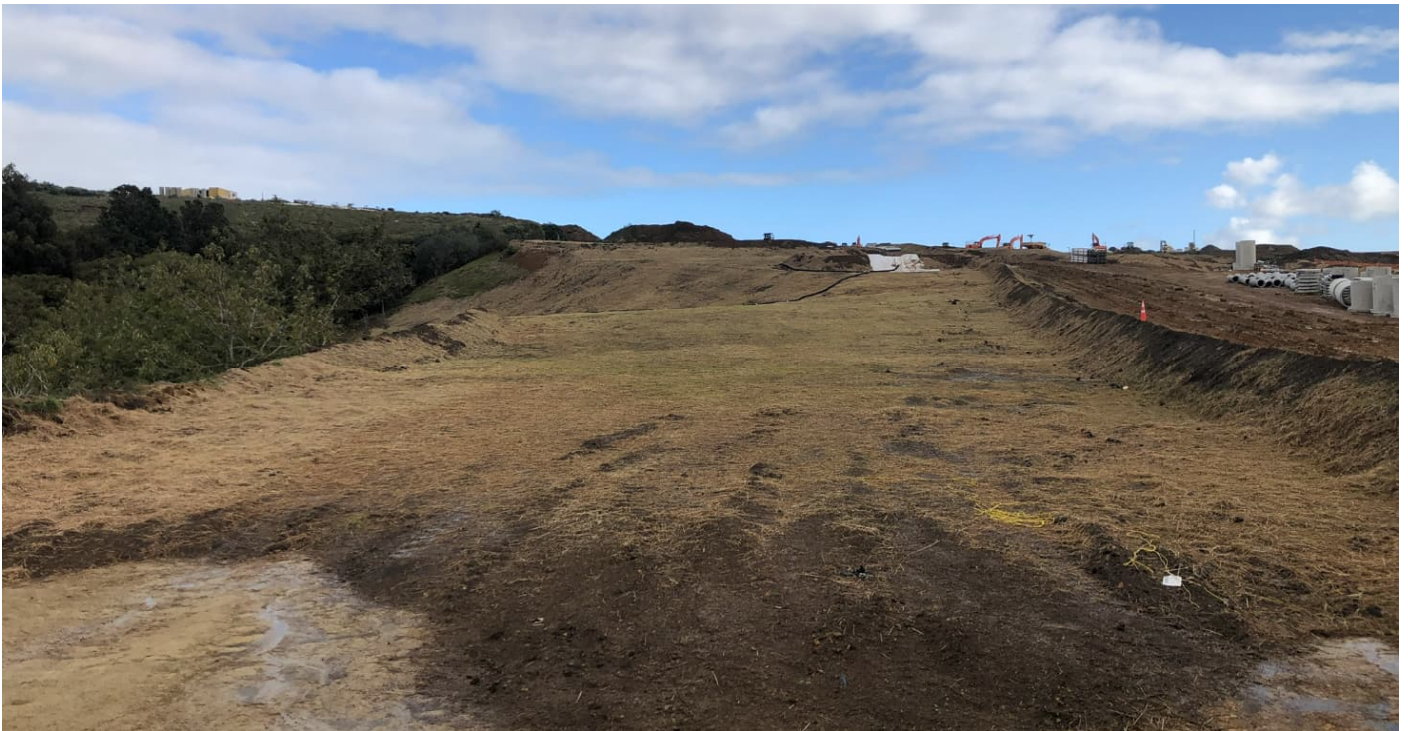
- Counterfort Drains 2-5 completed, counterfort drain 1 yet to be fully excavated.
- Observed topsoil spread over meadows area.

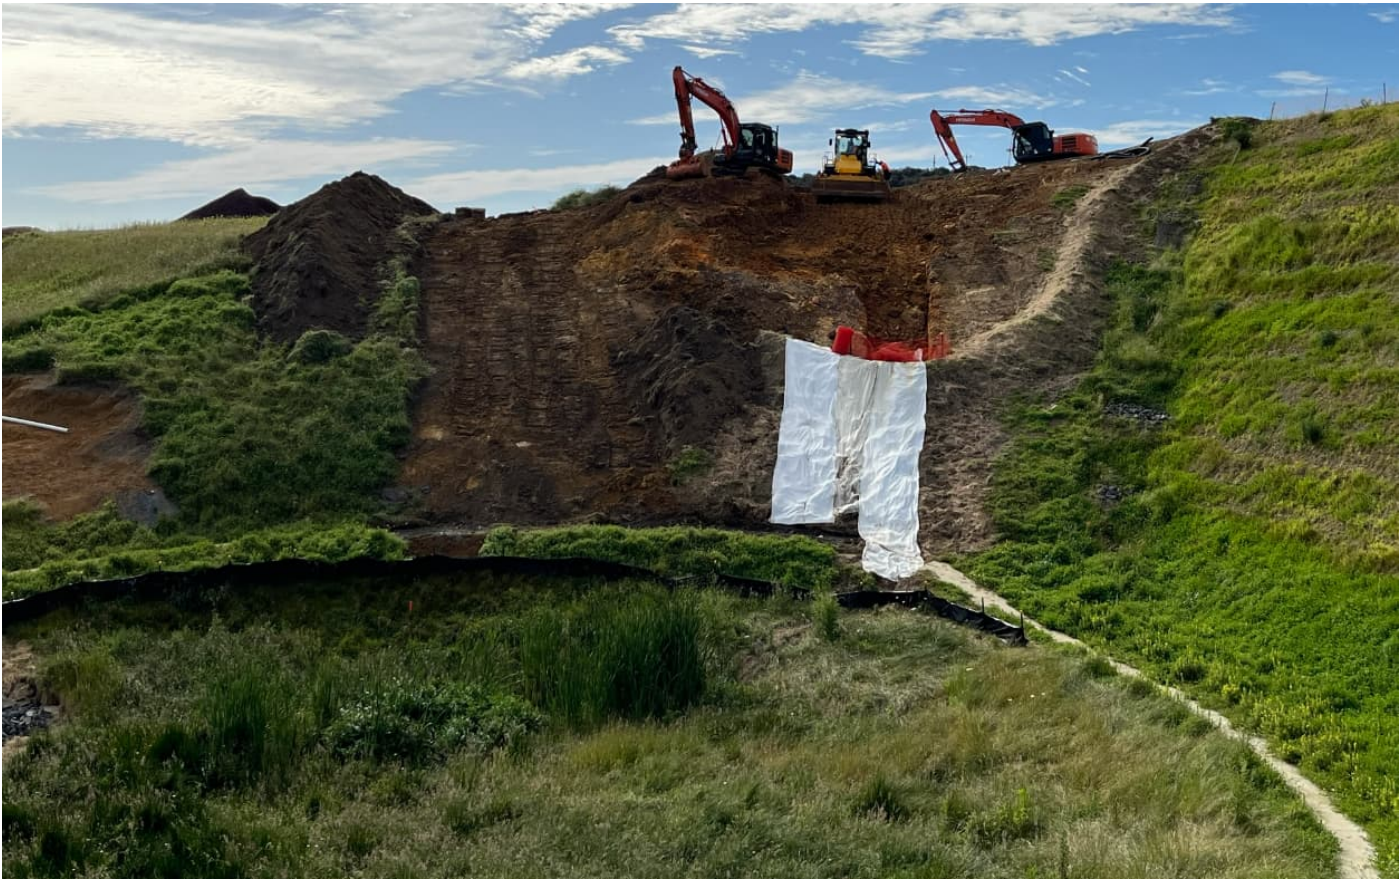
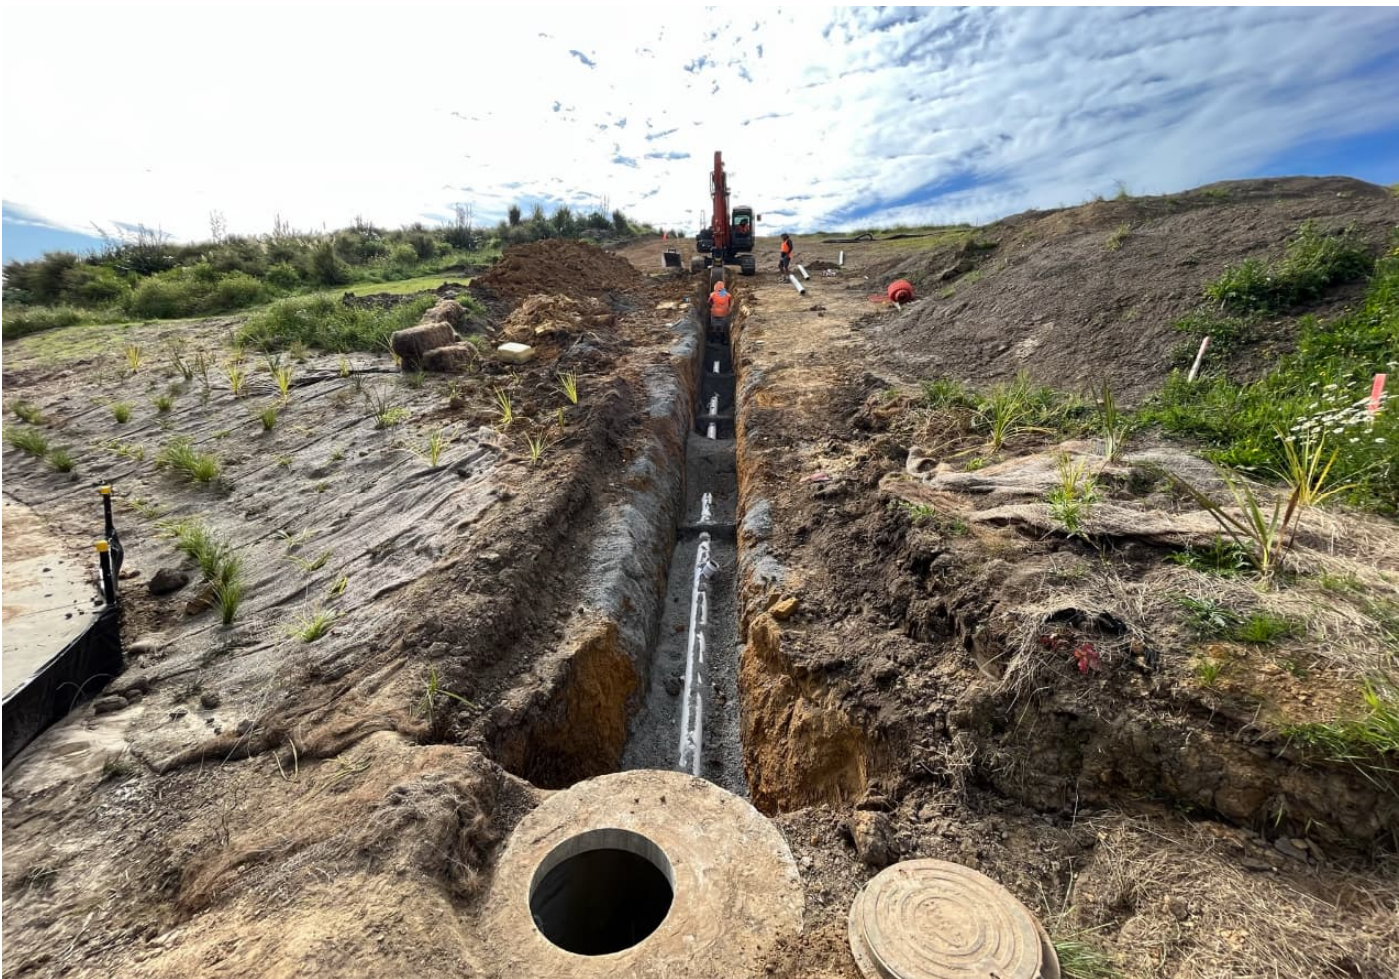
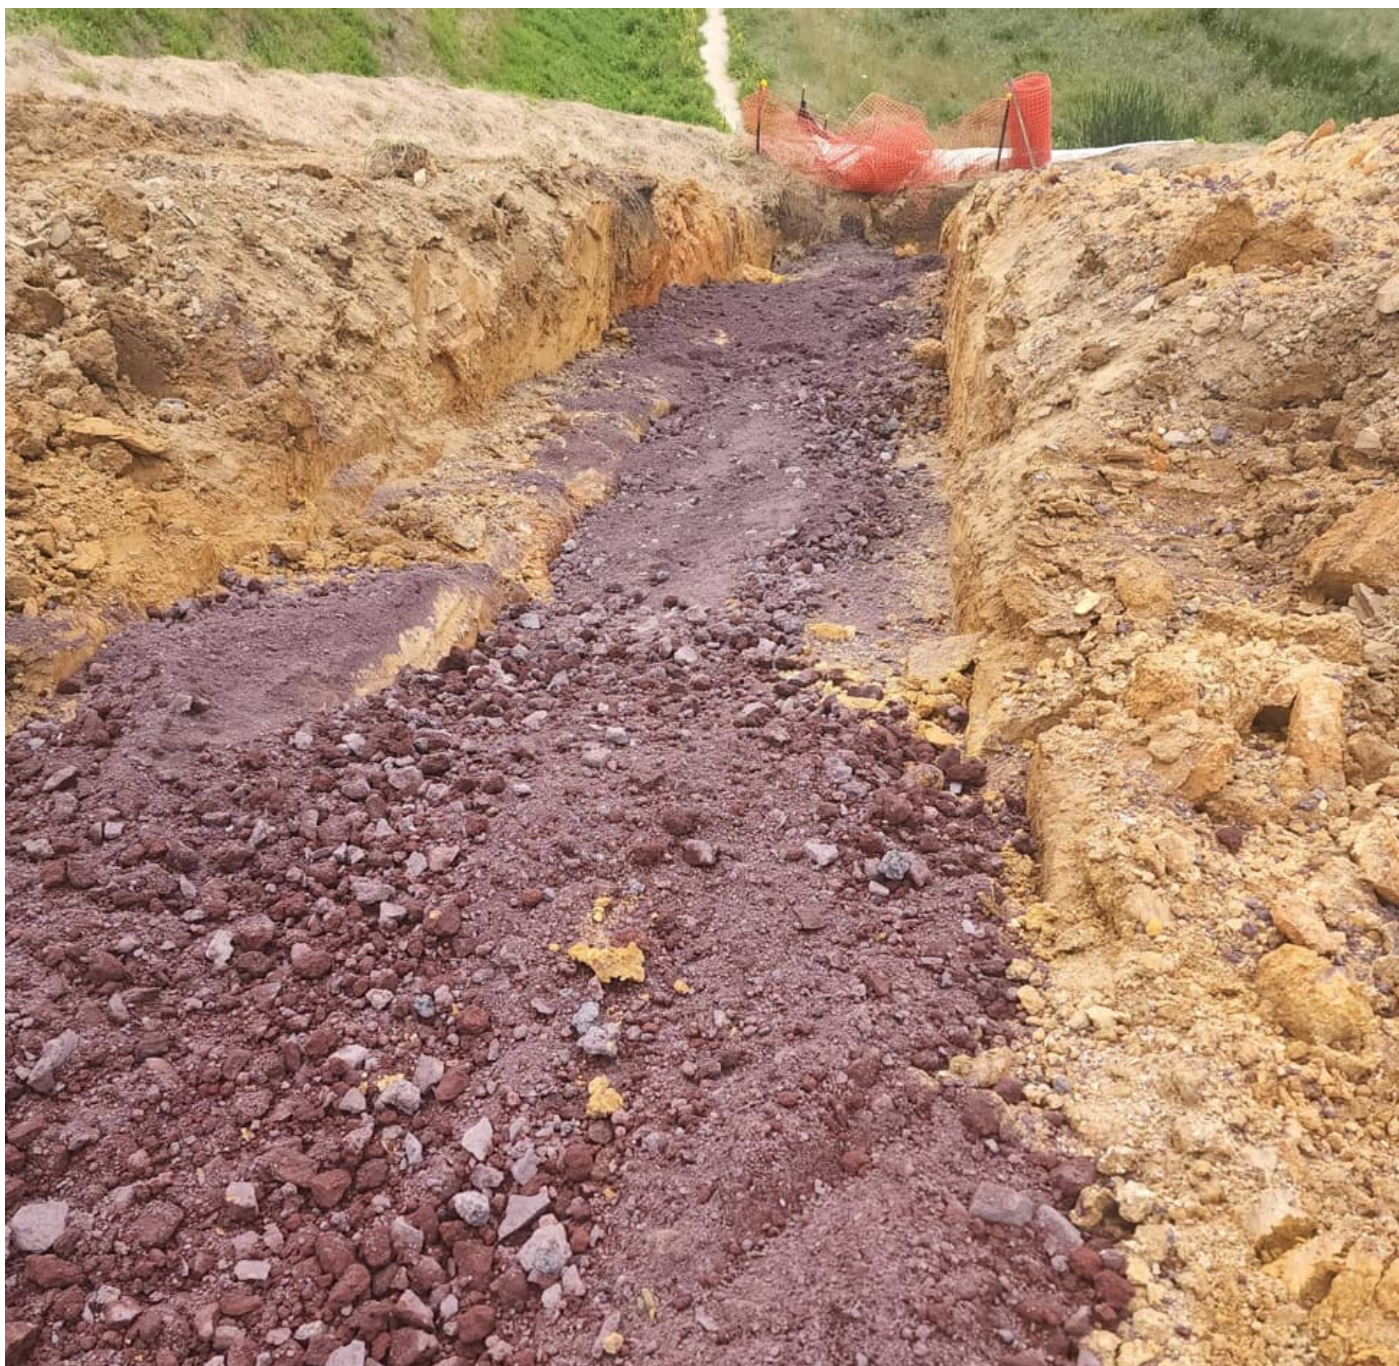
- REB 1 appears to have new vegetation growth within the face of the slope. Contractor advised that the face will be hydroseeded during the next fine weather window. They are aiming for today or tomorrow.
- Inspected the existing slip behind Lot 945. No additional movement appears to have happened since this was originally observed and assessed in September 2022. Groundwater was noted to be seeping from several points within the exposed transition materials.
- Contractor awaiting fine weather window to continue work on cutting the building platform within Lot 951.
- Inspected backfill along WWN1, which returned shear vanes in excess of 150kPa.
- Observed set out of 3x counterfort drains below Lot 925 with set out in accordance with our recommendations. Contractor advised a maximum distance between these drains of 7.5m applies at the upslope extent of the drains.

Counterfort construction in accordance with our design. Drainage line subgrade suitable for pipe placement.

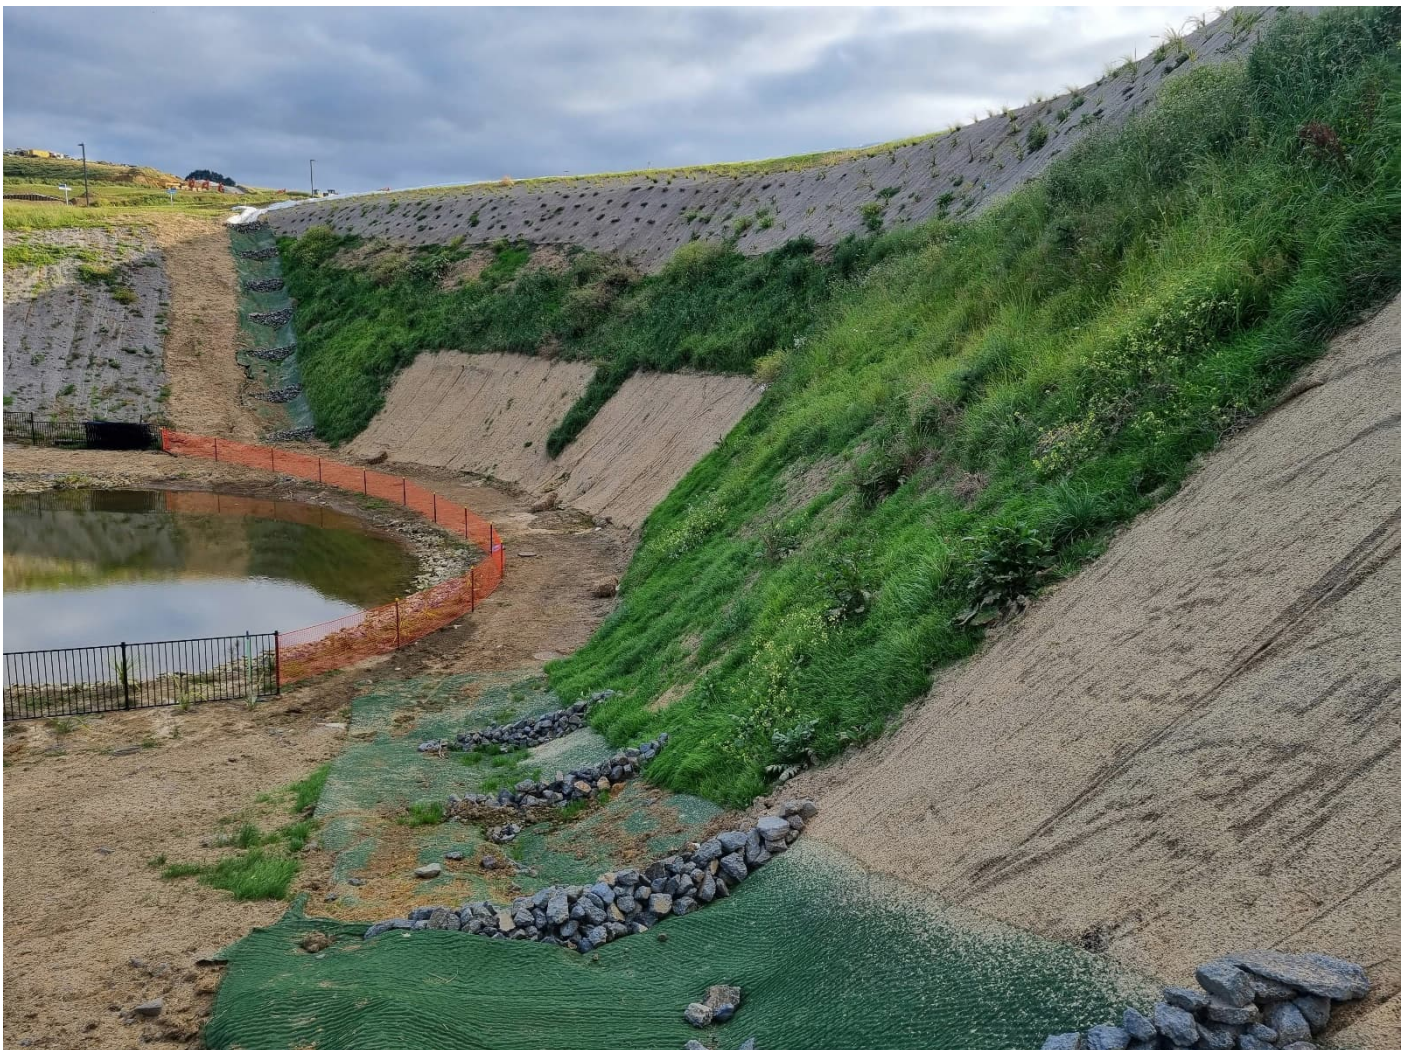
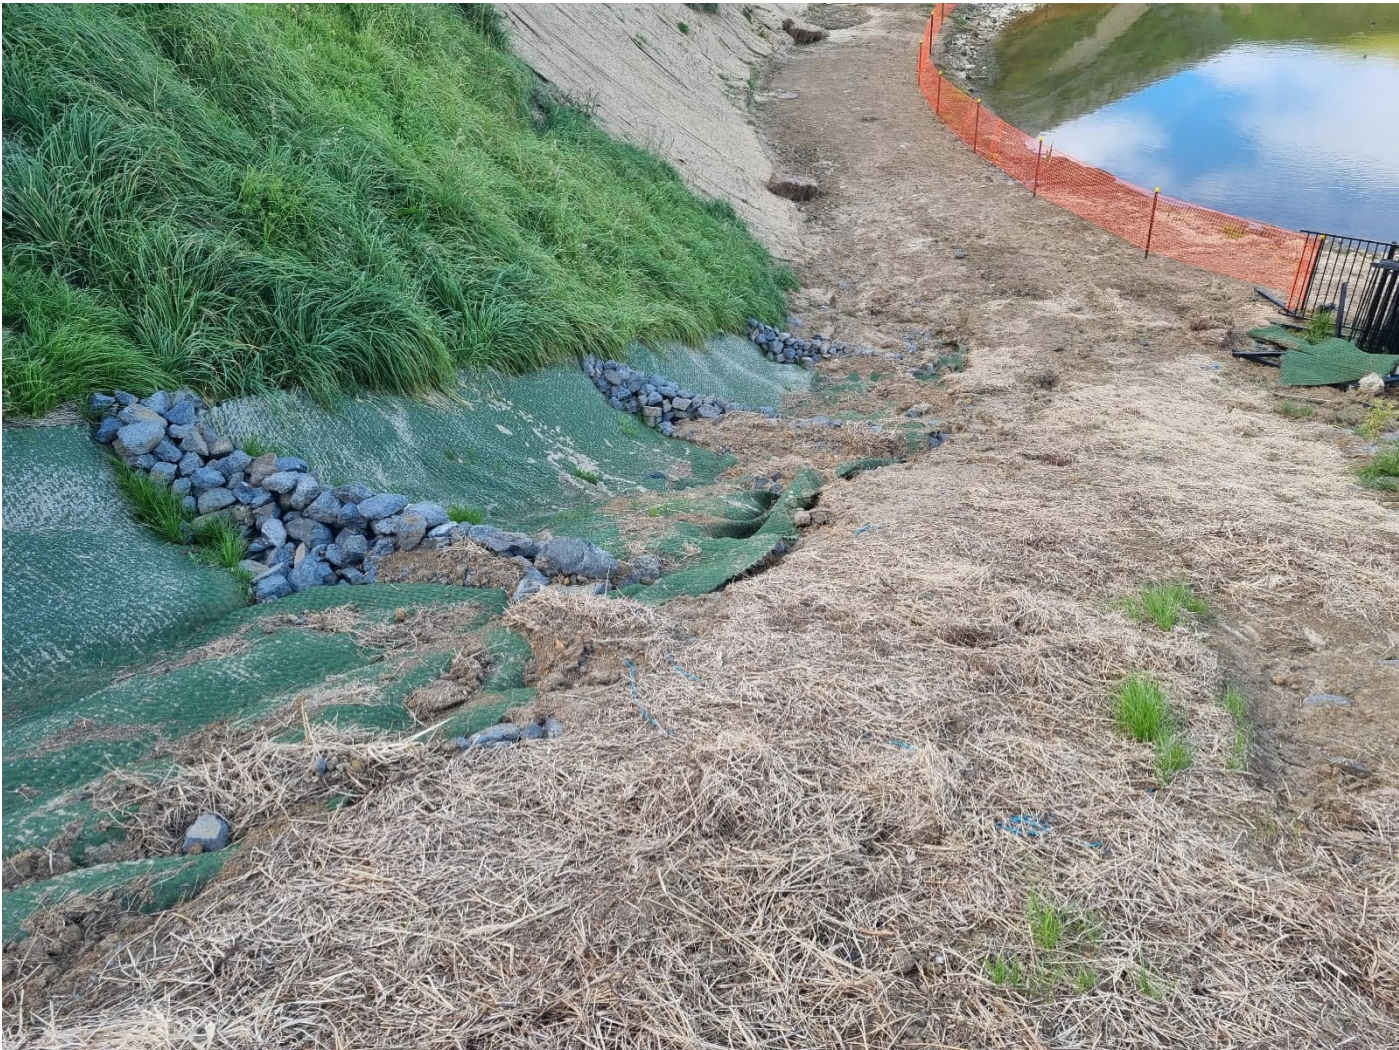
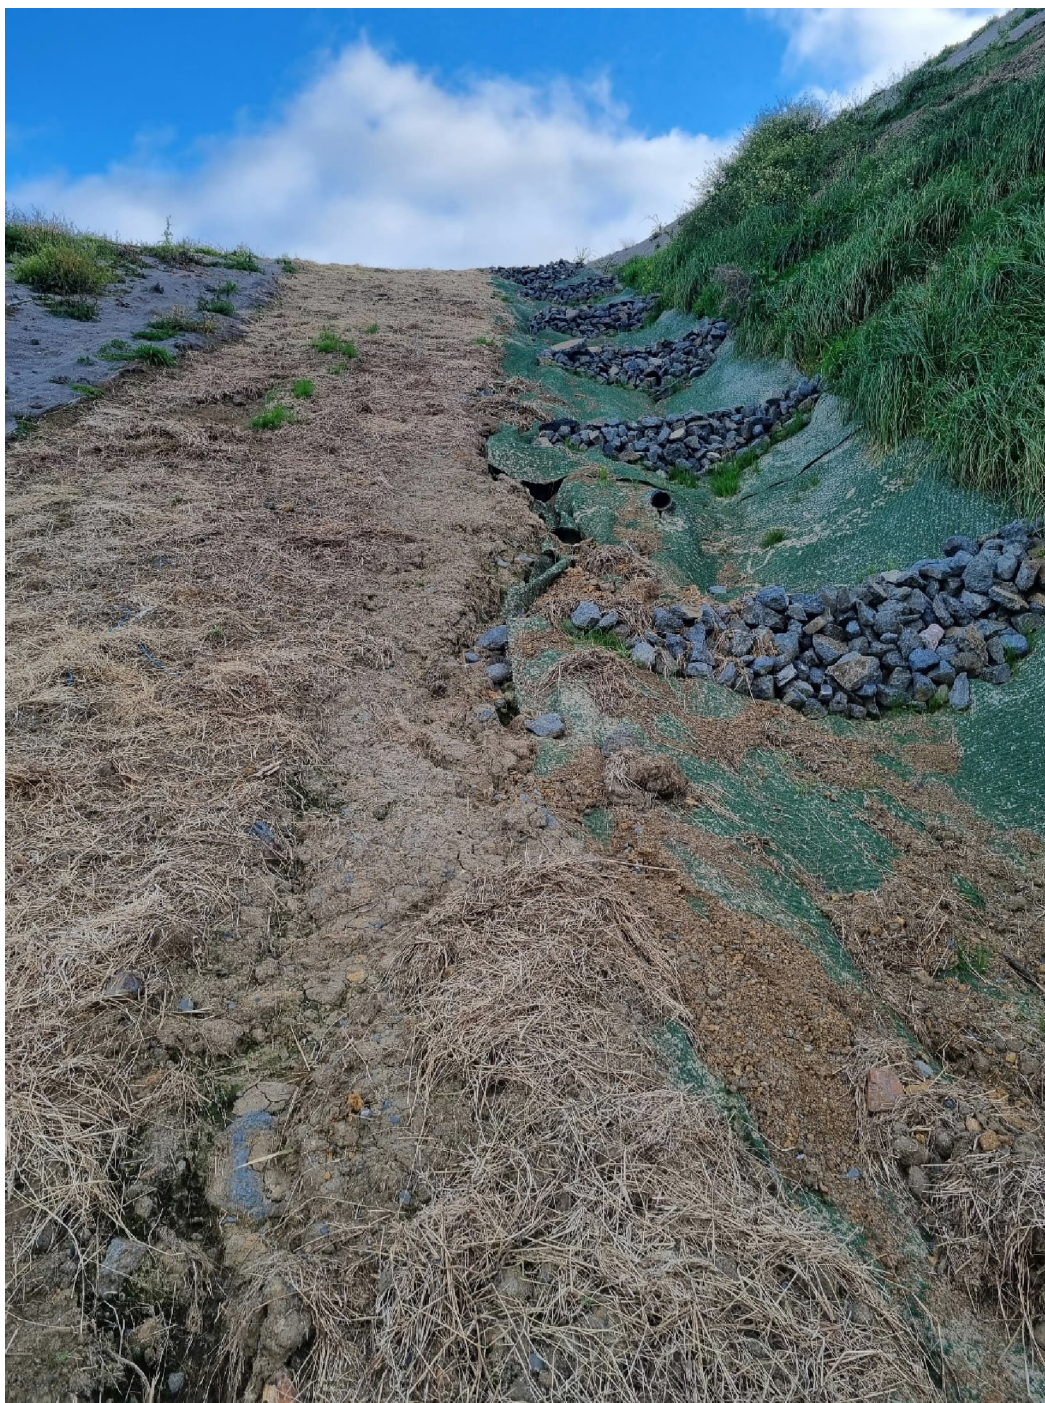
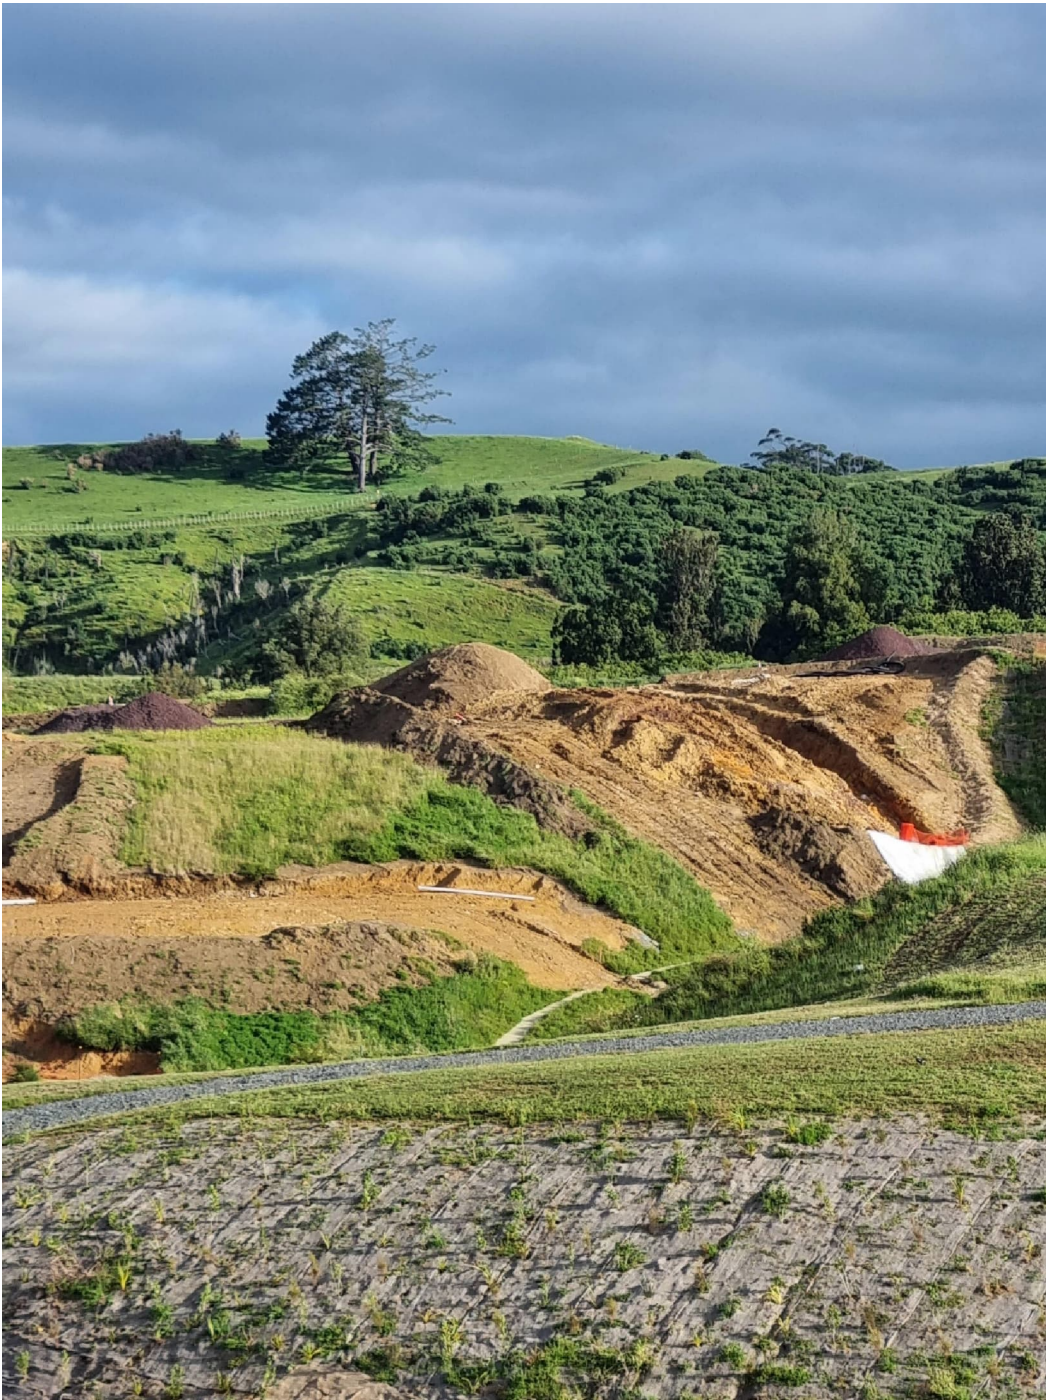
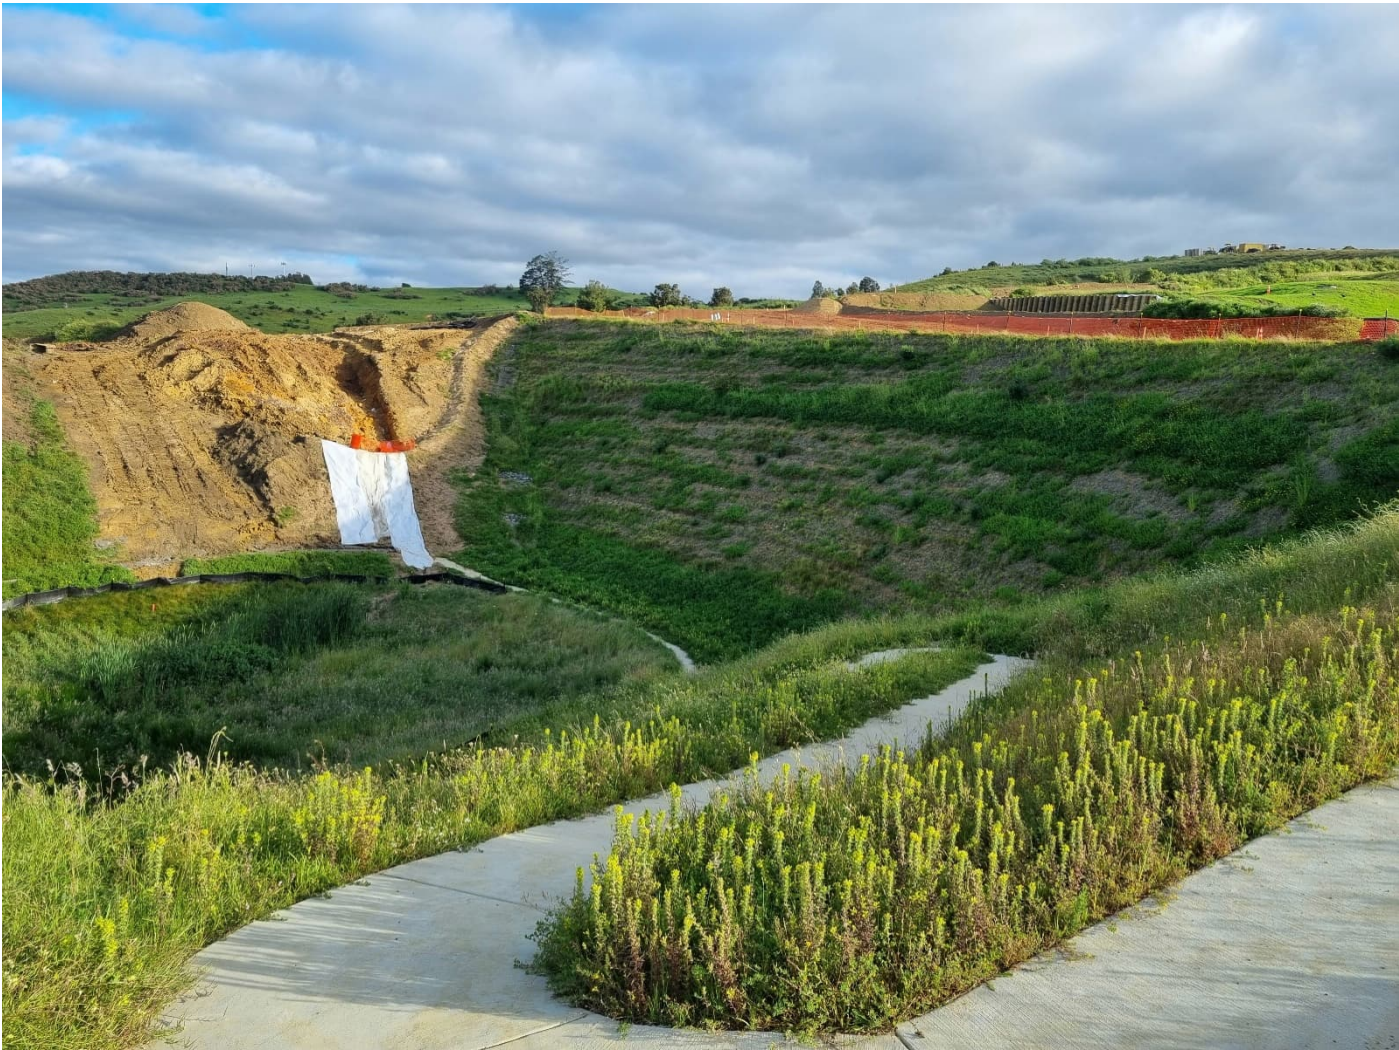
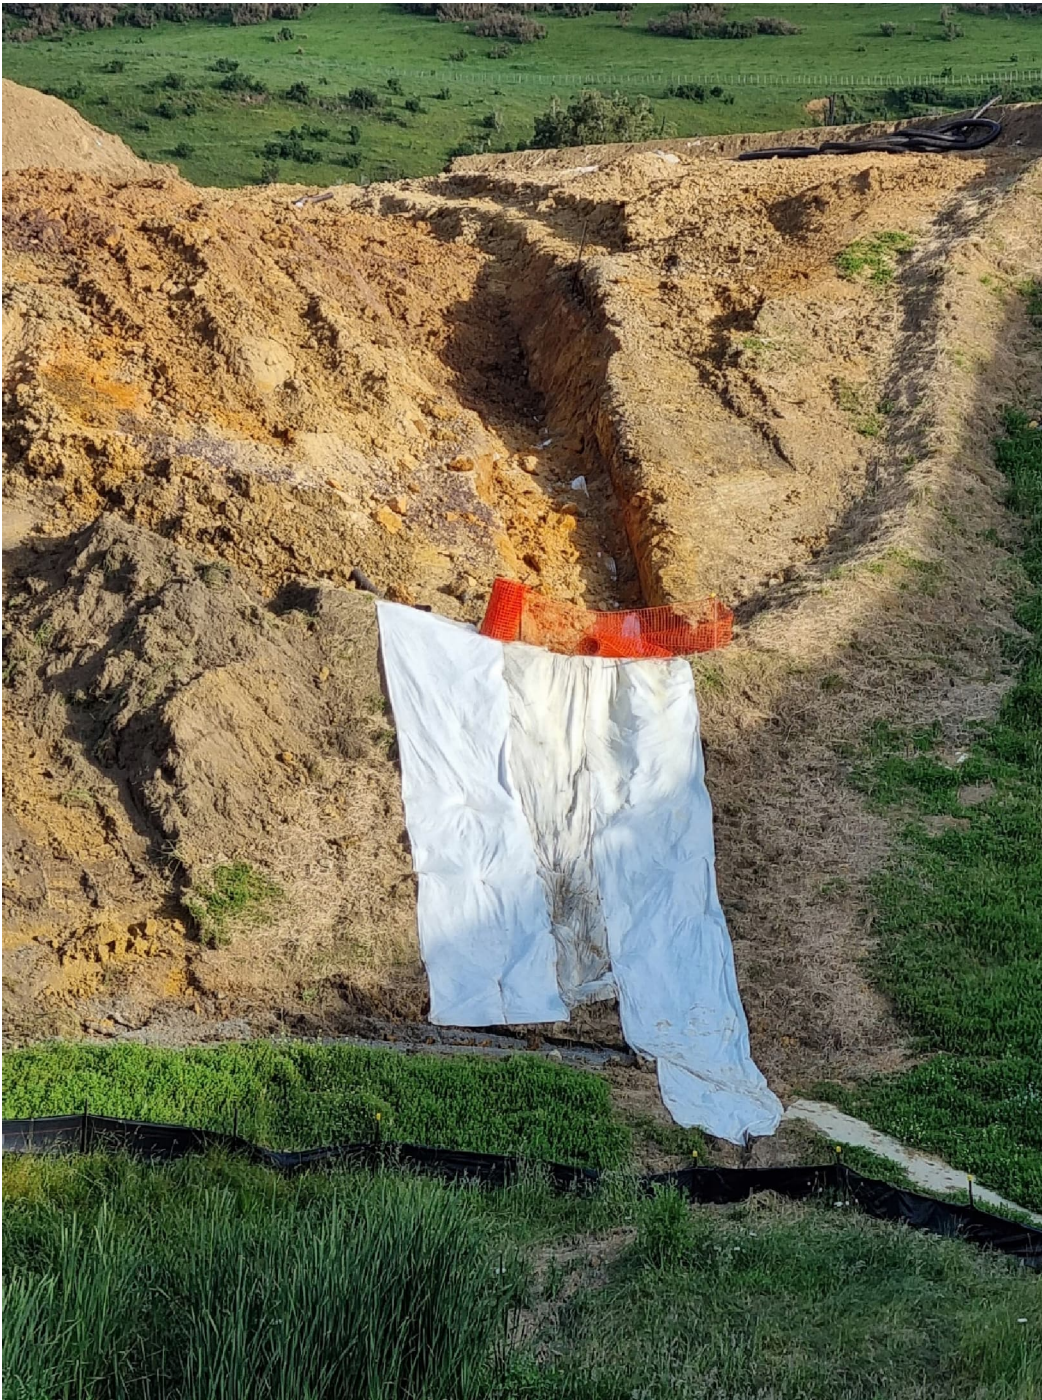
Date:	7/12/2022	Time:	4pm
LDE Project Ref:	J00113	Inspected by:	Chris Edwards
Project:	J00113 - Hitchen Block Stage 2, Pokeno

- REB 1 has been hydroseeded again. There has been some slumping beneath the matting again (but is minor visually).
- The side check dams appear ok, but there is erosion occurring along the edge of the matting where the water is getting beneath the matt. Need to fix this and plan out the sides in due course.
- Counterfort drains appear to be being installed. See photos.
