DFH Joint Venture Limited

GEOTECHNICAL COMPLETION REPORT

Hitchen Block Stage 18, Pokeno

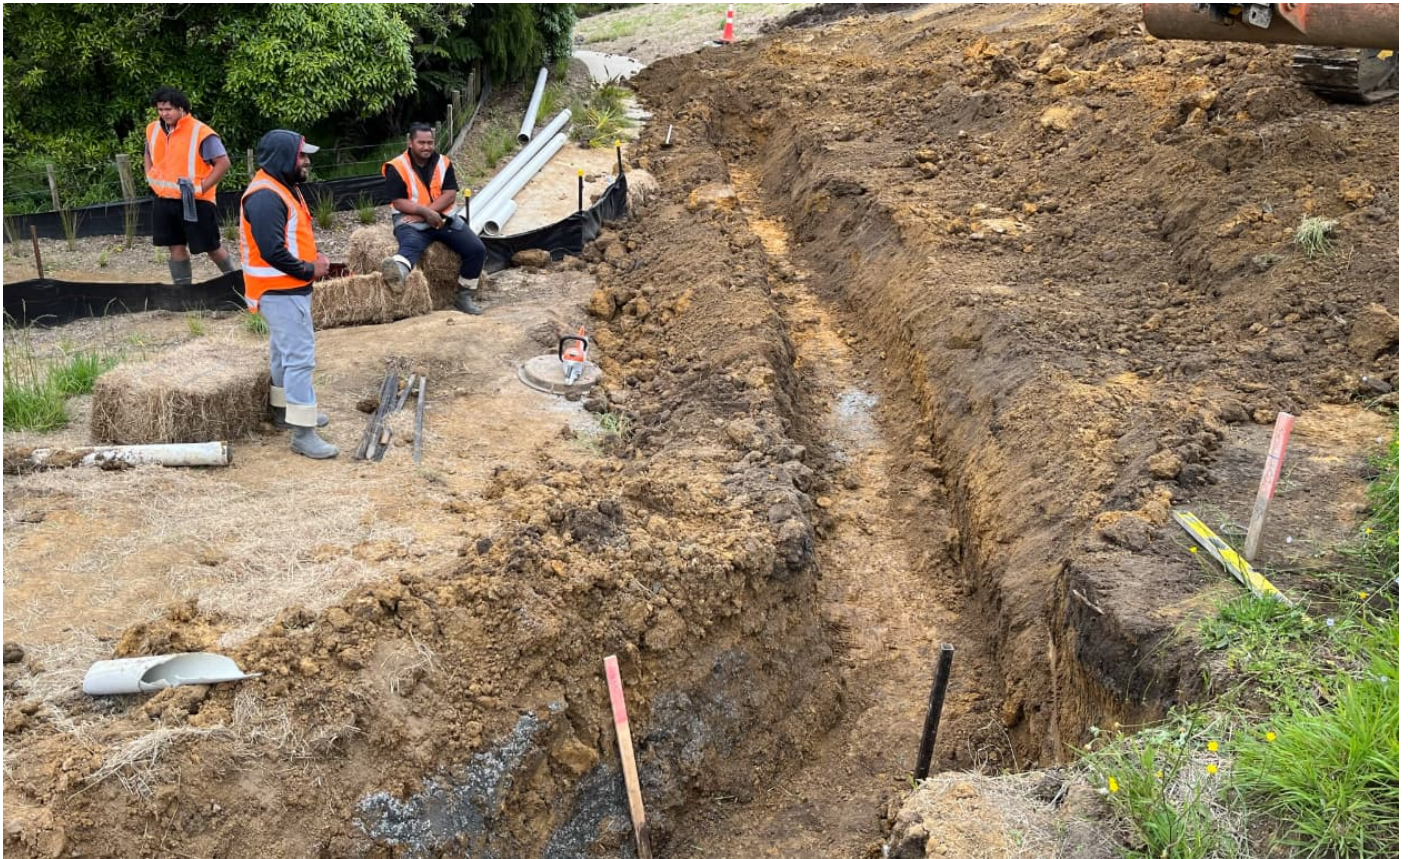
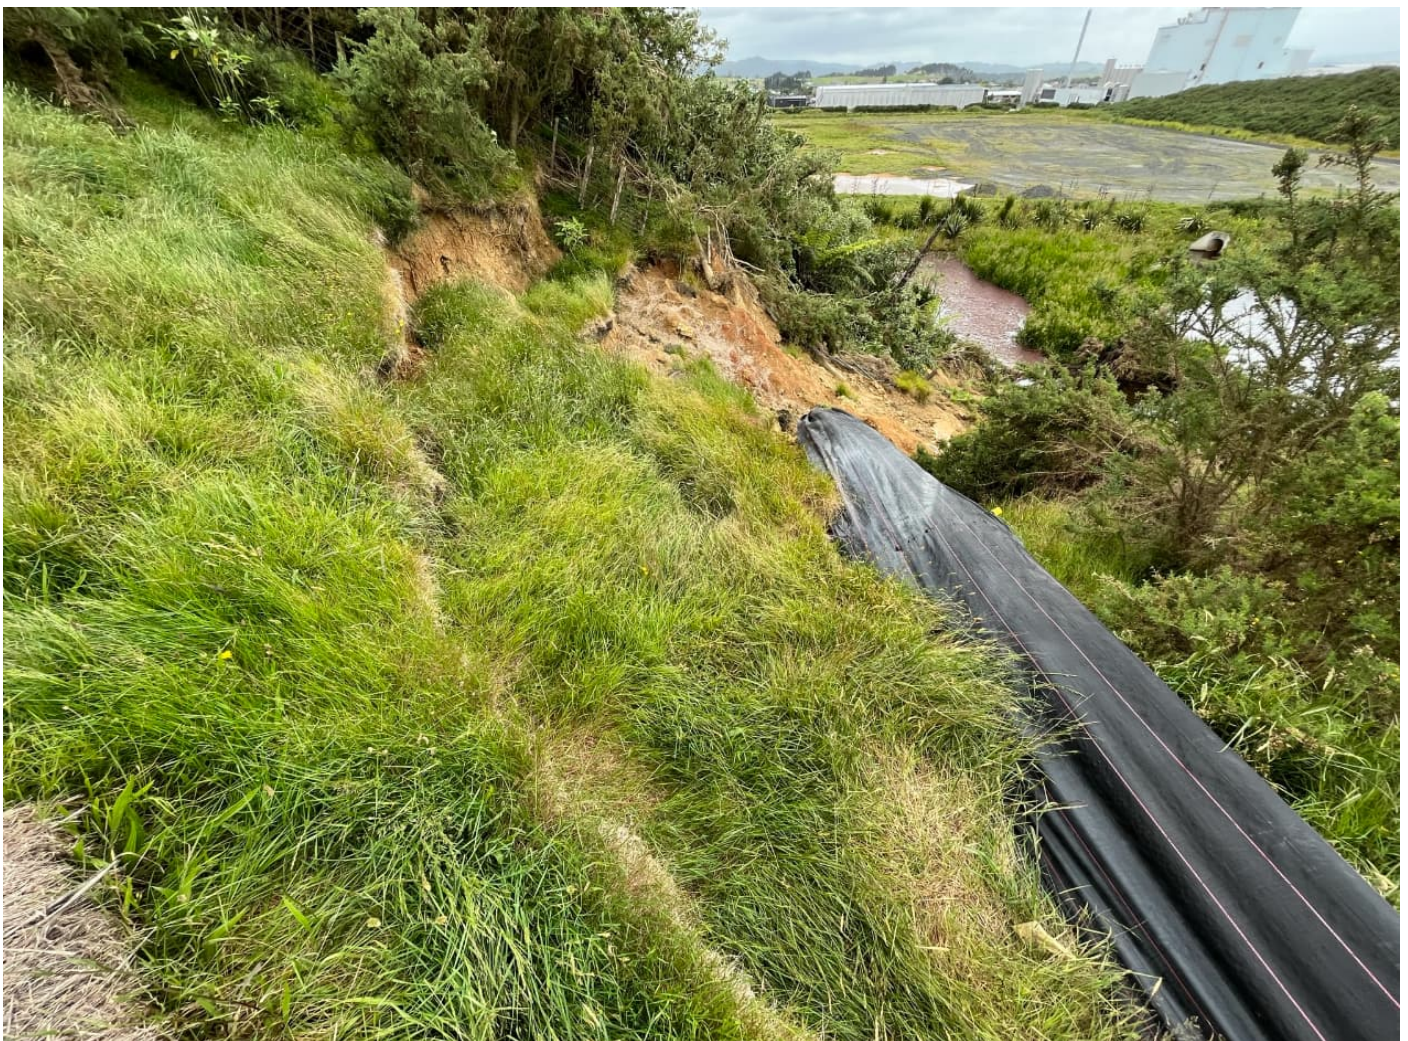
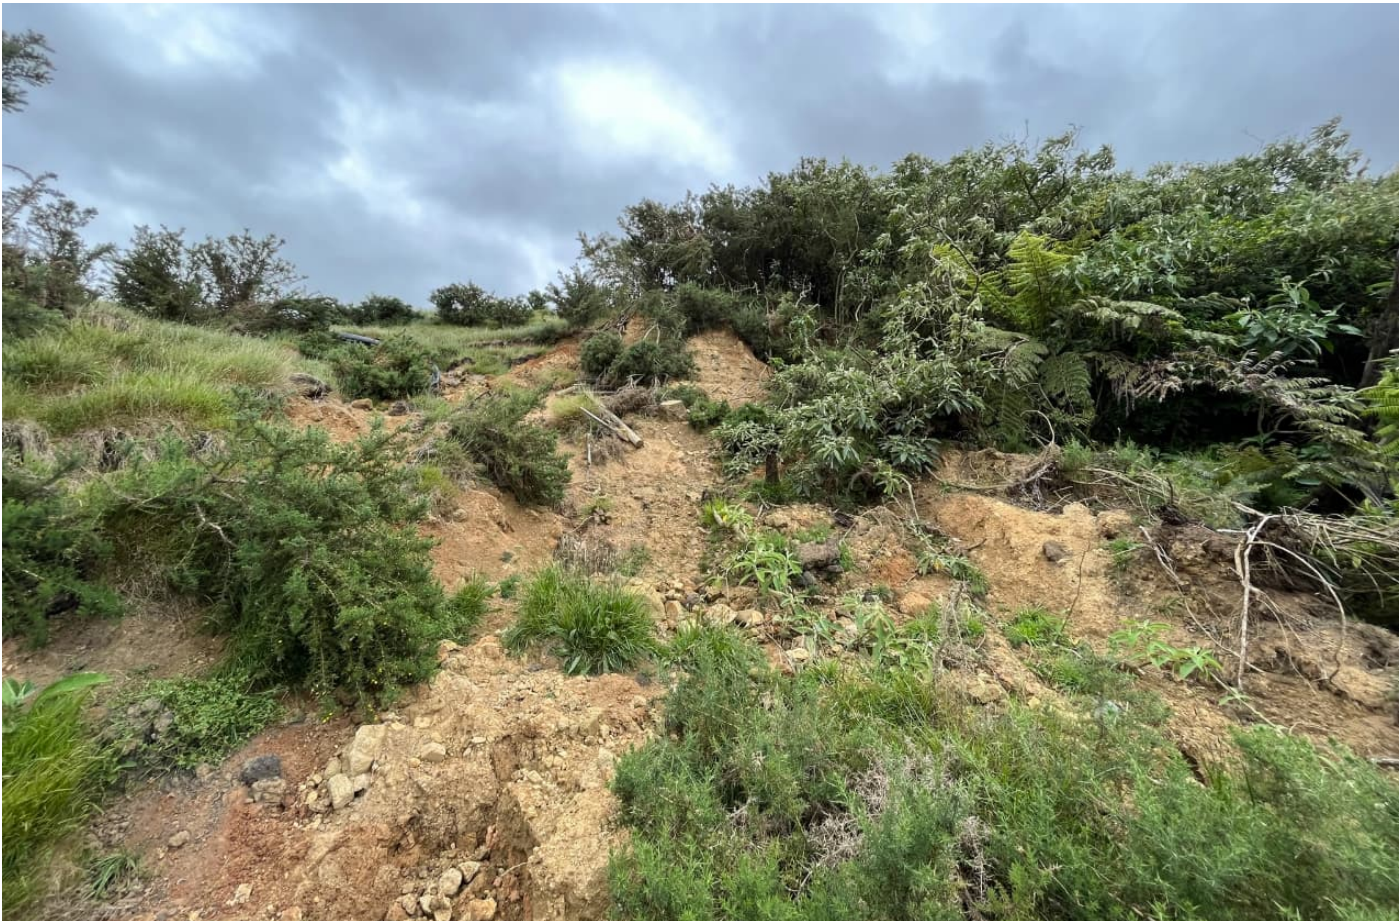
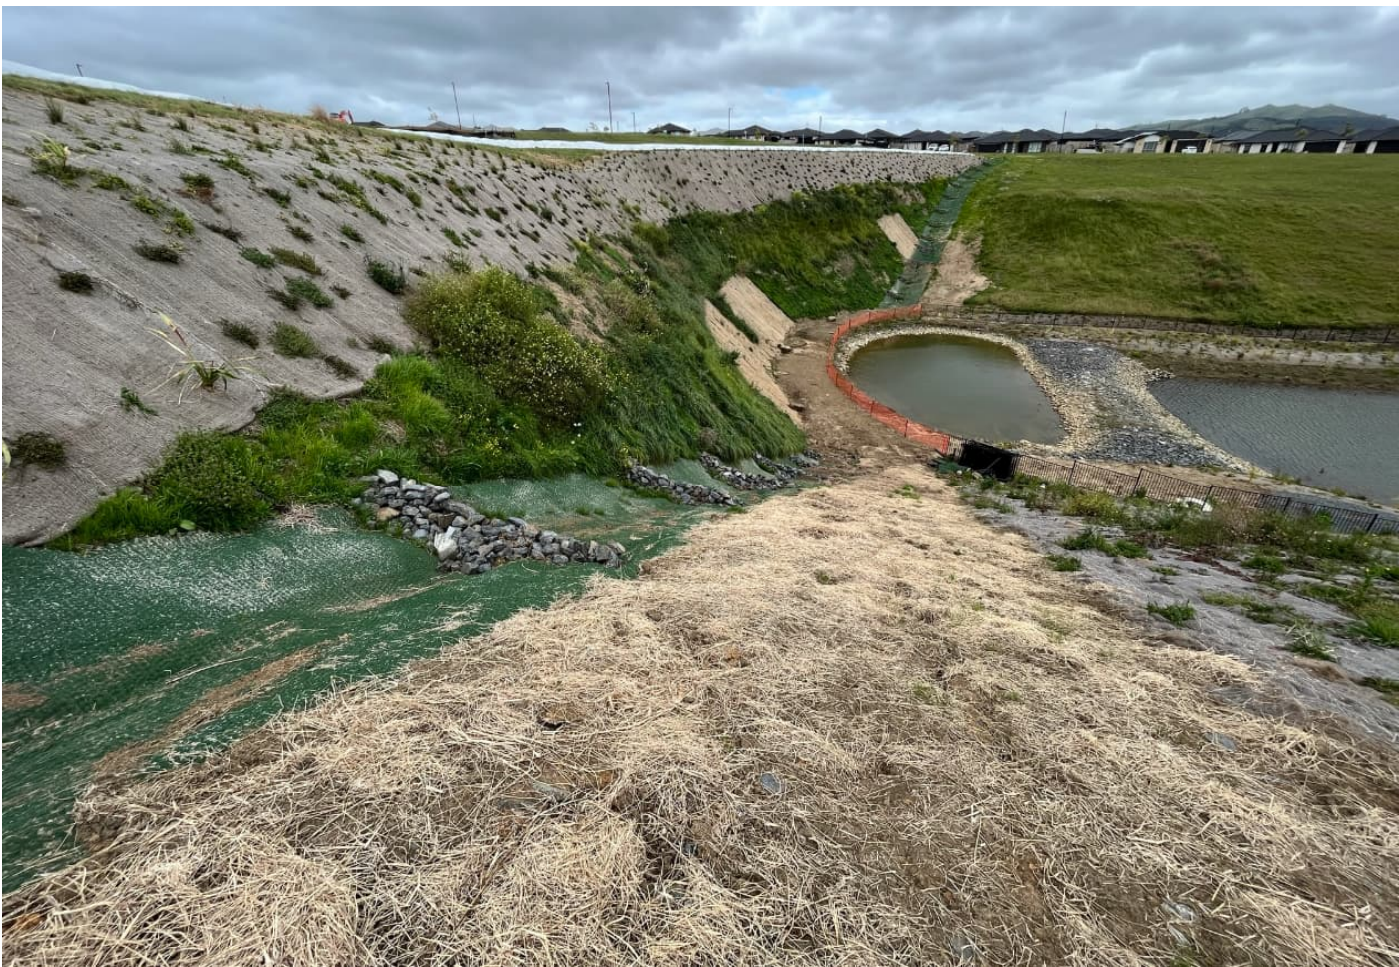
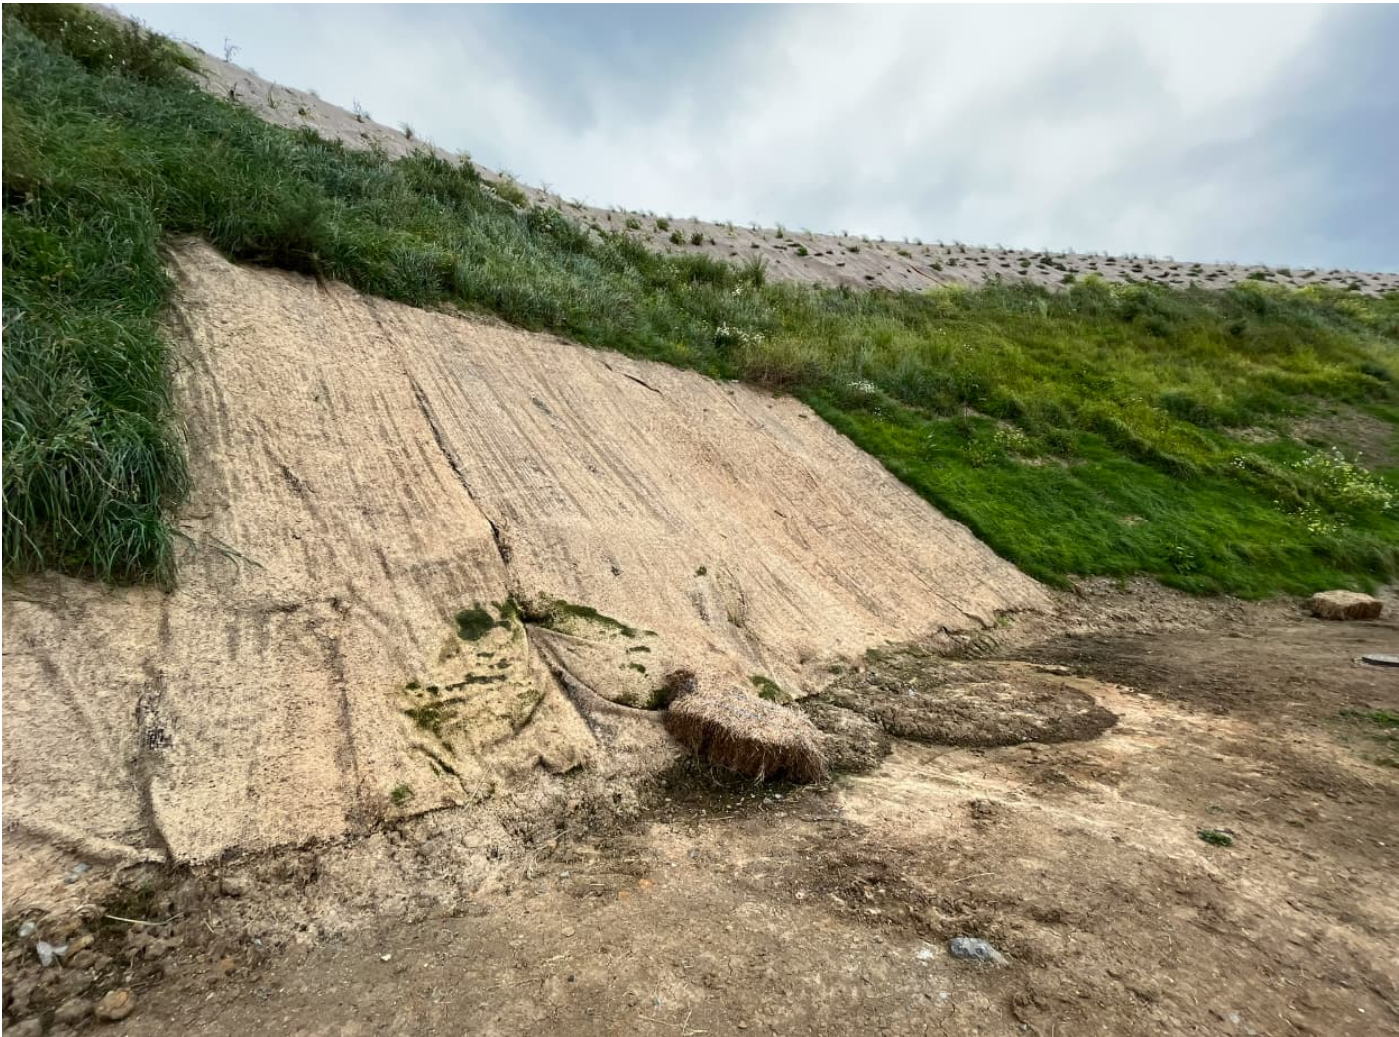
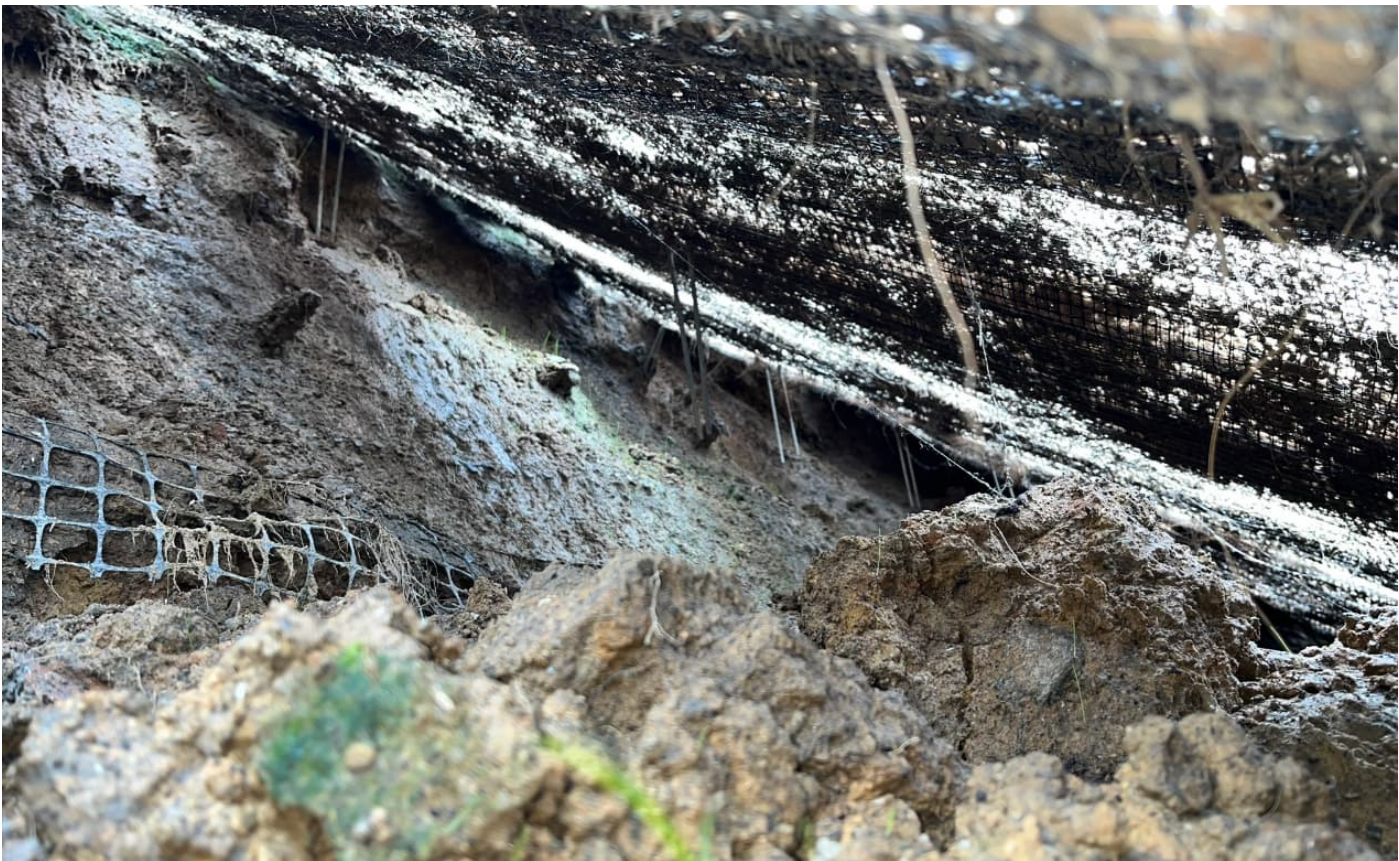
Date:	8/12/2022	Time:	10AM
LDE Project Ref:	J00113	Inspected by:	Alex Tanner
Project:	J00113 - Hitchen Block Stage 2, Pokeno

- Inspected current excavation progression for counterfort drain. Depth of drain was approximately 6 metres below cleared ground level. Contractor advised that the side walls of the trench were stiff, with no instability / failures during excavation progress. Drain appears in accordance with our design.

- Slip behind Lot 945 appears to remain unchanged since our last inspection (28/11/22). Recommended to contractor to monitor the face for movement. Recommended to hold meeting between LDE and Dines to confirm remediation methodology during earthworks season.

- Observed topsoil slumping beneath matting at base of REB. Inspection beneath matting revealed an area (roughly 2x2m in size) where recently placed topsoil has slipped, exposing the geogrid and fill behind. Recommended to contractor to bury long edge of check dam matting into the slope to prevent overland flows from eroding beneath the matting. Recommended to remediate topsoil slumping and re-hydroseed during the next fine weather window.

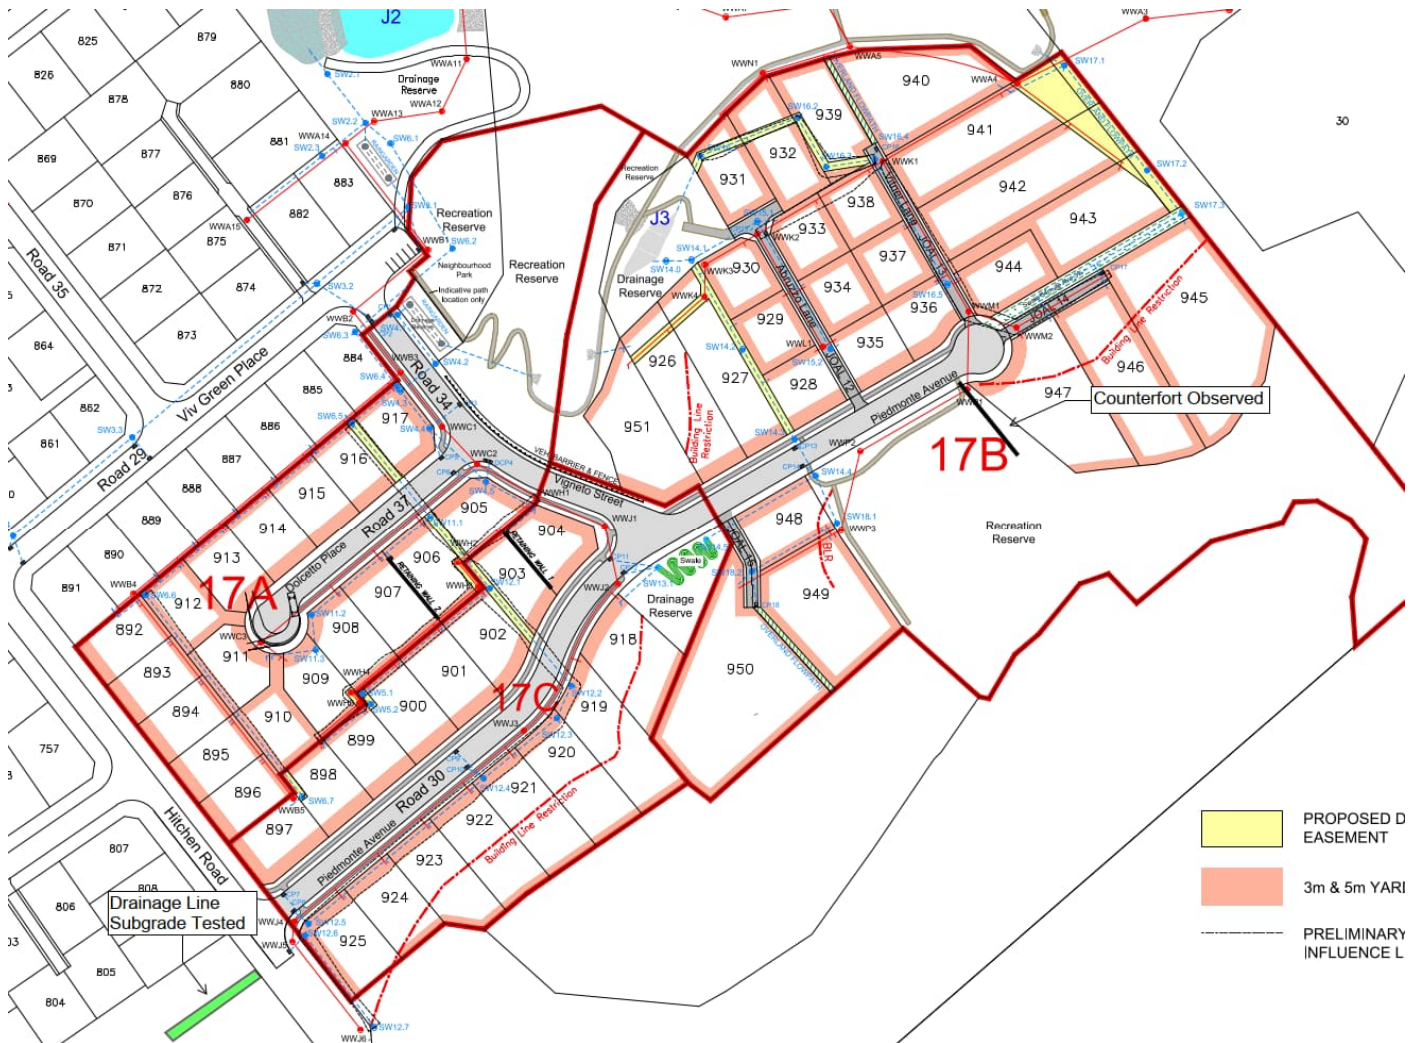
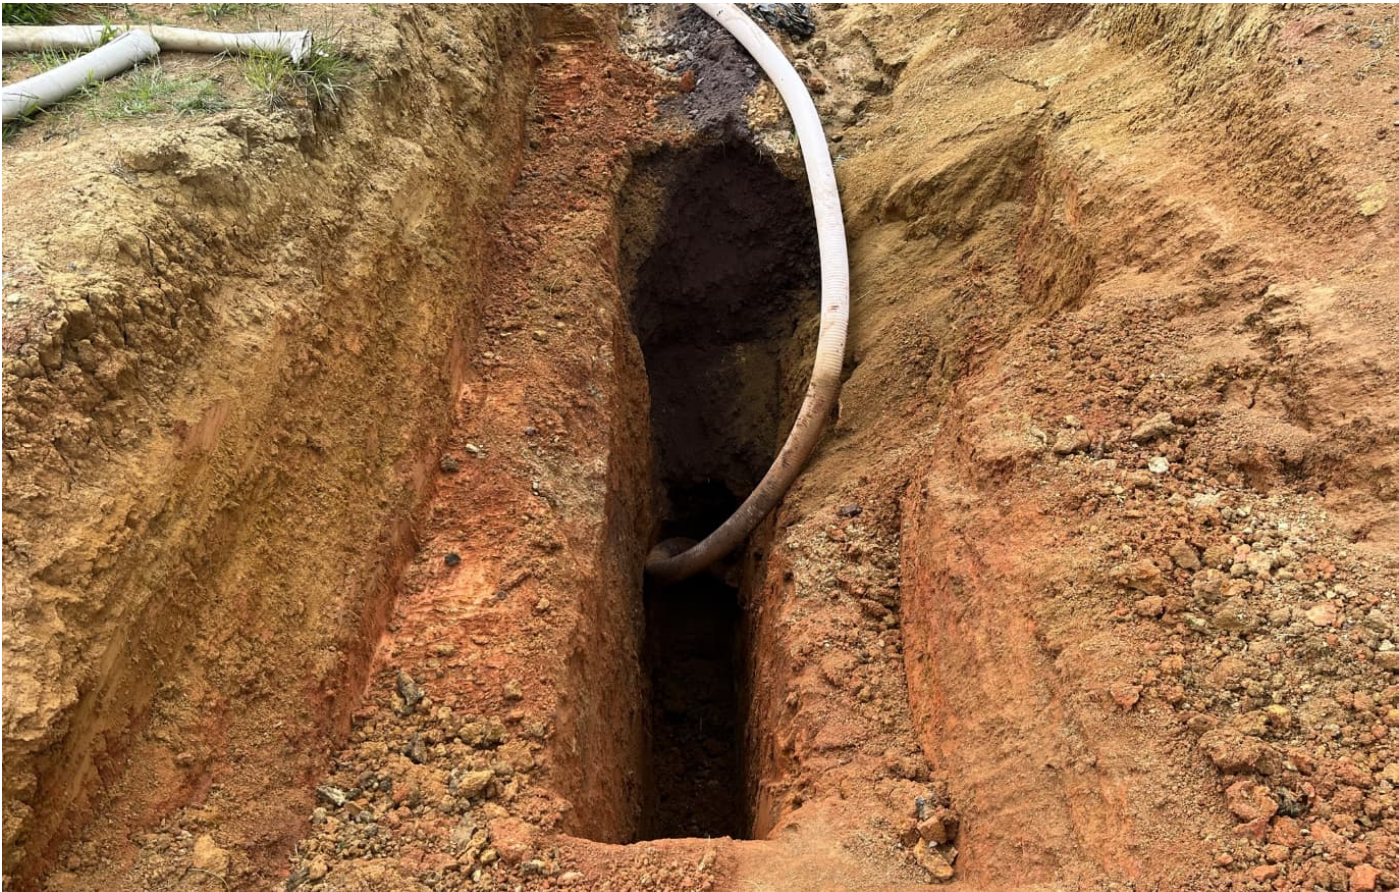
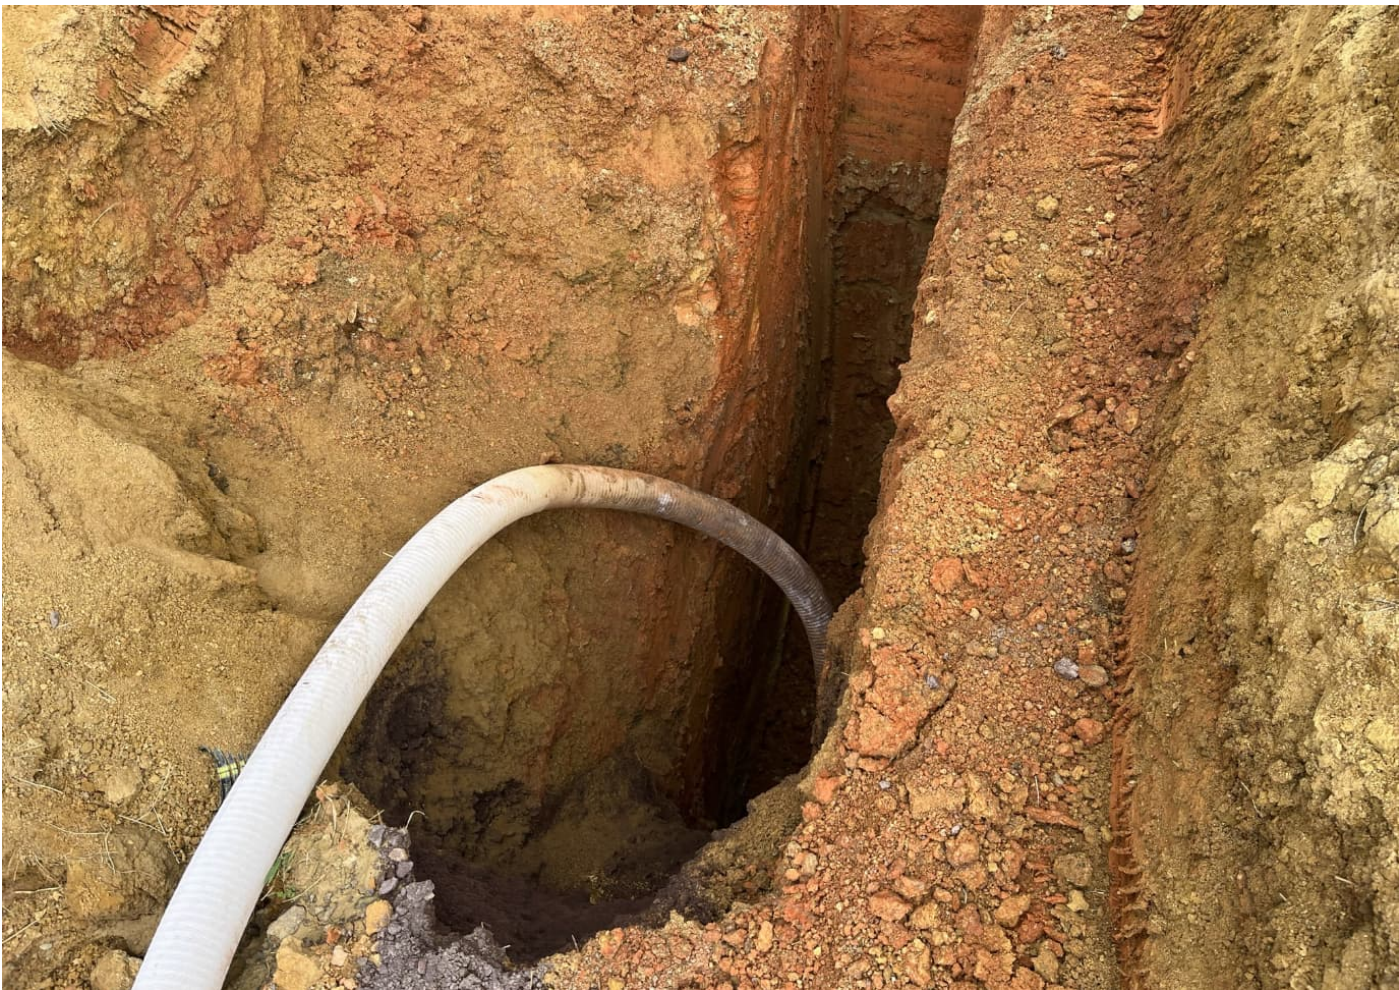
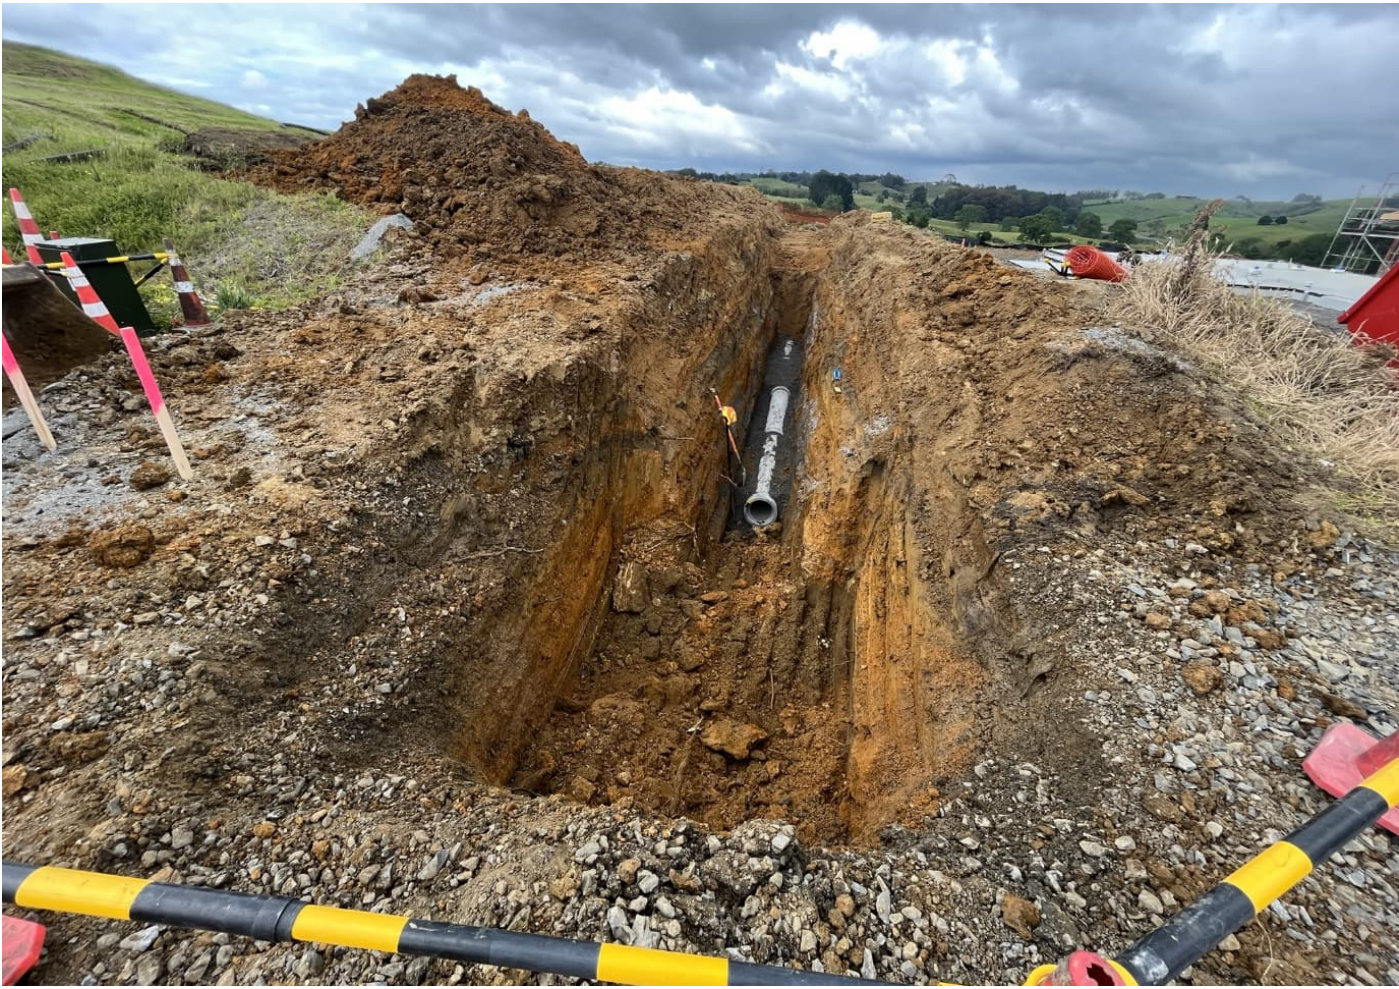
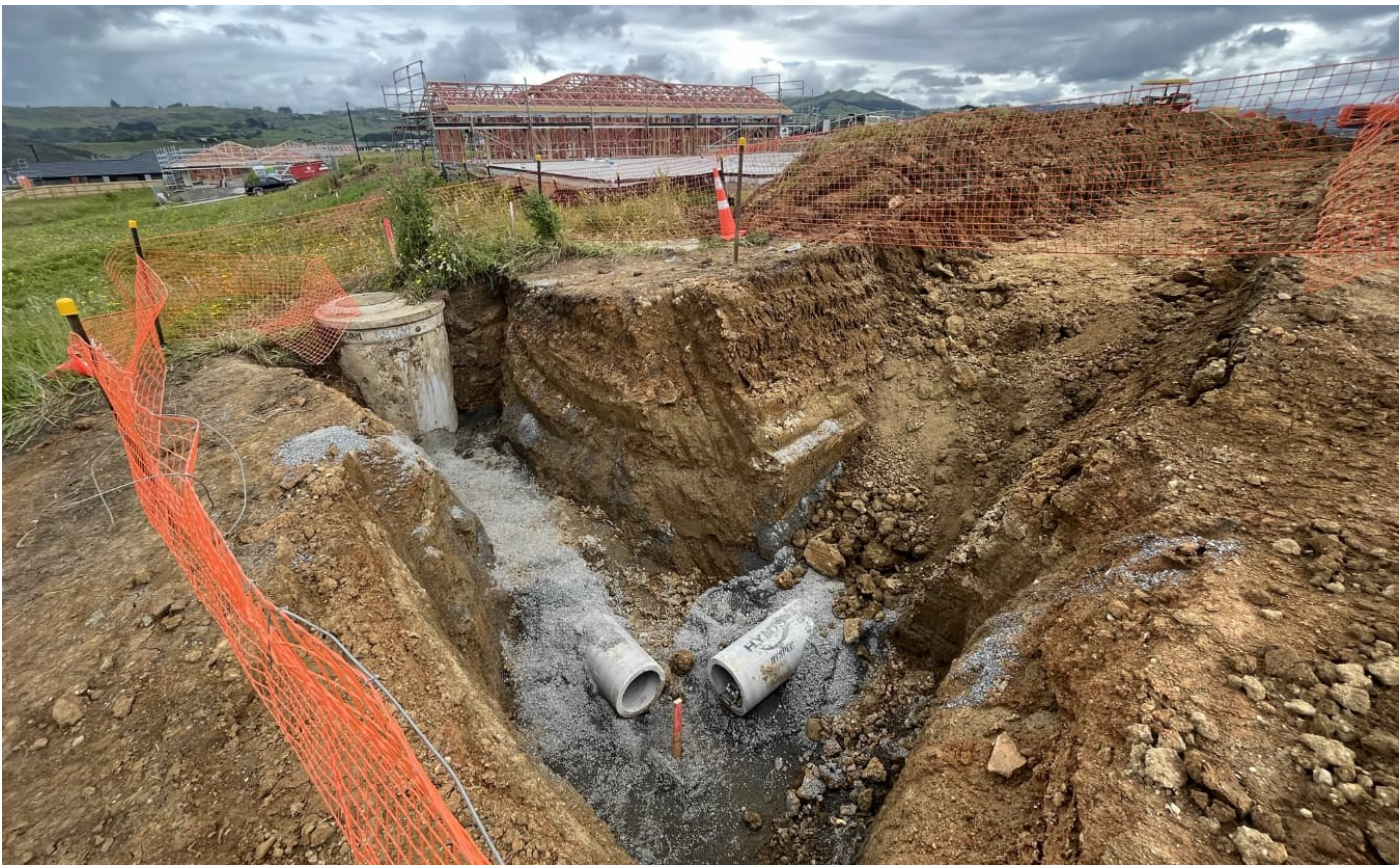
Date:	13/12/2022	Time:	11AM
LDE Project Ref:	J00113	Inspected by:	Alex Tanner
Project:	J00113 - Hitchen Block Stage 2, Pokeno

- Counterfort excavation was approximately 6 metres in depth, and was founded in natural materials. Drainage coil and backfill material in accordance with our design.
- Drainage line inspected was founded in very stiff, inorganic, natural materials with measured shear vanes in excess of 100kPa.

Counterfort in accordance with design. Drainage subgrade satisfactory for pipe placement.

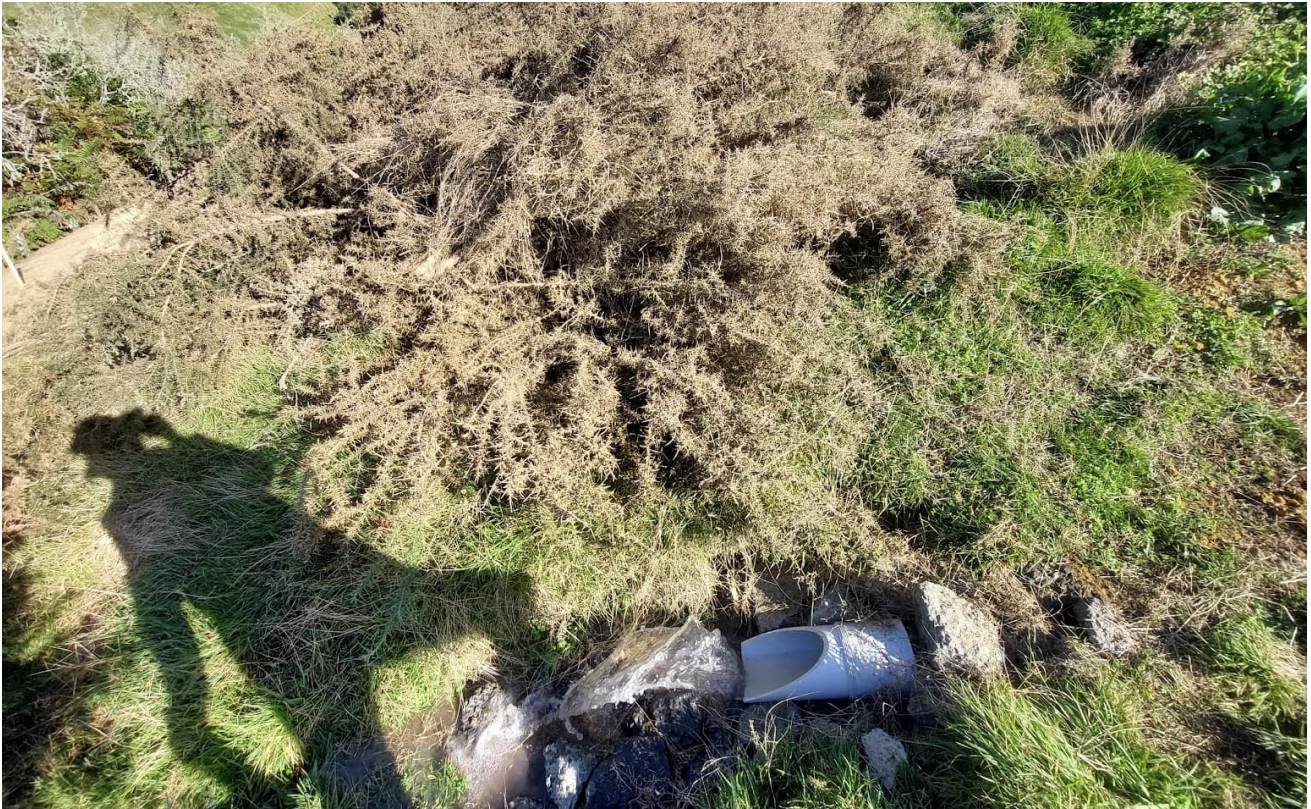
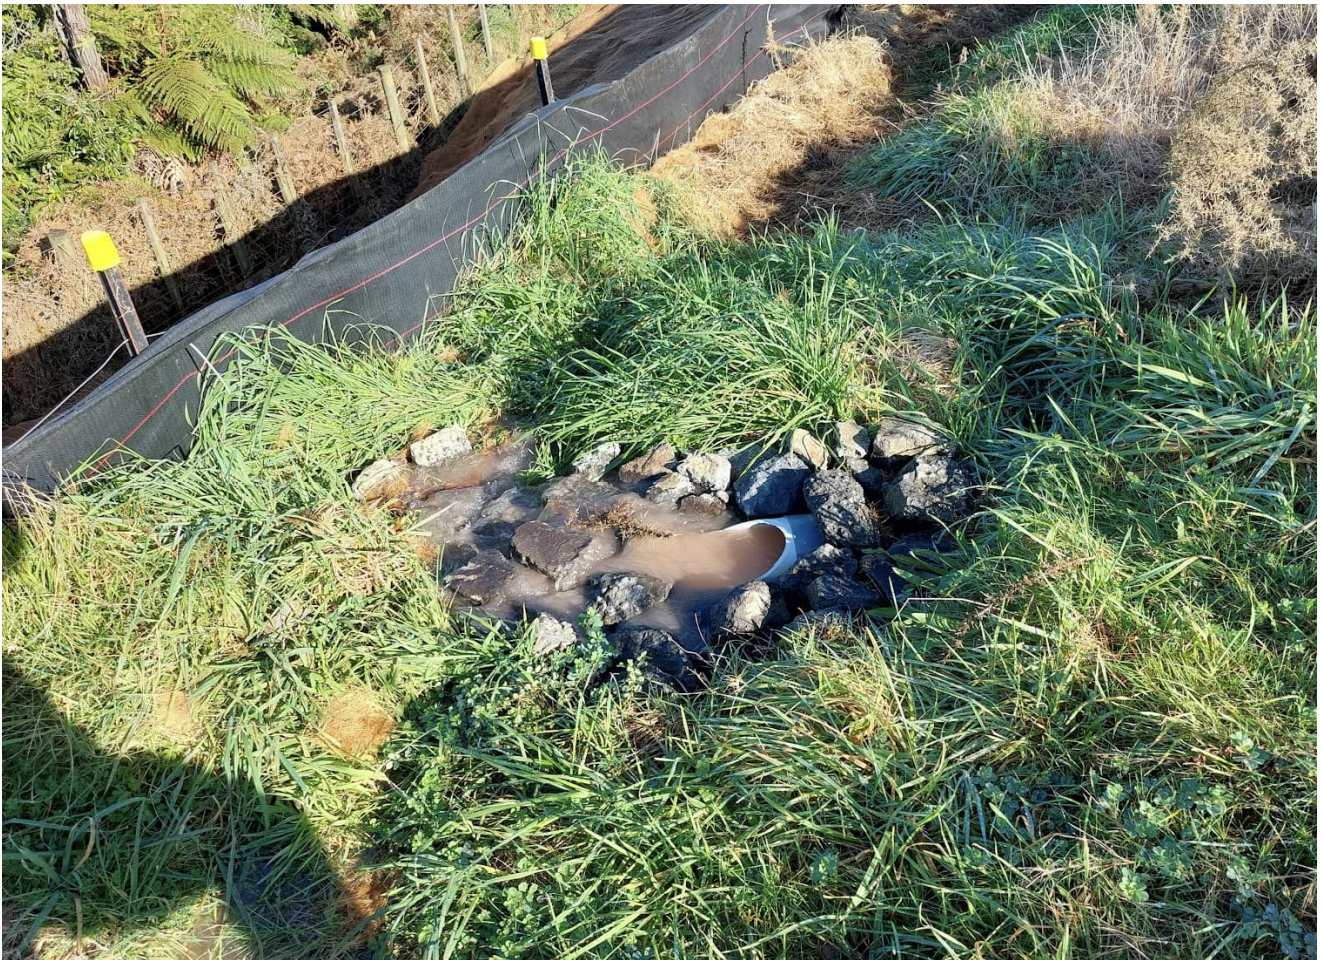
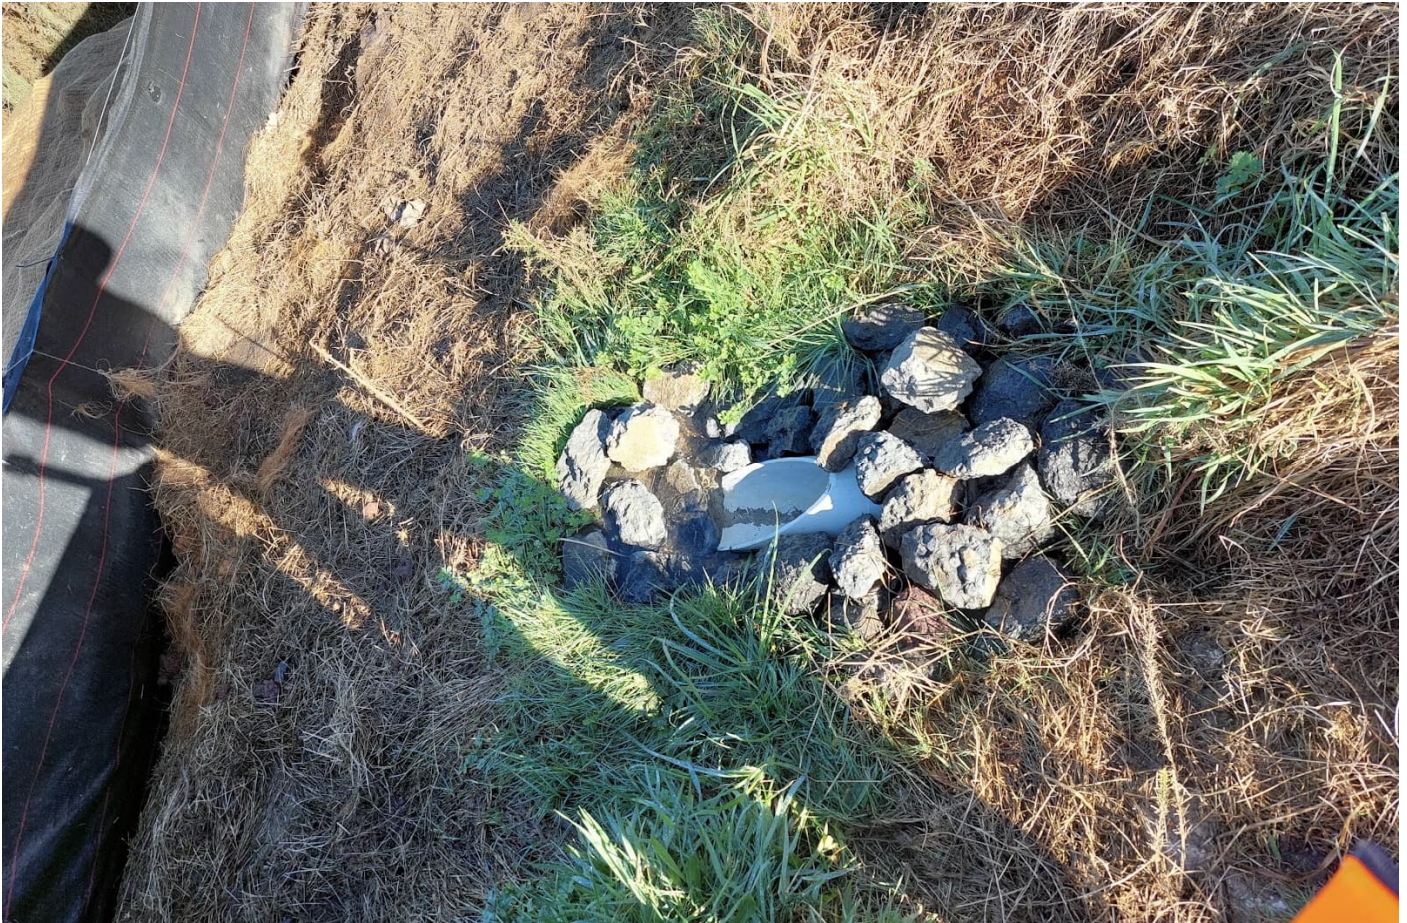
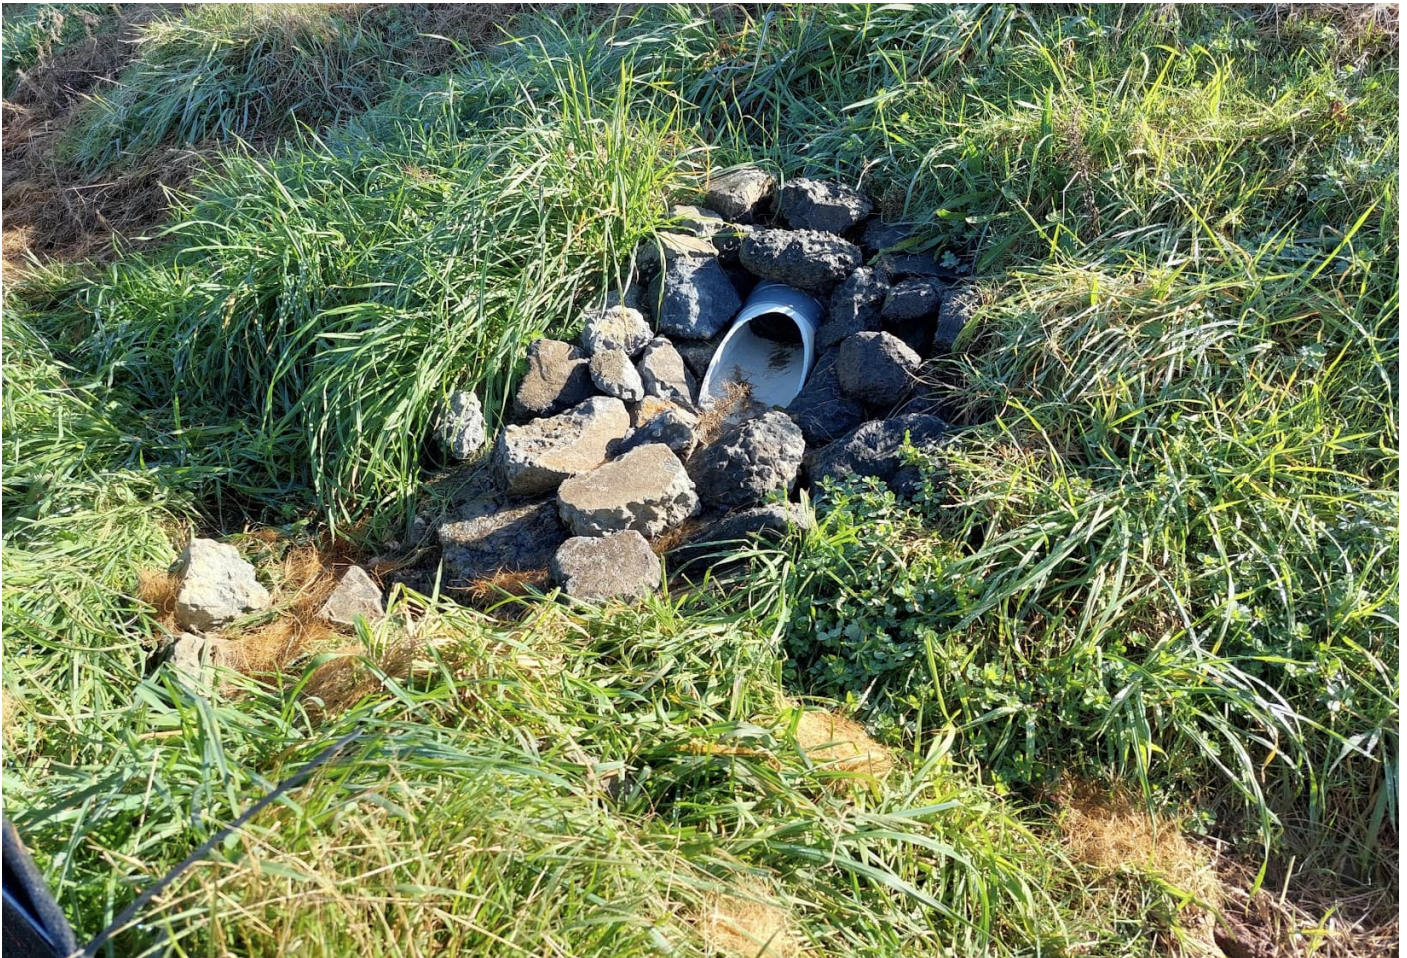
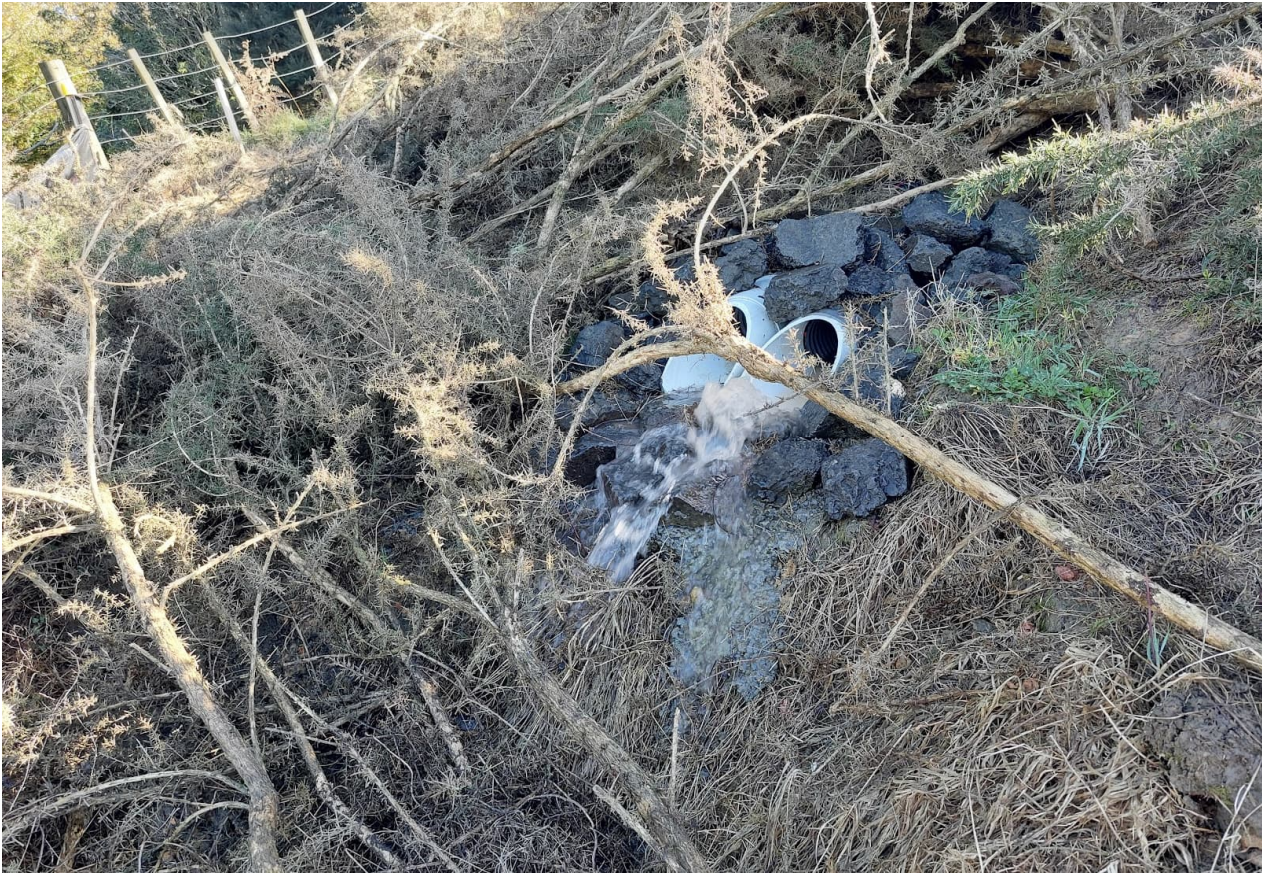
- All counterfort drains function properly as per design. Water outlet observed at the end of the drains.
- Checked underfill drain at the toe of REB1, contractor exposed the outlets and cleared debris
- Checked underfill drain in lots 949 and 950, contractor exposed the outlets and placed boulders at the outlet.

The 5 counterdrain fort drains along lots 945-947
