DFH Joint Venture Limited

GEOTECHNICAL COMPLETION REPORT

Hitchen Block Stage 18, Pokeno

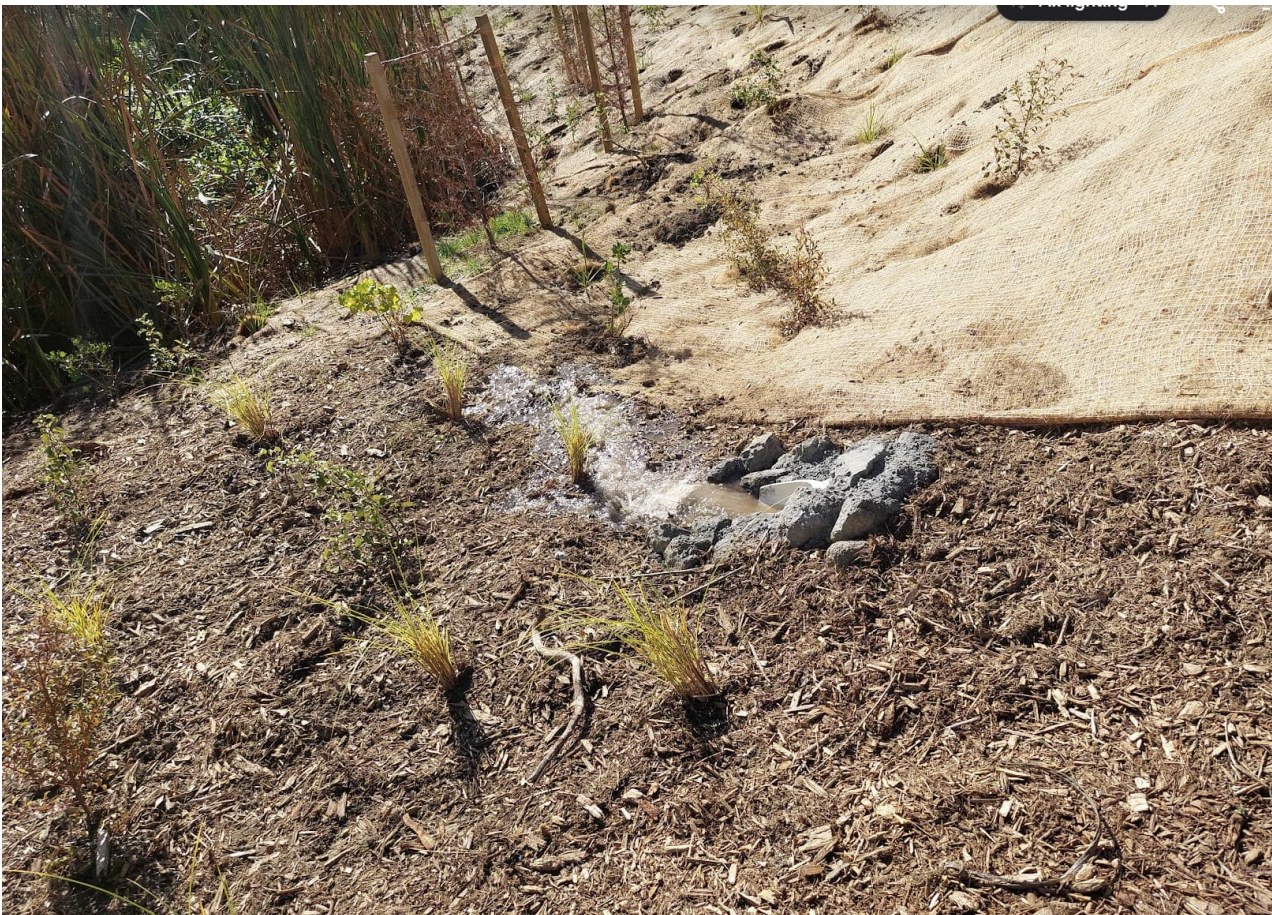
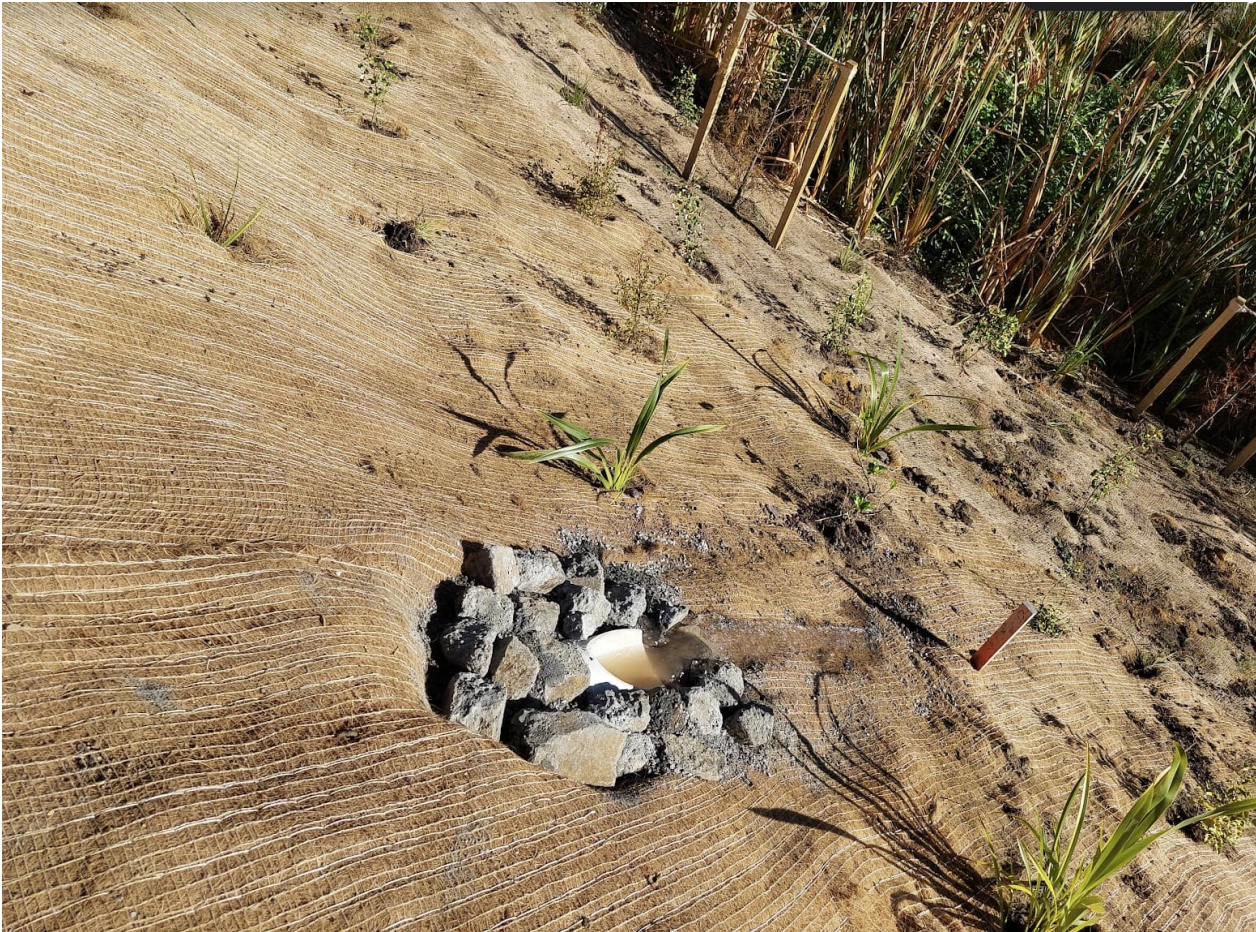
2 counterfort drains adjacent to lot 926

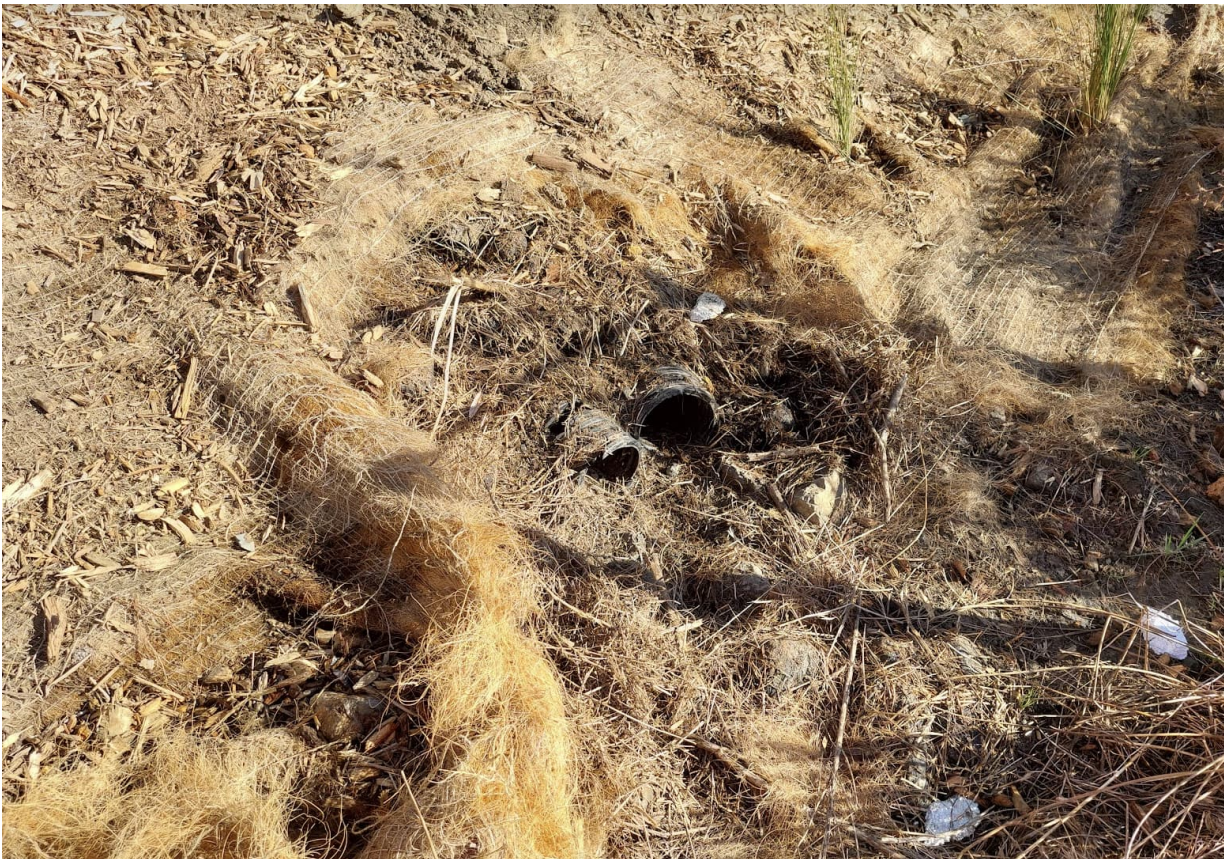
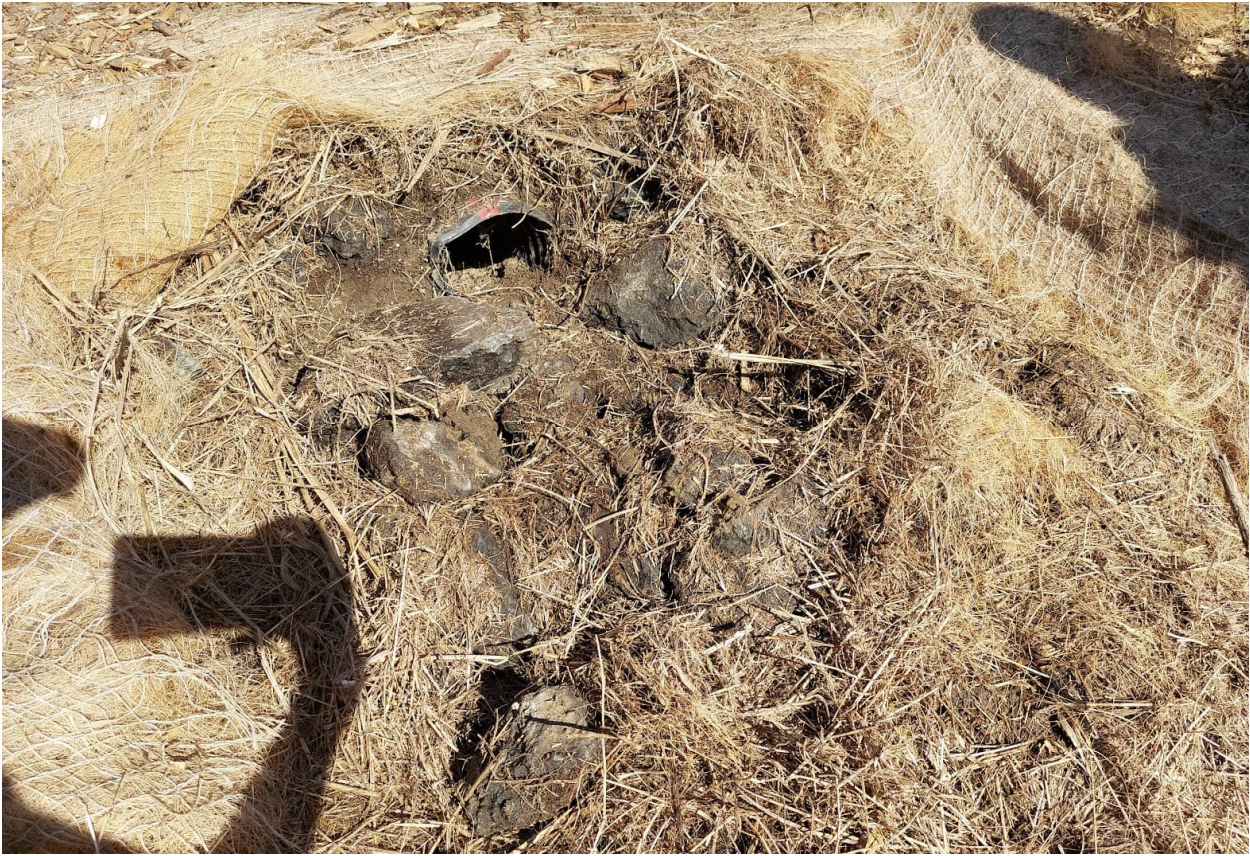
Contractor exposed underfill drain (toe of REB1) that was previously covered in vege mat

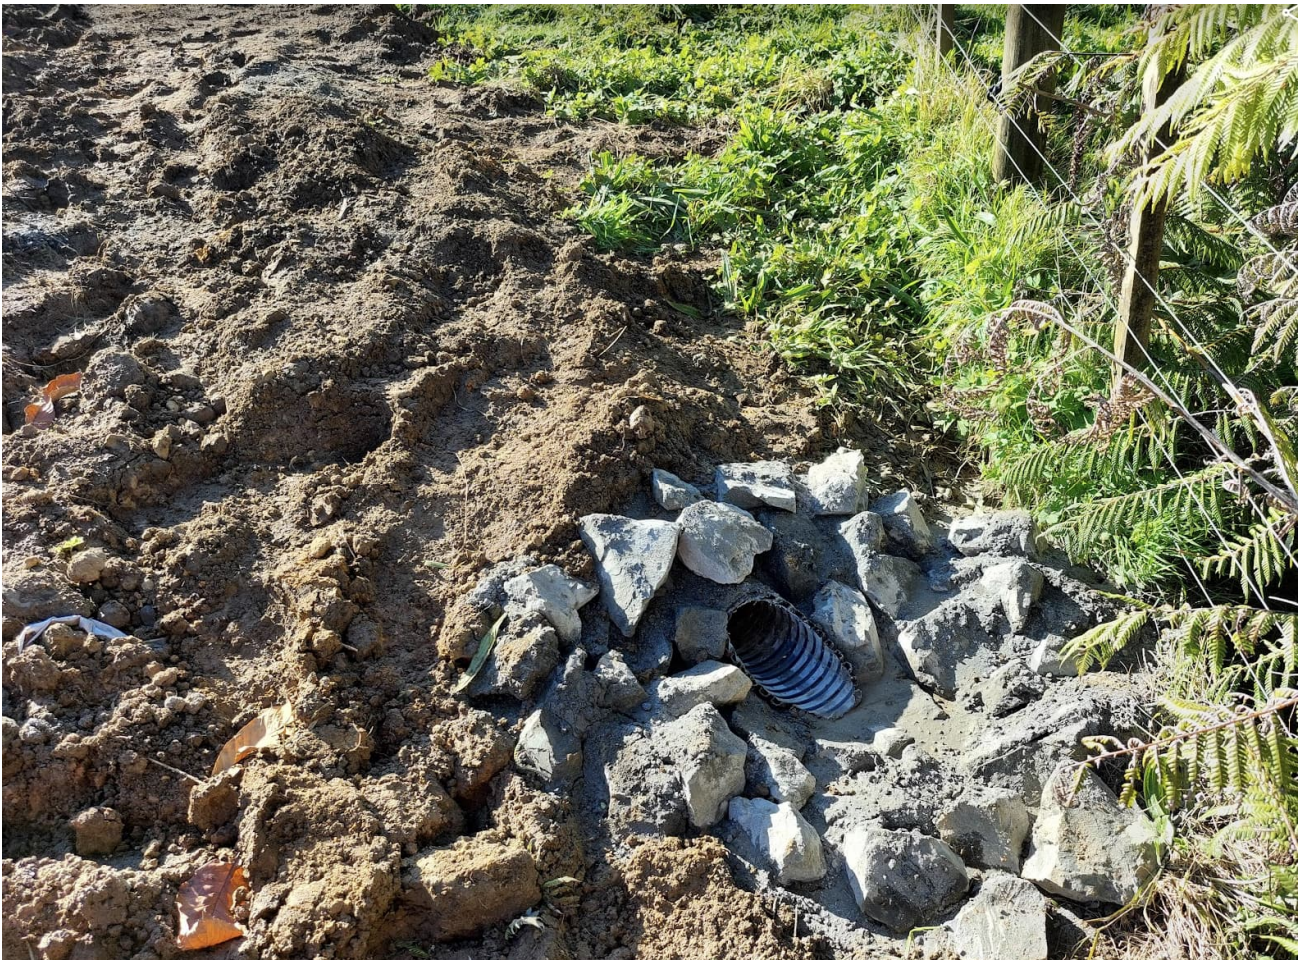
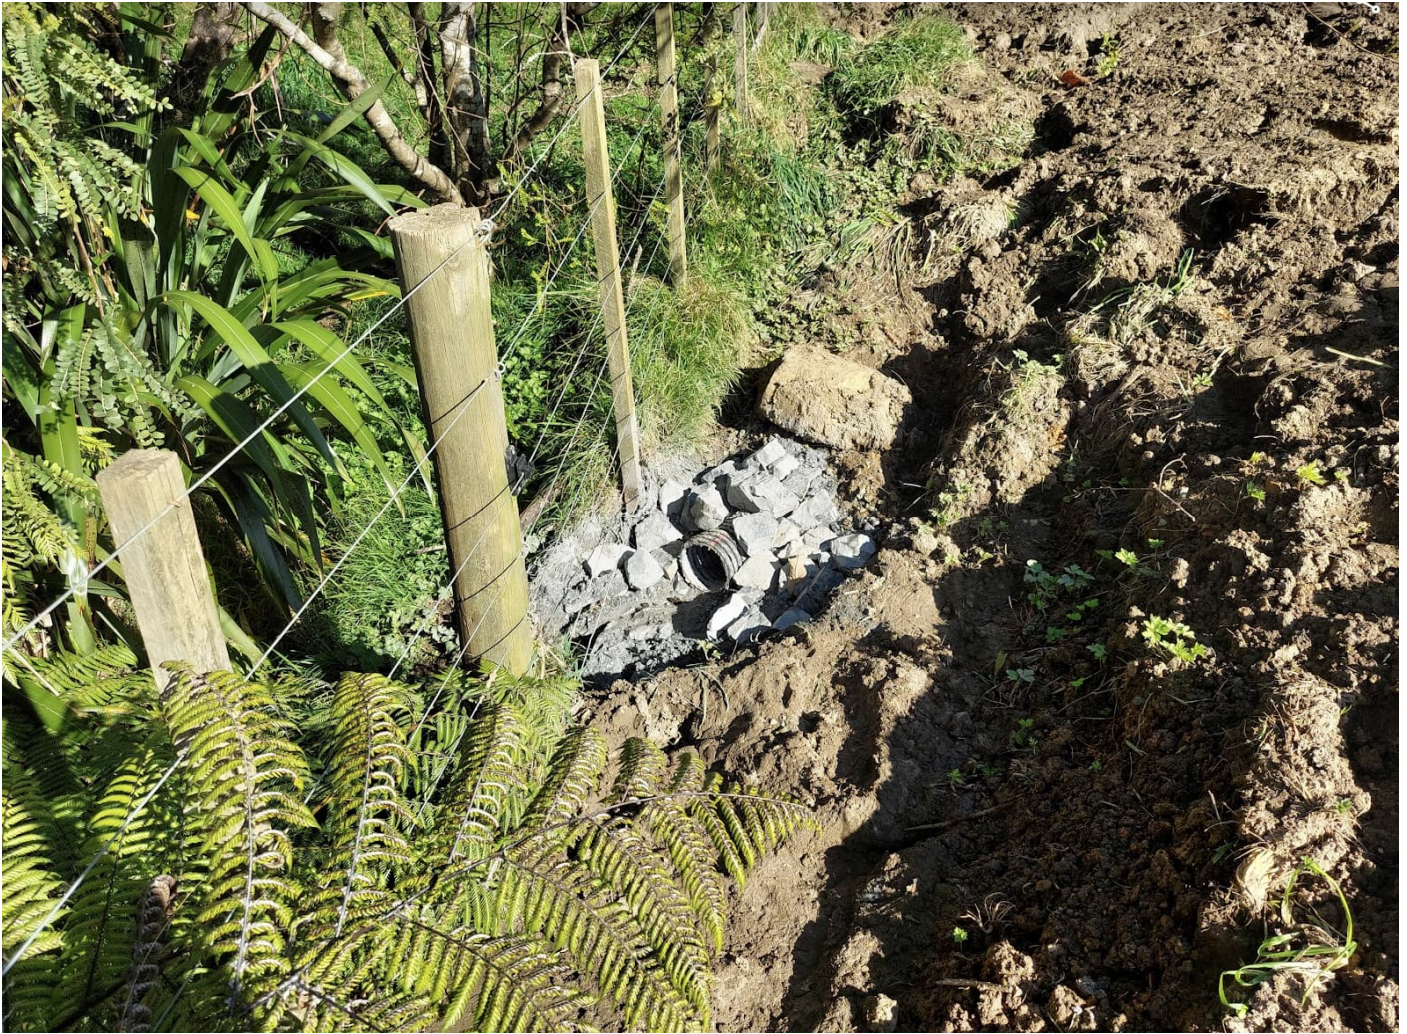
Underfill drain outlets at Lot 950 and 949

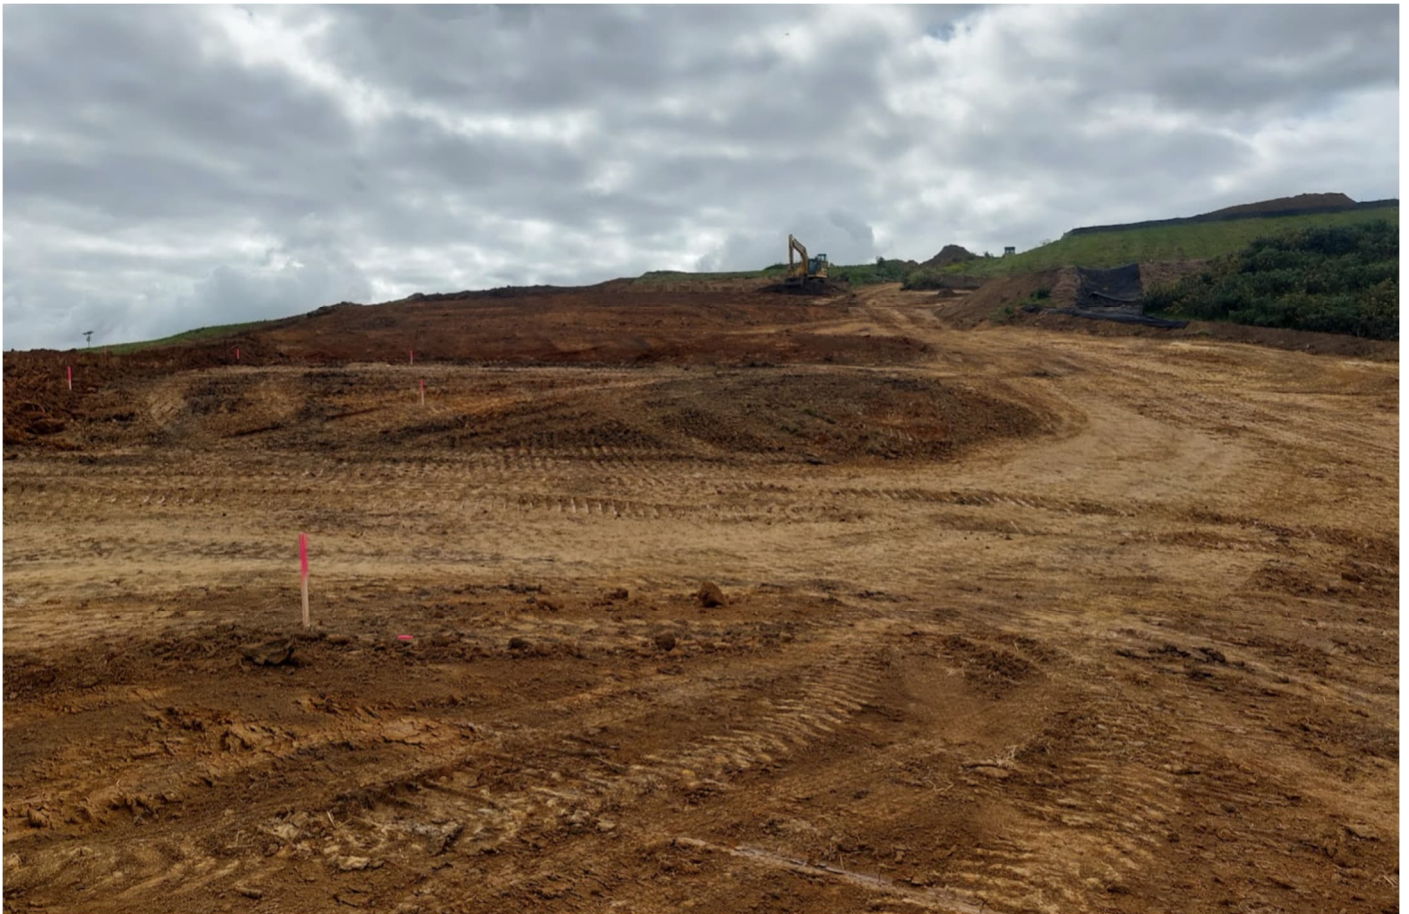
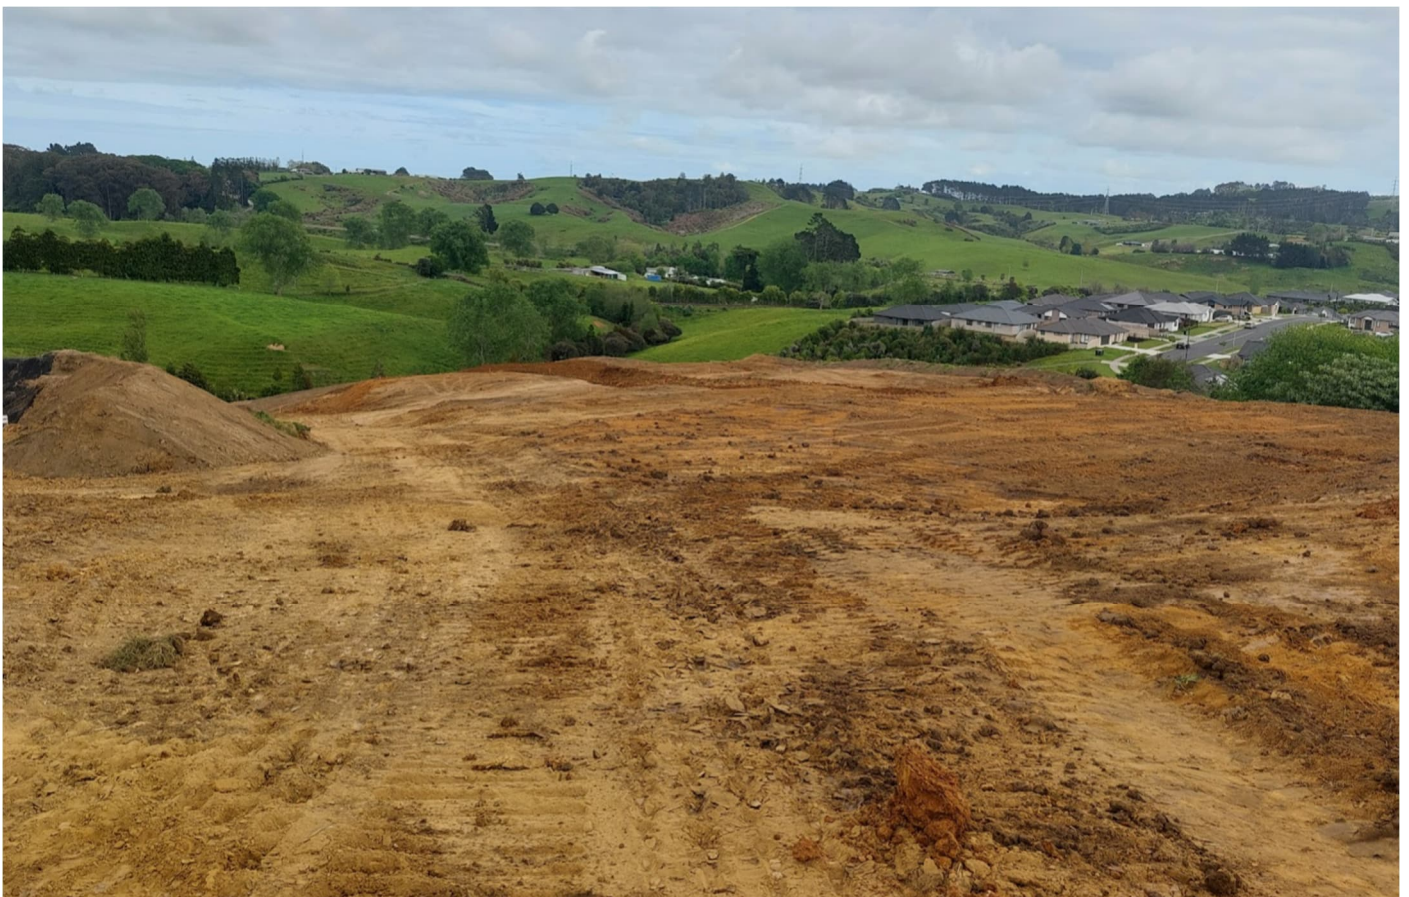
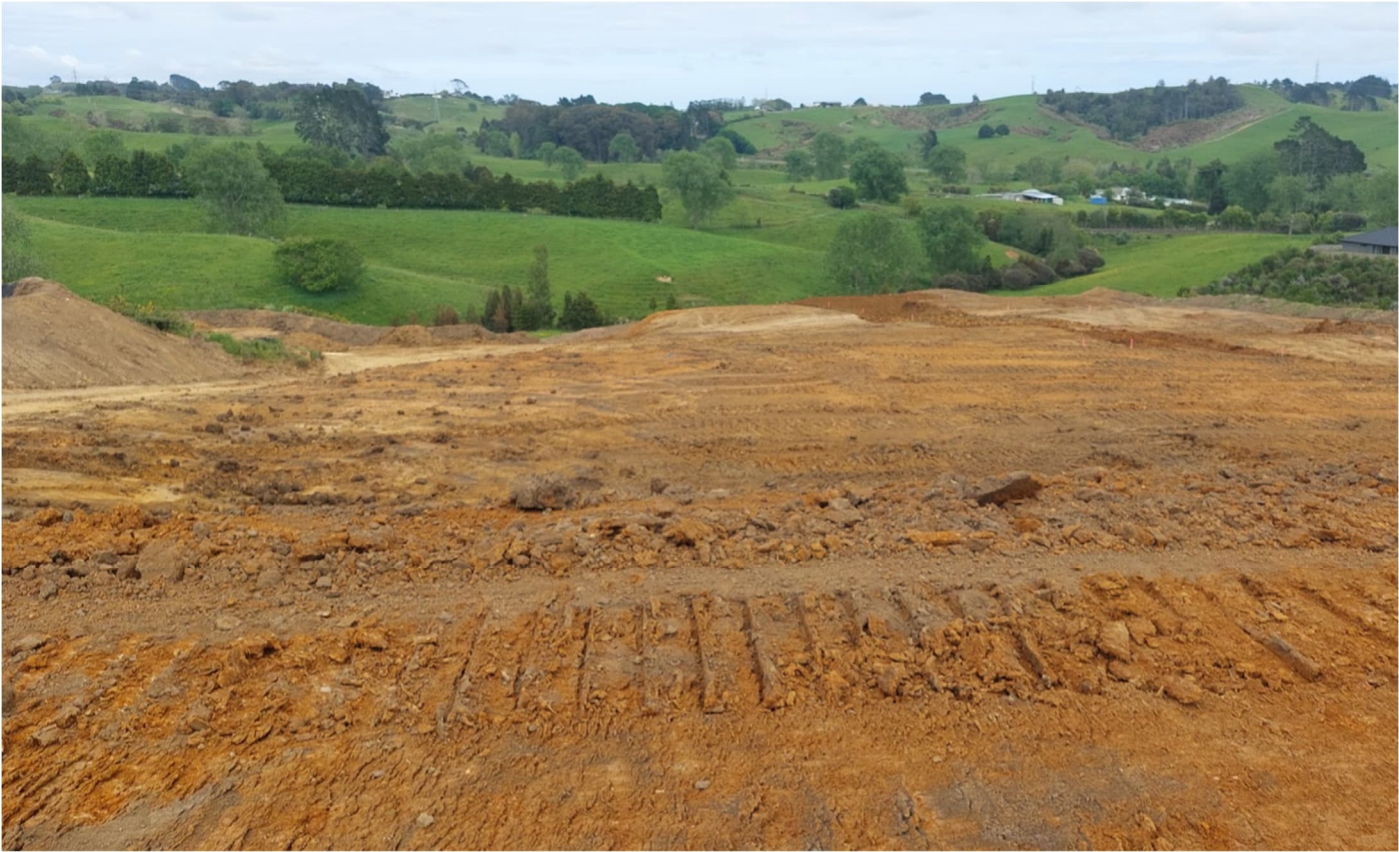
- Area highlighted in pink:
 - Ground revealed engineered fill. Contractor noted this area is near finished level and will be ready for topsoil placement once the minor trimming is completed. We consider the ground conditions are suitable for topsoil placement.
- Area highlighted in yellow:
 - Contractor has placed clay fill prior to our stripped subgrade inspection.
 - Several shallow hand augers were conducted, the ground revealed 400-500mm of clay fill and competent natural ground is found below.
 - Shear vane readings within the natural ground were in excess of 100kPa.
 - We consider the clay fill is suitable to remain. Recommended the contractor to contact us prior to bulk filling.

Subgrade near finished level

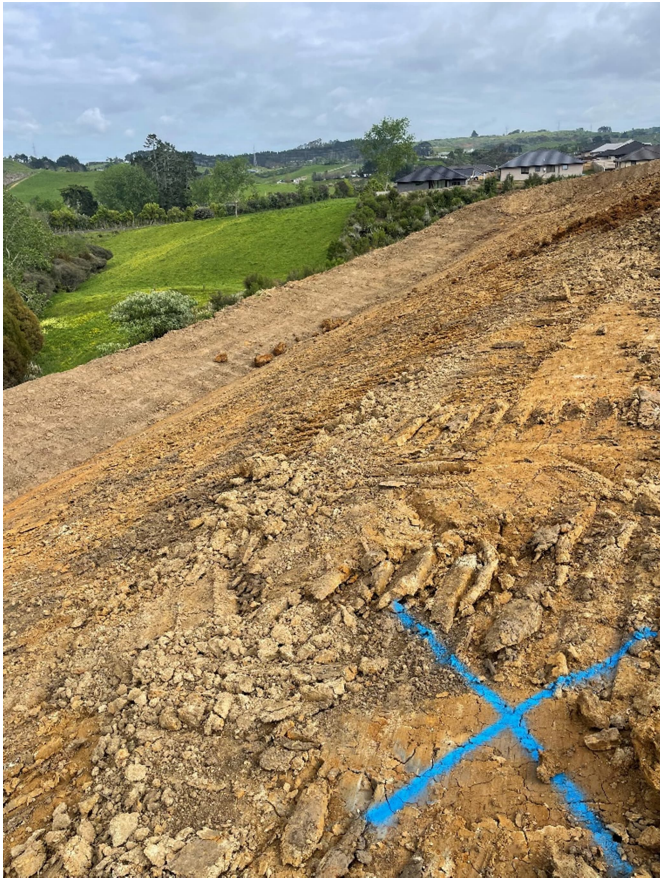
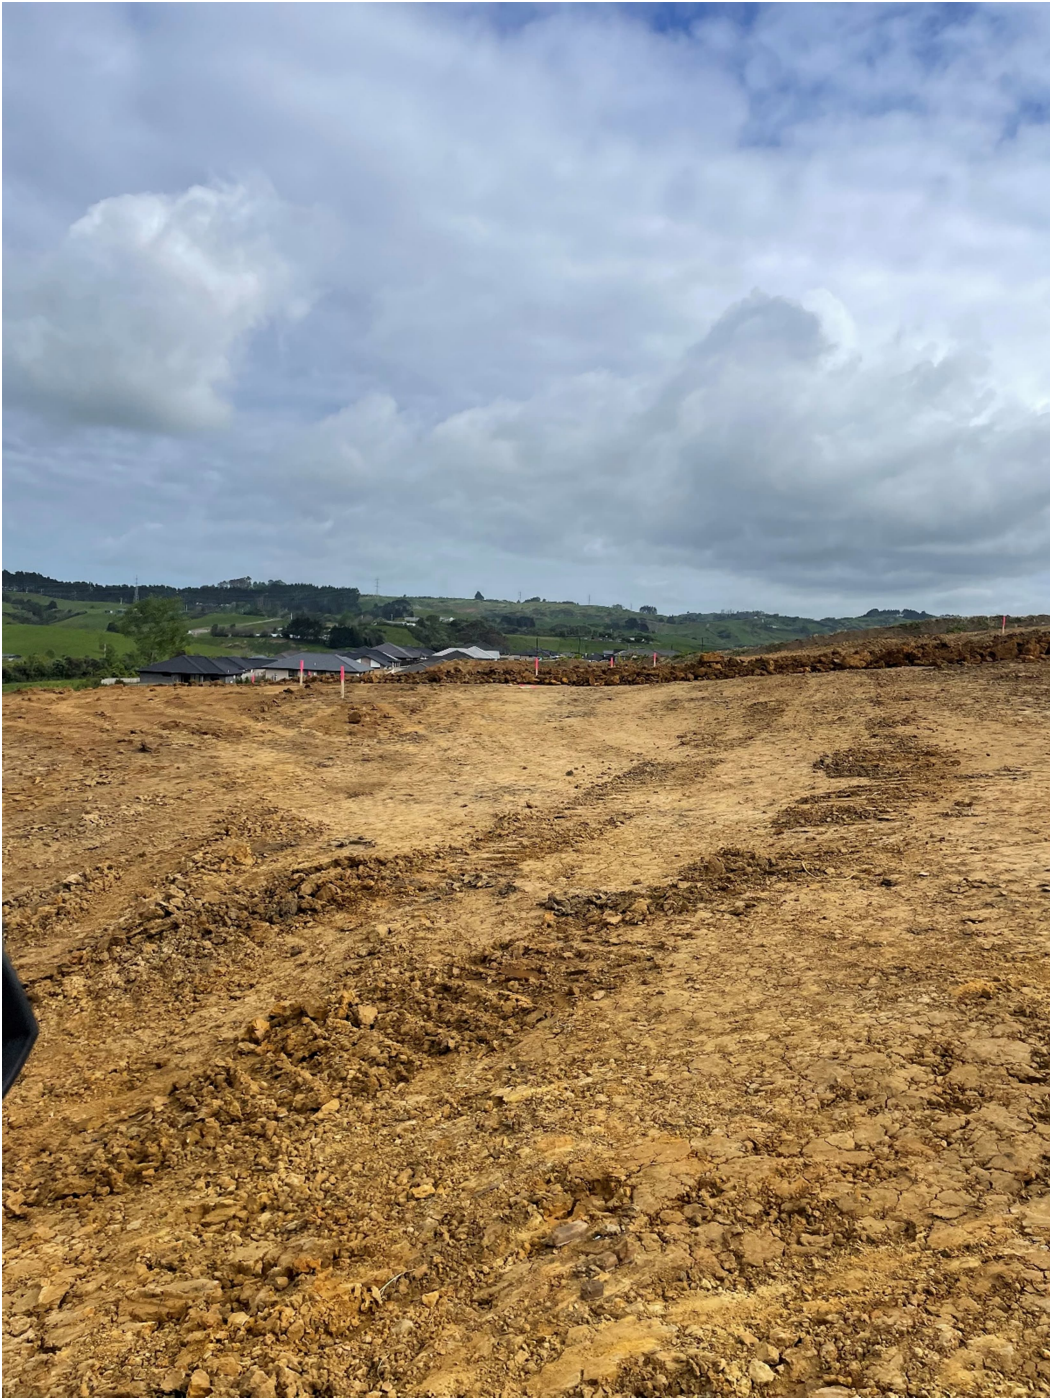
Contractor provided photos: prior to filling

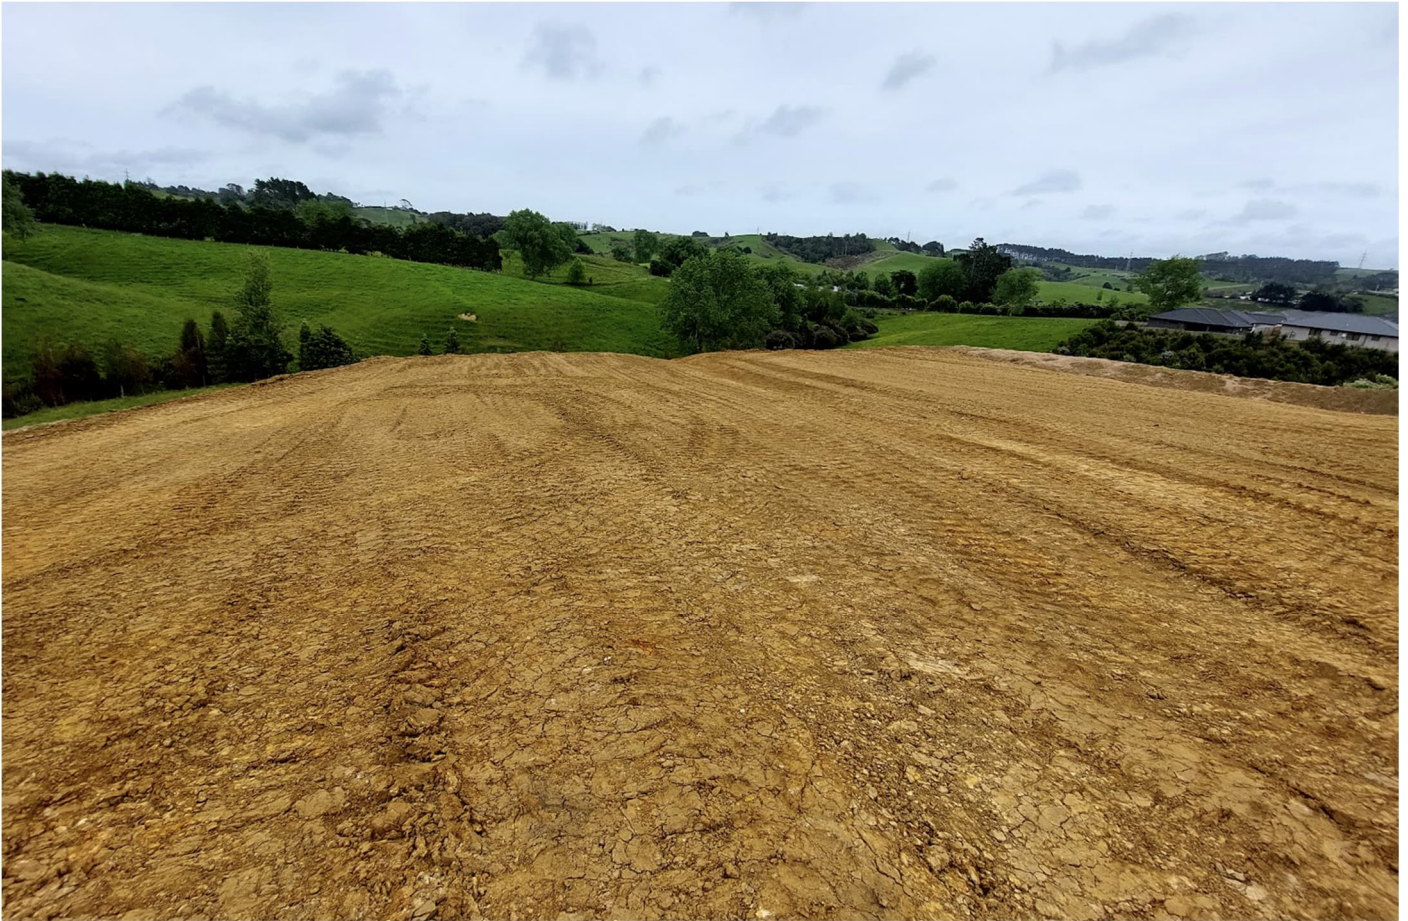
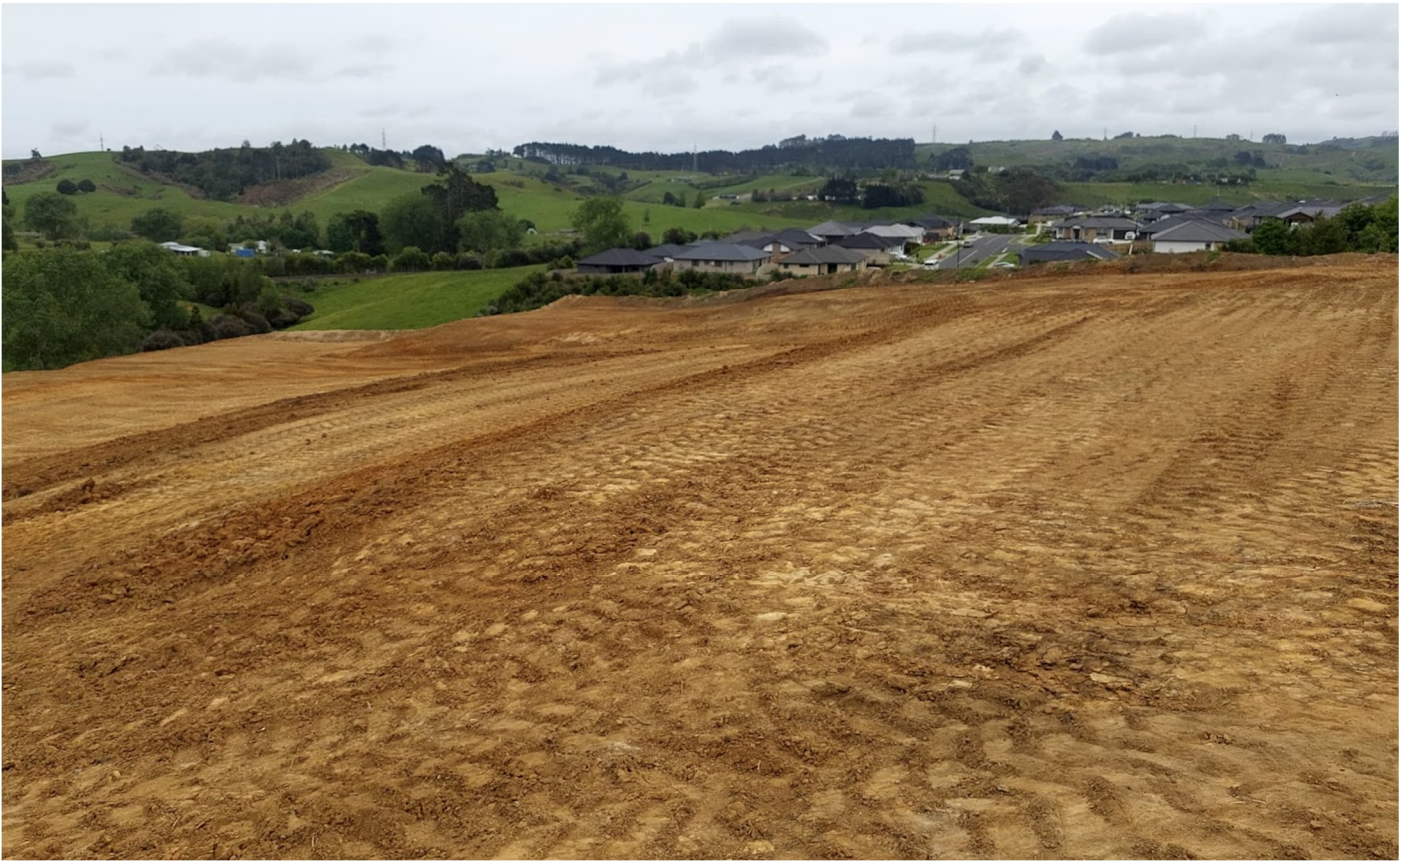
- Finished subgrade
 - Ground revealed engineered fill. Shear vane readings were mostly in excess of 200+kPa or UTP. Contractor noted they are planning to place minor fill to shape and extend the batter. We understand it will be less than 600mm high and consider the ground is suitable to place fill upon.

Finished subgrade

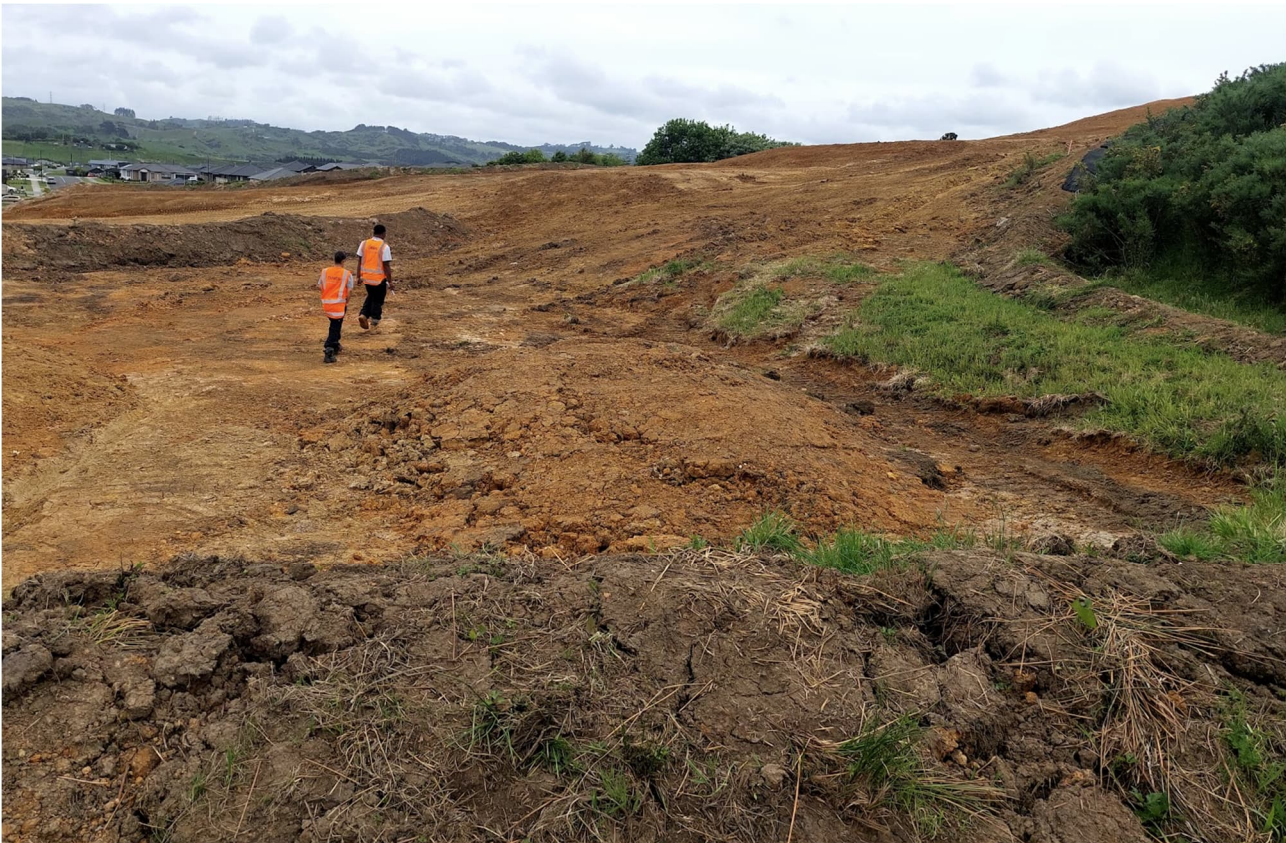
Area 1 – up to 300mm of fill proposed to be placed in this corner, we consider is it appropriate.

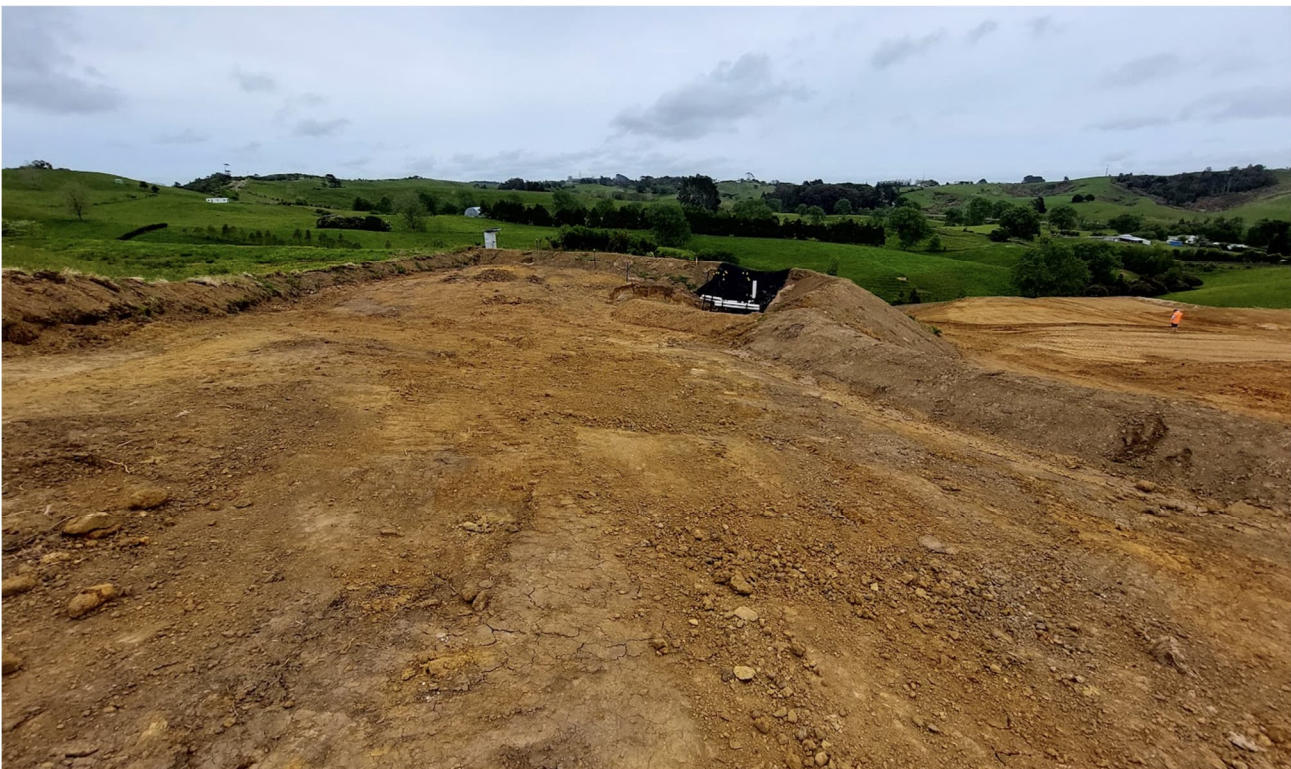
Area 2 – contractor put the work on hold.

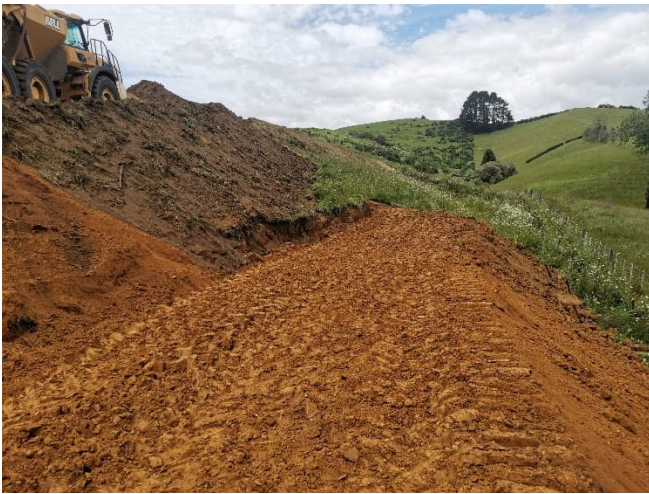
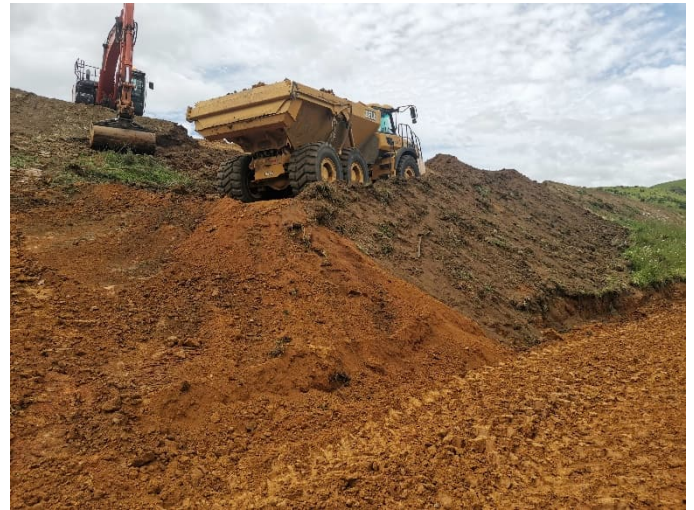
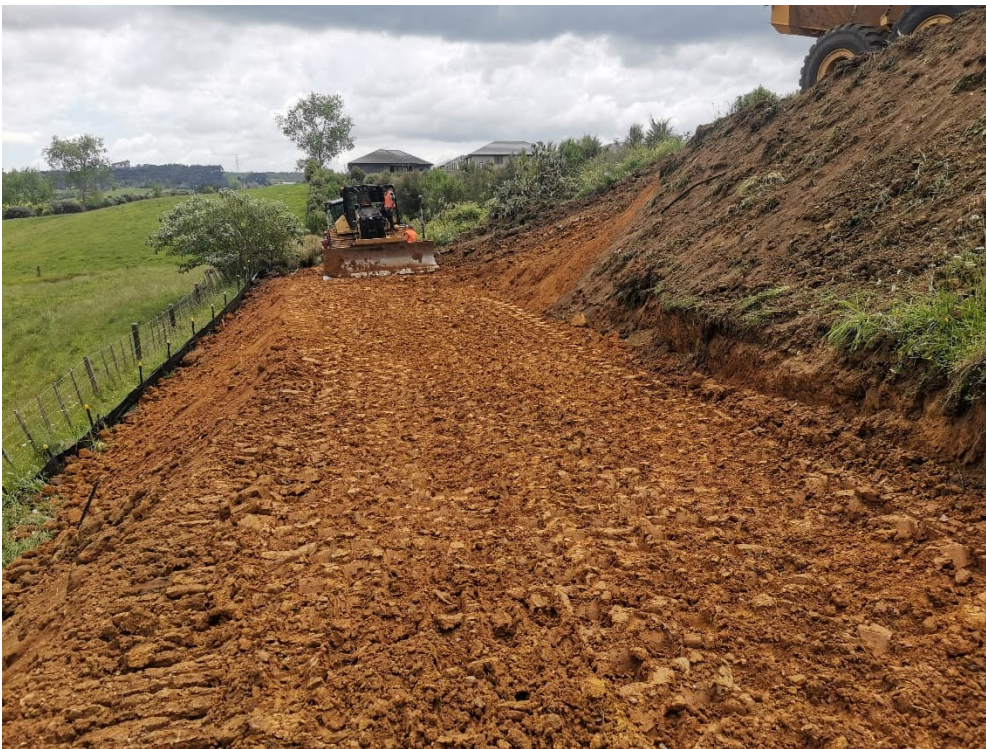
- Inspected fills being placed in the lower portions of Stage 18 where a permanent bund is being formed.
- Fill compaction and contractors operations appear suitable. Contractor advised that fills have been benched in and some of the batter will be trimmed back to final proposed grade.
- Requested compaction control testing be completed on the existing surface and also on the finished bund once formed.
