DFH Joint Venture Limited

GEOTECHNICAL COMPLETION REPORT

Hitchen Block Stage 18, Pokeno

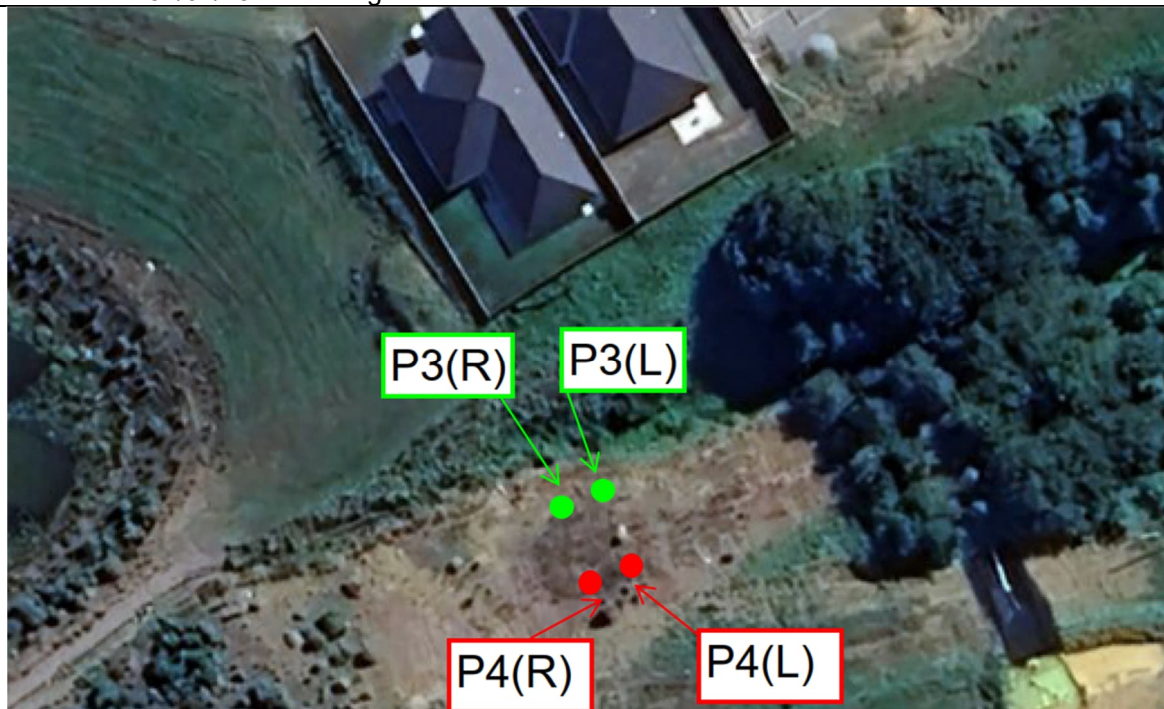
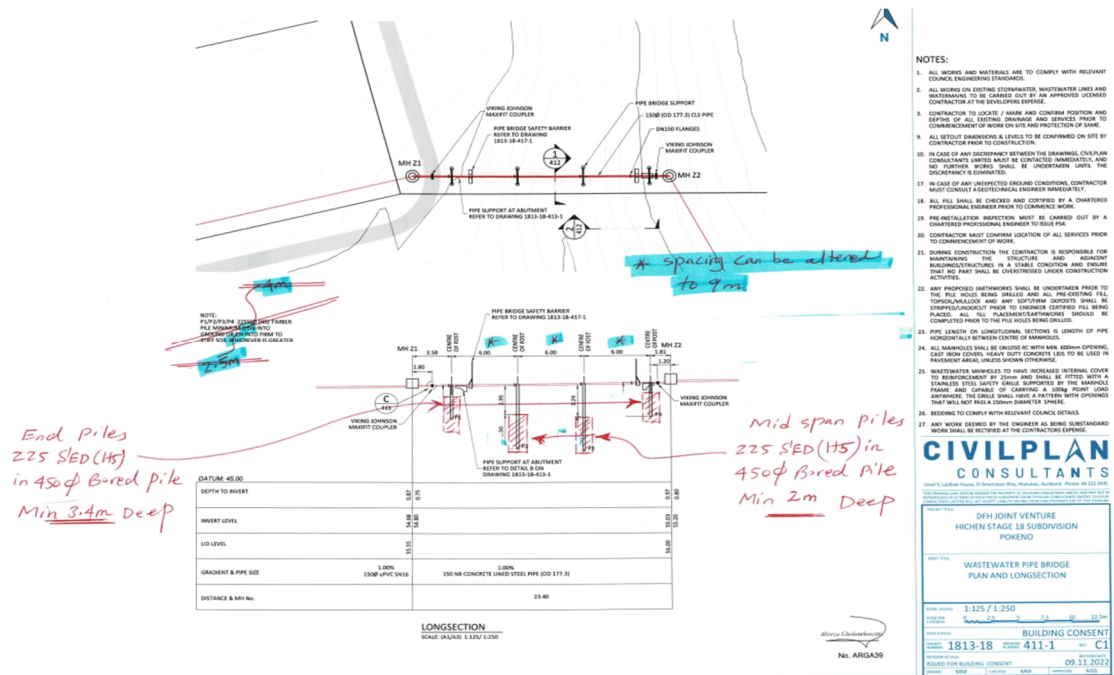
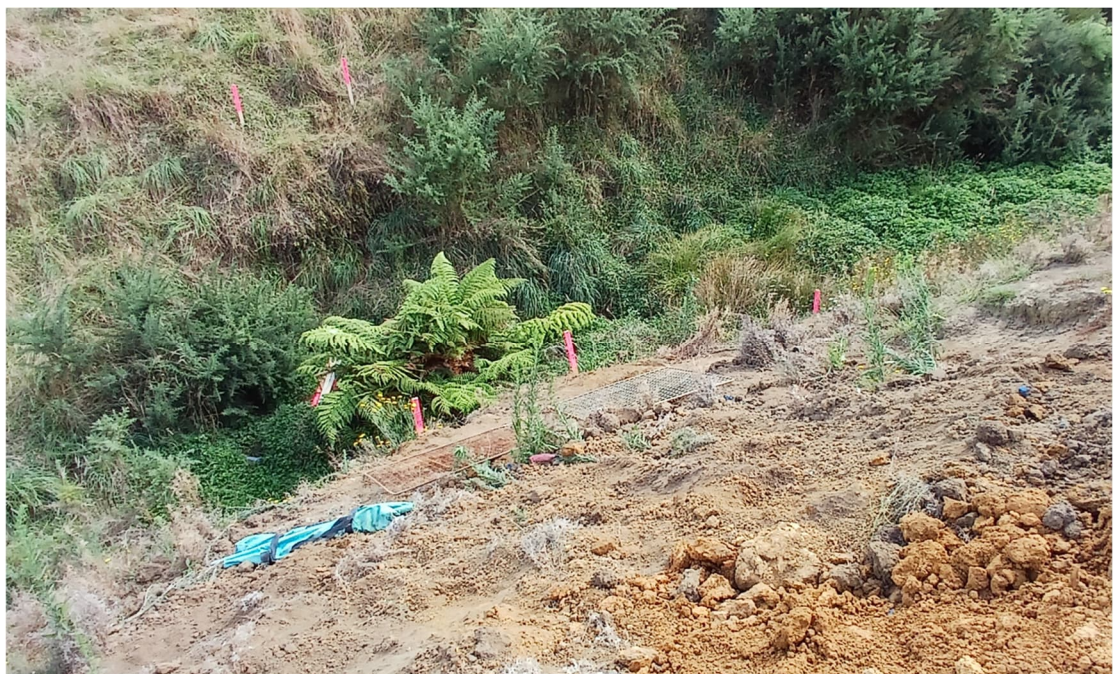
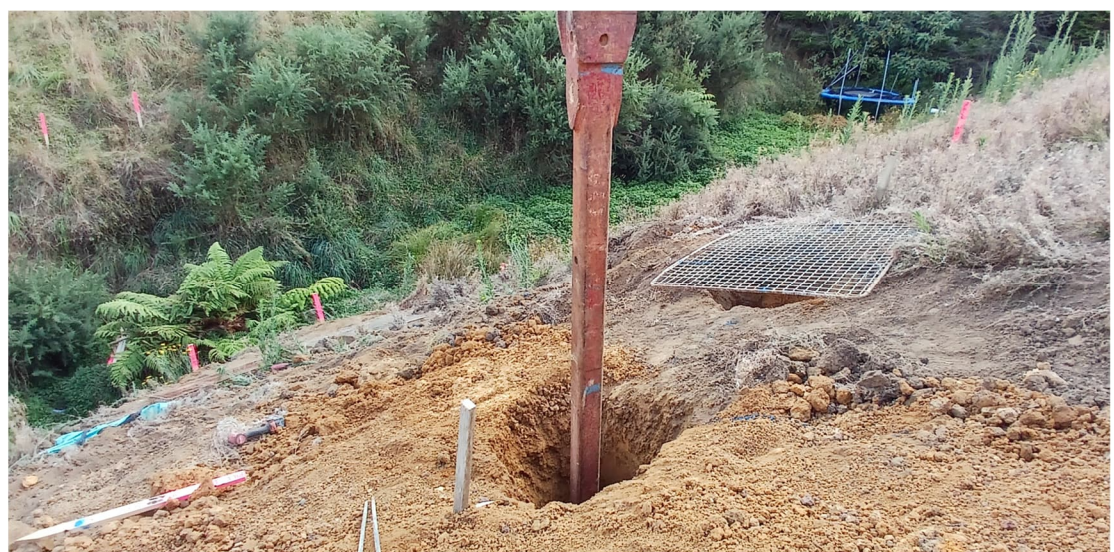
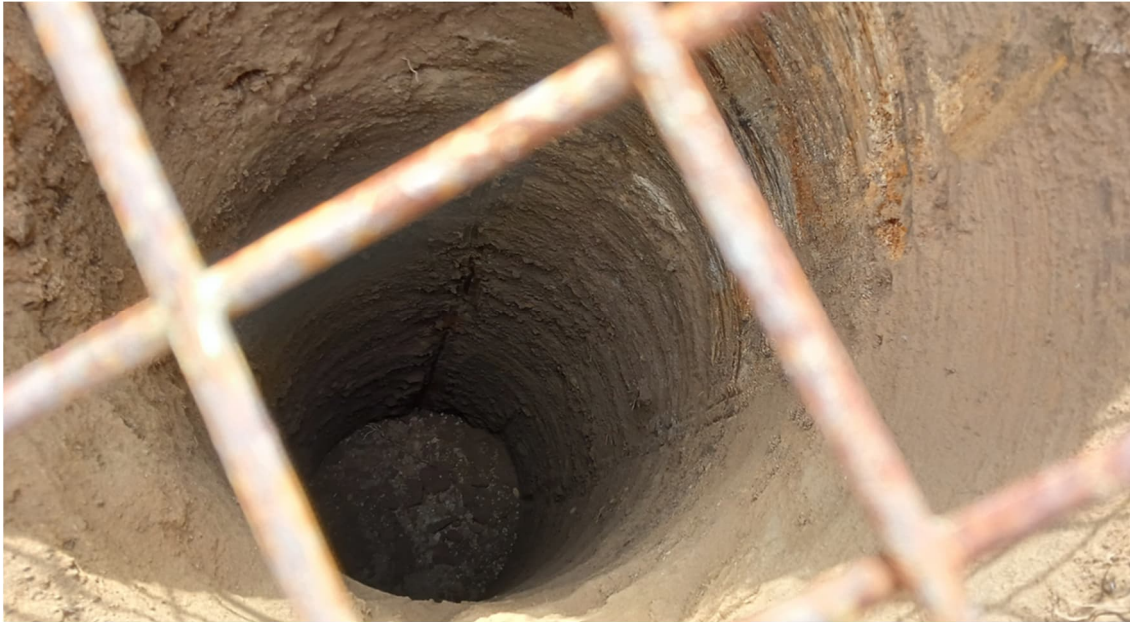
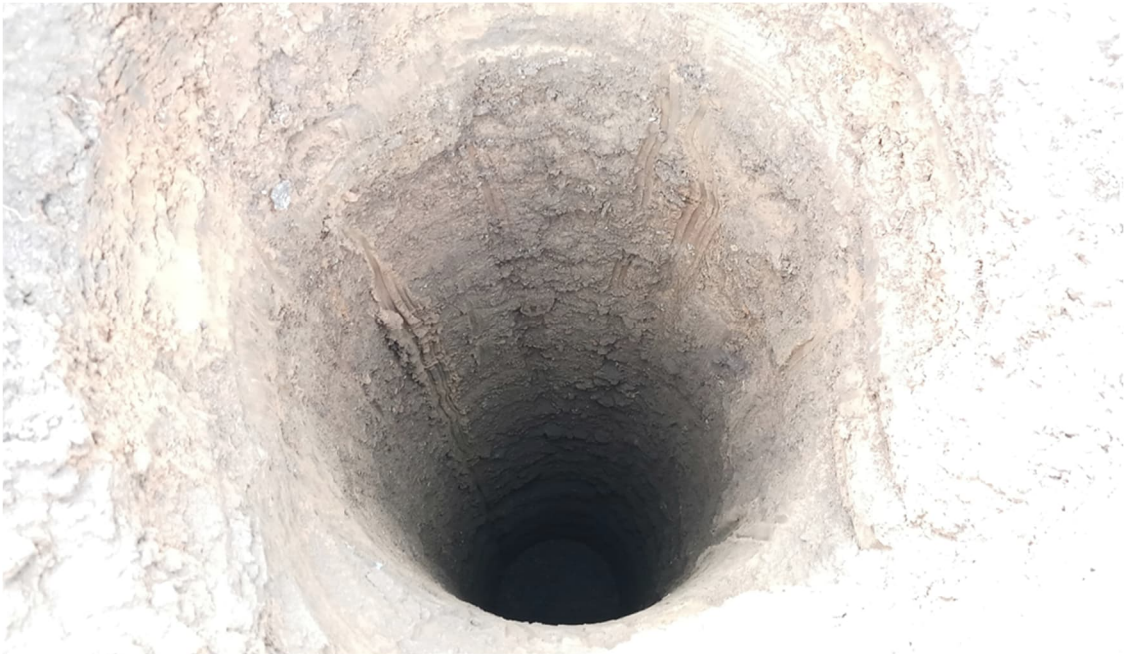
- The spoil observed and ground within the pile holes confirmed the presence of natural volcanic ash and weathered tuff deposits. The ground comprised of hard brown/orange and grey clayey silts and sandy silts with traces of gravel consistent with ash to approximately 1.5m to 2.0m depth and transitioned to sandy silt with trace fine gravel consistent with tuff deposits to the end of the hole. The contractor advised that during drilling, the ground generally became harder at approx. 1.5m depth, continuing to the bottom of the holes and this was confirmed with spoil observed from the base of pile hole 'P4(L)'. The shear vane was unable to penetrate the base of sides of the holes (UTP).

- Ground conditions are satisfactory.
- Advised contractor (ICB) to send photo of pile hole P3(R) confirming depth when drilled is completed. Photo received on 31/01/25 confirming dimensions.

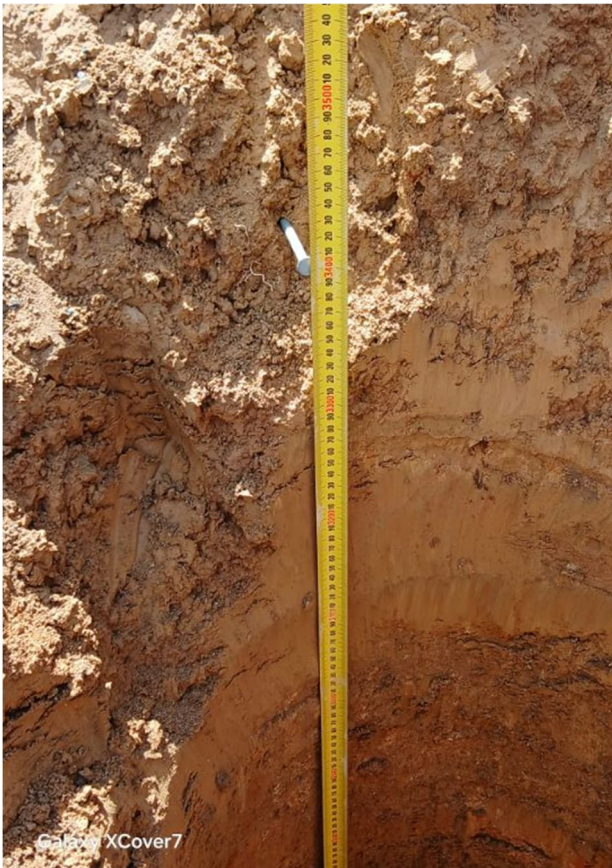
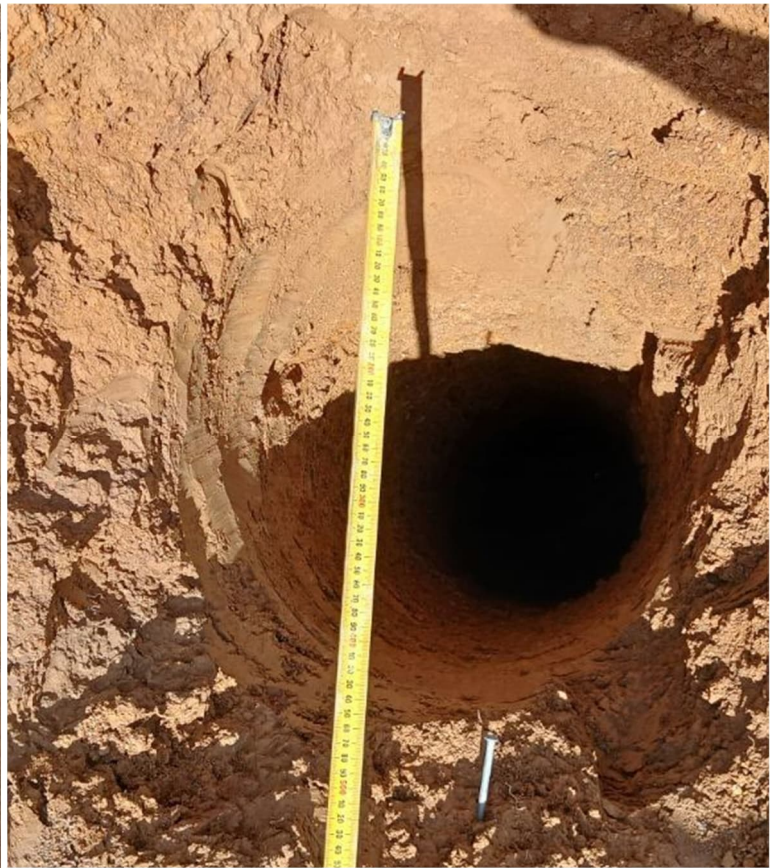
Photos below received from contractor confirming pile hole depth and dimensions (31/01/2025):

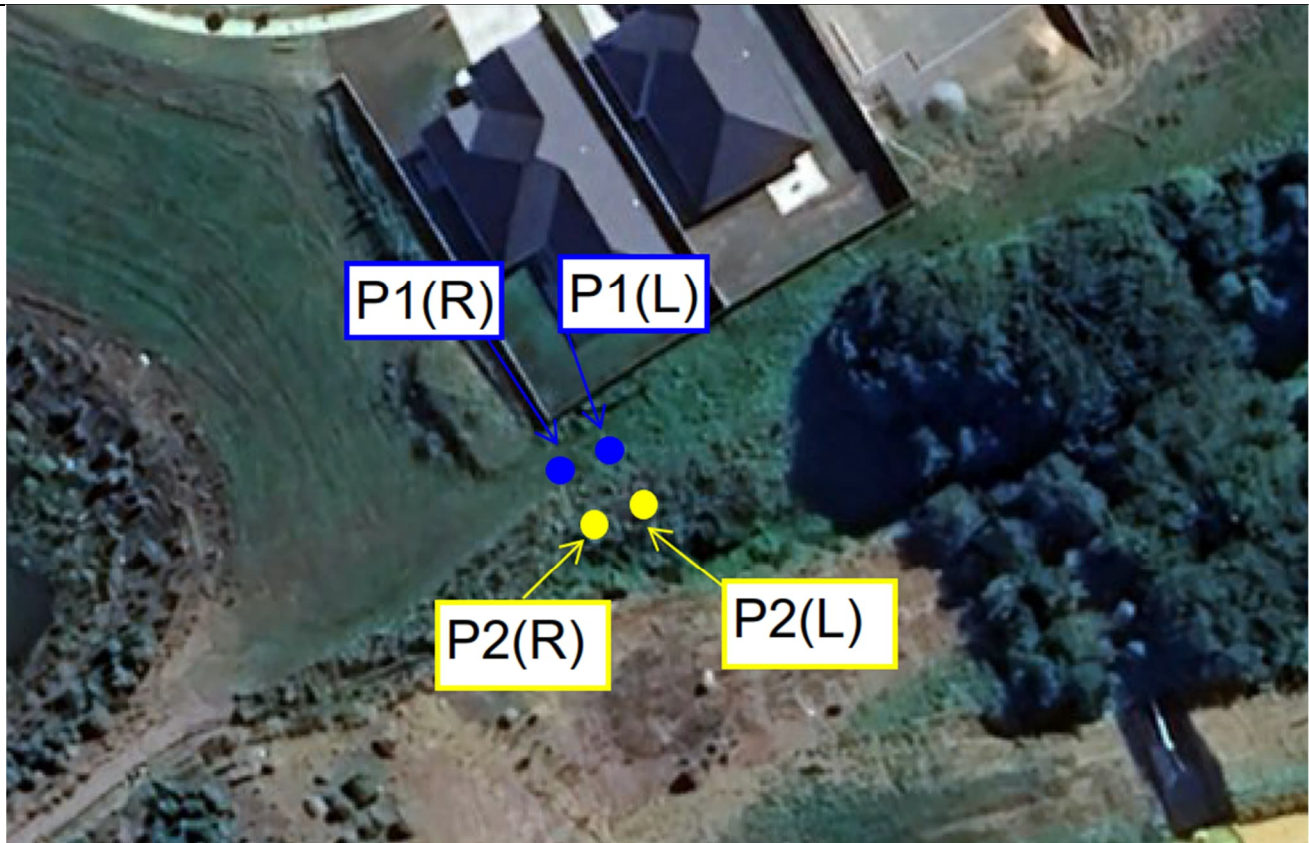
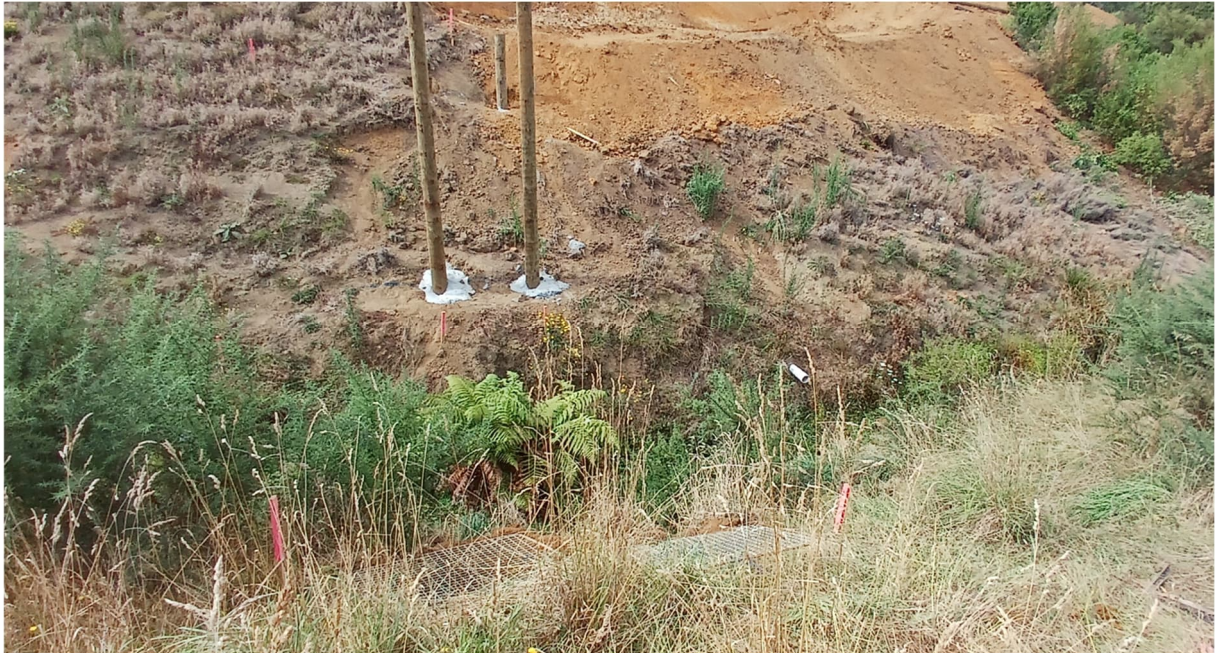
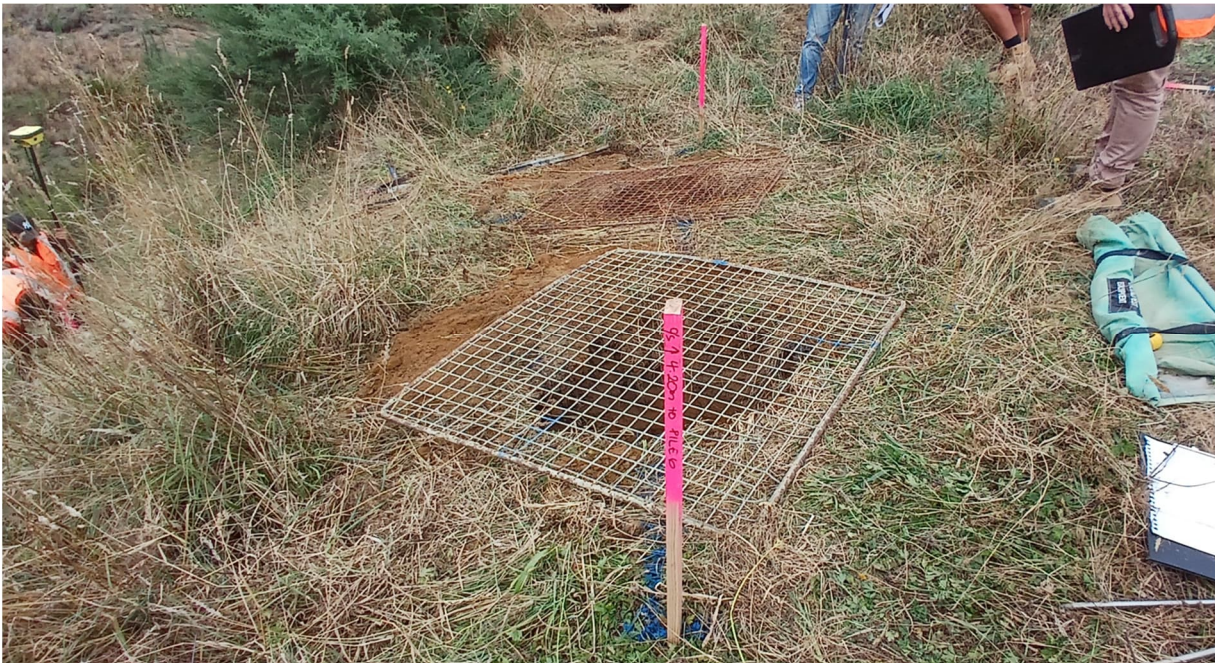
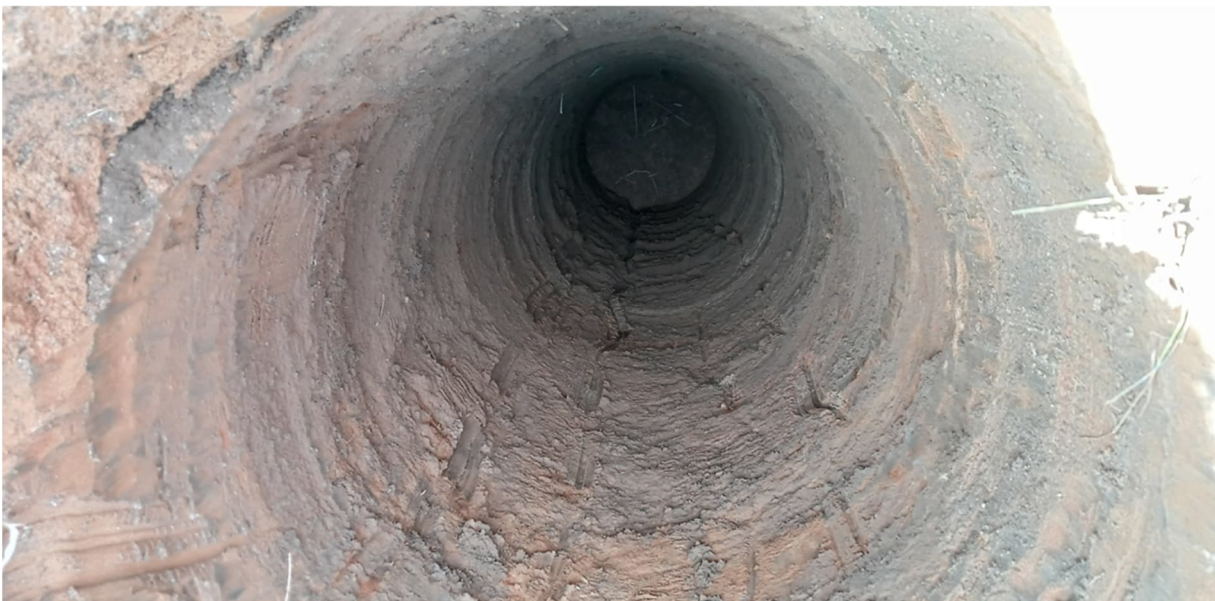
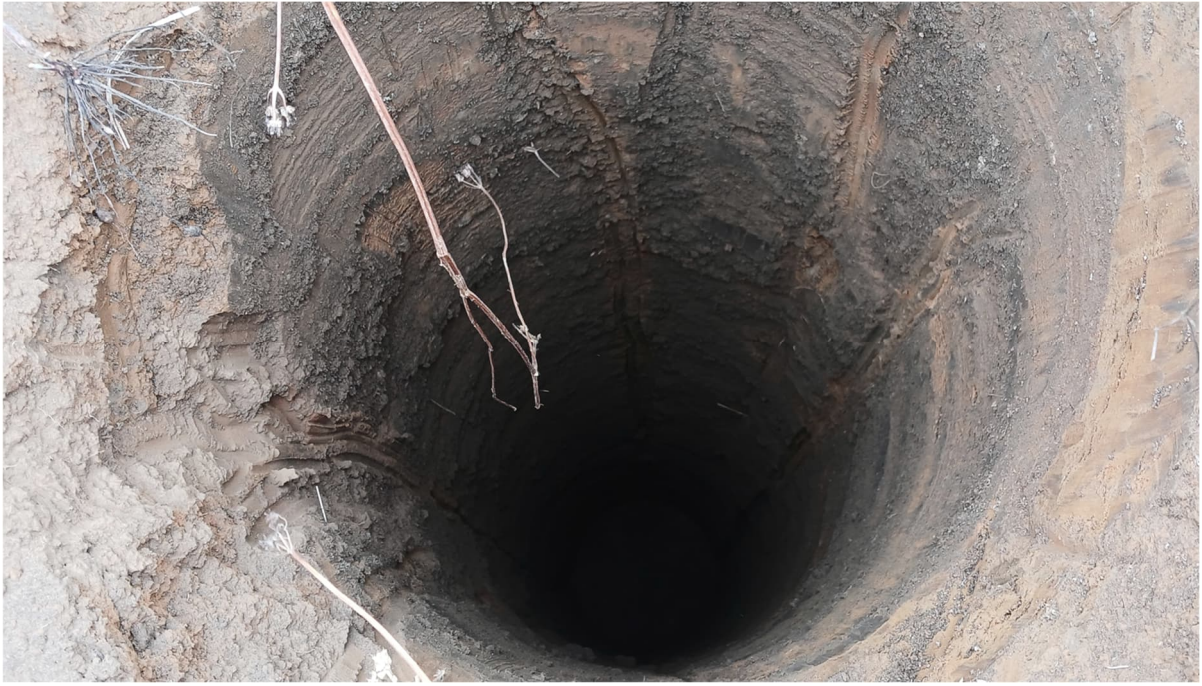
Visited the site at the request of Dines to inspect ground conditions in pipe bridging pile holes (approx. locations marked up in blue and yellow in inset below).

- Ground conditions are satisfactory, providing spoil is removed from base of holes.

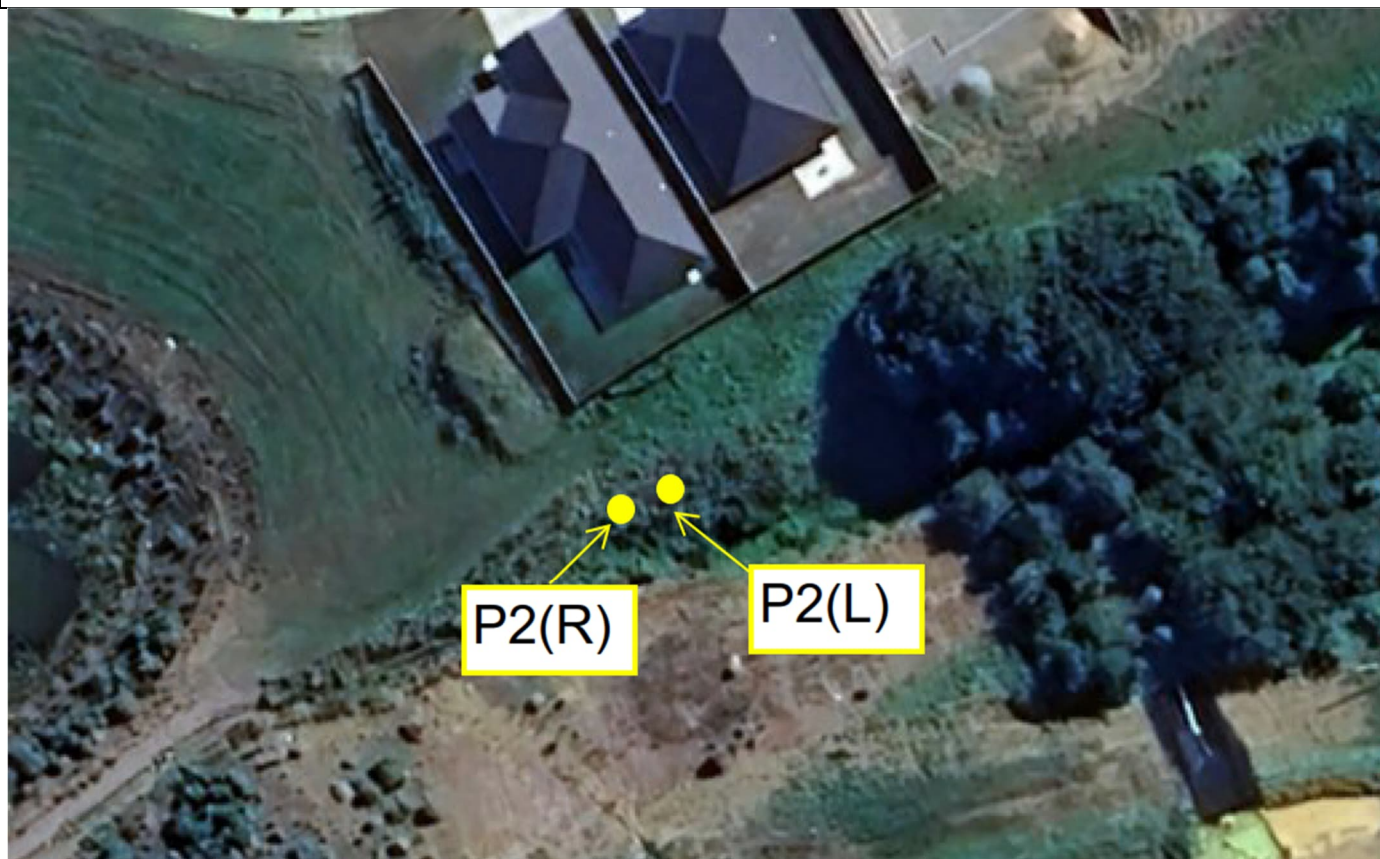
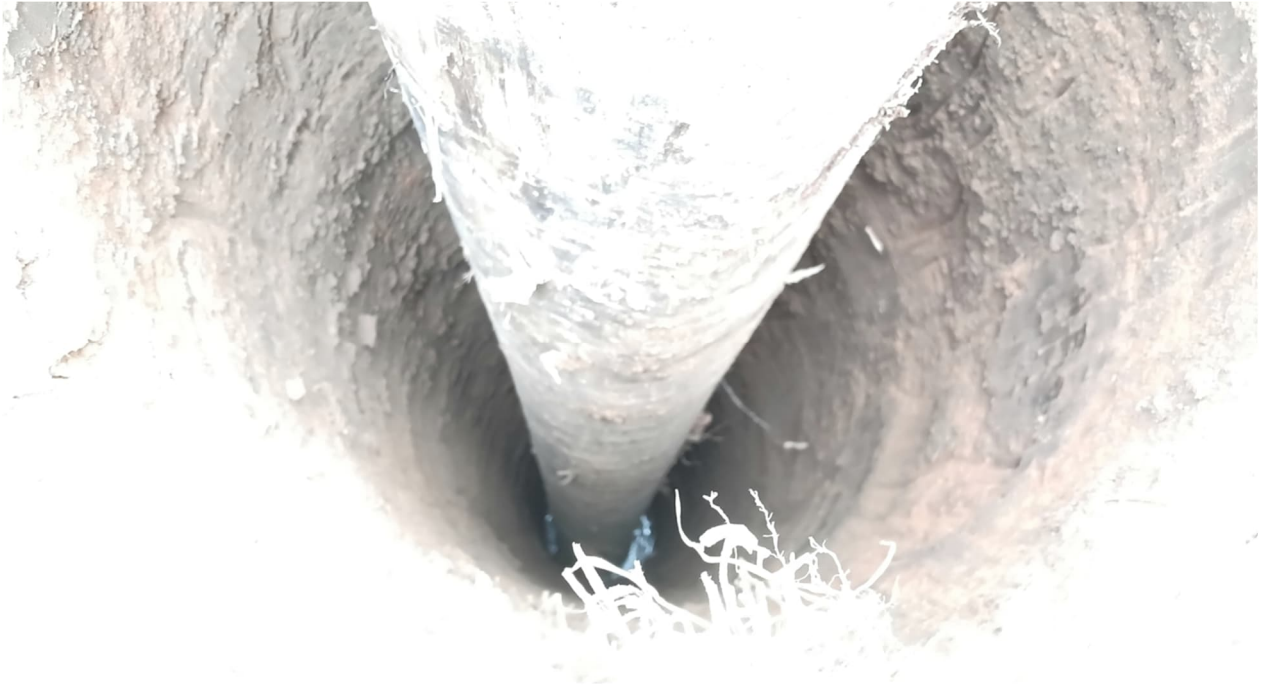
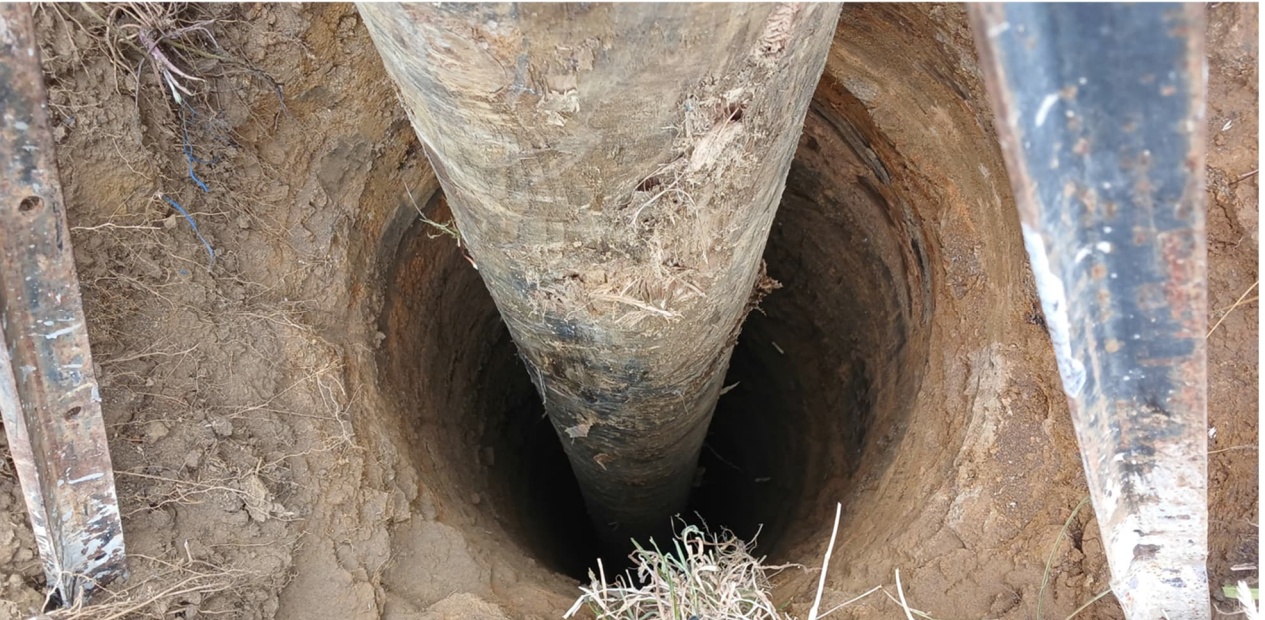
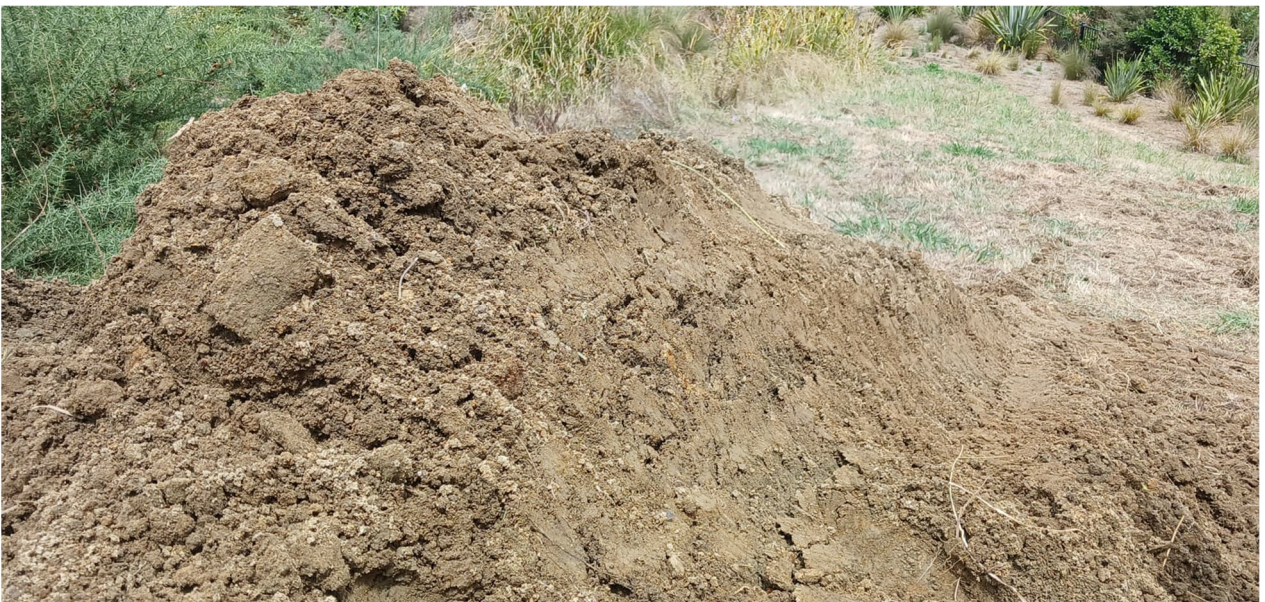
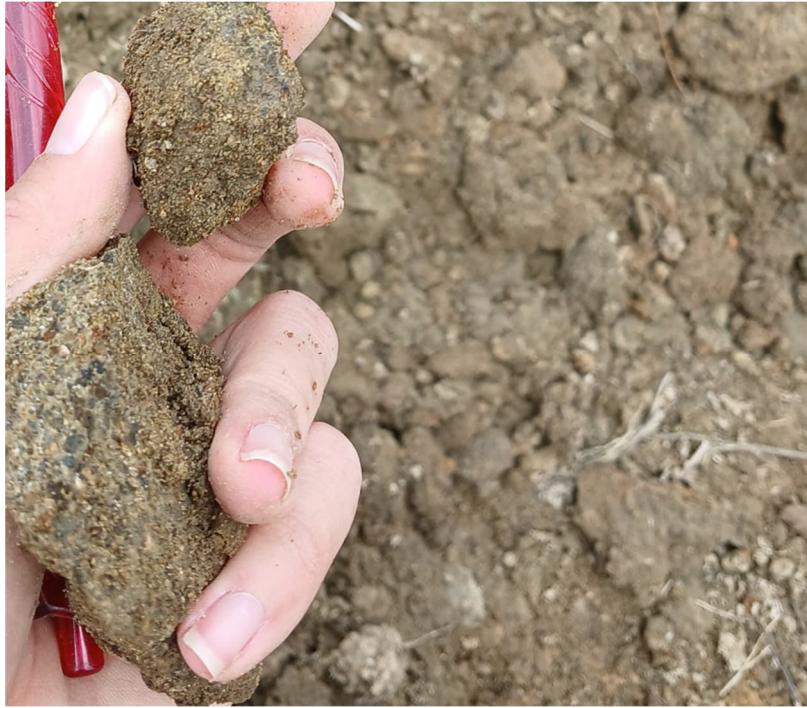
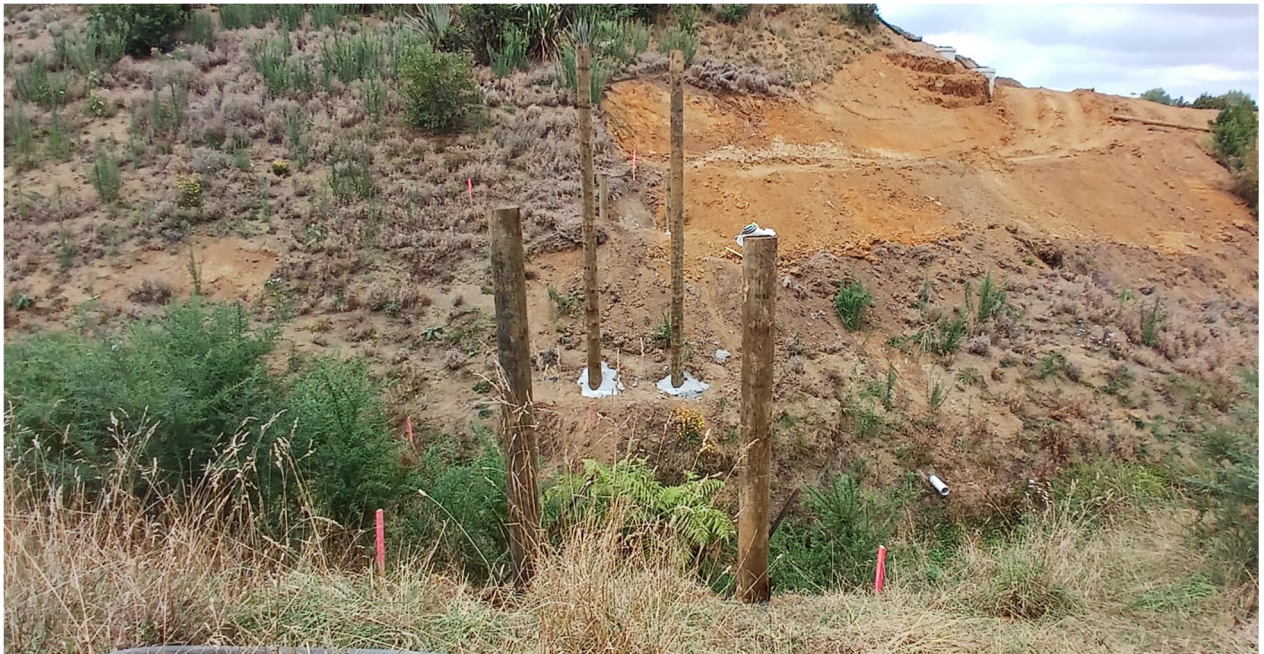
Visited the site at the request of Dines to inspect ground conditions in pipe bridging pile holes (approx. locations marked in yellow in inset below).

- Ground conditions are satisfactory.

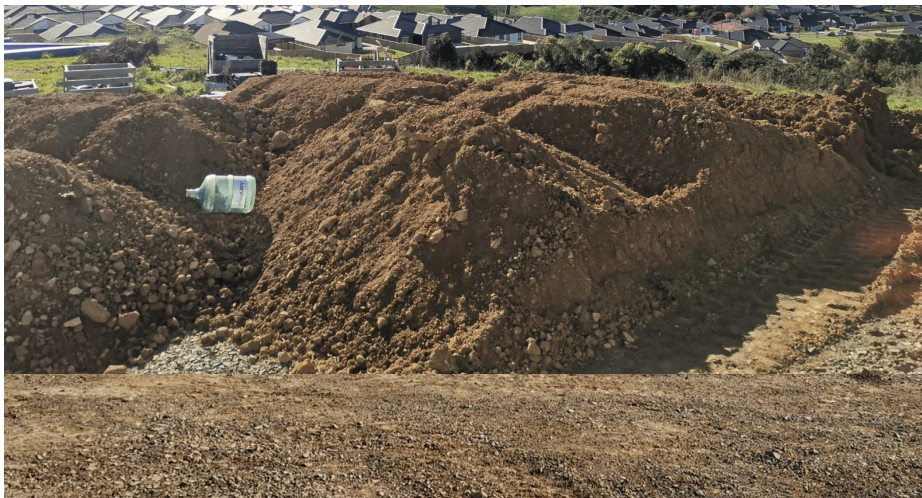
There are various stockpiles present in Stage 19 and we will just need to sight the area once those are removed in due course.

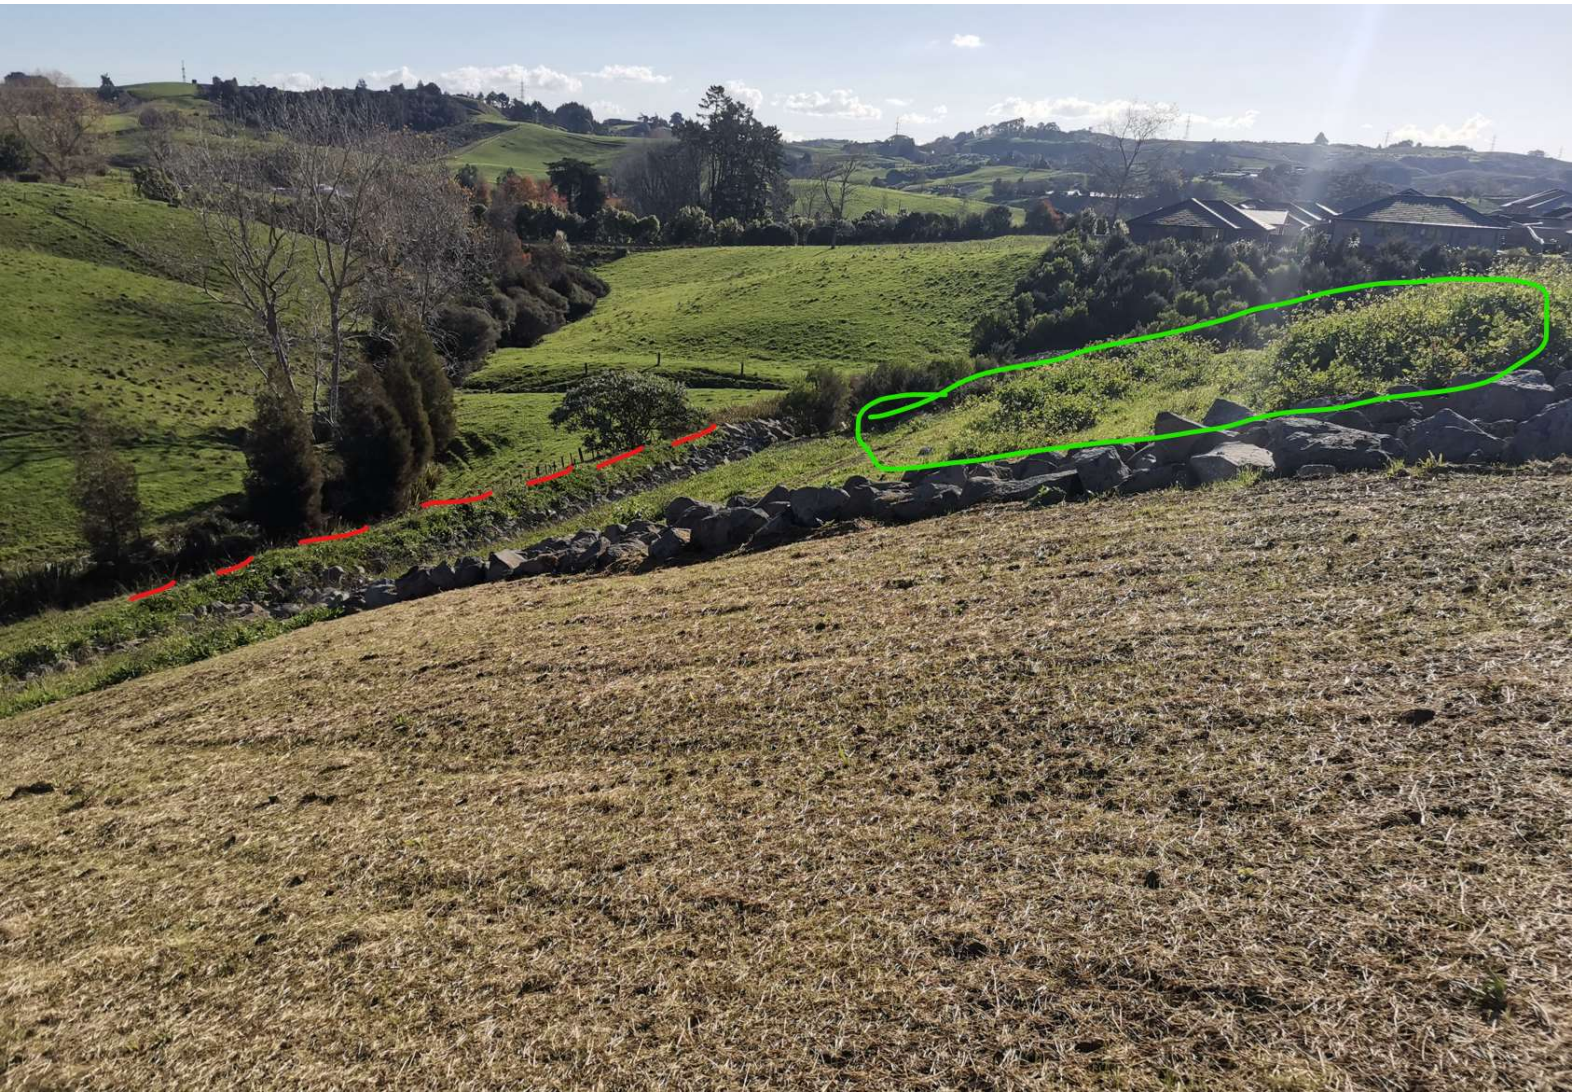
There is also a section of slope above this which appears to be steeper than 1(v) in 3(h) - marked in green below. We will check this as part of our slope stability verification, but just wanted to double check this was the proposed profile through this area?

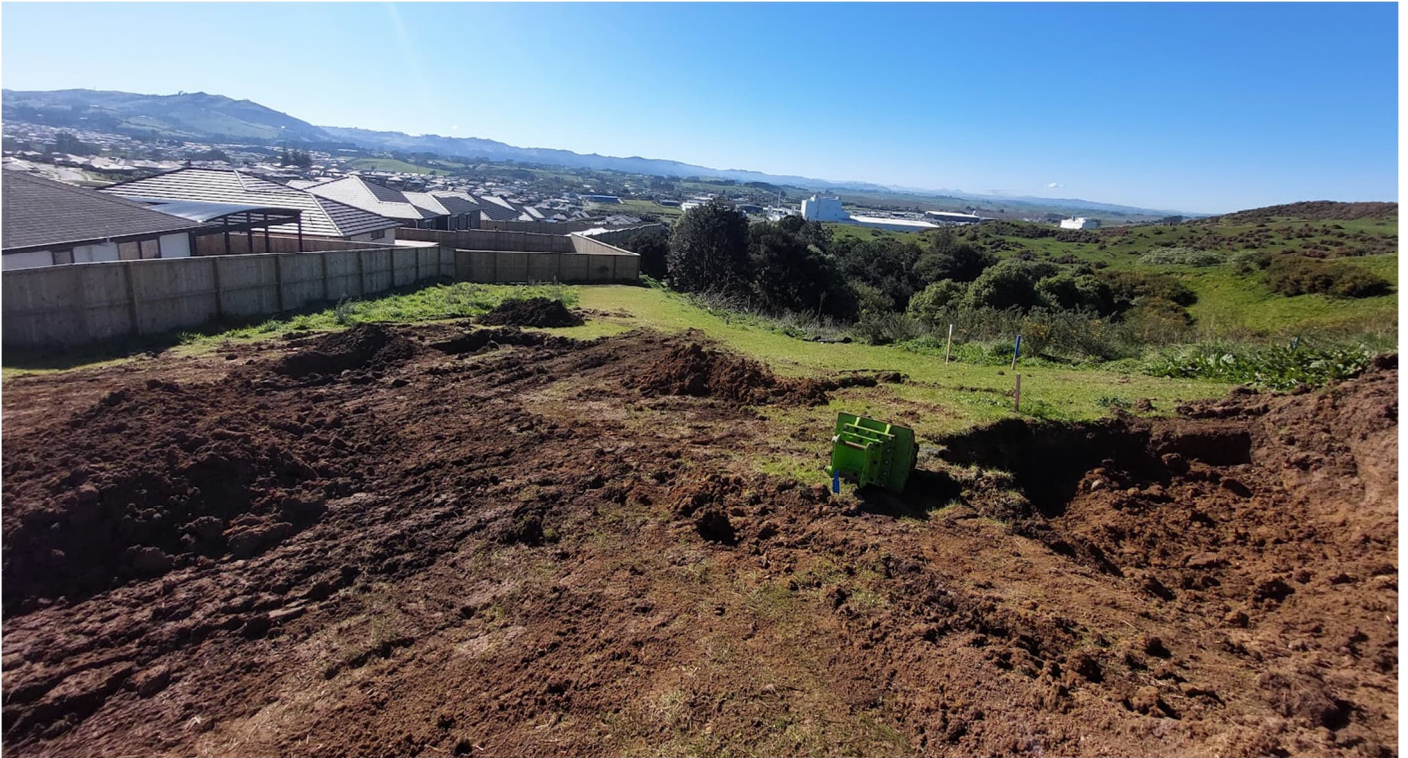
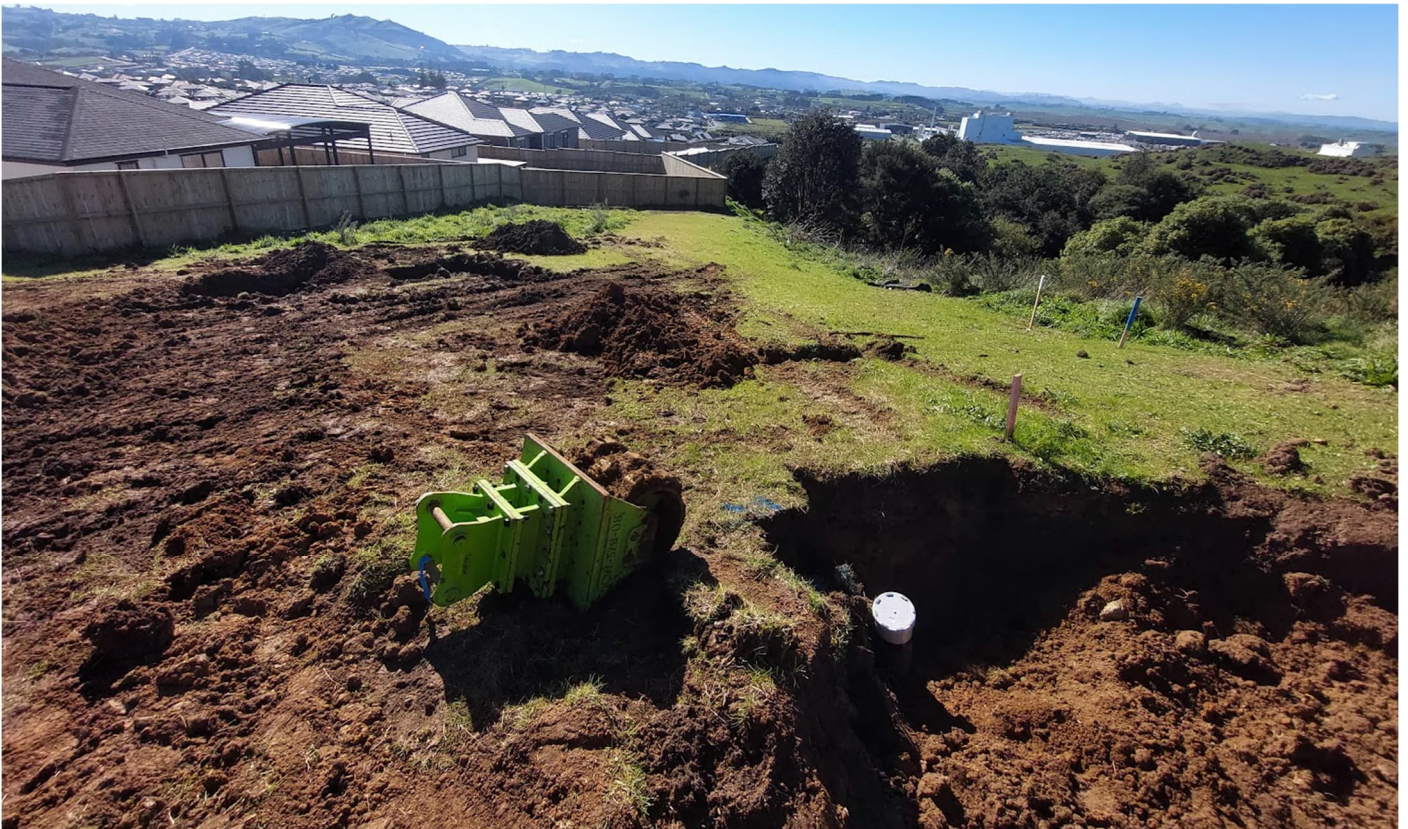
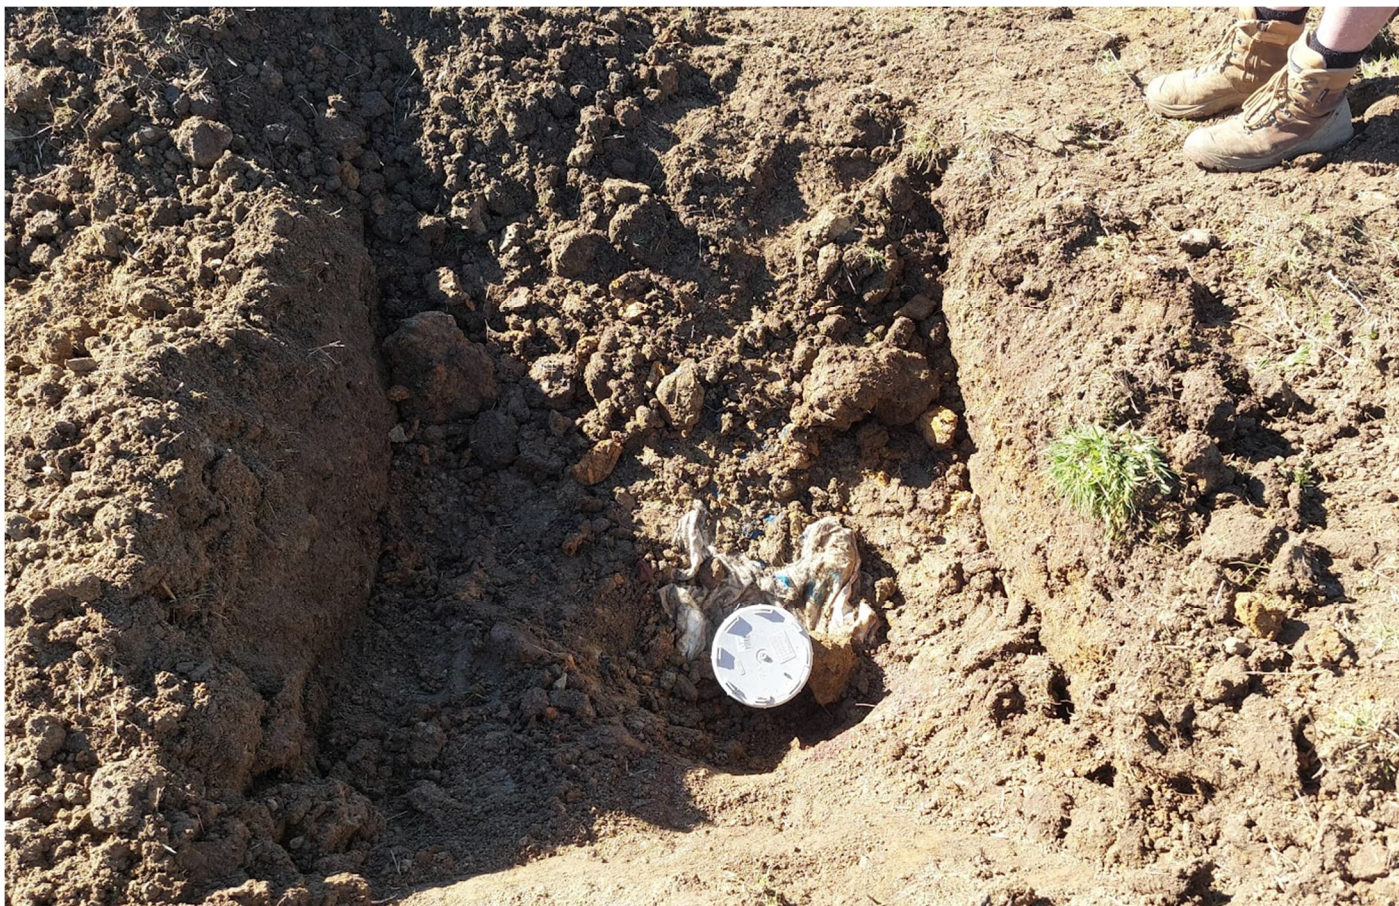
3 Pits opened up to locate the capping of the 3 counterfort drains.

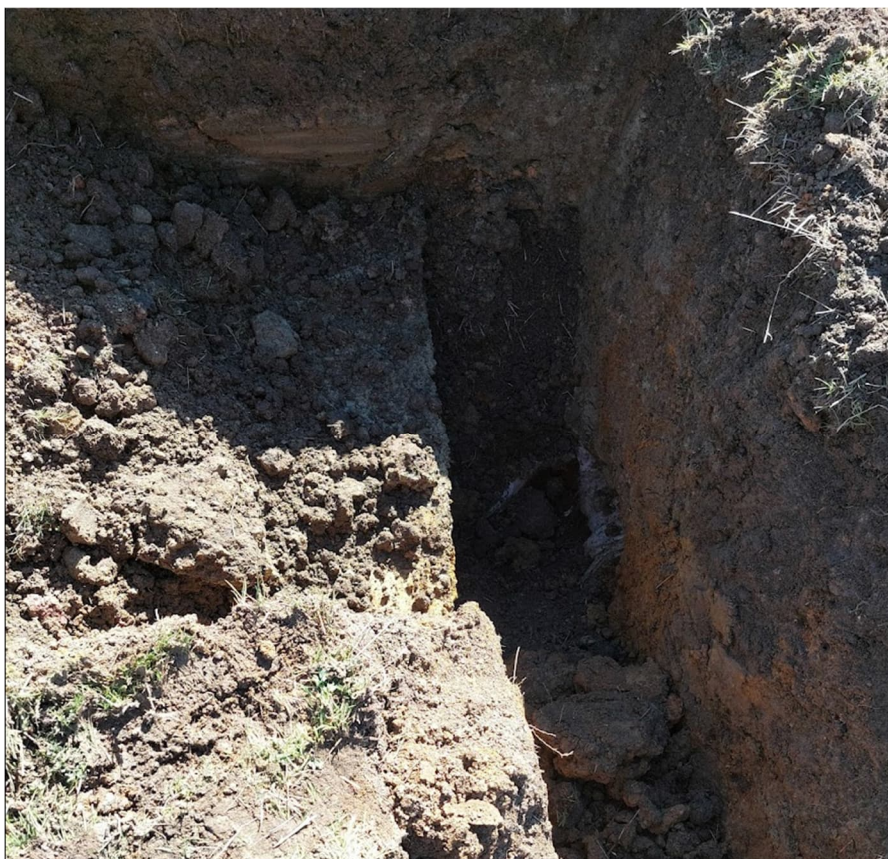
Scoria present below the cloth
