DFH Joint Venture Limited

GEOTECHNICAL COMPLETION REPORT

Hitchen Block Stage 18, Pokeno

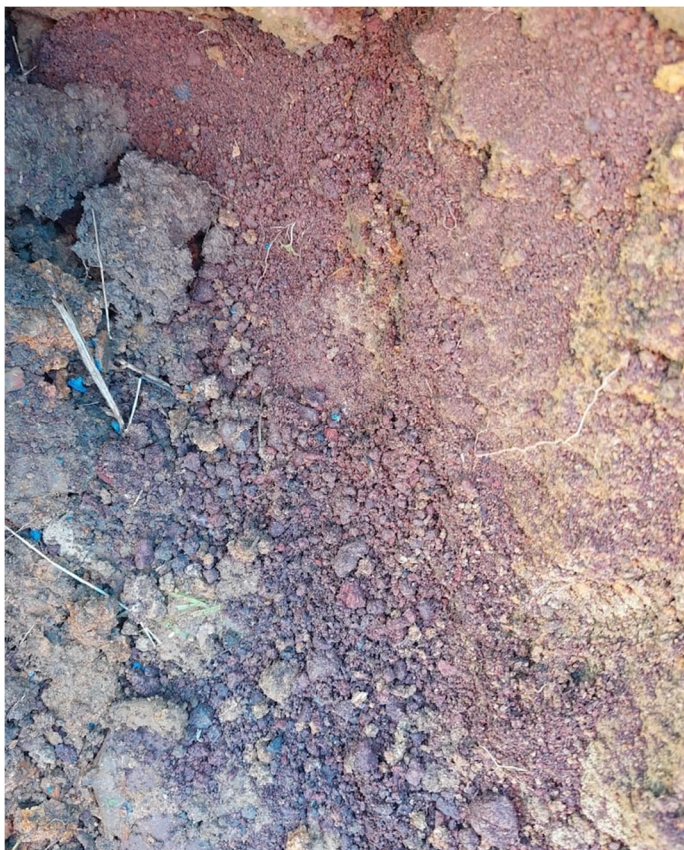
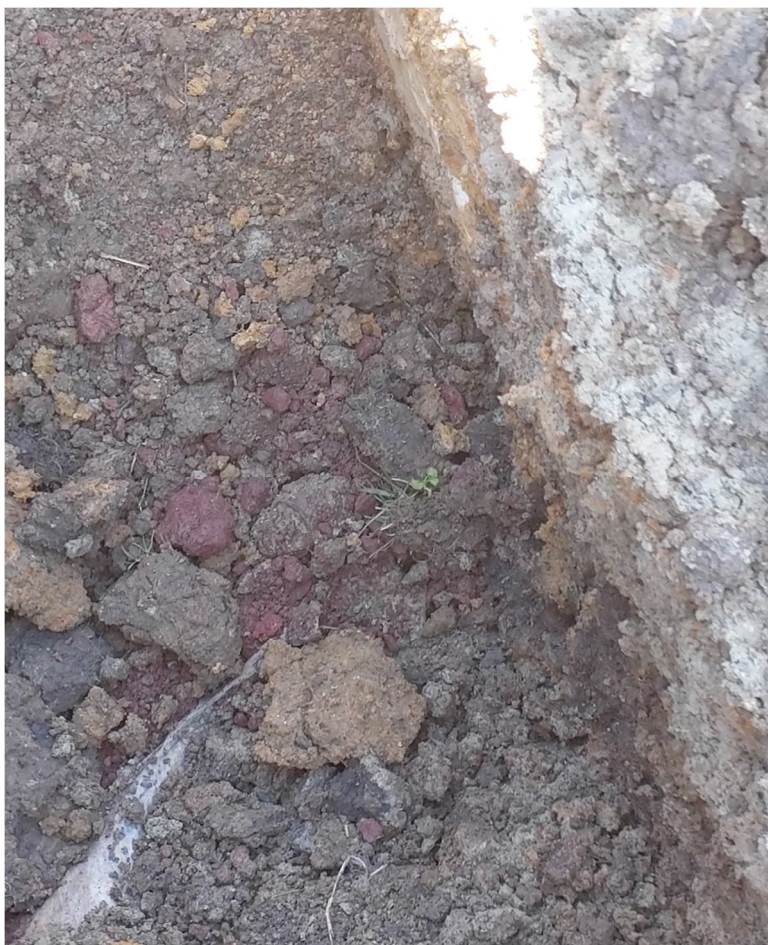
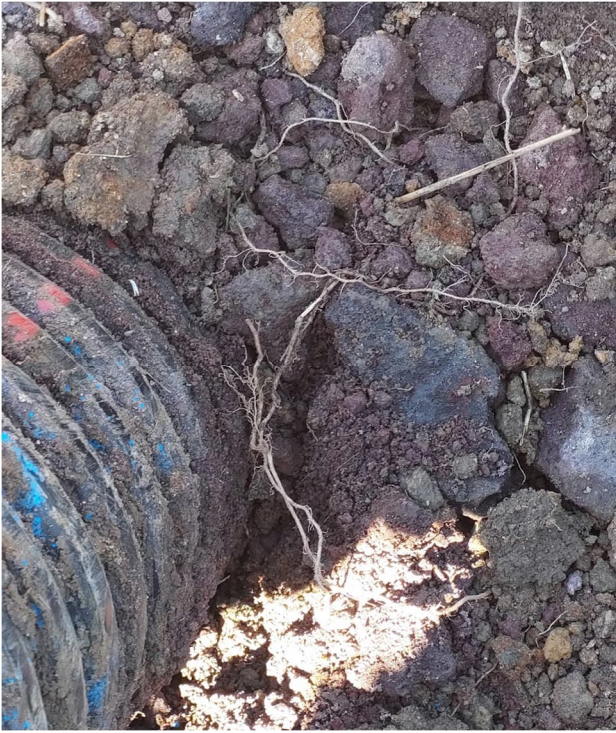
Scoria present below the cloth

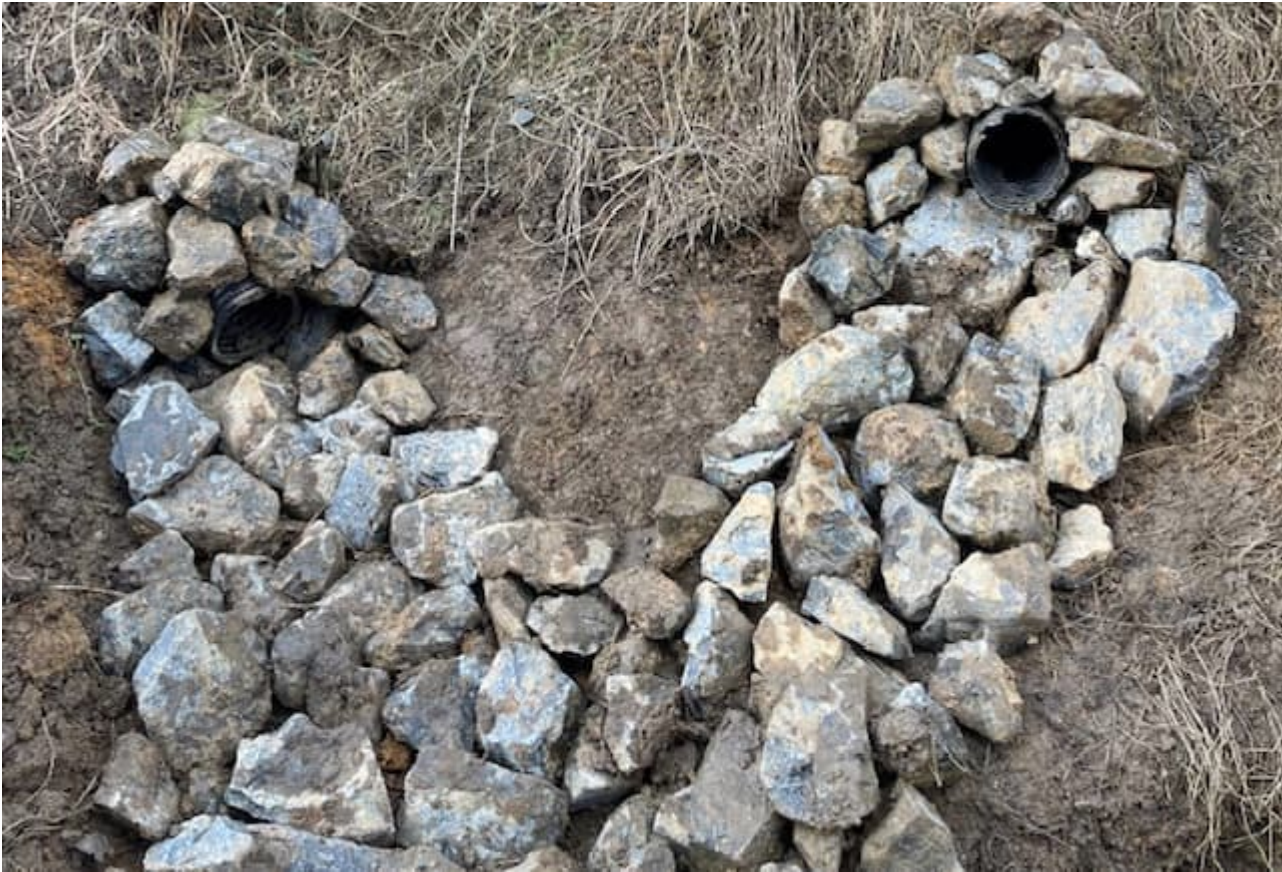
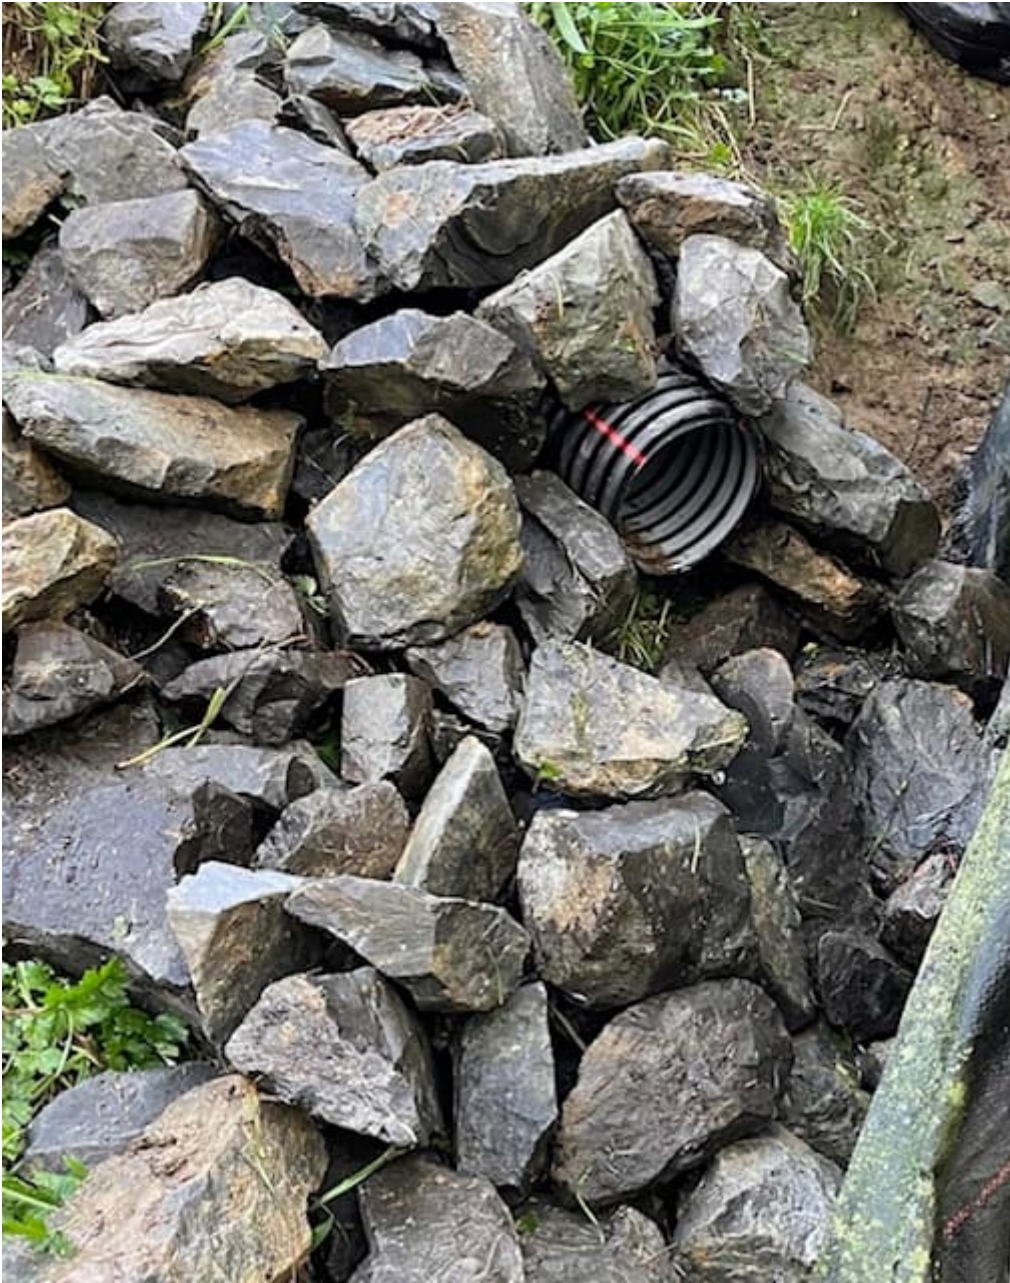
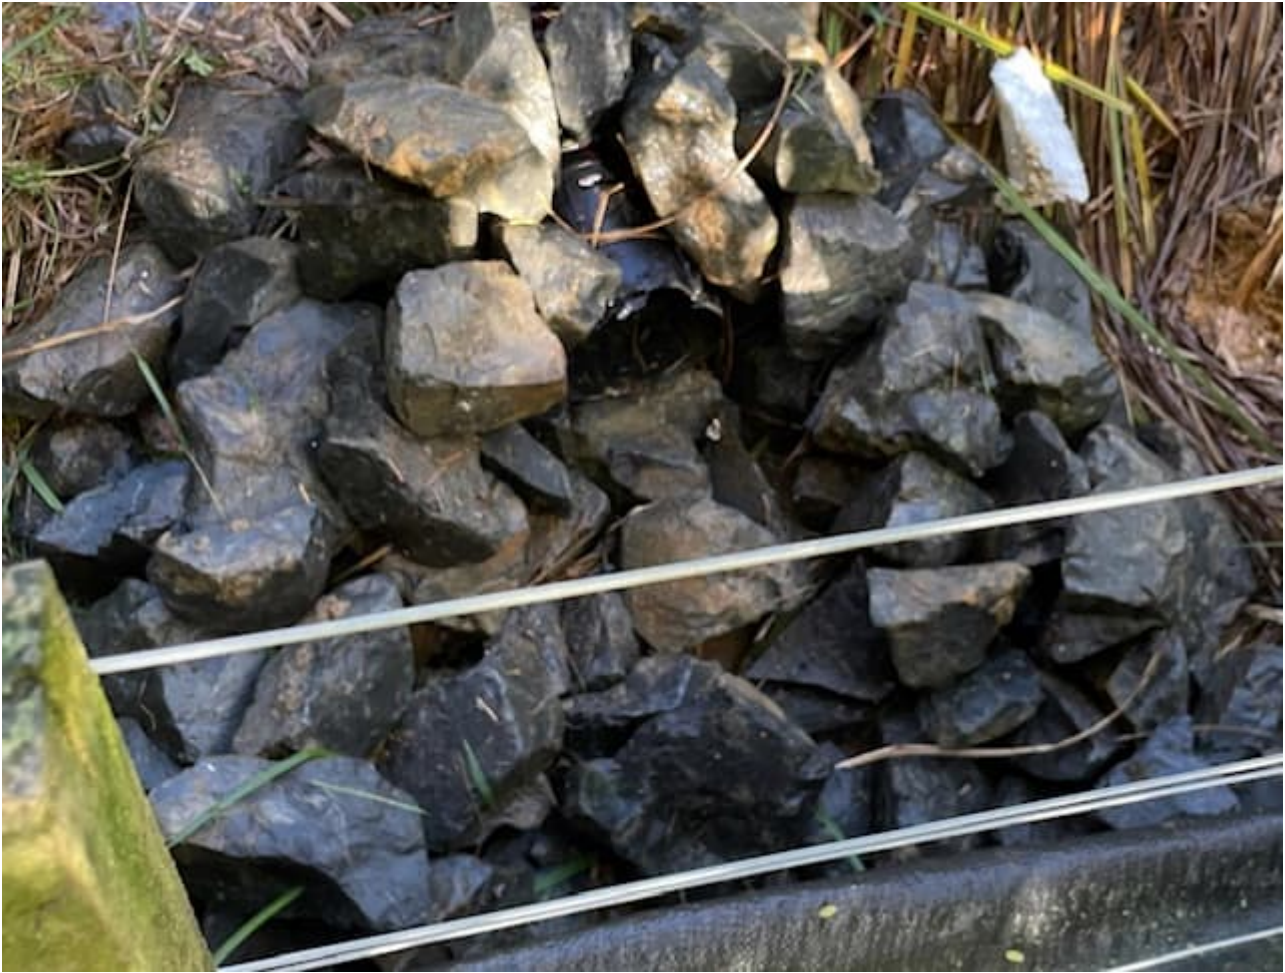
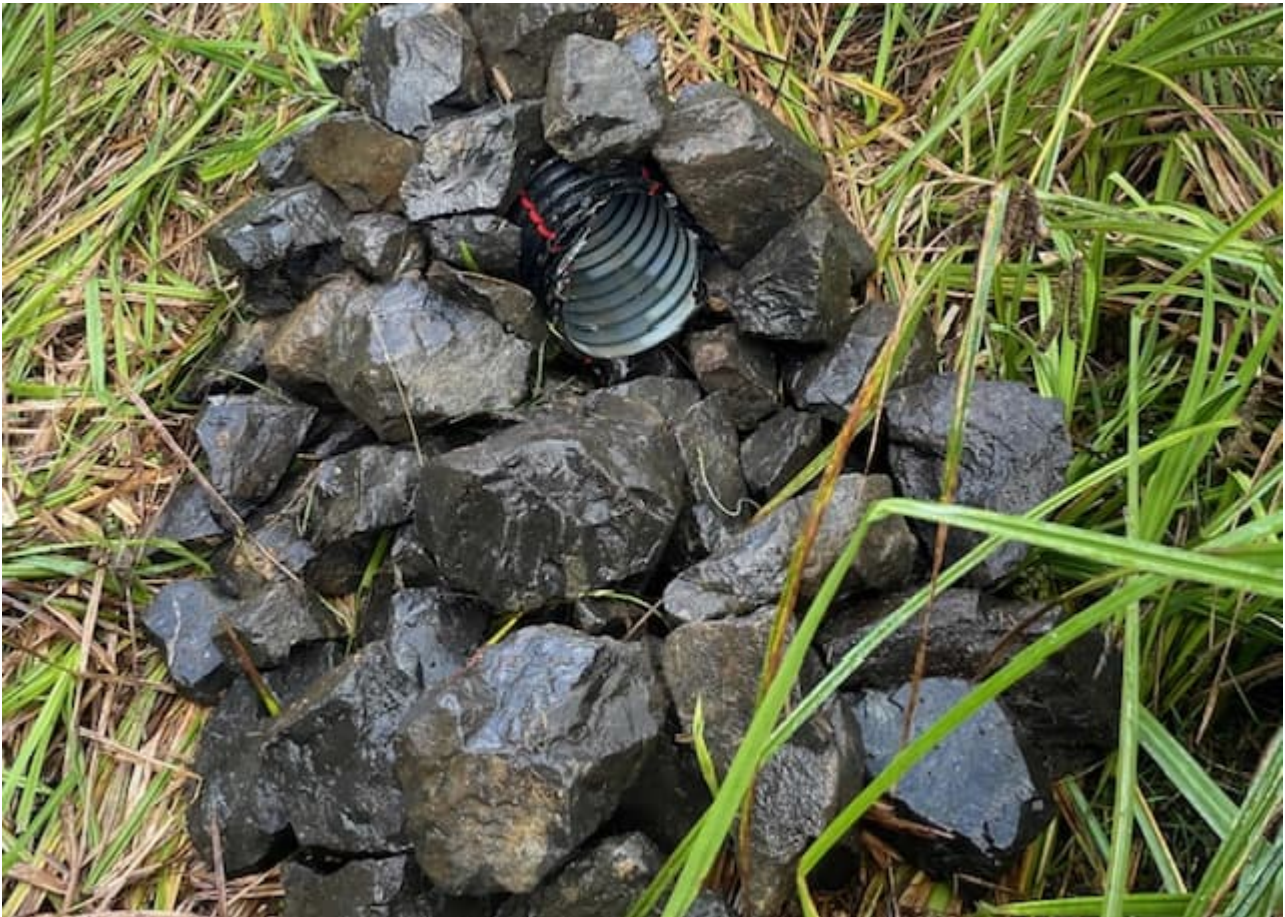
Stage 18 & 19 drain outlets, provided by the contractor on 23/07/25:
