DFH Joint Venture Limited

GEOTECHNICAL COMPLETION REPORT

Hitchen Block Stage 19, Pokeno

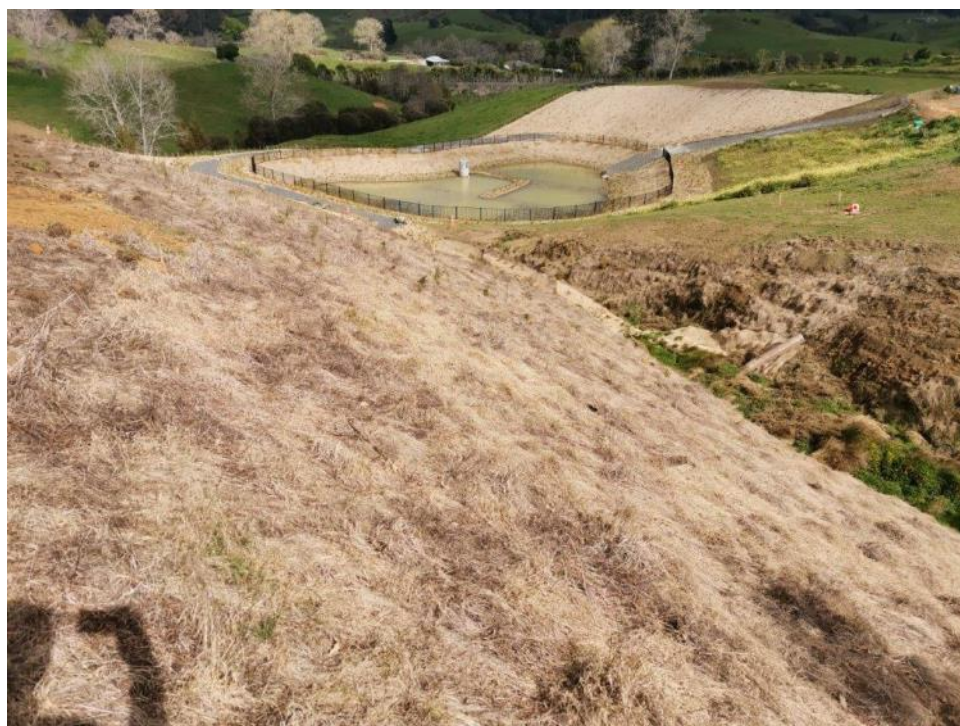
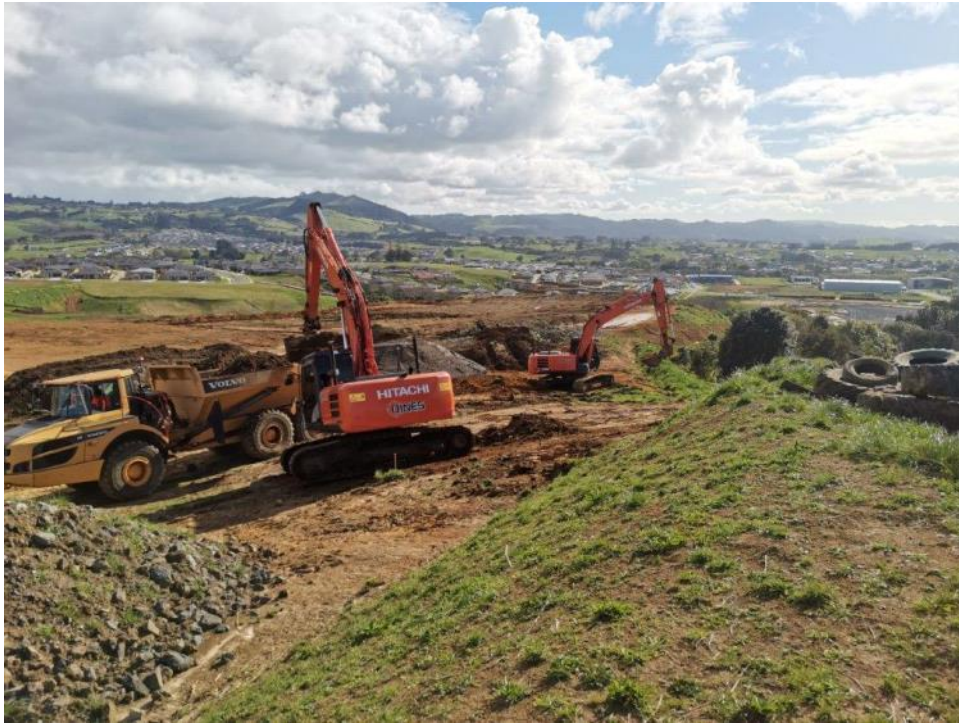
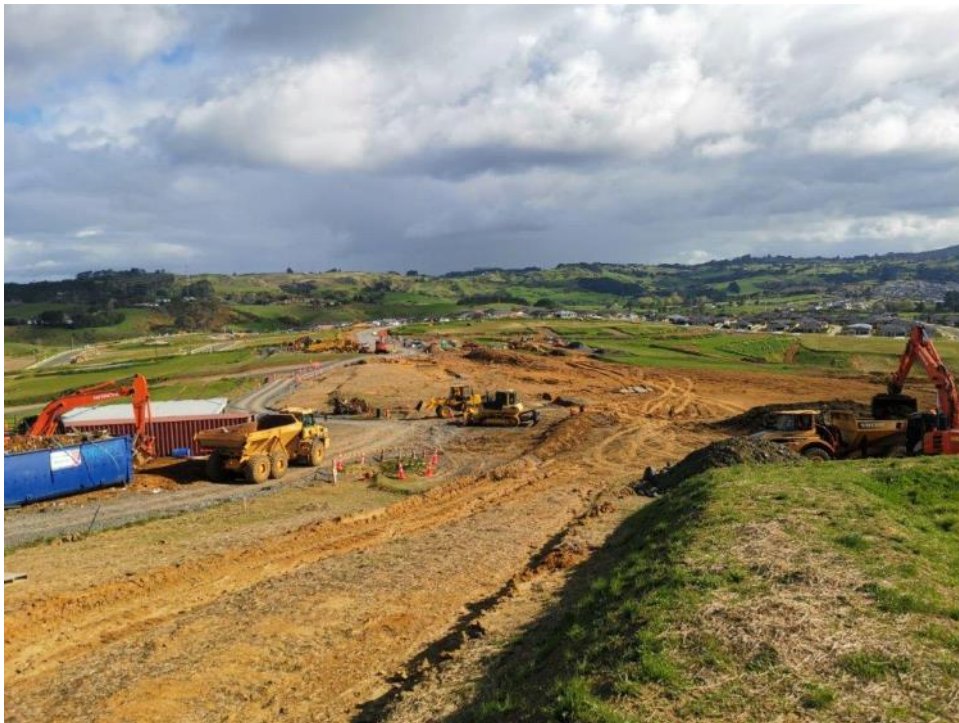
- Visited site to discuss Stage 6 earthworks with Trevor and Simon (new foreman for Dines). Items discussed were:
 - o Nominal toe keys required at toe of proposed fills. 1m depth minimum into very stiff soils.
 - o Nominal underfill drains will be required, must keep 2m of fill cover wherever possible. Some drains will likely need to be trenched in 0.5m. Drains will outlet over the top of the toe keys into the gullies.
 - o Counterfort drains: 4x required below proposed retaining wall. Will discuss flush point with Chris. Dines may have to bench the slope to get the drains in as the slopes are very steep.
 - o Retaining walls will be constructed by Dines as part of the civil works. Drain outlets will be directed to the public reticulation network.

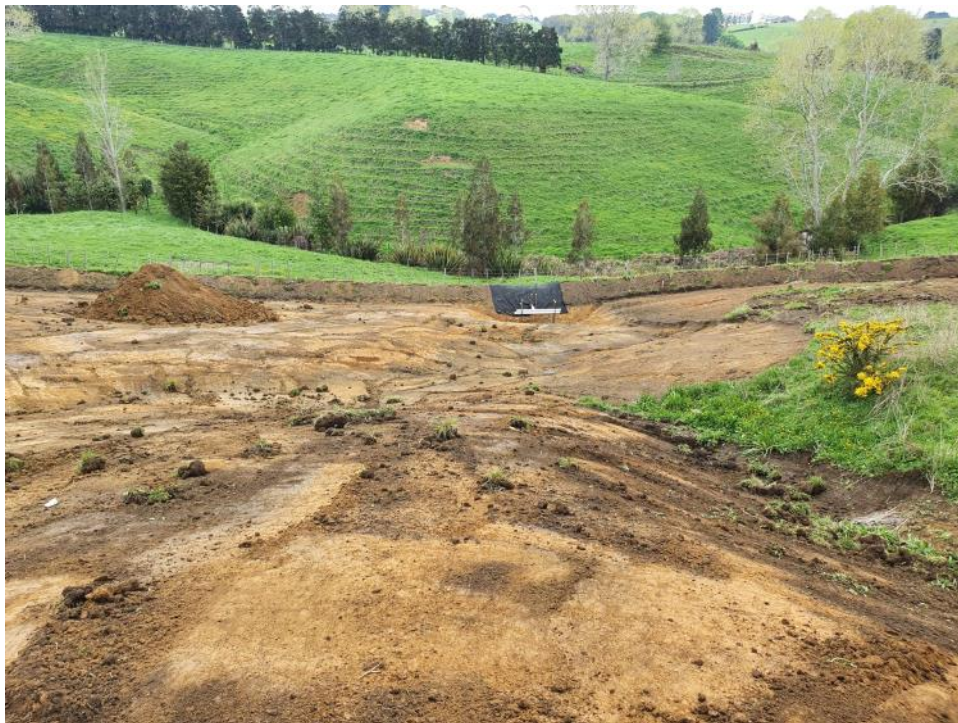
06/10/21 - Site Walkover

Attended site for a site walkover/ handover from KM to RG. Observed the beginning of works (forming of drainage) within Stage 6. The beginning site strip was occurring within stiff to very stiff natural Ash soils.

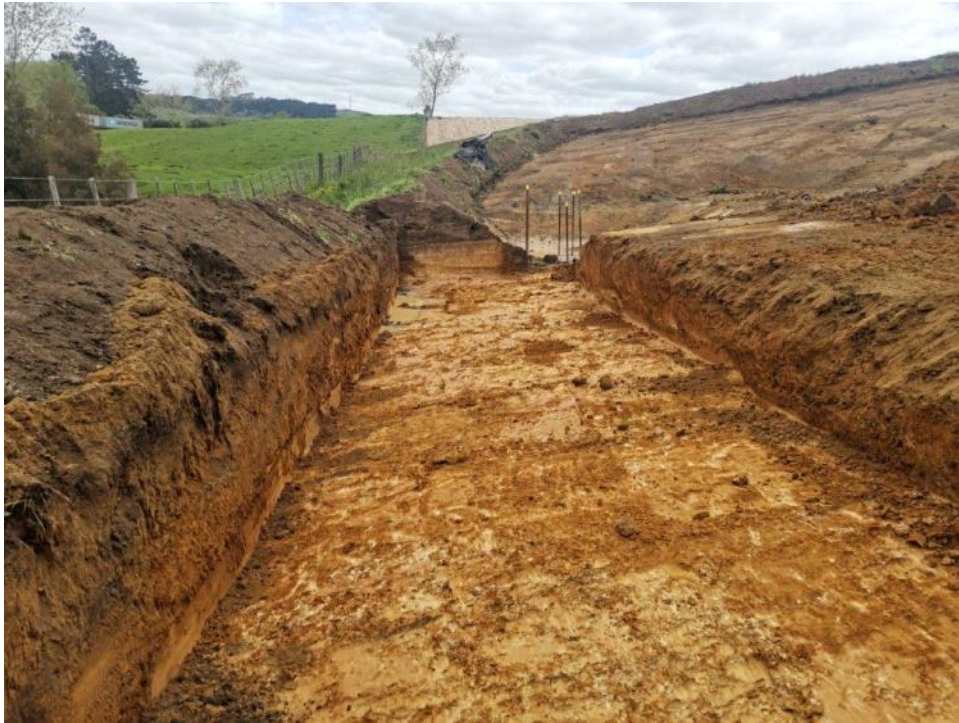
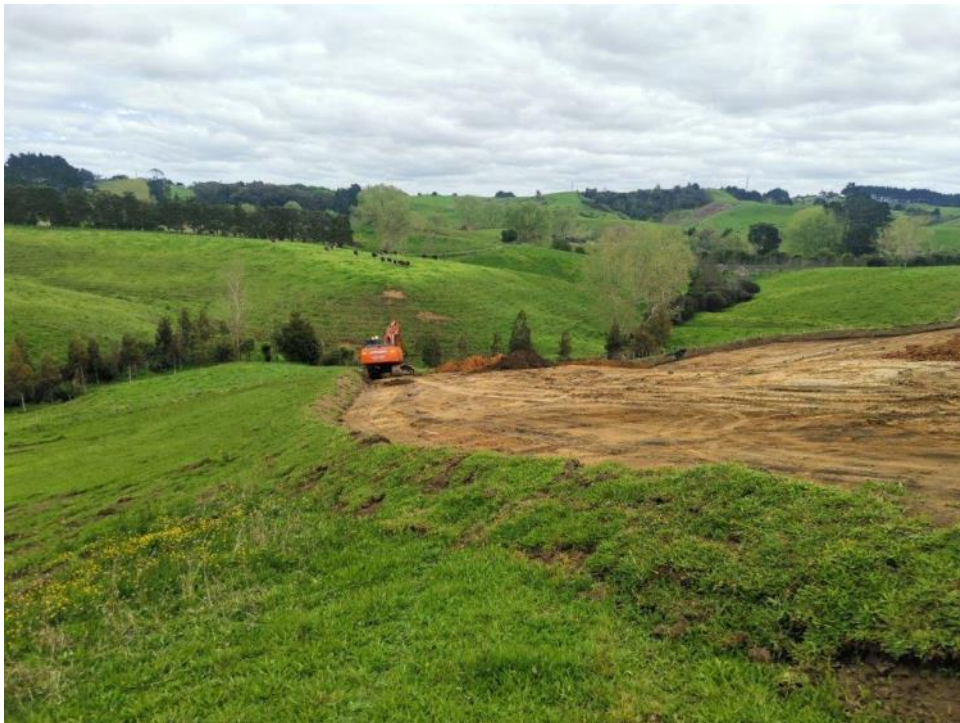
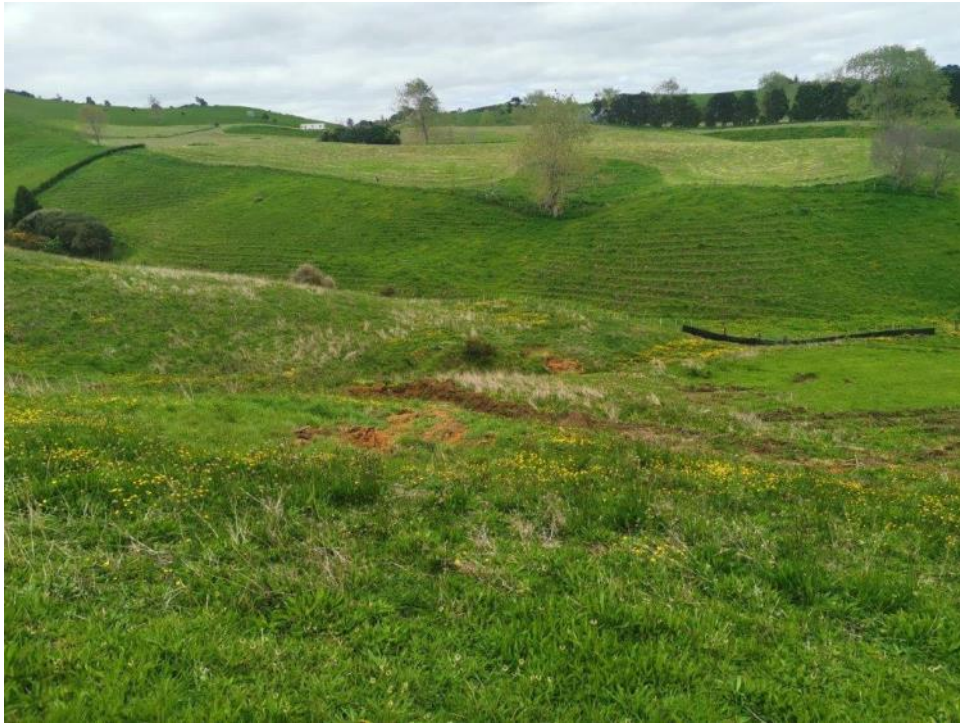
11/10/21

Observed excavation of toe key at least 1m below original ground level as per purple outline on the annotated plan below. Advised contractor to bench the sides and then fill compaction with clay can commence. Also advised that the underfill drains be installed as per our detail and should not extend beyond the lower retaining wall.

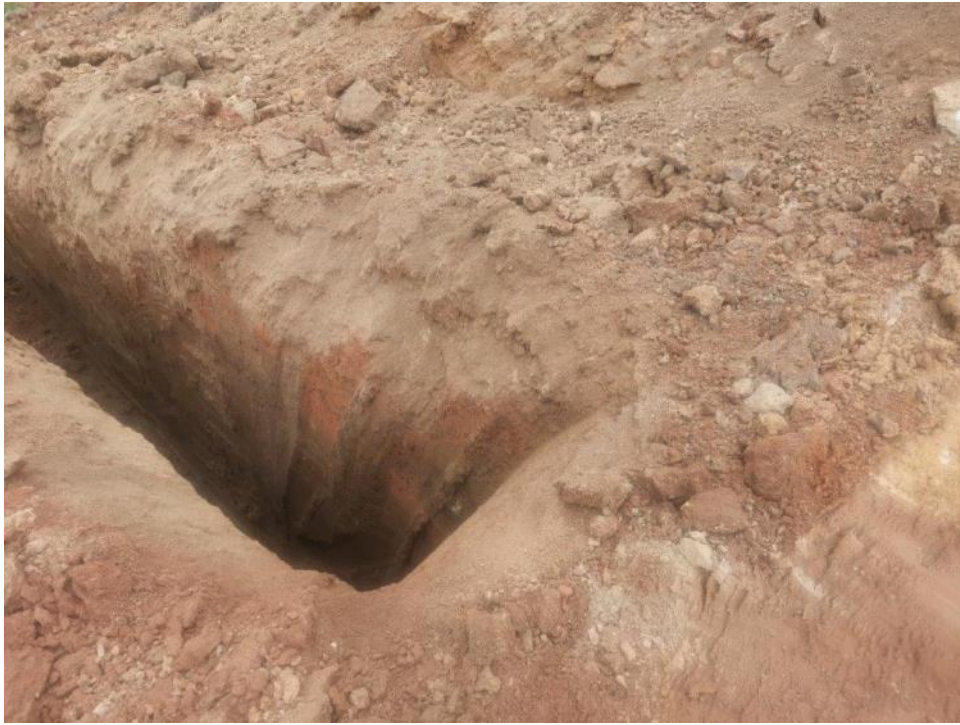
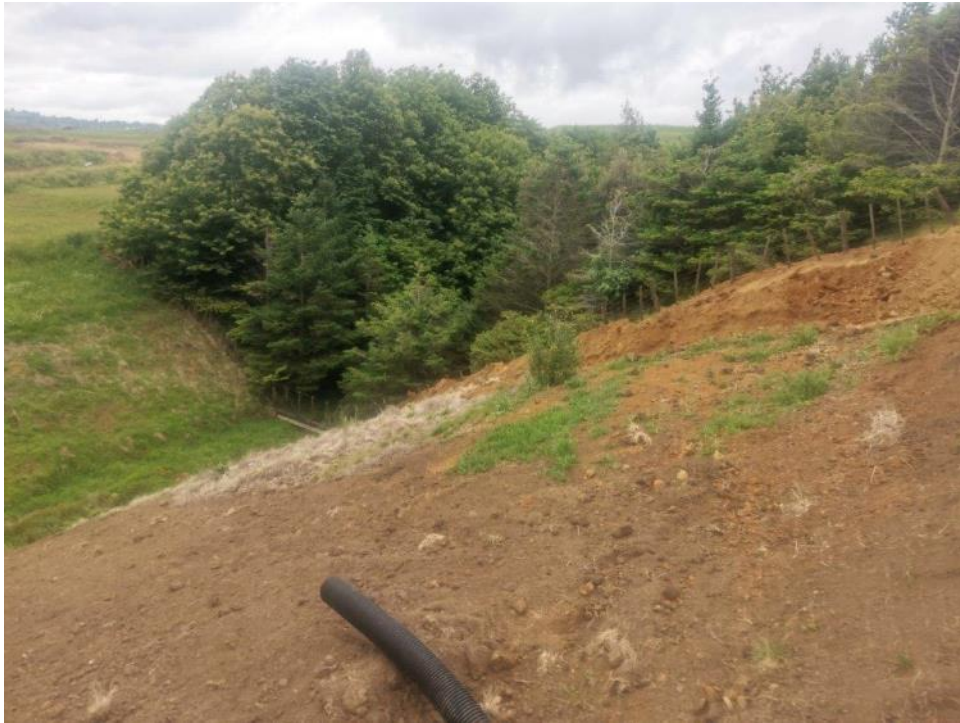
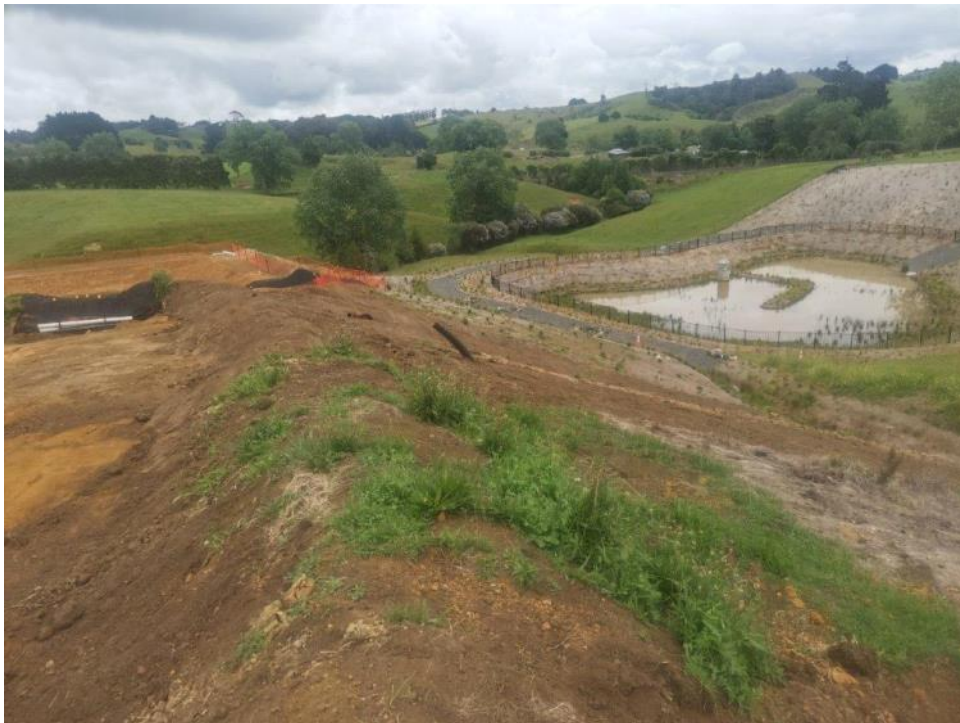
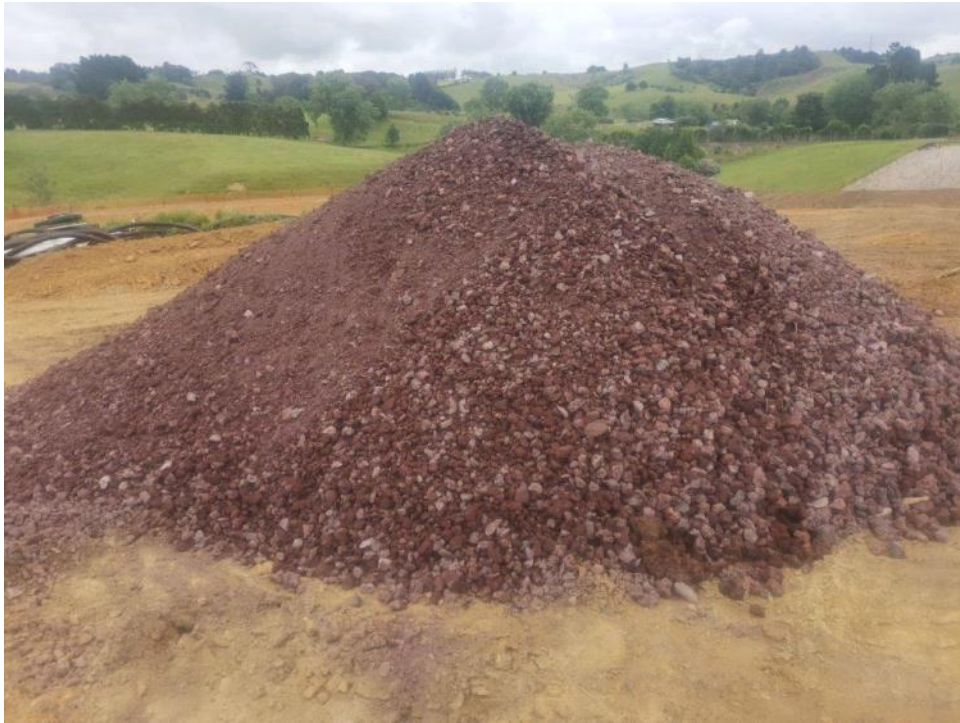
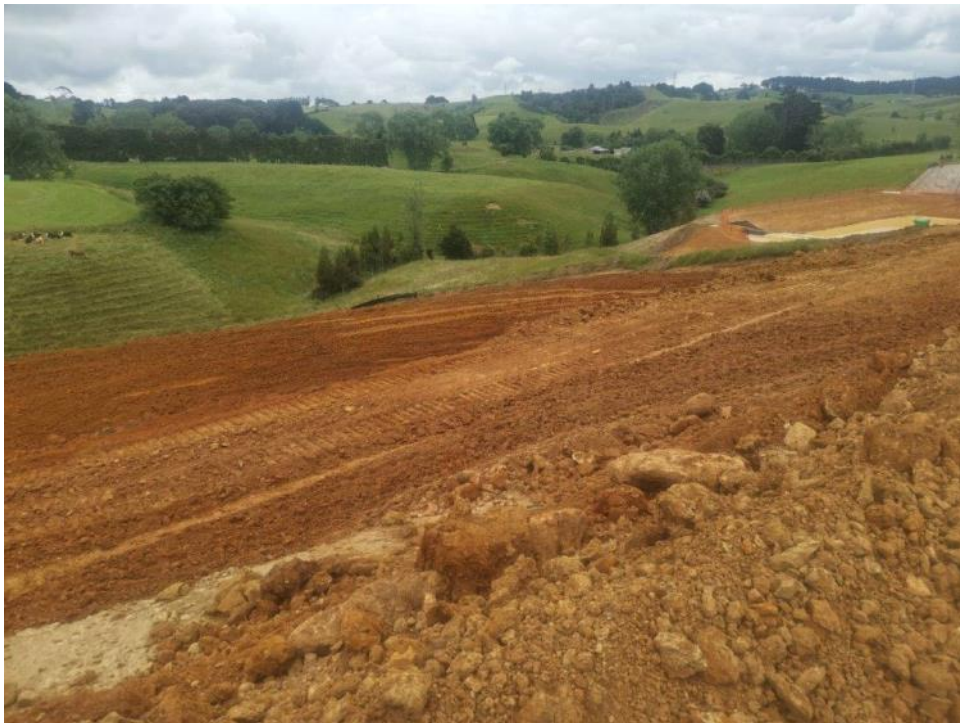
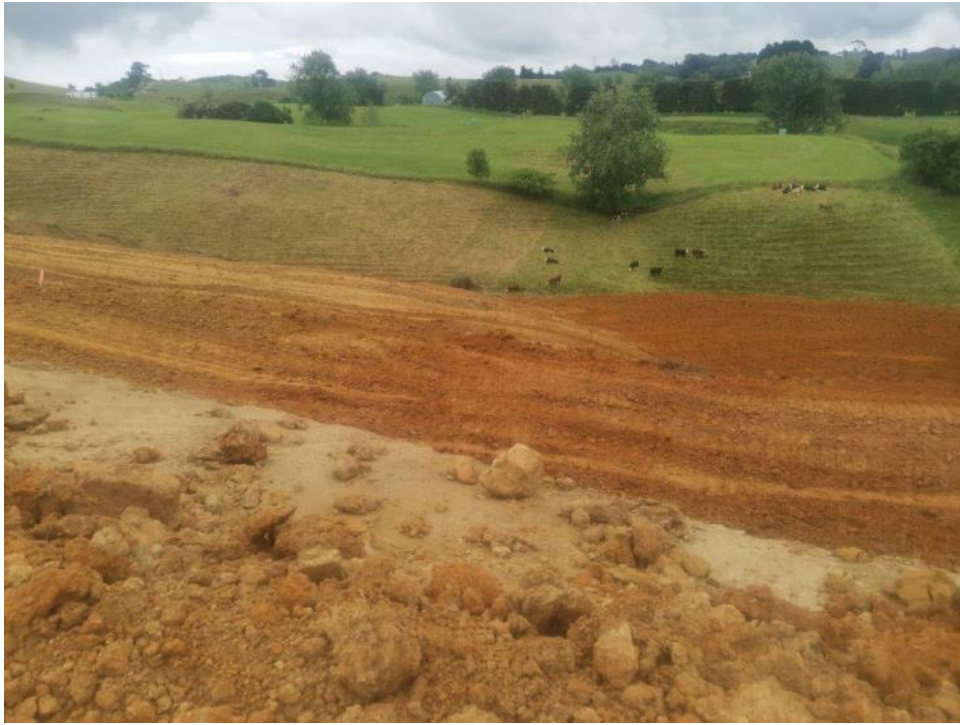
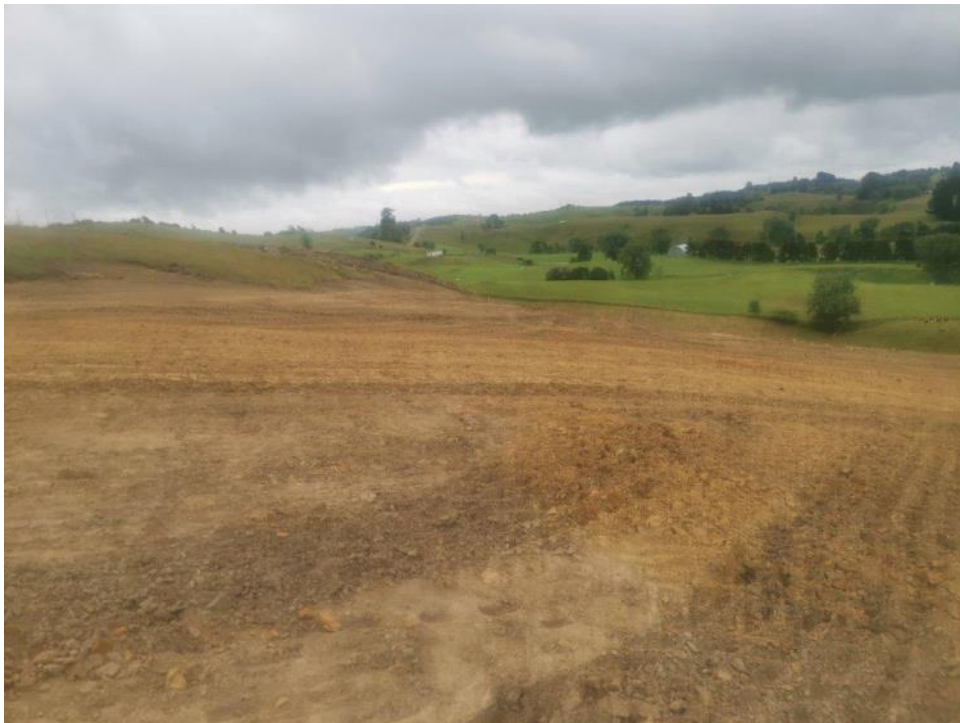
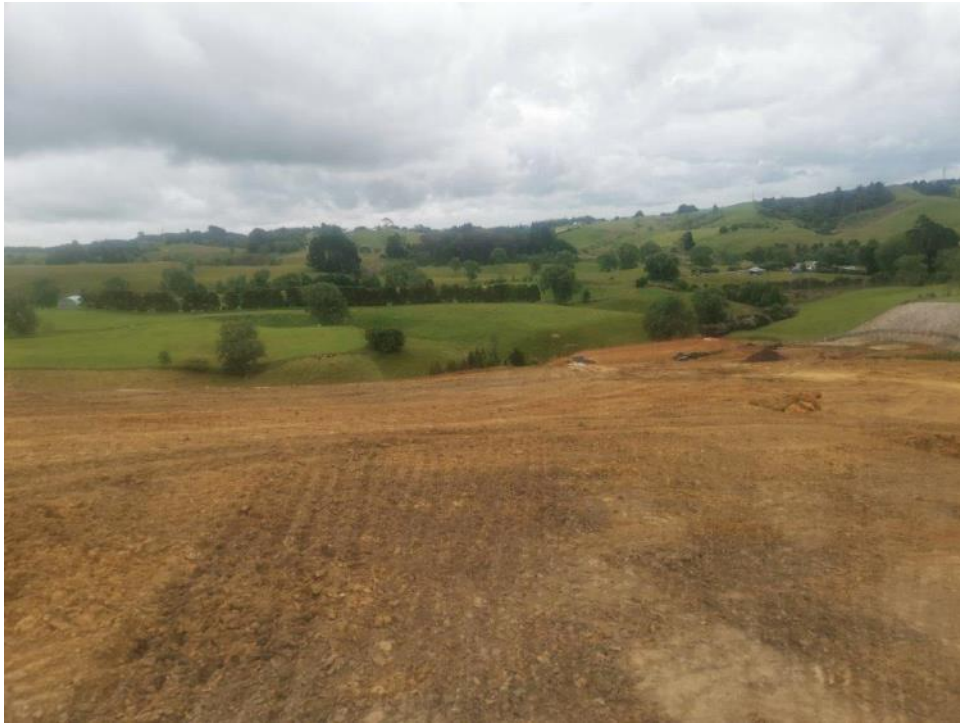
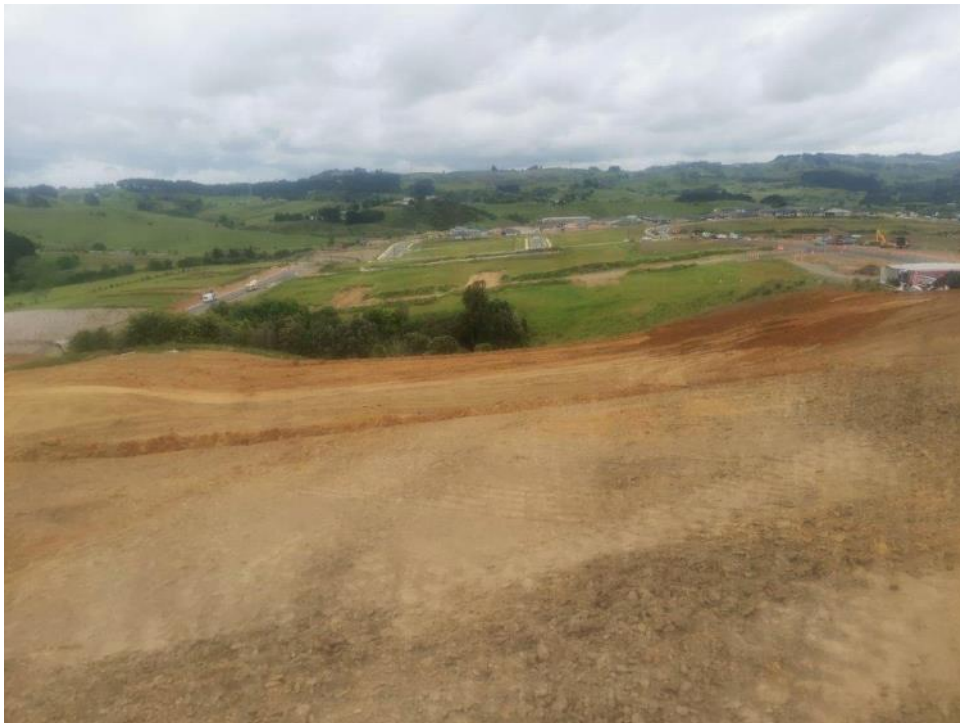
30/11/21

Counterfort drains in are mostly complete, the final drain is still being constructed - loose materials have been undercut, benched out and clay fill placed. Drain depth to digger reach.

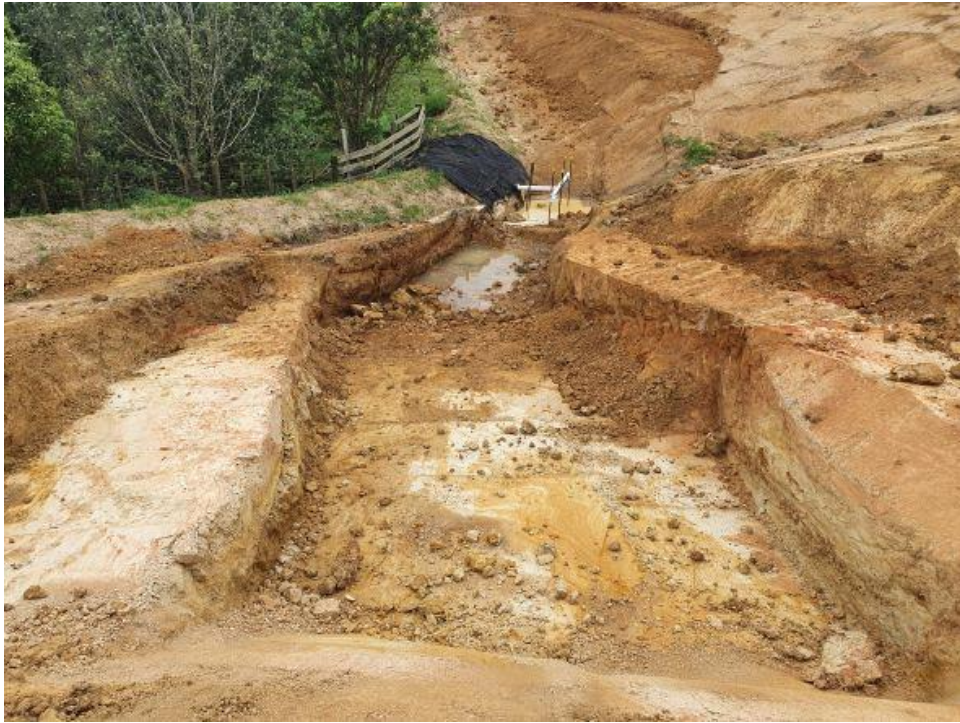
05/11/21

Observed excavation of toe key at least 1m below original ground level as per purple outline on the annotated plan below.

- Base of the toes key returned shear vanes of greater than 217kPa, with the vane blade unable to penetrate the soil in some instances.
- Discussed with contractor that they would bench the sides and then fill compaction with clay can commence.

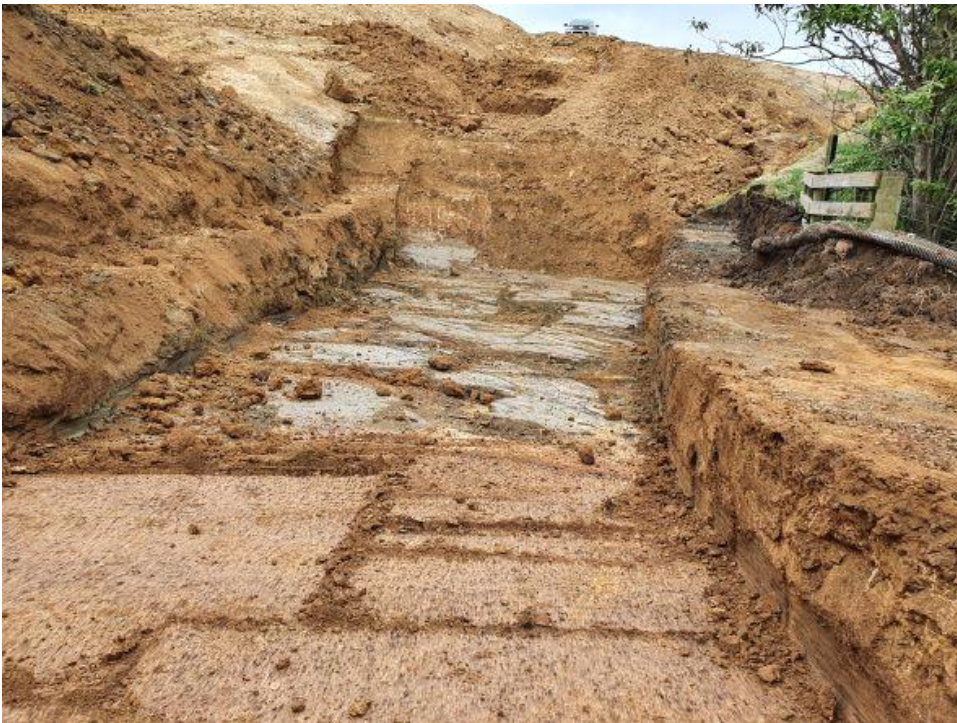
Observed excavation of toe key at least 1m below original ground level as per red and blue outline on the annotated plan below.

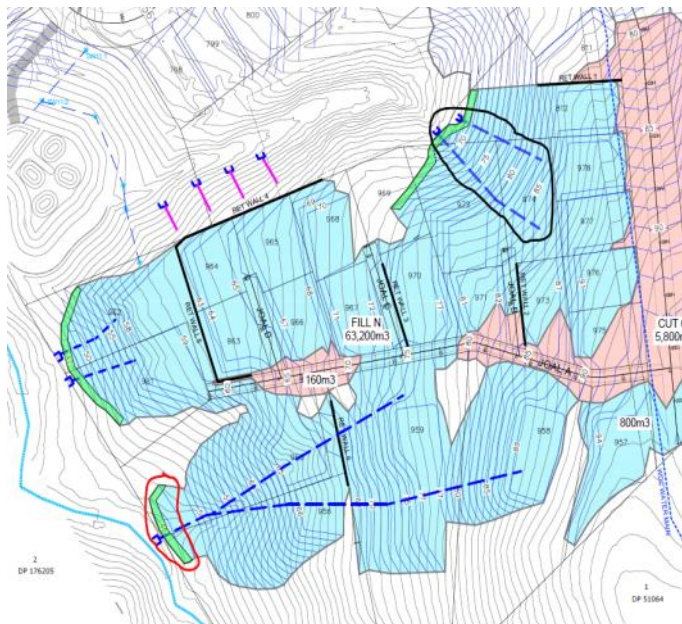
09/11/21

Observed toe key circled in red on the below site plan:

- Toe key was around 3m deep, founding on stiff to very stiff natural clays.
- Some water seepage from the creek was noted within the base of the toe key, this was scraped off by the digger and then capped with compacted clay. We will return tomorrow to check the fill.

Also observed the underfill drains circled in black below:

- Drains consisted of cloth wrapping around 160mm heavy duty novocoil, covered by hardfill and were in the positions indicated on the below plan.

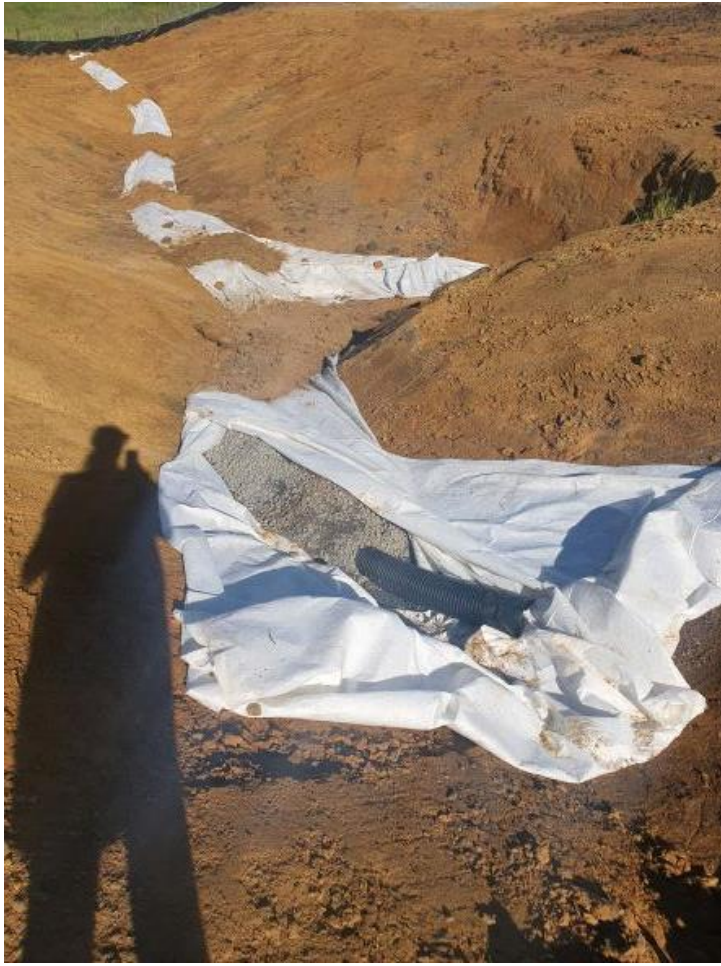
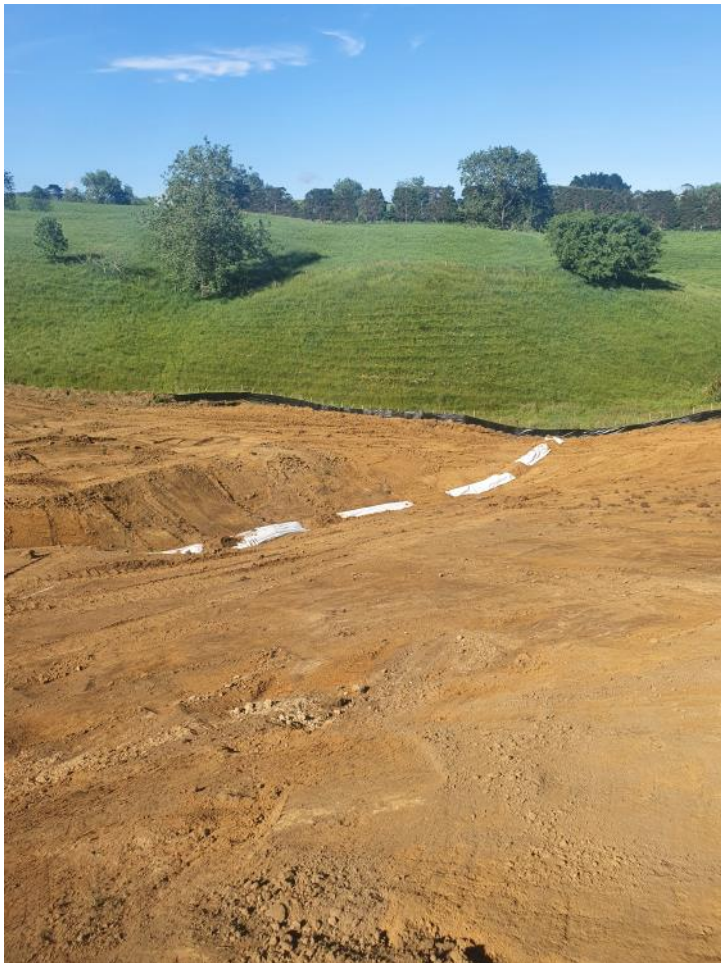
11/11/21

Attended site to observe to underfill drains (circled red) and counterfort drain locations (circled blue).

- Underfill drains were located within the low points of the slope and consisted of 160mm heavy duty novocoil, covered with 20/7 fill and wrapped with bidim cloth.
- The drains will be continued further up the slope once filling near the toe of the slope has been completed.
- The location of the counterfort drains had been pegged out. The counterfort on the west end is to be moved around 1m to the east to be located within a natural low point in the slope.
- From the top of the slope, these were set around 1.5m away from the approximate retaining wall location.
- Each counterfort was spaced by 15m.
- Contractor bringin in scoria backfill today, drain construction to start next week.

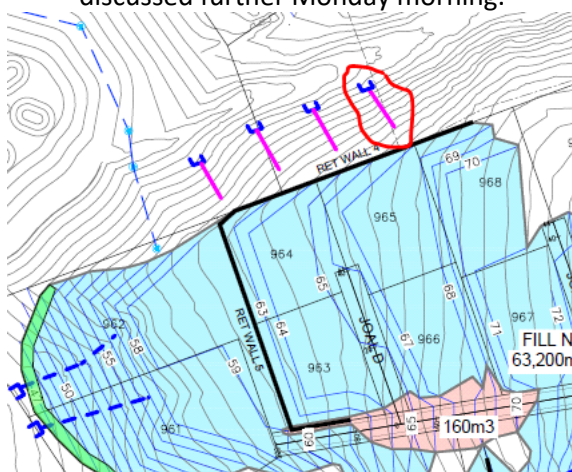
Attended site to observe construction of counterfort drain circled red below.

- Drain was constructed to approximately halfway up the slope and was 6m deep, in accordance with our design.
- Contacted by contractor around 1.5 hrs later to say the drain had collapsed. This is to be discussed further Monday morning.

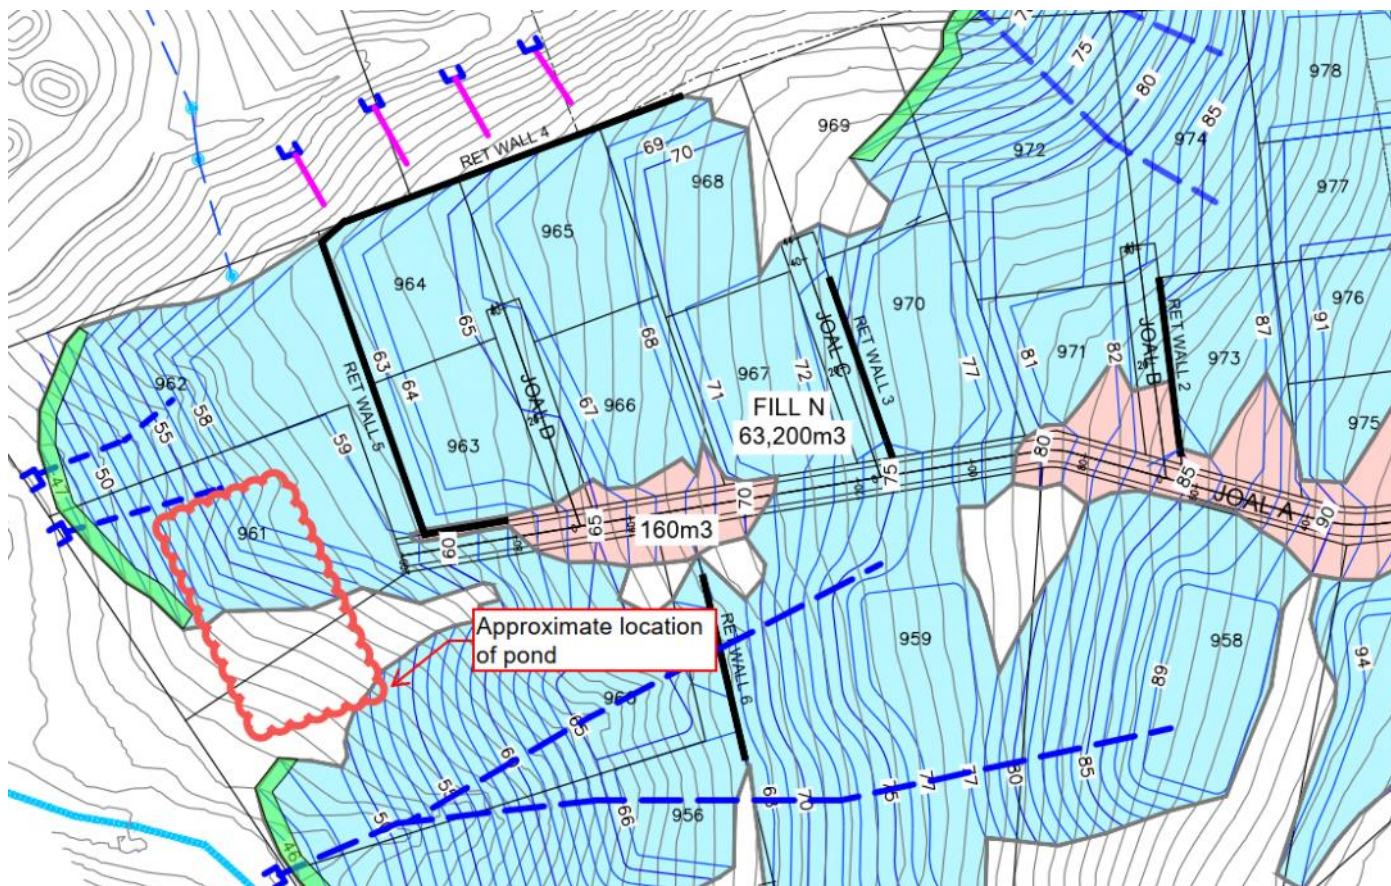
- Base of pond consisted of natural, inorganic material.
- Shear strengths greater than 100 kPa
- Satisfactory to place fill
- Minor vegetation was noted on pond batters. Recommended to remove prior to fill.

Visual Inspection of meadows shear key construction. Hardfill at final height (observed being rolled).

Drainage to be placed tomorrow.

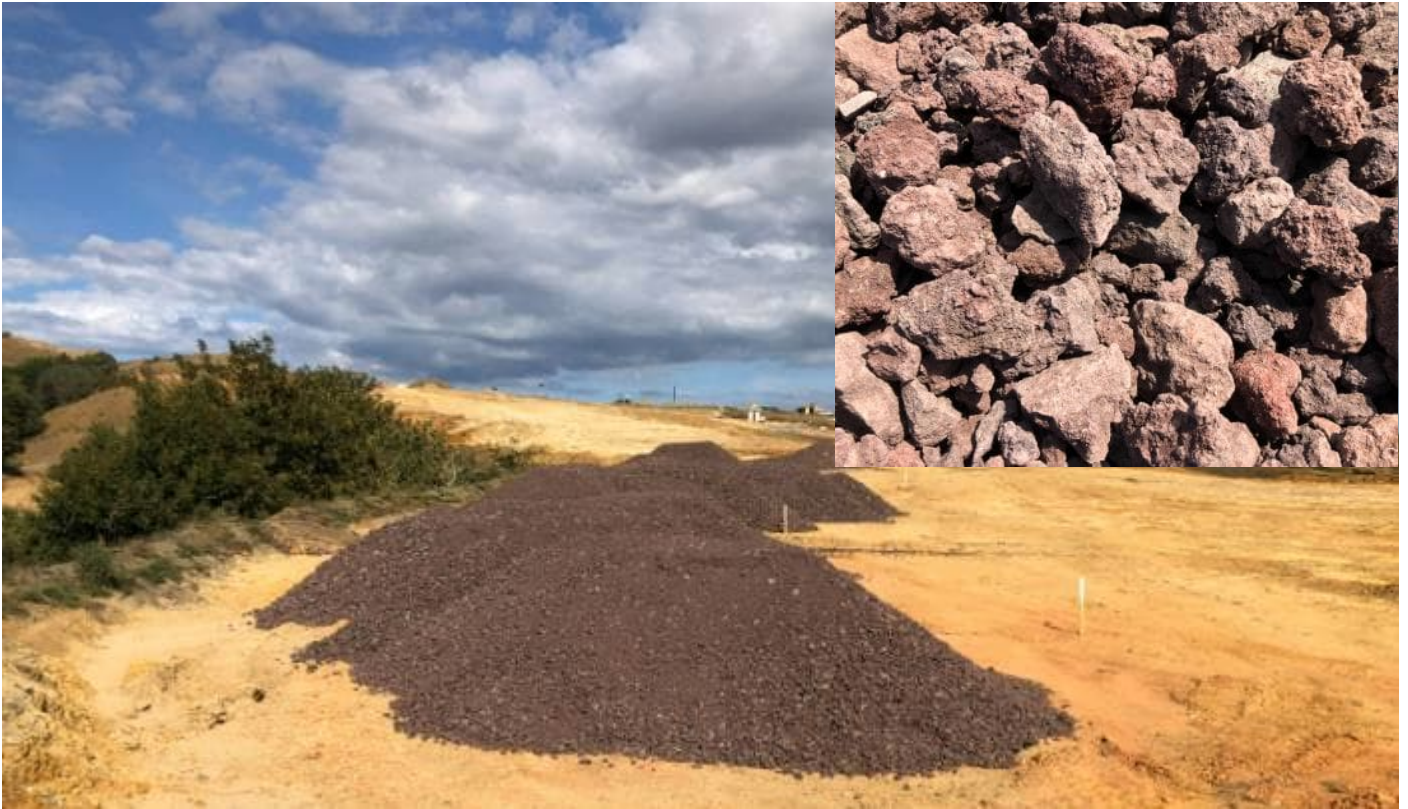
Attended site to observe beginning of meadows shear key underfill drain trenching. Observed stripping of topsoil for Counterfort Drain 01. Drainage aggregate stockpiled near Counterfort Drains is SAP50.

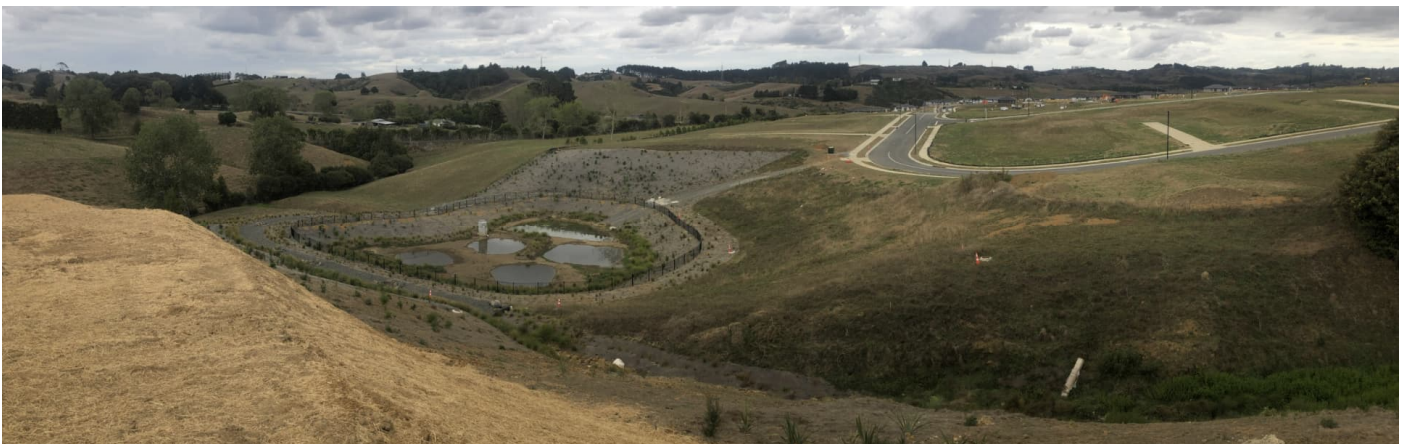
- Observed construction of underfill drainage installation in stage 17 meadows.
- Observed collector drain outlet point from stage 17.
- Observed outlet drains on REB walls.
- Observed rain garden geotextile materials.

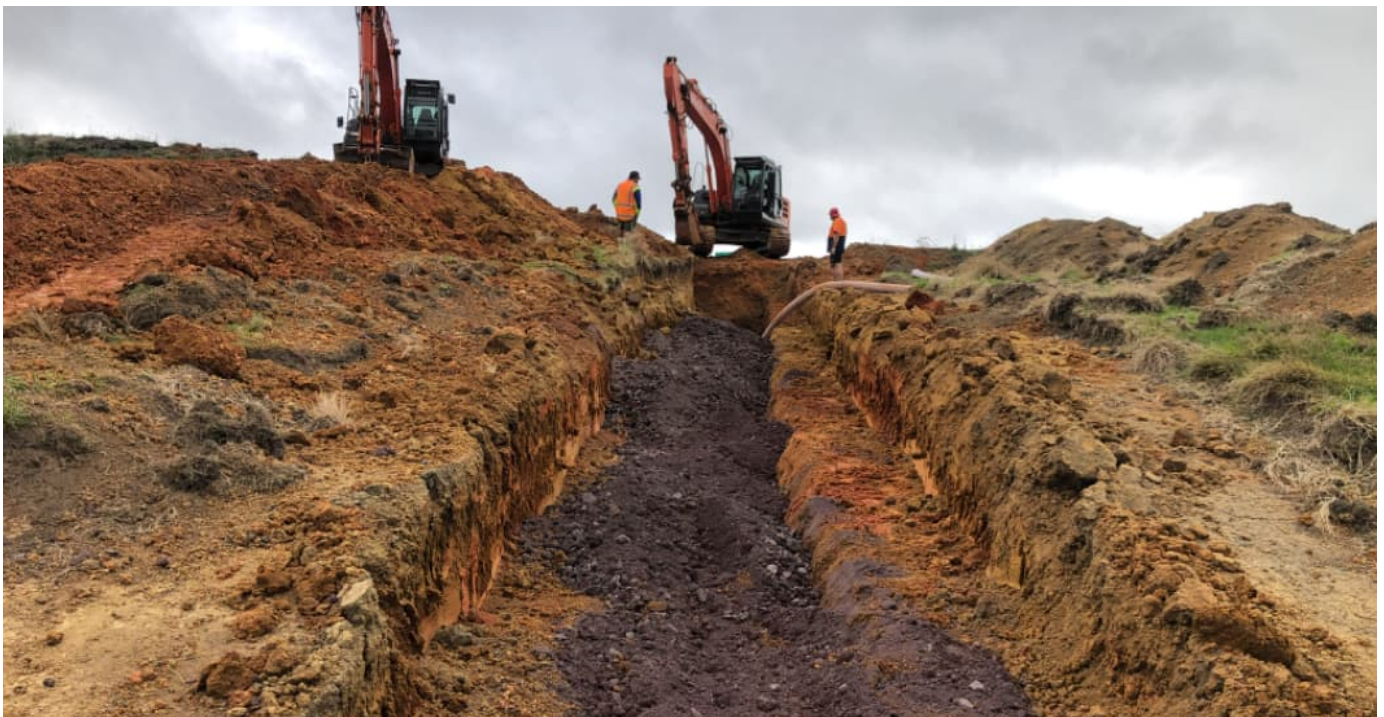
- Contractor advised that trench collapse was occurring once the trench reached 6 metres below existing ground level.
- Single 160mm nova coil placed in base of trench, backfilled with SAP50, compliant with design.
- Observed Stage 17 Meadows shear key completion. Underfill drainage has been backfilled and connected into collector drains.

Counterfort trench progress to be inspected frequently. Contractor advised that alternate excavation methodology (ie benching) may be required to address trench collapse issues.

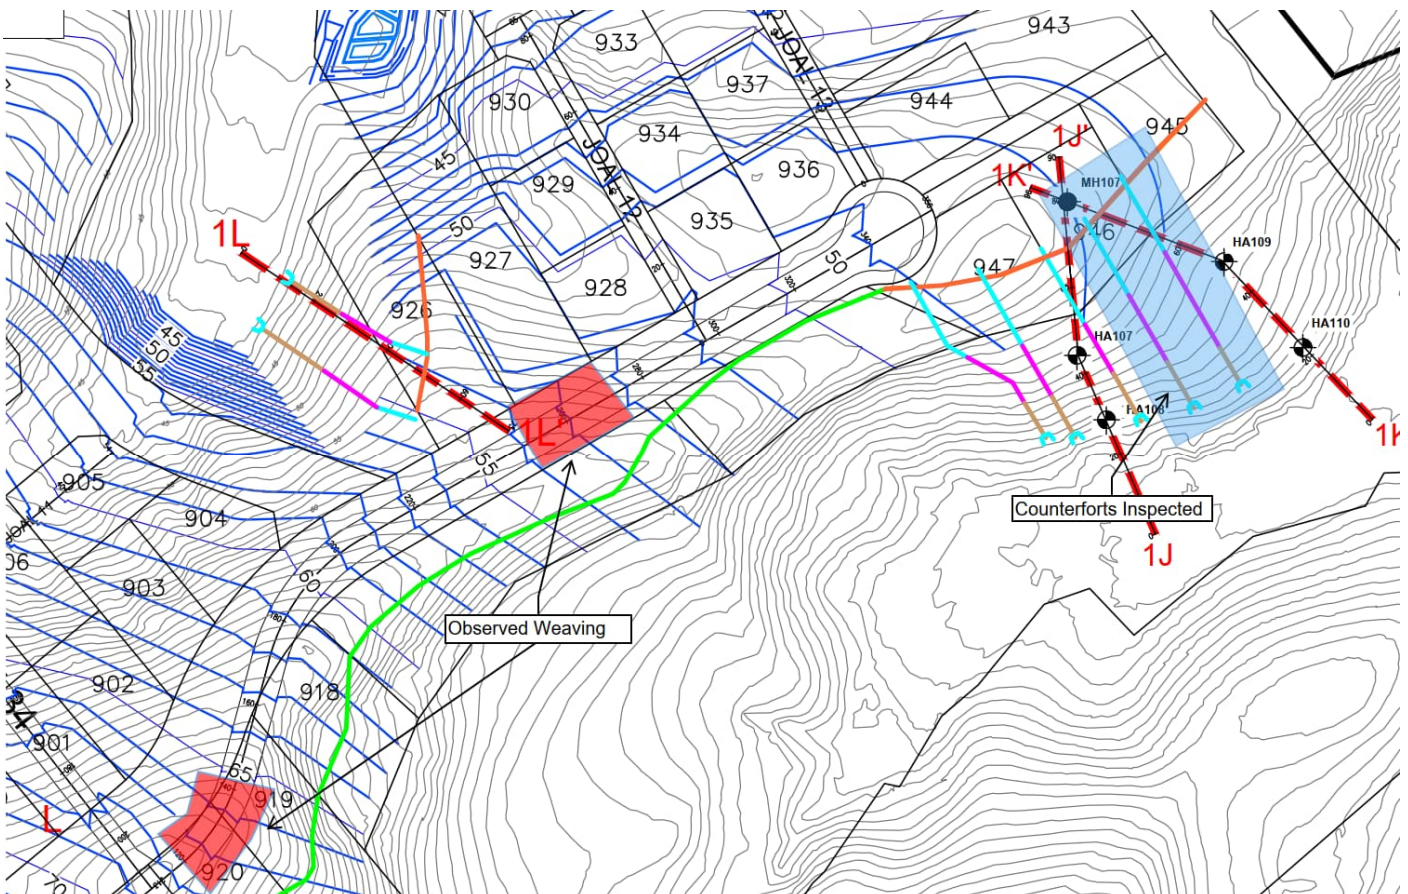
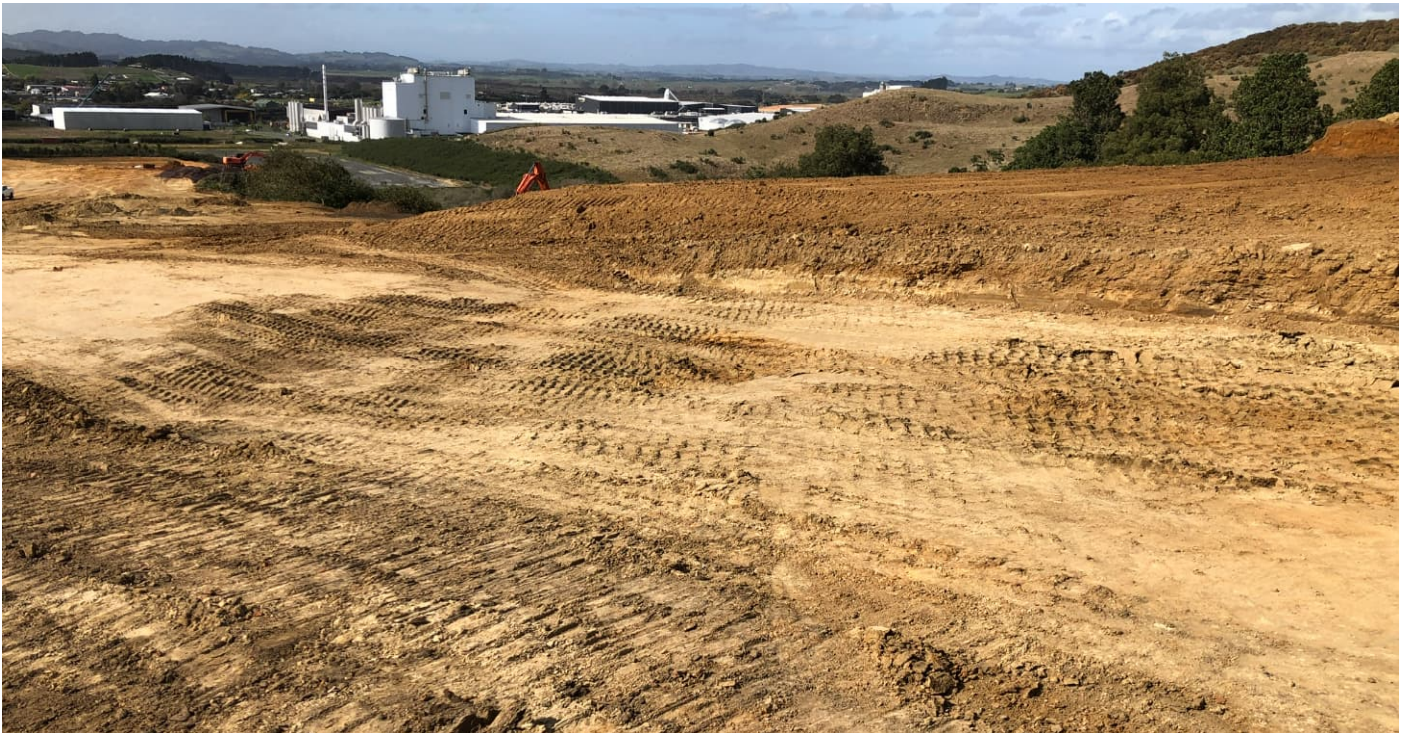
Attended site to observe construction of counterfort drains highlighted in plan below. Additionally observed two areas of weaving along Road 30 with Ali (Dines).

- Counterfort drains appear compliant with design.
- Two areas of weaving/soft material were observed between chainage 120-140, and 250-270. Test pits revealed very stiff, natural material at a depth of approximately 0.3m below current ground level. CAN to follow regarding remediation recommendations.

Counterforts to be inspected regularly until completed. CAN to follow regarding road subgrade.
