DFH Joint Venture Limited

GEOTECHNICAL COMPLETION REPORT

Hitchen Block Stage 19, Pokeno

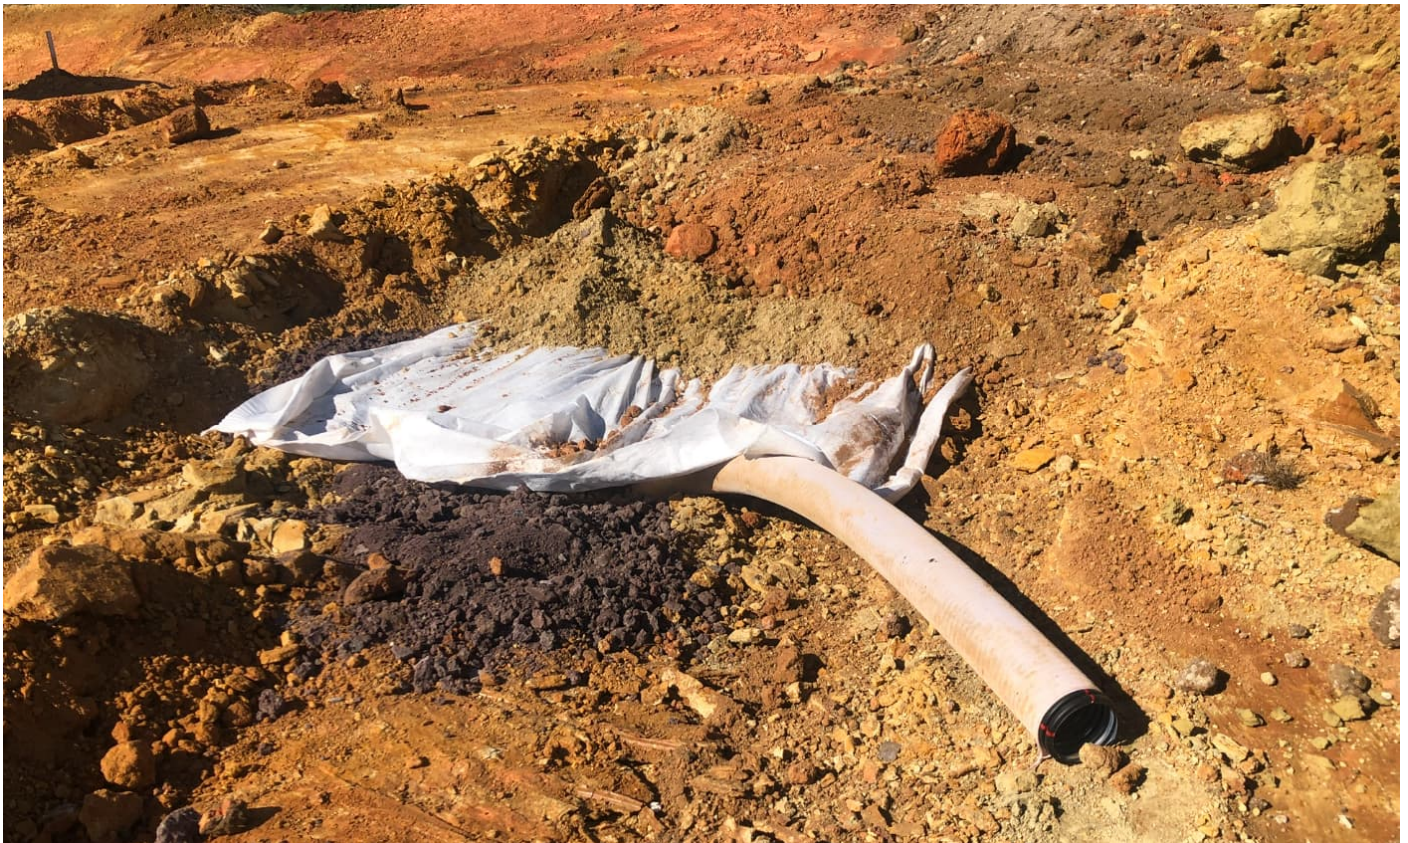
- Contractor advised that excavations were going well with no trench stability issues on the current trench.
- Contractor advised that additional scoria required for backfill is expected to be delivered to site in 5-7 days time.
- Observed topsoil being spread across stage 17 meadows.

N/A. Counterforts to be inspected once additional scoria is delivered.

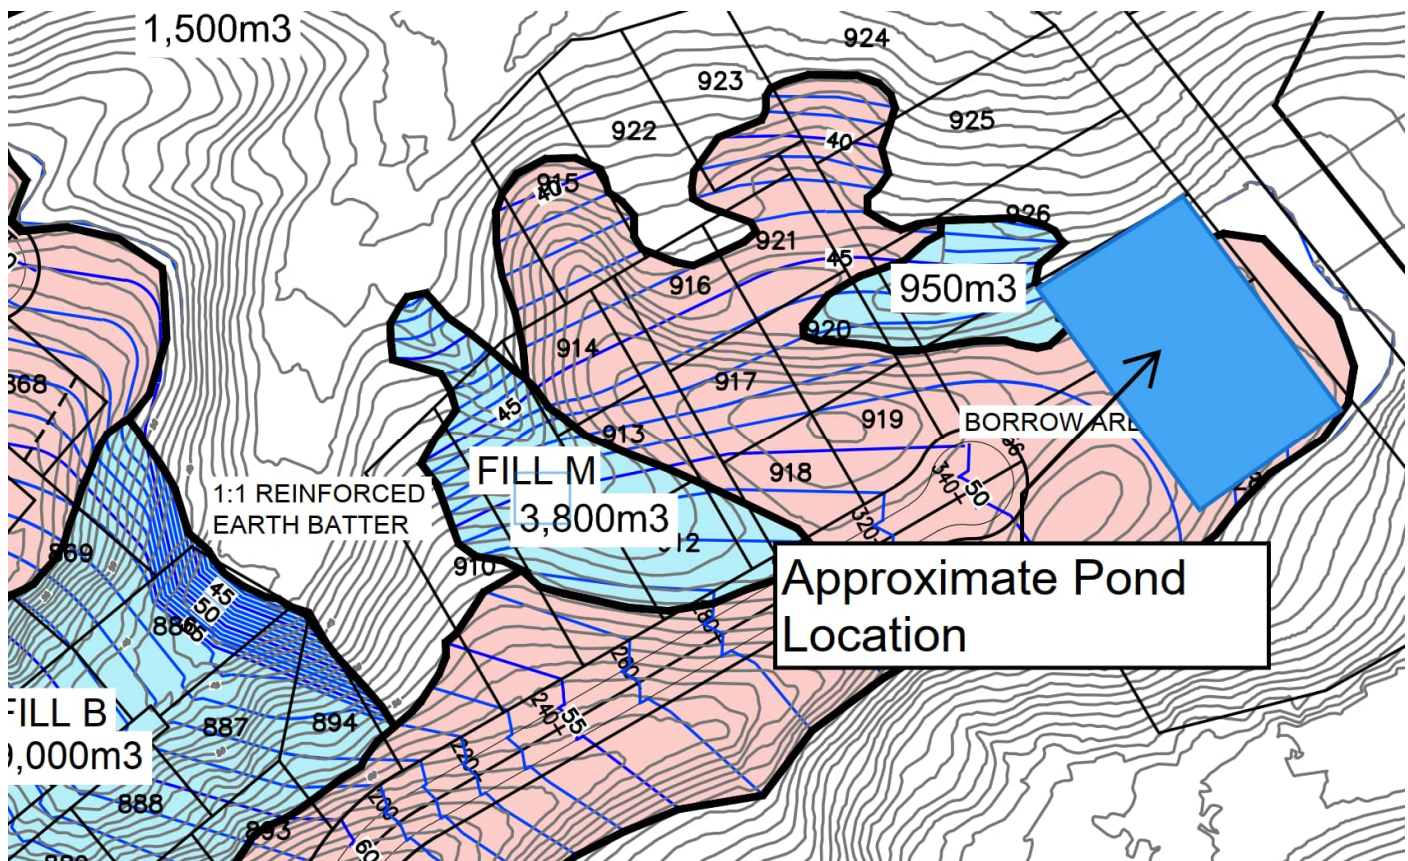
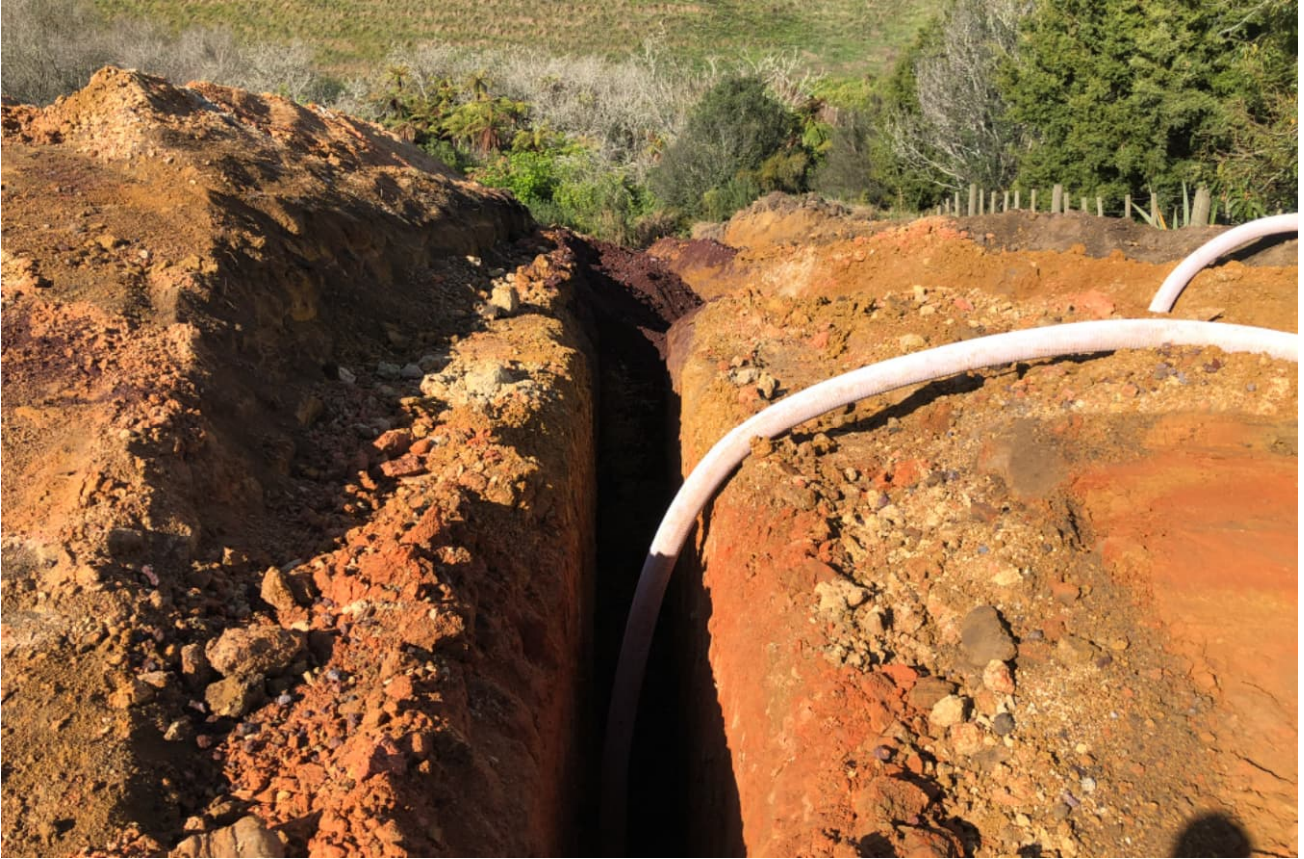
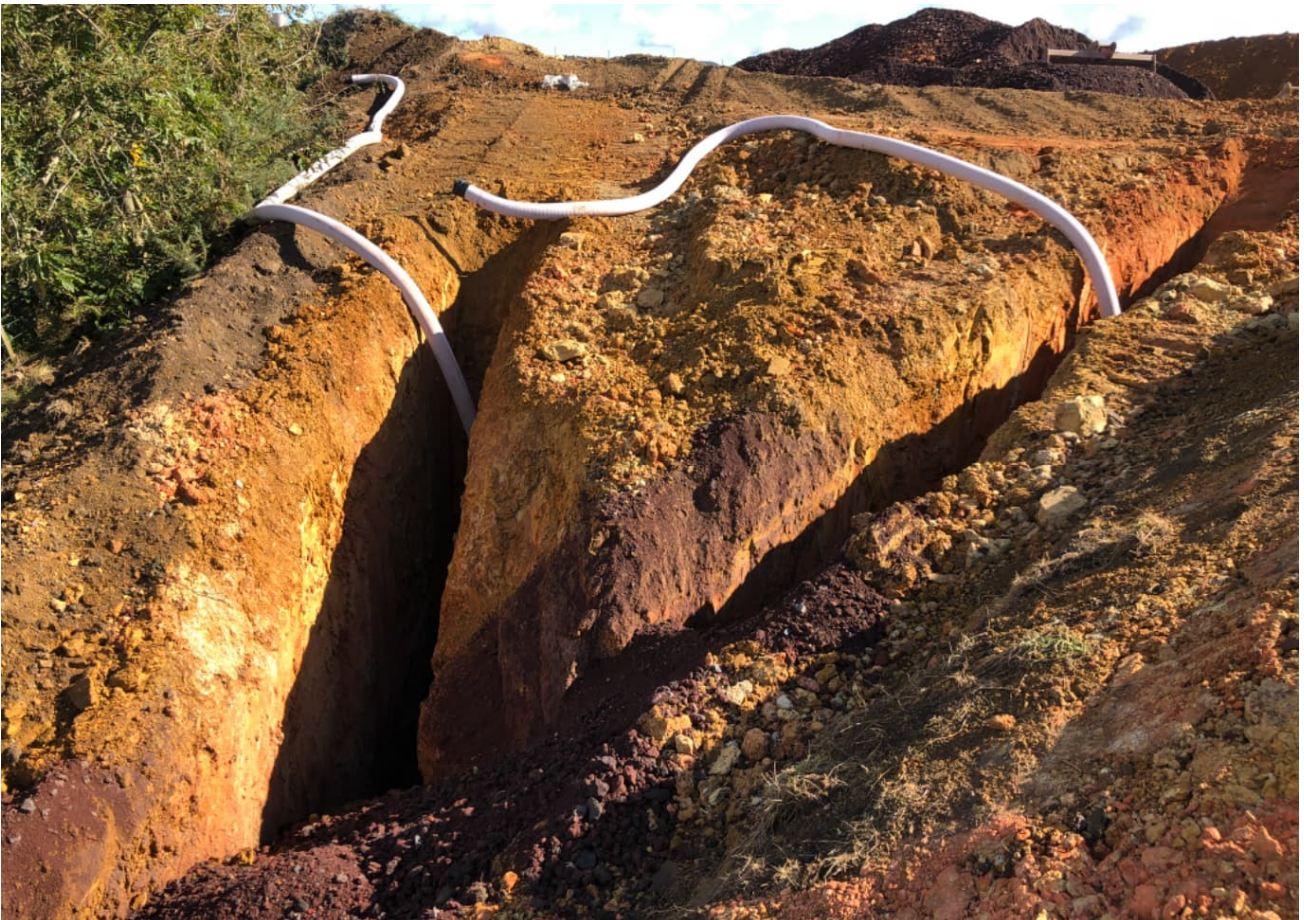
Attended site to observe pond muck out highlighted in annotation below. Additionally observed construction of counterfort drains.

- Pond base comprised very stiff, inorganic, natural material, with the shear vane unable to penetrate across the base.
- Minor vegetation was observed on north-western batter.
- Counterforts 4 & 5 Intersection point observed.

Recommended to Contractor (Ali) to trim off vegetation on north-western batter. Otherwise, pond satisfactory for backfill.

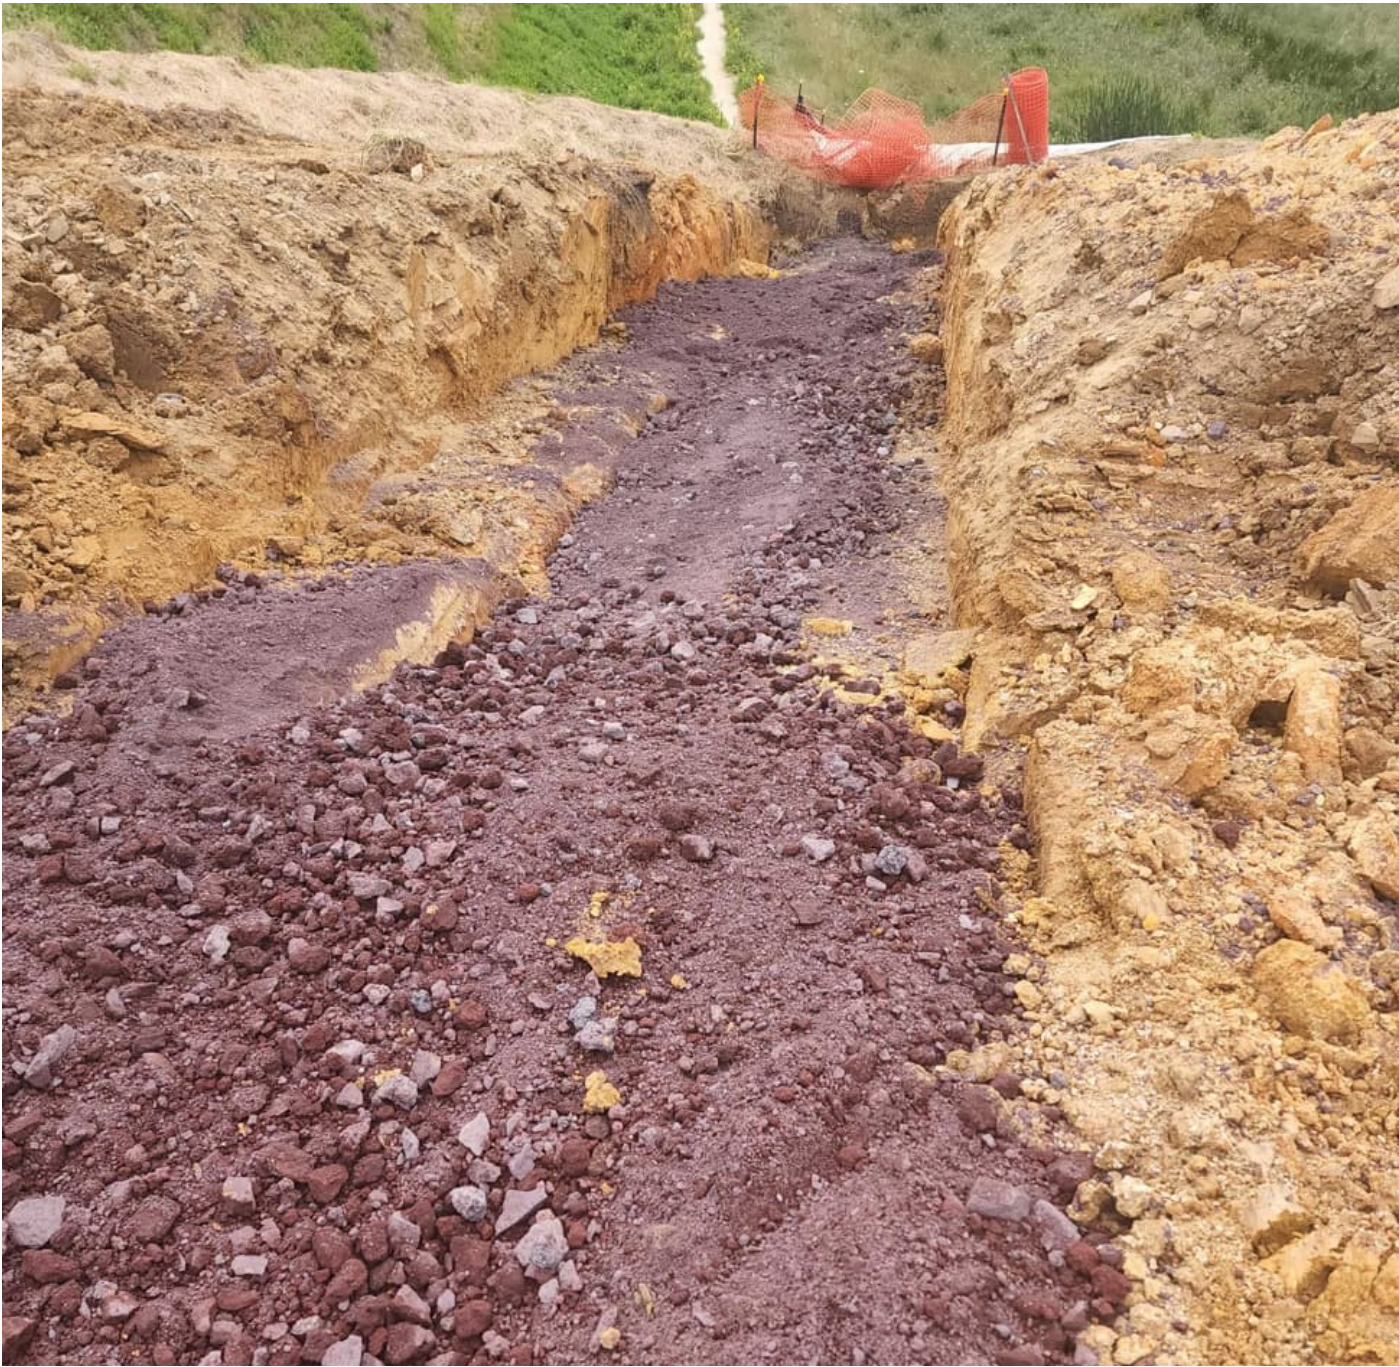
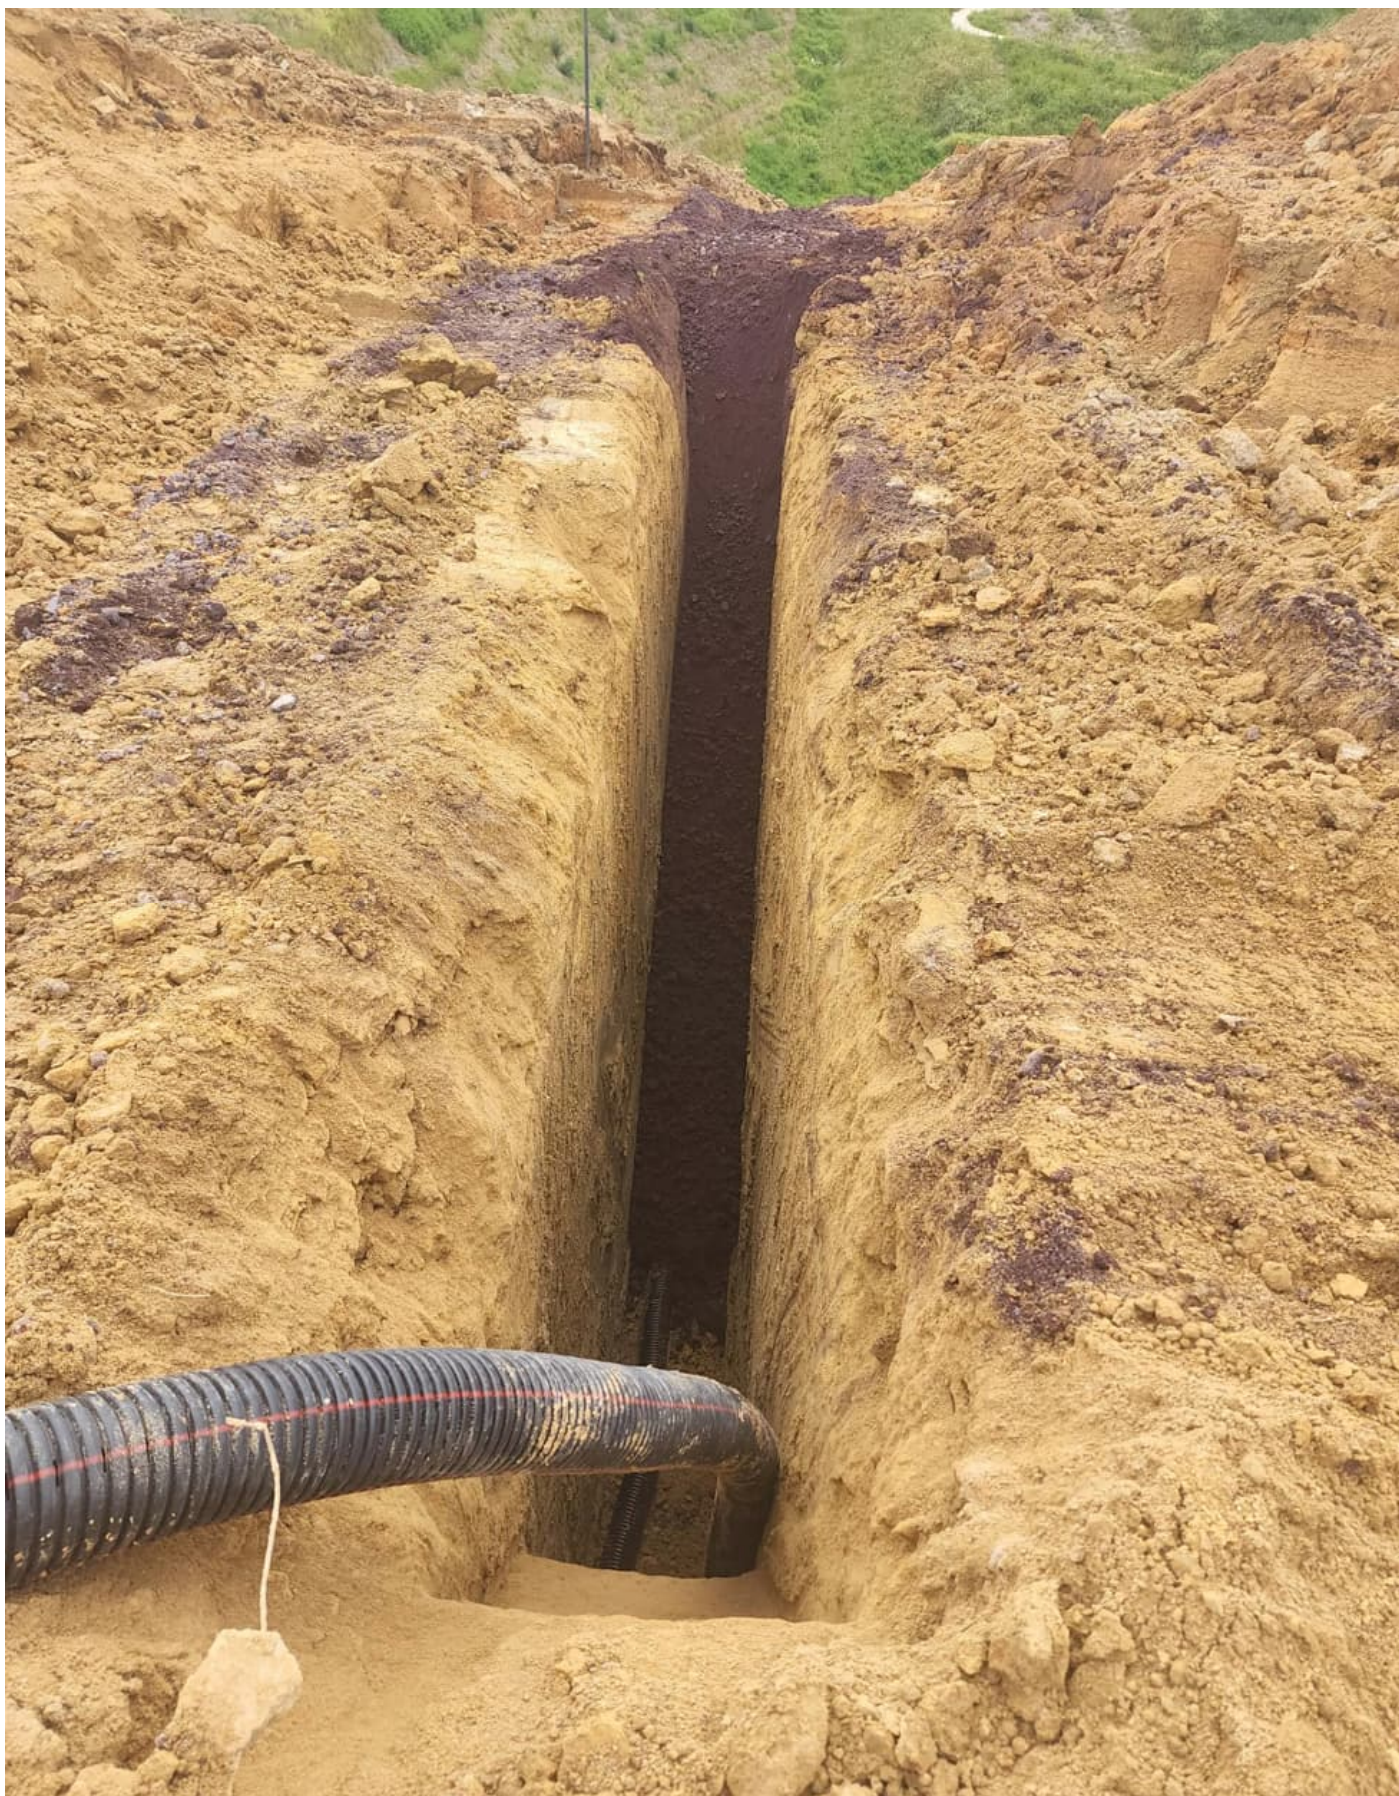
- REB 1 appears to have new vegetation growth within the face of the slope. Contractor advised that the face will be hydroseeded during the next fine weather window. They are aiming for today or tomorrow.
- Inspected the existing slip behind Lot 945. No additional movement appears to have happened since this was originally observed and assessed in September 2022. Groundwater was noted to be seeping from several points within the exposed transition materials.
- Contractor awaiting fine weather window to continue work on cutting the building platform within Lot 951.
- Inspected backfill along WWN1, which returned shear vanes in excess of 150kPa.
- Observed set out of 3x counterfort drains below Lot 925 with set out in accordance with our recommendations. Contractor advised a maximum distance between these drains of 7.5m applies at the upslope extent of the drains.

Counterfort construction in accordance with our design. Drainage line subgrade suitable for pipe placement.

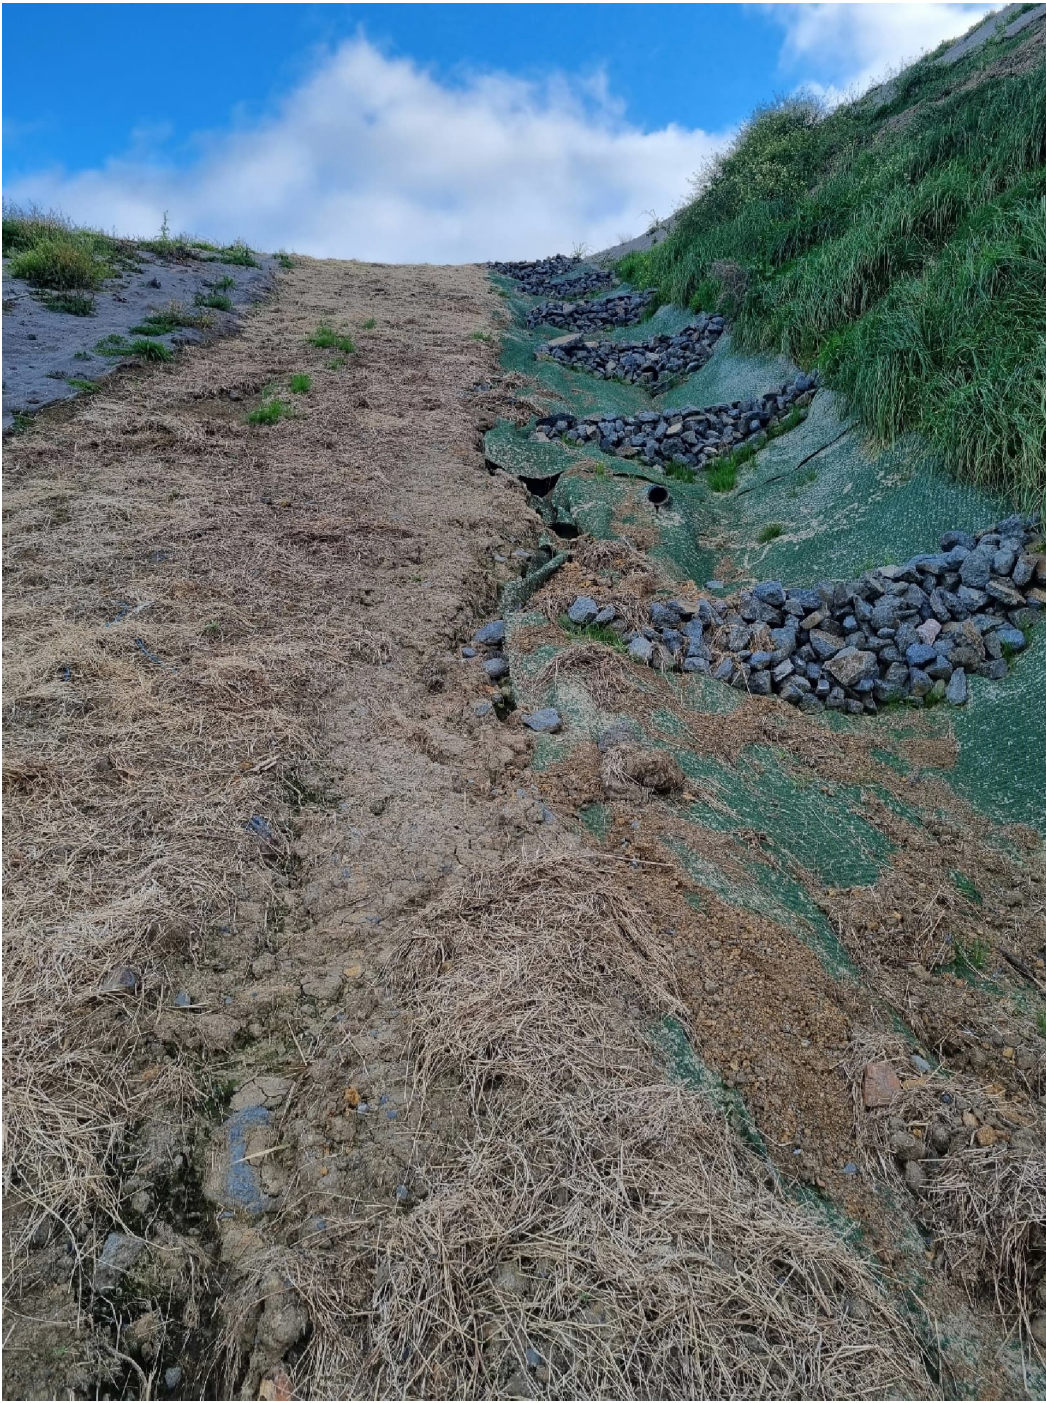
- REB 1 has been hydroseeded again. There has been some slumping beneath the matting again (but is minor visually).
- The side check dams appear ok, but there is erosion occurring along the edge of the matting where the water is getting beneath the matt. Need to fix this and plan out the sides in due course.
- Counterfort drains appear to be being installed. See photos.

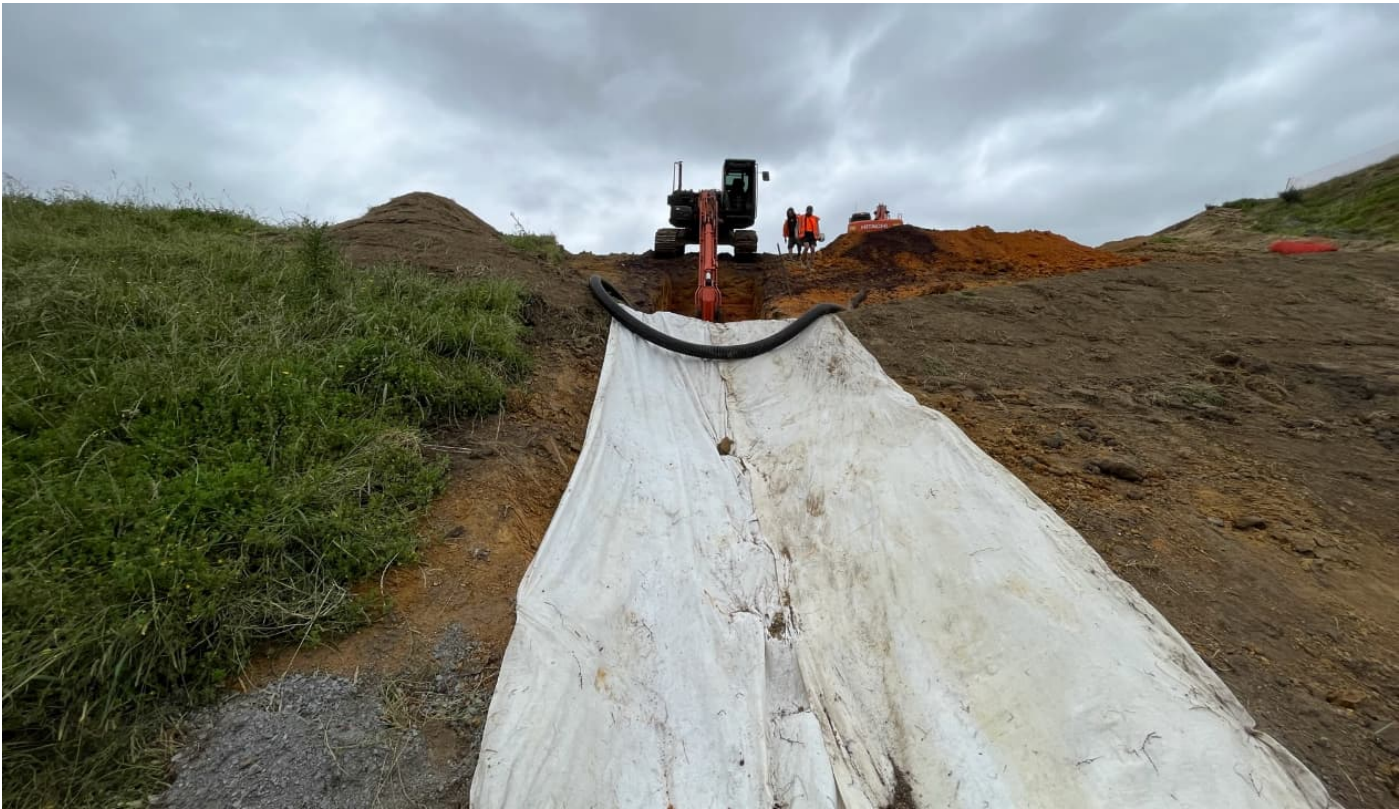
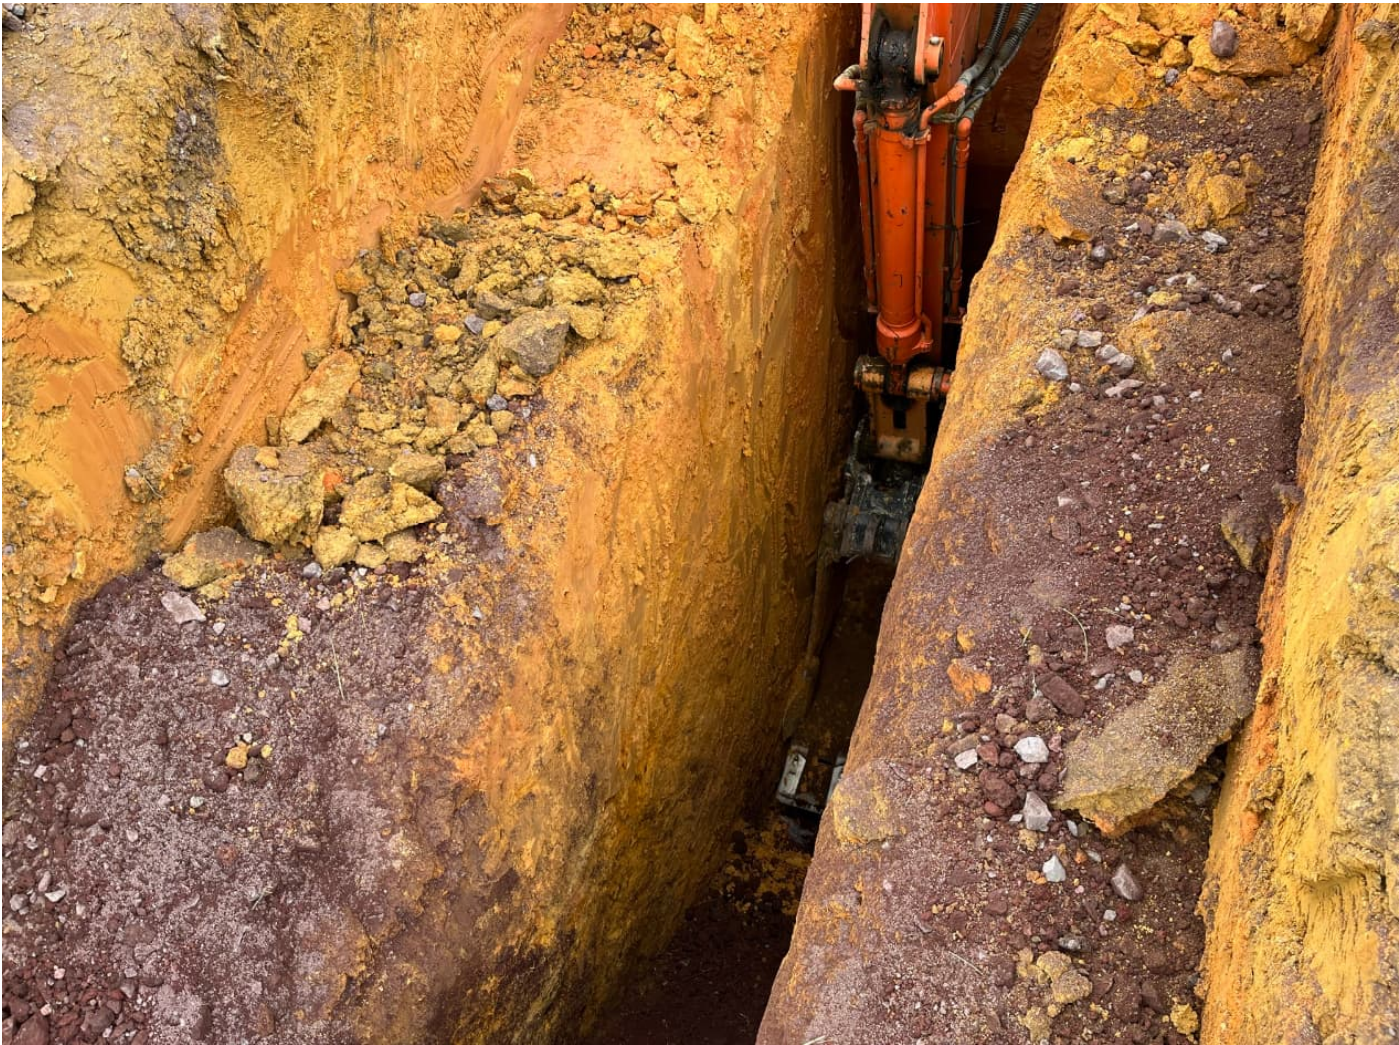
- Inspected current excavation progression for counterfort drain. Depth of drain was approximately 6 metres below cleared ground level. Contractor advised that the side walls of the trench were stiff, with no instability / failures during excavation progress. Drain appears in accordance with our design.

- Slip behind Lot 945 appears to remain unchanged since our last inspection (28/11/22). Recommended to contractor to monitor the face for movement. Recommended to hold meeting between LDE and Dines to confirm remediation methodology during earthworks season.

- Observed topsoil slumping beneath matting at base of REB. Inspection beneath matting revealed an area (roughly 2x2m in size) where recently placed topsoil has slipped, exposing the geogrid and fill behind. Recommended to contractor to bury long edge of check dam matting into the slope to prevent overland flows from eroding beneath the matting. Recommended to remediate topsoil slumping and re-hydroseed during the next fine weather window.

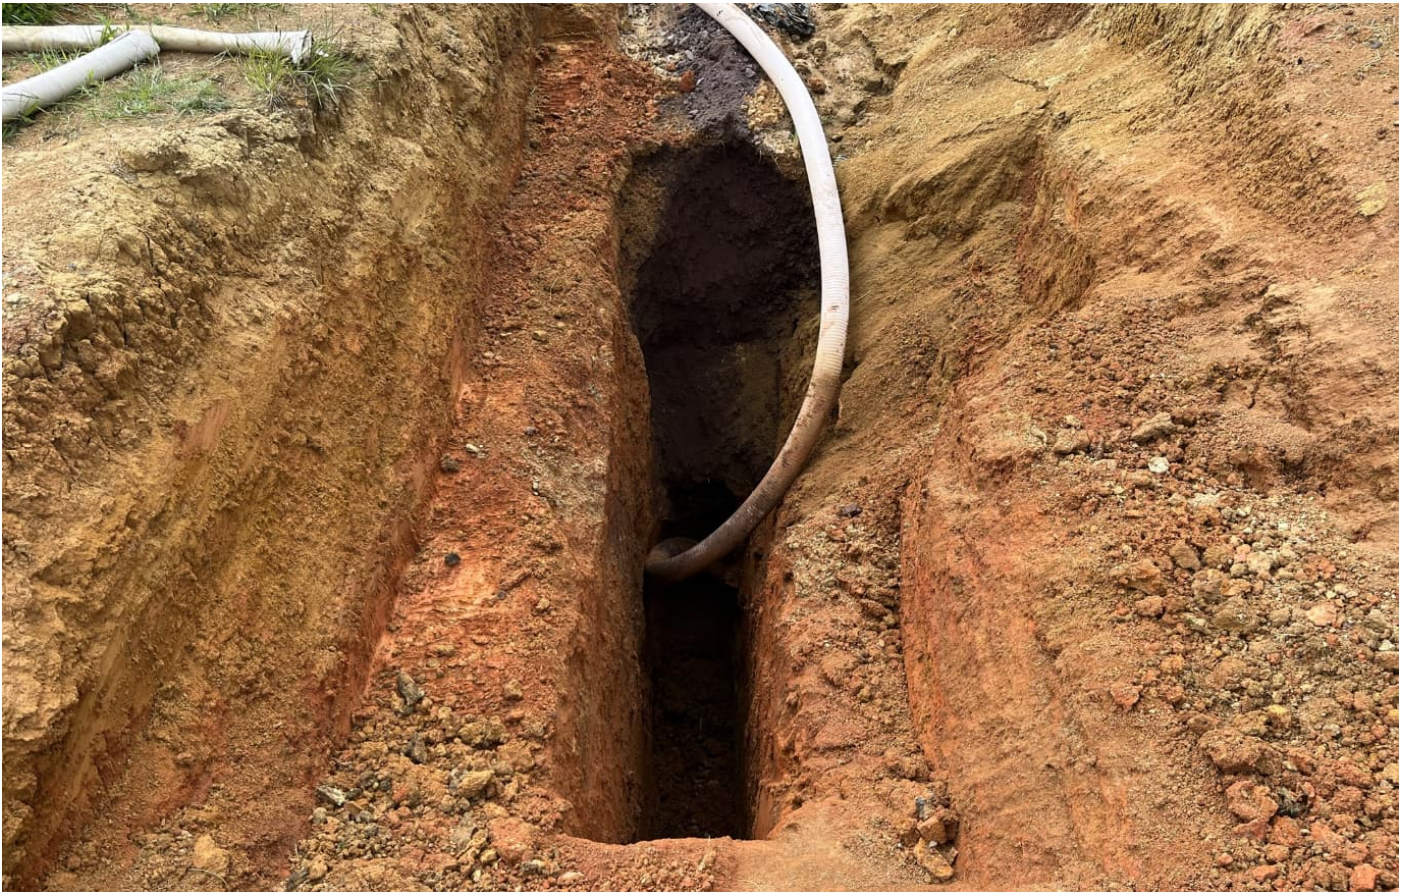
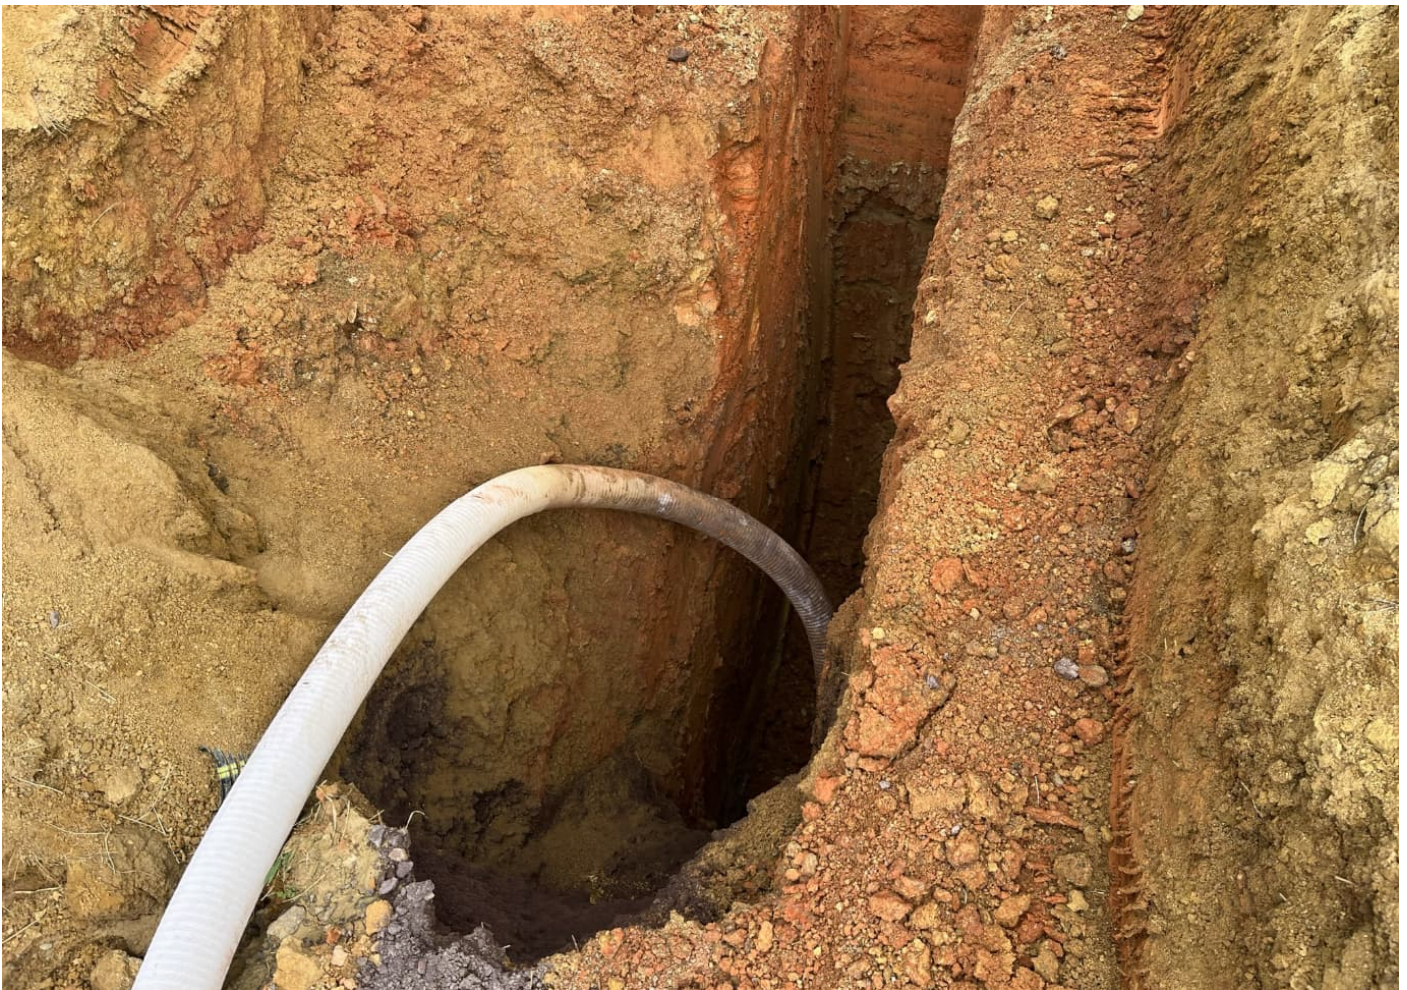
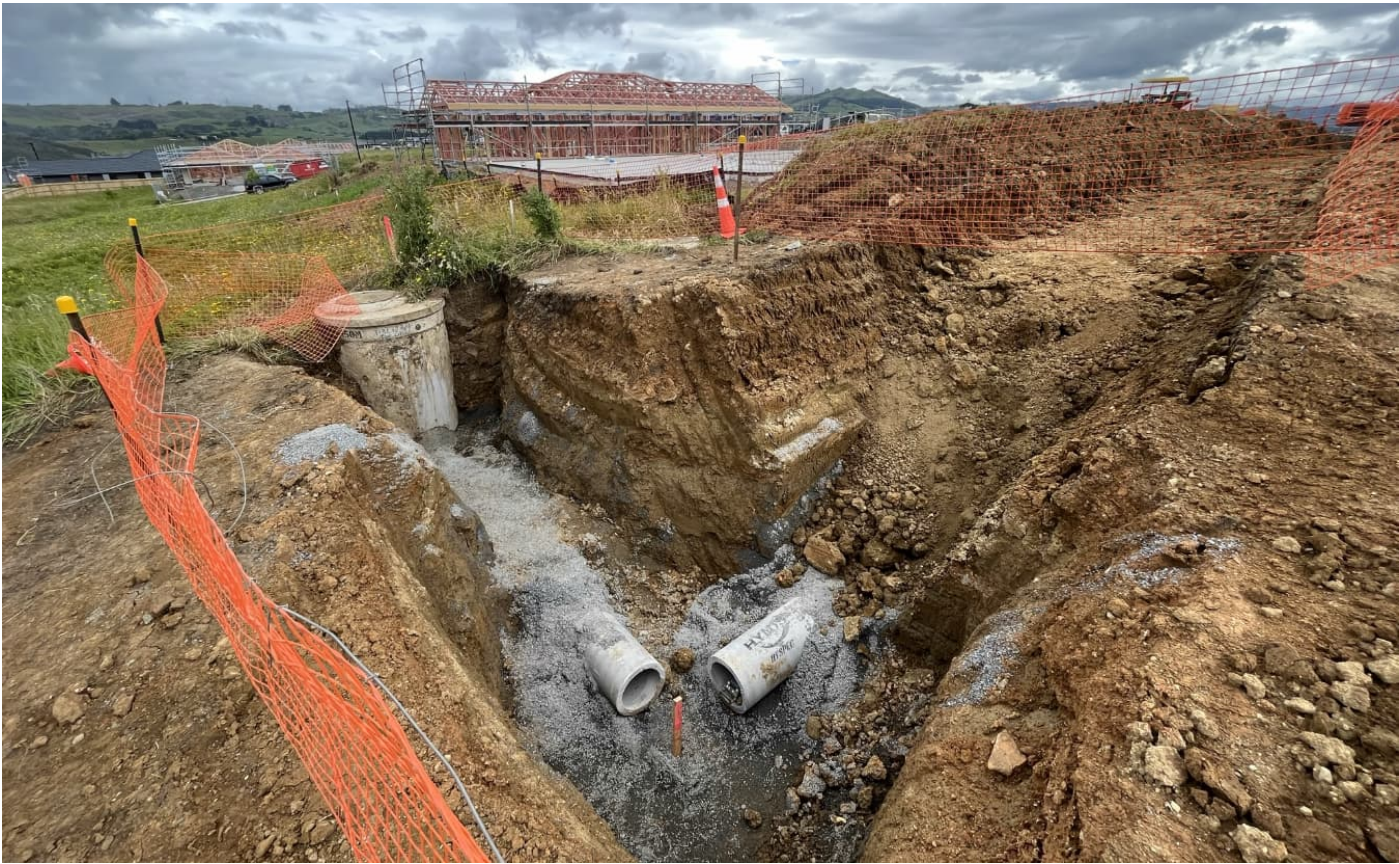
- Counterfort excavation was approximately 6 metres in depth, and was founded in natural materials. Drainage coil and backfill material in accordance with our design.
- Drainage line inspected was founded in very stiff, inorganic, natural materials with measured shear vanes in excess of 100kPa.

Counterfort in accordance with design. Drainage subgrade satisfactory for pipe placement.

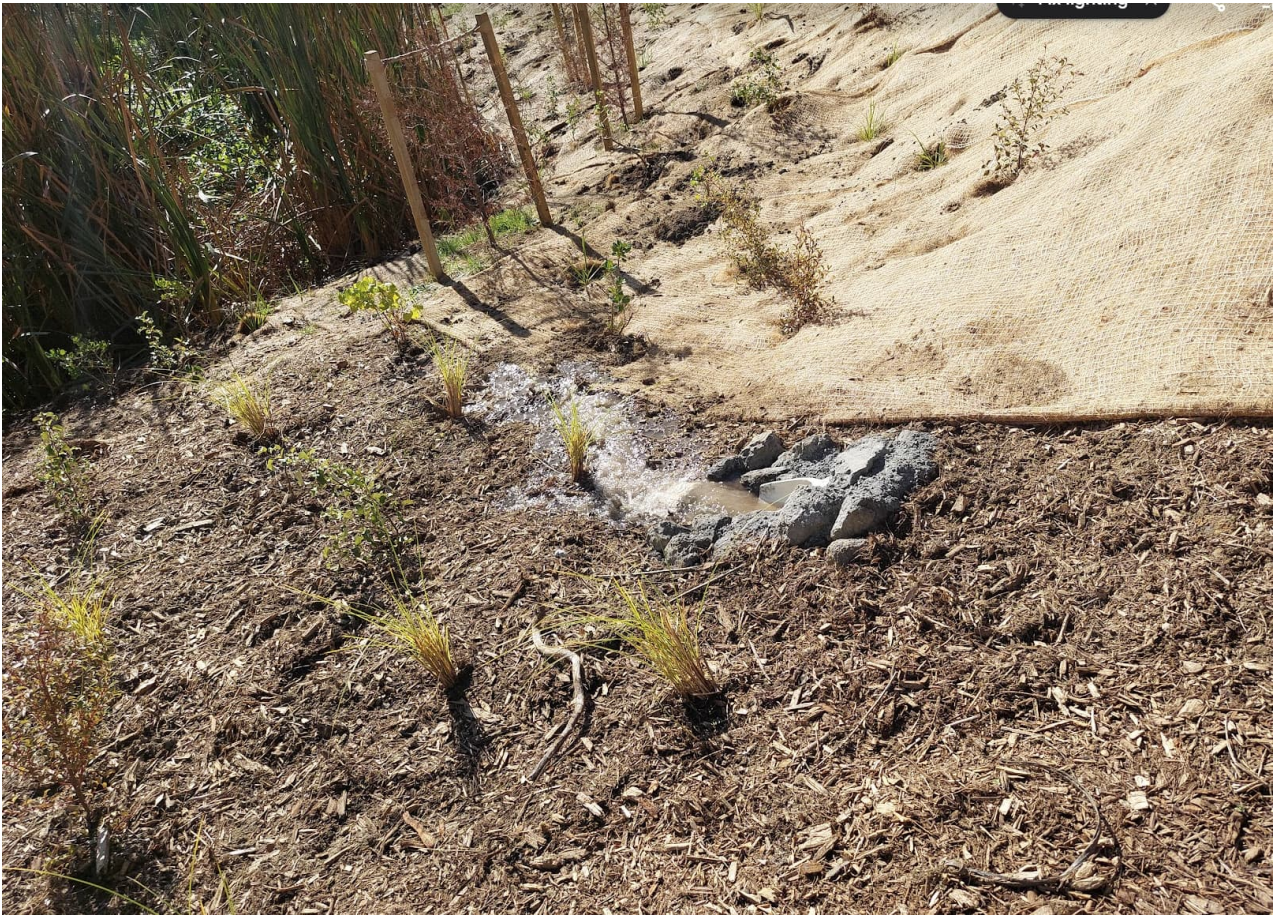
2 counterfort drains adjacent to lot 926

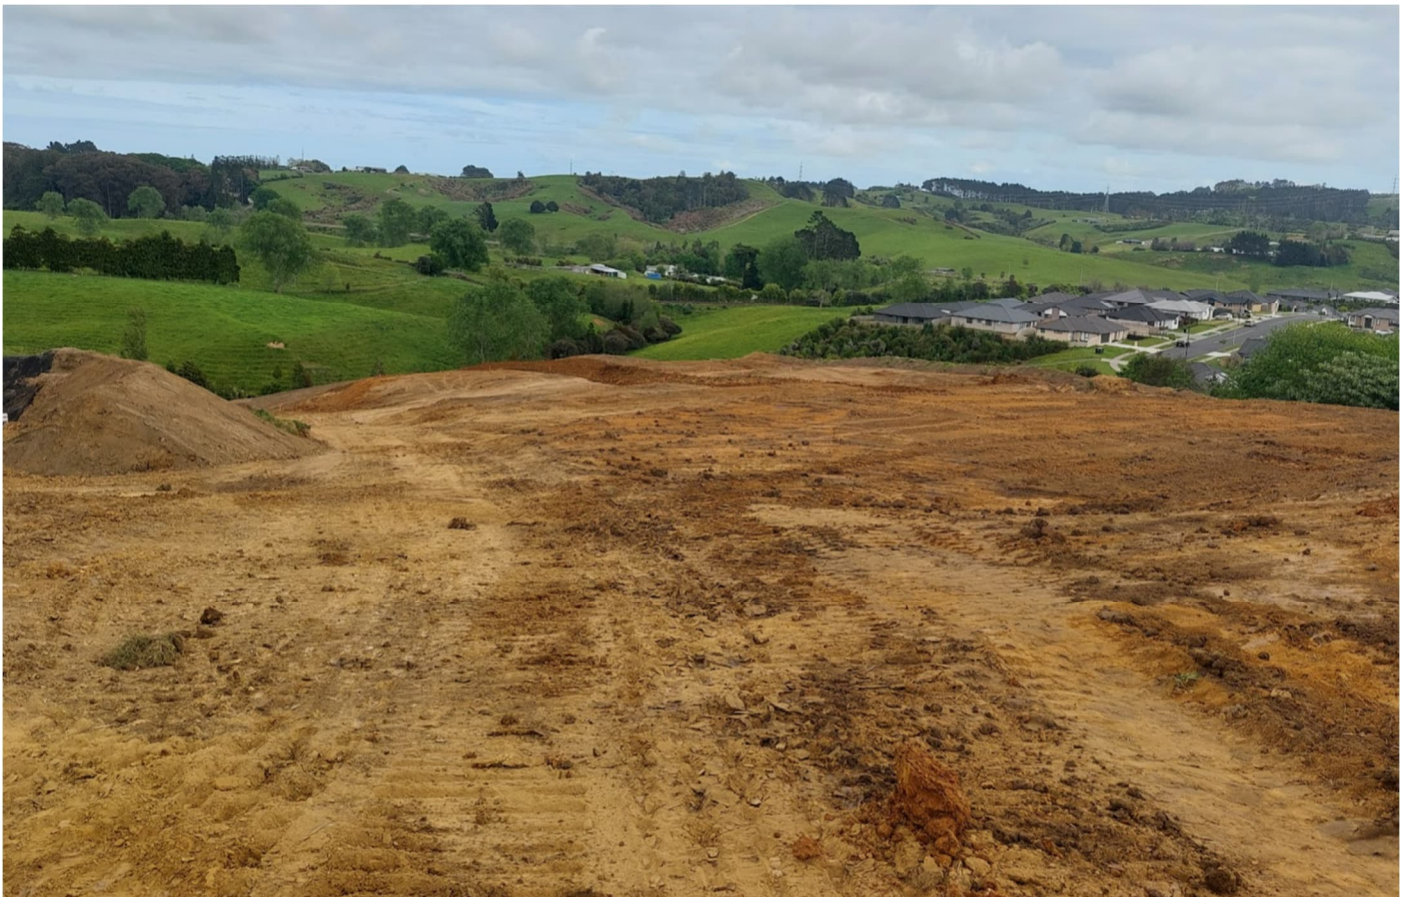
- Area highlighted in pink:
 - Ground revealed engineered fill. Contractor noted this area is near finished level and will be ready for topsoil placement once the minor trimming is completed. We consider the ground conditions are suitable for topsoil placement.
- Area highlighted in yellow:
 - Contractor has placed clay fill prior to our stripped subgrade inspection.
 - Several shallow hand augers were conducted, the ground revealed 400-500mm of clay fill and competent natural ground is found below.
 - Shear vane readings within the natural ground were in excess of 100kPa.
 - We consider the clay fill is suitable to remain. Recommended the contractor to contact us prior to bulk filling.

Subgrade near finished level

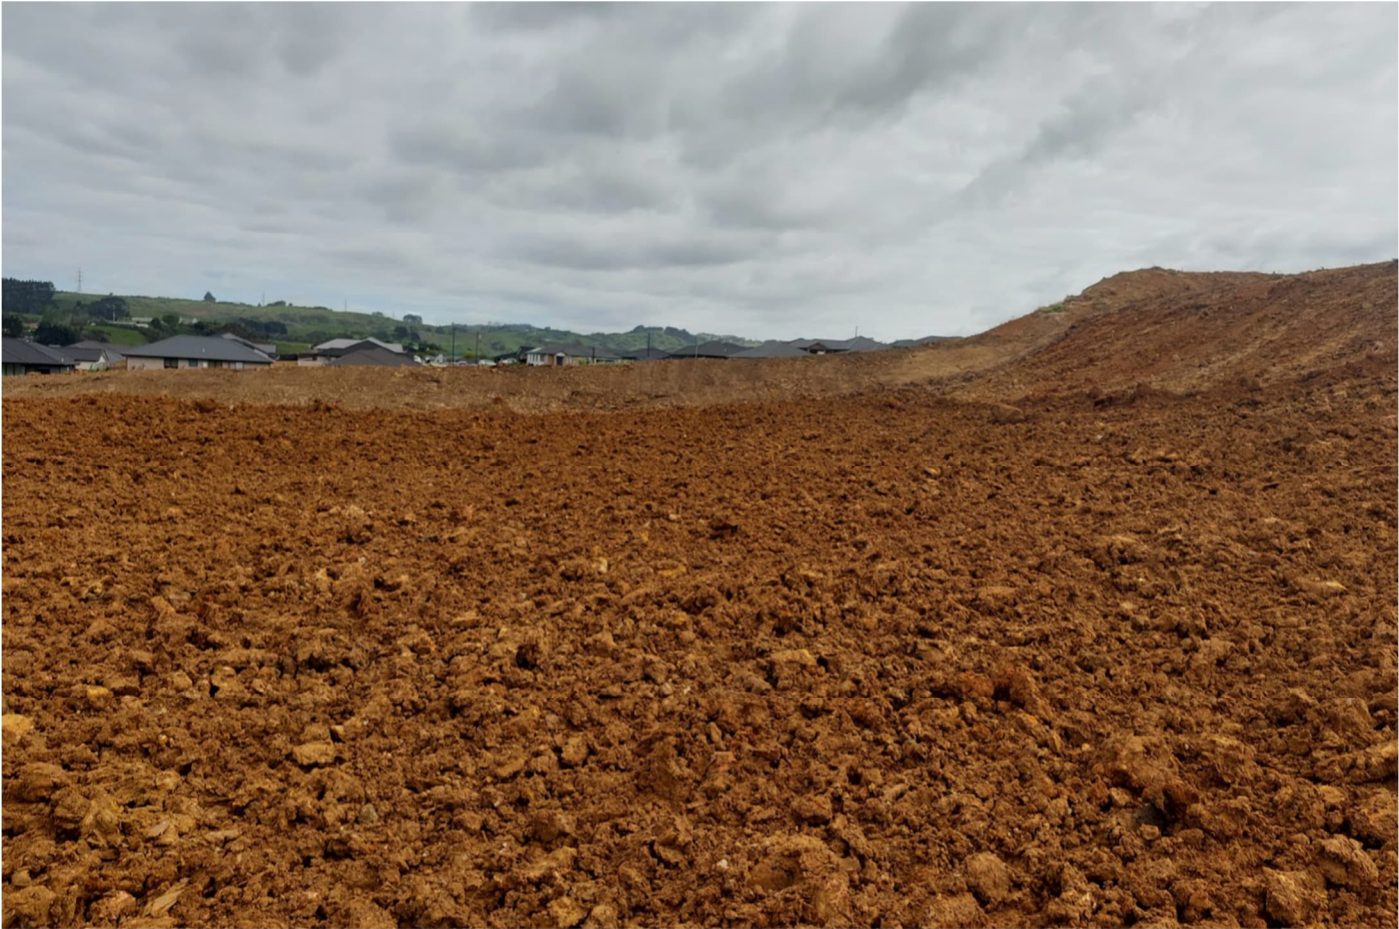
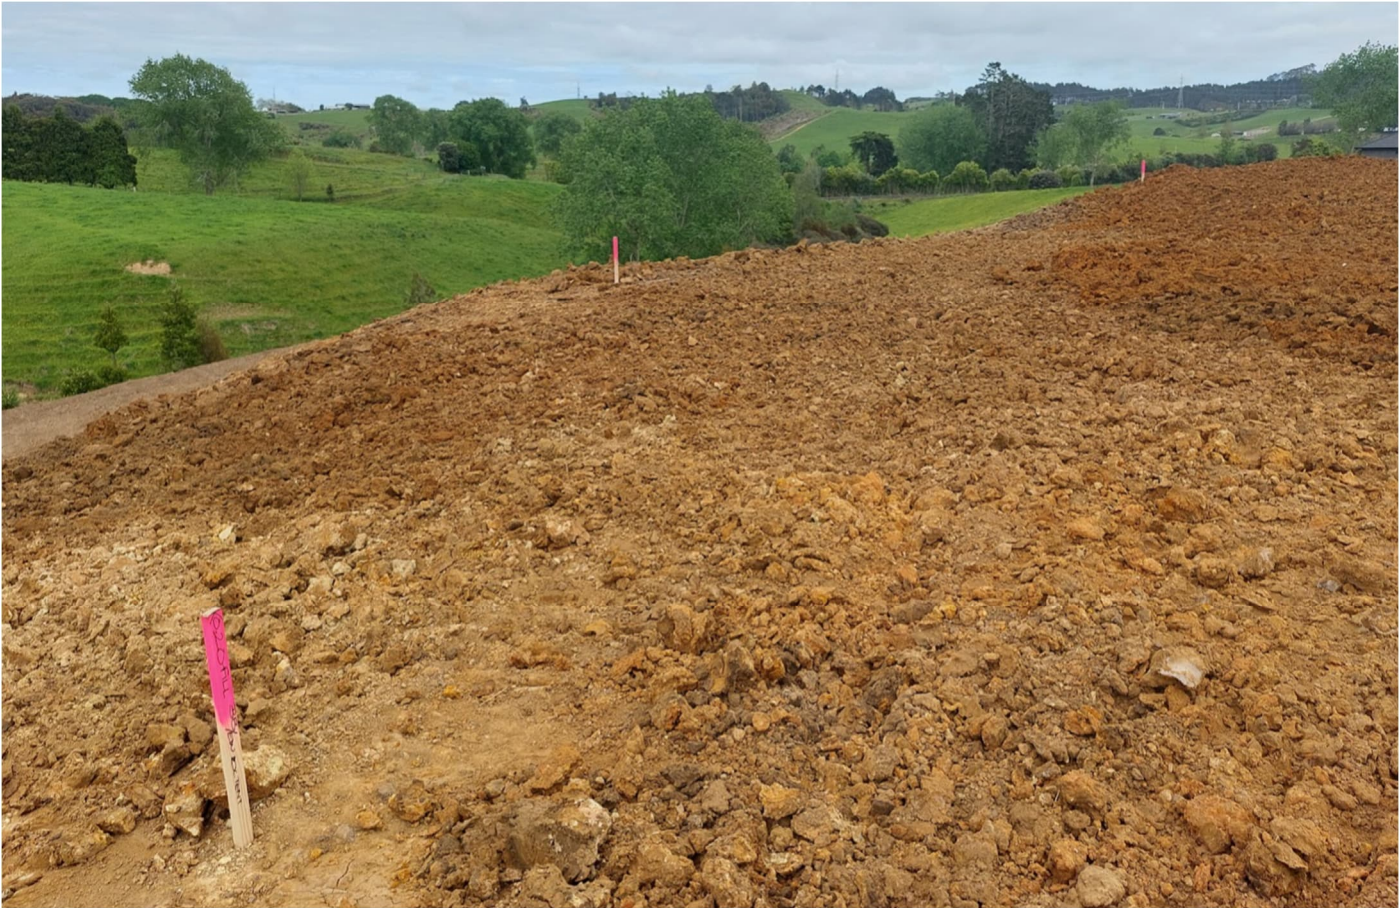
Clay fill area
