DFH Joint Venture Limited

GEOTECHNICAL COMPLETION REPORT

Hitchen Block Stage 19, Pokeno

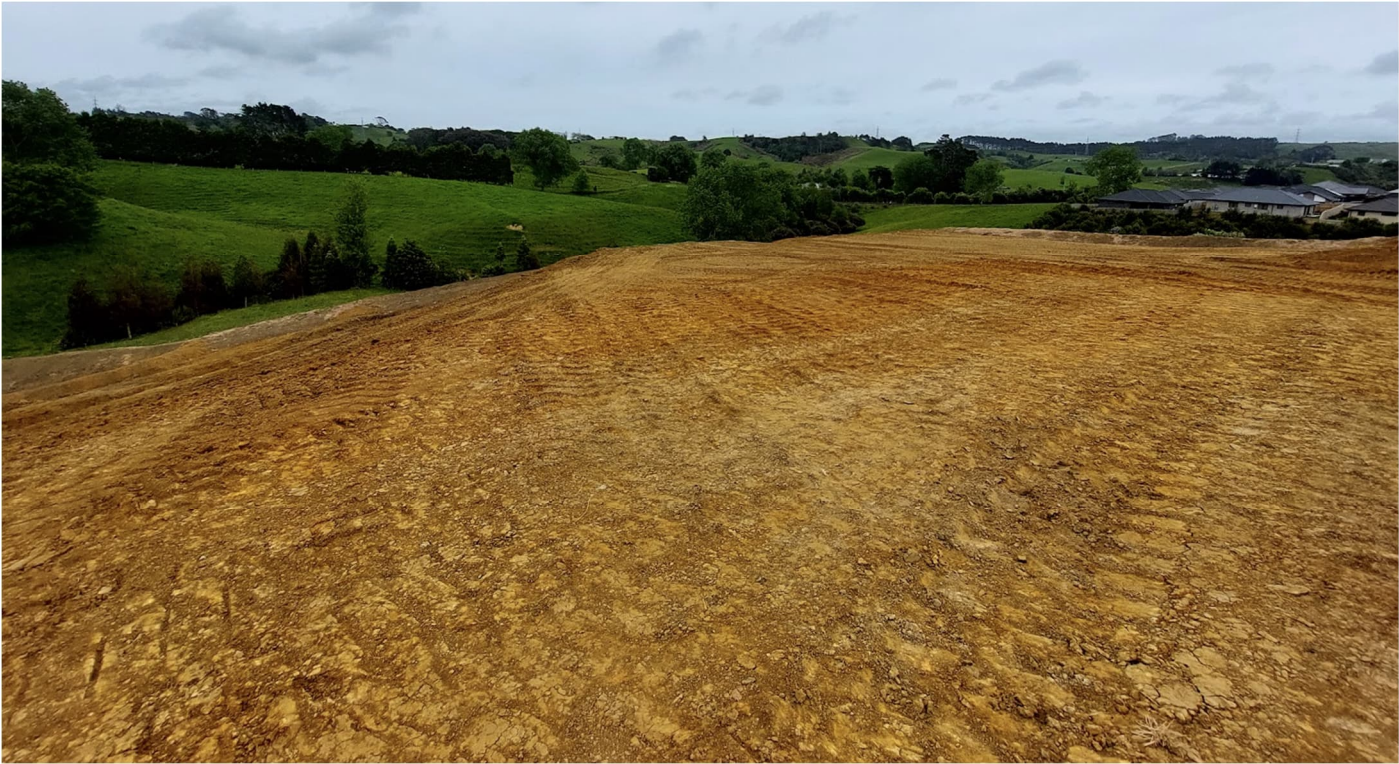
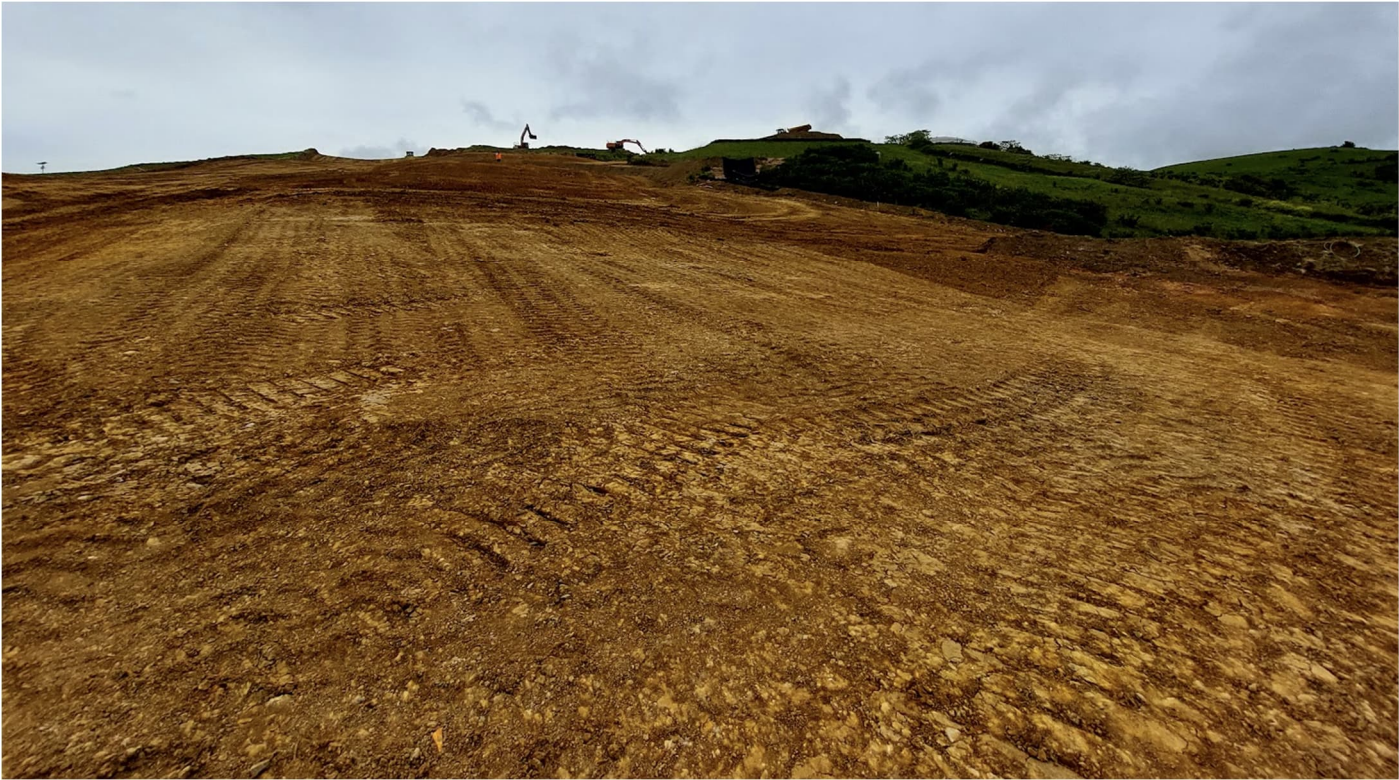
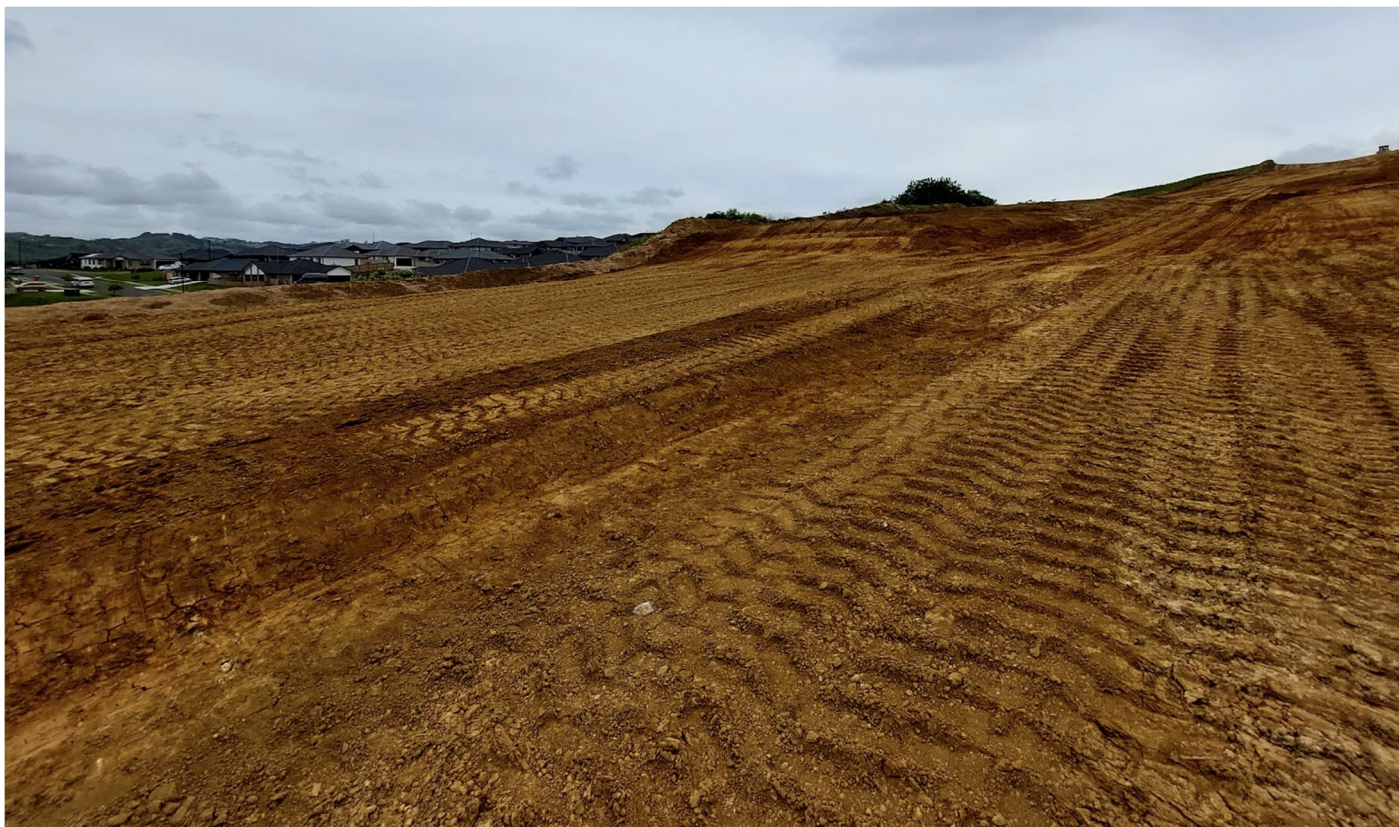
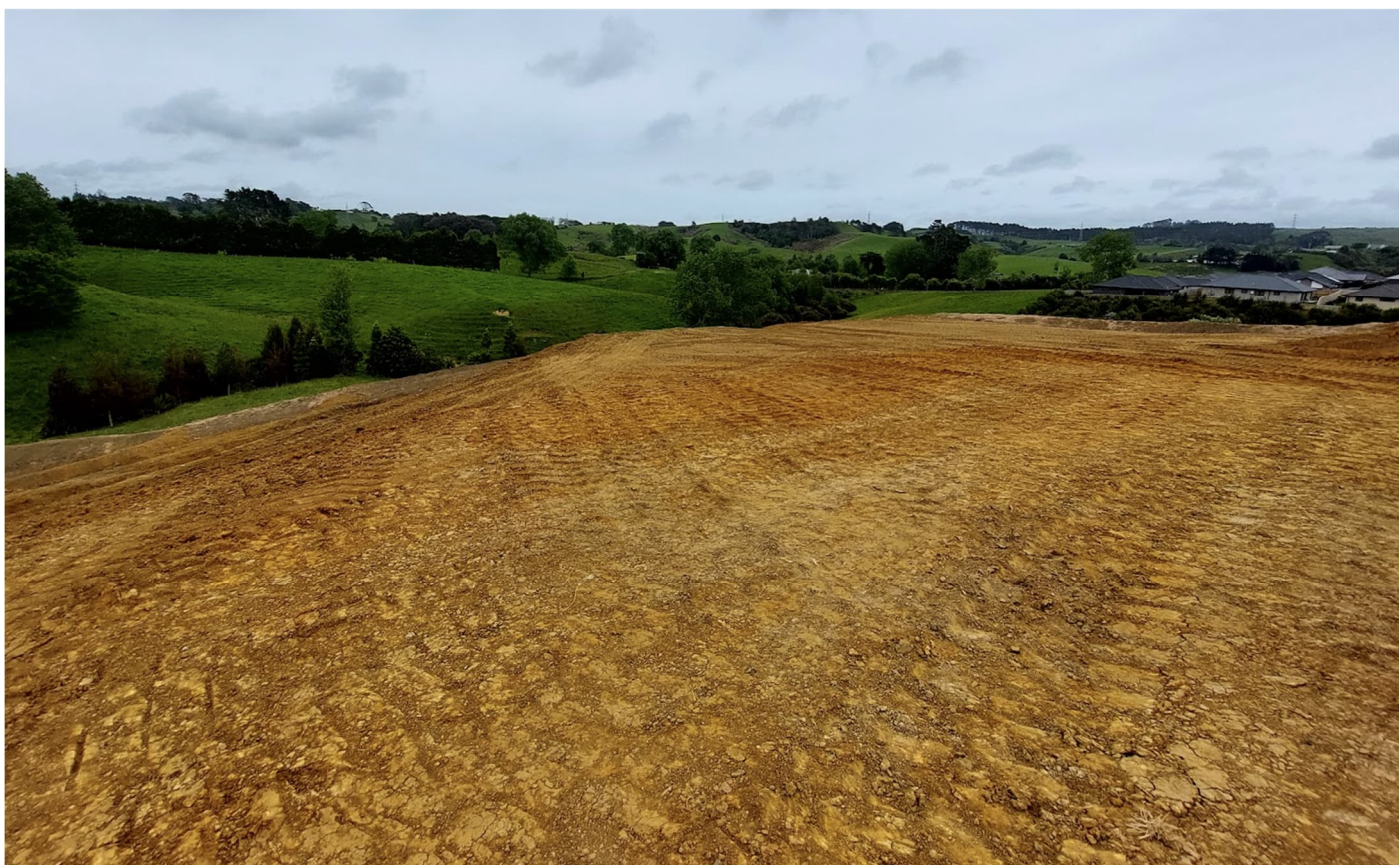
- Finished subgrade
 - Ground revealed engineered fill. Shear vane readings were mostly in excess of 200+kPa or UTP. Contractor noted they are planning to place minor fill to shape and extend the batter. We understand it will be less than 600mm high and consider the ground is suitable to place fill upon.

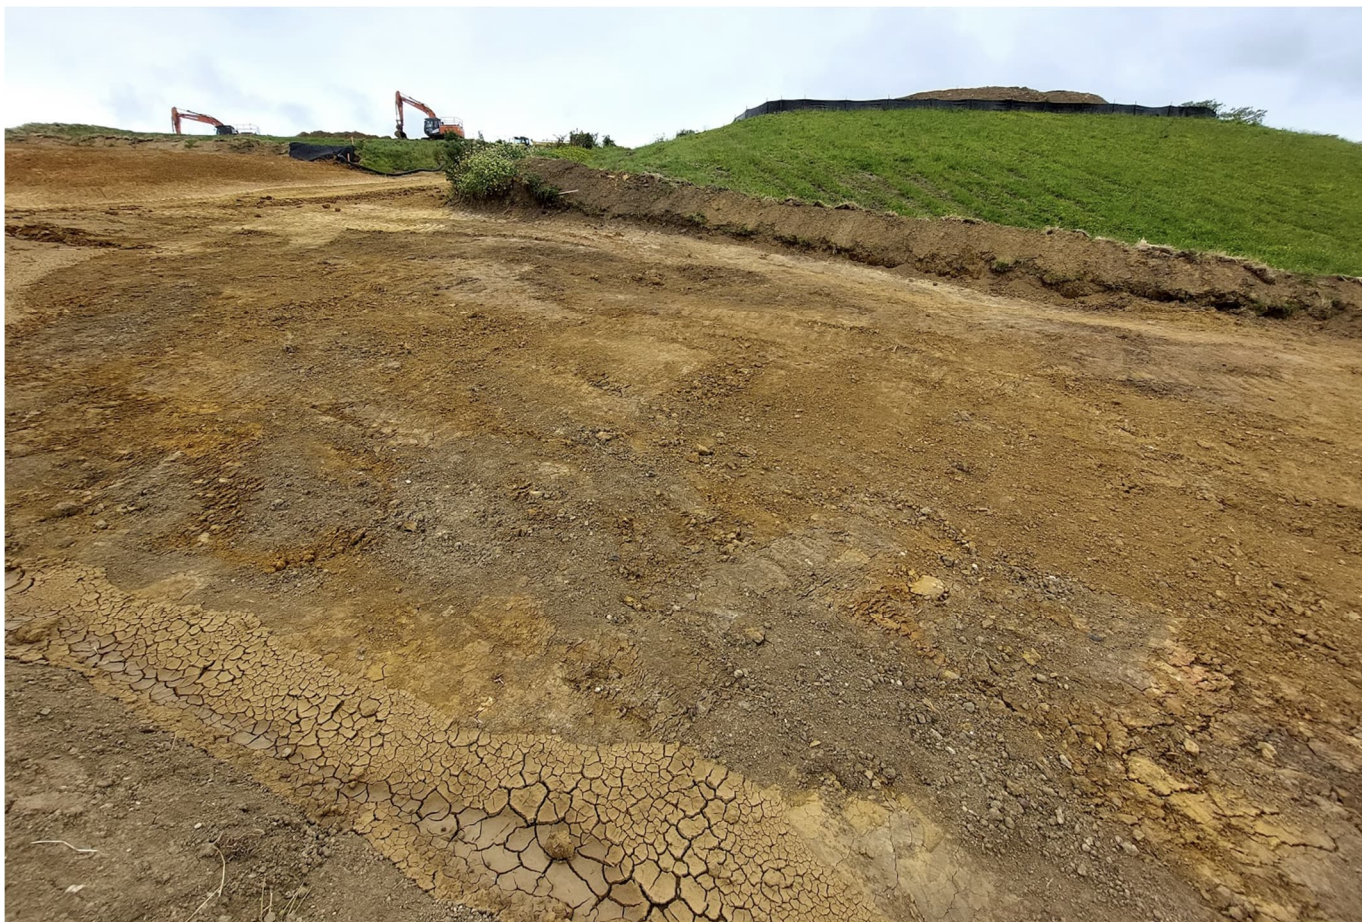
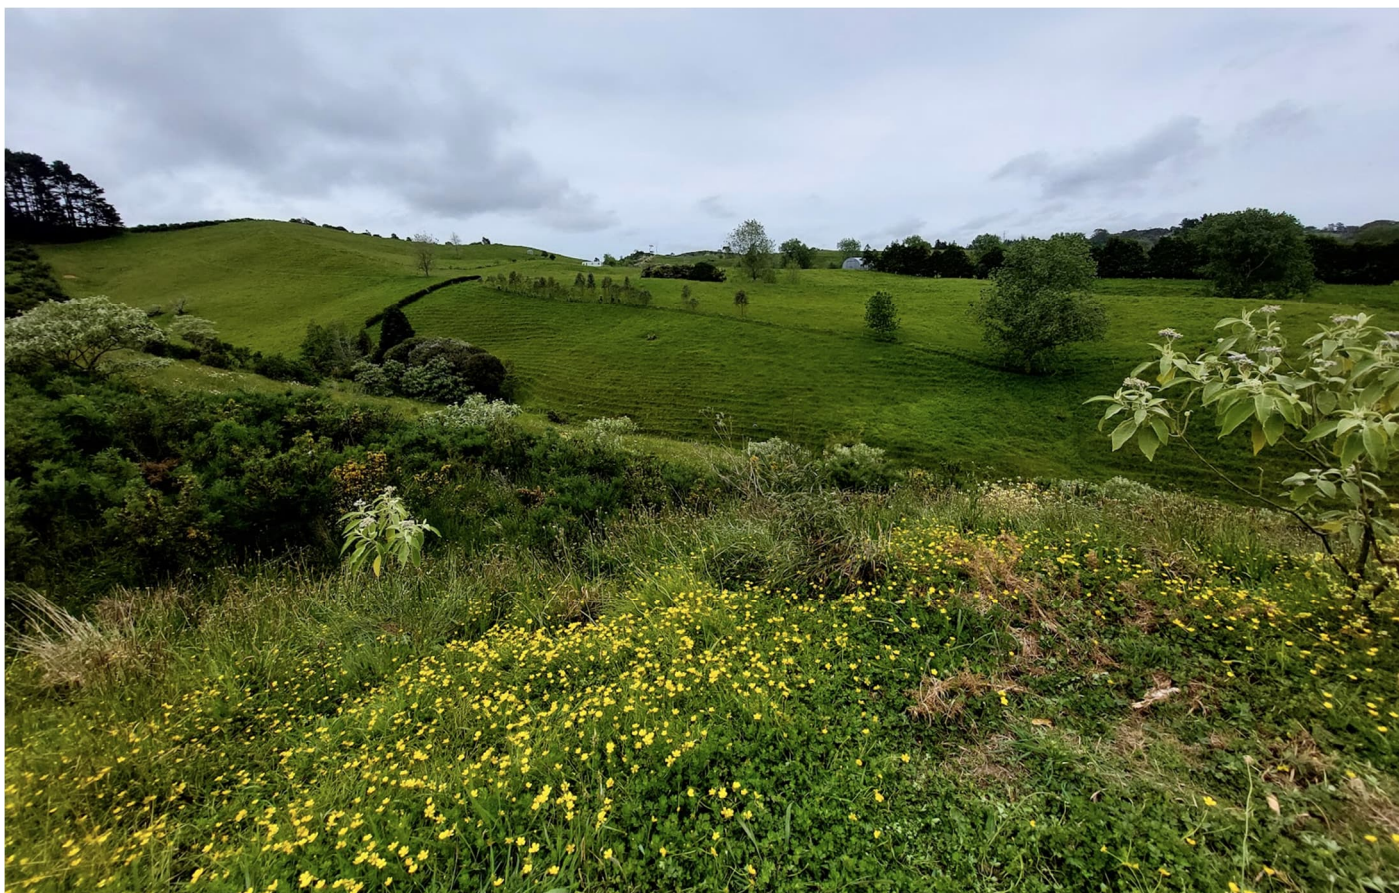
Area 2 – contractor put the work on hold.

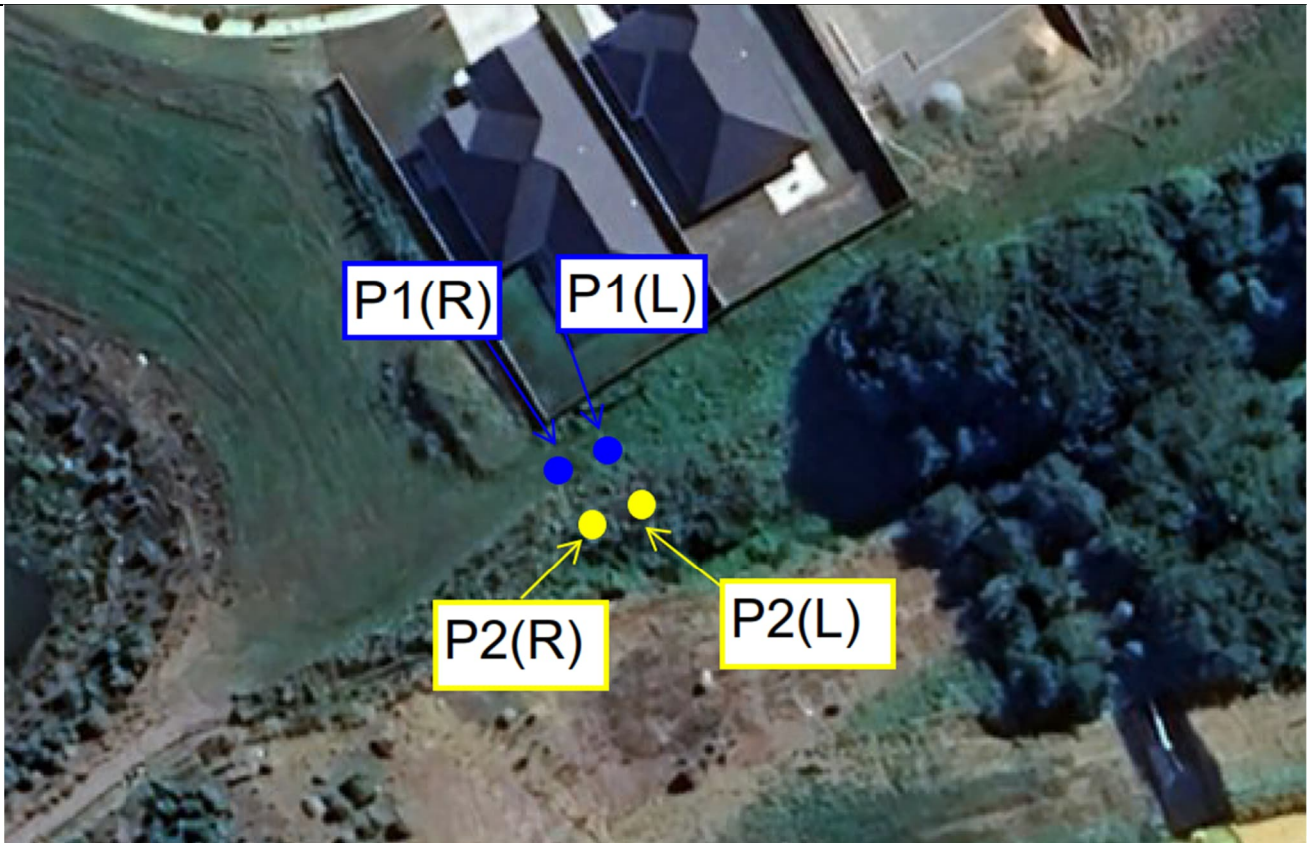
Visited the site at the request of Dines to inspect ground conditions in pipe bridging pile holes (approx. locations marked up in blue and yellow in inset below).

- Ground conditions are satisfactory, providing spoil is removed from base of holes.

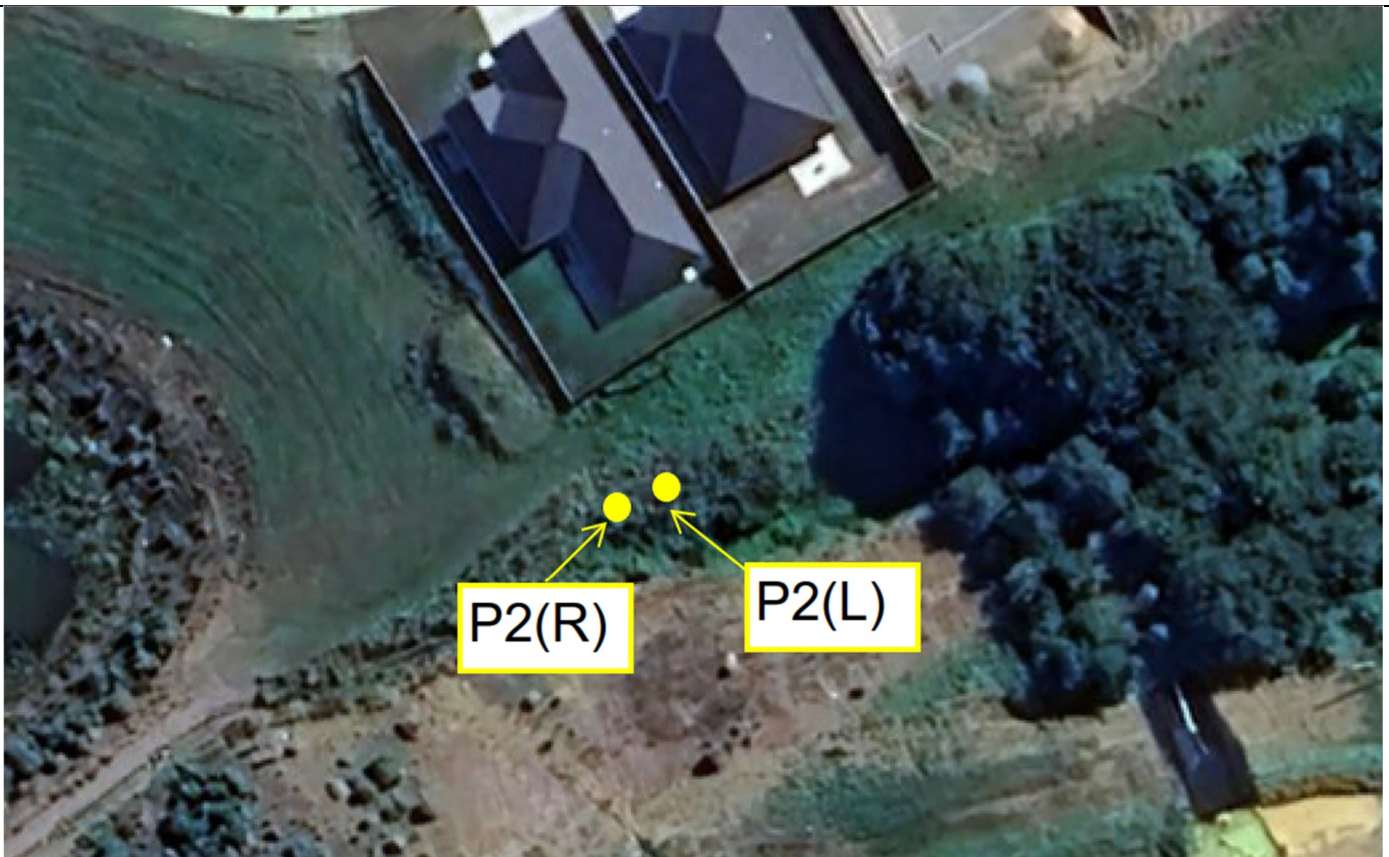
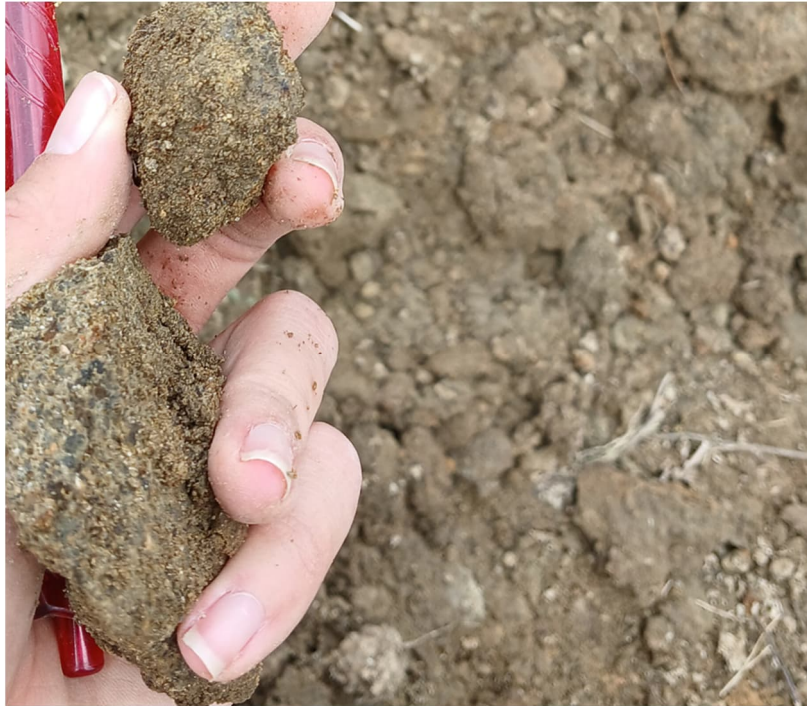
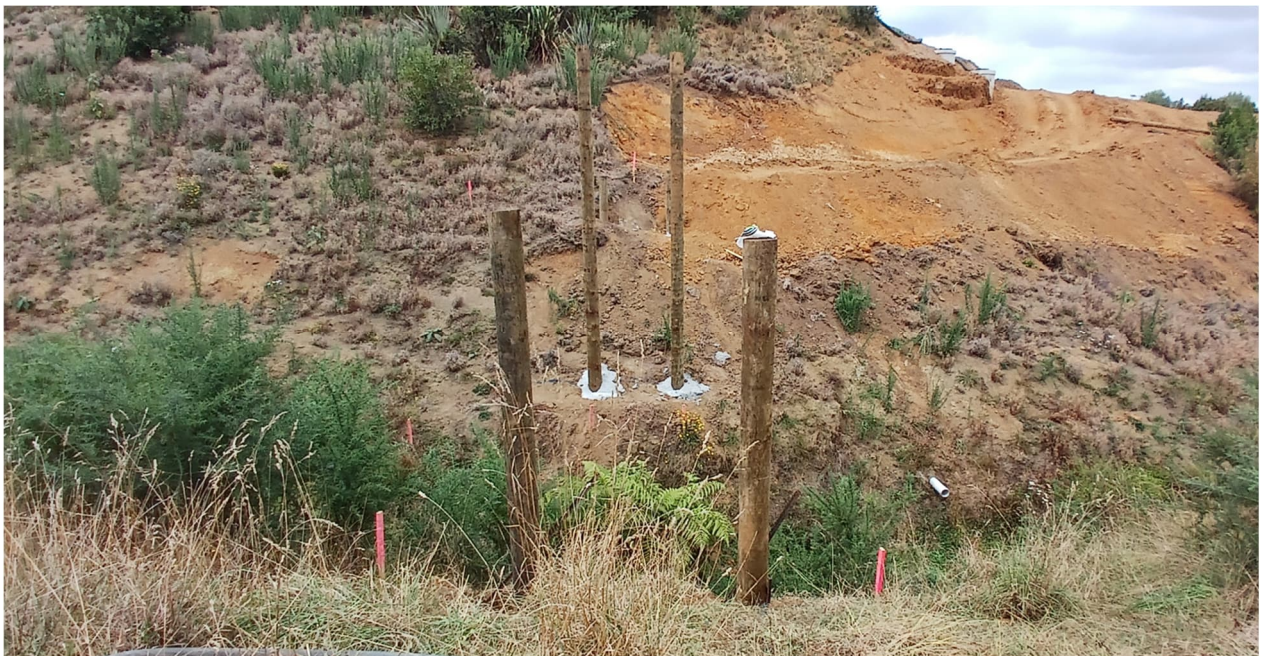
Visited the site at the request of Dines to inspect ground conditions in pipe bridging pile holes (approx. locations marked in yellow in inset below).

- Ground conditions are satisfactory.

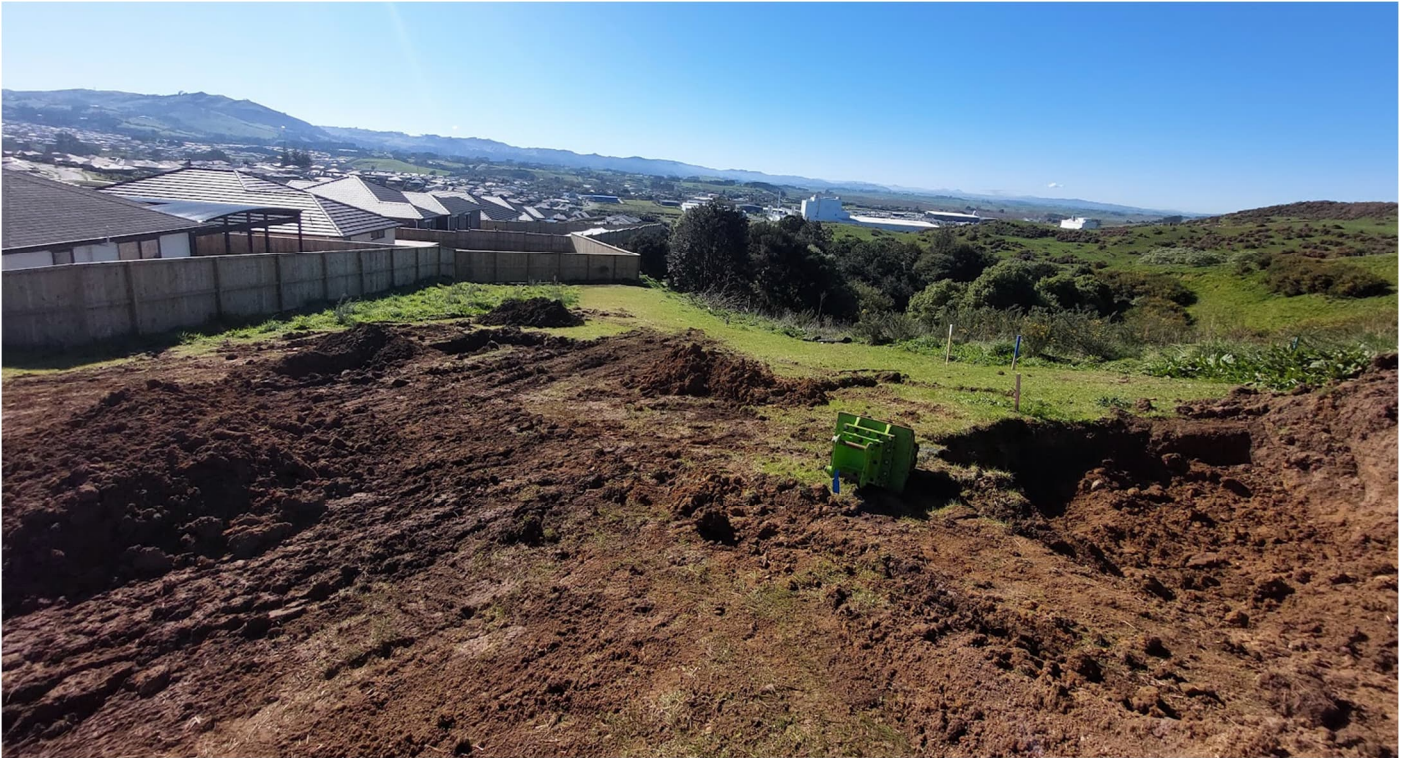
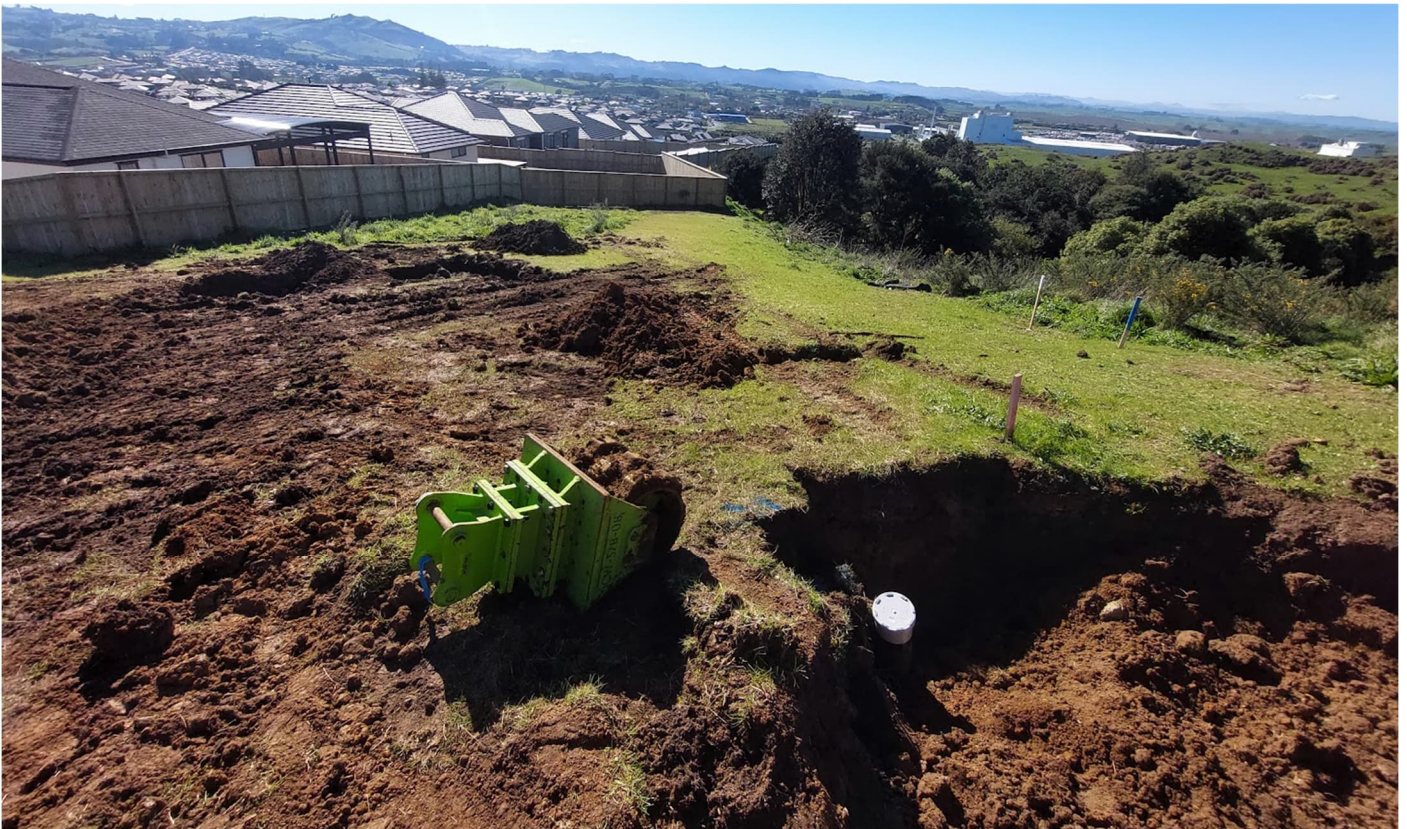
3 Pits opened up to locate the capping of the 3 counterfort drains.

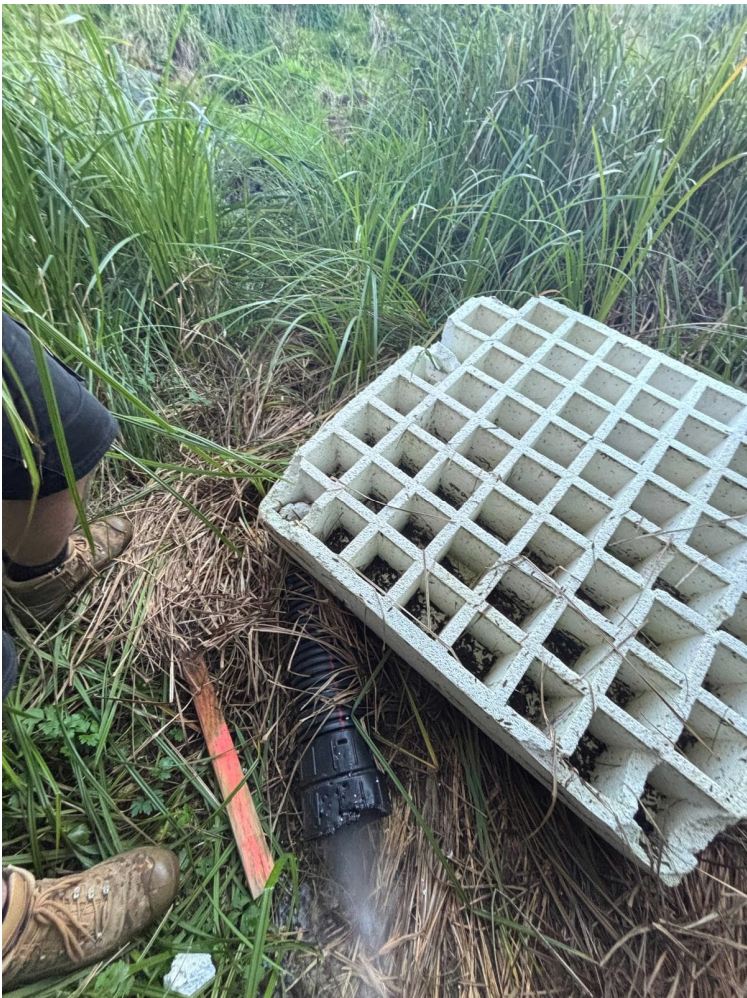
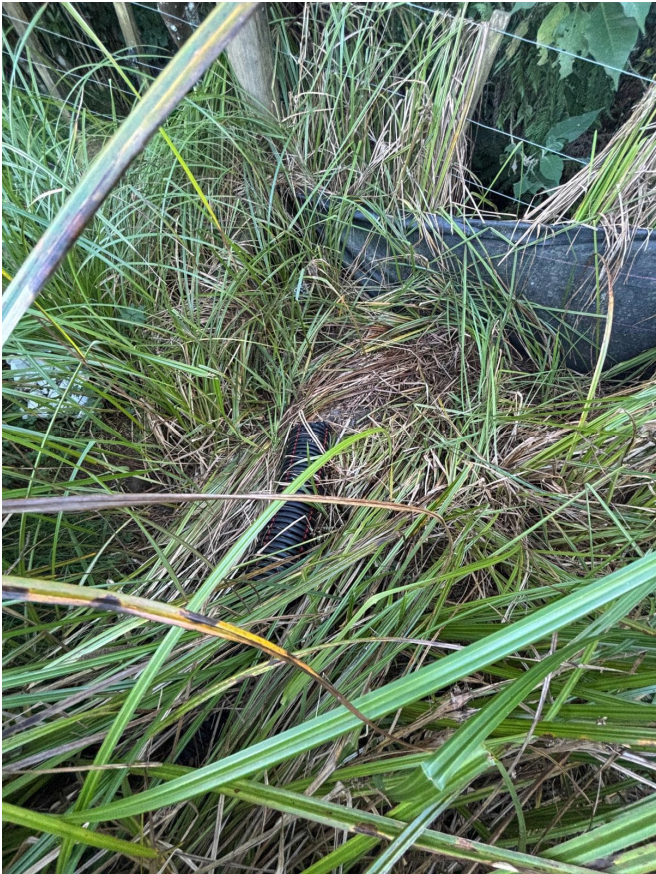
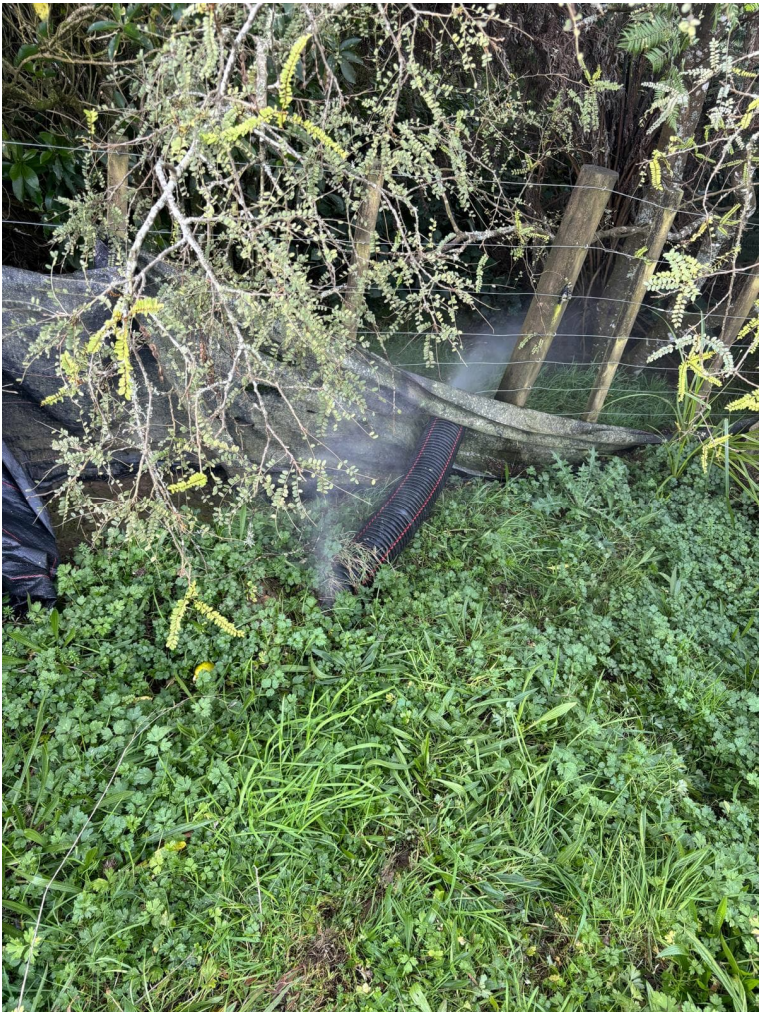
3x Counterfort drain flushing

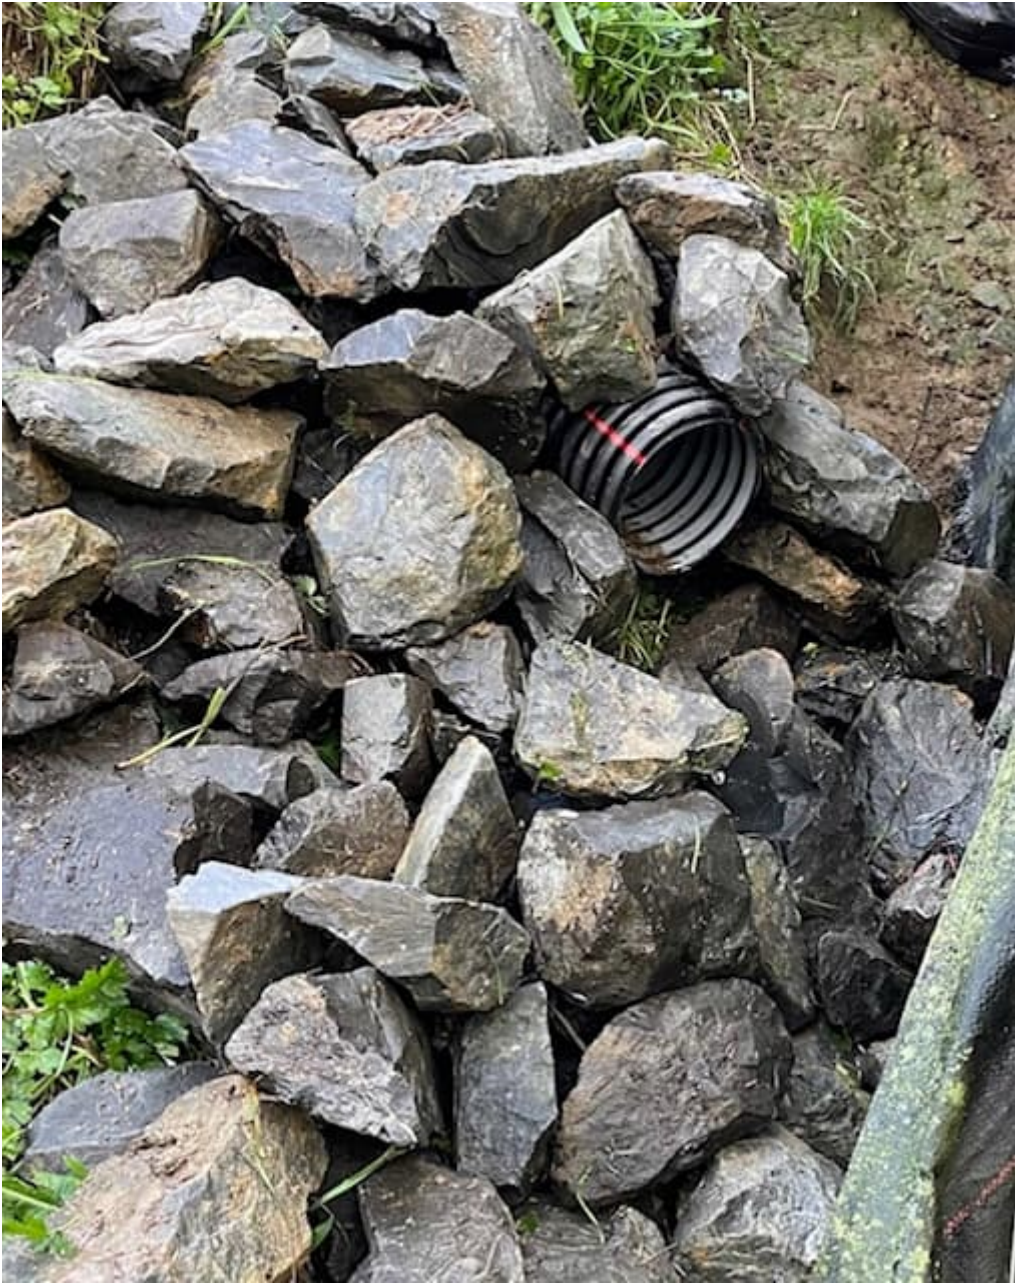
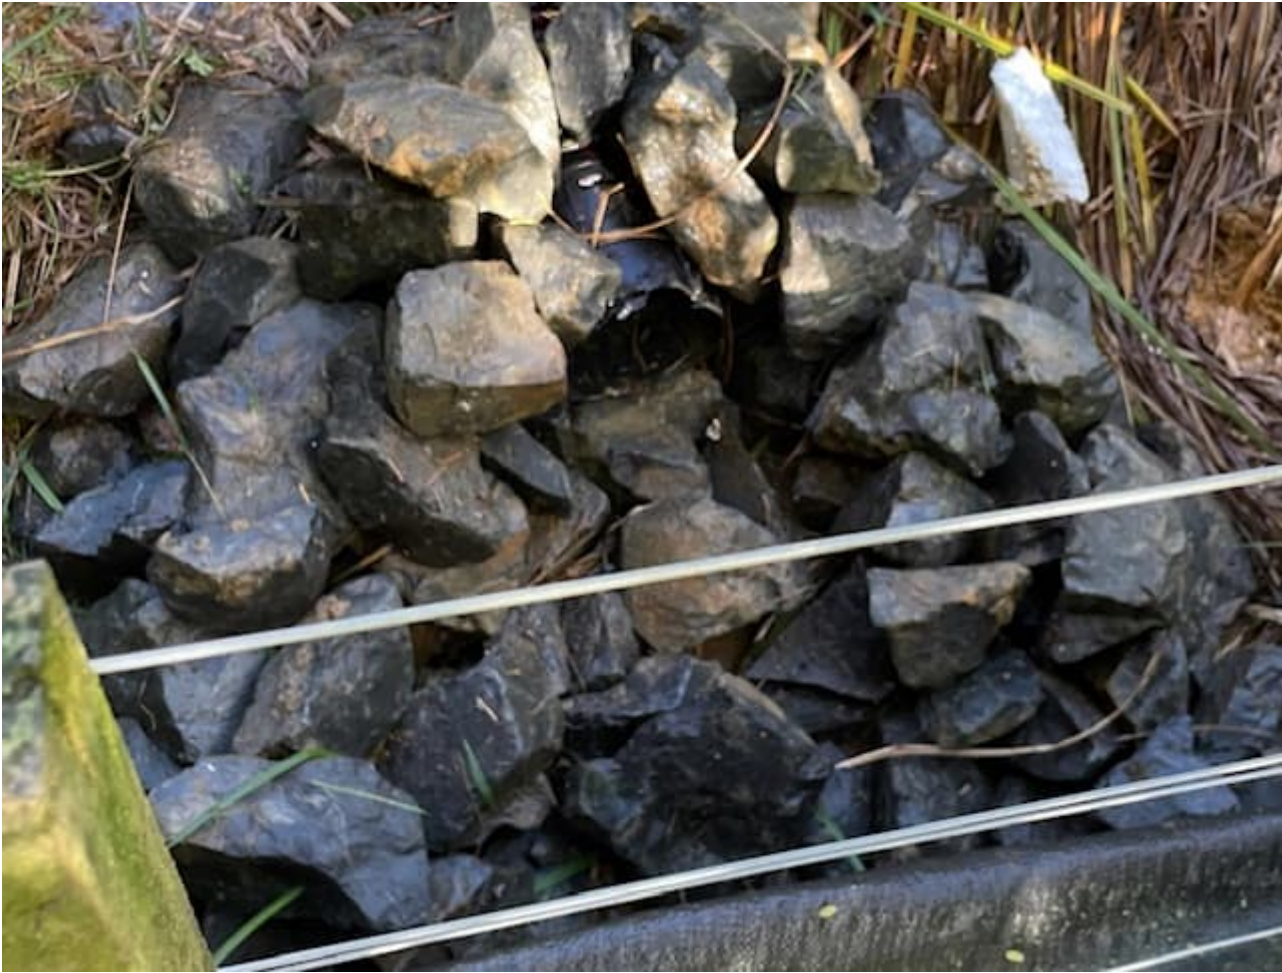
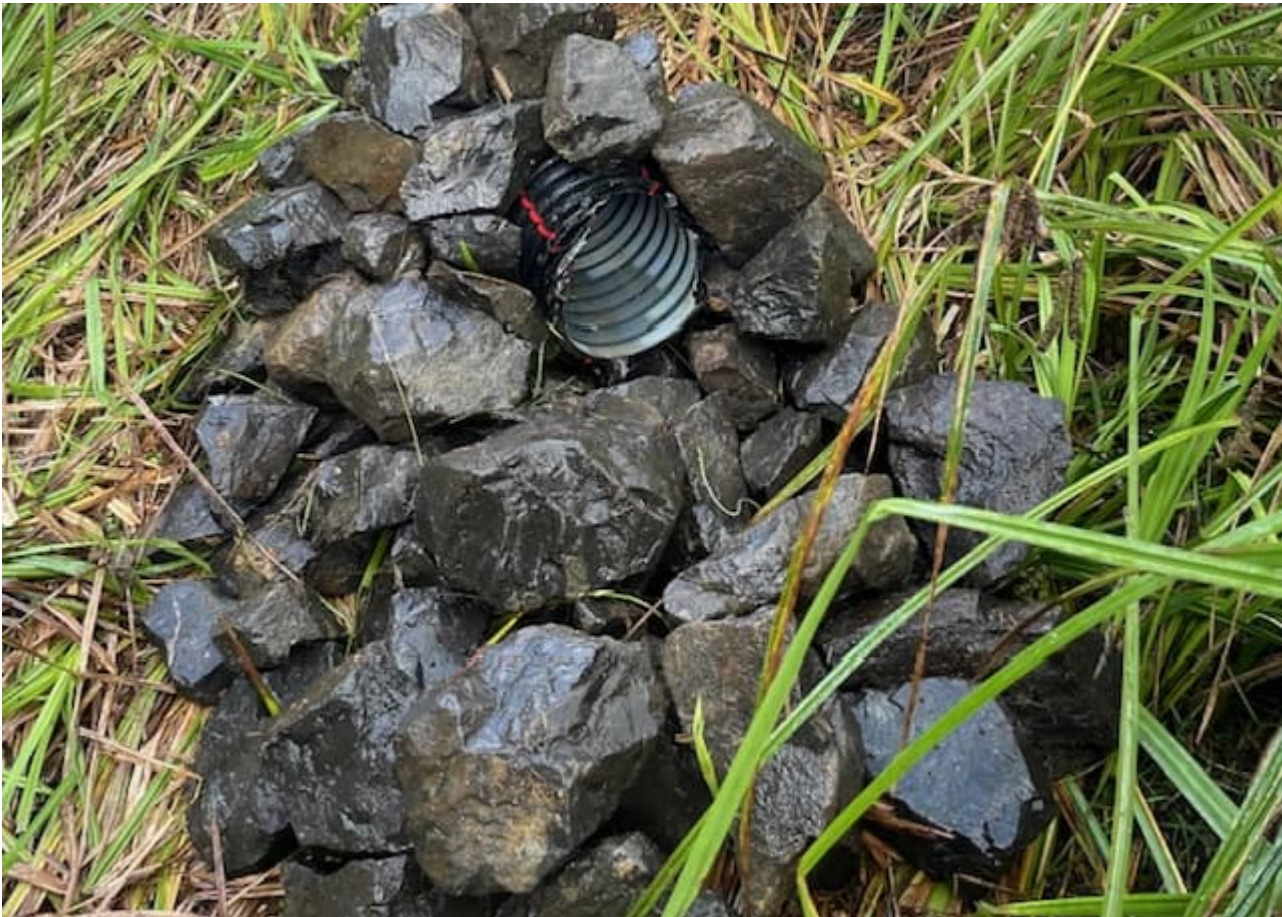
Stage 18 & 19 drain outlets, provided by the contractor on 23/07/25:
