Geotechnical Completion Report

HITCHEN BLOCK STAGE 13B

17 January 2022

Ref No: J00113

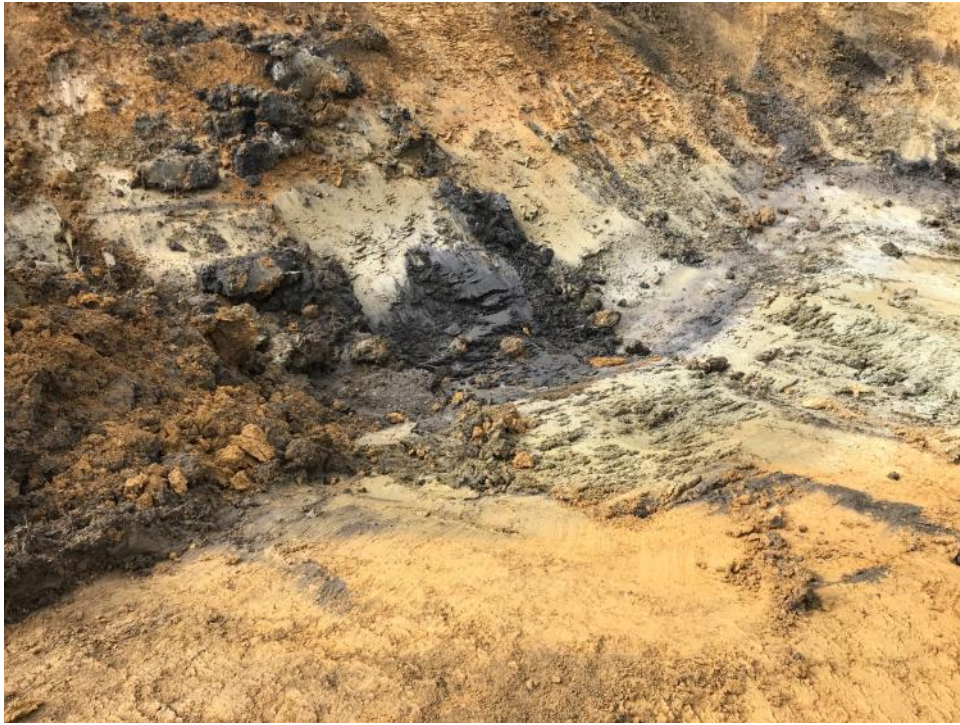
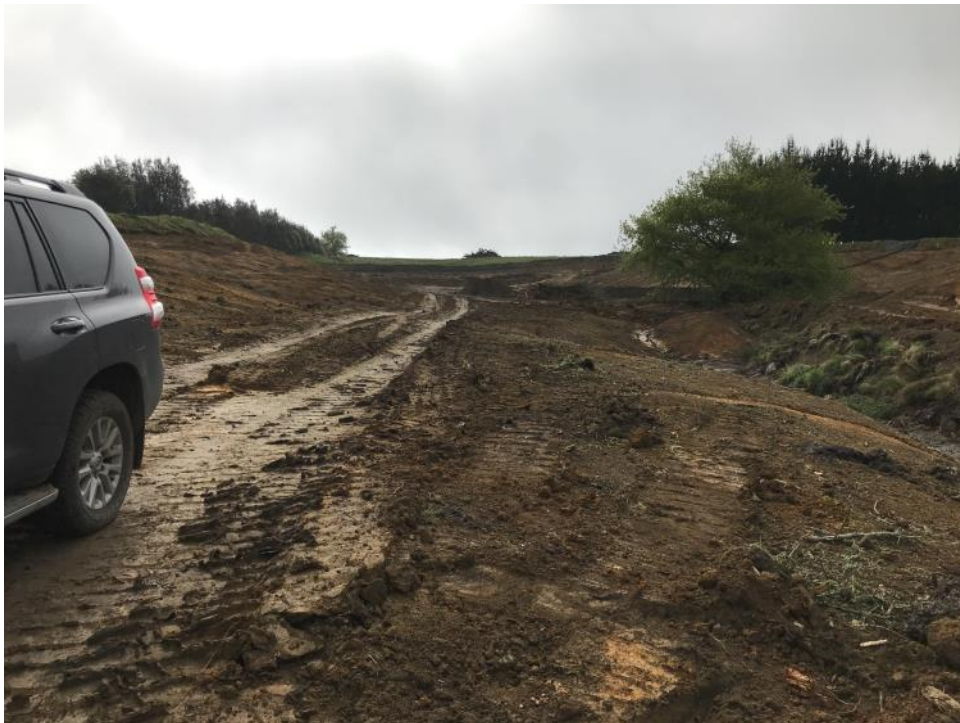
Contractor also to install nominal toe key. Discussed with Trevor that this should be a buckets width wide at base and should extend across the face of the gully. Trevor to send photos once this is complete.

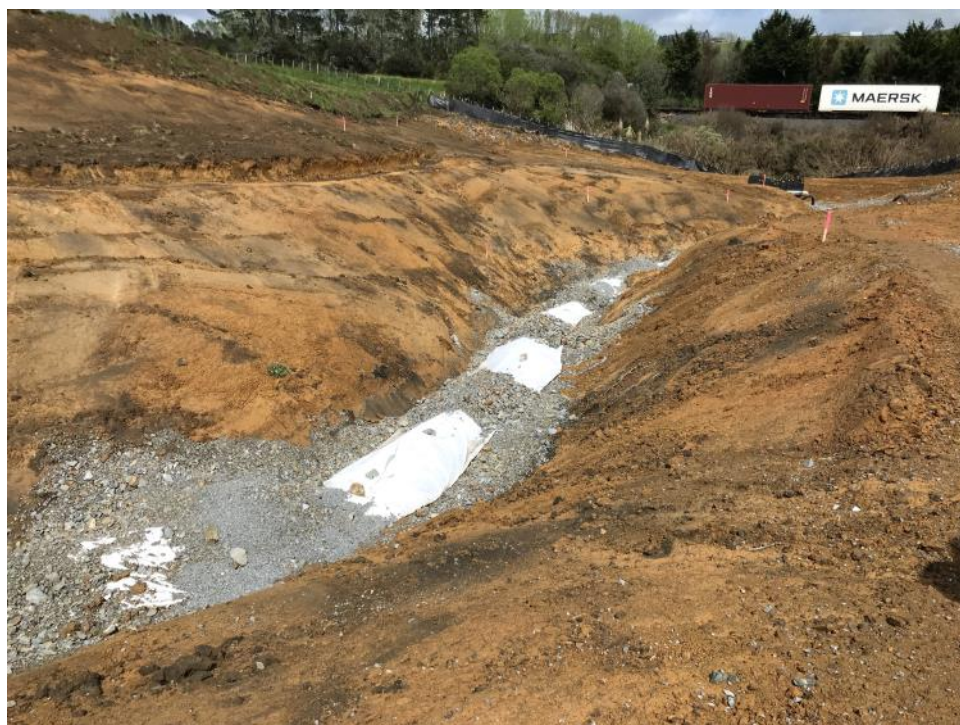
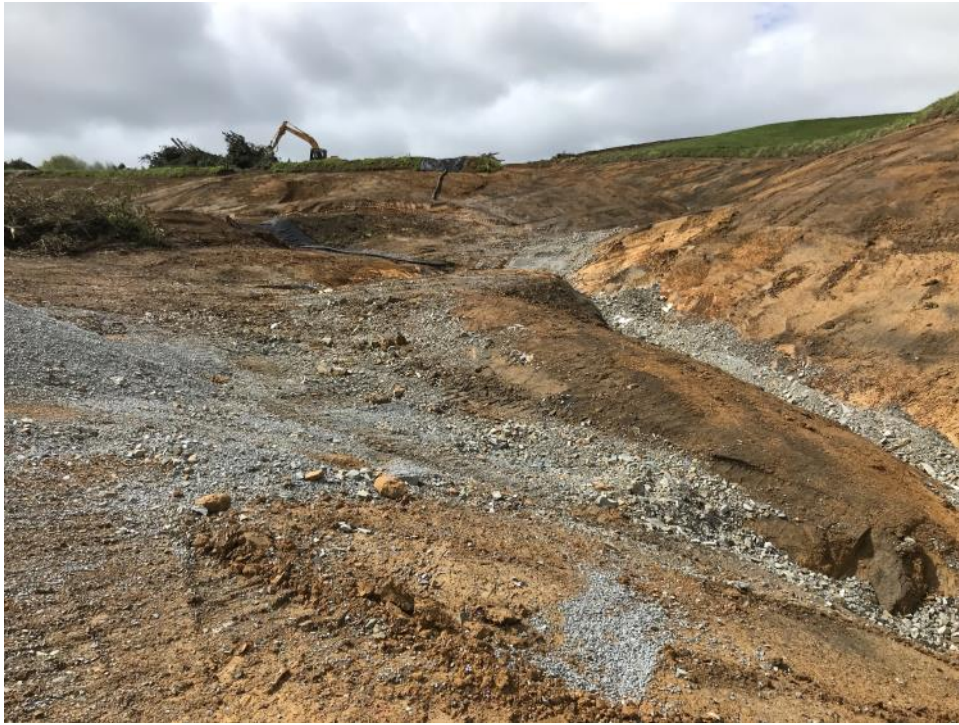
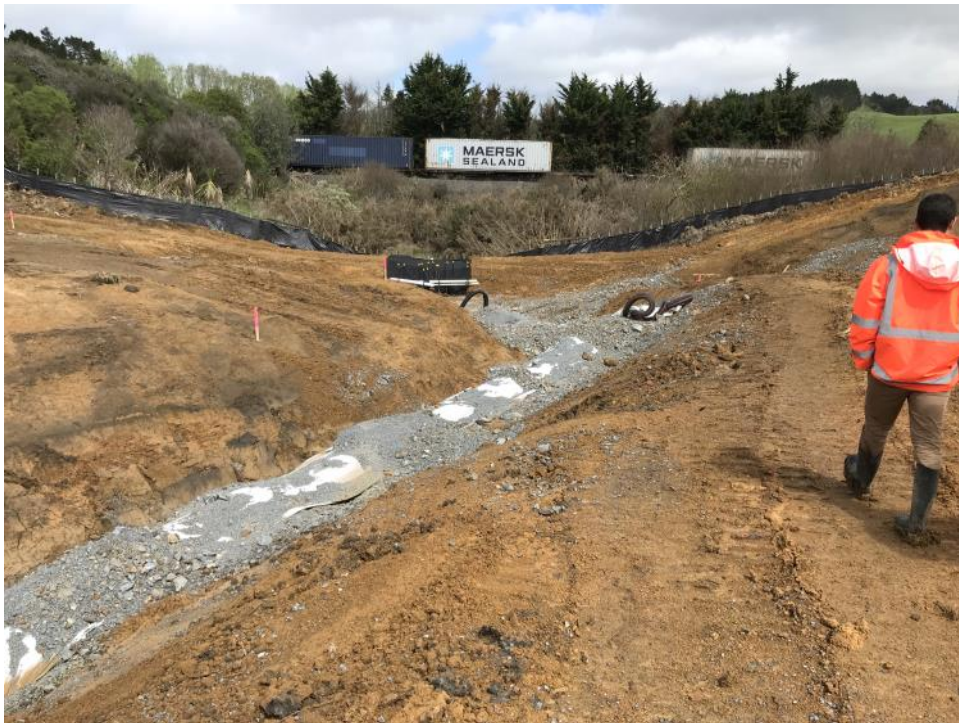
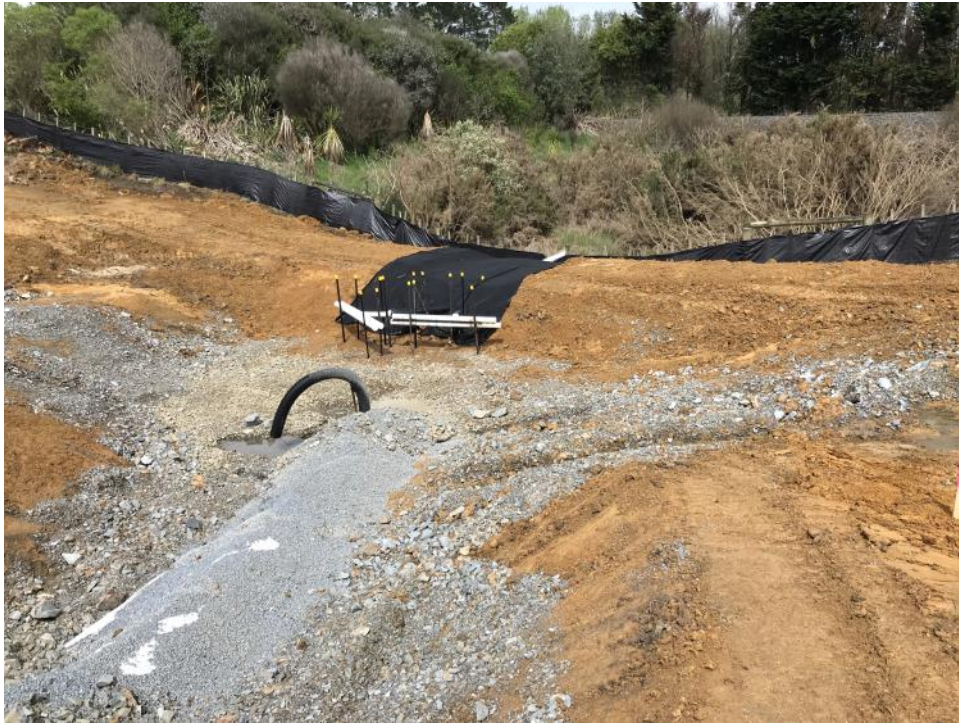
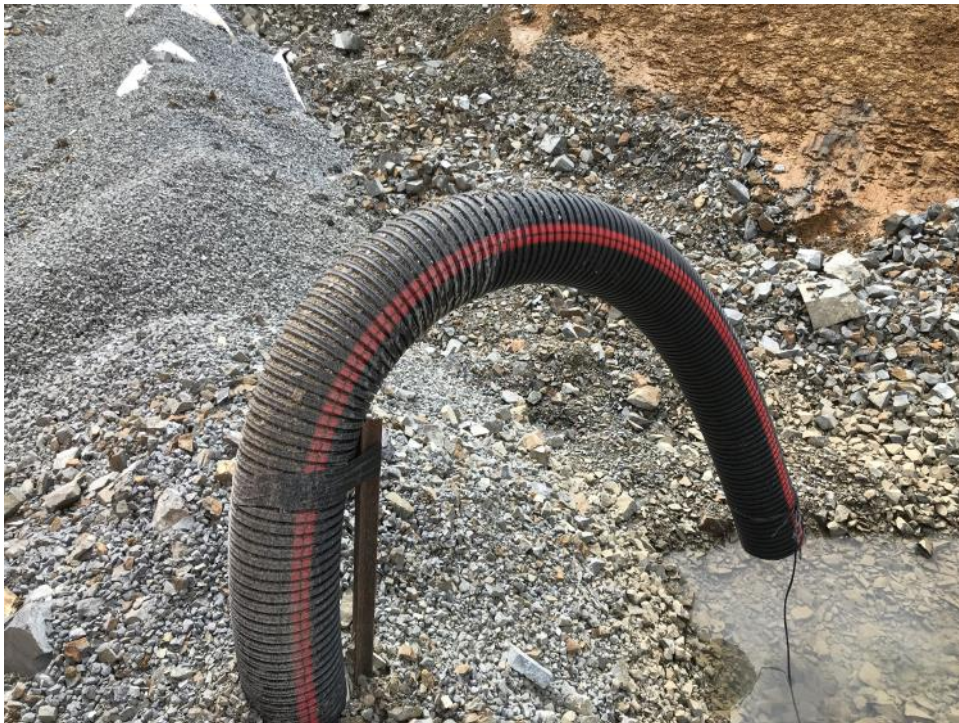
Discussed likely outcomes for this season and next at Hitchen Stage 5 and also discussed toe key requirements - these being nominal keys 4-5m wide at base and keyed into the sides of the gullies.

Will return to site tomorrow morning to inspect remediated toe key in fill F which is being widened to meet the 5m width criteria.

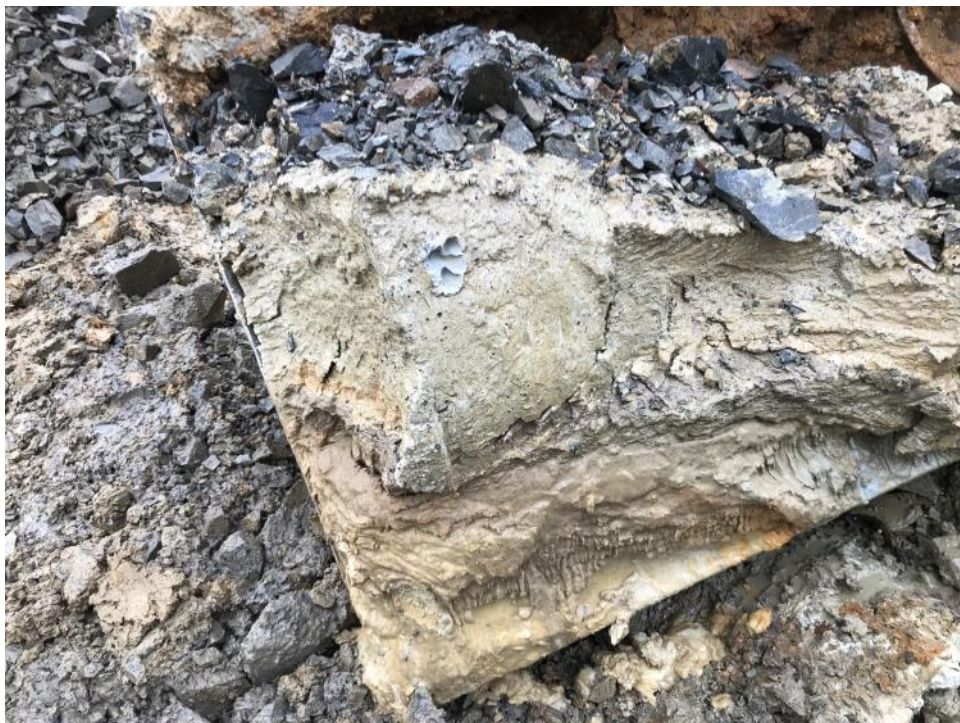
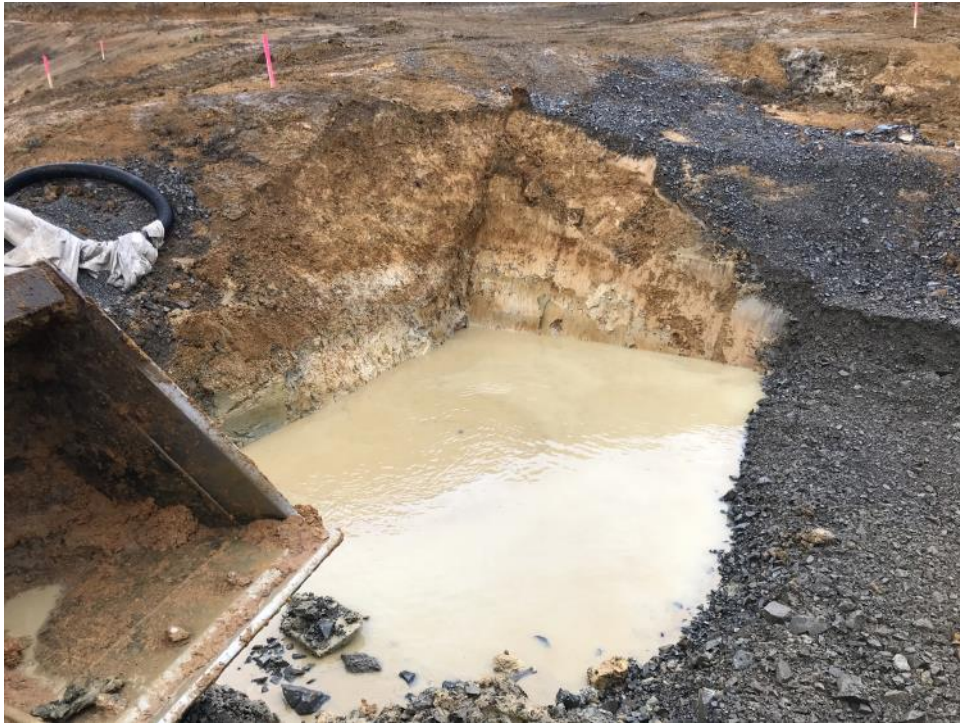
17/10/19

Visited site to inspect excavation of toe key in Fill F. Key excavated 5m at base with very stiff material at base as per our requirements. Some water ponding at base which will require pumping prior to filling.

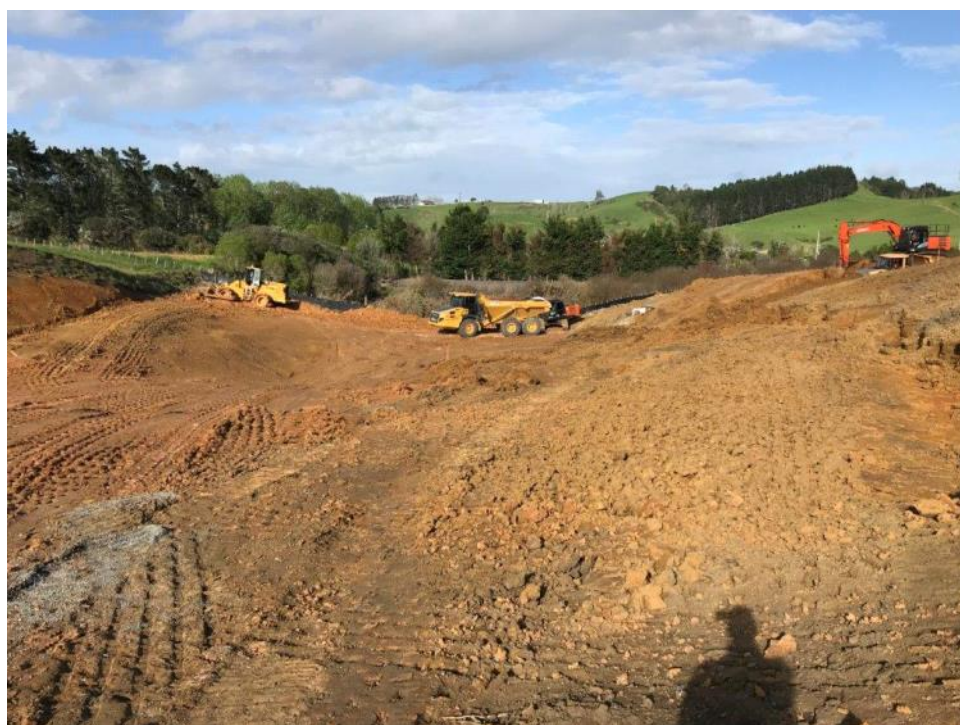
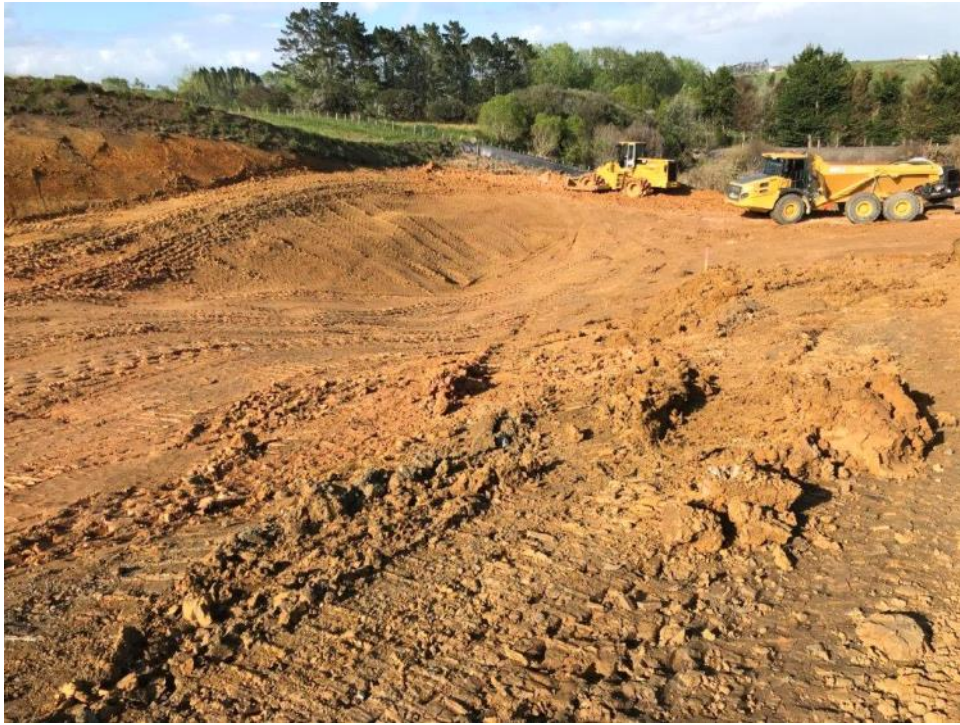
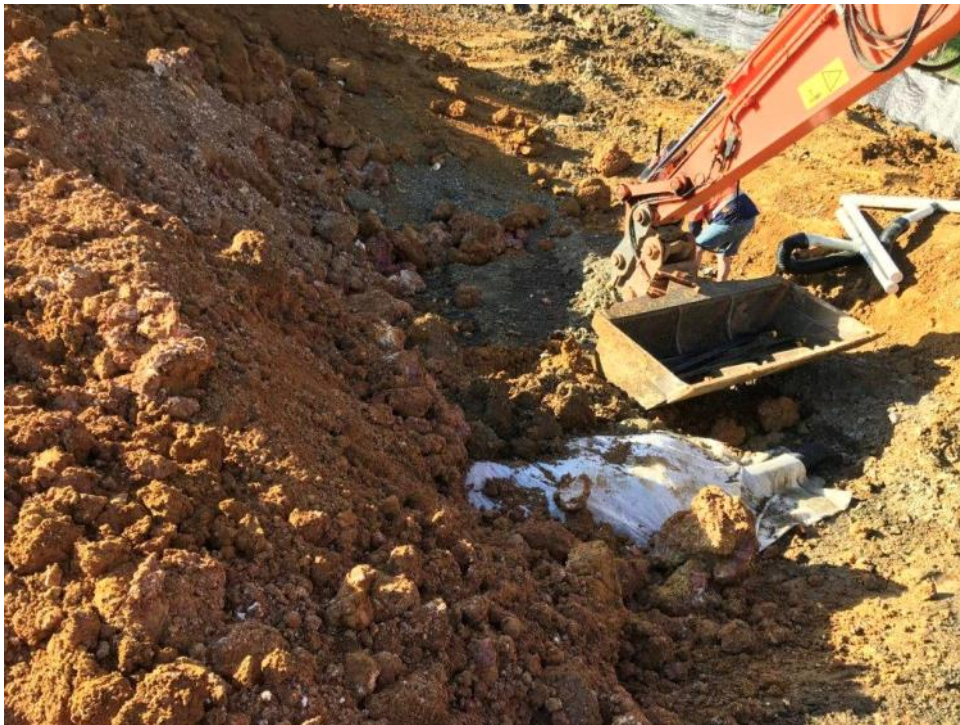
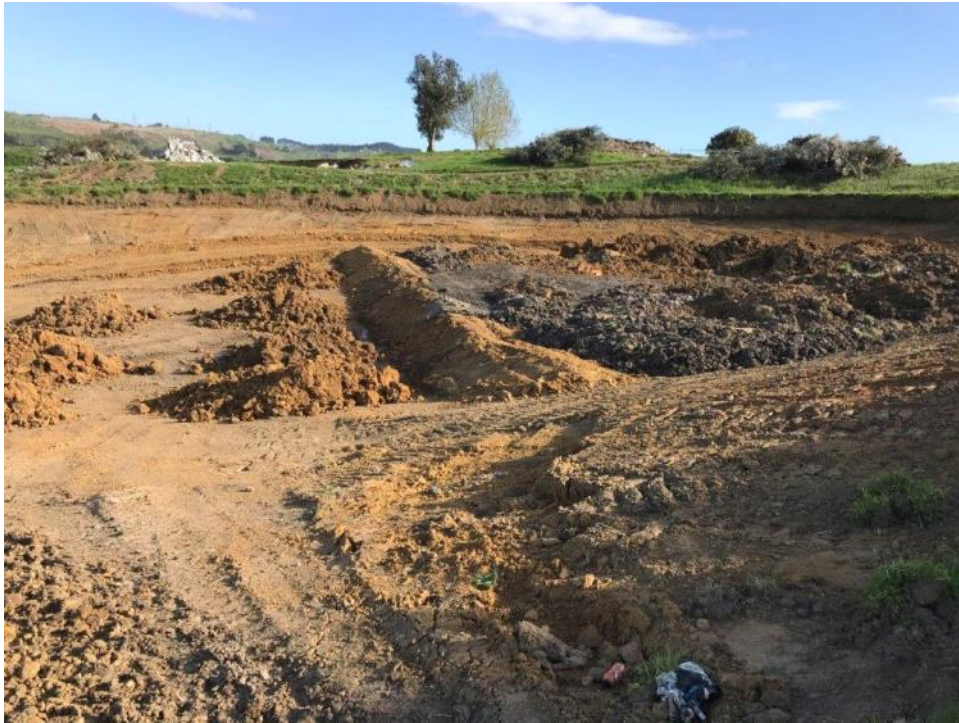
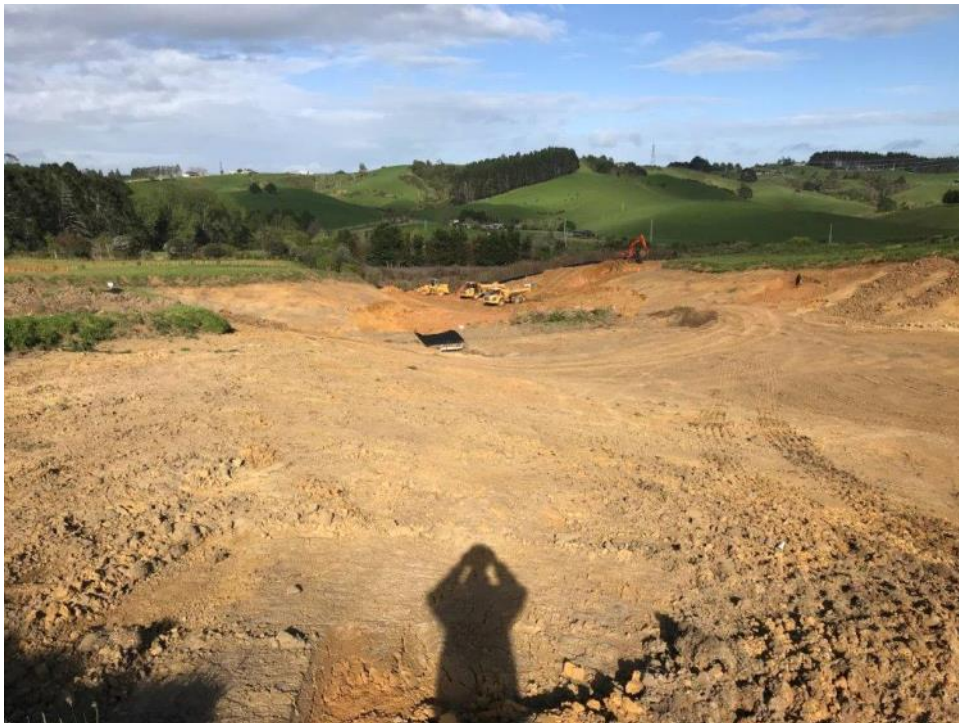
21/10/19

Visited site to check earthworks operations in Fill E/F areas. Toe key has been filled up and tersed since last visit and contractors are beginning to form permanent pond wall.

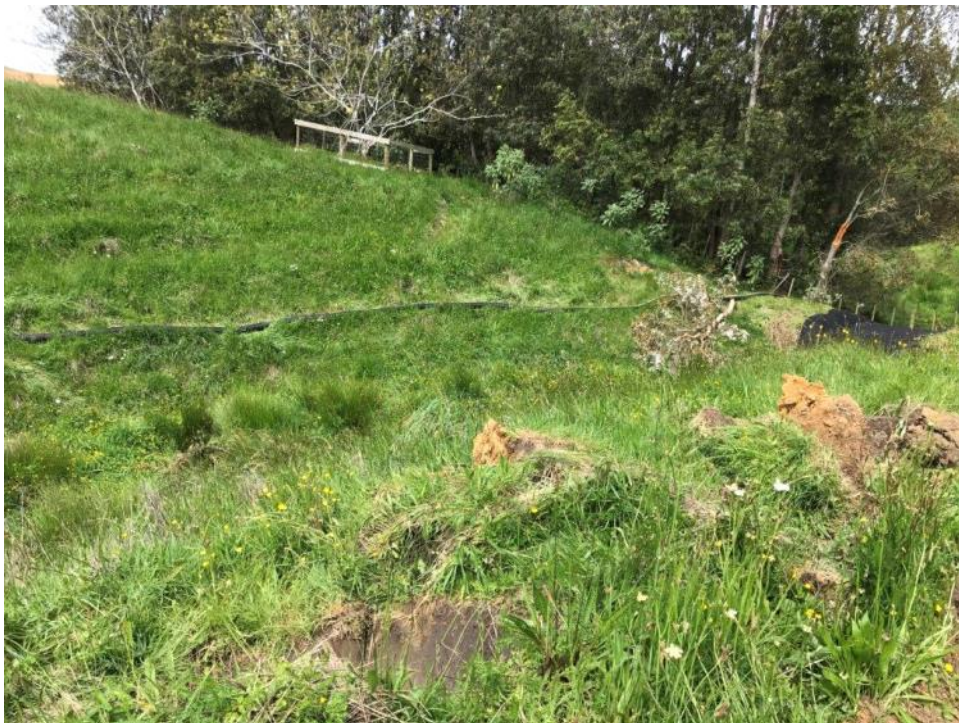
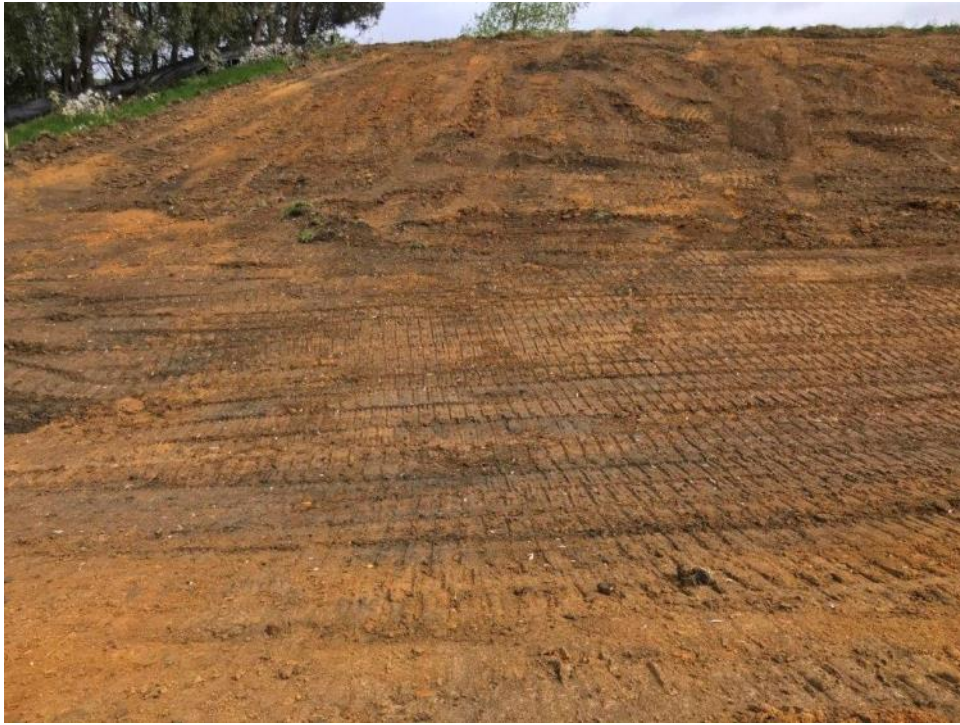
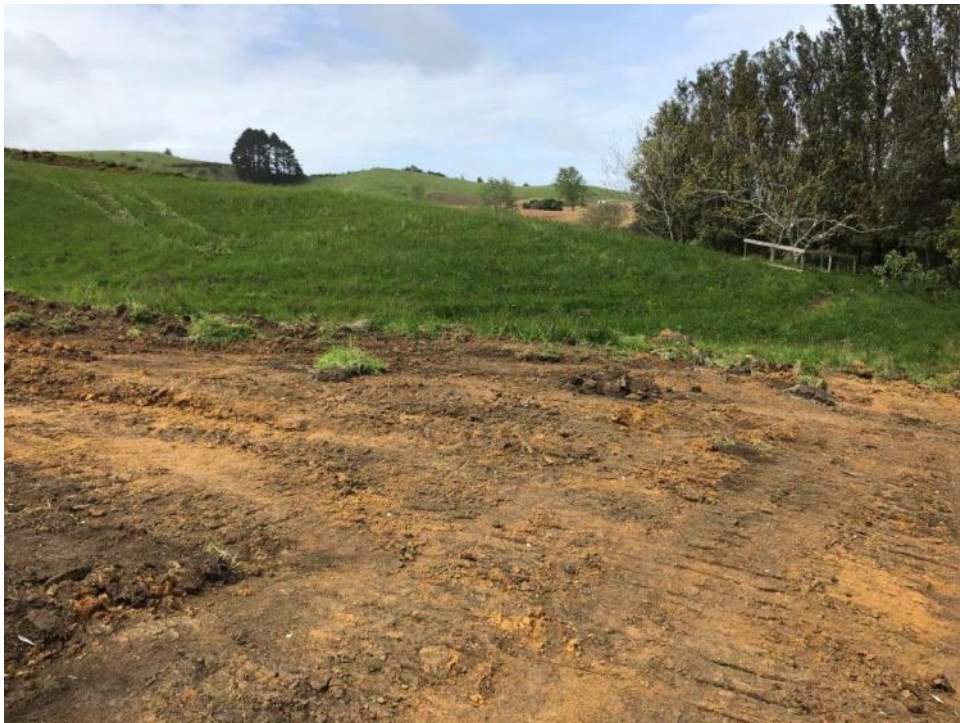
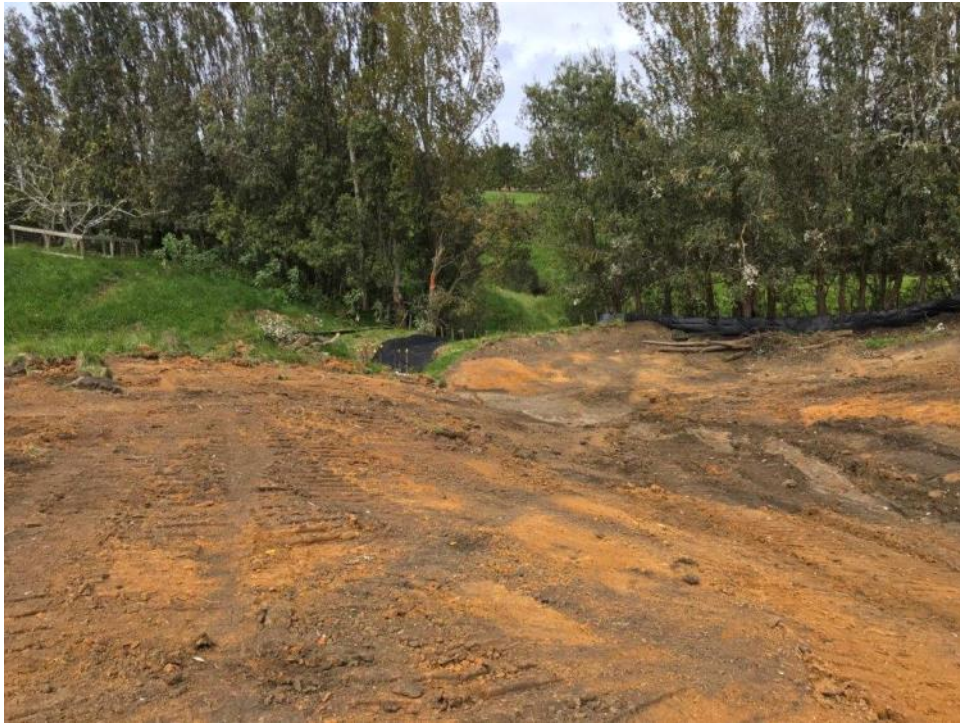
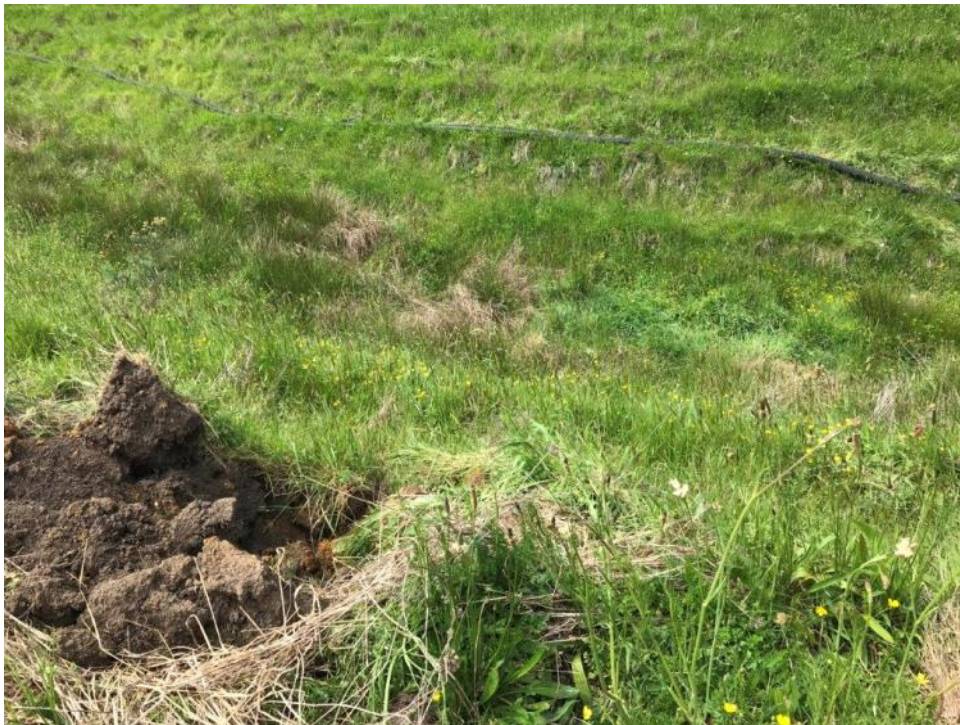
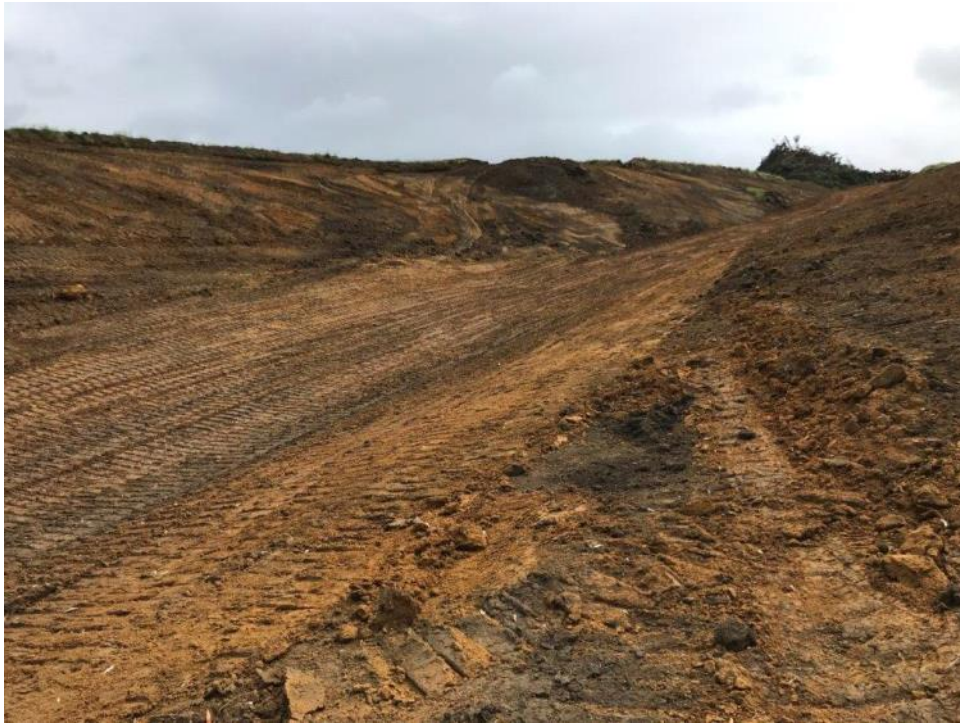
24/10/19 - Fill K

Visited site at request of Dylan (Dines) to inspect stripping in area of Fill K / Cut 2. Only a small area within the area of the silt pond had been stripped back to very stiff natural ground. The gully for Fill K had no been mucked out yet, and no excavations to form the silt pond had been started either.

Discussed with Dylan that we should return to site once the gully is mucked out and we can carry out a shallow trial pit in the area of the proposed toe key prior to excavations.

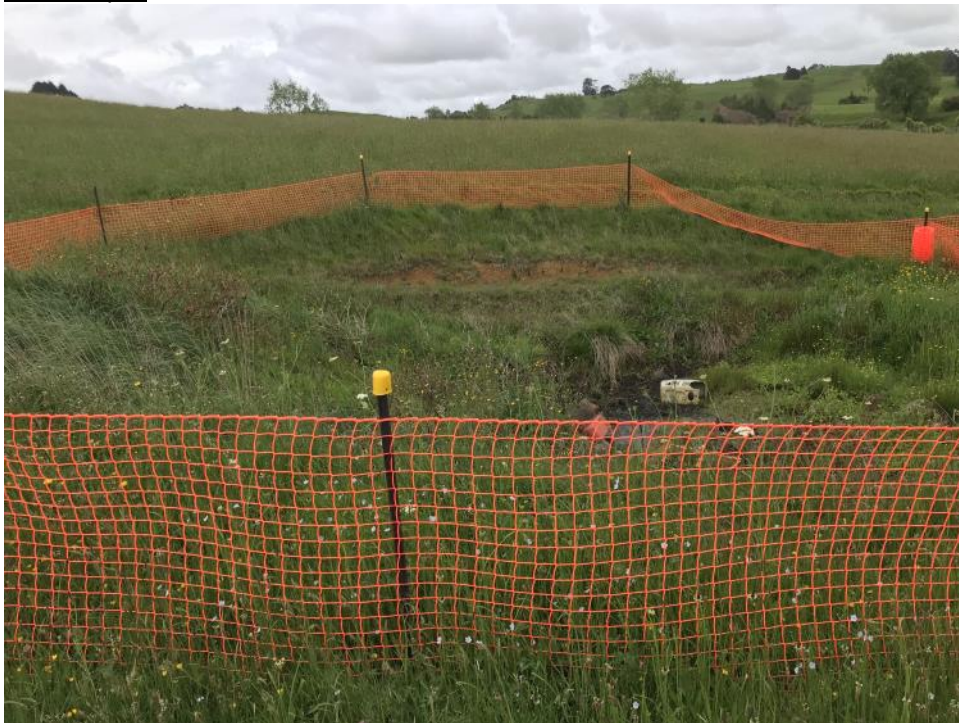
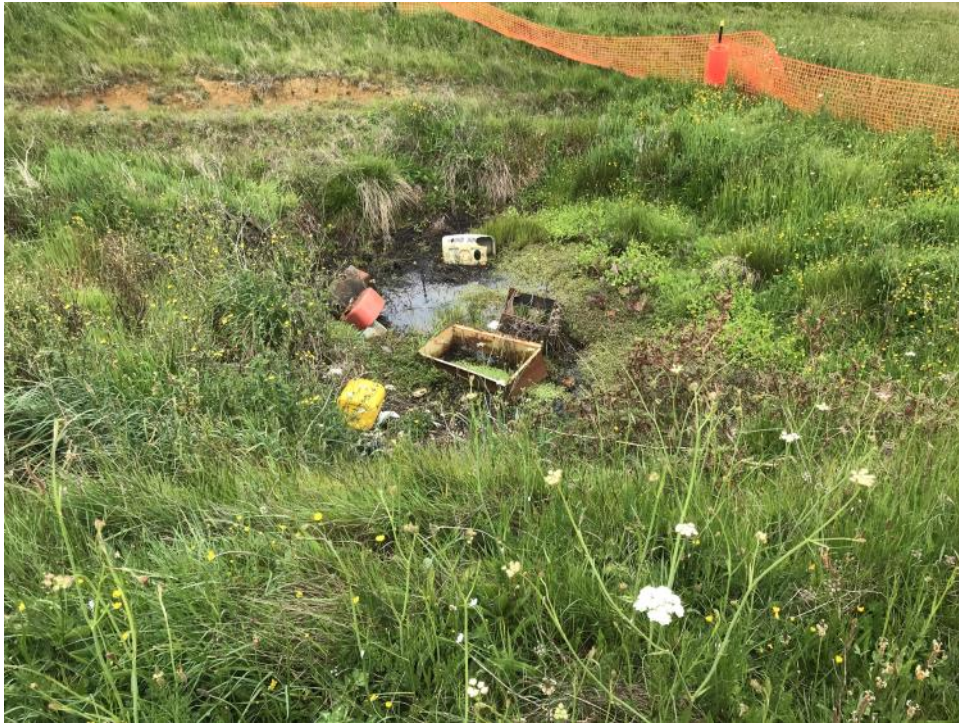
Rubbish pit:

Also found an old rubbish pit exposed which is marked out by the contractors. This will require undercutting also.

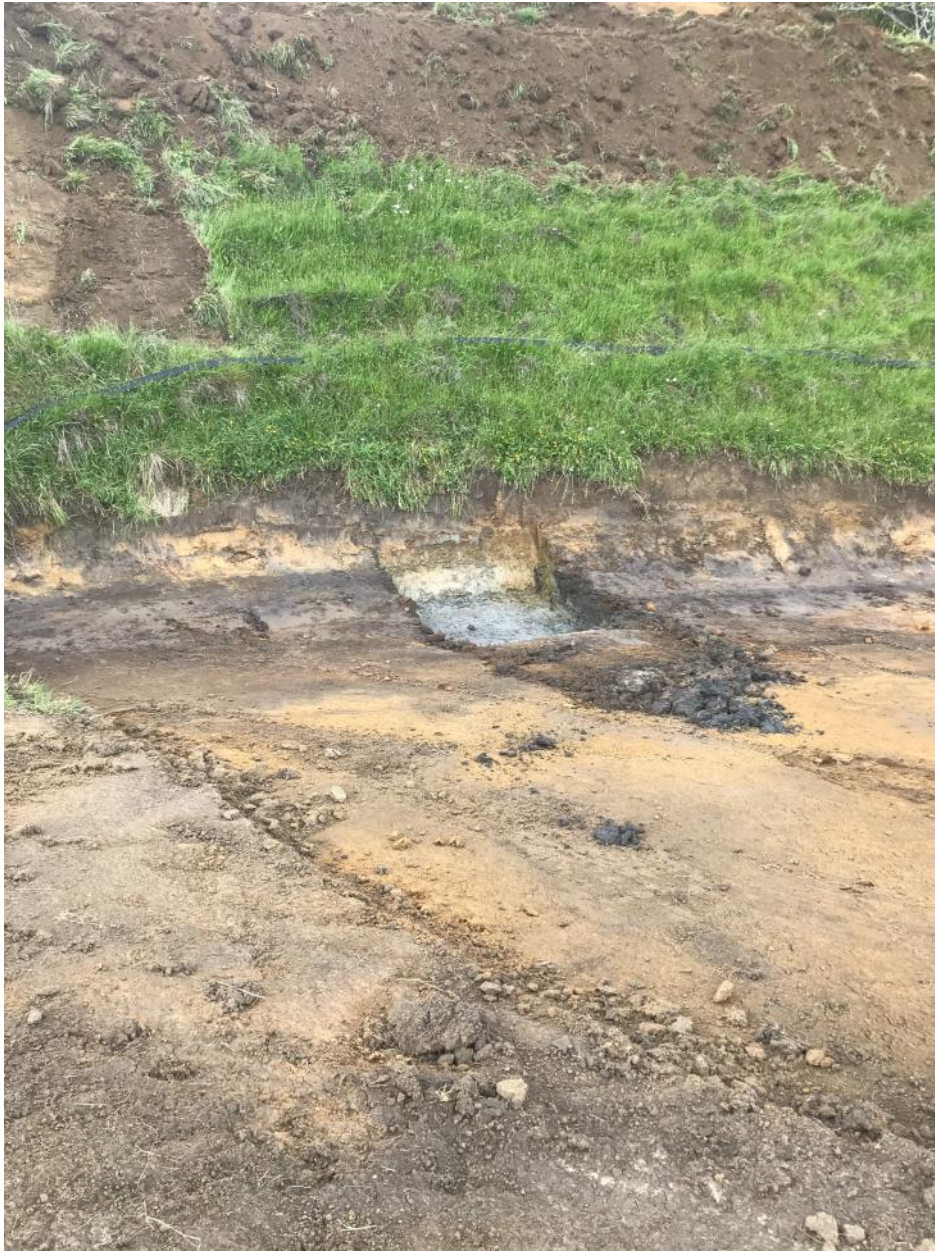
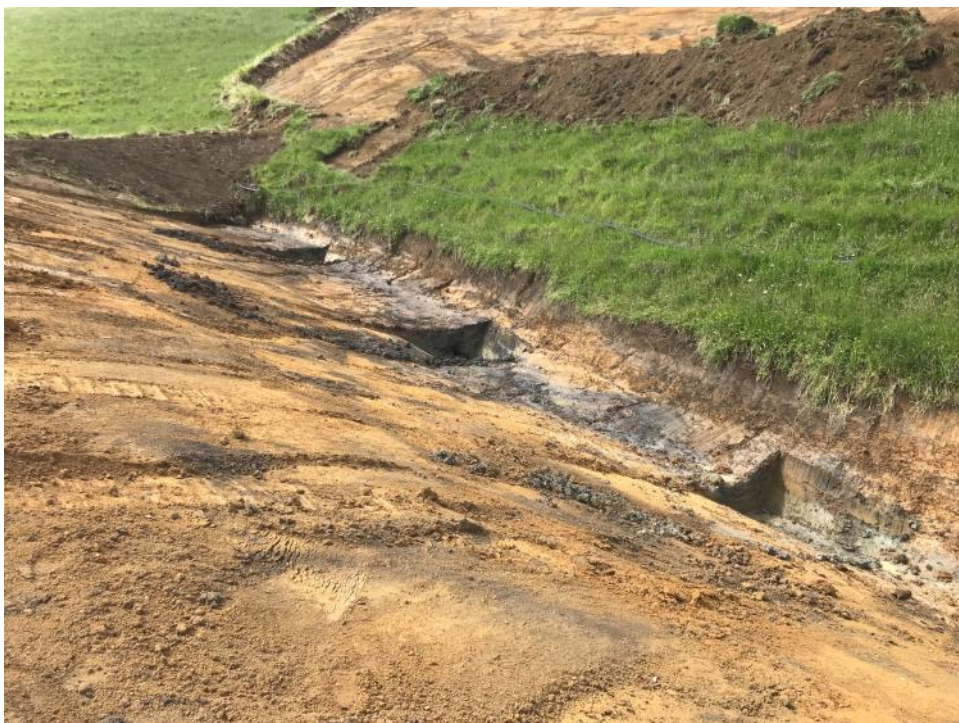
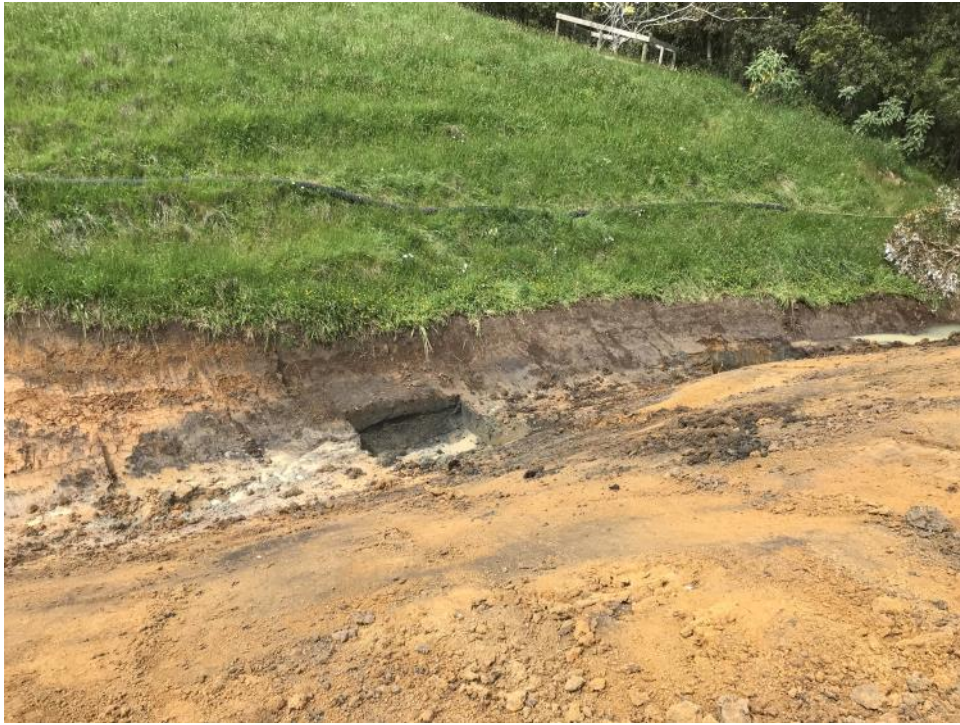
Fill K undercut/pit photos:

Visited site to inspect Fill K gully muckout. Inorganic, natural soils exposed throughout, however, soils were firm along a large part of the gully invert. Drilled two shallow hand augers which revealed stiff natural ground approximately 0.5m to 0.8m below current invert levels and we recommended an undercut to this depth. Refer plan attached.
