Geotechnical Completion Report

HITCHEN BLOCK STAGE 13B

17 January 2022

Ref No: J00113

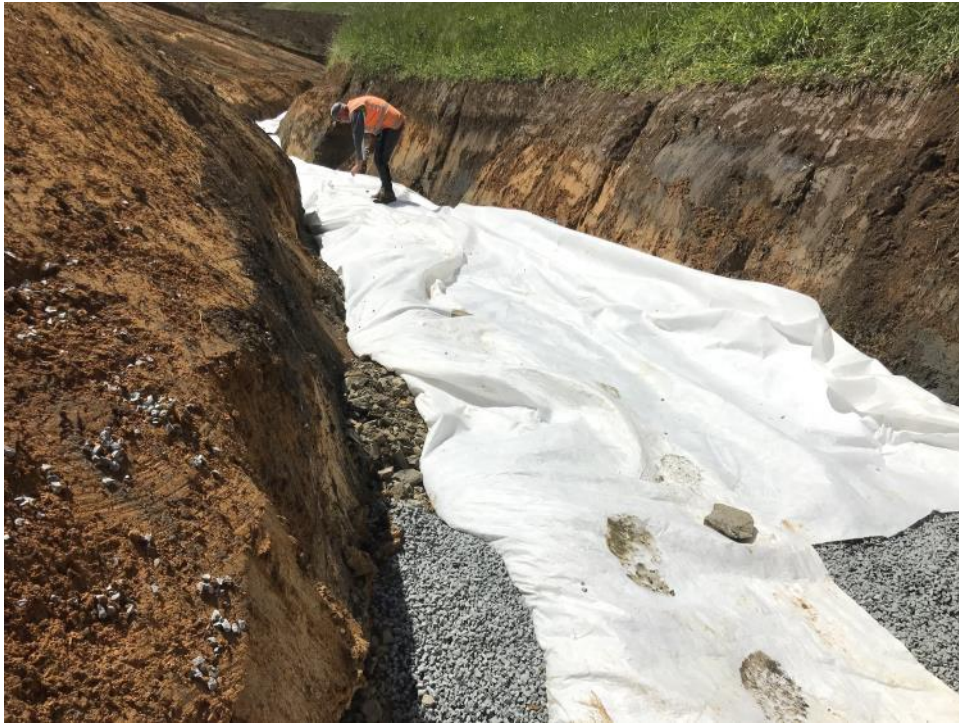
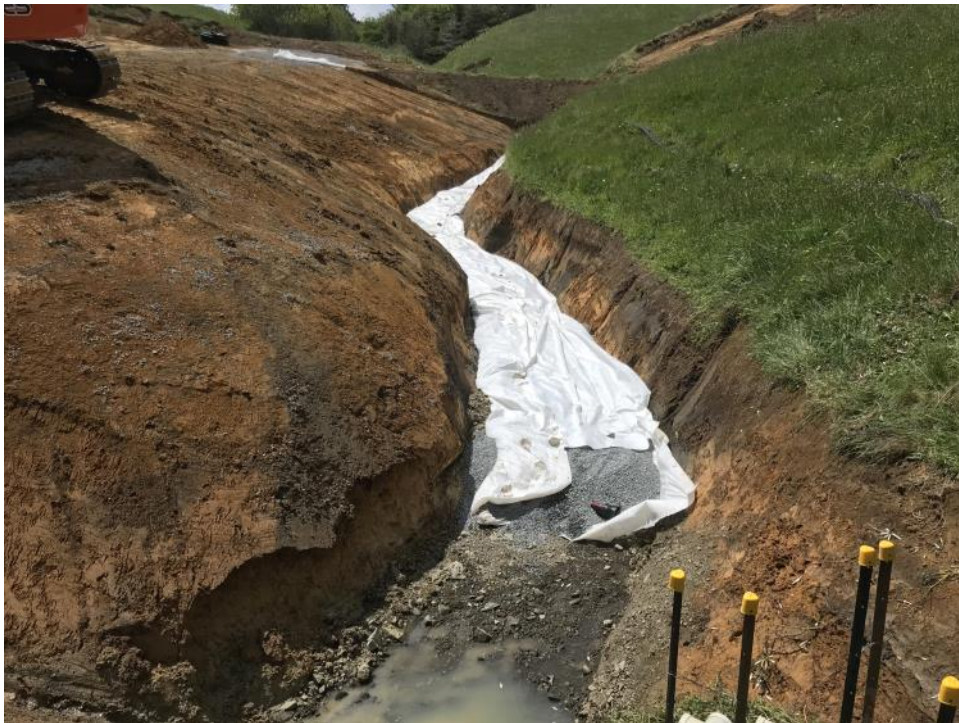
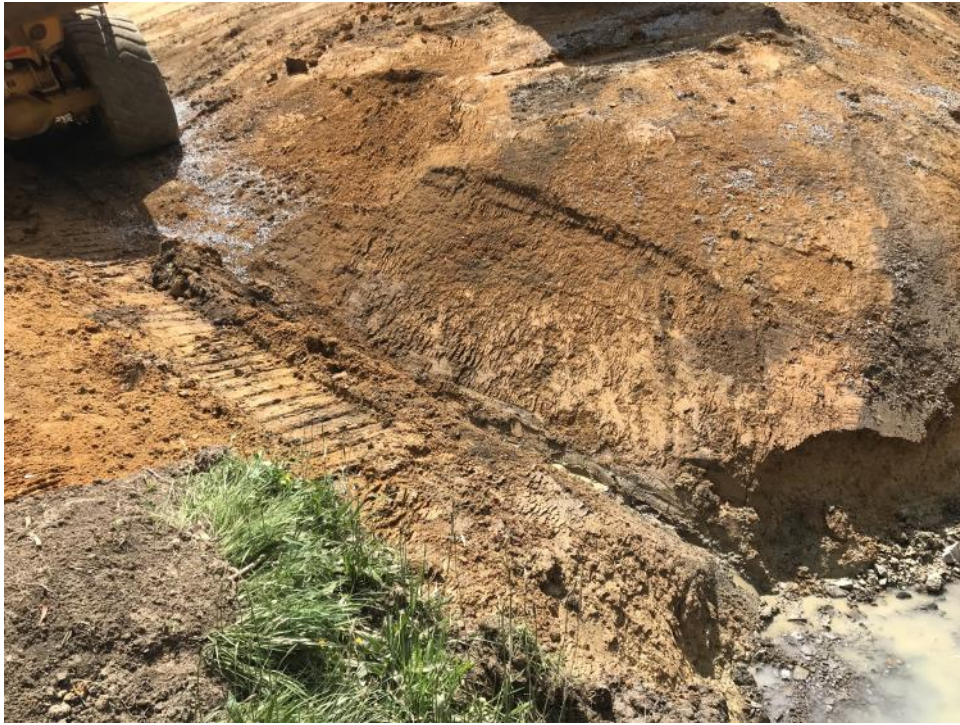
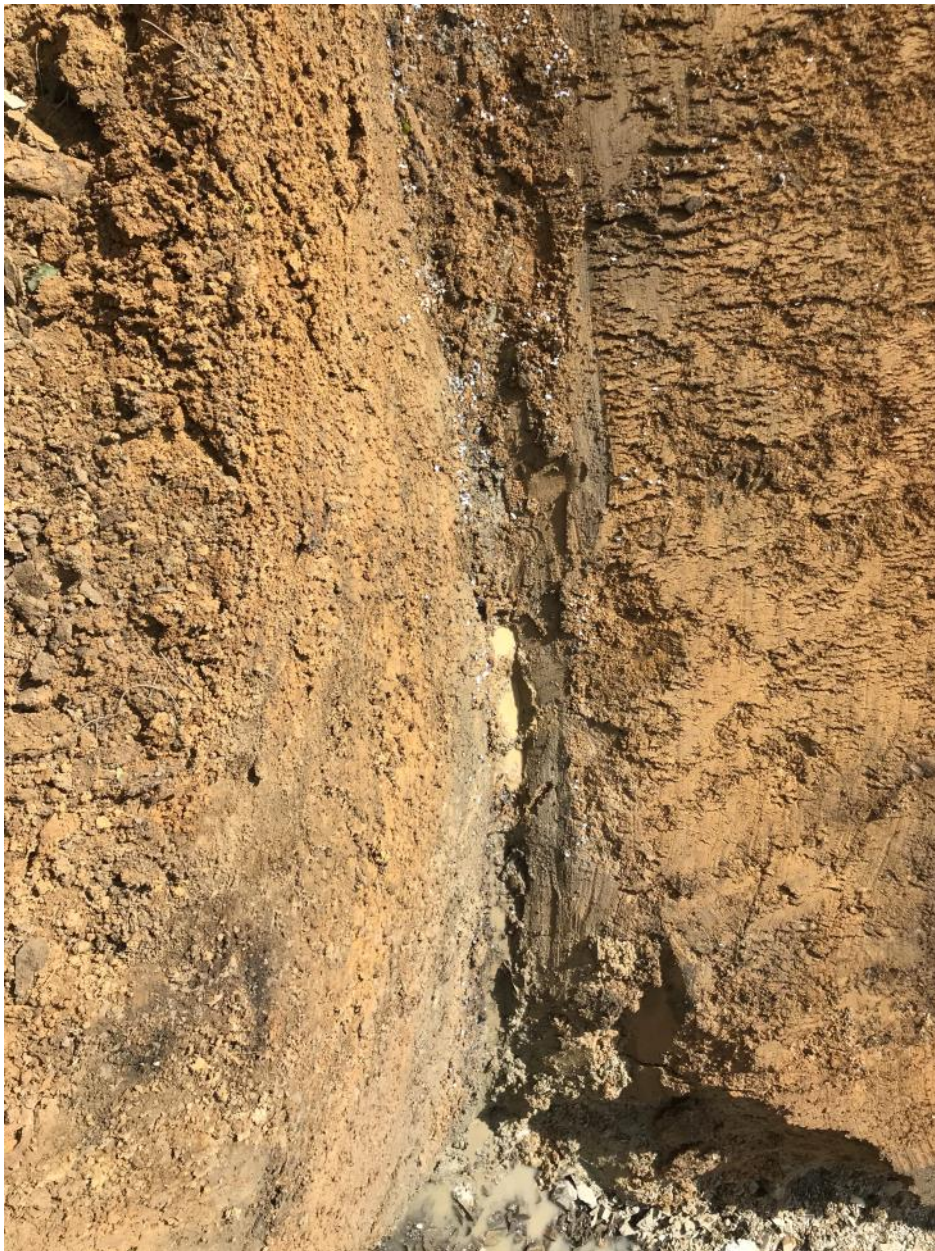
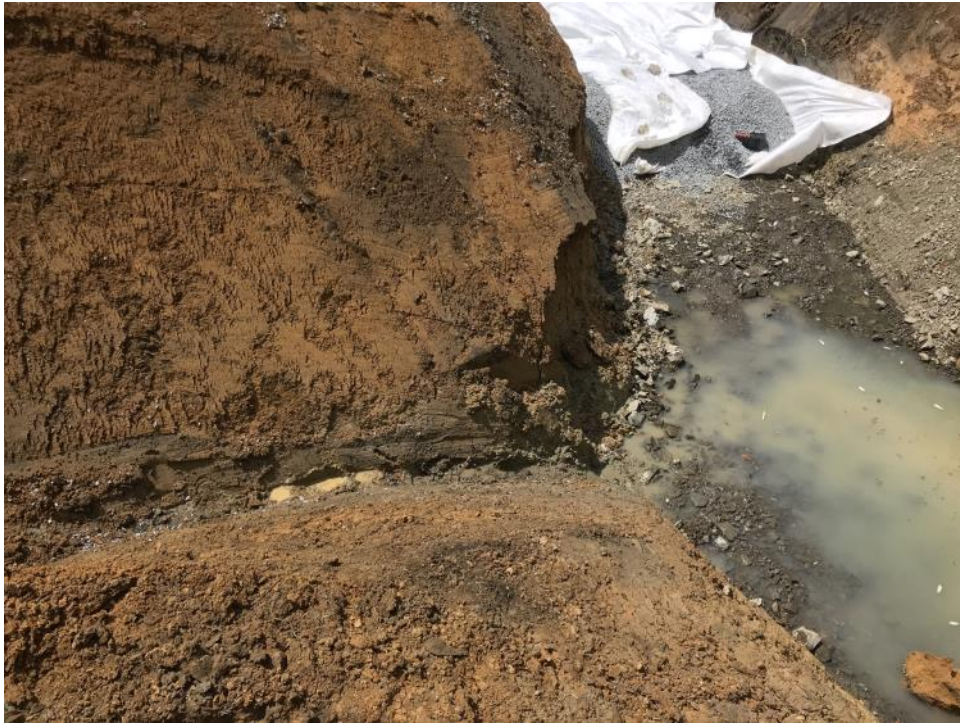
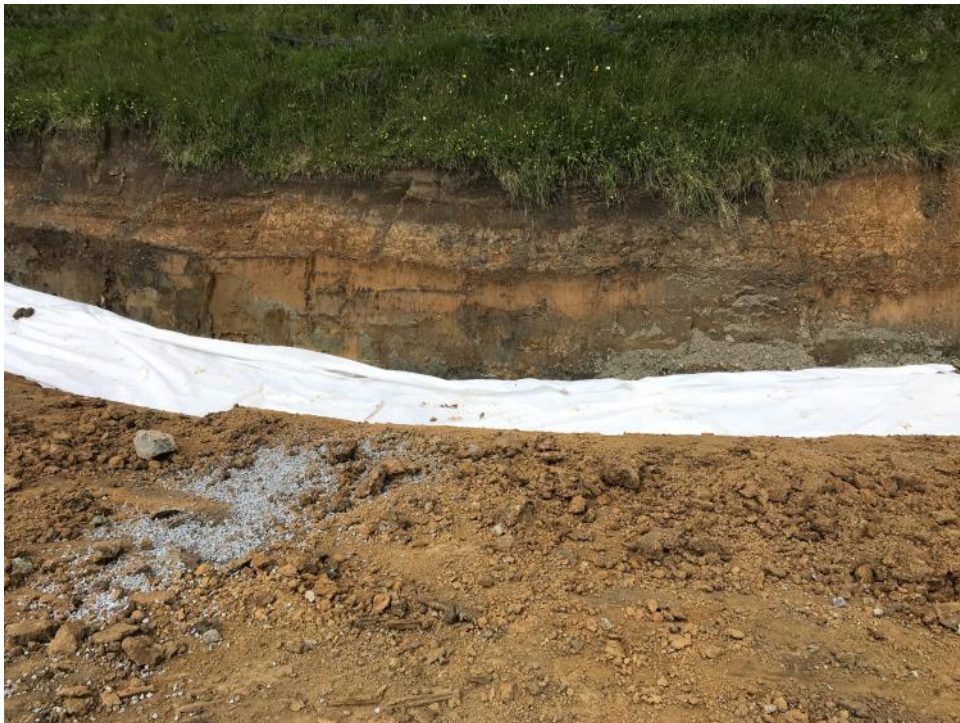
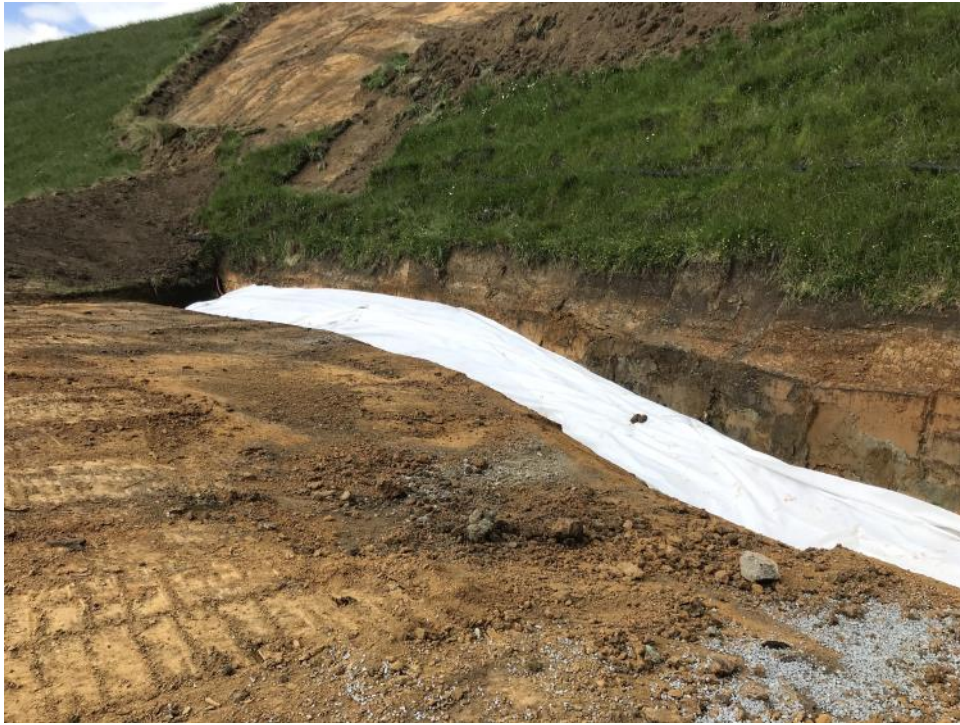
Visited site to observe gully muckout and drain installation. Muckout was deeper than our previous recommendation due to a 1m clay cap needed below the pond.

There is a small area of seepage near the base of the gully muckout which showed some seepage. We recommended that an extra drain is installed here to connect into the main underfill, ensure a 1m clay cap beyond the pond is satisfied. We will prepare a CAN detailing this.

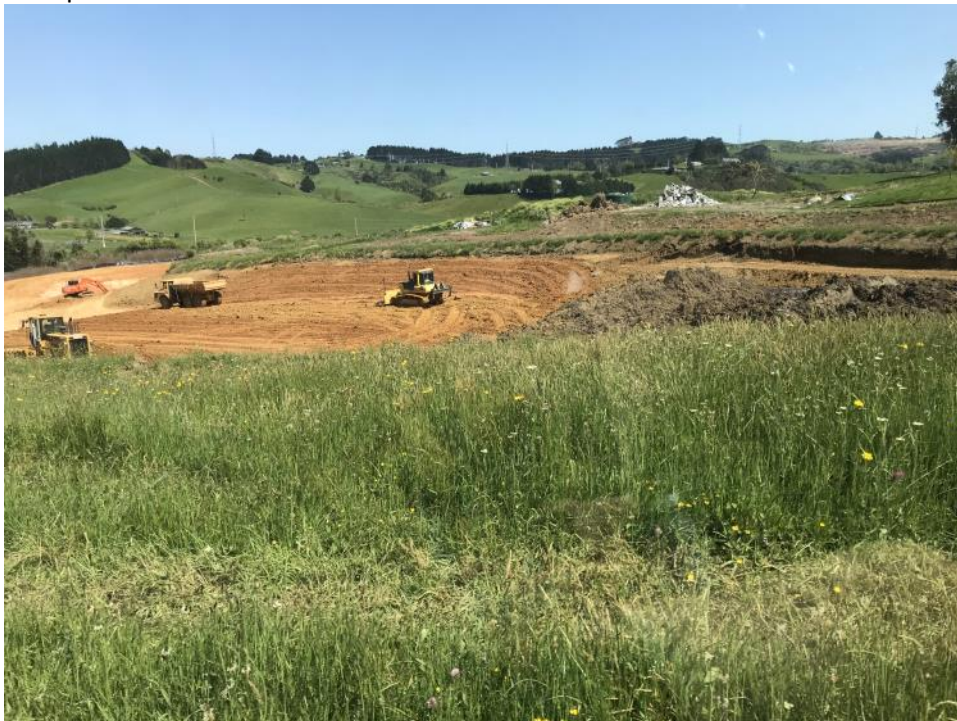
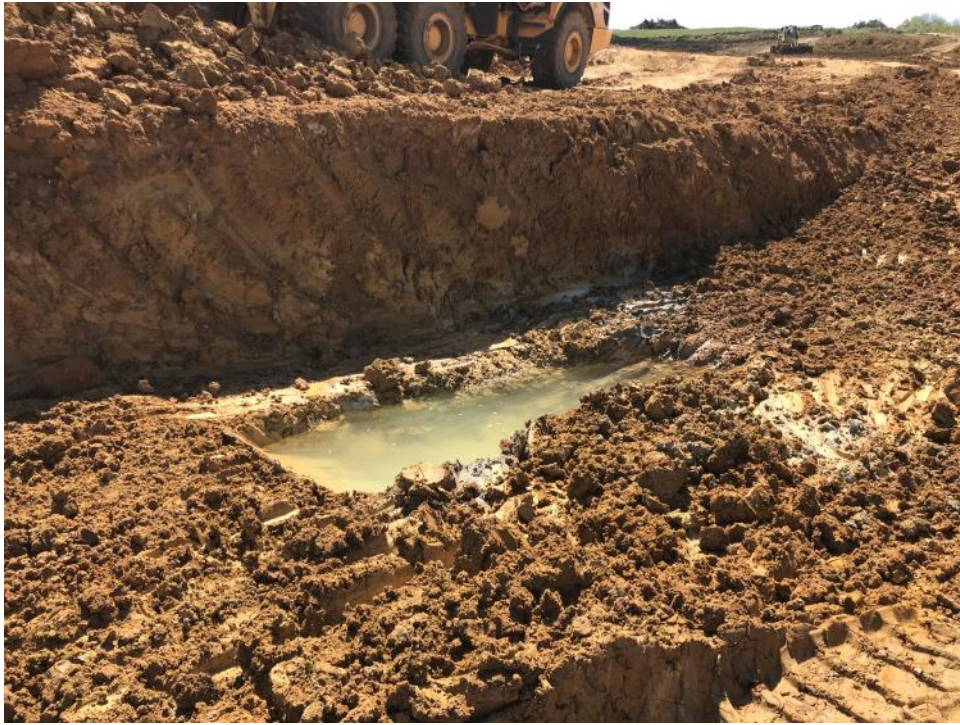
Fill K photos:

While on site we also visited the pond area in Fill K. There are groundwater seepages, however, are at the base of the pond. Advised the contractors they should continue preparing the pond, with the likely outcome being a underfill drain connecting into the primary collector drain.

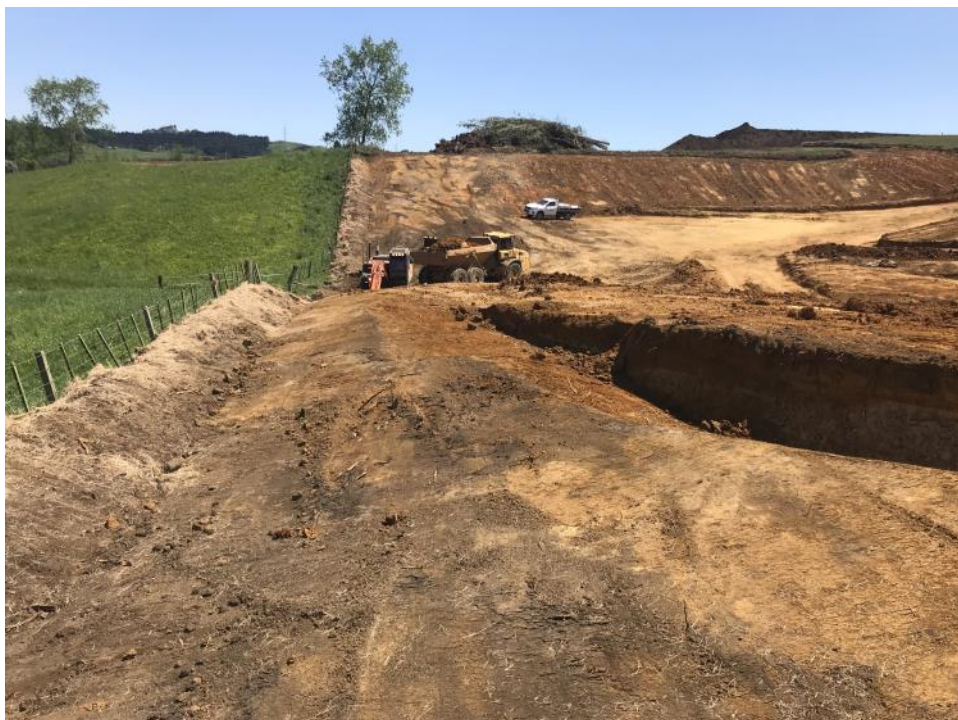
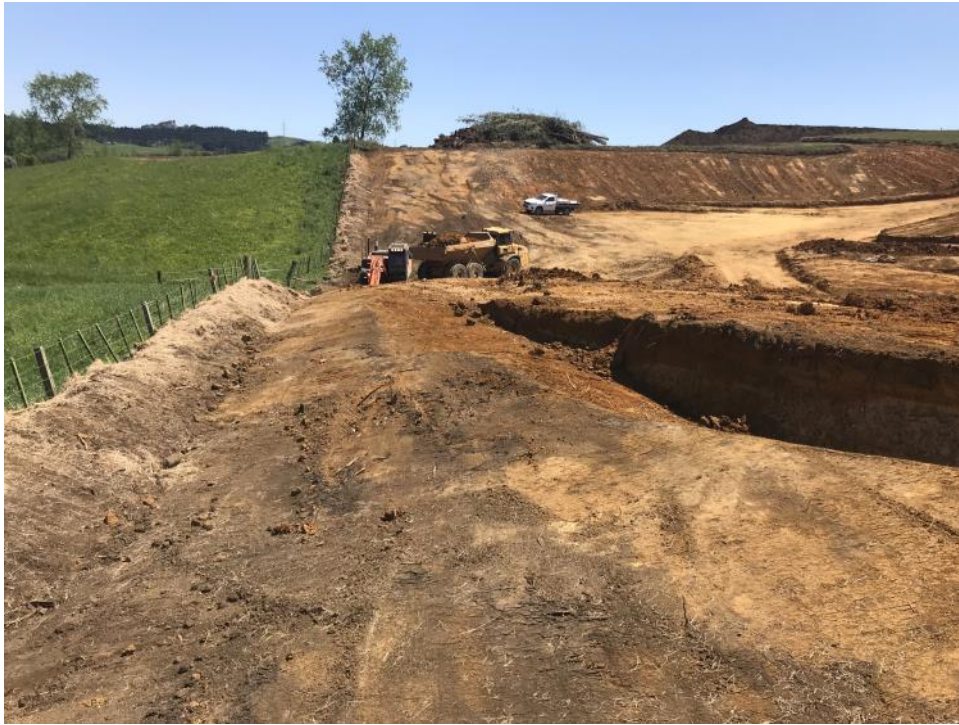
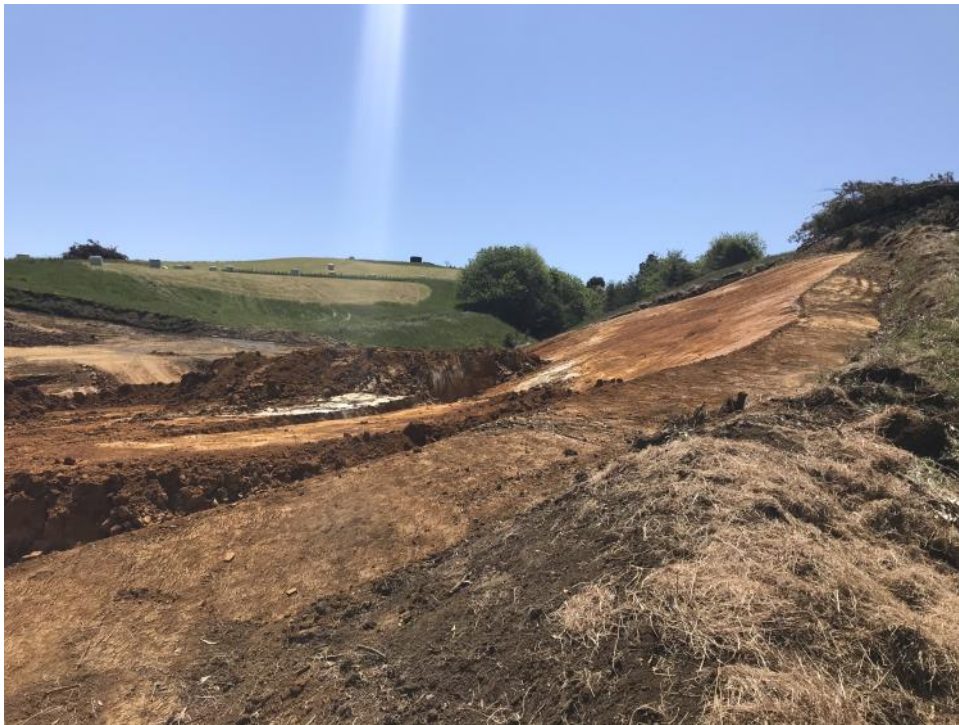
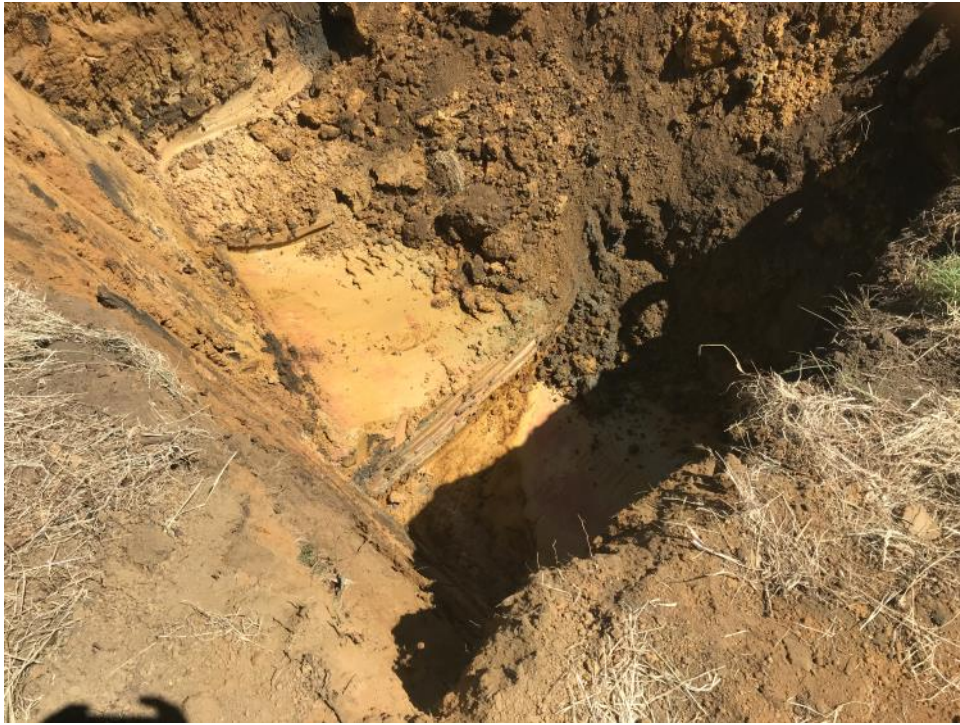
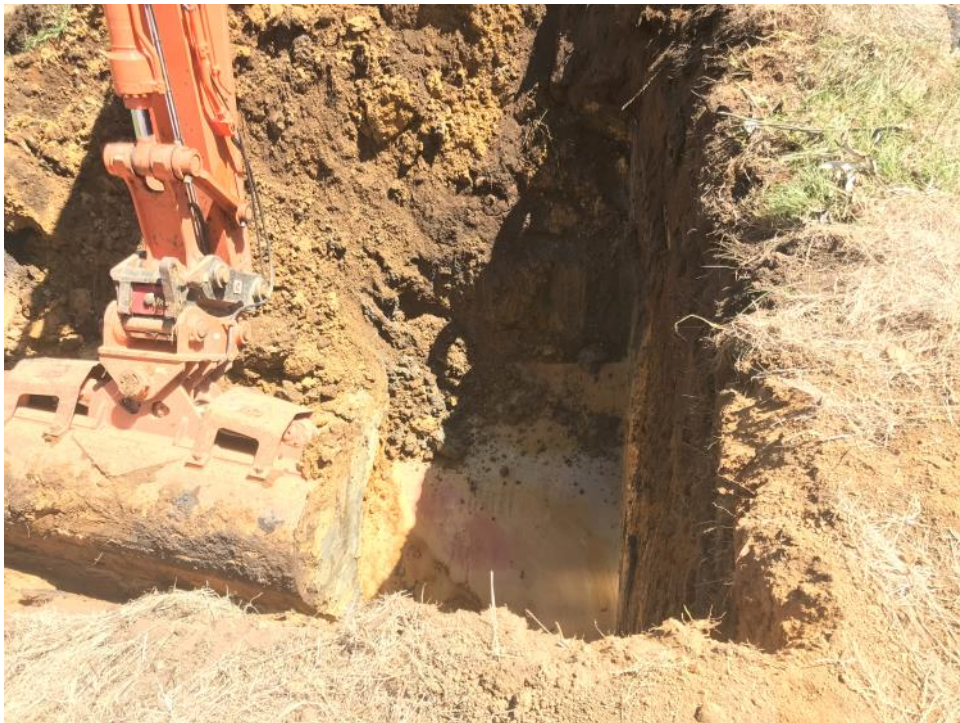
Fill K:

Carried out three trial pits within the area of the shear key and one within the pond area. The ground had been brought down approximately 2m from our previous visit when the initial trial pits were carried out. The additional pits found the hard layer identified during the previous visit at approximately 1m below the top of the pit, and this was proven for approximately 3m beyond this depth (the excavator was struggling to remove the material at the base of the pit with a rock bucket).

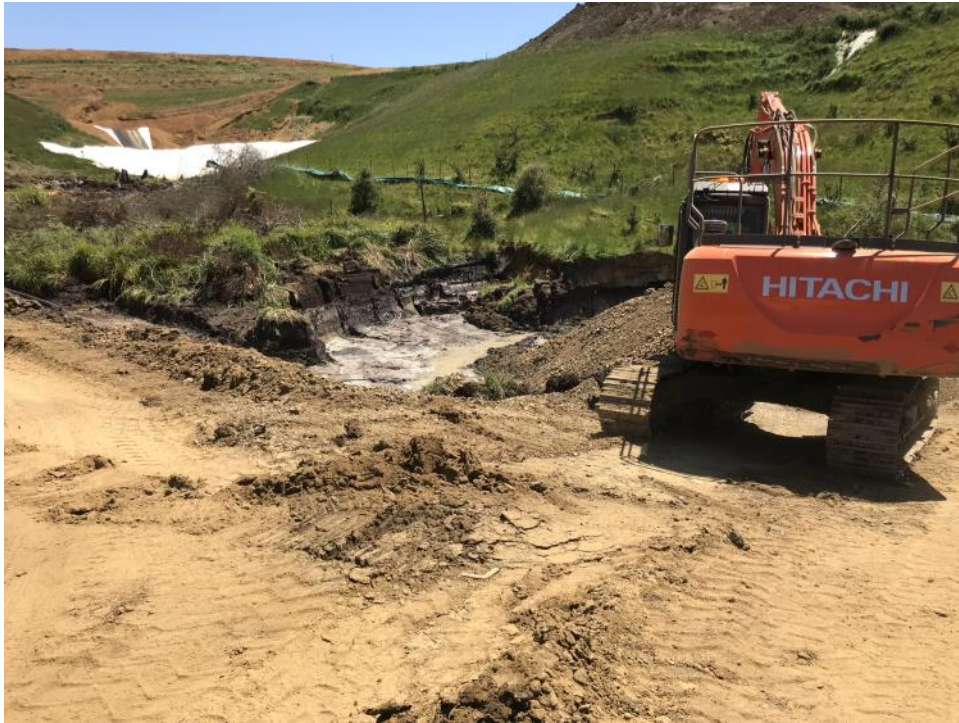
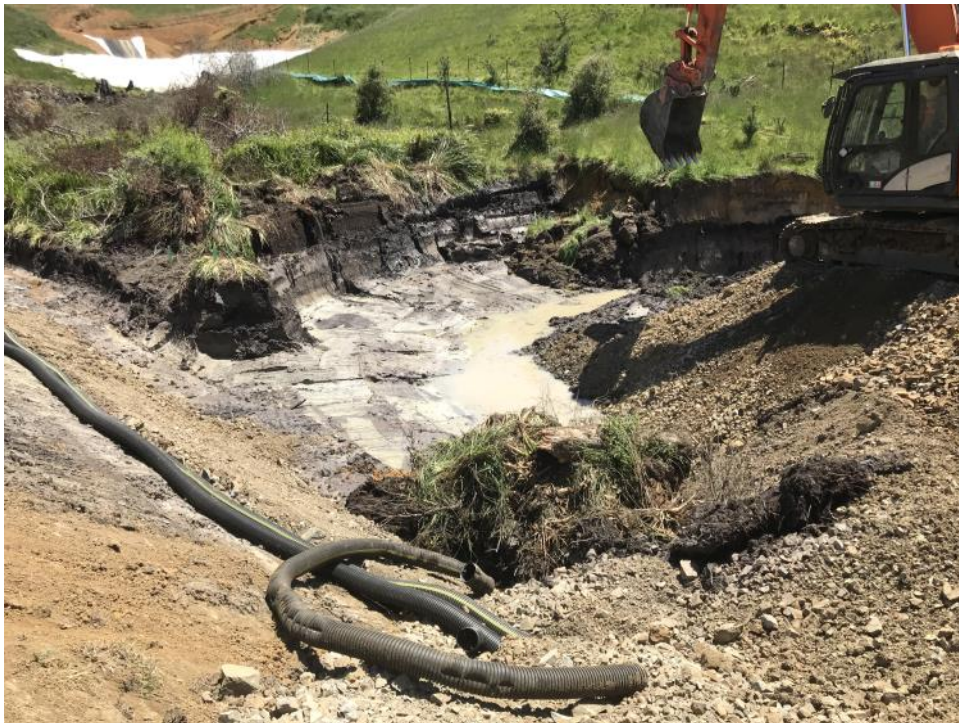
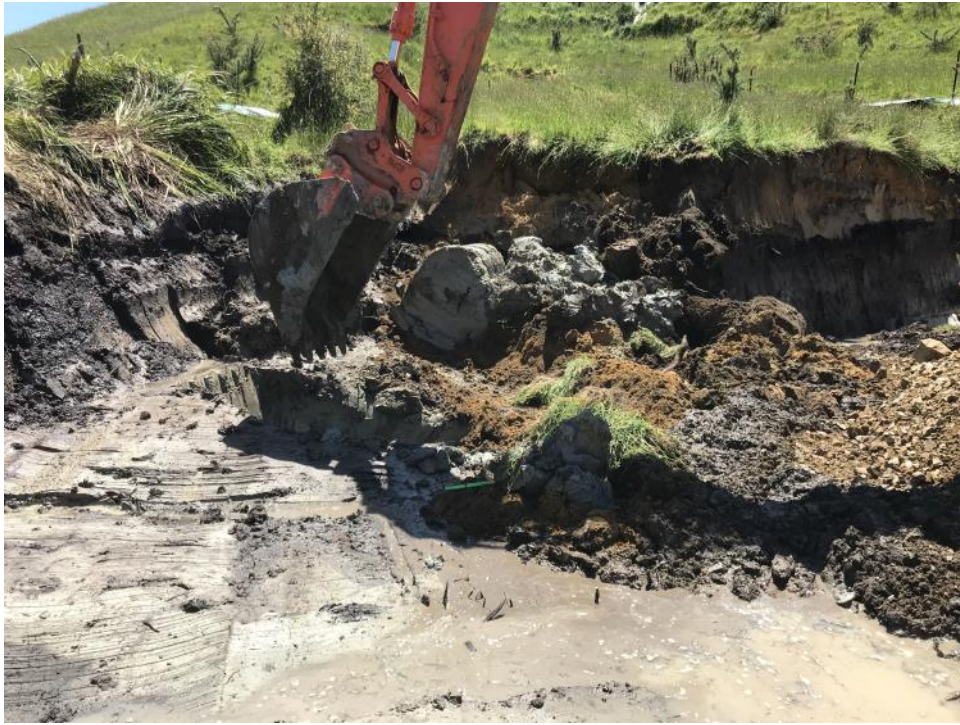
Pond area:

Within the pond area the contractors had already excavated about 2m - 2.5m from original ground level, exposing stiff ground at this level. The hard layer identified in the previous trial pits was identified approximately 2m from this level.

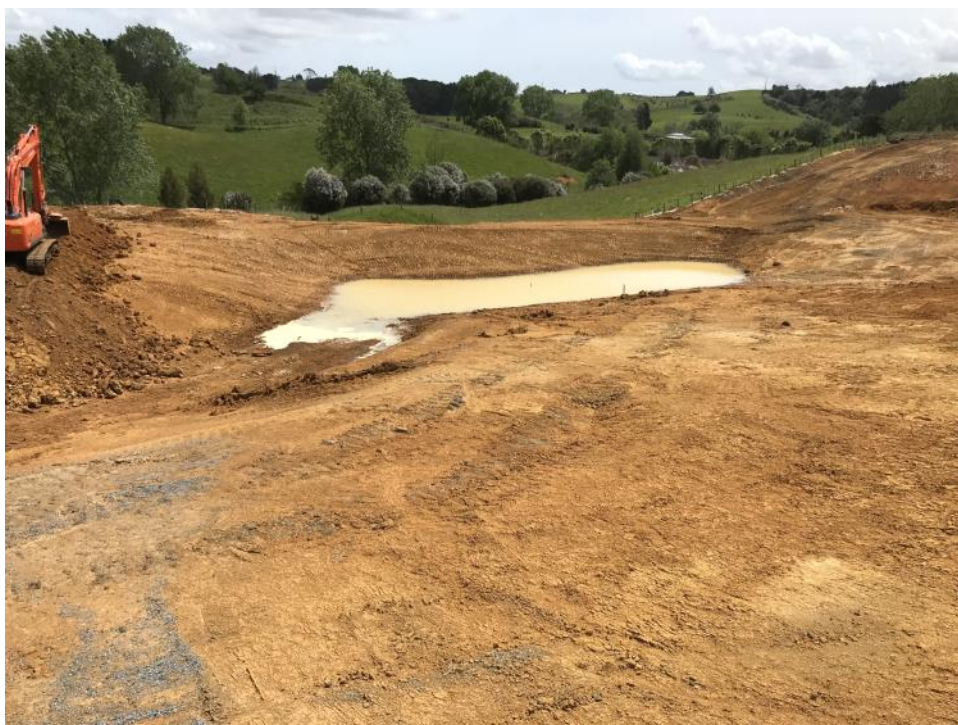
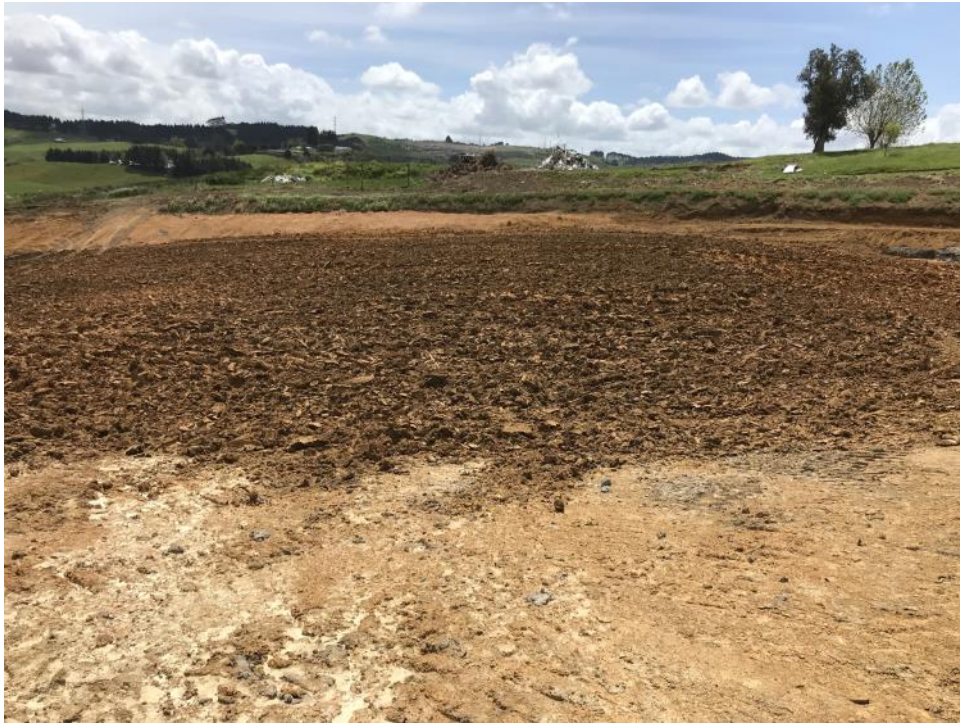
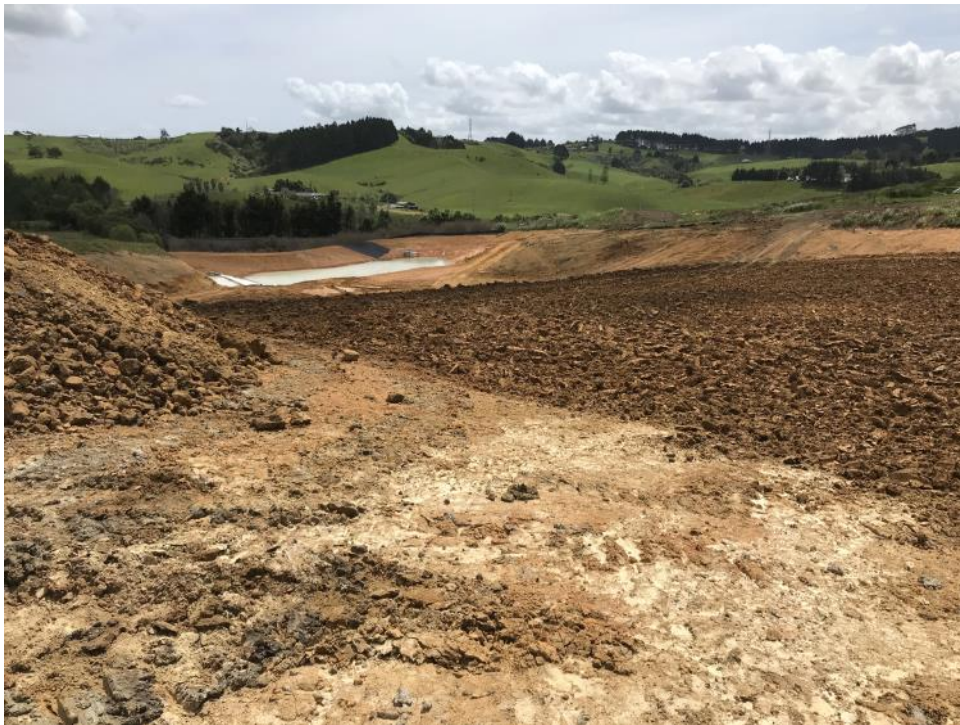
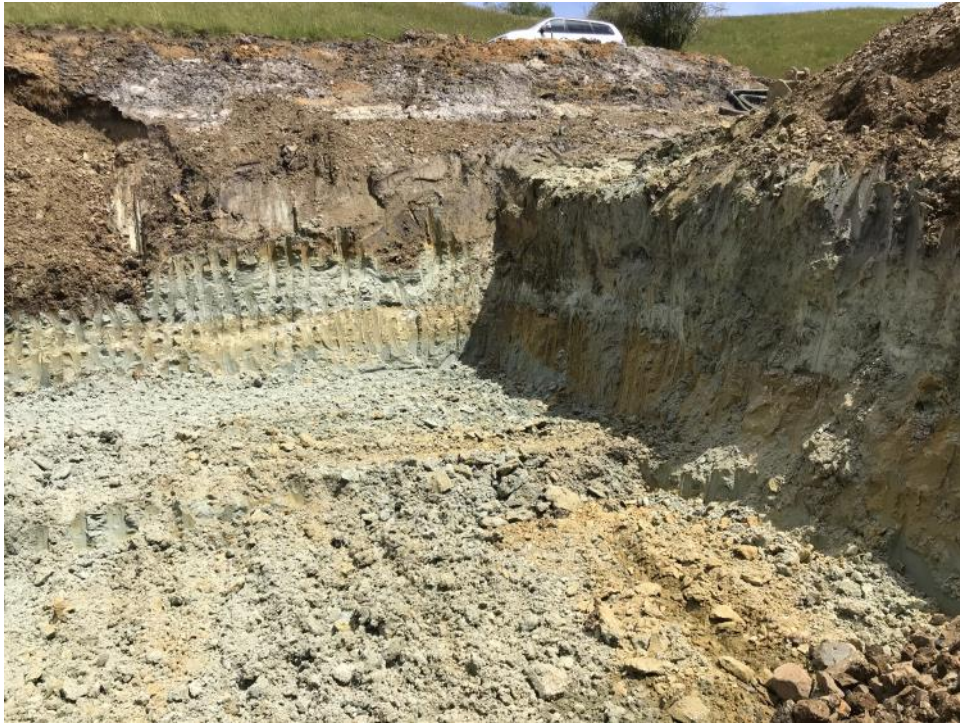
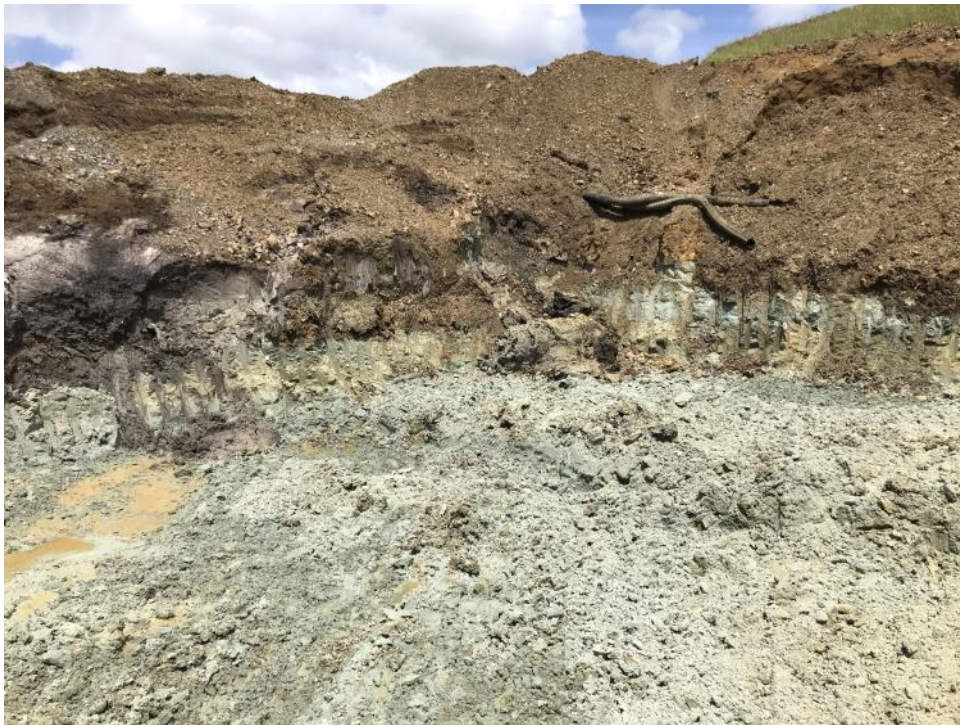
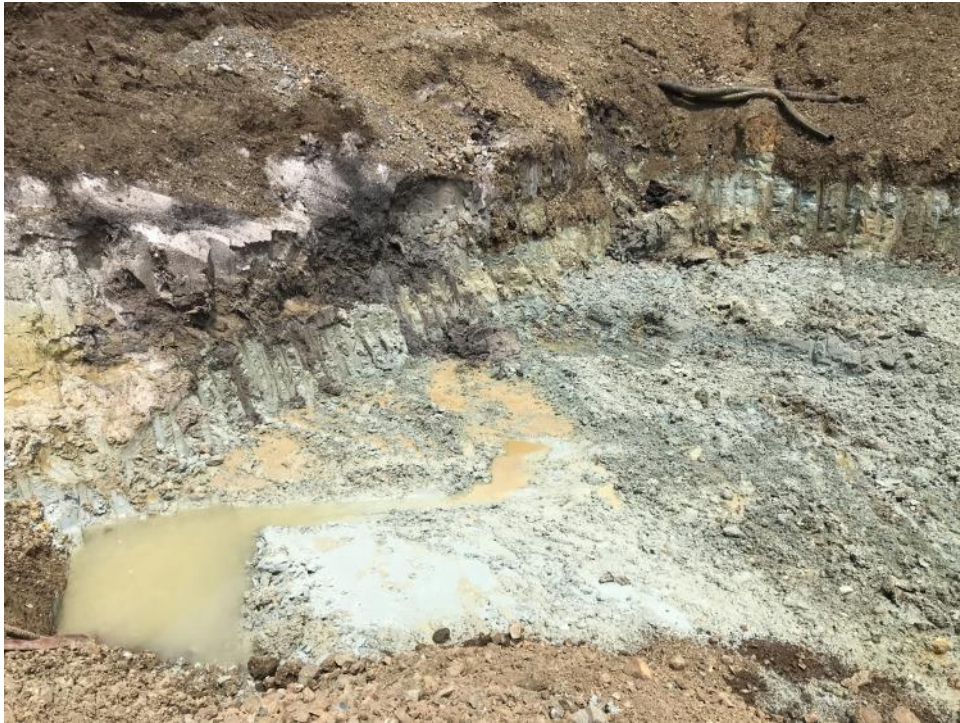
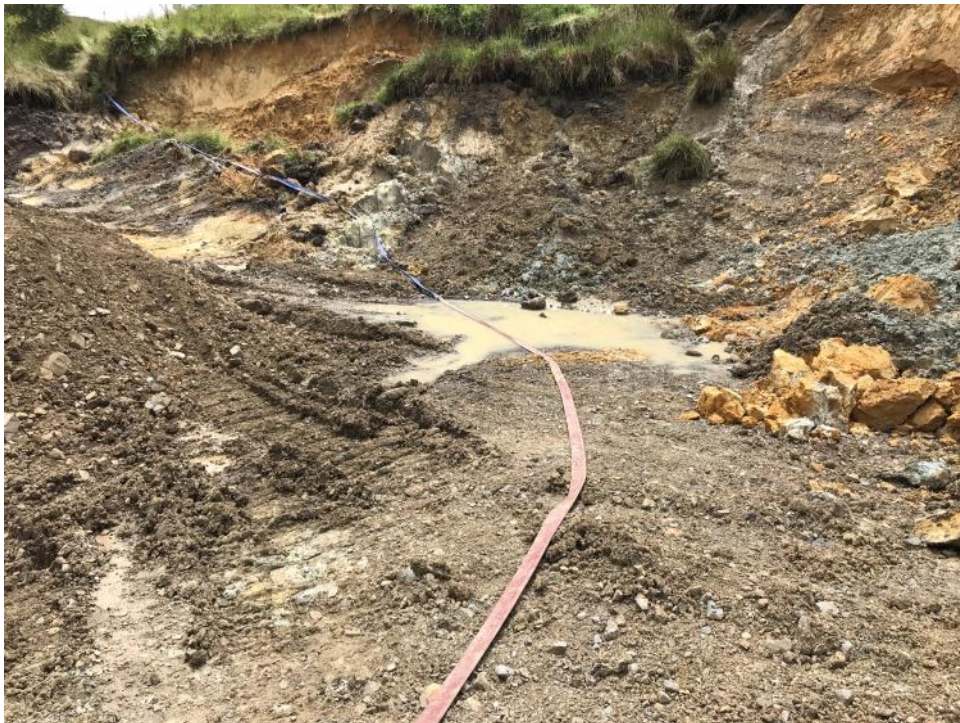
22/11/19 - REB1 pond base

Ground had softened at the base of the pond due to water seepages. Recommended that a nominal undercut of say 0.2m to 0.5m be carried out (based on shallow hand augers drilled), ensuring the area remains drained (i.e. leave the pumps on while filling) to ensure the subgrade stays dry. We will need to inspect the final subgrade and so recommended this should be carried out in small stages with filling operations commencing immediately after we have seen the subgrade.

Also brought up the idea of laying some trenches to catch water seepages. I will discuss this with Chris later and prepare a CAN outlining our recommendations.

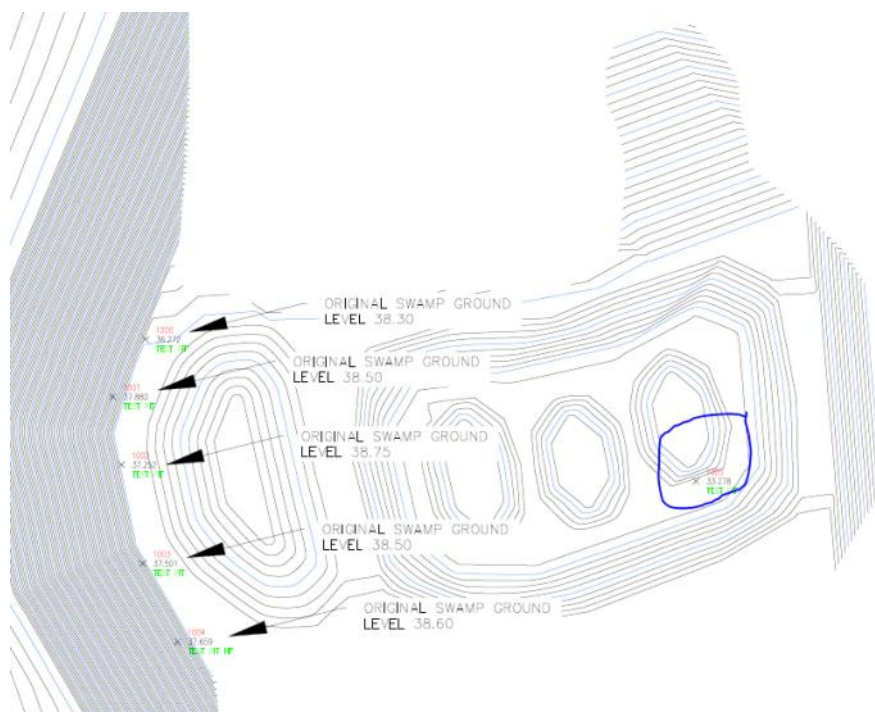
Visited site to inspect first area of pond undercut (cut 4) as shown in blue on the plan below. Stiff natural ground in excess of 60kPa throughout. There is a small area of water ponding in the area of deepest cut and we recommended that that be pumped out / dug out prior to placing fill.

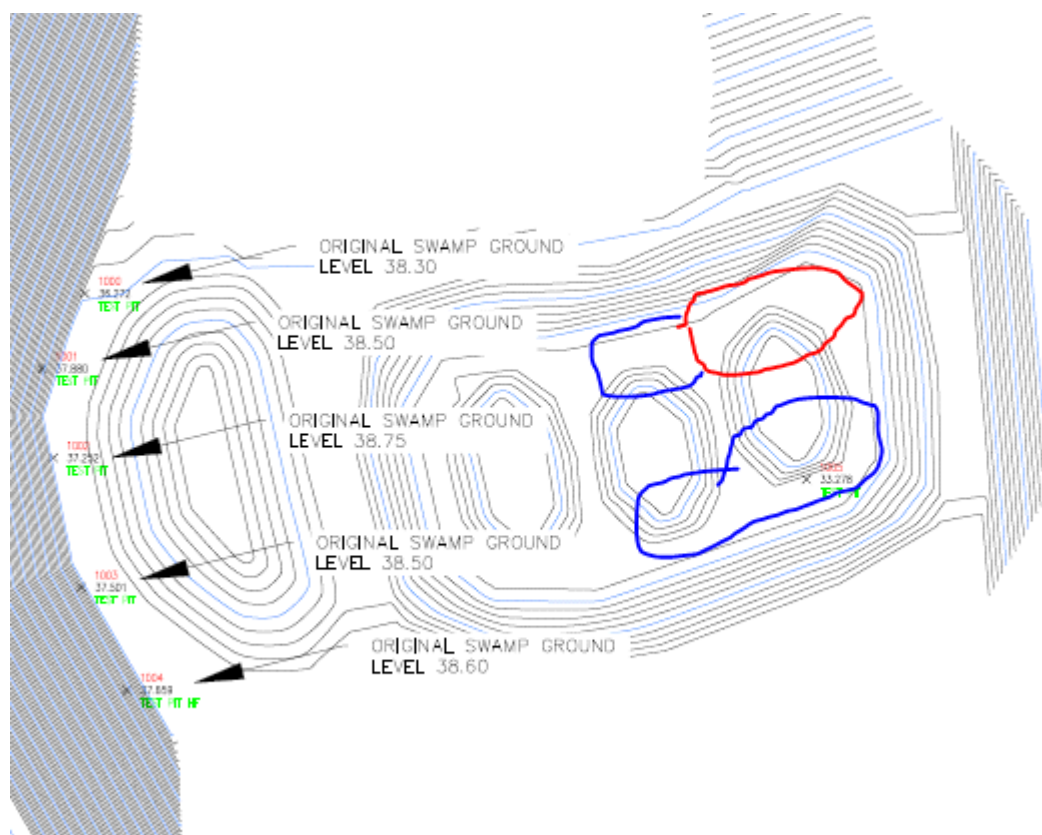
Visited site at request of Dylan to inspect next section of pond base subgrade to fill up to pond invert. Stiff to very stiff, inorganic natural ground exposed throughout (blue). The hardfill track still remains to be removed and we will look at this once they remove this. The area in red was not fully stripped yet, however, several areas were exposed with ground being consistent throughout. Asked contractor to send photos once complete so they commence filling to stabilise a small slip which had formed in the side of the bank.

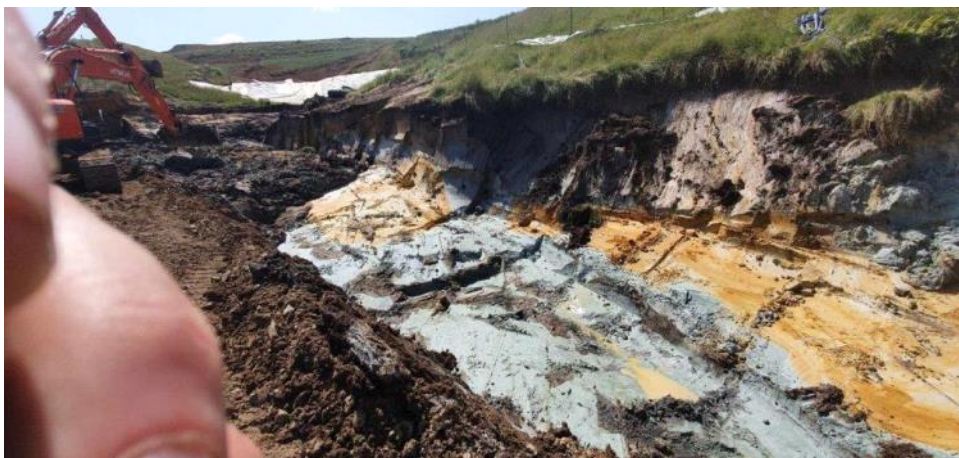
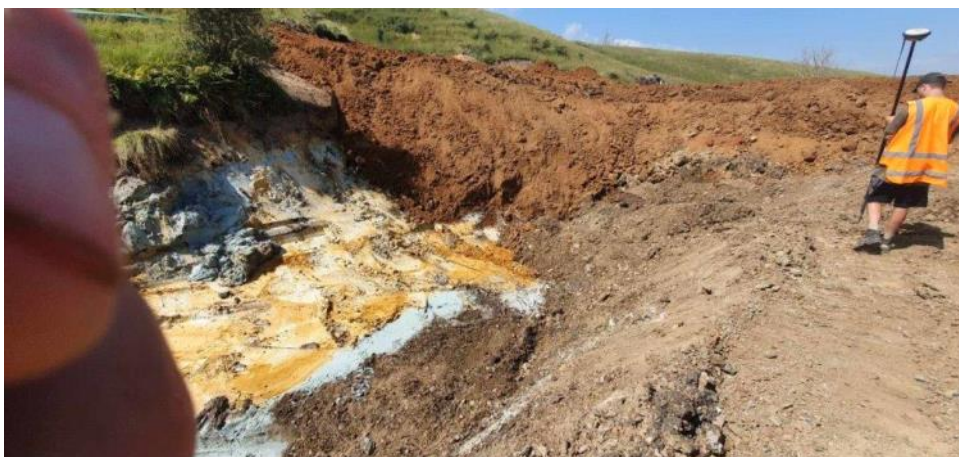
Photos from Dylan 29/11/19:

Visited site at request of Dylan to inspect next section of pond base fill subgrade. Very stiff ground throughout. Some areas had softened where water is ponding and we recommended that these areas be undercut to remove the softer soils. We have now seen almost all of the pond base. There is only a small area and Dylan will send photos once this is down to subgrade level.

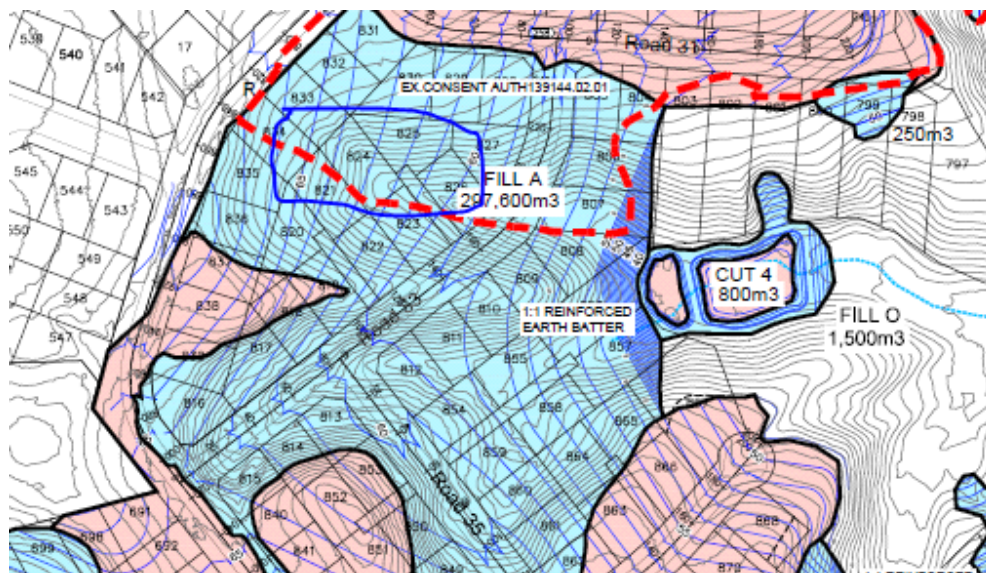
Visited site at the request of Dylan to inspect gully stripping in the area outlined on the plan below (Fill A).

Generally stiff ground was exposed throughout, however, at the base of the gully invert (lower half) water seepages were causes the ground to soften. We recommend an undercut of approx. 0.5m to 1m here prior to placement of the underfill drain. There is some material in place which is going to be undercut as there is seepage coming out below and the underfill drain will be aligned through here.
