Geotechnical Completion Report

HITCHEN BLOCK STAGE 13B

17 January 2022

Ref No: J00113

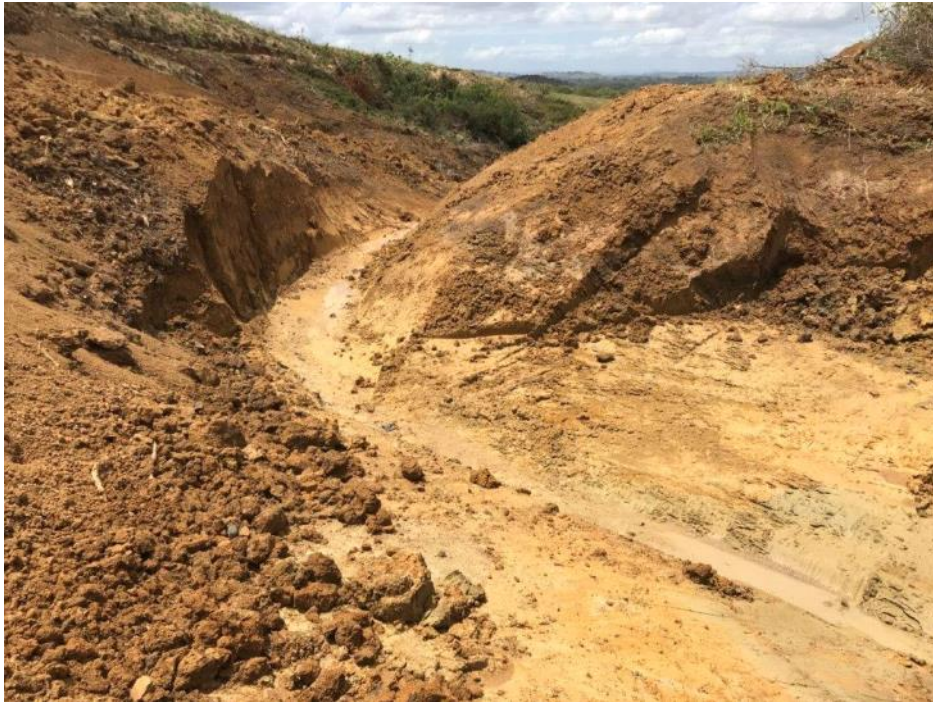
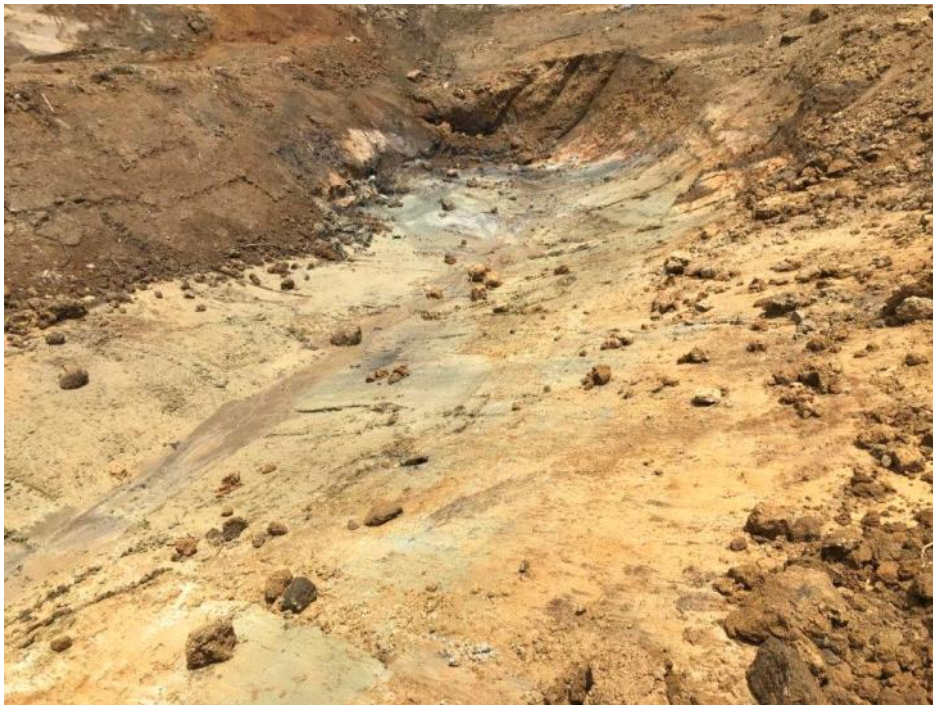
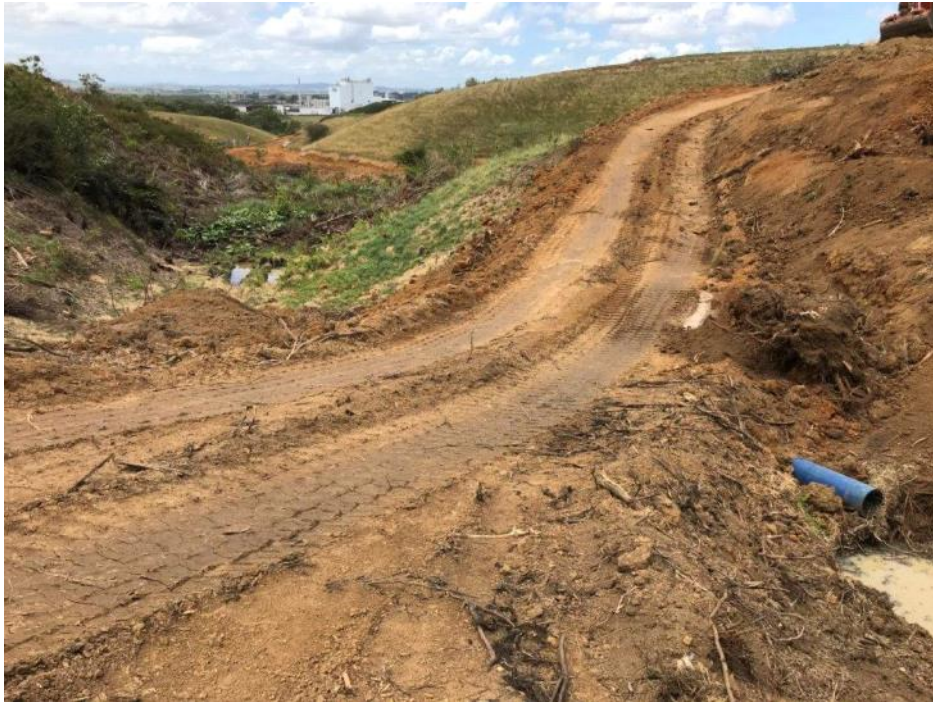
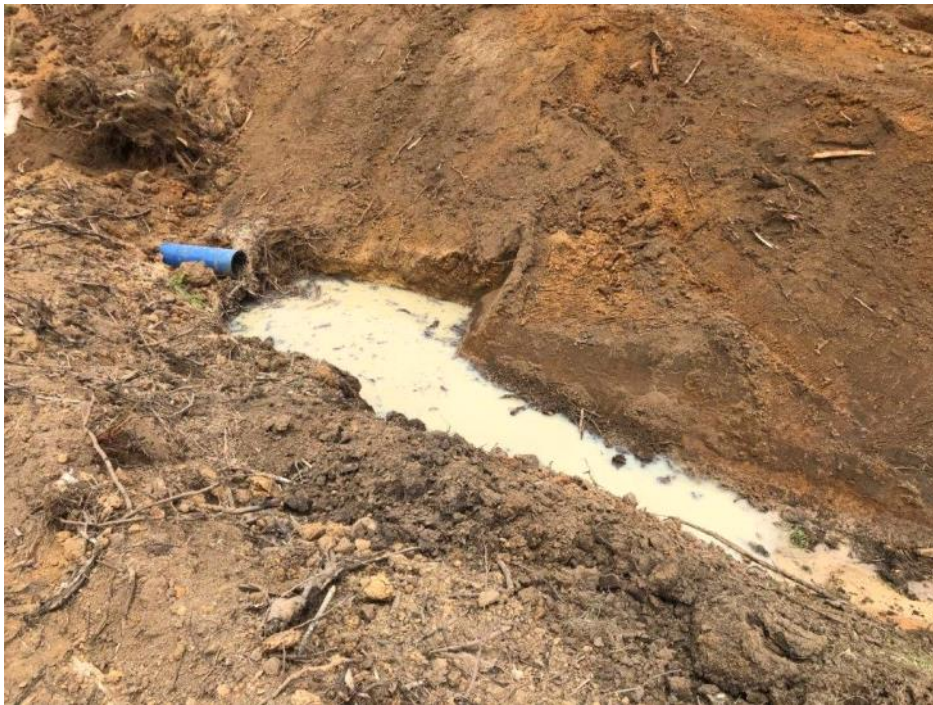
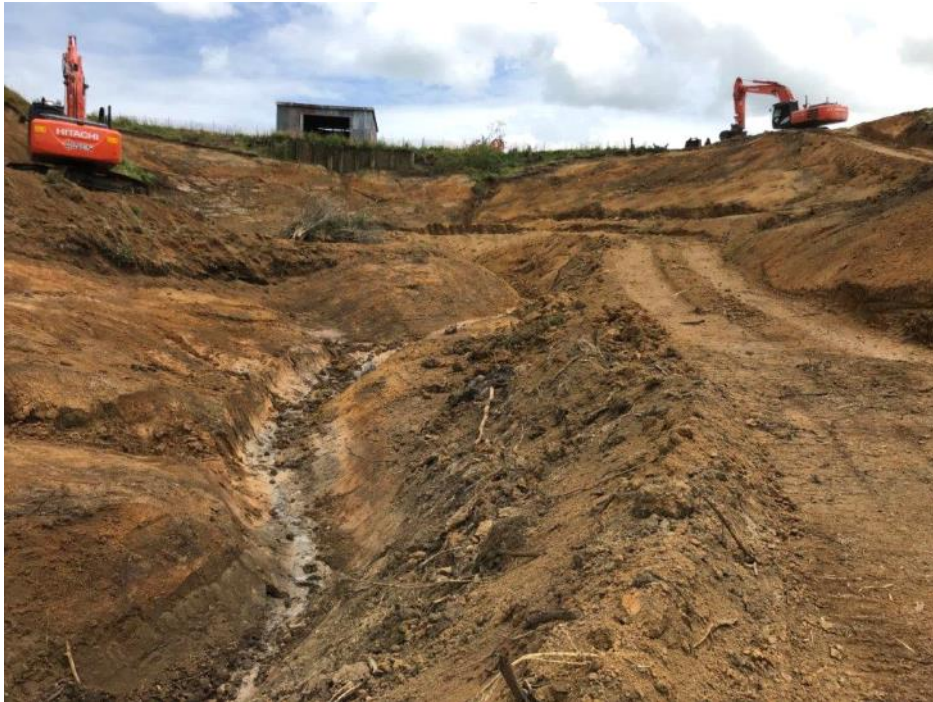
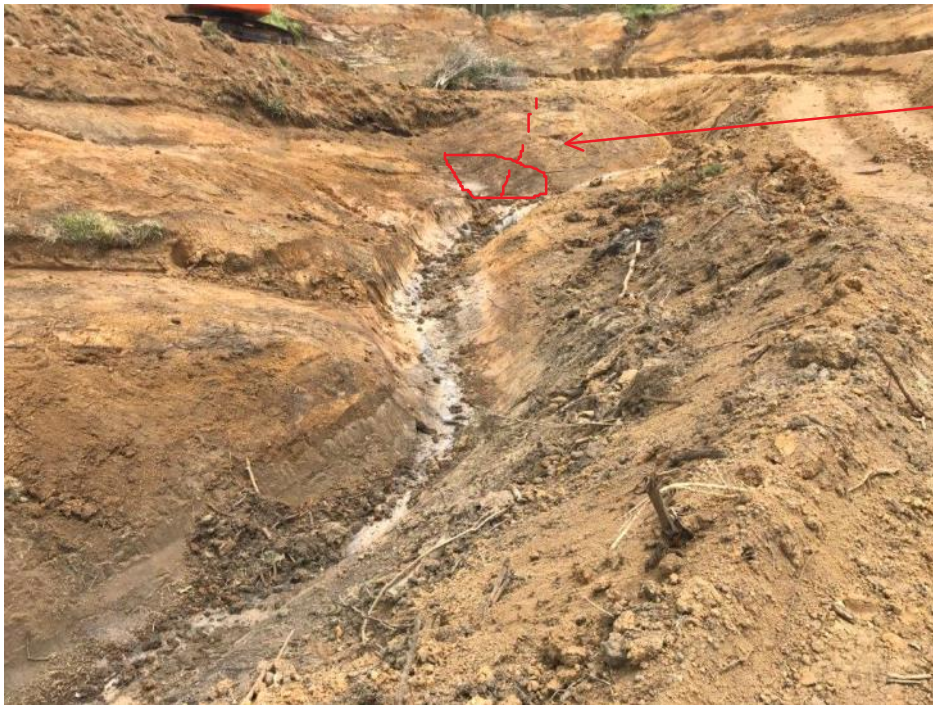
Groundwater seepage

Generally stiff ground was exposed throughout, however, at the base of the gully invert (lower half) water seepages were causes the ground to soften. We recommend an undercut of approx. 0.5m to 1m here prior to placement of the underfill drain. There is some material in place which is going to be undercut as there is seepage coming out below and the underfill drain will be aligned through here.

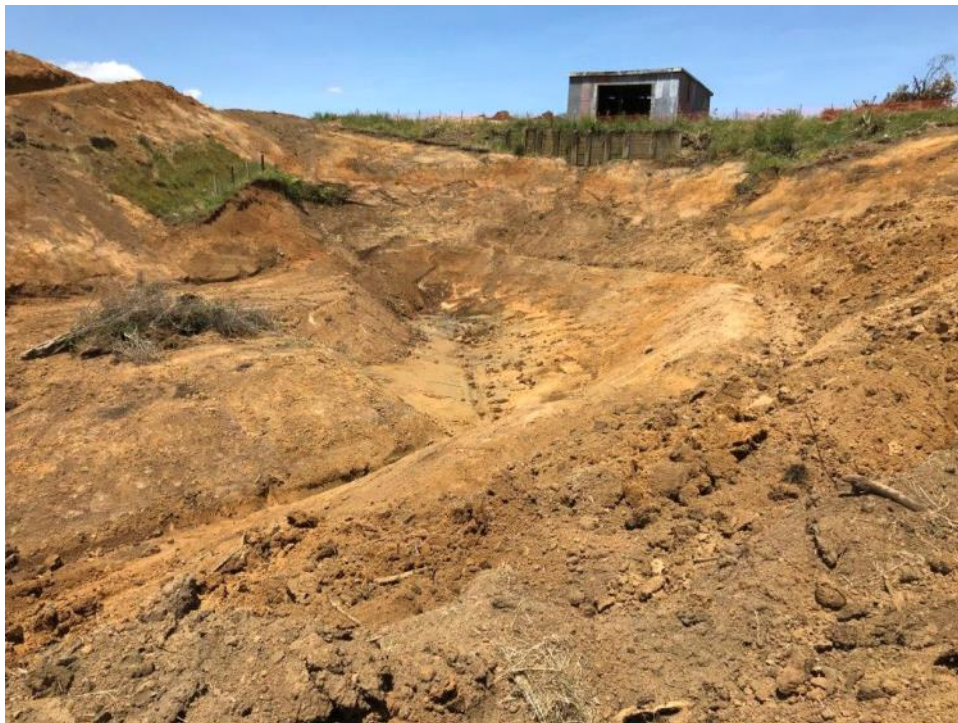
Visited site at the request of Dylan to inspect muckout of lower portion of gully as per yesterdays recommendation. Generally stiff soils exposed at the base of the gully.

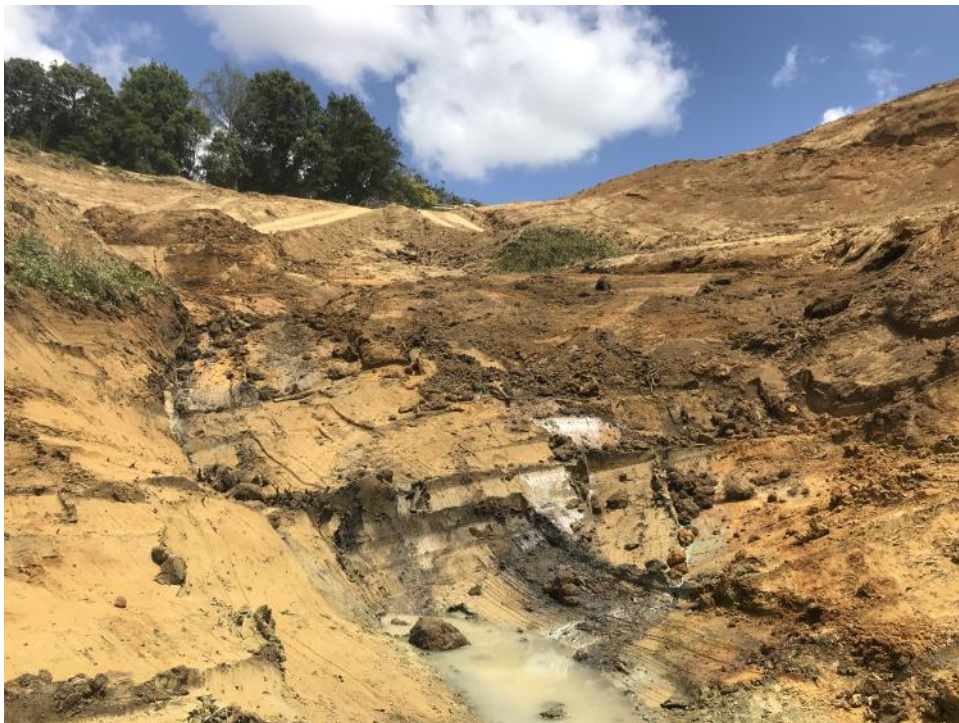
Visited site at the request of Dylan to inspect gully muckout in Fill A. Stiff to hard natural ground observed throughout.

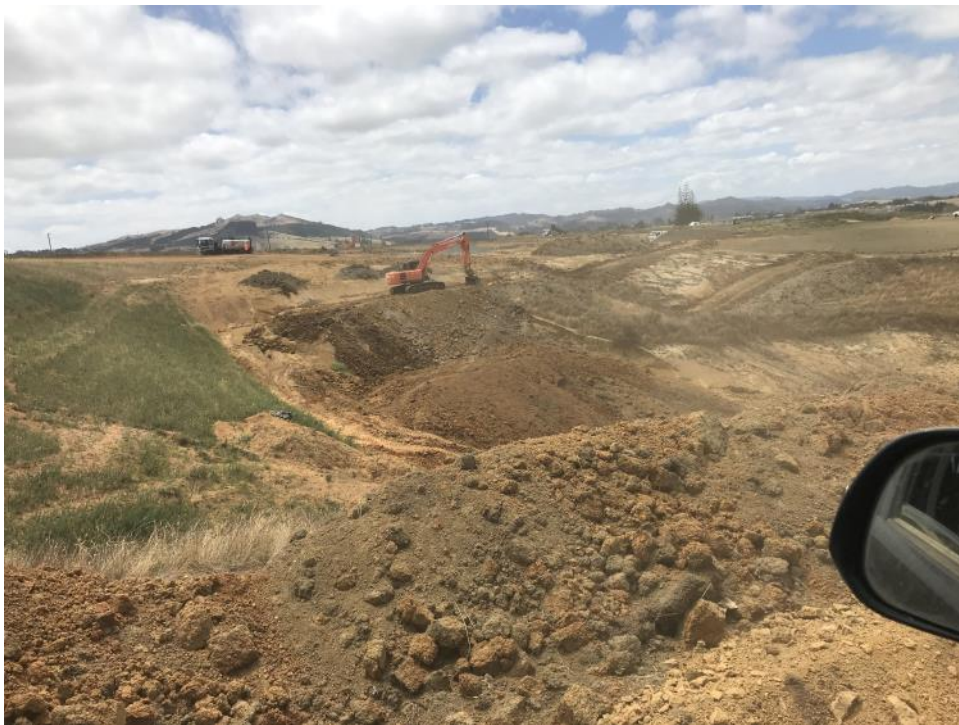
Visited old slip site with Dylan and discussed benching the slip debris out.

Advised Dylan that the slip should be fully benched out to the natural ground (i.e. removing all the slip debris) at which point we can observe and provide further recommendations. This will likely be to recommend a series of benched drains running parallel along the slope with one or two collector drains running along the extend of the slip area. We also advised that the lateral drains be installed within the vicinity of the existing chimney drain as per our design (this was never done during the earlier earthworks stage).

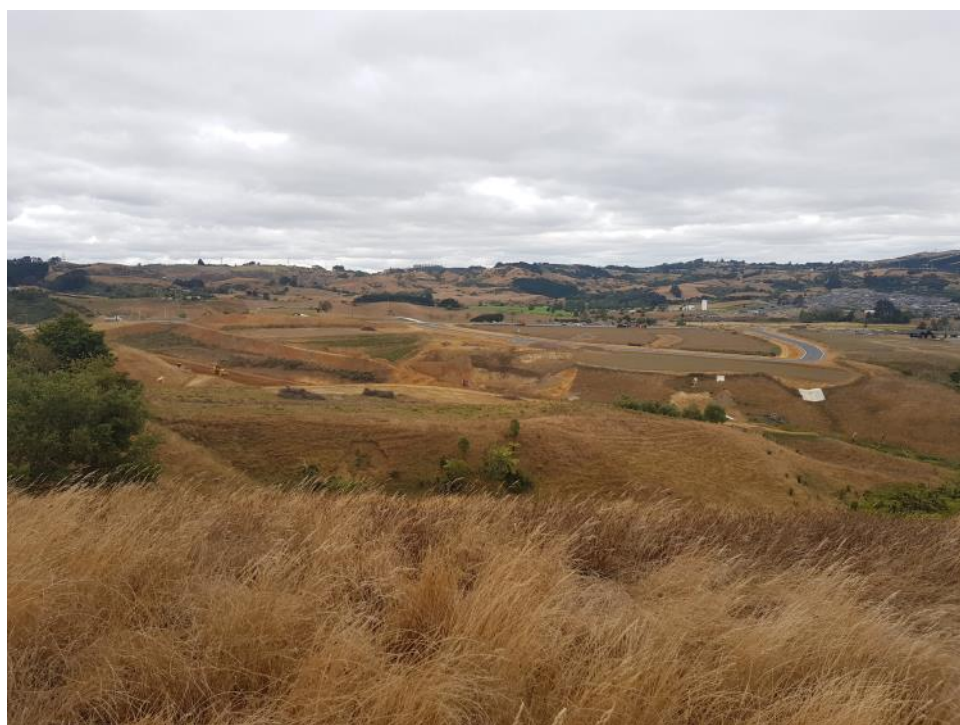
REB1 area

CE - photos from my visit below. They appear to be progressing with REB1 pre construction work (i.e. filling in gullies upslope of it and remediating slip on site of Stage 4 which will be filled as part of REB1.

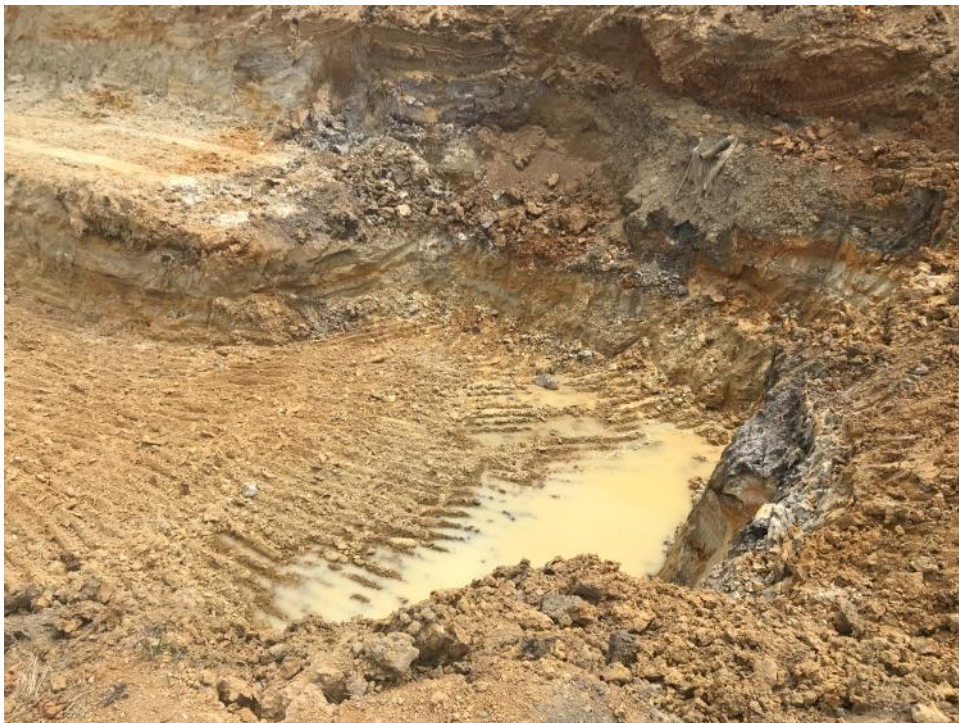
Inspected next section of shear key undercut. Hard materials exposed at base as per previous sighting.

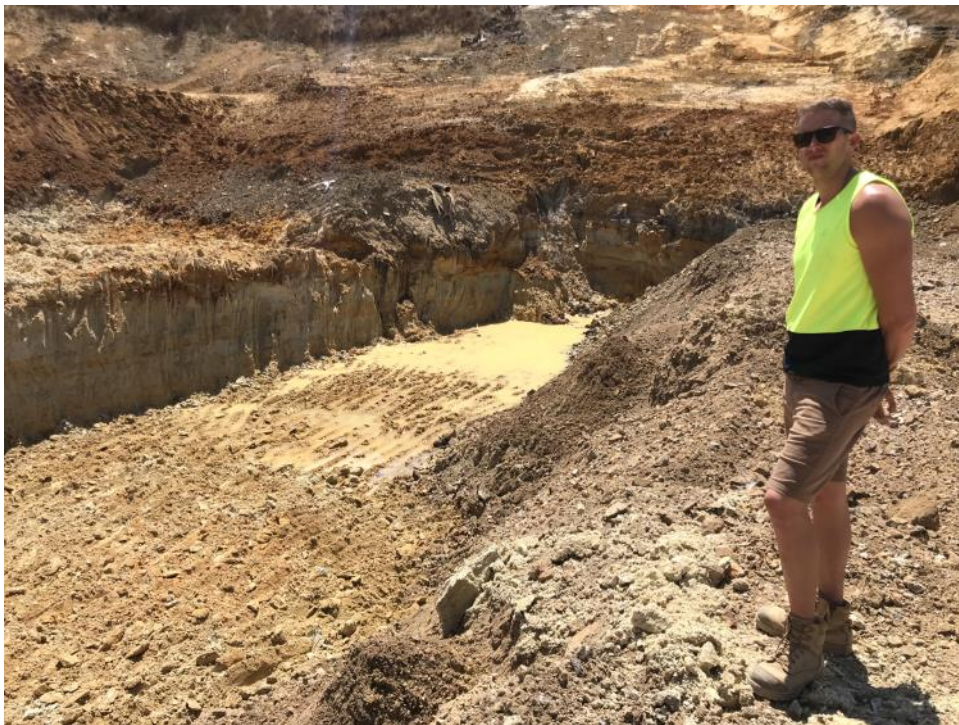
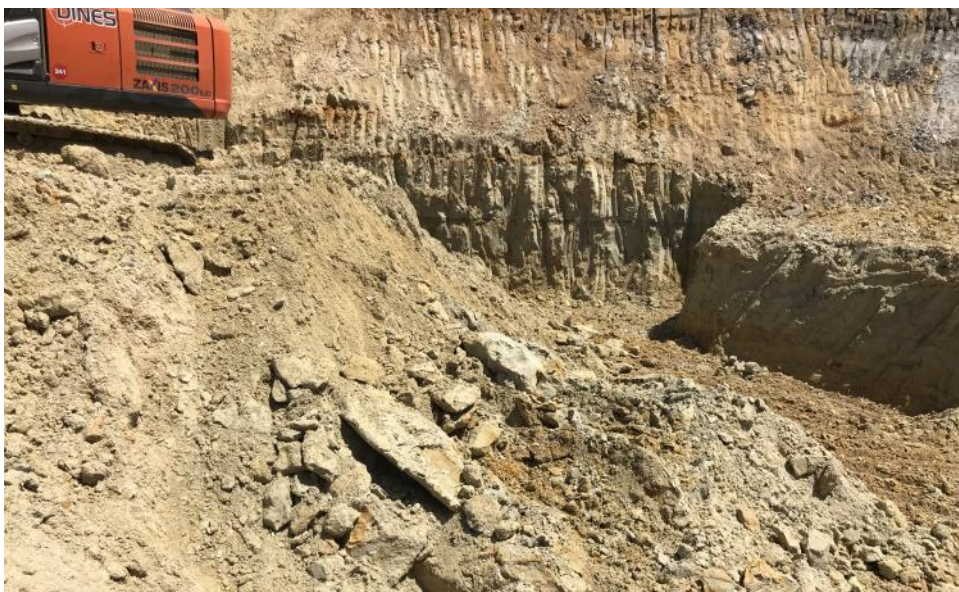
Shear key excavations proving hard.

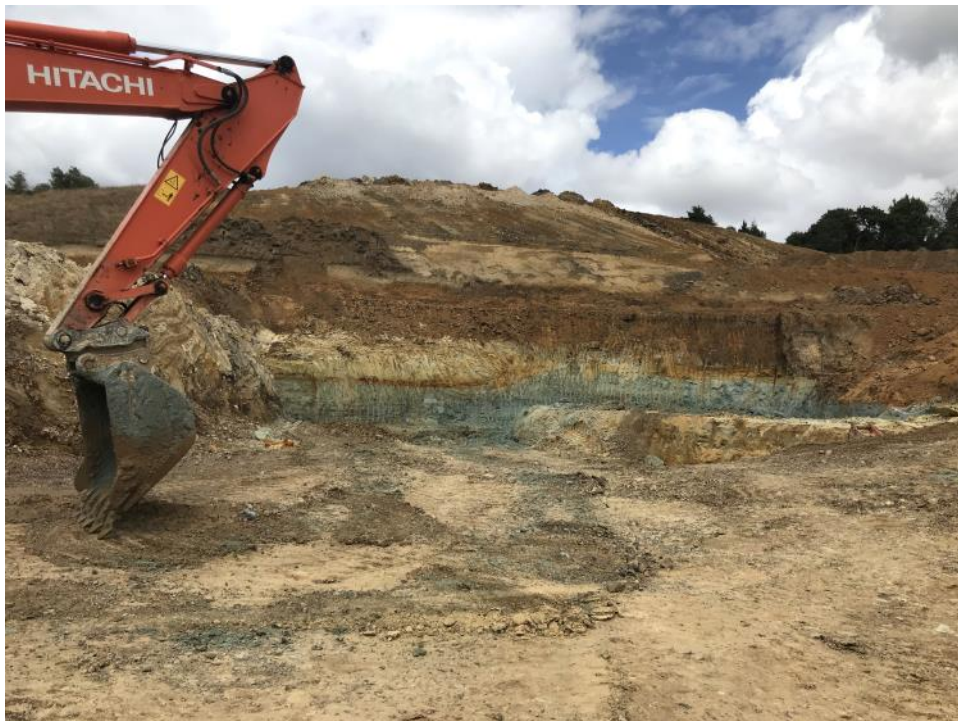
Shear key excavations completed. Competent hard ground exposed throughout. Plateau test being undertaken while we were on site.

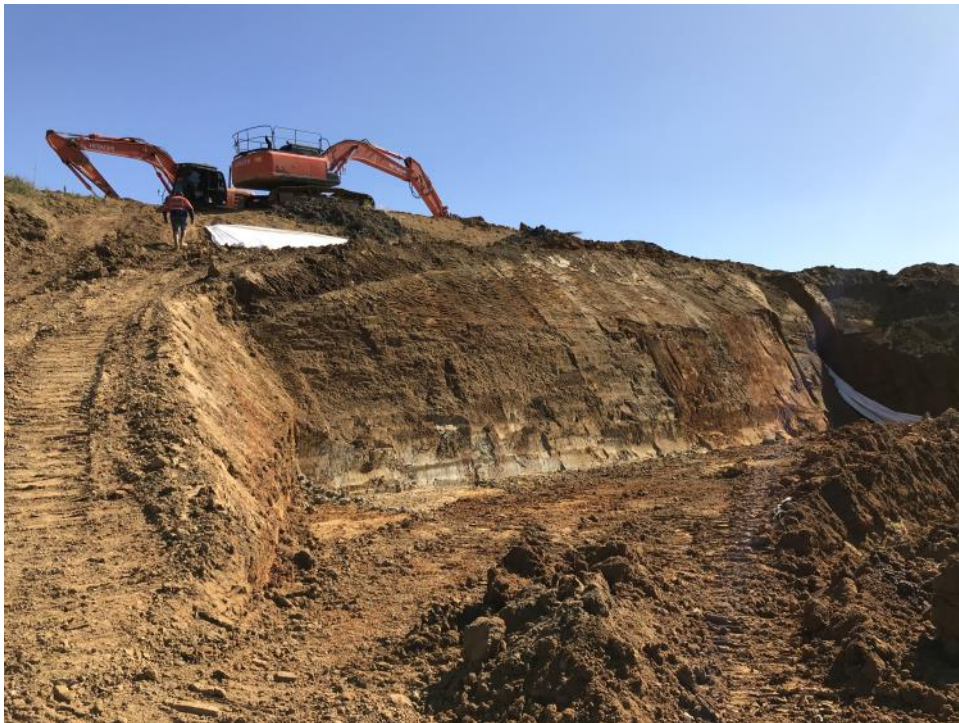
Visited site at the request of Dylan to inspect top two benches into the remediated slip adjacent to REB1. Benches have been excavated into the natural ground and the contractors have further a small trench along the rear face to installed drainage. Attached below is their proposed plan.

Shear key filling still coming up. Photo below.

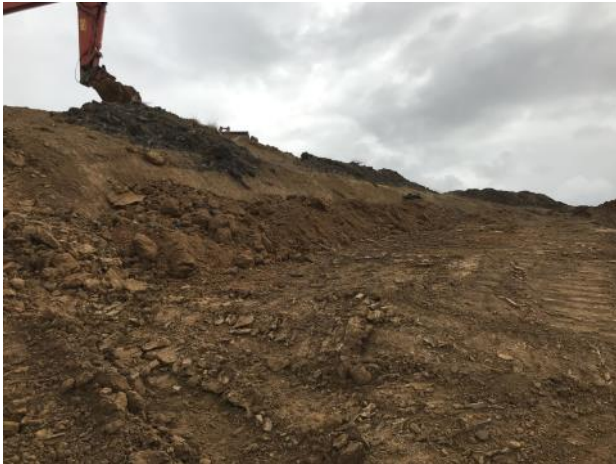
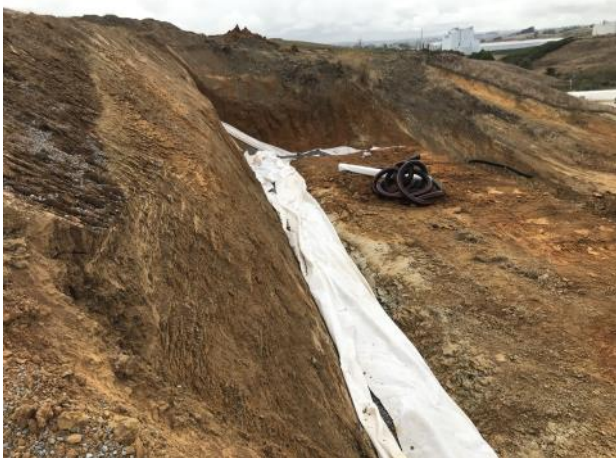
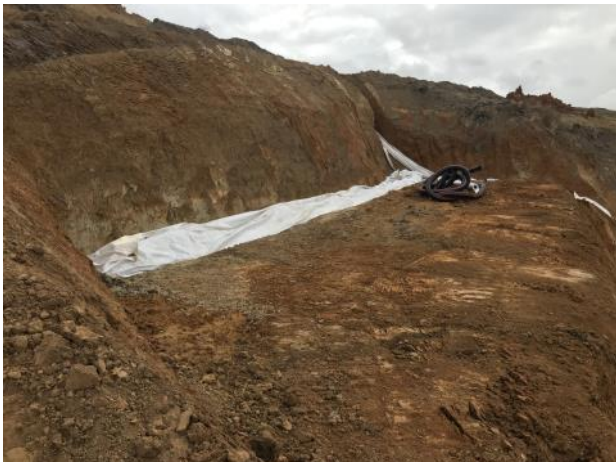
Slip remediation works are continuing and they are down to the final bench. Drainage has been installed on the top two benches, with a collector also placed down to the second bench. The material on the bottom bench is a stiff, wet alluvium. Recommended to Dylan that the batter faces be supported by backfilling or temporary face support and also be covered with polythene if they are to remain open.

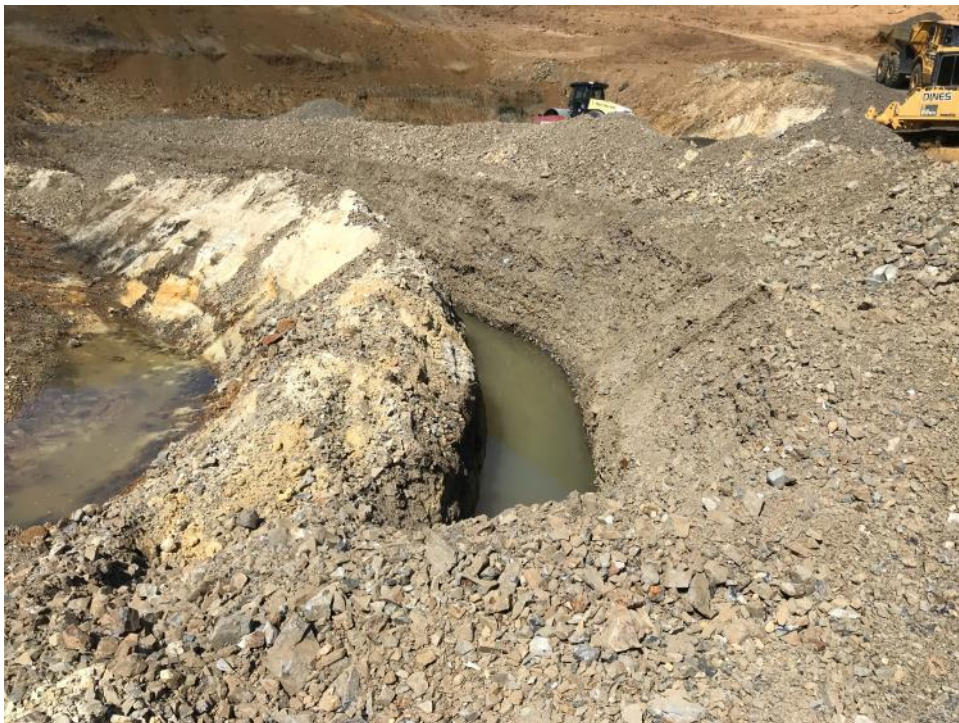
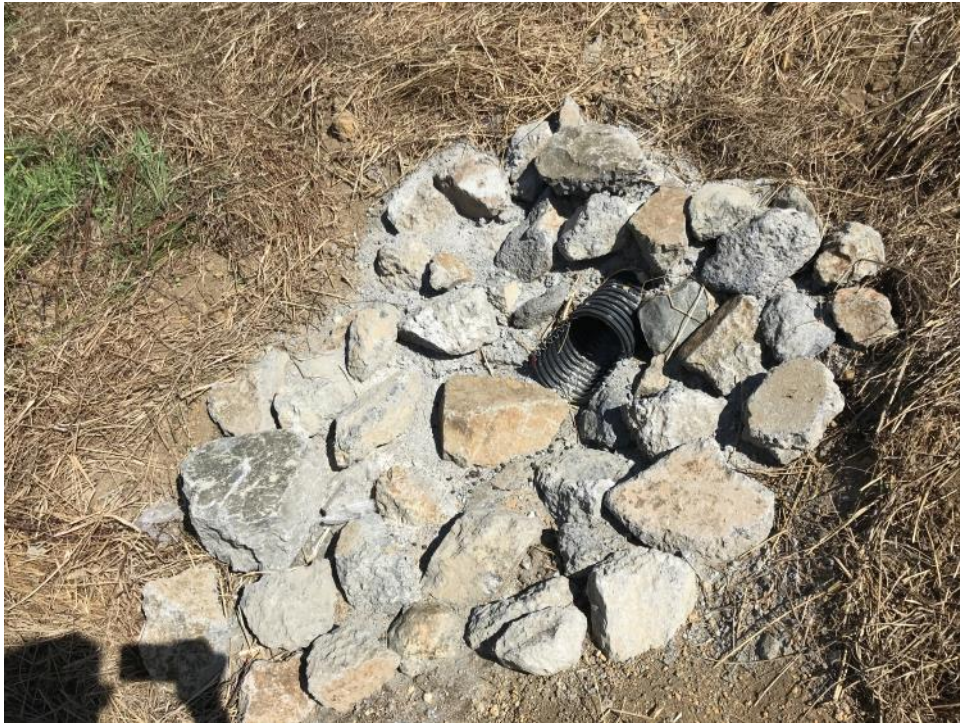
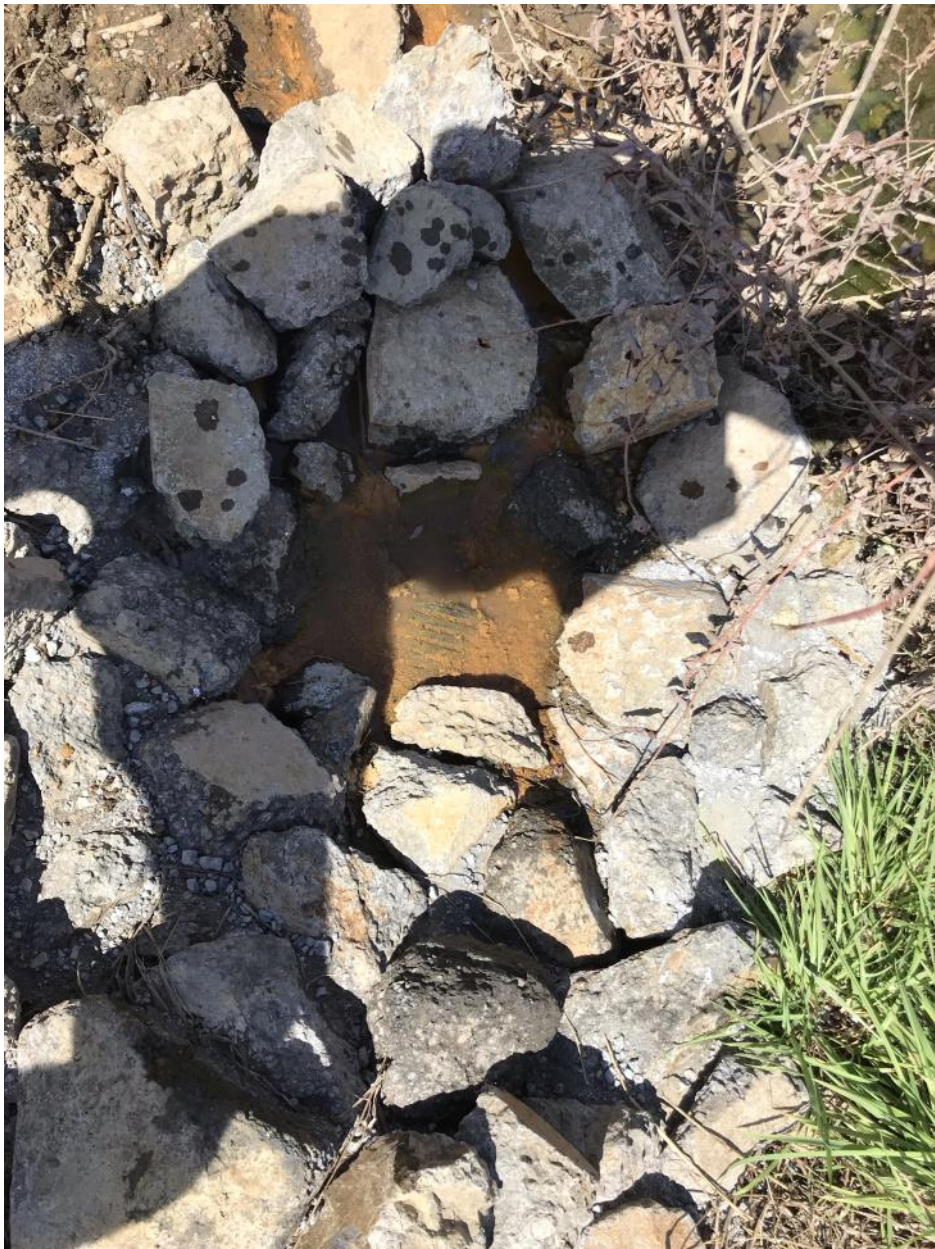
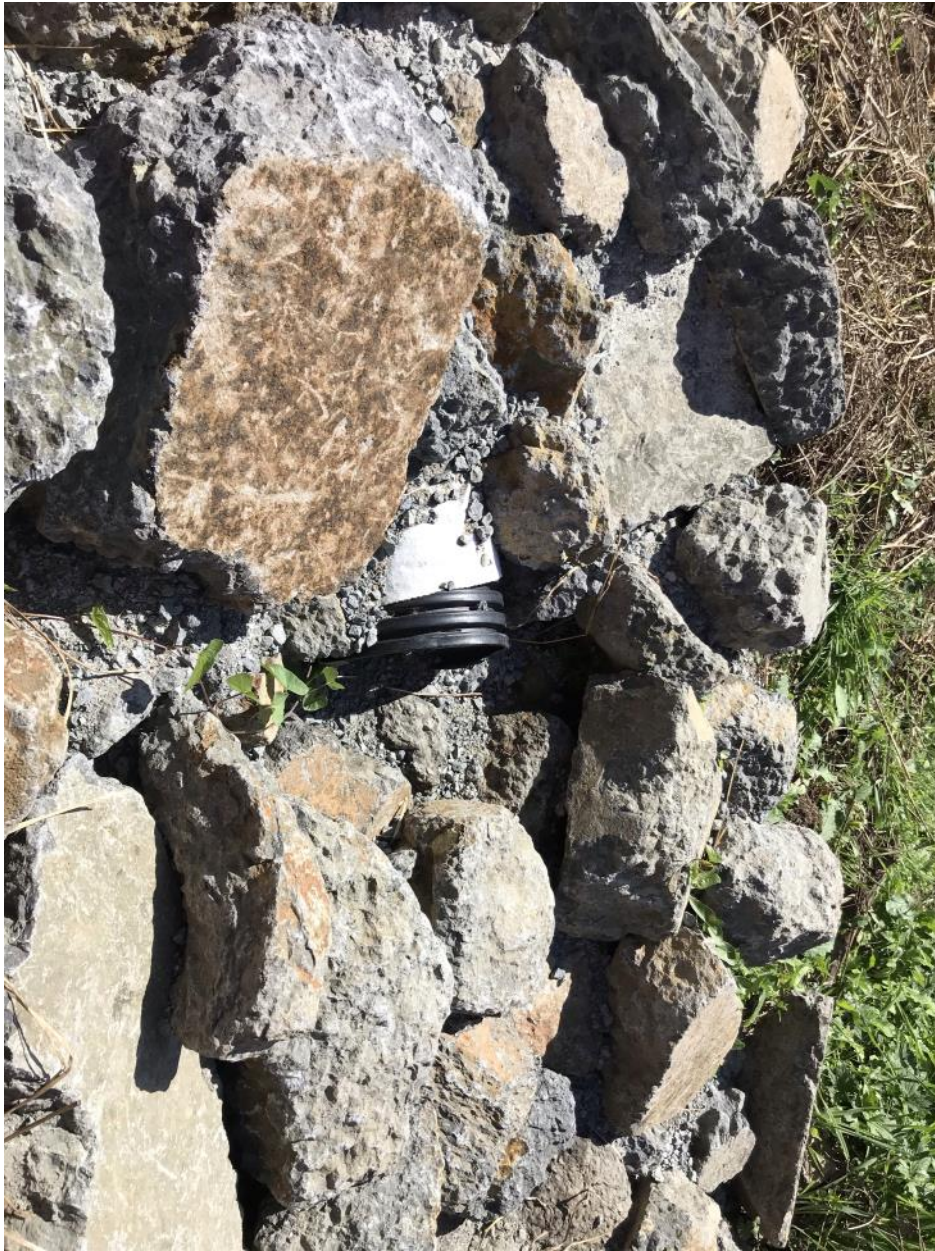
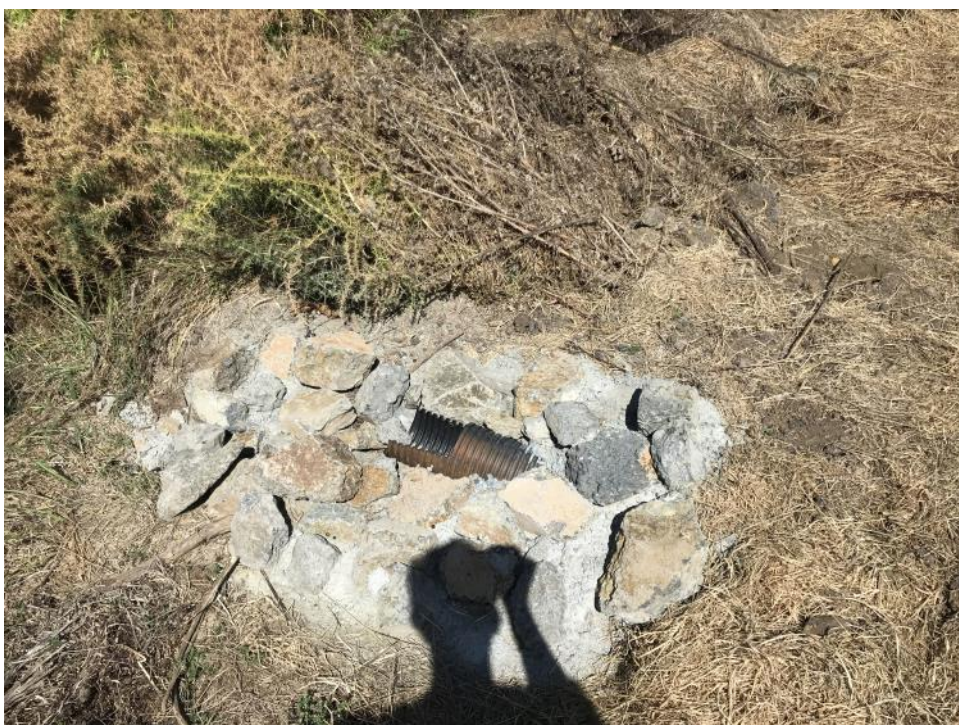
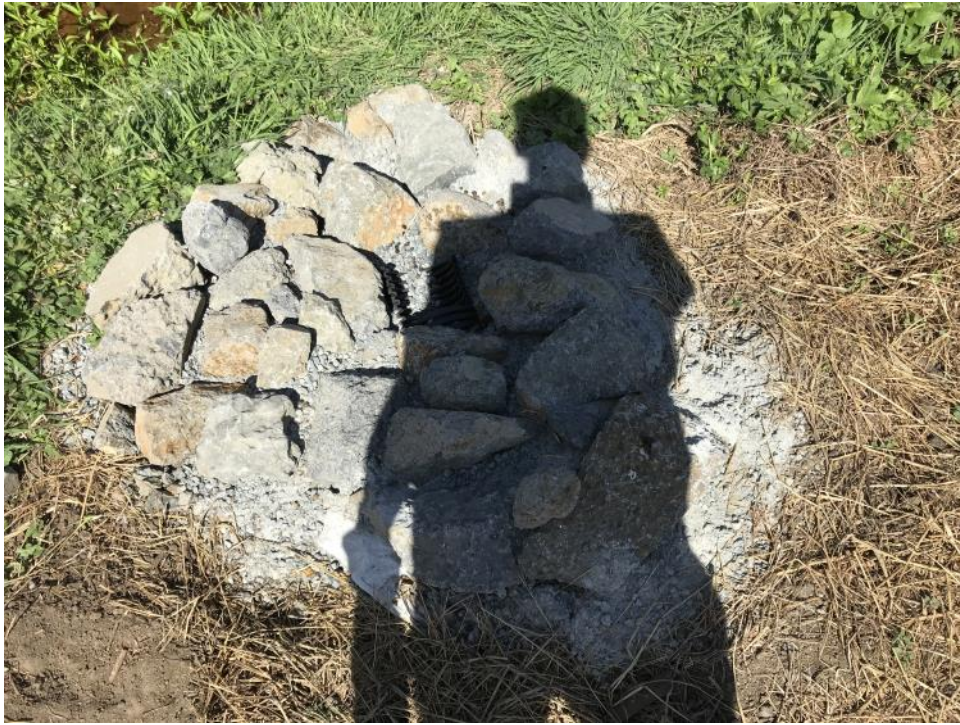
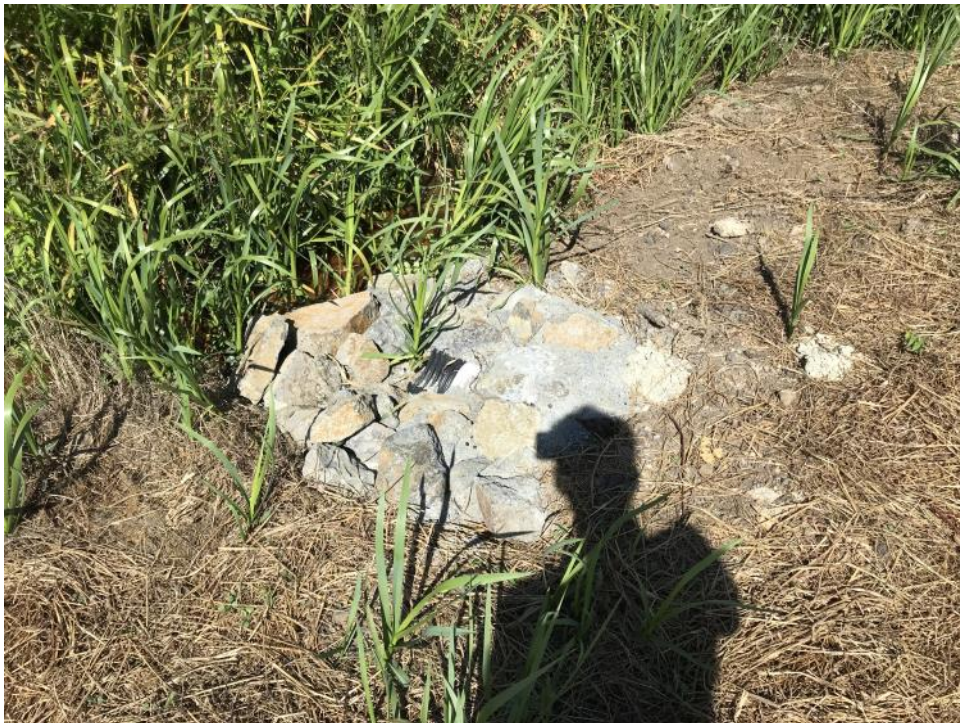
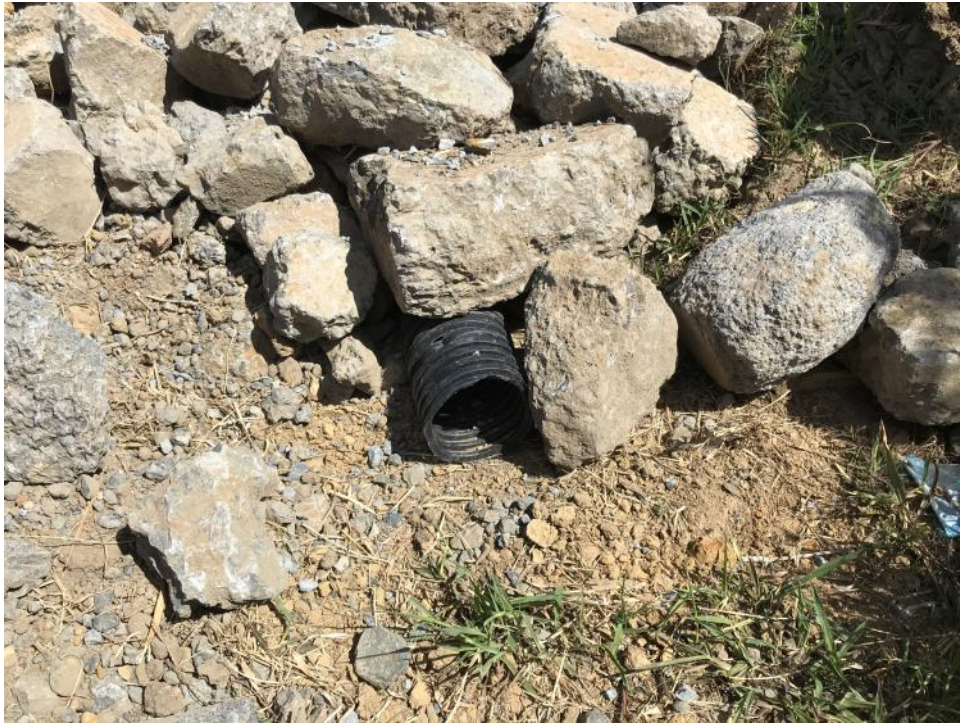
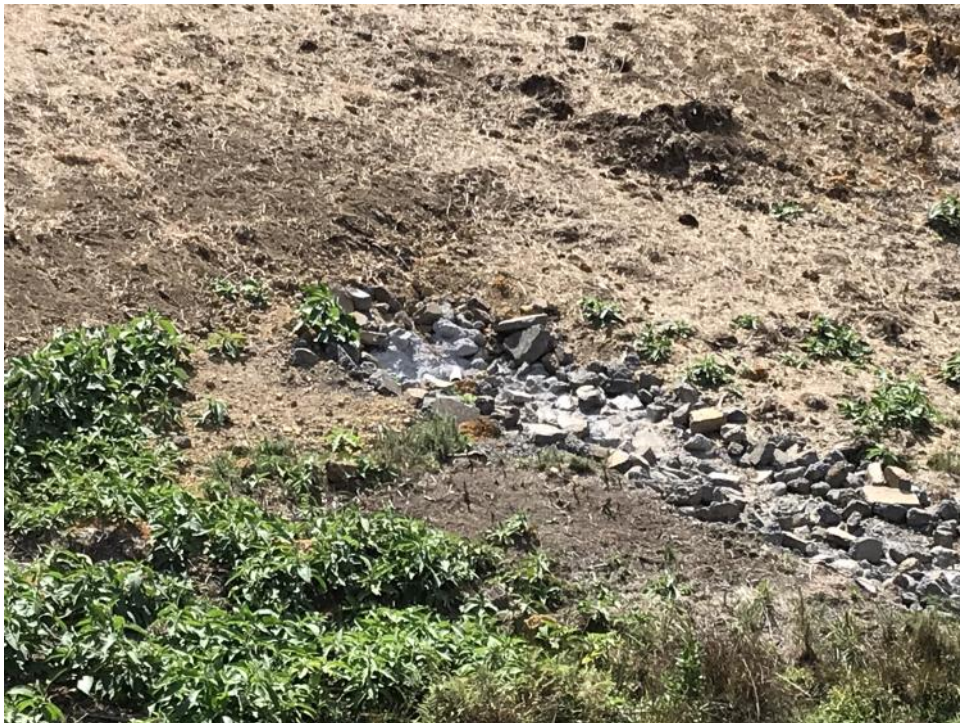
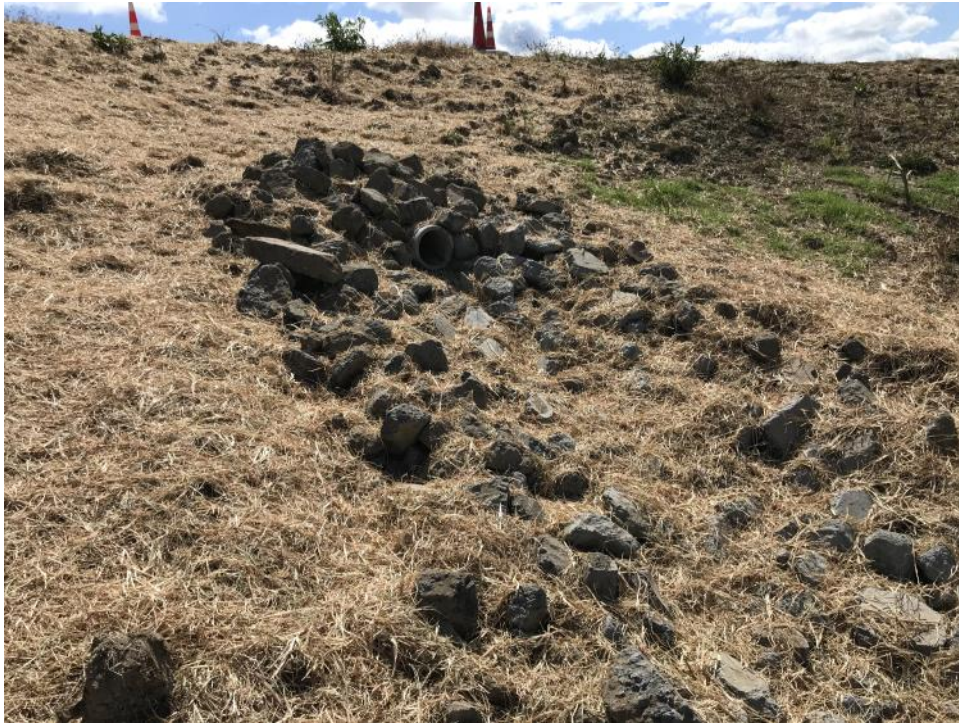
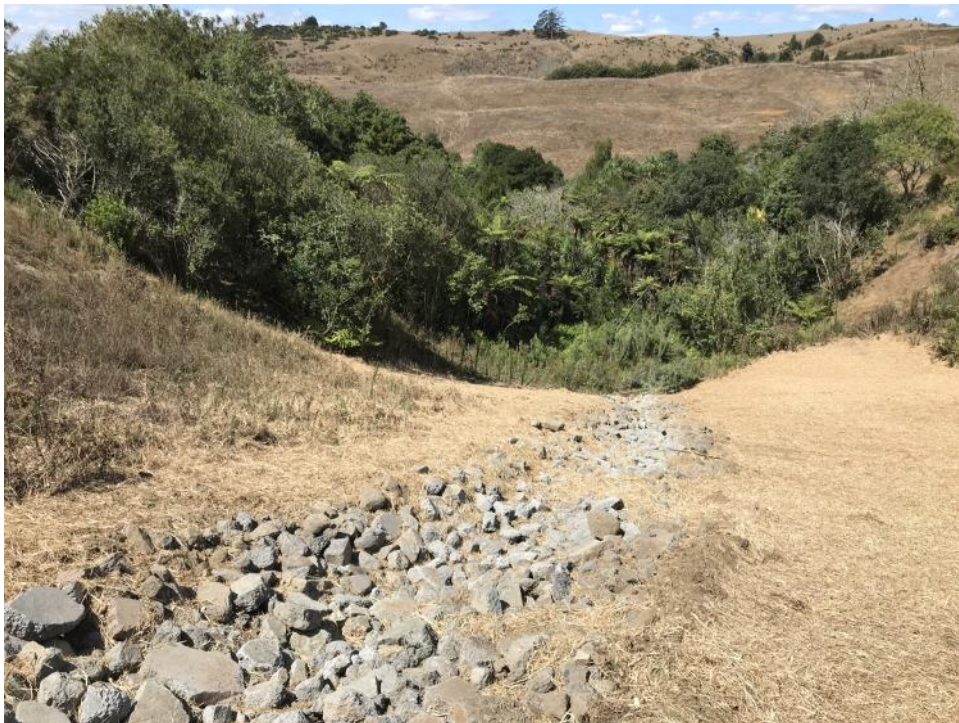
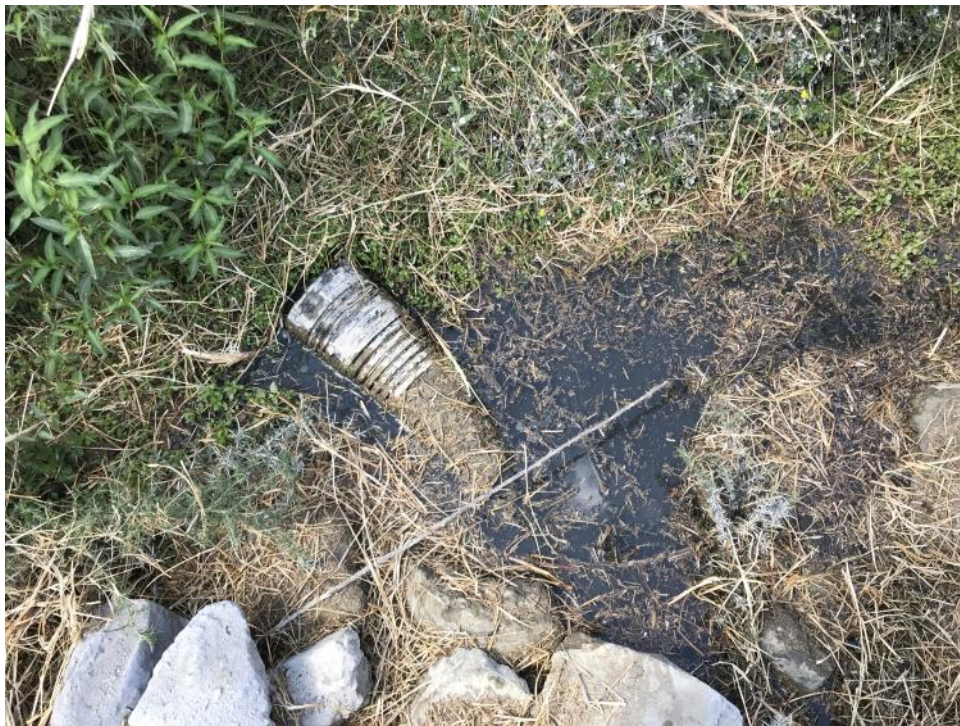
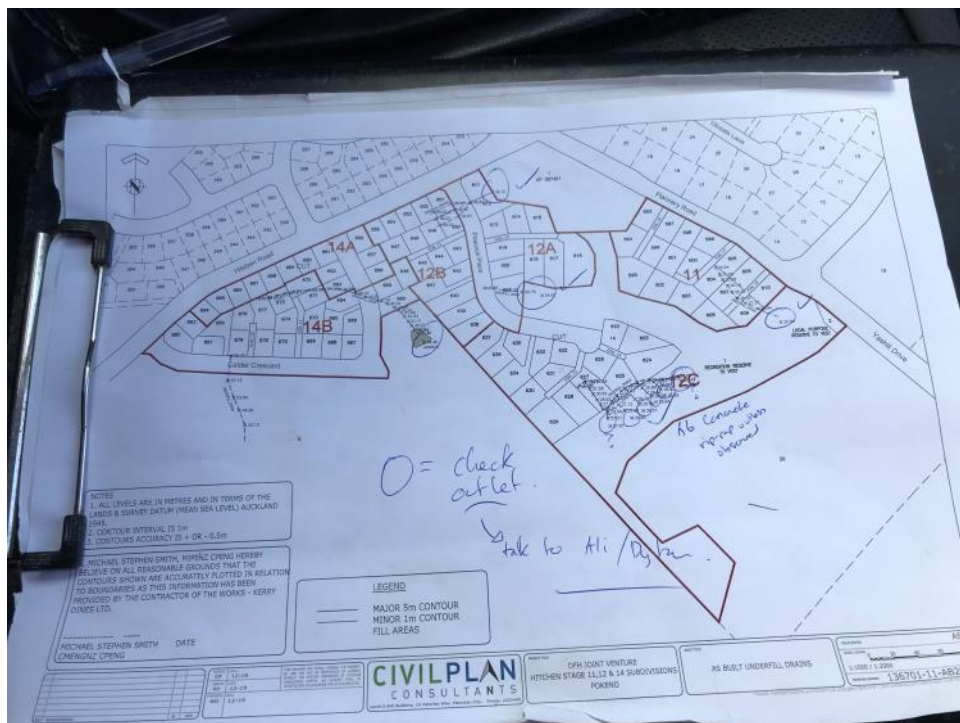
06/03/20

Visited site to check in on shear key. The contractors are excavating the 2m beyond the fill batter now. Will return to site with Chris early next week to REB requirements.

Also checked outlets for Hitchen 11, 12, 14 GCR. All outlets correctly formed with concrete rip rap.
