Geotechnical Completion Report

HITCHEN BLOCK STAGE 13B

17 January 2022

Ref No: J00113

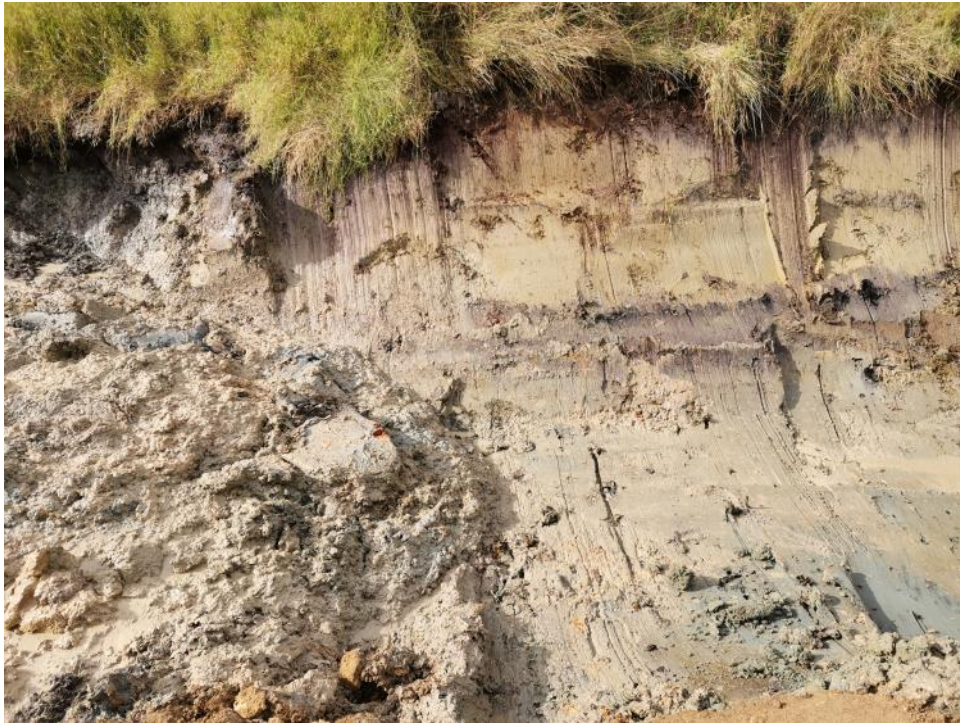
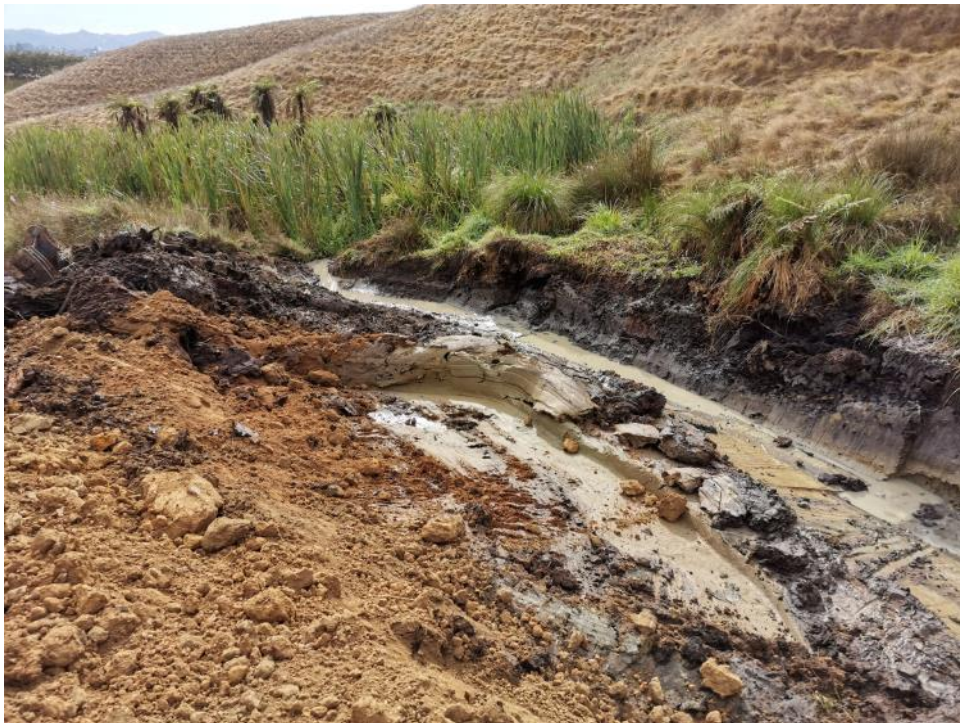
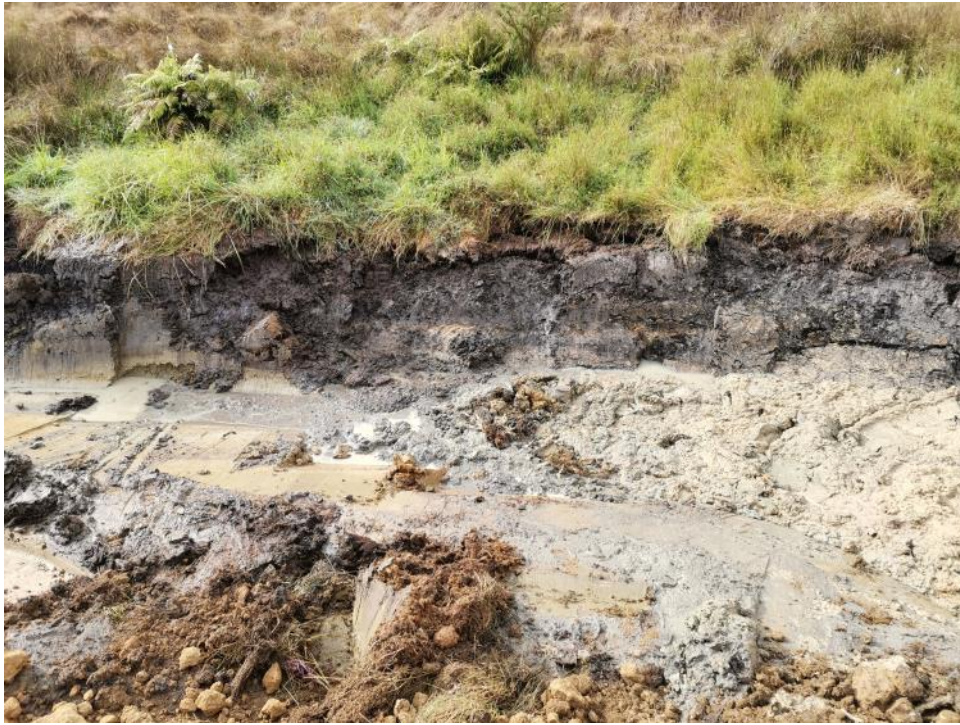
10/03/20

Also discussed installing another underfill drain up the gully branches as there has been some groundwater seepage / slippage observed which the contractor has cleared out prior to our visit. Advised we can look at this which stripping operations commence in this area.

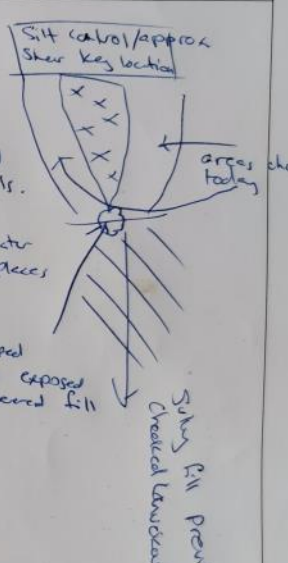
SITE INSPECTION RECORD	
Project no. and name: <u>300113 Hitchen Block</u>	Date & Time: <u>29.4.20</u> <u>9am</u>
Client/contractors present: <u>Dylan (Dines)</u>	Lander staff: <u>1cm</u> SV no: <u>SV2396</u>
Plant operating: <u>1x 20T excavator</u>	
Inspection for (tick all that apply): Shallow Foundations <input type="checkbox"/> Pile Foundations <input type="checkbox"/> Site Meeting <input type="checkbox"/> Subgrade <input checked="" type="checkbox"/> Retaining Wall <input type="checkbox"/> Other <input type="checkbox"/>	
Observations/Notes: <ul style="list-style-type: none"> - Visited site at the request of Dylan to inspect gully mudcut for REG 2 underfill drain. - Generally stiff (loose) soils exposed at base of gully. Inorganic AZ soils. - Contractor also advised that steep-groundwater seepages were obs noted in several places coming from the gully flanks.

Discussions/Recommendations given: <ul style="list-style-type: none"> - Recommended some of the silt/liner soils be shipped back ~0.5m prior to placing underfill drain. - Also recommended that localized seepages be topped by collector underfill drains where observed and connected to main underfill gully drain.

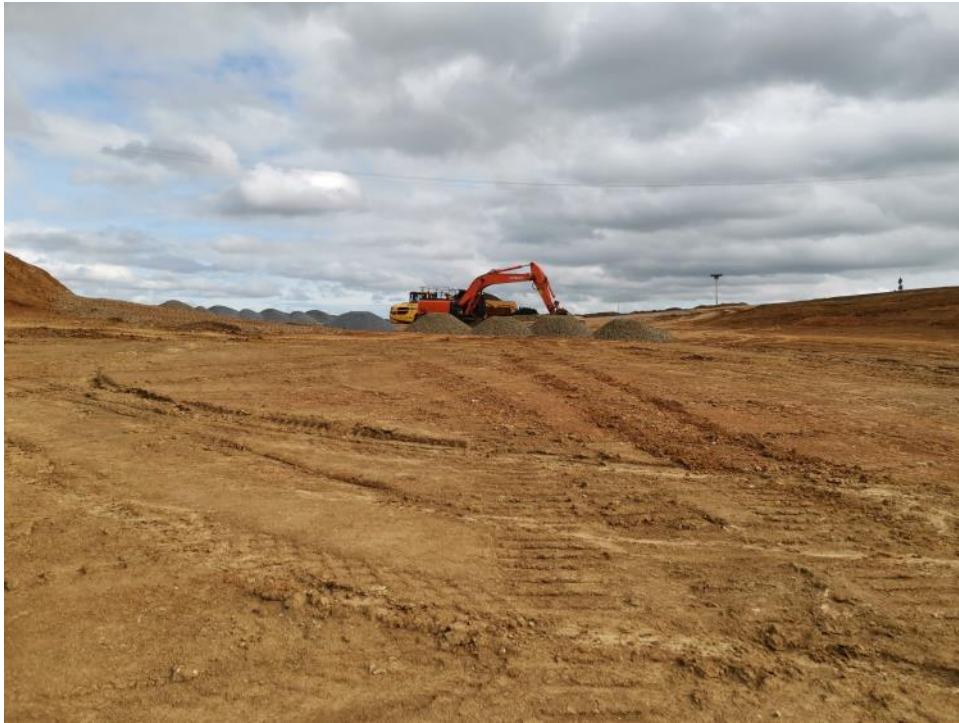
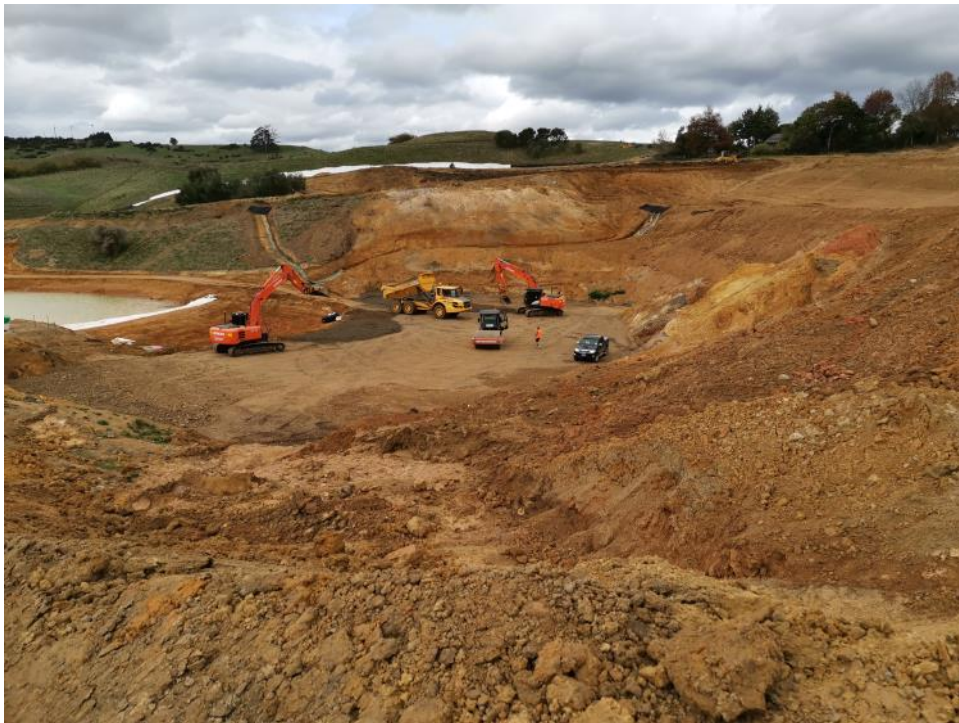
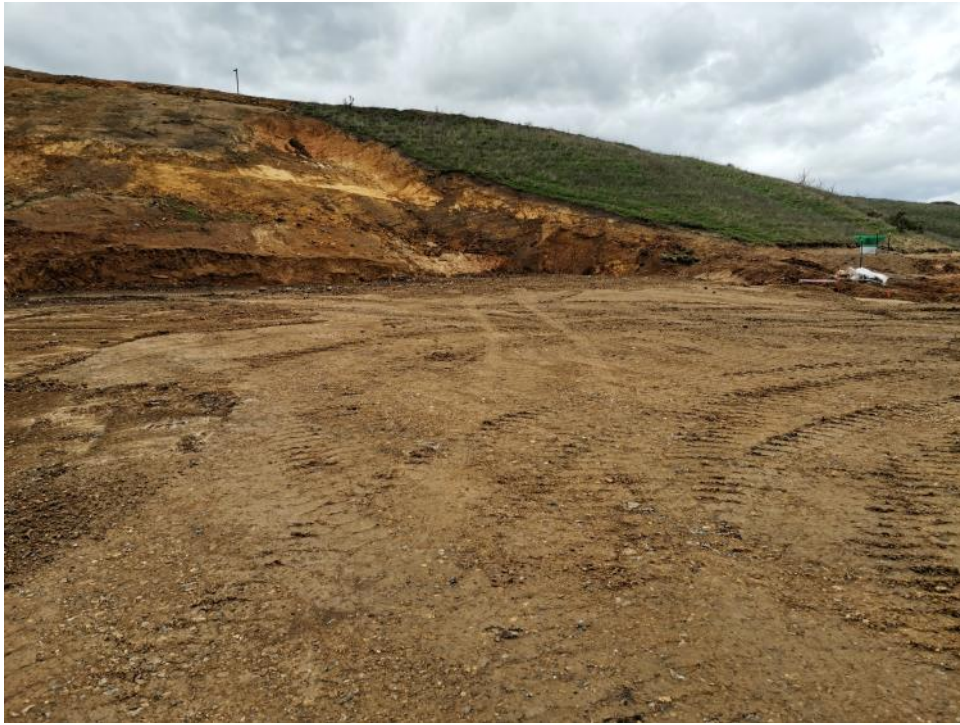
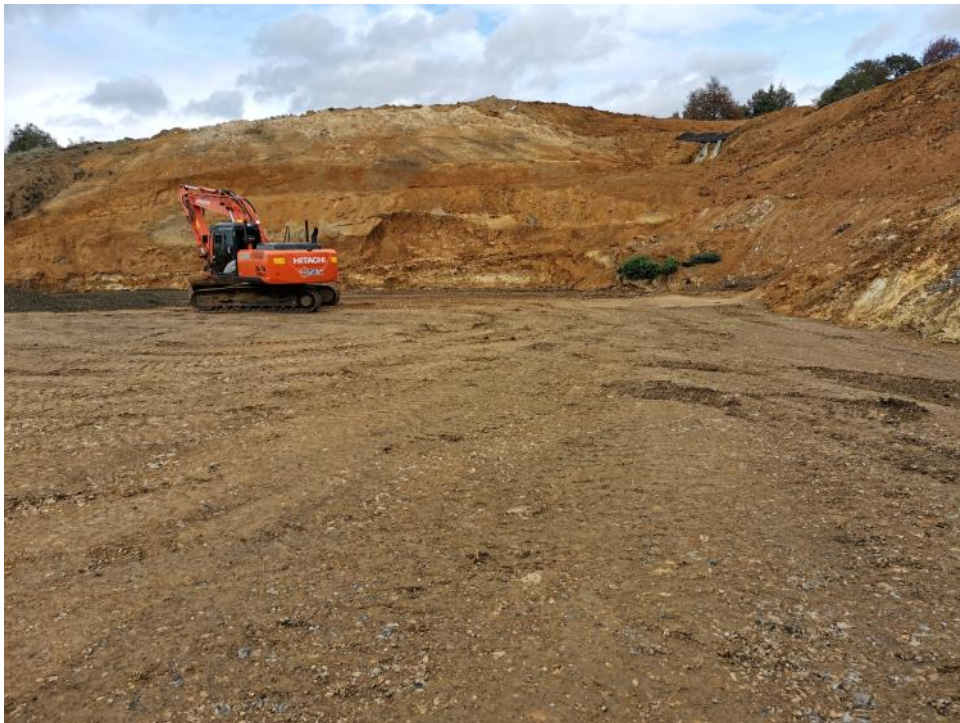
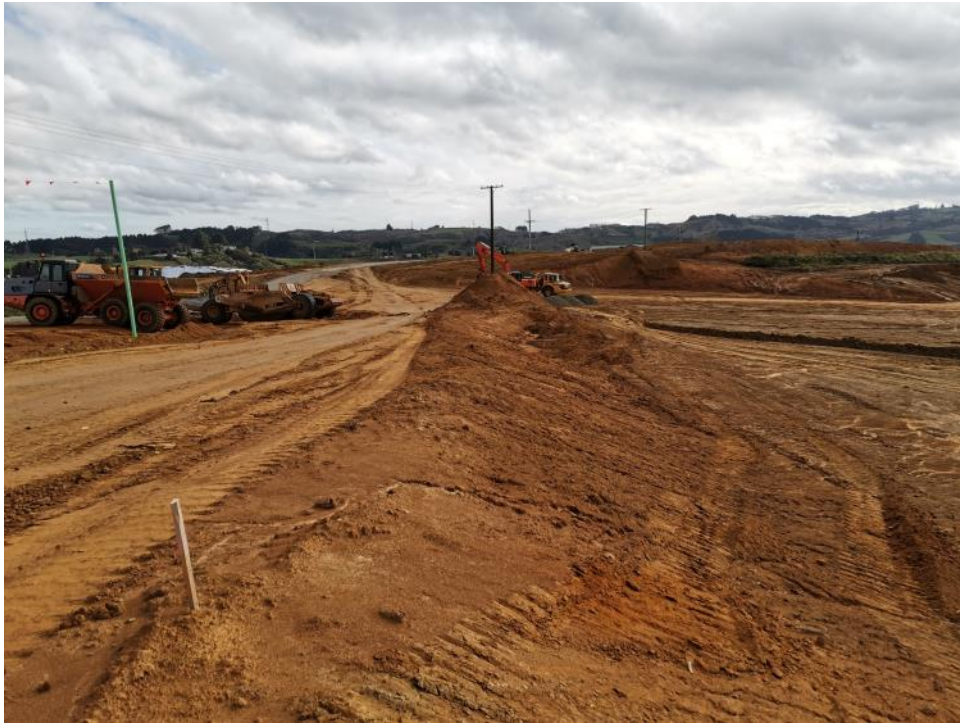
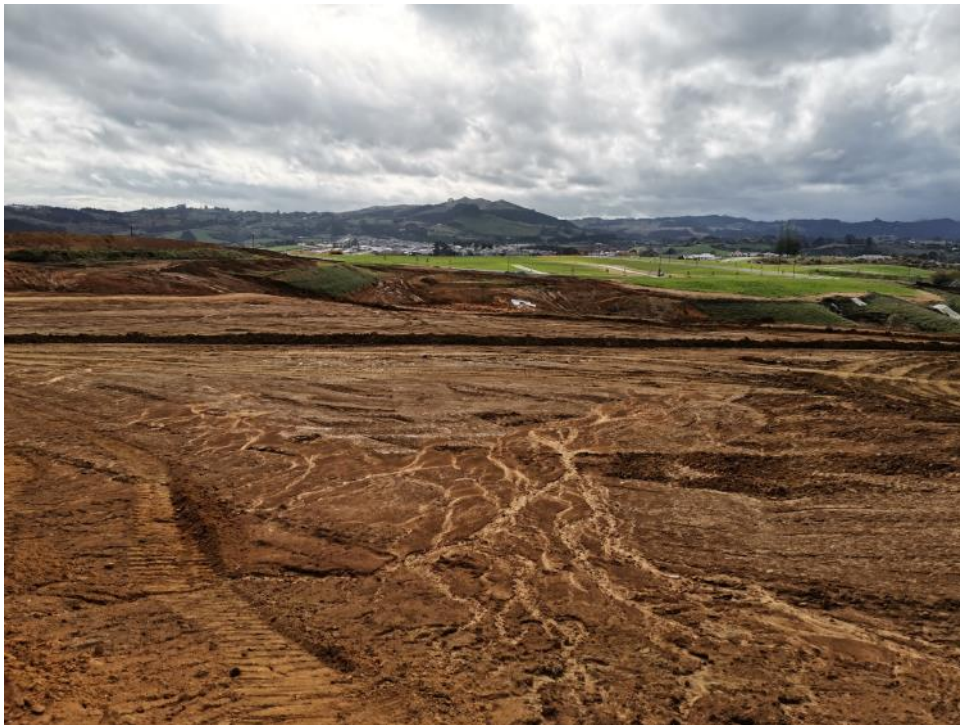
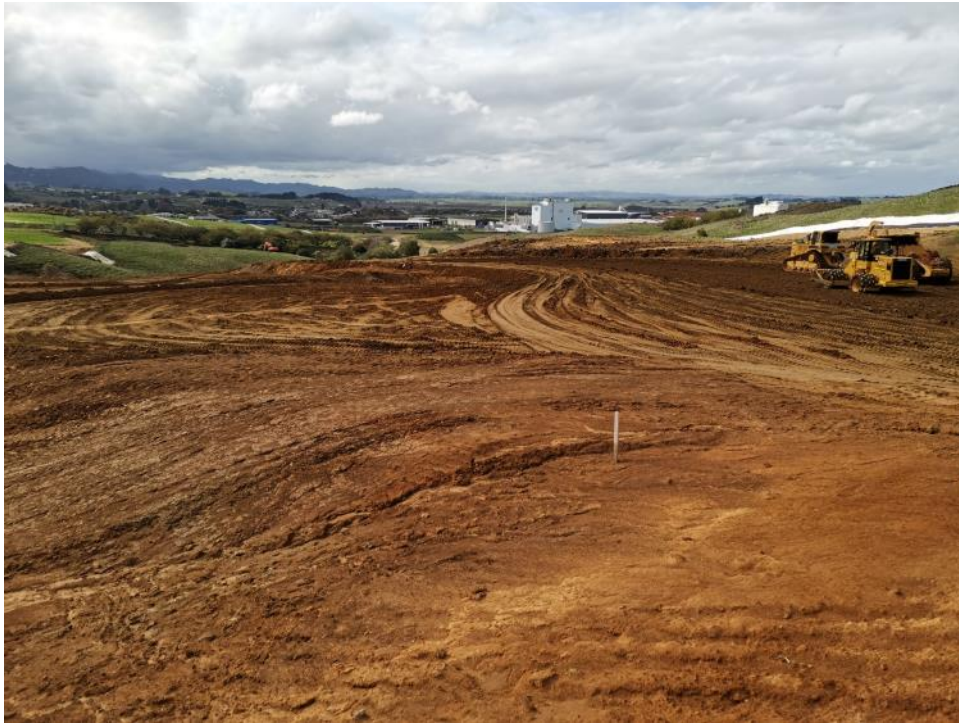
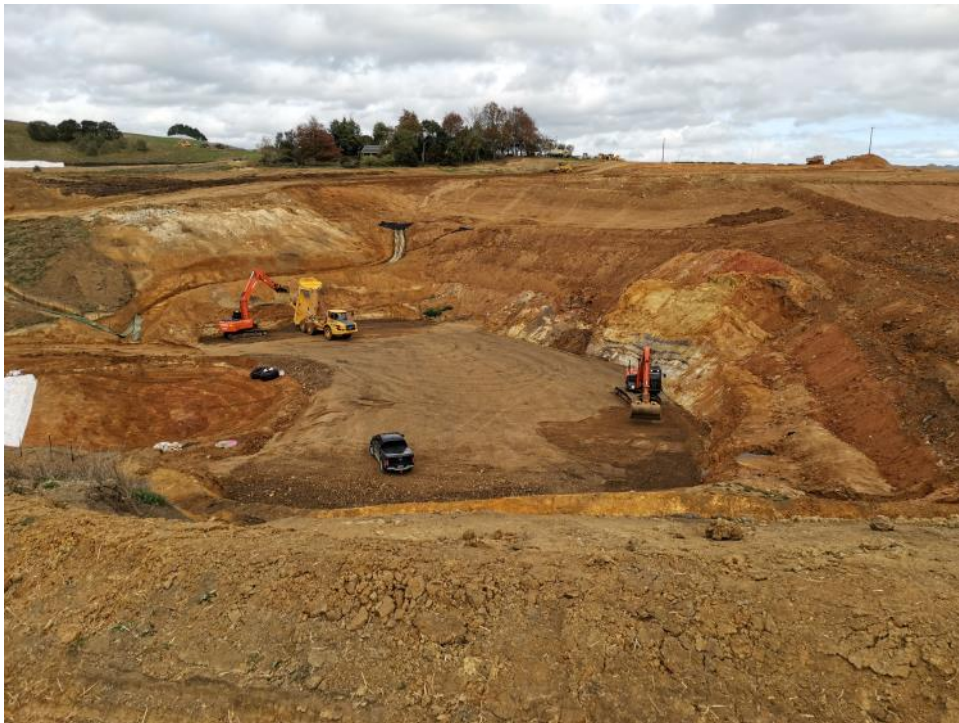
13/03/20

Project no. and name: J00113 - Hitchen Block		Date & Time: 13/5/20 11:30am
Client/contractors present: Dylan (Dines)		Lander staff: km SV no:
Plant operating:		
Inspection for (tick all that apply): Shallow Foundations <input type="checkbox"/> Pile Foundations <input type="checkbox"/> Site Meeting <input type="checkbox"/> Subgrade <input type="checkbox"/> Retaining Wall <input type="checkbox"/> Other <input checked="" type="checkbox"/> REB1 shear key		
Observations/Notes: - Visited REB1 area at the request of Dylan. Contractors have filled the shear key to final height with SPR. Next plans are to install the lateral drains perpendicular to the slope face and they will then connect into the rear blanket drain. → Next the initial layer of grid will be placed and OAP65 will be used for the first 1m lift. - Discussed with CE while on site (phone) issues about how to place the grid as the MSE wall/batter starts to cut away from the batter face. Chris has gotten in touch with Cirtex. In the meantime the contractor has been advised to overlap the grid by a minimum of 200mm and place extra layers if and when the grid separates (doesn't overlap) if they don't want to wait for advice from Cirtex.

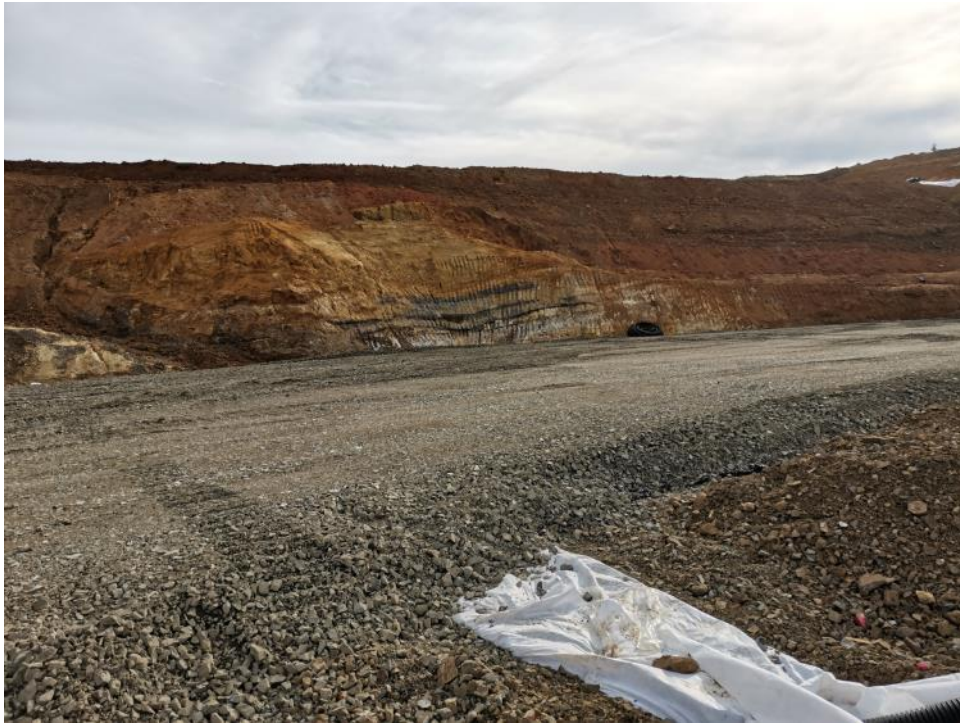
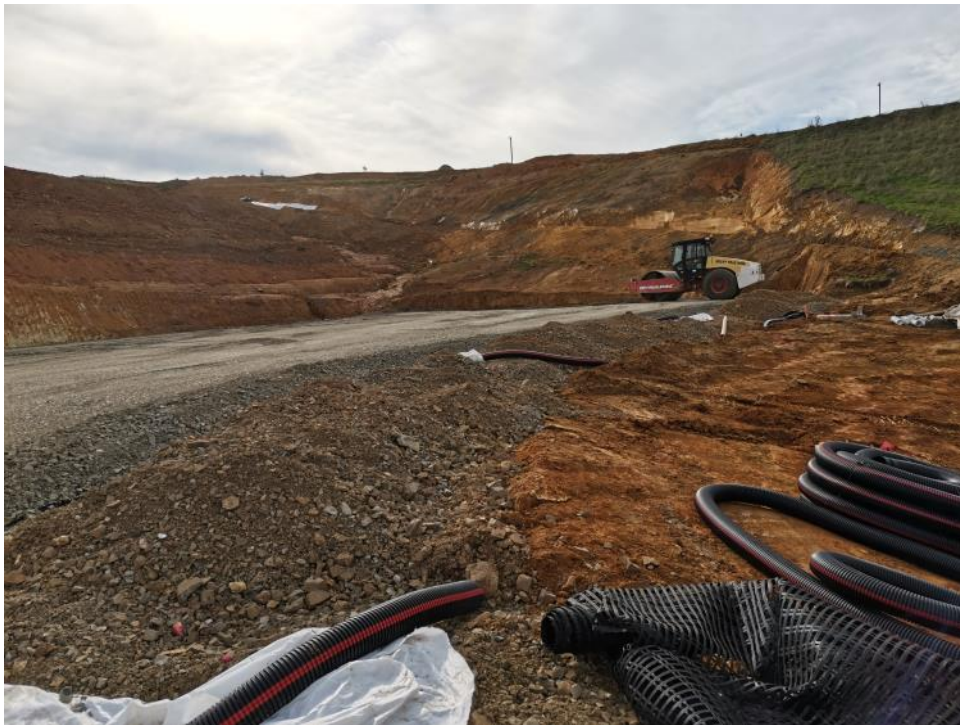
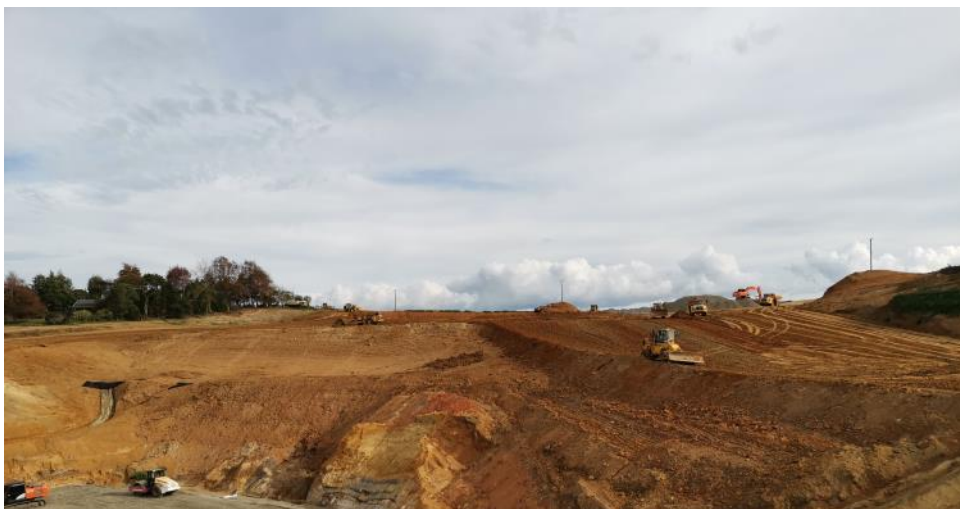
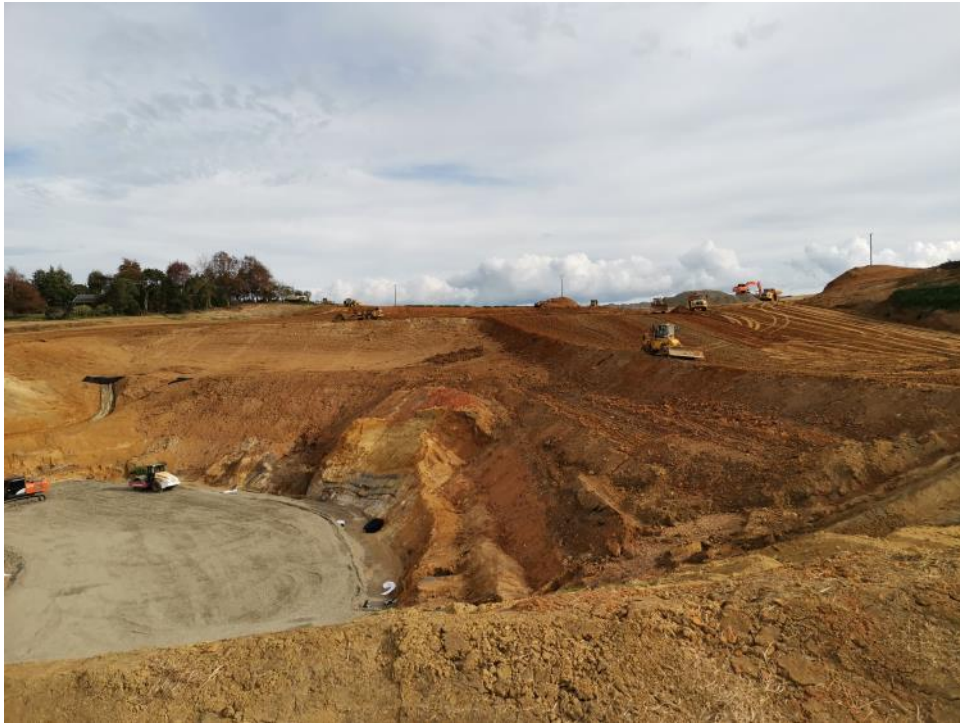
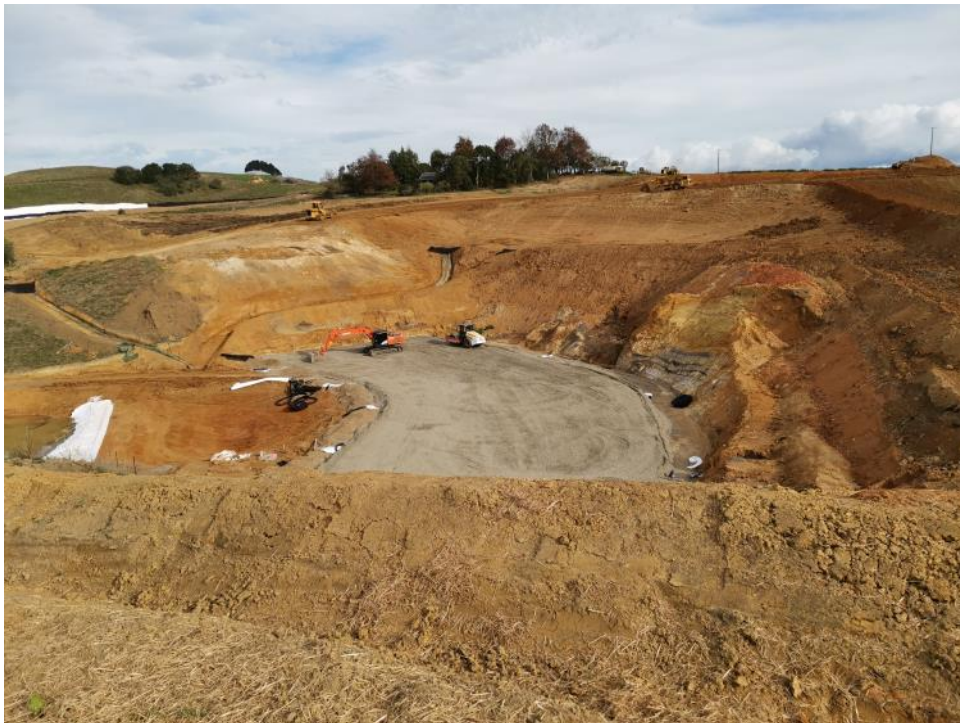
15/05/20

SITE INSPECTION RECORD	
Project no. and name: J00113 - Hitchen Block	Date & Time: 15/5/20 - 2:30pm
Client/contractors present: —	Lander staff: km SV no:
Plant operating:	
Inspection for (tick all that apply):	
Shallow Foundations <input type="checkbox"/>	Pile Foundations <input type="checkbox"/>
Subgrade <input type="checkbox"/>	Retaining Wall <input type="checkbox"/>
Site Meeting <input type="checkbox"/>	
Other <input checked="" type="checkbox"/> REB 1 Shear Key	
Observations/Notes:	
<ul style="list-style-type: none">- Visited site to observe site earthworks for the completion of the REB 1 Shear Key.- Lx underfill drains fully wrapped and backfilled with drainage aggregate sighted at both the front and rear faces of the shear key.- Currently rollers are compacting GAPS, which comprises the first 1m of the REB batter.- Will return to site with CE on Monday to observe geosrid placement.	
Discussion/Recommendations given:

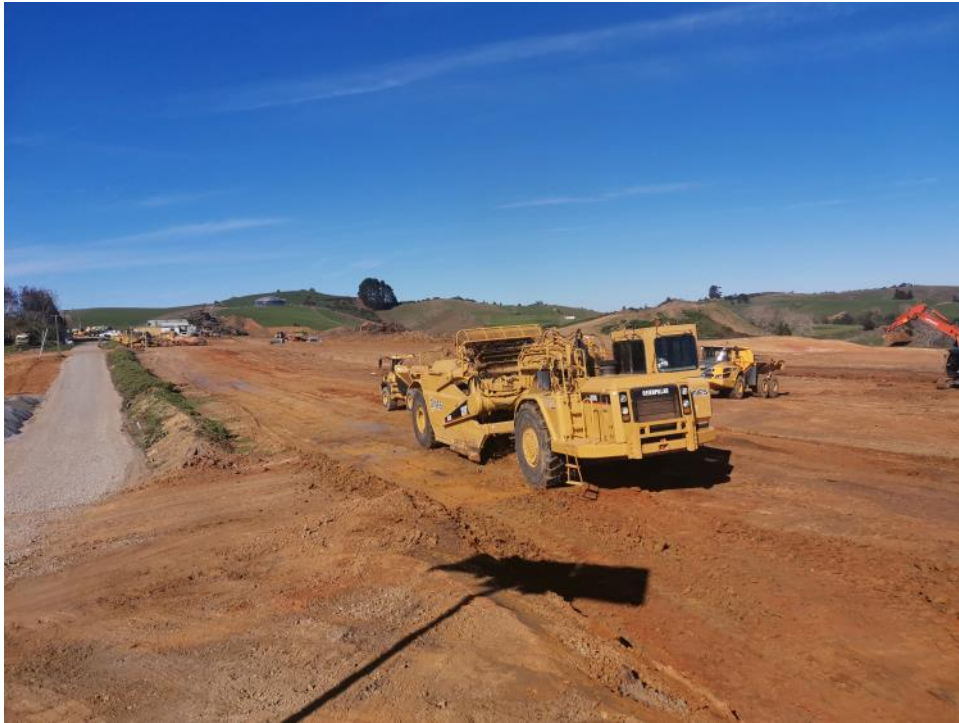
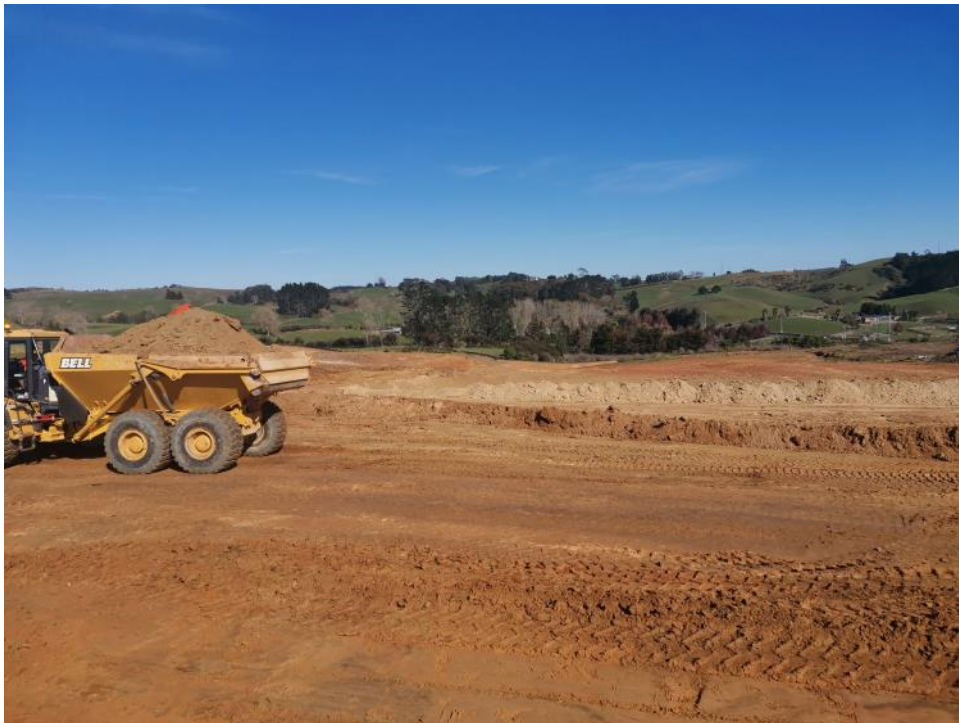
18/05/20

- Visited site at the request of Dylan to inspect subgrade level in cut lots. The lots are being formed to their final levels within cut ground. Very soft AS's exposed at the stripped surface.
- There is some scarring / water damage over the area. The contractors plan to tidy this up and then topsoil the lots.
- In REBZ, GAD6R filling operations are continuing. Discussed that GE would come out to site on Wednesday to discuss geogrid placement and the rear drainage blanket.

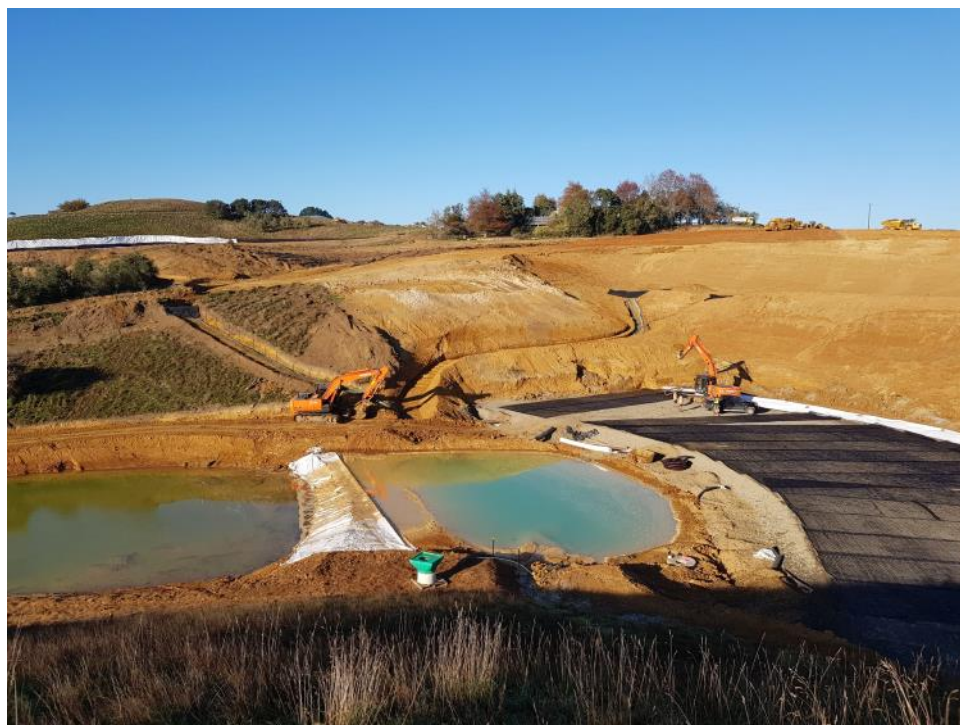
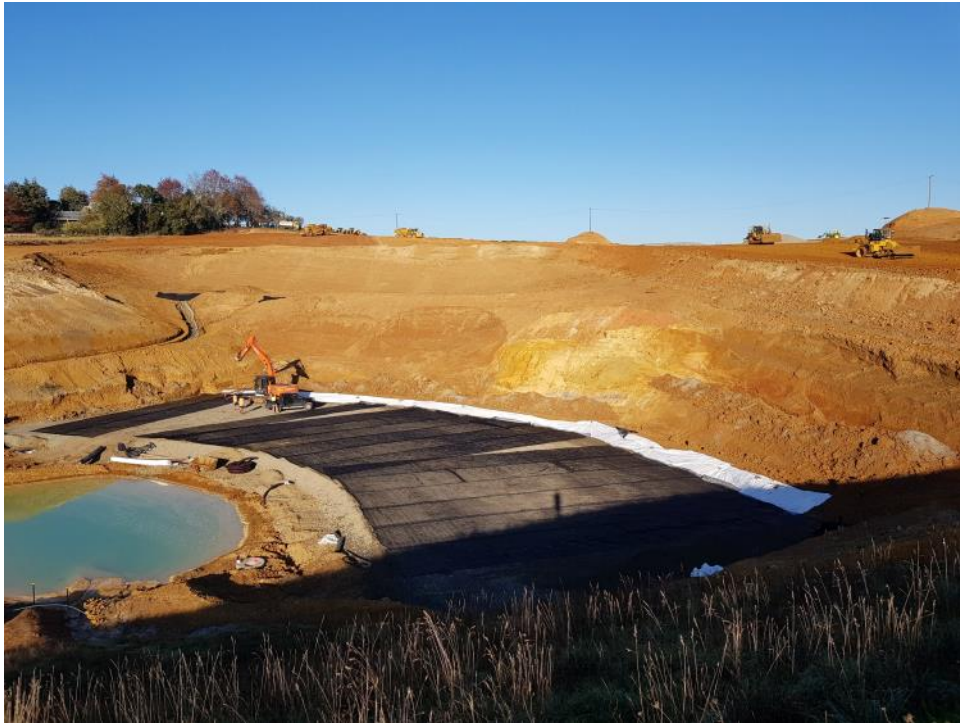
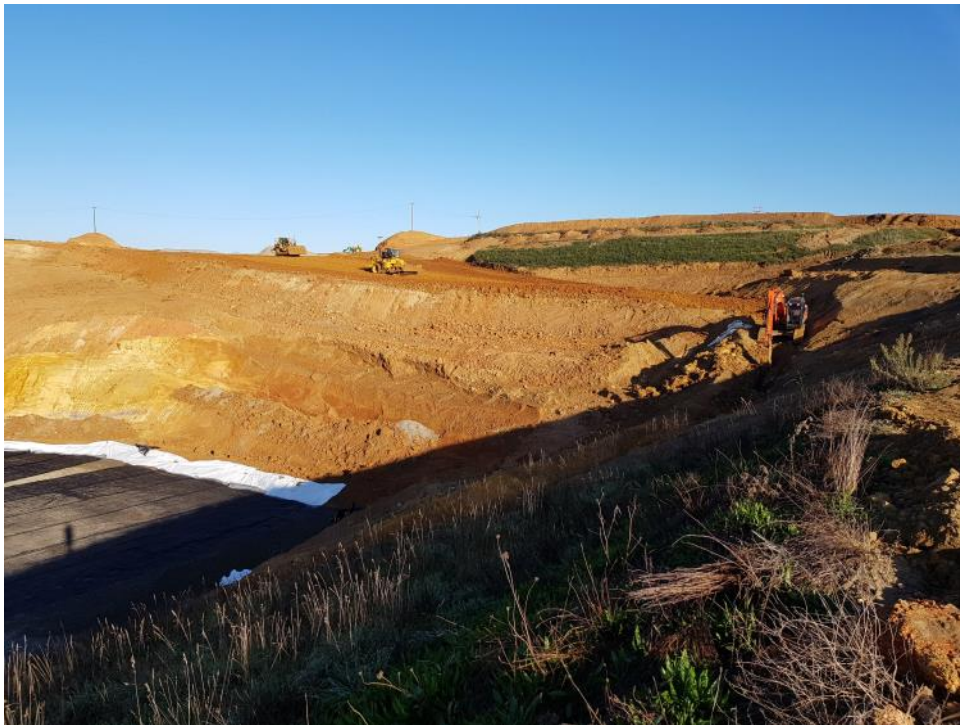
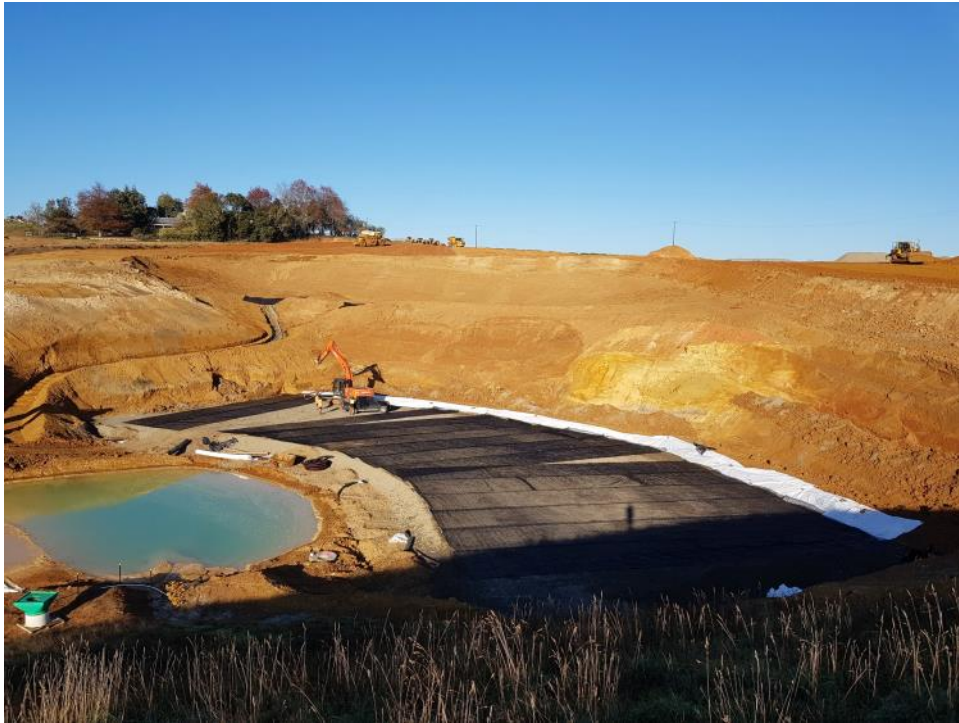
21/05/20

Meeting with Dylan to observe second layer of primary grid on REB1. They are having issues with grid coverage as the wall goes round the curve. Have queried this with Michael Sorrenson and will get him to comment on the best way to fix this issue. Meeting with Cirtex set up for tomorrow morning to discuss this, no more grid to be placed until issue resolved.

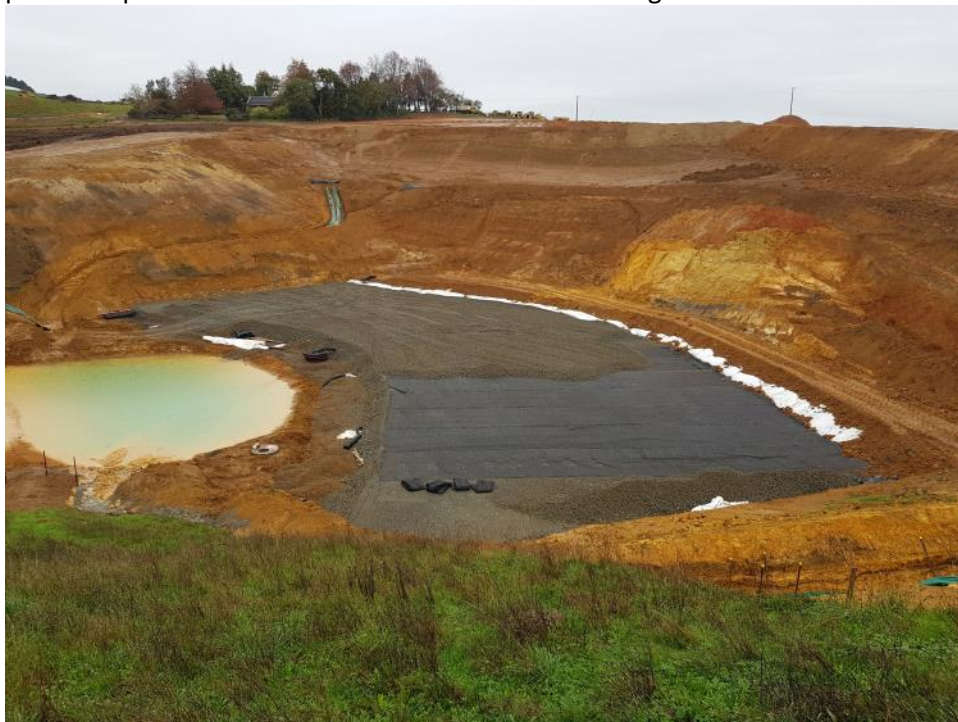
27/05/20

Quick stop by to see progress of REB1. Looks like they have stopped due to the weather.

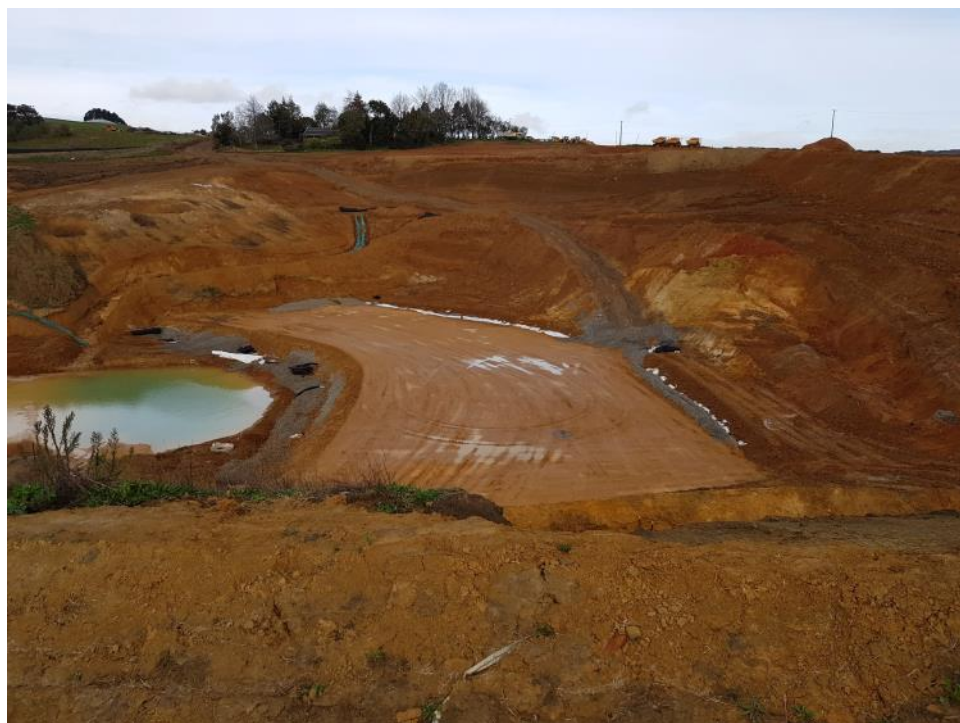
24/06/20

Observed muck out of portion of gully circled below. Decant to be formed here to allow further earthworks up slope within gully. Muck out looked suitable with benches to be formed 2 compactors width in flanks to lock this fill batter in. Batter only temporary until next season when earthworks occur downslope. Underfill drain to be placed through this area (discussed specs which are consistent with other drains across site) that will lead into the earthworks upslope and eventually downslope as well. Fill materials to cut from cut area above which looked fine to use. Testing to take place every 1m lift. Contractor to get in touch when gully upslope is being stripped.

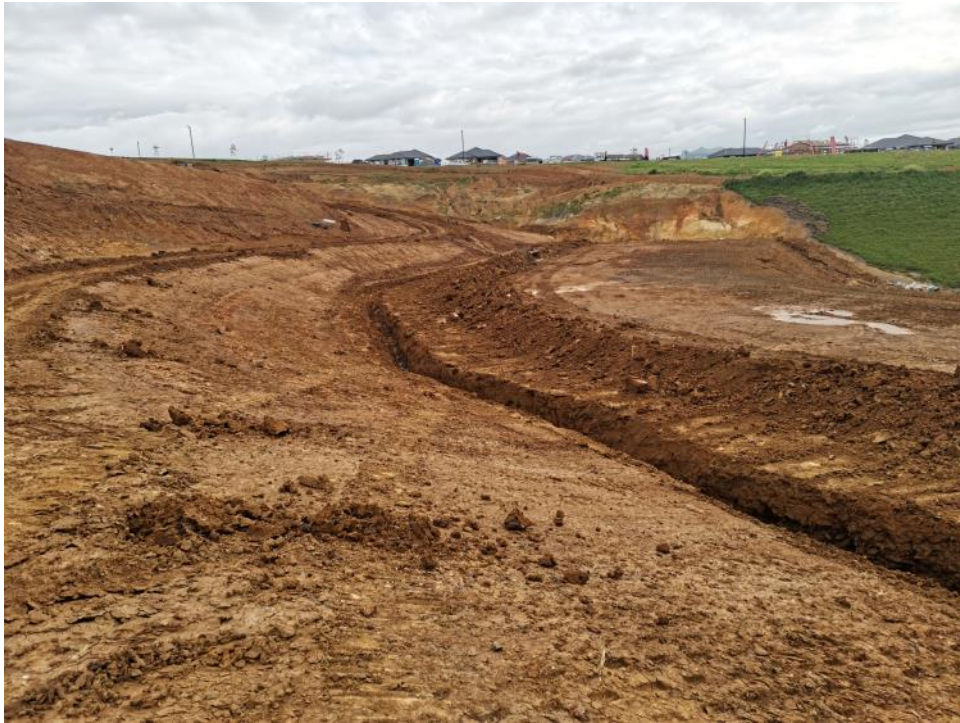
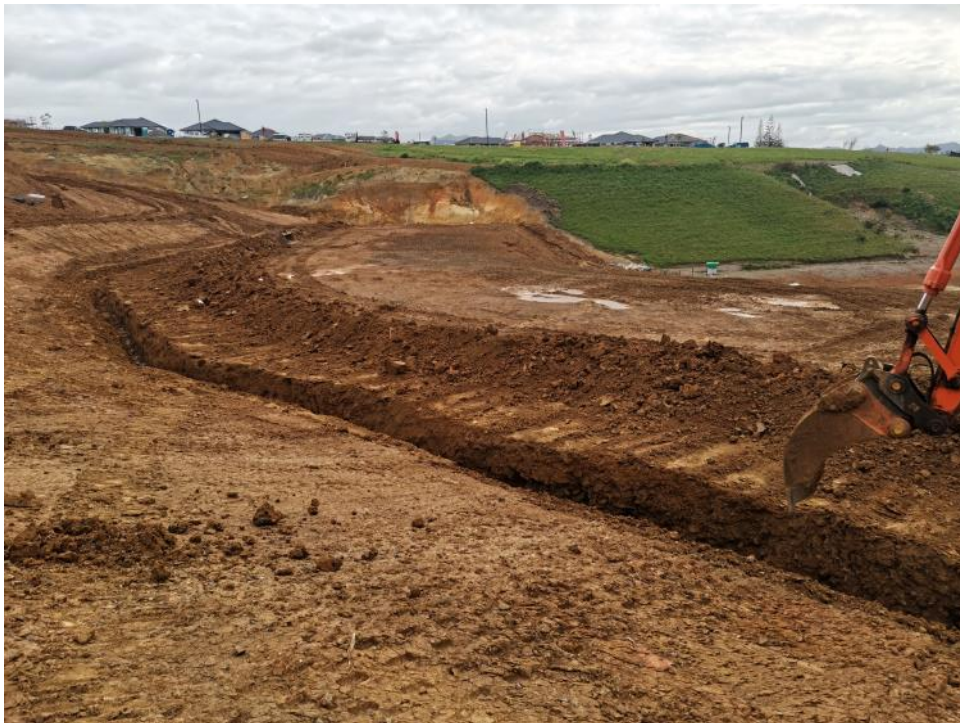
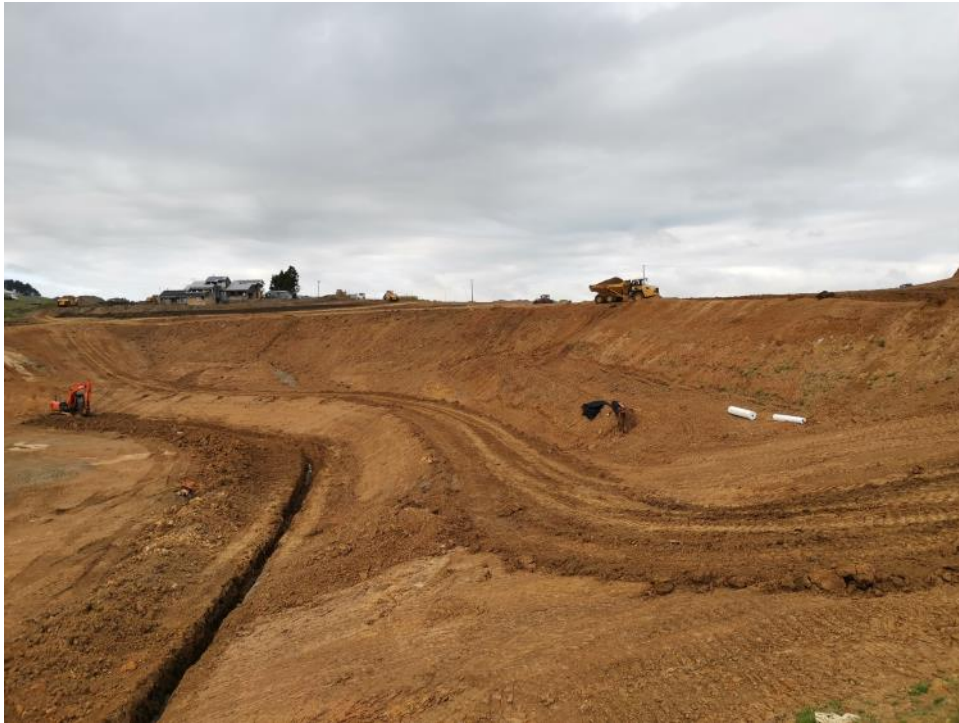
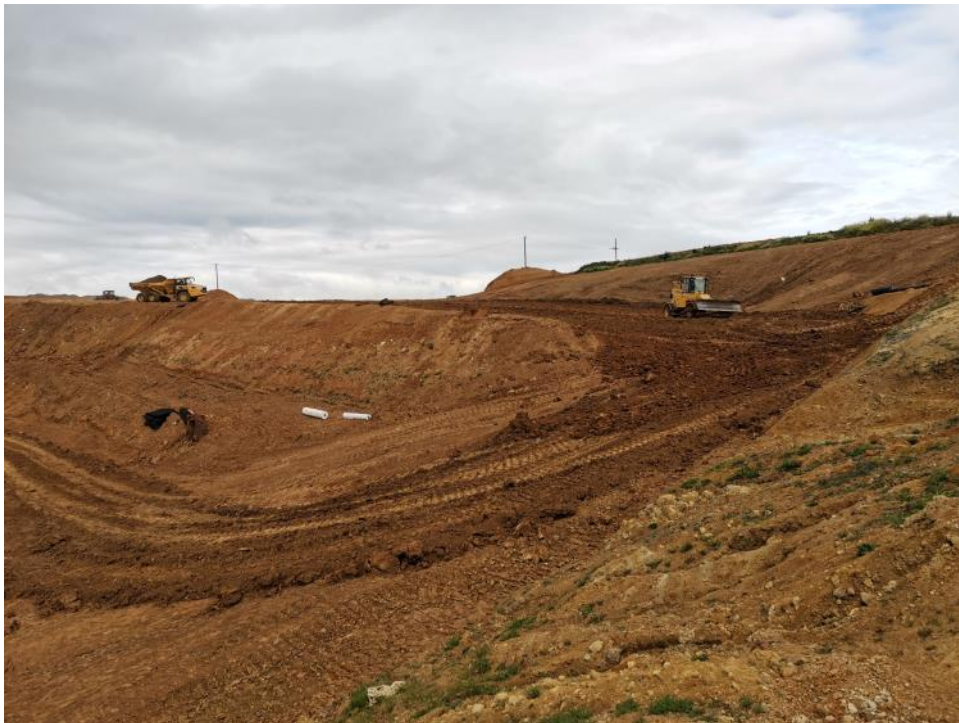
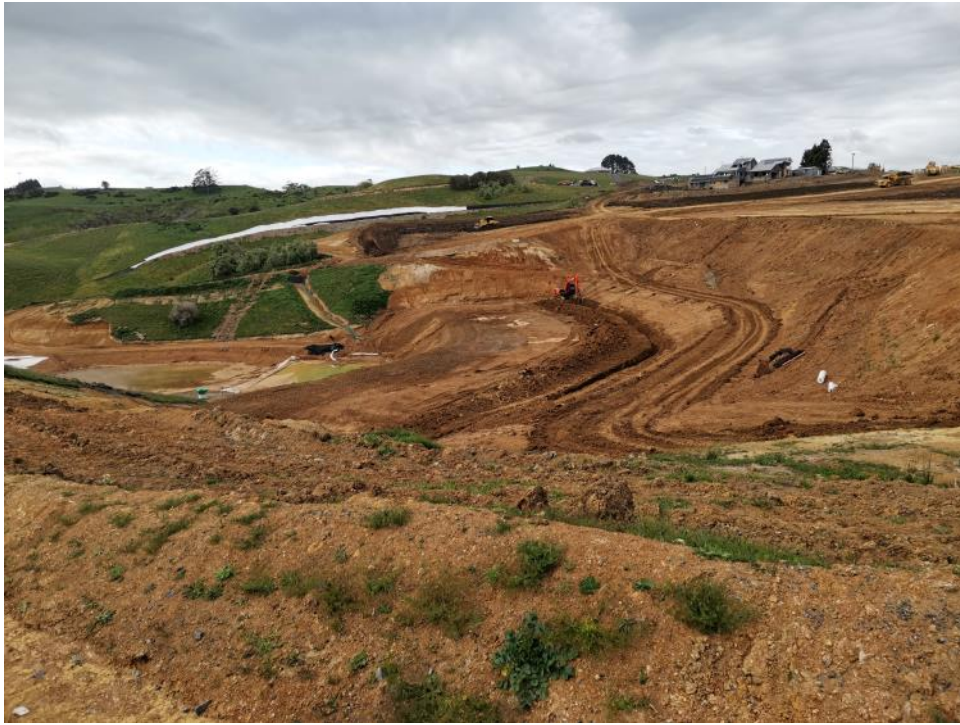
19/10/20

Project no. and name: J00113 - Hitchen Block		Date & Time: 19.10.20 - 9am
Client/contractors present:		Lander staff: KM SV no:
Plant operating:		
Inspection for (tick all that apply):		
Shallow Foundations <input type="checkbox"/>	Pile Foundations <input type="checkbox"/>	Site Meeting <input type="checkbox"/>
Subgrade <input type="checkbox"/>	Retaining Wall <input type="checkbox"/>	Other <input checked="" type="checkbox"/> Drainage
Observations/Discussions: - Visited site to observe general earthworks operations in REBZ. - Minor progress has been made since our last site visit. Currently the contractors are trenching in their rear face blanket drain, with the lateral drains to be trenching in later today. Will try to return to site later today if time allows, or will get Dylan to take photos/read as built.		
Inspection Result: Pass <input checked="" type="checkbox"/> Fail <input type="checkbox"/>
