Geotechnical Completion Report

HITCHEN BLOCK STAGE 13B

17 January 2022

Ref No: J00113

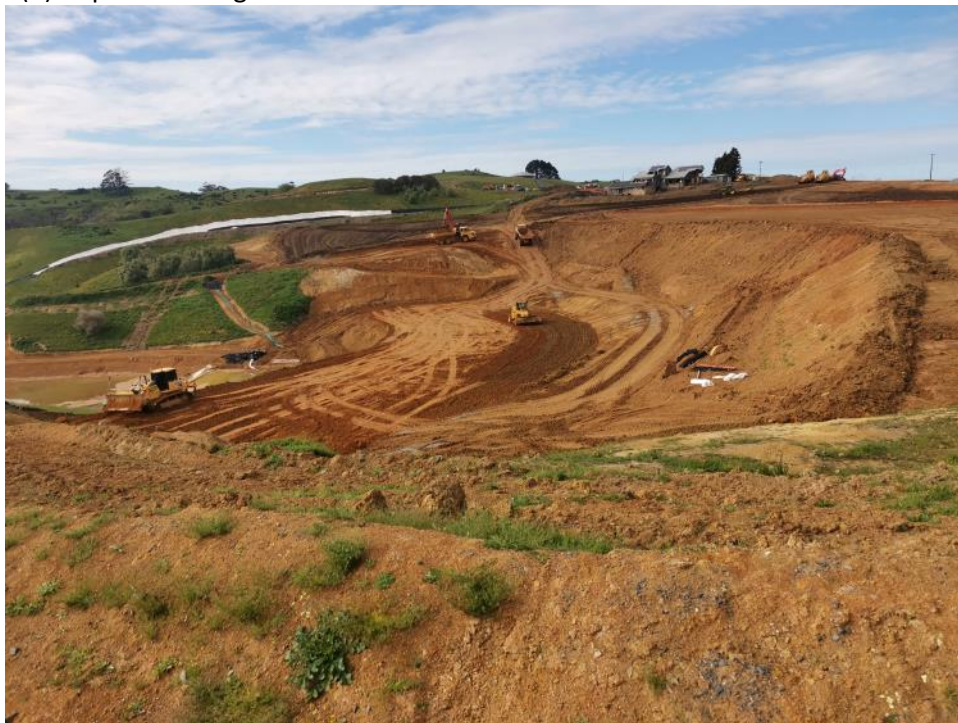
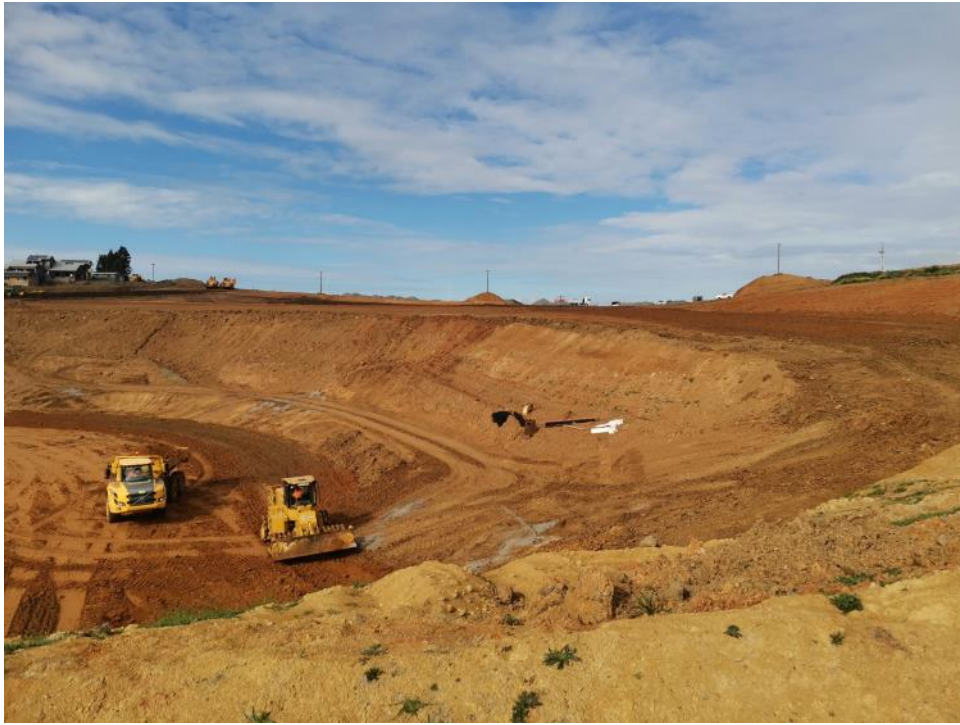
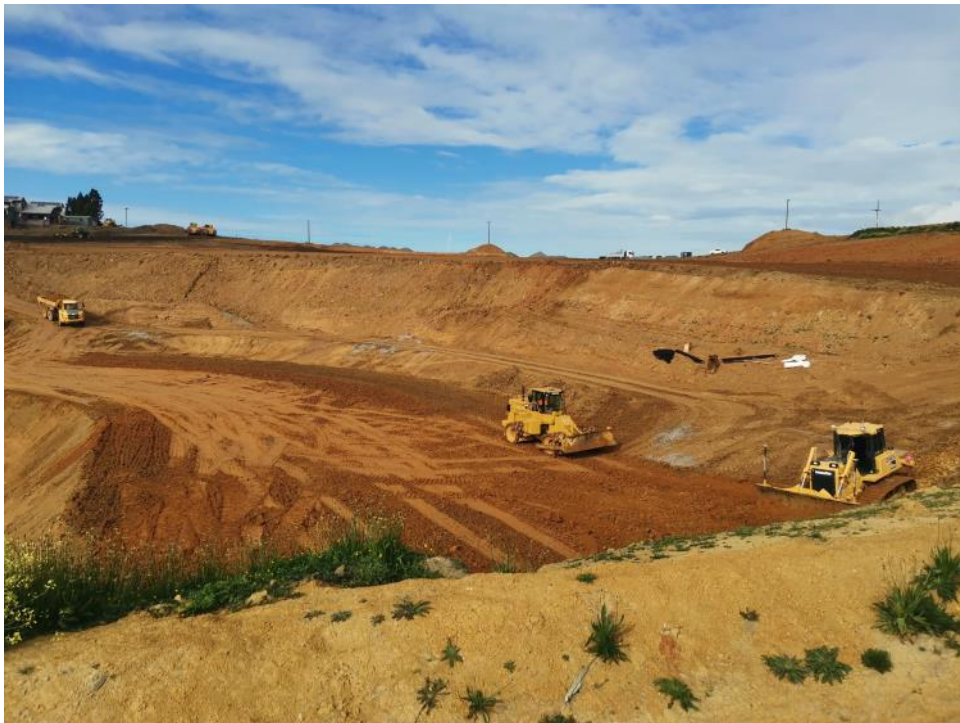
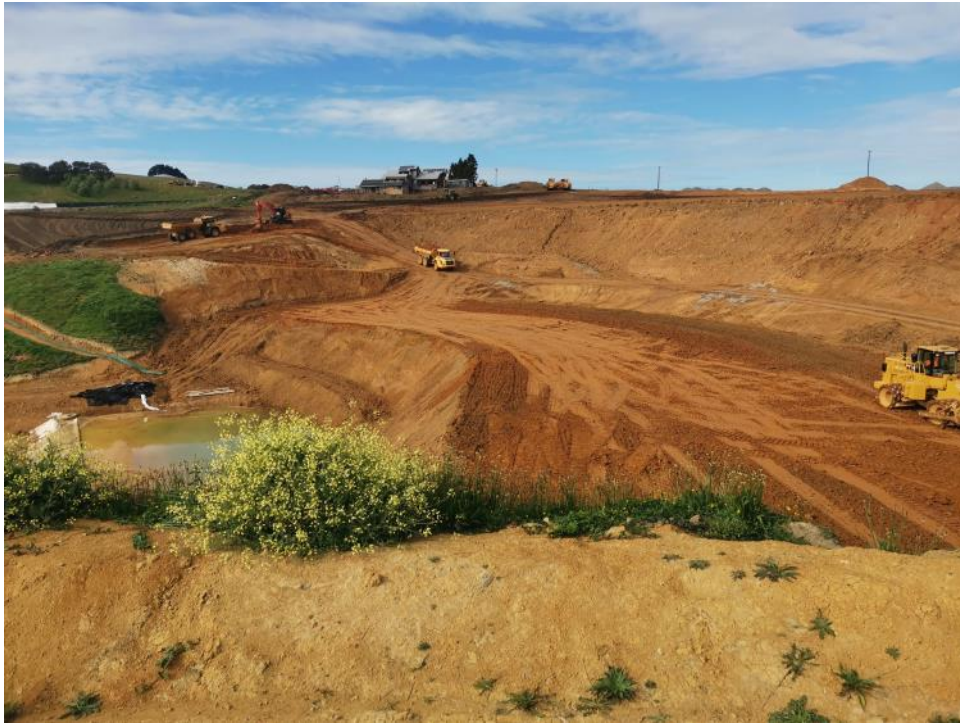
23/10/20

Visited site to observe earthworks operations in REB1. Clay fill is progressing and they had just covered up a layer of grid at the time of our inspection. Batter slope appears to be approx. 1(v) in 1(h) as per the design.

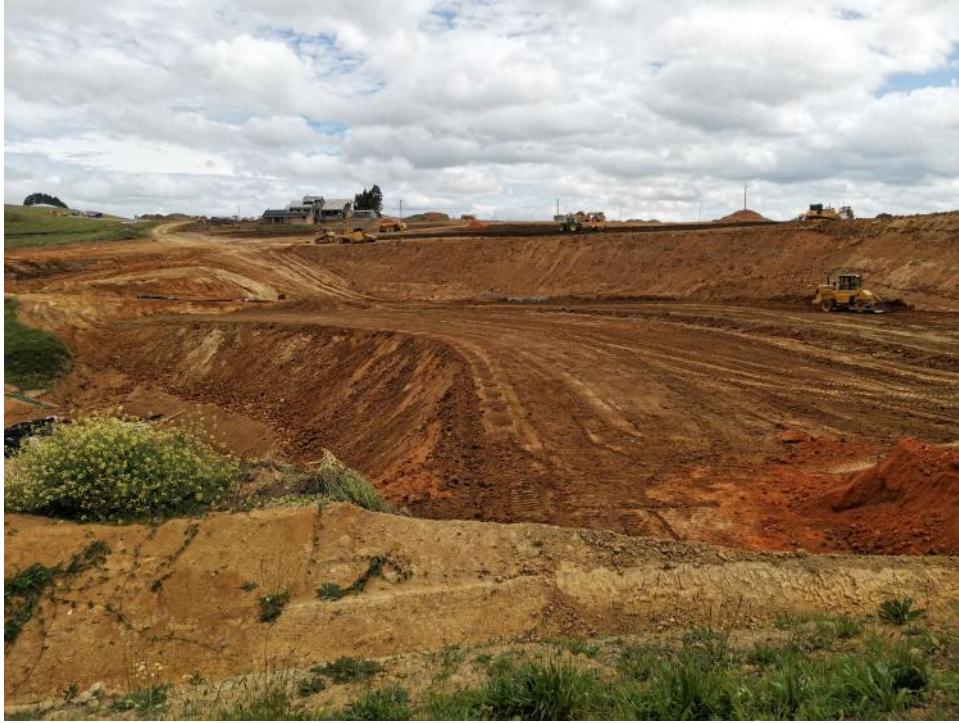
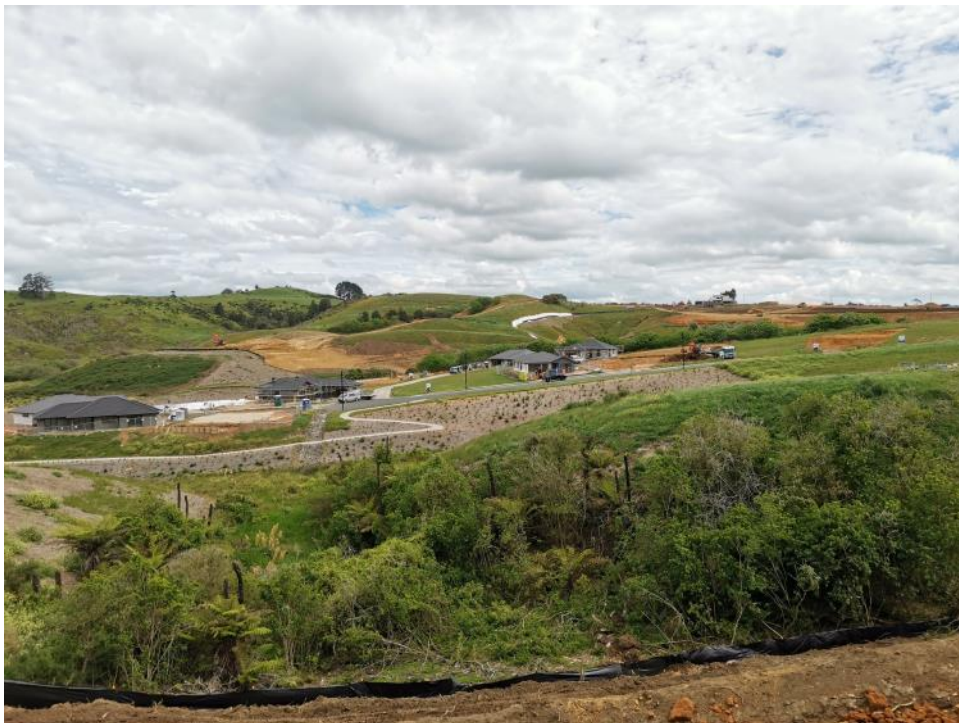
03/11/20

Project no. and name: <u>200113 - Kitchin Road</u>	Date & Time: <u>3.11.20 - 3pm</u>
Client/contractors present:	Lander staff: <u>KM</u> SV no:
Plant operating:	
Inspection for (tick all that apply): Shallow Foundations <input type="checkbox"/> Pile Foundations <input type="checkbox"/> Site Meeting <input type="checkbox"/> Subgrade <input type="checkbox"/> Retaining Wall <input type="checkbox"/> Other <input checked="" type="checkbox"/> <u>REB1</u>	
Observations/Discussions:	
<p>- Visited Kitchin 120 to inspect earthworks operations. Fill placement is in progress and they are planning on opening up the remainder of the gully once they have a spell of fine weather.</p> <p>- REB1 earthworks are still in progress. At the time of inspection the contractors were preparing their benches ready for the placement of the next layer of fill, which is likely to be tomorrow morning.</p> <p>- Silt pond excavations are still underway at the far end of site (relict ship area)</p>

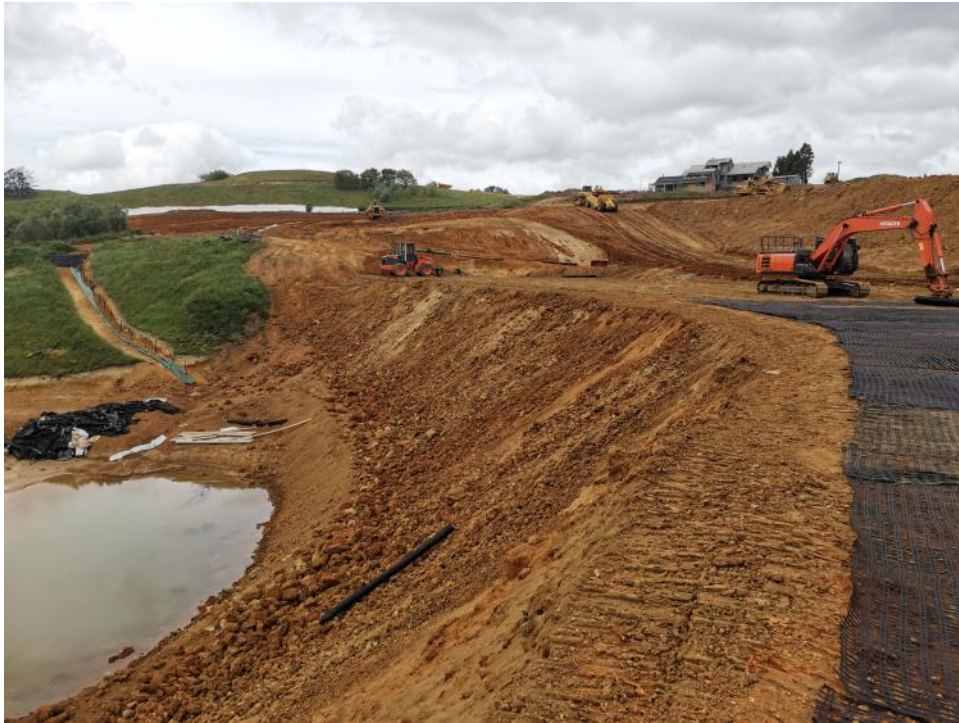
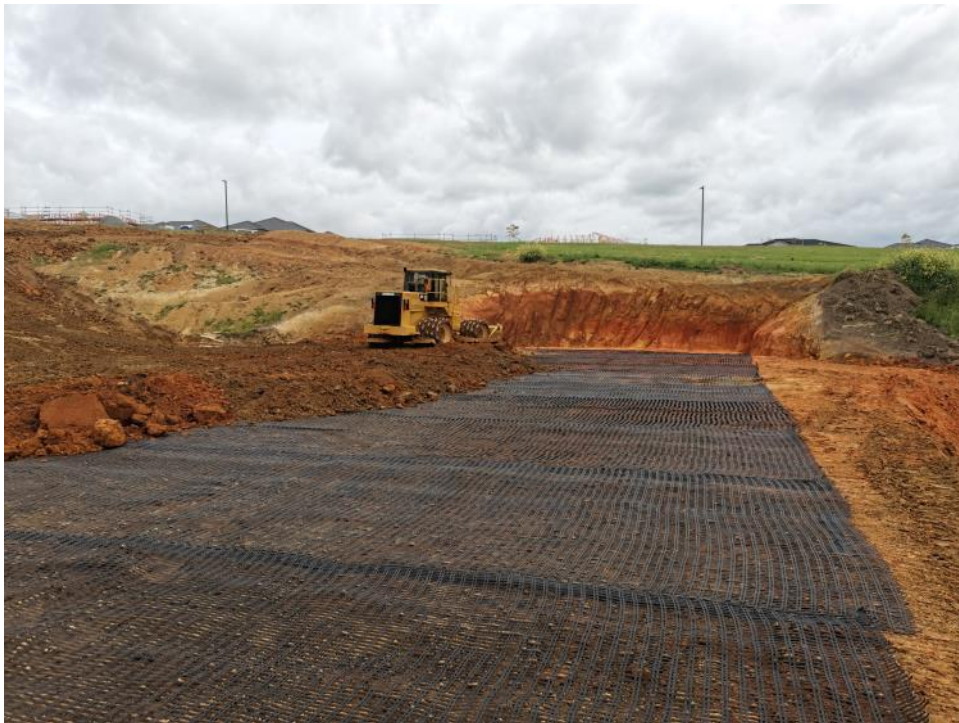
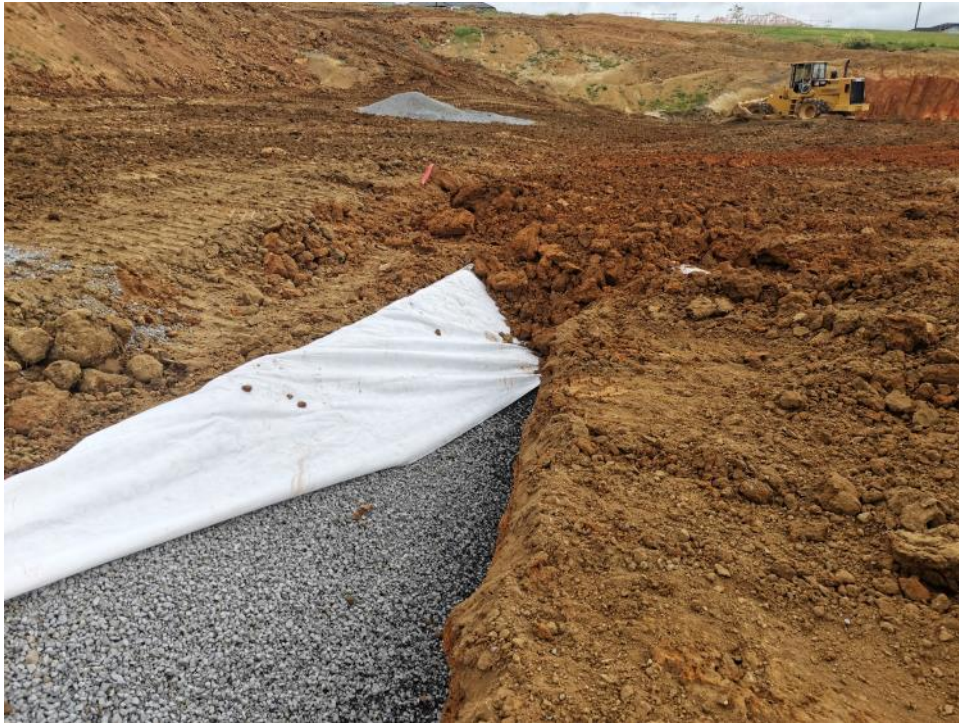
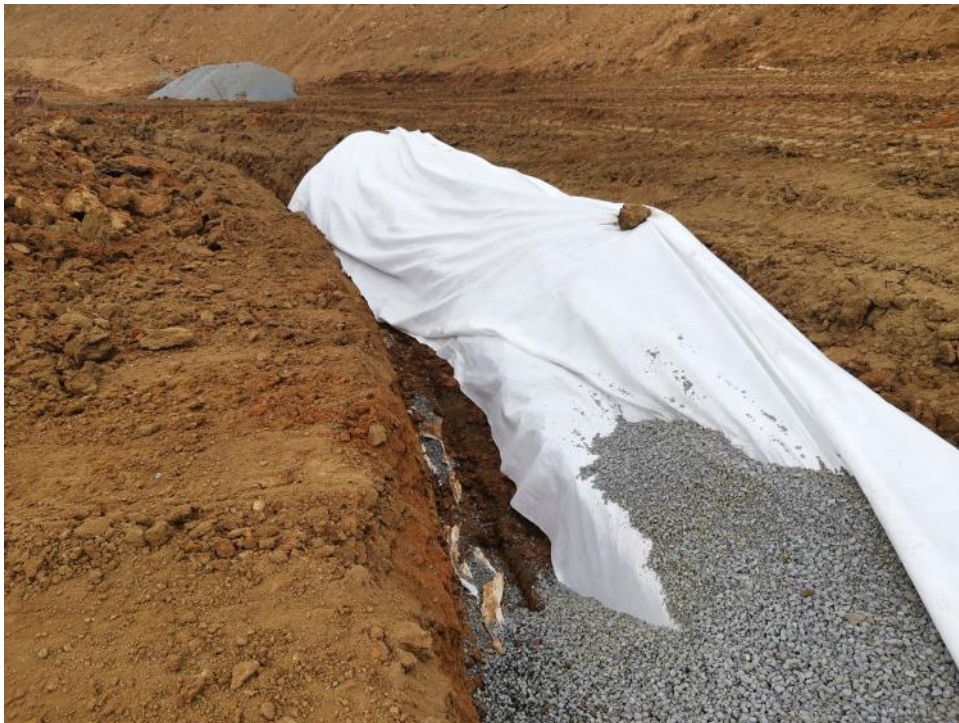
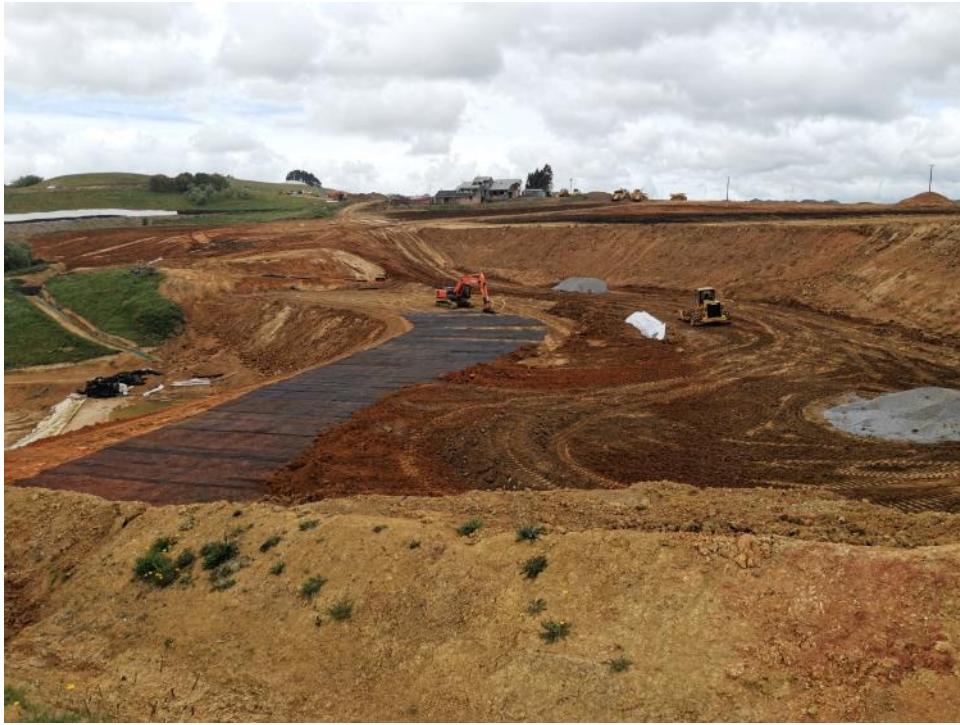
04/11/20 - REB1

SITE INSPECTION RECORD	
Project no. and name: J00113 - Hitchen Block	Date & Time: 4.11.20
Client/contractors present:	Lander staff: EM SV no:
Plant operating:	
Inspection for (tick all that apply):	
Shallow Foundations <input type="checkbox"/>	Pile Foundations <input type="checkbox"/>
Subgrade <input type="checkbox"/>	Retaining Wall <input type="checkbox"/>
Site Meeting <input type="checkbox"/>	
Other <input type="checkbox"/>	
Observations/Discussions:	
<ul style="list-style-type: none">- Visited site to inspect earthworks in REB1.- Contractors are currently laying SG700 grid to 13m length. Grid overlap is sufficient (approx 200mm) and grid placement looks tidy.- Advised operator that grid grade can be reduced to SG700 now as per our REB1 detail.	
Inspection Result: Pass <input checked="" type="checkbox"/> Fail <input type="checkbox"/>

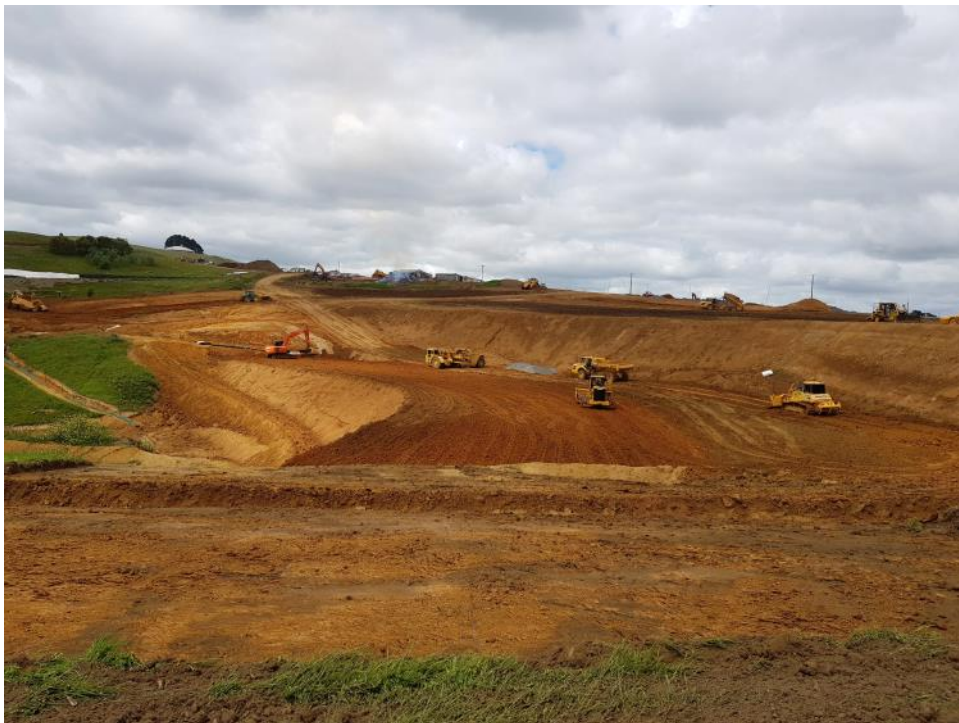
13/11/20

Works have re-started on REB1 after the wet weather. Contractor was about to commence placement of another grid layer. Clay material still being dried out/ conditioned.

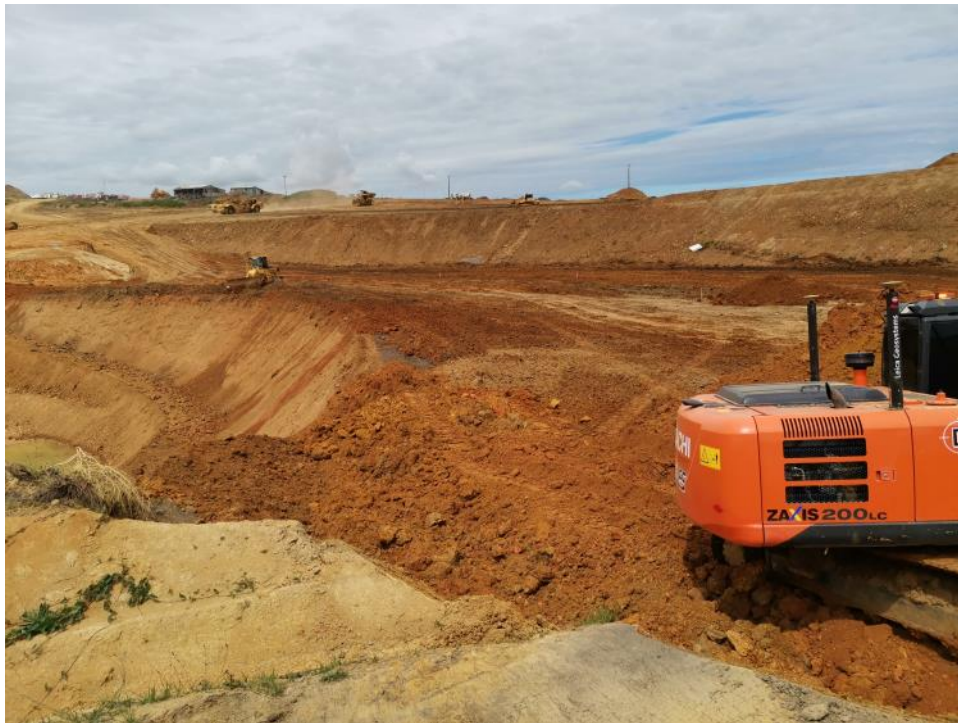
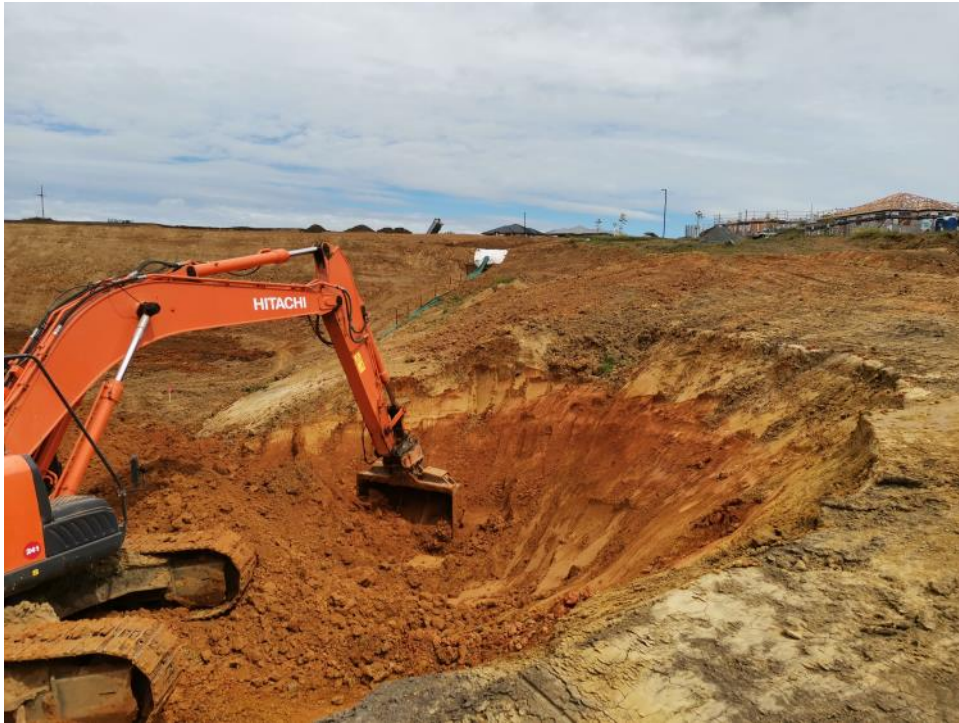
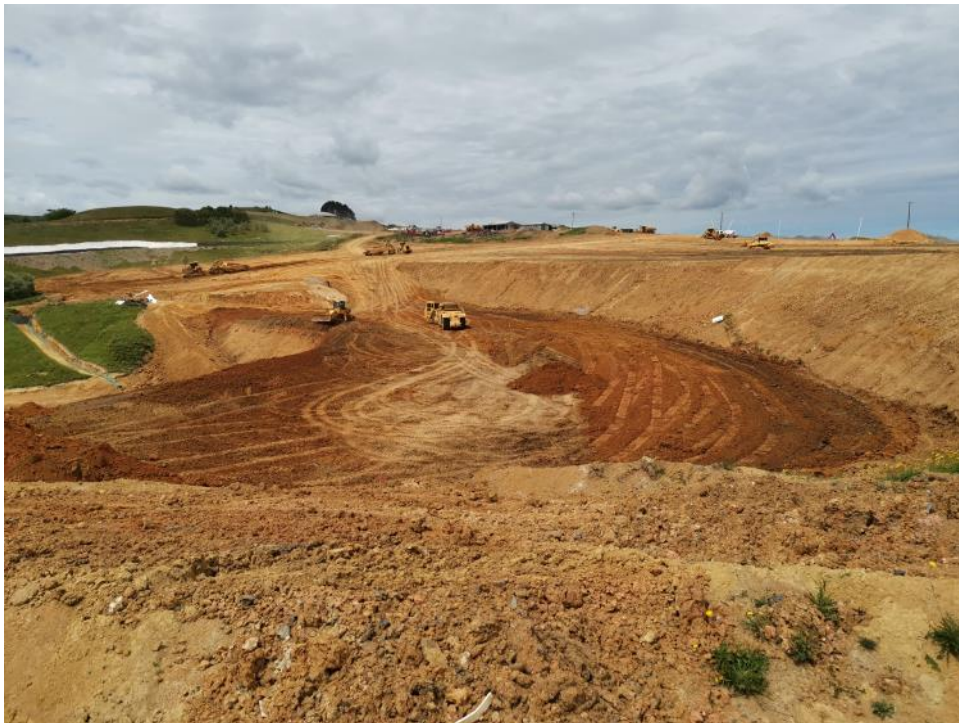
Visited site to observe earthworks operations in REB1. The REB is now up to chainage 49.5 and a layer of intermediate grid had just been placed and covered by clay. The next bench was being prepared at the time of inspection. Contractor informed that the next grid would likely be placed tomorrow morning so will do another inspection of the grid then.

Was also informed that the lateral drain was trenched and installed mid-last week, for which we received the as-builts. Advised we should try inspect the next section of drainage installation if possible.

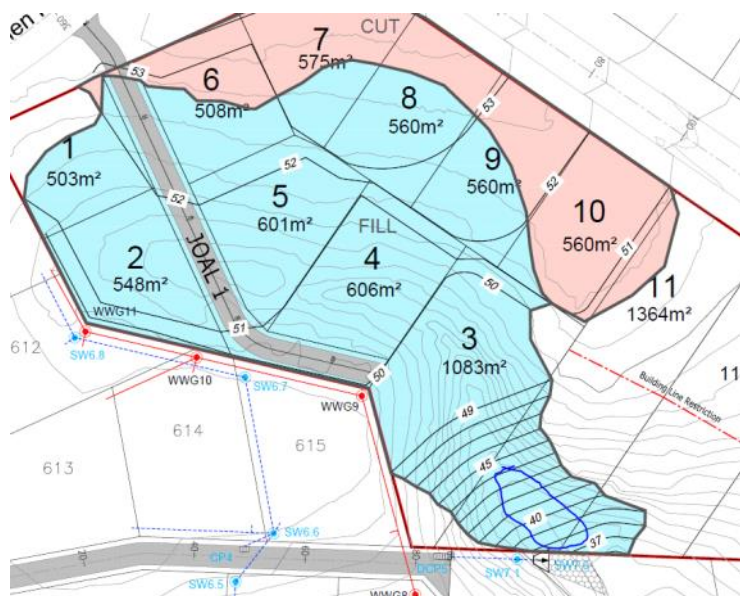
Visited site to observe the gully muckout within Stage 12D. The muckout is commencing from the lower portion of the gully and will tie in with the existing underfill drain once some engineered fill has been placed in the area to allow digger access. Approx. area sighted shown in blue annotation below. Will return to site tomorrow to observe progress here.

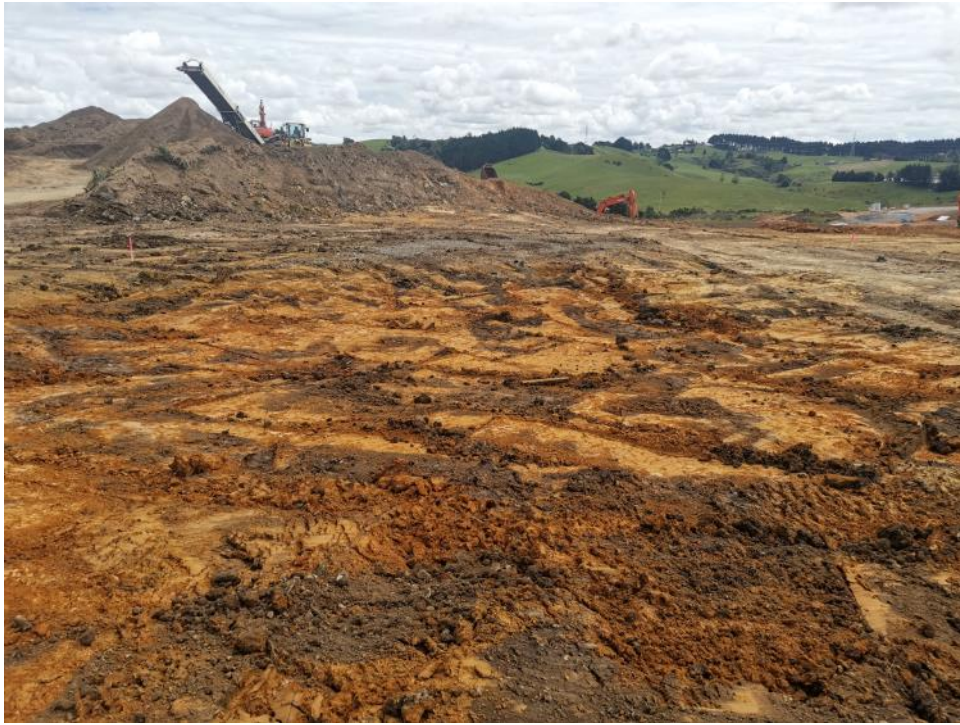
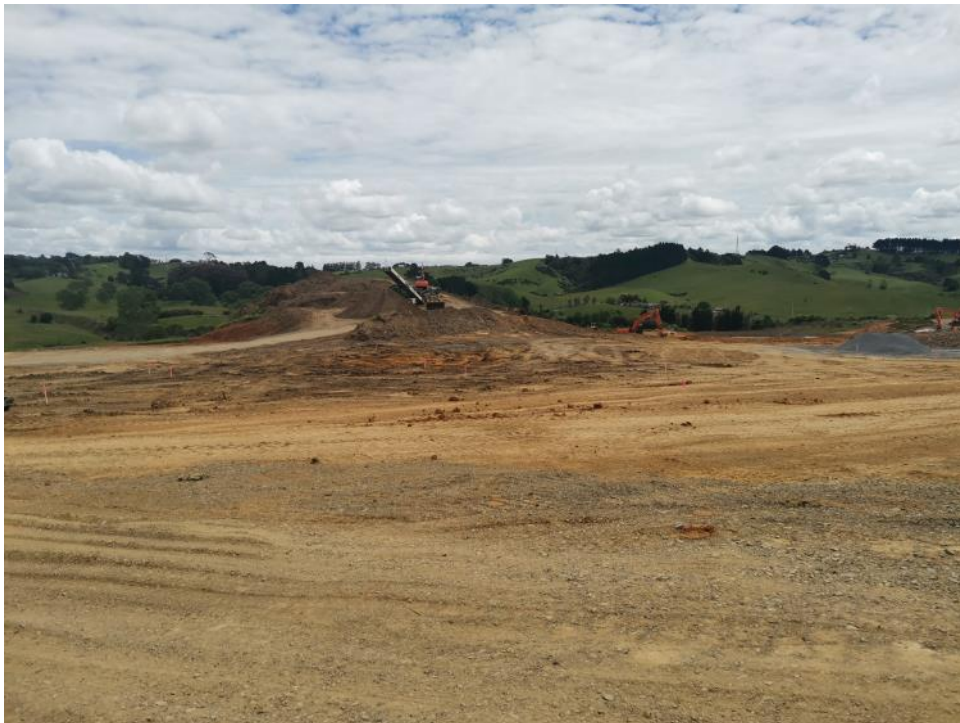
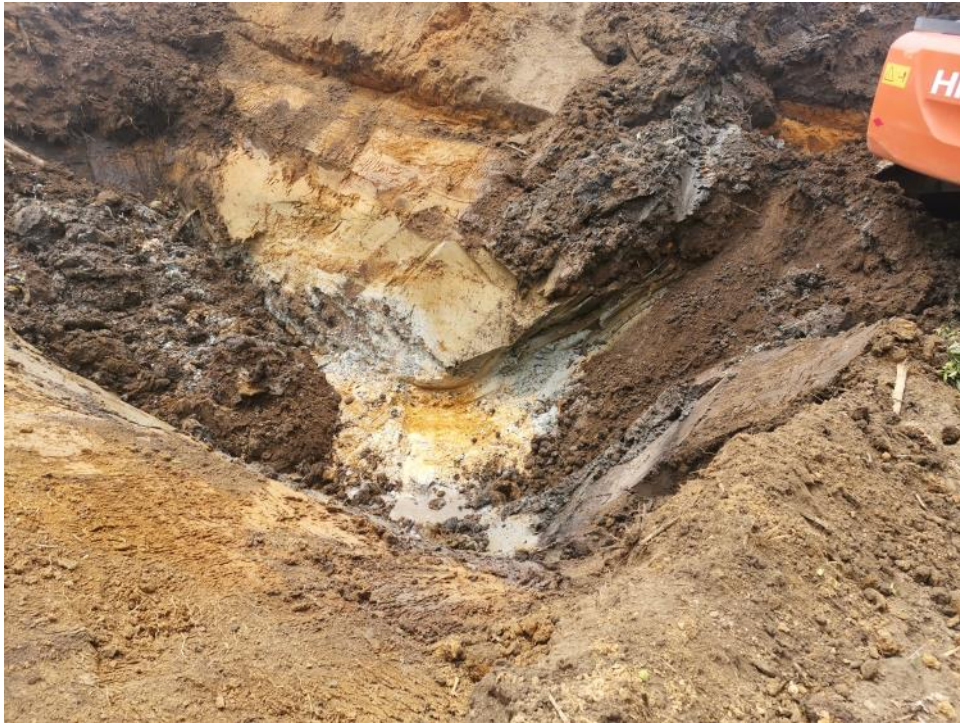
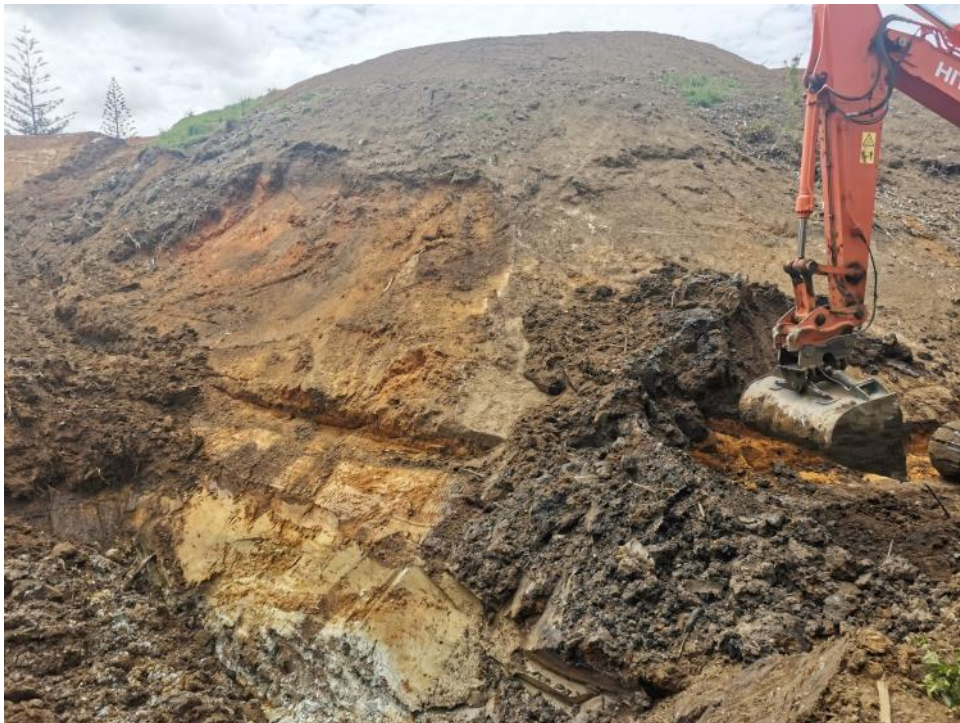
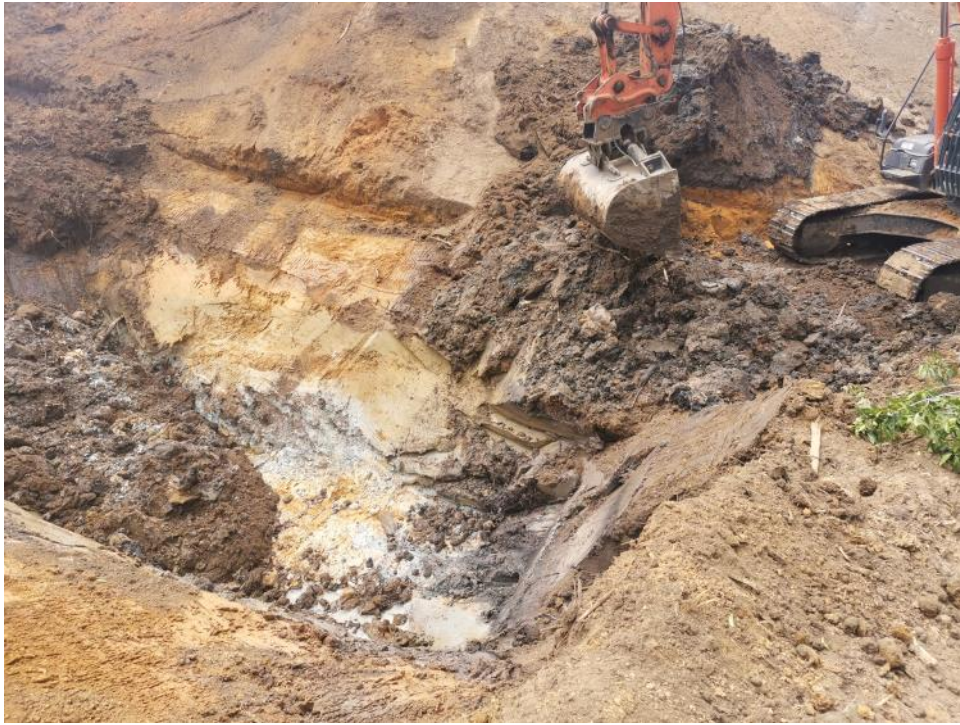
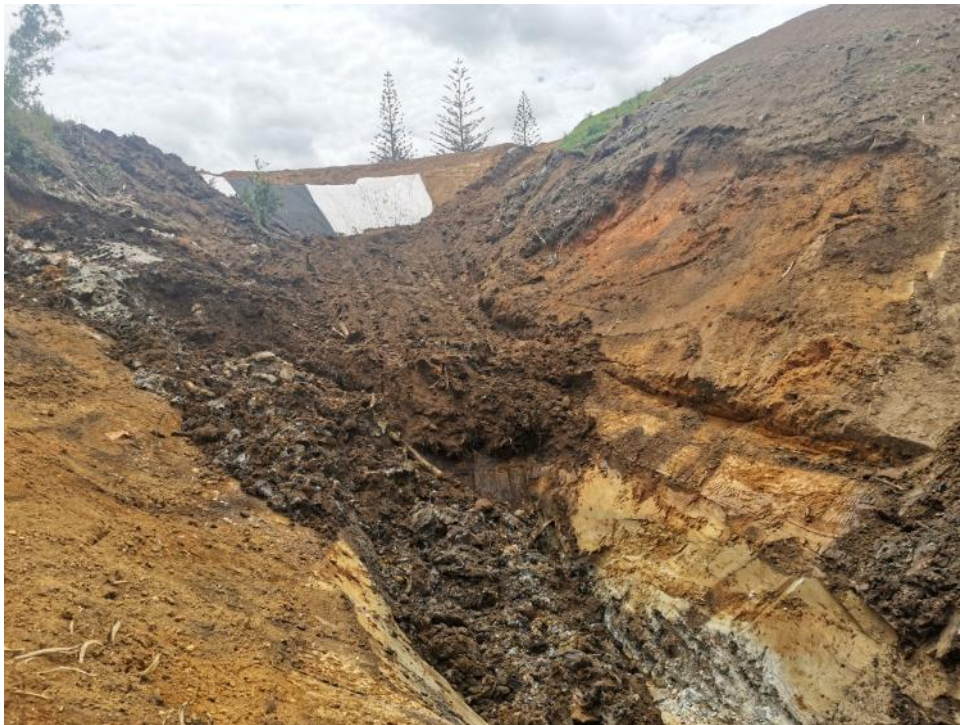
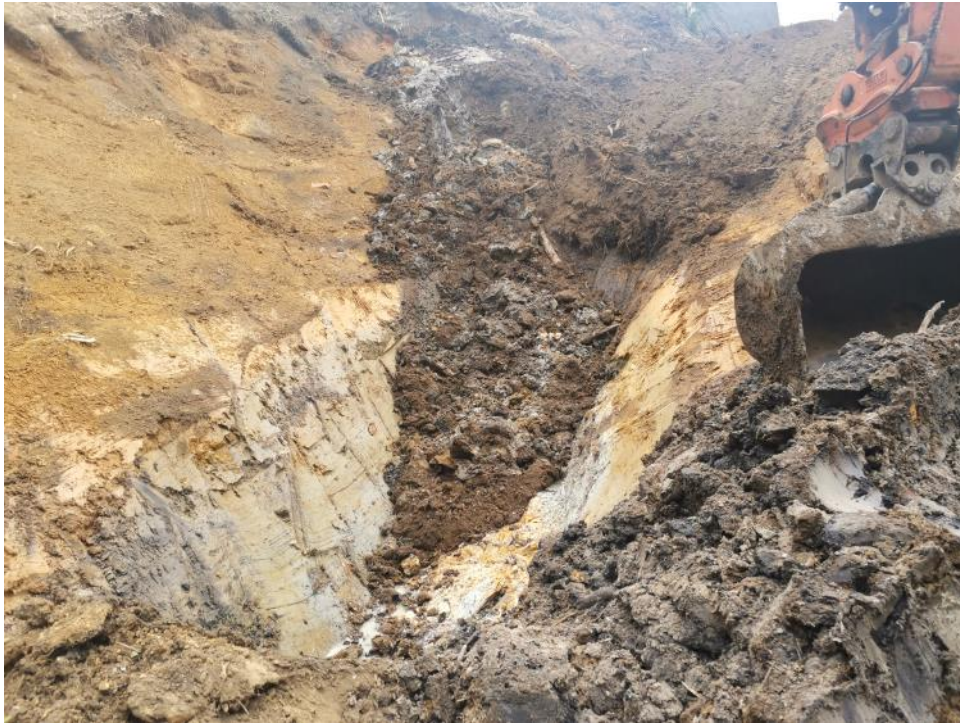
Also inspected the removal the stockpile materials within Fill D. Very stiff, orange/brown ash soils were exposed consistent with the stripped soils previously sighted within the adjacent cut areas.

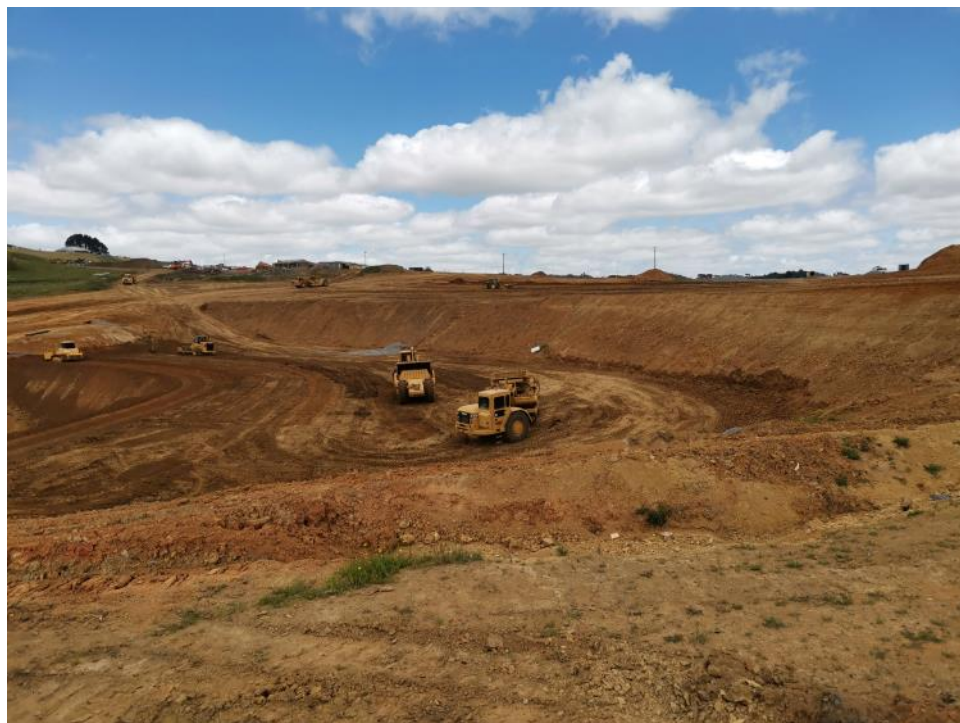
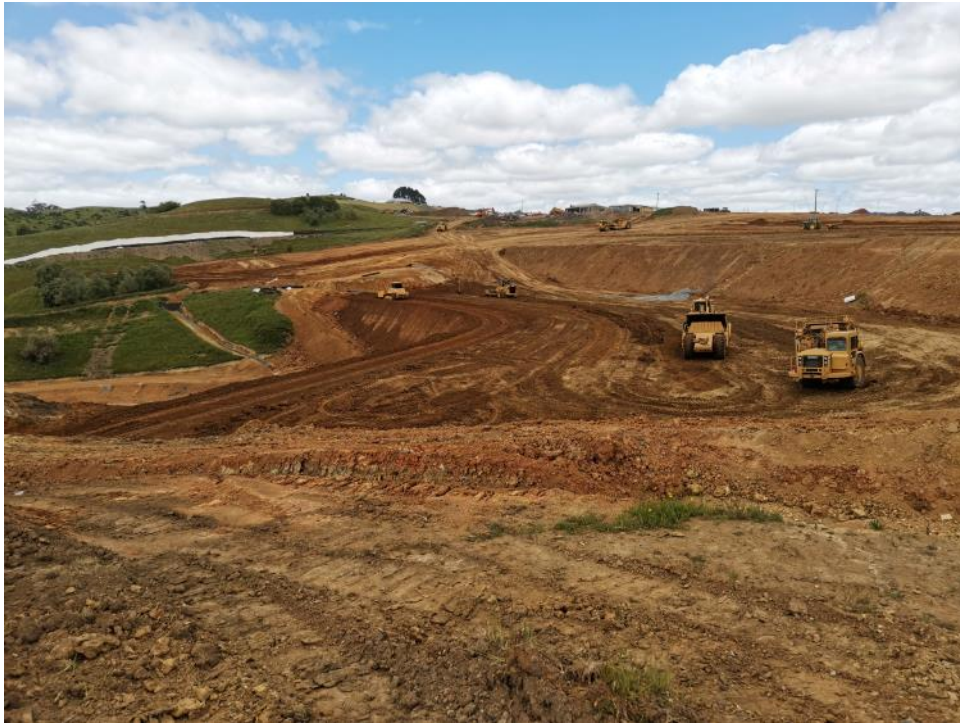
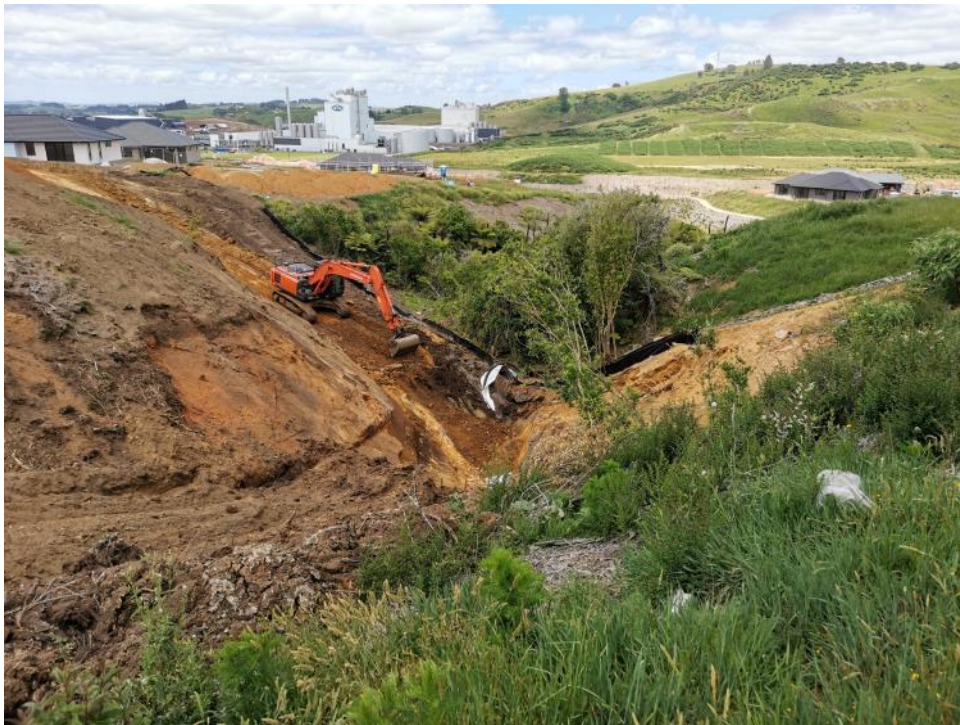
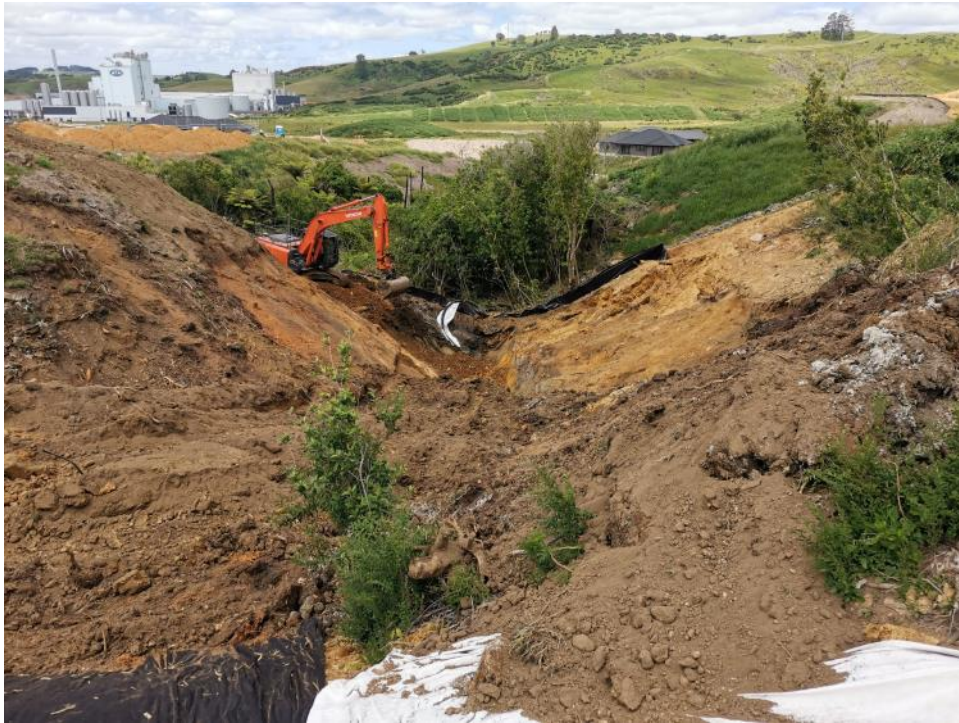
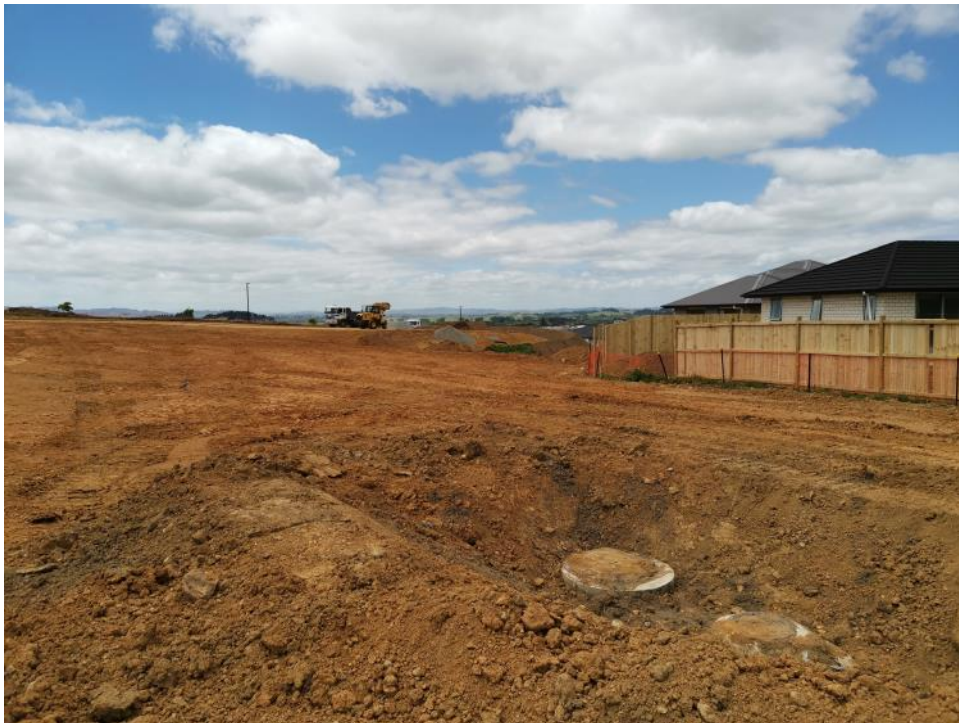
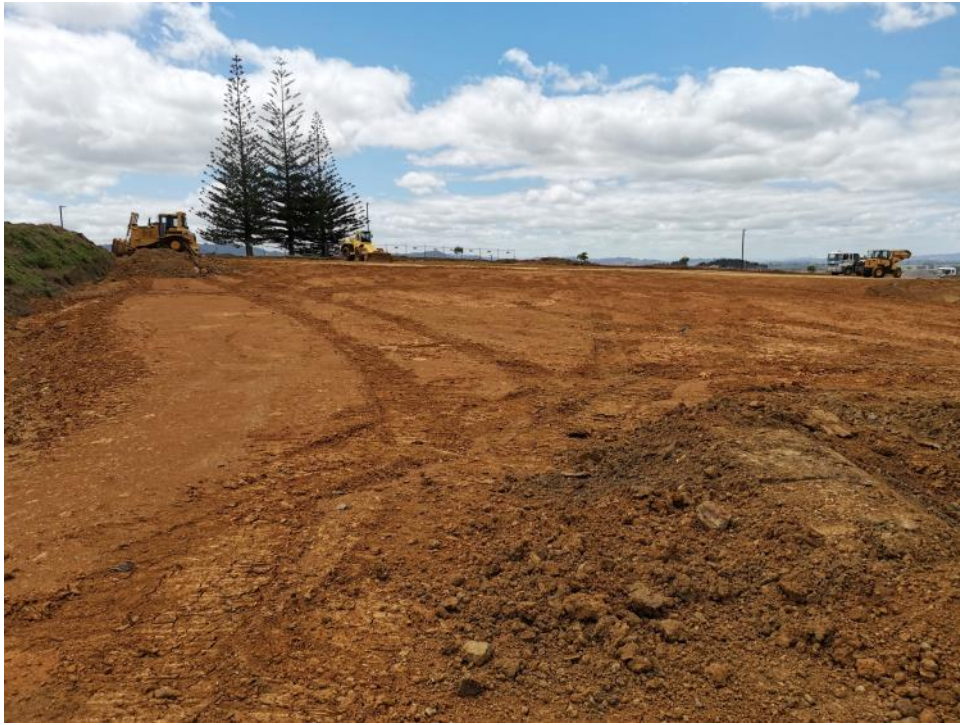
Visited site to observe general earthworks operations. Within Stage 12D the base of the gully had been mucked out slightly further upslope and the drain coil and bidim cloth were in place at the base of the muckout. SPR was being placed over the drain to be compacted.

Within REB1 clay fill was still being compacted. It appeared that the geogrid had already been placed.
