Geotechnical Completion Report

HITCHEN BLOCK STAGE 13B

17 January 2022

Ref No: J00113

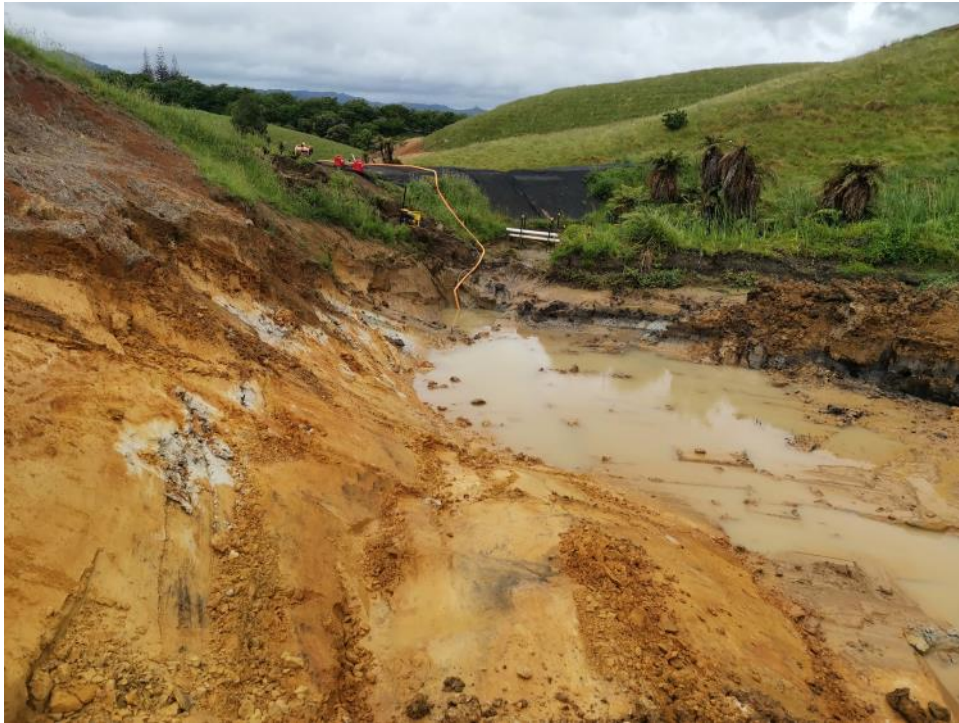
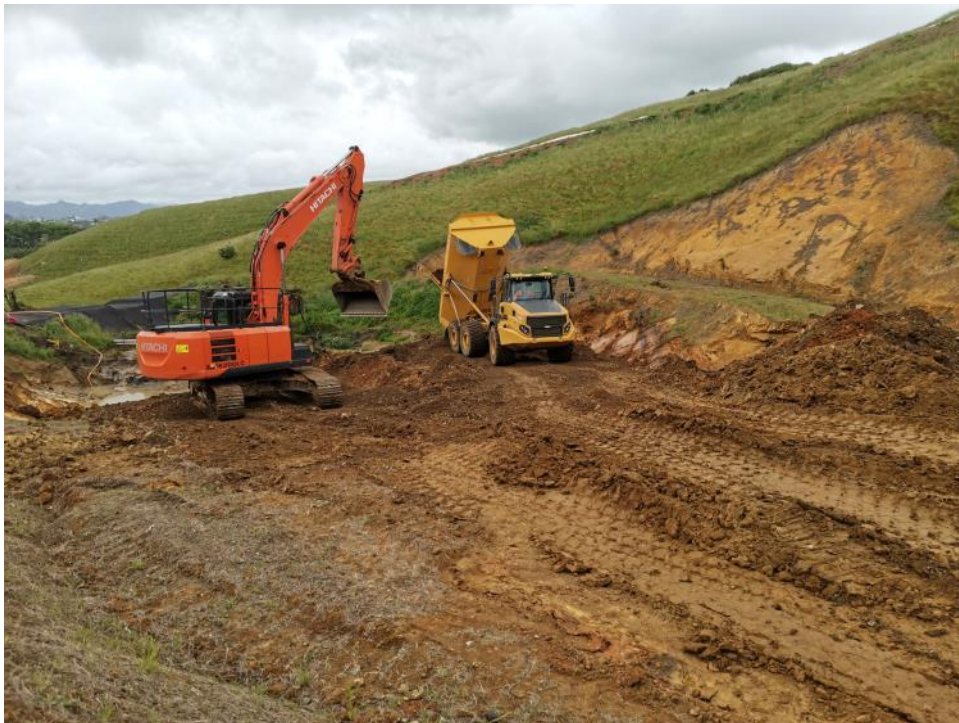
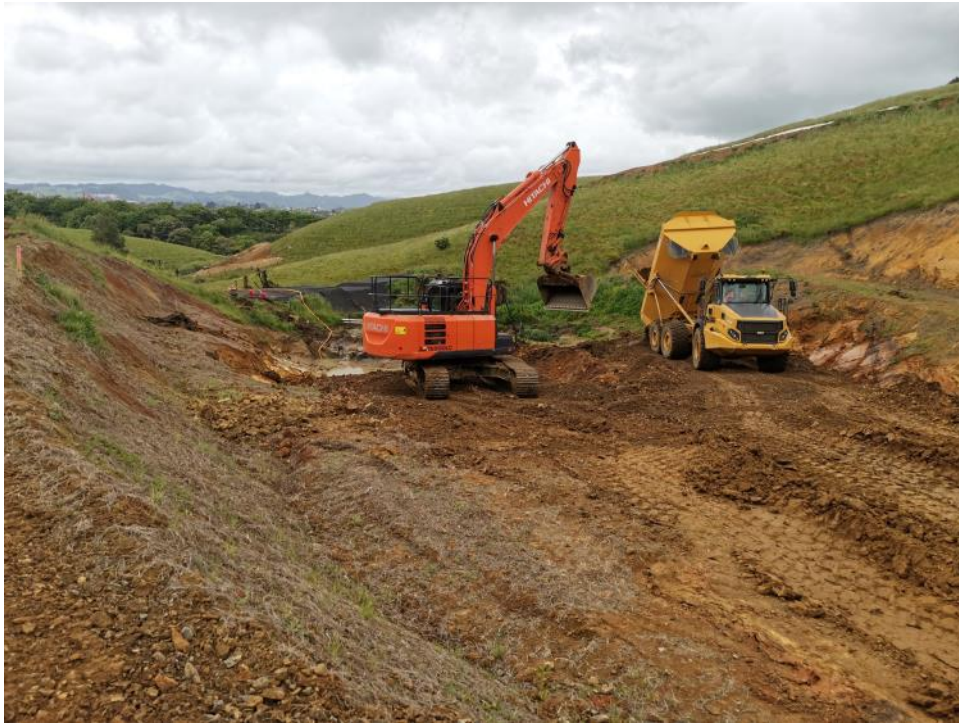
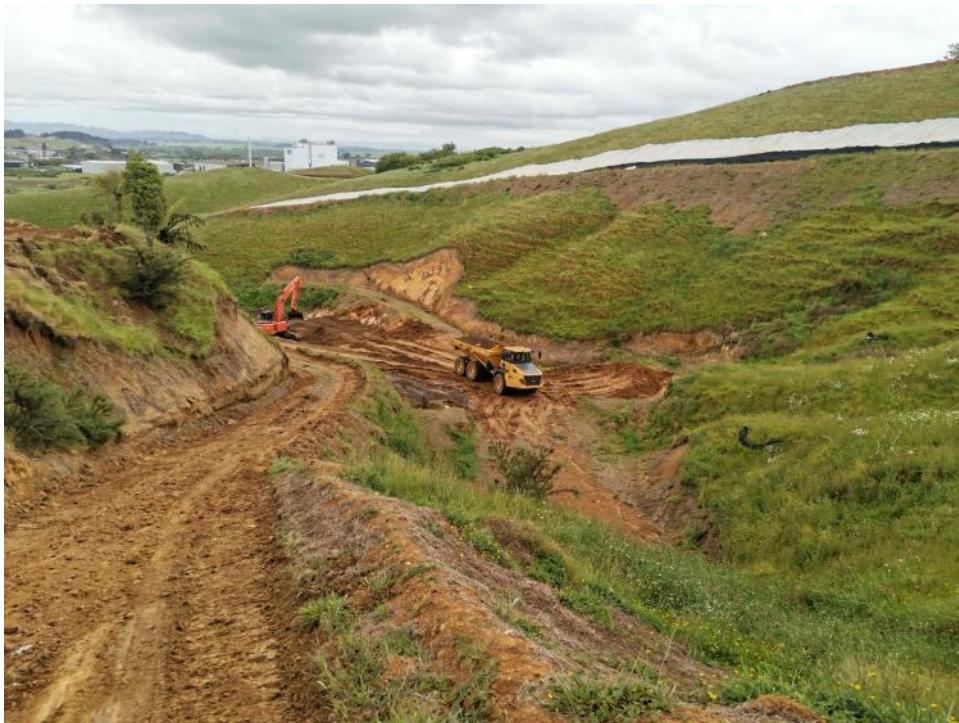
Checked these works against our model which confirmed that the approximate depths and materials were consistent with our model. Informed Dylan that shear key operations could continue as planned, but 2 or 3 trial pits will be required in the base of the shear key once it has been opened up to further validate the ground conditions beneath the base of the shear key.

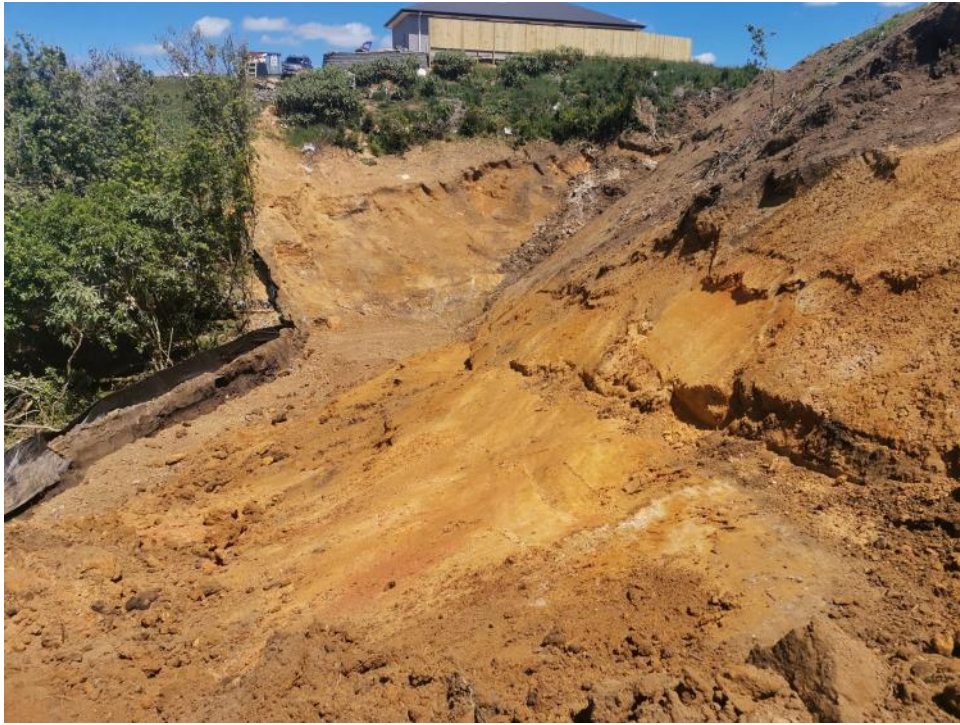
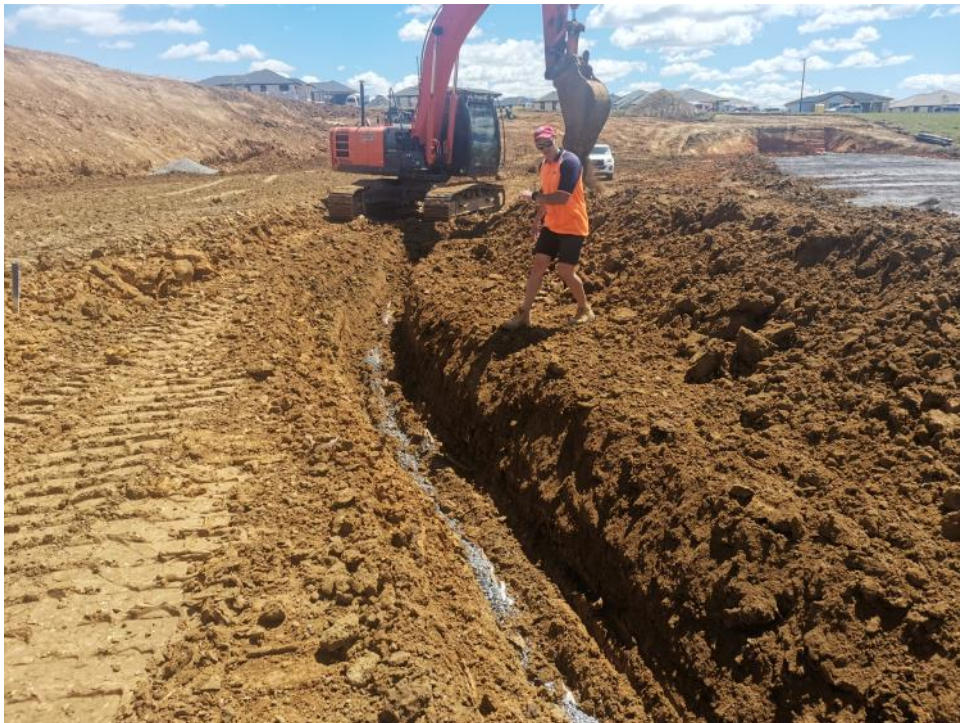
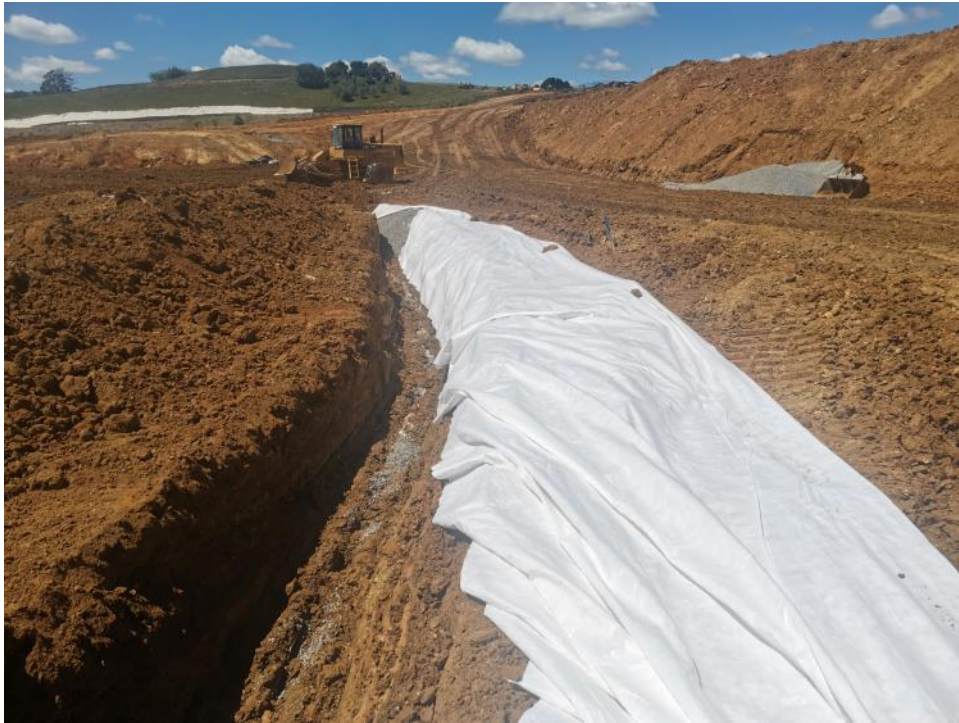
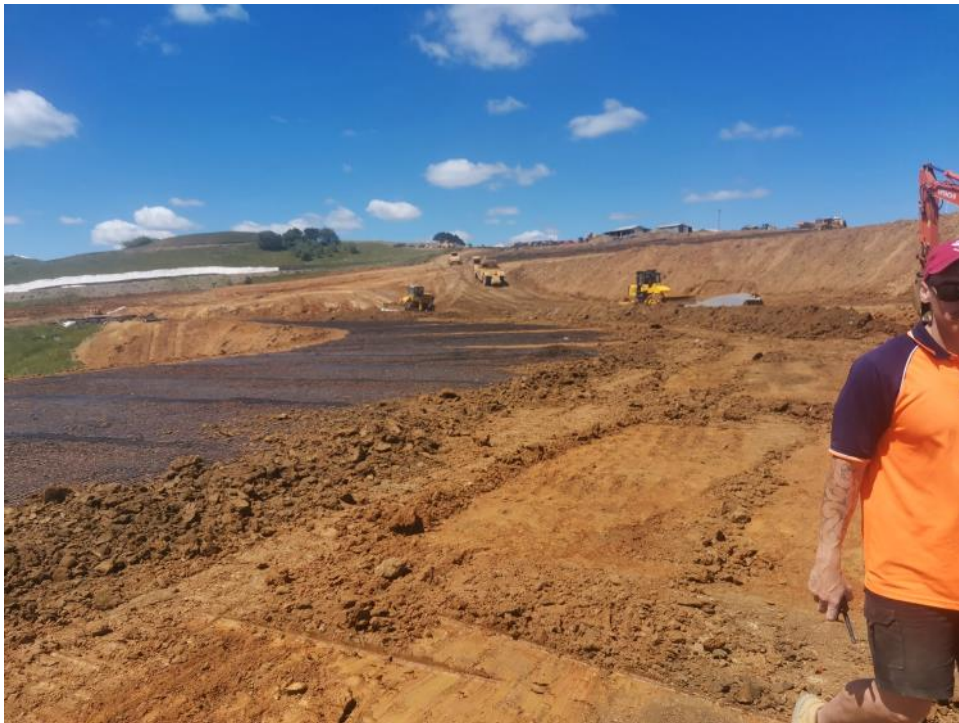
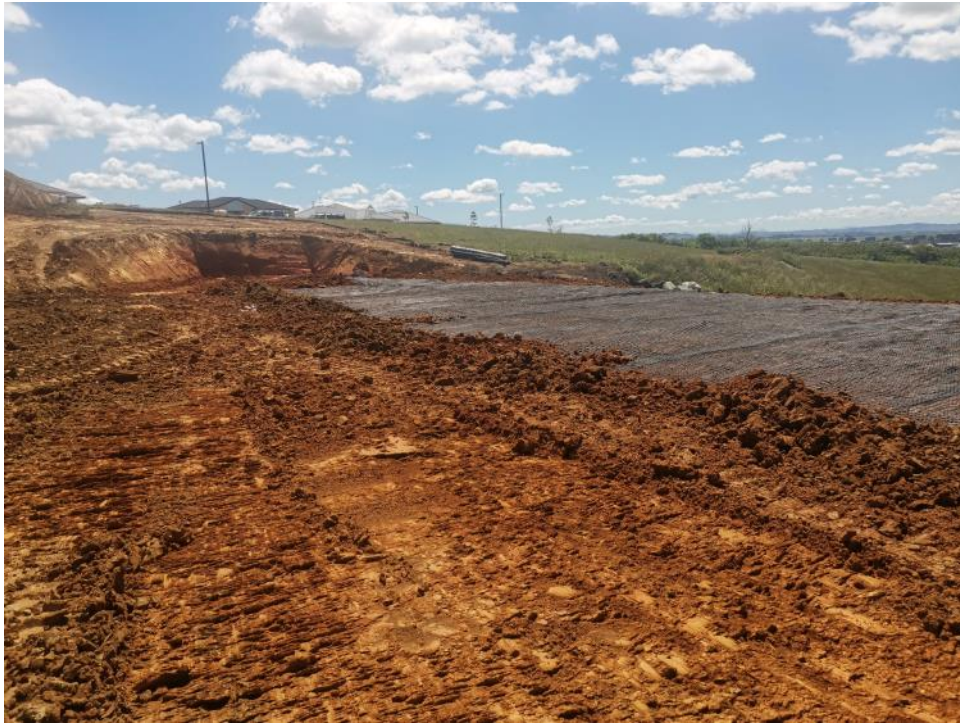
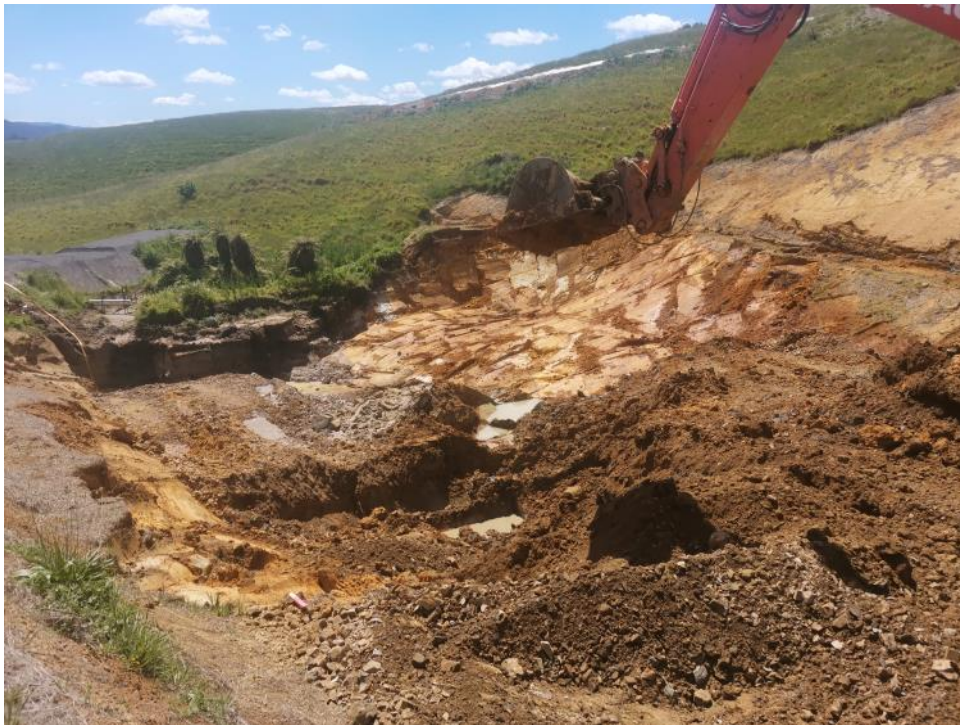
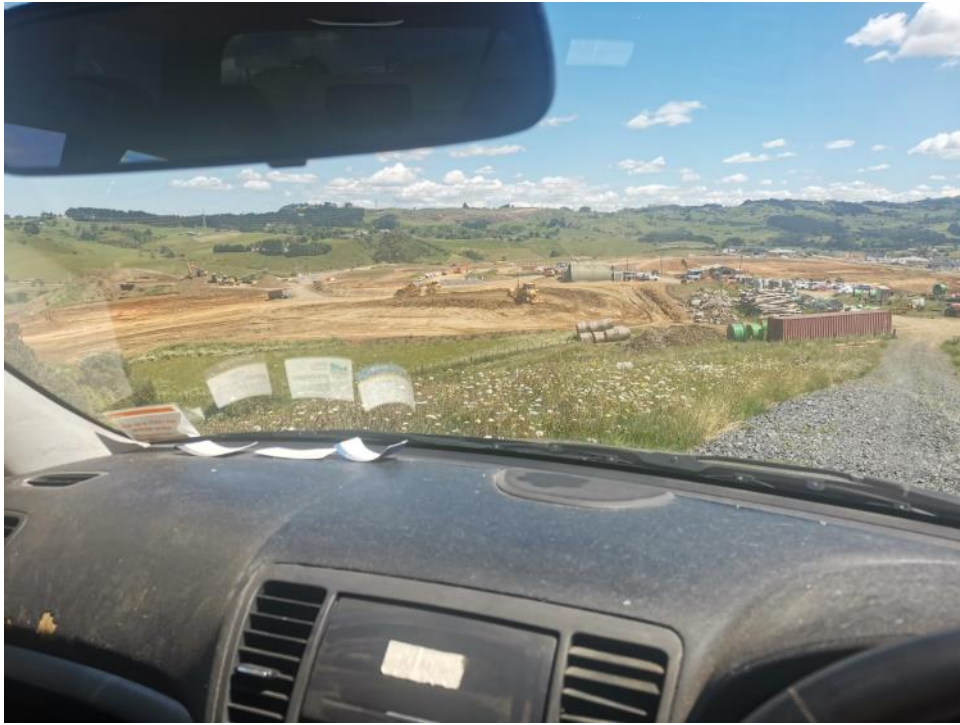
Observed shear key operations in this gully. The shear key looked that same as our previous inspection, and the gully is still being mucked out for the shear key. From what we can see the base appears hard, however, we haven't been able to test the base of the shear key yet due to the muckout still needing to progress.

Not much progress has been made since our last inspection in this area. The SPR in the base of the gully is still loose and requires compaction. The contractor is planning to bring a pad-foot roller down to this area to start backfilling the gully.

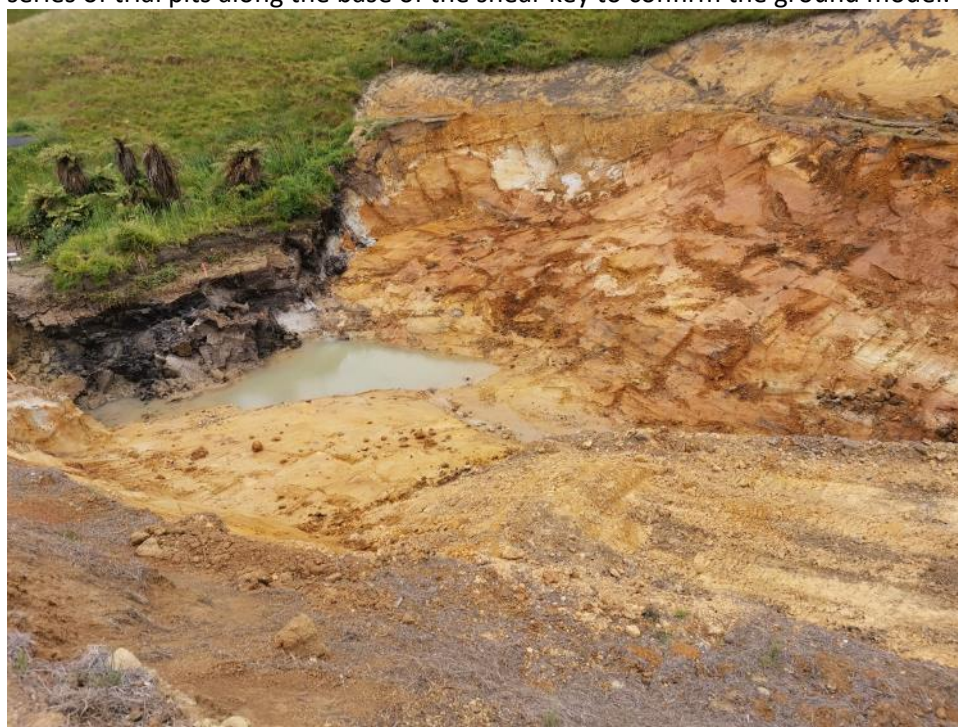
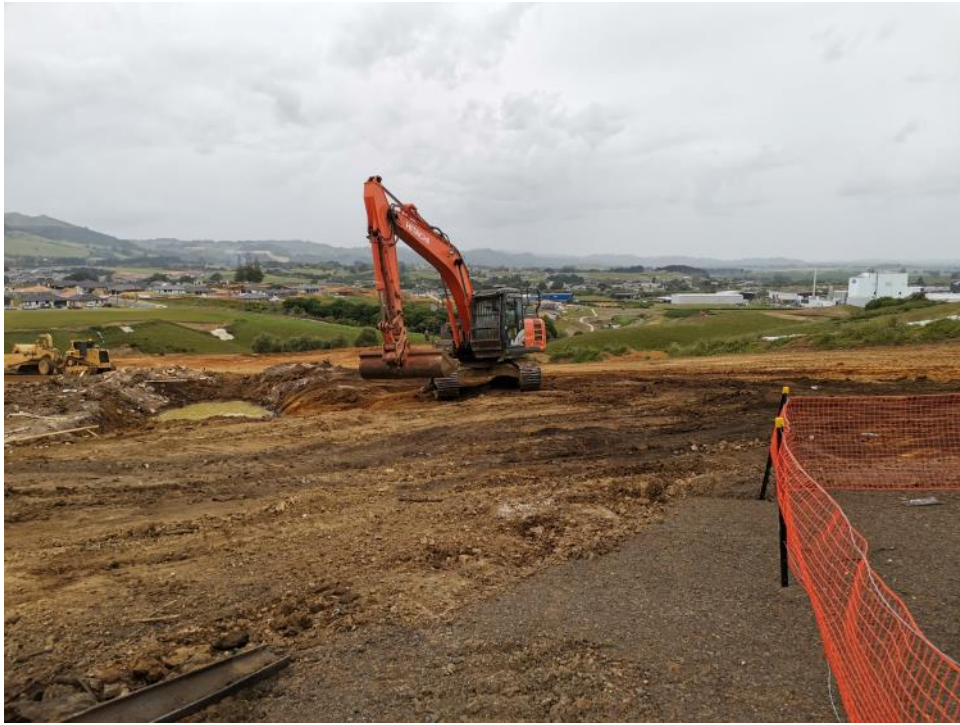
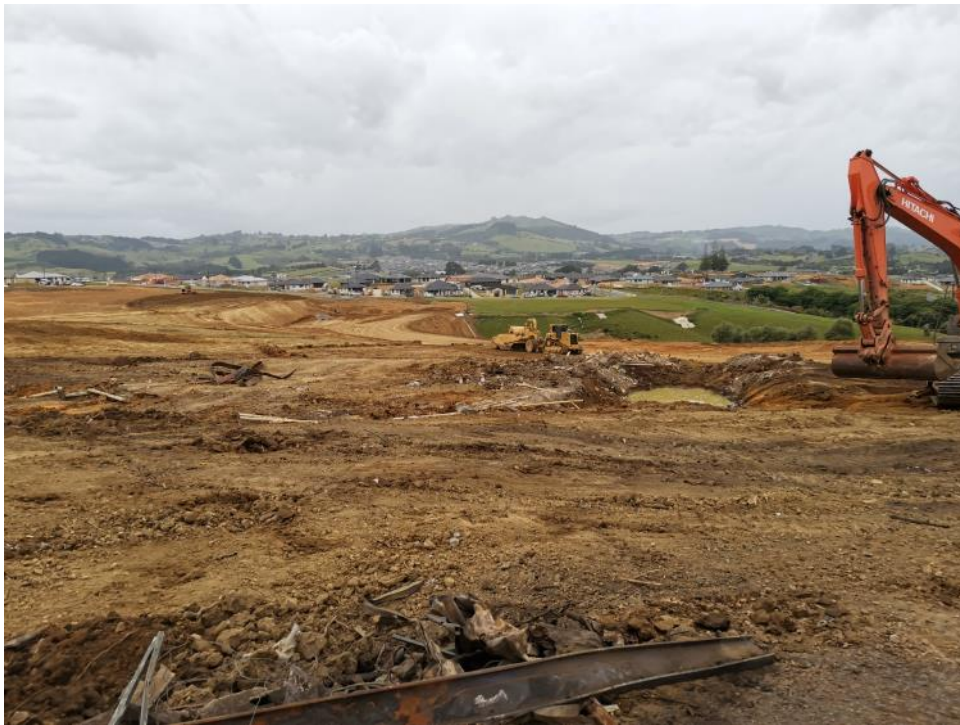
Visited site at the request of Dylan to inspect earthworks operations in REB2 shear key.

The shear key has been opened up slightly more since our last inspection, however, more works are still required to enable proper access into the shear key. Once this has been done we will observe a series of trial pits along the base of the shear key to confirm the ground model.

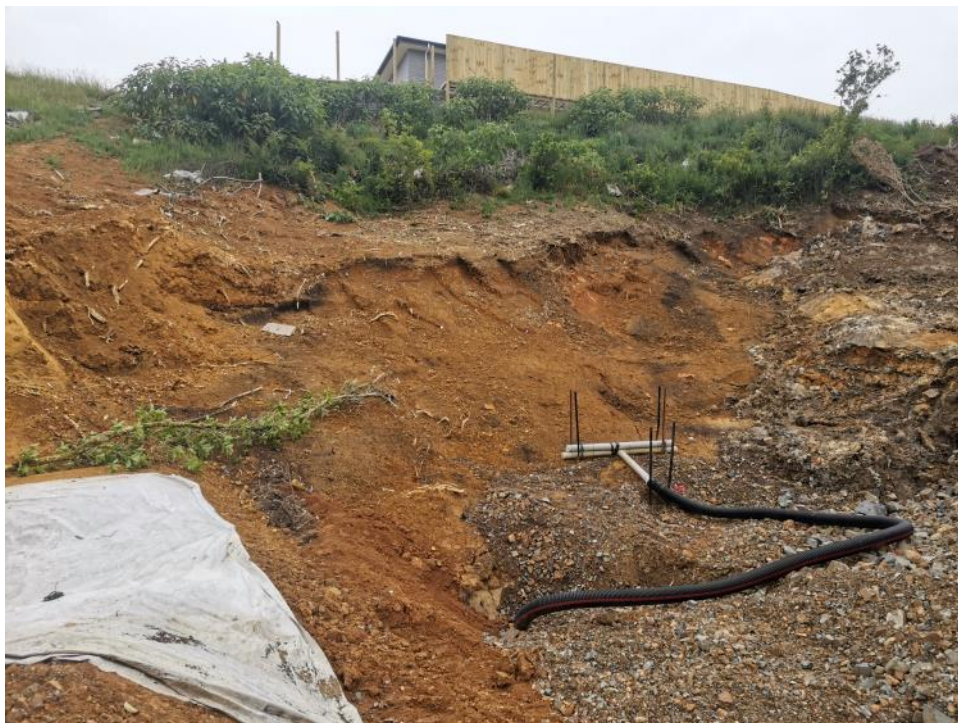
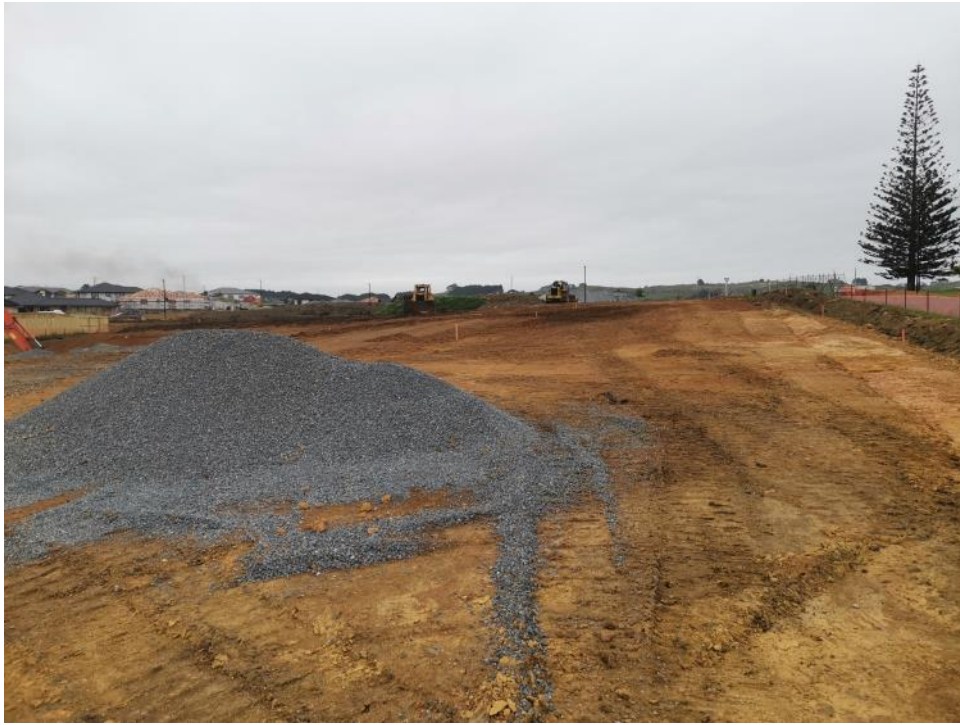
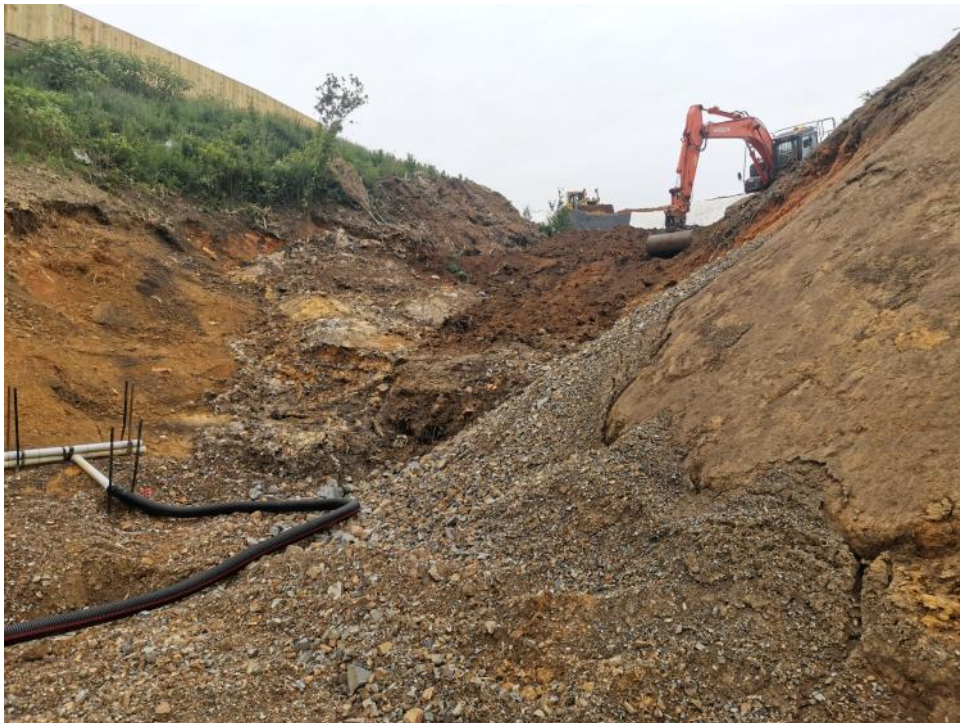
Not much progress has been made since our previous inspection and there is spoil along the gully which is still to be cleared. Also discussed that a toe key is required at the base of the proposed fill batter, which the contractors are proposing to install prior to building the fill batter.

Also discussed the stripping in Lots 611 and 612 which Russell emailed about last week. This area is still covered by a topsoil stockpile. Advised the operator to get Dylan to get us in for an inspection prior to placing fill in this area.

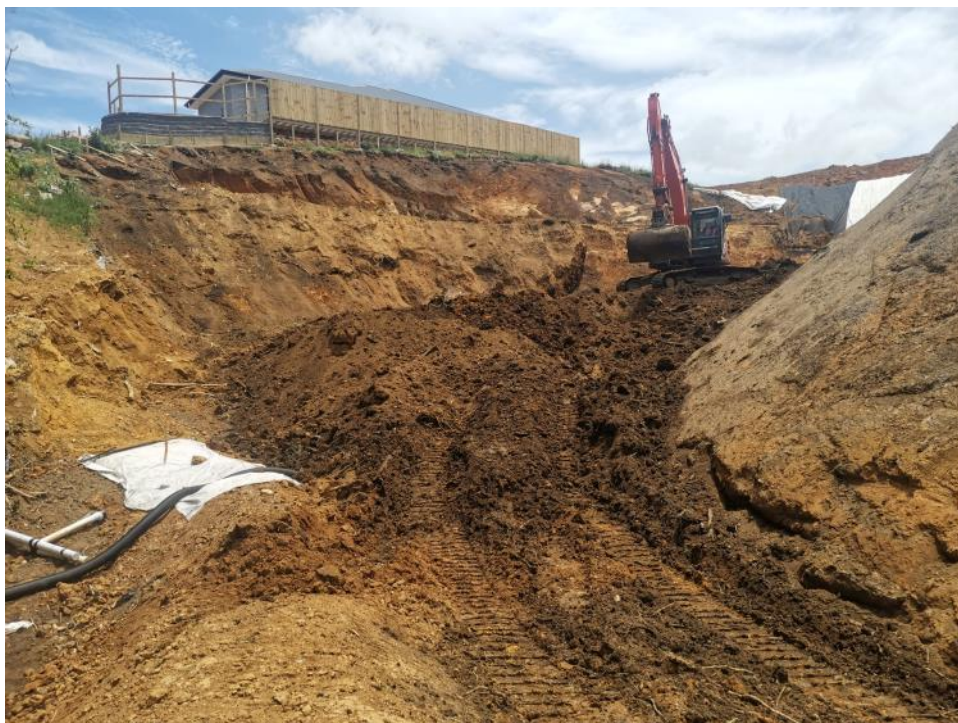
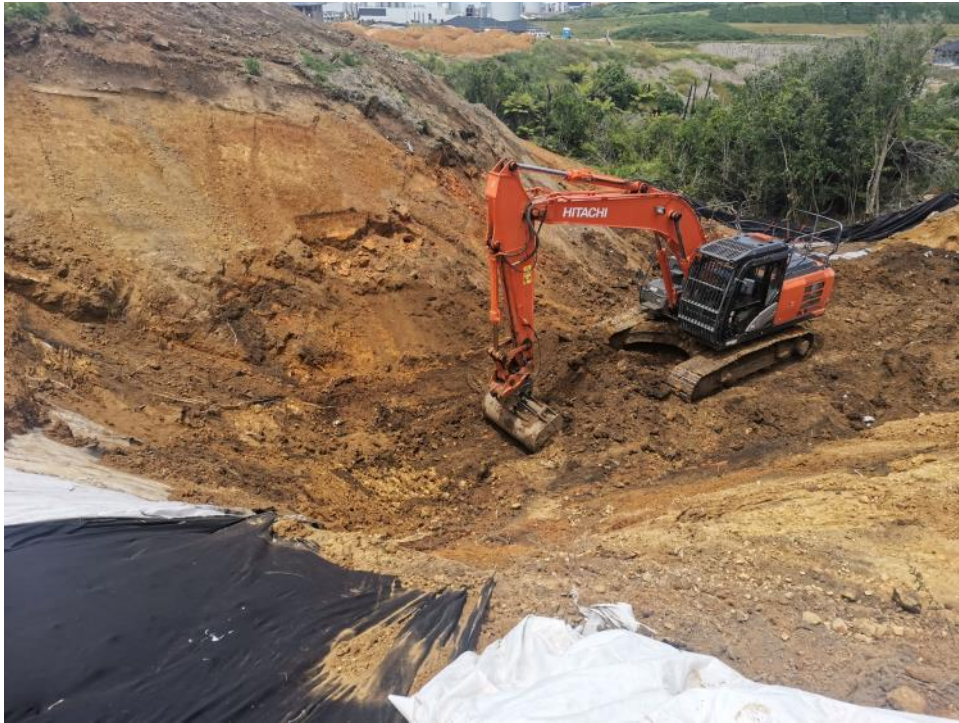
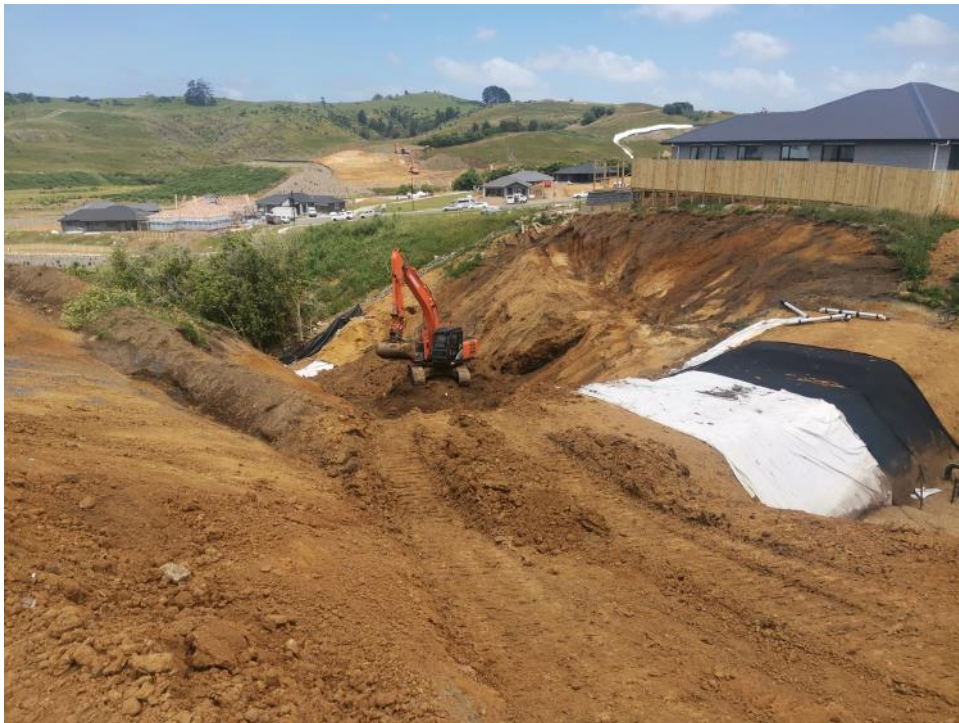
The remained of the gully is still being stripped, and excess spoil is still placed along the gully waiting to be loaded out. There is a vertical cut along the gully flank which is located just below an existing dwelling. Advised this should be backfilled and supported in the short term to provide stability to the dwelling.

Filling has also occurred over lots 612 and 613 from the adjacent GCR stage. We will drill several 2m boreholes here to confirm adequate stripping. Asked Trevor to also organise a fill test in this area for inclusion in our addendum GCR letter.

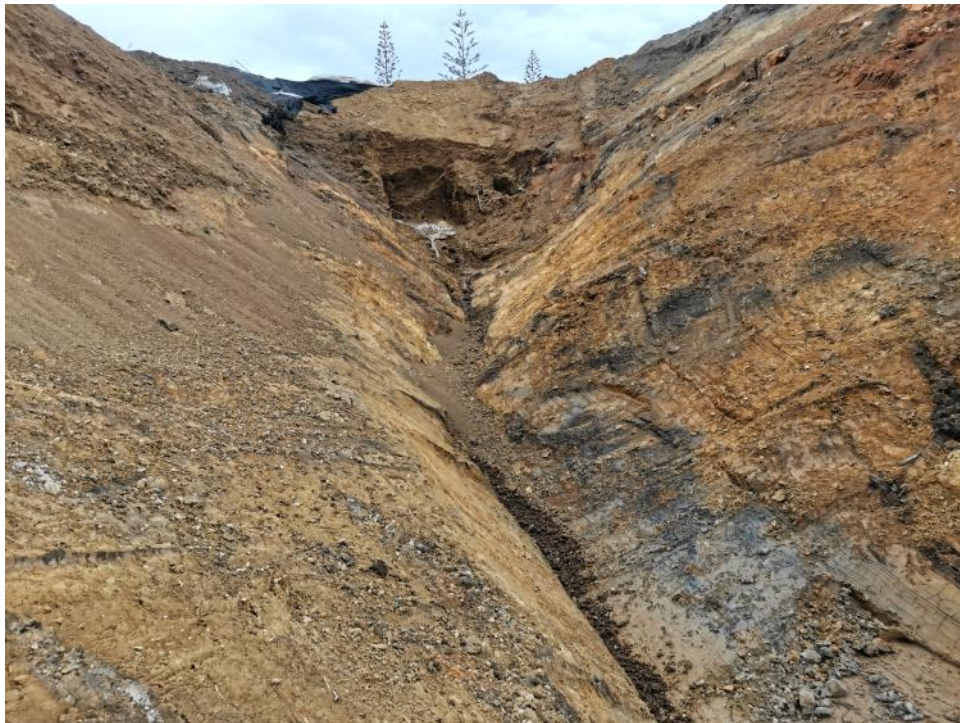
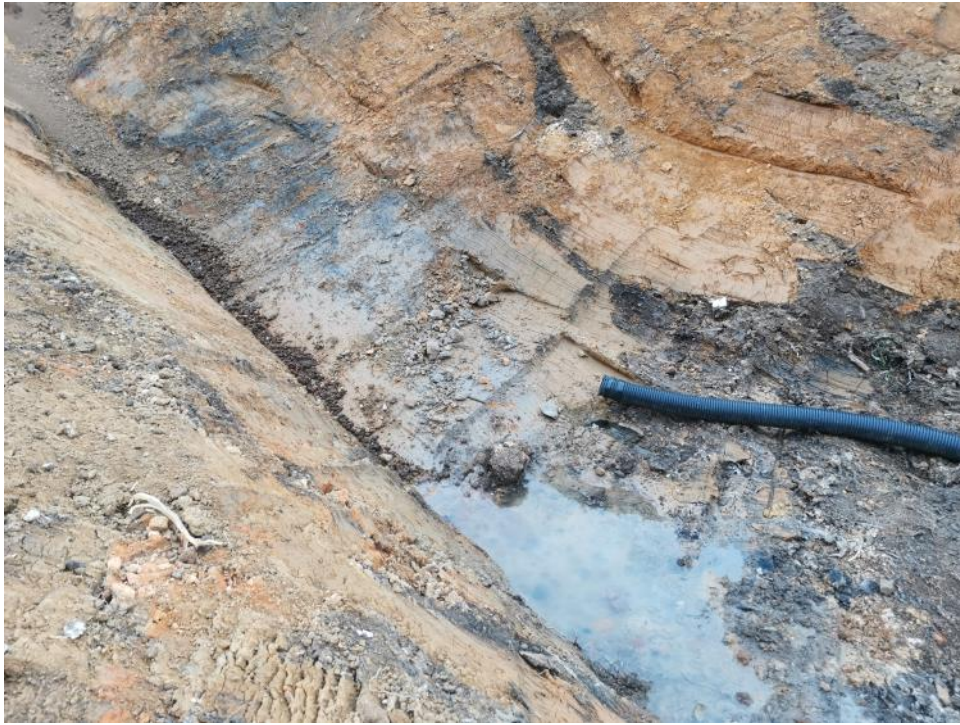
The gully has also been stripped and the underfill drain is to be placed next.

Dines has also placed some temporary fill in the cut that was open below the existing house.

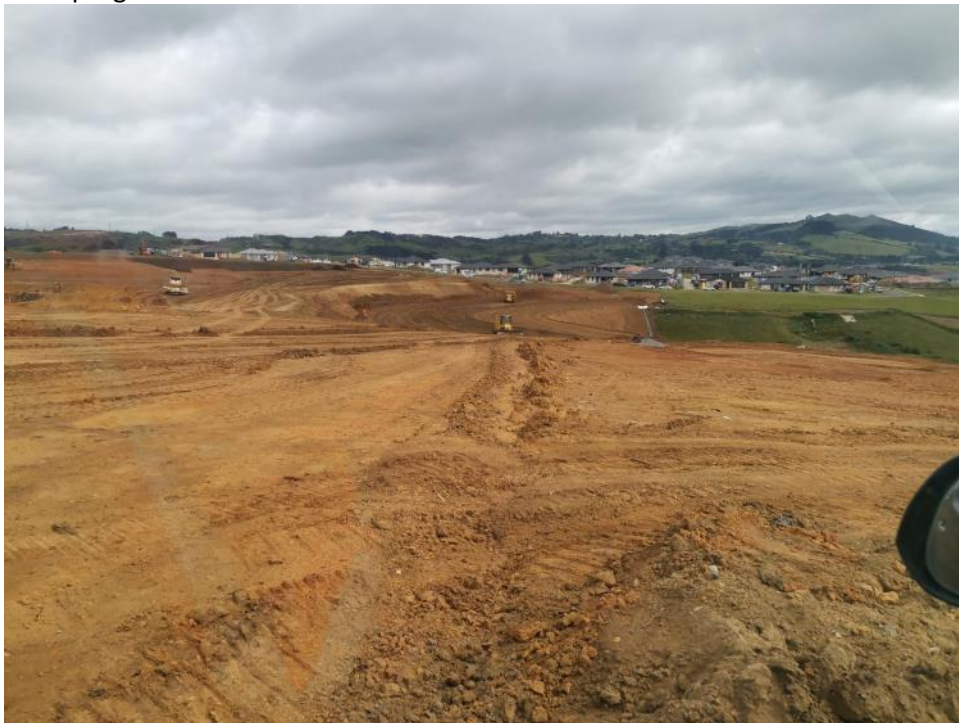
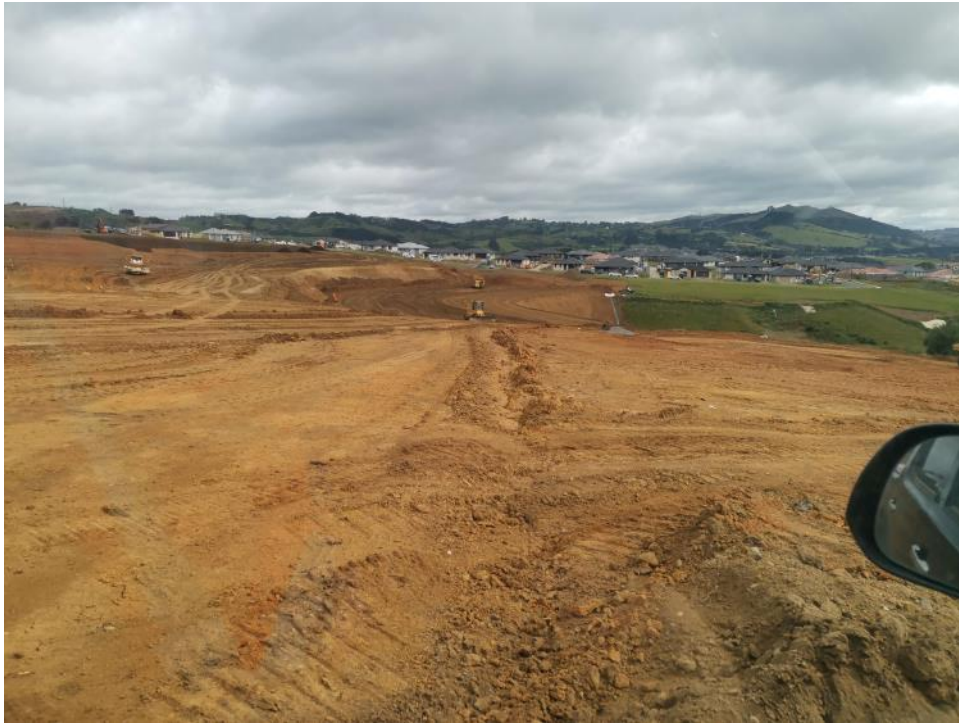
REB1 progress:

Works have re-started on REB1 after the wet weather. Contractor was about to commence placement of another grid layer. Clay material still being dried out/ conditioned.

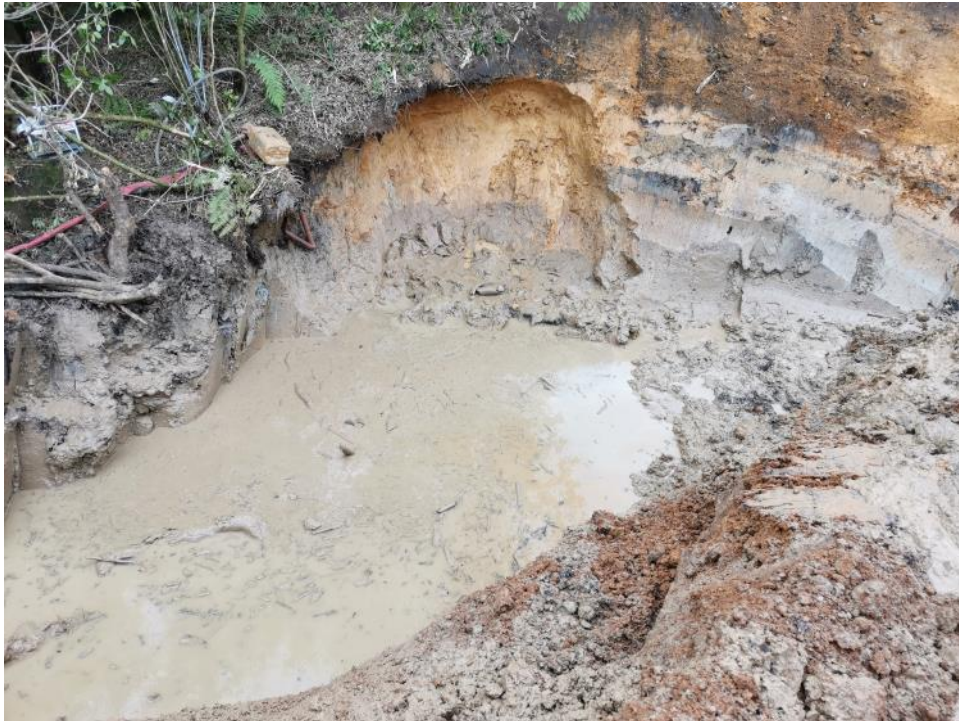
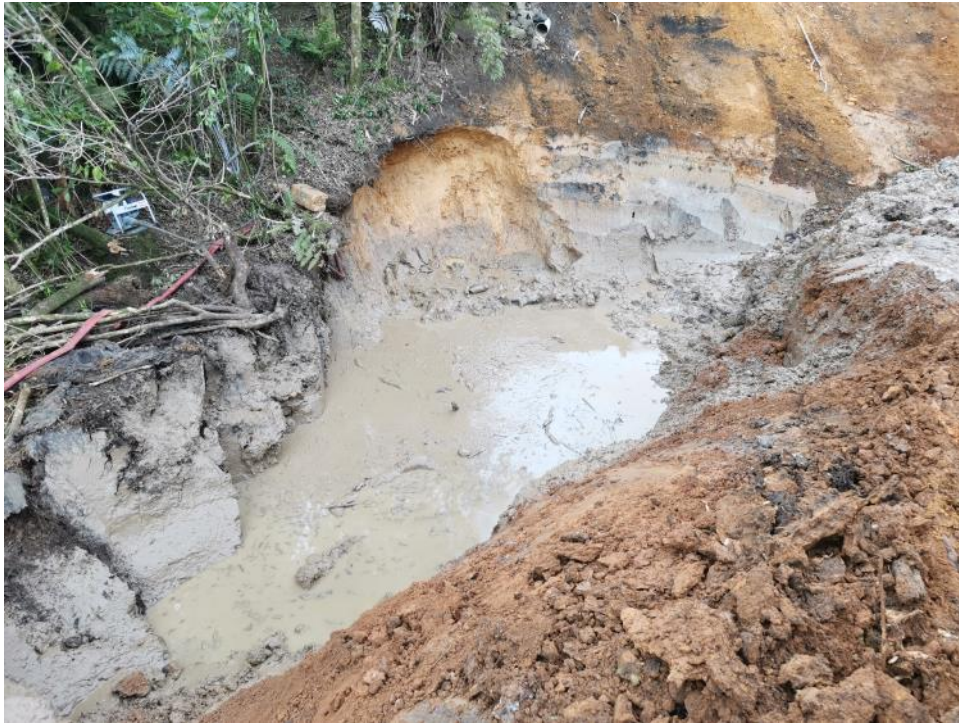
12D toe key:

Toe key construction is still in progress. The contractors have excavated down approximately 3m and have encountered slop. Advised them to clean this out and continue to muck out the area to very stiff soils as per our detail.

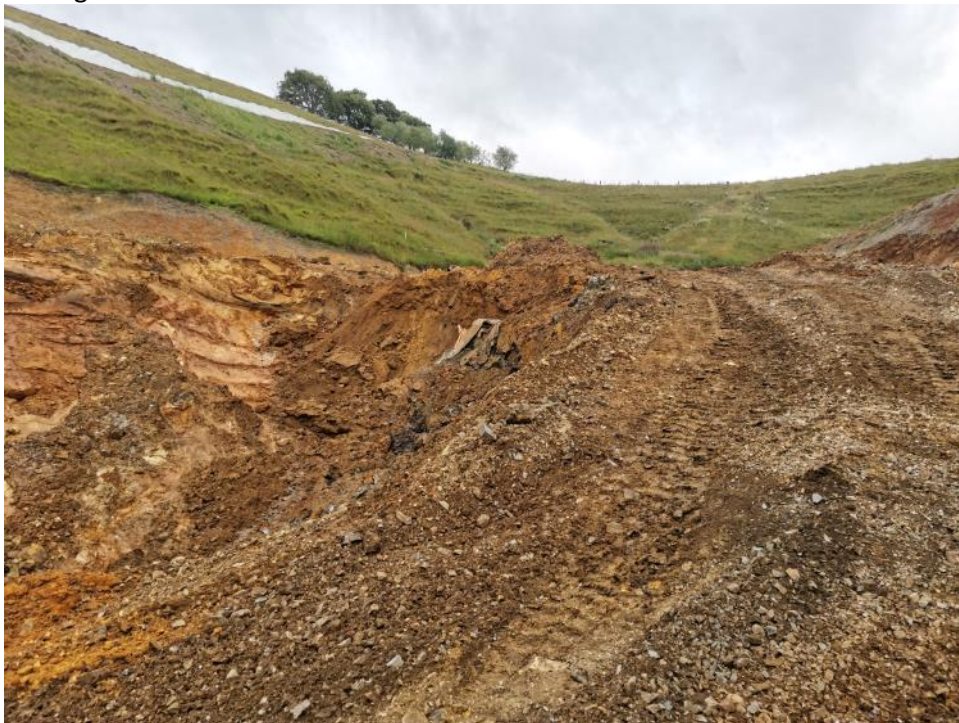
Damaged underfill drain in REB2:

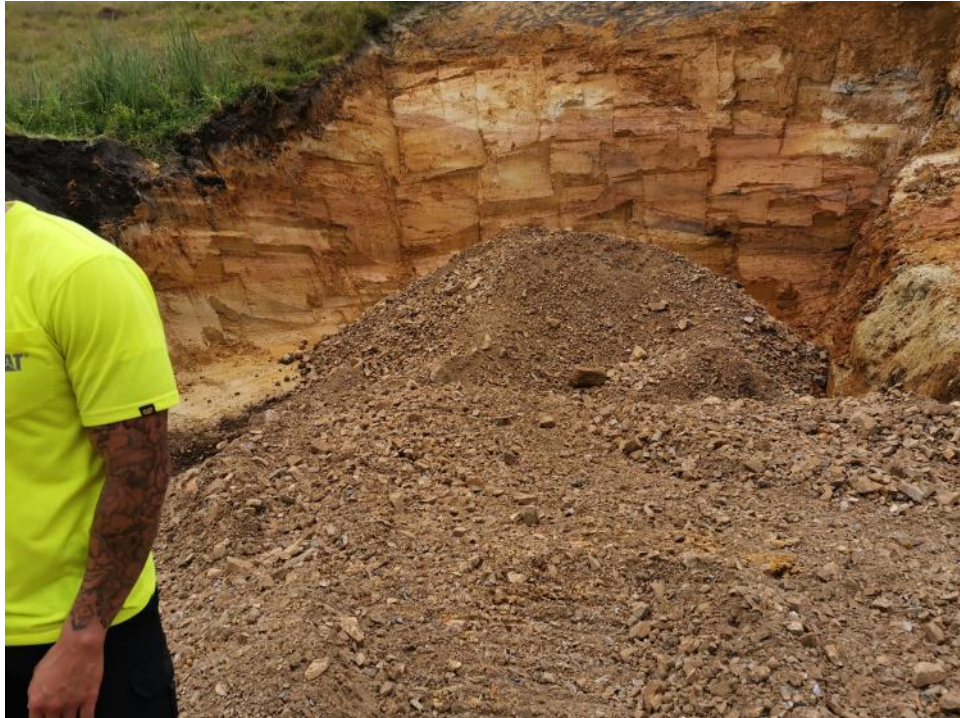
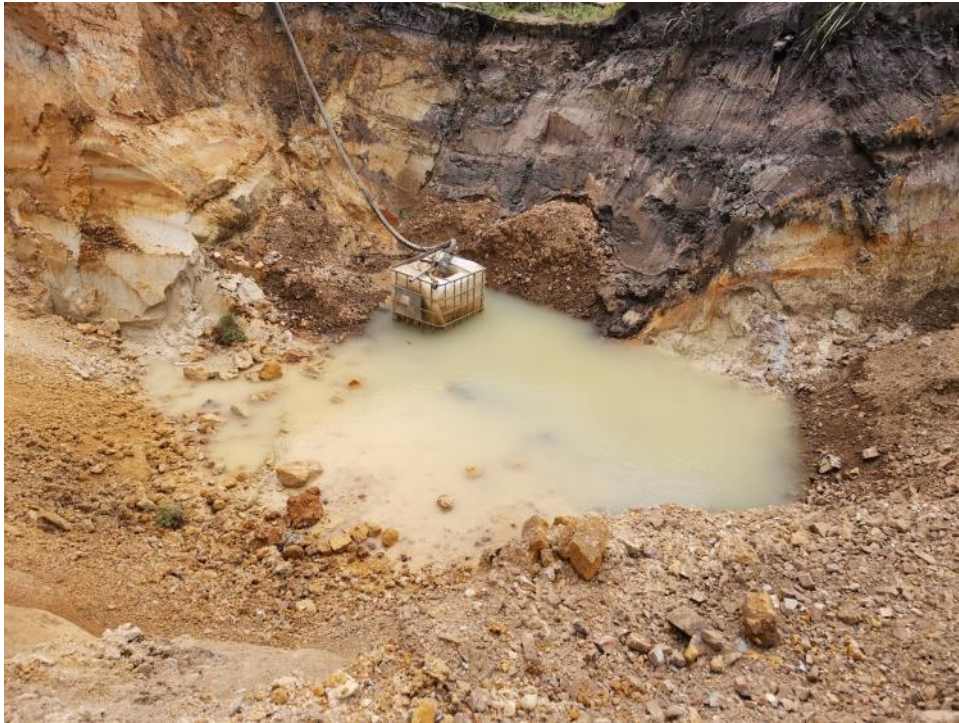
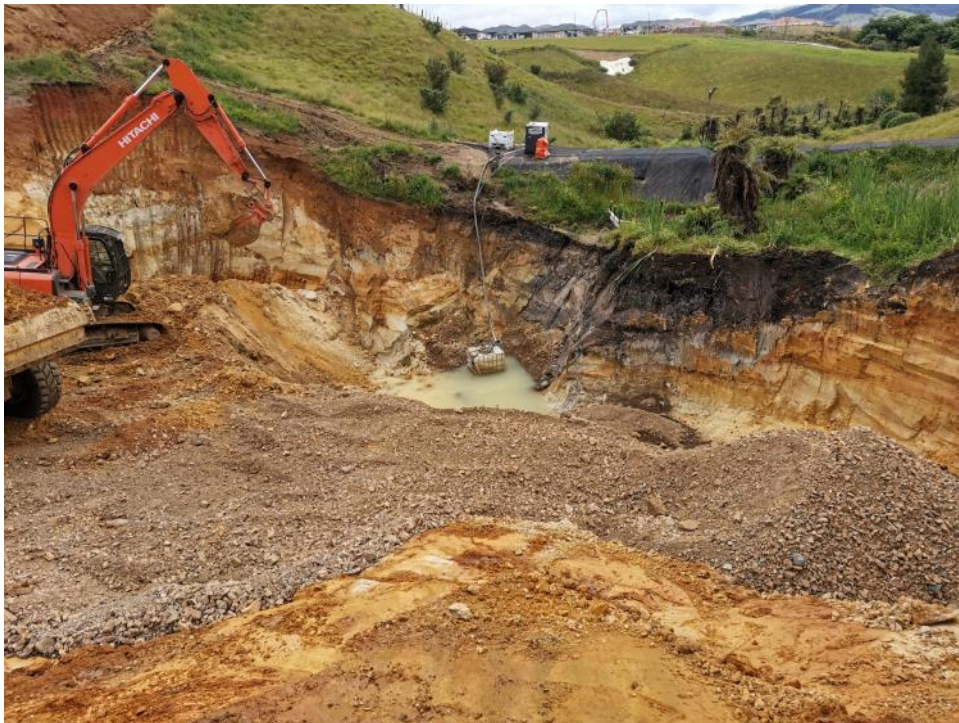
REB 2 shear key:

- Inspected toe key in Stage 12D. Contractors have excavated to approx. 4m with no improvement in ground conditions. Advised that they could place a 500mm raft of compacted SPR to allow them to start backfilling.
- Inspected shear key excavations in REB2. Hard ground exposed throughout along the base of the key which had been further excavated since yesterday. Advised that backfilling can commence with SPR100 once they have pumped the water out of the excavation. Plateau test from REB1 will still remain relevant.
