Geotechnical Completion Report

HITCHEN BLOCK STAGE 13B

17 January 2022

Ref No: J00113

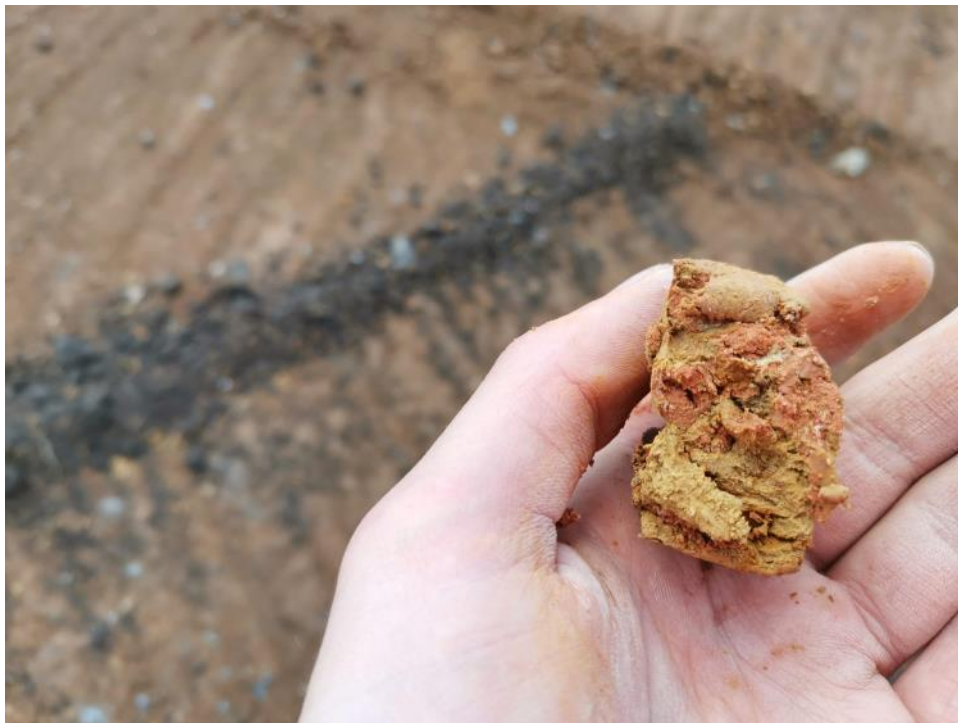
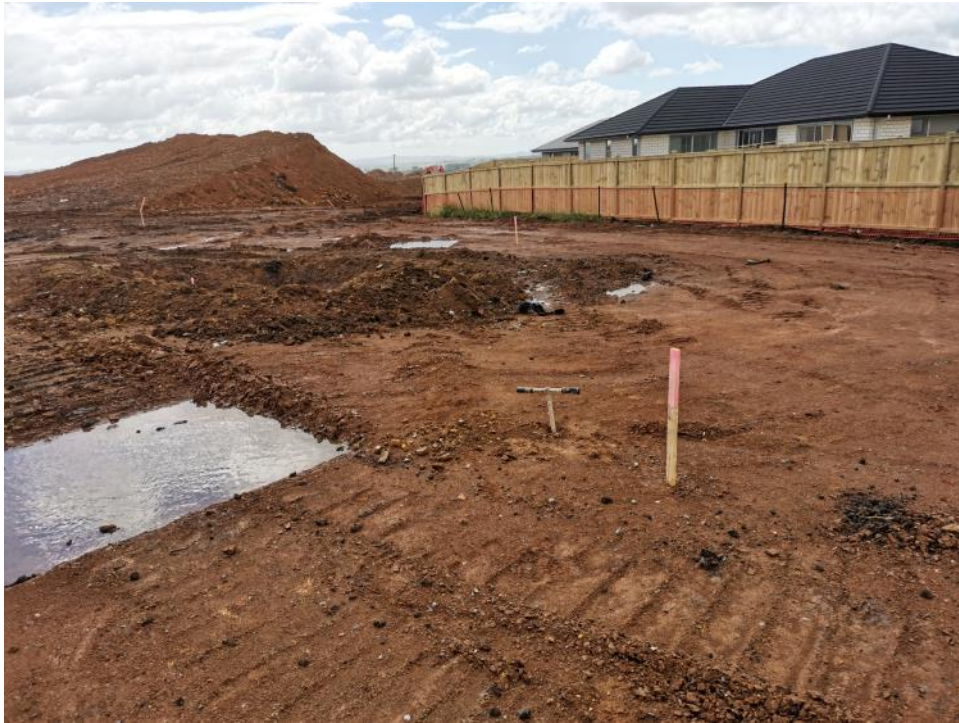
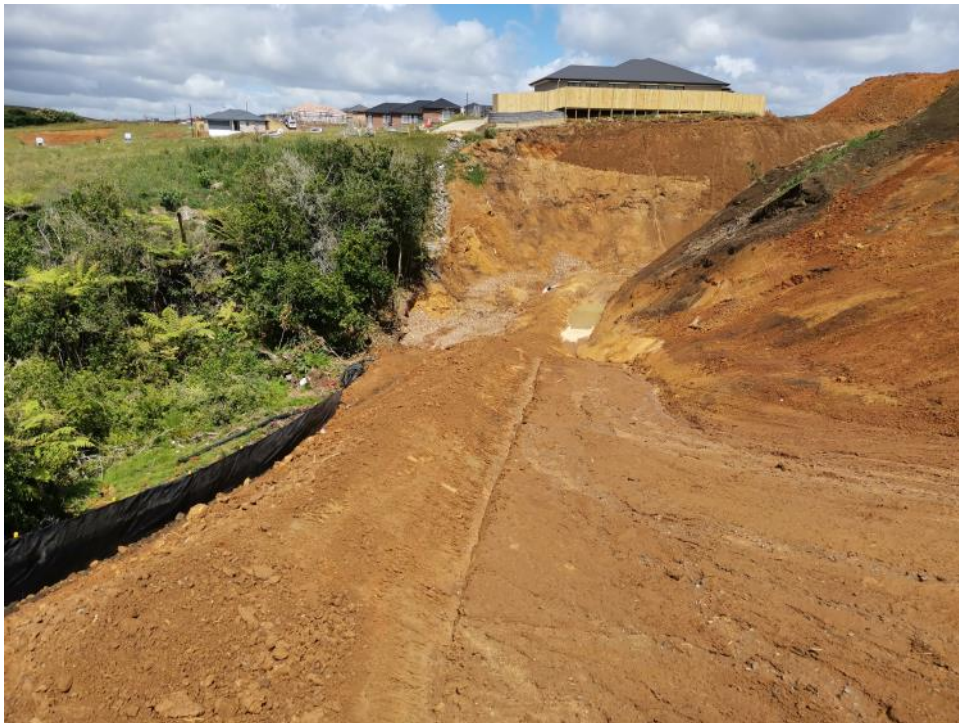
Visited site to check on toe key works in Stage 12D. The first section of the toe key has been backfilled with hardfill.

Also, drilled at hand auger in Lot 612. Encountered approx. 0.6m of fill overlying very stiff, natural ash soils.

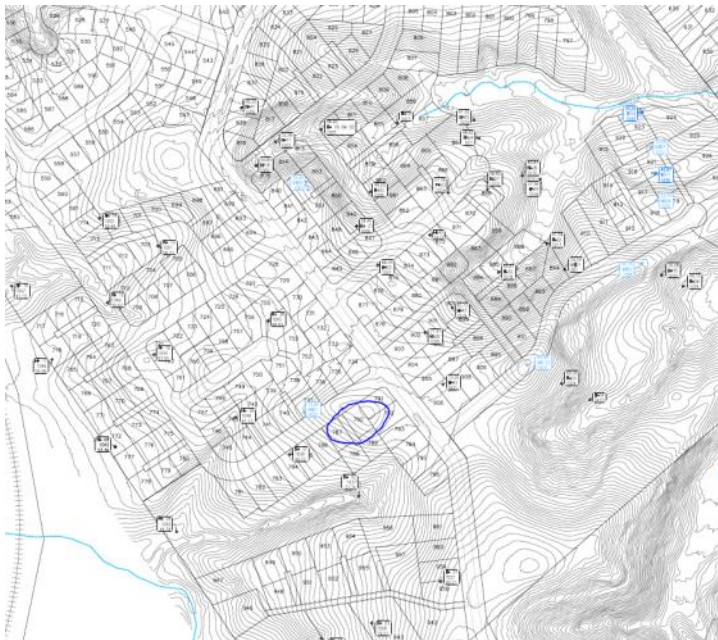
Visited site at the request of Dylan to inspect an area of cut which the contractors are struggling to excavate. Dylan was concerned that the material may cause limitation for future end-users / builders. Dines were querying whether an undercut backfilled with certified clay would be a good solution.

On site, the material comprised of a welded tuff. Advised that I would talk to Chris or Shane before providing any advice.

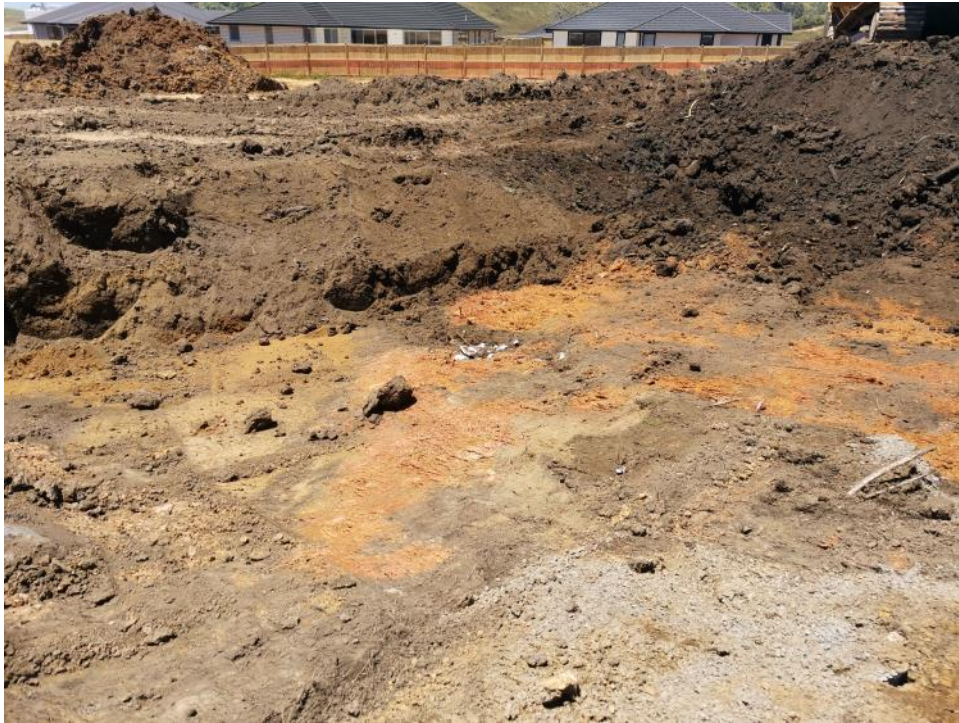
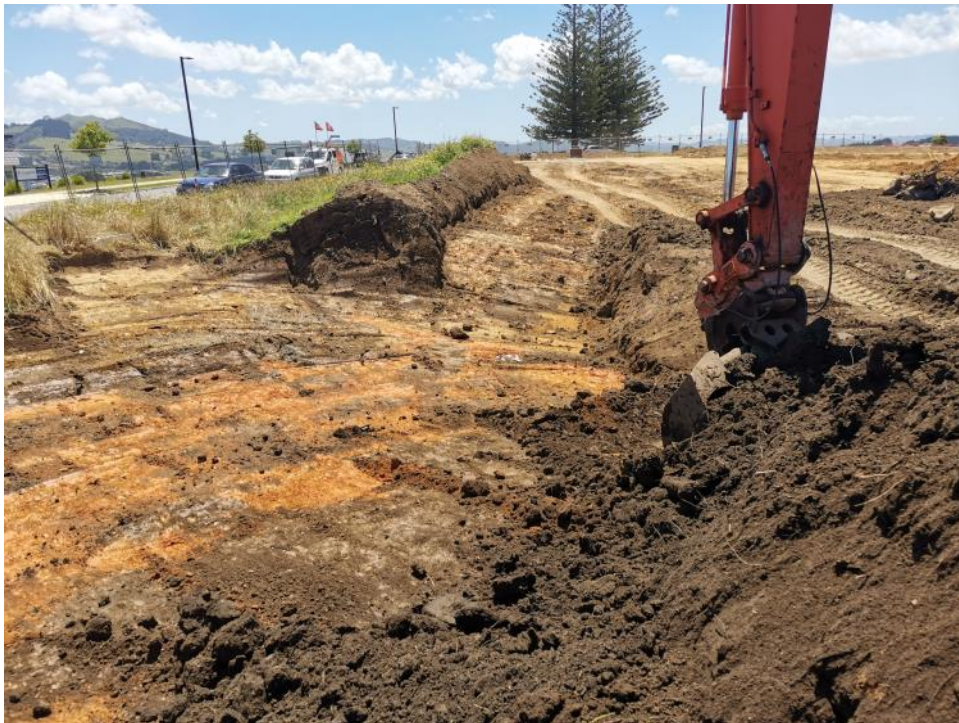
12D topsoil stripping:

Also, inspected stripping over Lots 612 & 612. Generally very stiff natural ash soils were exposed, however, some topsoil/rubbish was observed which we recommended be undercut to natural ground. Will look at this again tomorrow afternoon with Chris.

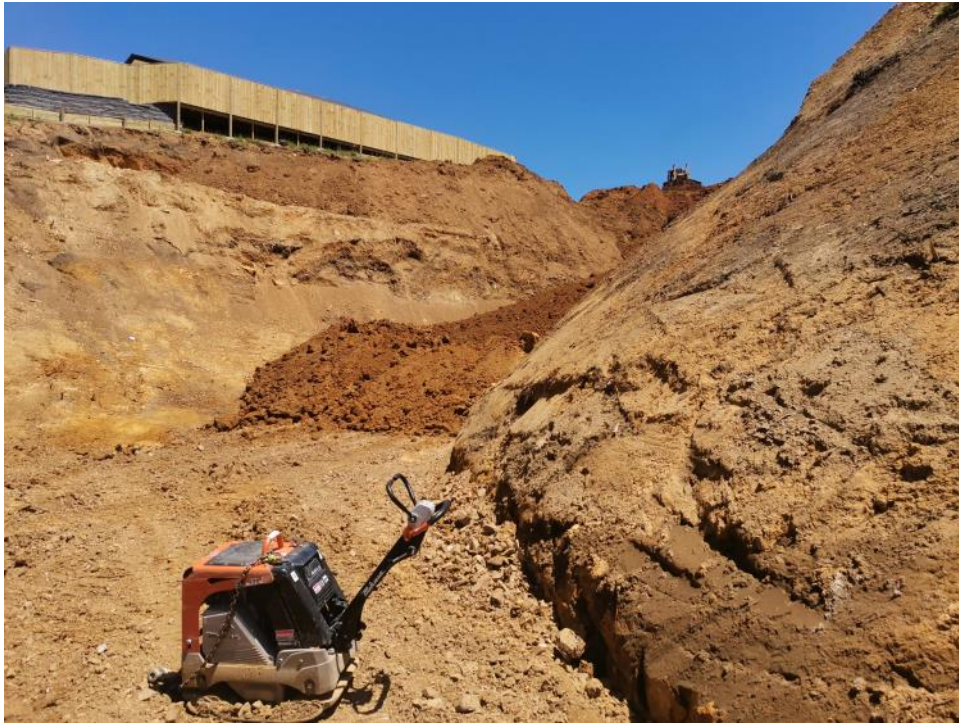
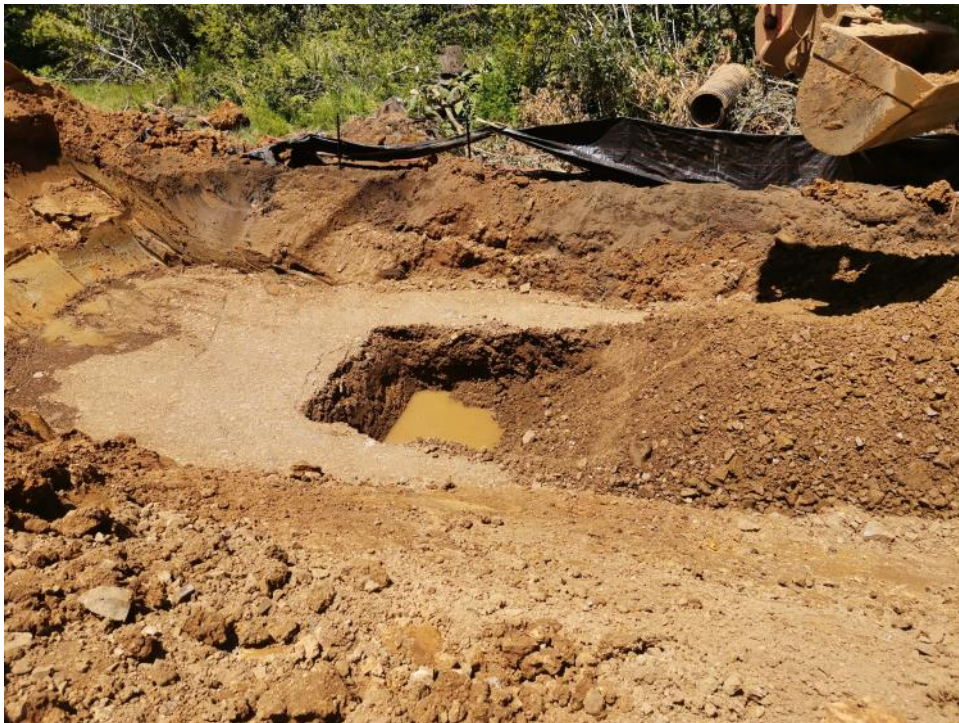
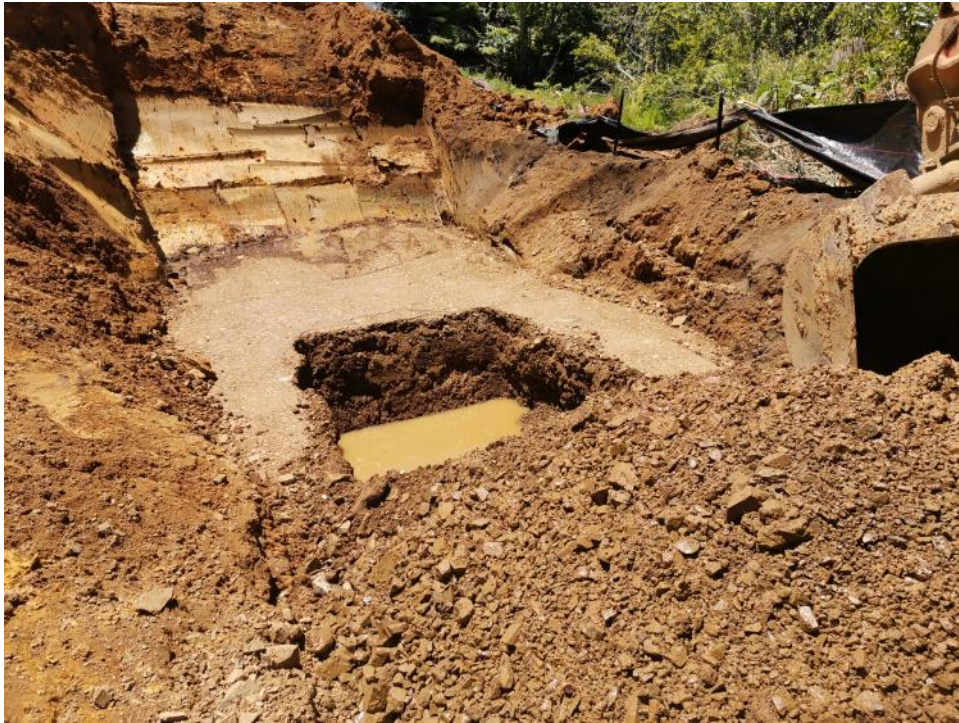
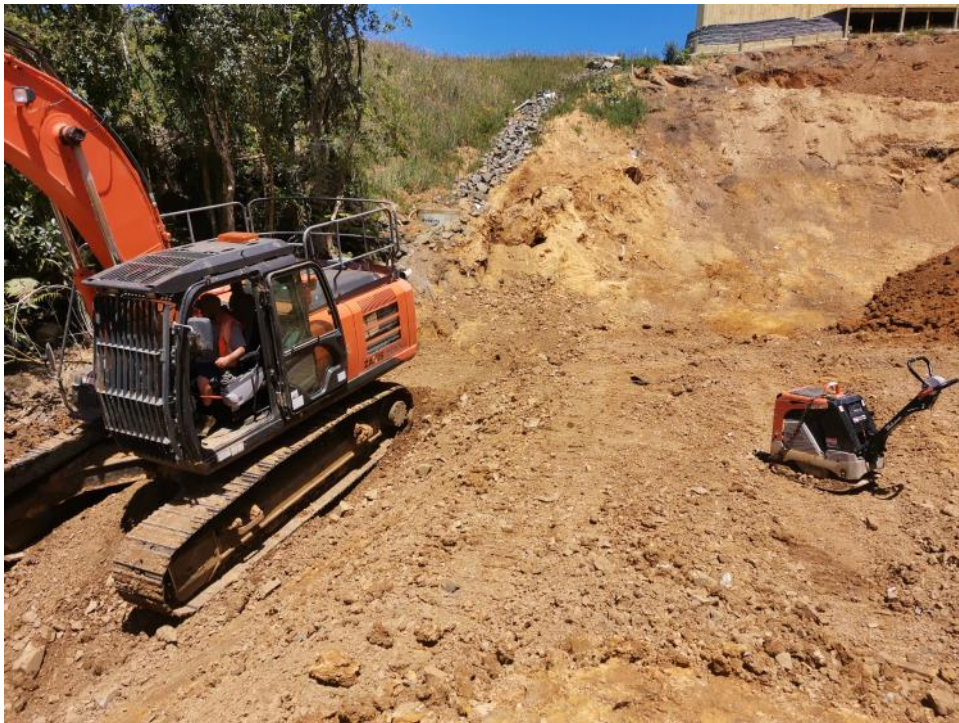
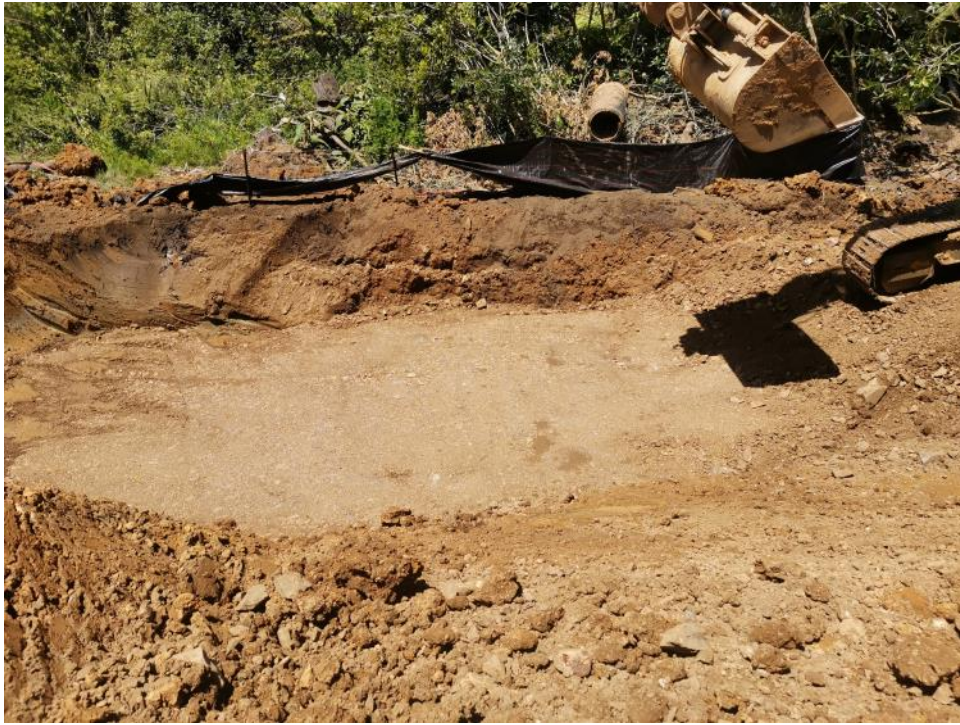
12D fill/toe key area:

Visited site to inspect 12D toe key. Contractor had already filled with SPR to 1.5m without getting us to inspect or getting fill testing so asked them to dig back to subgrade in the centre. Firm soils exposed at the base, however, the toe key will be about 2-3m thick so no undercut was recommended. Contractors said they needed to backfill the area immediately. We advised that they need to give adequate notice for geotech and fill test inspection in this case.

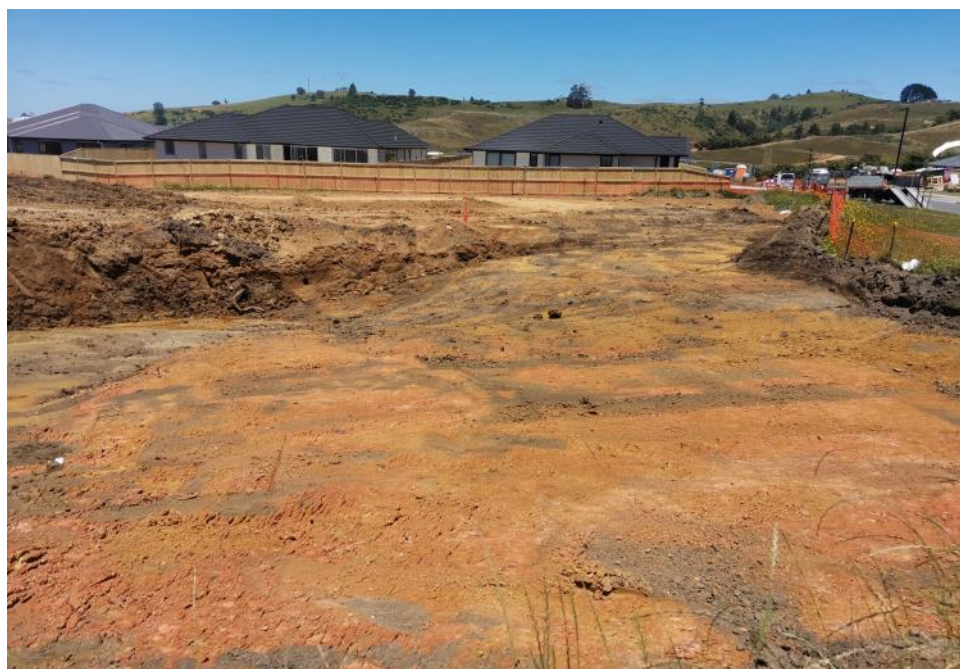
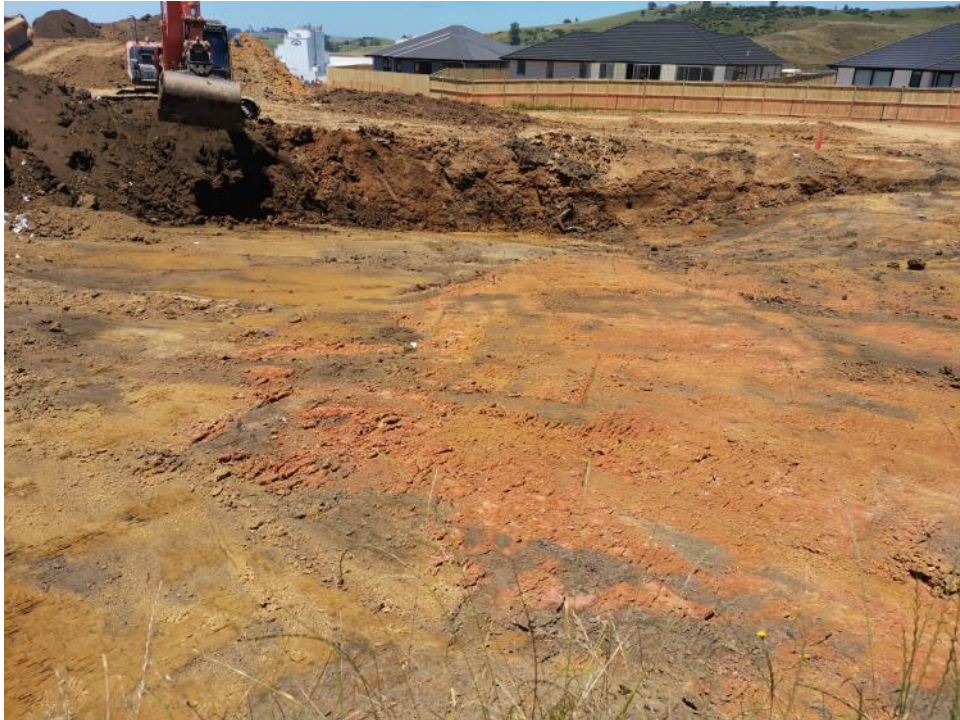
- Stage 12D toe key. The contractors failed their previous test here, achieved CIV readings of around 10. They removed the material, discarded the wetter SPR and refilled with a heavier roller. Josh to retest. The model also needs to be rechecked to confirm minimum toe key requirements are adequate.

- Also observed the stripping area in lots 611 and 612. Rubbish/pre-existing fills are still present. Reiterated that these materials be fully undercut. Will return to site tomorrow to observe general earthworks operations.

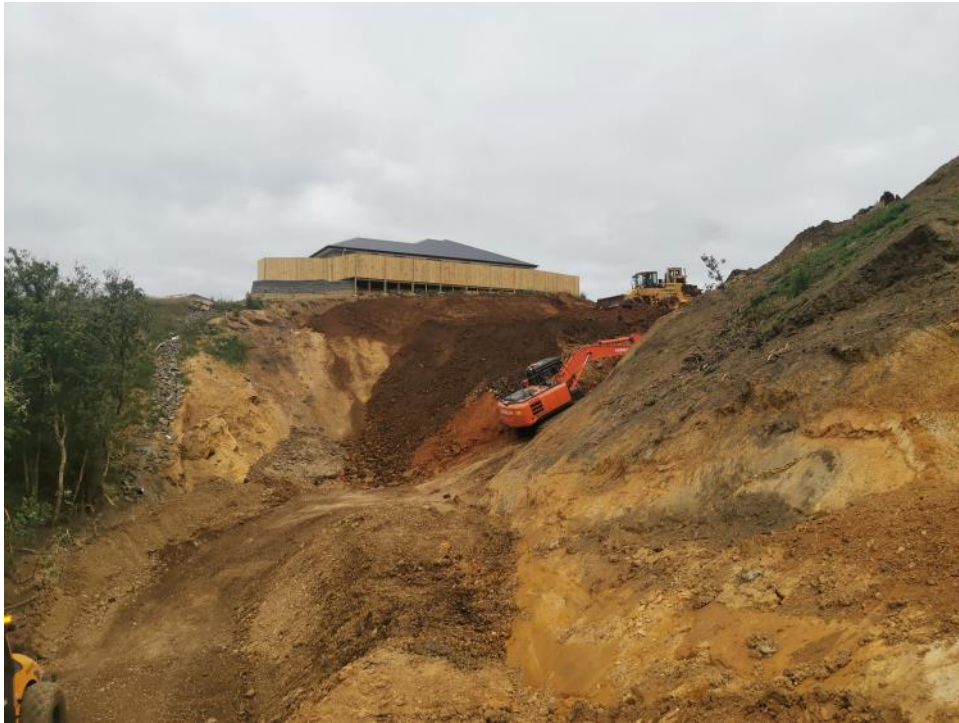
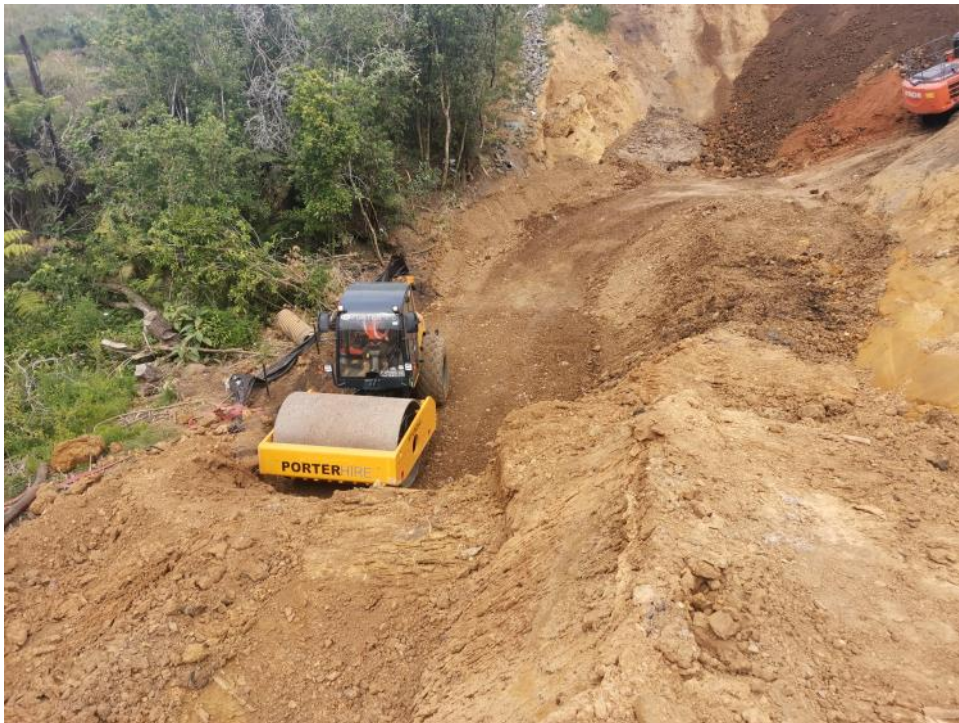
Inspected backfill in 12D toe key. Compaction appears to be going well with no obvious deflections noted under a 12T smooth drum roller. The latest fill test passed on both clegg hammer and backscatter testing.

Also observed undercutting of topsoil/pre-existing fill in the top section of Stage 12D. The base of the undercut is generally down to natural ground, although there is some minor topsoil mottling to chase out. The existing fill cut shows a layer of topsoil within the fill placed by Dines which is within 2m of surface level. Advised that this should be undercut and removed from the fill. Will return to site again tomorrow morning to inspect.

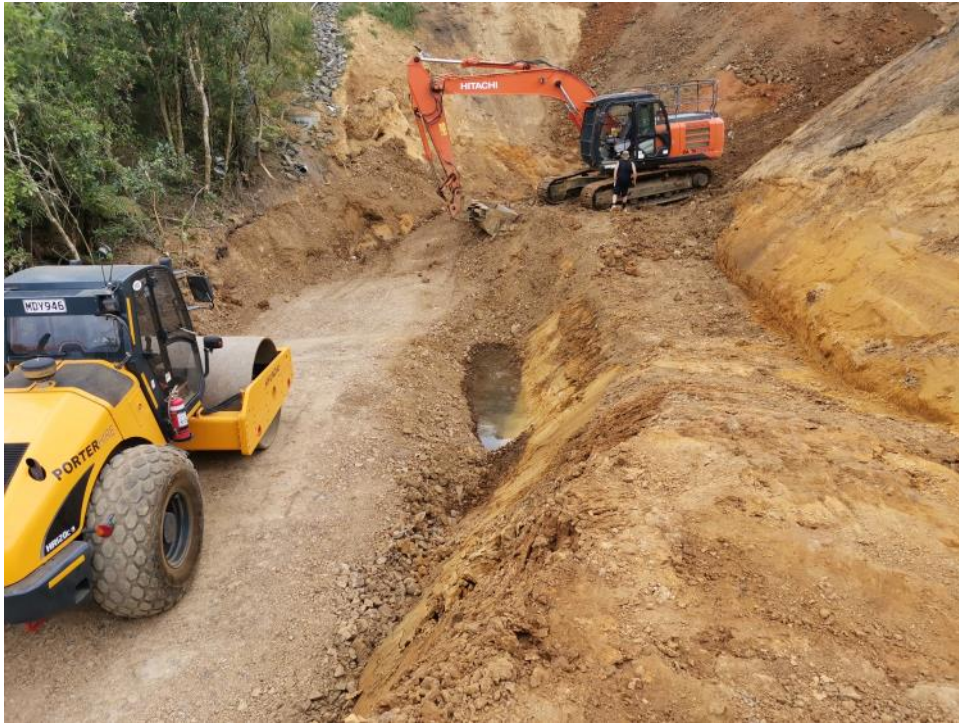
Stage 12D toe key:

- At top of Stage 12D, topsoil horizon has been chased out and is ready to be filled again.
- At Stage 12D toe key, they have filled up another metre and are waiting for the next test. Hardfill surface appears well compacted visually. Asked Dylan to get the extent of the key surveyed to ensure that the key matches the full extent of the fill batter.
- At REB1, geogrid is being laid out, with grid lengths of around 5m and 14m being recorded as per our design for the top layers.
- At REB2 shear key, contractor has informed that additional testing was undertaken at 1m and 2m fill heights. Also observed stripping to the base of the key in the rear portions. Hard surface encountered here. A trial pit at the base was only able to be excavated approximately 1m with a rock bucket, consistent with the previous test.

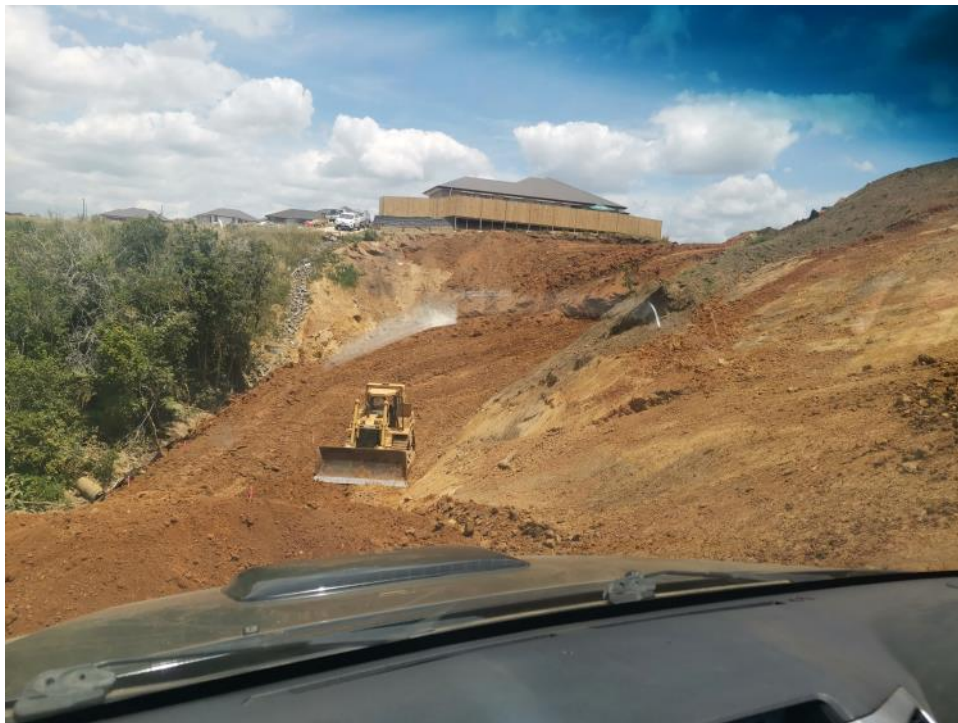
21/12/20 - Stage 12D

Visited site at request of Dylan to observe site works prior to the Christmas break. Not much has progressed since our previous visit. Toe key has been completed and clay fill for the 1(v) in 3(h) batter is now commencing.

Also requested that some more fill be placed to buttress the site cut at the top of the gully flank to ensure stability is maintained to the house.

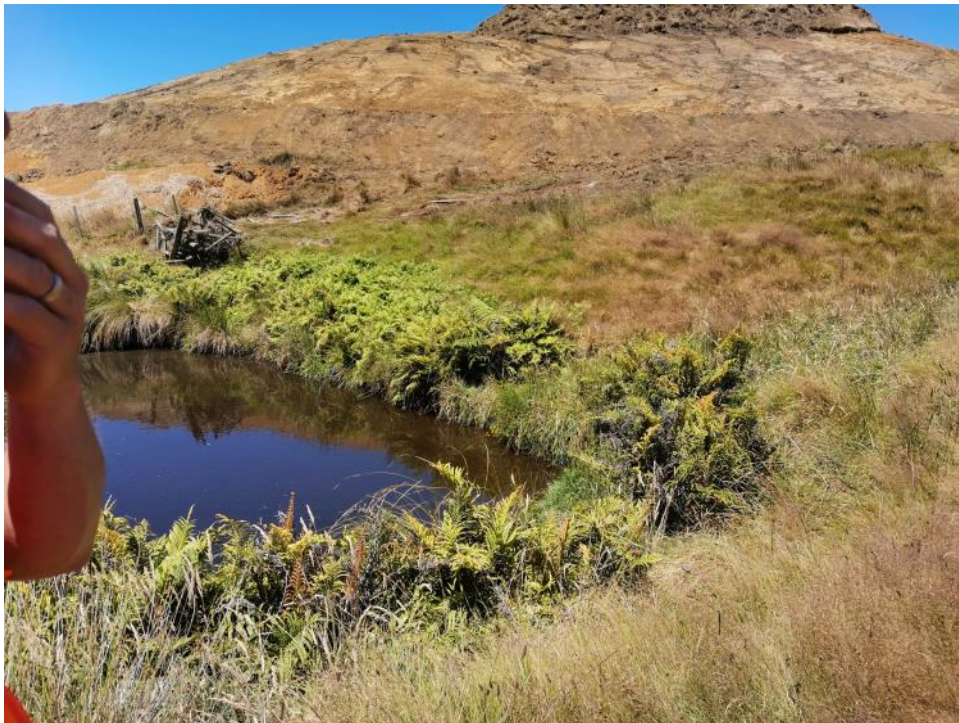
Addition to extent of works

- Extent of works adjacent to Fill K: Approximate area shown in blue on the annotated drawing below. Trevor discussed that the area is to be extended down to the main gully now. Advised that any stripping needs to be down to the stiff natural ground and any mullock or colluvium removed. Further advice to be given once the area is opened up and we can observe ground conditions. Trevor will send some plans through to us for our initial thoughts on what engineering solution may be required.

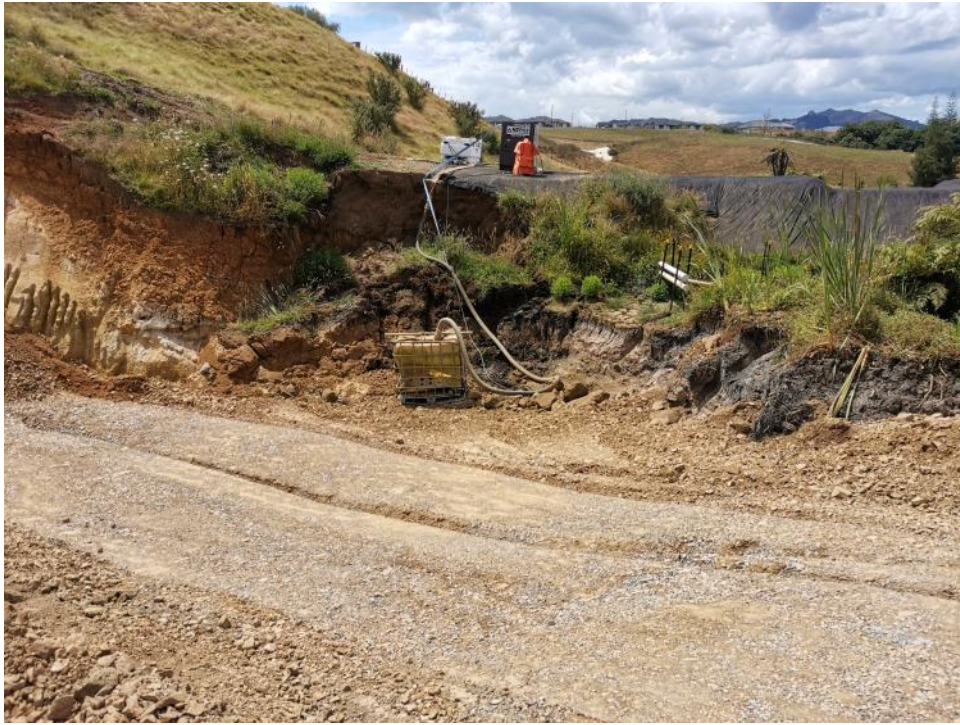
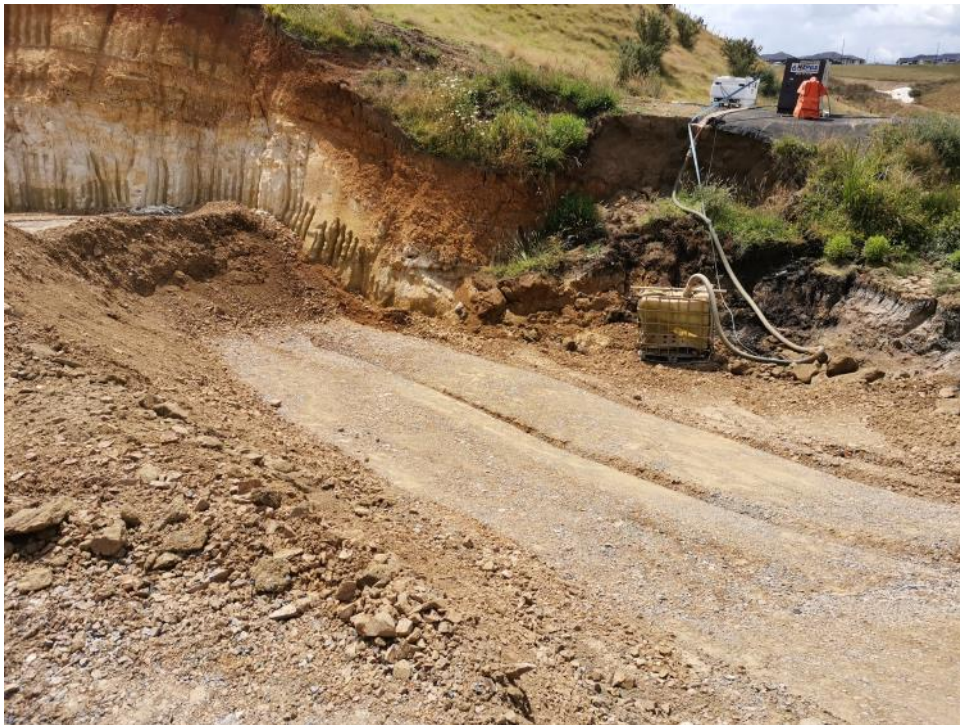
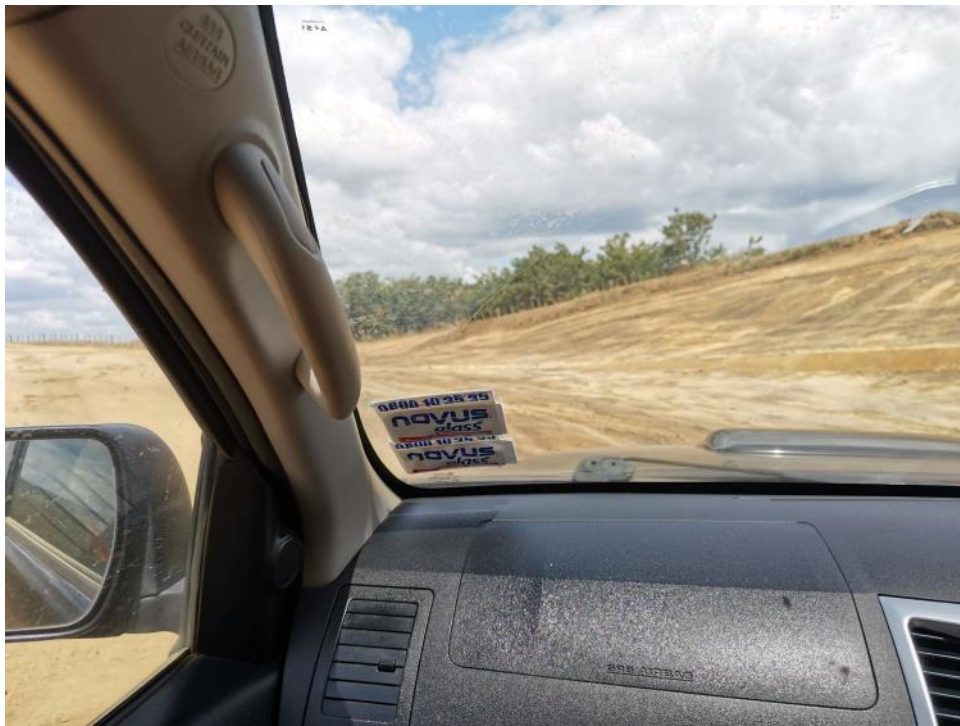
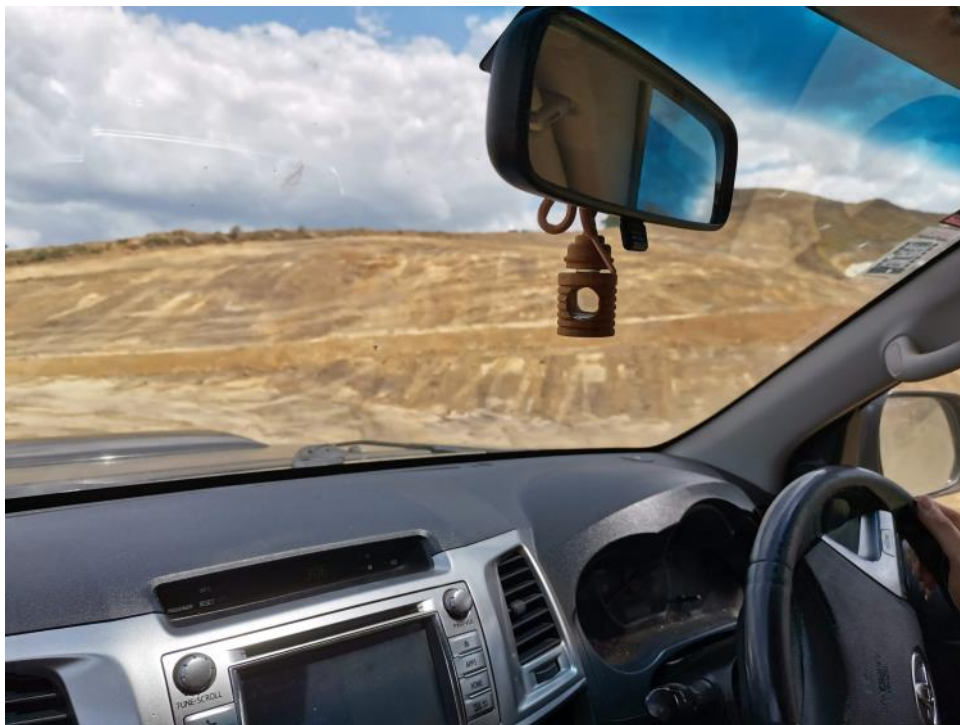
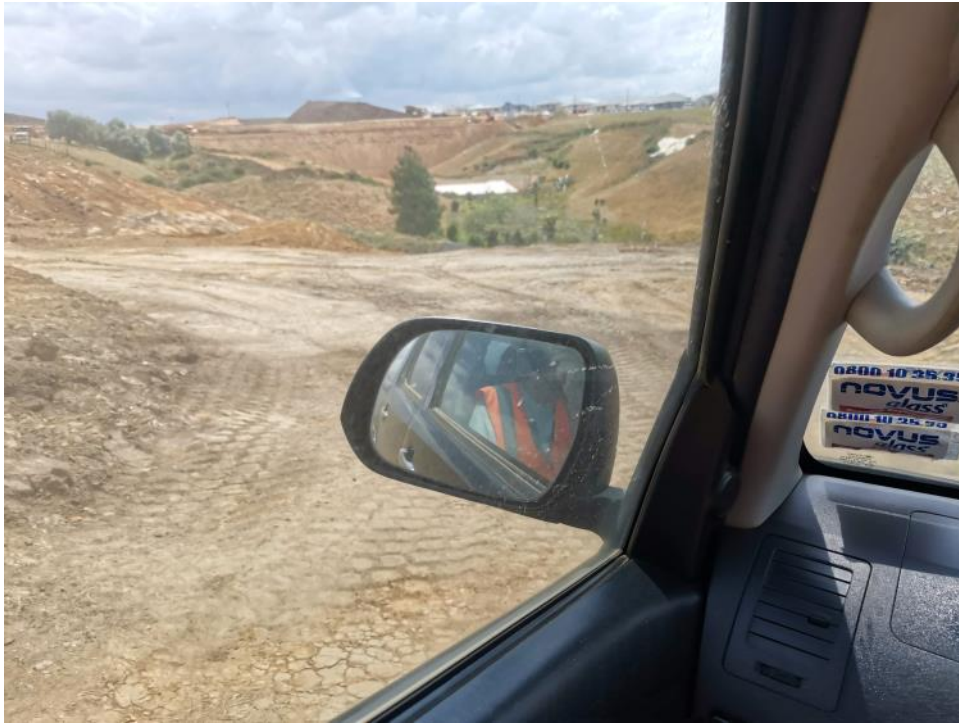
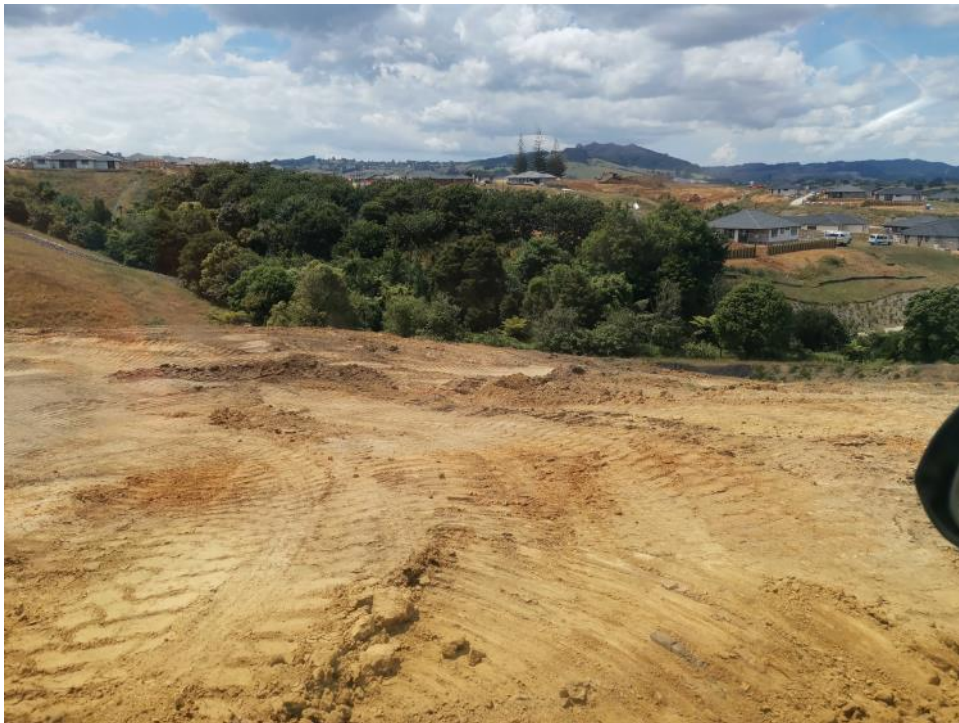
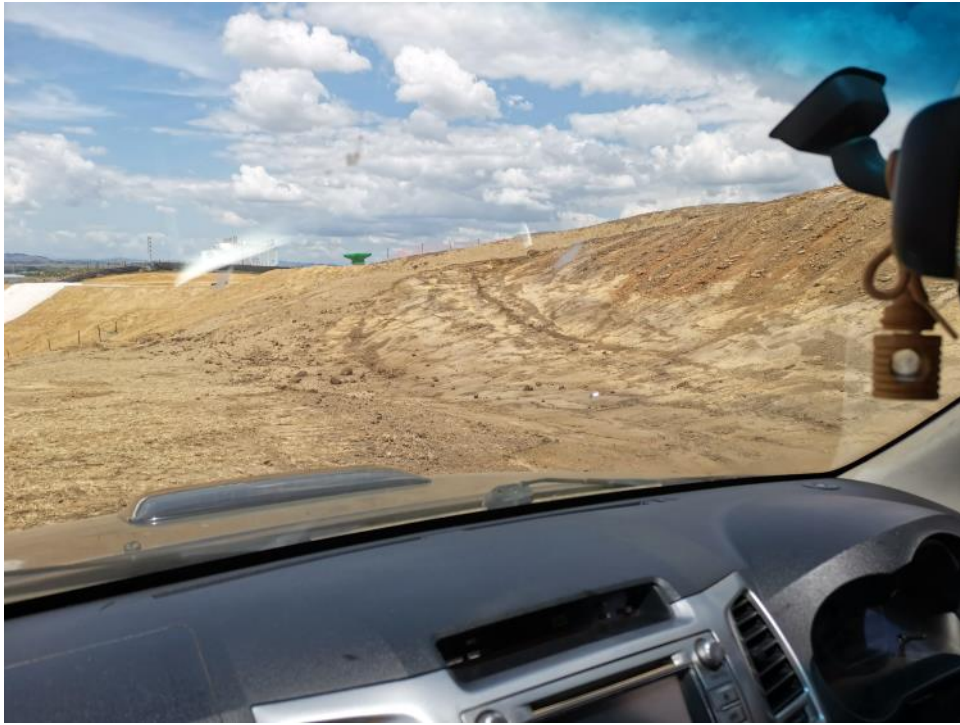
12/01/21 - REB2, old slip area

Visited site at the request of Dylan to inspect stripping for cut 1 in the approximate area outlined in red on the image below. Cut exposed very stiff natural ground. No seepages or soft ground observed though this area. Minor fills to be placed in this area next.

Also inspected REB 2 shear key progress. Backfill of the shear key in progress. Fill testing was being carried out at the time of our inspection of the area beyond the key where the groundwater was being pumped from.

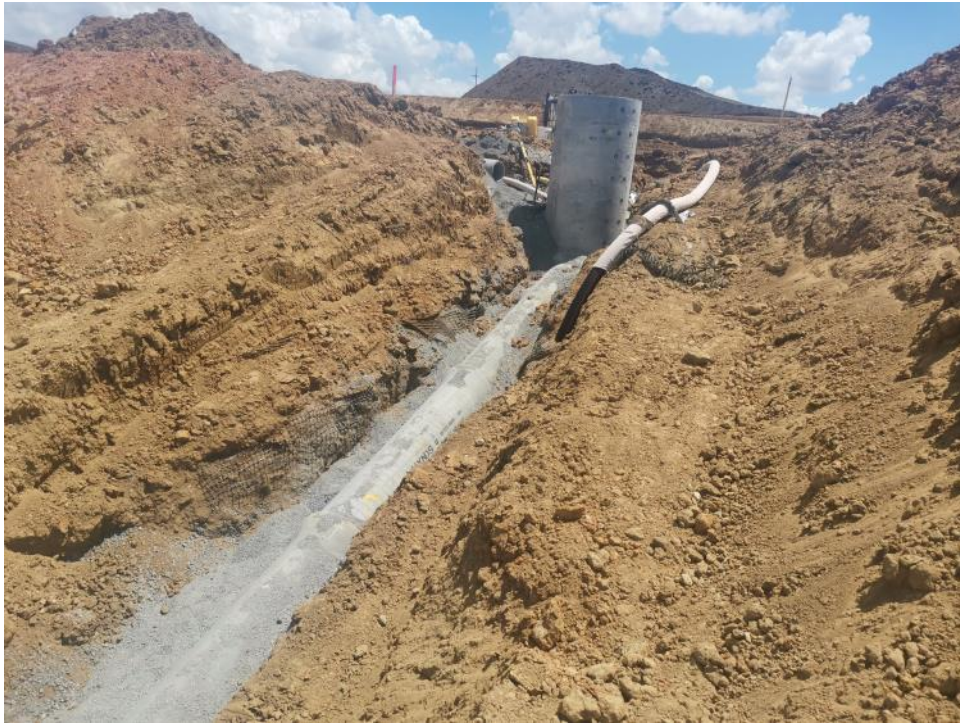
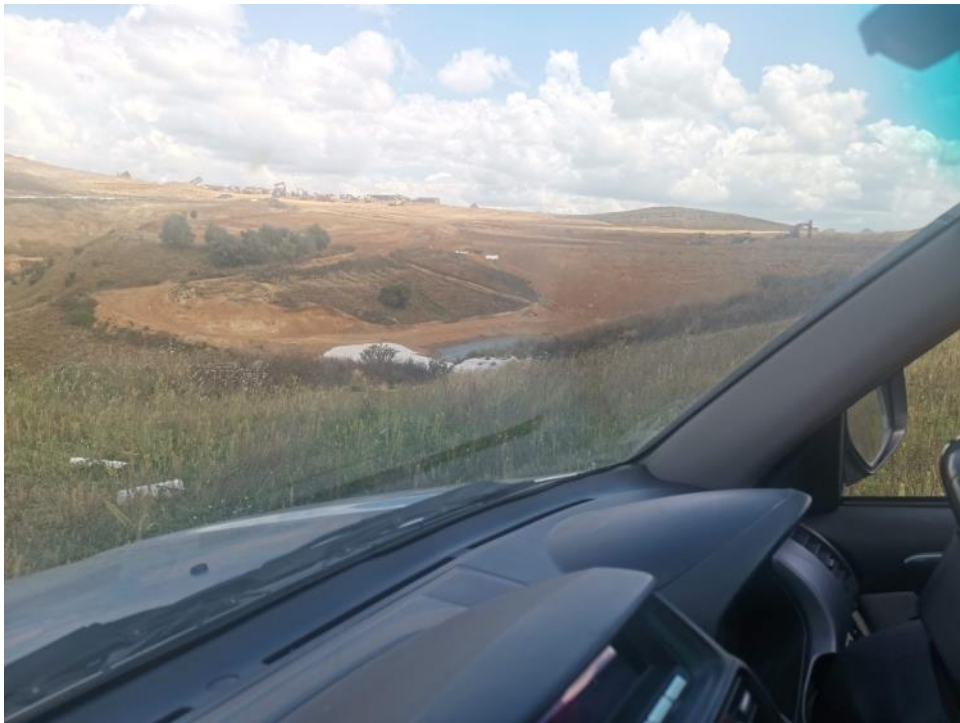
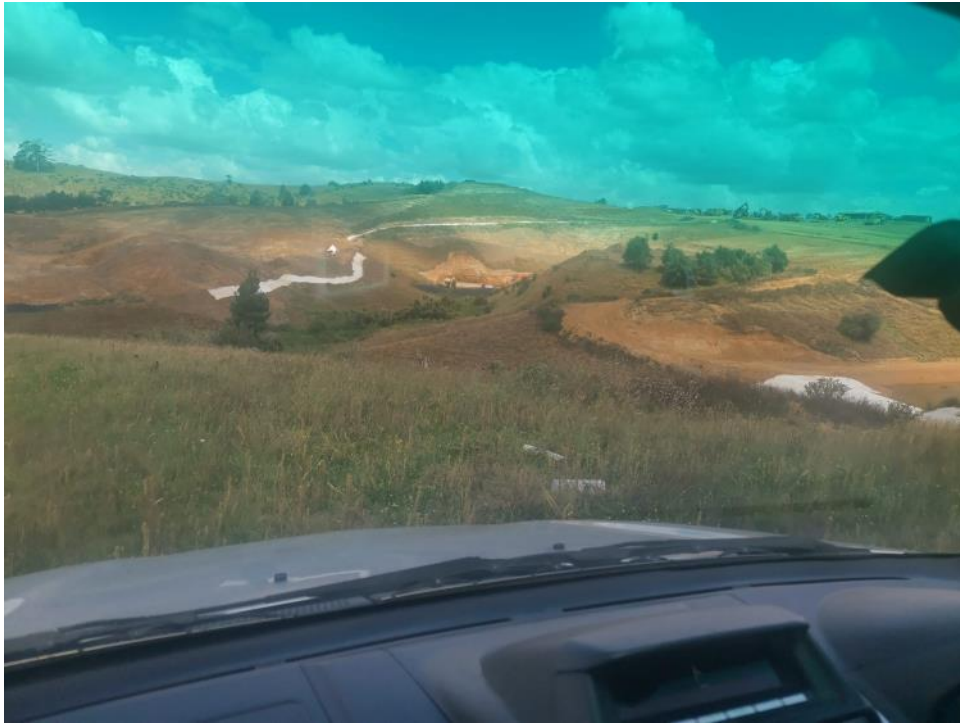
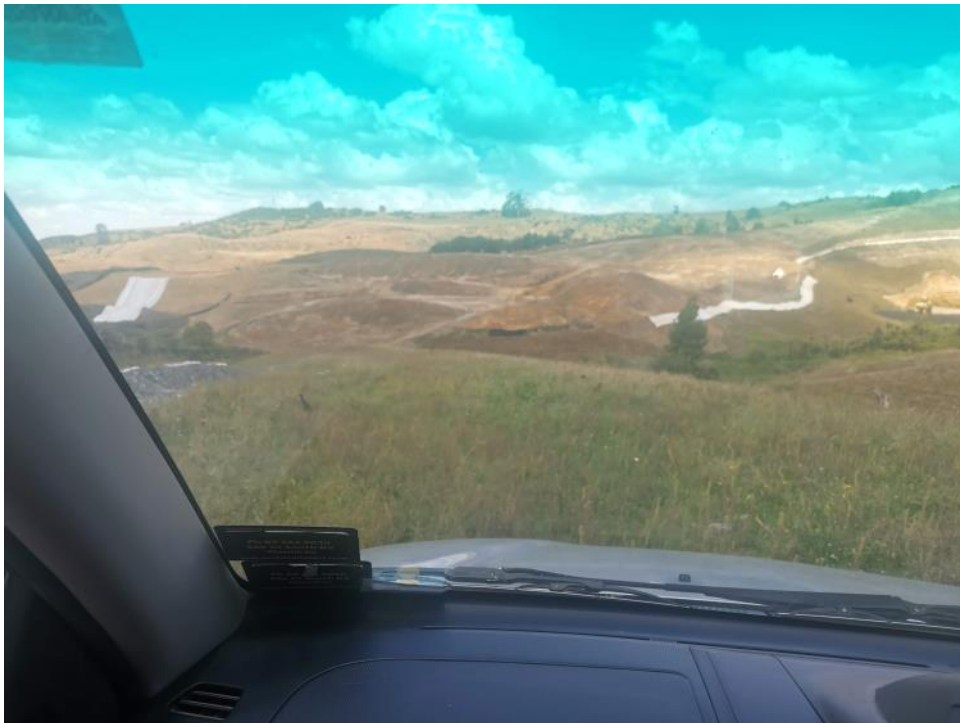
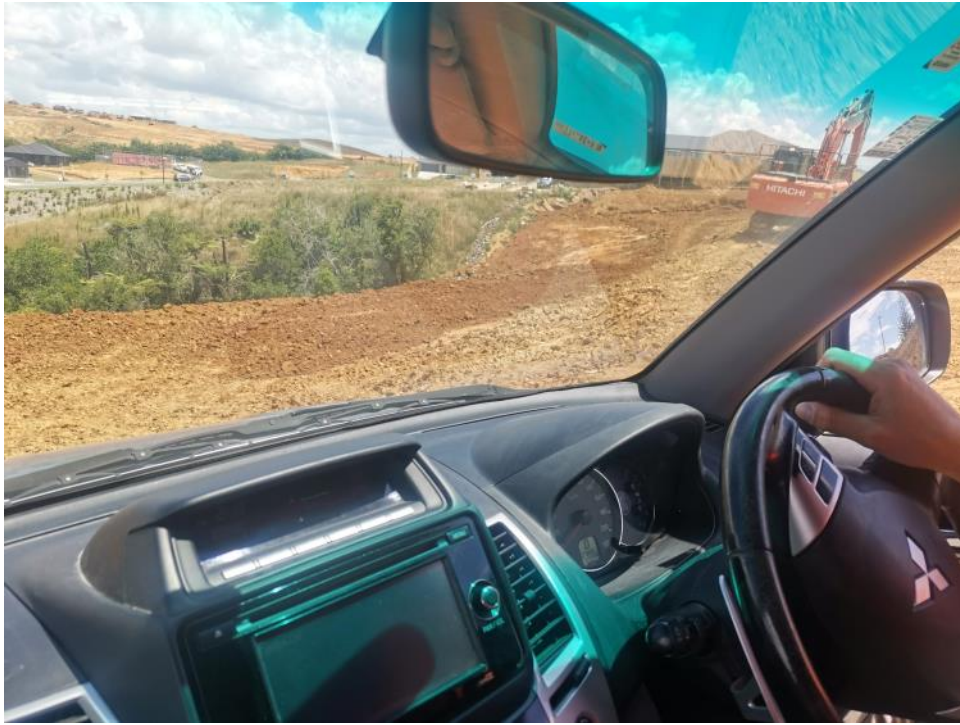
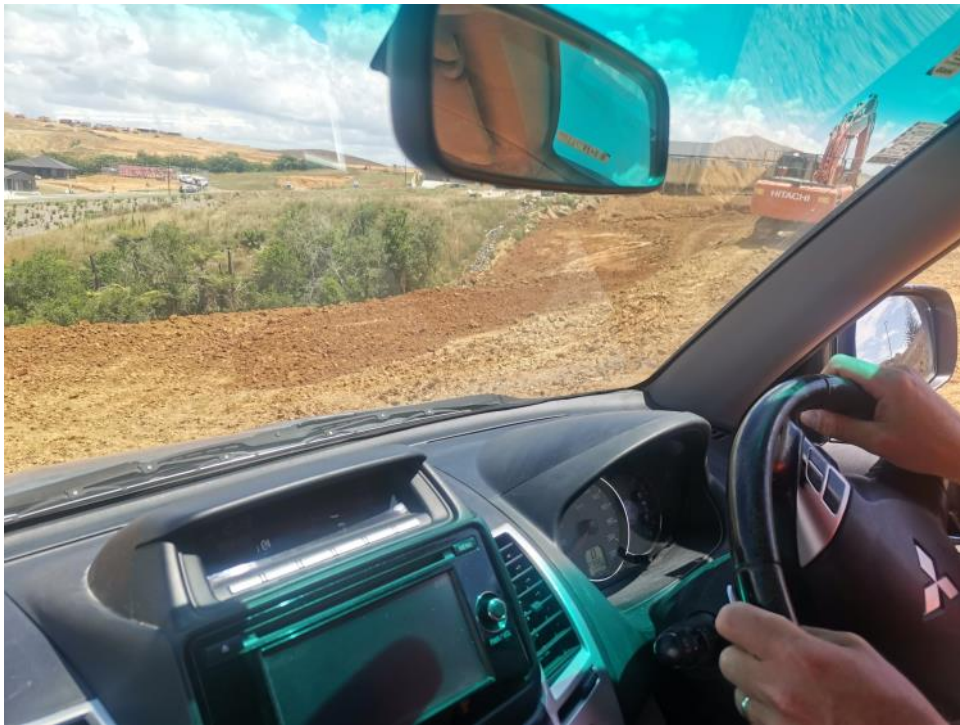
13/01/21 - REB1&2

Observed cut 1 stripping (which was observed with Dylan yesterday). Will have a look at recent reporting and assessments that Matt has done recently with Chris tomorrow to determine if there are any additional requirements here.
