Geotechnical Completion Report

HITCHEN BLOCK STAGE 13B

17 January 2022

Ref No: J00113

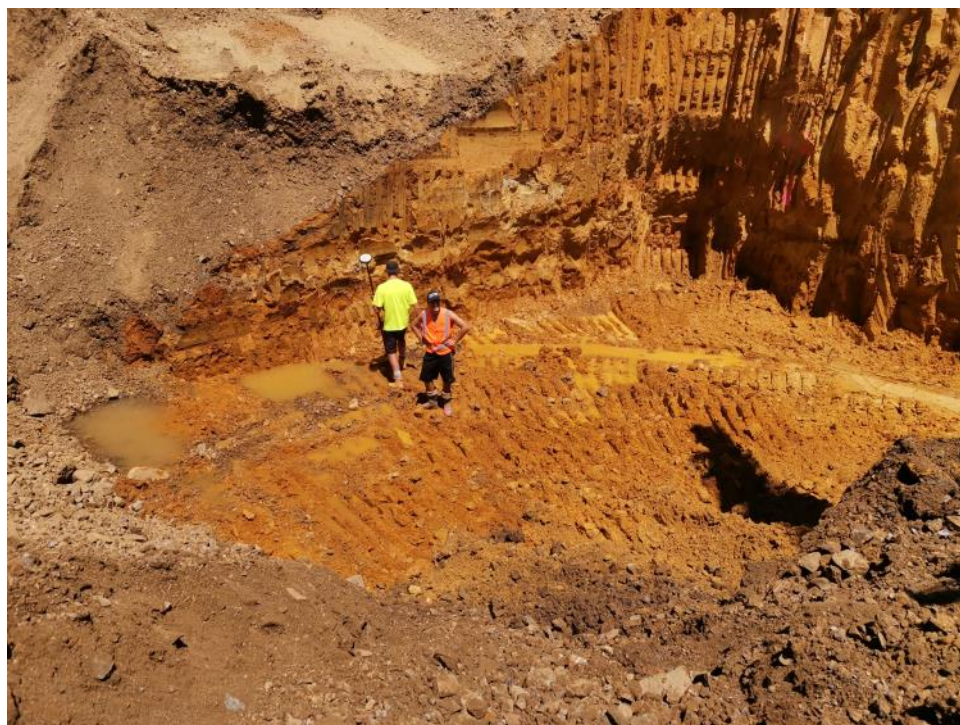
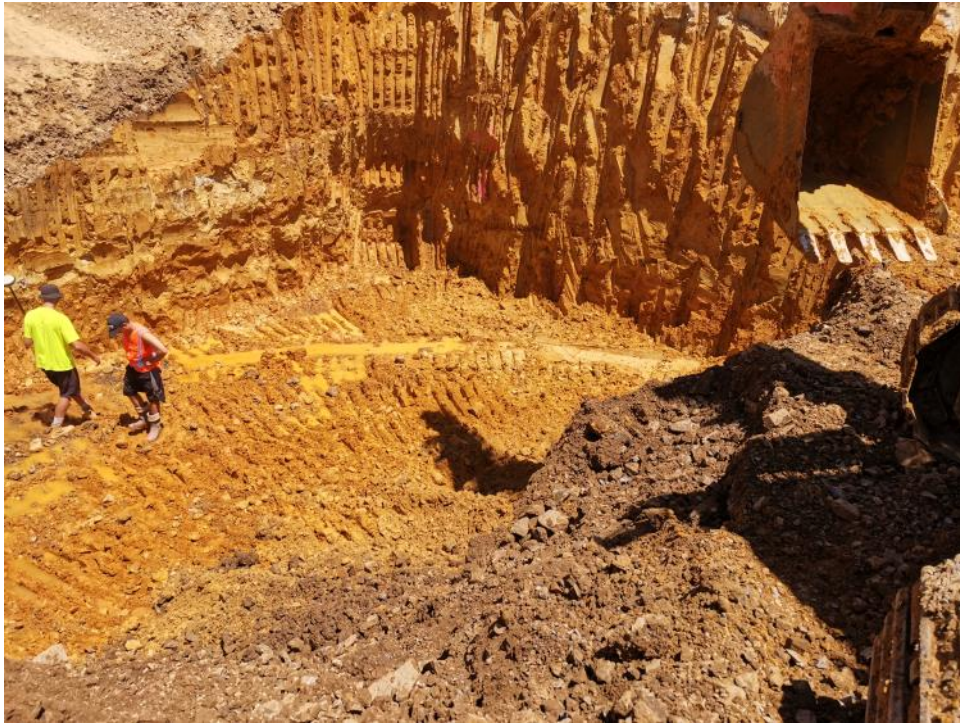
15/01/21 - REB2

On site Mitchell confirmed that 1.4m of SPR hardfill is required until the base of the GAP65 layer at the base of the REB batter.

Mitchell is also planning on the setout for the counterfort drains next week. Advised we will inspect the setout and modify this if required.

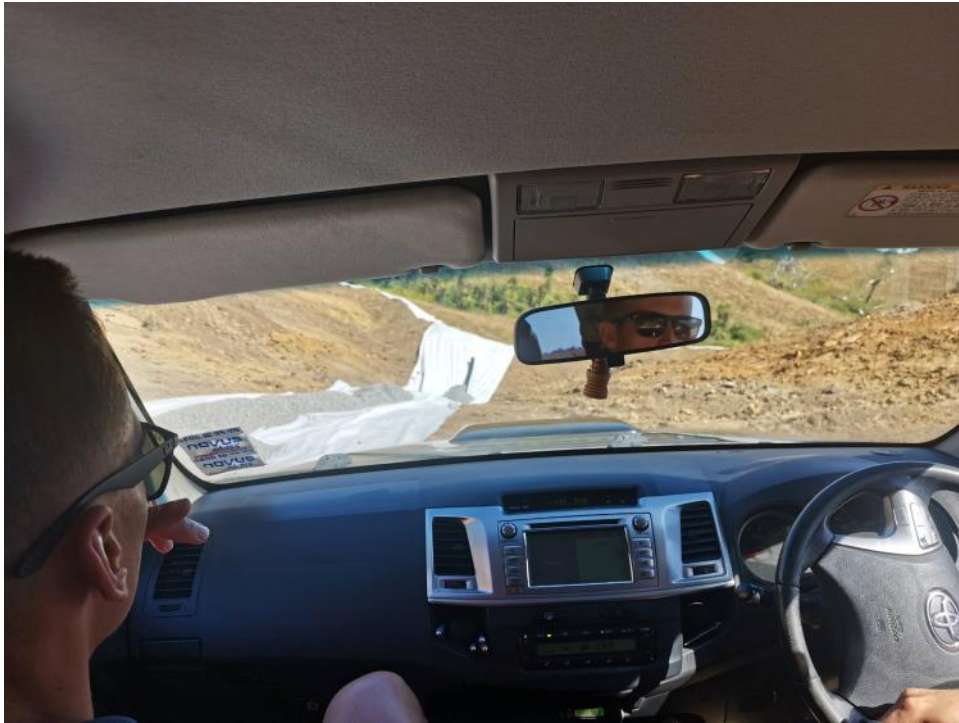
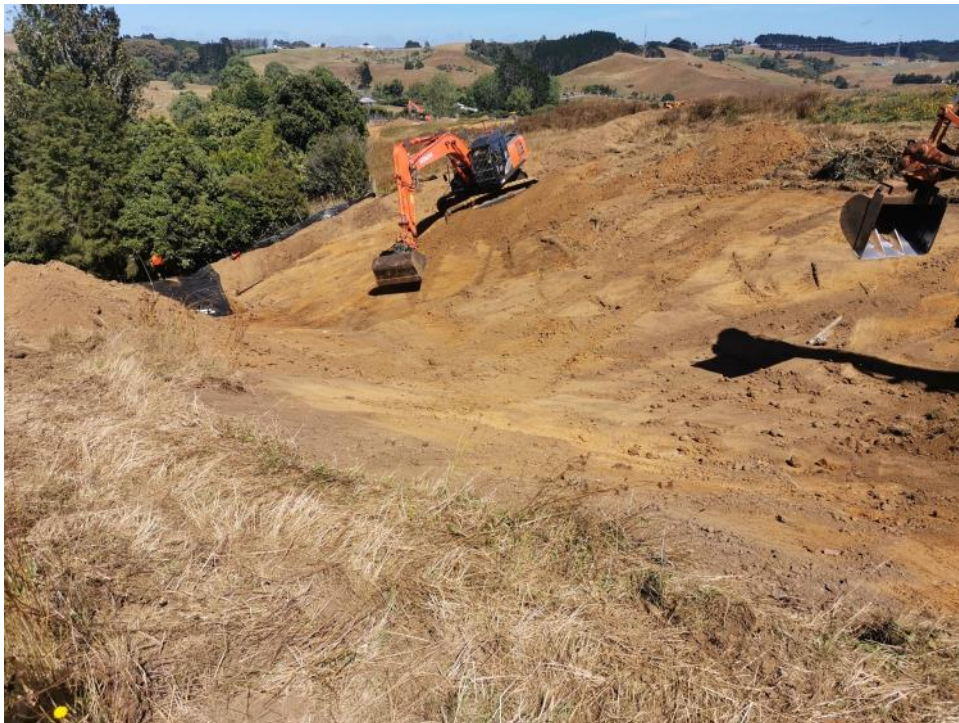
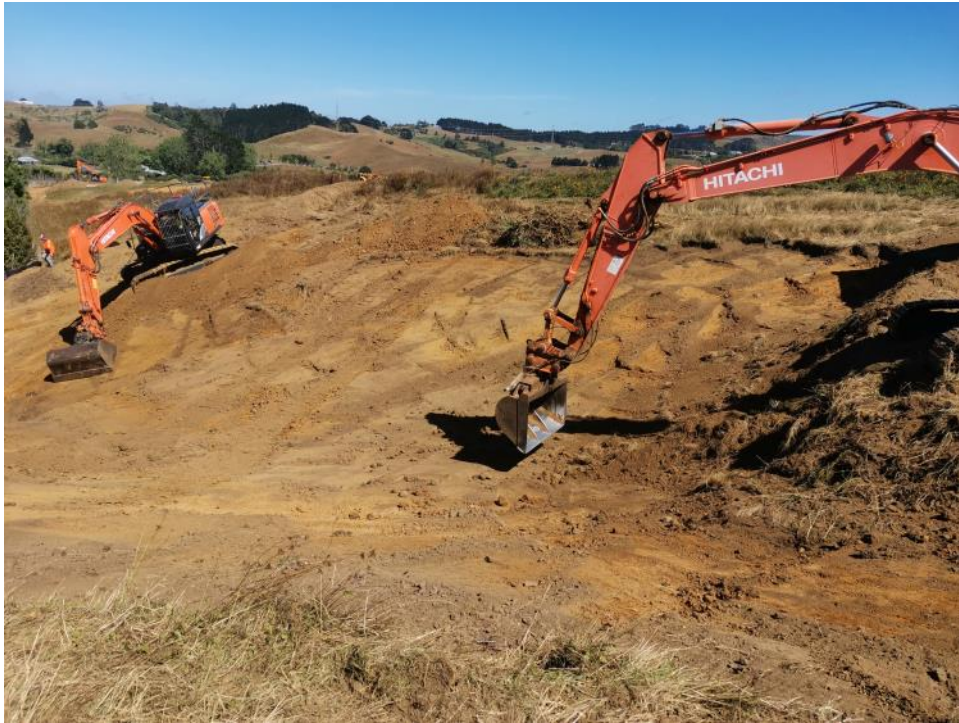
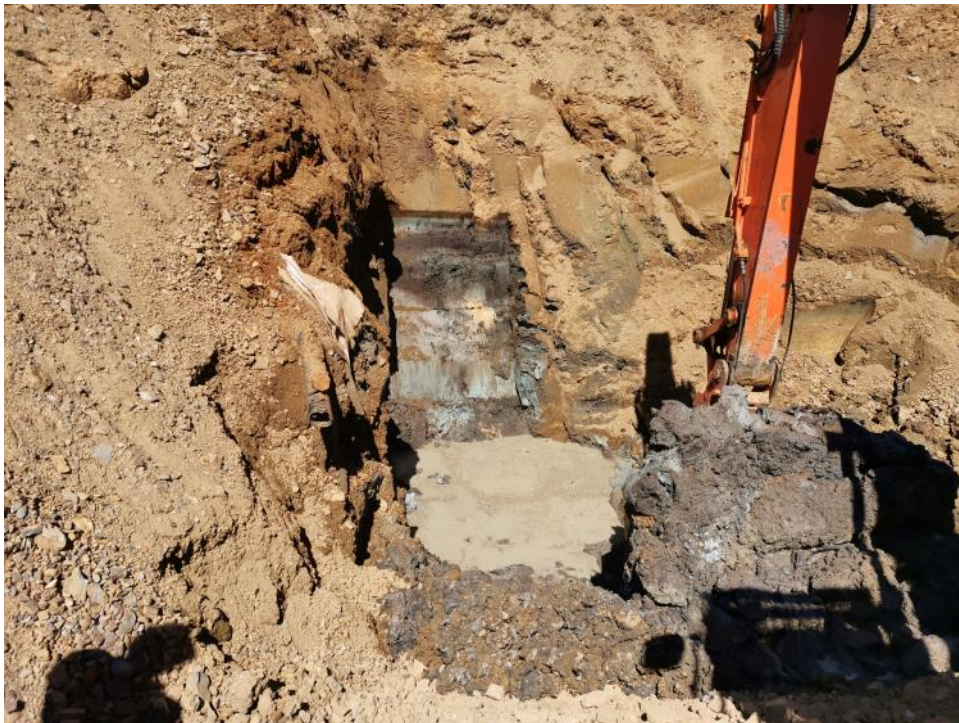
18/01/21 - REB1

- Observed placement of underfill drain within Fill M. Advised contractors that they could remove the top half of the drain as this is above the natural gully feature.

- Observed stripping operations below proposed Fill C. The topsoil strip revealed hard ash soils and tuff materials consistent with the materials observed in our trial pits from the GIR. Advised that an underfill drain should be trenched in here similar to below Fill M.

- Observed muckout of organic and soft alluvium materials below the underfill drainage line upslope of the REB2 shear key. The contractor had excavated down to the hard materials exposed at the base of the shear key. Advised him that this could be reduced to the base of any major organic layers, provided that the inorganic soils are competent enough to place and compact engineered certified fills upon. Will return in a day or two to observe progress.

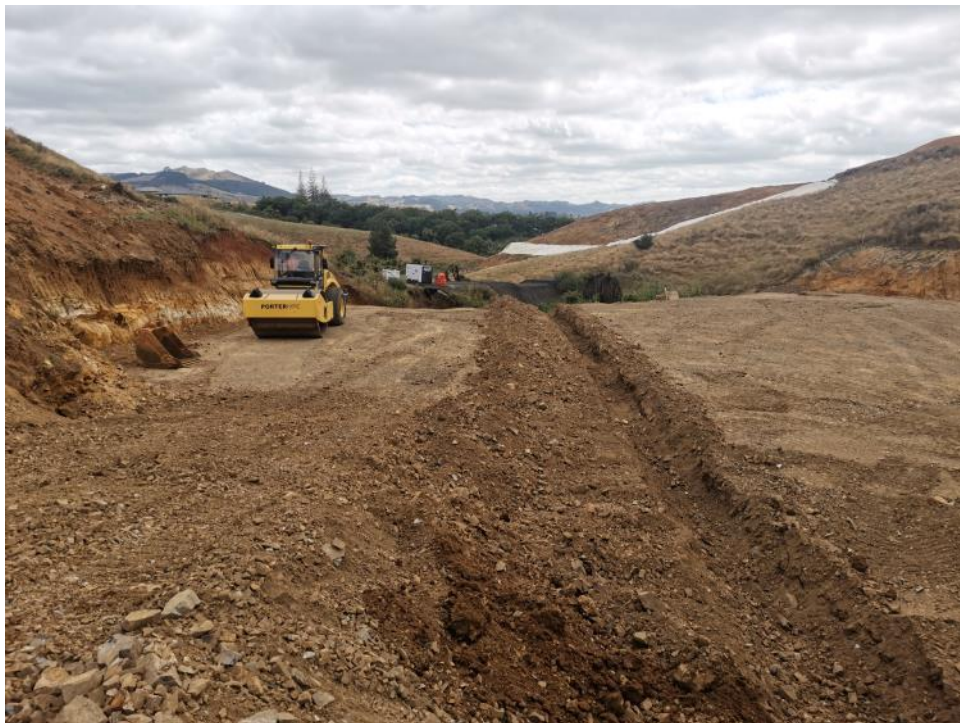
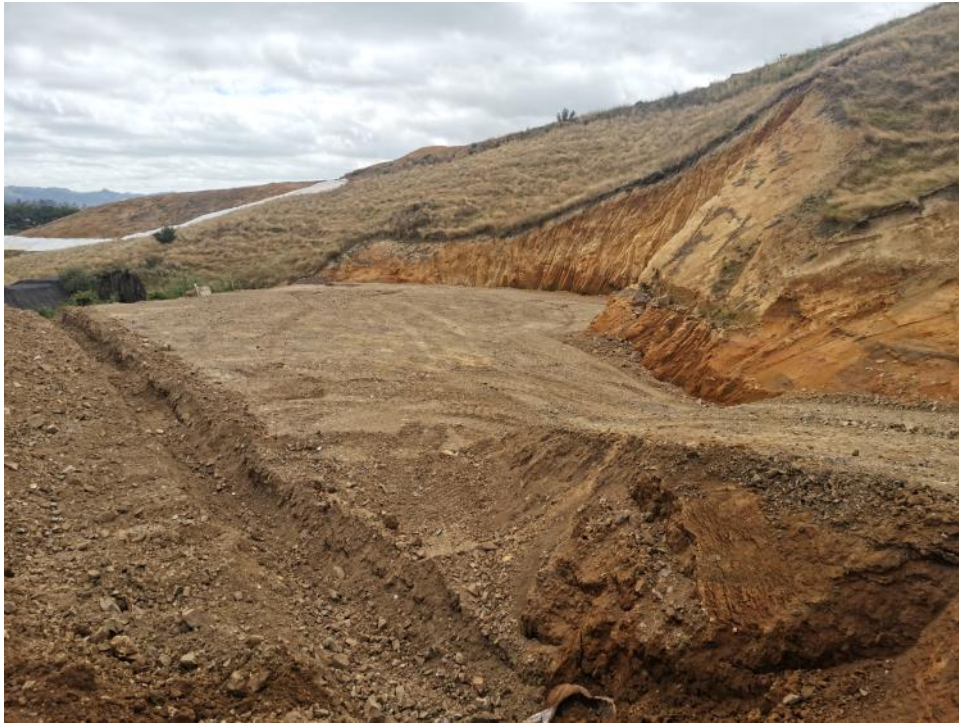
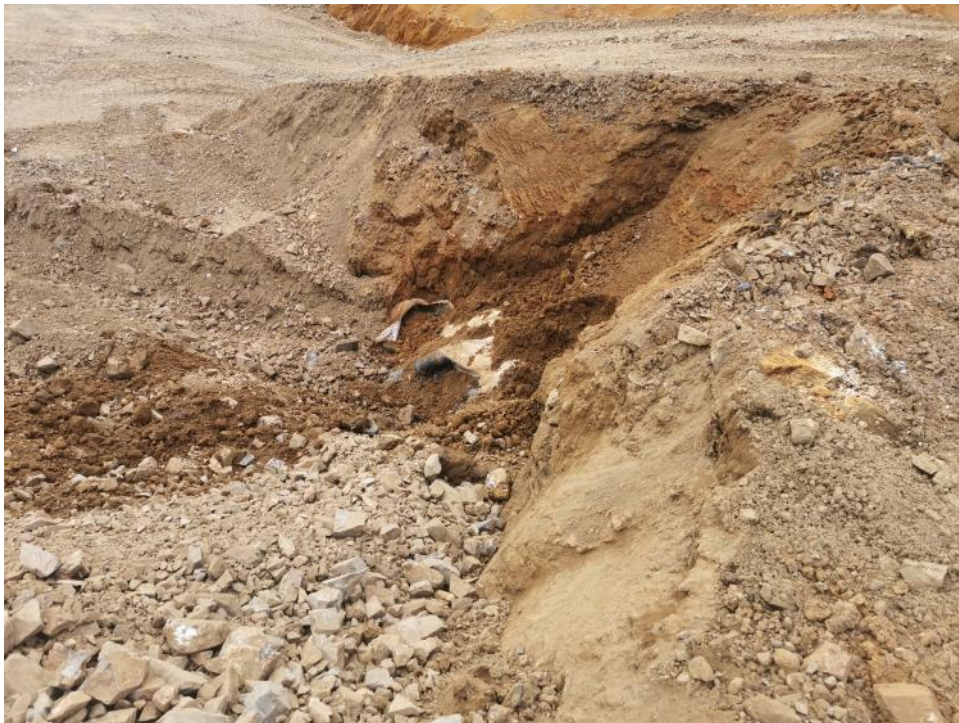
26/01/21 - REB2

The undercut of organic alluvium has now been backfilled with SPR and the undercut had extended back into the gully to intercept the undisturbed/intact underfill drain. A drainage line has been trenched through the centre of the shear key to allow this drain to outlet into the main gully. The contractors plan to place two coils in this trench for redundancy.

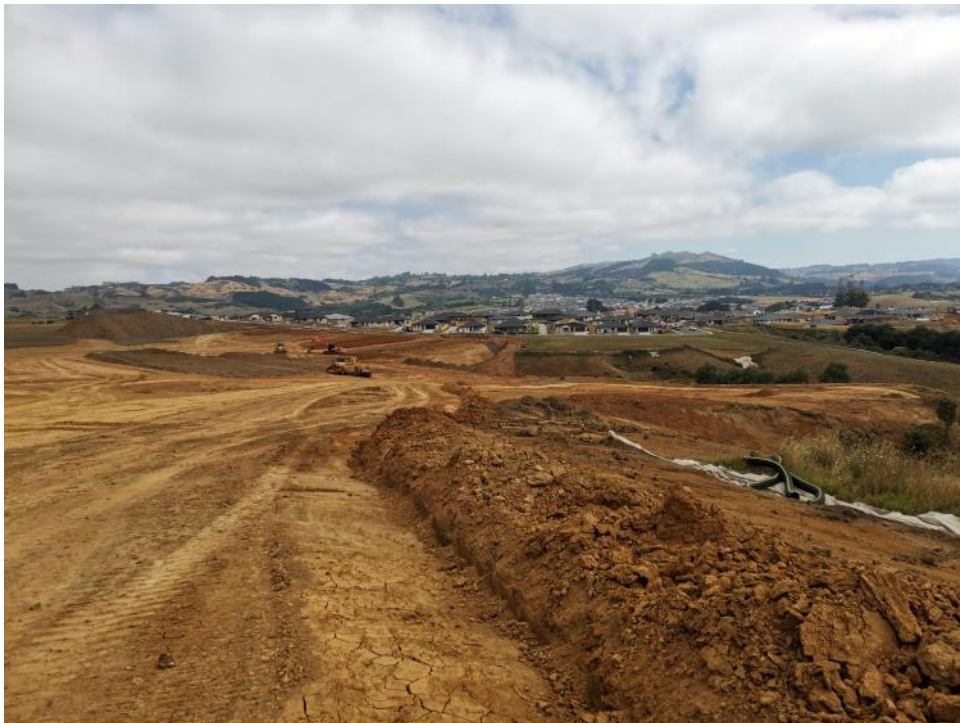
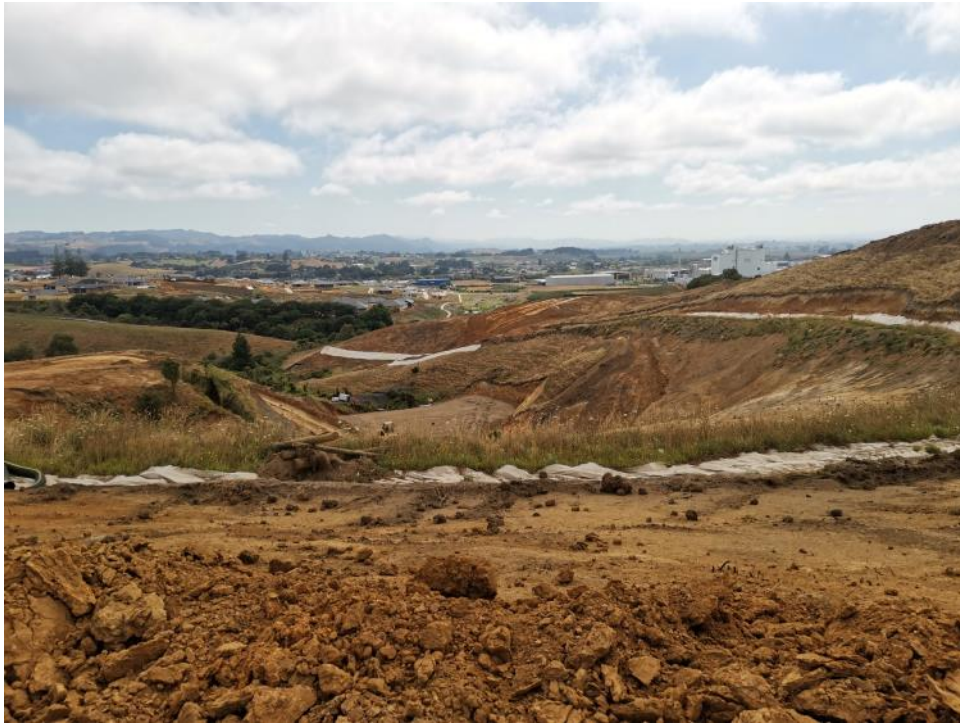
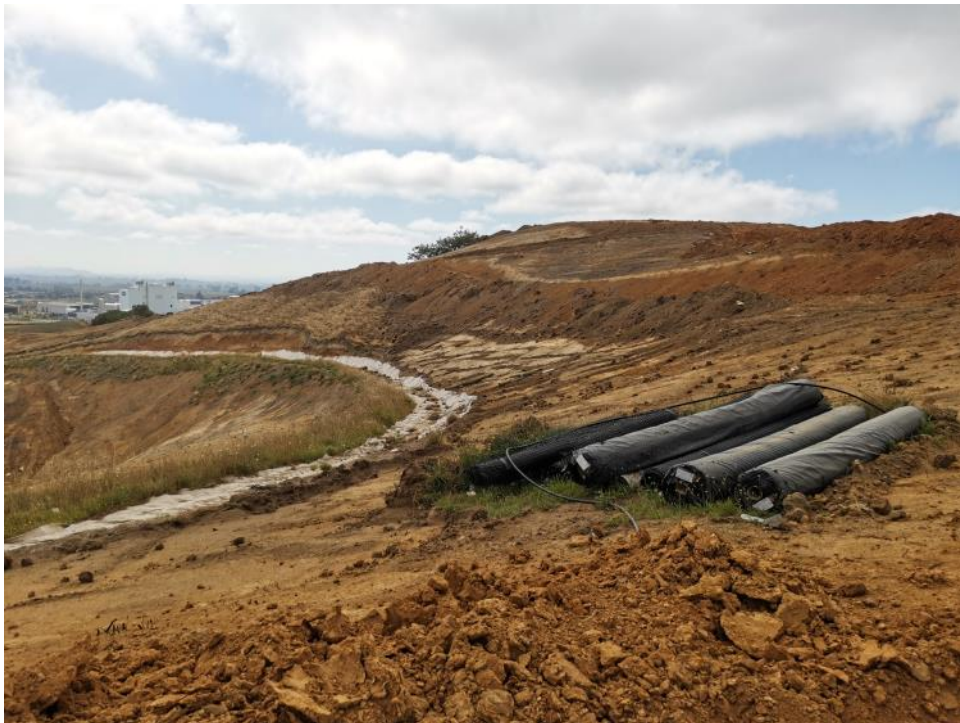
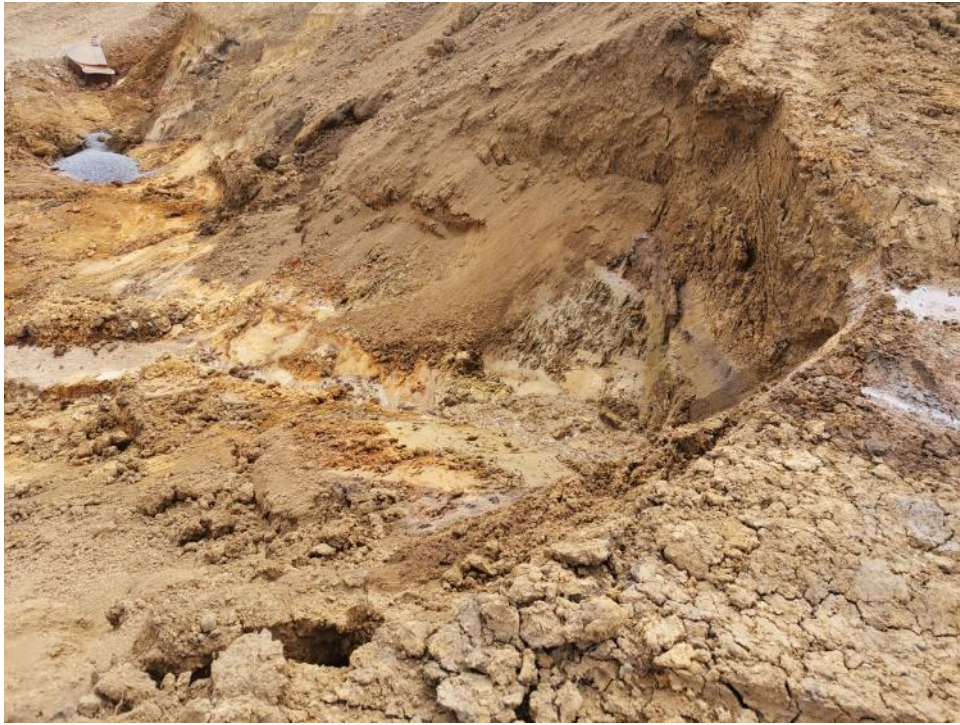
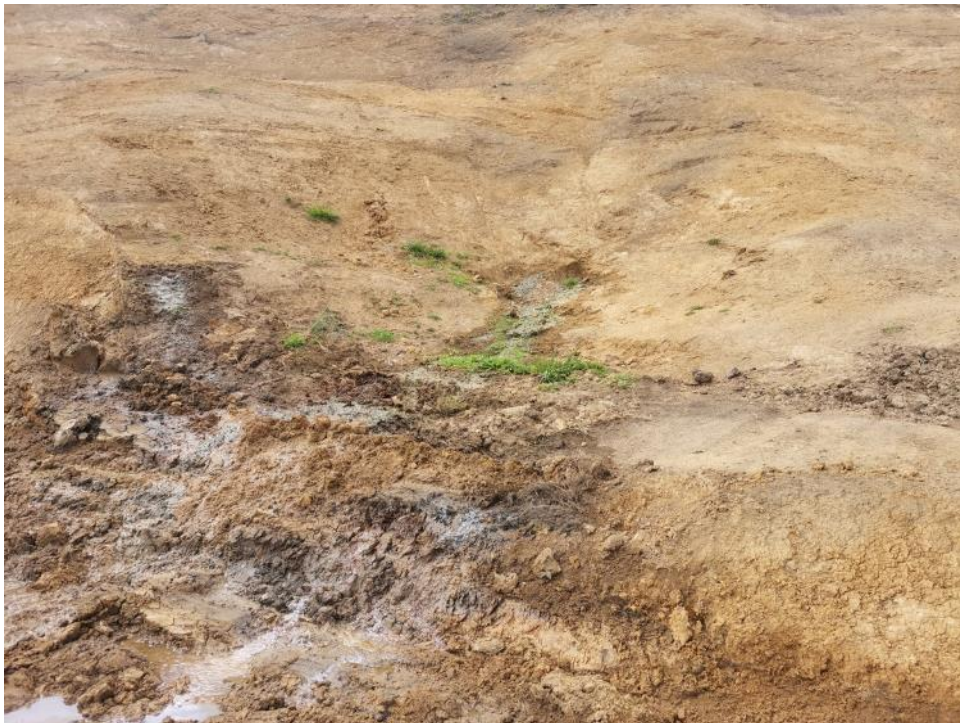
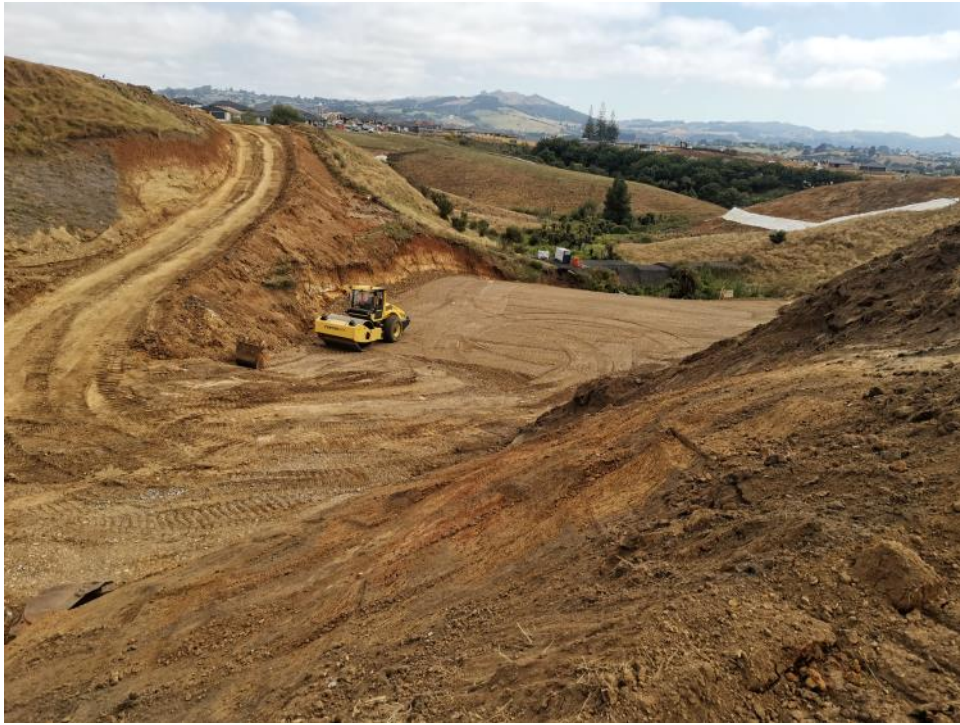
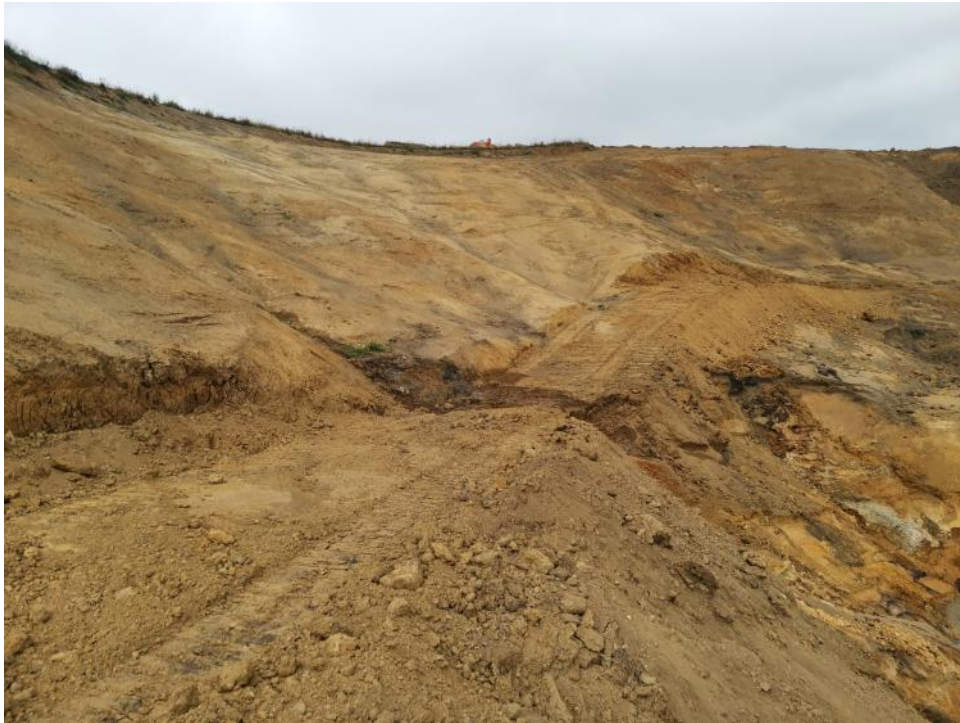
- Within Stage 12D the 1(v) in 3(h) batter has been formed to final height and has been trimmed and topsoiled.
- Stripping has commenced up the flanks of the gully in REB2 for preparation of the fill batter placement. Recommended the installation of 3 additional underfill drains in areas of seepage, two up the eastern flank and one up the southern (rear) which will connect into the existing underfill drain.
- Discussed that benching into the flanks will require an average bench depth of 2m which Dines have already programmed up.
- Will meet on Friday with Cirtex and Chris to discuss topsoiling the face of REB1 as the contractors are having difficulty getting the topsoil to stay in place.

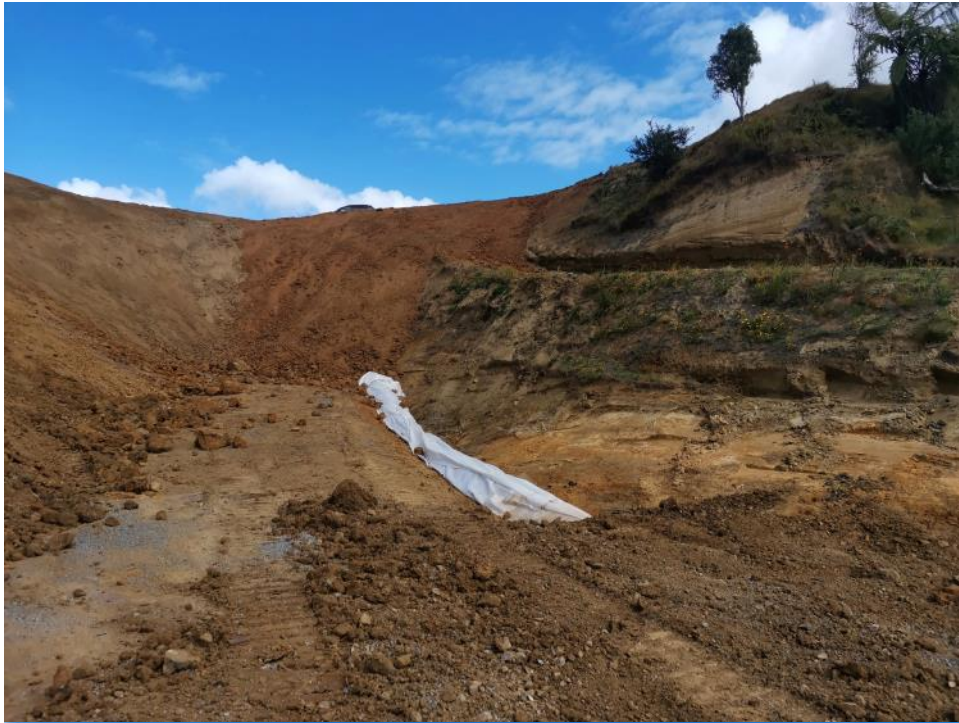
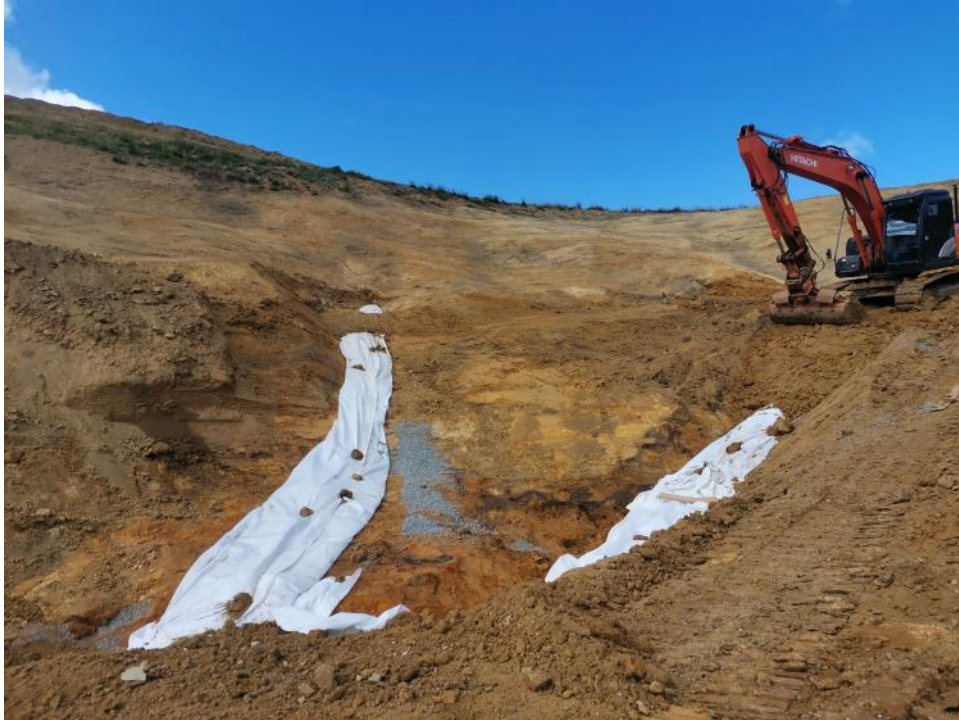
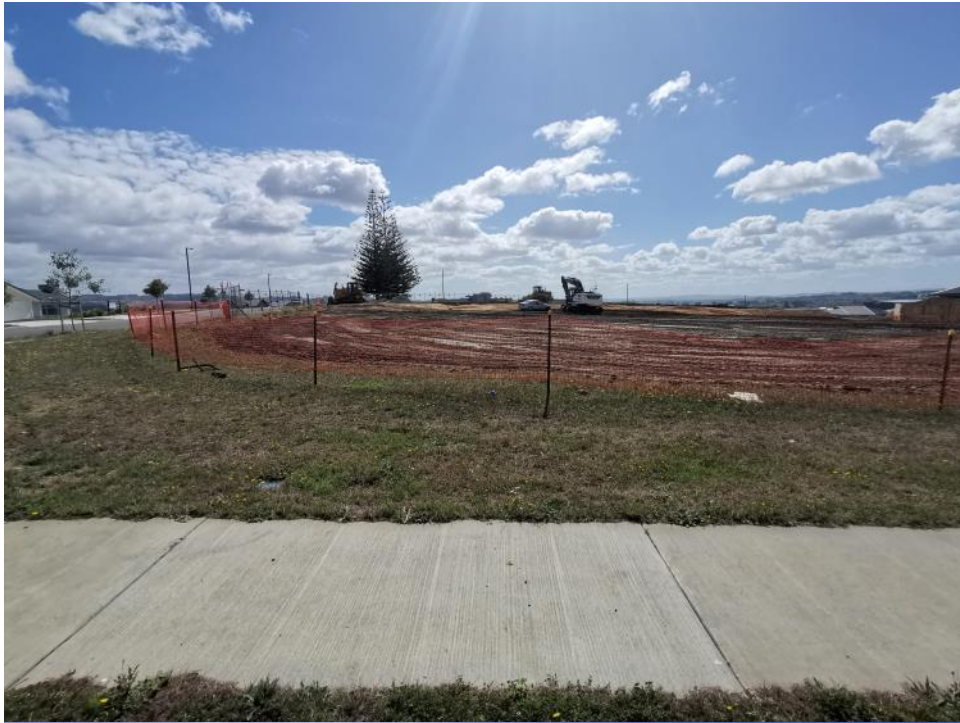
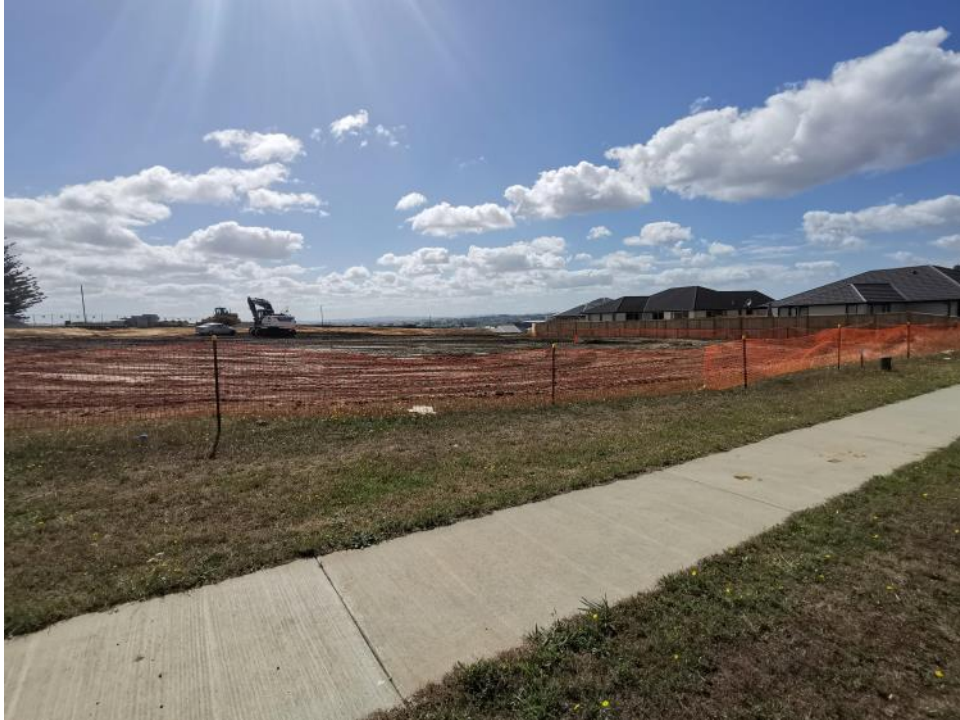
At REB 2, construction of the shear key is almost complete and several underfill drains have been installed as per our recommendations.

Also inspected final works for lots 611 and 612, adjacent to stage 12D. Both lots have been topsoiled, with 100mm of topsoil measured in both lots.

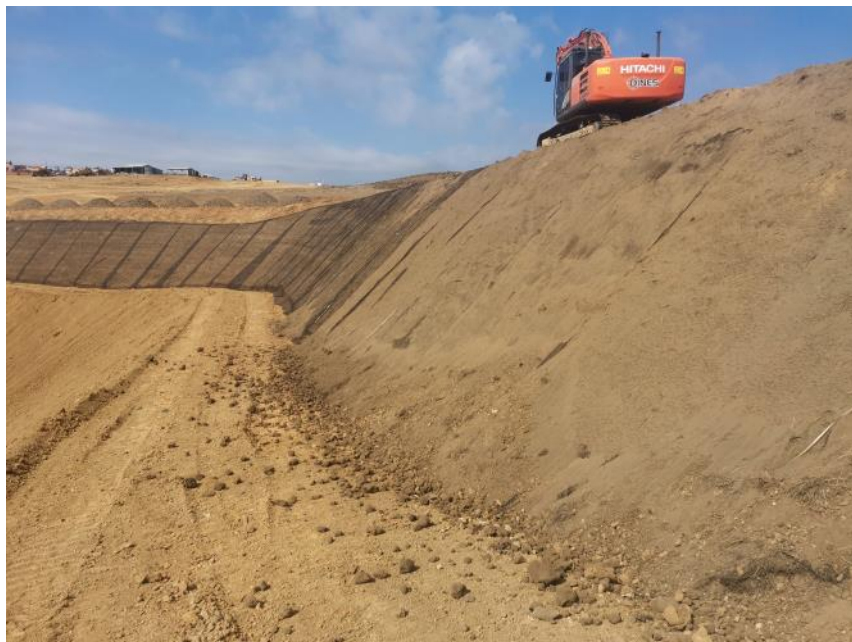
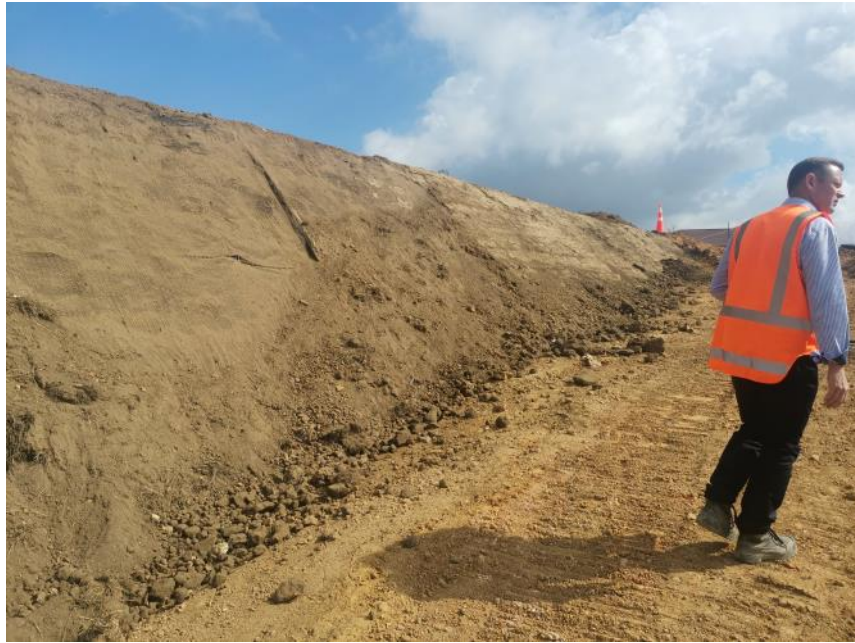
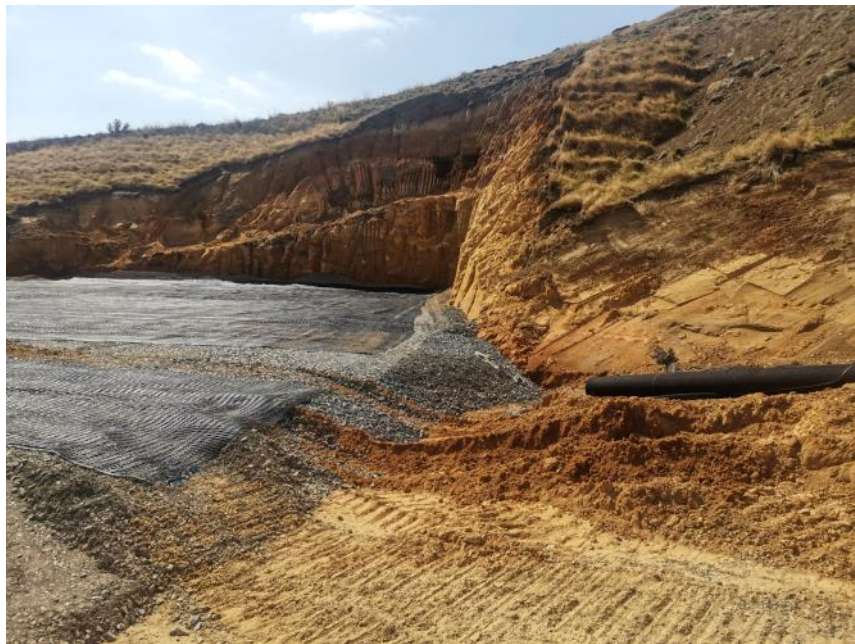
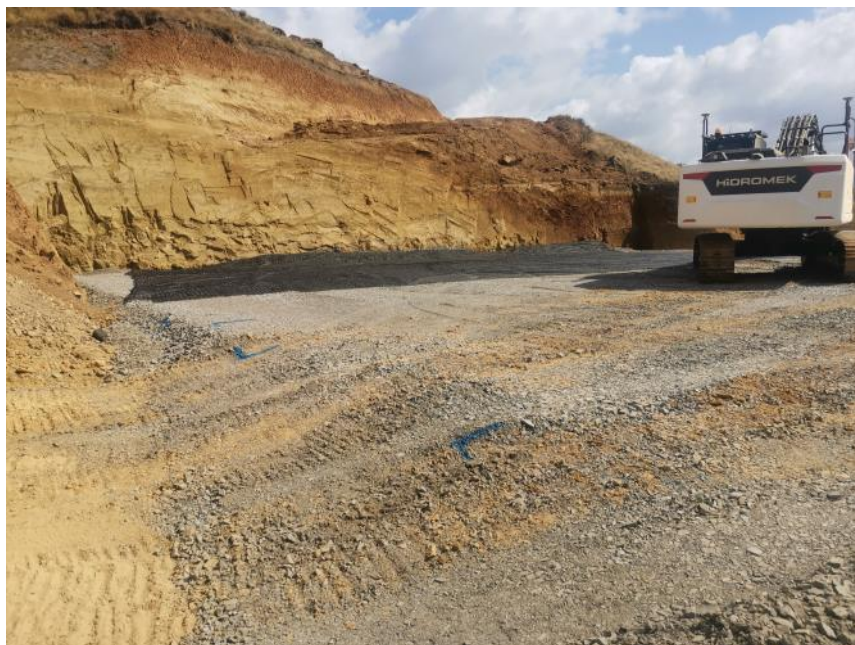
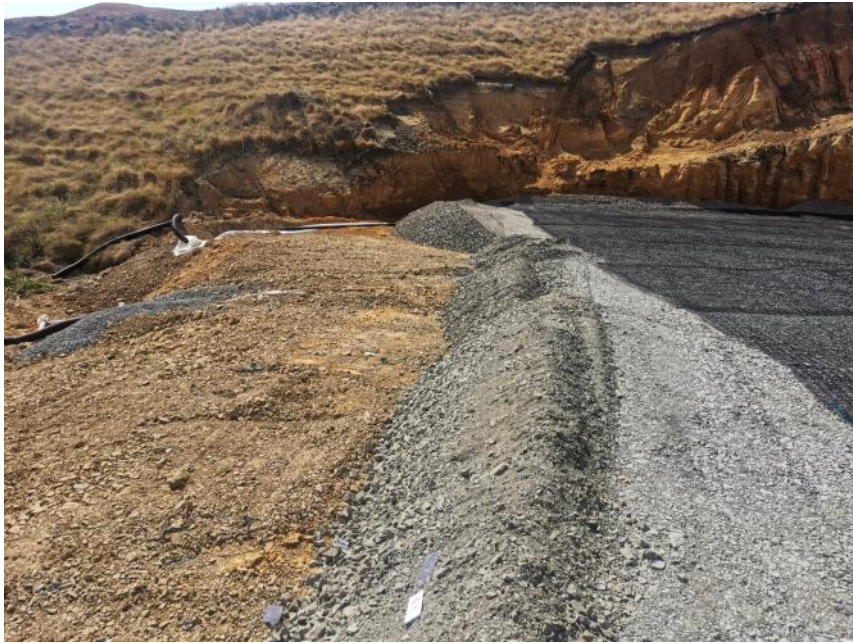
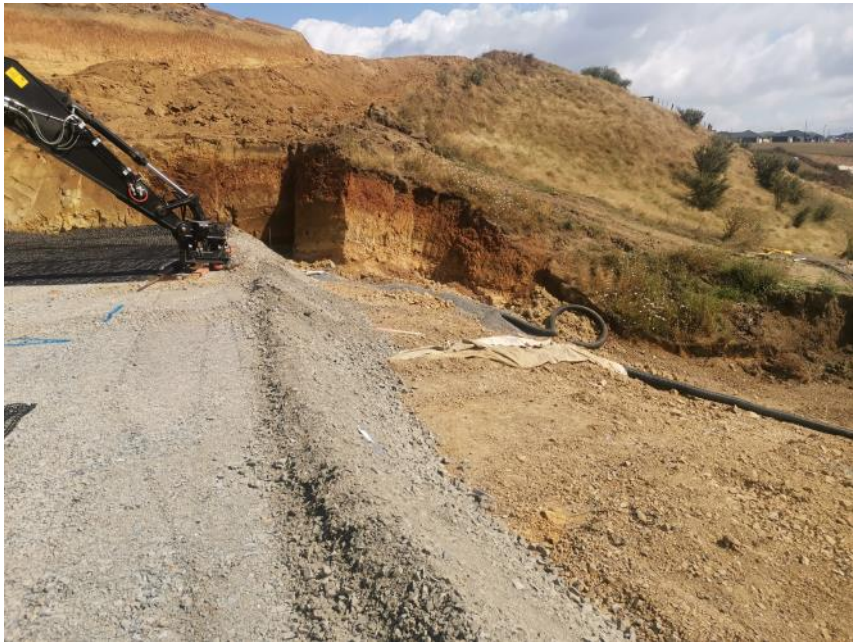
05/02/21 - REB 1

Grant advised the product Dines are using is not the best for such a steep slope, however, he is going to discuss options with others at Cirtex and provide further advice as to how the facing mat should be installed and how they are joined down the slope.

Also inspected REB2 - the 1m GAP65 layer has been placed and tested via clegg hammer, and the 19m long layer of grid is laid over top as per our design recommendations.

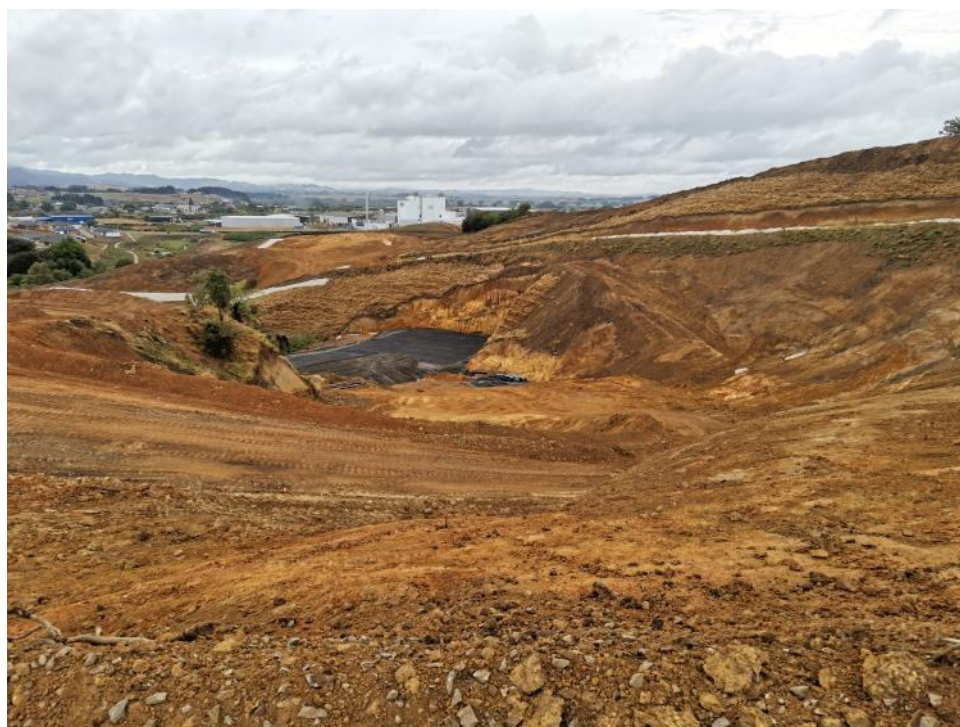
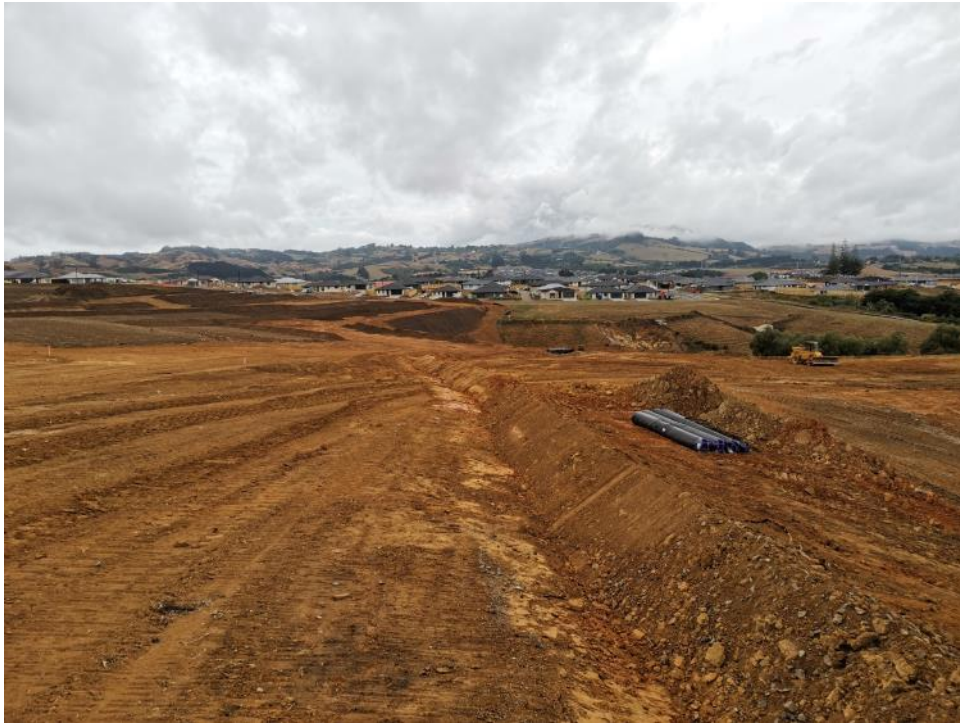
09/02/21 - REB2

Visited site to observe earthworks progress over the weekend, however, not much had been done since last week.

There is still one more layer of GAP65 to place in REB2 prior to clay filling starting.
