Geotechnical Completion Report

HITCHEN BLOCK STAGE 13B

17 January 2022

Ref No: J00113

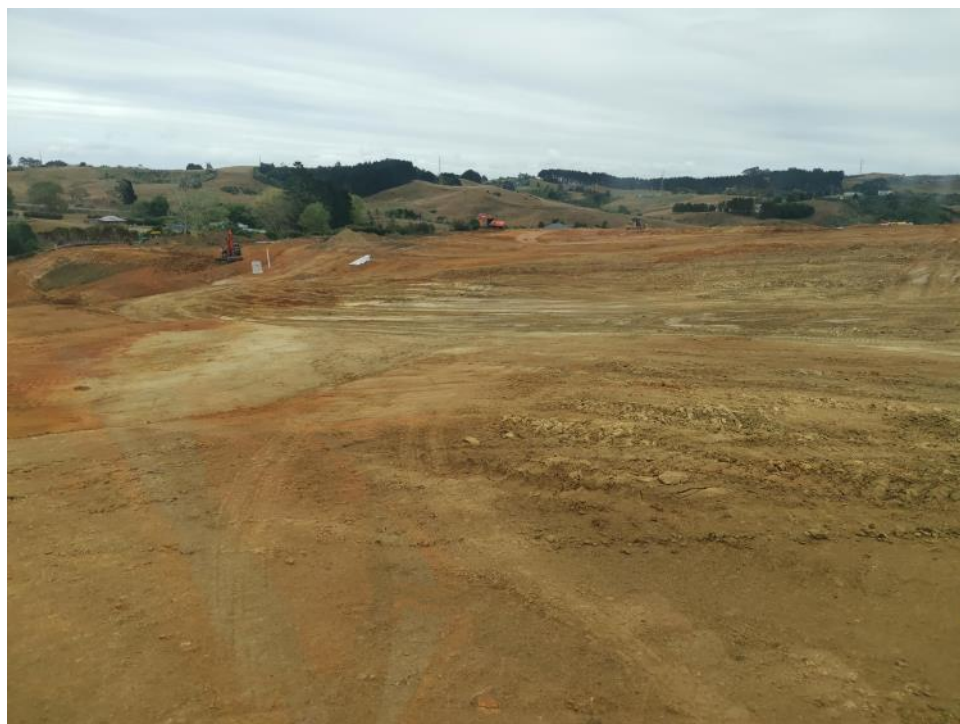
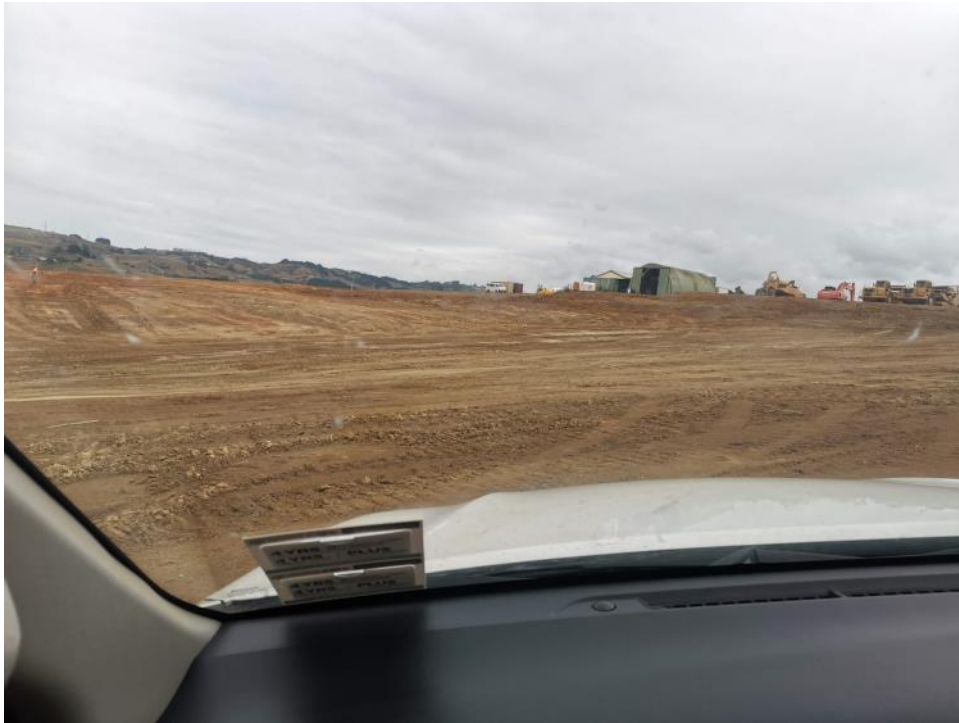
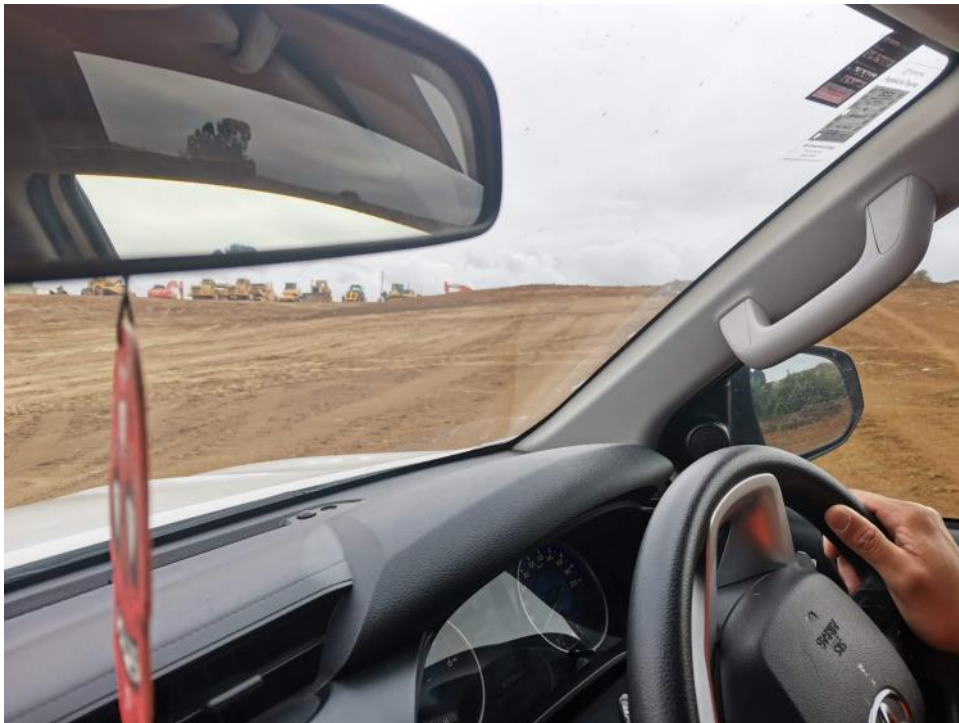
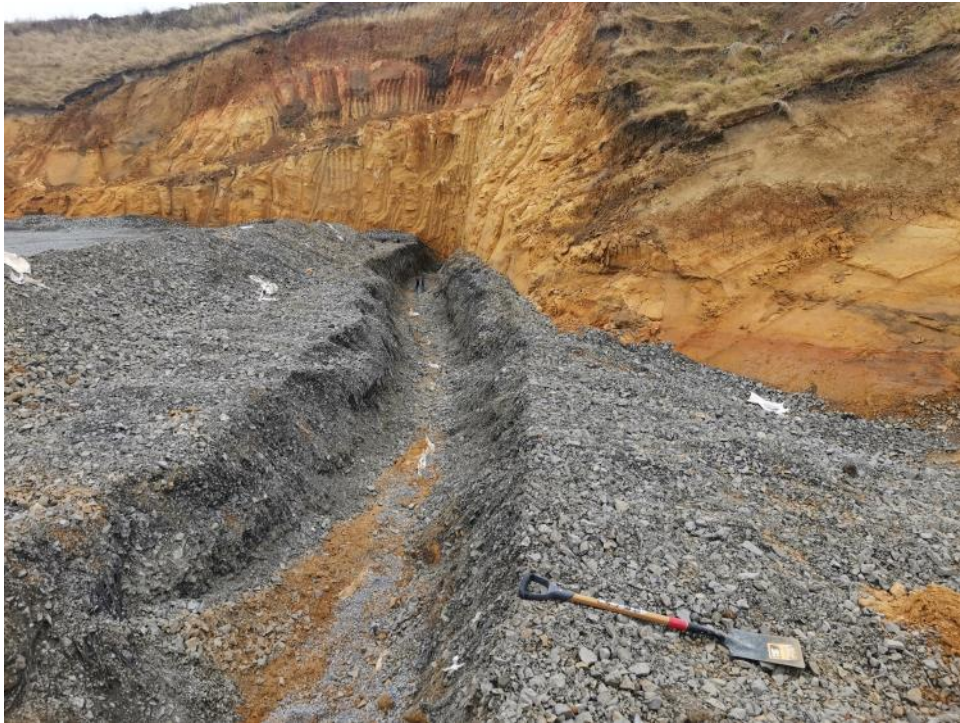
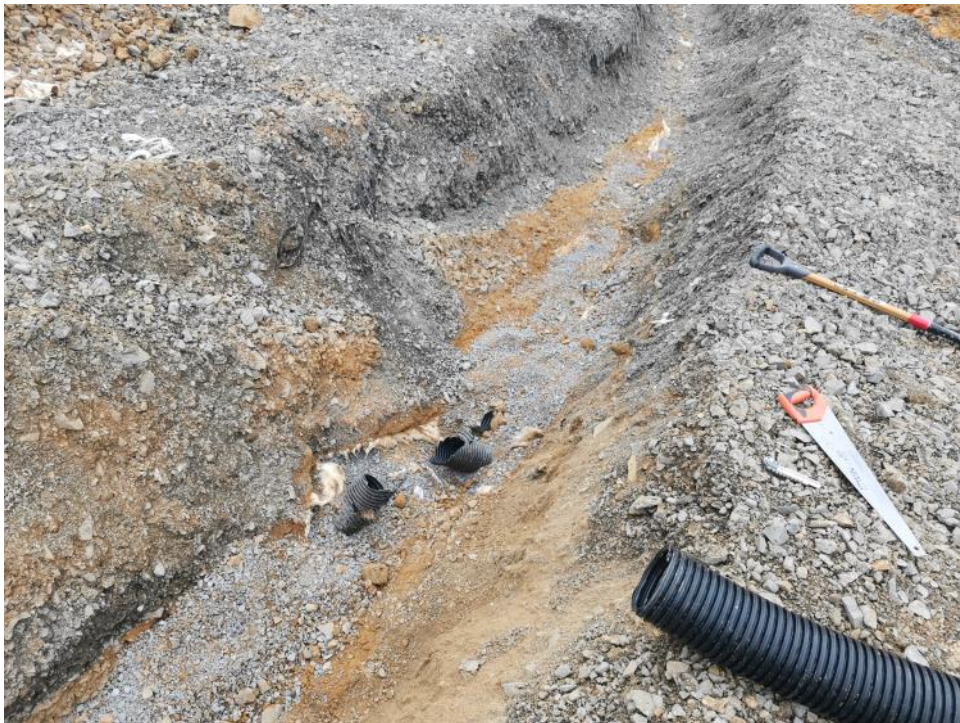
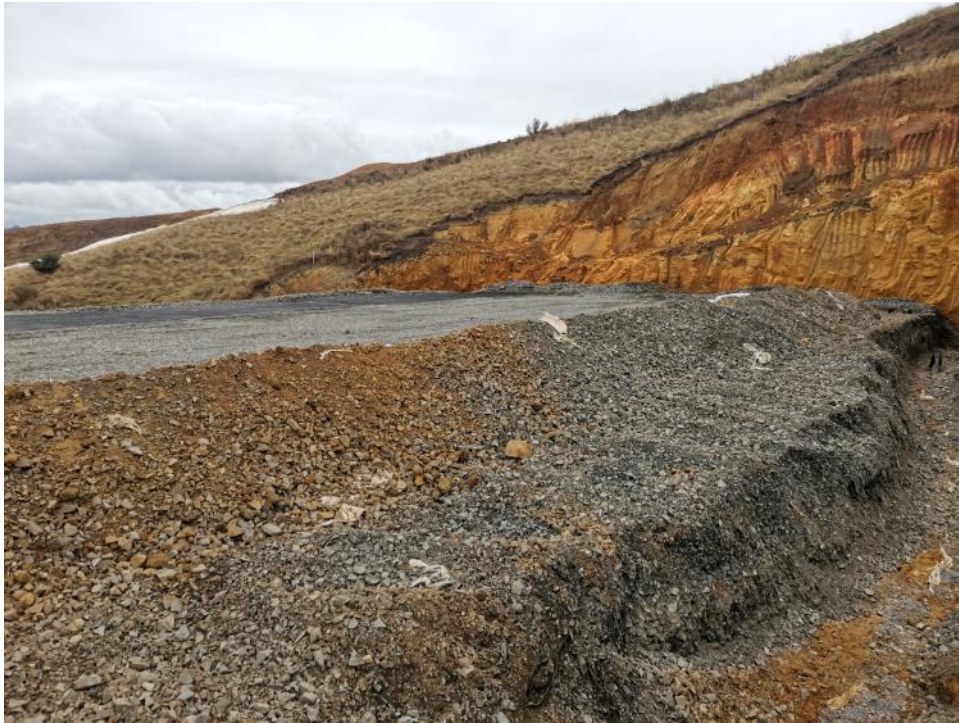
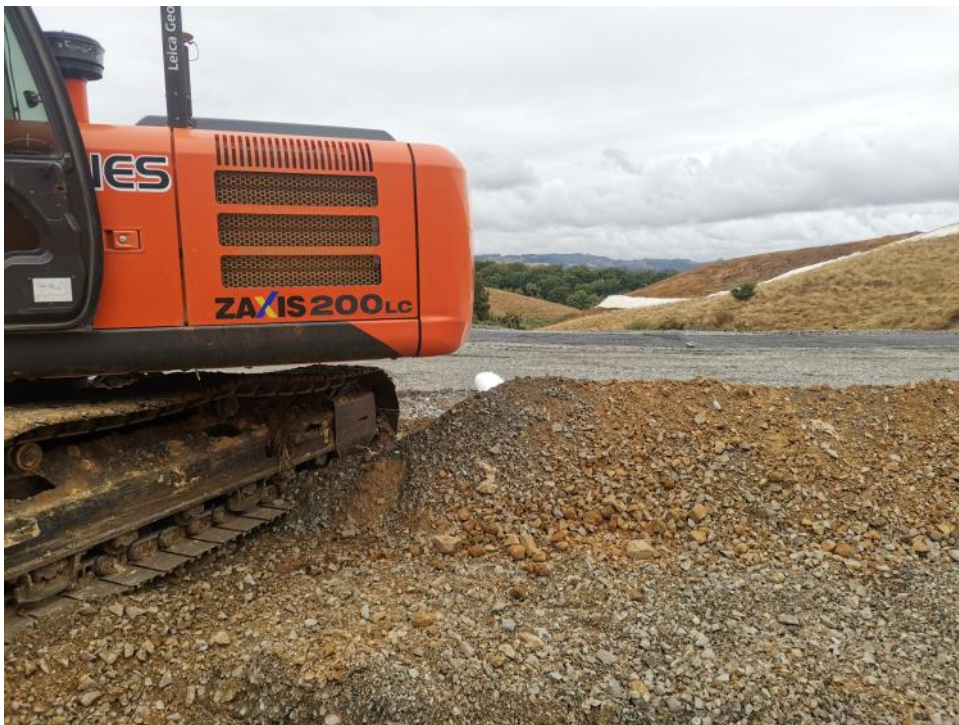
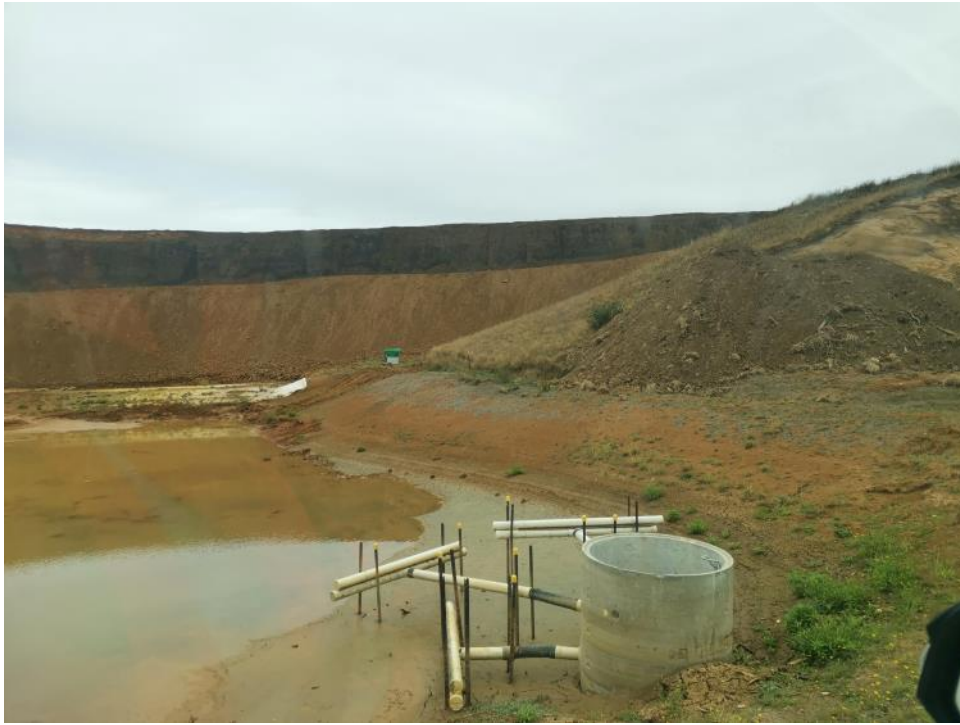
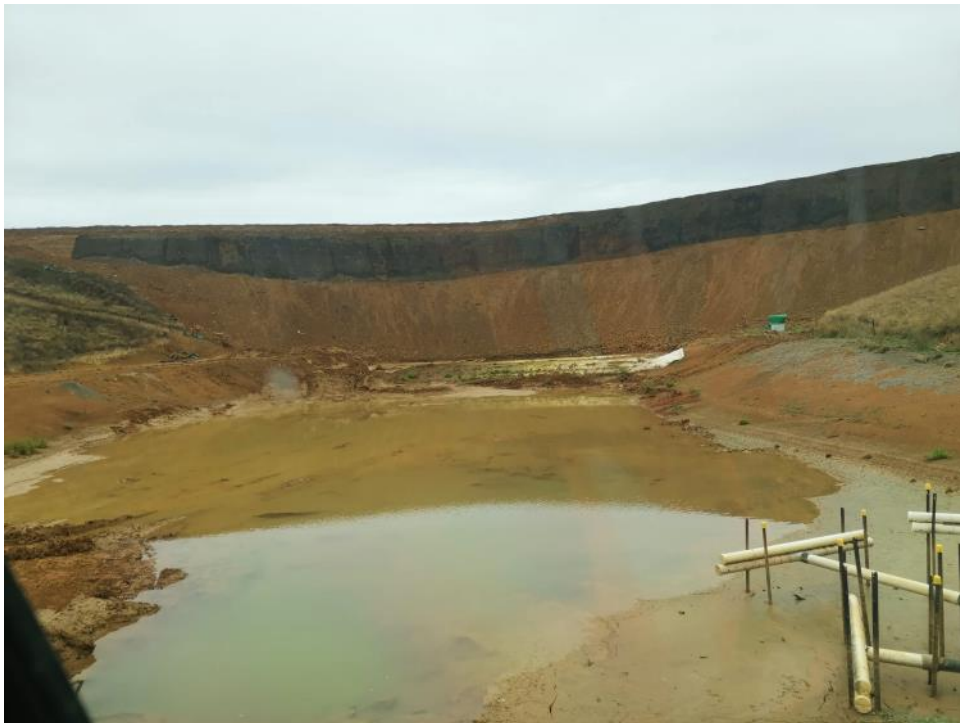
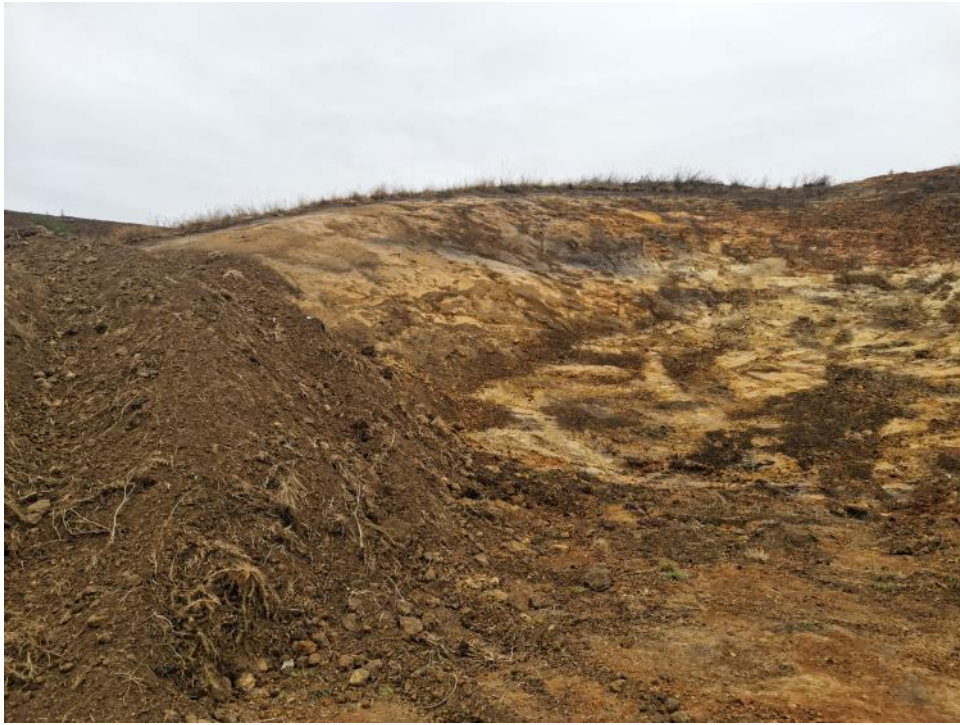
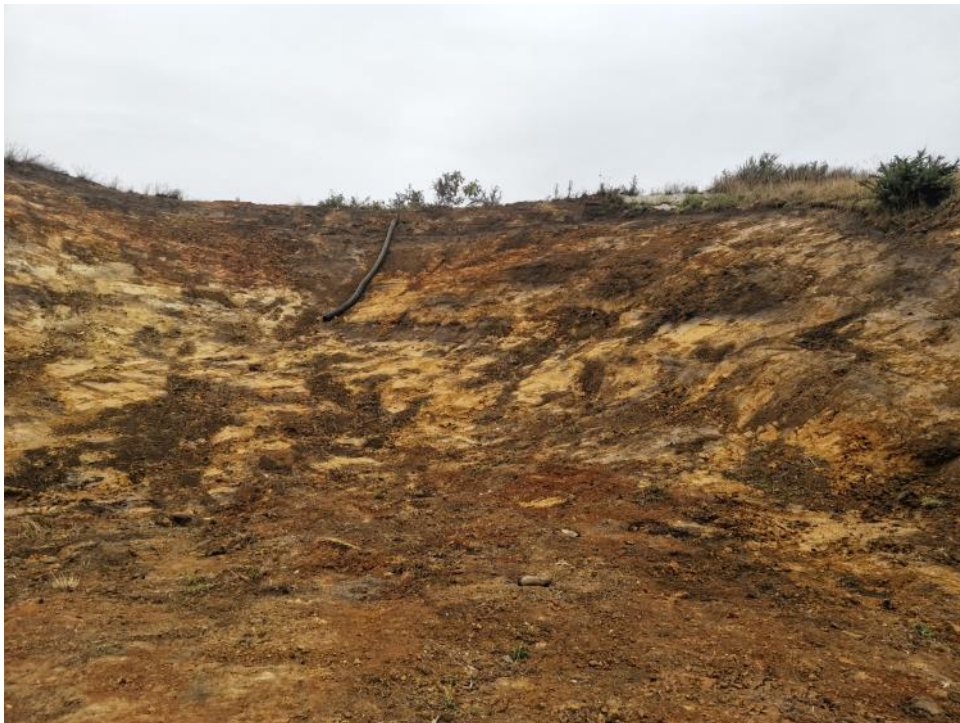
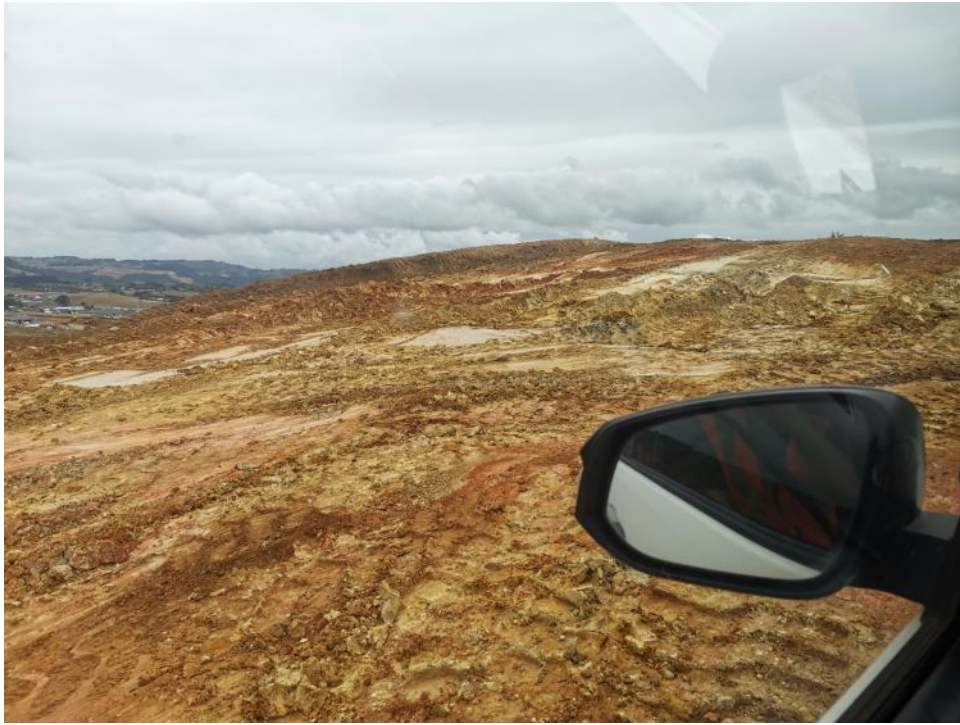
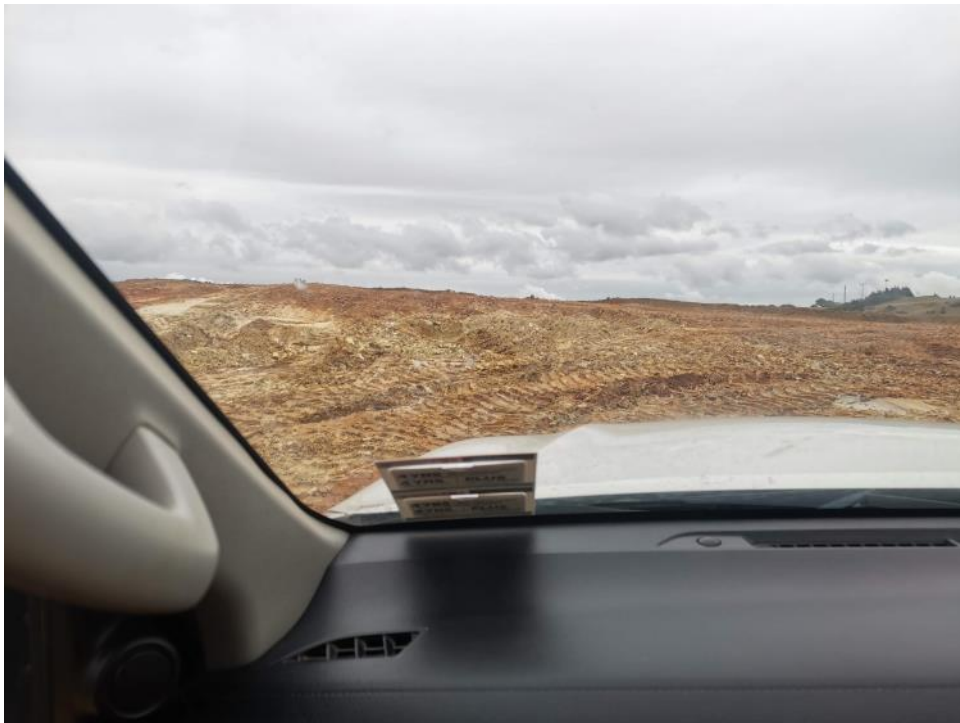
11/02/21 - REB1&2,welded tuff area

- Within REB2, the 1m GAP65 layer is now complete and clay filling is about to commence. The rear blanked drain is being installed, however, the main underfill drain has been severed and the contractors were advised to repair this prior to backfilling.

- At the REB1 wall face, the contractors are still having difficulty placing topsoil along the facing. Advised the contractor to keep talking to Cirtex and their hydroseeders for advice as necessary.

- The old slip above the REB1 silt pond is about to be backfilled. Advised contractors to trench in an underfill drain prior to benching into the slope and filling. The underfill drain will outlet at the same point at the REB underfill drains, but with a different outlet point.

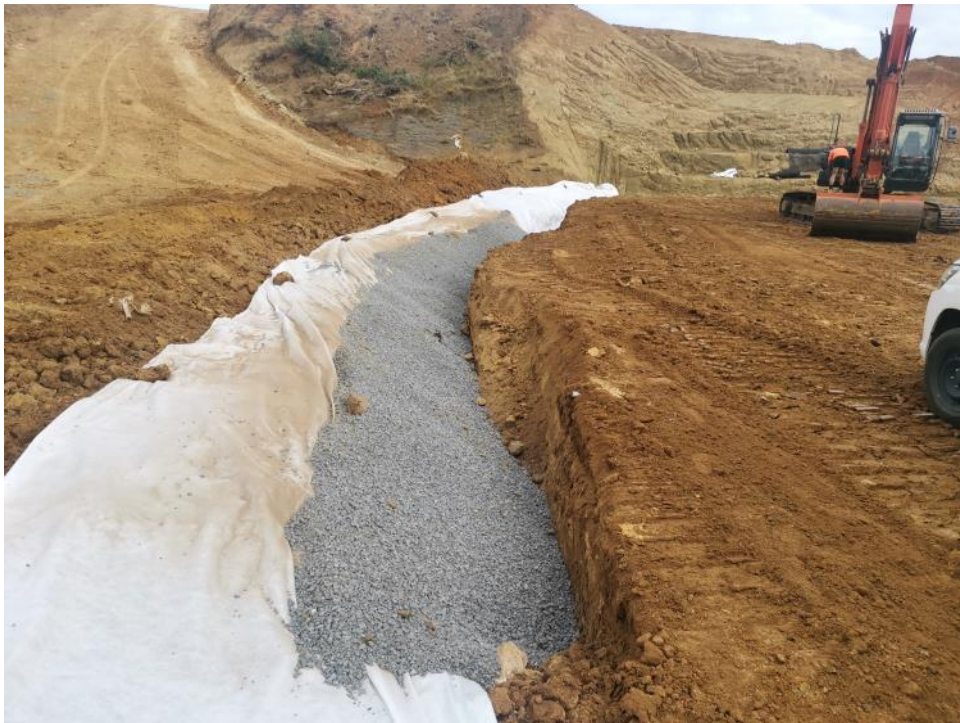
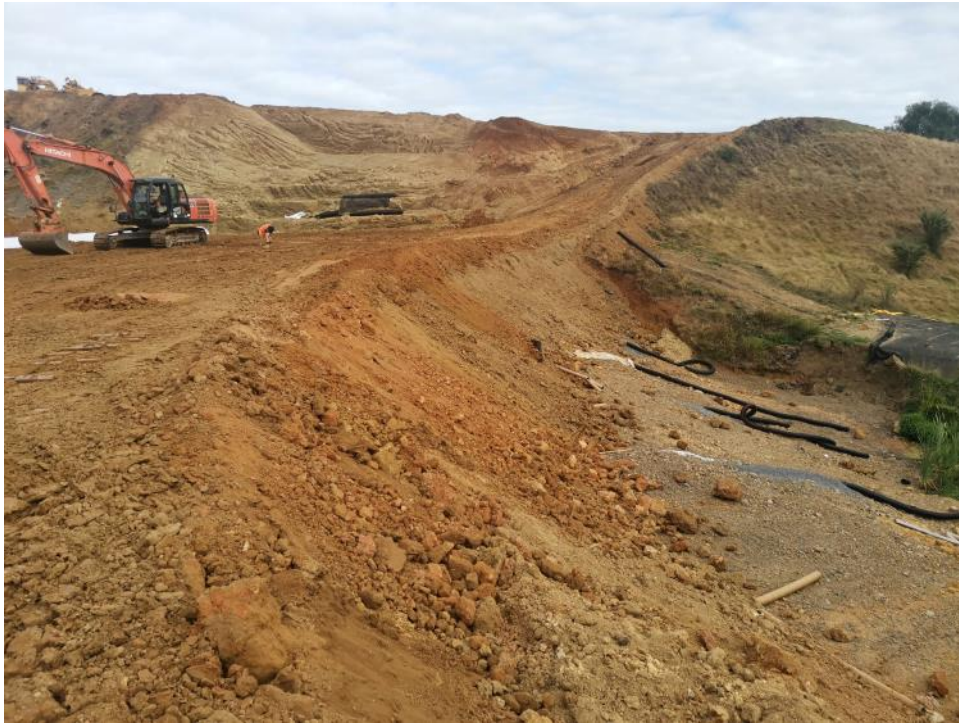
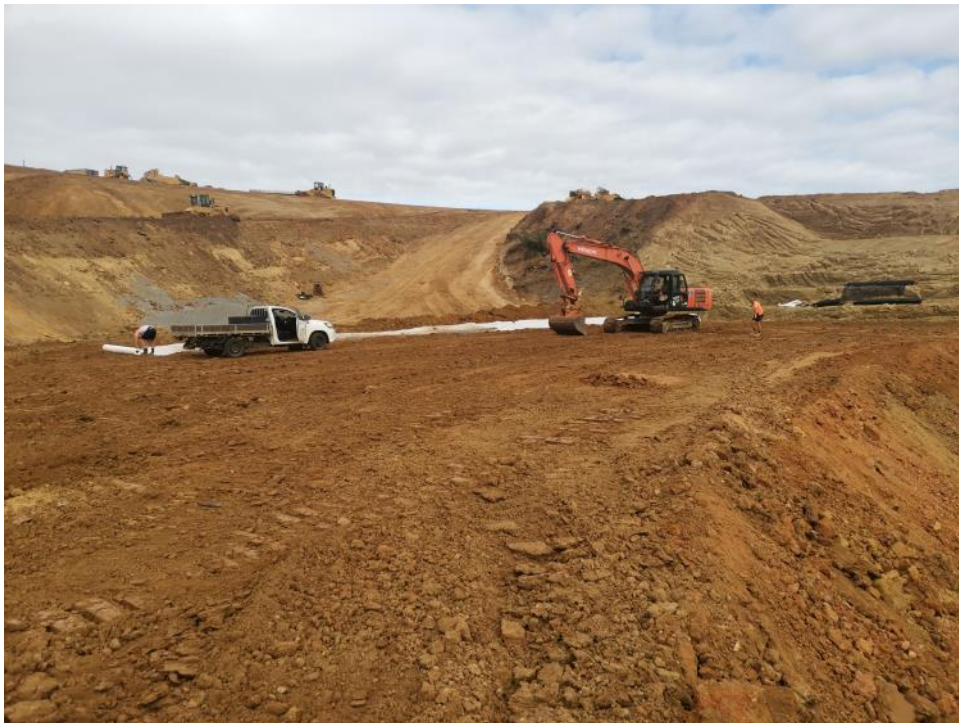
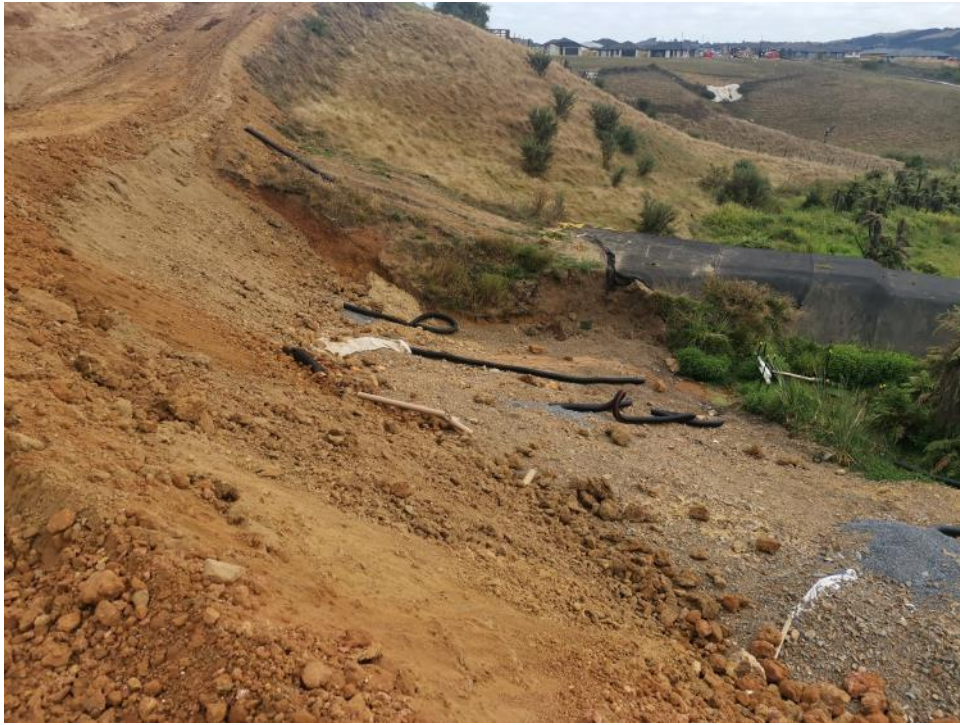
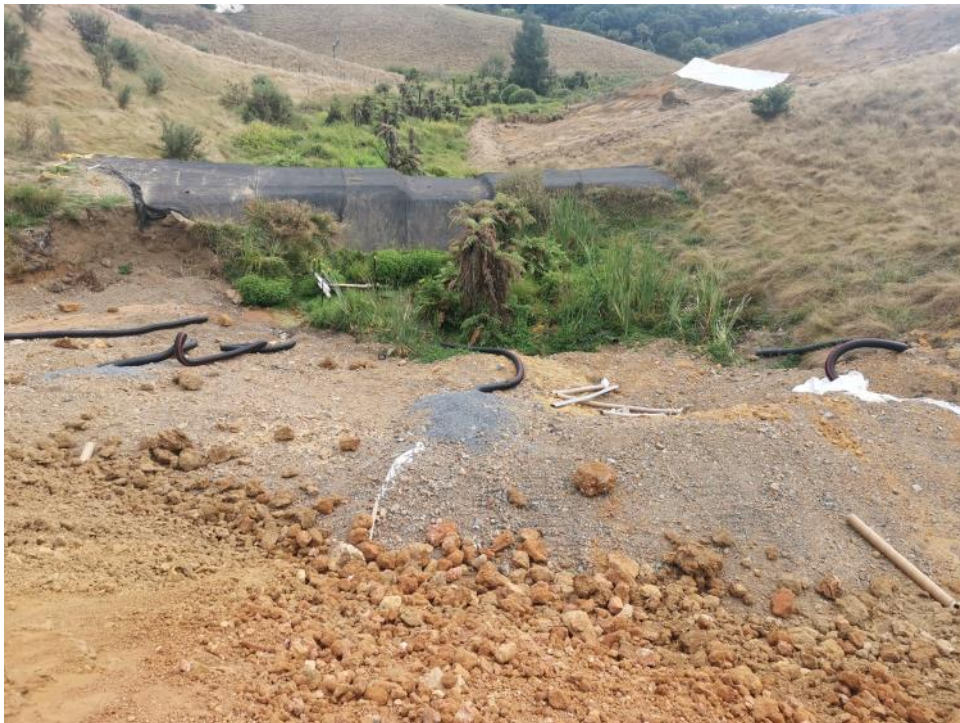
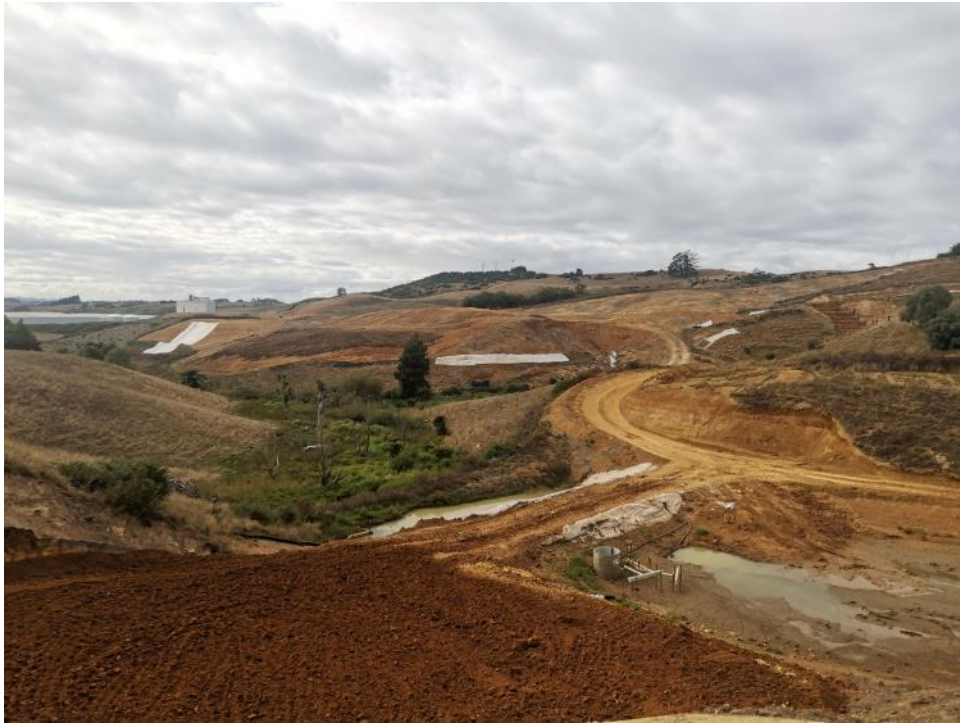
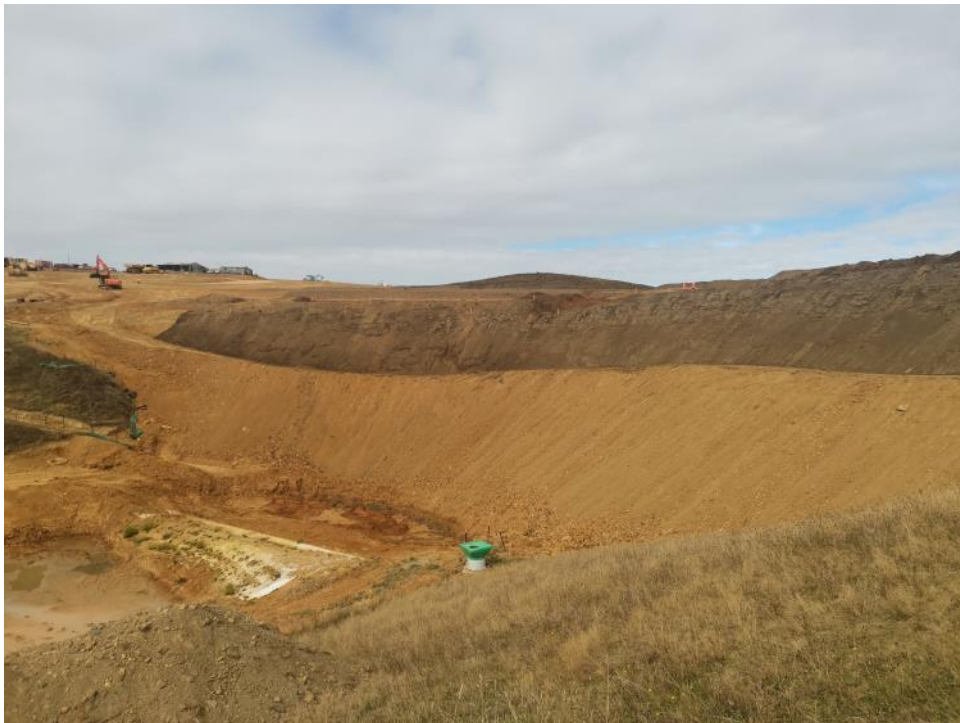
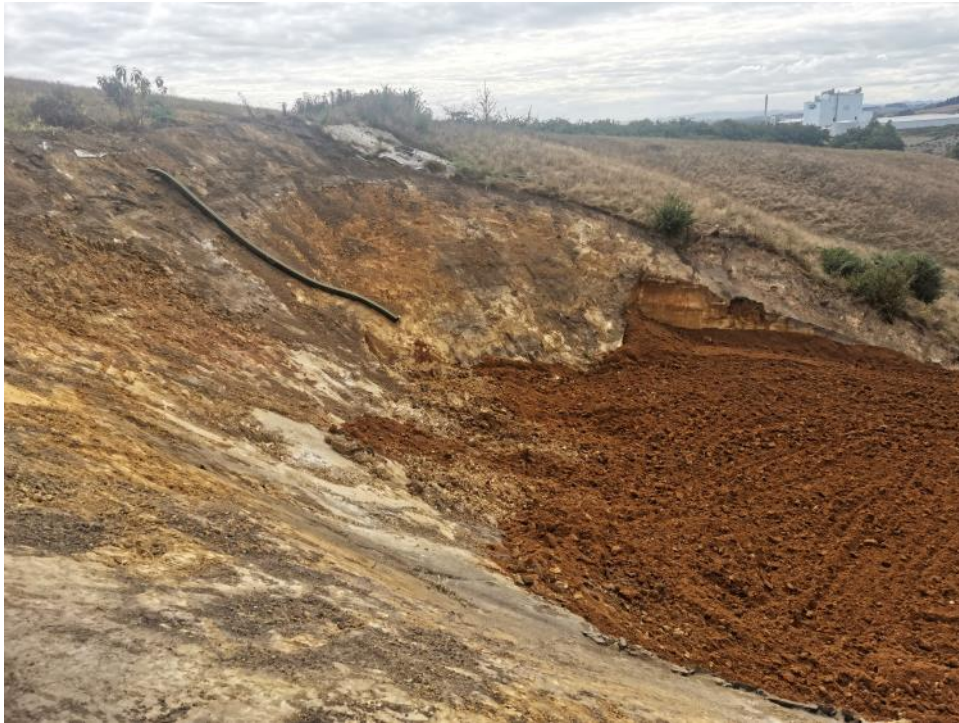
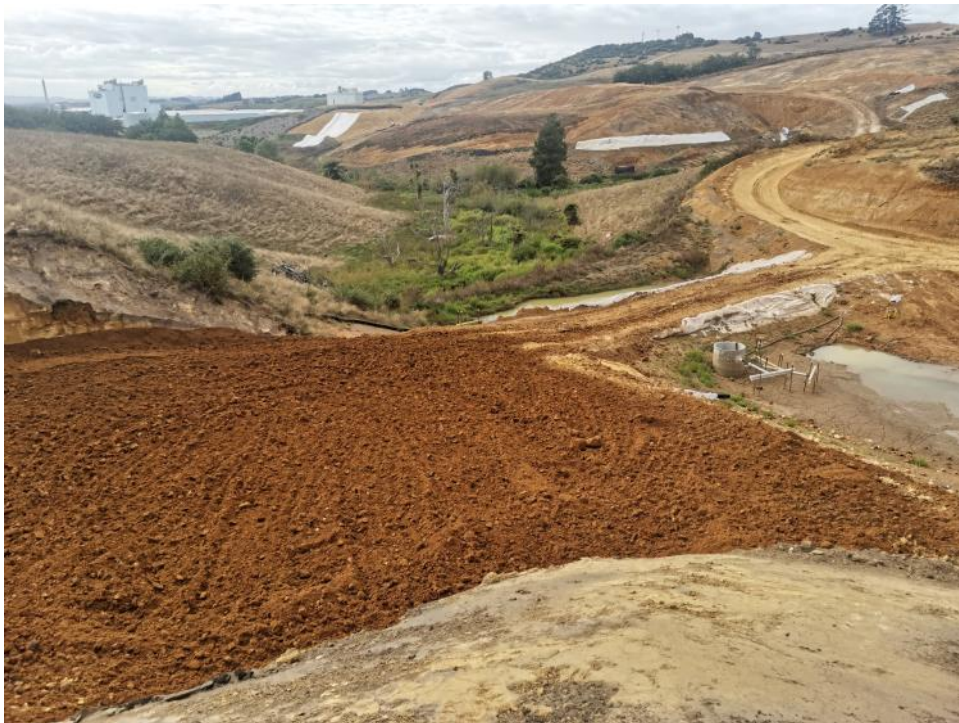
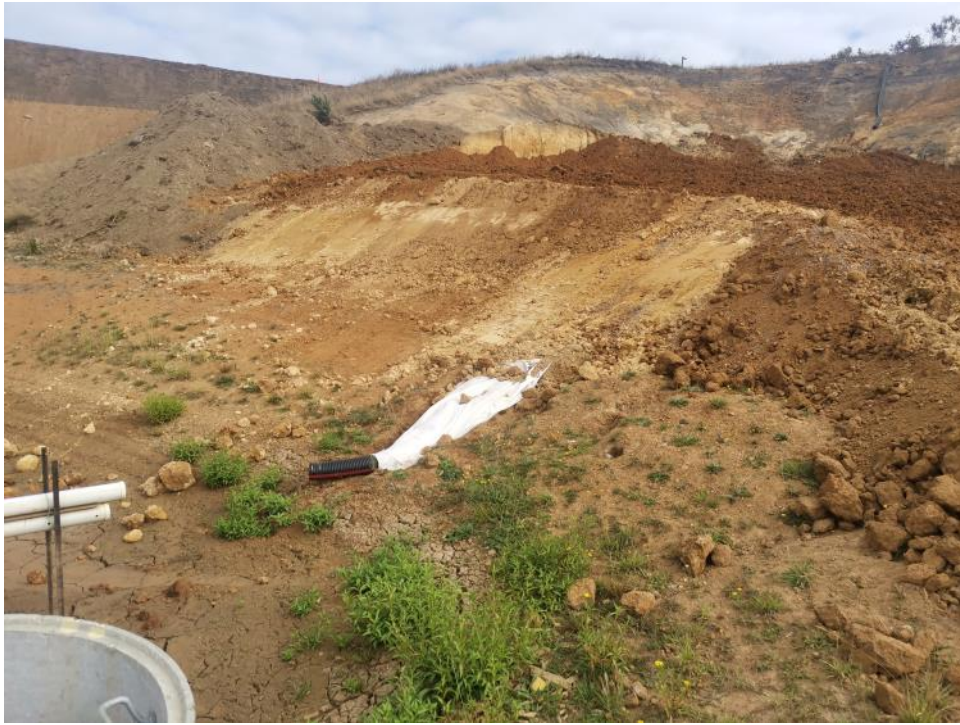
24/02/21 - REB1&2

- Fills are progressing in REB2. All 4x underfill drains can still be observed at the toe of the batter.
- Slip remediation works progressing below DEB10 (adjacent to REB1 silt pond). Underfill drain observed below current fill batter as per our recommendations.

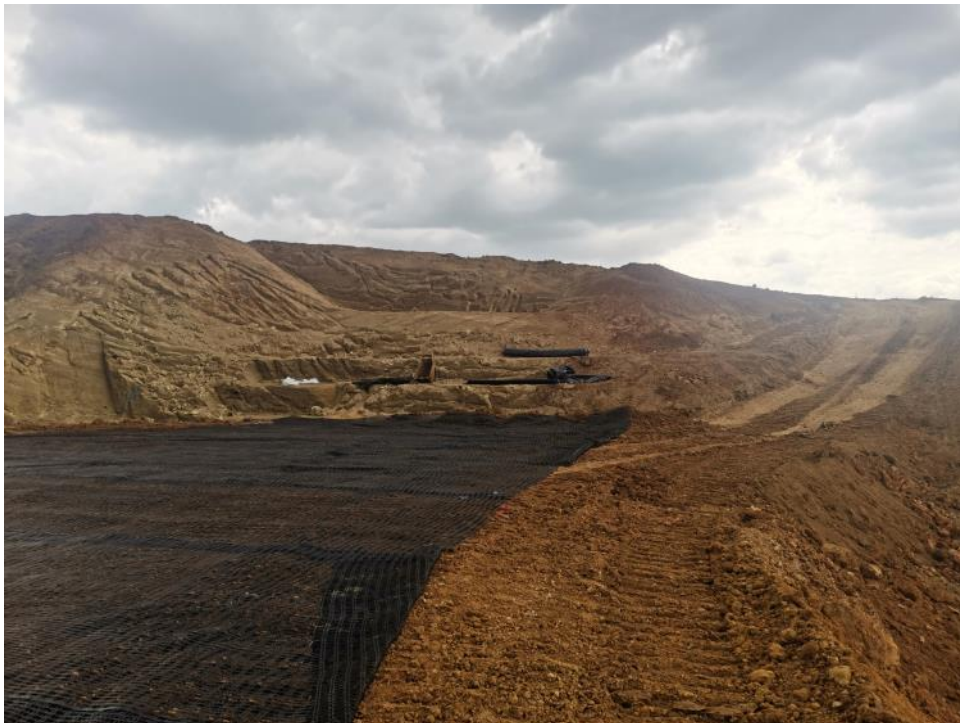
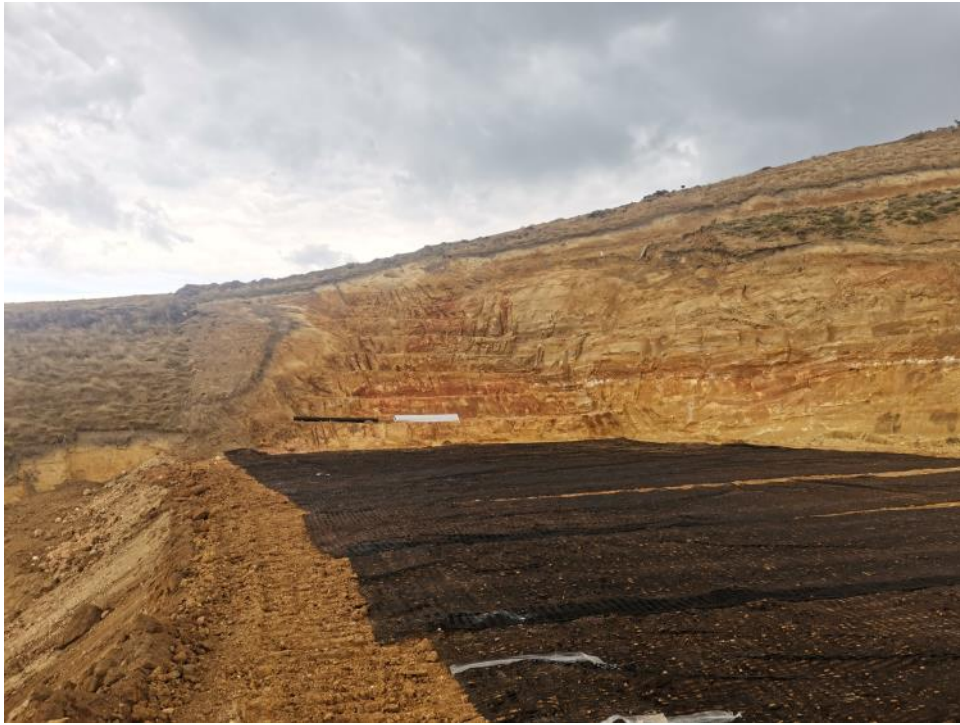
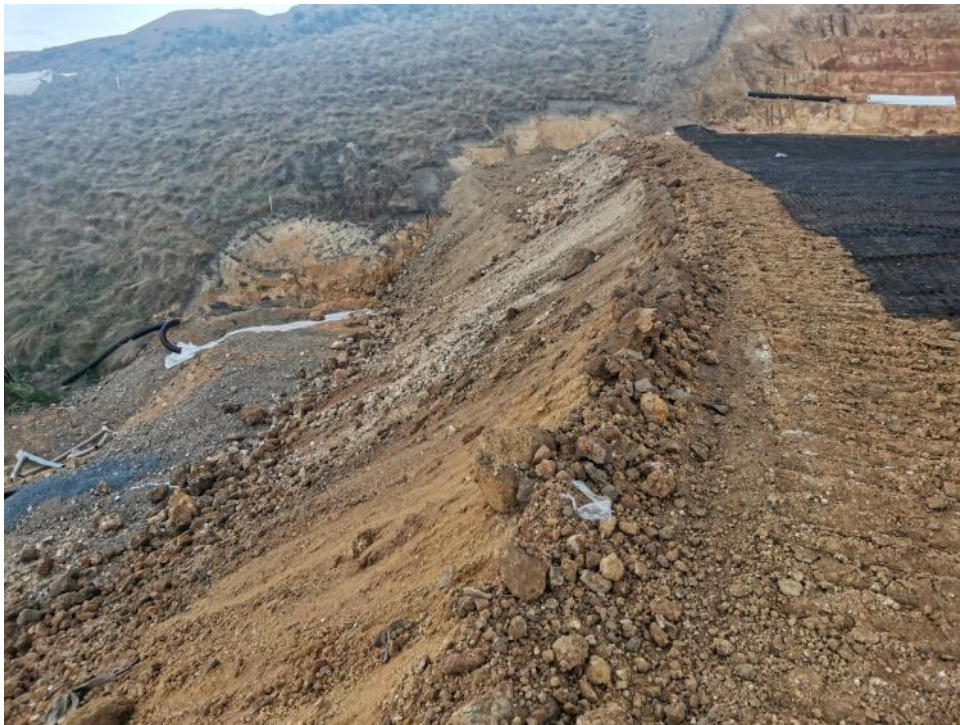
- Observed progress of REB2 batter fill operations.
- Geogrid laid out to approx. 19m length as per our design. A gap remains in the centre section which is to be picked up and covered at the next primary grid lift.
- Fill compaction results have generally been passing, after a series of failed fill tests a few weeks ago (failed on air voids).
- Adequate benching exposed along the gully flanks.
