Geotechnical Completion Report

HITCHEN BLOCK STAGE 13B

17 January 2022

Ref No: J00113

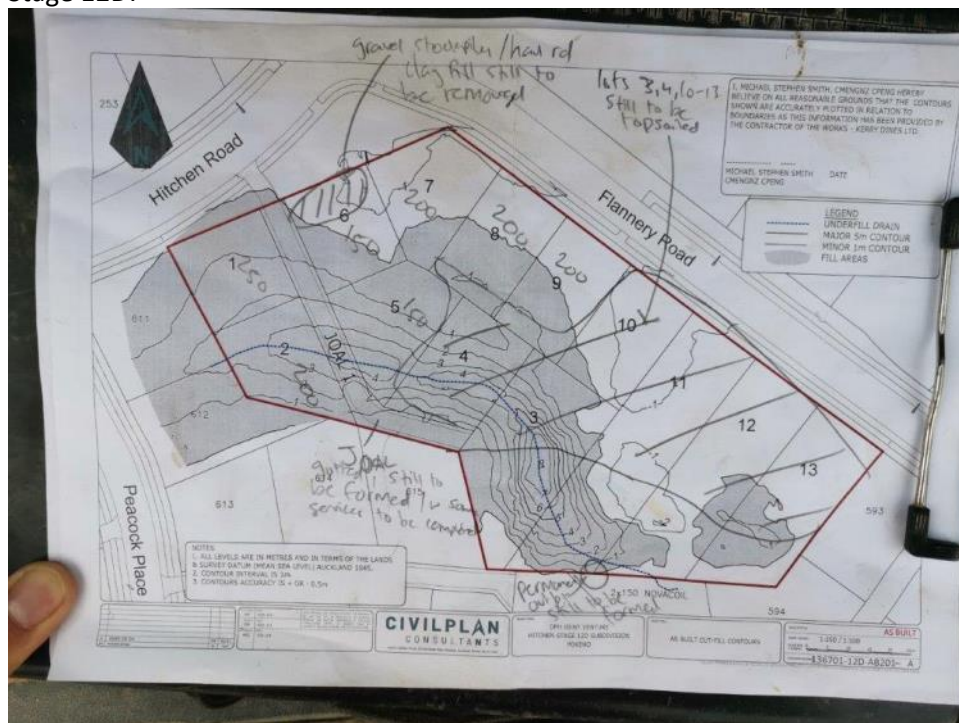
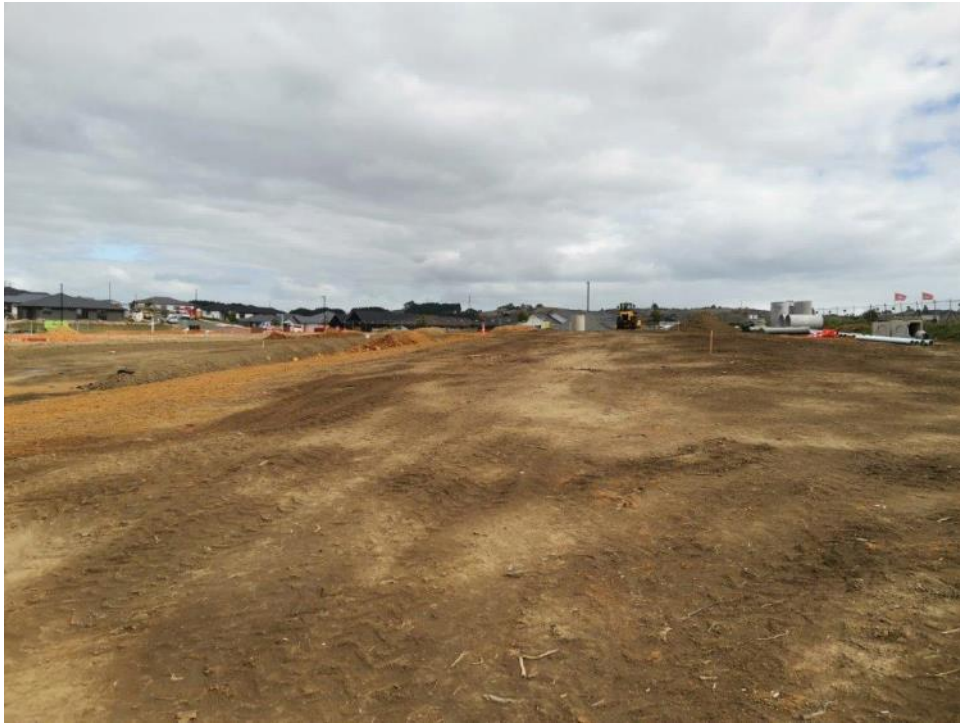
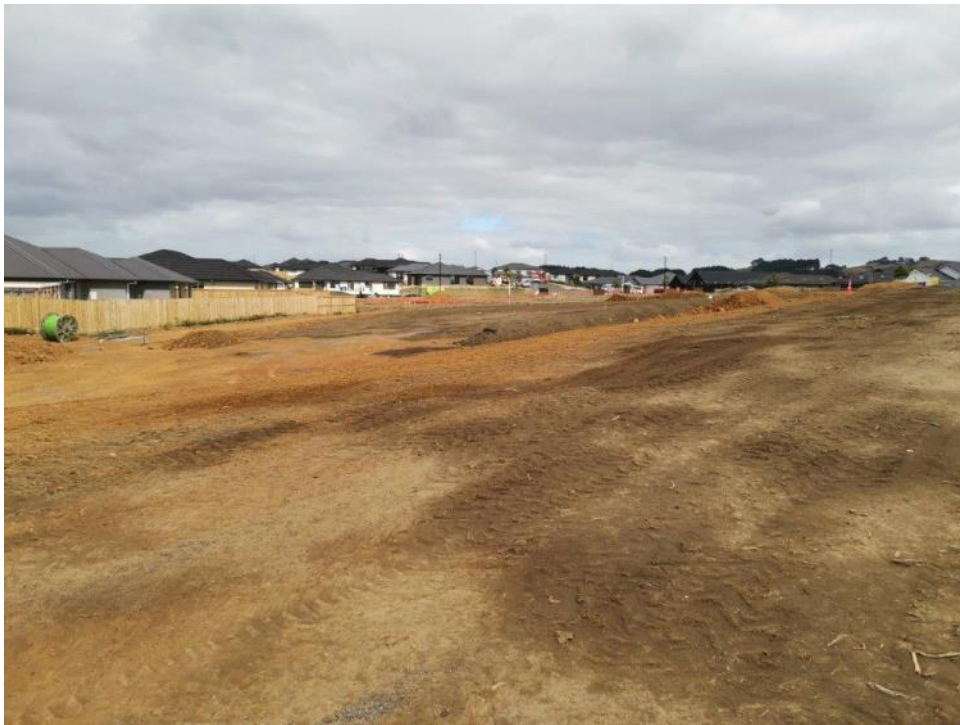
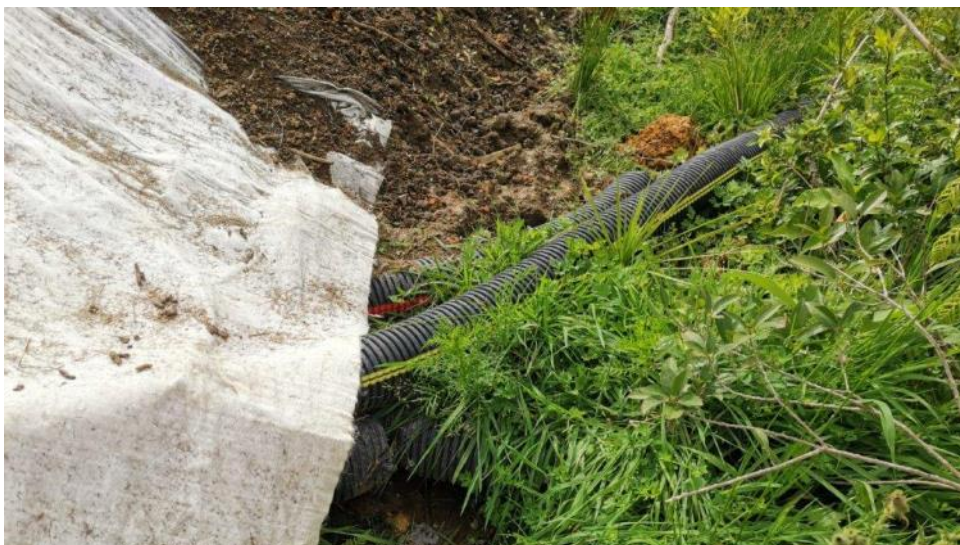
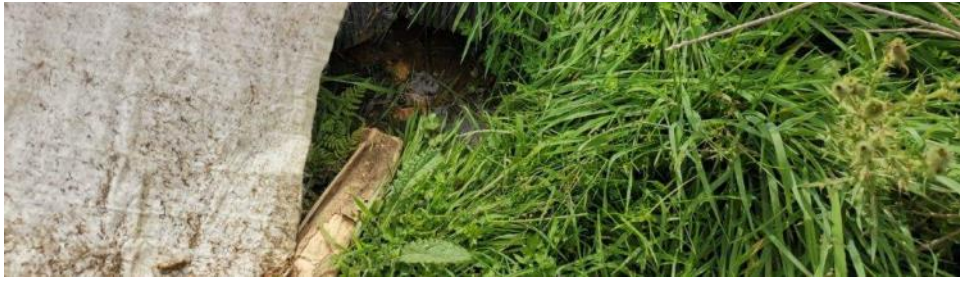
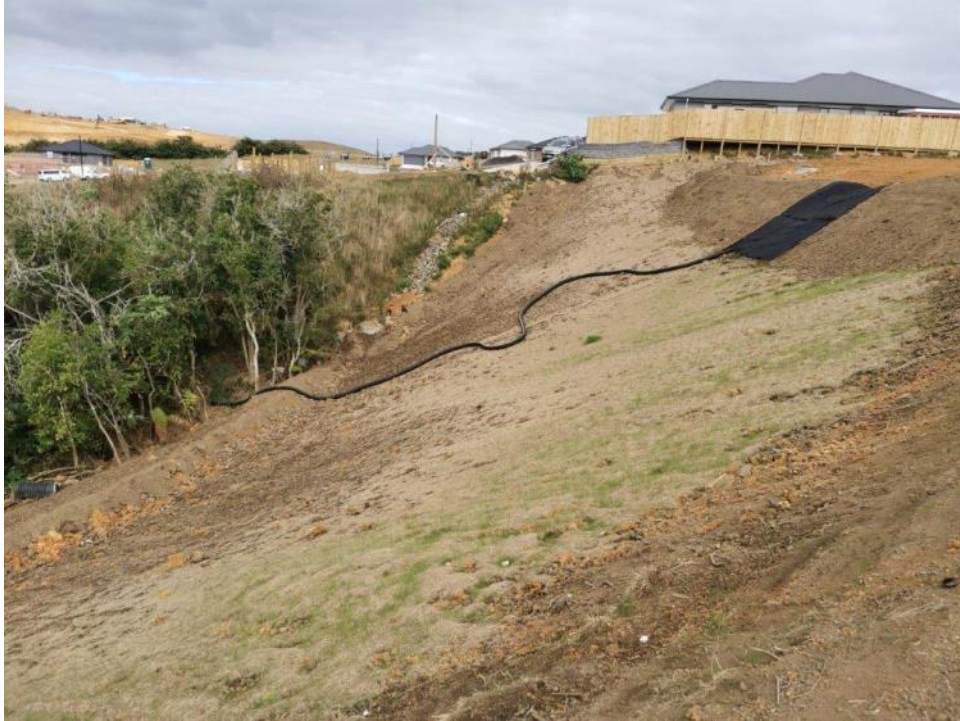
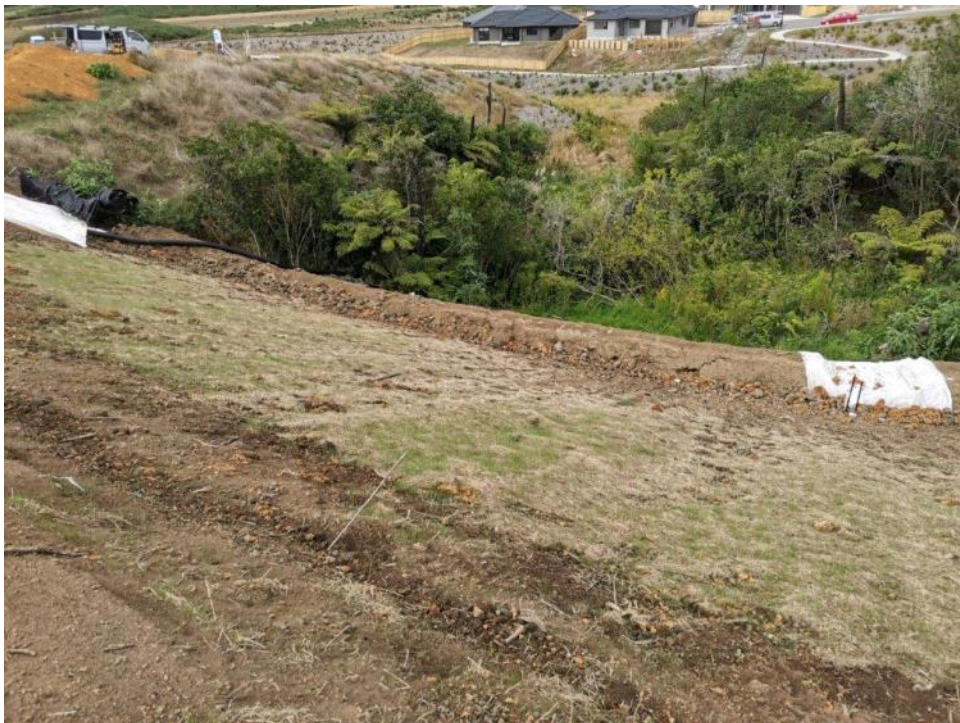
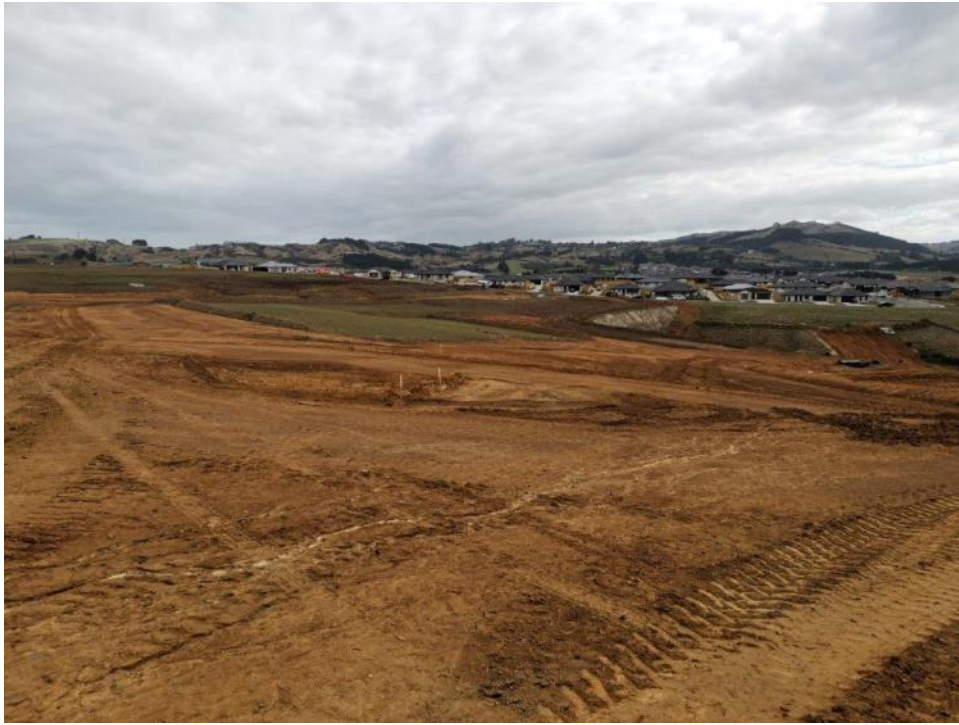
Stage 12D:

- REB2 fill placement is progressing. 2m face tightening grid currently exposed and waiting for the next layer of clay fill.
- At stage 12D carried out topsoil measurements. The following still needs to be addressed:
 - o No permanent concrete outlet formed for underfill drain at toe of batter.
 - o Lots 3,4, 10-13 are still to be topsoiled
 - o Stockpile of gravel / loose clay present adjacent to JOAL within lot 6, to be cleared and topsoiled

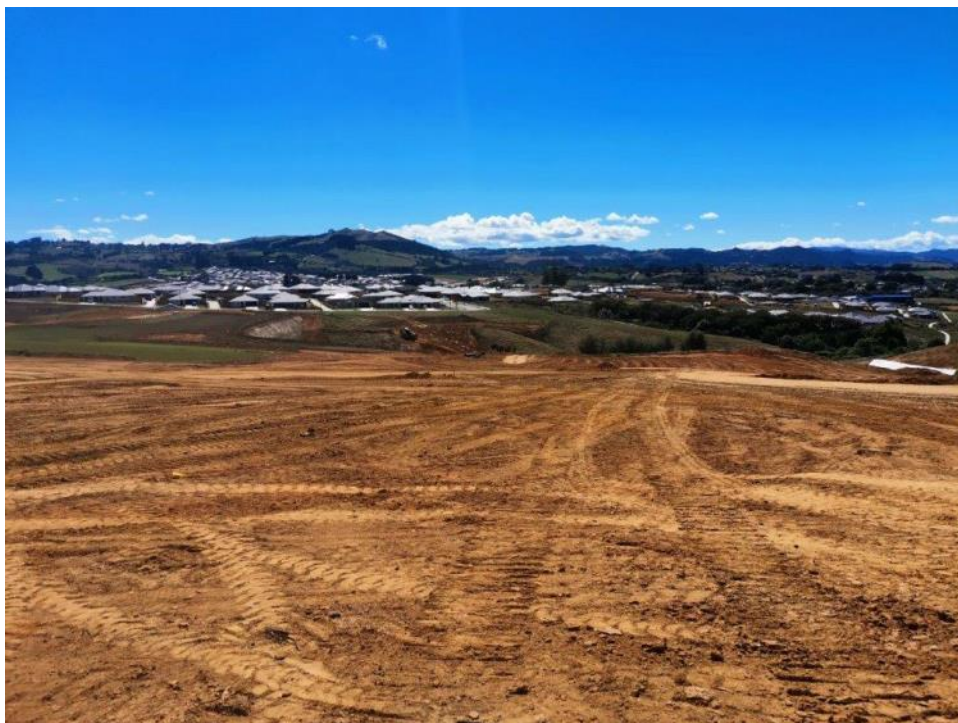
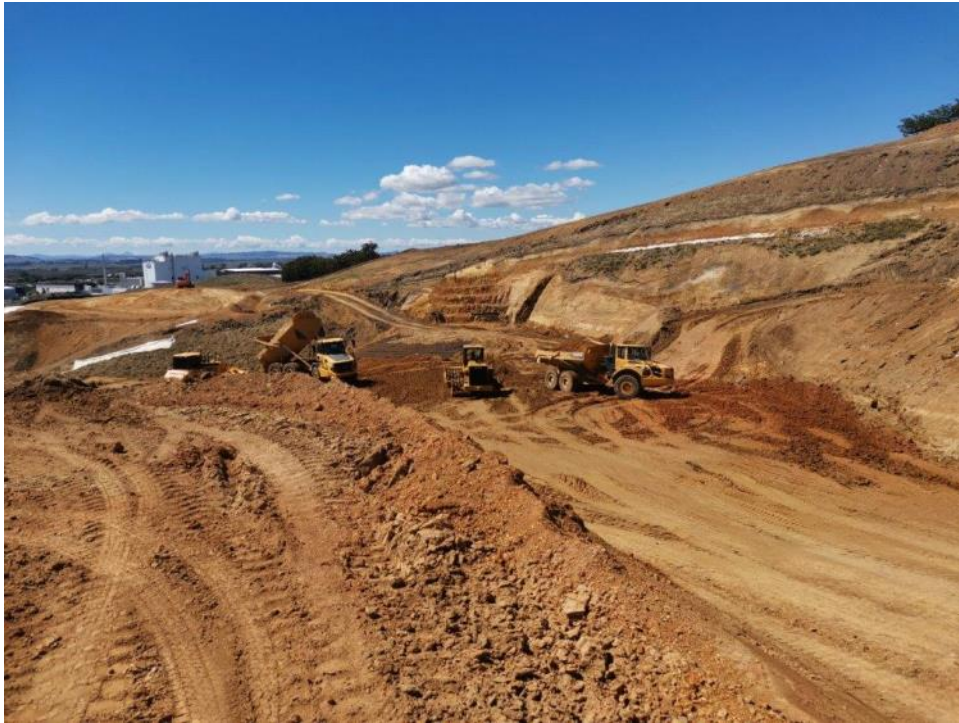
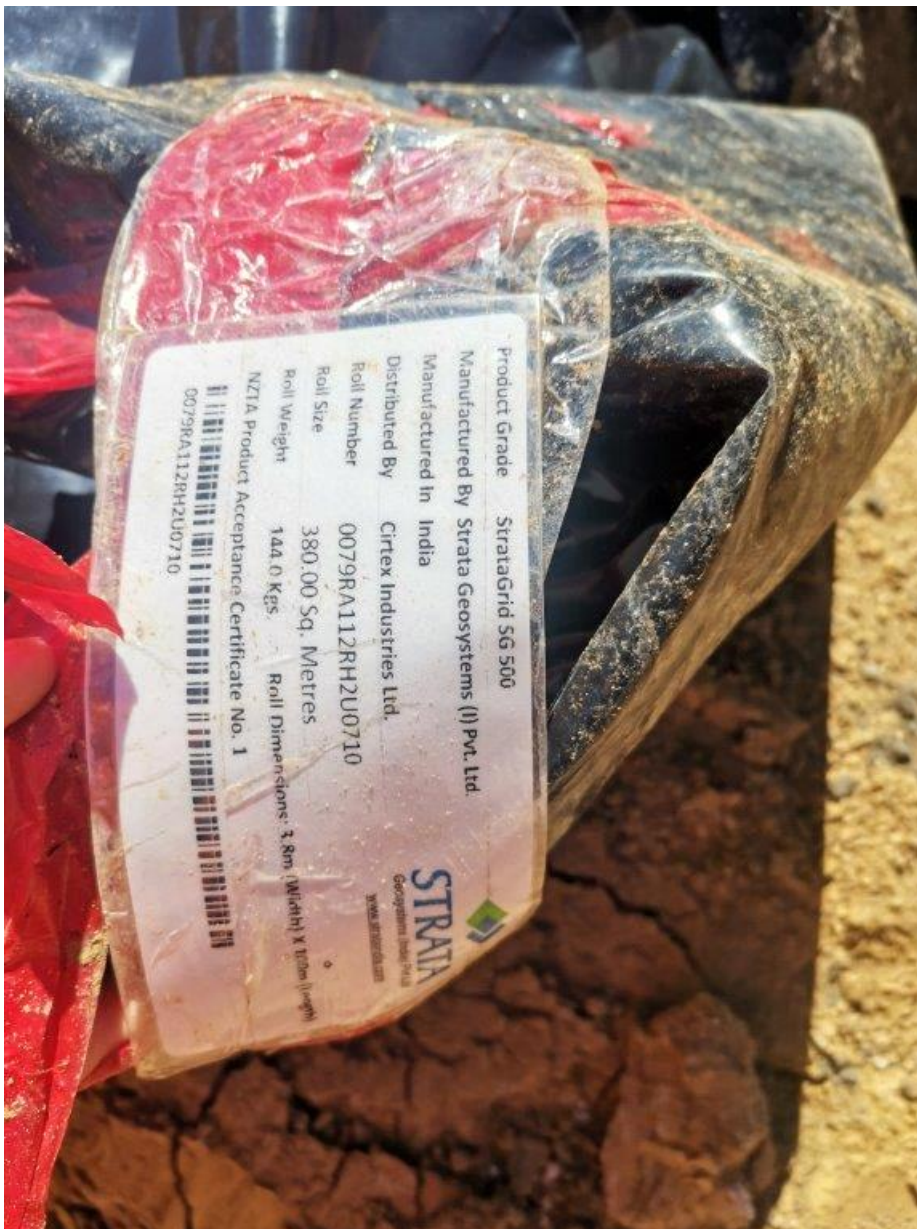
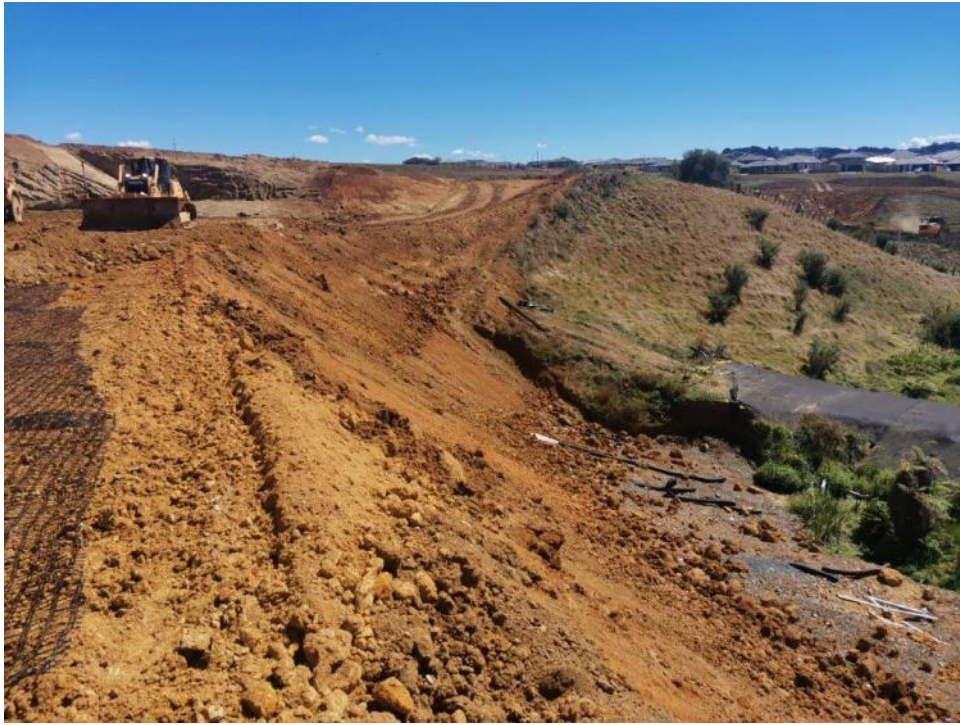
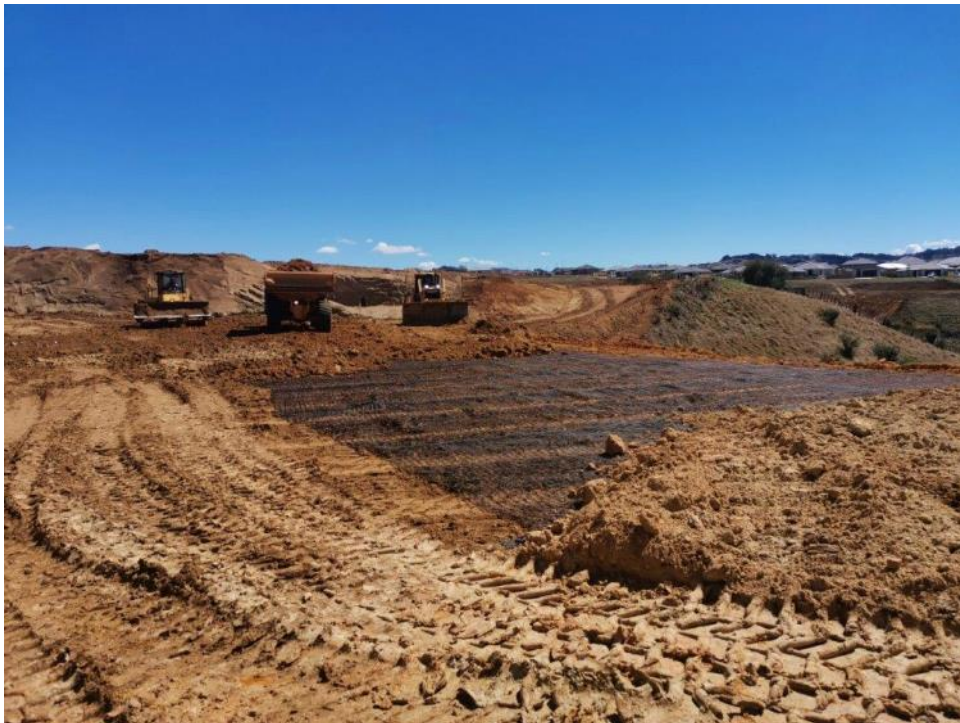
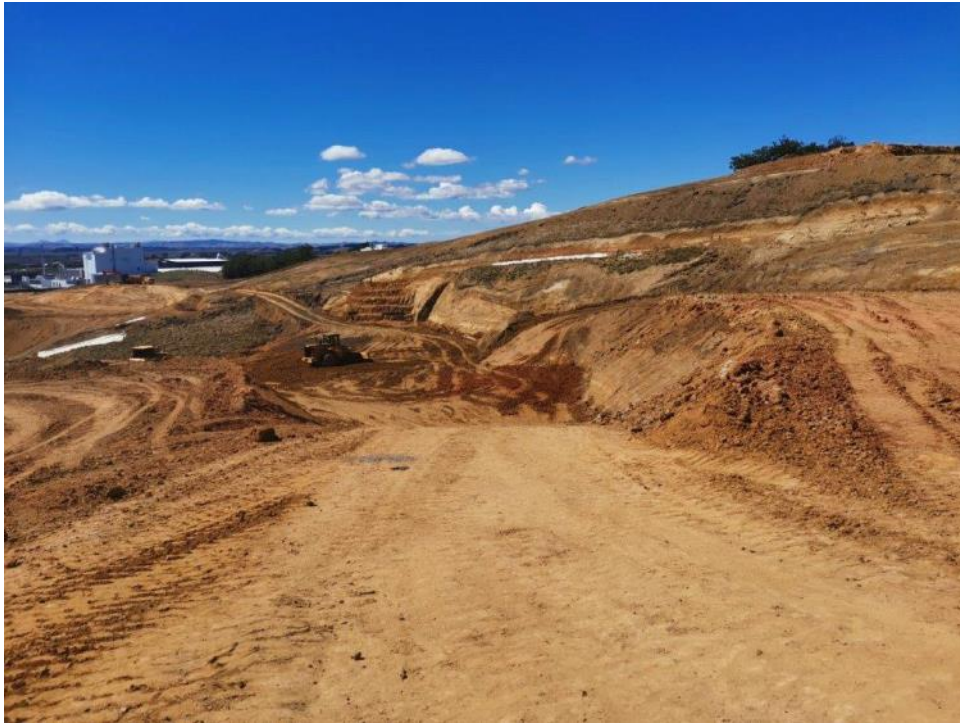
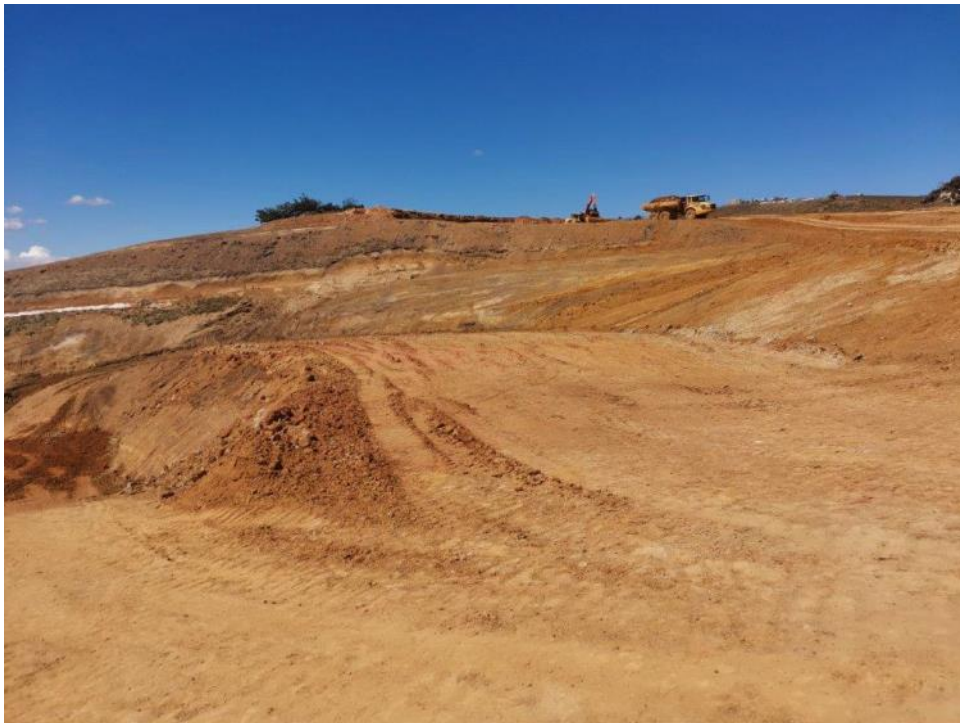
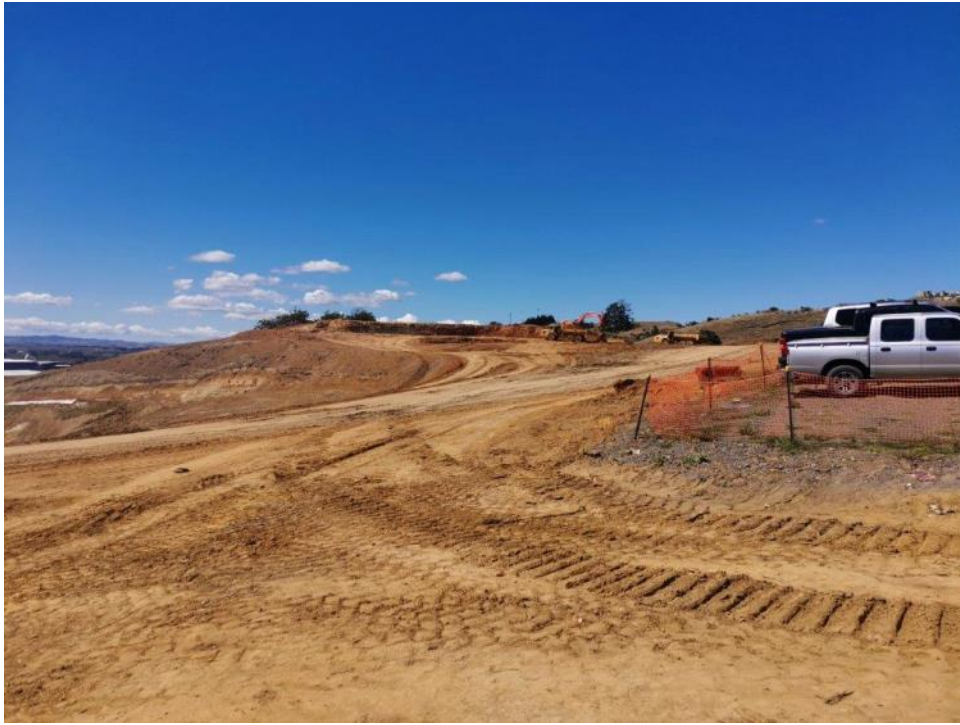
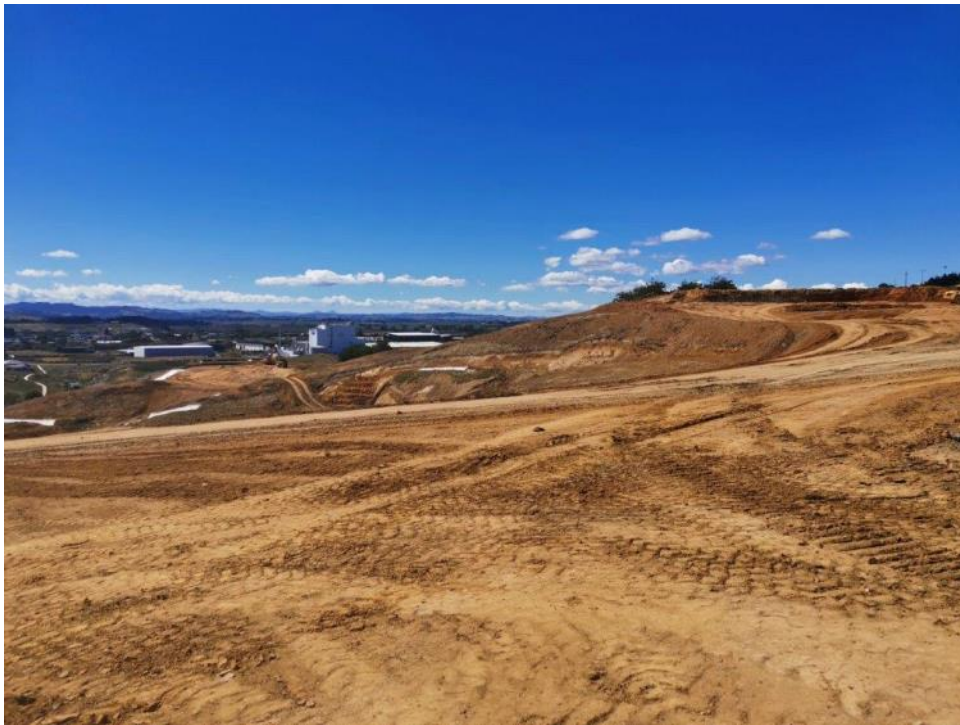
12/03/21 - REB1, REB2

- Filling is now complete in the old slip adjacent to the stormwater pond below REB1. The area is now being trimmed and topsoiling is planned soon.
- Inspected filling operations in REB2. The REB is now in the middle grid area and 10m lengths of SG500 grid were recorded throughout.
- Cut progressing above REB2.

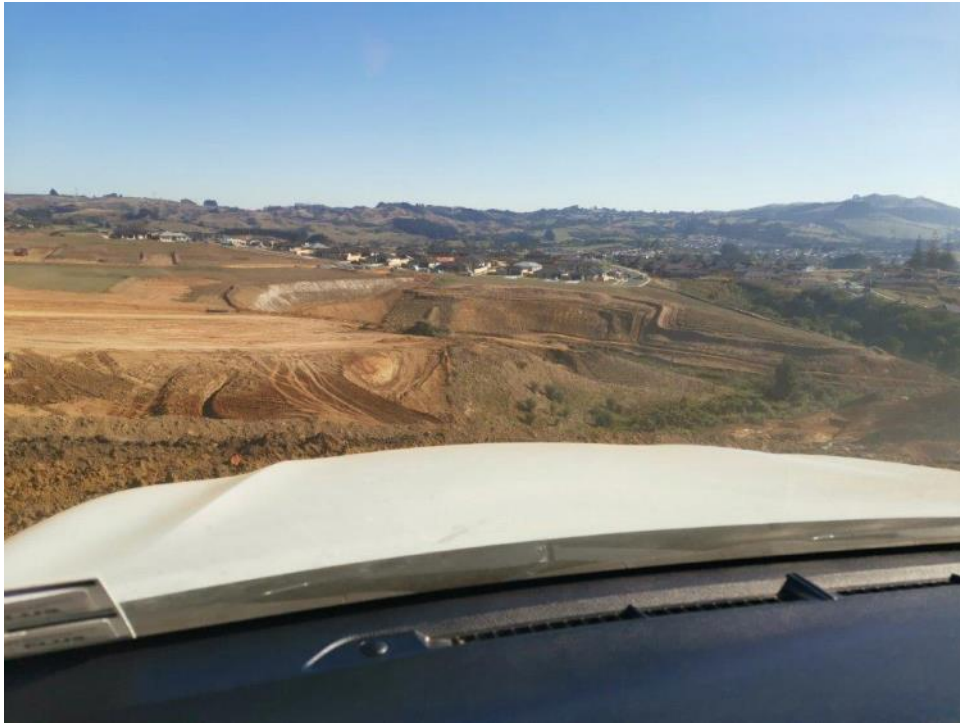
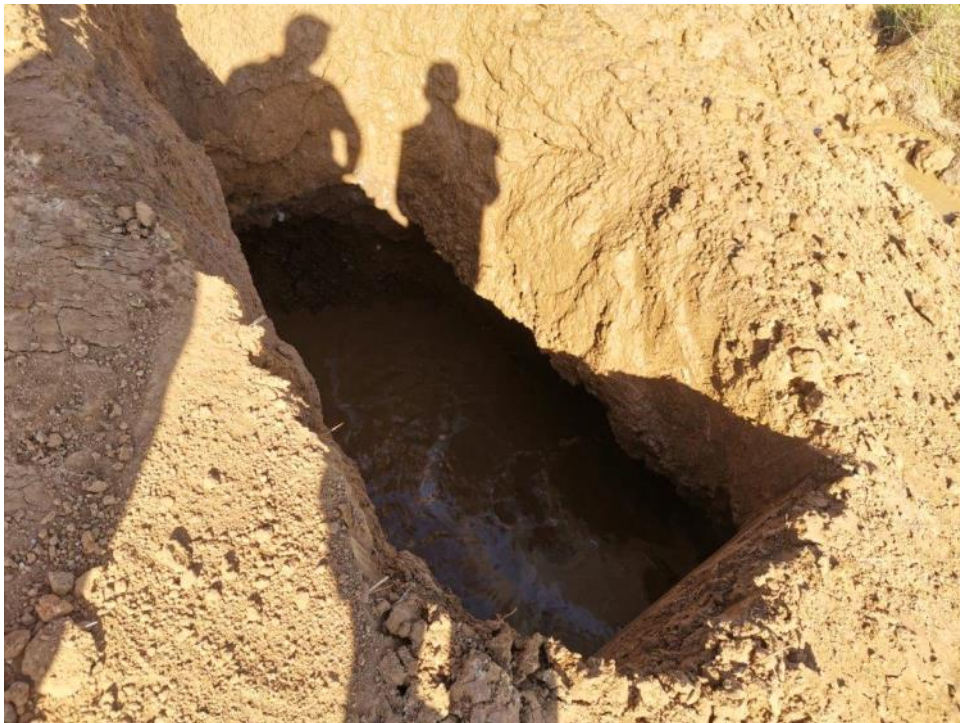
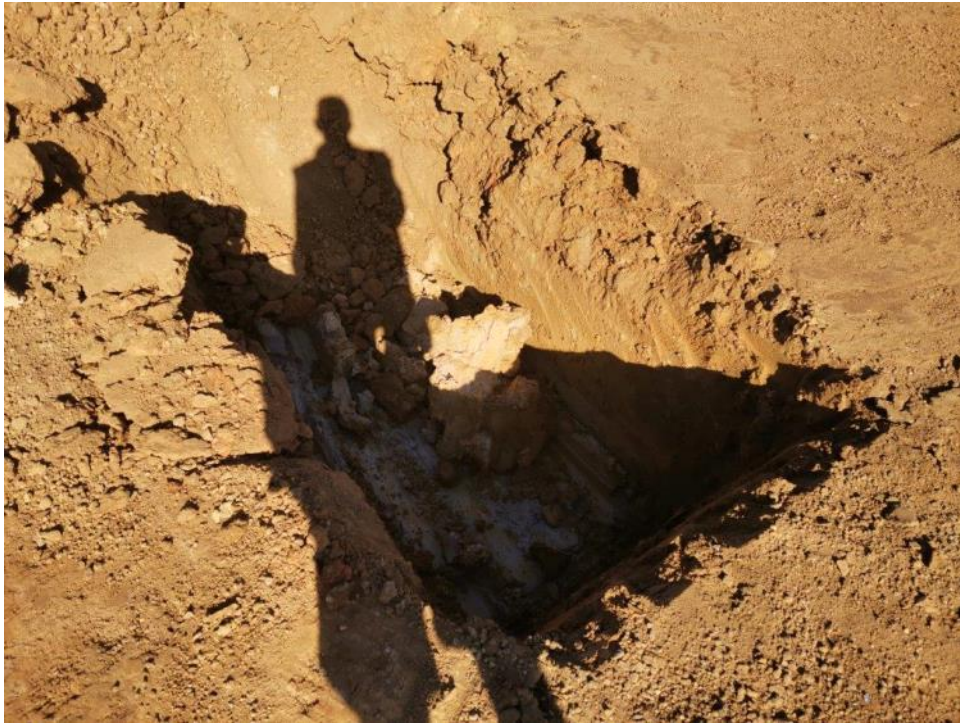
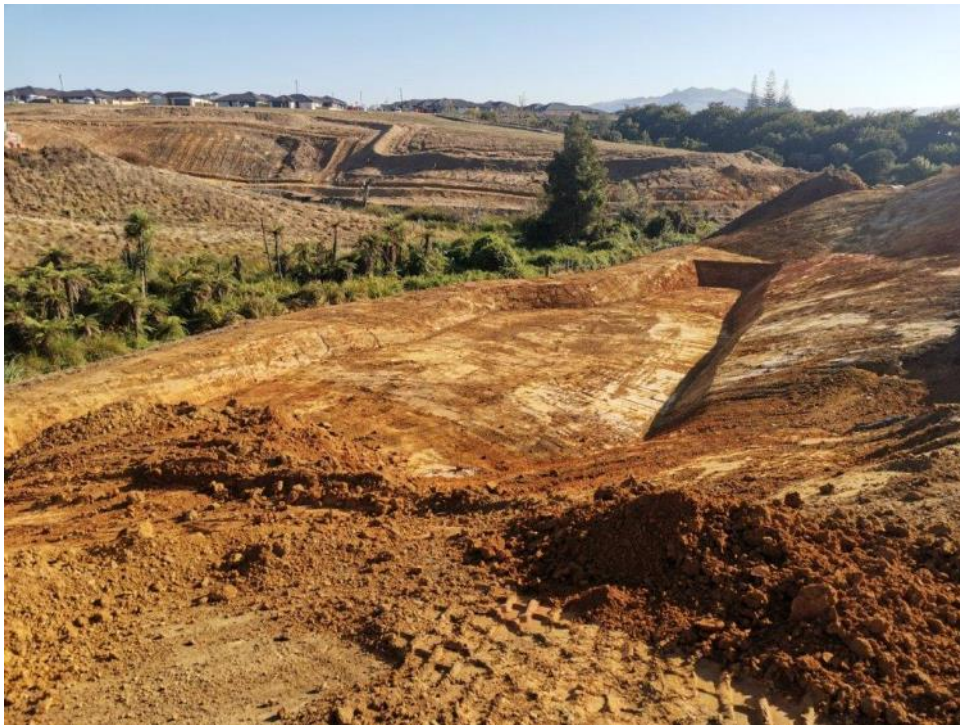
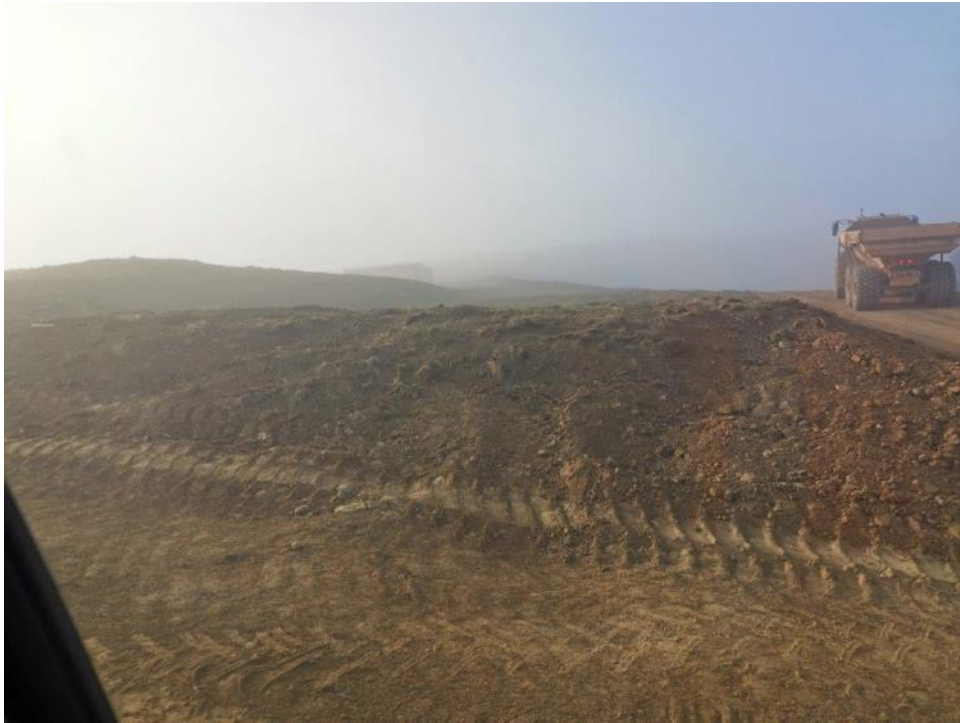
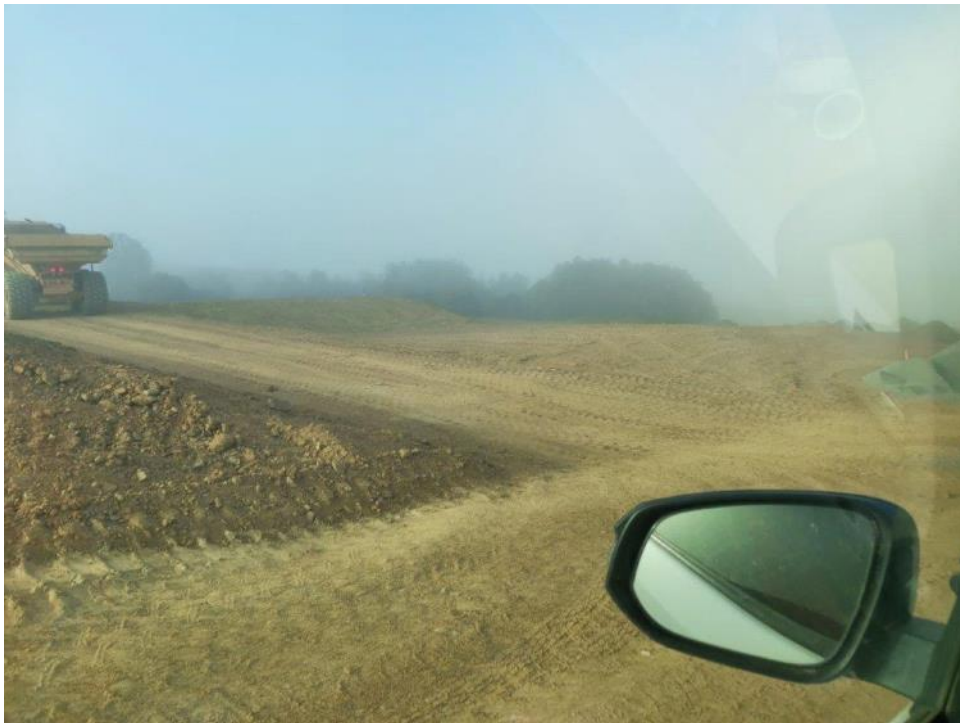
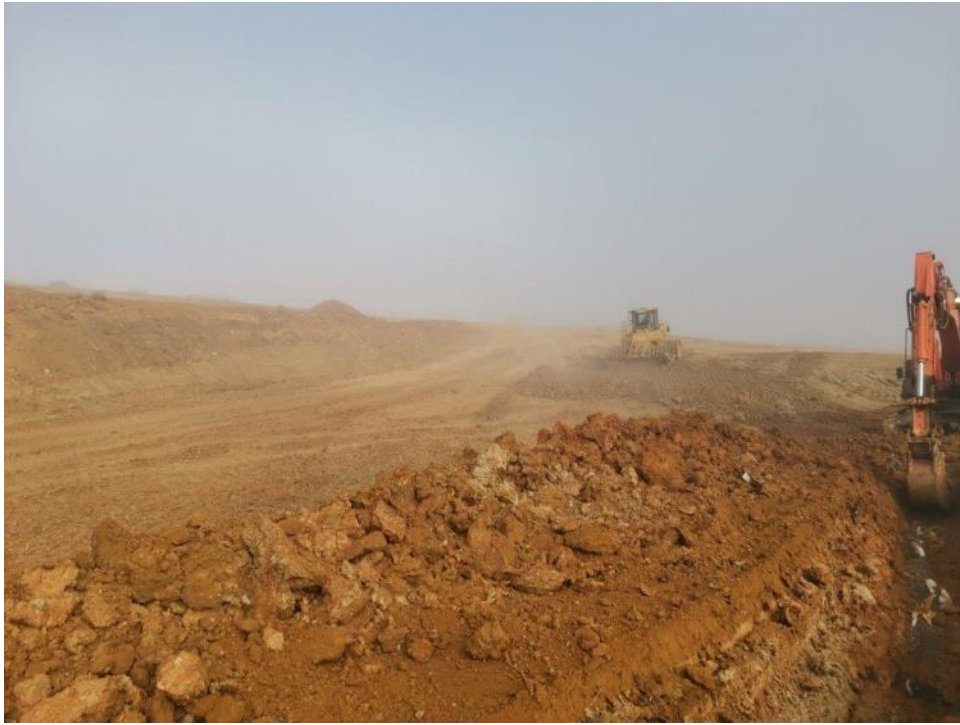
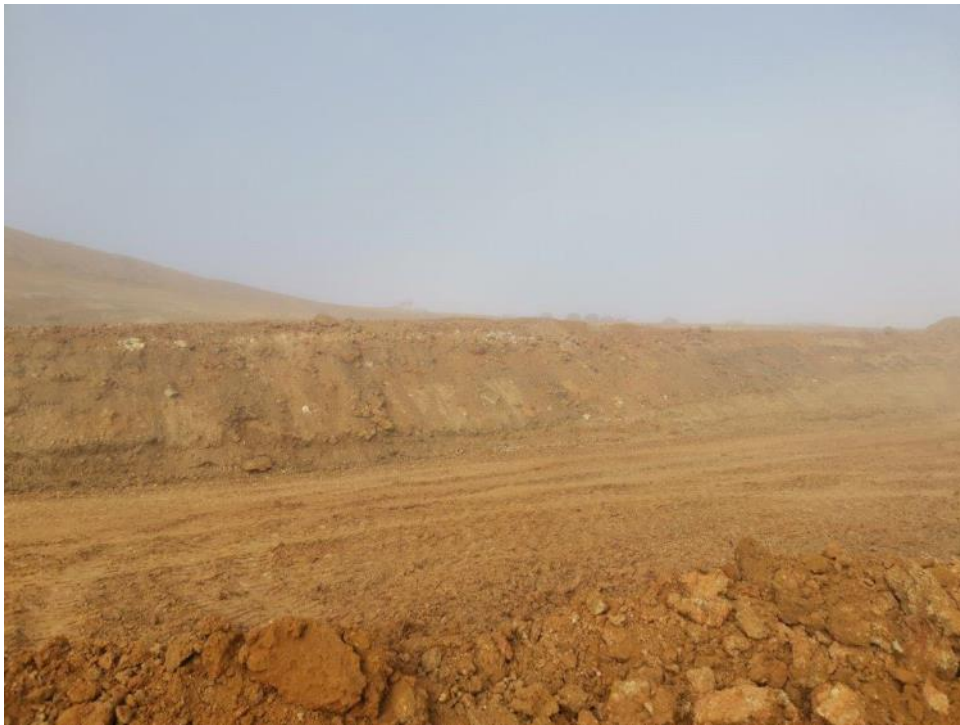
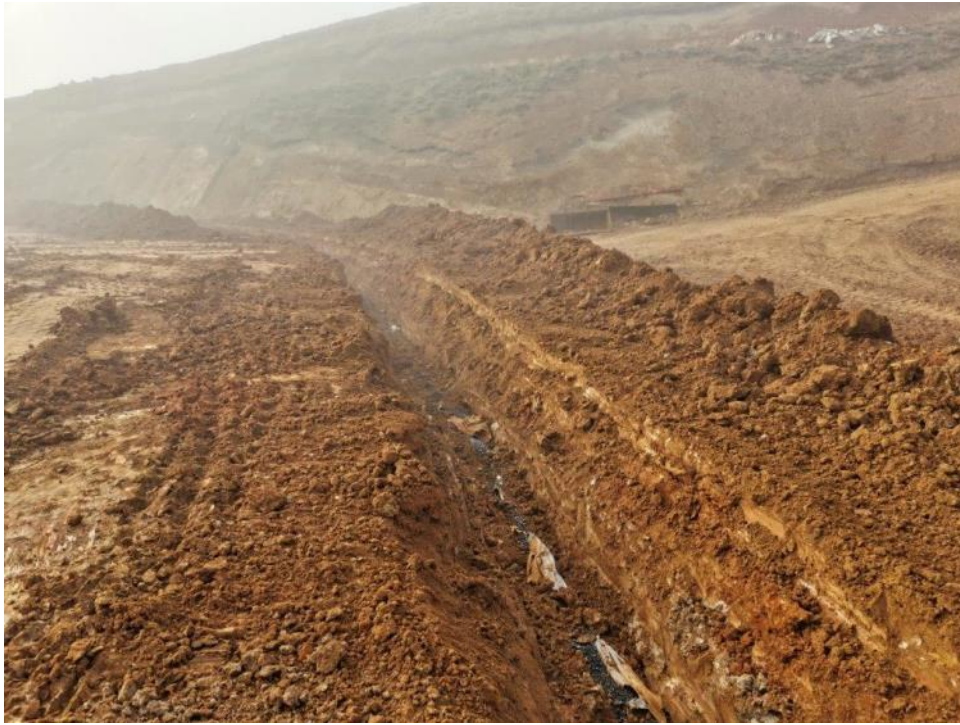
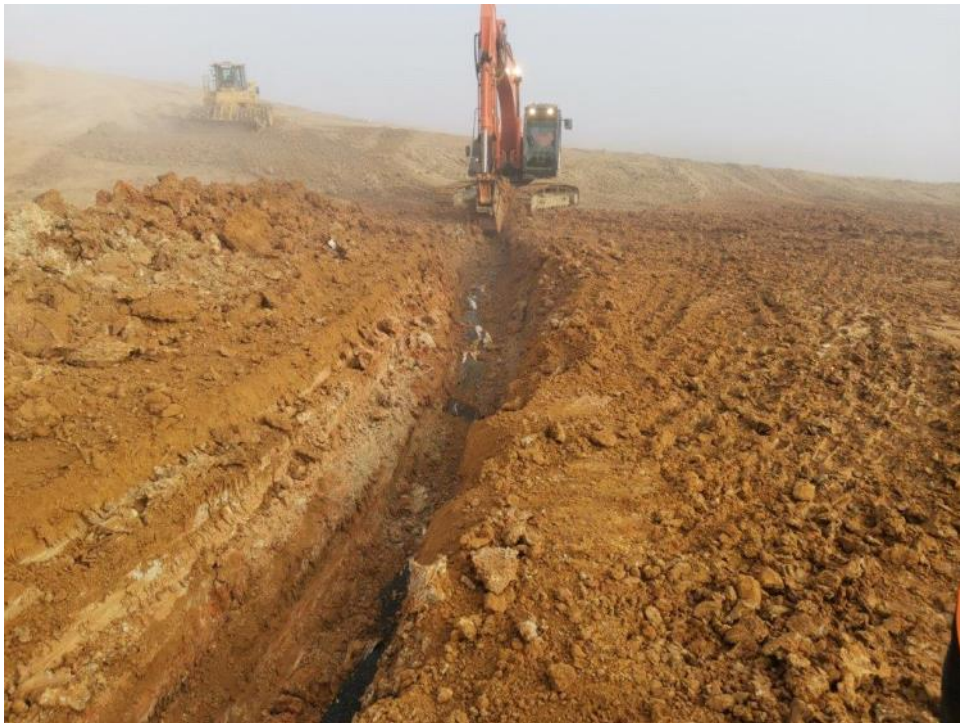
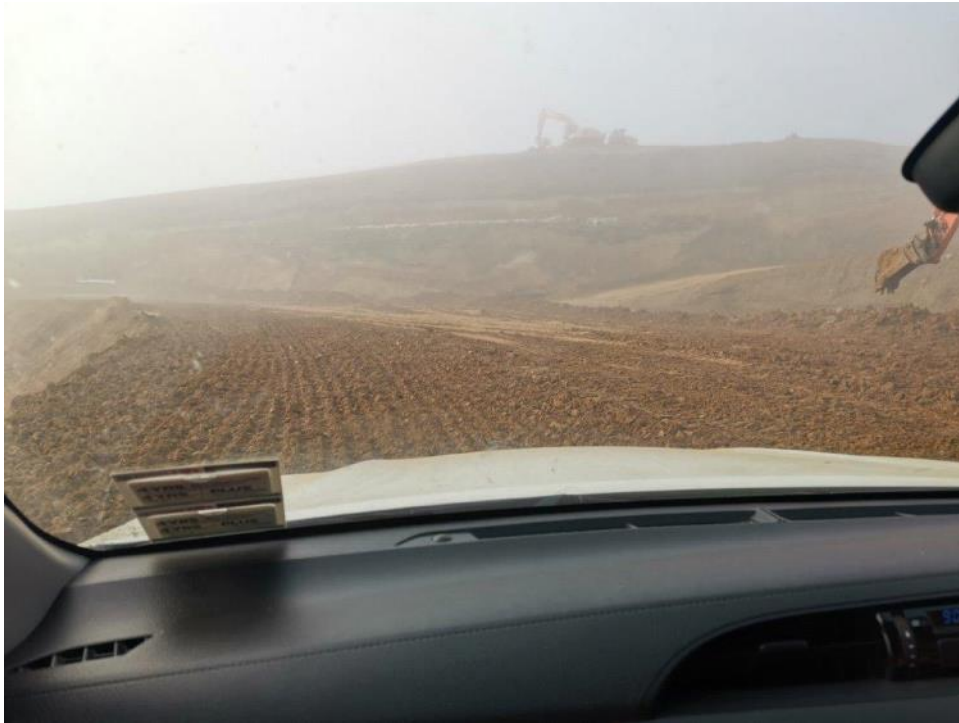
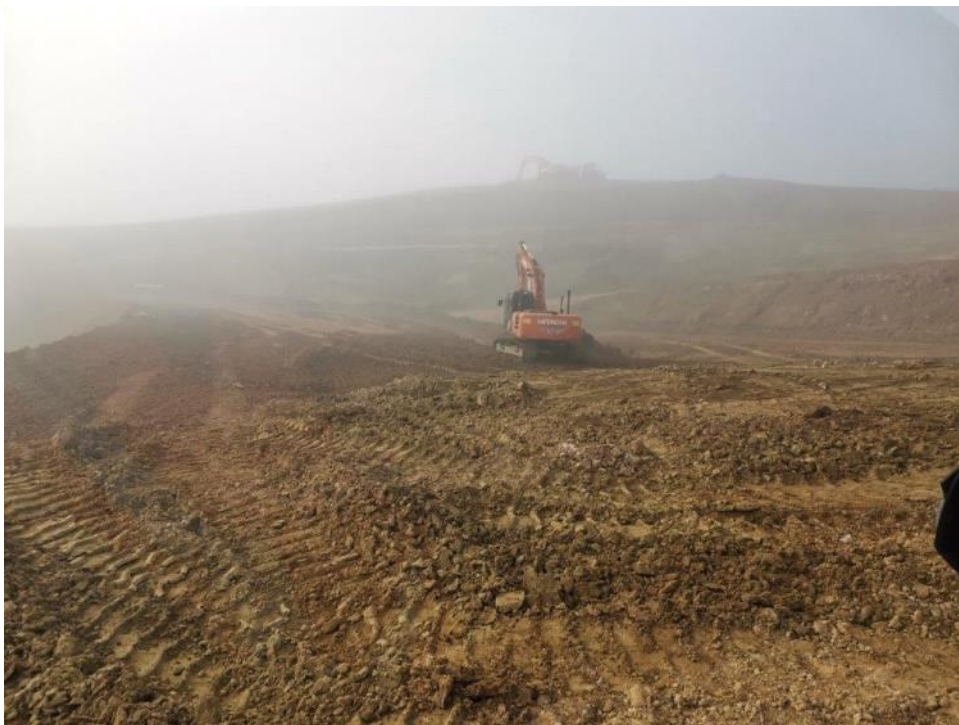
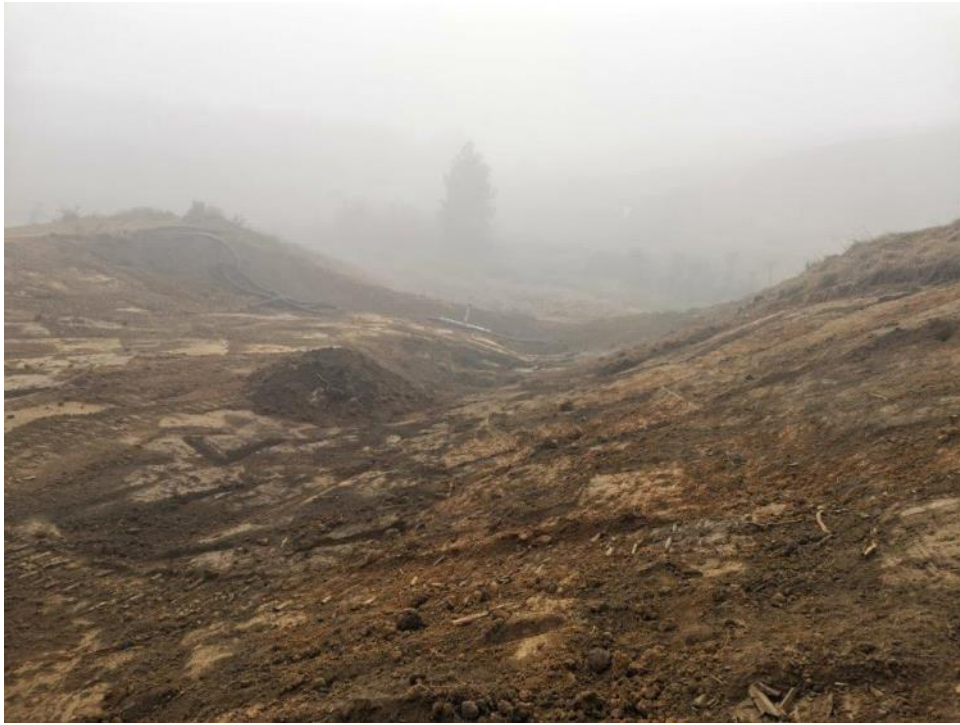
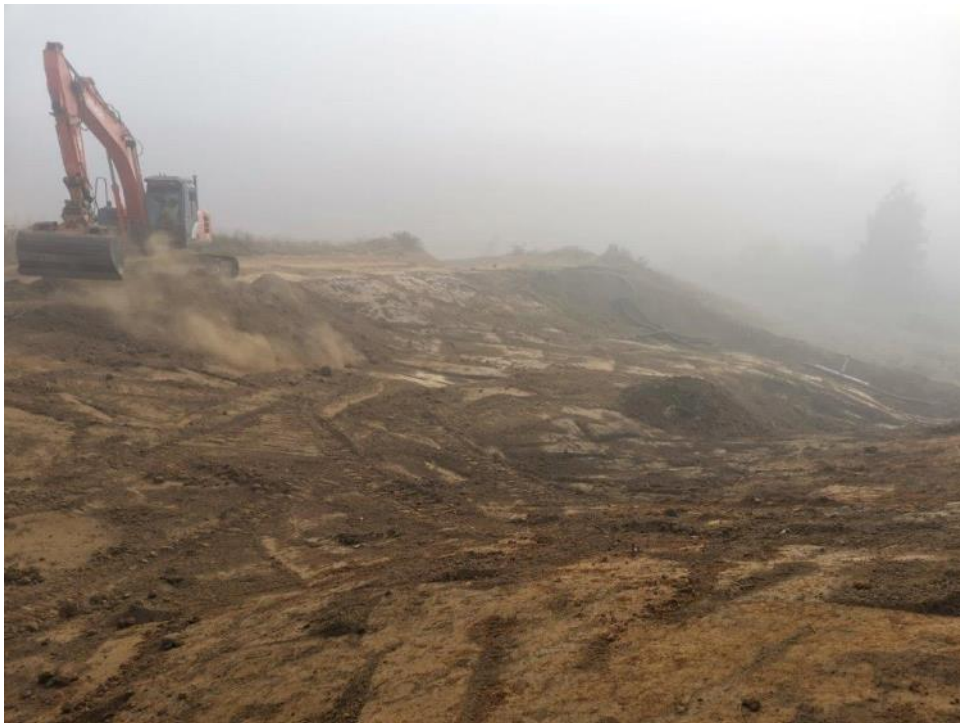
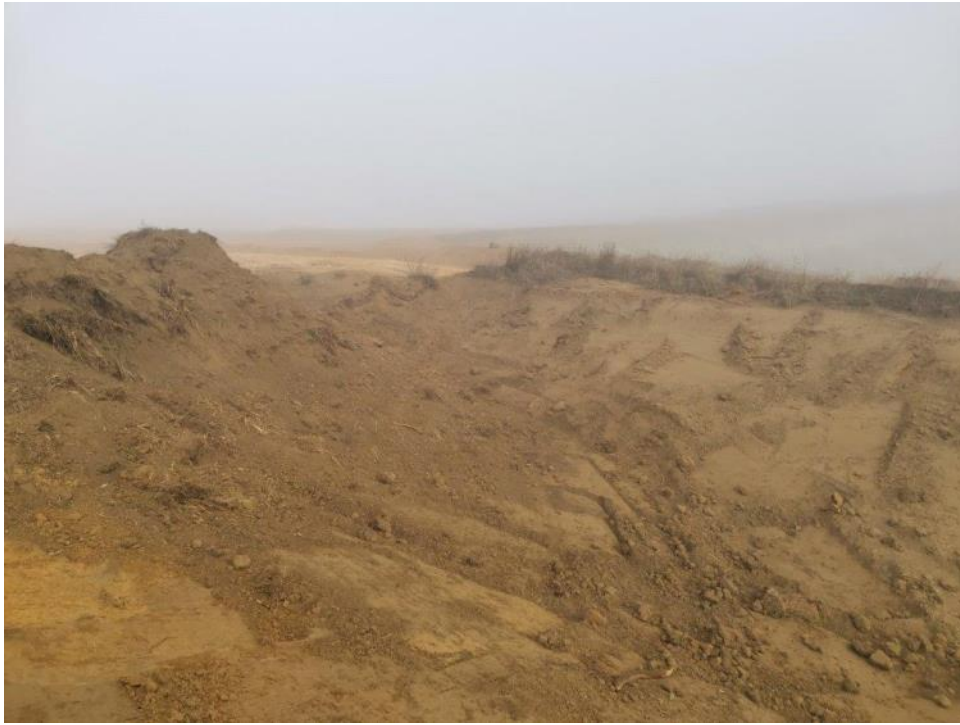
- Inspected topsoil stripping in Fill O. Approximate location shown by black annotation. Very stiff ash soils exposed throughout. Recommended that an underfill drain to be placed along the existing overland flowpath here.
- Observed progress of REB 2 fill works. Approx. 3.5m of fill left to place before trimming of the 1(v) in 1(h) batter begins. Rear face drain is now complete, with the final section of this drain being installed today.
- Observed permanent stormwater pond below Fill M, approximate position shown in red below. Contractors had mucked out the pond and backfilled without notifying us. Several trial pits dug in this area which identified SPR to beyond 3m and at least 1.5-2m below the adjacent fully invert.
