Geotechnical Completion Report

HITCHEN BLOCK STAGE 13B

17 January 2022

Ref No: J00113

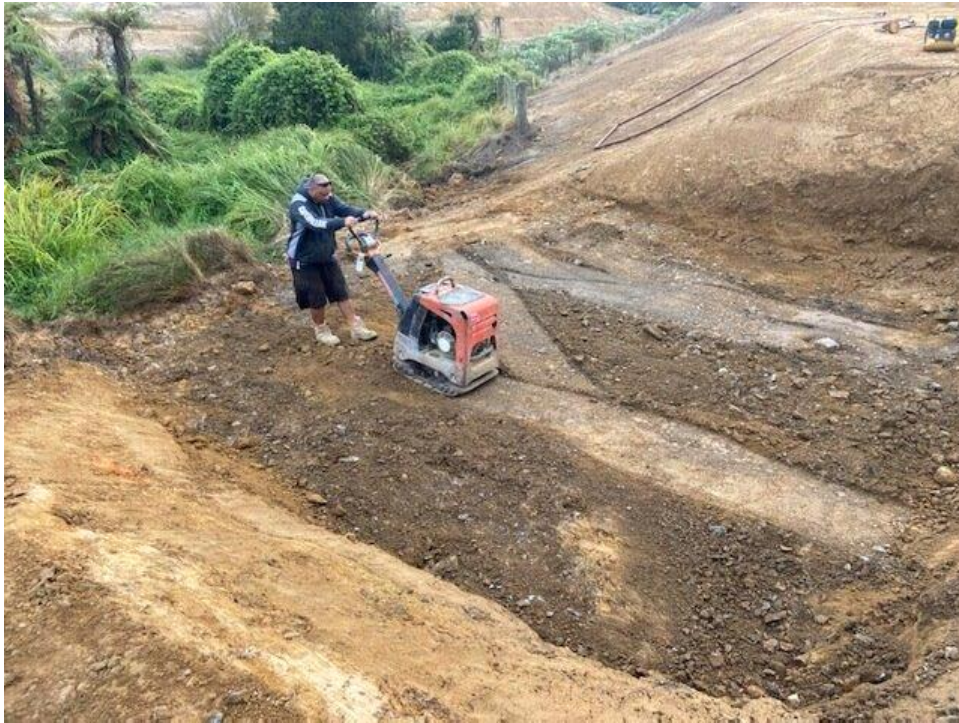
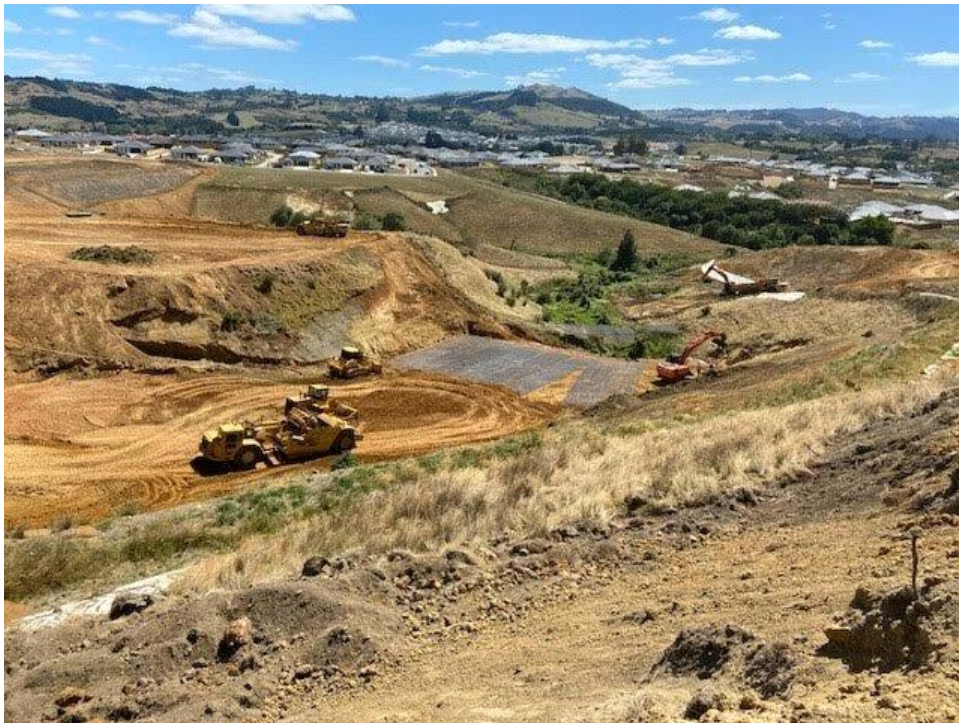
26/03/21 - Fill M&O, REB2

- Filling operations continuing in REB 2. Another layer of primary grid was in the process of being laid out. Grid measured at 10m as per the design.
- Trial pits in the Fill M stormwater pond have been partially backfilled with SPR and fill testing has come back indicating adequate compaction and density. The contractors intend to backfill the remainder of the pond with at least 1m of clay as per our advice. Pond construction will be finalised next season.
- Fill O underfill drain has not been installed yet due to bad weather forecast next week.

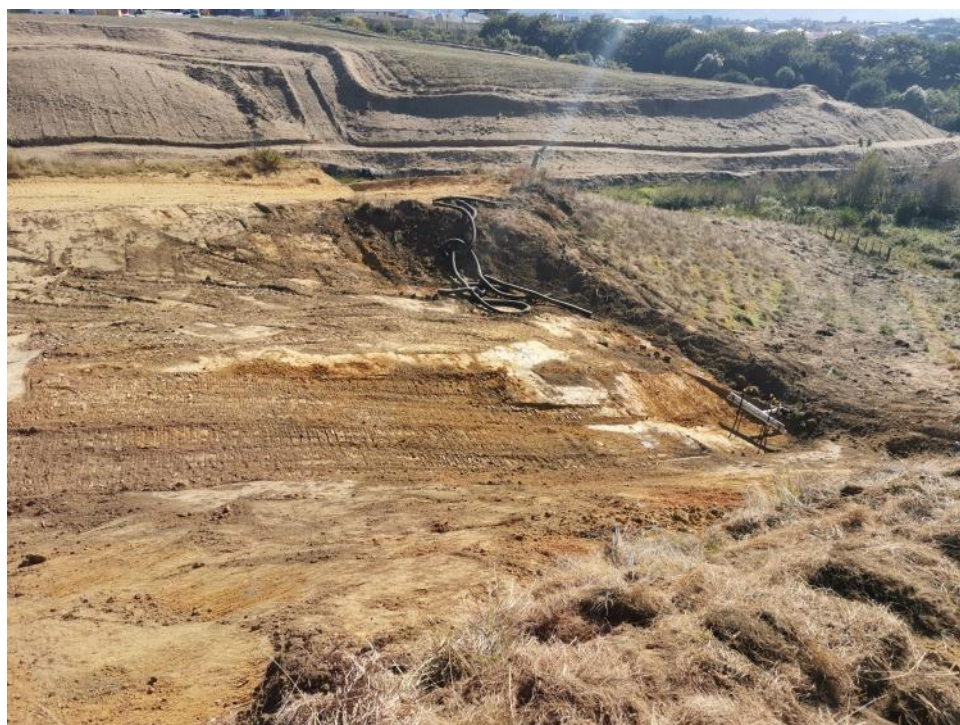
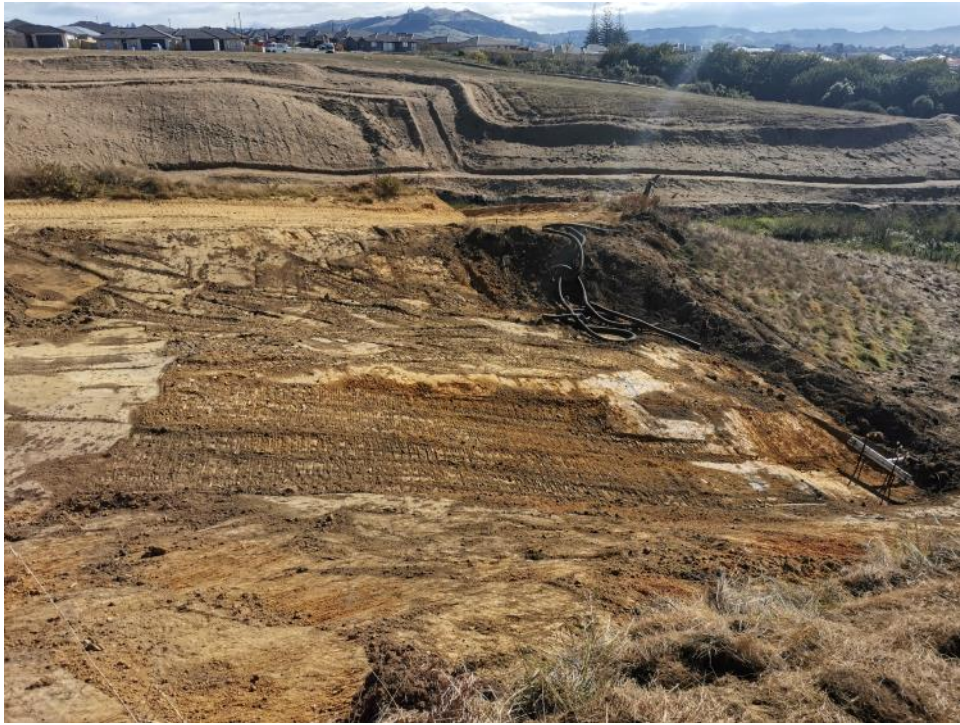
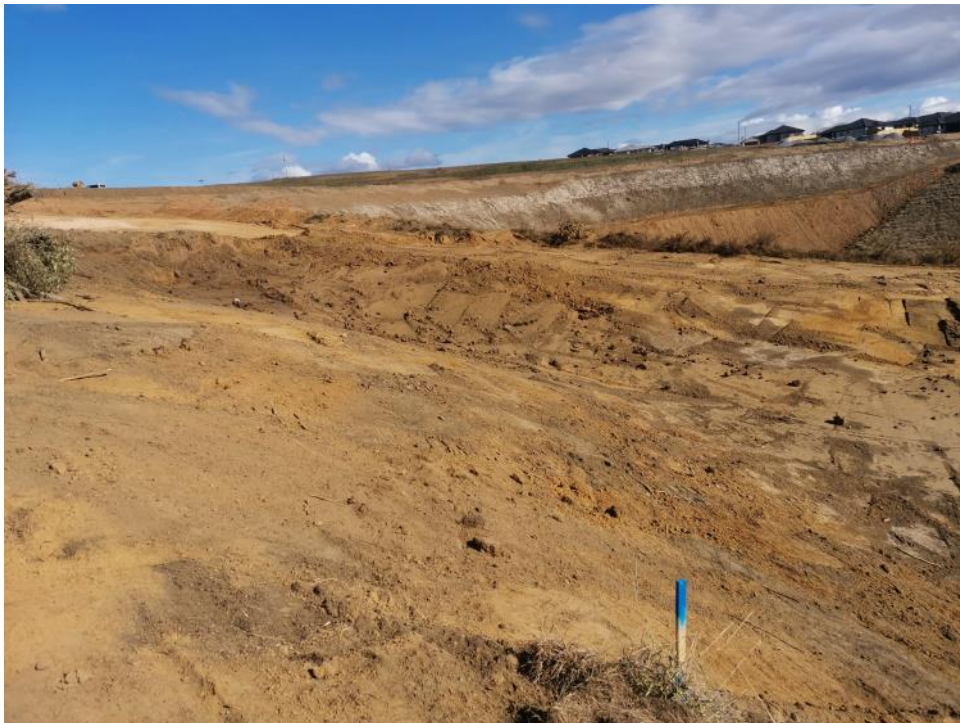
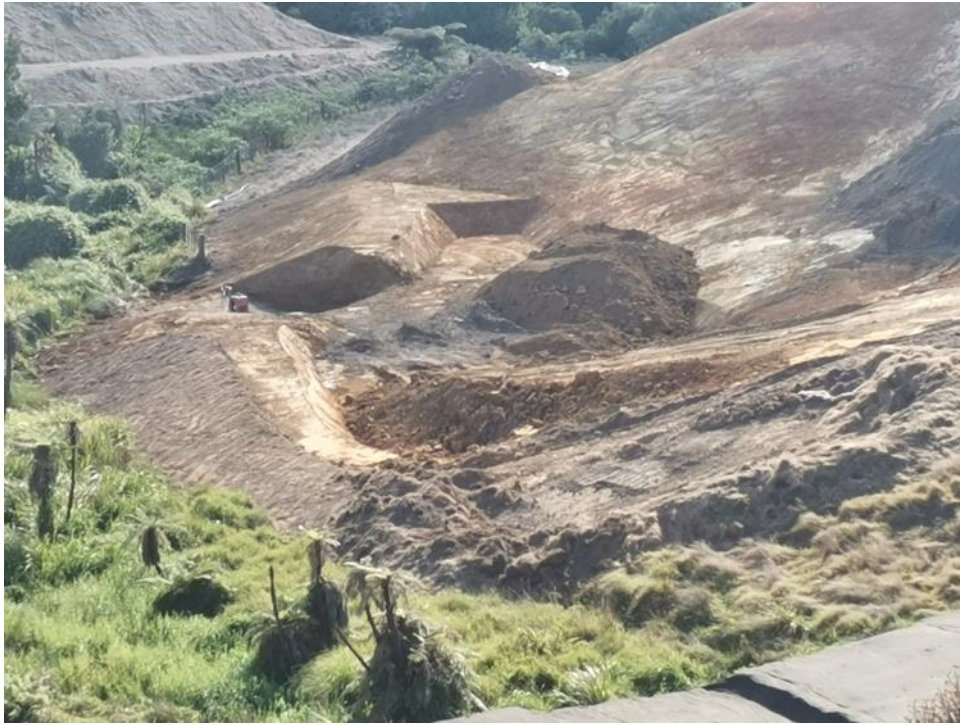
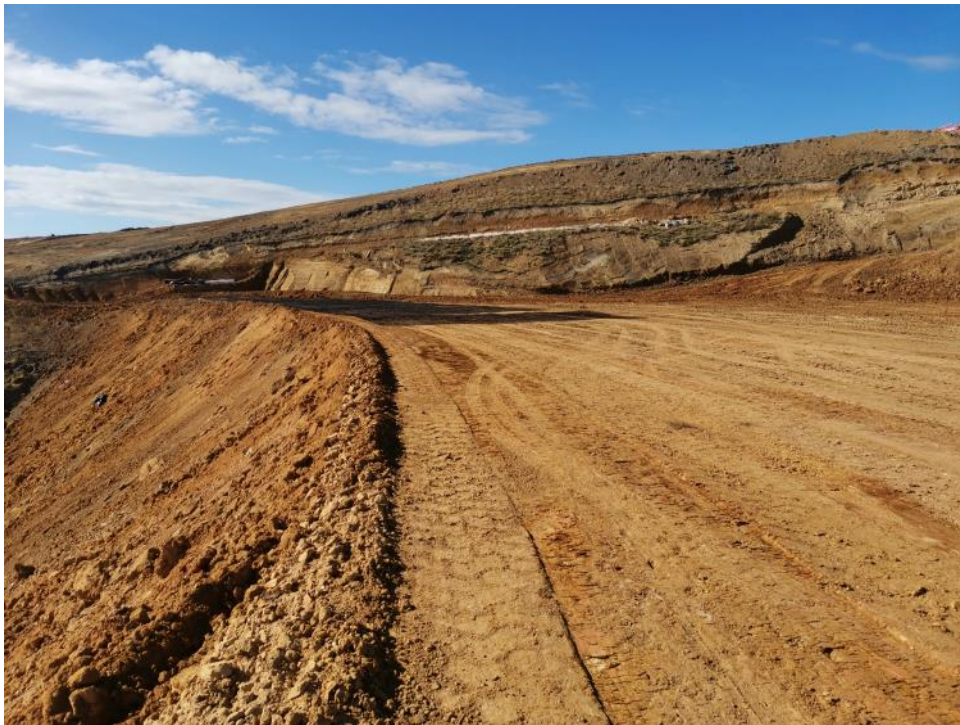
07/04/21 - REB1, REB2

- REB 1 face is currently being trimmed. The contractors are working along a bench at approx. mid slope height and trimming back to design level. No grid was observed on the face of the excavation. Requested that up to date as-builts be supplied to us to ensure that design requirements are being met
- REB 2 has been filled to near full height and a layer of secondary grid was exposed at the time of inspection.

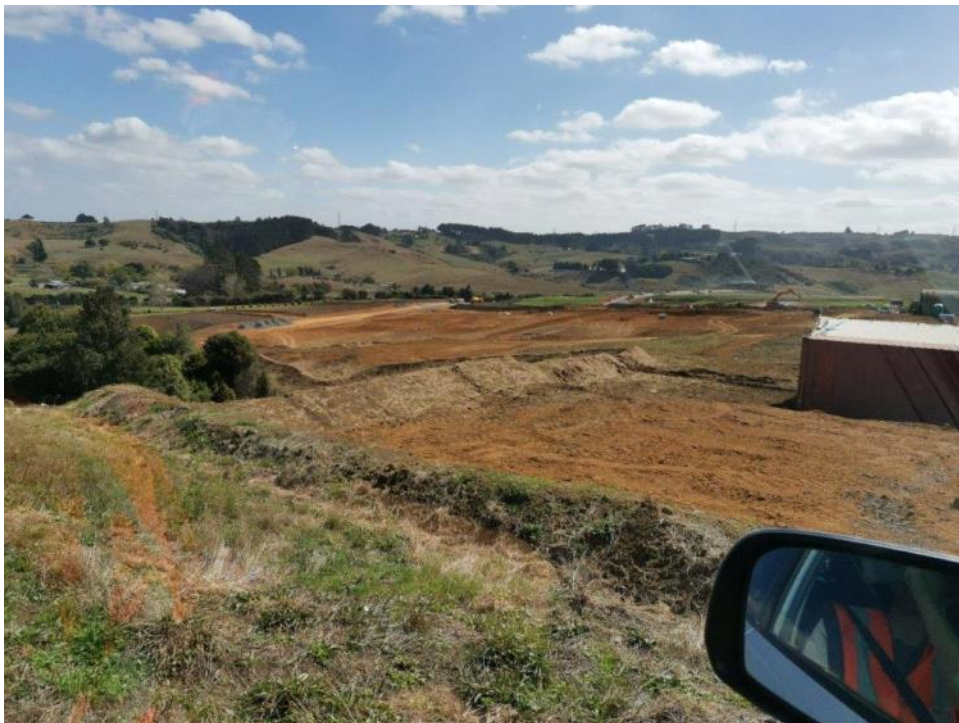
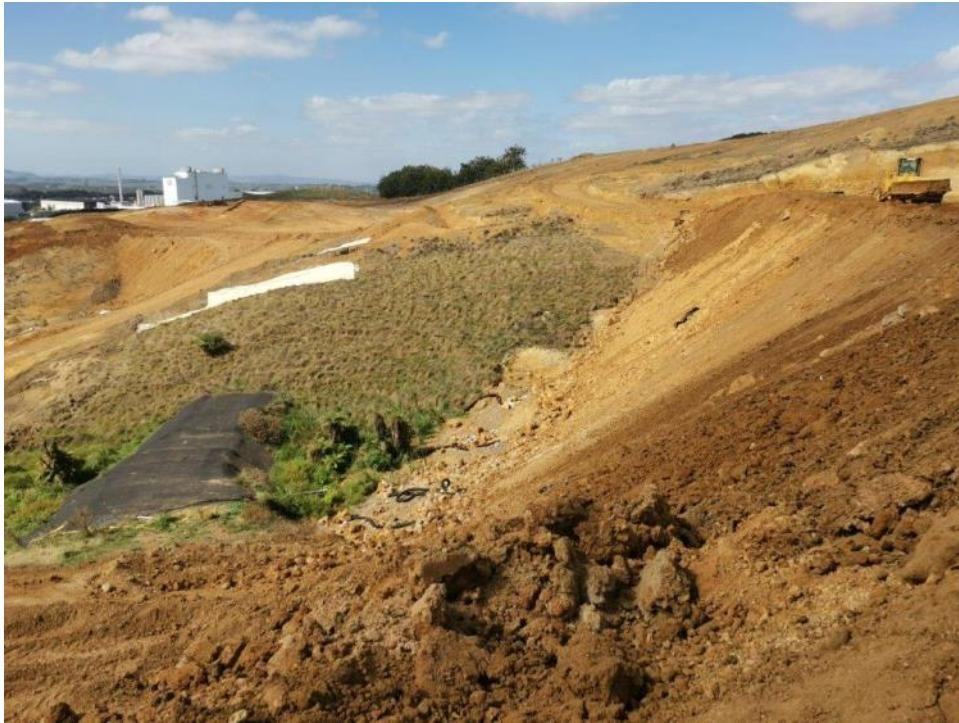
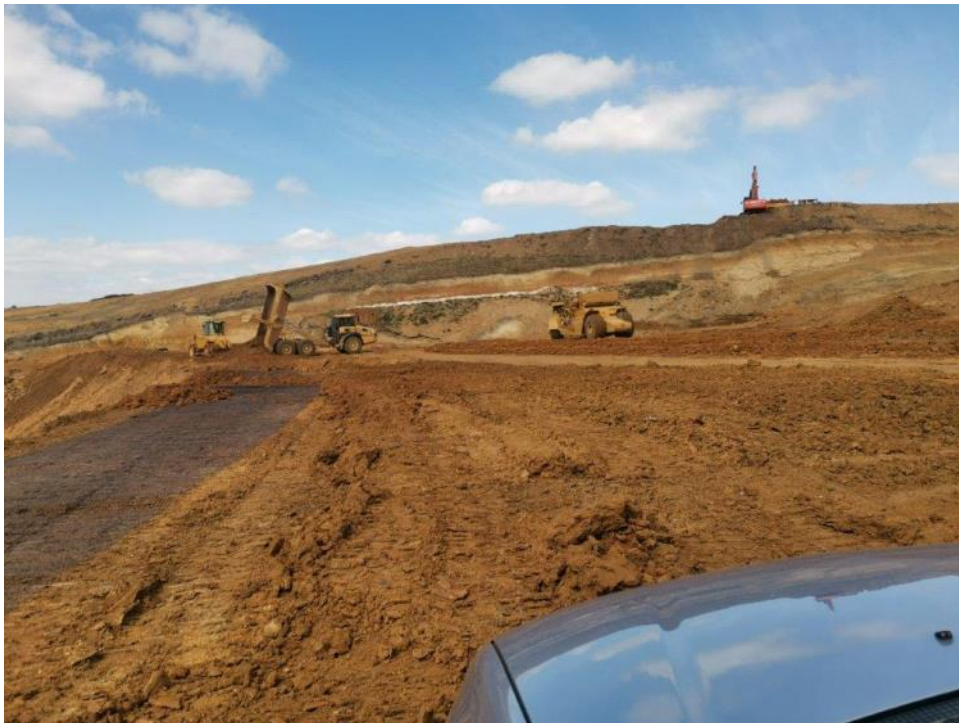
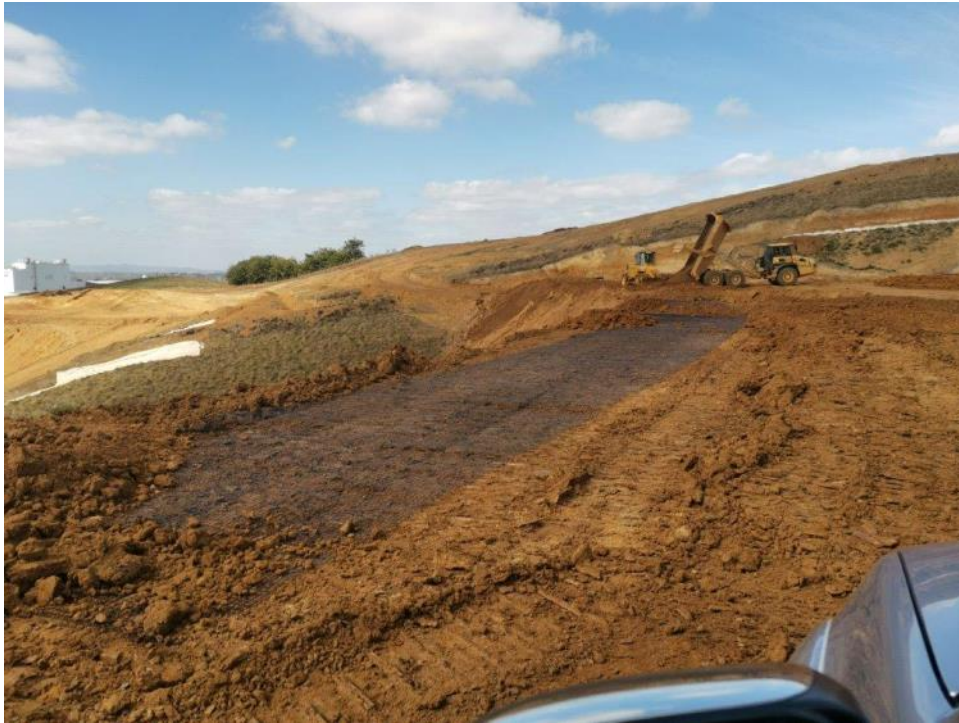
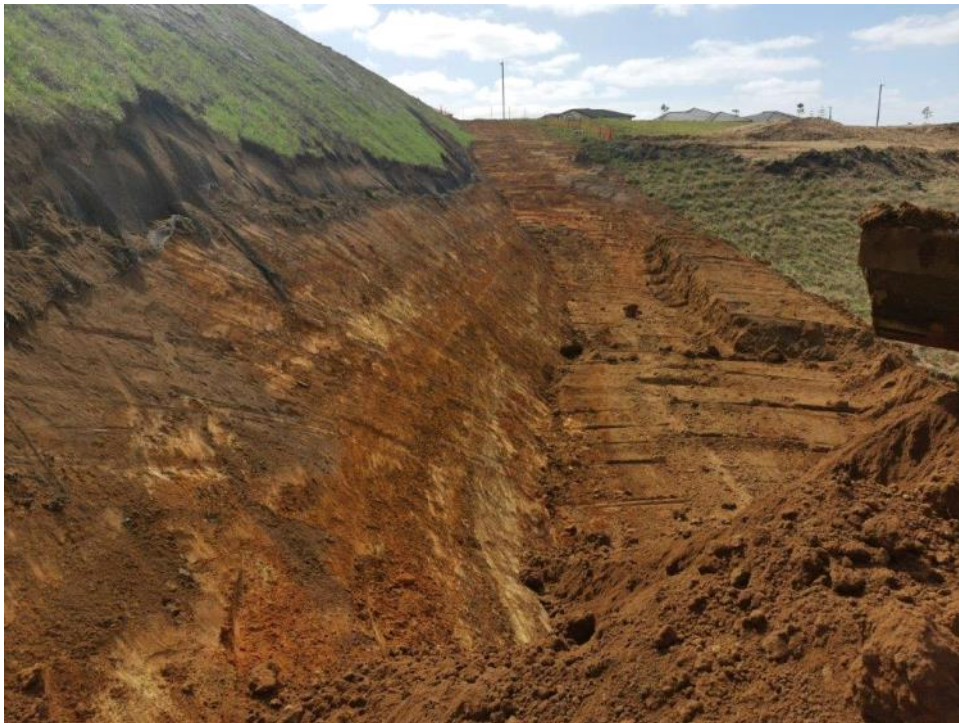
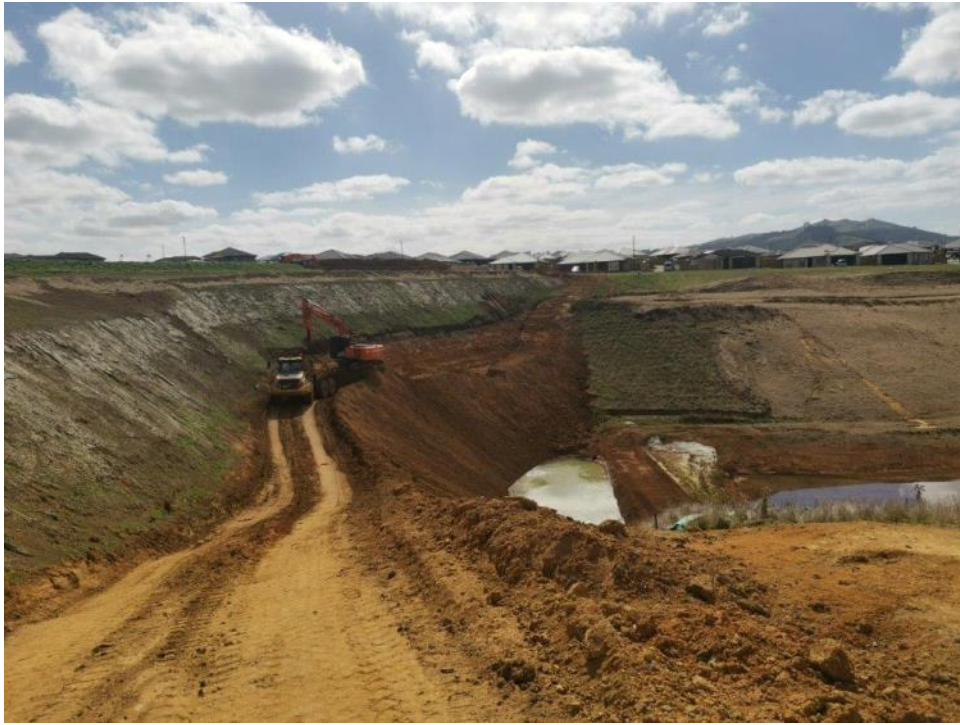
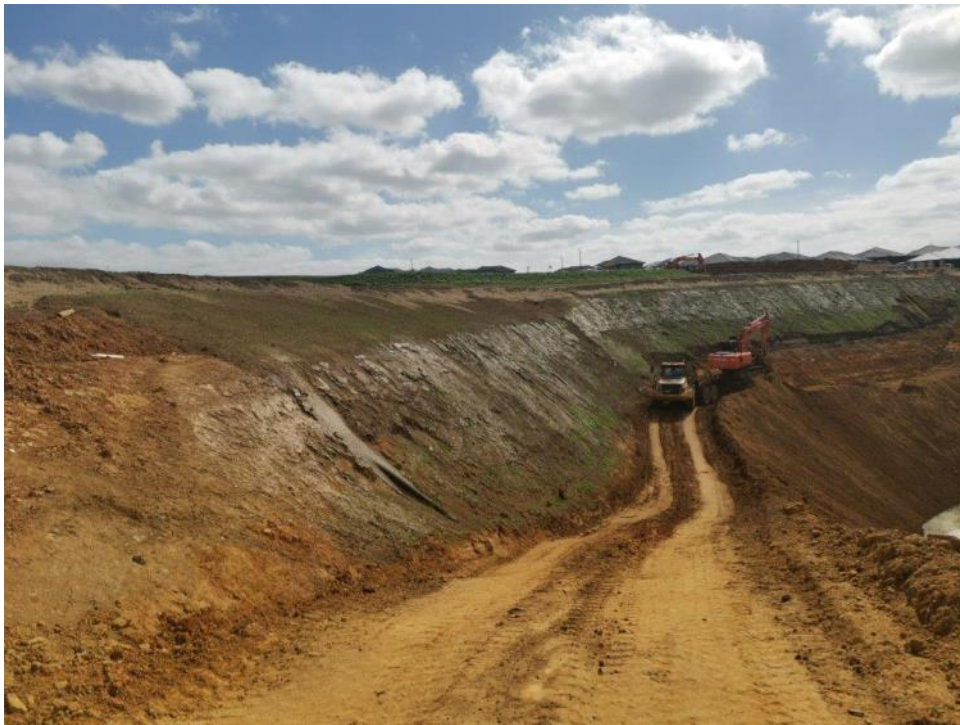
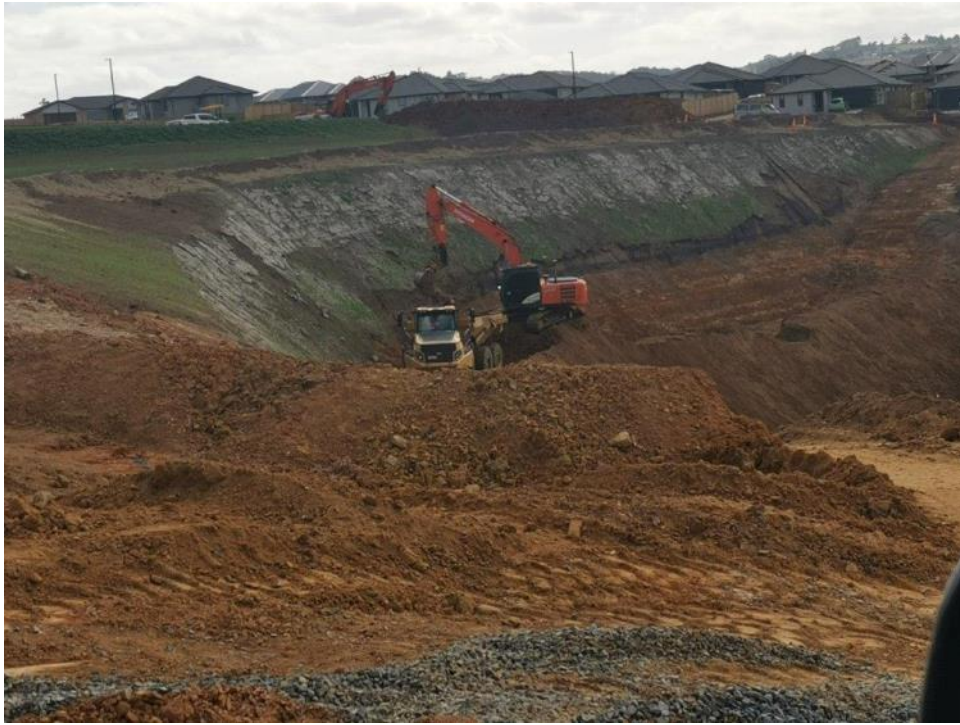
16/04/21 - Stage 12D

Telecom with Trevor, discussed that underfill drain was not visible. He is going to install a solid pipe to avoid blockage of the drain through the topsoil at the toe of the 1(v) in 3(h) batter, and then form the permanent outlet structure at the end of the solid pipe. Advised to return on Monday to sight this.

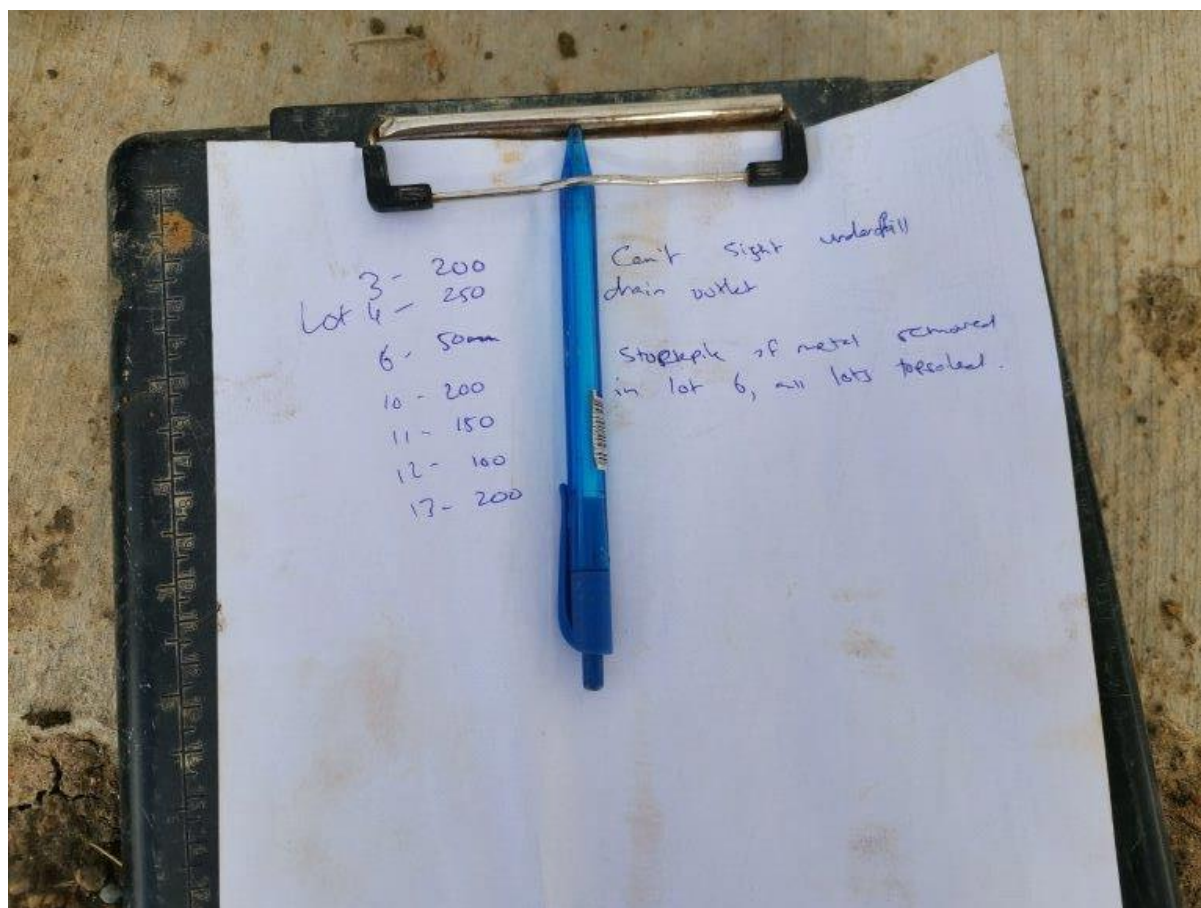
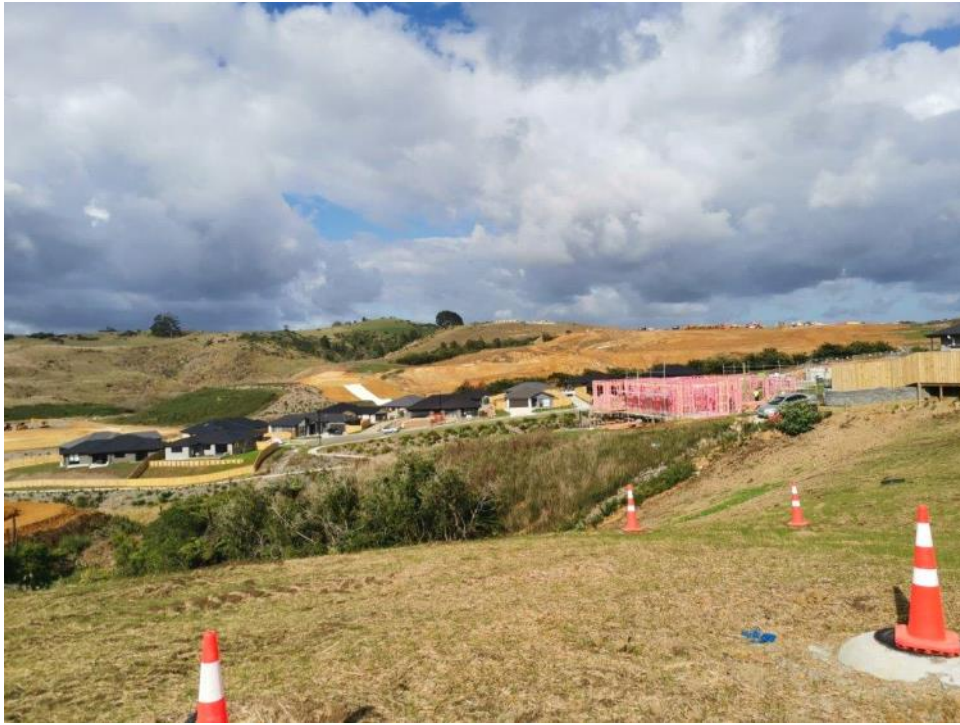
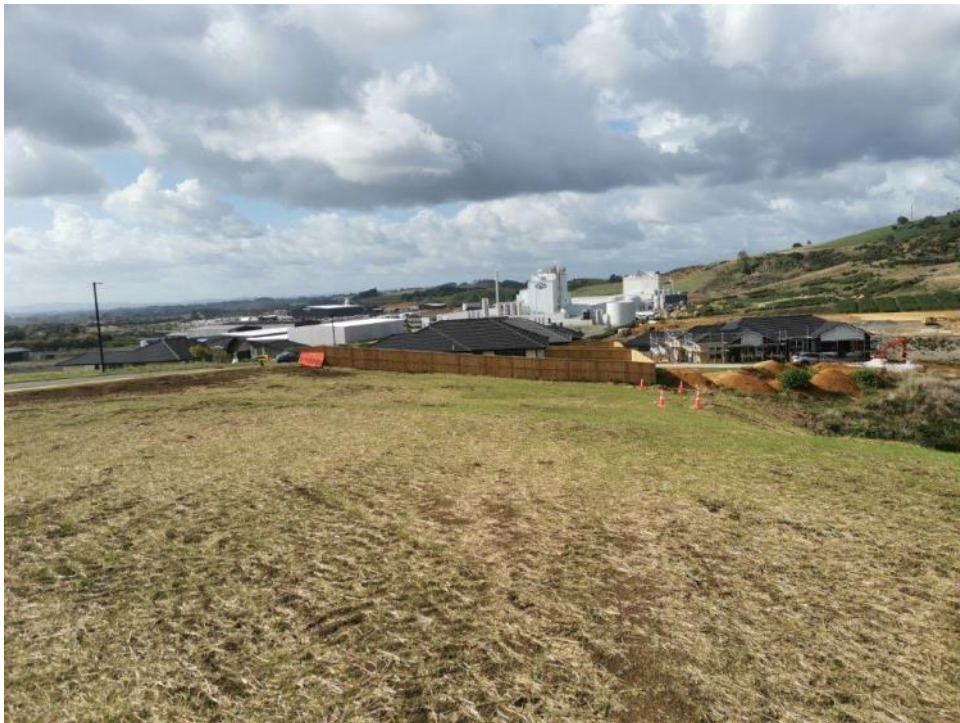
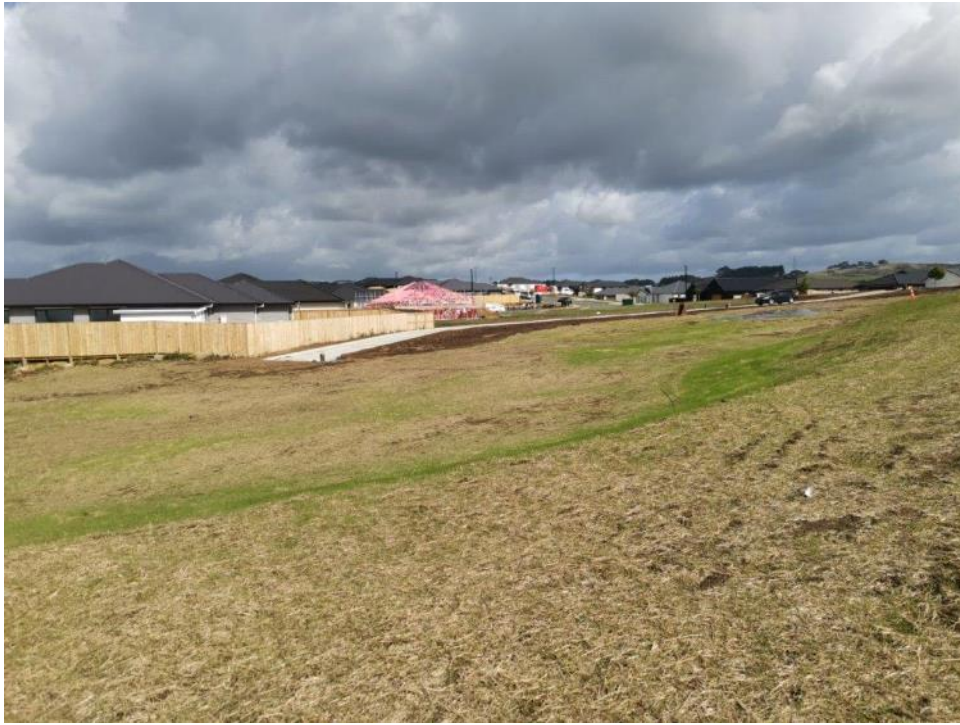
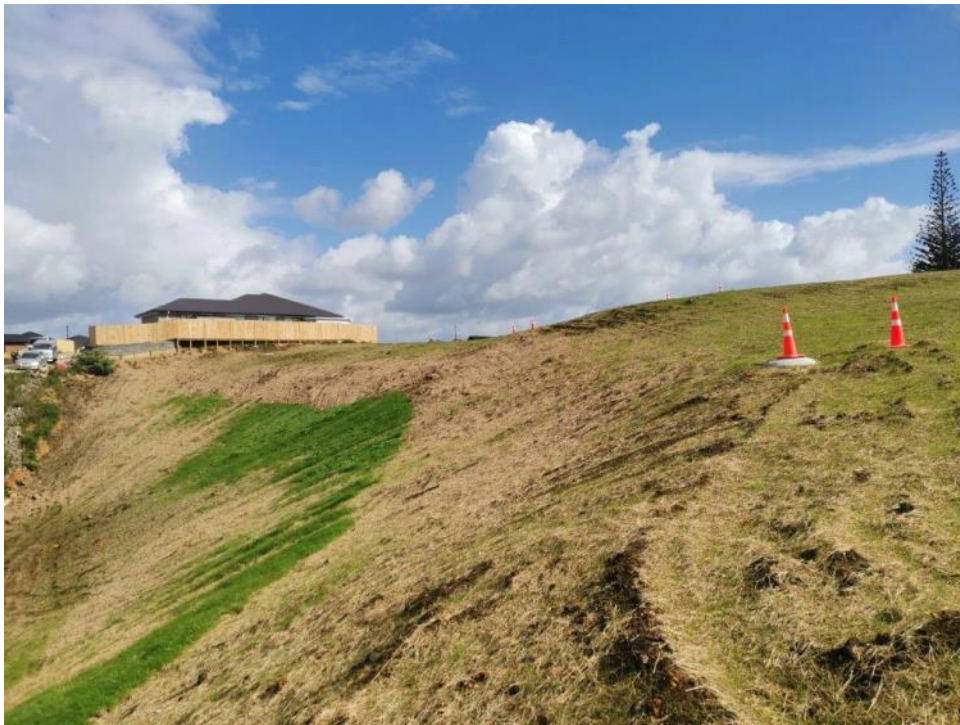
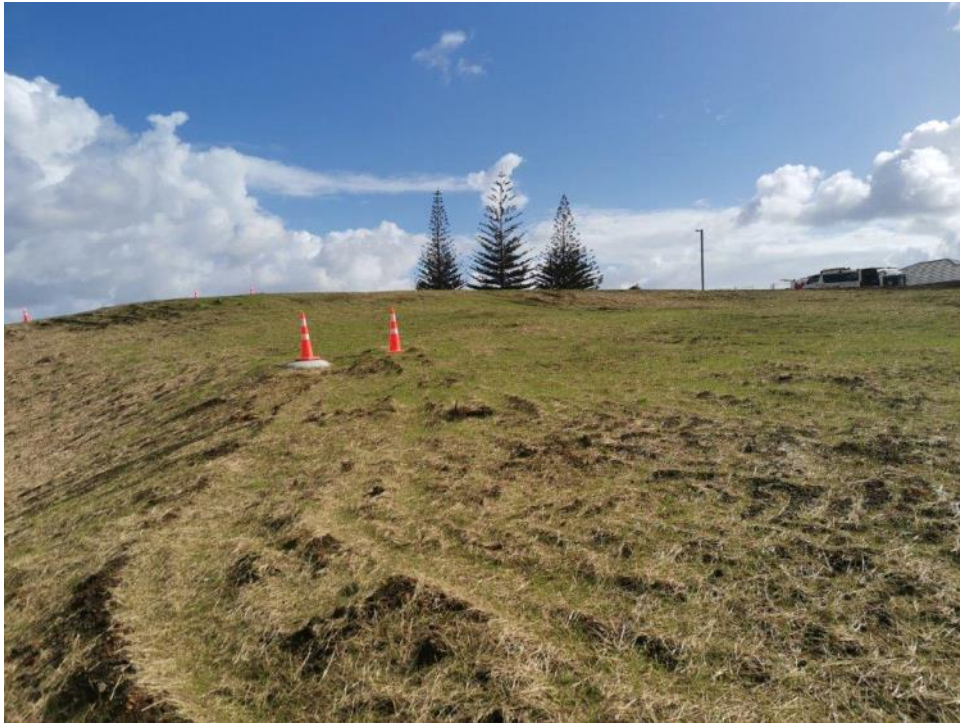
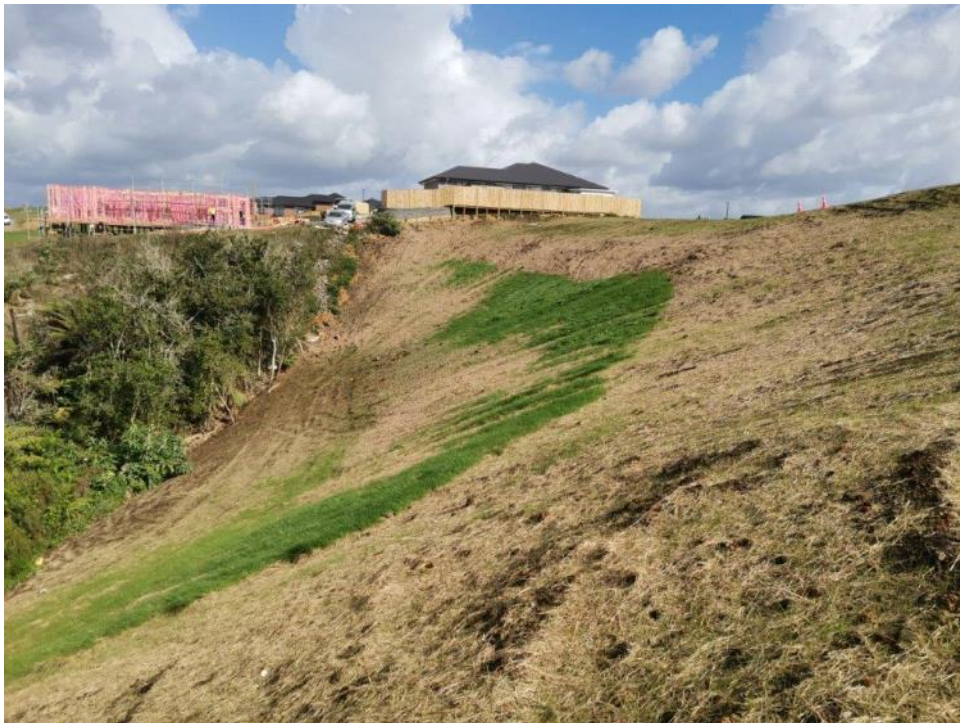
20/04/21 - Stage 12D, REB2, Fill M

- Sighted underfill and permanent outlet structure in Stage 12D.
- Filling progressing in REB2, with fill placement near final subgrade level. Several more layers of fill to be placed near the crest to meet design heights.
- Underfill drain in Fill M is to outlet into the permanent stormwater pond. Advised that this should be protected with a rock channel or similar to prevent scour along the side of the pond.

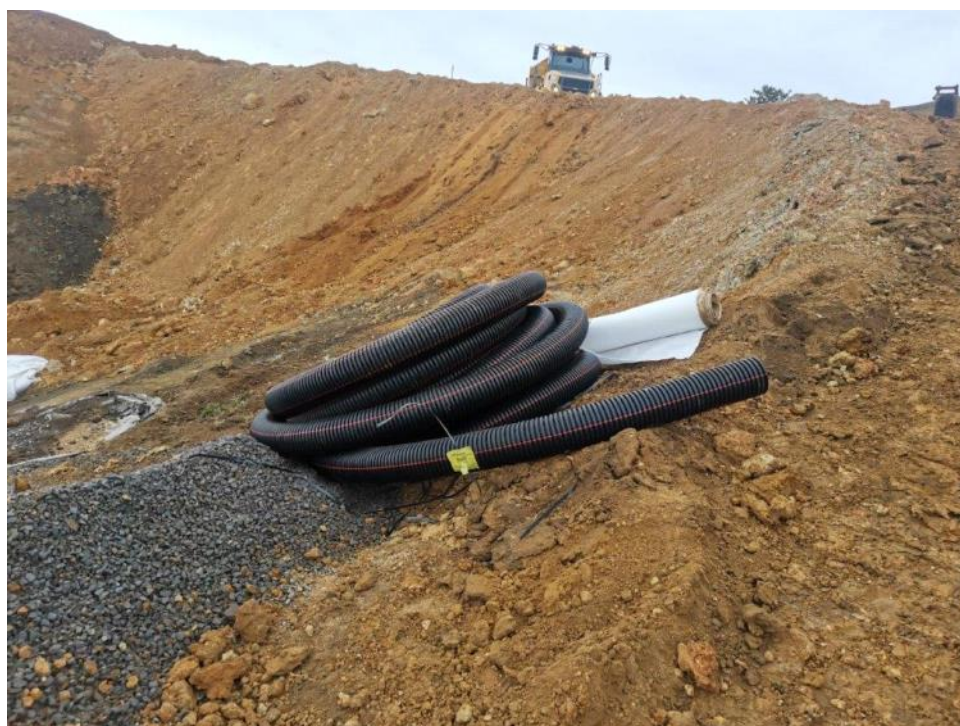
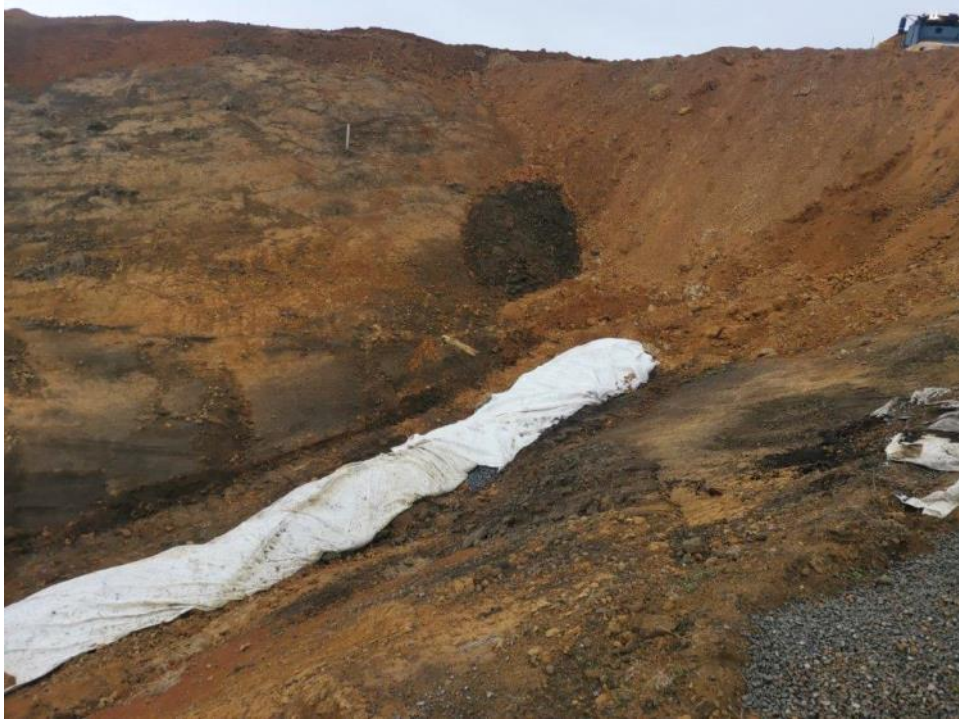
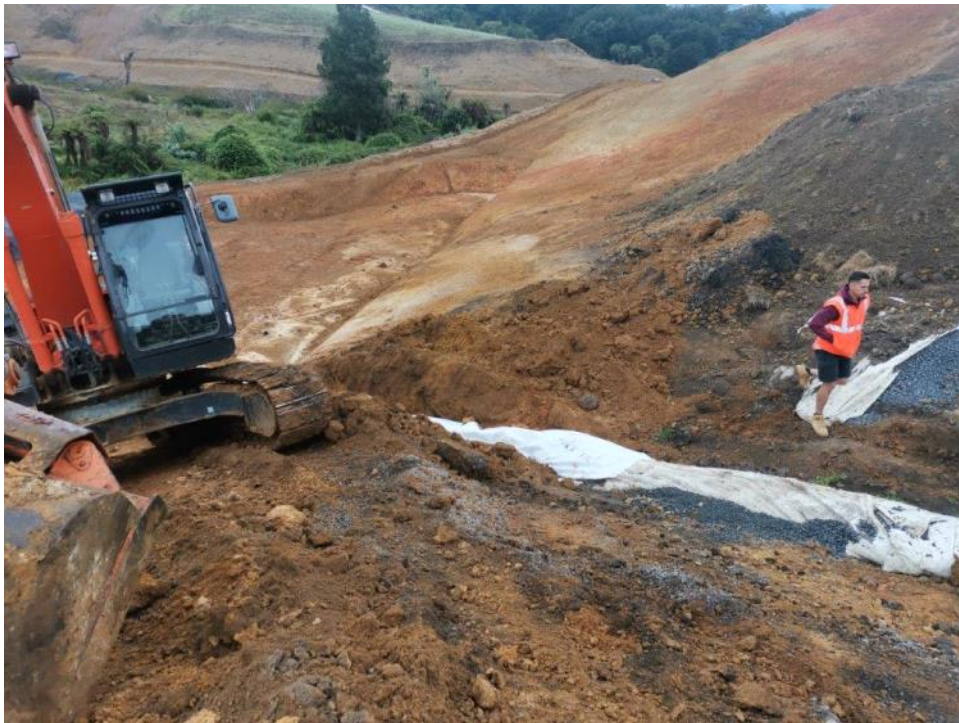
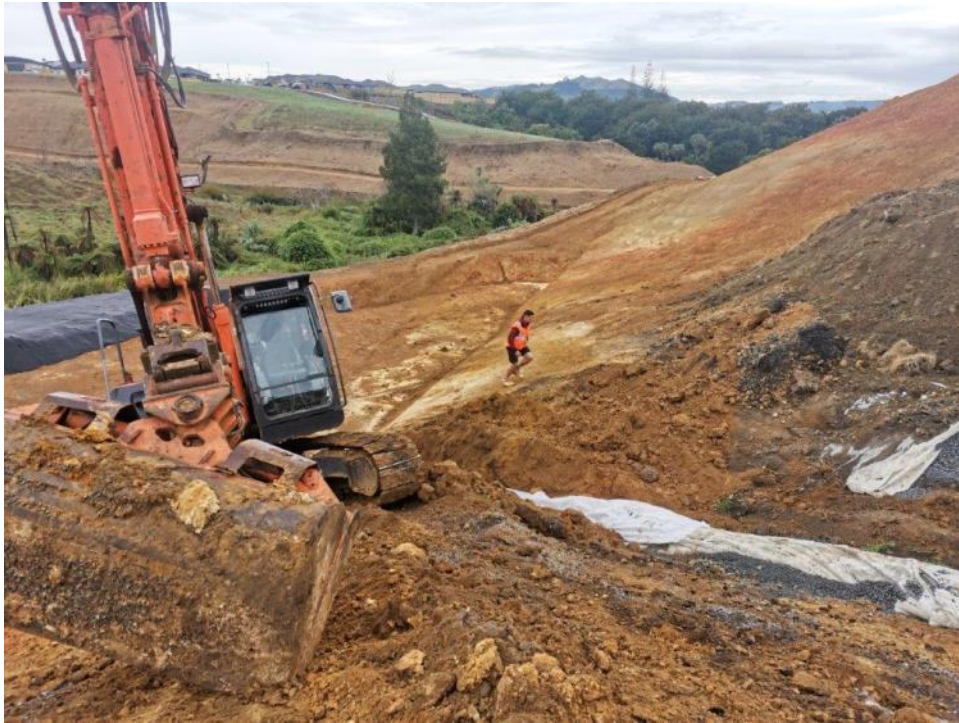
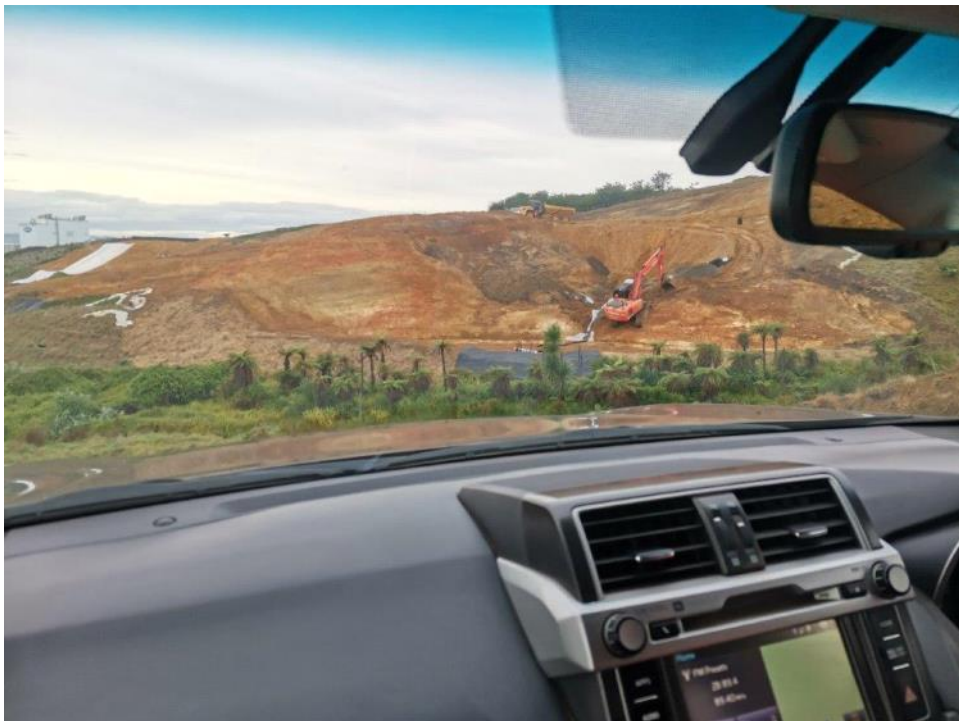
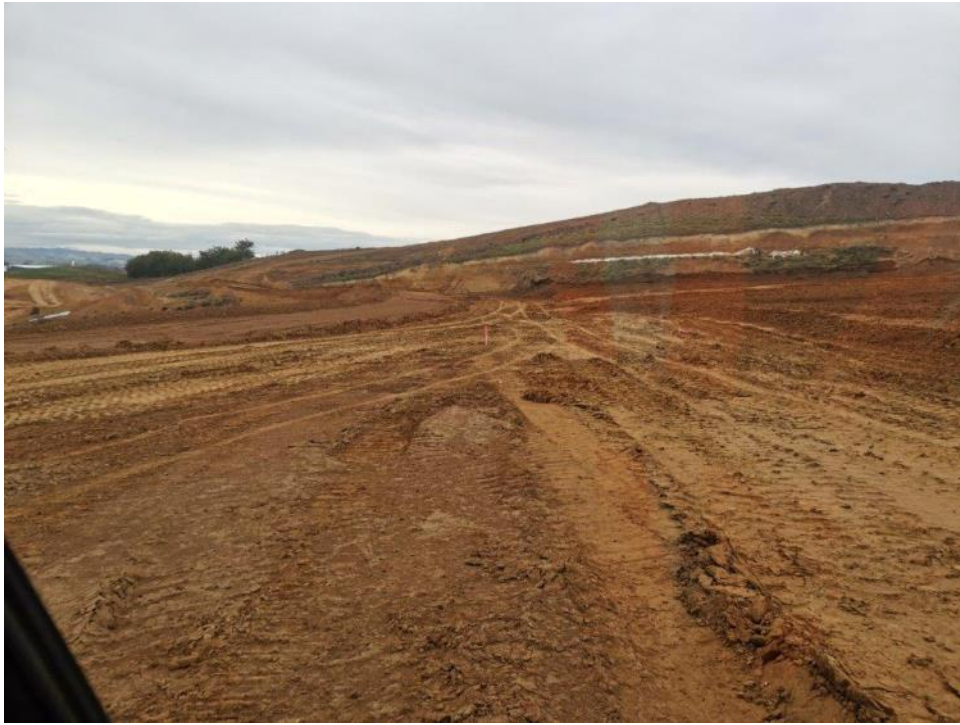
30/04/21

- Received a phone call from Mitchell Rutter (surveyor) this morning advising that the second to last layer of primary grid has been placed using SS20 secondary grid instead. Advised that this should be removed and the appropriate primary grid be placed. He said they would undercut the clay fill over this layer and install the correct grid.
- Primary grid had already been placed and covered at the time of arrival on site. Secondary grid was being trimmed and excavation was at least 2m wide as per the design.
