Geotechnical Completion Report

HITCHEN BLOCK STAGE 13B

17 January 2022

Ref No: J00113

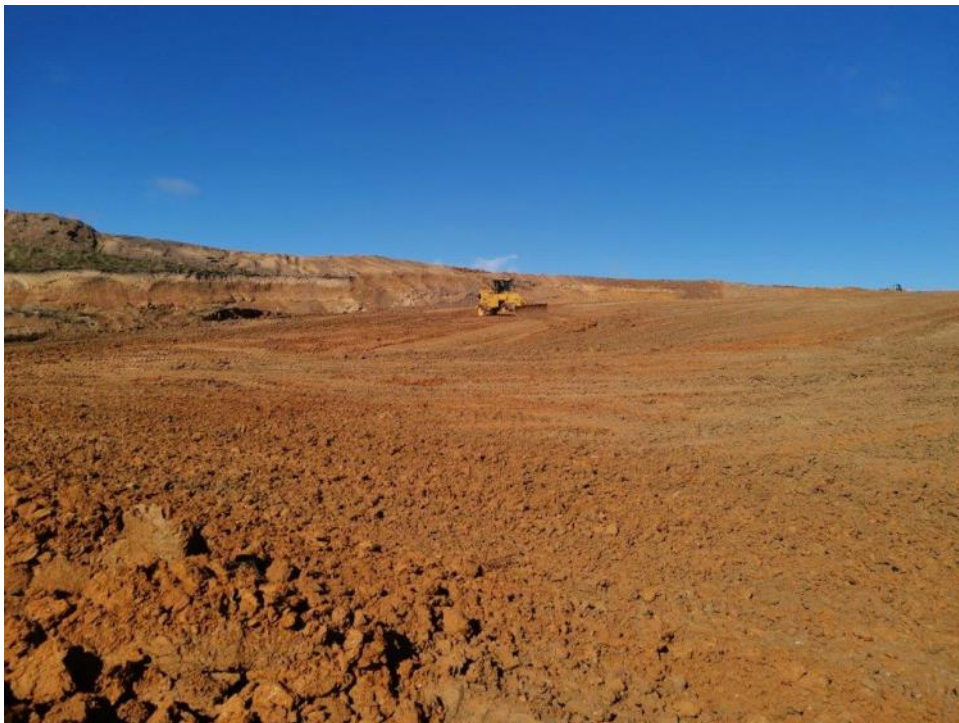
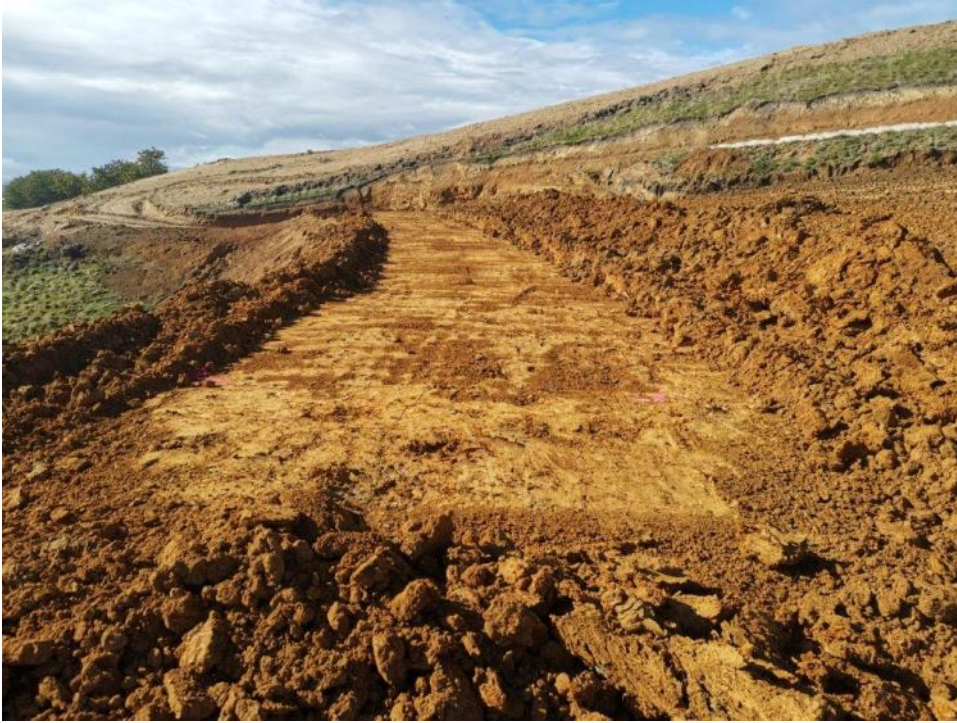
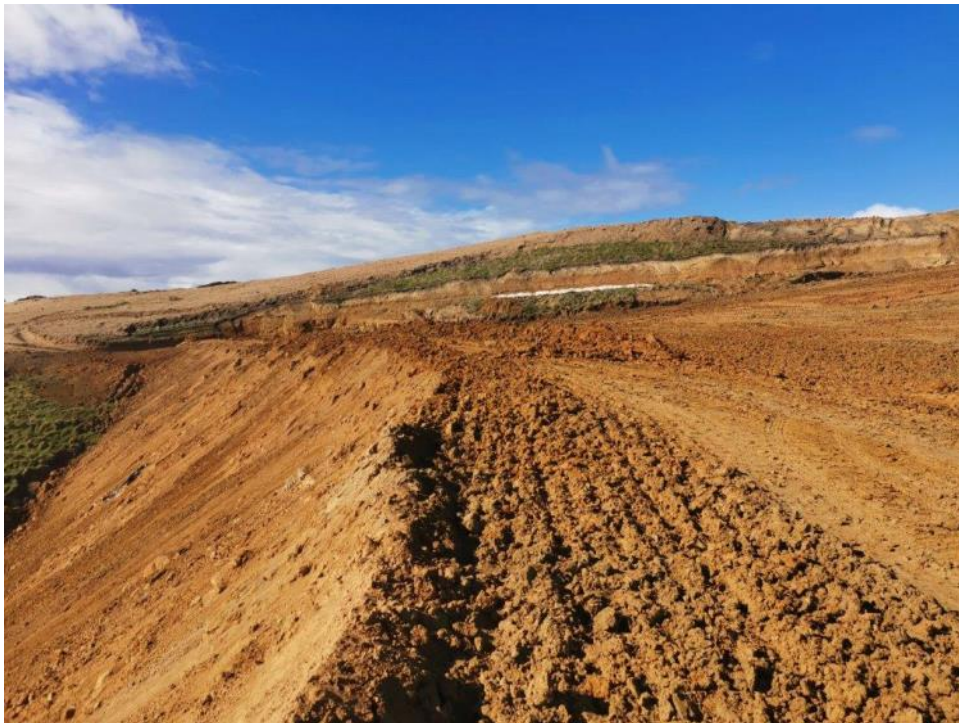
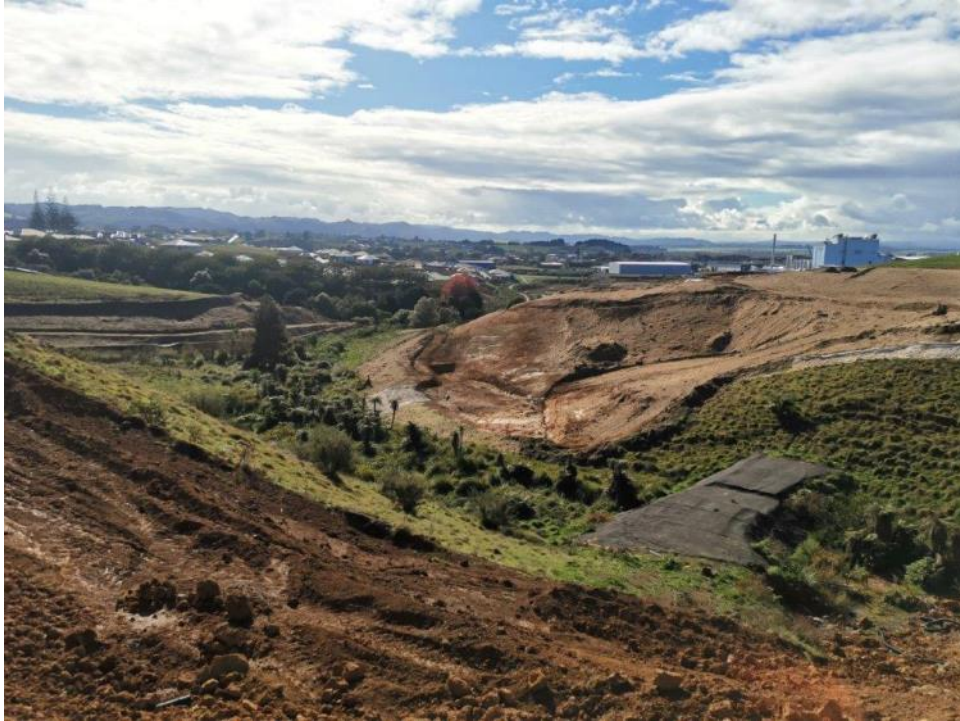
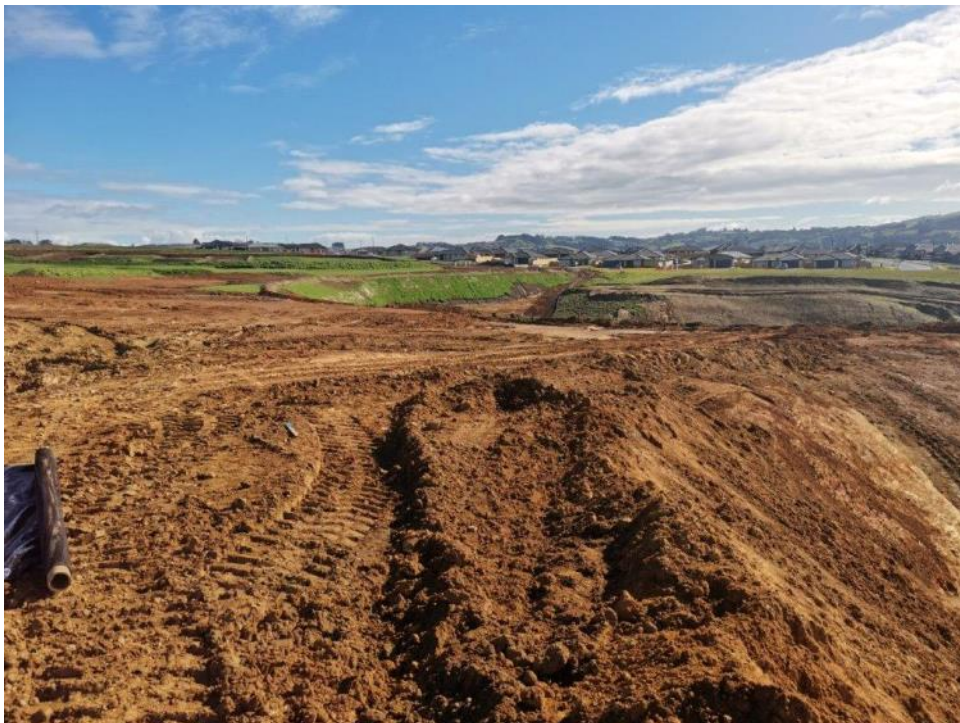
28/05/21 - REB1 & 2, Stage 13

- Stage 13 nearly complete. Observed permanent underfill drain outlet beneath the permanent stormwater pond.
